Little Crow

Little Crow Solar Park, Scunthorpe

PHASE 1 GROUND CONDITIONS DESK STUDY

Intégrale Report No. 1844, Version 9, November 2020, Submission

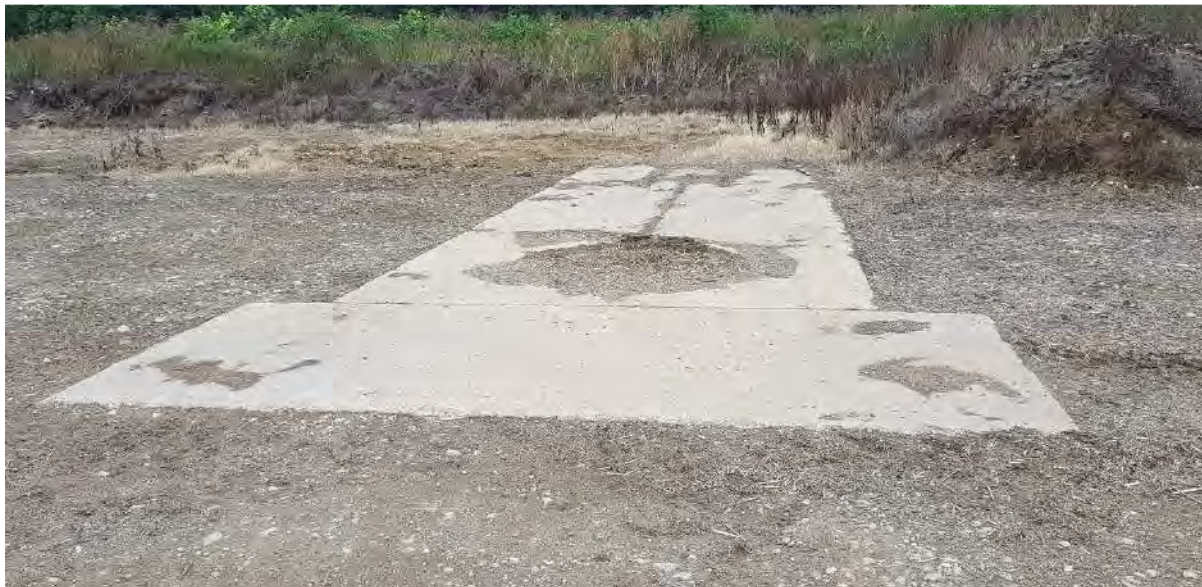
Concrete slab assumed capping decommissioned well

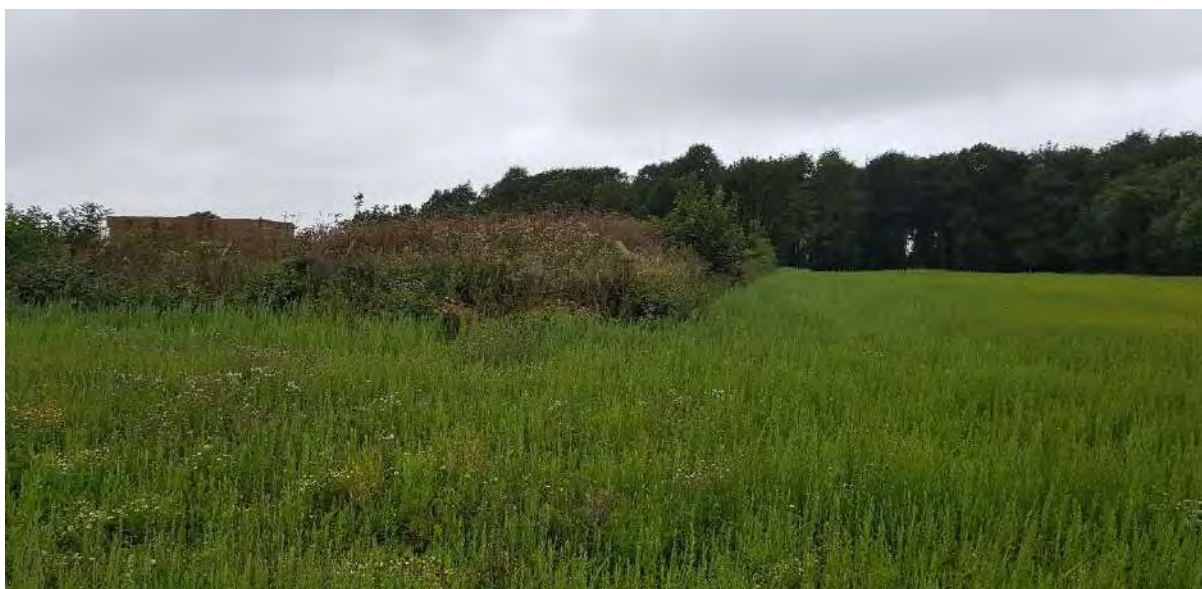
Vegetated bund surround
