Little Crow Solar Park, Scunthorpe

GEOTECHNICAL AND PHASE II CONTAMINATION REPORT

Geotechnical and Phase II Contamination Report
Proposed Solar Energy Scheme
Little Crow Solar Park
Scunthorpe
Lincolnshire
DN20 0BG

Intégrale Report No. 1997/02, Version 5, November 2020, Submission

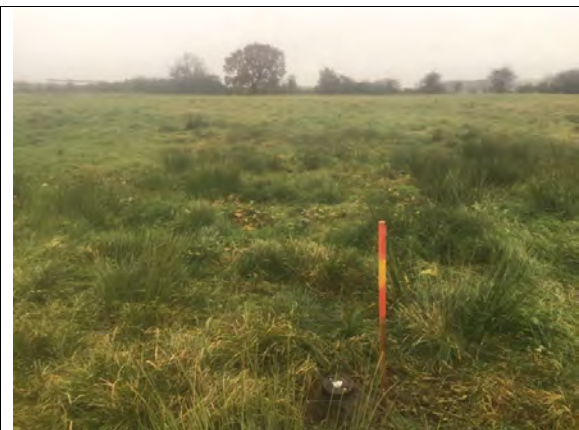
Plate 12 – Hydrophilic vegetation in depression in SW of the site (WS7 pictured in foreground).

Trial Pit 21 was an anomaly and was located within a 'bean' shaped depression in the lower southwestern area, suspected as a past area of ironstone working. This pit found Made Ground to 2.3m depth, comprising an upper organic red brown silty sand, over a thick deposit of burnt shale and resinous, odorous slag, becoming ironstone gravel and ashy slag. This presumably represents filling from the adjacent iron/steel works. The area was further investigated with 4 boreholes: the same Made Ground was not proven in the boreholes, although the (presumed in-situ) Blown Sand was a more reddish brown in this area. The boreholes were located at the periphery, but still within the depression (WS8 & WS9), at the deepest point of the depression (WS7) and just beyond the depression (WS6). There is no strong evidence of substantial backfilling of the depression / ironstone working, but the ground gas in this area is somewhat abnormal, with carbon dioxide of 2.5-8% and markedly reduced oxygen at 0.4-10%.
