PROJECT : Preliminary Onshore Ground Investigation for NZT

CONSOLIDATED UNDRAINED TRIAXIAL WITH MEASUREMENT OF PORE WATER PRESSURE

## Determination of Point Load Index

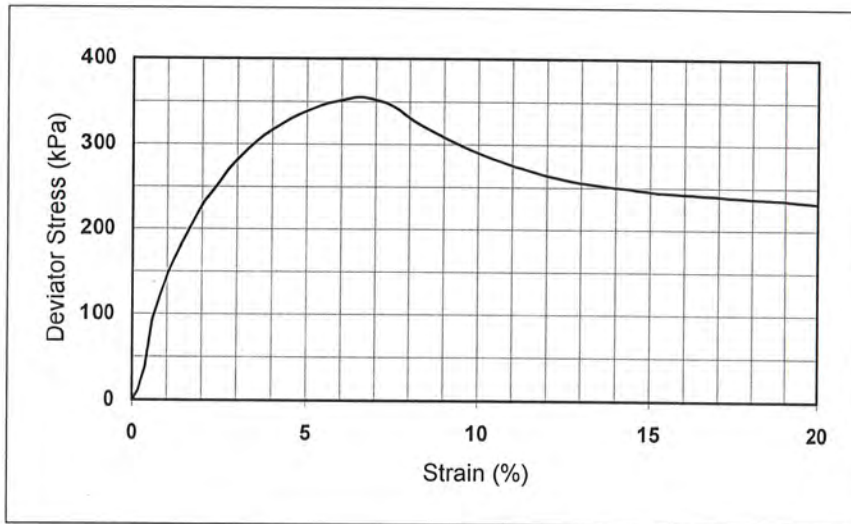
**At maximum stress ratio**

<i>strain</i>	3.54 %
<i>deviator stress</i>	302.9 kPa
<i>stress ratio</i>	3.18

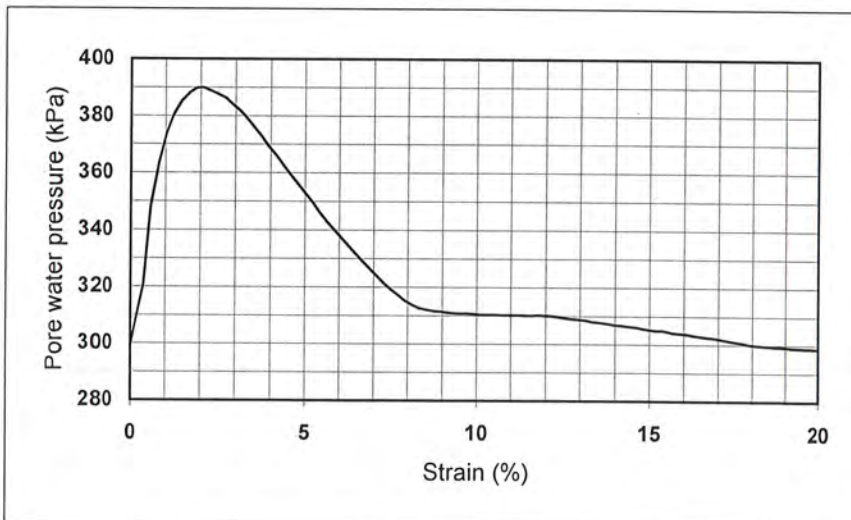
**At maximum deviator stress**

<i>strain</i>	6.44 %
<i>deviator stress</i>	355.3 kPa
<i>stress ratio</i>	2.94

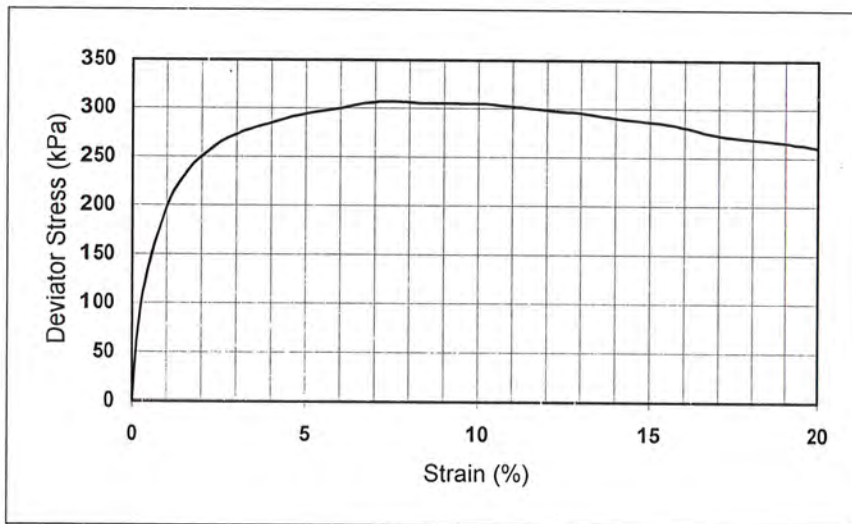
**At maximum stress ratio**

<i>strain</i>	3.18 %
<i>deviator stress</i>	276.2 kPa
<i>stress ratio</i>	2.84

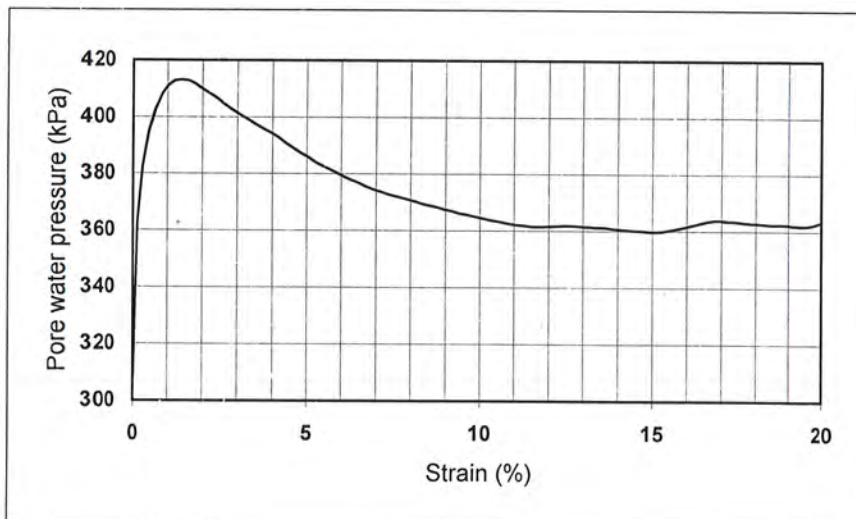
**At maximum deviator stress**

<i>strain</i>	7.13 %
<i>deviator stress</i>	306.9 kPa
<i>stress ratio</i>	2.74

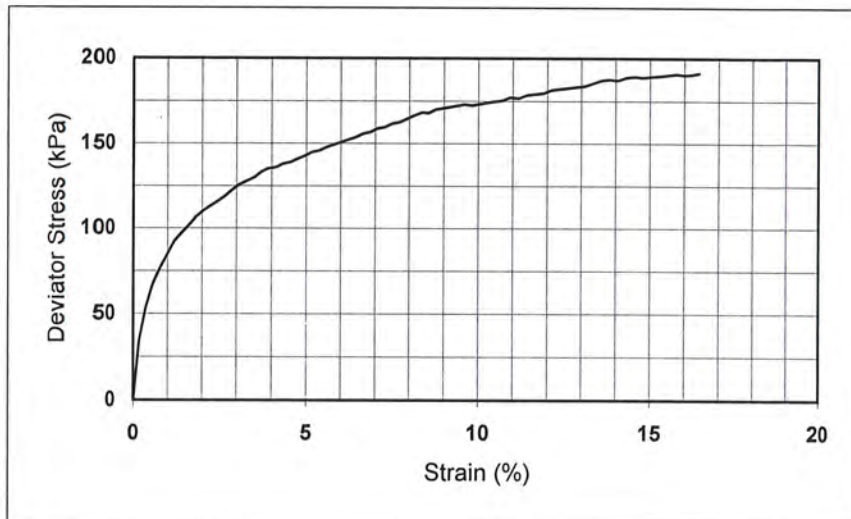
**At maximum stress ratio**

<i>strain</i>	9.61	%
<i>deviator stress</i>	172.9	kPa
<i>stress ratio</i>	2.71

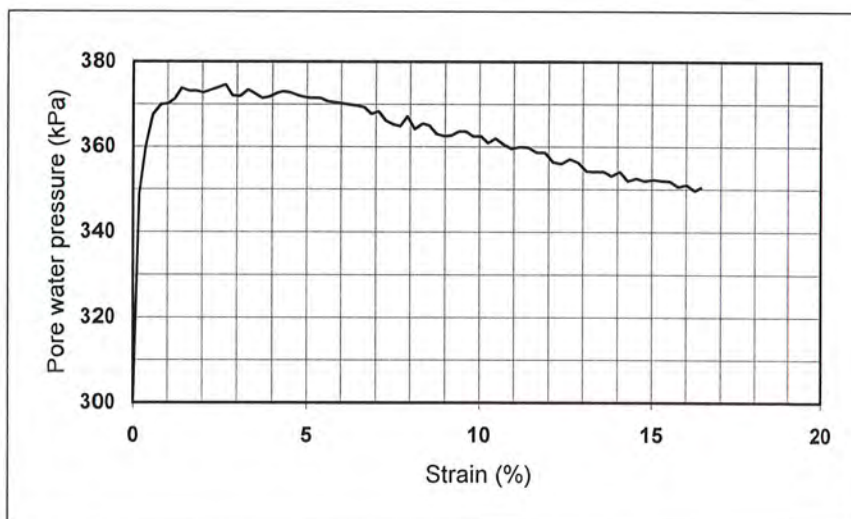
**At maximum deviator stress**

<i>strain</i>	16.43	%
<i>deviator stress</i>	191.5	kPa
<i>stress ratio</i>	2.67

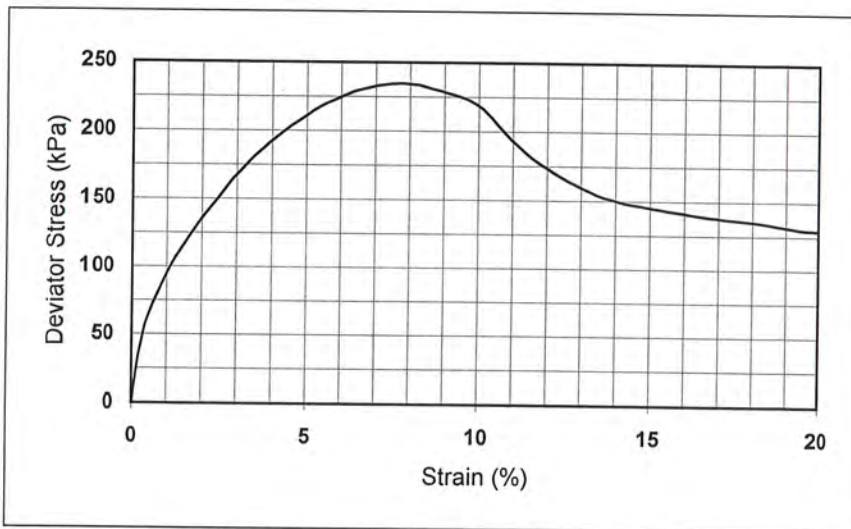
At maximum stress ratio

strain	5.78 %
deviator stress	222.8 kPa
stress ratio	2.75

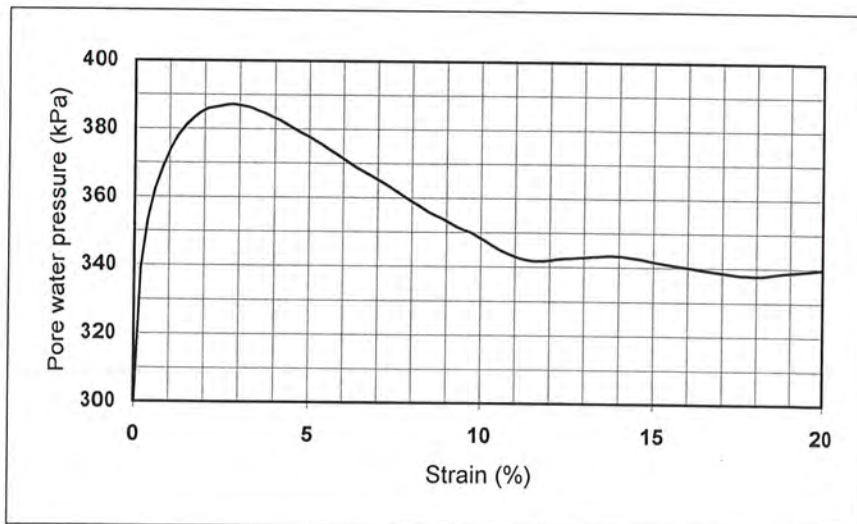
At maximum deviator stress

strain	7.65 %
deviator stress	234.6 kPa
stress ratio	2.69

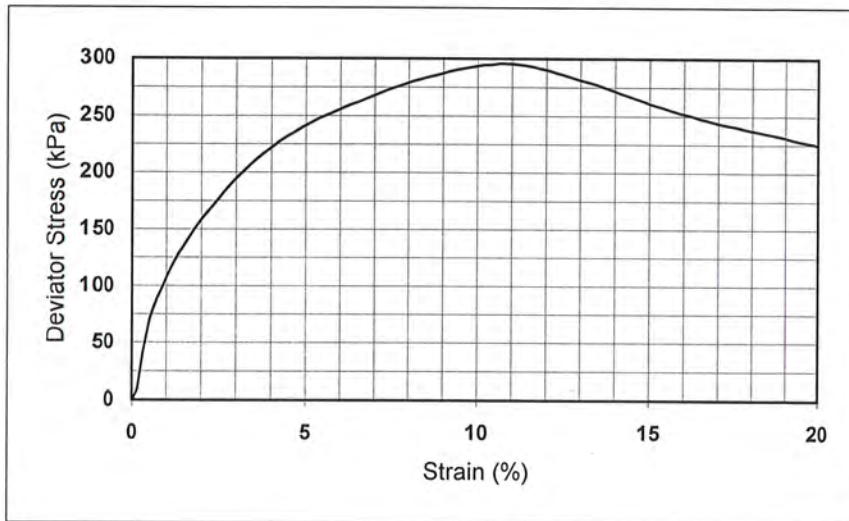
**At maximum stress ratio**

<i>strain</i>	4.66 %
<i>deviator stress</i>	235.5 kPa
<i>stress ratio</i>	3.17

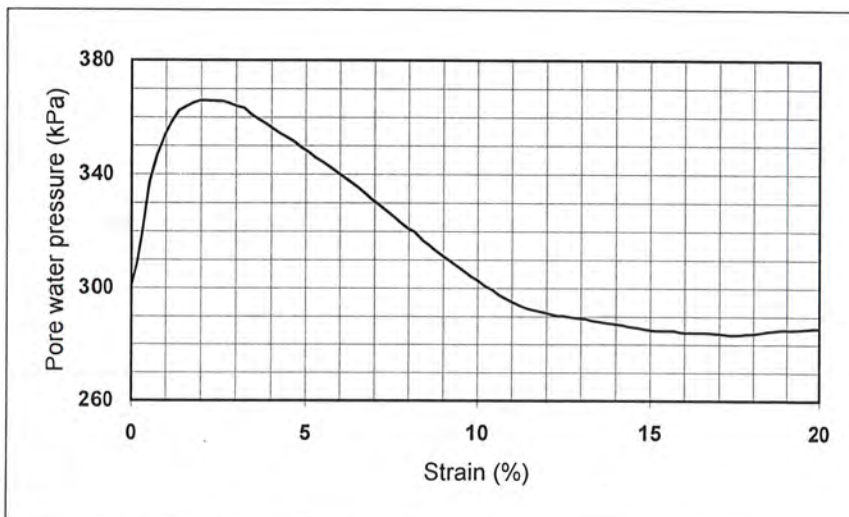
**At maximum deviator stress**

<i>strain</i>	10.63 %
<i>deviator stress</i>	295.7 kPa
<i>stress ratio</i>	2.82

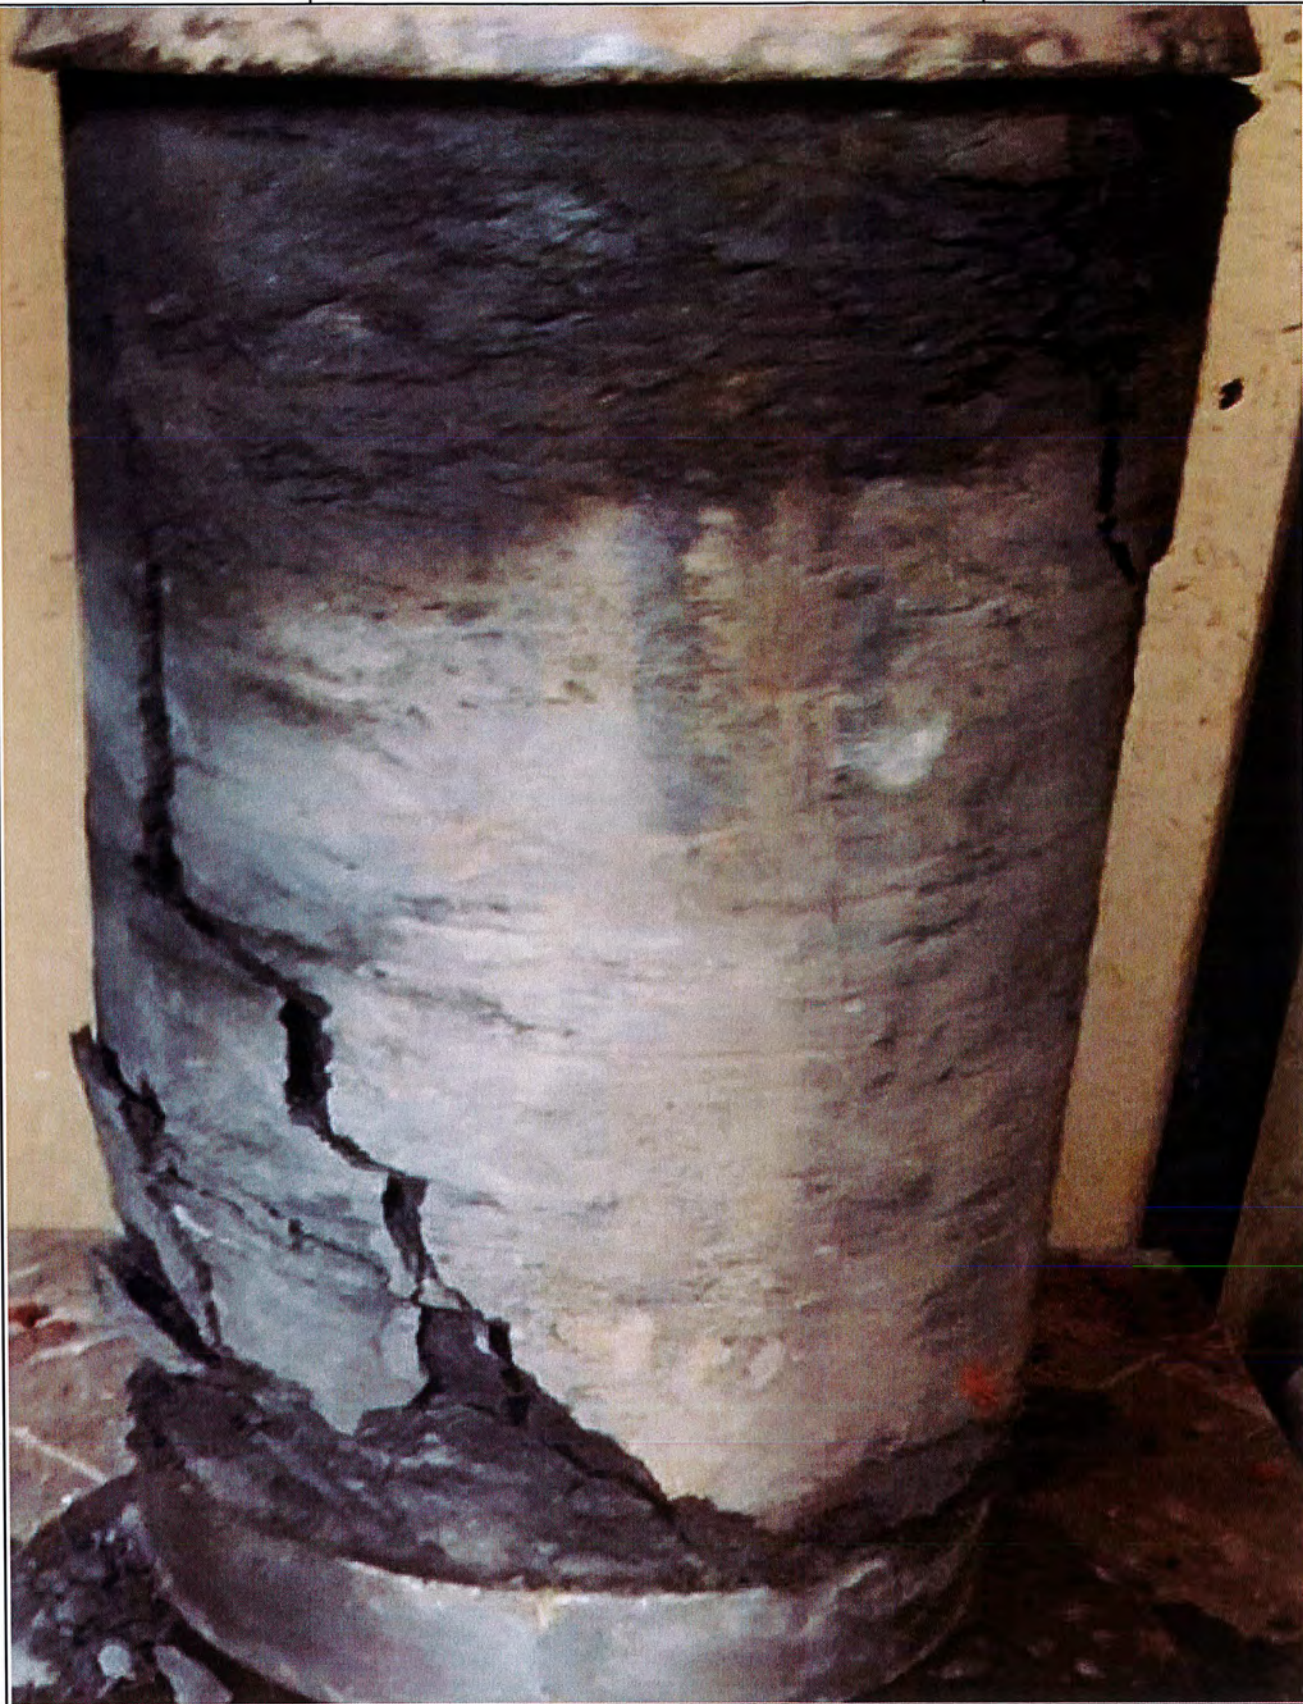
<b>TERRA TEK</b> <small>SITE INVESTIGATION AND LABORATORY SERVICES</small>	Site	PRELIMINARY ONSHORE GROUND INVESTIGATION FOR NZT	Contract No	<b>A14067</b>
	Client		Hole ID	LFVBH01
	Engineer		Sample Ref	
			Depth (m)	30.60
			Sample Type	C

Originator	Checked & Approved	<b>PHOTOGRAPHS OF SPECIMEN FAILURE</b>

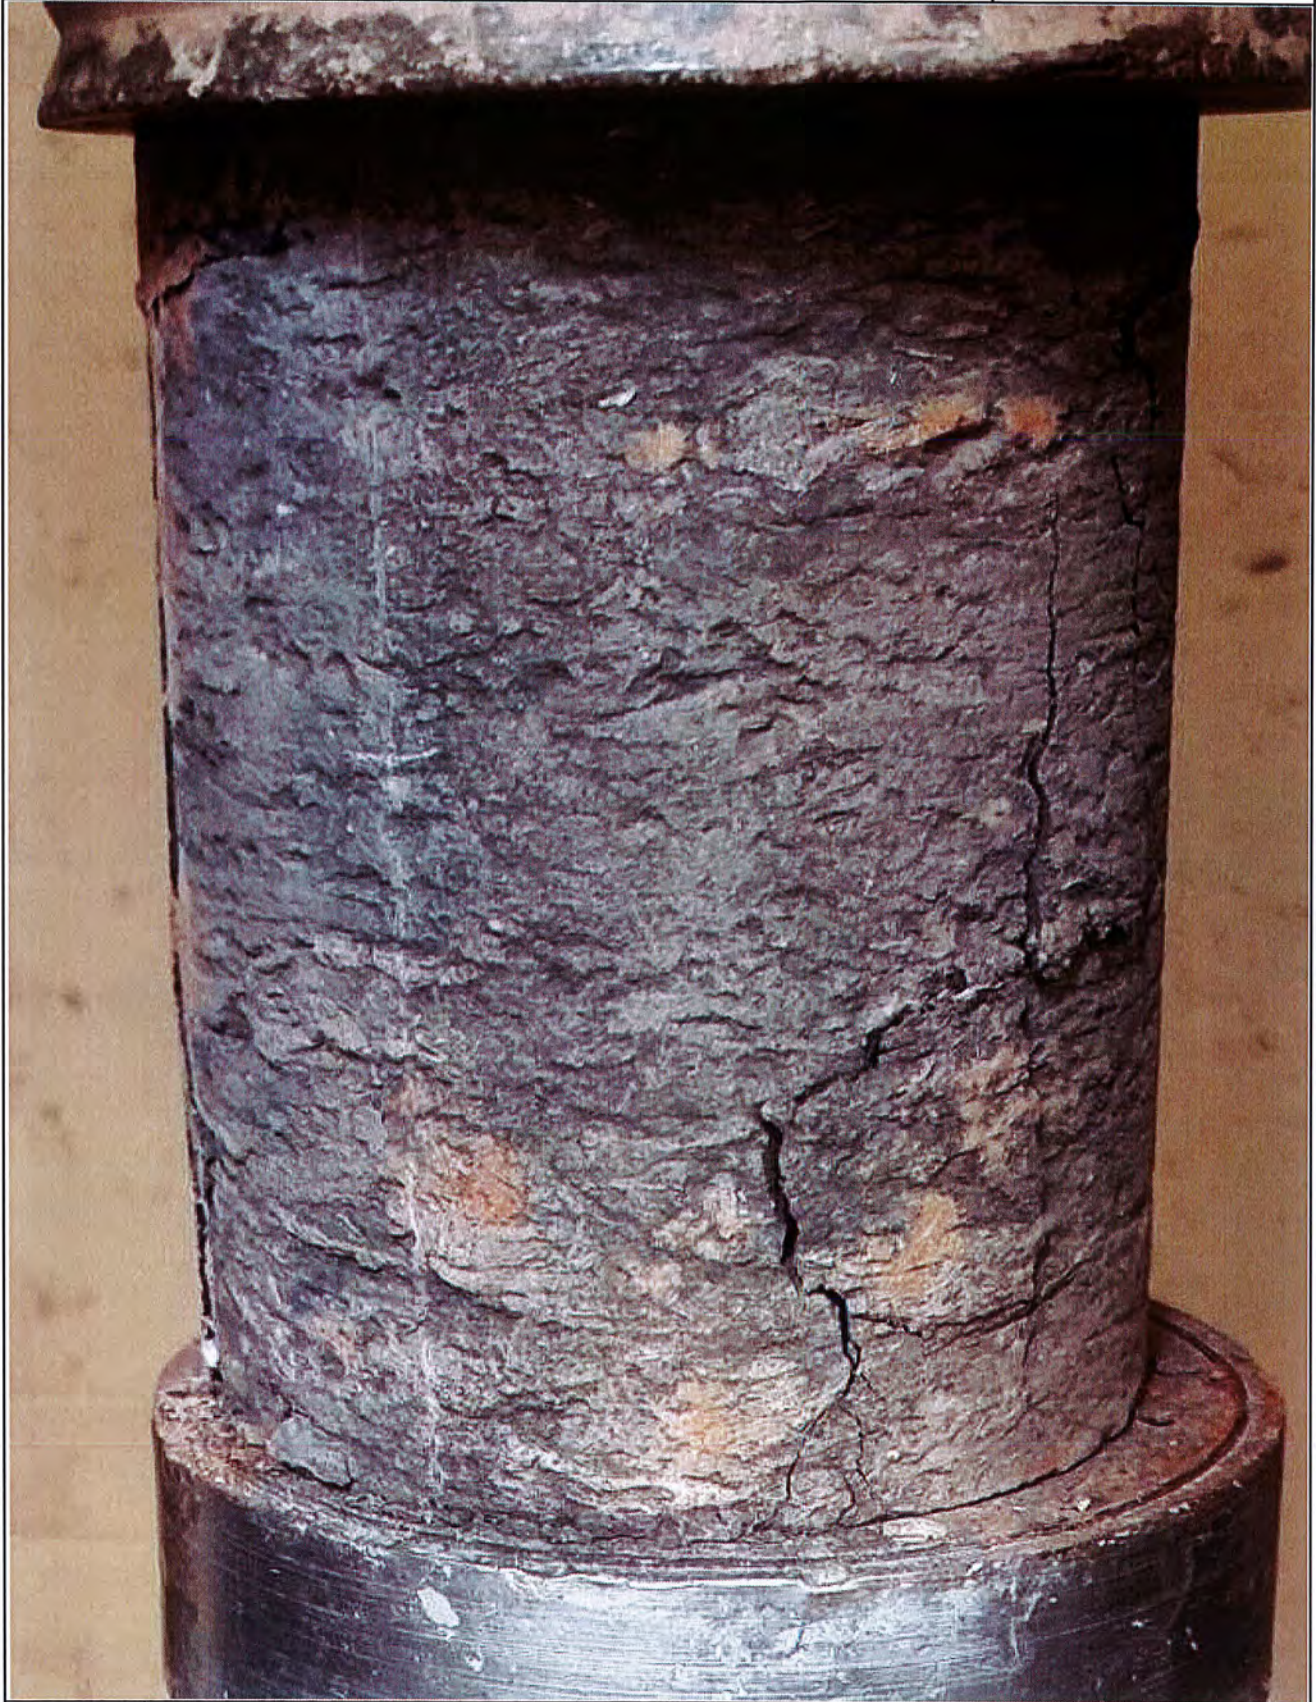
<b>TERRA TEK</b> <small>SITE INVESTIGATION AND LABORATORY SERVICES</small>	Site PRELIMINARY ONSHORE GROUND INVESTIGATION FOR NZT	Contract No <b>A14067</b>
	Client Engineer	Hole ID LF\BH01 Sample Ref Depth (m) 34.40 Sample Type C

Originator	Checked & Approved	<b>PHOTOGRAPHS OF SPECIMEN FAILURE</b>	
SE	 28/09/2021

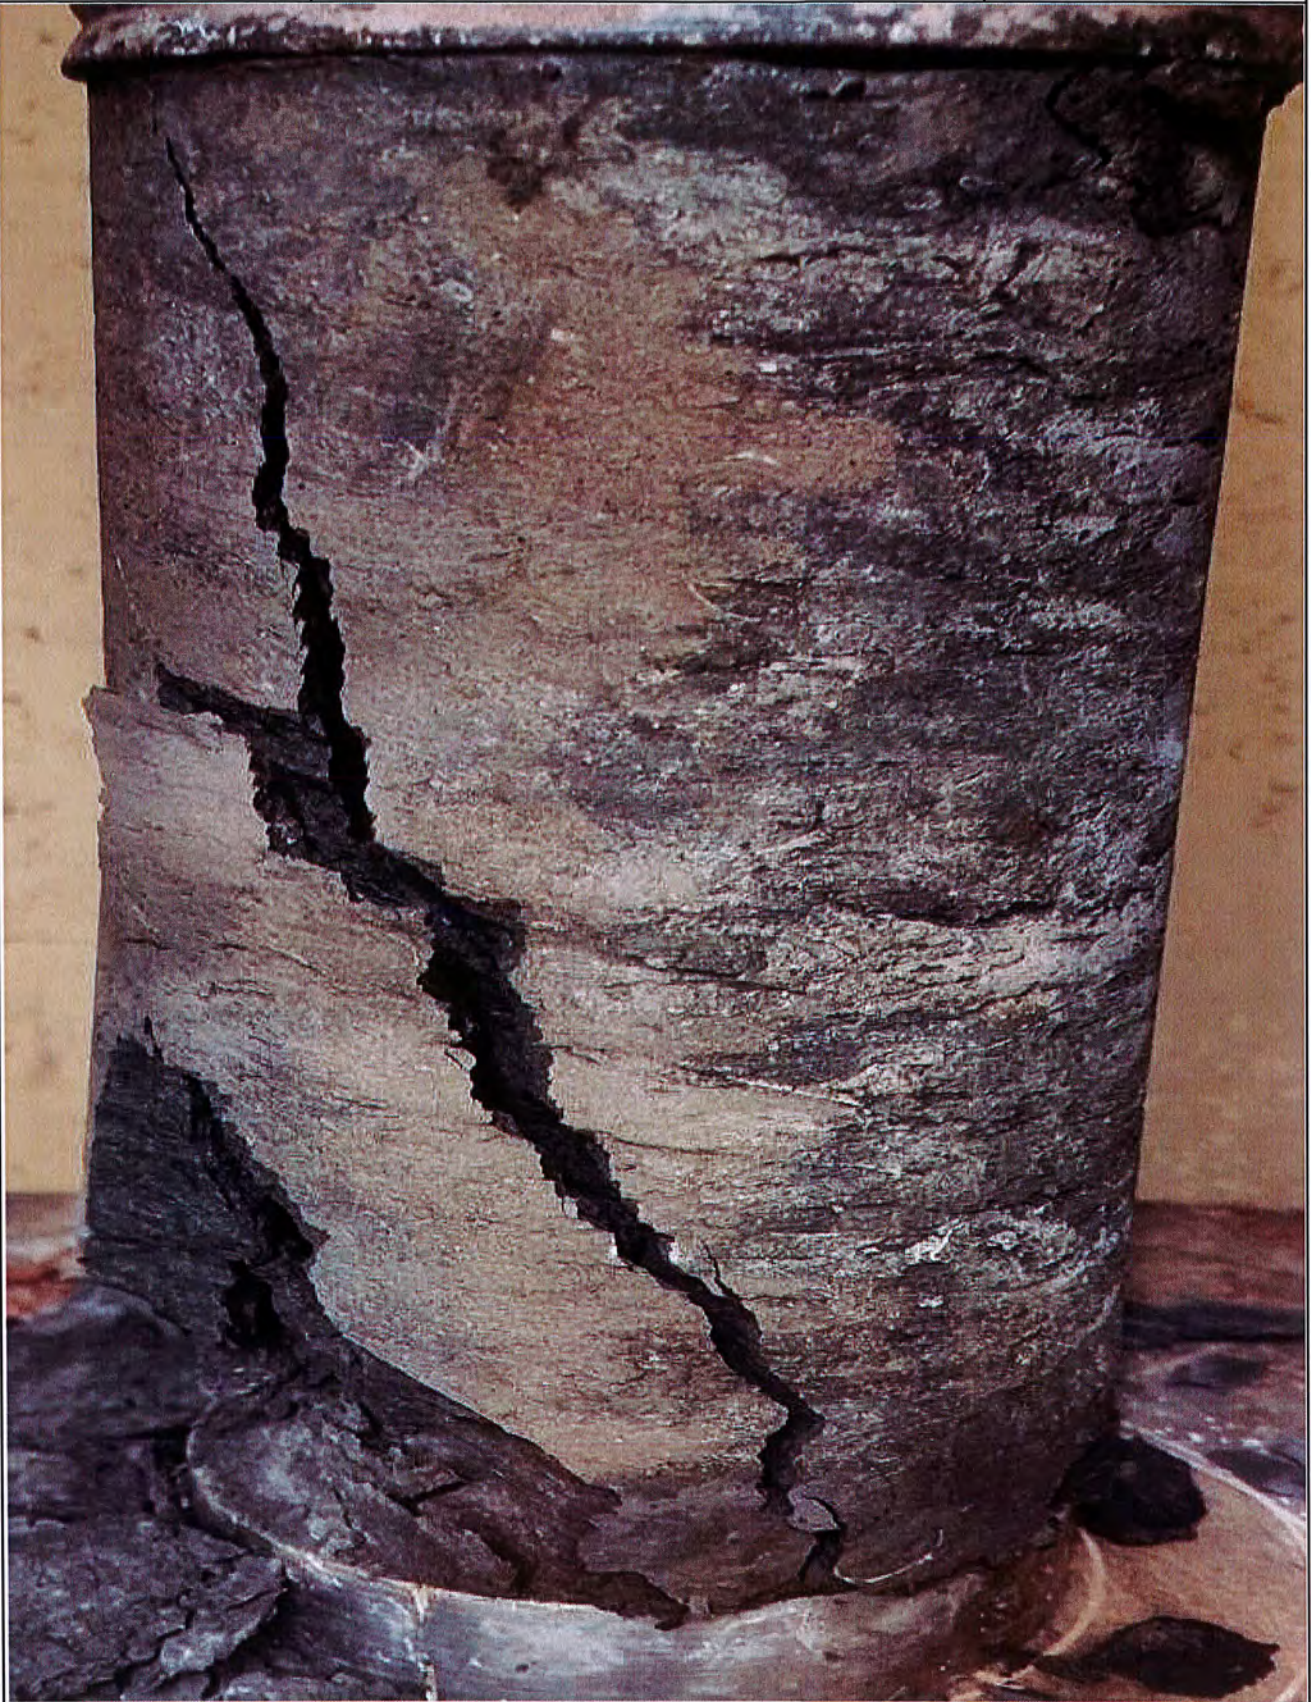
<b>TERRA TEK</b> ■■■■ SITE INVESTIGATION AND LABORATORY SERVICES	Site	PRELIMINARY ONSHORE GROUND INVESTIGATION FOR NZT	Contract No	<b>A14067</b>
	Client		Hole ID	LFVBH02
	Engineer		Sample Ref	
			Depth (m)	29.88
			Sample Type	C

Originator	Checked & Approved	<b>PHOTOGRAPHS OF SPECIMEN FAILURE</b>
SE

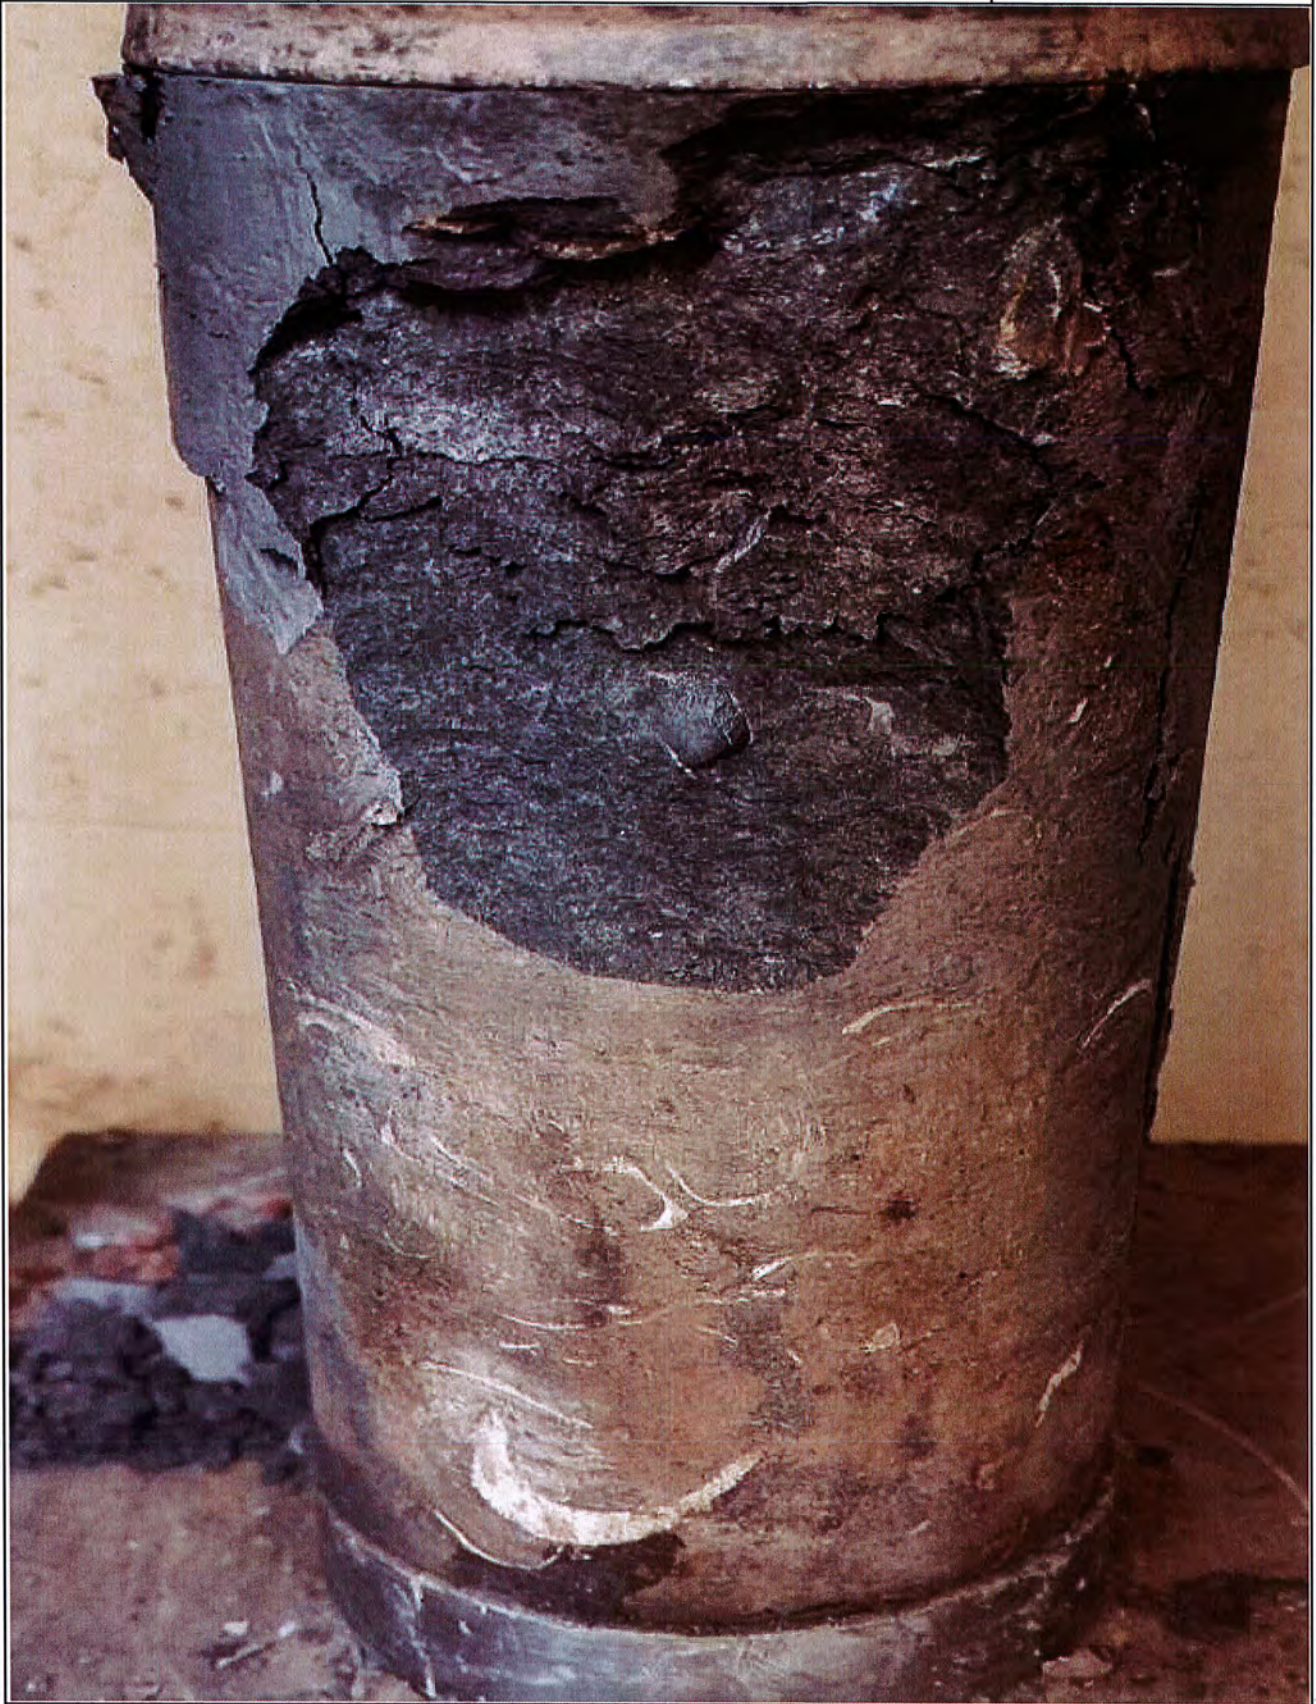
Contract No	<b>A14067</b>
Hole ID	LF\BH02
Sample Ref	
Depth (m)	30.65
Sample Type	C

**PHOTOGRAPHS OF SPECIMEN FAILURE**

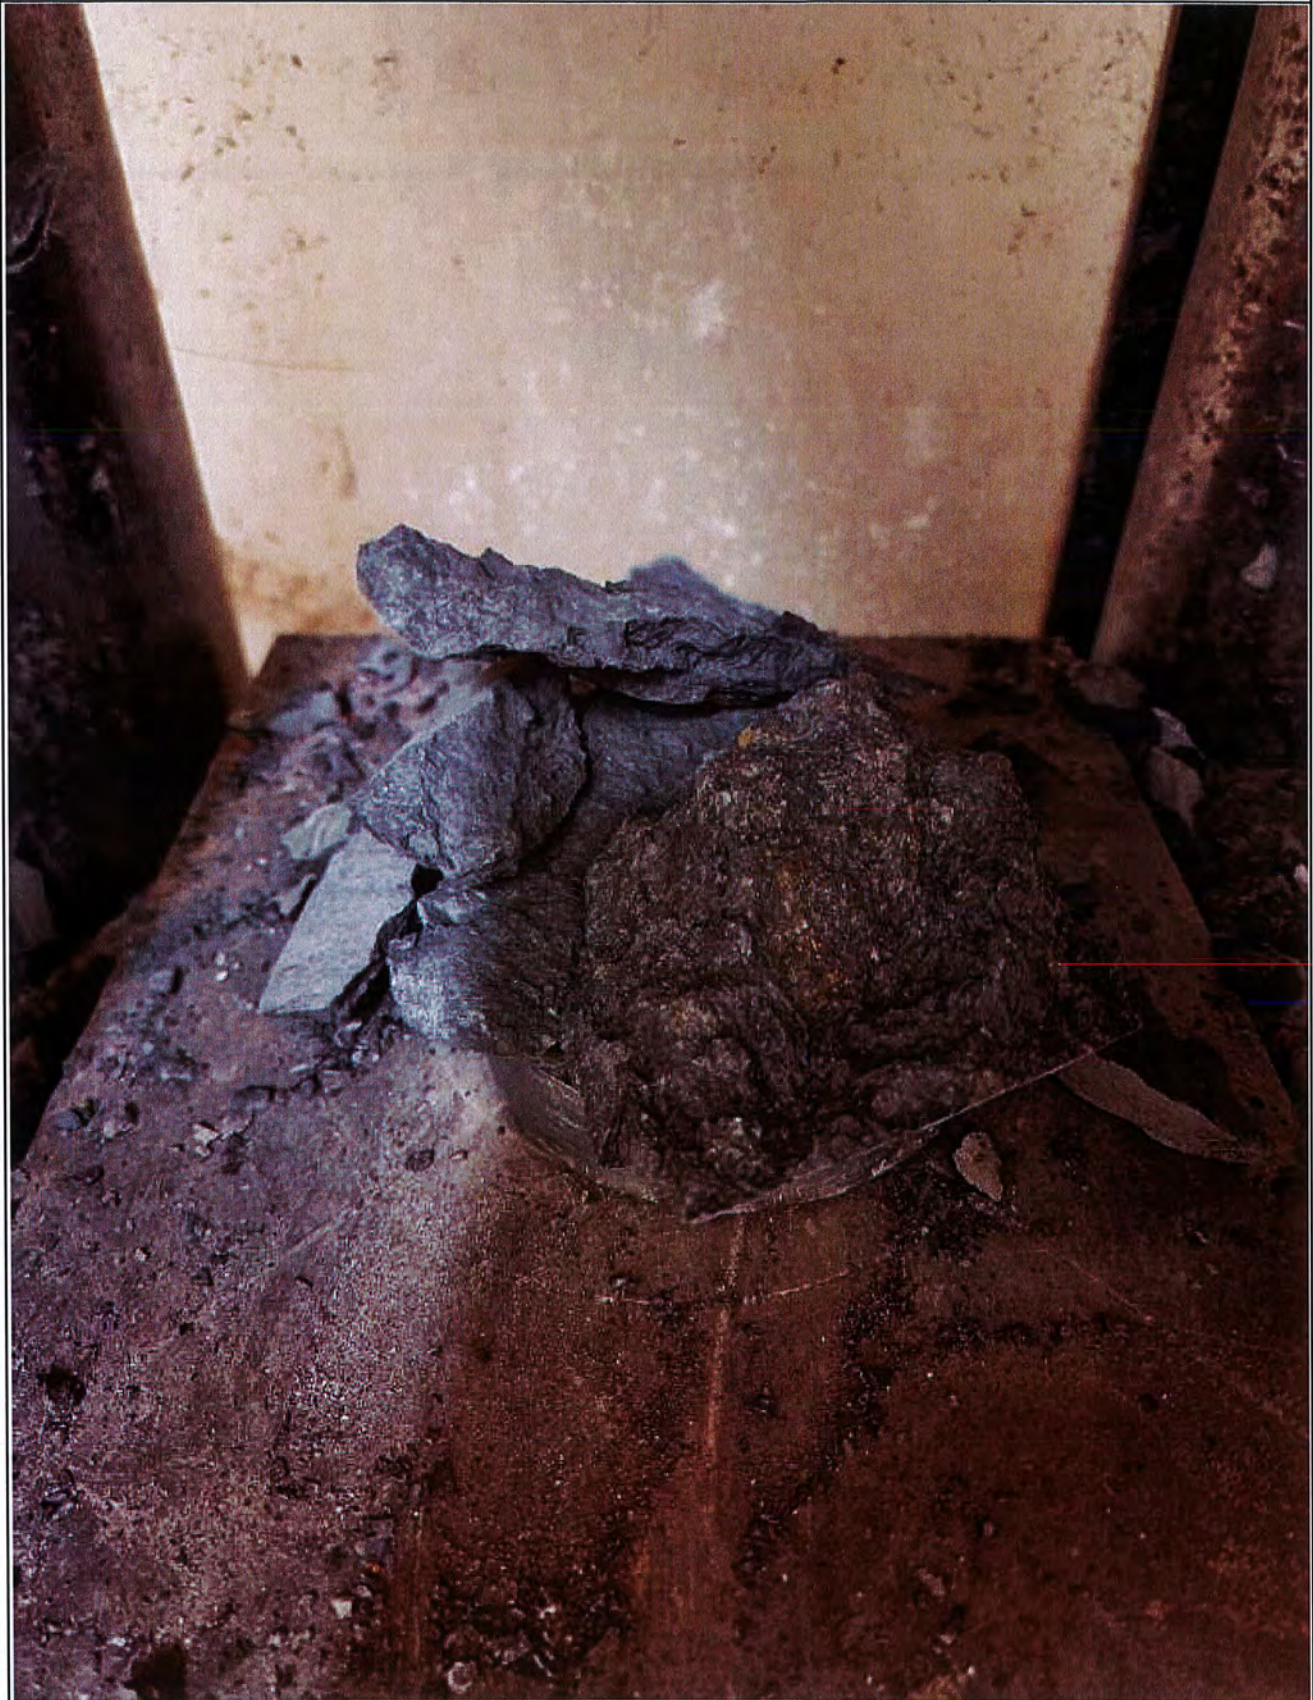
<b>TERRA TEK</b> <small>SITE INVESTIGATION AND LABORATORY SERVICES</small>	Site	PRELIMINARY ONSHORE GROUND INVESTIGATION FOR NZT	Contract No	<b>A14067</b>
	Client		Hole ID	MS\BH02
Engineer			Sample Ref	
			Depth (m)	28.70
			Sample Type	C

Originator	Checked & Approved	<b>PHOTOGRAPHS OF SPECIMEN FAILURE</b>

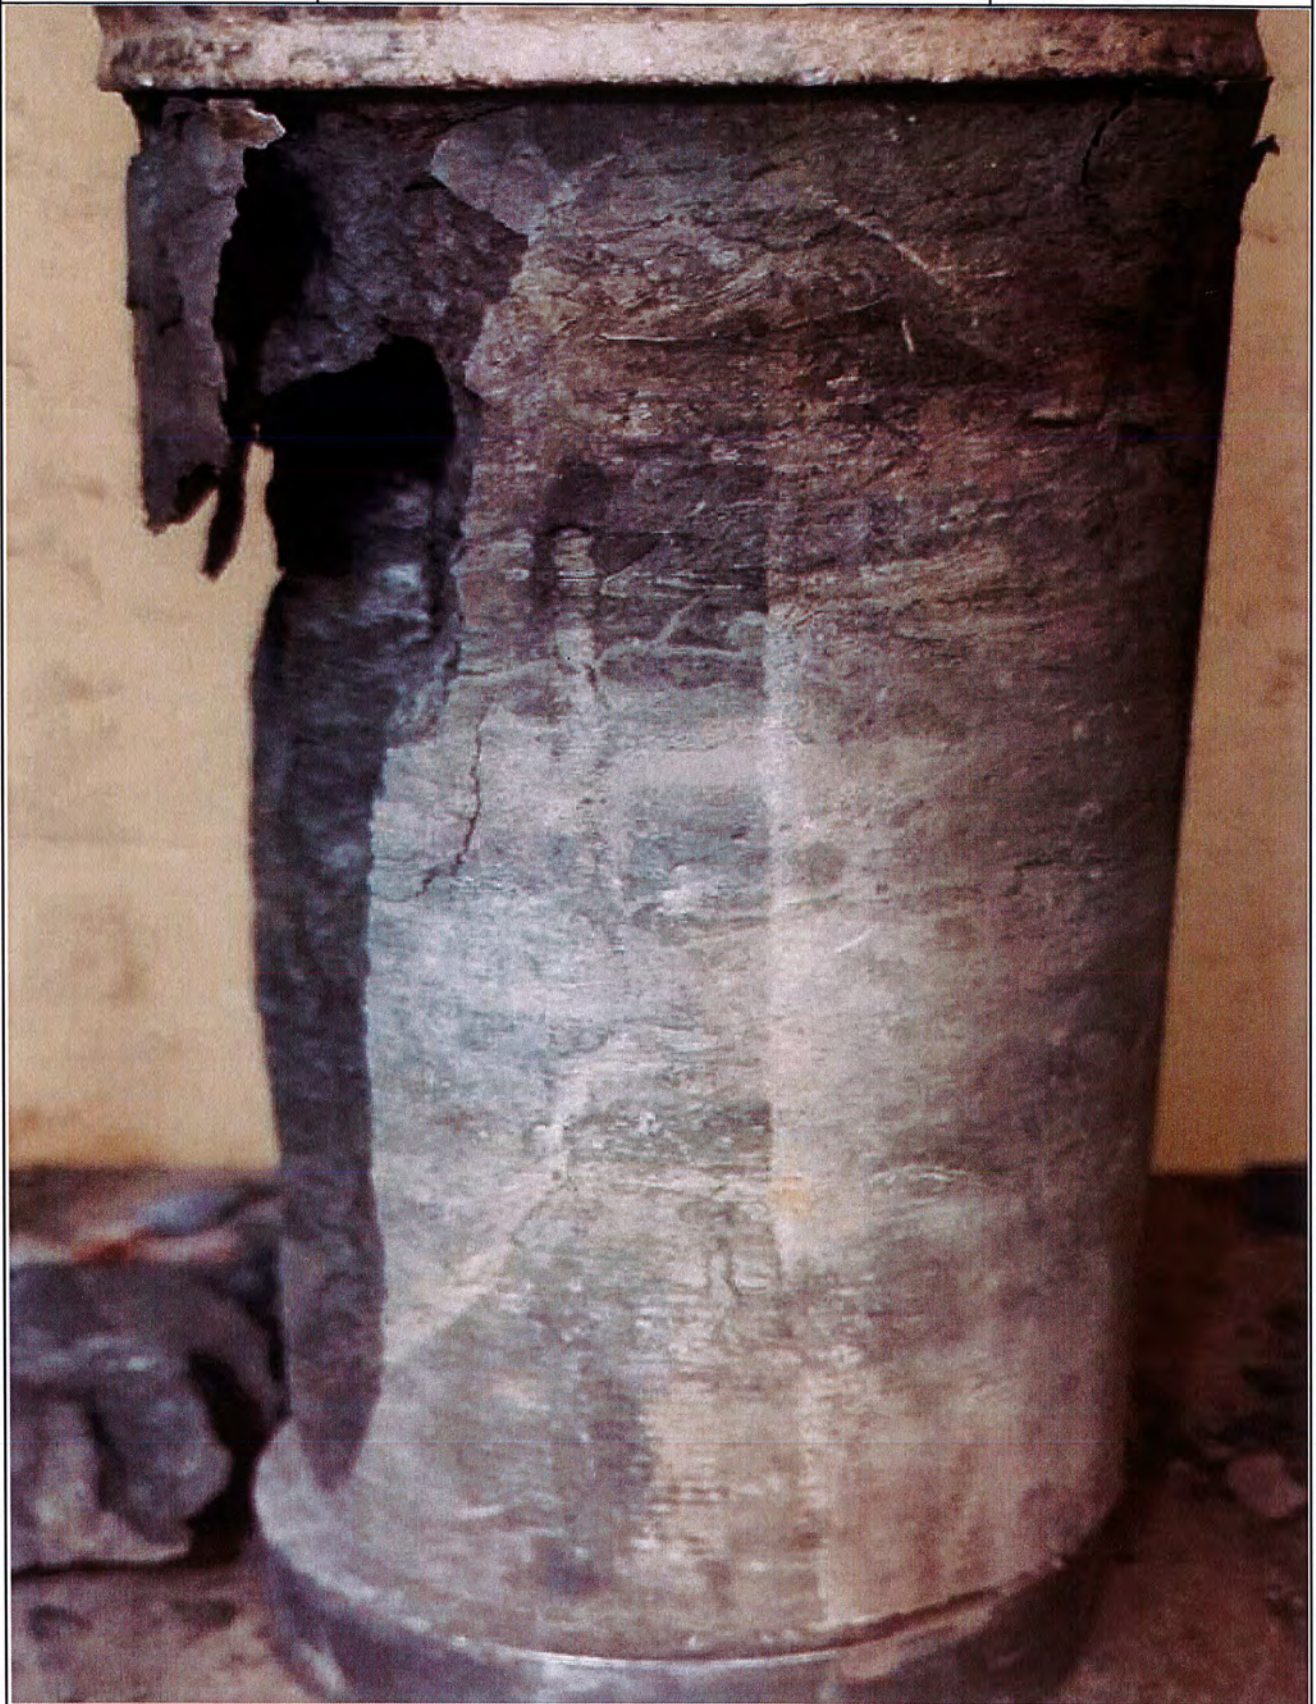
Contract No **A14067**  
 Hole ID MS\BH03  
 Sample Ref  
 Depth (m) 26.20  
 Sample Type C

**PHOTOGRAPHS OF SPECIMEN FAILURE**
