# Net Zero Teesside Project

Planning Inspectorate Reference: EN010103

Document Reference: 9.26 – Riparian Mammal Survey Report

Date: August 2022

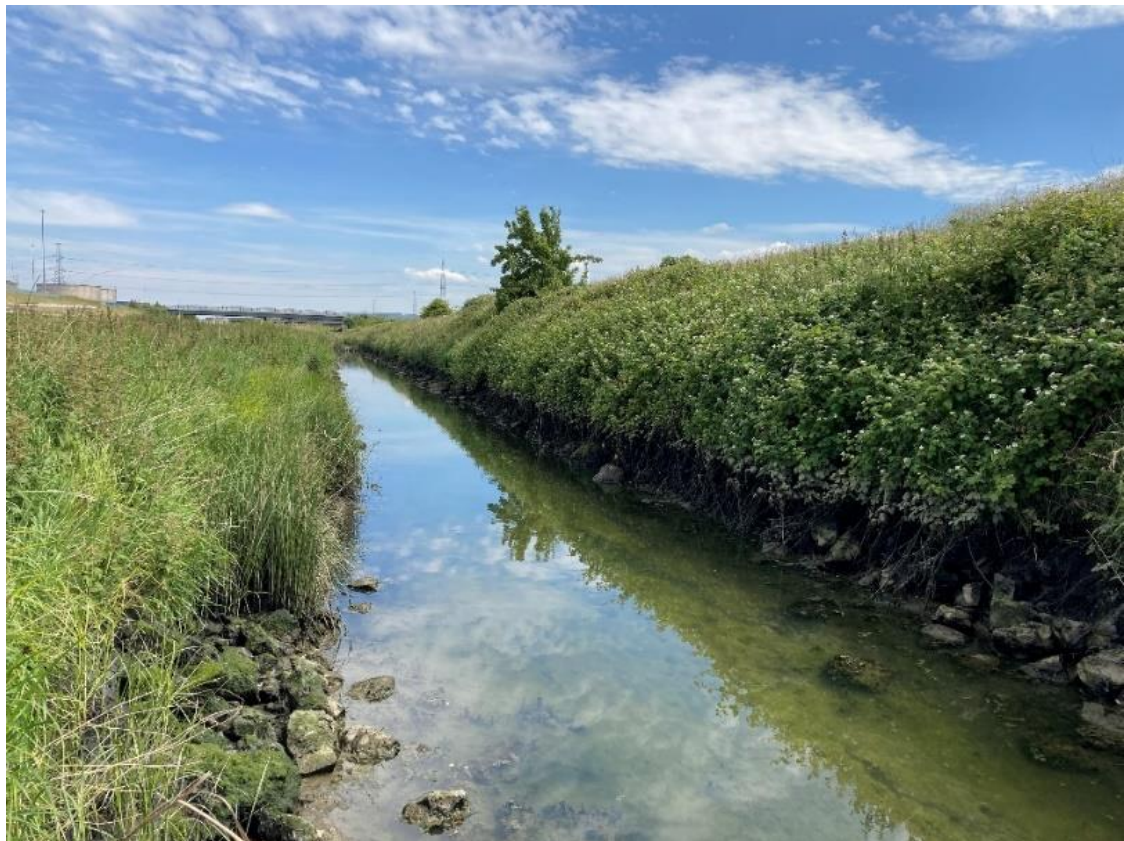
Photograph 1 - Dabholm Gut (Eastern Section)

- 6.1.1 Dabholm Gut is a small tidal creek which flows within an artificially realigned channel within the Wilton International industrial complex (Photograph 1). The eastern section of the watercourse was approximately 4 m in width and shallow (less than 0.2 m in depth), with the base of the channel comprised of a silt and large stone substrate. The banks were reinforced with large boulders and in-channel and marginal aquatic vegetation was generally absent.

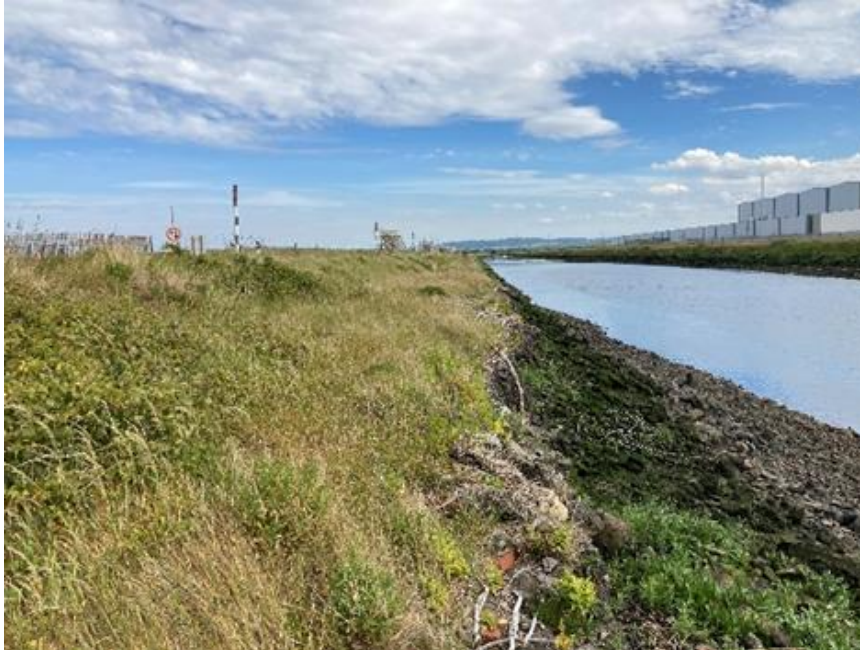
Photograph 2 - Dabholm Gut (Western Section)

- 6.1.2 Further downstream, it merges with a number of large outfalls associated with consented discharges from Northumbrian Water Ltd's Bran Sands Wastewater Treatment Works and other industrial site discharges. This, in addition to the tidal influence within this section, creates a larger watercourse, approximately 60 m in width with the substrate formed of silt, sand and larger rocks (Photograph 2). The banks throughout this section of the watercourse and surrounding its mouth at the confluence with the River Tees, are comprised of small rocks affording negligible refuge opportunities.
- 6.1.3 Dabholm Gut runs parallel to the existing pipeline corridor, but with a standoff distance of approximately 30 m throughout, comprising mown grassland and an access road (Photograph 3). The pipeline route does not cross the Dabholm Gut.

- 
- 6.1.5 No water vole field signs were found along Dabholm Gut. Given this and the sub-optimal habitat conditions (tidal influence, general absence of aquatic vegetation and unsuitable bank habitat), water vole is considered absent.
- 6.1.6 A single otter spraint (NZ 56402 23885) was recorded within the eastern section of Dabholm Gut. However, throughout this area, the terrestrial habitat does not provide sufficient cover or other habitat features suitable for use by otters as couches or holts. Given this, although otter will likely forage and or commute along this watercourse, it is highly unlikely to rest within these areas.

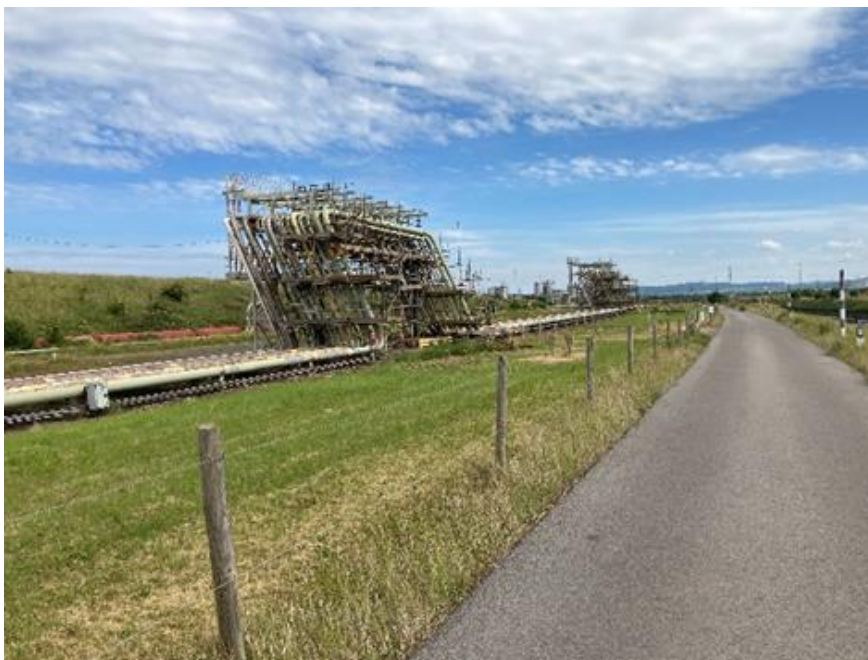
Photograph 3 - Managed grassland areas within the pipeline corridor

- 6.1.4 The wider terrestrial habitat along the existing pipeline corridor is formed of rank semi-improved grassland with occasional areas of scattered scrub and small bramble patches. However, the bramble stands were relatively small and generally only afforded thin cover. The grassland areas associated with the pipeline corridor also appeared to be routinely managed through regular cutting (Photograph 3).

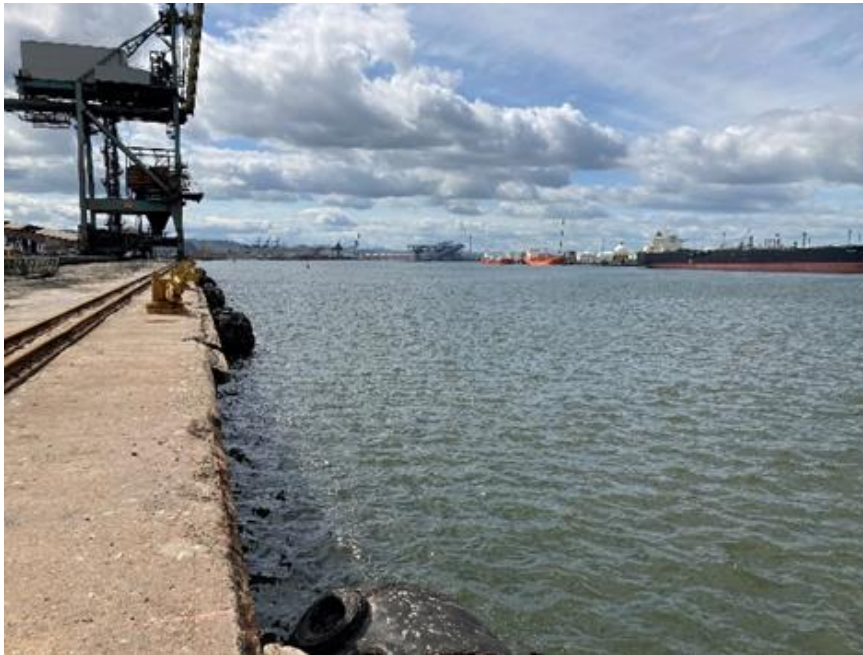
Photograph 4 - The waterfront at Redcar Bulk Terminal

- 6.1.8 The banks of the River Tees at this location are within the Redcar Bulk Terminal which is used to offload shipping cargo (Photograph 4). Within the survey area the banks were vertical (approximately 5 m in height) and made of concrete, offering no potential refuge opportunities. The vertical banks also pose a potential barrier to otters accessing terrestrial areas from the river. The associated terrestrial habitat is formed of hardstanding, buildings and infrastructure associated with the Bulk Terminal operation (Photograph 5).

- 6.1.9 No evidence of otter was recorded at this location and the banks and terrestrial habitats are considered highly unsuitable for this species given the lack of cover and the high levels of disturbance associated through regular ship traffic and associated operational activities. Accordingly, otter is considered absent. Given this, no direct or indirect disturbance impacts on otter are likely as a consequence of the Proposed Development.

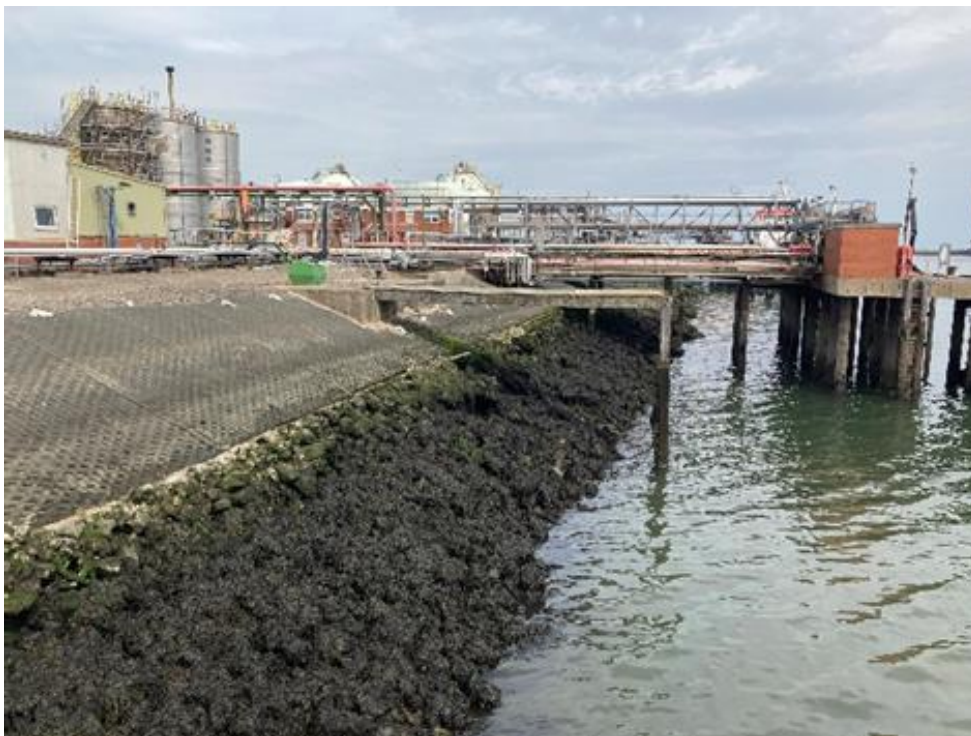
Photograph 6 - Waterfront at the Exolum Terminal

- 6.1.11 The associated terrestrial habitats and landuses comprise hardstanding, buildings, and infrastructure associated with the Exolum Terminal (Photograph 6). There are some areas of semi-natural habitat associated with the existing pipeline corridor and the land to the south of the Exolum Terminal. However, these habitats do not provide sufficient cover or other habitat features suitable for use by otters as couches or holts. Although brambles are present in this area, they were not well established and only afforded thin cover.

- 6.1.12 No evidence of otter was recorded at this location and the bank and terrestrial habitats are considered highly unsuitable for this species given the lack of cover and the high levels of disturbance associated through regular ship traffic and associated terminal activities. As such, otter is considered absent. Given this no direct or indirect disturbance impacts on otter are likely as a consequence of the Proposed Development.

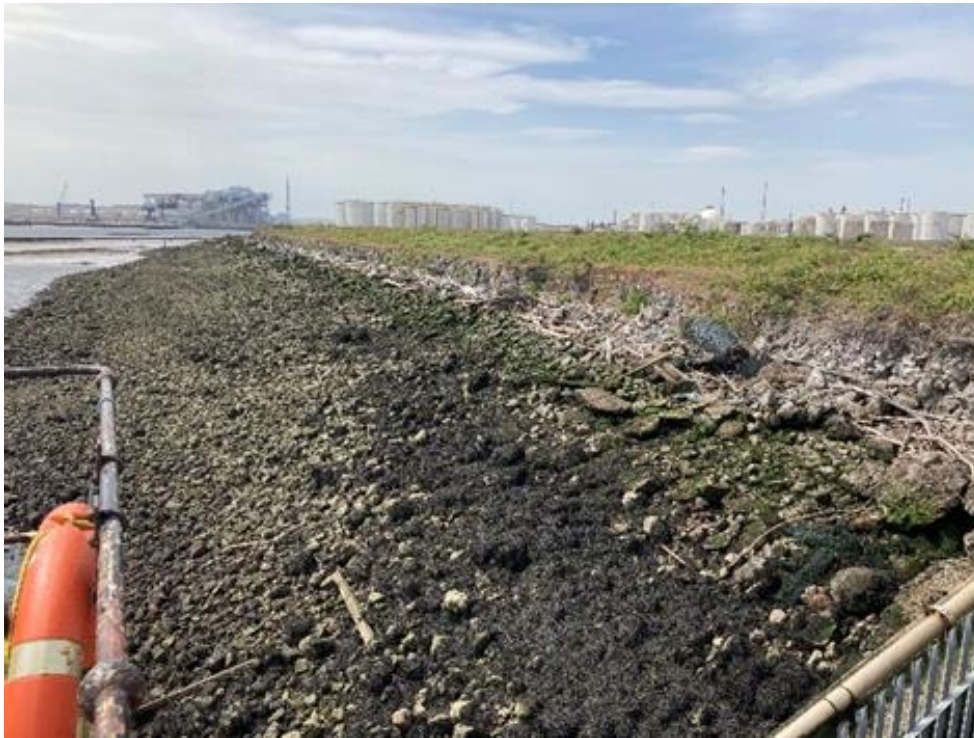
Photograph 7 - The waterfront and semi-natural habitats south of the Exolum Terminal

- 6.1.10 The banks of the River Tees at this location are adjacent to the Exolum Terminal which is used to offload shipping cargo. Within the survey area the banks of the River Tees are comprised of small rocks on the lower foreshore, with areas of concrete present in upper areas. Strandline deposits and other evidence (as readily apparent in Photographs 6 and 7) indicate that the majority of this area is submerged at high tide, making it unsuitable for resting or breeding otter.

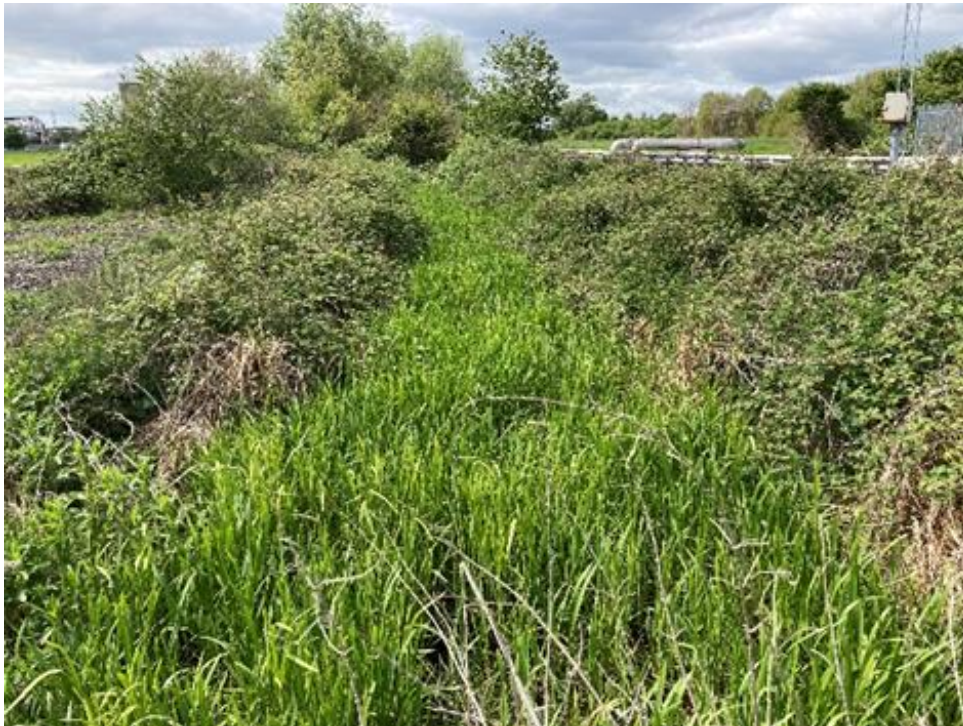
Photograph 8 - Belasis Beck

- 6.1.13 A 1.4 km section of Belasis Beck is associated with the Proposed Development. Within the western section of the survey area (approximately 600 m long), the watercourse is a small drainage ditch with little to no flow. The wetted channel was up to 2 m wide and shallow (less than 10 cm deep), with a deep substrate of silt. There was emergent vegetation throughout this area, dominated by reed sweet-grass (*Glyceria maxima*). The banks were earth and shallow in profile (<45°), with the bank tops supporting areas of tall ruderals and brambles (Photograph 8).

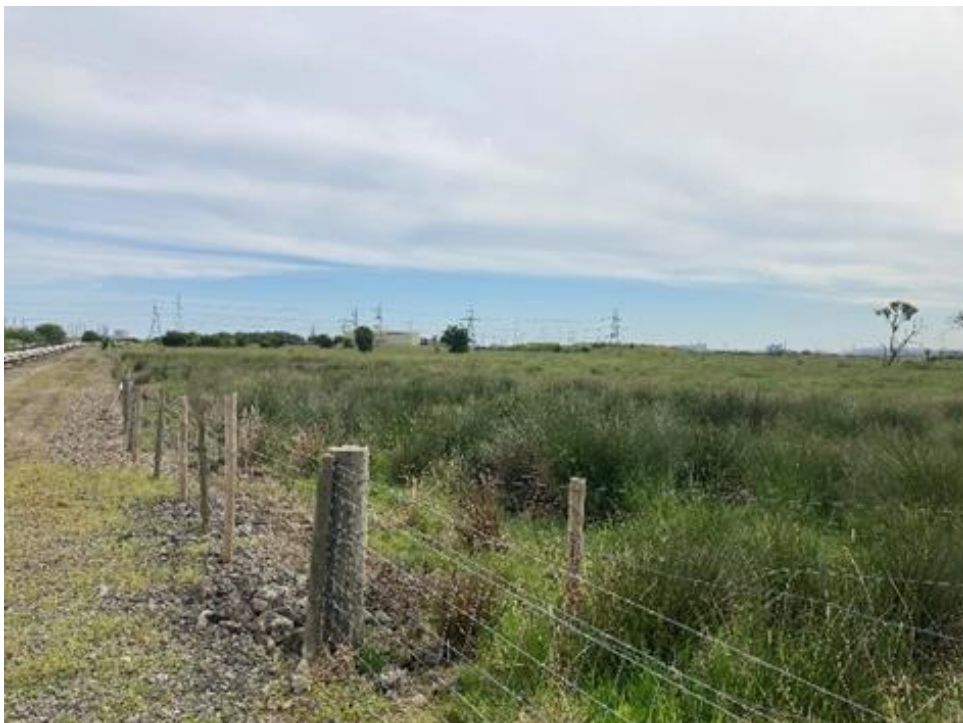
Photograph 9 - Habitats adjacent to Belasis Beck

- 6.1.16 The habitats associated with the existing pipeline rack are comprised of hardstanding, which includes two access roads. The wider habitat surrounding the Belasis Beck is dominated by grazing pasture and swamp which supported only occasional scattered scrub (Photograph 9).

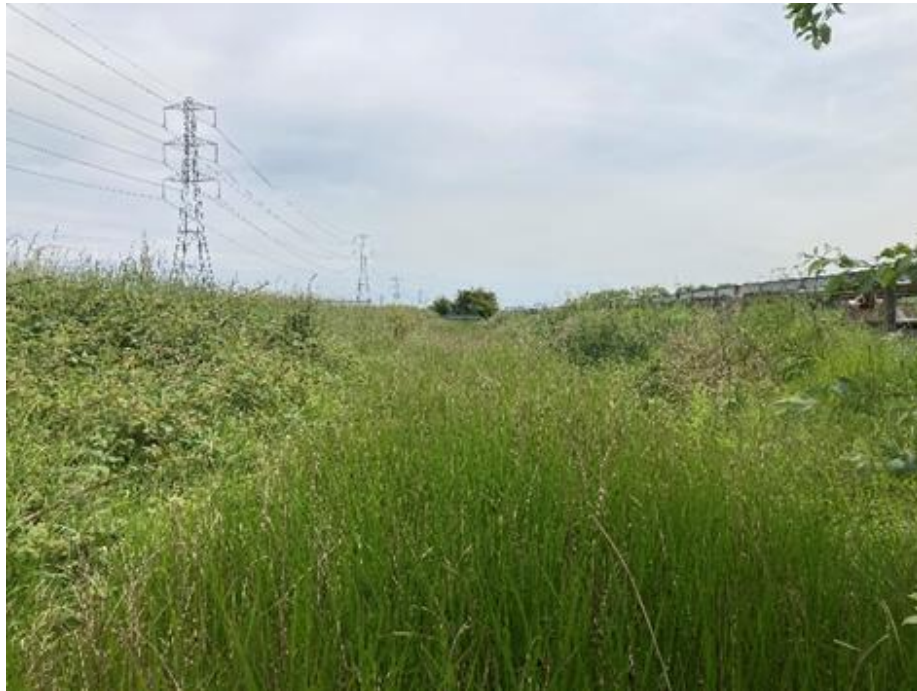
Photograph 10 - Unnamed watercourse (western end)

- 6.1.24 The western section of this watercourse had little to no flow, with the wetted channel approximately 1 m in width and shallow (less than 10 cm deep). Emergent vegetation was present throughout this area with the substrate consisting of silt. The banks were earth and steep in profile (>45°) with the bank tops supporting areas tall ruderals, scattered scrub and brambles (Photograph 10).

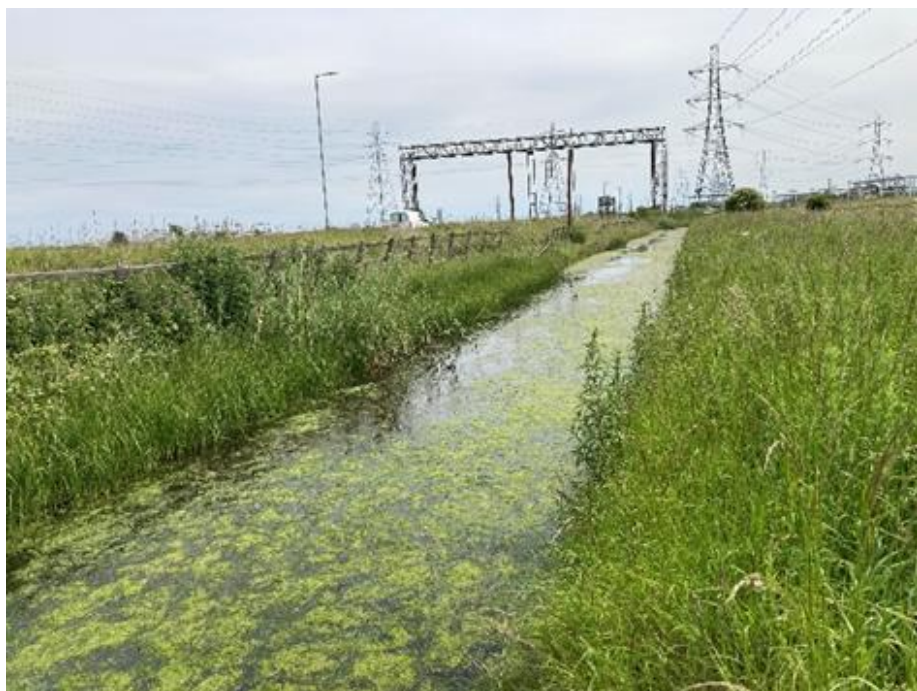
Photograph 11 - Unnamed watercourse (eastern end)

- 6.1.25 Further along its course to the east, it merges with two other minor drainage ditches becoming deeper and wider (>1 m and 5 m respectively). Emergent vegetation was again present, but mostly restricted to the margins (Photograph 11).

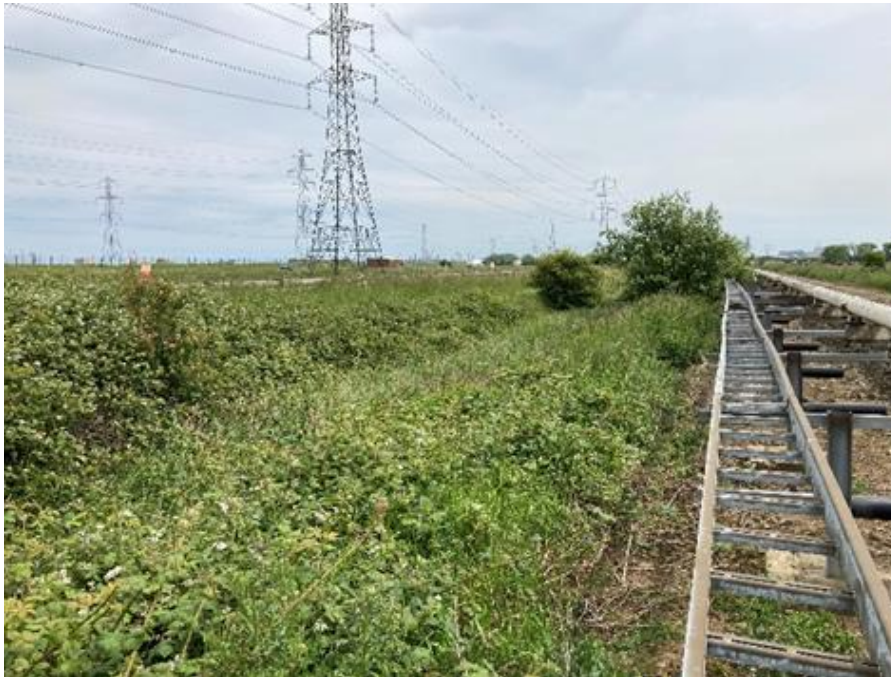
Photograph 12 - Standoff between the watercourse and the existing rack

- 6.1.27 Along the length of the proposed pipeline corridor there was a stand-off of at least 5 m between the existing pipeline rack and the banks of the watercourse, although again in many areas this distance was greater (Photograph 13).
