SUNNICA ENERGY FARM

6.2 Appendix 16B: Ground Conditions Phase 1 Preliminary
Environmental Risk Assessment

Sunnica Energy Farm

**Environmental Statement
Appendix 16B: Ground Conditions Phase 1 Preliminary Environmental
Risk Assessment**

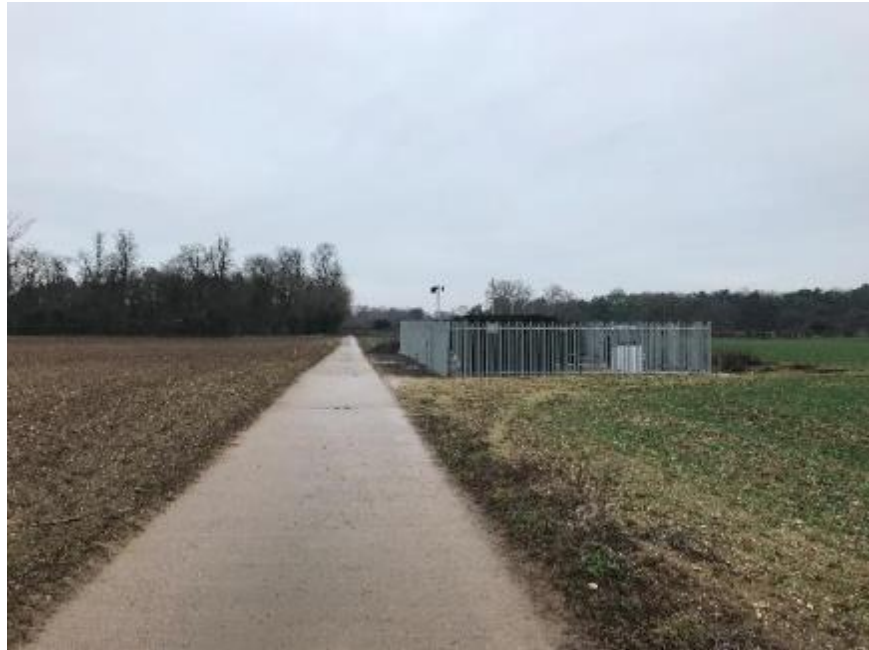
Gas sub-station with
the Sunnica East Site B
boundary (tree line).
(www.safegas.it)

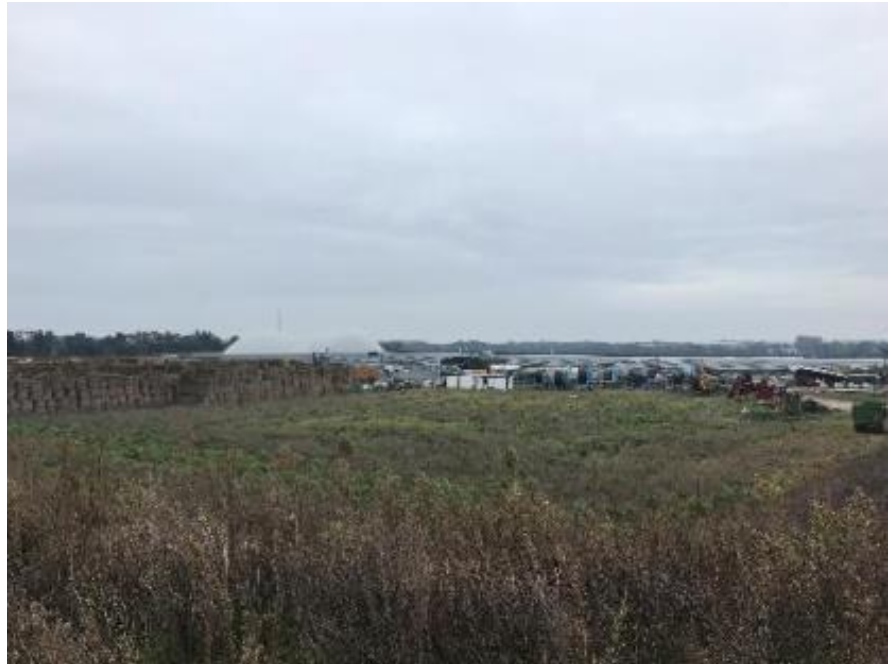
Photo No.
9a

Elevated made ground (bundings) adjacent to the Solar Farm.

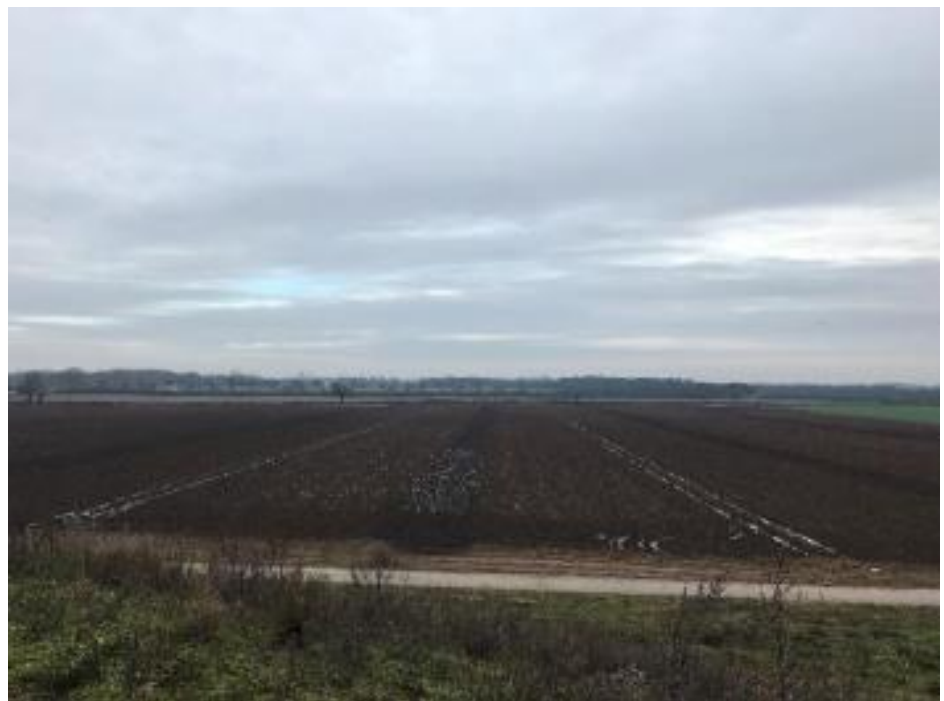
Elevated made ground (bundings) with view to the west.

Photo No. 9b	Date: 15/01/19
Direction Photo Taken: South-west	
Description: Elevated made ground (bunding) with view to the south-west.

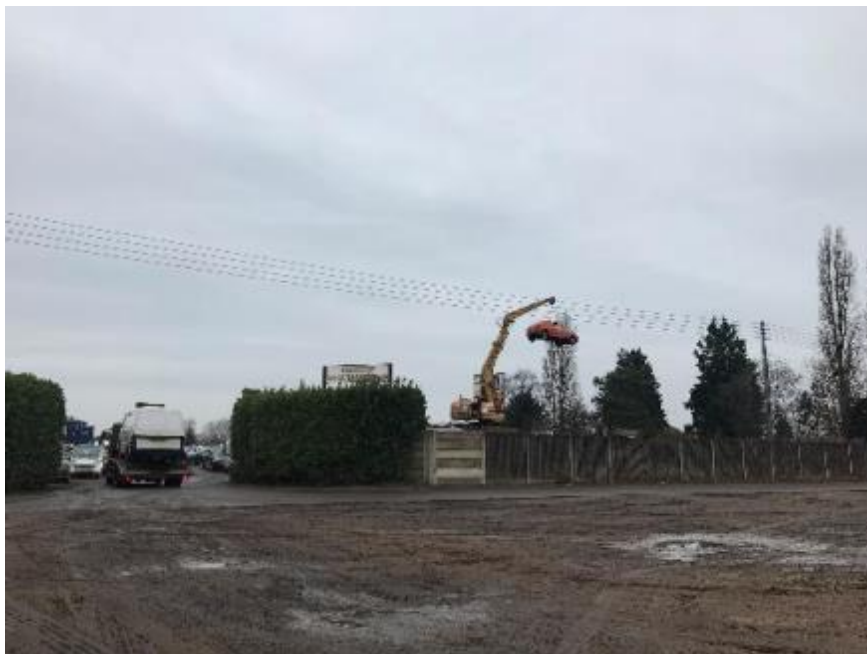
Photo No.
10a

Vehicle Dismantling site.

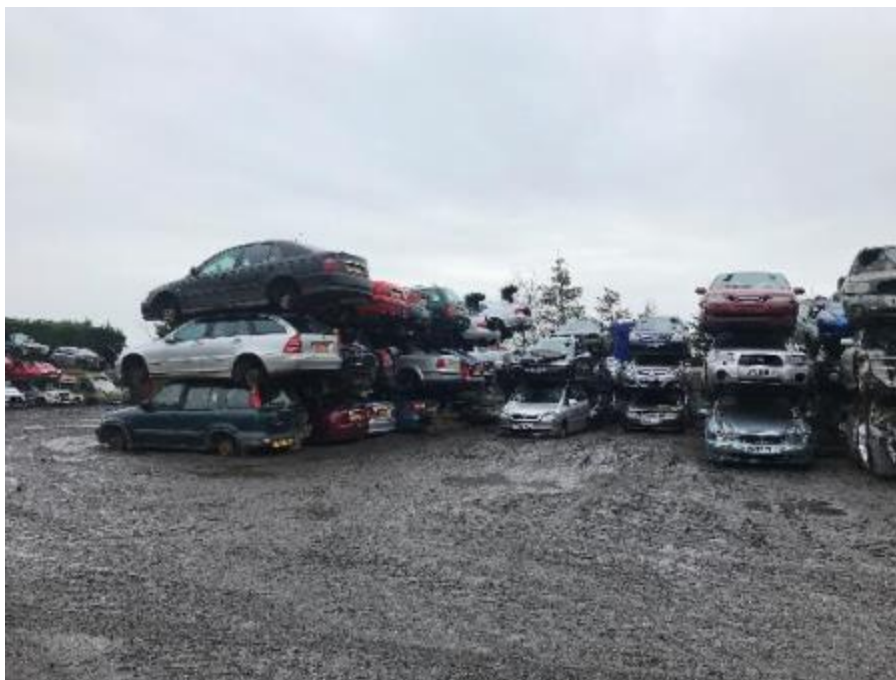
Vehicle Dismantlers.
Potential for hydrocarbon contaminated ground.

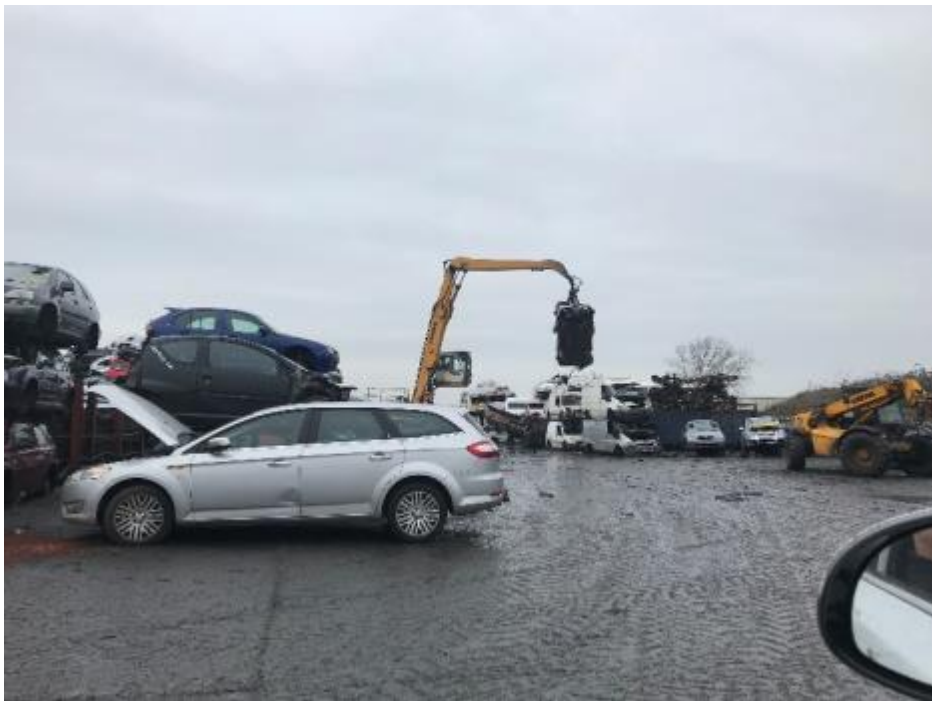
Photo No. 10b	Date: 15/01/19

Direction Photo Taken: West		
Description: Vehicle Dismantlers. Potential for hydrocarbon contaminated ground.

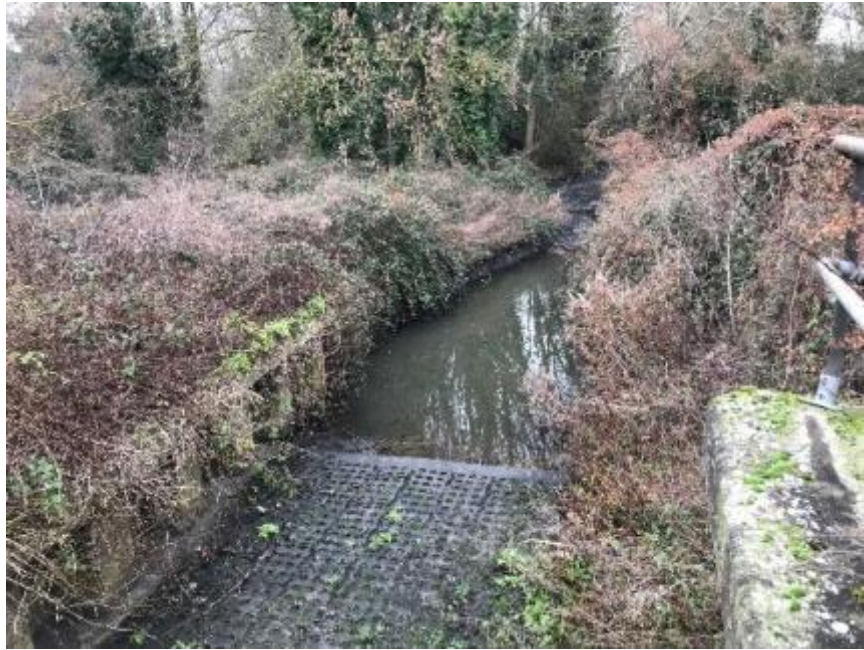
Photo No.
12a

River Kennett
(presence of unidentified cloudy sheen on the water surface).

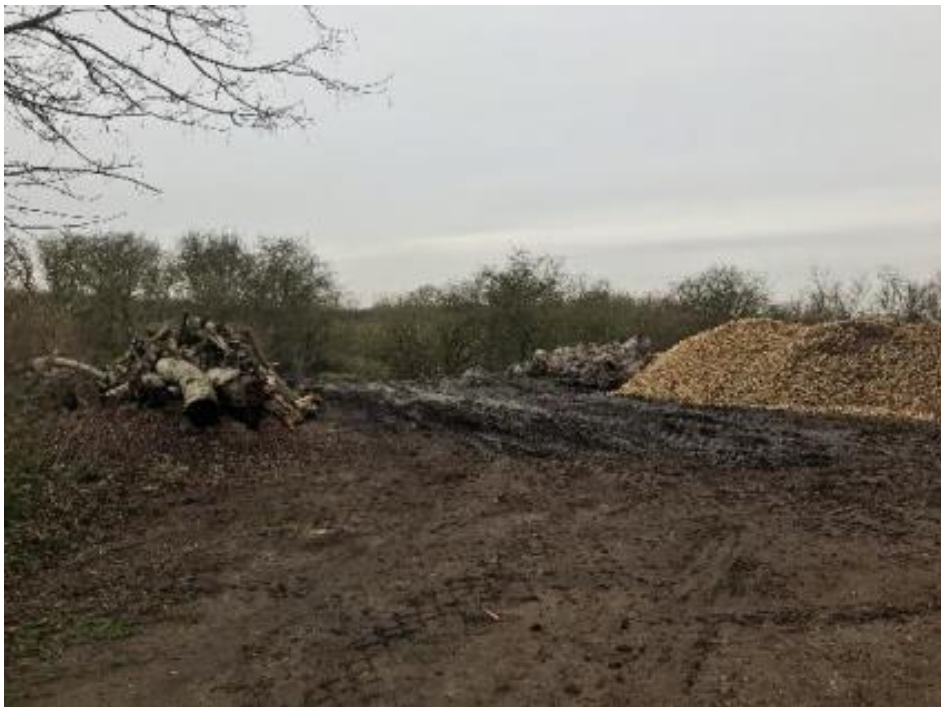
PHOTOGRAPHIC LOG	
Client Name: Sunnica Ltd.		Site Location: Sunnica East Latitude: 52; 18; 4.63 Longitude: 0; 28; 0.51 Altitude: 19.68m	Project No. 60589004
Photo No. 14	Date: 15/01/19

Direction Photo Taken: South			
Description: Potentially infilled land (historic), with evidence of wood burning adjacent to the cable route.

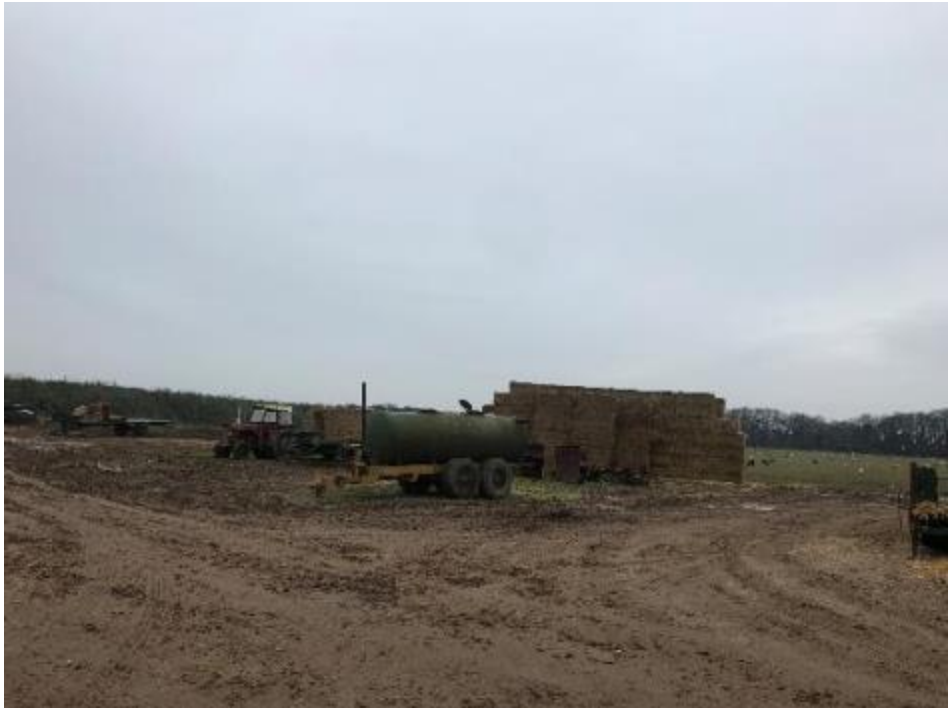
Client Name: Sunnica Ltd.		Site Location: Sunnica East Latitude: 52; 18; 0.83 Longitude: 0: 28; 19.21 Altitude: 7.42m	Project No. 60589004
Photo No. 15	Date: 15/01/19

Direction Photo Taken: South-west			
Description: Agricultural machinery including a tanker (likely to be for slurry).

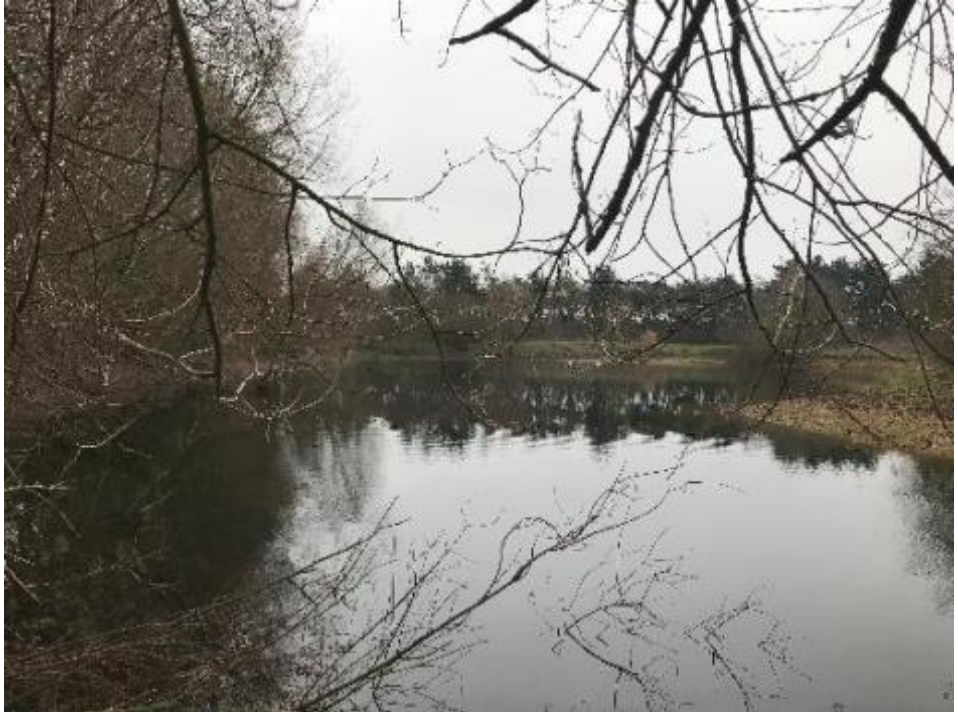
Client Name: Sunnica Ltd.		Site Location: Sunnica East Latitude: 52; 19; 32.21 Longitude: 0; 29; 1.92 Altitude: 9.72m	Project No. 60589004
Photo No. 19	Date: 15/01/19

Direction Photo Taken: South			
Description: Large pond in the central / north-eastern part of the site. (possibly groundwater fed)

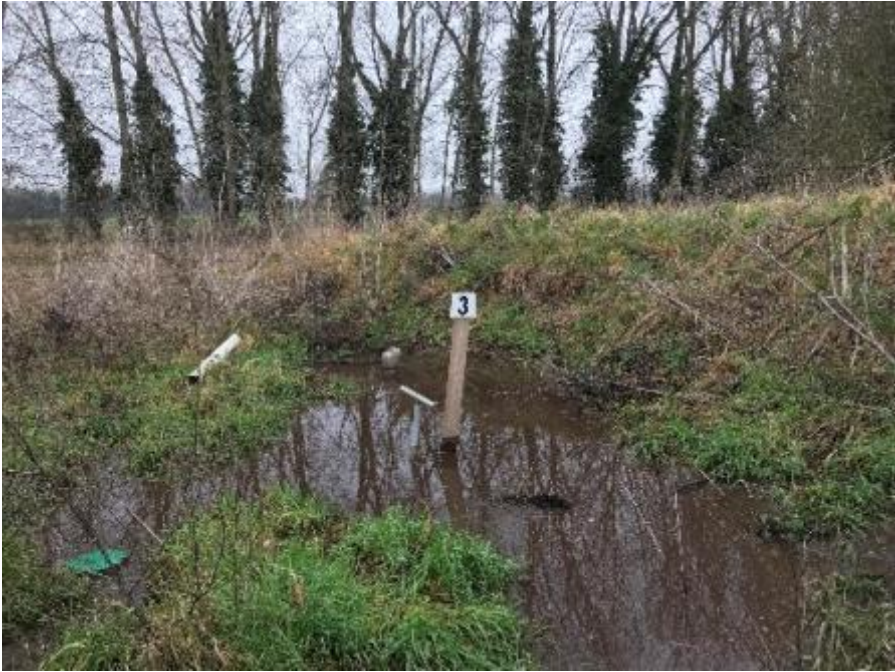
PHOTOGRAPHIC LOG	
Client Name: Sunnica Ltd.		Site Location: Sunnica East Latitude: 52; 19; 31.16 Longitude: 0: 29; 58.82 Altitude: 9.42m	
Project No. 60589004			
Photo No. 21	Date: 15/01/19

Direction Photo Taken: East			
Description: Possible groundwater abstraction point adjacent to large pond (Sign labeled '3').

- 2.3.6 According to the Groundsure Report, there are 24 active groundwater abstraction licences on-site and within 250m from the Site. Groundwater abstraction points were observed during the site visit (photos 20 and 21, Annex 16A); it is possible that these relate to the abstraction licences for spray irrigation, at Upton Suffolk Farms. Available BGS borehole logs show a groundwater level of between 4.0m bgl and 5.25m bgl.

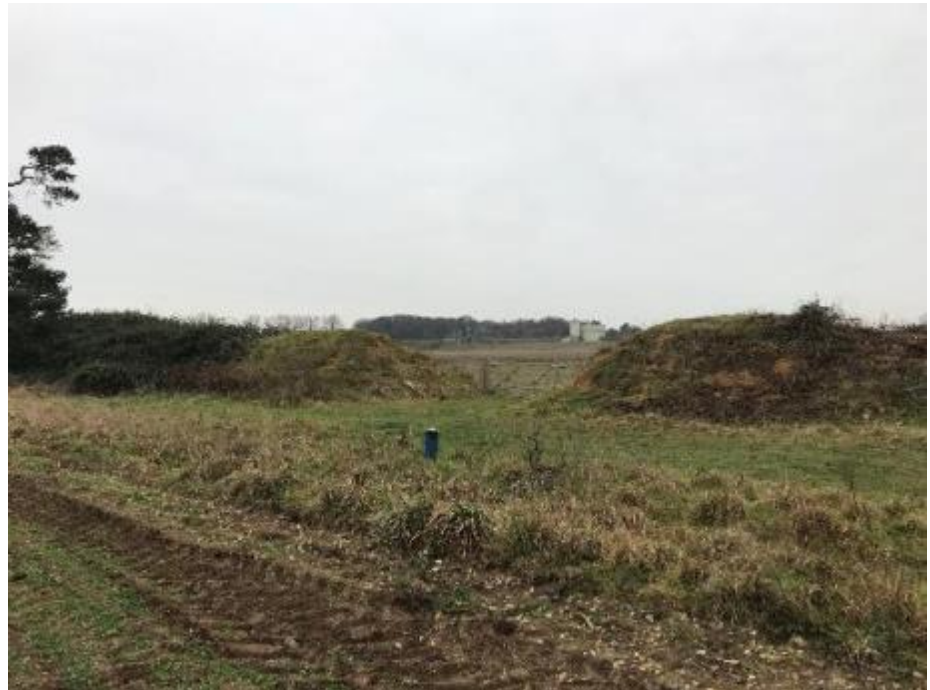
Photo No.
24a

Groundwater monitoring well

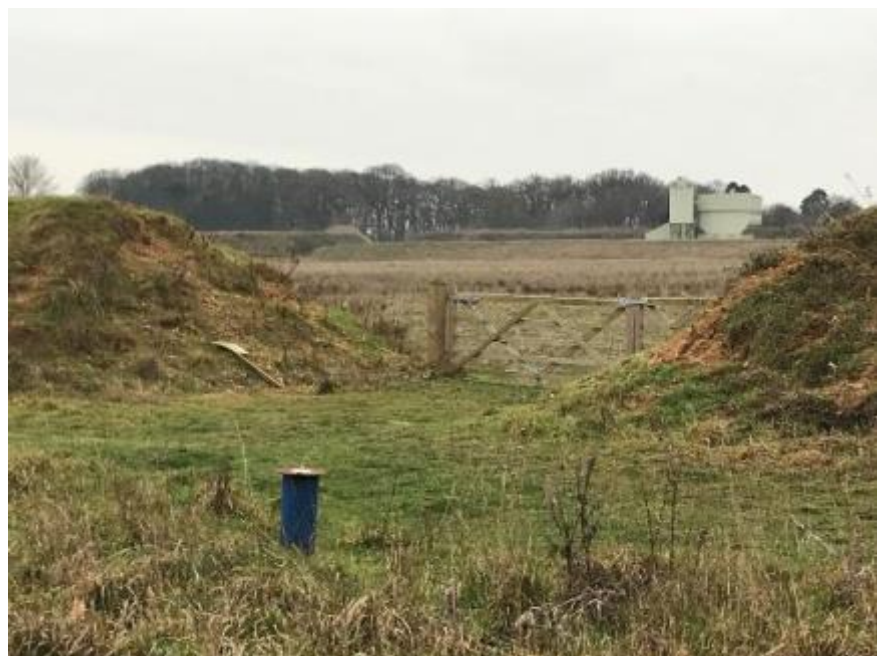
Groundwater monitoring well towards the south-east corner of the Sunnica East Site B.

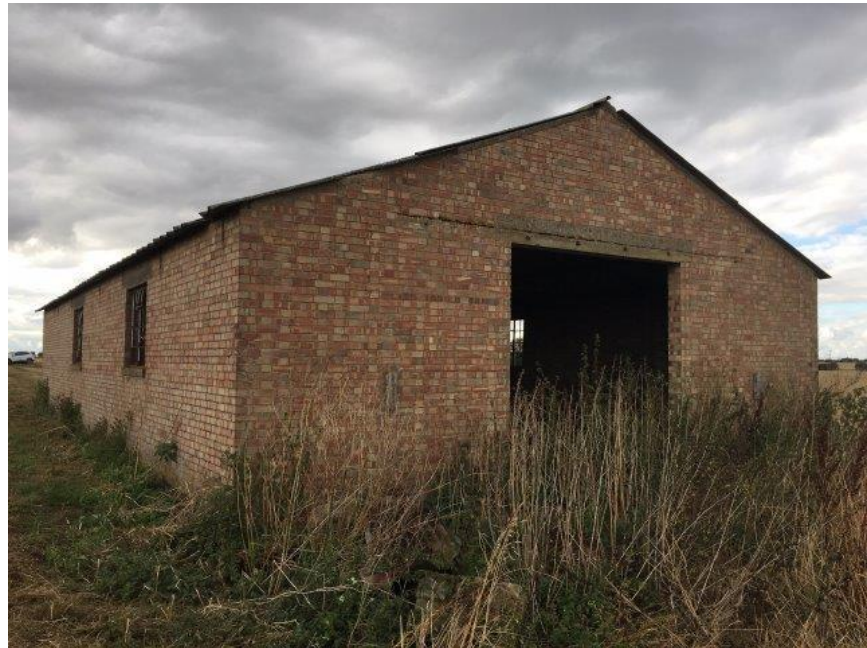
Barn at the north-western part of Sunnica East Site A. Potential for ACMS.

Japanese Knotweed or other invasive species were not observed in the areas visited during AECOM's walkover surveys. Although two of the three surveys have been carried out during the winter months when Japanese knotweed and Giant Hogweed do die back making identification more difficult.
Tanks, plant and electric substations:	None identified on-site.
Ancillary Infrastructure	None identified on-site.
Asbestos on Site:	Potential Asbestos Containing Material (ACM) was observed in a barn to the north of Beck Road, in the form of corrugated roofing, at the north-western part of the Sunnica East Site A (photos 58 and 58a, Annex 16A).

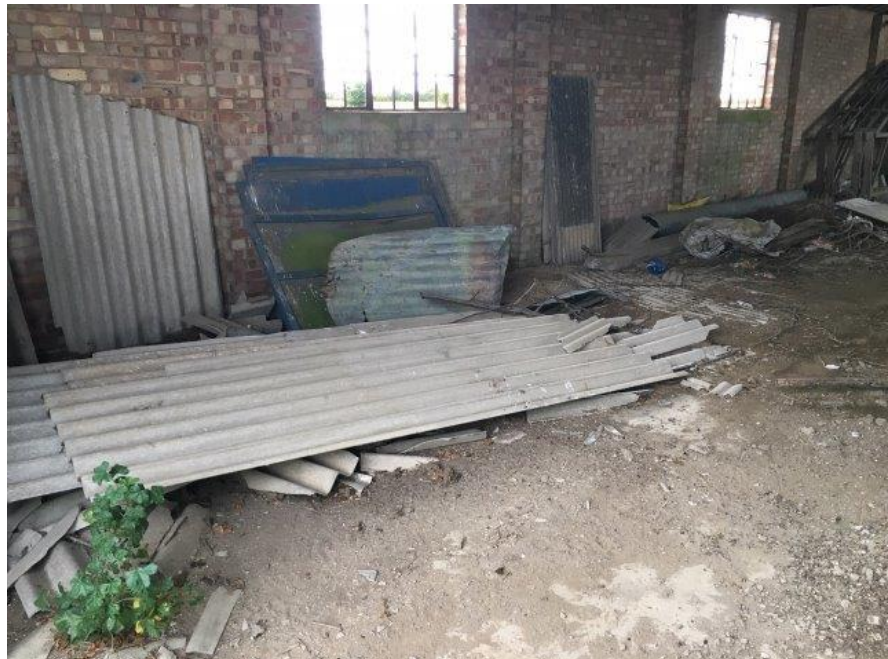
Photo No.
58a
Date:
25/09/19
Direction Photo Taken:

Barn at the north-western part of Sunnica East Site A. Potential for ACMS.

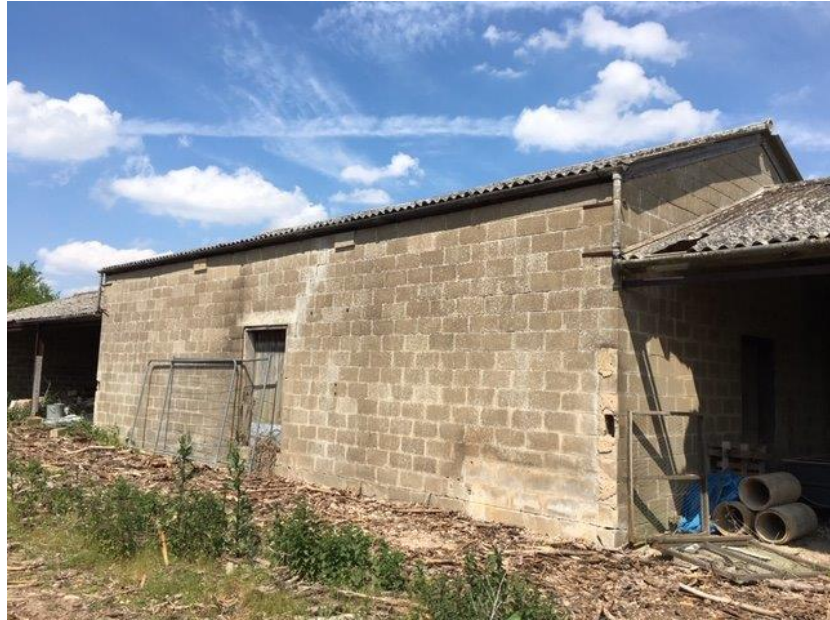
Barn at the central part of Sunnica West Site A. Potential for ACMS.

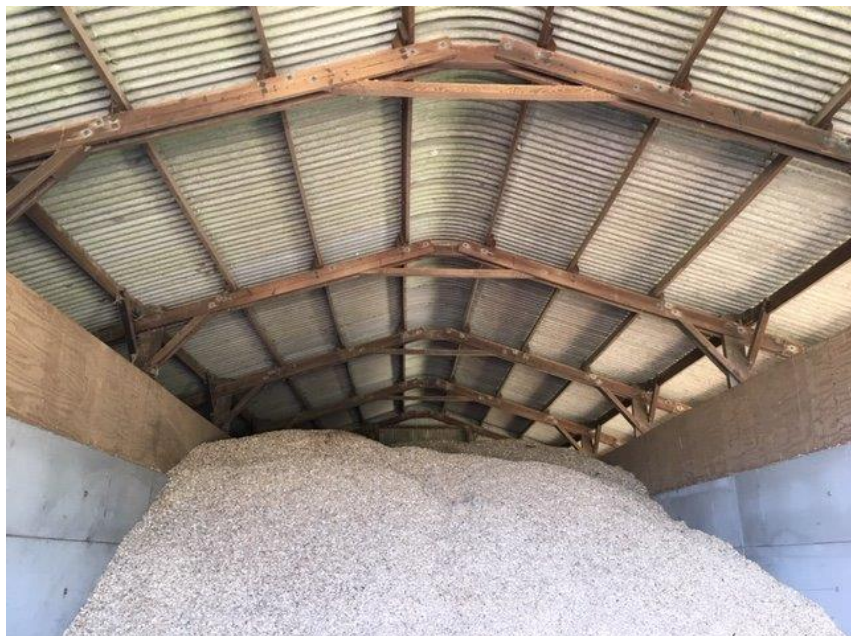
Photo No.
 59a

Barn at the central part of Sunnica West Site A. Potential for ACMS.
