**“McMicken BESS event: Technical Analysis and Recommendations”**

# McMicken Battery Energy Storage System Event Technical Analysis and Recommendations

**Document No.:** 10209302-HOU-R-01

**Date:** July 18, 2020

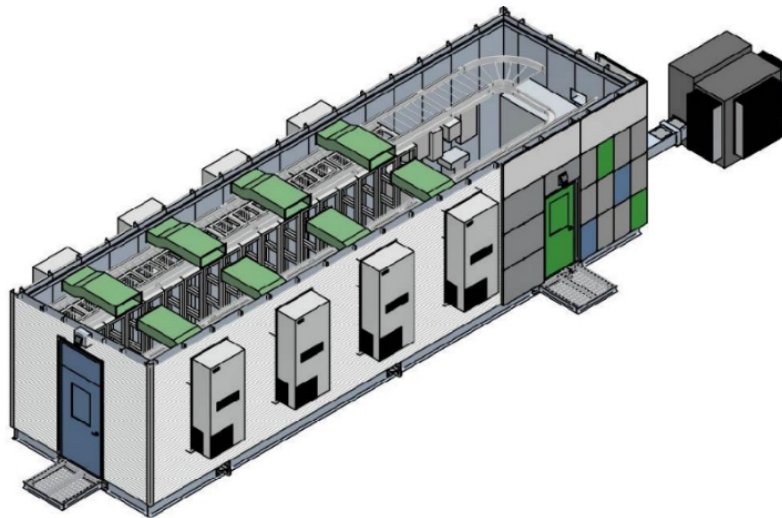
APS placed the McMicken BESS into service on March 14, 2017. [46] The general layout of the system is shown in Figure 1. From the date of commissioning until January 2018, APS used the BESS for the various research and development purposes described earlier. Following completion of that research, the BESS was used daily as a load serving resource to charge with solar energy produced during the daytime and discharge the solar energy back onto the grid in the evening when solar systems were no longer producing.

**Figure 1 General layout of the BESS (image credit: APS)**

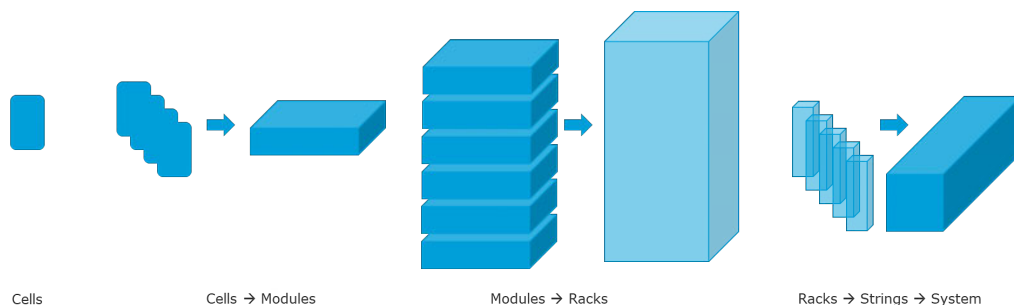
Battery modules are assembled into larger sub-assemblies with varying names; they can be racks, packs, or sometimes cabinets. These module sub-assemblies are then strung together, usually in strings, which comprise the system. A system may have one or more strings. The architecture of a typical energy storage system (ESS) is shown in Figure 2.<sup>3</sup> In the McMicken BESS, the modules were assembled into racks.

**Figure 2 Generalized system architecture**

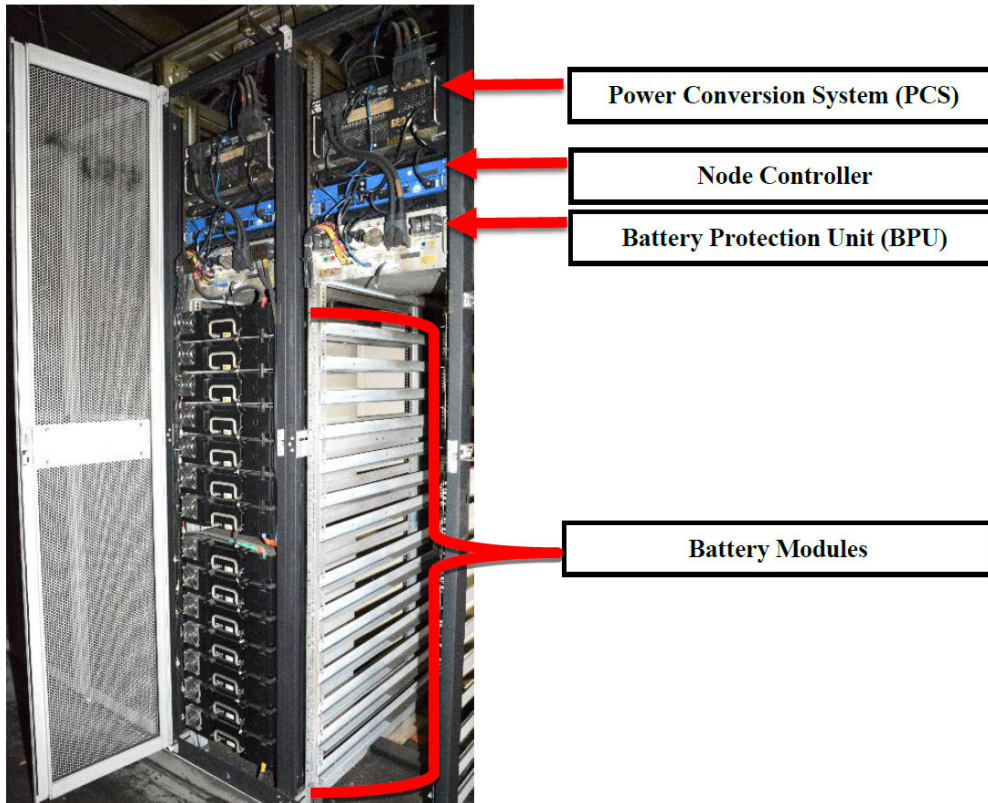
- 64 Ah, 0.24 kWh pouch cells, operational voltage range 3.0-4.2V
- 28 cells per module in a 2P14S configuration
- 6.7 kWh modules (14 modules per rack see Figure 3)
- 27 fully populated racks in the system, and several additional empty racks for future expansion
- 2.0MW/2.0 MWh nameplate rating for the container

**Figure 3 Racks within the energy storage system comprising LG Chem battery cells, modules, inverter, controller, and battery protection unit (image credit: APS)**

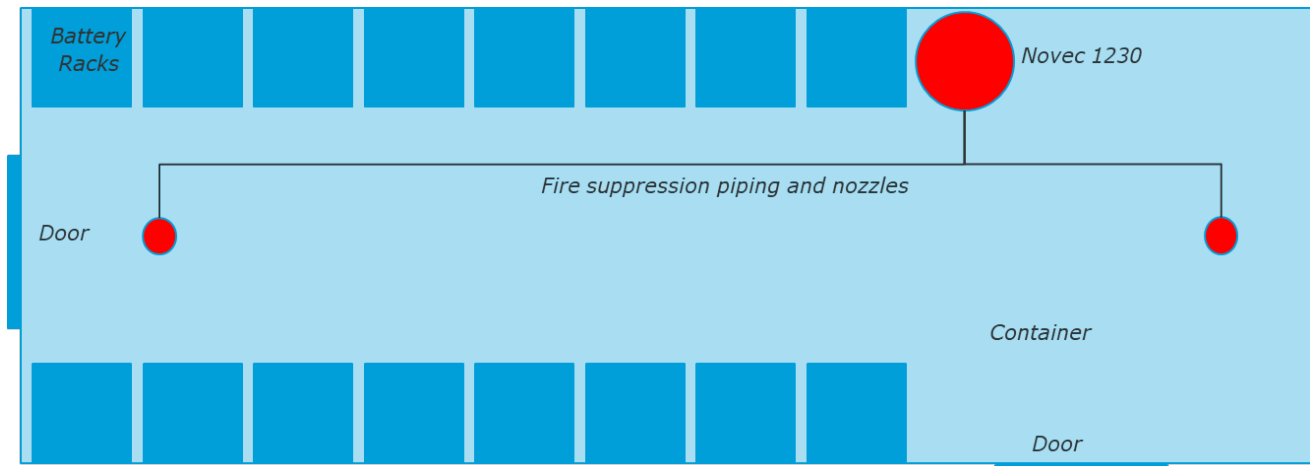
When the fire detection system detects a fire, the fire suppression system discharges the agent through a piping system with nozzles mounted on the ceiling, which emits the agent in a fine mist, dispersing and evaporating in the atmosphere. Clean agents are typically used to extinguish incipient (i.e., small) fires before significant damage occurs to the remaining equipment.

**Figure 4 A simplified illustration of a typical fire suppression system within an energy storage container similar to McMicken**

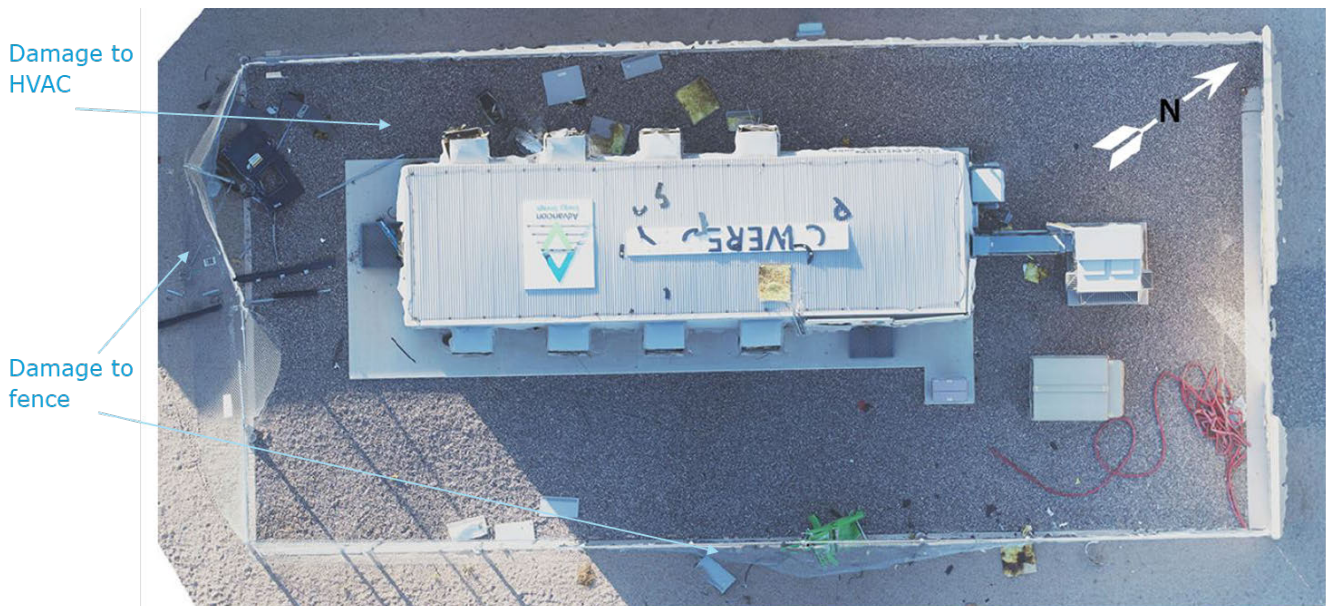
Approximately 3 hours after the initial voltage drop and discharge of the fire suppressant, firefighters opened the side container door, and approximately 2-3 minutes after the door was opened, an explosion occurred. The doors on the side and rear of the BESS and other debris were ejected by the explosion as shown in the figures below. The HVAC systems were also significantly damaged.

**Figure 5 Aerial view of damaged BESS (image credit: Colwell Consulting)**

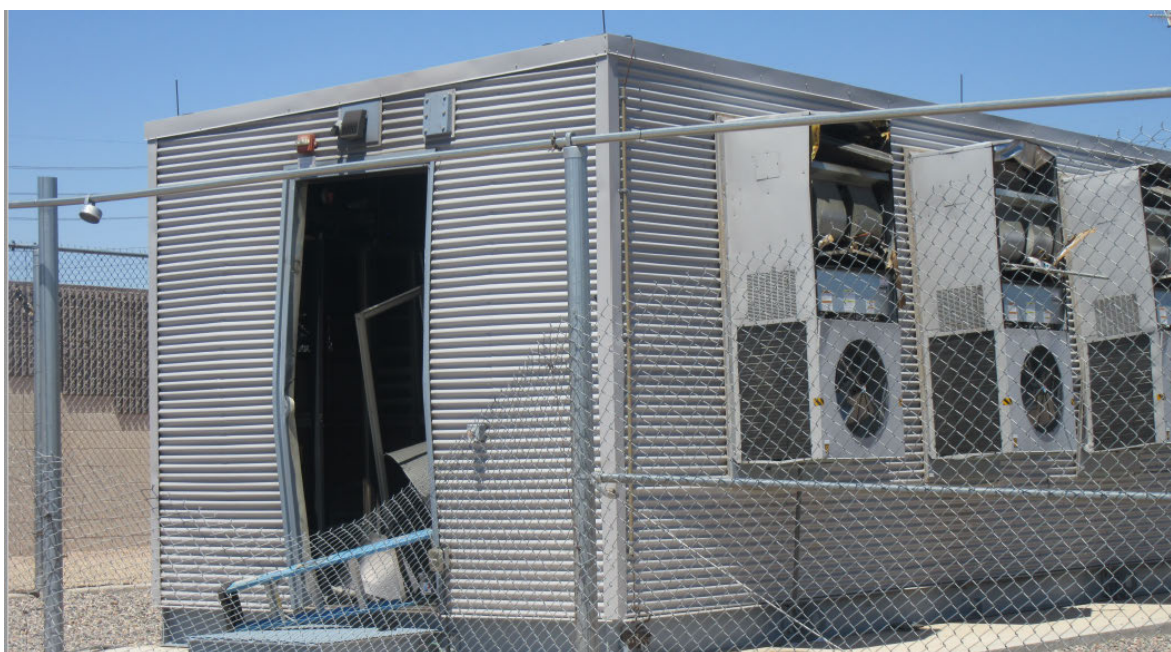
**Figure 6 Damage to the rear door and HVAC systems of the McMicken BESS**

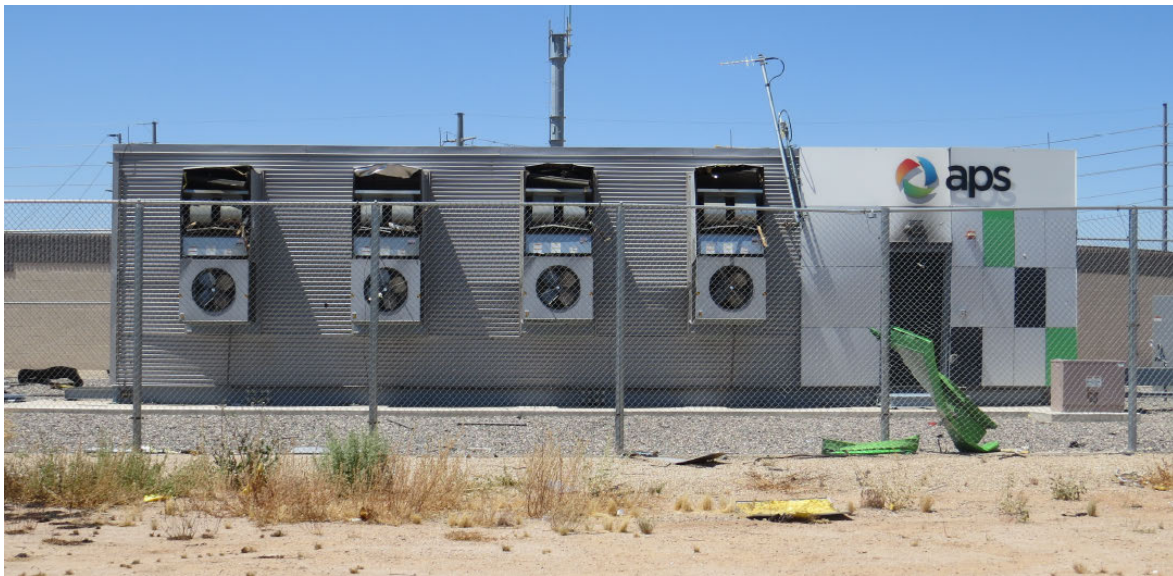
**Figure 7 The side door to the McMicken BESS was ejected in the explosion and can be seen laying against the fence in the foreground**

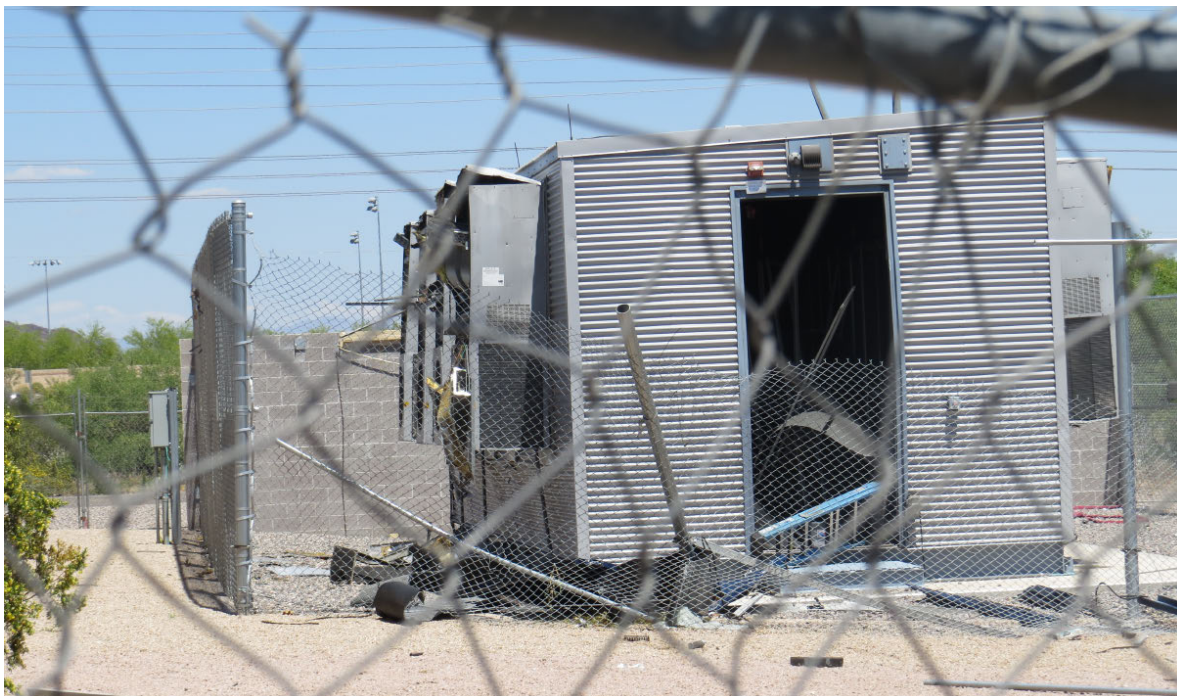
**Figure 8 Additional view of debris and damage to the rear door, HVAC systems, and the container**

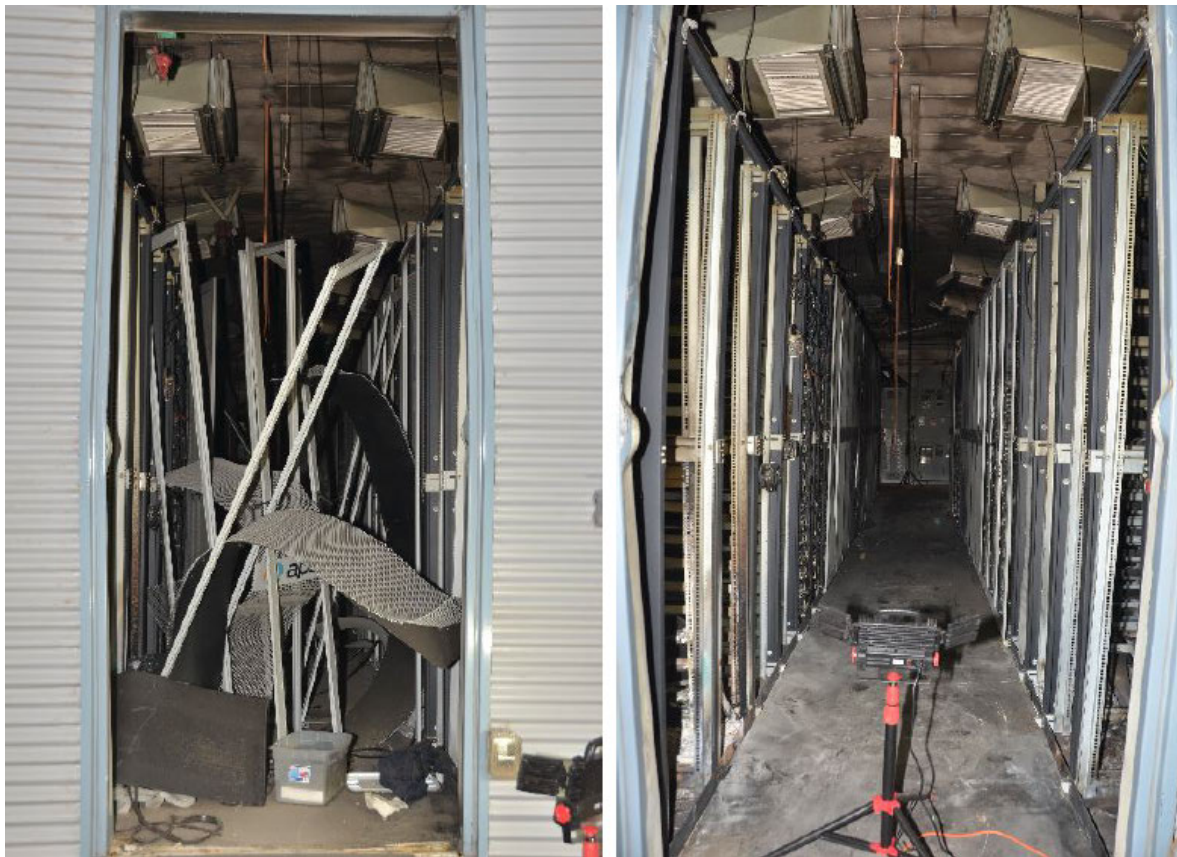
**Figure 9 Interior damage to the energy storage system with the condition after the explosion (left), and condition after debris was removed to gain access to the interior and begin the forensics analysis (right)**

APS built a temporary work environment around the BESS, which included power connections, facilities for staff and evidence storage, and a secure, environmentally controlled tent over the entire BESS container (as shown in Figure 10). Prior to the dismantling and discharging of the battery racks and modules, a team had to enter the container and clear access to the critical BESS equipment. This required clearing of debris from the hallway (Figure 9).

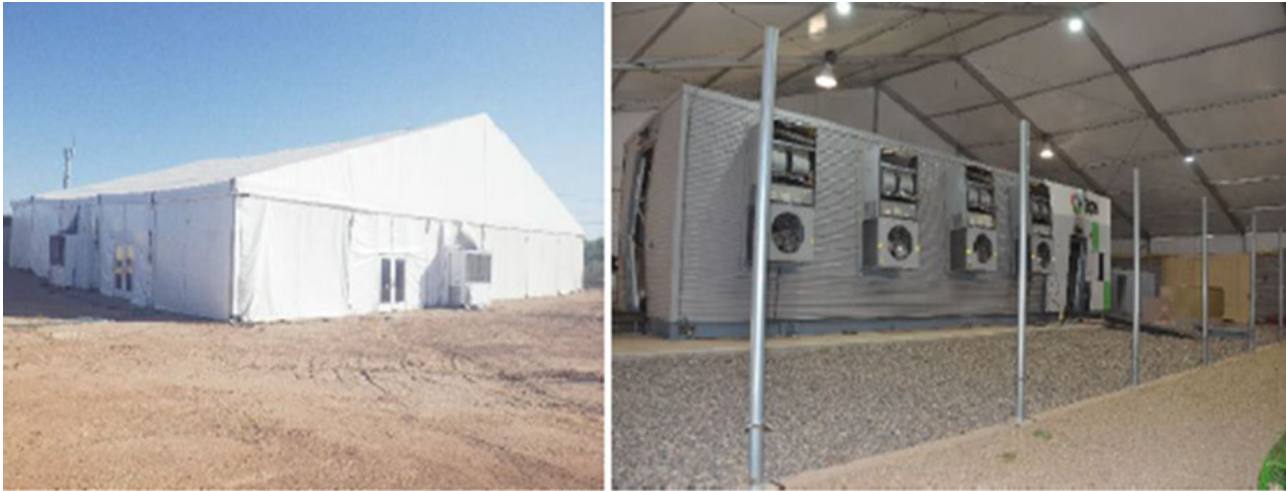
**Figure 10 Climate controlled tent structure erected by APS to preserve the BESS site during the investigation (image credit: APS)**

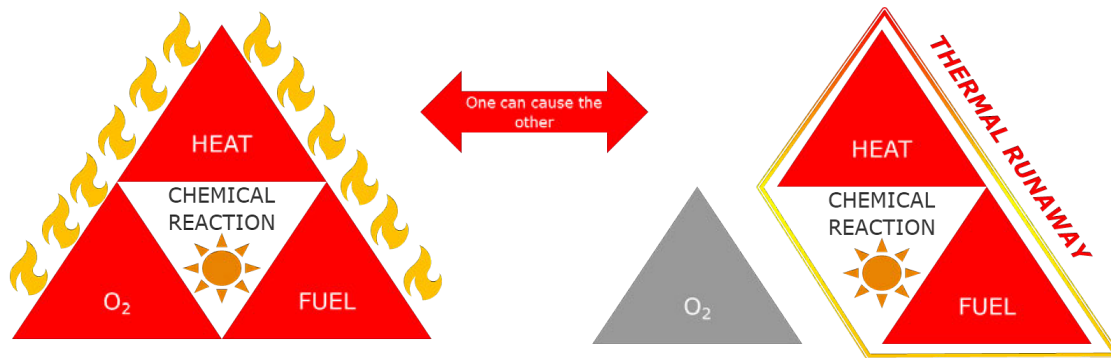
**Figure 11 The fire triangle and its relationship to thermal runaway**

During the test it is shown that even after thermal runaway ended and the exterior temperatures are decreasing, the interior temperature (between the cells) remains nearly unmitigated. This residual heat can cause reignition of battery cells after extinguishing has occurred and can become an ignition source if it comes into contact with the flammable gases released during and after the thermal runaway event. In a large group of battery cells, such as the BESS, this residual heat poses a risk to restart propagation of thermal runaway for minutes to hours. Cells that have not yet undergone thermal runaway eventually will unless the batteries are separated or cooled (recall the fire triangle in Figure 11).

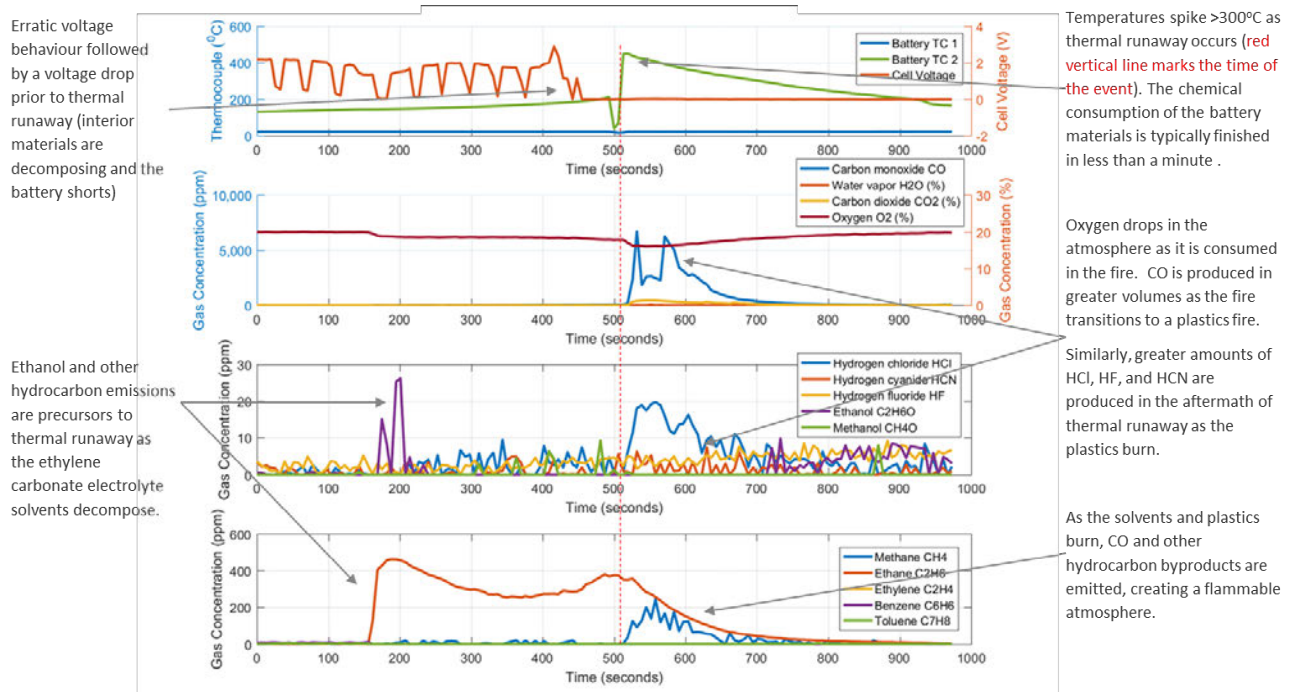
In a module, rack, and system, battery cells can fail at different rates under different modes of off-gassing—with or without flaming. Because thermal runaway can occur without flame, gases may not be consumed by an ignition source immediately after they are emitted from a consumed cell. The presence of a fire suppression agent will also inhibit ignition of these off-gases. **In fact, the potential of a non-flame thermal runaway event creates a scenario where high heat and combustible gases can coexist without igniting.** This is an important aspect of thermal runaway that is relevant to the cause of the explosion at the McMicken facility.

**Figure 12 A typical pattern of a Li-ion battery cell thermal runaway event in air with observed temperature behavior and gases**

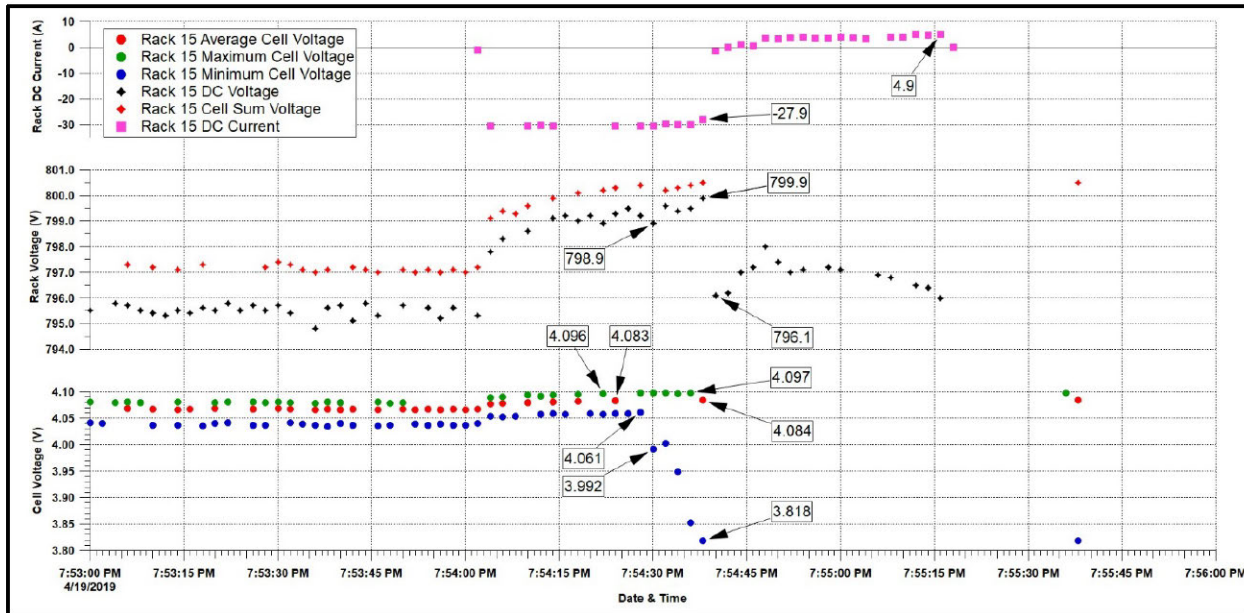
**Figure 14 Voltage data for the minimum cell voltage in the rack and total rack voltage showed a drop (image and analysis: SEL)**

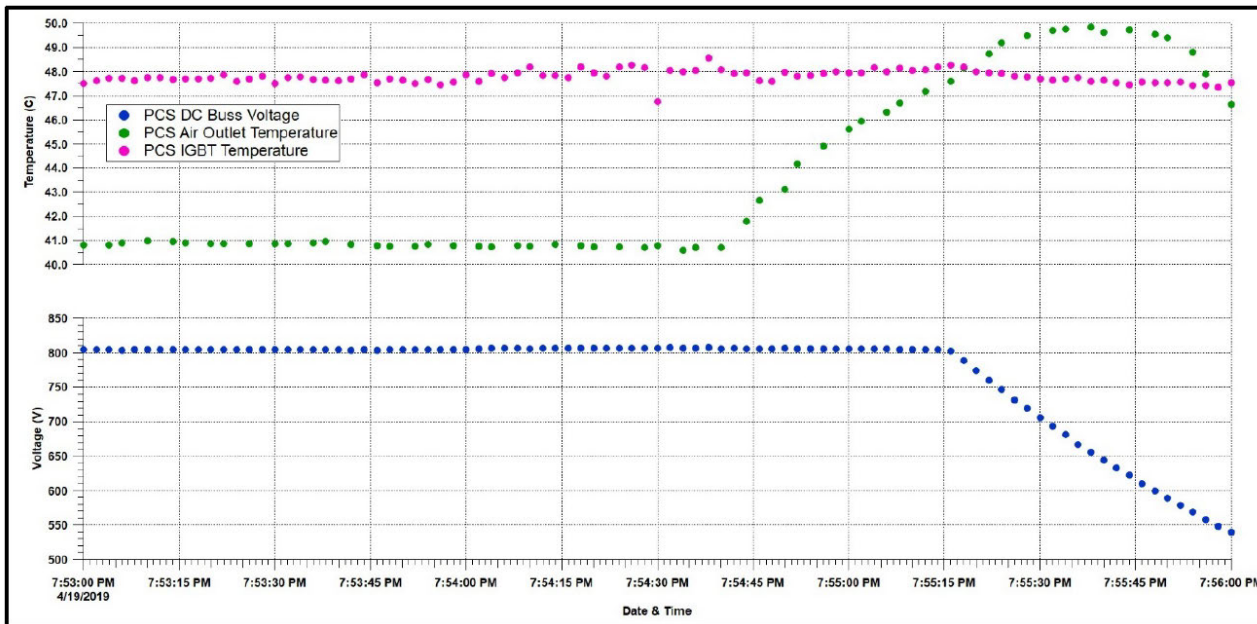
**Figure 15 Air temperatures increased as voltage in Rack 15 declined (image and analysis: SEL)**

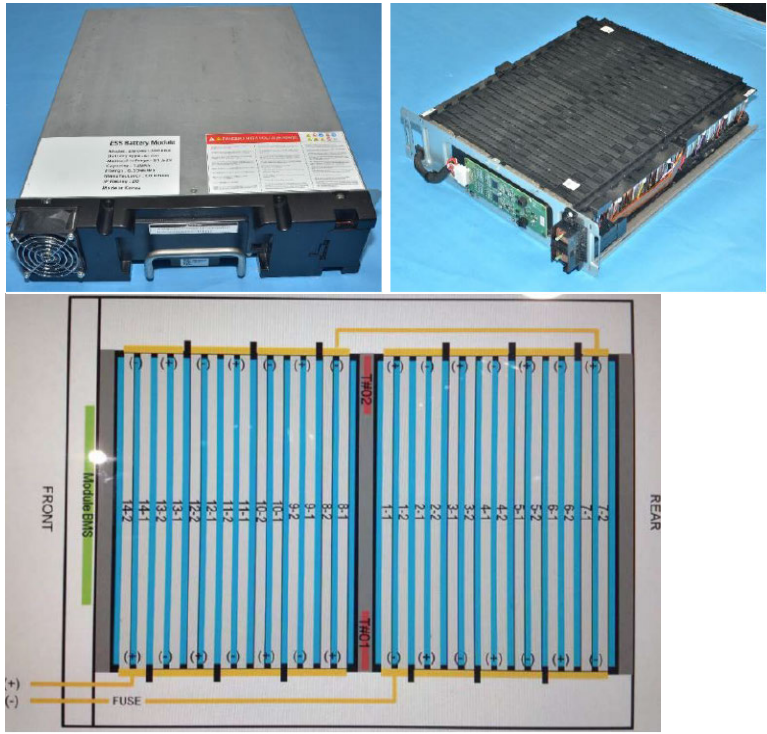
The evidence provided by the APS investigation teams provides strong data supporting that rack 15, module 2, battery cell pair 7 was the origin. Specifically, battery 7-2, located at the very rear of the module suffered an internal failure, which was indicated by the ejection of internal battery cell material and further confirmed by visual observations of the heat damage on neighboring cells and the module exterior. The location of battery 7-2 is shown in Figure 16.

**Figure 16** A description of the battery cell numbering in the LG Chem battery modules. Battery 7 is the last two cells (pair); 7-1 is next one inward, 7-2 is rearmost (image credit: APS)

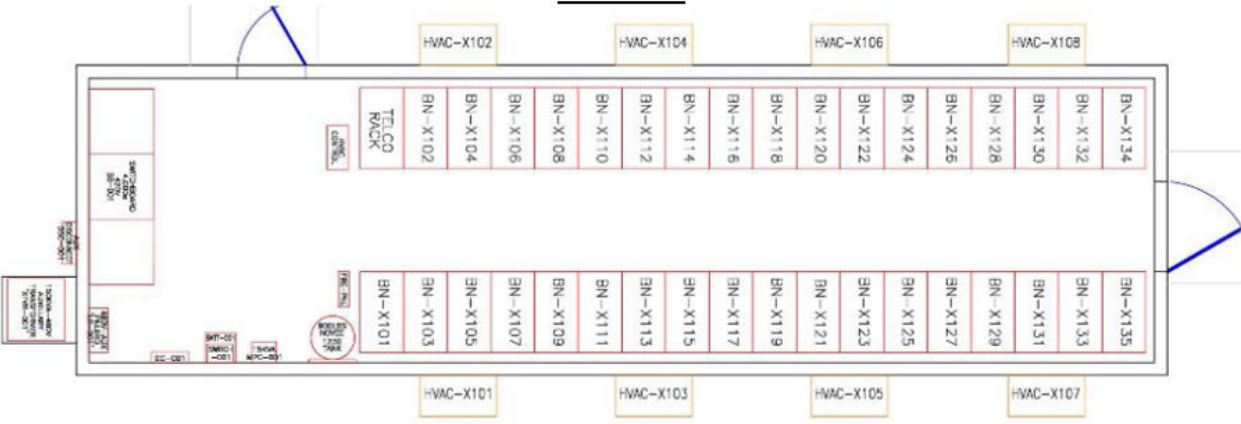
With the exception of the telecommunications rack, the official nomenclature of the racks follow a BN-X## format. The rack where the failure occurred was BN-X115. Modules are numbered from the bottom upward. There are 36 rack positions in the system. (BN-X115 position in the BESS is shown in Figure 17.)

**Figure 17** Rack numbering layout inside the energy storage container

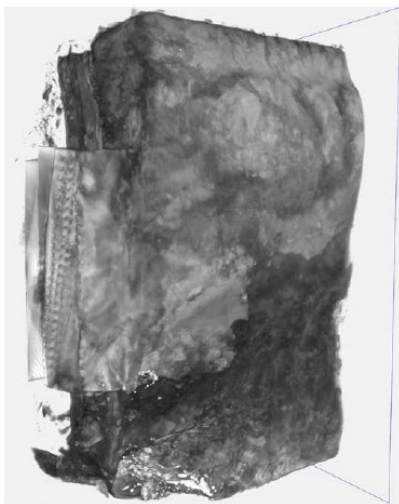
**Figure 18 A 3D reconstructed image of the CT-scanned battery cell 7-2 demonstrates the absence of material in the bottom corner of the battery cell (image credit: SEL)**

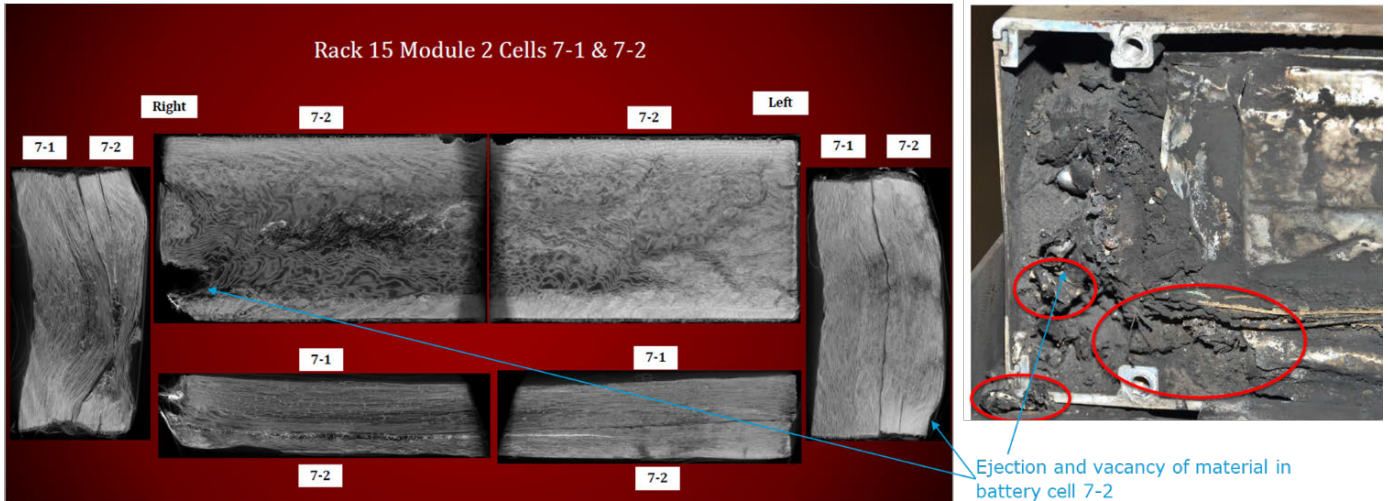
**Figure 19 Vacancy of material in battery cell 7-2 during x-ray tomography (left) and evidence of ejected material during the disassembly of Module 2, Rack 15 (right) (images and analysis: SEL)**

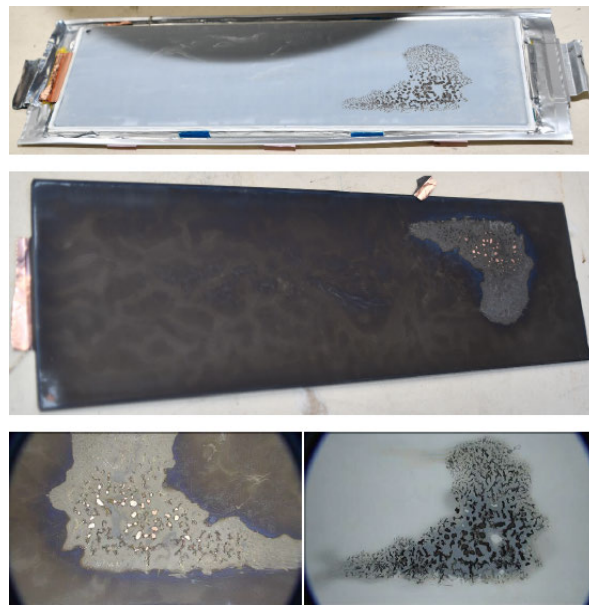
Throughout its investigation and analysis, SEL analyzed and inspected a random subset of non-Rack 15 modules, as well as modules from the Festival Ranch BESS. Analysis of battery cells from non-rack 15 battery modules from the BESS revealed internal Lithium deposits and abnormal dendritic growth populating the electrode layers of a significant number of cells. Their presence on the surface of the anode and their propensity to absorb moisture and react exothermically when exposed to open air makes them consistent with metallic Lithium plating. These deposits were also observed in similar frequency and morphology on many of the Festival Ranch battery cells analyzed. For example, Figure 20 demonstrates the internal Lithium deposits and dendritic growth found in battery cell 7-2 of Module 6 of Rack 24 of the McMicken BESS.

**Figure 20 Deposits and dendritic growth observed on other McMicken battery cells during the investigation (image credit: SEL)**

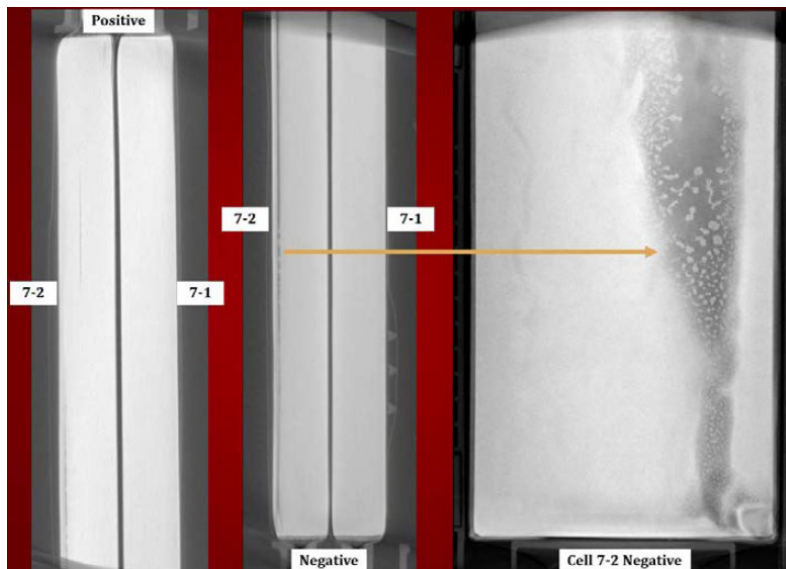
**Figure 21 Deposits and dendritic growth observed in other McMicken battery cells outside of Rack 15 (Rack 24, Module 6, Cells 7-1 and 7-2) (image credit: SEL)**

SEL determined that the presence of both Lithium deposits and dendritic growths in both McMicken and Festival Ranch battery cells, which had similar operational parameters and use histories, provided evidence that these deposits were inherent in the battery cells themselves, and not the result of any misuse from operation in the BESS.

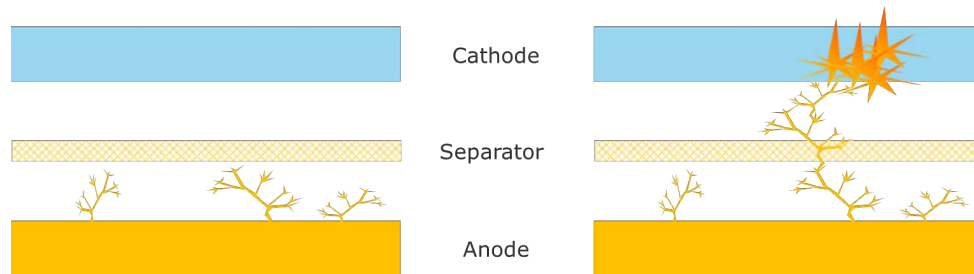
**Figure 22 Li dendrites form during cycling (left), but under certain conditions may cyclically grow to penetrate the separator and short the electrodes (right), causing thermal runaway**

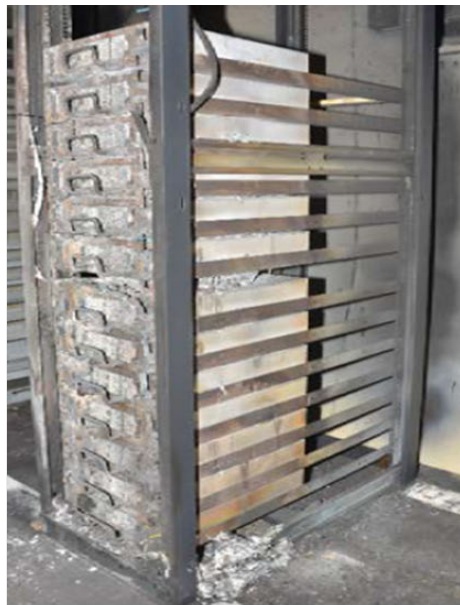
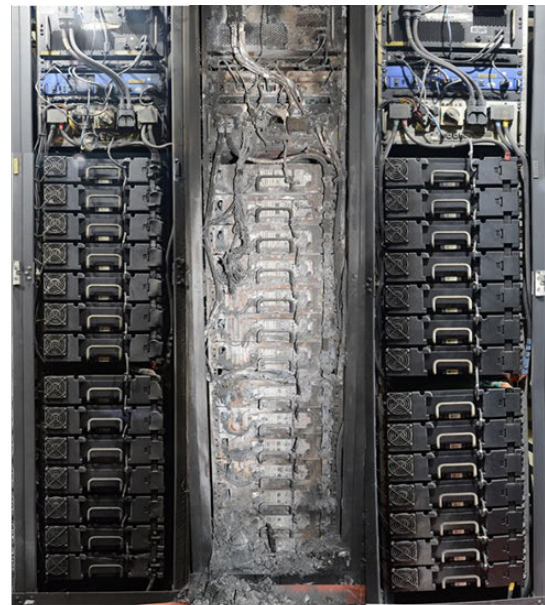
Rack 17    Rack 15    Rack 13

Modules 1-13 were partially melted and fused from the heat of thermal runaway.

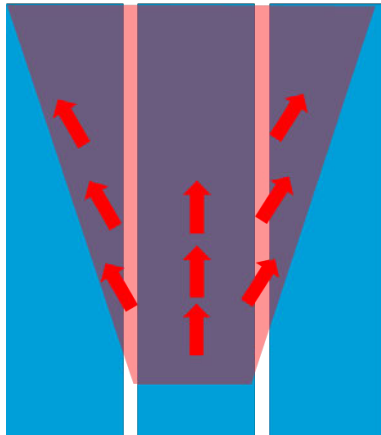
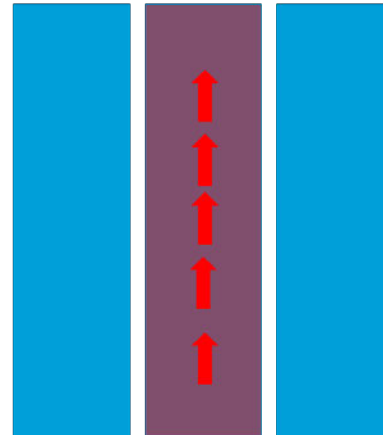
Conventional fire, V-shape direction due to direct flame and heat.

Thermal runaway, primarily heat transfer

**Figure 24** Difference in expected damage pattern between an open fire in the battery rack, and heat transfer vertically through the rack due to thermal runaway

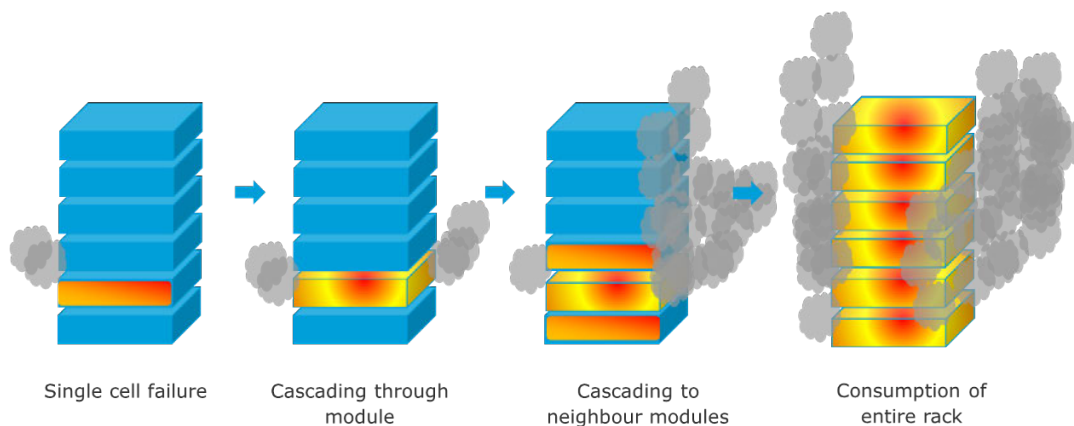
A key factor exacerbating this incident was the absence of any means by which the battery modules could prevent the continued propagation and cascading from a single cell. The Novec 1230 discharged shortly after the first cell failed, yet thermal runaway continued to propagate. (Figure 25) The Novec 1230 system could only discharge once, by design, yet the flammable gases continued to emerge as each new cell cascaded in thermal runaway. The Novec 1230 discharge may have played a role in preventing the ignition of flammable gases when they were released, but Novec 1230 and other clean agents are not intended to stop the progression of a cascading thermal runaway. Consequently, the spread of thermal runaway led to the generation of a large quantity of gases, **which were not burned as they were emitted**. Figure 25 illustrates the chain of events based on the evidence available.

**Figure 25** A single cell failure propagated through Module 2, then consumed the whole rack, releasing a large plume of explosive gases. This process could have occurred without visible flame, which would explain why the gases were not burned as they were emitted.

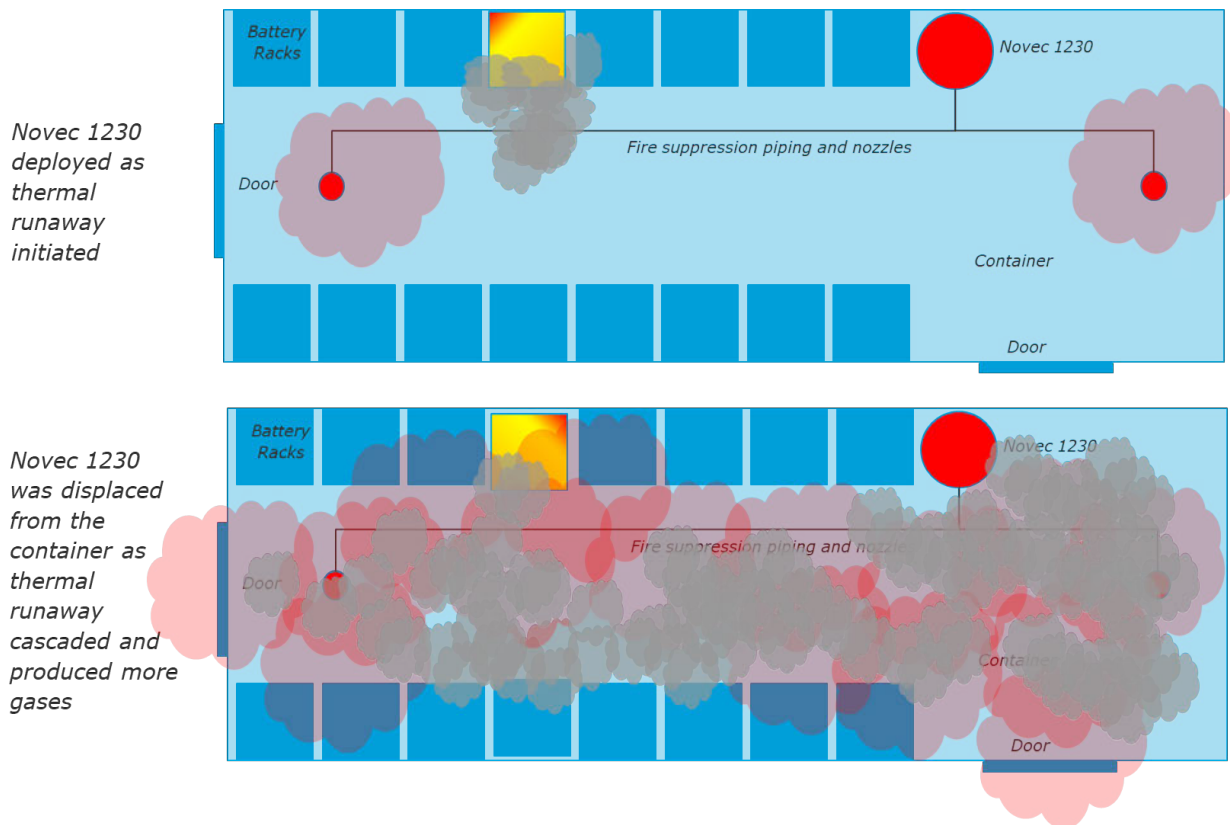
Colwell's analysis of the BESS suggests that the hotter, flammable gases rose to the upper level of the container while the Novec 1230-air mixture would descend due to its higher mixture density and cooler temperature. Over time, the hotter rising flammable gases displaced the Novec 1230-air mixture as it leaked from the doors and other seals in the container. The amount of time from the initial discharge of Novec 1230 to the opening of the door provided ample opportunity for the flammable gases to concentrate, as illustrated in Figure 26. The Novec 1230 is red in the figure, and the flammable gases from thermal runaway are grey.

**Figure 26 Flammable gases continued to concentrate as thermal runaway propagated through the rack**

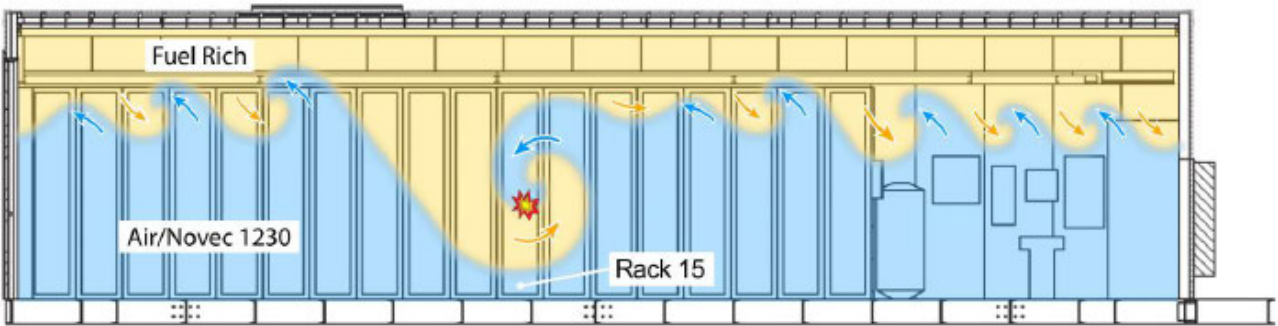
Colwell hypothesized that when the container door was opened, the flammable mixture came into contact with a thermal source, which was likely to be the still hot batteries in Rack 15, as illustrated in Figure 27. It is Dr. Hill's experience that residual heat within a battery module that has experienced thermal runaway damage can remain for minutes and hours after thermal runaway appears to be complete (see Figure 34 in following sections), so this ignition mode is plausible.

**Figure 27 Colwell’s simplified illustration of flammable gases near the top of the container rolling back as a reaction to the door opening, putting them in contact with residual heat or spark at Rack 15 (image credit: Colwell)**

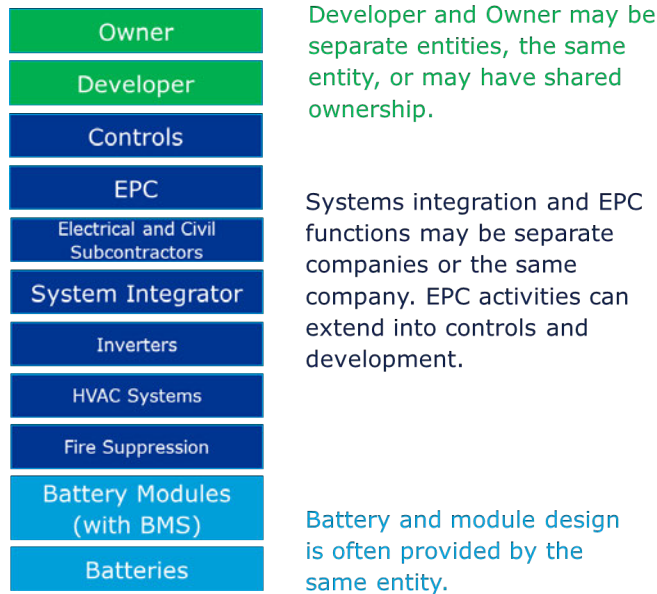
**Figure 29 Division of roles and responsibilities in a typical commercial energy storage project, 2014-present**

Another human factors issue with NFPA 855 is that it does not distinguish between the roles of the parties (as shown in Figure 29) involved in the procurement and development of a battery energy storage system, and instead generally states that the owner or their authorized representatives shall provide training and response.

However, the insistence on the owner to provide training is not always appropriate with today’s practice in the energy storage industry, where owners of energy storage systems are more frequently private equity firms, investment funds, and independent power producers (IPPs) who might not be engaged directly in operations—and are less frequently utilities, although that is changing. Today, it is the practice in the industry that the EPC contractor—in this case AES and its subcontractors—take the lead in advising, training, and recommending practices for design and safety, as well as assume maintenance and response operations.

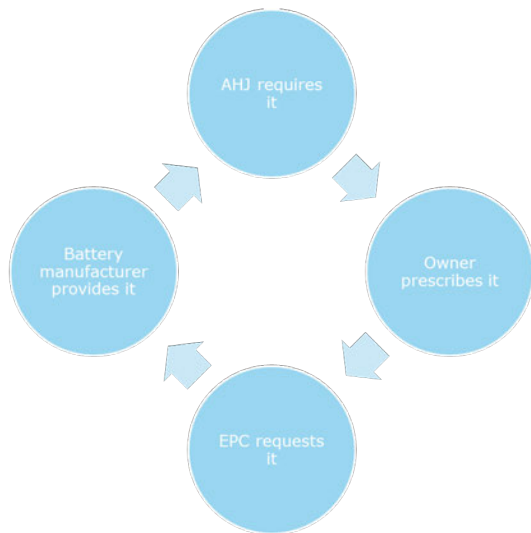
**Figure 30 Multiple parties involved in safety and design data information exchange**

The key issue here is that the entire supply chain needs to know what to ask for—otherwise it may not be disclosed. If the battery manufacturer is not a direct participant in providing thermal runaway safety data for their product, the entire supply chain may not receive the necessary data. If the AHJ does not require it, the manufacturer may not voluntarily disclose it. If the owner does not prescribe it, then the supplier may not provide it, and the AHJ may not know to ask for it either. The cycle shown in Figure 30 demonstrates this classic chicken-egg problem—where the whole cycle is broken if any single party does not initiate, respond to, or request the appropriate information.

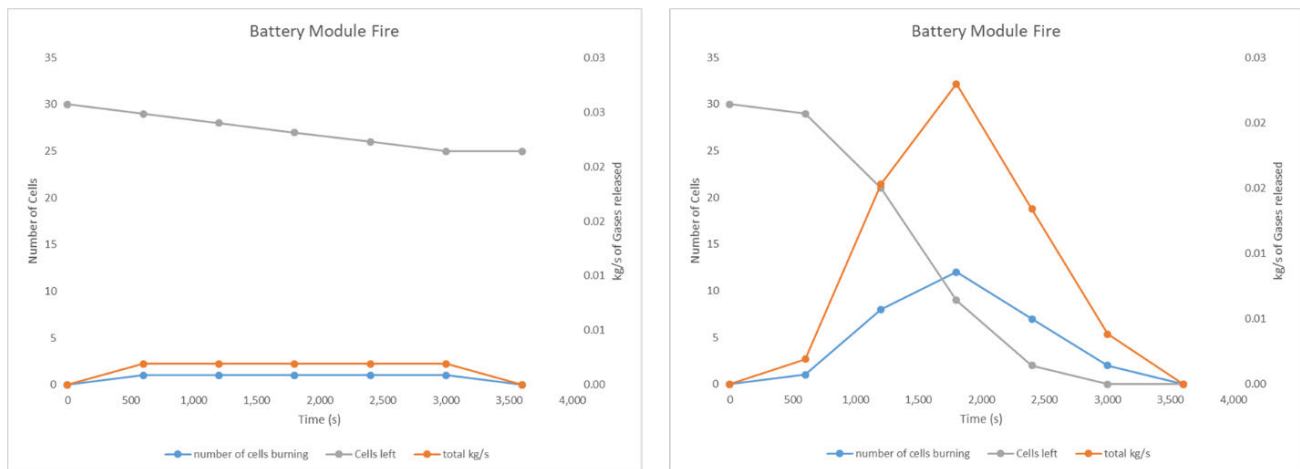
In 2015-2017, DNV GL published results related to the management of flammable gases from Li-ion battery thermal runaway for stationary storage systems and their contribution to an explosion risk. [16] As shown in Figure 31, DNV GL models demonstrate the gas release rate of Li-ion cells as they burn; as one would expect, the gas release is larger when multiple cells are cascading versus when no more than one cell is burning at a time.

No more than one cell burning at a time  
**Lower gas release**

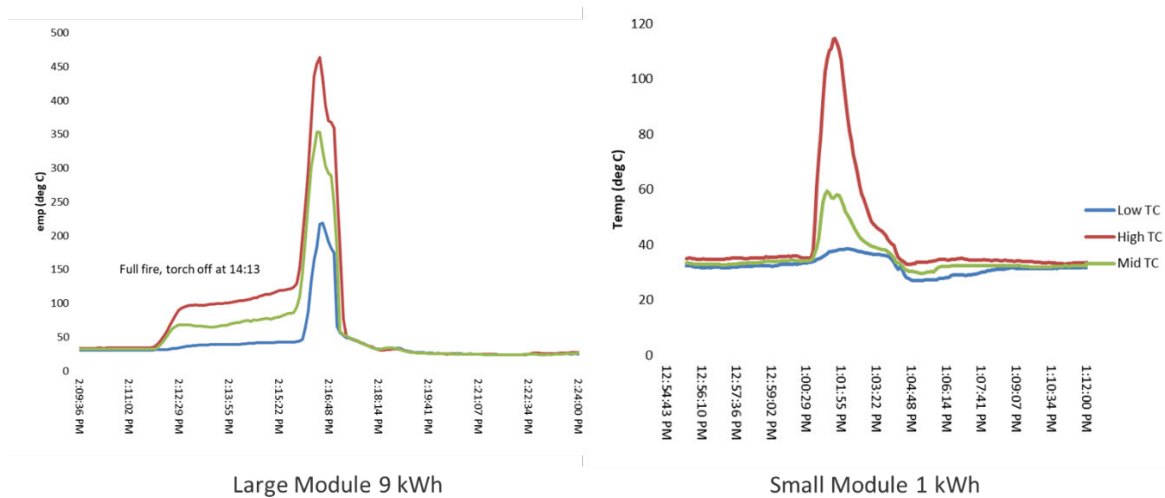
Additionally, Figure 32 exhibits the intense heat produced during thermal runaway, and demonstrates the temperature differences between large and small battery modules. For comparison, the McMicken BESS modules were 6.7 kWh, so they would be more in line with the left graph depicting the temperature for the large module.

**Figure 32 Comparison of temperature during a fire test, large modules vs. small modules**

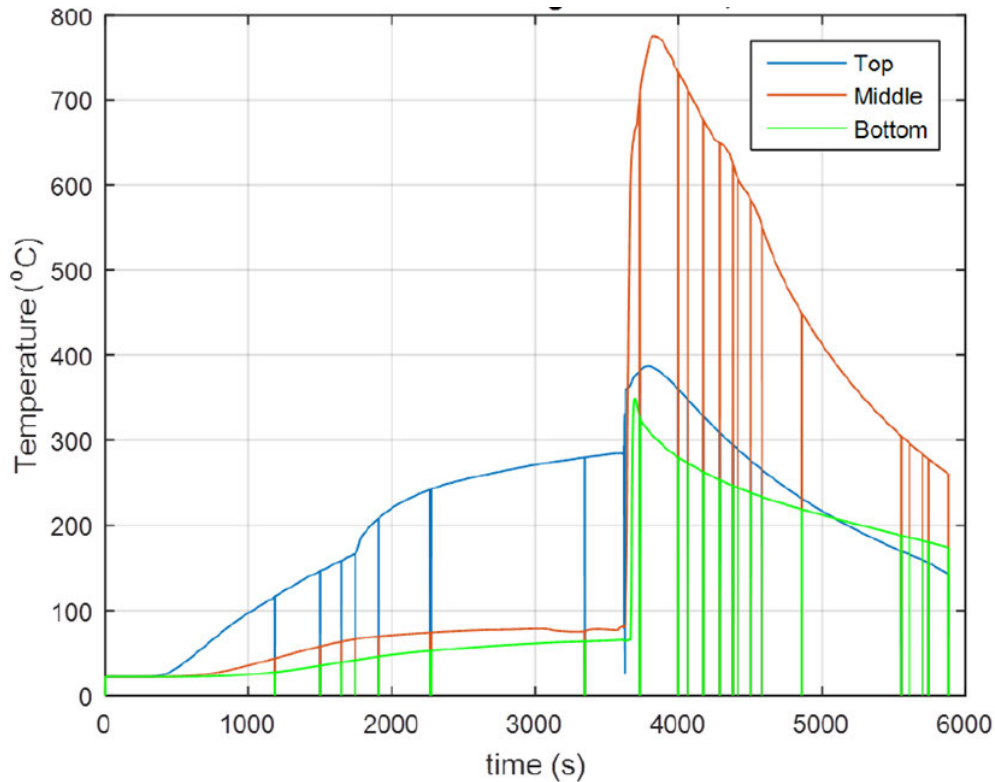
**Figure 33 Temperatures between cells remained ~300 °C higher than external temperatures during aerosol extinguishing**

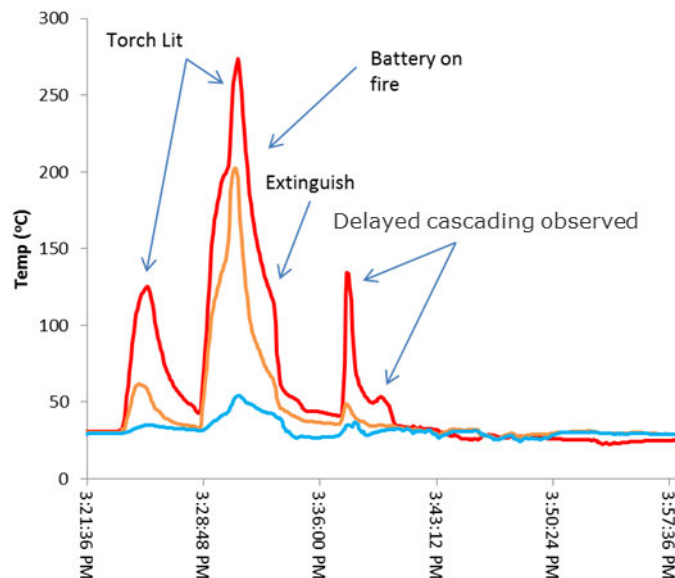
Time 0:	Torch is lit and test starts.
7 Minutes:	The battery temperatures spike. Thermal runaway has begun, eventually open flames are produced.
13 Minutes:	Fire is extinguished with water. The smoldering battery continues to be observed with a thermal camera.
13-19 Minutes:	The thermal camera measures a gradual temperature rise on the smoldering battery. No external heat is being applied. Test engineers and fire crews watch as the battery continues to self-heat and gradually produce more smoke.
18-19 Minutes:	The module reignites into flame and temperatures spike again. It is allowed to burn for another 3-4 minutes.
23 Minutes:	The fire is extinguished to final test completion.

**Figure 34 A thermal runaway test demonstrates a battery that contained residual heat, which restarted the cascading process within 20 minutes after the initial fire was extinguished**
