**“McMicken BESS event: Technical Analysis and Recommendations”**

# McMicken Battery Energy Storage System Event Technical Analysis and Recommendations

**Document No.:** 10209302-HOU-R-01

**Date:** July 18, 2020

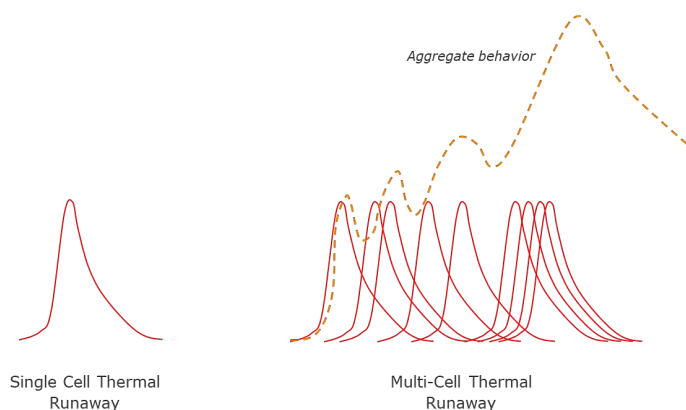
thermal runaway, the associated heat and gas behavior is a building sum of all the smaller events that produced it (recall Figure 31). This is illustrated conceptually in Figure 35. The heat load and gas load follow similar behaviors, looking like bell curves over time.

**Figure 35 Single cell thermal runaway produces a single peak, while multi-cell thermal runaway produces a cumulative buildup of heat and gases (illustrative)**

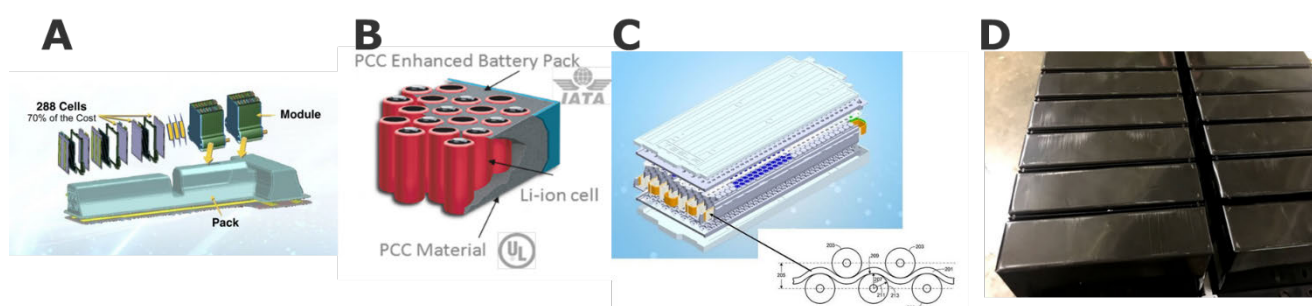
As demonstrated in Figure 36, there are several commercially available approaches that can be used to achieve all of the above goals.

**Figure 36 Examples of different approaches to cooling and anti-propagation measures**

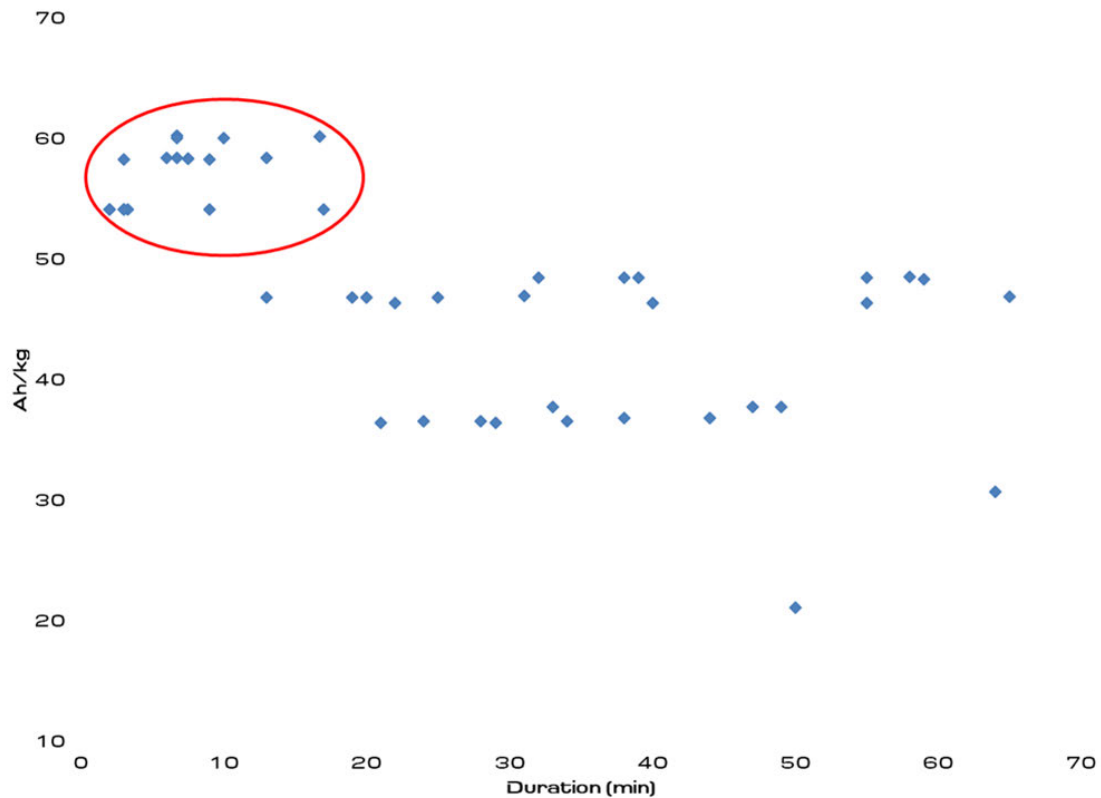
**Figure 37 The difference in duration of a cell failure for small cells vs. larger cells**

This demonstrates that smaller cells burn for a shorter amount of time and emit less gas overall. Therefore, a design philosophy that can isolate, contain, and independently vent sub-groups of batteries will allow for safer management of battery thermal runaway by reducing the overall quantity of explosive gases. Both smaller cells and smaller sub-groups would achieve the same goal. It should then be no surprise that there is a correlation in Figure 38 between module mass and peak temperatures reached.

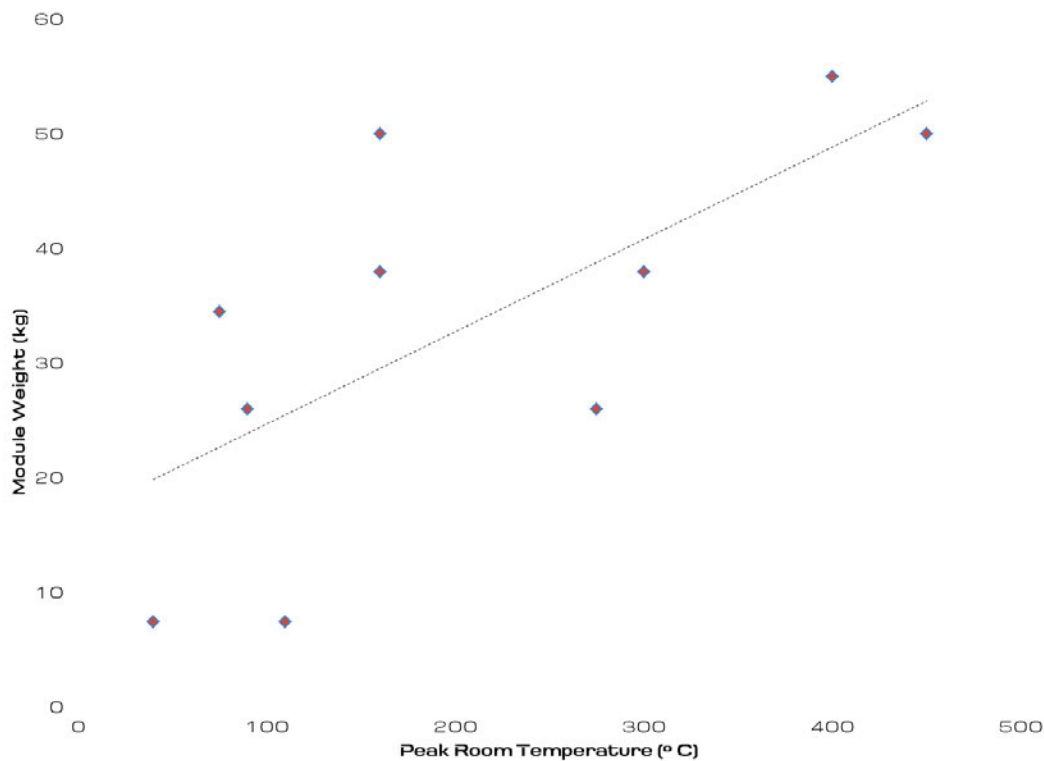
**Figure 38 Peak temperatures reached in a thermal runaway testing chamber are directly proportional to the mass of the modules**

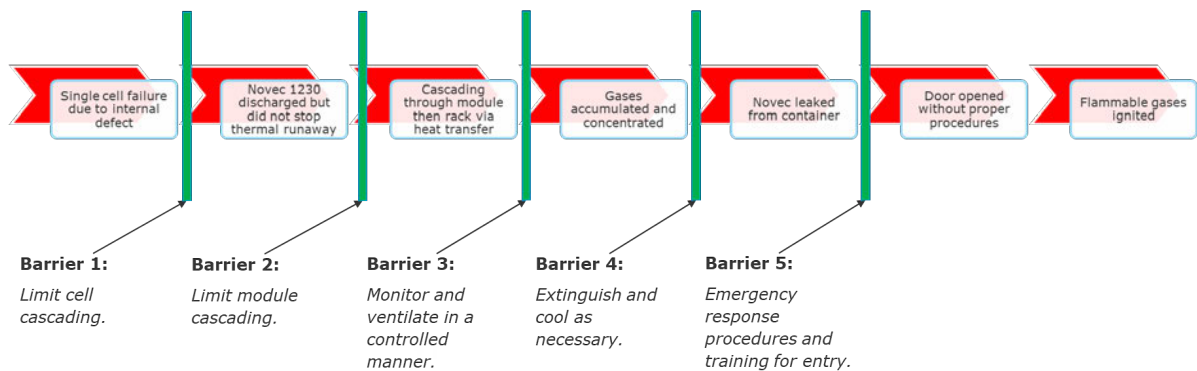
**Figure 39 Five barriers, if implemented in this scenario, may have ultimately prevented an explosion**
