Item 1: Victorian Big Battery Fire: July 30, 2021

Report of Technical findings

Victorian Big Battery Fire: July 30, 2021

REPORT OF TECHNICAL FINDINGS

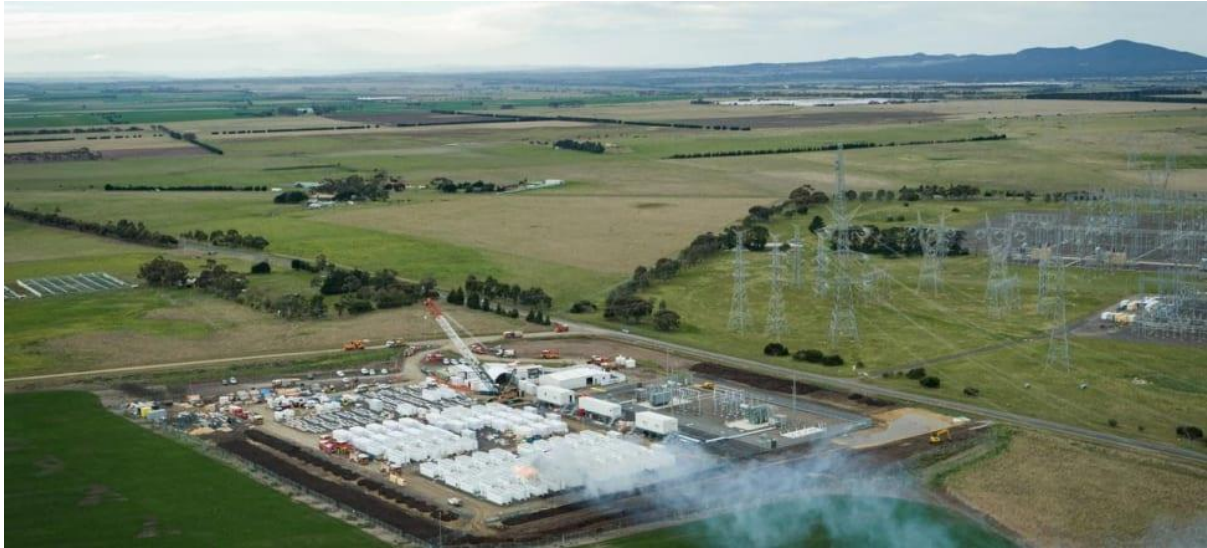
A large blaze at Victoria's "big battery" project has been brought under control by firefighters after burning for more than three days, allowing investigators to begin examining the site.

The Tesla battery bank caught fire while it was being set up in Moorabool on Friday morning, and then spread to a second battery.

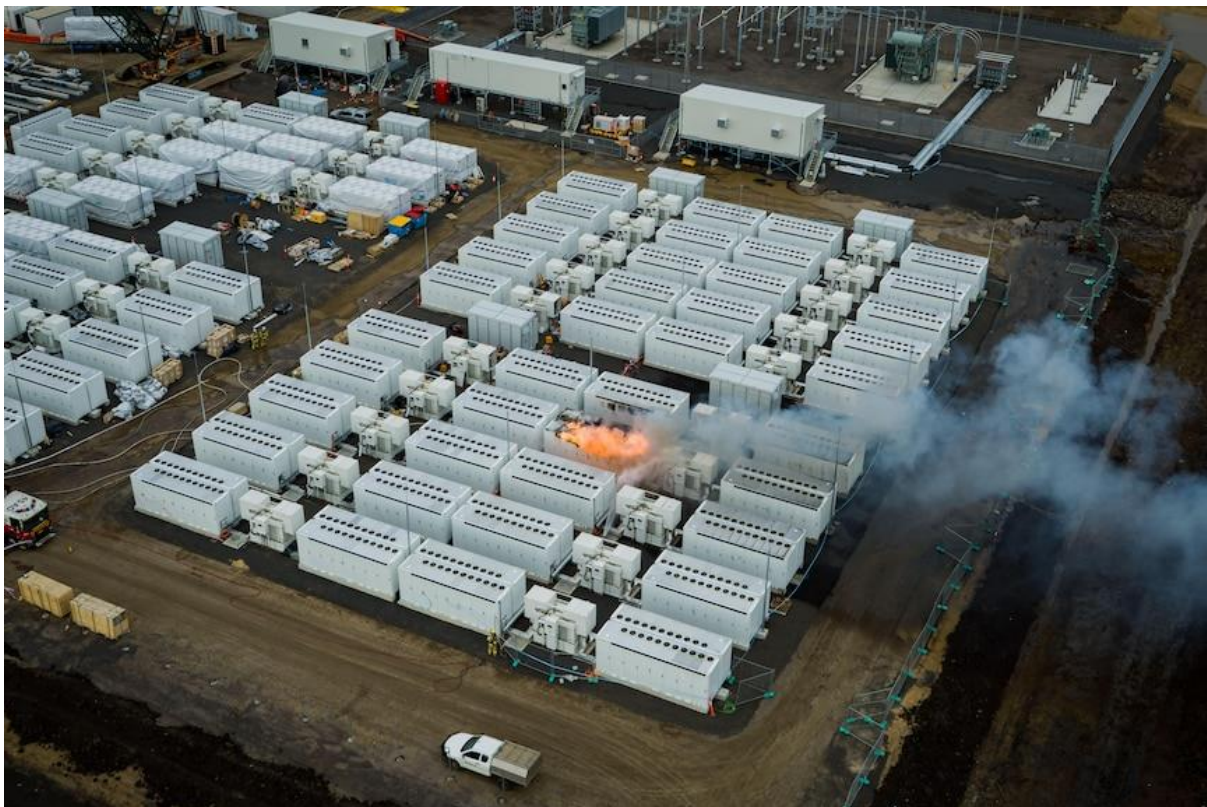
The fire broke out during testing of a Tesla megapack at the Victorian Big Battery site near Geelong.

A 13-tonne lithium battery was engulfed in flames, which then spread to an adjacent battery bank.

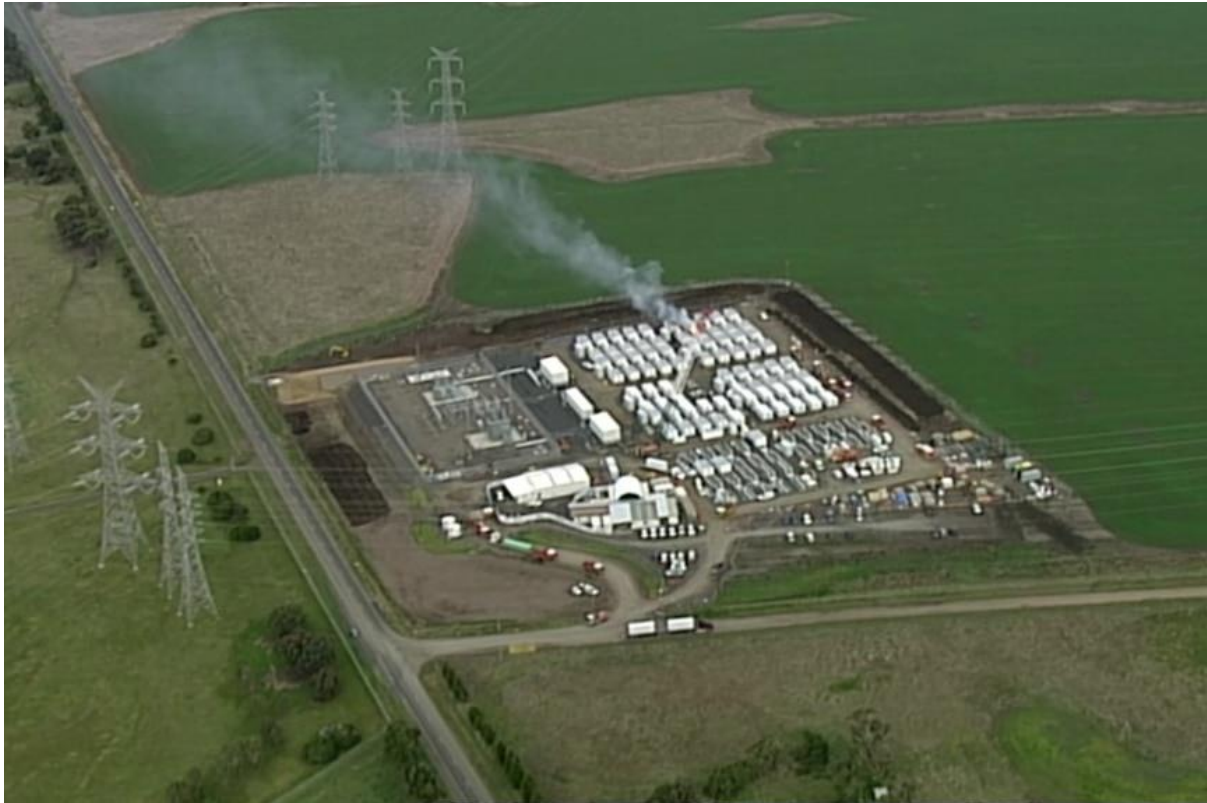
No-one was injured and the site has been evacuated.

Australian Energy Market Operator (AEMO) said the battery had been isolated and disconnected from the main electricity grid and "there are no implications" for supply.

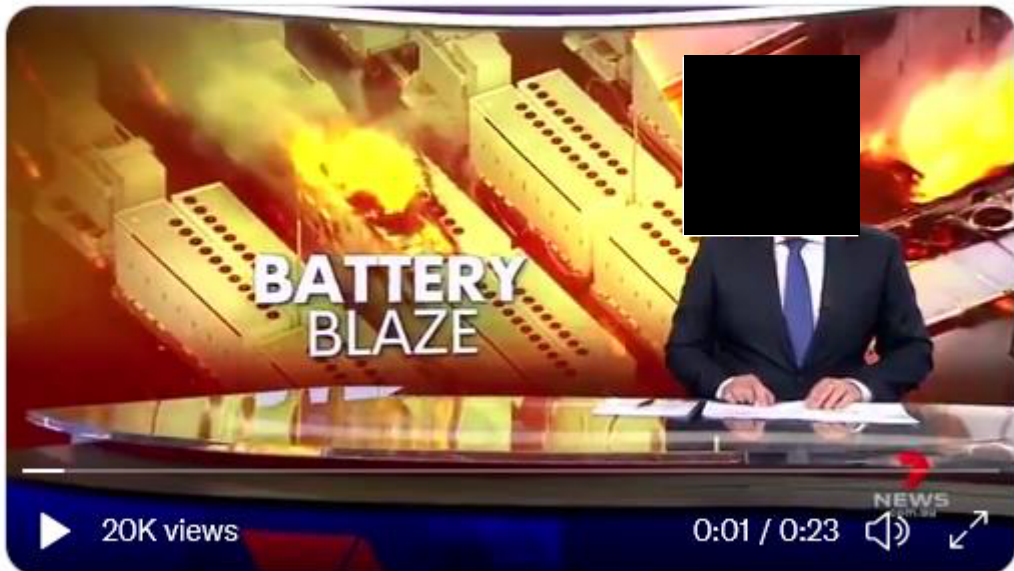
Victoria's big battery project has hit a snag. One of the massive Tesla battery packs at the Moorabool site has gone up in flames. [7NEWS.com.au](https://www.7news.com.au) #7NEWS
