## **Red Lodge Parish Council Written Representation**

Please accept the following written representation on behalf of Red Lodge Parish Council - reference: 20031138

**Fire Investigation Report 132-20**

**Incident Number 018965**

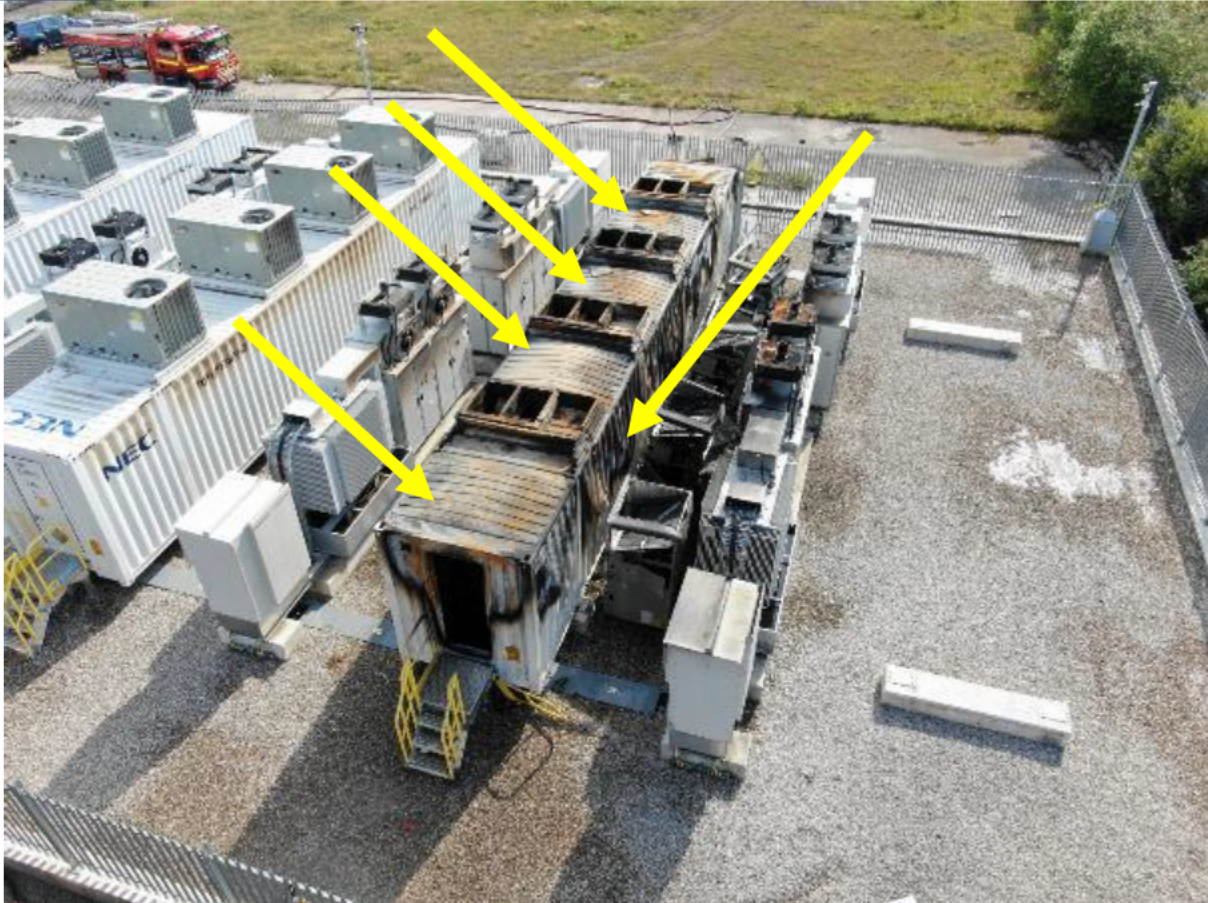
- 4.3 The container affected by fire was at the end of the row, it exhibited clear signs of pressure building-up and deflagration. This was evident by the expansion and distortion of the sides and top of the container.

*Image 2 shows the damaged container with signs of expansion/distortion that is equal across the container and not localised to the area of the initial failure.*

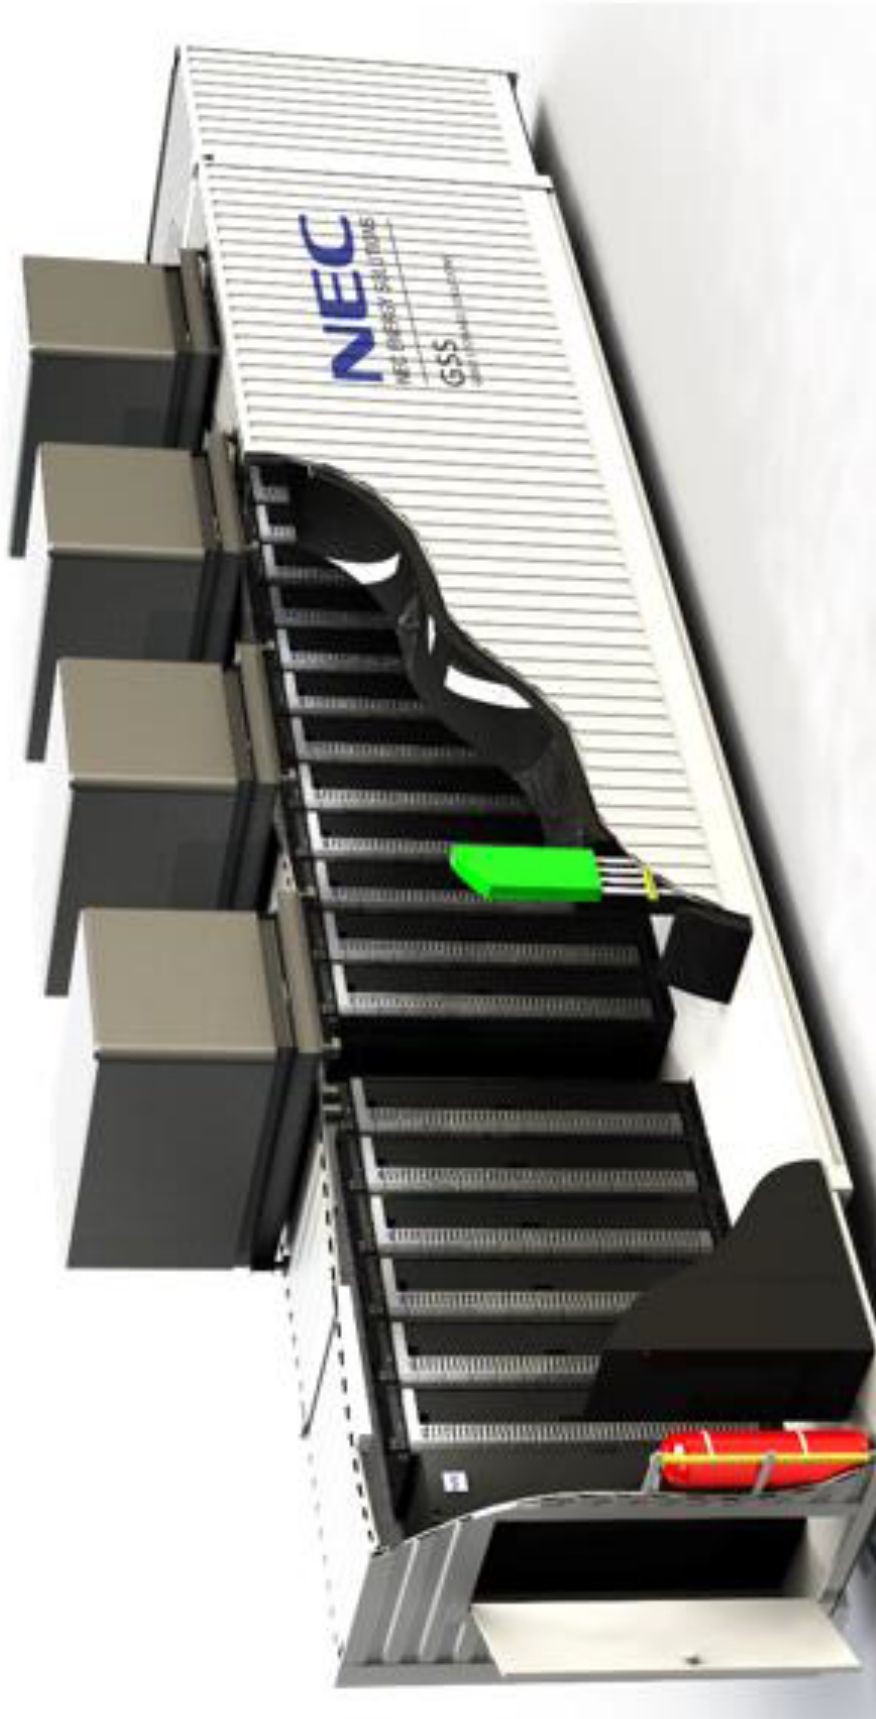
- 6.5 The affected container holds 5 Battery Zones, 9 racks per zone and 17 modules which is an assembly containing lithium ion cells. (Image 5)
- 6.6 Racks line both sides of the container and each rack has a vented doors. (Image 6 & 9)

*Image 5 is an example of how the containers are set up <sup>4</sup>*

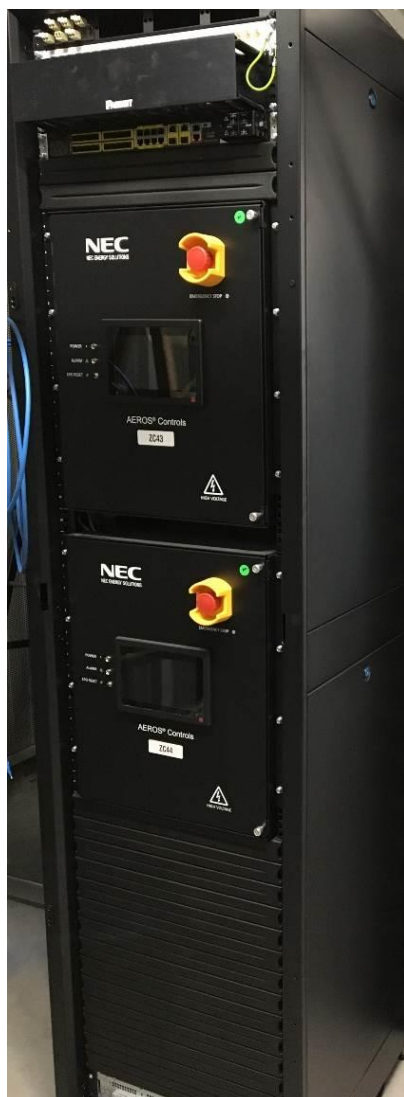
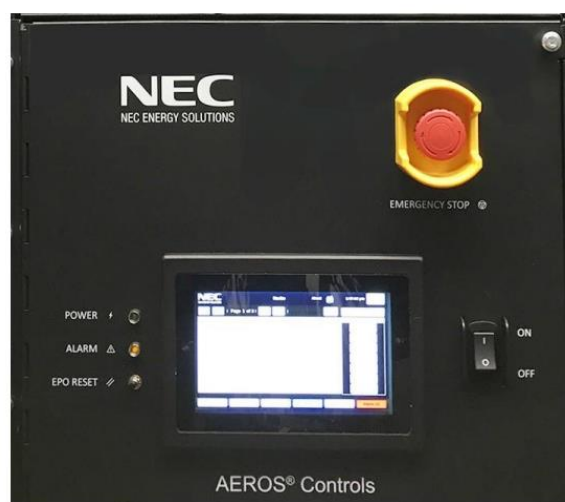
*Image 7 is an example of the Control System Monitors at the Module, Rack, Zone, Powerblock and System Levels<sup>6</sup>*

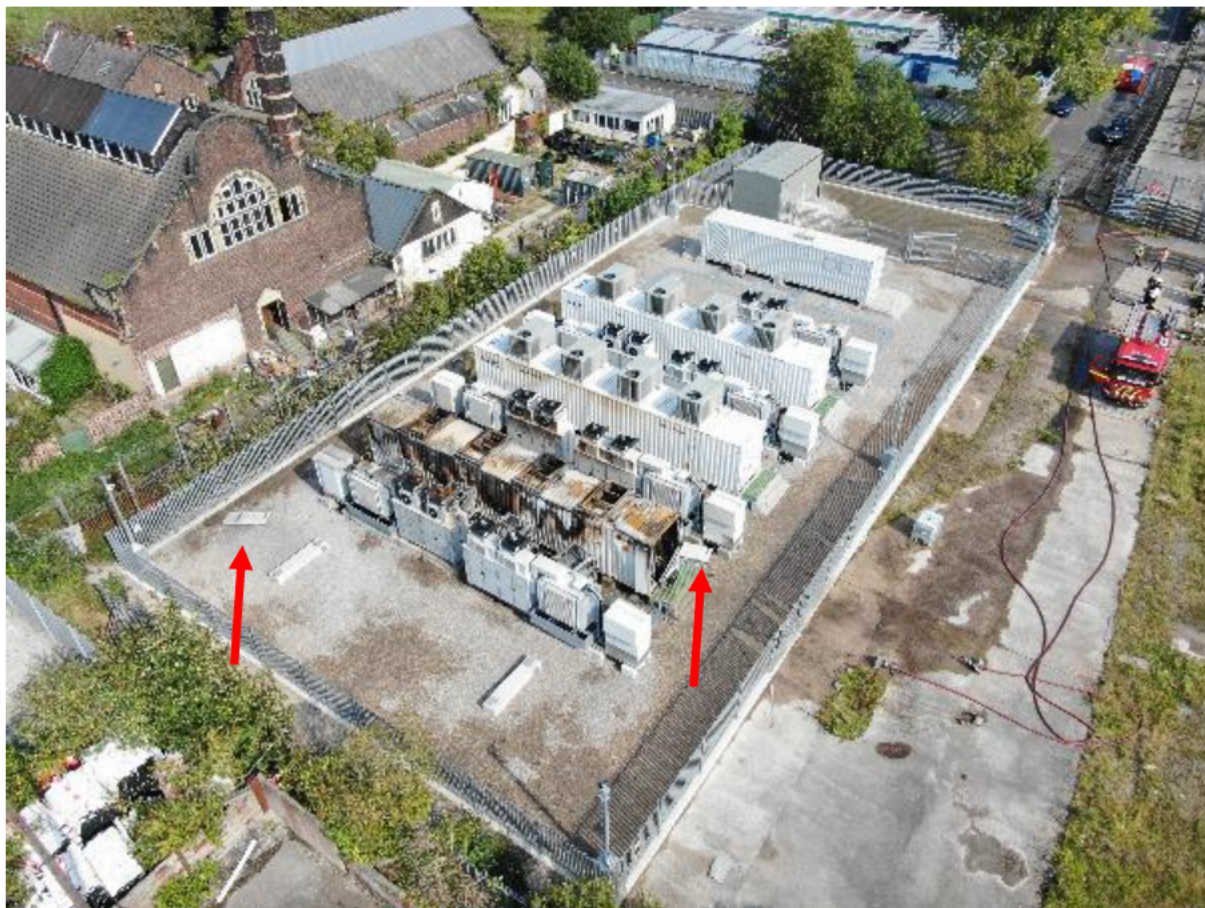
2

Air unit overview. The red arrows show the resting place of the doors

- The door closest to The Fisheries had been blown off its hinges and had ripped through the yellow safety rails before landing in the compound. These doors are of substantial weight and it would have taken great internal pressure and force to eject them to the distance observed.

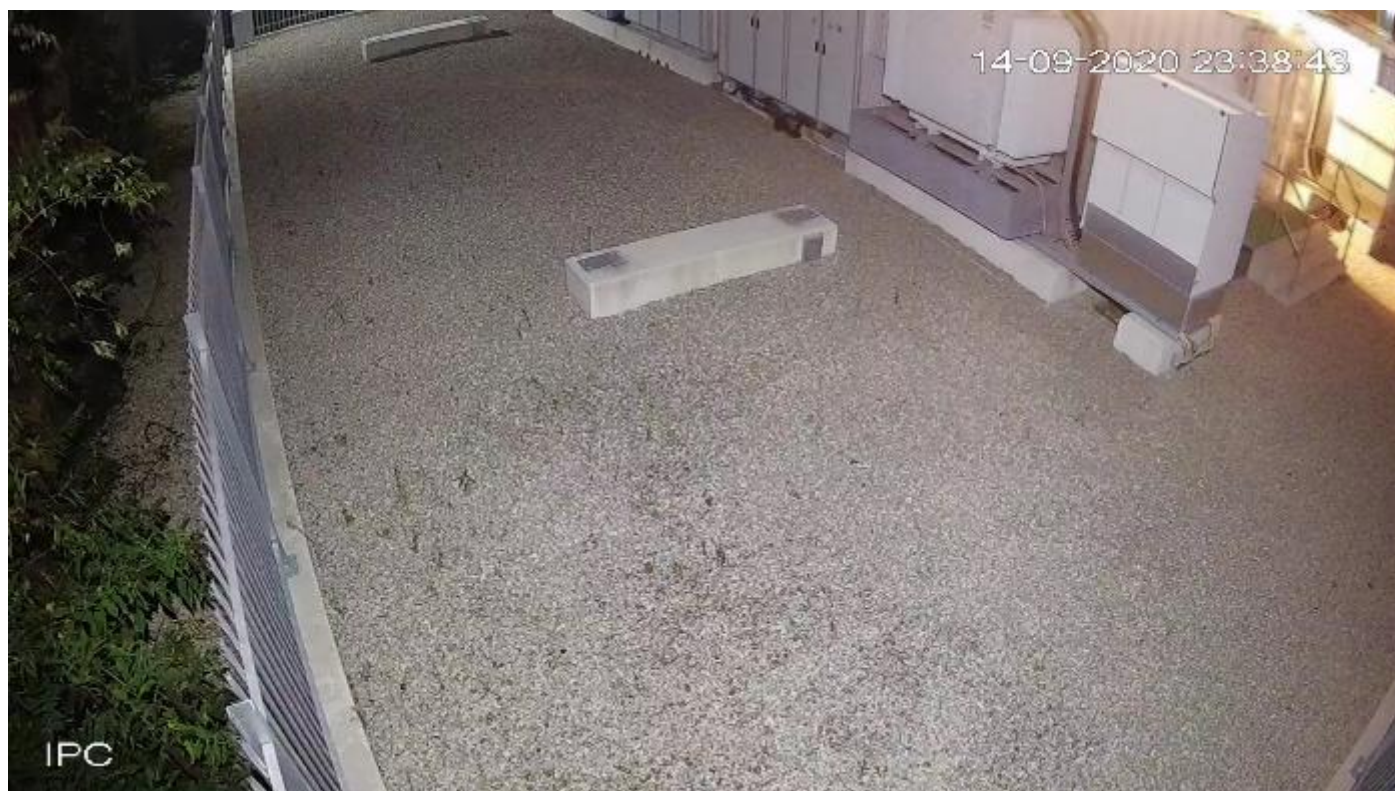
12

External CCTV at point of blast for the door fails

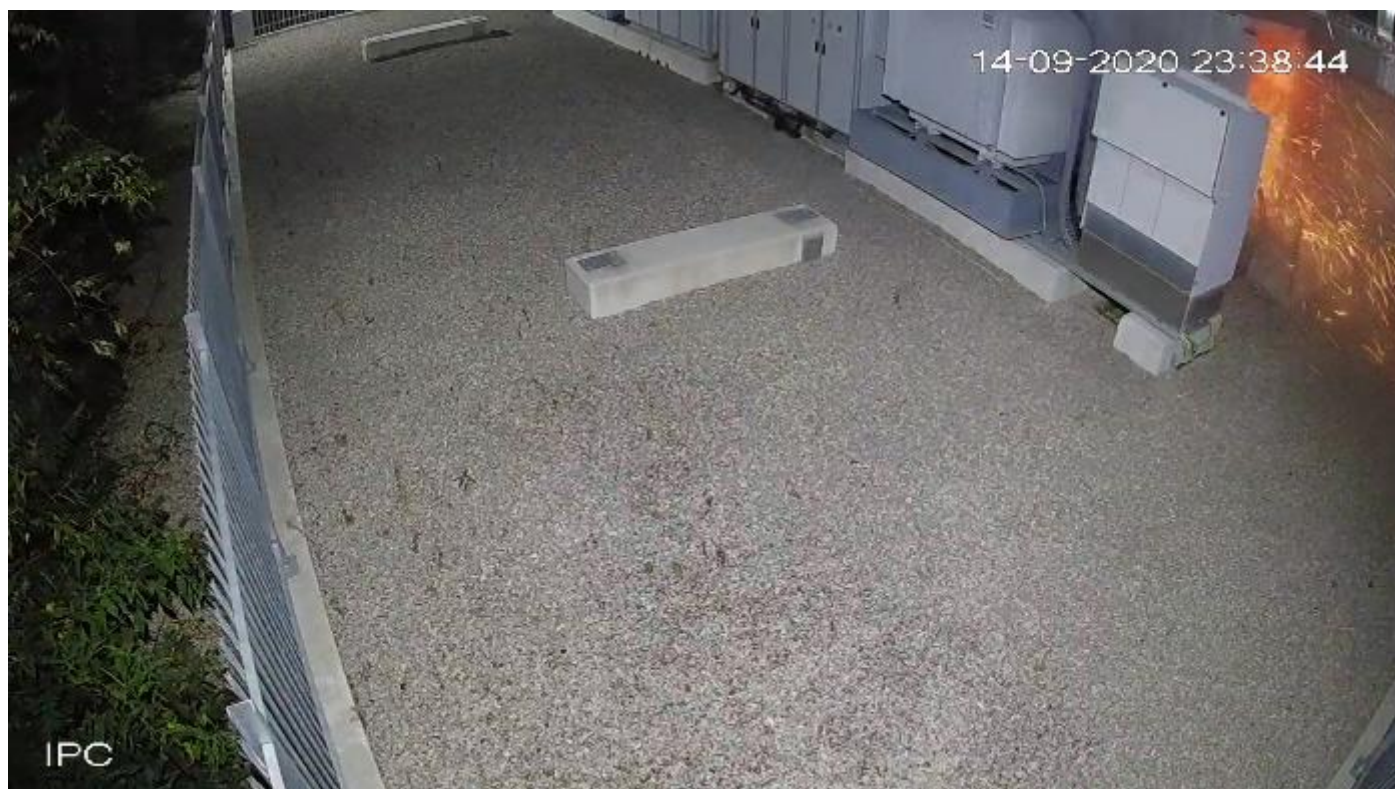
13

External CCTV showing flaming discharge consistent with a failing Lithium cell

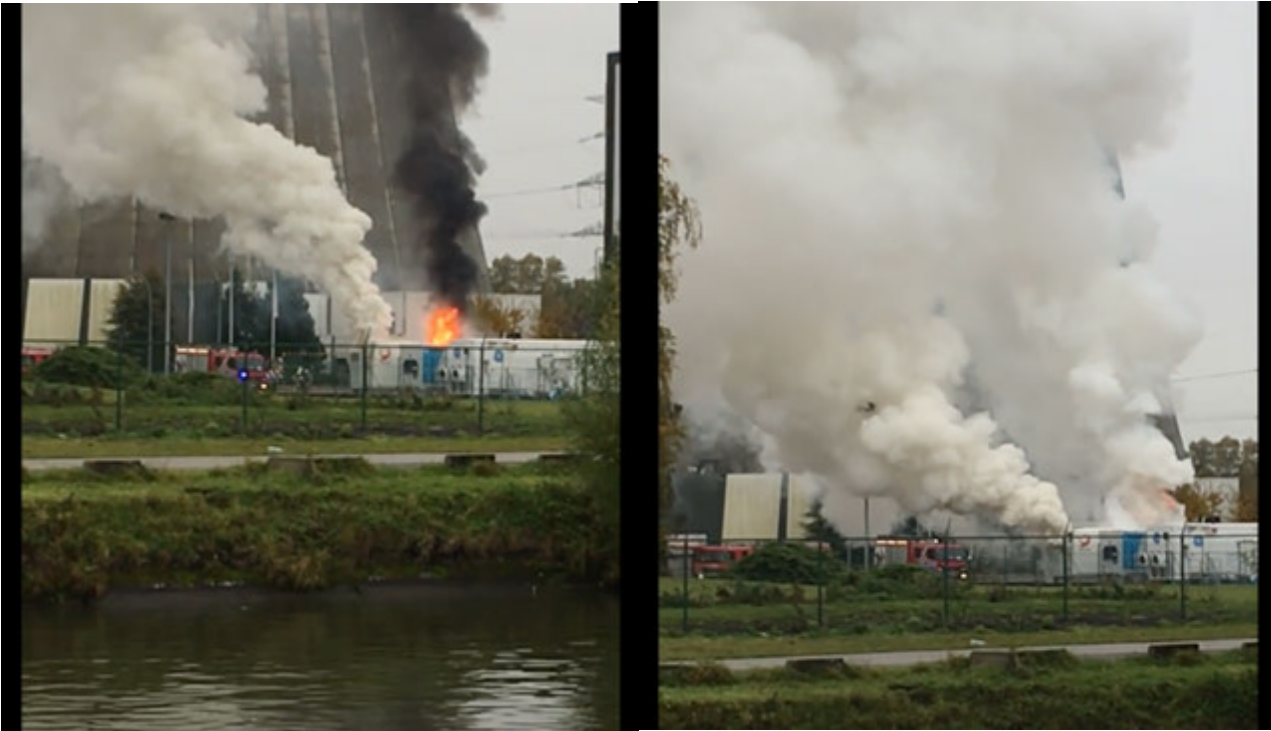
**Figure 4:** The 2 MWh McMicken (Arizona) BESS after the explosion on 19 April 2019

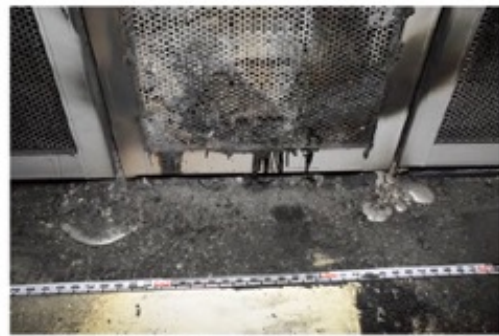
Detail: molten aluminium pools (exceeded 660 °C)

Figure A.1: Photograph taken during decommissioning of the ESS shows a pool of solidified aluminum on the floor in front of Rack 15 [1].

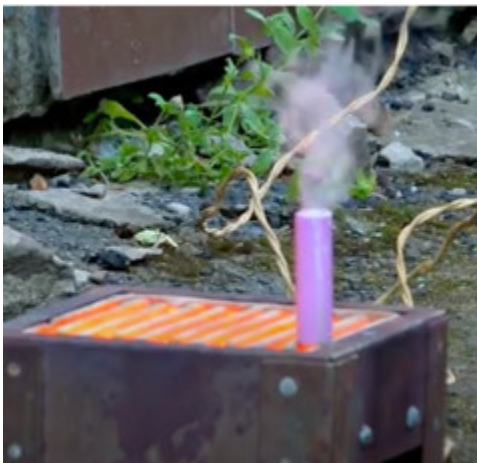
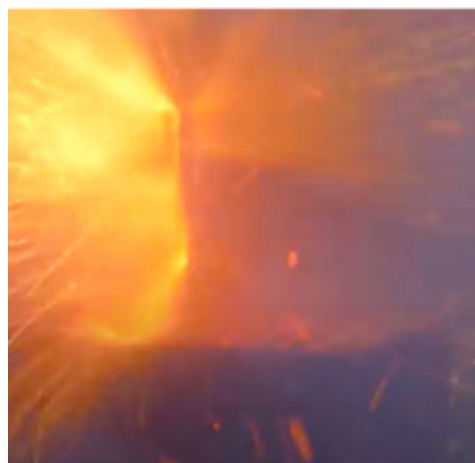
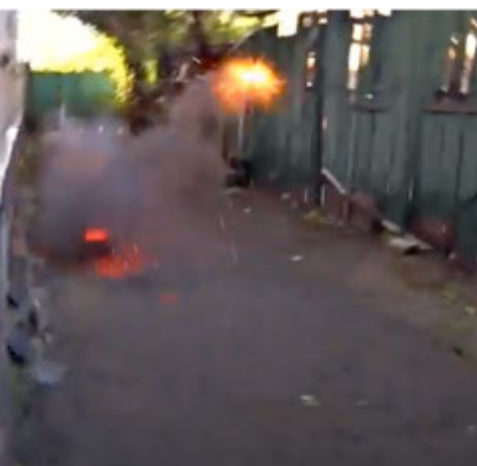
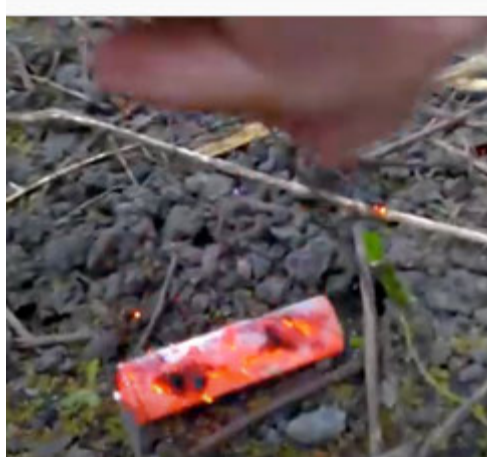
**Figure 14:** (a) A charged 2.6 Ah cell being deliberately overheated. (b) at the point of rupture (c) the cell takes off as a rocket (d) seconds later the discharge is complete, and the cell is red hot.
