Annex E – Stage 1 Road Safety Audit

Sunnica Solar Farm: Newmarket Road/ Site Access Junction

Stage 1 Road Safety Audit

Project number: 60589004

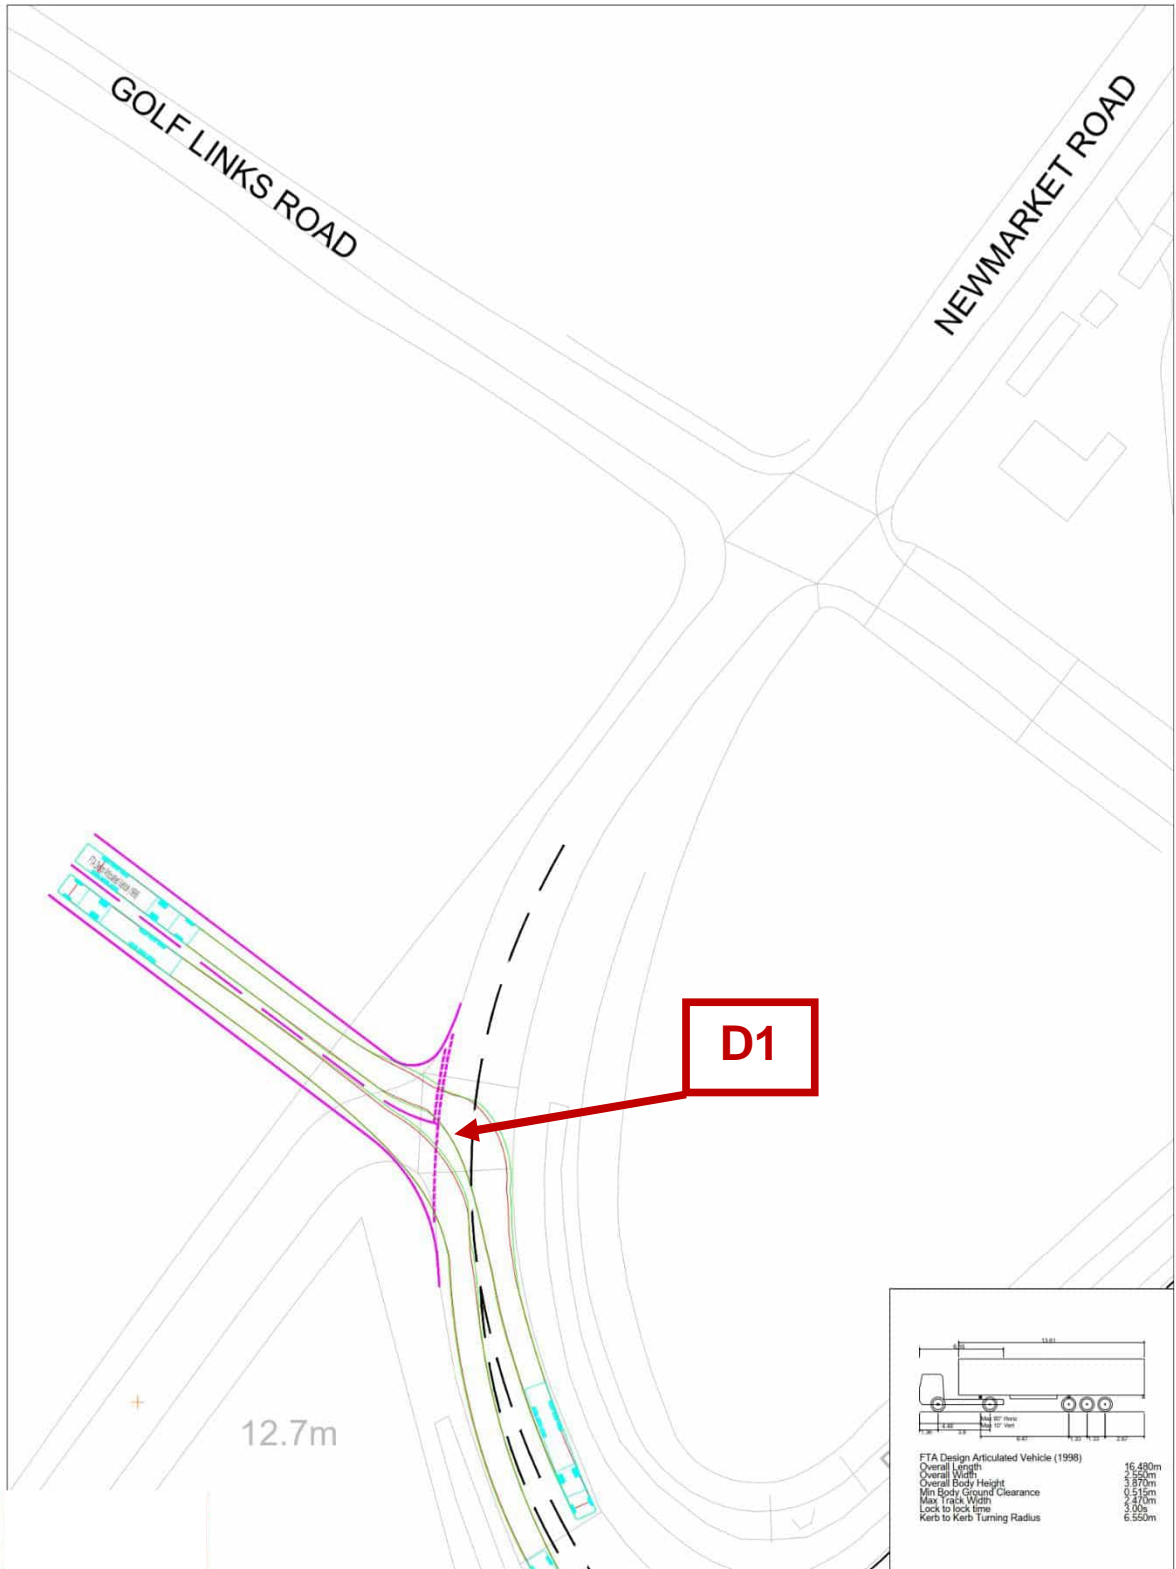
Appendix B Locations of Problems

Location: Proposed construction access junction.

Drawing: TRA_003_Golf_Links_Road_Option_2

Summary: Slow moving HGVs turning right from access may be at risk of being struck by northbound vehicles on Newmarket Road.

The proposed construction access is located close to the A11(T) junction. Construction vehicles turning right out of the site will do so relatively slowly and vehicles heading north on Newmarket Road, having turned from the A11 may collide with the slow turning construction vehicles.

Although it is acknowledged that the RSA brief states that warning signs are proposed along Newmarket Road warning motorists of the site access and HGVs turning, it is recommended that, at detailed design stage, a suitable clear warning signage strategy is designed (and reviewed as part of the Stage 2 Road Safety Audit) to ensure that drivers joining Newmarket Road from the A11 are aware of the construction access and potential for slow turning vehicles ahead. It is advised that the signage is provided as a 'gateway' on entry to Newmarket Road so that it is clearly seen by both right turning and left turning traffic from the A11.
