SOUTH HUMBER BANK ENERGY CENTRE – SITE INVESTIGATION WORKS

REPORT ON GROUND INVESTIGATION

Report No A9020-19/2

VOLUME 2 : INTERPRETATIVE REPORT

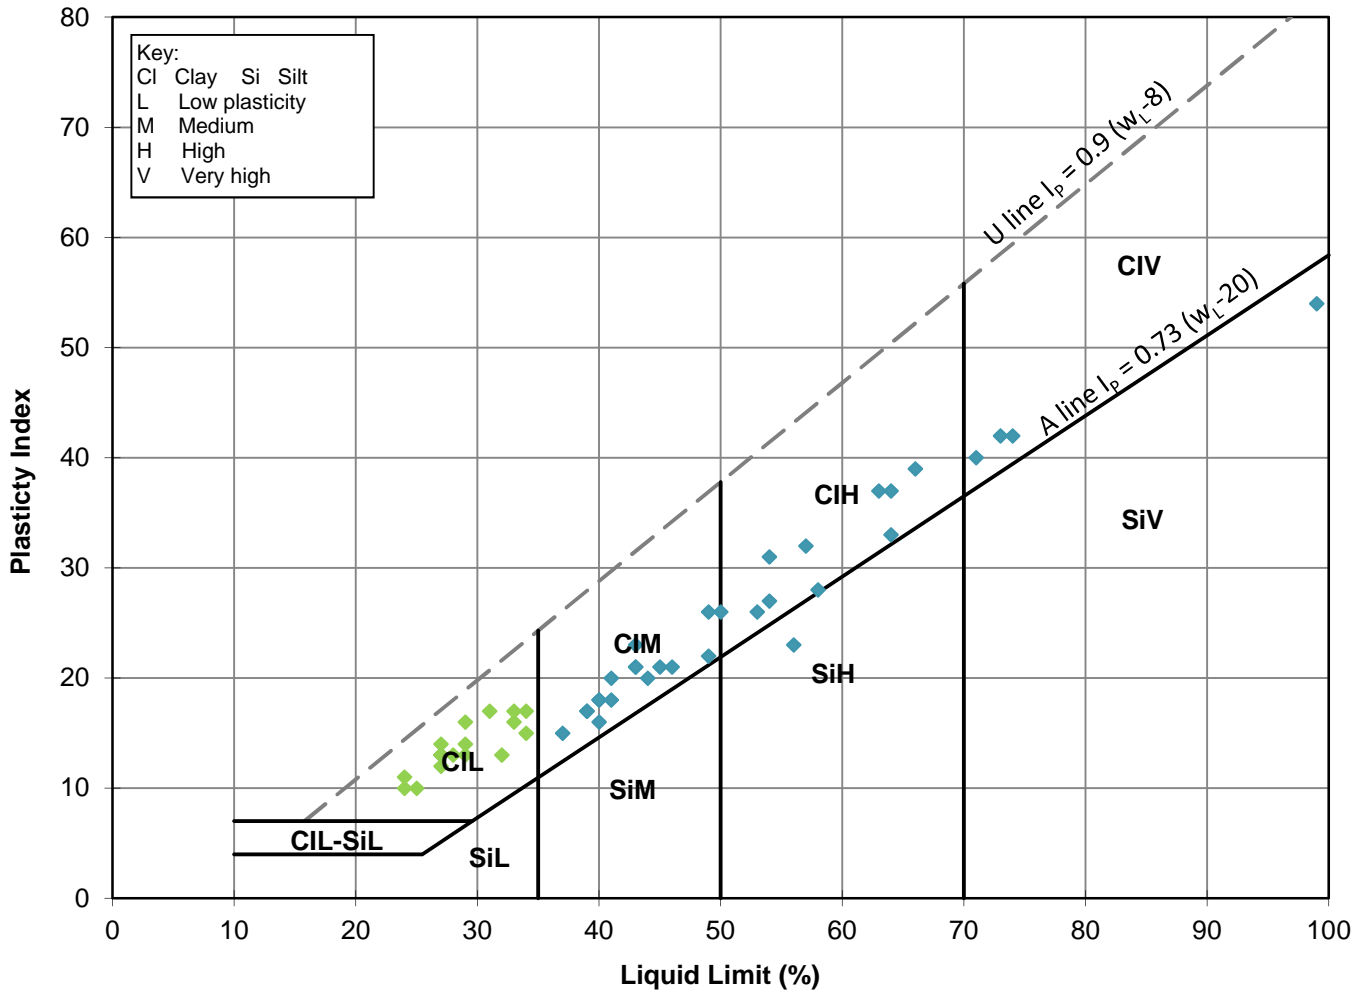
Seventeen Atterberg limit determinations measured liquid limits of between 24 and 34 % and plastic limits of between 13 and 19 %. These tests indicate the clay is of low plasticity, see Plasticity Chart Figure 1. Moisture contents typically ranged from 11 to 19 %. The moisture contents generally fall around the plastic limit, and are reasonably consistent with depth, see Figure 2.

Thirty five Atterberg limit determinations measured liquid limits of between 33 and 99 % and plastic limits of between 16 and 45 %. These tests indicate that the materials comprise predominantly clays (locally silt), generally of medium and high plasticity, with some low and very high results, see Plasticity Chart Figure 1. Two samples, BH03 9.50 m and BH05 8.00 m were recorded as non plastic. Moisture contents typically ranged from 26 to 81 %, with one extreme result of 338 % on a stratum described as a peat. The moisture contents are generally closer to the liquid limit, though above 2 m tend to be closer to the plastic limit indicating a higher strength (possibly a dessicated crust), see Figure 2.
