# Sheringham Shoal and Dudgeon Offshore Wind Farm Extension Projects

### Appendix 18.3 - Geomorphological Baseline Survey Technical Report

August 2022

Document Reference: 6.3.18.3

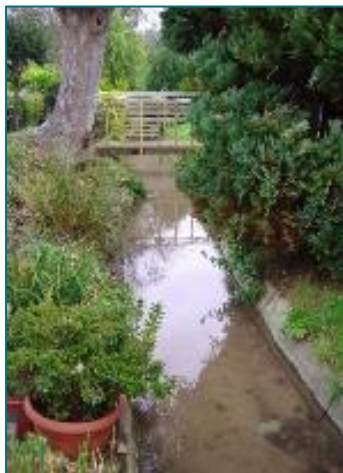
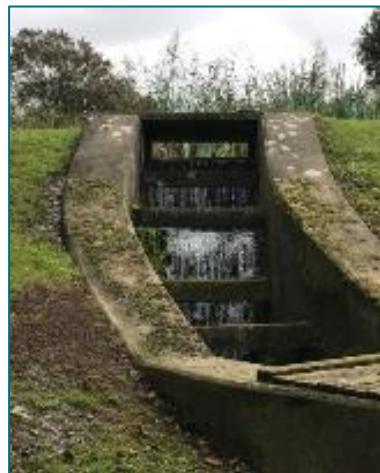
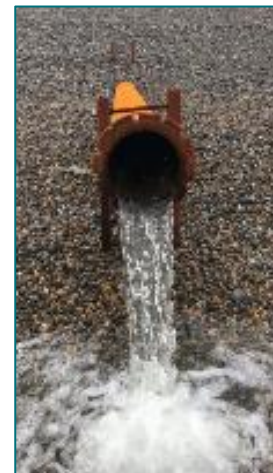
*Plate 18.3.1: Spring Beck*

15. Spring Beck has been modified (see below) and is predominantly characterised by low energy glide and impounded flows, with limited flow diversity or in channel features. Faster flow habitats (such as runs) were observed, although these occurred through the artificial sections of the beck.

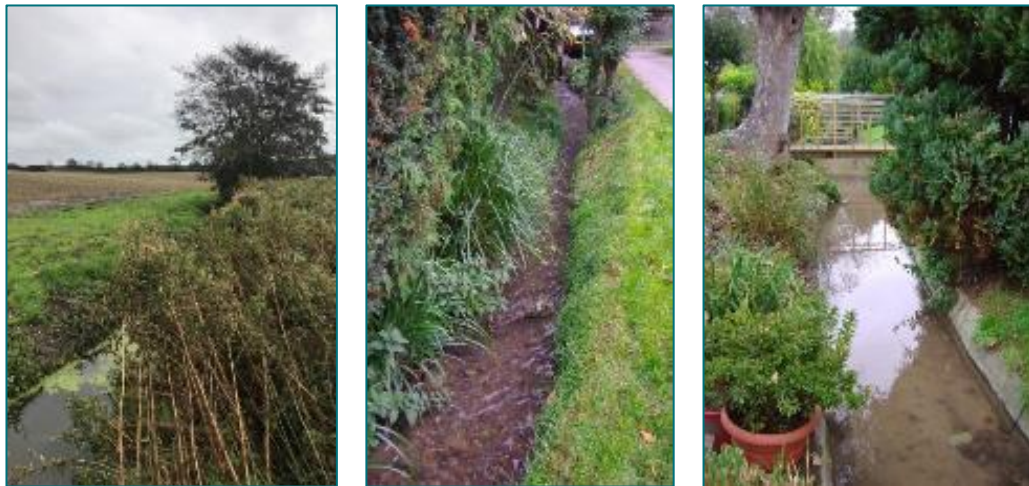
*Plate 18.3.2: Spring Beck Channel Form*

16. The course of Spring Beck was modified in the eighteenth century in response to the construction of a watermill and dammed to create a substantial mill pond. As such, the beck in places does not follow the natural watercourse alignment and is diverted along an artificial course for some length through the village of Weybourne. The channel form of the beck through the village is therefore predominately straight, with artificial (concrete) bed and banks in places. The channel is approximately 1m – 2m wide at the bank top; 1m wide at the bank base, with a bankfull depth between 0.5m – 1m. Thus, the overall form of the beck through the village displays a typical box shape uniform channel, with limited instream morphological complexity (). On the outskirts of the village, the beck although less confined, displays a U shape uniform channel, typical of drainage ditches in open fields (**Plate 18.3.2**).

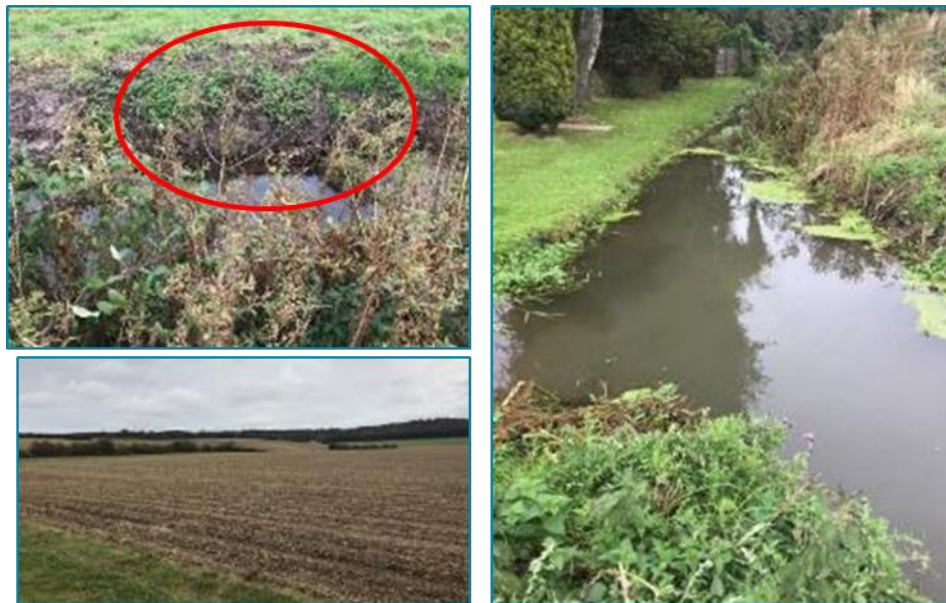
*Plate 18.3.3: Sediment Sources and Local Impoundment*

17. Spring Beck within the study area is associated with colluvium soils; loose unconsolidated sediments typically composed of a heterogeneous range of rock types; and sediments ranging from silt to rock fragments of various sizes. The beck is also associated with peat soils, an accumulation of partially decayed vegetation or organic matter.
18. The overall substrate of the beck throughout the study area is thus dominated by sands, silts and gravels. The dominant fluvial process appears to be sediment deposition, with slow glide flows, local impoundments caused by small weirs, the mill pond, dense in-stream vegetation, low gradients and low velocities all contributing to the settling out of fine sediments/silts (**Plate 18.3.3**).

19. Although a proportion is likely to be derived from exposed banks during higher-energy flows, the majority of the fine sediment load is likely to be sourced from the agricultural fields on the outskirts of the village (i.e. surface runoff) (**Plate 18.3.3**).

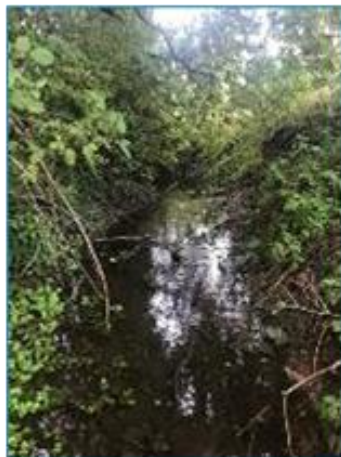
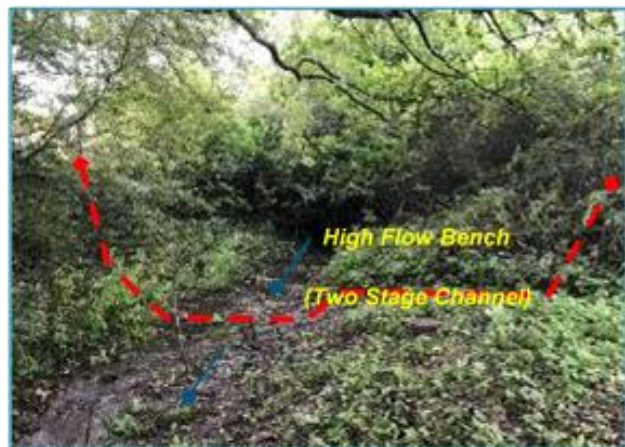
*Plate 18.3.6: River Glaven Channel Form*

25. The channel has straight planform sections within the study area, which are incised in places into the floodplain and surrounded by agricultural fields and fishing lakes. The banks are relatively steep, stable and well vegetated throughout the study area. The channel (not including the online pond) varies between 1m – 5m wide at the bank top; 0.5m – 1.5m wide at the bank base, with a bankfull depth between 1m – 2m. The overall channel morphology of the River Glaven displays a predominately uniform channel, with the exception of the start and end locations of the study area in which the River Glaven displays more complex geomorphology, including a high flow bench or two-stage channel on the left bank (**Plate 18.3.6**).

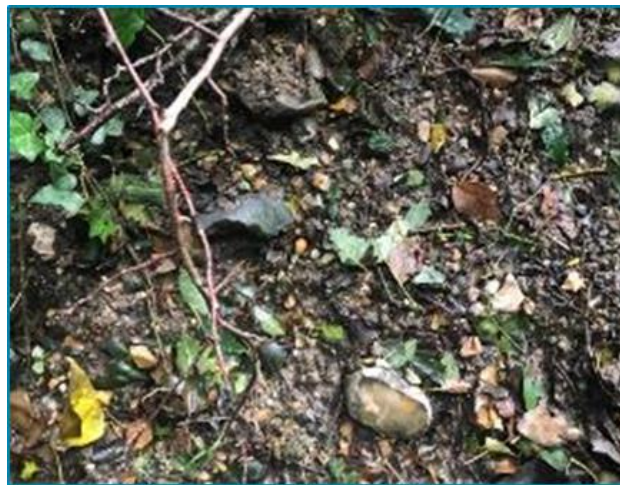
*Plate 18.3.7: Glacial Till Bank Composition in the River Glaven*

26. The River Glaven within the study area is associated with glacial till, with the banks of the river comprised of clay, sand, gravel, cobbles and boulders (**Plate 18.3.7**).

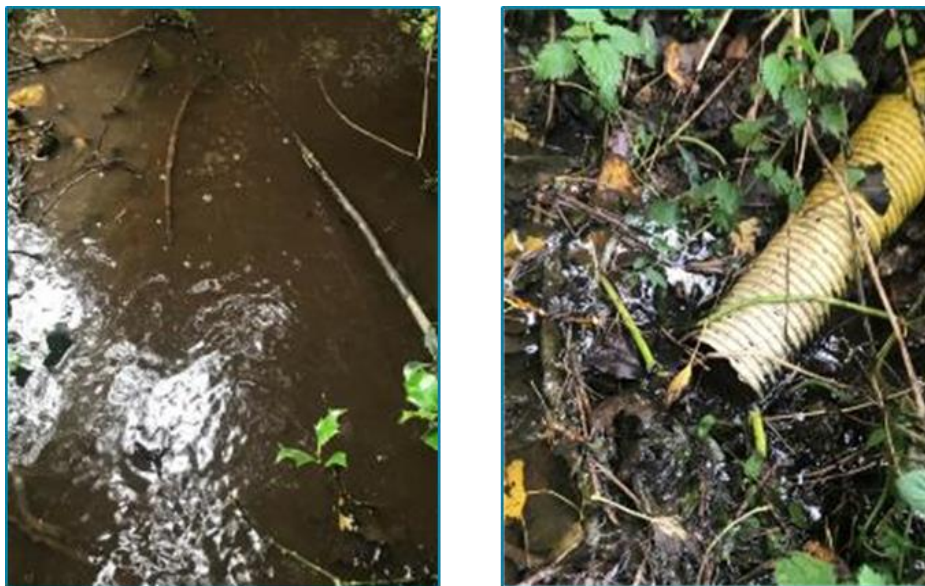
*Plate 18.3.8: Silt Deposition and Outfall Pipe*

27. The substrate of the River Glaven throughout the study area is thus dominated by clay, sand, boulders, minerals, and gravel. The dominant fluvial process appears to be sediment deposition, with slow flows, low gradients, dense in-channel vegetation (undergrowth) and low velocities contributing to the settling out of fine sediments/silts (**Plate 18.3.8**).

28. A portion of the fine sediment load is likely to be derived from exposed banks during higher-energy flows, outfall pipes, drainage ditches, access tracks and road runoff (noted towards the far downstream end of the study area). The adjacent agricultural fields are also likely to be a major source of fine sediment load through diffuse surface runoff.

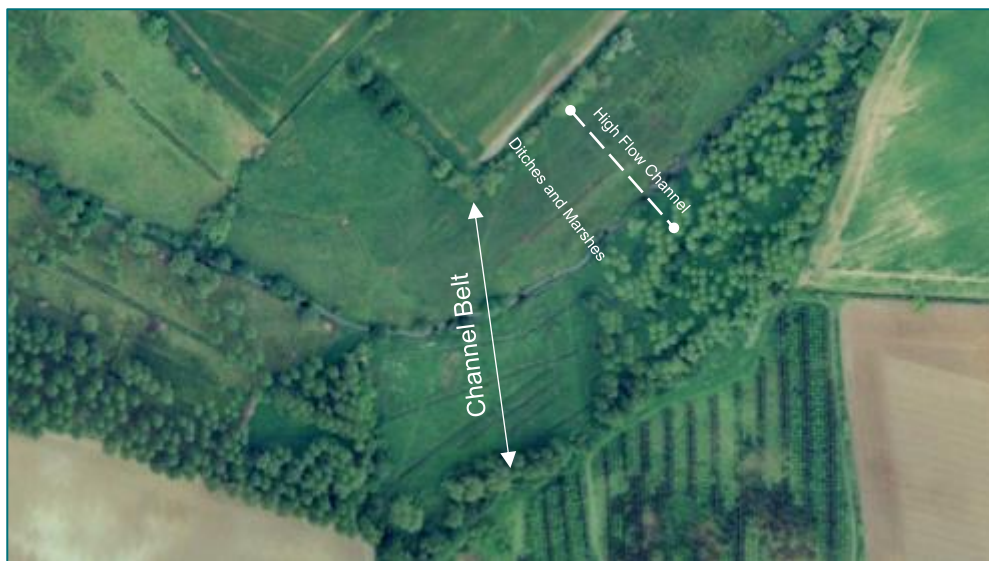
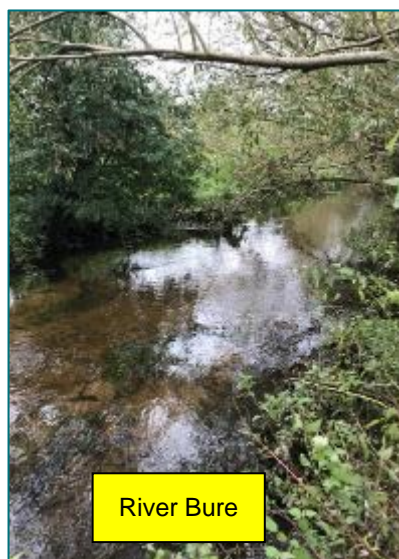
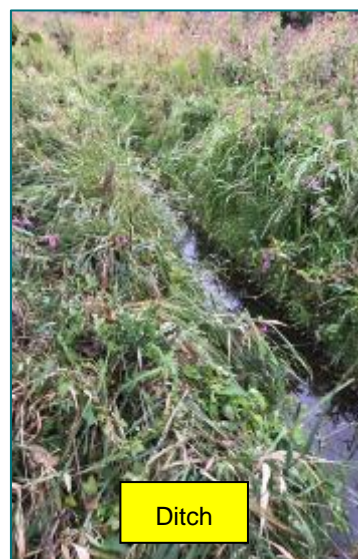
Plate 18.3.10: River Bure Floodplain and Channel Features

35. The channel has a straight planform within the study area, although displays geomorphological complexity varying in size and shape surrounded by agricultural fields, woodland and open fields with wetland (marsh) features. In general, the banks are relatively stable and well vegetated with the channel size between 4m – 6m at the bank top; 2m – 3m wide at the bank base, with a bankfull depth between 1m – 2m. The main channel is contained within a wider channel belt (approximately 100m – 250m wide) also consisting of a network of ditches and vegetated islands forming a wetland (marsh) system (**Plate 18.3.10**). The River Bure within the wider channel belt takes the form of a large two-stage channel.

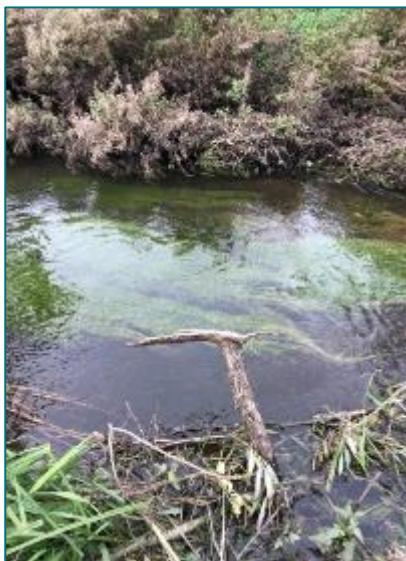
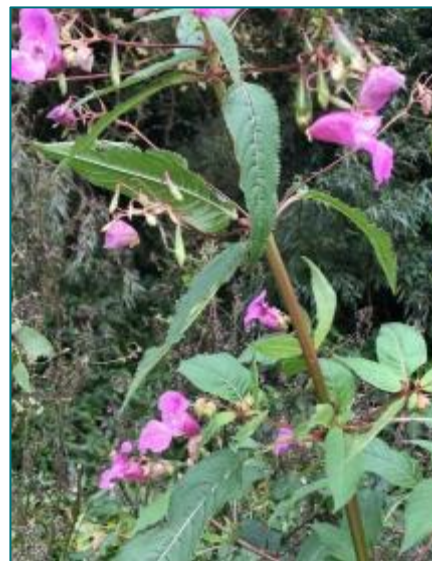
*Plate 18.3.11: Water-Crowfoot (Left) and Himalayan Balsam (Right)*

40. The banks and margins of the River Bure are well vegetated and dominated by poor semi-improved grassland with occasional shrubs. There is good coverage of aquatic plants along the bed of the river, including pockets of water-crowfoot ([Plate 18.3.11](#)). The channel belt has an array of terrestrial and wetland plants, although Himalayan balsam is present.

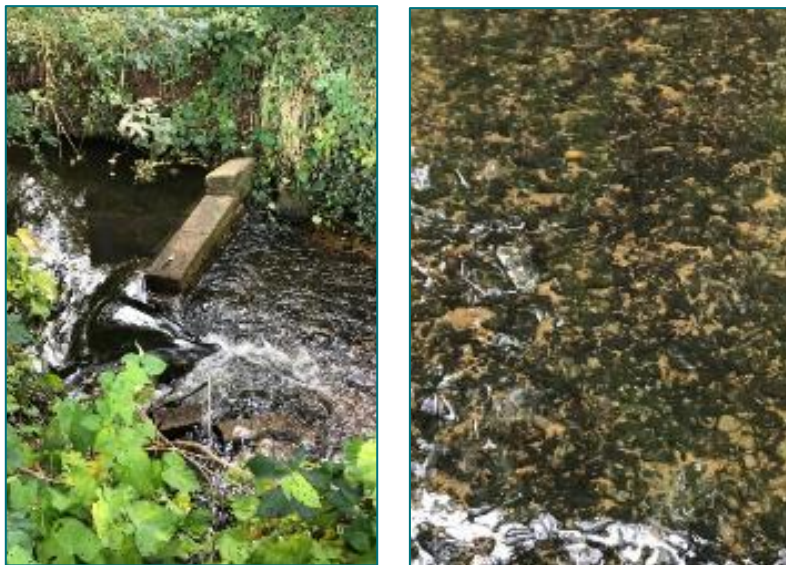
*Plate 18.3.15: Weir and Bed Armouring Along the Swannington Beck*

48. The Swannington Beck within the study area is associated with riverine clay, sands and gravels, with the banks predominantly composed of clay and sand (i.e. clay to sandy loam banks), with the properties of the soils (along with the in-channel vegetation, such as sedges and grasses) providing good filtration of water.
49. The substrate of the primary channel of the Swannington Beck throughout the study area is thus dominated by clay and sand. The dominant fluvial process appears to be sediment deposition triggered by slow flows, debris and impoundment caused by a small weir (**Plate 18.3.15** and **Plate 18.3.16**). The bed in some places was also armoured, in which coarse grains were on the surface protecting finer particles underneath from erosion (**Plate 18.3.15**).

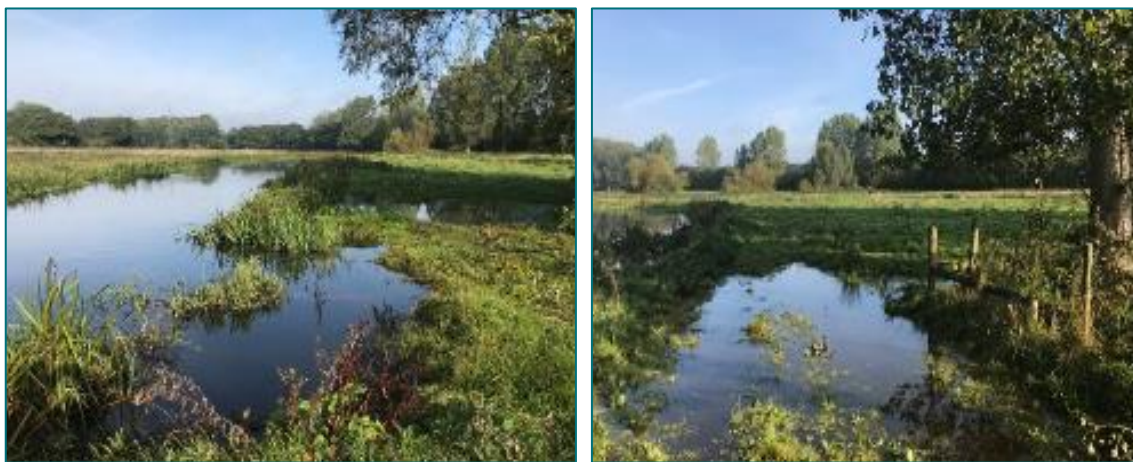
*Plate 18.3.18: Channel and Floodplain Features.*

58. The primary channel of the River Wensum has a straight to sinuous planform within the study area and flows through an open floodplain characterised by a wide and deep channel, with the bank top width between 8m – 10m and width at the base between 5m – 6m. Bankfull depth is approximately 2m (Plate 18.3.17). Key channel and floodplain features include small benches (steps in the channel which accumulate organic debris and silts), backwaters and wetlands, providing geomorphic complexity and habitat diversity (Plate 18.3.18).

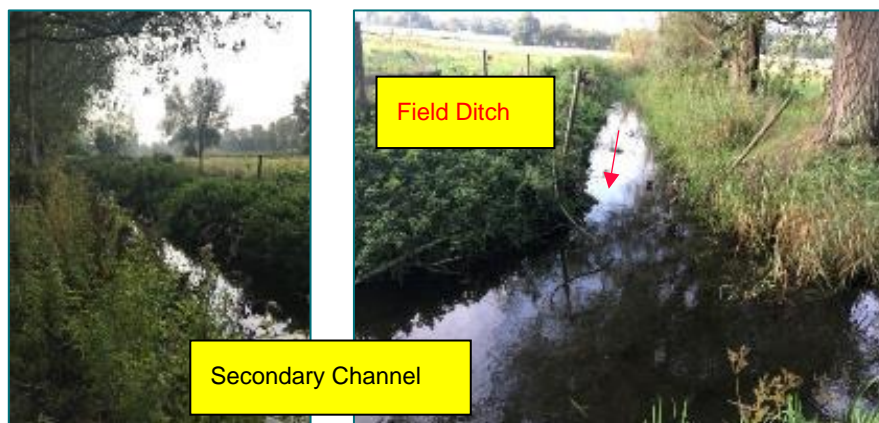
*Plate 18.3.19: Secondary Channel and Field Ditches*

59. The secondary channel of the River Wensum is wide and relatively deep (incised), with dense in-channel vegetation. The channel size is approximately 5m at the bank top; 1m at the bank base, with a bankfull depth of approximately 0.5m – 1m. Three small ditches connect to the secondary channel along its length (Plate 18.3.19).

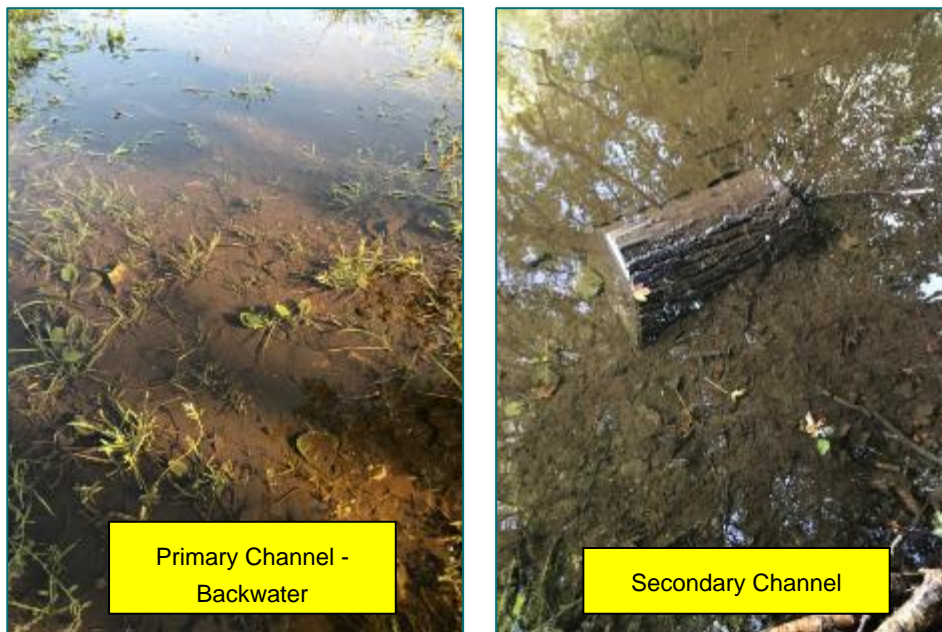
*Plate 18.3.20: Silt Deposition*

62. The secondary channel of the River Wensum and field ditches are dominated by silts in response to slow flows and debris causing settling out of fine sediments (**Plate 18.3.20**).

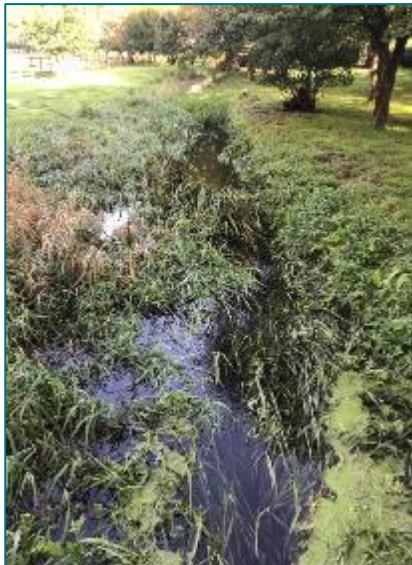
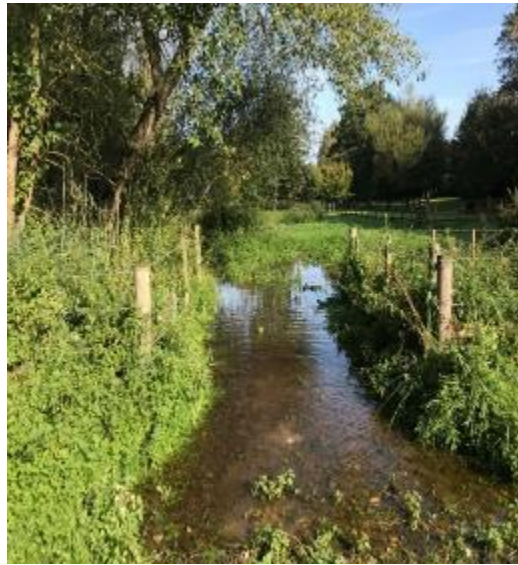
*Plate 18.3.21: Secondary Channel Floodplain Connectivity*

63. Good floodplain connectivity along the primary channel of the River Wensum within the study area was clearly evident during the walkover survey (**Plate 18.3.21**).
64. Good floodplain connectivity was also evident towards Old Fakenham Road (downstream end of study area) along the secondary channel in response to the change in channel morphology, with the channel not incised and channel banks gently sloping allowing inundation of the floodplain in places (**Plate 18.3.21**).

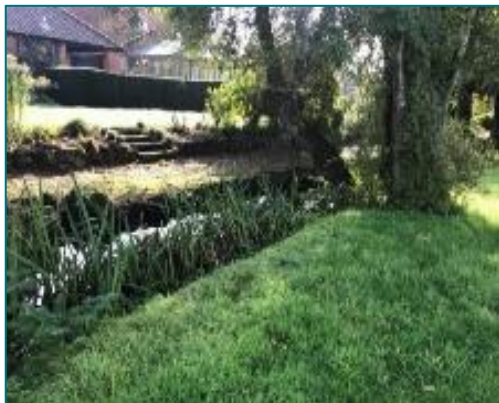
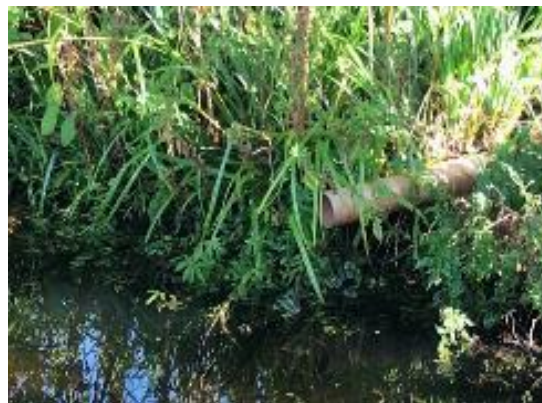
*Plate 18.3.22: Modification of the Secondary Channel*

66. No modifications or structures, such as hard engineering bank protection works were observed during the walkover along the primary channel of the River Wensum, although the secondary channel in places is modified with stone bank protection along the back of a housing estate. Two small pipes also discharge into the secondary channel towards the downstream end of the study area ([Plate 18.3.22](#)).

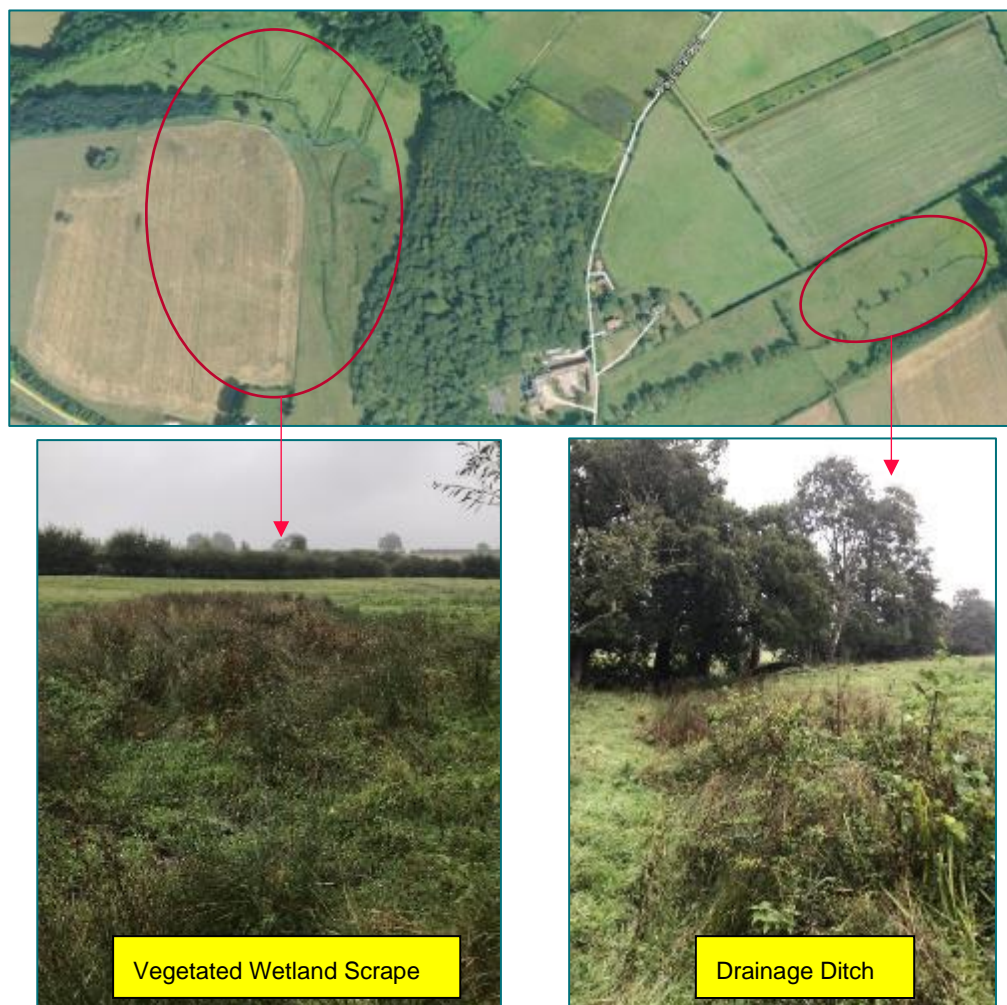
*Plate 18.3.24: River Tud Floodplain Features*

69. The River Tud has a straight to sinuous planform within the study area and flows through an open floodplain characterised by a wide and shallow channel, with the bank top width between 5m – 8m and width at the base between 4m – 5m. Bankfull depth is approximately 2m (**Plate 18.3.23**). Key channel and floodplain features include small benches (steps in the channel which accumulate organic debris and silts), relic channels, drainage ditches, scrapes (or ponds) and wetlands, providing geomorphic complexity and habitat diversity (**Plate 18.3.24**).

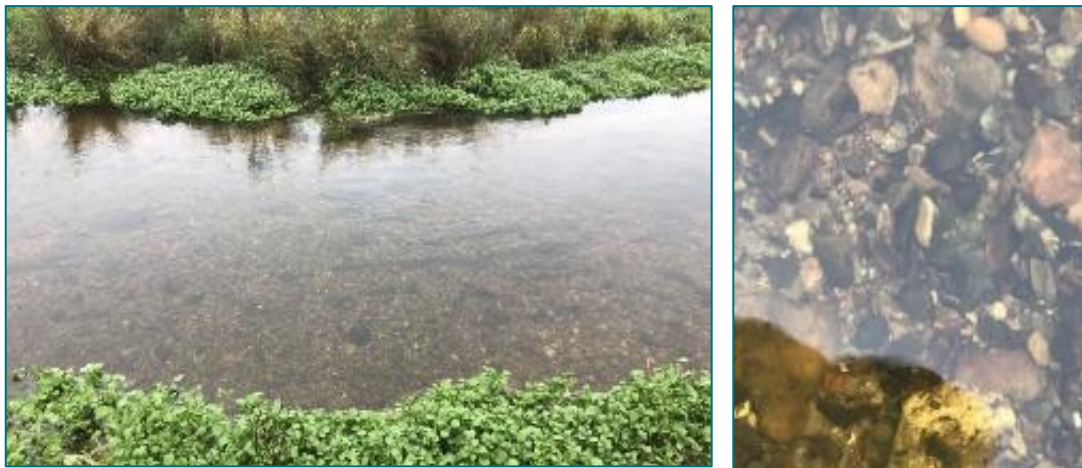
*Plate 18.3.25: Clean Gravel Bed Substrate*

70. The River Tud within the study area is associated with riverine clay, sands and gravels, with the banks predominantly composed of clay and sand (i.e. clay to sandy loam banks), with the properties of the soils (along with the in-channel and marginal vegetation, such as sedges and grasses) providing good filtration of water and clean gravels (**Plate 18.3.25**).

71. The substrate of the River Tud throughout the study area is thus dominated clay and sand. The dominant fluvial process appears to be sediment transport with very little sediment deposition on the bed during the time of the walkover (**Plate 18.3.25**). However, fine sediments were evident along the margins of the river.
72. Despite livestock poaching prevalent within the study area, there was minimal fine sediments on the riverbed, although poaching is likely to be a key sediment source along with point source pollution from ditches (iron leaching observed in one ditch) and upstream land management. A potential reason why livestock poaching did not have an impact on bank erosion and thus contribute more as a sediment source, appears to be in response to the well vegetated floodplain, banks and margins of the River Tud (**Plate 18.3.23**).

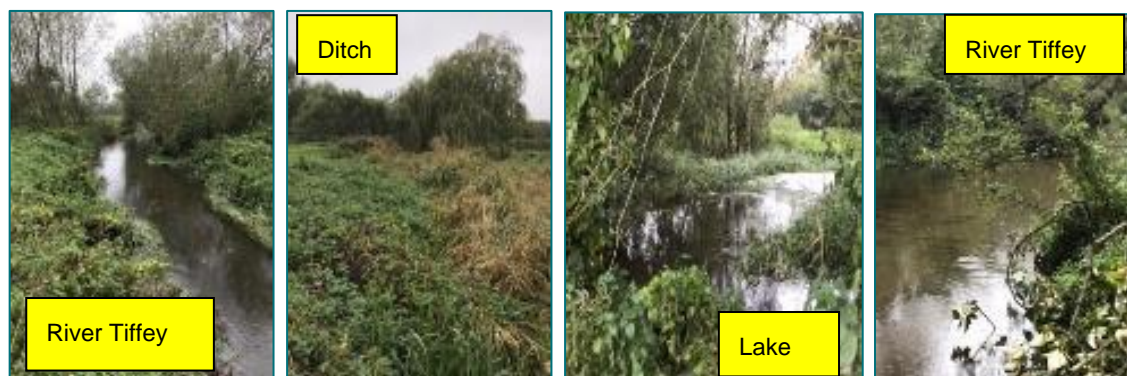
*Plate 18.3.29: River Tiffey and Floodplain Features*

84. The characteristics of the River Tiffey are described in **Table 18.3.9**. The River Tiffey, a tributary of the River Yare, rises near Hethel and flows north-eastwards through the central region of Norfolk and several villages before joining the River Yare near Barford. The River Tiffey within the study area is characterised by a relatively straight planform which is deep and narrow in places and dominated by glide and pool flow habitats (**Plate 18.3.29**). The river has good marginal vegetation including sedges, bladed grasses, iris, bull rushes and reed, with good floodplain connection. The floodplain contains ditches, a small lake (offline pond) and wet woodland (**Plate 18.3.29**).

86. The River Tiffey has a straight to sinuous planform within the study area and flows adjacent to woodland and open floodplain characterised by a relatively deep and narrow channel, with the bank top width between 4m – 5m and width at the base between 2m – 3m. Bankfull depth is approximately 2m (**Plate 18.3.30**). Key channel and floodplain features include several straight ditches 2m wide and approximately 0.5m deep which are well vegetated in places; and a small lake which was once used for angling (**Plate 18.3.29**). The lake is approximately 20m wide by 50m in length, although much of the lake has now been infilled within a planted woodland (**Plate 18.3.29**).

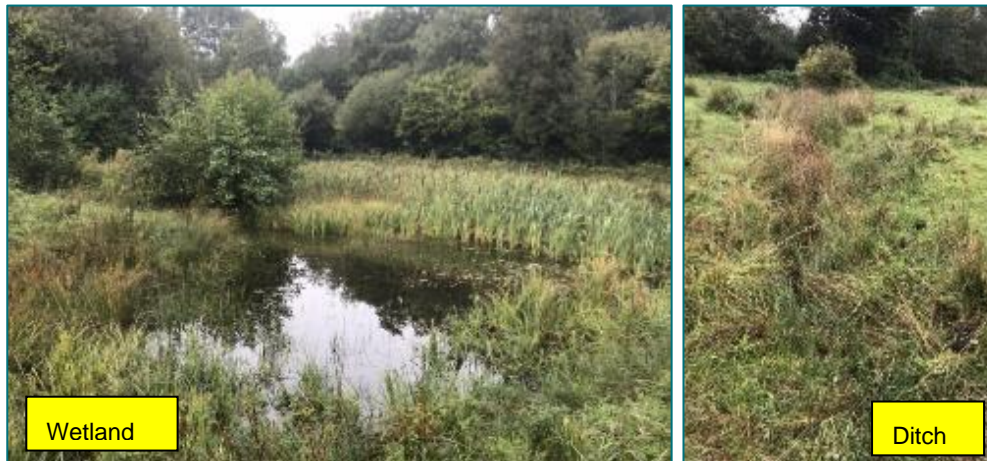
*Plate 18.3.36: Western Channel Wetland and Example Ditch*

98. The western channel of the Intwood Stream appears to have a modified planform which has been historically straightened, although despite this does show some geomorphic complexity within the study area varying in size and shape. The channel flows through an open floodplain and woodland, with the morphology of channel being deep and incised to wide and shallow, with good floodplain connectivity (see below). In places the channel had a bank top width between 3m – 4m and width at the base between 1m – 2m. Bankfull depth various between 1m – 2m (**Plate 18.3.36**).

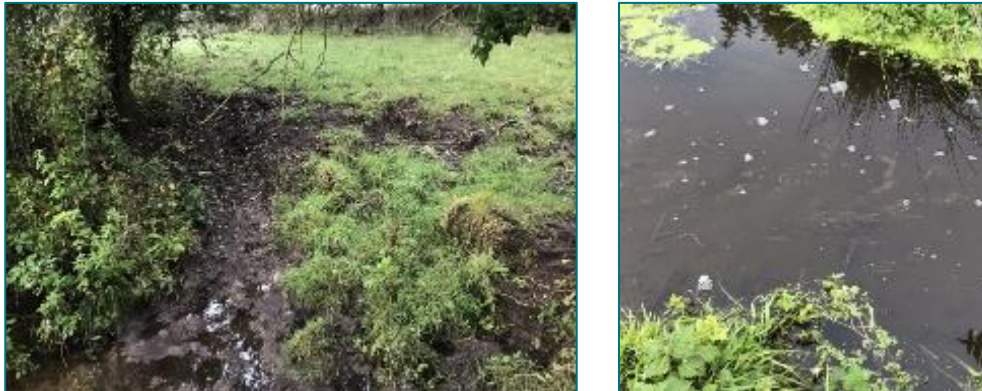
*Plate 18.3.38: Livestock Poaching and Silts on Channel Bed.*

- 103. A portion of fine sediment load along the channels is likely to be derived from exposed banks caused by livestock poaching, with higher-energy flows further eroding the banks contributing to fine silts on the channel beds (**Plate 18.3.38**). In addition, a pipe discharges into a land drainage ditch which joins the channel towards the downstream end of the study area potentially allowing fine sediment and/or contaminants to enter the watercourse **Plate 18.3.38**.
