THE NORFOLK RIVERS TRUST
RESTORING NORFOLK'S RIVERS

SPRING BECK

A WATER FRAMEWORK DIRECTIVE LOCAL CATCHMENT PLAN

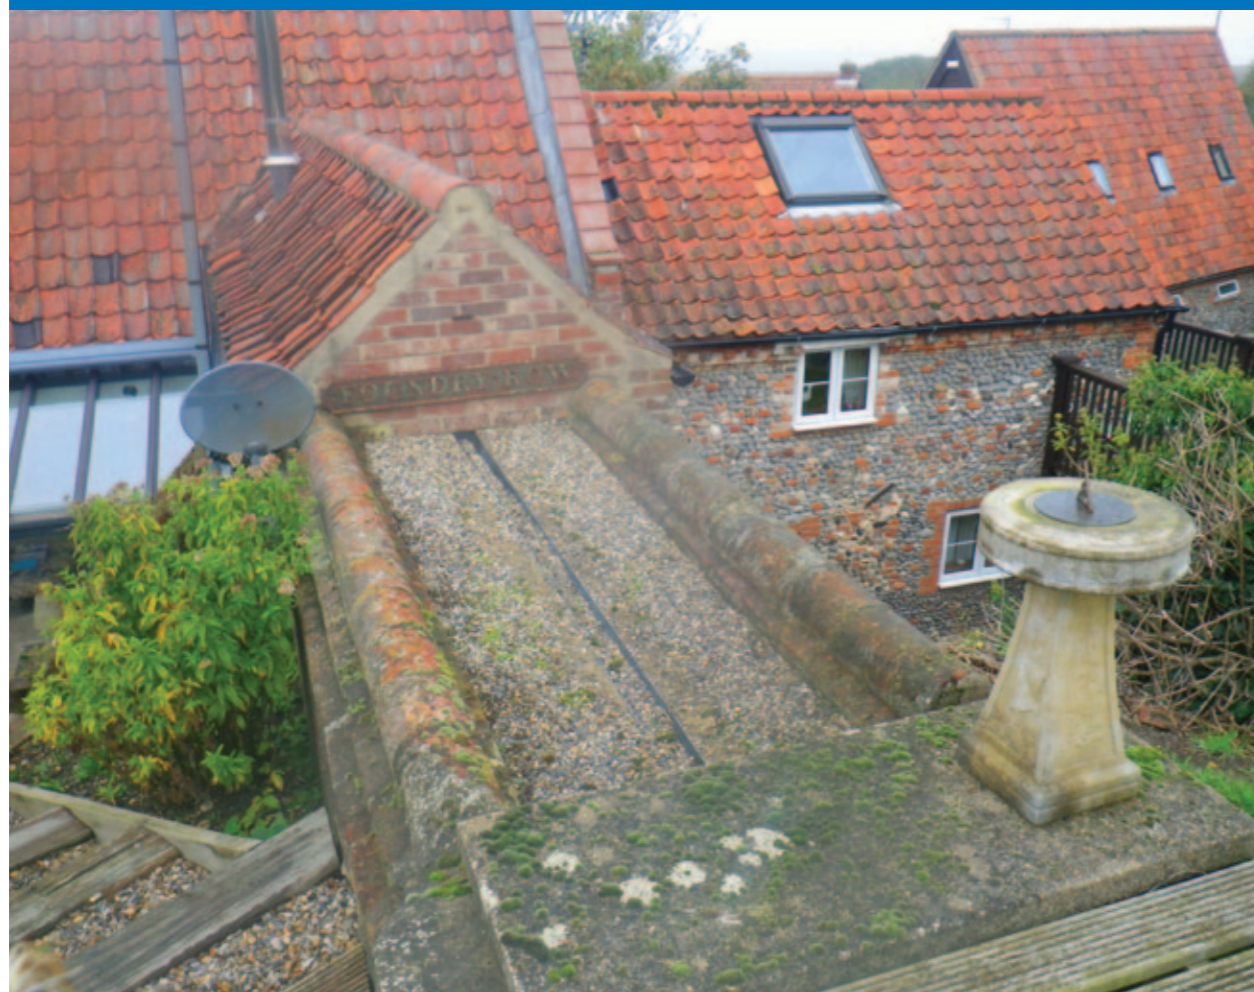
Due to the small amount of water flowing through the beck, it was necessary for Weybourne Mill to be powered by an overshot wheel, rather than the more commonly found undershot wheels. Overshot wheels are comparatively rare in Norfolk due to the mainly gentle terrain, however they make the best use of small

The old watermill, which has now been converted into a residential property

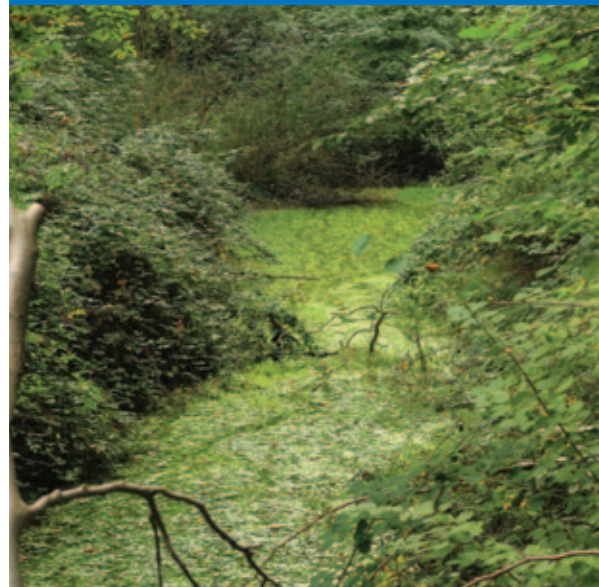
Stream leaving the hollow near the source of the beck. The watercress causes the water to appear green

Spring Beck rises from a spring on the edge of Hundred Acre Wood, near Weybourne Railway Station. The spring flows into a substantial hollow, which appears green due to an abundance of watercress. The stream then flows under the railway track and into Spring Head Plantation.

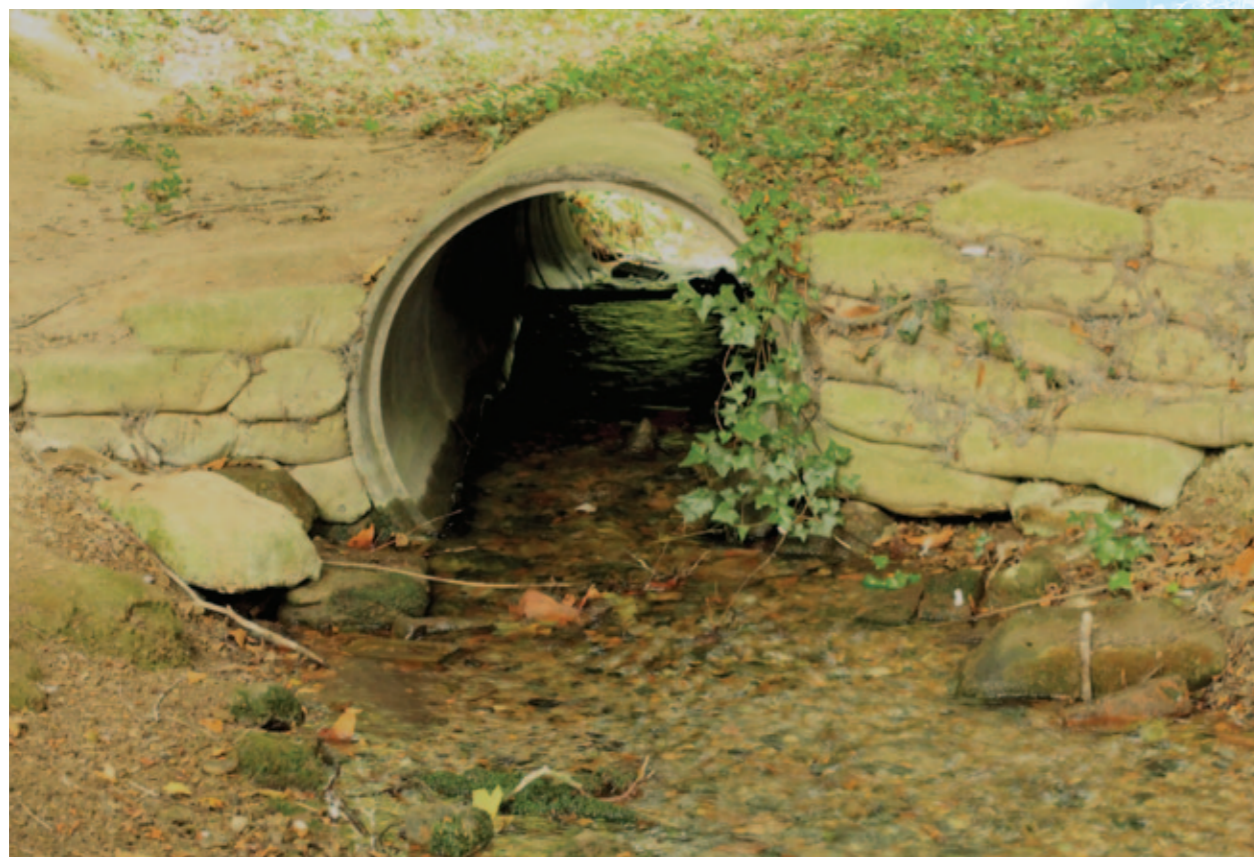
The stream flows through a culvert under the railway bridge.

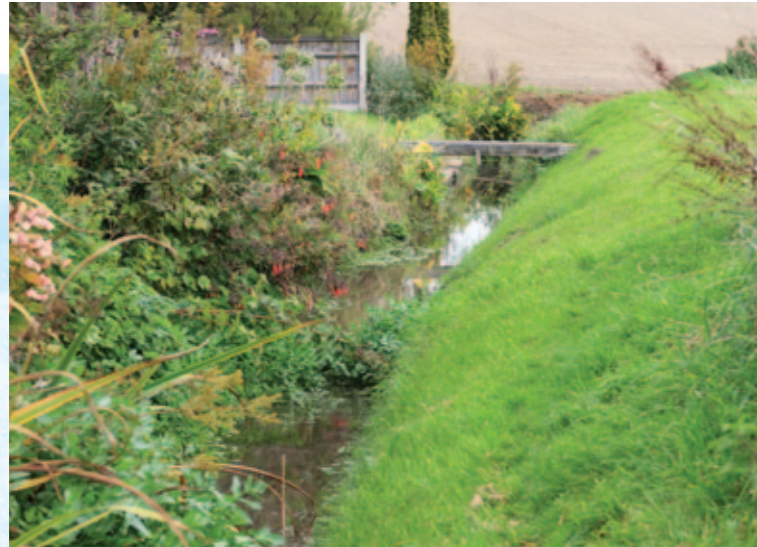
A small tributary to Spring Beck's main channel follows a straight course through the gardens of village residents.

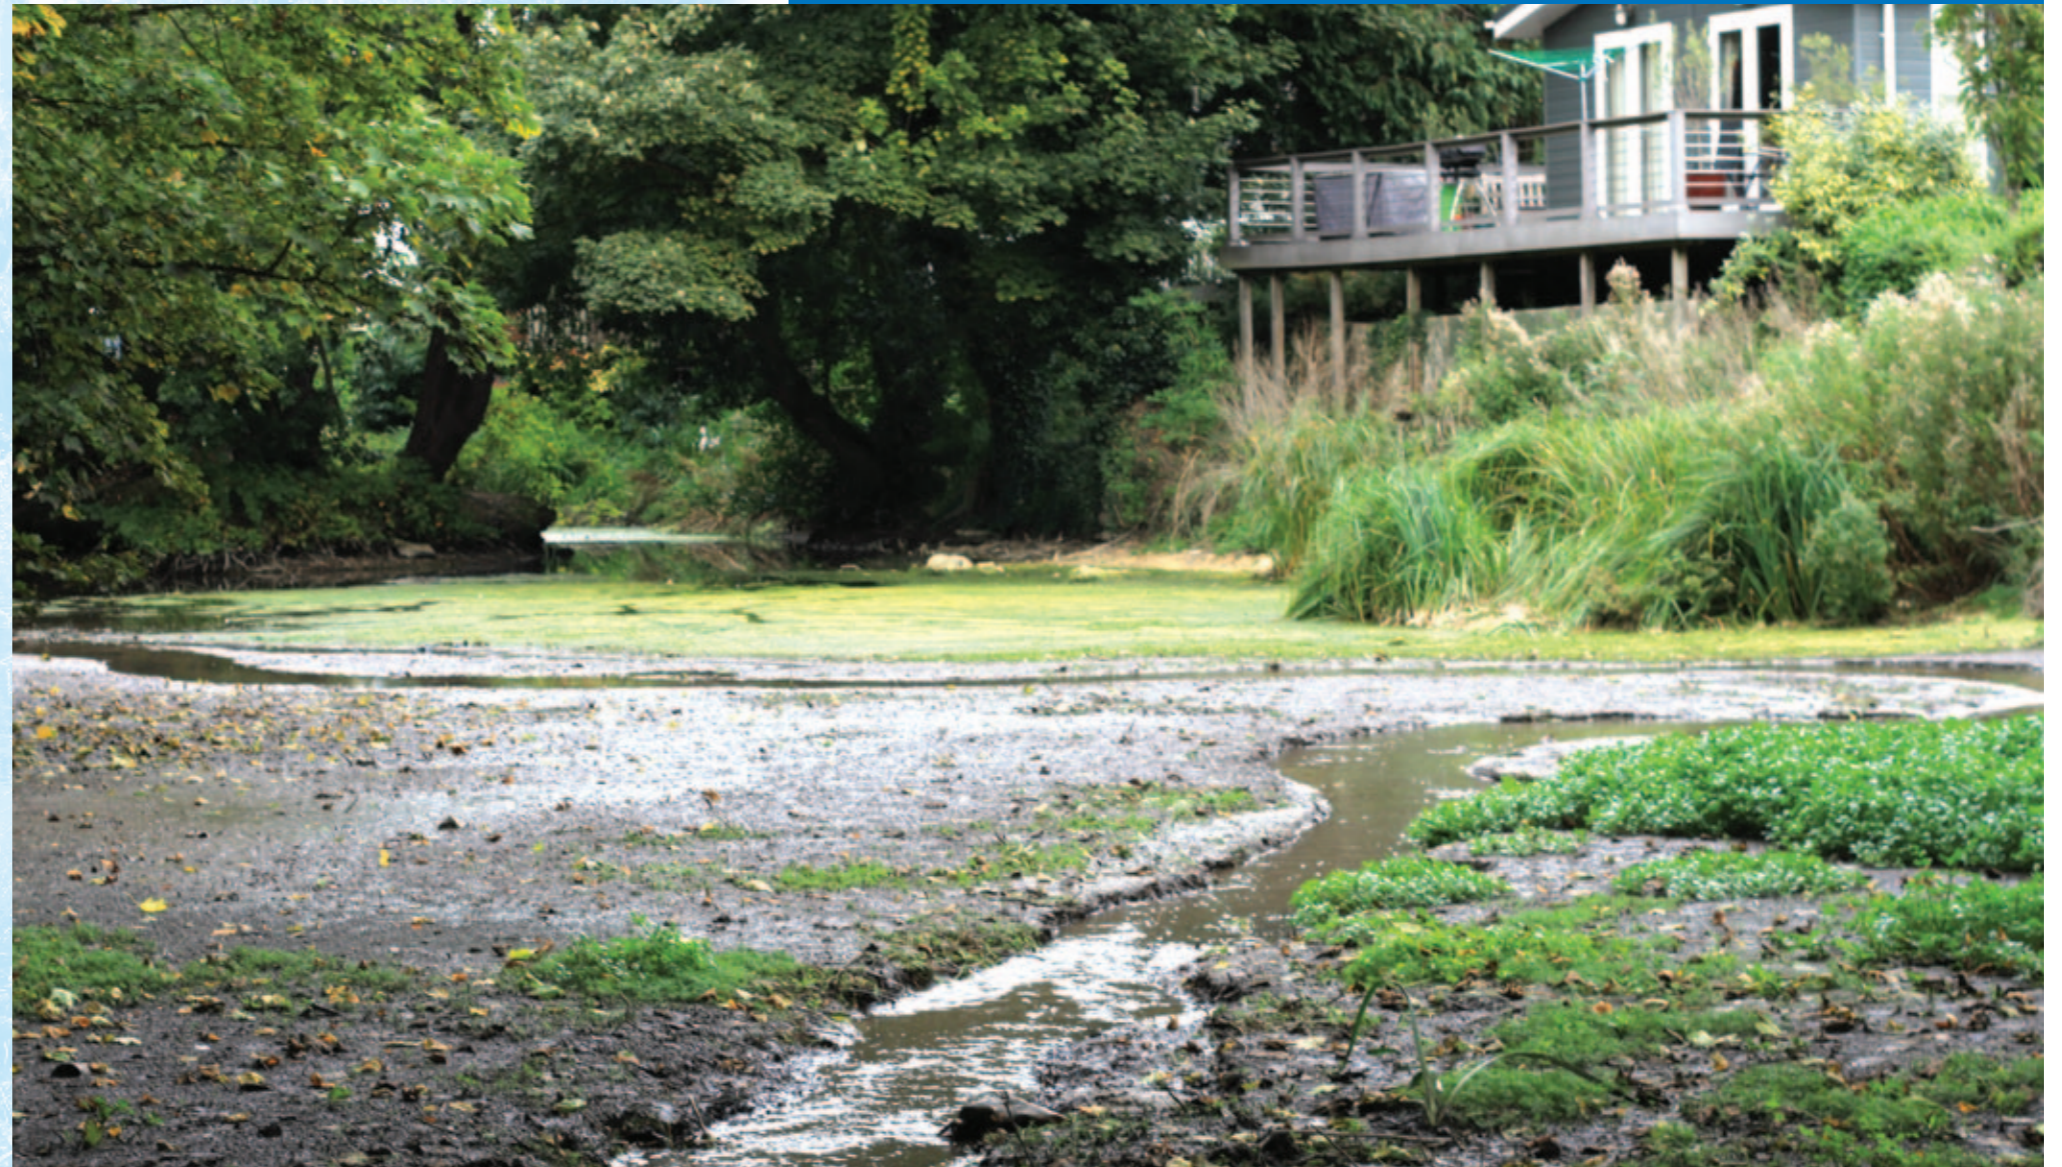
The pond behind the remains of Weybourne Priory suffers from notably high silt levels. A dense algal mat can also be seen in this photo.

The flow of the stream appears to speed up as it heads from Station Road toward the remains of Weybourne Priory. Behind the old priory the beck opens up into a highly silted pond; a large proportion of which is covered by filamentous algae and overgrown with reeds. The presence of a blanket of algae may indicate an unnaturally high nutrient load and may be detrimental to other aquatic life.

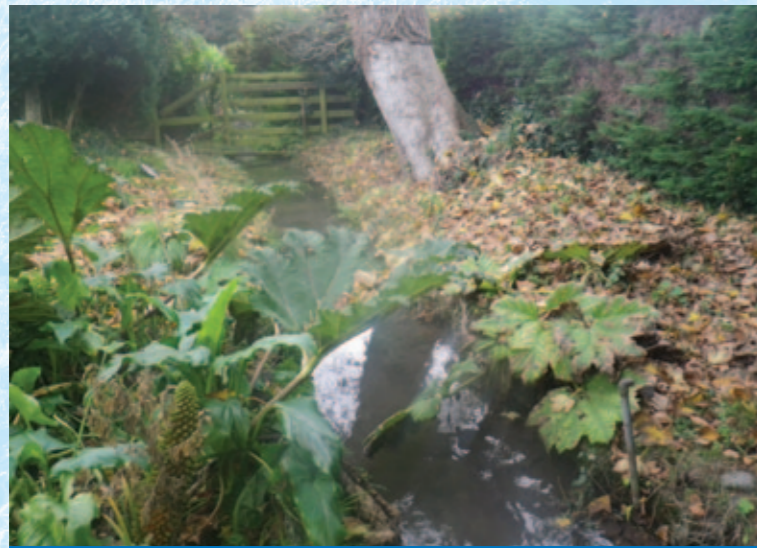
The stream flows through a number of village gardens.

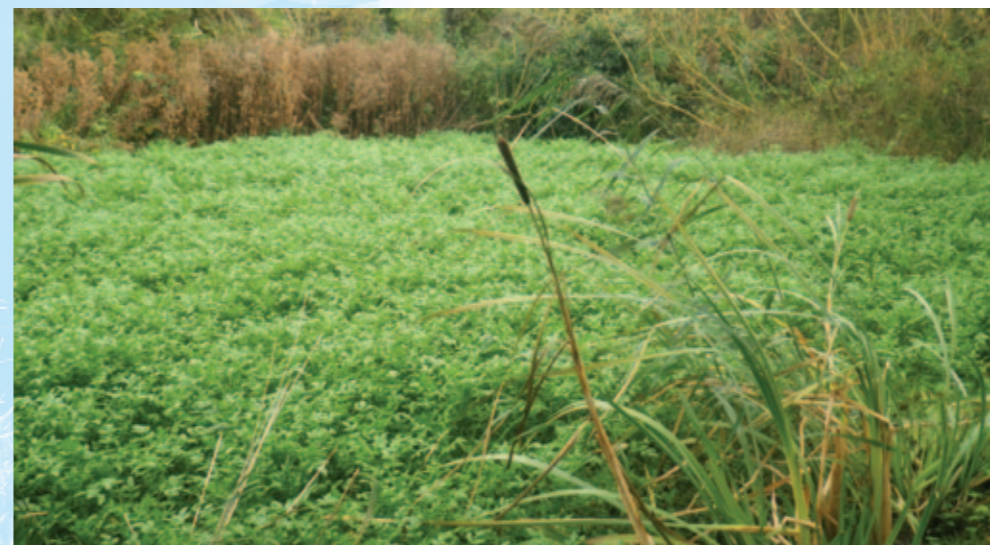
A dense bed of watercress at the entrance to the millpond

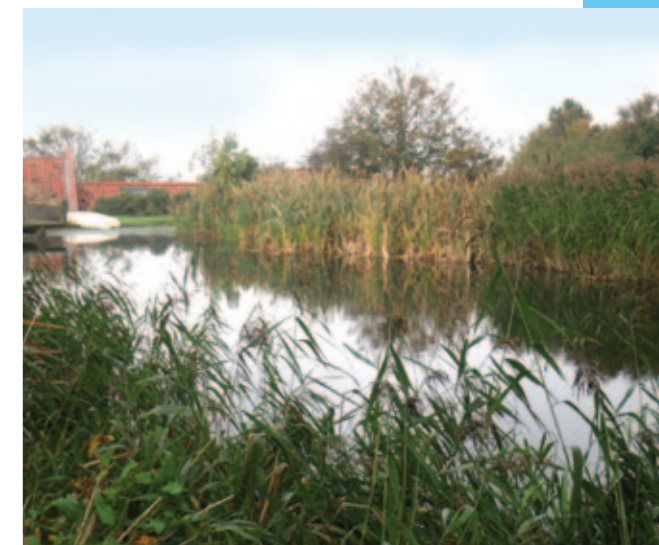
The millpond

Water exits the pond through a sluice gate and flows through agricultural land, before the channel widens into a millpond as the watercourse approaches Beach Lane. The stream exits the pond through another sluice and flows around the boundary of the old water mill, dropping by approximately 6 metres, via a series of concrete weirs. It is likely that this structure will present a serious obstacle to the passage of both eels and trout upstream into the higher reaches of Spring Beck. The water then passes through a culvert under Beach Road and flows out into a large lagoon.

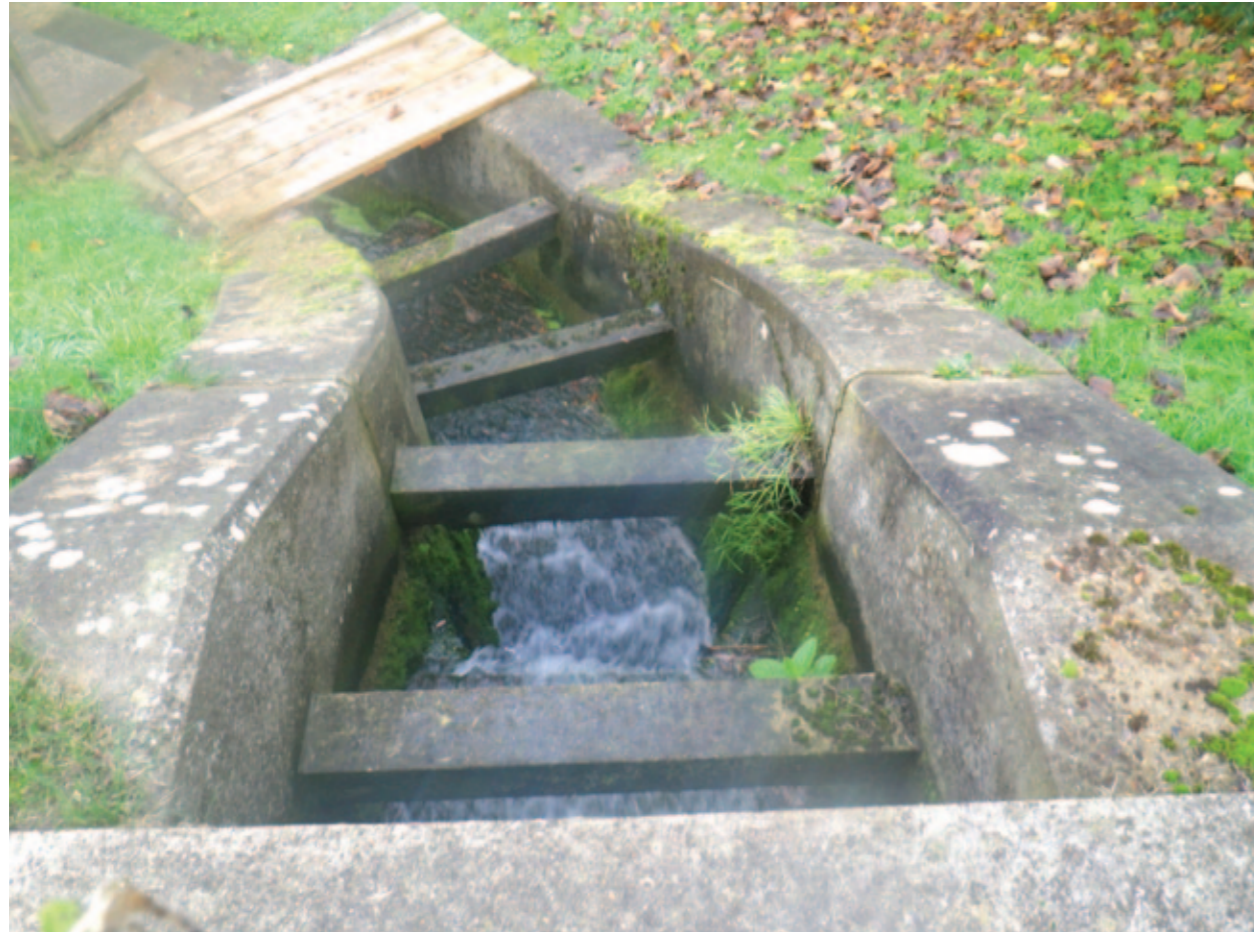
The water falls by approximately 6 metres via a weir as it exits the millpond

The weir at the old millhouse would benefit from the installation of an eel pass, which would aid the migration of the species within the stream

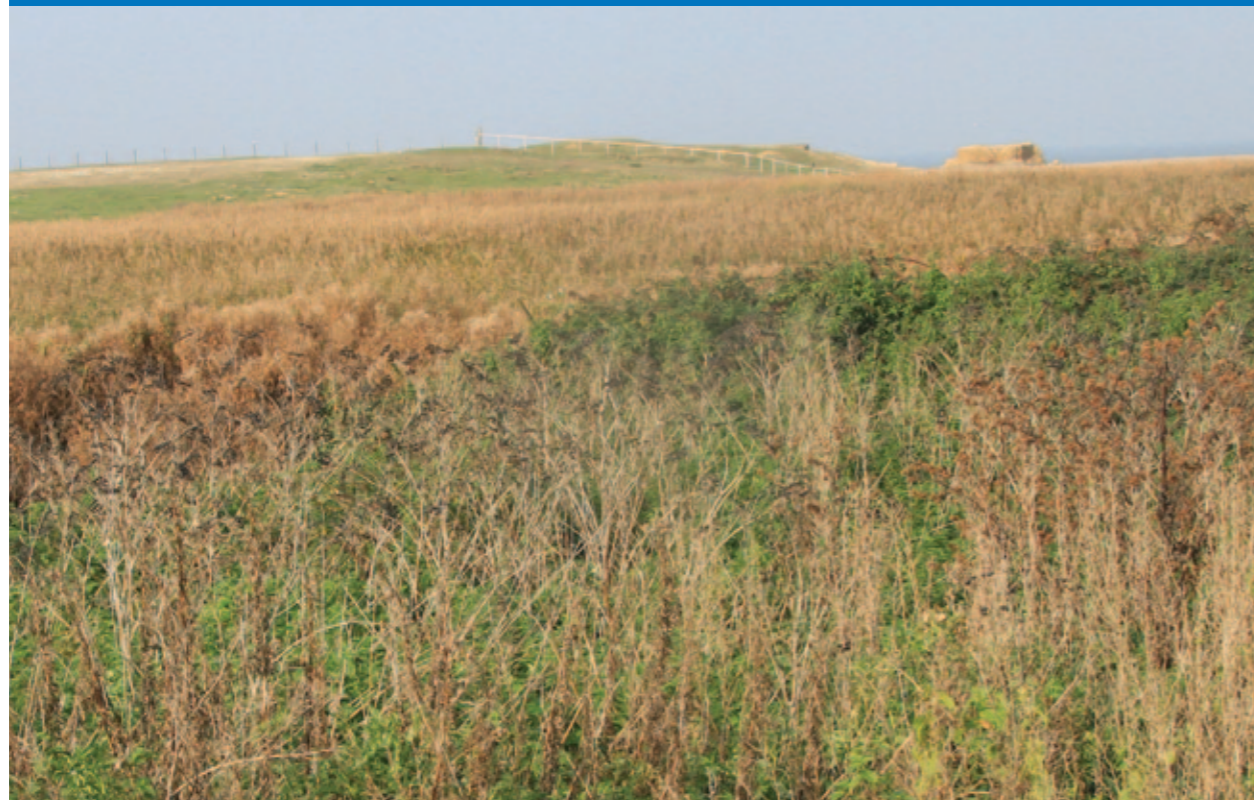
The lagoon is highly vegetated with reed and filled with silt. It is also reported to be prone to seasonal flooding. As such it may benefit from partial clearance to create a pond

feature, which could arguably improve the environment, both for wildlife and the local community.

The lagoon near the river's mouth

the lagoon at Weybourne will revert to marsh as the reeds continue to colonise over the next few years. The lagoon is also currently of little value to the community. It is, however, possible to enhance the stream as it flows into the lagoon by clearing the reed and narrowing the banks to promote a swifter flow. This will prevent the re-colonisation of reed and produce an attractive, clean gravel bed, which will be of benefit to the stream's fish and insects. It would be beneficial to leave reeds around the margins of the lagoon for the bird and dragonfly species, which use them, but to deepen the centre of the pond sufficiently (approx. 1.5m) to prevent rapid re-colonisation). This will create an attractive feature close to the village centre, which will be rich in wildlife.

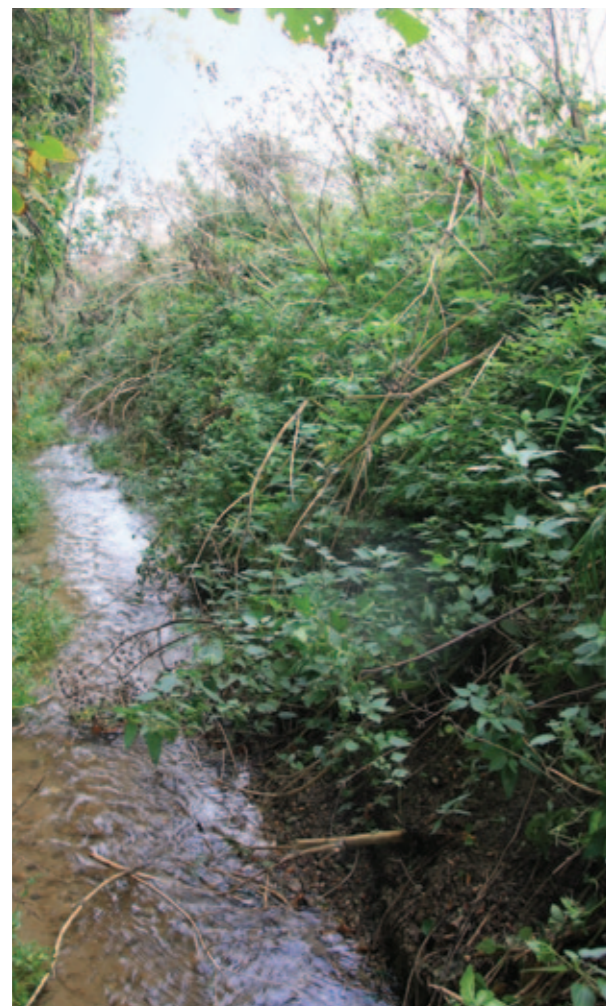
Over the years Spring Beck's channel has been straightened, which has allowed it to cut unnaturally deep channels through the bedrock

Over the centuries, Spring Beck's channel has been straightened and re-directed, therefore much of its variability has been lost. Straightening creates a uniformity of flow, and the faster flowing areas from which silt would naturally be scoured disappear, allowing silt deposition along the whole riverbed. Creatures adapted to uniform flows and silty substrates thrive in such conditions, but those requiring pools and riffles, clean gravels, or fast or slow water do not. Slowly the structure of the ecological community changes, and diversity is lost. Spring Beck has been straightened and marginalised throughout its entire course, with very little of the river retaining a "natural" form.

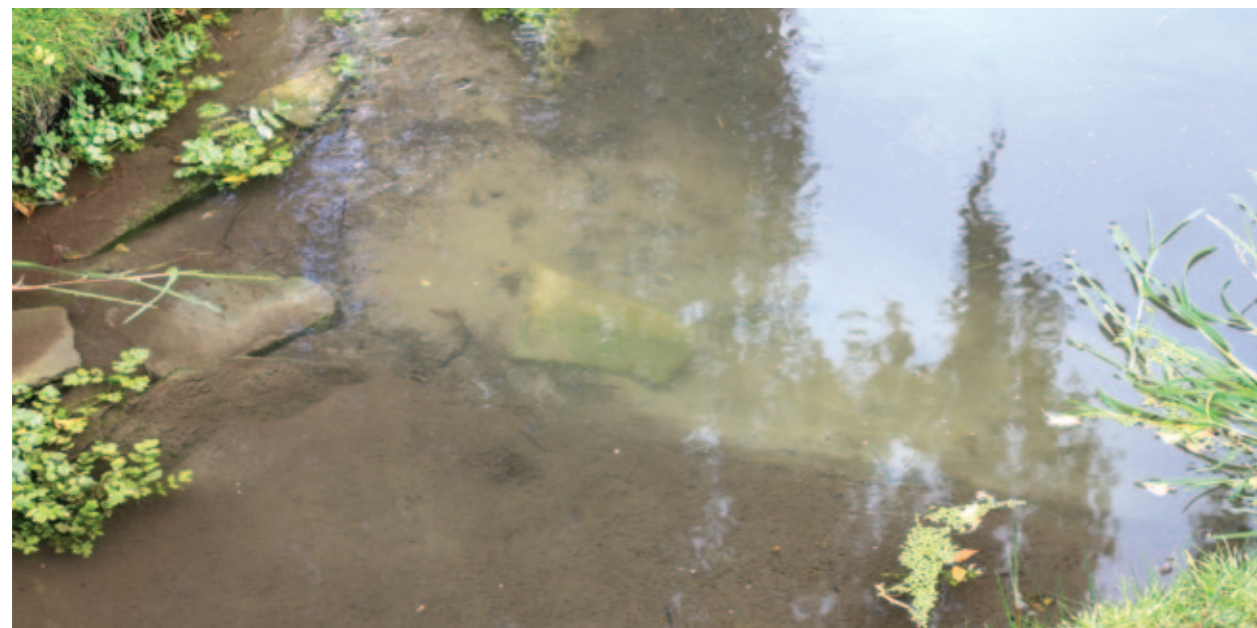
Residents have reported that silt levels in this low energy tributary stream have increased over recent years.

Recent work by Norfolk Rivers Trust on the Nar is showing how these problem points can be addressed relatively easily and cheaply, either by diverting rain-flow away from the river, or by trapping silt in the river close to its point of entry. Bringing back the banks and creating habitat complexity by adding woody material in the stretch of Spring Beck above Weybourne village, may help tackle siltation problems further downstream. The historic millpond, the pond next to Weybourne Priory and the lagoon at the bottom of Beach Road all have notably high silt content and may benefit from excavation.

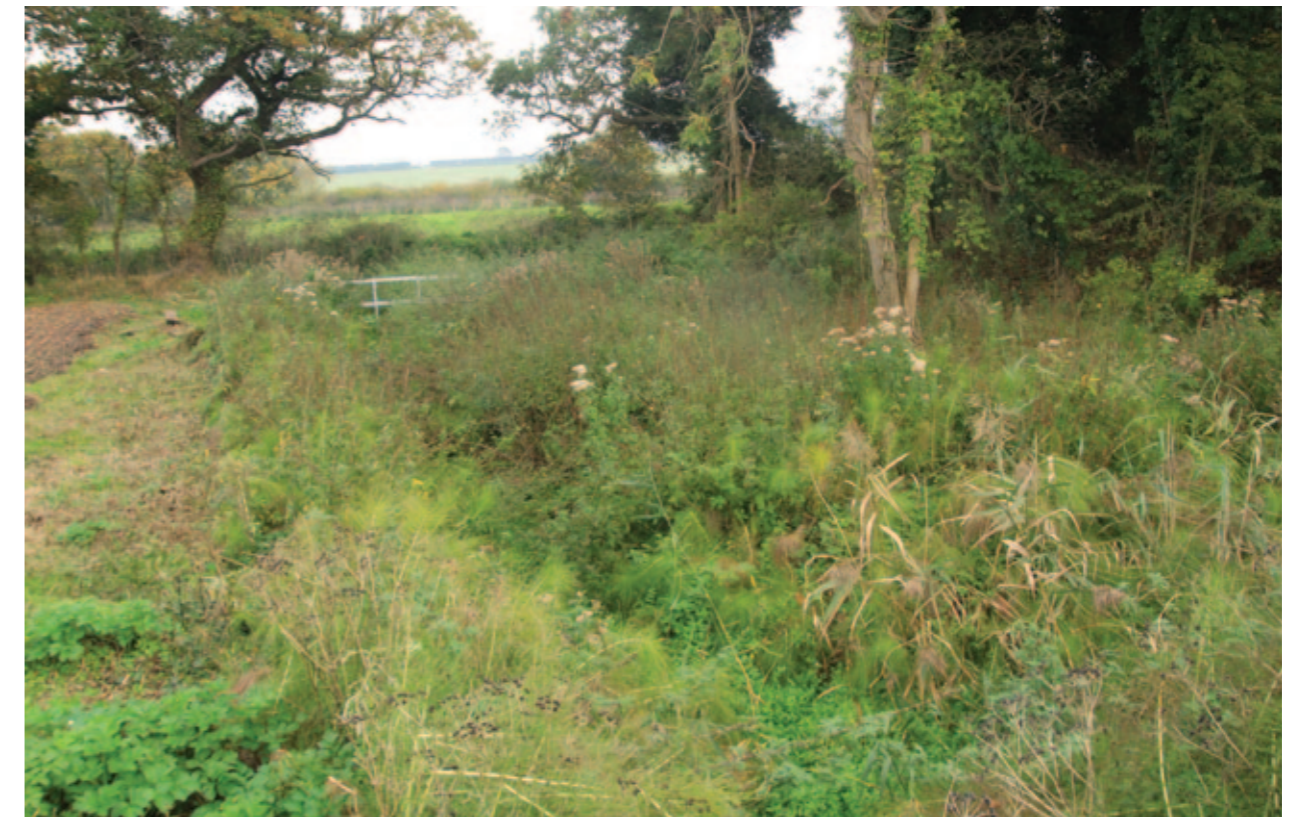
The old moat to the west of Holt Road is currently overgrown and full of silt.
