THE NORFOLK RIVERS TRUST
RESTORING NORFOLK'S RIVERS

SPRING BECK

A WATER FRAMEWORK DIRECTIVE LOCAL CATCHMENT PLAN

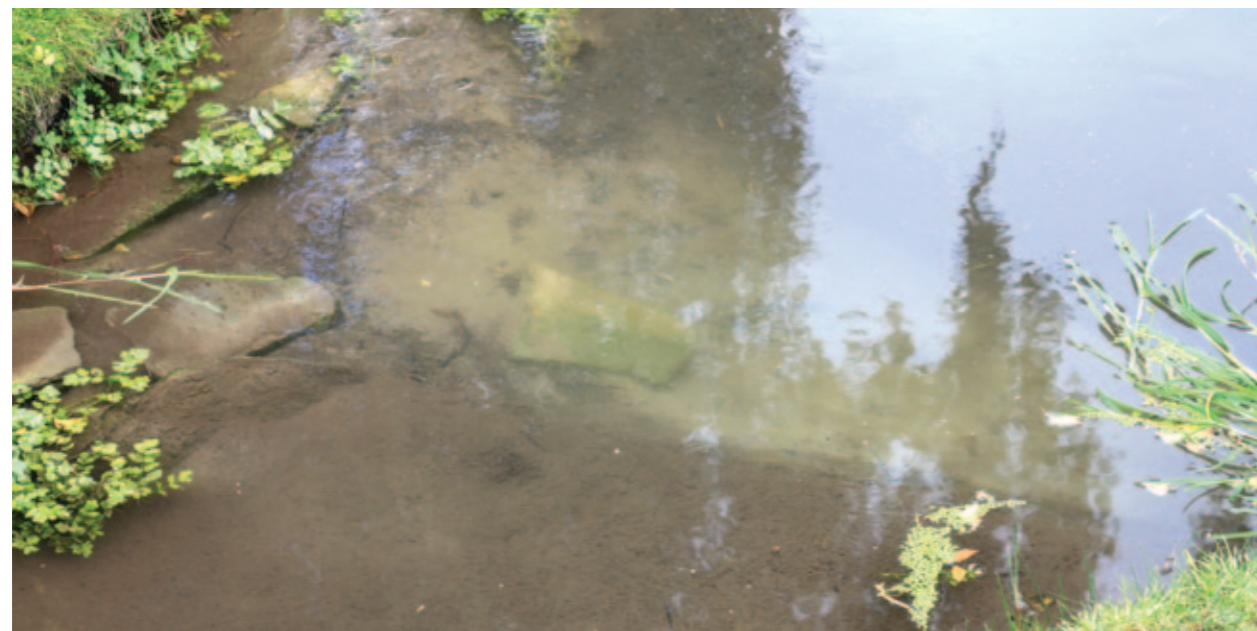
Residents have reported that silt levels in this low energy tributary stream have increased over recent years.

Recent work by Norfolk Rivers Trust on the Nar is showing how these problem points can be addressed relatively easily and cheaply, either by diverting rain-flow away from the river, or by trapping silt in the river close to its point of entry. Bringing back the banks and creating habitat complexity by adding woody material in the stretch of Spring Beck above Weybourne village, may help tackle siltation problems further downstream. The historic millpond, the pond next to Weybourne Priory and the lagoon at the bottom of Beach Road all have notably high silt content and may benefit from excavation.
