Sheringham Shoal and Dudgeon Offshore Wind Farm Extension Projects

Appendix 18.3 – Geomorphological Baseline Survey Technical Report (Revision B) (Clean)

Document Reference: 6.3.18.3

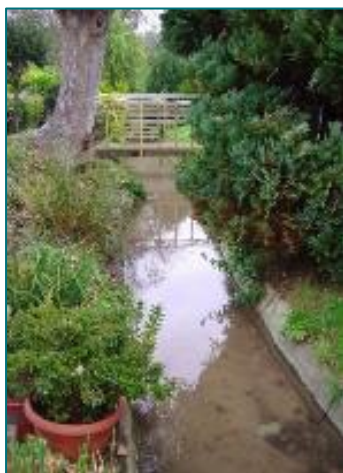
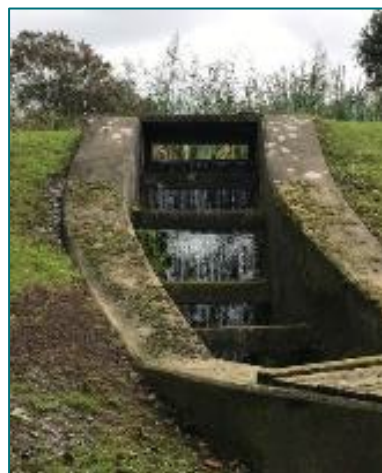
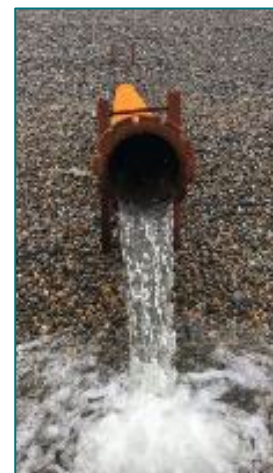
Plate 18.3.1: Spring Beck

15. Spring Beck has been modified (see below) and is predominantly characterised by low energy glide and impounded flows, with limited flow diversity or in channel features. Faster flow habitats (such as runs) were observed, although these occurred through the artificial sections of the beck.

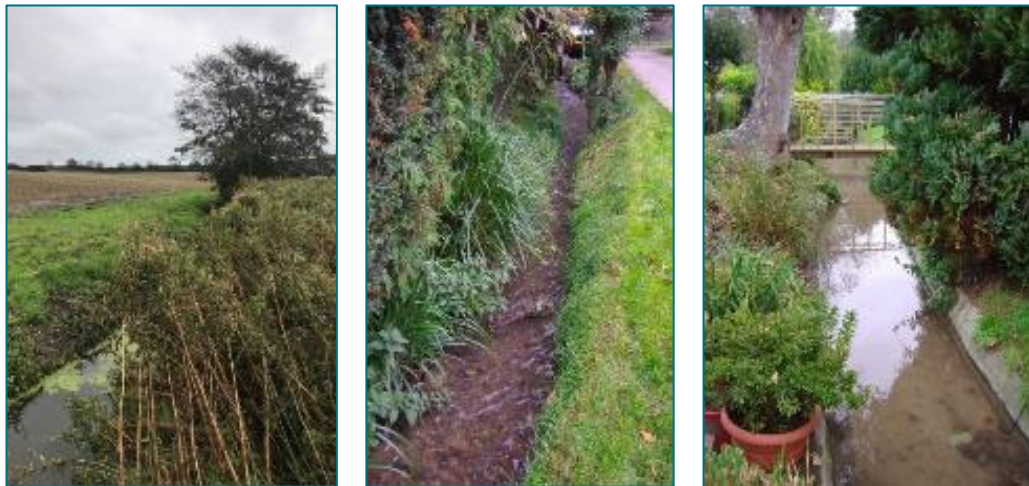
Plate 18.3.2: Spring Beck Channel Form

16. The course of Spring Beck was modified in the eighteenth century in response to the construction of a watermill and dammed to create a substantial mill pond. As such, the beck in places does not follow the natural watercourse alignment and is diverted along an artificial course for some length through the village of Weybourne. The channel form of the beck through the village is therefore predominately straight, with artificial (concrete) bed and banks in places. The channel is approximately 1m – 2m wide at the bank top; 1m wide at the bank base, with a bankfull depth between 0.5m – 1m. Thus, the overall form of the beck through the village displays a typical box shape uniform channel, with limited instream morphological complexity (). On the outskirts of the village, the beck although less confined, displays a U shape uniform channel, typical of drainage ditches in open fields (**Plate 18.3.2**).

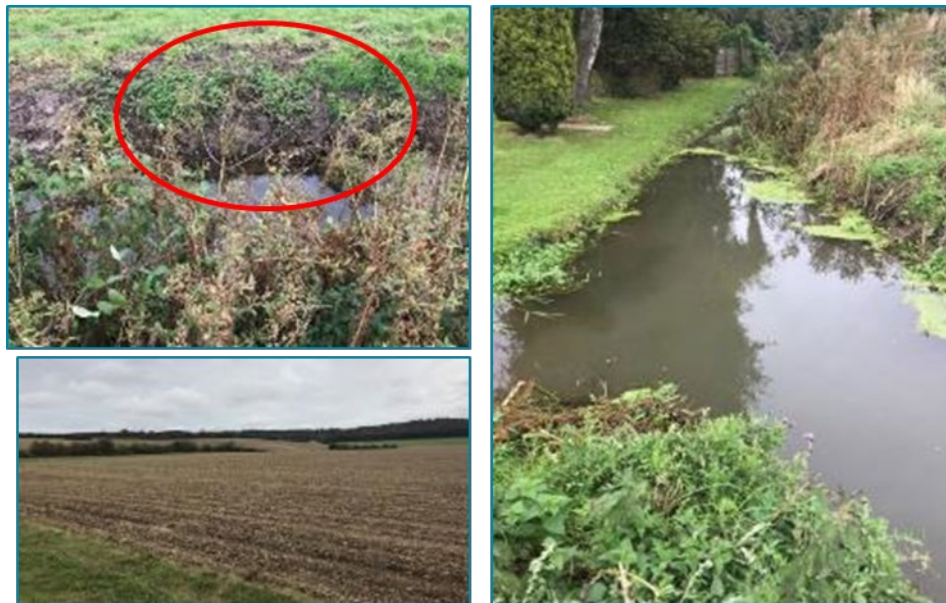
Plate 18.3.3: Sediment Sources and Local Impoundment

17. Spring Beck within the study area is associated with colluvium soils; loose unconsolidated sediments typically composed of a heterogeneous range of rock types; and sediments ranging from silt to rock fragments of various sizes. The beck is also associated with peat soils, an accumulation of partially decayed vegetation or organic matter.
18. The overall substrate of the beck throughout the study area is thus dominated by sands, silts and gravels. The dominant fluvial process appears to be sediment deposition, with slow glide flows, local impoundments caused by small weirs, the mill pond, dense in-stream vegetation, low gradients and low velocities all contributing to the settling out of fine sediments/silts (**Plate 18.3.3**).

19. Although a proportion is likely to be derived from exposed banks during higher-energy flows, the majority of the fine sediment load is likely to be sourced from the agricultural fields on the outskirts of the village (i.e. surface runoff) (**Plate 18.3.3**).

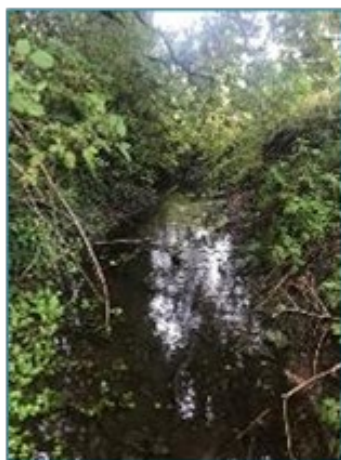
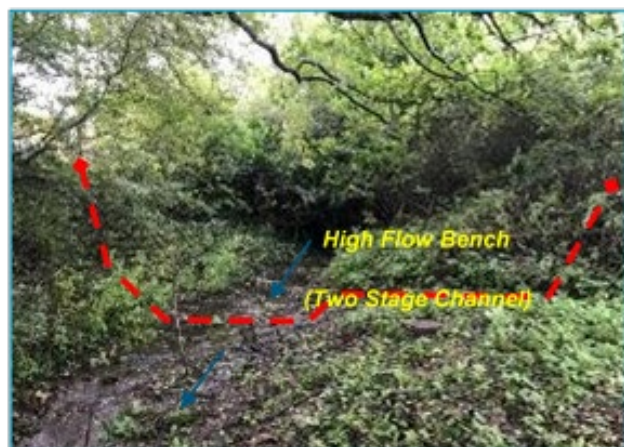
Plate 18.3.6: River Glaven Channel Form

25. The channel has straight planform sections within the study area, which are incised in places into the floodplain and surrounded by agricultural fields and fishing lakes. The banks are relatively steep, stable and well vegetated throughout the study area. The channel (not including the online pond) varies between 1m – 5m wide at the bank top; 0.5m – 1.5m wide at the bank base, with a bankfull depth between 1m – 2m. The overall channel morphology of the River Glaven displays a predominately uniform channel, with the exception of the start and end locations of the study area in which the River Glaven displays more complex geomorphology, including a high flow bench or two-stage channel on the left bank (**Plate 18.3.6**).

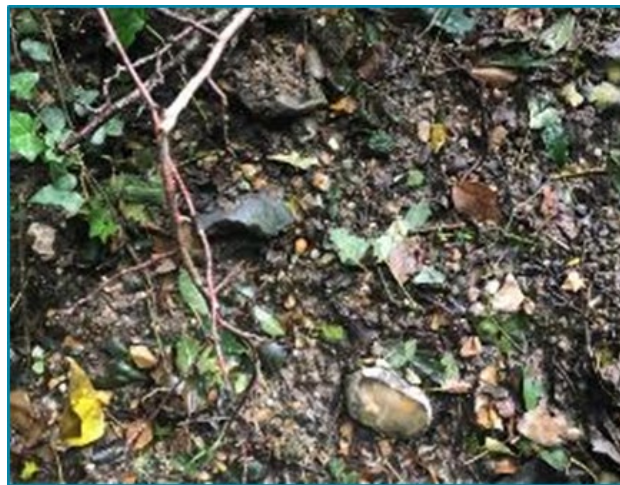
Plate 18.3.7: Glacial Till Bank Composition in the River Glaven

26. The River Glaven within the study area is associated with glacial till, with the banks of the river comprised of clay, sand, gravel, cobbles and boulders (**Plate 18.3.7**).

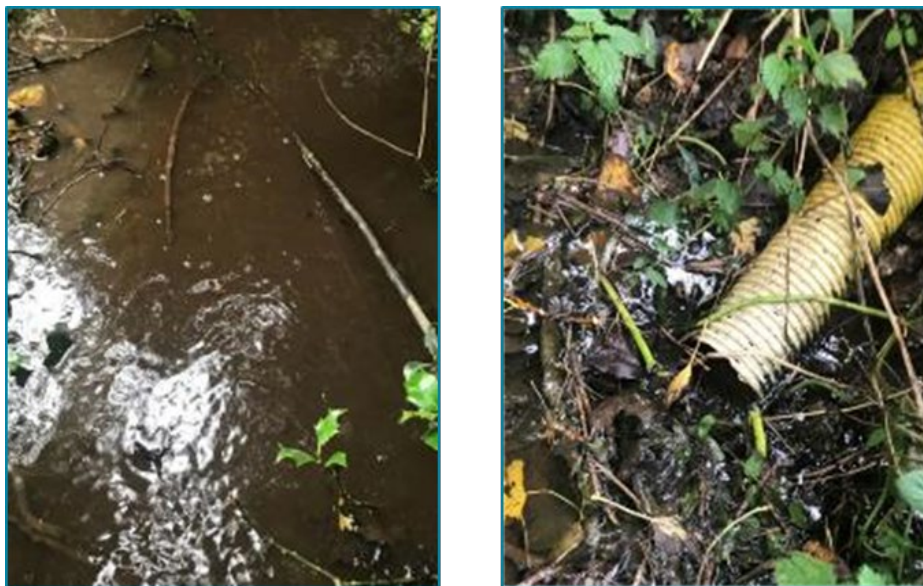
Plate 18.3.8: Silt Deposition and Outfall Pipe

27. The substrate of the River Glaven throughout the study area is thus dominated by clay, sand, boulders, minerals, and gravel. The dominant fluvial process appears to be sediment deposition, with slow flows, low gradients, dense in-channel vegetation (undergrowth) and low velocities contributing to the settling out of fine sediments/silts (**Plate 18.3.8**).

28. A portion of the fine sediment load is likely to be derived from exposed banks during higher-energy flows, outfall pipes, drainage ditches, access tracks and road runoff (noted towards the far downstream end of the study area). The adjacent agricultural fields are also likely to be a major source of fine sediment load through diffuse surface runoff.

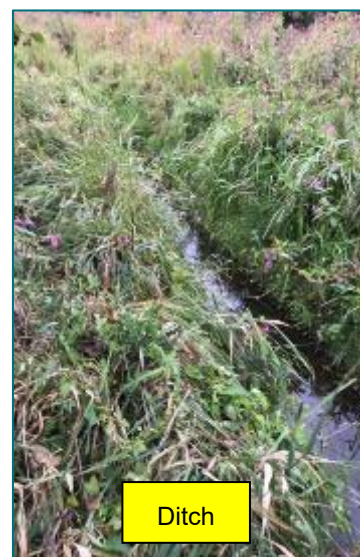
Plate 18.3.10: River Bure Floodplain and Channel Features

35. The channel has a straight planform within the study area, although displays geomorphological complexity varying in size and shape surrounded by agricultural fields, woodland and open fields with wetland (marsh) features. In general, the banks are relatively stable and well vegetated with the channel size between 4m – 6m at the bank top; 2m – 3m wide at the bank base, with a bankfull depth between 1m – 2m. The main channel is contained within a wider channel belt (approximately 100m – 250m wide) also consisting of a network of ditches and vegetated islands forming a wetland (marsh) system (**Plate 18.3.10**). The River Bure within the wider channel belt takes the form of a large two-stage channel.

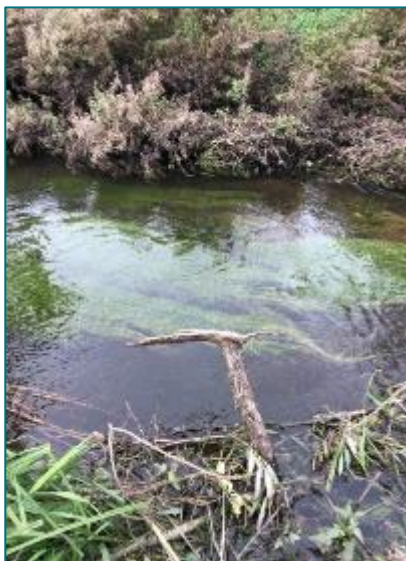
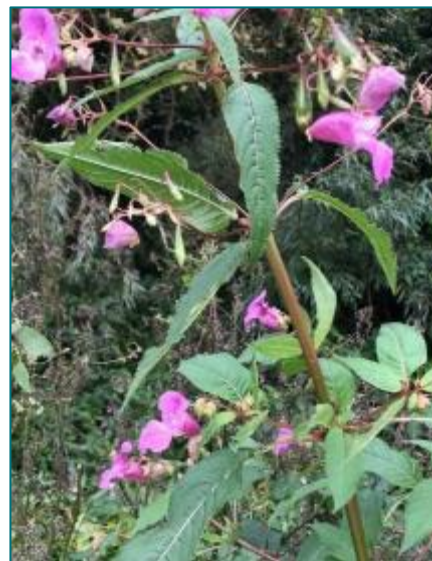
Plate 18.3.11: Water-Crowfoot (Left) and Himalayan Balsam (Right)

40. The banks and margins of the River Bure are well vegetated and dominated by poor semi-improved grassland with occasional shrubs. There is good coverage of aquatic plants along the bed of the river, including pockets of water-crowfoot ([Plate 18.3.11](#)). The channel belt has an array of terrestrial and wetland plants, although Himalayan balsam is present.

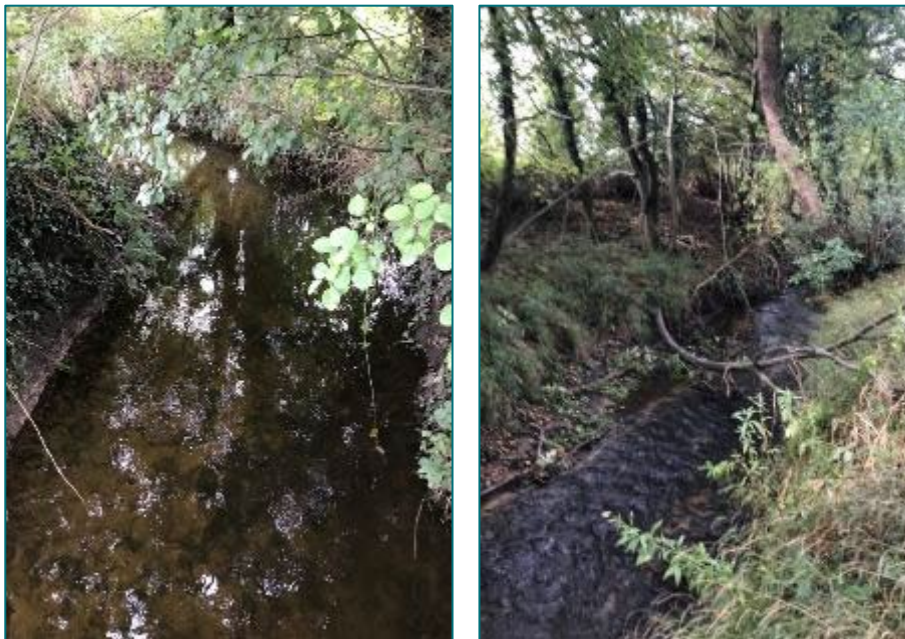
Plate 18.3.12: Swannington Beck – Primary Channel

43. The primary channel is also heavily vegetated, tree lined and incised in places (deep and narrow), with limited floodplain connectivity. Substrate sediments are comprised of clay, sands and gravels, with clean pockets of sand and gravel evident, and silt deposition in places (**Plate 18.3.12**). Likely sediment load into the Swannington Beck would be associated with local bank erosion and upstream land management, although banks of the beck within the study area are well fenced which has reduced the impacts of livestock poaching (trampling). The secondary channel (or northern arm) of the Swannington Beck is a smaller watercourse which is wide, deep, straight, tree lined with good marginal vegetation (sedges, bladed grasses – iris). The bed of watercourse is predominantly comprised of silts (**Plate 18.3.13**).

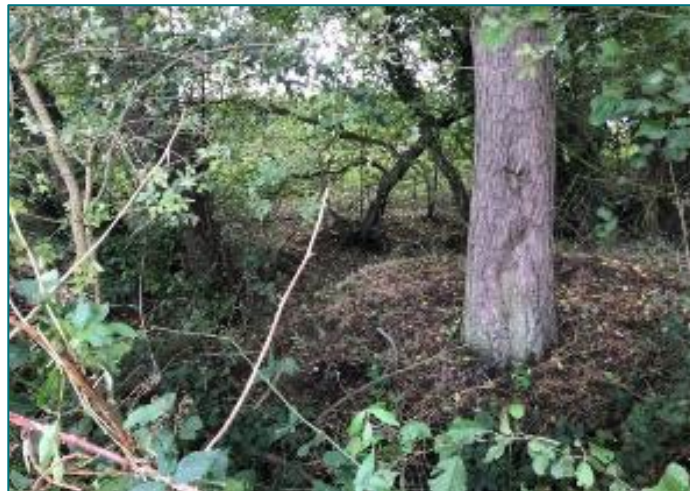
Plate 18.3.14: Anabranch and Wet Woodland

46. Given the tree lined nature of the channel, the majority of morphological adjustment is through increasing the bed gradient (slope) of the Swannington Beck. Other channel form adjustments, such as the development of anabranches (and in-channel bars) were evident along the beck, with anabranches generally formed through avulsion triggered by debris accumulation (**Plate 18.3.14**).
47. The secondary channel of the Swannington Beck is wide and relatively deep (incised), with dense in-channel vegetation. The channel size is approximately 5m at the bank top, 1m at the bank base, with a bankfull depth of approximately 1m.

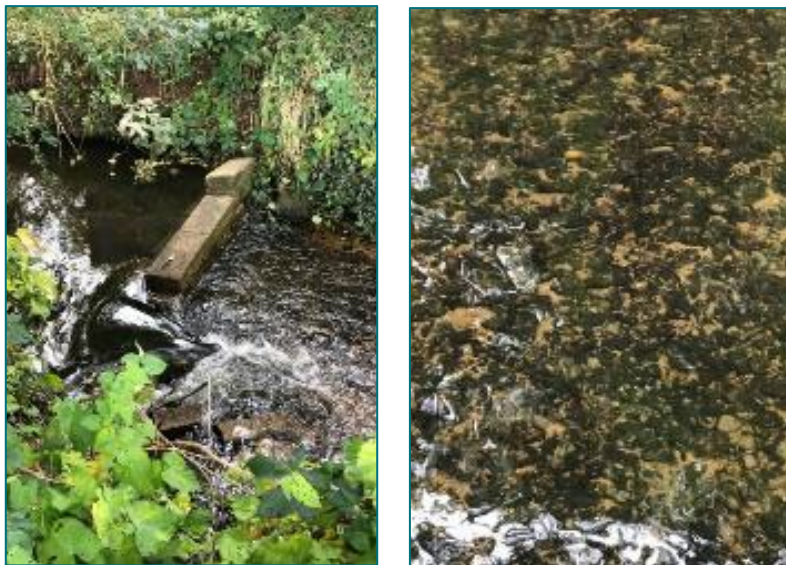
Plate 18.3.15: Weir and Bed Armouring Along the Swannington Beck

48. The Swannington Beck within the study area is associated with riverine clay, sands and gravels, with the banks predominantly composed of clay and sand (i.e. clay to sandy loam banks), with the properties of the soils (along with the in-channel vegetation, such as sedges and grasses) providing good filtration of water.
49. The substrate of the primary channel of the Swannington Beck throughout the study area is thus dominated by clay and sand. The dominant fluvial process appears to be sediment deposition triggered by slow flows, debris and impoundment caused by a small weir (**Plate 18.3.15** and **Plate 18.3.16**). The bed in some places was also armoured, in which coarse grains were on the surface protecting finer particles underneath from erosion (**Plate 18.3.15**).

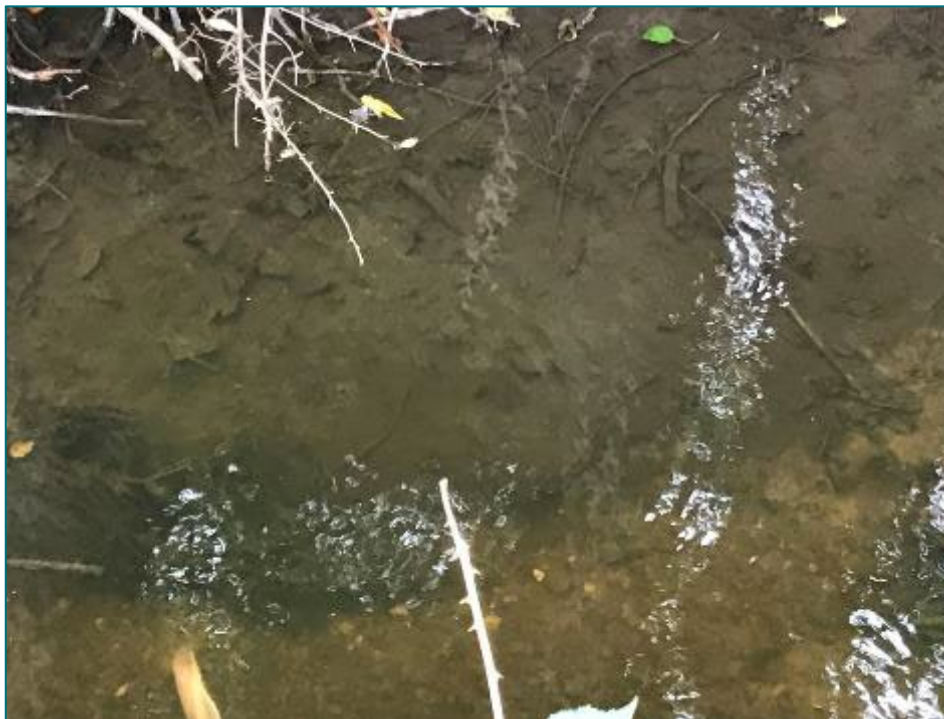
Plate 18.3.16: Sediment Deposition Upstream of Weir.

50. The secondary channel of the Swannington Beck is dominated by silts in response to slow flows and debris causing settling out of fine sediments.
51. Likely sediment load into the Swannington Beck would be associated with local bank erosion, access tracks and upstream land management. However, the banks of the beck along the primary channel within the study area are well fenced which has reduced the impacts of livestock poaching (and fine sediment input).

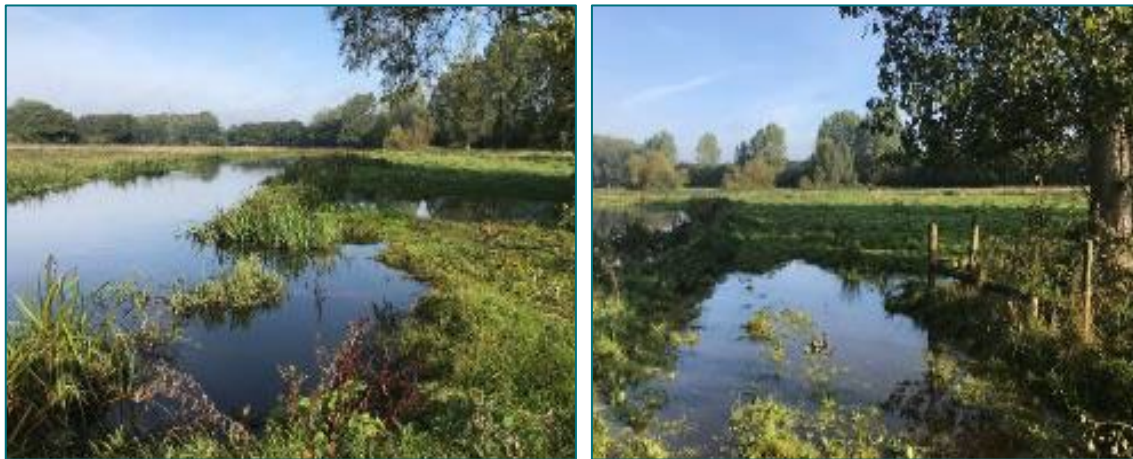
Plate 18.3.18: Channel and Floodplain Features.

58. The primary channel of the River Wensum has a straight to sinuous planform within the study area and flows through an open floodplain characterised by a wide and deep channel, with the bank top width between 8m – 10m and width at the base between 5m – 6m. Bankfull depth is approximately 2m (Plate 18.3.17). Key channel and floodplain features include small benches (steps in the channel which accumulate organic debris and silts), backwaters and wetlands, providing geomorphic complexity and habitat diversity (Plate 18.3.18).

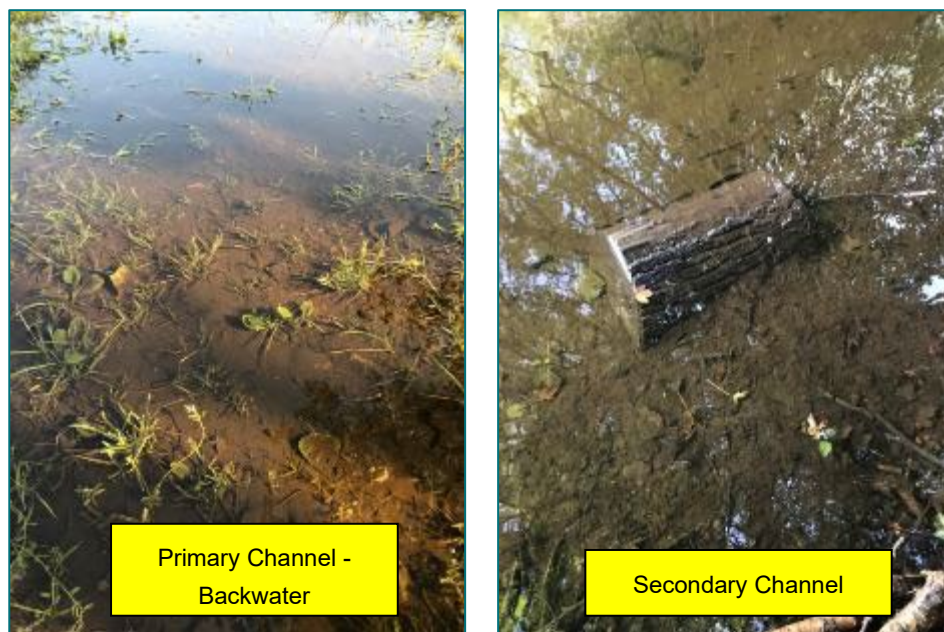
Plate 18.3.20: Silt Deposition

62. The secondary channel of the River Wensum and field ditches are dominated by silts in response to slow flows and debris causing settling out of fine sediments (**Plate 18.3.20**).

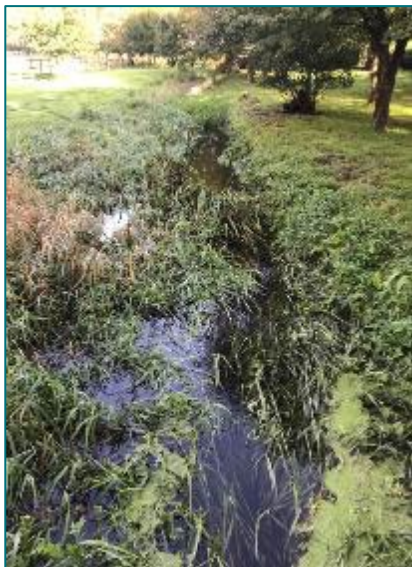
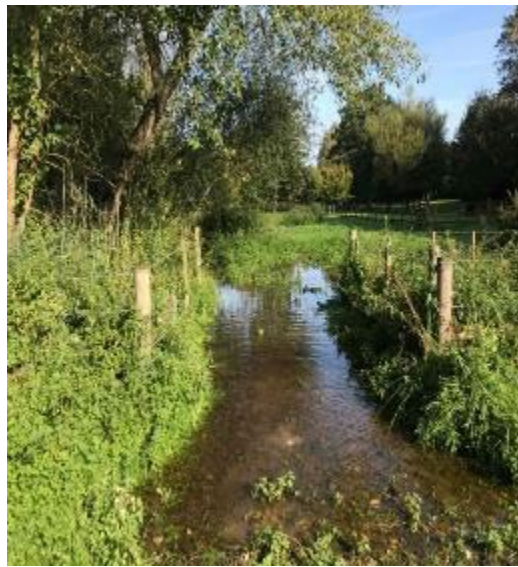
Plate 18.3.21: Secondary Channel Floodplain Connectivity

63. Good floodplain connectivity along the primary channel of the River Wensum within the study area was clearly evident during the walkover survey (**Plate 18.3.21**).
64. Good floodplain connectivity was also evident towards Old Fakenham Road (downstream end of study area) along the secondary channel in response to the change in channel morphology, with the channel not incised and channel banks gently sloping allowing inundation of the floodplain in places (**Plate 18.3.21**).

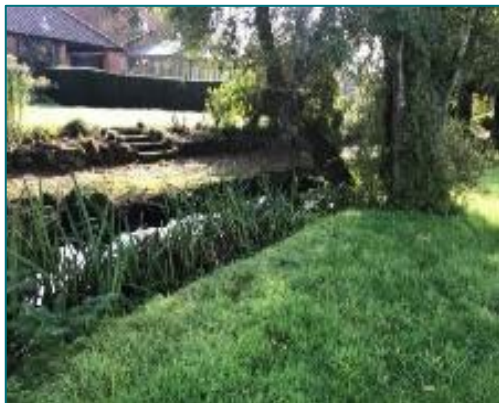
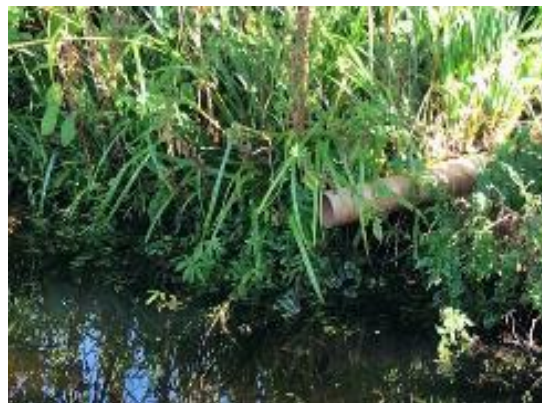
Plate 18.3.22: Modification of the Secondary Channel

66. No modifications or structures, such as hard engineering bank protection works were observed during the walkover along the primary channel of the River Wensum, although the secondary channel in places is modified with stone bank protection along the back of a housing estate. Two small pipes also discharge into the secondary channel towards the downstream end of the study area ([Plate 18.3.22](#)).

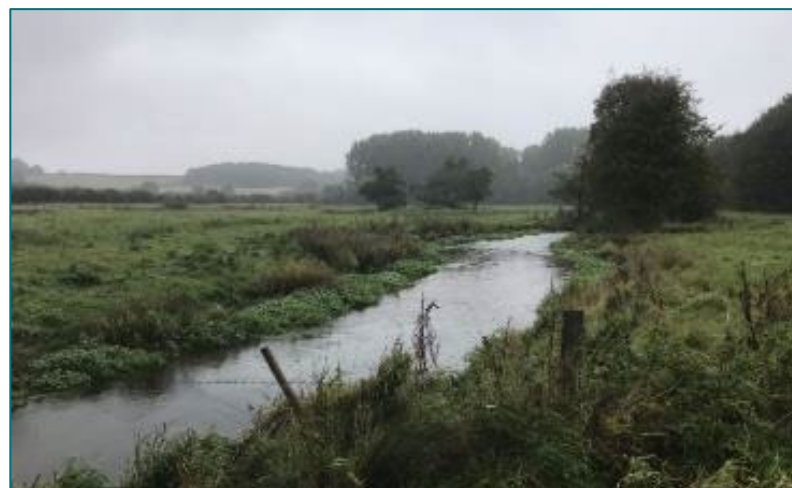
Plate 18.3.23: River Tud

68. The River Tud within the study area is characterised by various flow types, including glides, runs, pools and riffles, with strong eddies observed on the outside of meander bends.

71. The substrate of the River Tud throughout the study area is thus dominated clay and sand. The dominant fluvial process appears to be sediment transport with very little sediment deposition on the bed during the time of the walkover (**Plate 18.3.25**). However, fine sediments were evident along the margins of the river.
72. Despite livestock poaching prevalent within the study area, there was minimal fine sediments on the riverbed, although poaching is likely to be a key sediment source along with point source pollution from ditches (iron leaching observed in one ditch) and upstream land management. A potential reason why livestock poaching did not have an impact on bank erosion and thus contribute more as a sediment source, appears to be in response to the well vegetated floodplain, banks and margins of the River Tud (**Plate 18.3.23**).

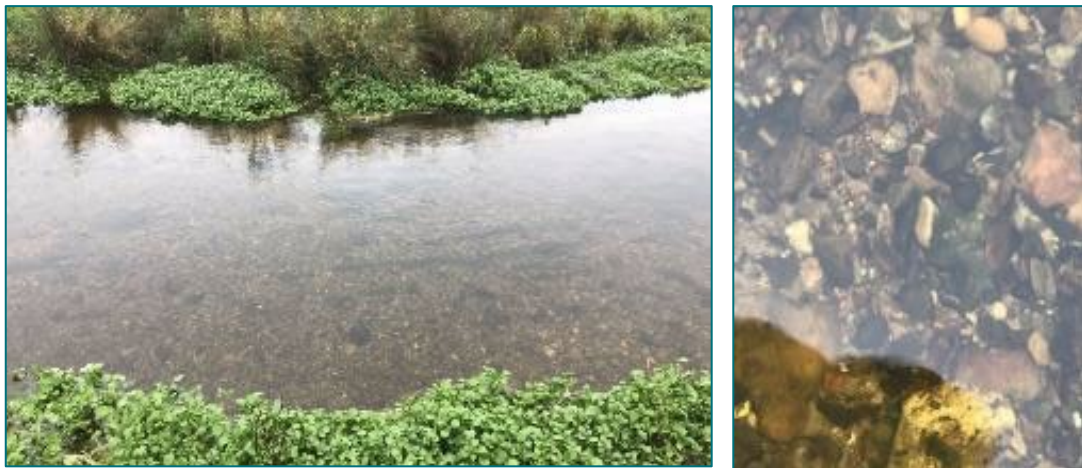
Plate 18.3.25: Clean Gravel Bed Substrate

70. The River Tud within the study area is associated with riverine clay, sands and gravels, with the banks predominantly composed of clay and sand (i.e. clay to sandy loam banks), with the properties of the soils (along with the in-channel and marginal vegetation, such as sedges and grasses) providing good filtration of water and clean gravels (**Plate 18.3.25**).

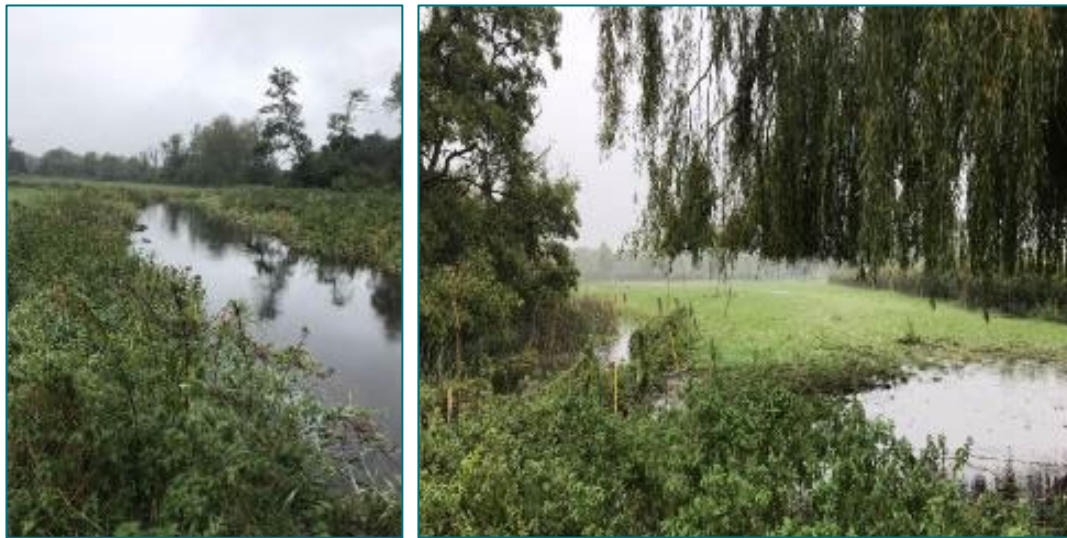
Plate 18.3.28: River Yare Channel Form and Floodplain Features

78. The River Yare has a straight to sinuous planform within the study area and flows adjacent to Colton Wood and open floodplain, characterised by a wide and deep channel, with the bank top width between 5m – 8m and width at the base between 4m – 5m. Bankfull depth is approximately 2m. Key channel and floodplain features include wetland scrapes and backwaters (**Plate 18.3.28**).

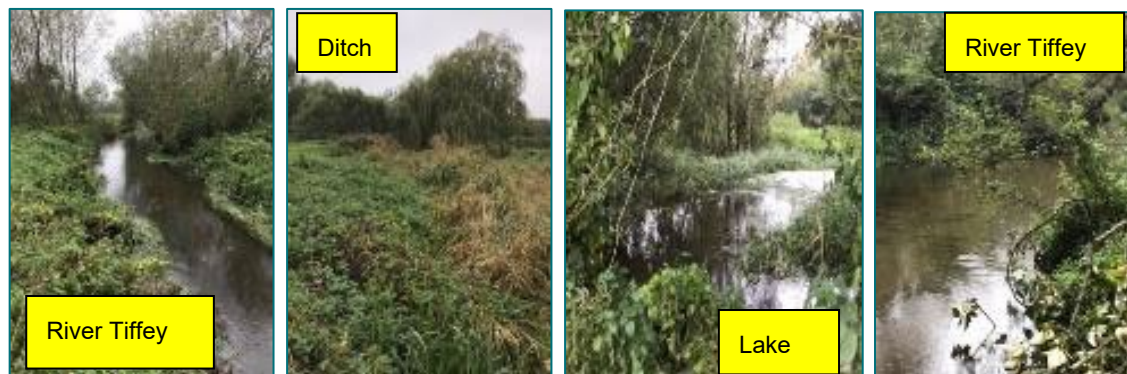
Plate 18.3.29: River Tiffey and Floodplain Features

84. The characteristics of the River Tiffey are described in **Table 18.3.9**. The River Tiffey, a tributary of the River Yare, rises near Hethel and flows north-eastwards through the central region of Norfolk and several villages before joining the River Yare near Barford. The River Tiffey within the study area is characterised by a relatively straight planform which is deep and narrow in places and dominated by glide and pool flow habitats (**Plate 18.3.29**). The river has good marginal vegetation including sedges, bladed grasses, iris, bull rushes and reed, with good floodplain connection. The floodplain contains ditches, a small lake (offline pond) and wet woodland (**Plate 18.3.29**).

86. The River Tiffey has a straight to sinuous planform within the study area and flows adjacent to woodland and open floodplain characterised by a relatively deep and narrow channel, with the bank top width between 4m – 5m and width at the base between 2m – 3m. Bankfull depth is approximately 2m (**Plate 18.3.30**). Key channel and floodplain features include several straight ditches 2m wide and approximately 0.5m deep which are well vegetated in places; and a small lake which was once used for angling (**Plate 18.3.29**). The lake is approximately 20m wide by 50m in length, although much of the lake has now been infilled within a planted woodland (**Plate 18.3.29**).

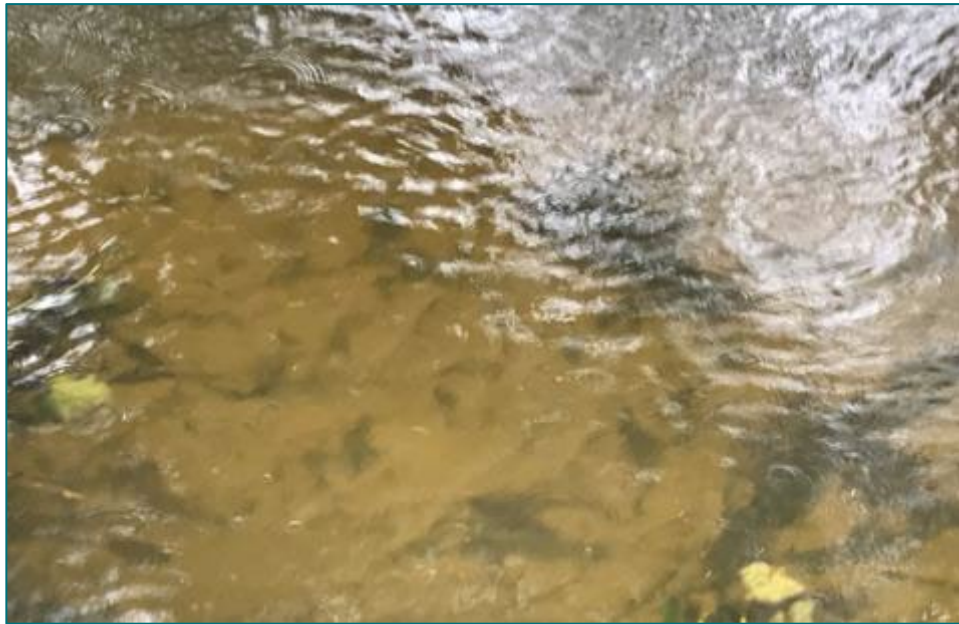
Plate 18.3.31: Sand Ripples

87. The River Tiffey within the study area is associated with riverine clay, sands and gravels, with the banks predominantly composed of clay and sand (i.e. clay to sandy loam banks), with the properties of the soils (along with the in-channel and marginal vegetation, such as sedges and grasses) providing good filtration of water.
88. The substrate of the River Tiffey throughout the study area is thus dominated by clay and sand. The dominant fluvial process appears to be sediment deposition in response to the slow flows (low velocities) contributing to the settling out of sediments. However, there was minimal silt deposition, with the majority of deposition associated with coarser sediments, such as sand (**Plate 18.3.31**).
89. Likely sediment load into the River Tiffey would be associated with local bank erosion and upstream land management.

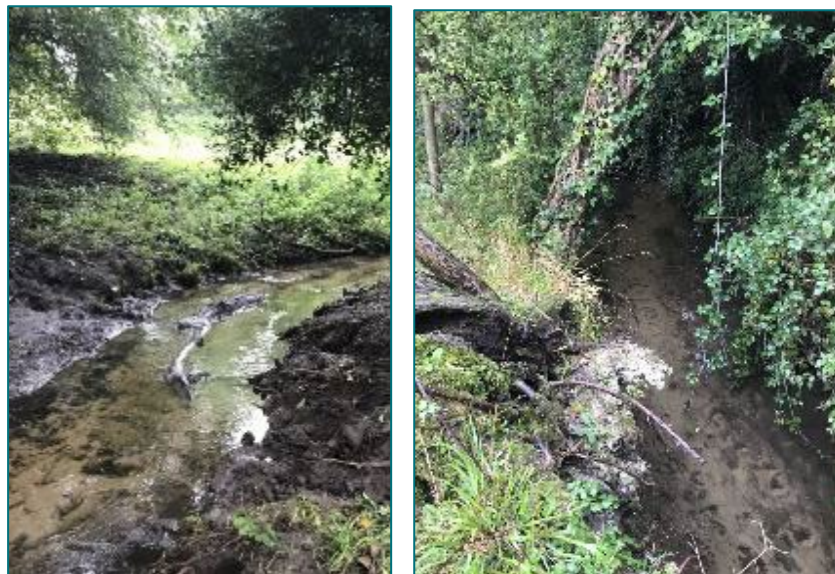
Plate 18.3.33: Western Channel of the Intwood Stream

94. The western channel of the Intwood Stream within the study area is characterised by a straight planform which varies in size and shape from a deep incised channel to a wide and shallow channel with good floodplain connectivity. The channel has varied flow habitats including glides, riffles and runs and contains wooded debris, with good marginal vegetation comprised of sedges, bladed grasses and iris (**Plate 18.3.33**). Floodplain features include ditches and ponds, although livestock poaching is prevalent along the western channel contributing to silt deposition on the bed. However, in places the bed shows some good clean sand and gravel deposition, associated with the glacial till nature of the surrounding soils, which are free of silt.

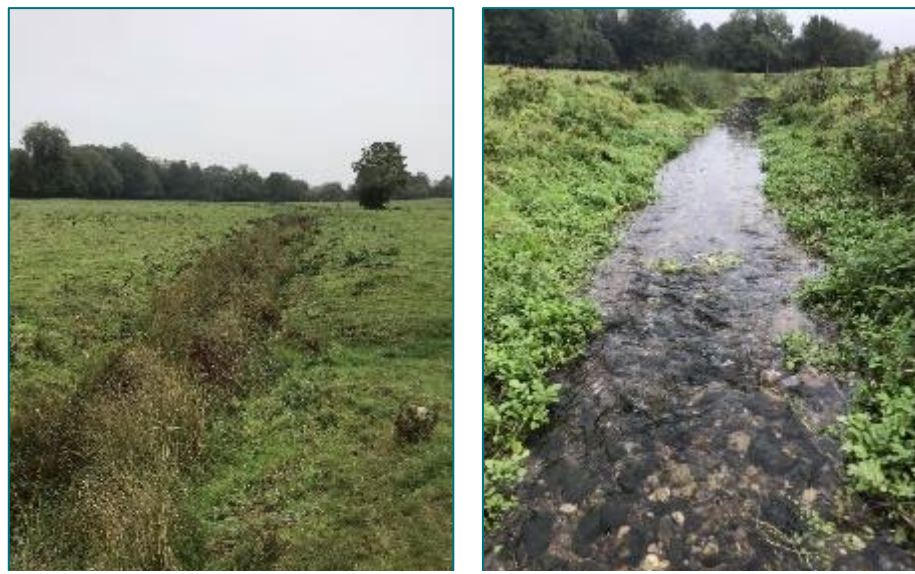
Plate 18.3.34: Eastern Channel of the Intwood Stream

95. The eastern channel of the Intwood Stream within the study area is a smaller watercourse than the western channel and resembles a wide shallow drainage ditch, although does display varied flow habitats, including runs, riffles and pools, with pockets of pond weed. There is good marginal vegetation, such as bull rushes and sedges; and there is good floodplain connectivity (**Plate 18.3.34**). However, livestock poaching is also prevalent contributing to silt deposition on the channel bed. However, in places the bed shows some good clean coarse sand and gravel substrates (associated with the glacial till nature of the surrounding soils) which are free of silt.

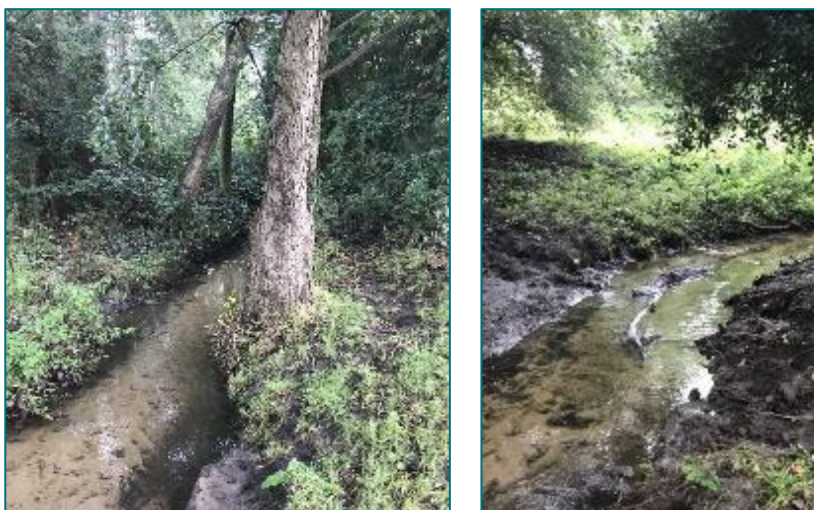
Plate 18.3.35: Western Channel Form

98. The western channel of the Intwood Stream appears to have a modified planform which has been historically straightened, although despite this does show some geomorphic complexity within the study area varying in size and shape. The channel flows through an open floodplain and woodland, with the morphology of channel being deep and incised to wide and shallow, with good floodplain connectivity (see below). In places the channel had a bank top width between 3m – 4m and width at the base between 1m – 2m. Bankfull depth various between 1m – 2m (**Plate 18.3.36**).

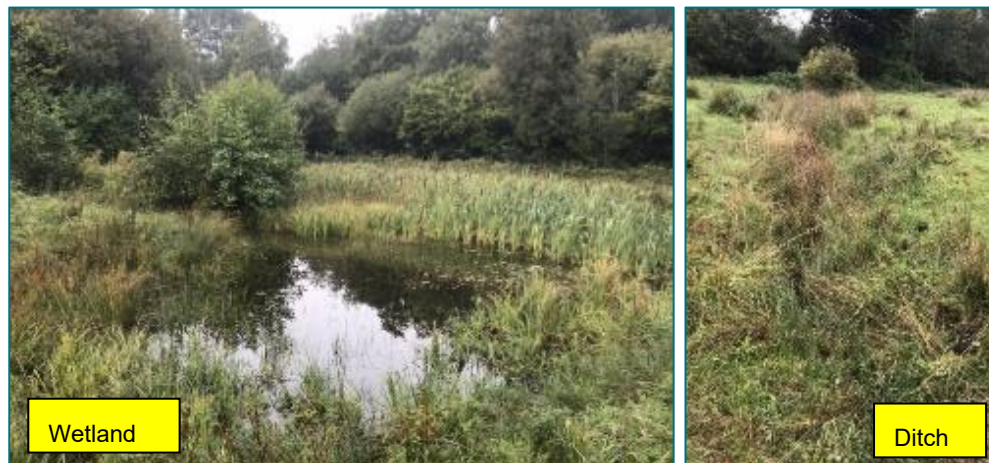
Plate 18.3.36: Western Channel Wetland and Example Ditch

99. Key channel and floodplain features included backwaters, ditches and wetlands, providing geomorphic complexity and habitat diversity (**Plate 18.3.36**).

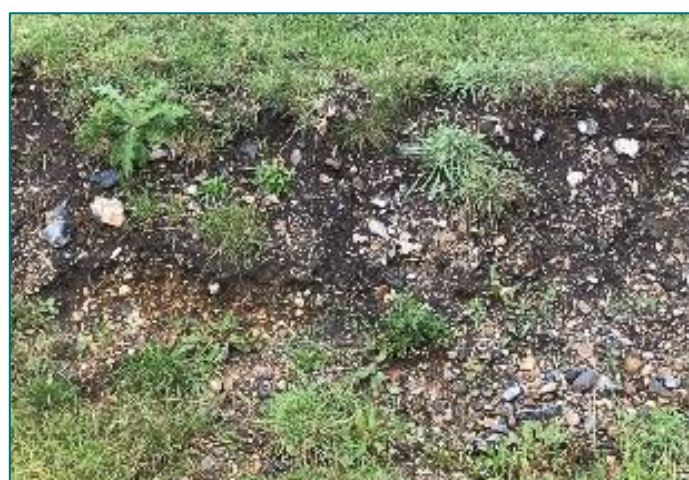
Plate 18.3.37: Glacial Till Bank Composition

101. The Intwood Stream within the study area is associated with glacial till with the banks of the channels through the study area comprised of clay, sand, boulders, minerals, and gravel (**Plate 18.3.37**).
102. The Intwood Stream channels throughout the study area are thus dominated by clay, sand, boulders, minerals, and gravel. There is not one dominant fluvial process, with both sediment deposition and transport occurring at a similar degree along both channels in response to the varied nature of the flow habitats.

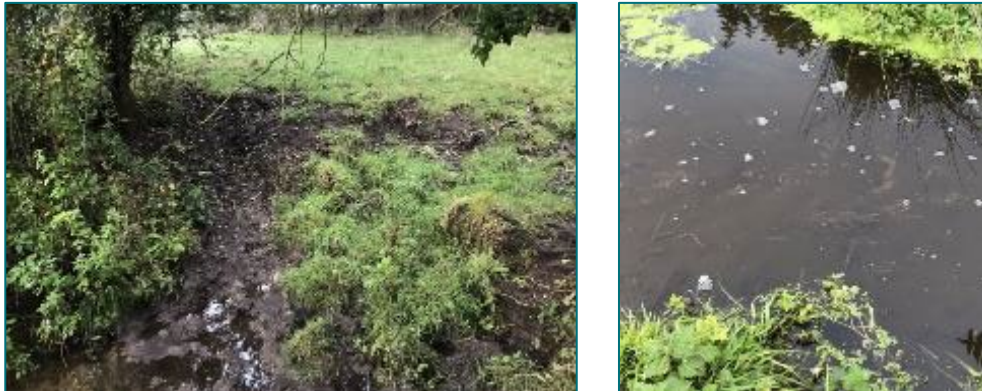
Plate 18.3.38: Livestock Poaching and Silts on Channel Bed.

103. A portion of fine sediment load along the channels is likely to be derived from exposed banks caused by livestock poaching, with higher-energy flows further eroding the banks contributing to fine silts on the channel beds (**Plate 18.3.38**). In addition, a pipe discharges into a land drainage ditch which joins the channel towards the downstream end of the study area potentially allowing fine sediment and/or contaminants to enter the watercourse **Plate 18.3.38**.

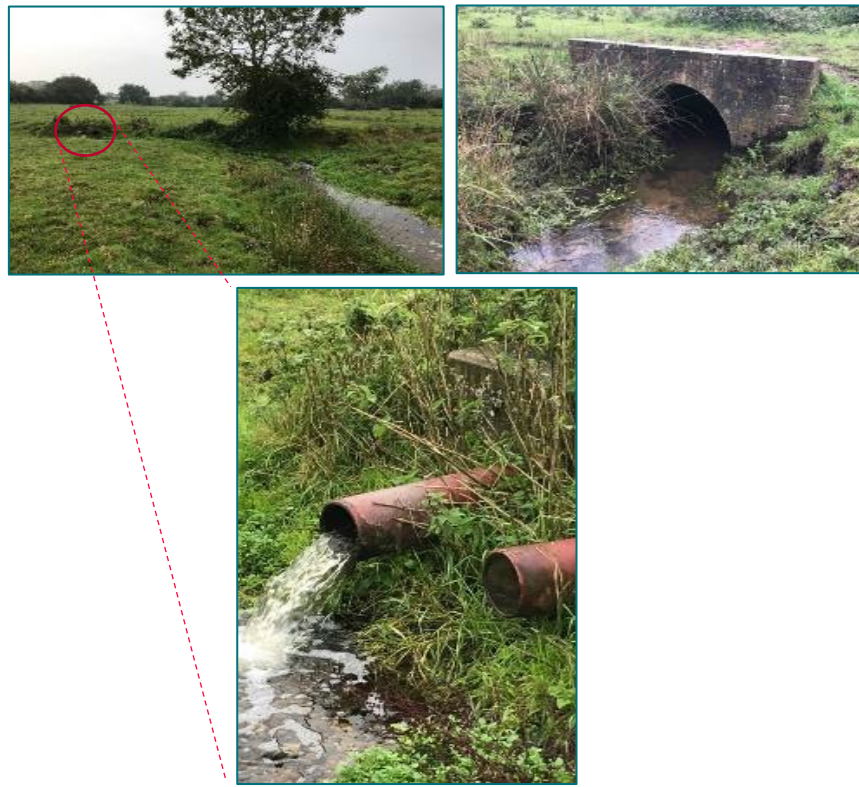
Plate 18.3.39: Outfall Pipes and Small Culvert

106. Two pipe outfalls drain into a land drainage ditch which joins the eastern channel towards the downstream end of the study area. The central reach of the eastern channel also has a culvert providing access to the inner floodplain (**Plate 18.3.39**).
