# Sheringham Shoal and Dudgeon Offshore Wind Farm Extension Projects

## Environmental Statement

## Appendix 18.3 – Geomorphological Baseline Survey Technical Report (Revision B) (Tracked)

Document Reference: 6.3.18.3.1

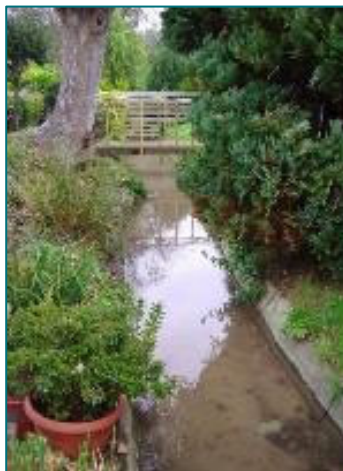
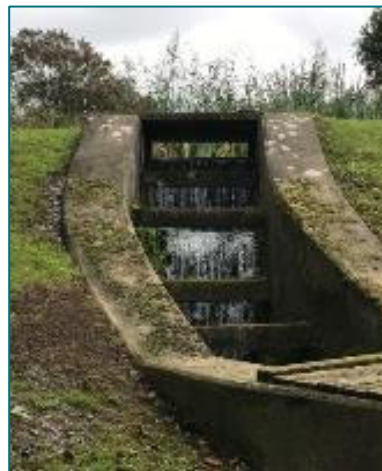
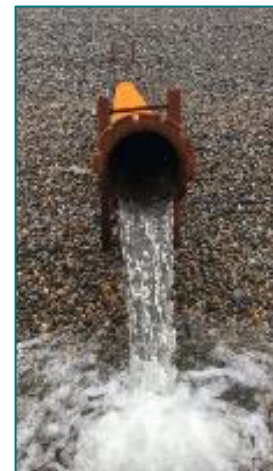
*Plate 18.3.1: Spring Beck*

15. Spring Beck has been modified (see below) and is predominantly characterised by low energy glide and impounded flows, with limited flow diversity or in channel features. Faster flow habitats (such as runs) were observed, although these occurred through the artificial sections of the beck.

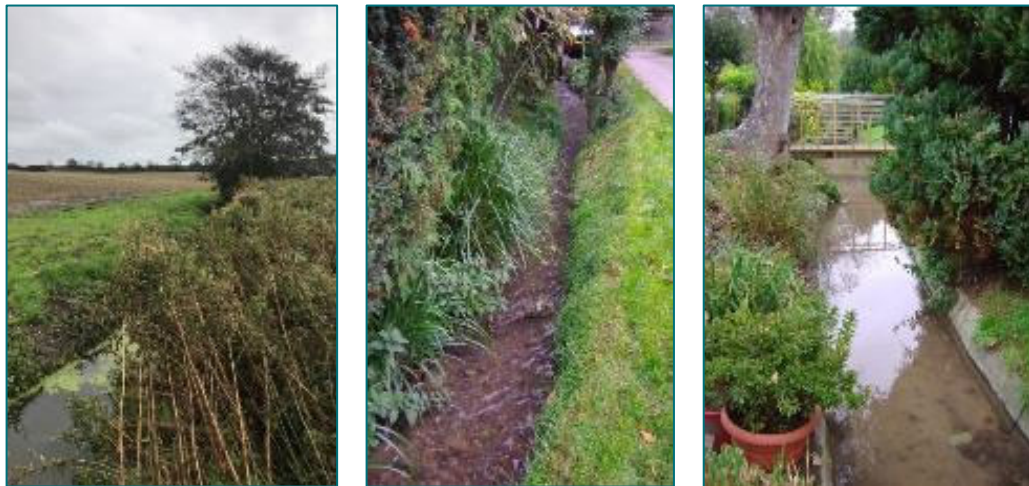
Plate 18.3.2: Spring Beck Channel Form

16. The course of Spring Beck was modified in the eighteenth century in response to the construction of a watermill and dammed to create a substantial mill pond. As such, the beck in places does not follow the natural watercourse alignment and is diverted along an artificial course for some length through the village of Weybourne. The channel form of the beck through the village is therefore predominately straight, with artificial (concrete) bed and banks in places. The channel is approximately 1m – 2m wide at the bank top; 1m wide at the bank base, with a bankfull depth between 0.5m – 1m. Thus, the overall form of the beck through the village displays a typical box shape uniform channel, with limited instream morphological complexity (). On the outskirts of the village, the beck although less confined, displays a U shape uniform channel, typical of drainage ditches in open fields (Plate 18.3.2).

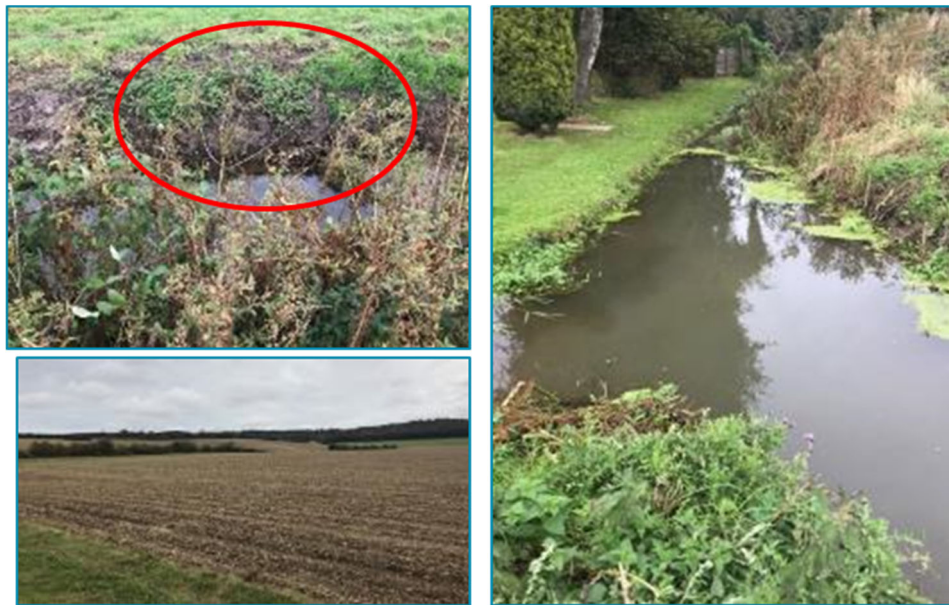
*Plate 18.3.3: Sediment Sources and Local Impoundment*

17. Spring Beck within the study area is associated with colluvium soils; loose unconsolidated sediments typically composed of a heterogeneous range of rock types; and sediments ranging from silt to rock fragments of various sizes. The beck is also associated with peat soils, an accumulation of partially decayed vegetation or organic matter.
18. The overall substrate of the beck throughout the study area is thus dominated by sands, silts and gravels. The dominant fluvial process appears to be sediment deposition, with slow glide flows, local impoundments caused by small weirs, the mill pond, dense in-stream vegetation, low gradients and low velocities all contributing to the settling out of fine sediments/silts (Plate 18.3.3).

19. Although a proportion is likely to be derived from exposed banks during higher-energy flows, the majority of the fine sediment load is likely to be sourced from the agricultural fields on the outskirts of the village (i.e. surface runoff) (Plate 18.3.3).

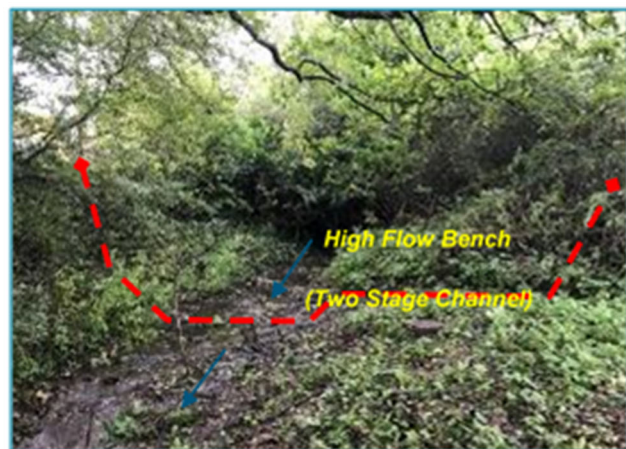
*Plate 18.3.6: River Glaven Channel Form*

25. The channel has straight planform sections within the study area, which are incised in places into the floodplain and surrounded by agricultural fields and fishing lakes. The banks are relatively steep, stable and well vegetated throughout the study area. The channel (not including the online pond) varies between 1m – 5m wide at the bank top; 0.5m – 1.5m wide at the bank base, with a bankfull depth between 1m – 2m. The overall channel morphology of the River Glaven displays a predominately uniform channel, with the exception of the start and end locations of the study area in which the River Glaven displays more complex geomorphology, including a high flow bench or two-stage channel on the left bank (**Plate 18.3.6**).

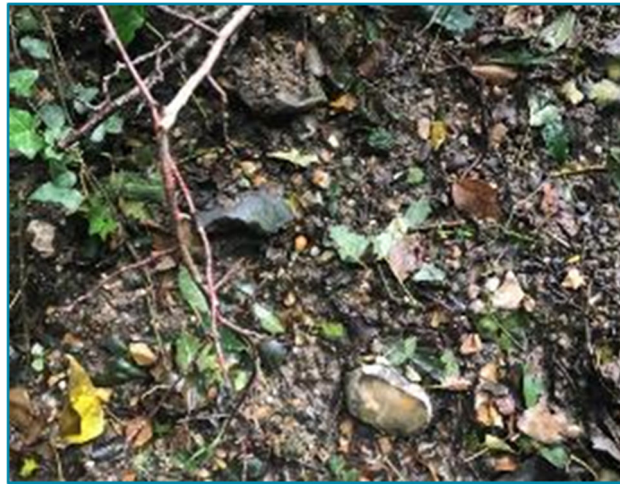
*Plate 18.3.7: Glacial Till Bank Composition in the River Glaven*

26. The River Glaven within the study area is associated with glacial till, with the banks of the river comprised of clay, sand, gravel, cobbles and boulders (**Plate 18.3.7**).

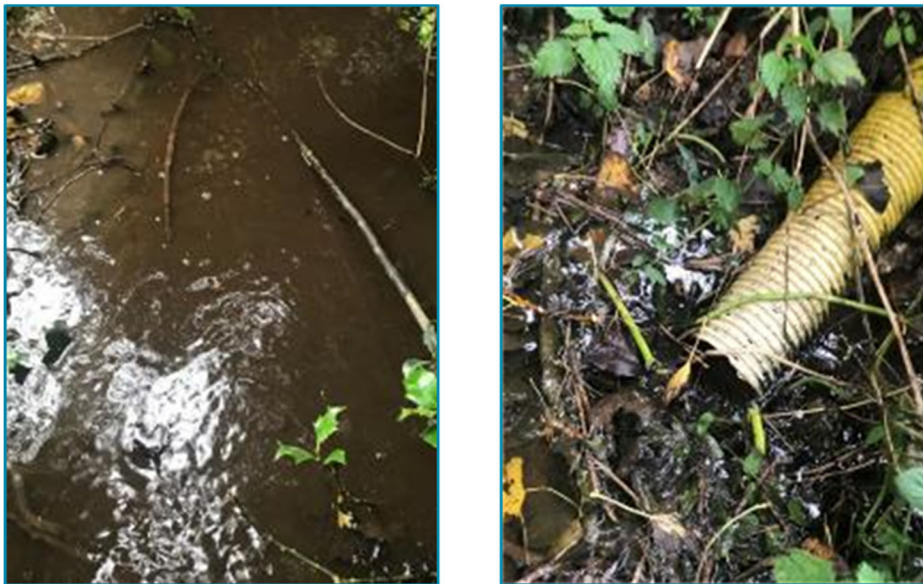
*Plate 18.3.8: Silt Deposition and Outfall Pipe*

27. The substrate of the River Glaven throughout the study area is thus dominated by clay, sand, boulders, minerals, and gravel. The dominant fluvial process appears to be sediment deposition, with slow flows, low gradients, dense in-channel vegetation (undergrowth) and low velocities contributing to the settling out of fine sediments/silts (**Plate 18.3.8**).

28. A portion of the fine sediment load is likely to be derived from exposed banks during higher-energy flows, outfall pipes, drainage ditches, access tracks and road runoff (noted towards the far downstream end of the study area). The adjacent agricultural fields are also likely to be a major source of fine sediment load through diffuse surface runoff.

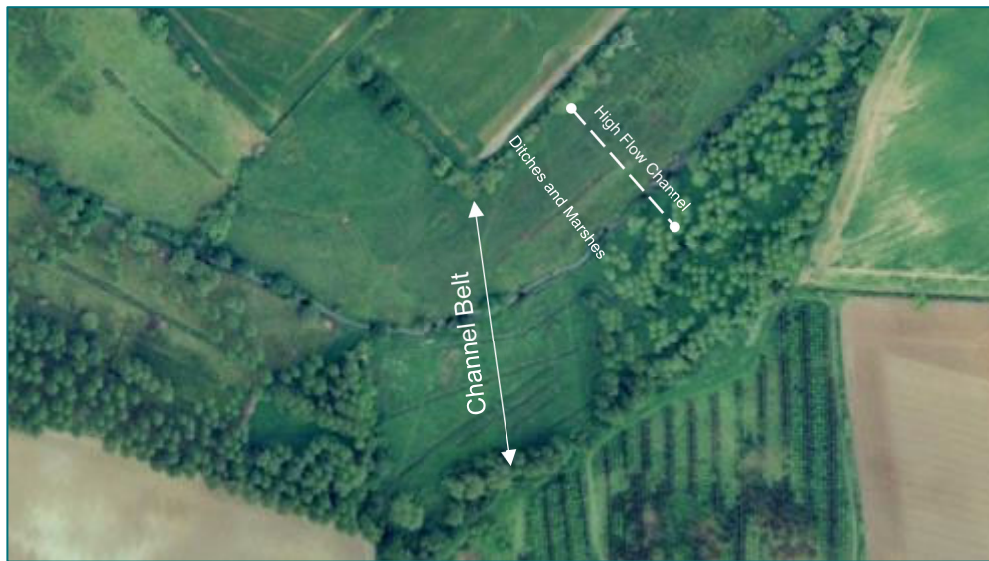
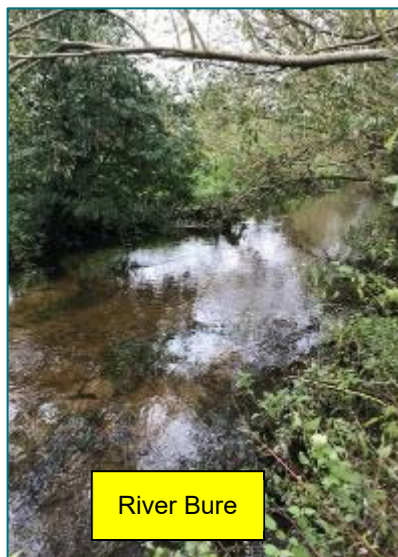
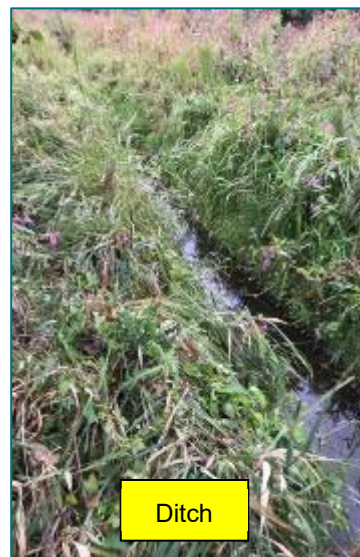
*Plate 18.3.10: River Bure Floodplain and Channel Features*

35. The channel has a straight planform within the study area, although displays geomorphological complexity varying in size and shape surrounded by agricultural fields, woodland and open fields with wetland (marsh) features. In general, the banks are relatively stable and well vegetated with the channel size between 4m – 6m at the bank top; 2m – 3m wide at the bank base, with a bankfull depth between 1m – 2m. The main channel is contained within a wider channel belt (approximately 100m – 250m wide) also consisting of a network of ditches and vegetated islands forming a wetland (marsh) system (**Plate 18.3.10**). The River Bure within the wider channel belt takes the form of a large two-stage channel.

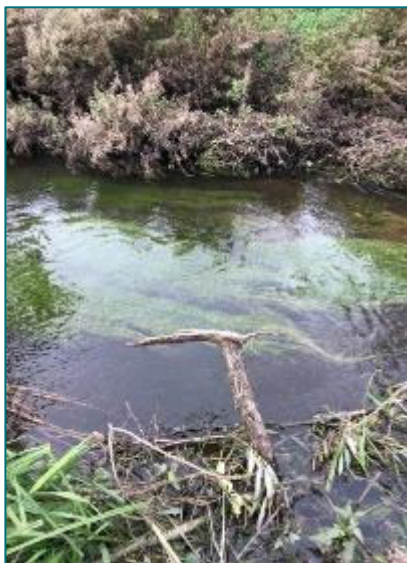
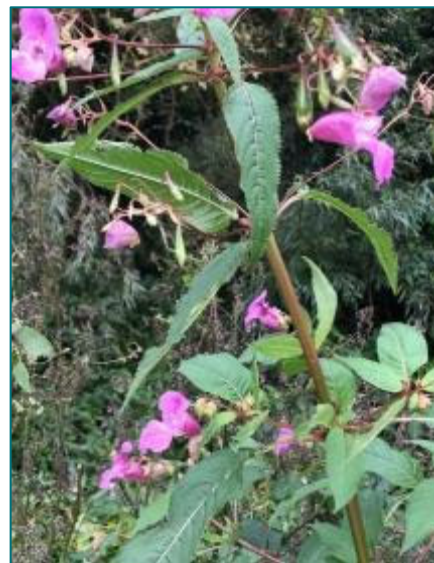
*Plate 18.3.11: Water-Crowfoot (Left) and Himalayan Balsam (Right)*

- 40. The banks and margins of the River Bure are well vegetated and dominated by poor semi-improved grassland with occasional shrubs. There is good coverage of aquatic plants along the bed of the river, including pockets of water-crowfoot (**Plate 18.3.11**). The channel belt has an array of terrestrial and wetland plants, although Himalayan balsam is present.

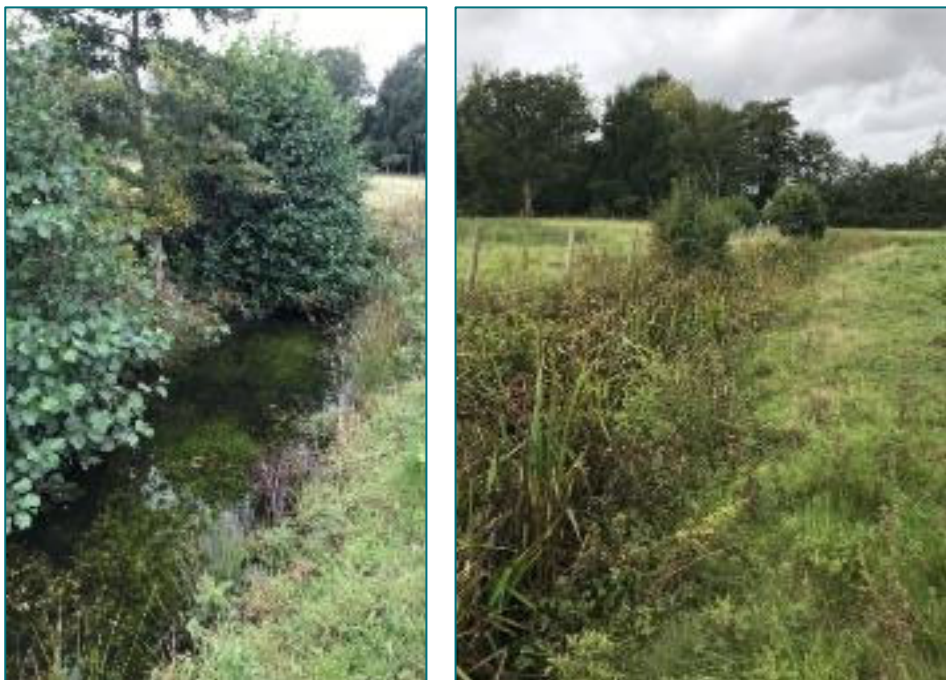
*Plate 18.3.13: Swannington Beck – Secondary Channel*

43. The primary channel is also heavily vegetated, tree lined and incised in places (deep and narrow), with limited floodplain connectivity. Substrate sediments are comprised of clay, sands and gravels, with clean pockets of sand and gravel evident, and silt deposition in places (**Plate 18.3.12**). Likely sediment load into the Swannington Beck would be associated with local bank erosion and upstream land management, although banks of the beck within the study area are well fenced which has reduced the impacts of livestock poaching (trampling). The secondary channel (or northern arm) of the Swannington Beck is a smaller watercourse which is wide, deep, straight, tree lined with good marginal vegetation (sedges, bladed grasses – iris). The bed of watercourse is predominantly comprised of silts (**Plate 18.3.13**).

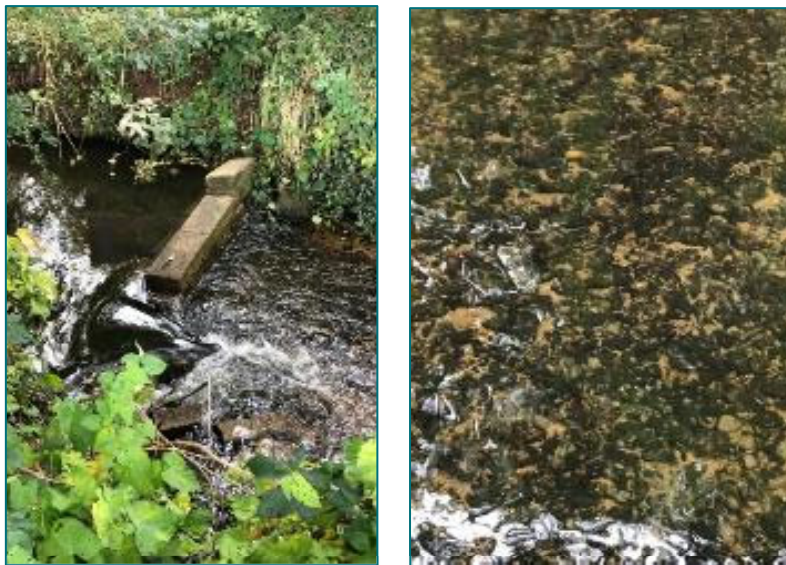
*Plate 18.3.15: Weir and Bed Armouring Along the Swannington Beck*

- 48. The Swannington Beck within the study area is associated with riverine clay, sands and gravels, with the banks predominantly composed of clay and sand (i.e. clay to sandy loam banks), with the properties of the soils (along with the in-channel vegetation, such as sedges and grasses) providing good filtration of water.
- 49. The substrate of the primary channel of the Swannington Beck throughout the study area is thus dominated by clay and sand. The dominant fluvial process appears to be sediment deposition triggered by slow flows, debris and impoundment caused by a small weir (**Plate 18.3.15** and **Plate 18.3.16**). The bed in some places was also armoured, in which coarse grains were on the surface protecting finer particles underneath from erosion (**Plate 18.3.15**).

54. No modifications or structures, such as hard engineering bank protection works were observed during the walkover. However, along the primary channel of the Swannington Beck, water is abstracted upstream of the small weir at grid reference TG 14193 18842.

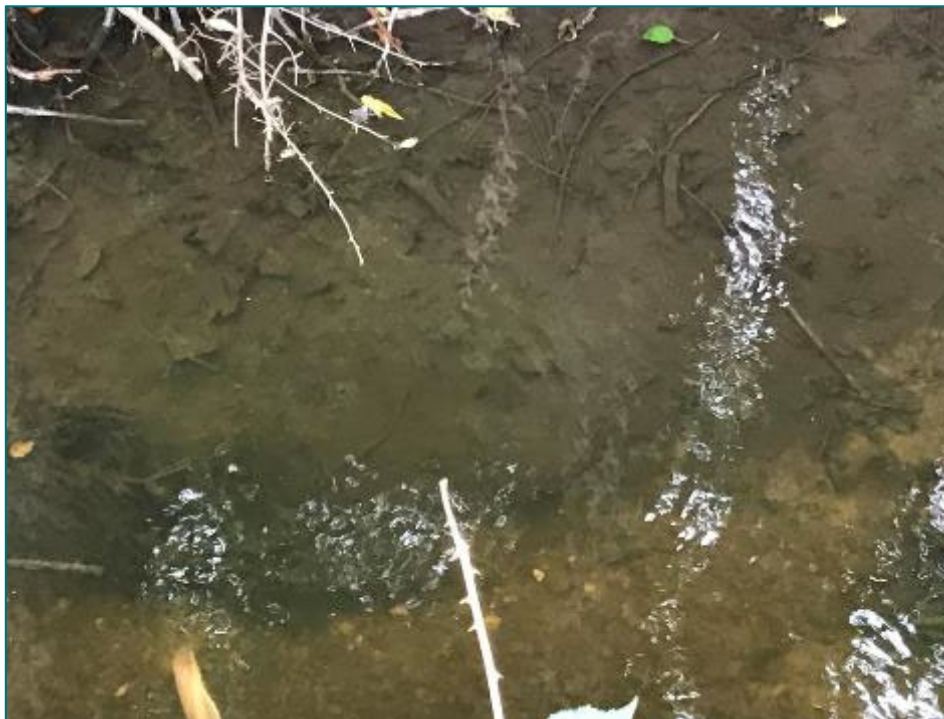
*Plate 18.3.16: Sediment Deposition Upstream of Weir.*

- 50. The secondary channel of the Swannington Beck is dominated by silts in response to slow flows and debris causing settling out of fine sediments.
- 51. Likely sediment load into the Swannington Beck would be associated with local bank erosion, access tracks and upstream land management. However, the banks of the beck along the primary channel within the study area are well fenced which has reduced the impacts of livestock poaching (and fine sediment input).

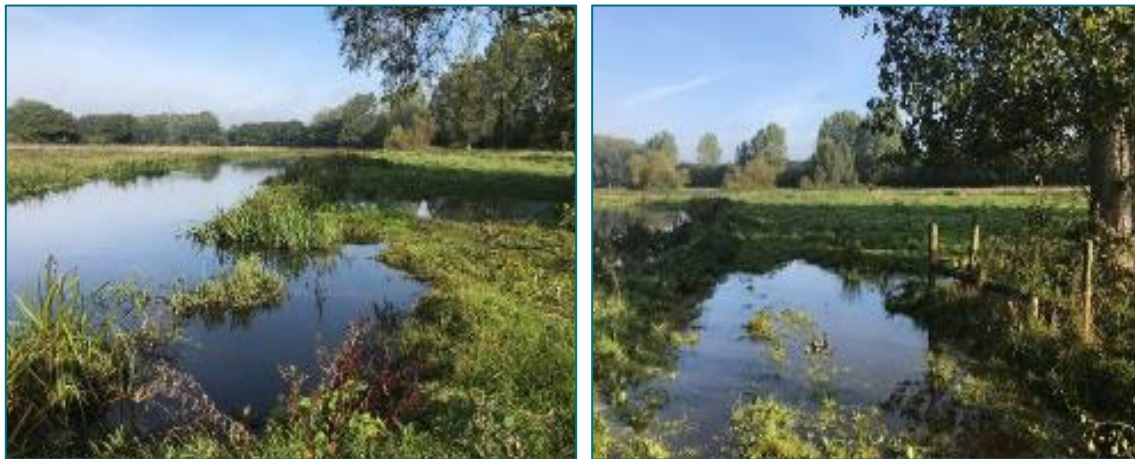
*Plate 18.3.18: Channel and Floodplain Features.*

58. The primary channel of the River Wensum has a straight to sinuous planform within the study area and flows through an open floodplain characterised by a wide and deep channel, with the bank top width between 8m – 10m and width at the base between 5m – 6m. Bankfull depth is approximately 2m (Plate 18.3.17). Key channel and floodplain features include small benches (steps in the channel which accumulate organic debris and silts), backwaters and wetlands, providing geomorphic complexity and habitat diversity (Plate 18.3.18).

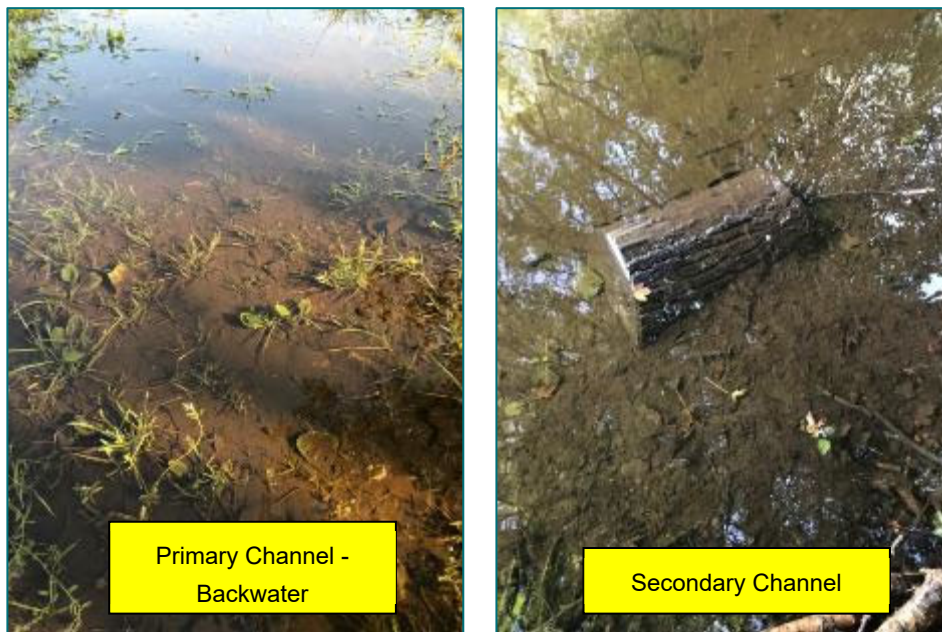
*Plate 18.3.20: Silt Deposition*

62. The secondary channel of the River Wensum and field ditches are dominated by silts in response to slow flows and debris causing settling out of fine sediments (**Plate 18.3.20**).

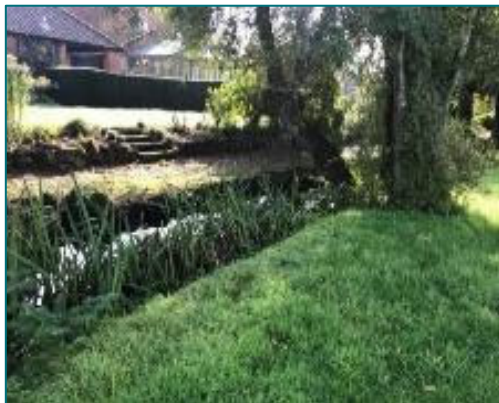
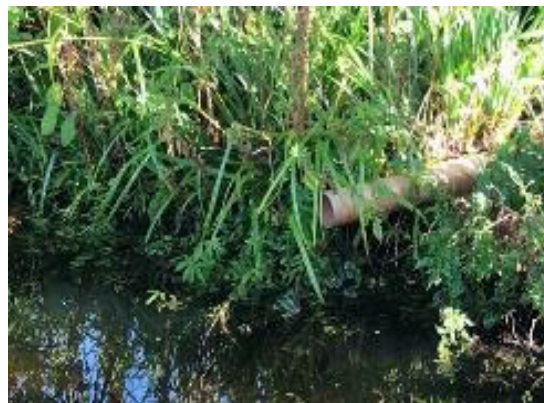
*Plate 18.3.22: Modification of the Secondary Channel*

66. No modifications or structures, such as hard engineering bank protection works were observed during the walkover along the primary channel of the River Wensum, although the secondary channel in places is modified with stone bank protection along the back of a housing estate. Two small pipes also discharge into the secondary channel towards the downstream end of the study area (**Plate 18.3.22**).

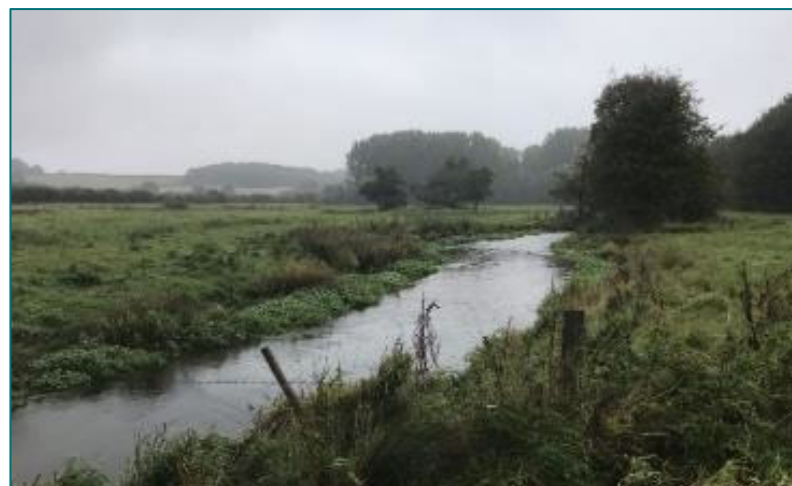
*Plate 18.3.23: River Tud*

68. The River Tud within the study area is characterised by various flow types, including glides, runs, pools and riffles, with strong eddies observed on the outside of meander bends.

- 71. The substrate of the River Tud throughout the study area is thus dominated clay and sand. The dominant fluvial process appears to be sediment transport with very little sediment deposition on the bed during the time of the walkover (**Plate 18.3.25**). However, fine sediments were evident along the margins of the river.
- 72. Despite livestock poaching prevalent within the study area, there was minimal fine sediments on the riverbed, although poaching is likely to be a key sediment source along with point source pollution from ditches (iron leaching observed in one ditch) and upstream land management. A potential reason why livestock poaching did not have an impact on bank erosion and thus contribute more as a sediment source, appears to be in response to the well vegetated floodplain, banks and margins of the River Tud (**Plate 18.3.23**).

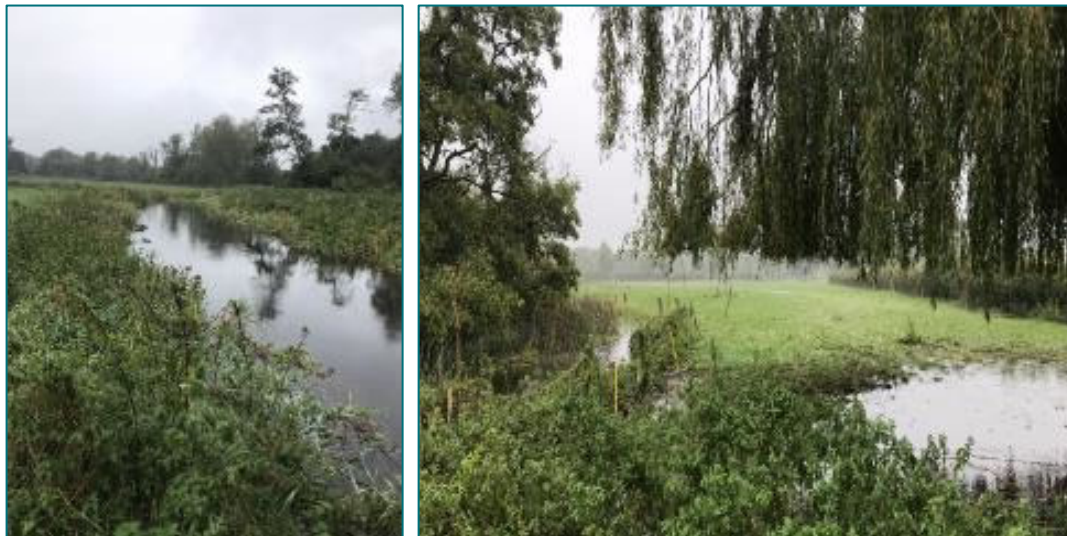
*Plate 18.3.28: River Yare Channel Form and Floodplain Features*

78. The River Yare has a straight to sinuous planform within the study area and flows adjacent to Colton Wood and open floodplain, characterised by a wide and deep channel, with the bank top width between 5m – 8m and width at the base between 4m – 5m. Bankfull depth is approximately 2m. Key channel and floodplain features include wetland scrapes and backwaters (**Plate 18.3.28**).

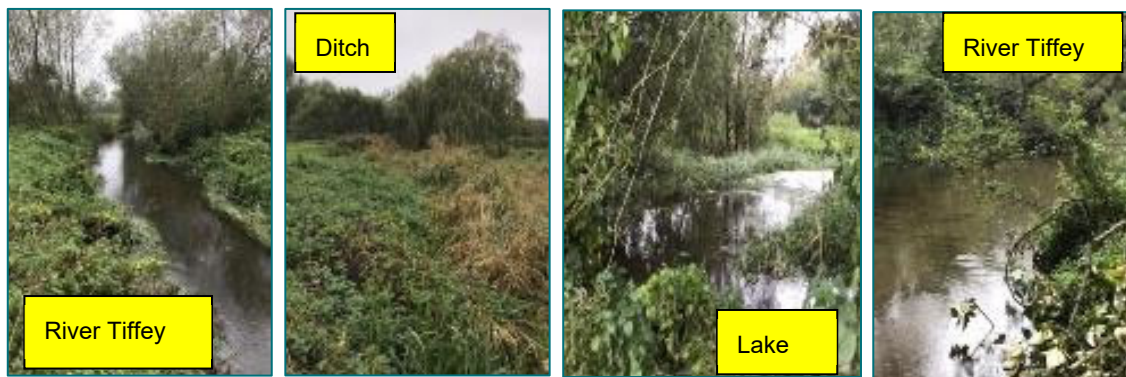
*Plate 18.3.29: River Tiffey and Floodplain Features*

84. The characteristics of the River Tiffey are described in **Table 18.3.9**. The River Tiffey, a tributary of the River Yare, rises near Hethel and flows north-eastwards through the central region of Norfolk and several villages before joining the River Yare near Barford. The River Tiffey within the study area is characterised by a relatively straight planform which is deep and narrow in places and dominated by glide and pool flow habitats (**Plate 18.3.29**). The river has good marginal vegetation including sedges, bladed grasses, iris, bull rushes and reed, with good floodplain connection. The floodplain contains ditches, a small lake (offline pond) and wet woodland (**Plate 18.3.29**).

86. The River Tiffey has a straight to sinuous planform within the study area and flows adjacent to woodland and open floodplain characterised by a relatively deep and narrow channel, with the bank top width between 4m – 5m and width at the base between 2m – 3m. Bankfull depth is approximately 2m (Plate 18.3.30). Key channel and floodplain features include several straight ditches 2m wide and approximately 0.5m deep which are well vegetated in places; and a small lake which was once used for angling (Plate 18.3.29). The lake is approximately 20m wide by 50m in length, although much of the lake has now been infilled within a planted woodland (Plate 18.3.29).

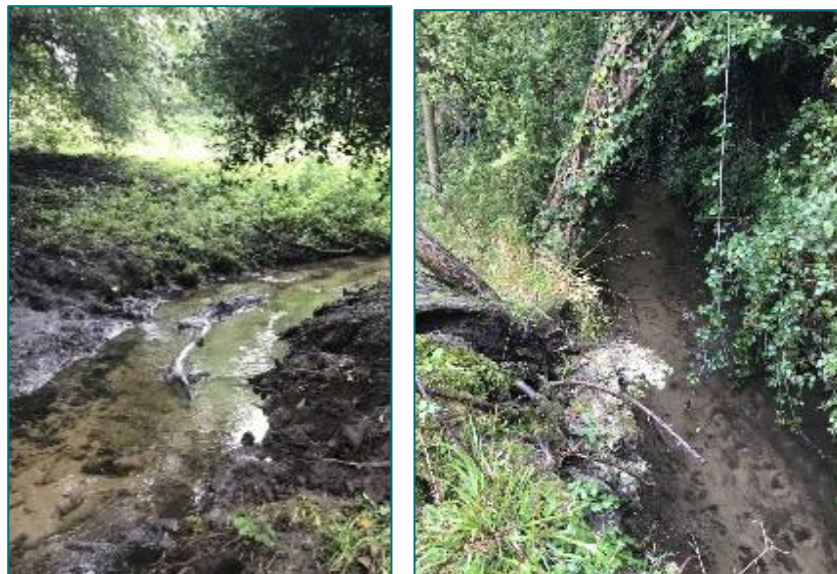
*Plate 18.3.33: Western Channel of the Intwood Stream*

94. The western channel of the Intwood Stream within the study area is characterised by a straight planform which varies in size and shape from a deep incised channel to a wide and shallow channel with good floodplain connectivity. The channel has varied flow habitats including glides, riffles and runs and contains wooded debris, with good marginal vegetation comprised of sedges, bladed grasses and iris (**Plate 18.3.33**). Floodplain features include ditches and ponds, although livestock poaching is prevalent along the western channel contributing to silt deposition on the bed. However, in places the bed shows some good clean sand and gravel deposition, associated with the glacial till nature of the surrounding soils, which are free of silt.

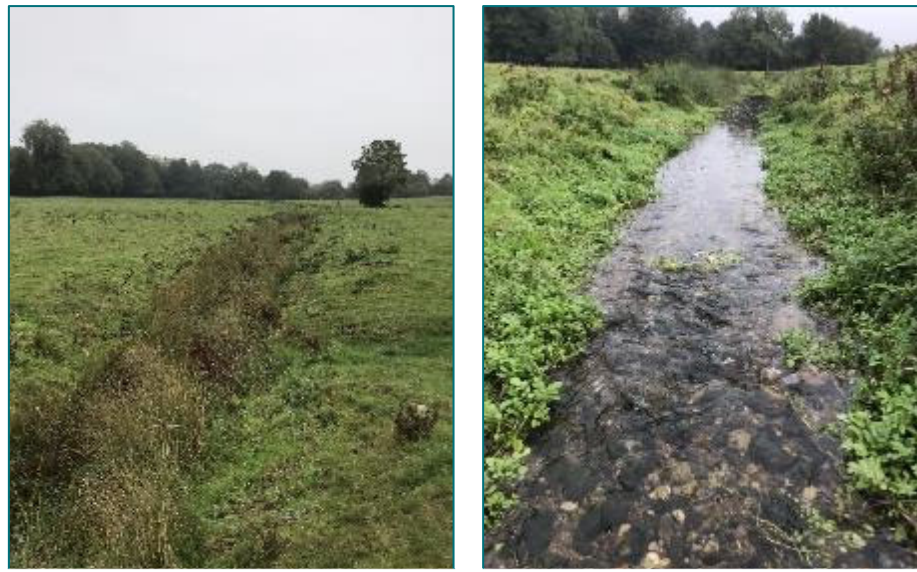
*Plate 18.3.34: Eastern Channel of the Intwood Stream*

95. The eastern channel of the Intwood Stream within the study area is a smaller watercourse than the western channel and resembles a wide shallow drainage ditch, although does display varied flow habitats, including runs, riffles and pools, with pockets of pond weed. There is good marginal vegetation, such as bull rushes and sedges; and there is good floodplain connectivity (**Plate 18.3.34**). However, livestock poaching is also prevalent contributing to silt deposition on the channel bed. However, in places the bed shows some good clean coarse sand and gravel substrates (associated with the glacial till nature of the surrounding soils) which are free of silt.

99. Key channel and floodplain features included backwaters, ditches and wetlands, providing geomorphic complexity and habitat diversity (**Plate 18.3.36**).
100. The eastern channel of the Intwood Stream within the study area is a smaller watercourse than the western channel and resembles a wide shallow drainage ditch, although does display some geomorphic complexity. The channel size is between 1 m - 2 m at the bank top; and approximately 1 m at the bank base, with a bankfull depth between 1 m – 1.5 m (**Plate 18.3.34**).

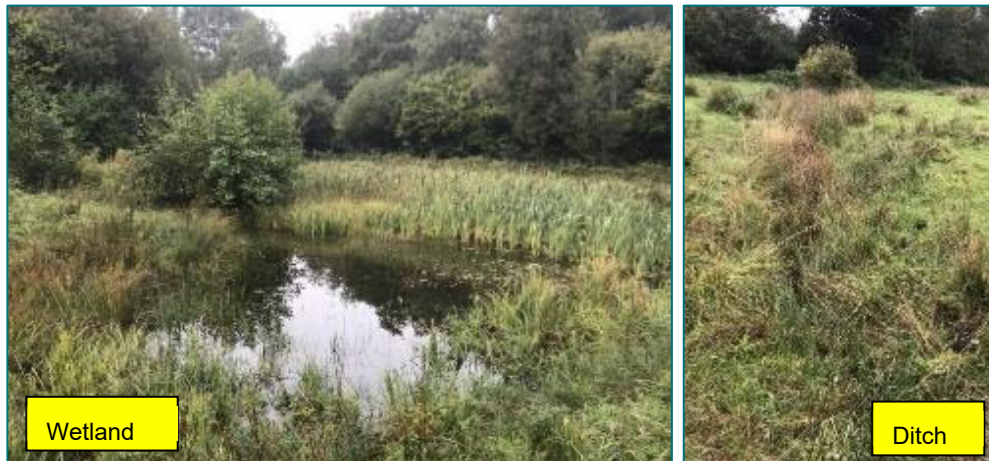
*Plate 18.3.36: Western Channel Wetland and Example Ditch*

98. The western channel of the Intwood Stream appears to have a modified planform which has been historically straightened, although despite this does show some geomorphic complexity within the study area varying in size and shape. The channel flows through an open floodplain and woodland, with the morphology of channel being deep and incised to wide and shallow, with good floodplain connectivity (see below). In places the channel had a bank top width between 3m – 4m and width at the base between 1m – 2m. Bankfull depth various between 1m – 2m (**Plate 18.3.36**).

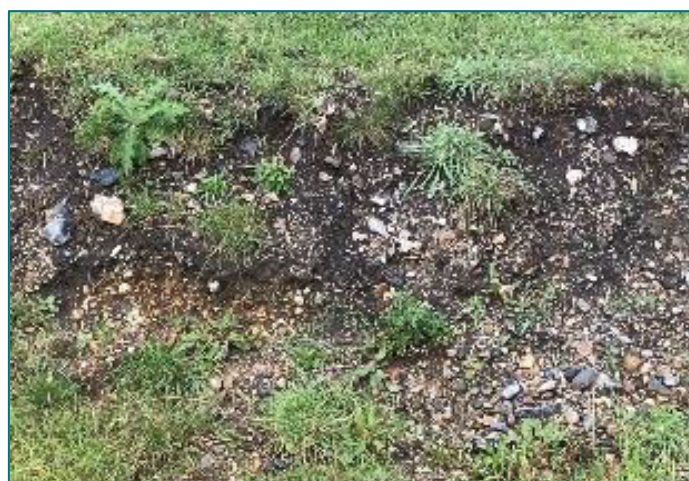
*Plate 18.3.37: Glacial Till Bank Composition*

101. The Intwood Stream within the study area is associated with glacial till with the banks of the channels through the study area comprised of clay, sand, boulders, minerals, and gravel (**Plate 18.3.37**).
102. The Intwood Stream channels throughout the study area are thus dominated by clay, sand, boulders, minerals, and gravel. There is not one dominant fluvial process, with both sediment deposition and transport occurring at a similar degree along both channels in response to the varied nature of the flow habitats.

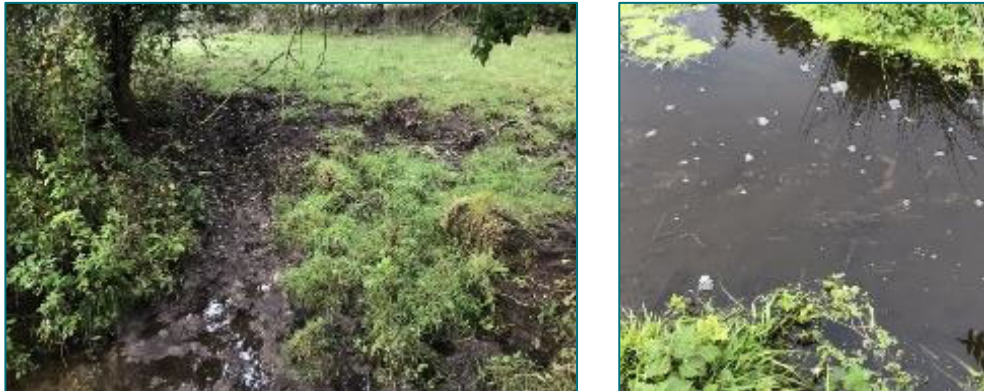
*Plate 18.3.38: Livestock Poaching and Silts on Channel Bed.*

103. A portion of fine sediment load along the channels is likely to be derived from exposed banks caused by livestock poaching, with higher-energy flows further eroding the banks contributing to fine silts on the channel beds (**Plate 18.3.38**). In addition, a pipe discharges into a land drainage ditch which joins the channel towards the downstream end of the study area potentially allowing fine sediment and/or contaminants to enter the watercourse **Plate 18.3.38**.
