Medworth Energy from Waste Combined Heat and Power Facility

PINS ref. EN010110
Document Reference Vol 6.4
Revision 1.0
June 2022

Environmental Statement

Appendix 13A: Wisbech Phases 1 and 2 Geoenvironmental Desk Study and Interpretative Report

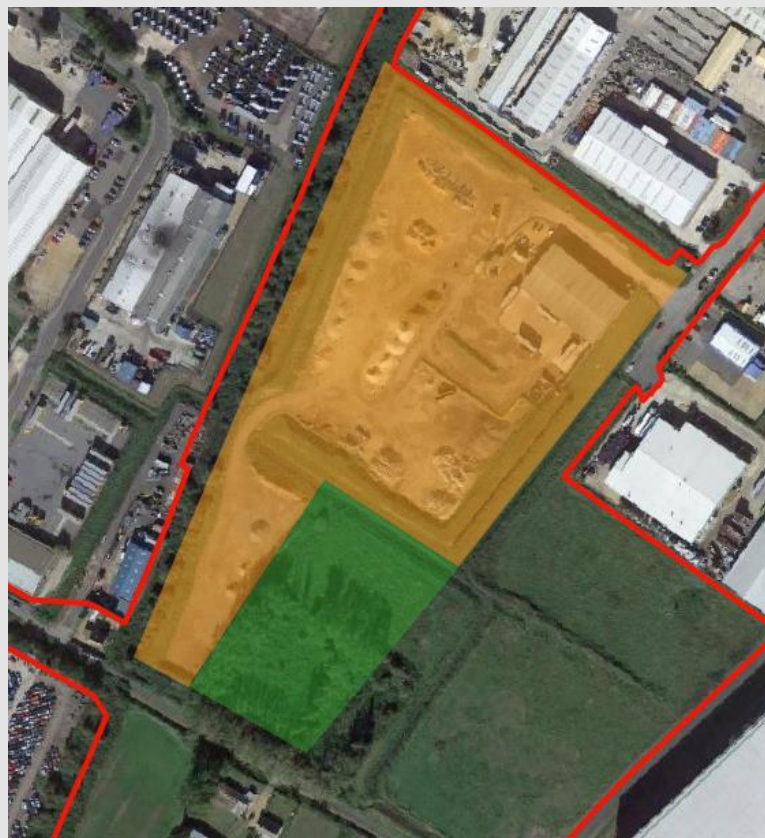
The EFW CHP Facility (additional area) comprises an area of greenfield land with onsite surface water drainage channels and some trees and hedging, located immediately southeast of the EfW CHP Facility (leased area). The area is not known to be currently in use. The additional area (green overlay) is shown in relation to the leased area (orange overlay) below.

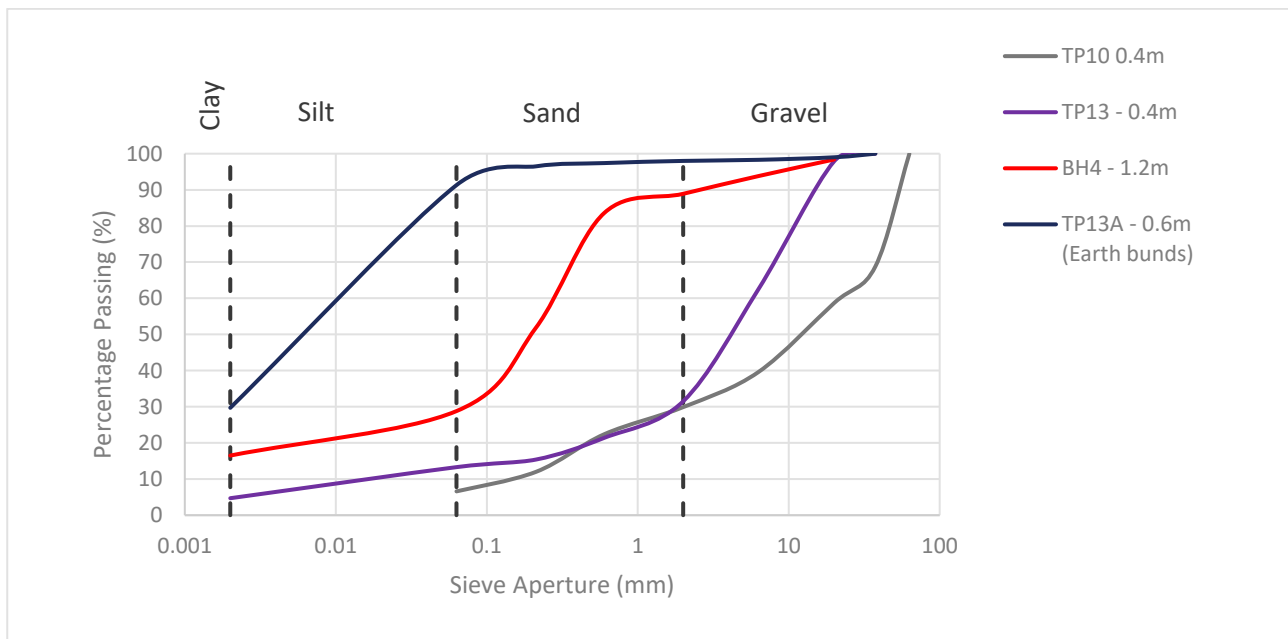
Graphic 11.1 Graphical Summary of PSD Results for made ground

11.3.7 The PSD test results are summarised graphically in **Graphic 11.1 Graphical Summary of PSD Results for made ground below:**

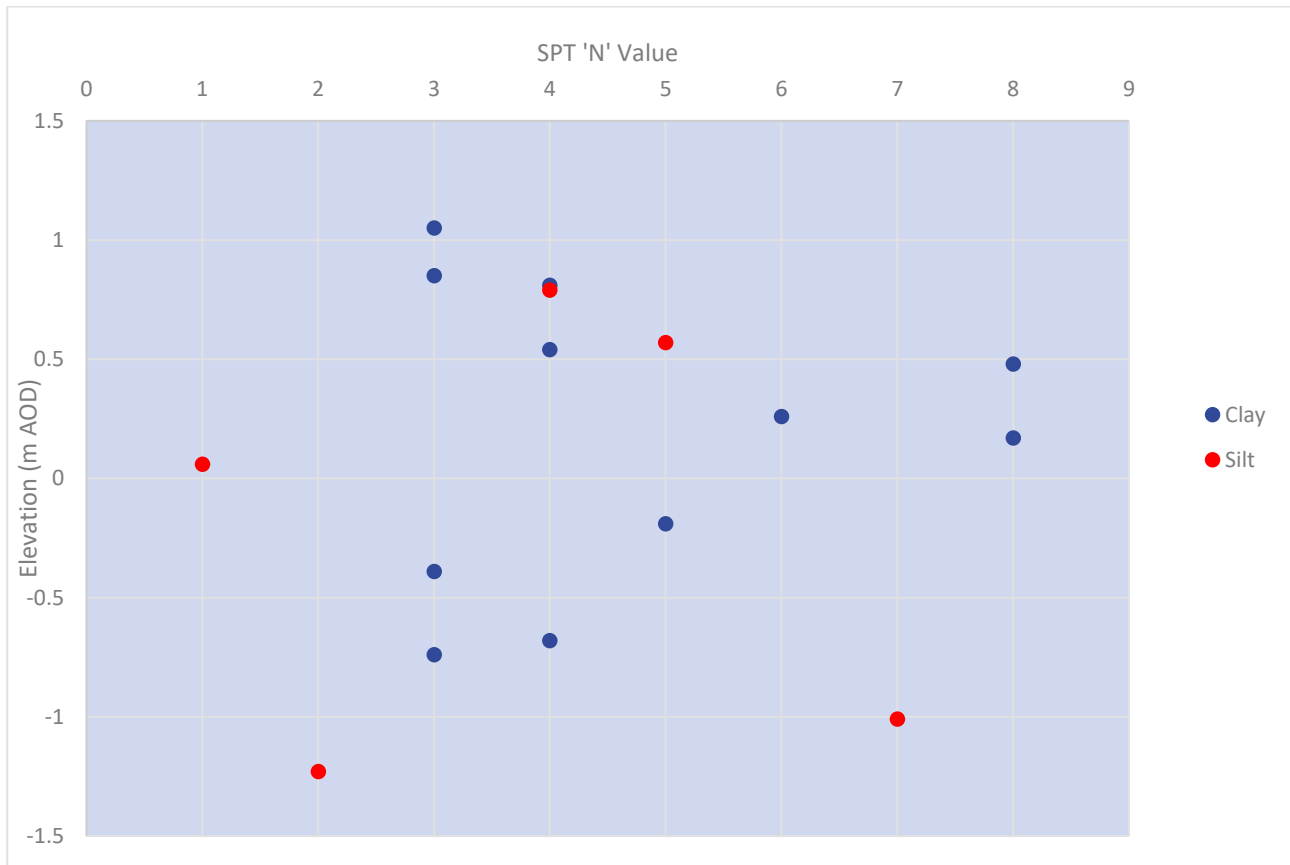
Graphic 11.2 SPT Data vs Depth for Tidal Flat Deposits

11.4.2 A review of the above results indicates two distinct discernible trends with depth: increasing with depth from 0.0m AOD before decreasing with depth after that down to about -1.5m AOD. This suggest that 1.5 to the first 1.5no discernible trend with depth. This indicates that decrease in consistency and therefore strength after 0.0mAOD to the base of the stratum.

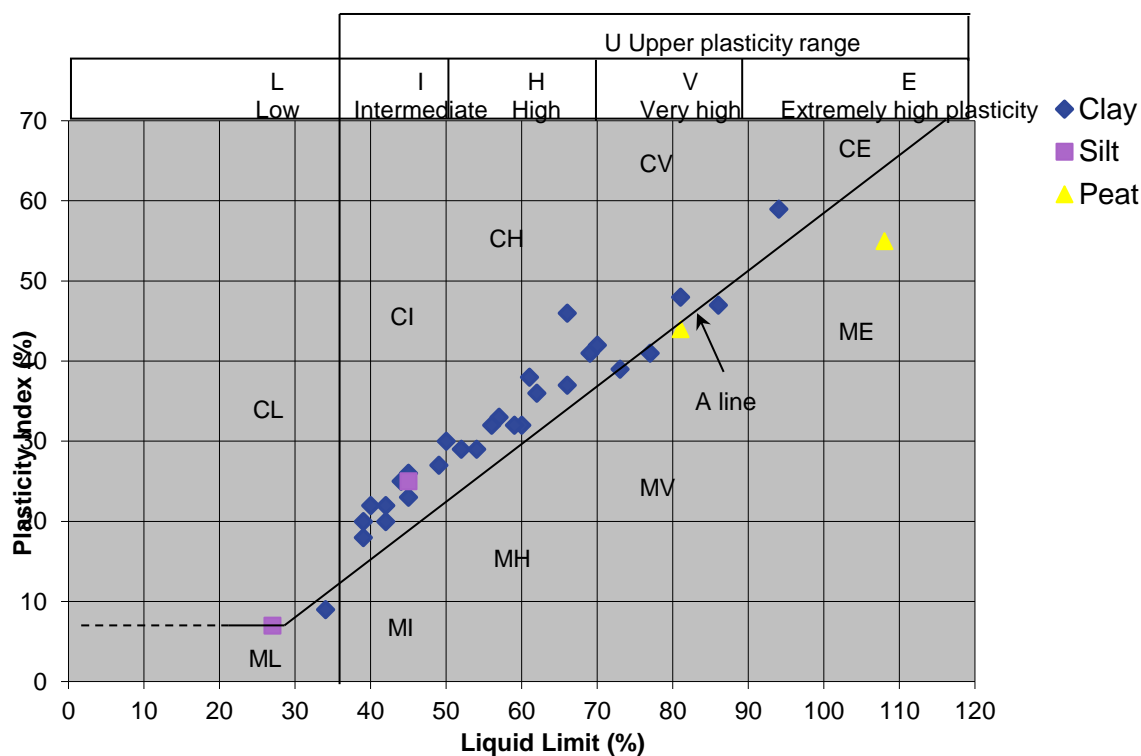
Graphic 11.3 Plasticity Chart for Cohesive Tidal Flat Deposits

11.4.7 Based on the above results and interpretation, a representative PI value of 35 is considered appropriate for design.

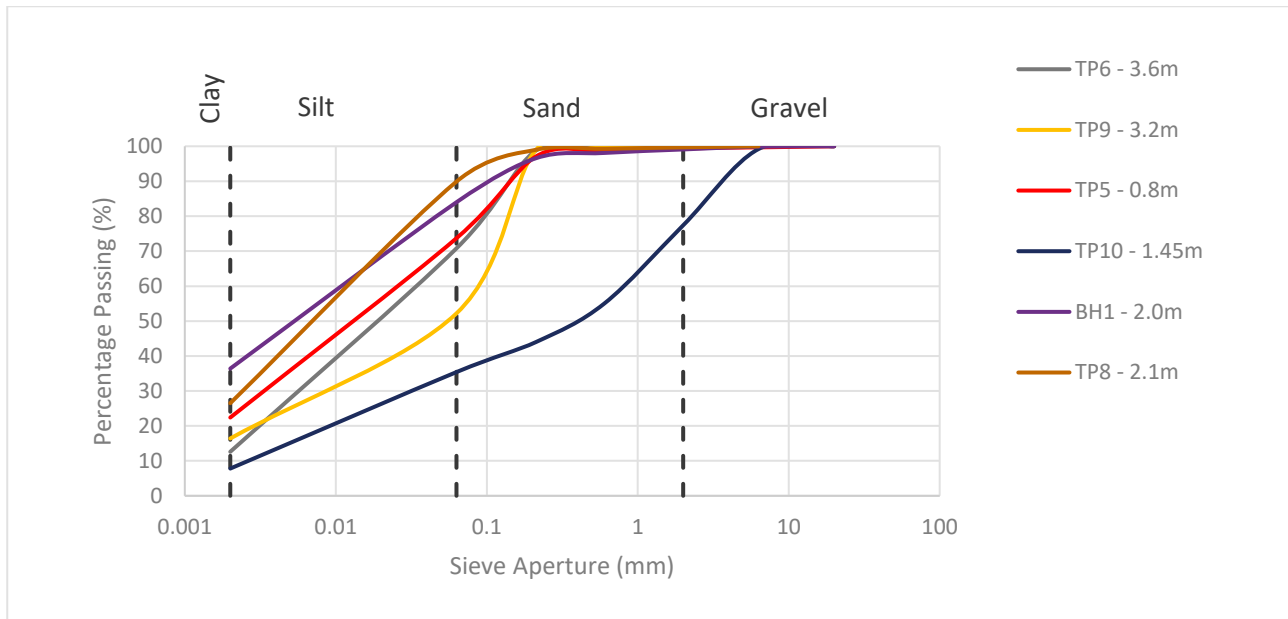
Graphic 11.4 PSD Plots – Cohesive Tidal Flat Deposits

11.4.9 The results of the PSD tests are summarised graphically in **Graphic 11.4 PSD Plots – Cohesive Tidal Flat Deposits** below.

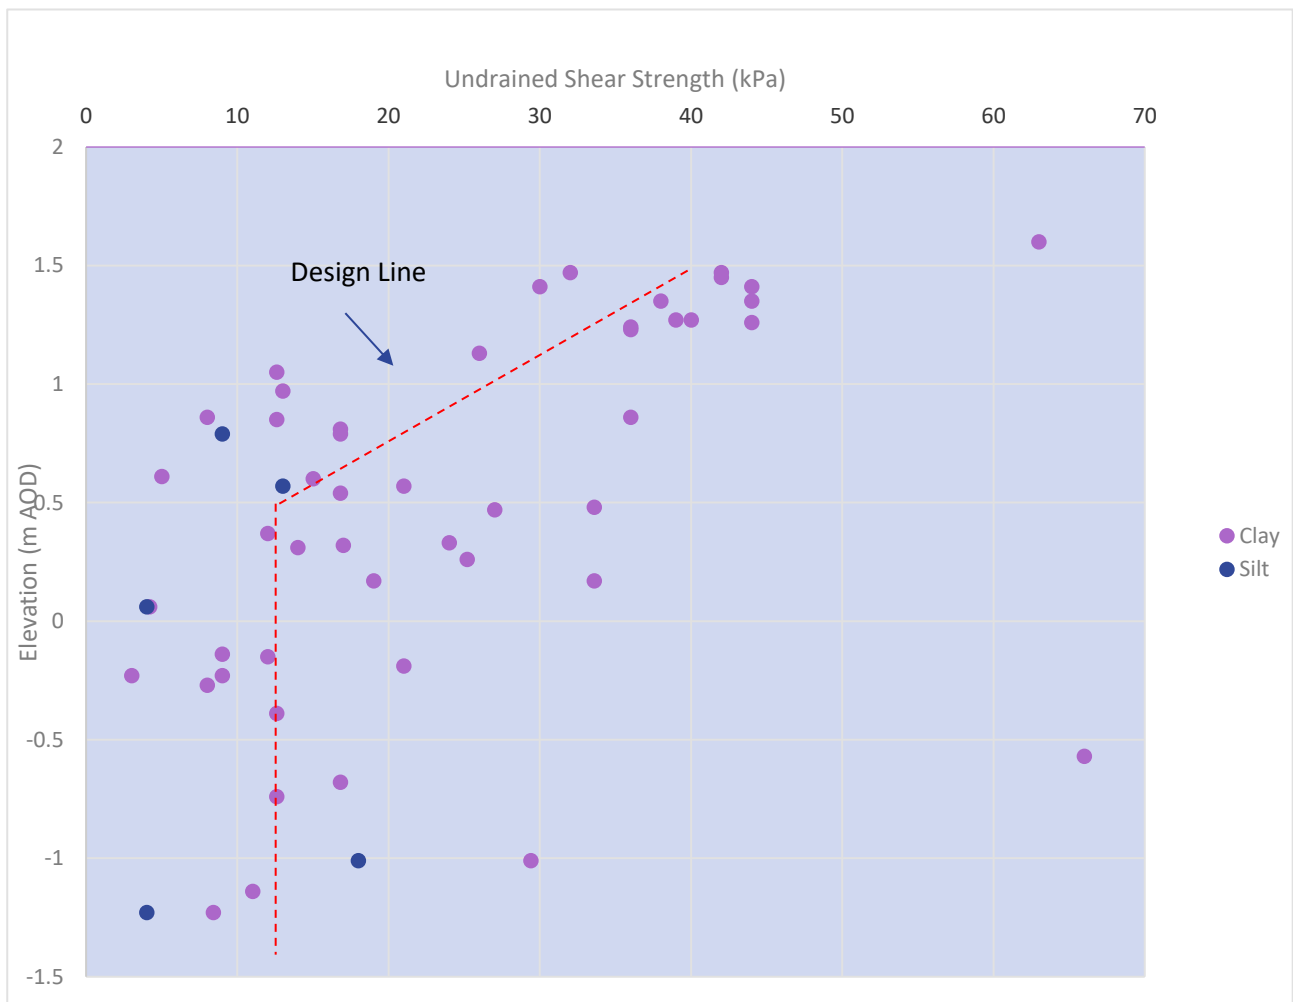
Graphic 11.5 Summary of Undrained Shear Strengths – Cohesive Tidal Flat Deposits

11.4.16 A total of 26 Hand Shear Vane tests were carried out on cohesive tidal flat deposits, at depths between 0.5m and 3.5m bgl; yielding peak shear strength values between 8 and 66 kPa, with residual strengths between 0 and 60kPa. The results indicate clay of very low to medium strength (very soft to firm).

11.4.17 Based on the above interpretation, the following undrained shear strength values are recommended for design:

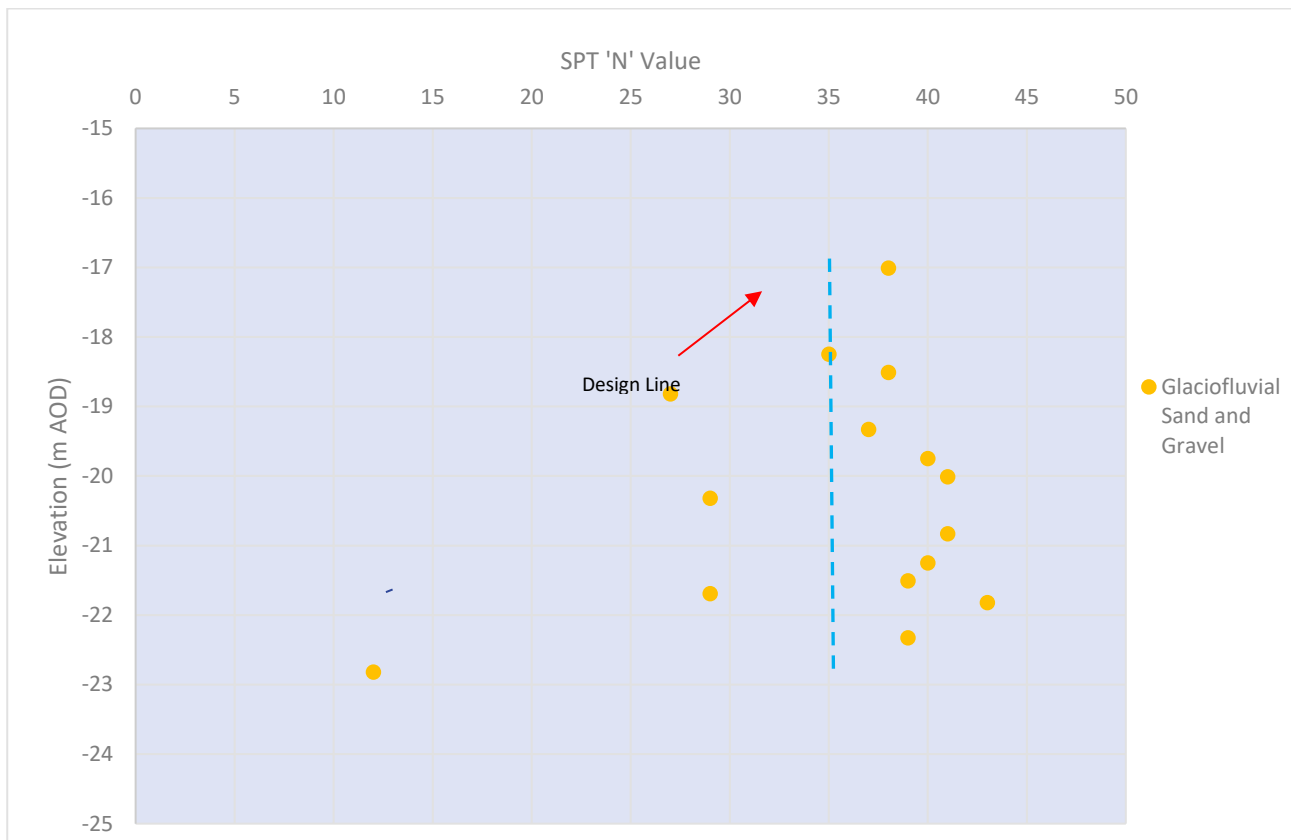
Graphic 11.9 SPT Results for Glaciofluvial Sand and Gravel

11.6.2 The results show no appreciable pattern in SPT value with elevation. Based on the range of SPT N values it is recommended that a design SPT value of N=35 be adopted, representing dense SAND and GRAVEL.

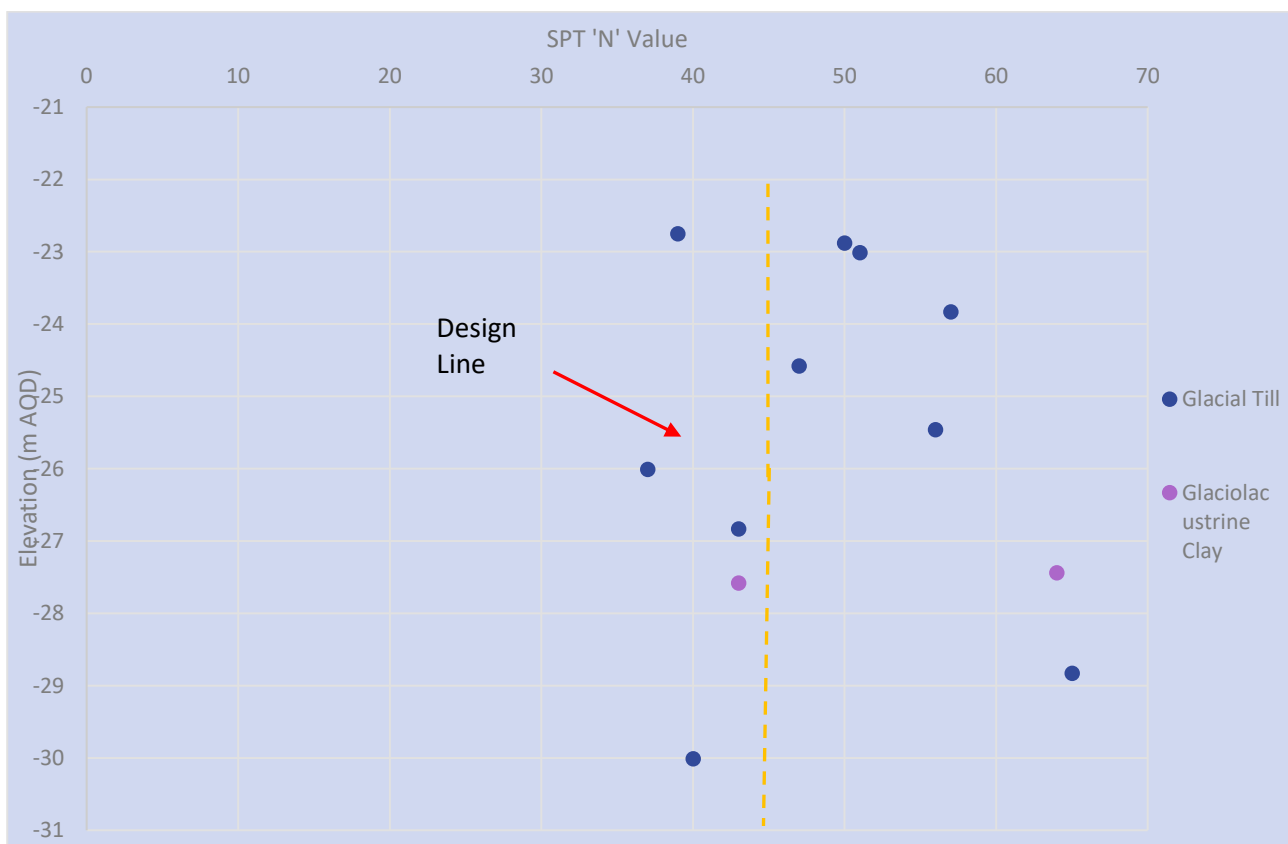
Graphic 11.11 SPT results versus depth – Glacial Deposits

11.7.2 No discernible pattern could be seen in the consistency of the stratum with elevation. Based on the above an SPT 'N' value of 45 is recommended for design. In addition, the results for Glacial Till (sandy gravelly CLAY) and the Glaciolacustrine Deposits (Stiff laminated CLAY) appear to be in concurrence.

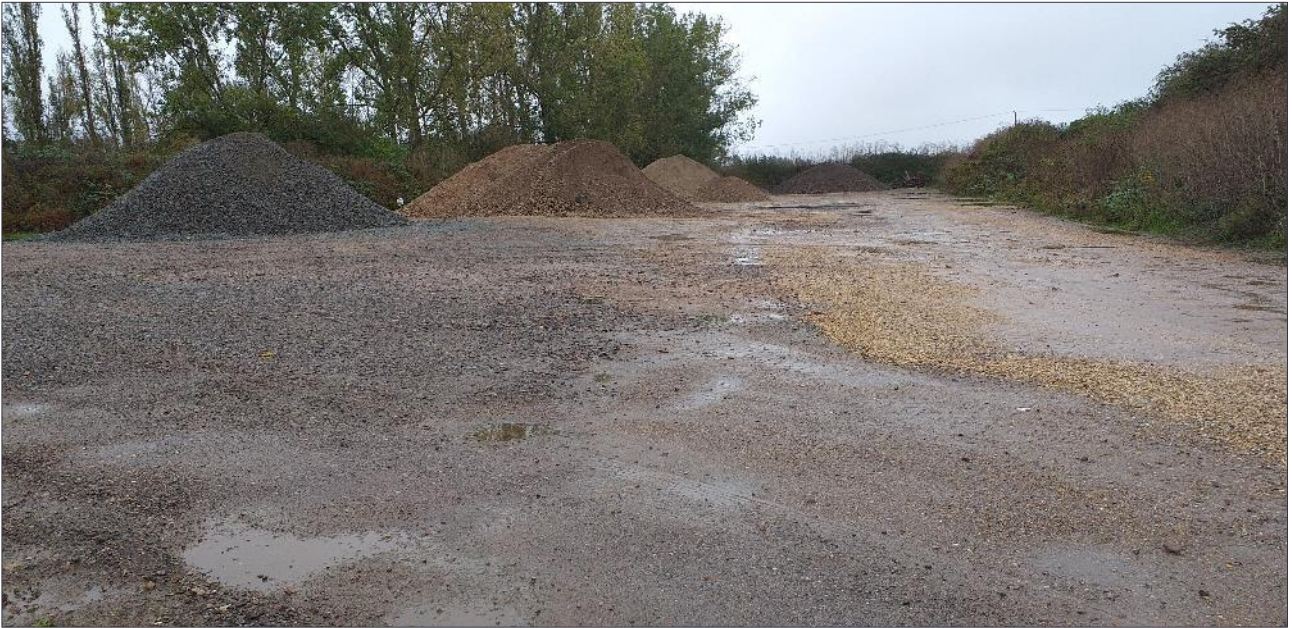
Plate 3

Looking south-east across Area B. Stockpiles of brick crush, concrete crush and granite are present.

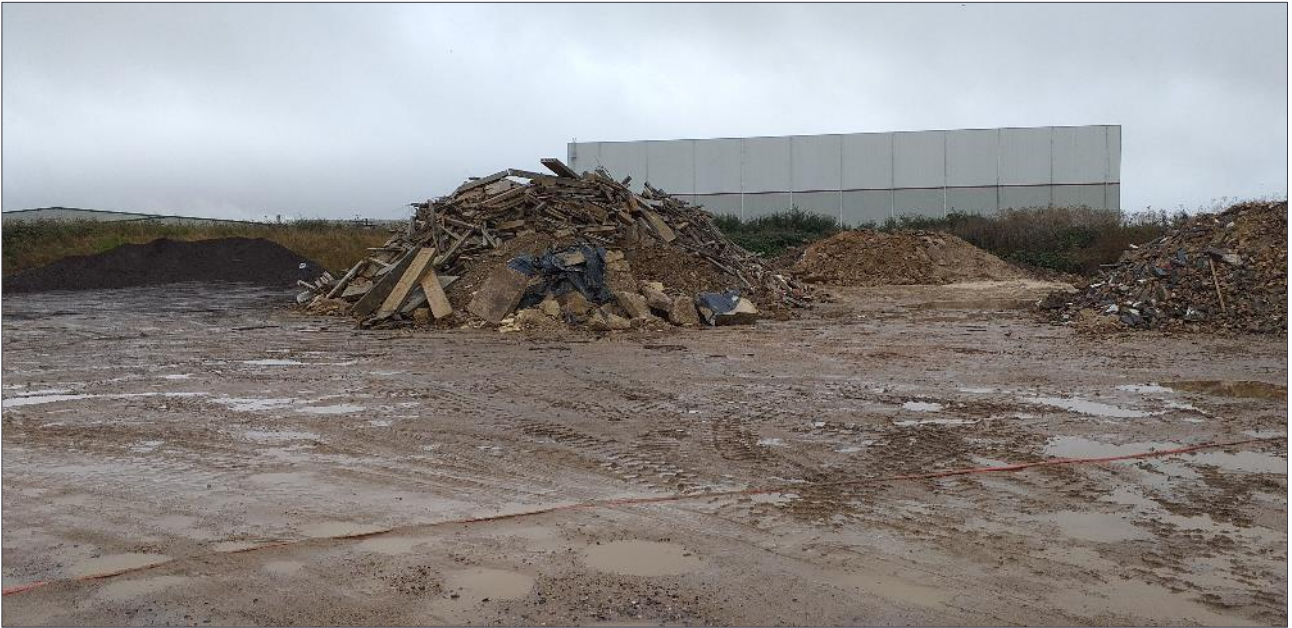
Plate 5

Looking south-east from the south-east quadrant of Area A. Stockpiles of road scalplings (left), concrete slabs (centre) and brick (right).

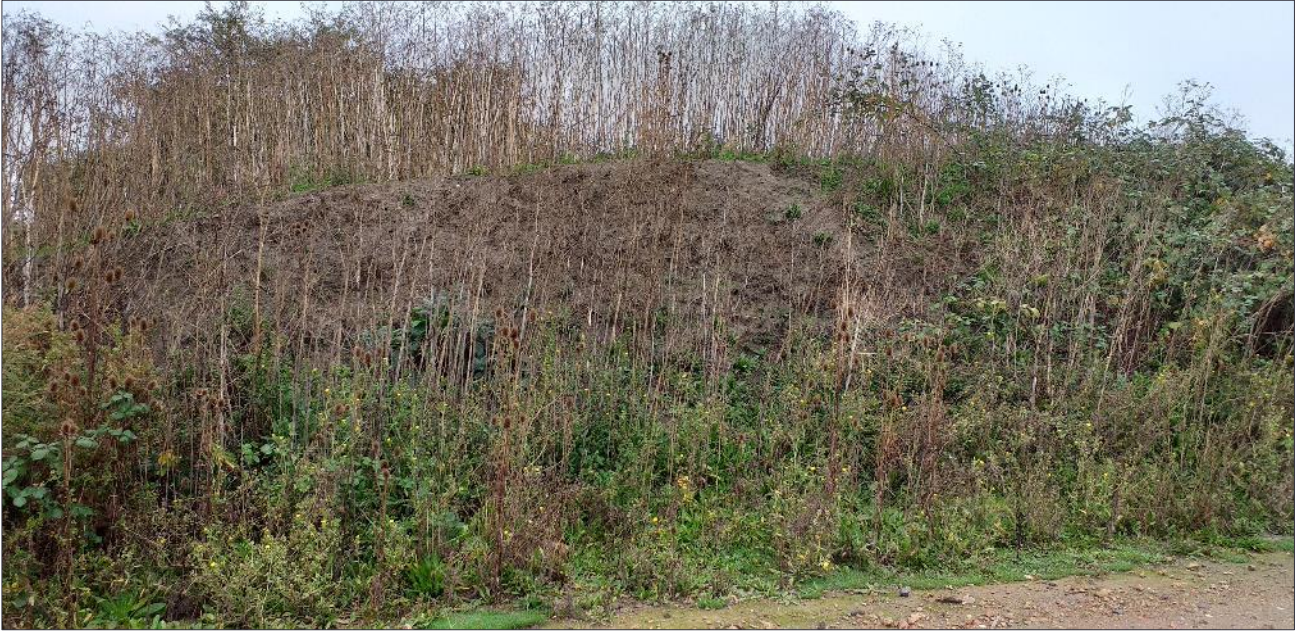
North-west boundary bund end located in the south-west corner of Area A. Exposed soil indicates the bund is composed of topsoil.

engineer was able to access a small section of the earth bund in the south-west corner of the EfW CHP Facility (leased area) site and confirmed the presence of topsoil (see Plate 7 in Appendix A).

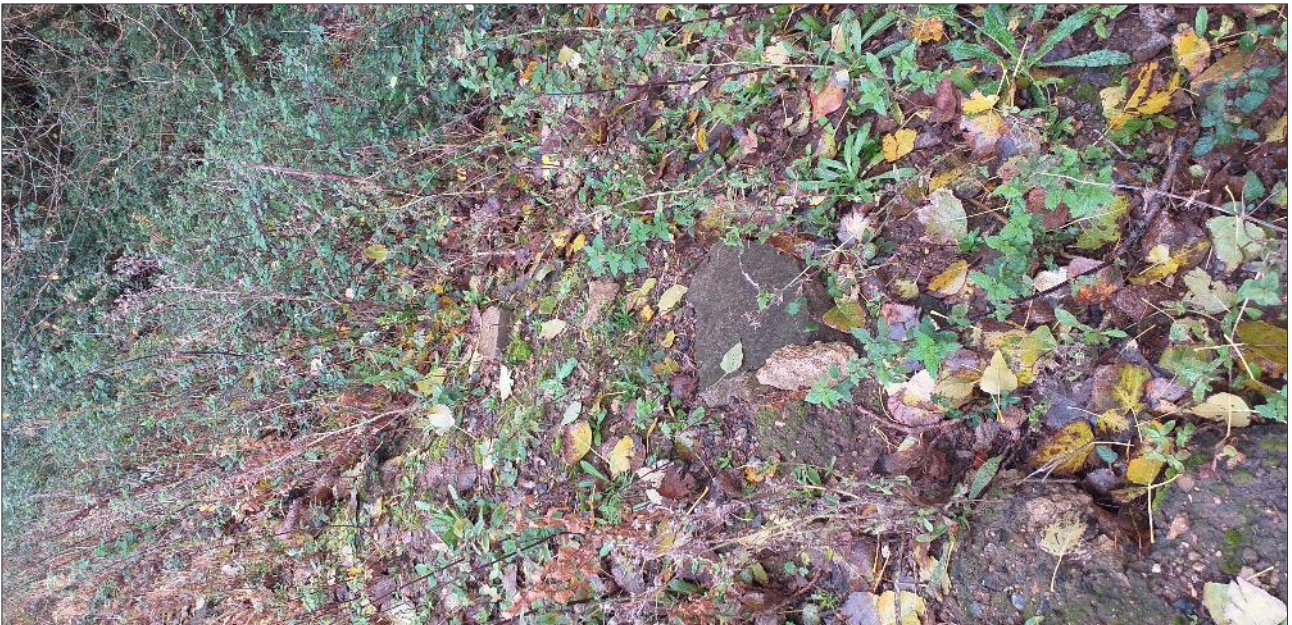
The south-east site bund of Area B. The surface of the bund comprises cobbles of brick and concrete indicating that the bund comprises Made Ground.

Area B is bunded on all sides. The Wood engineer observed anthropogenic fragments such as brick, macadam and concrete on the earth bund surface (see Plate 8 in Appendix A).

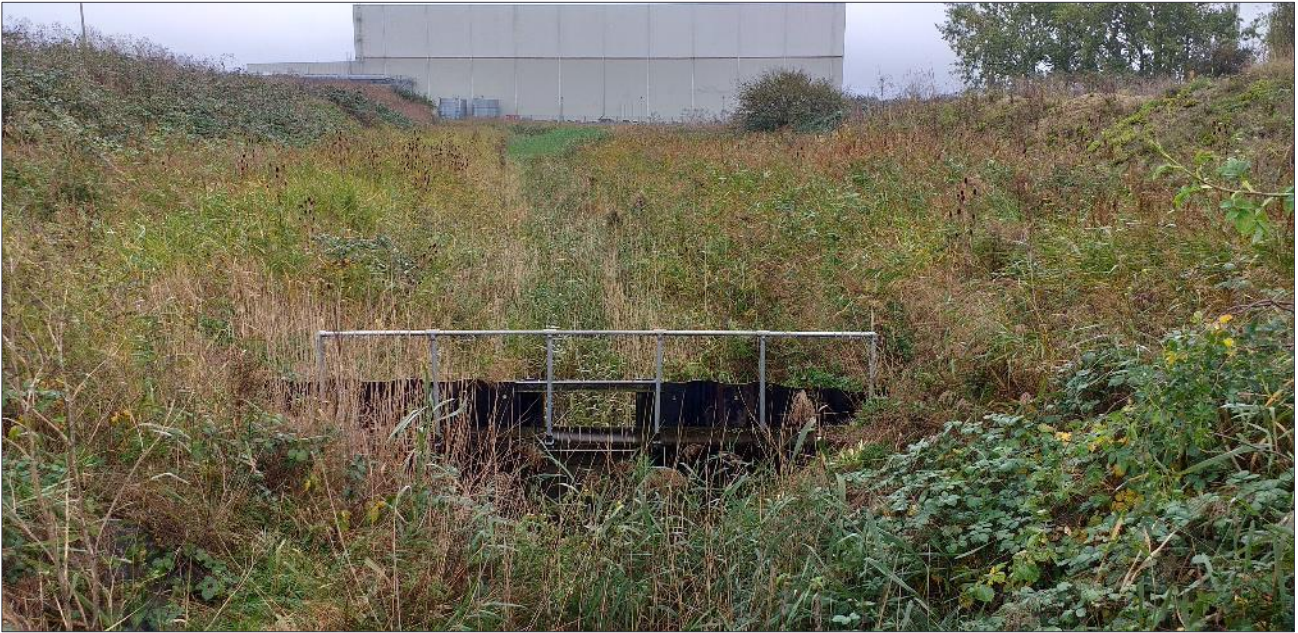
Plate 9

Looking south-east along the drainage channel separating Areas A and B of the site.

Surface water drainage channels are present off-site adjacent to the earth bunds, running along all boundaries of Area A. The southern surface water ditch intercepts the EfW CHP Facility site between Area A and Area B (see Plates 9 to 11 in Appendix A). The surface water channels are culverted in the north-east corner of the EfW CHP Facility (leased area) site adjacent to Algore Way.

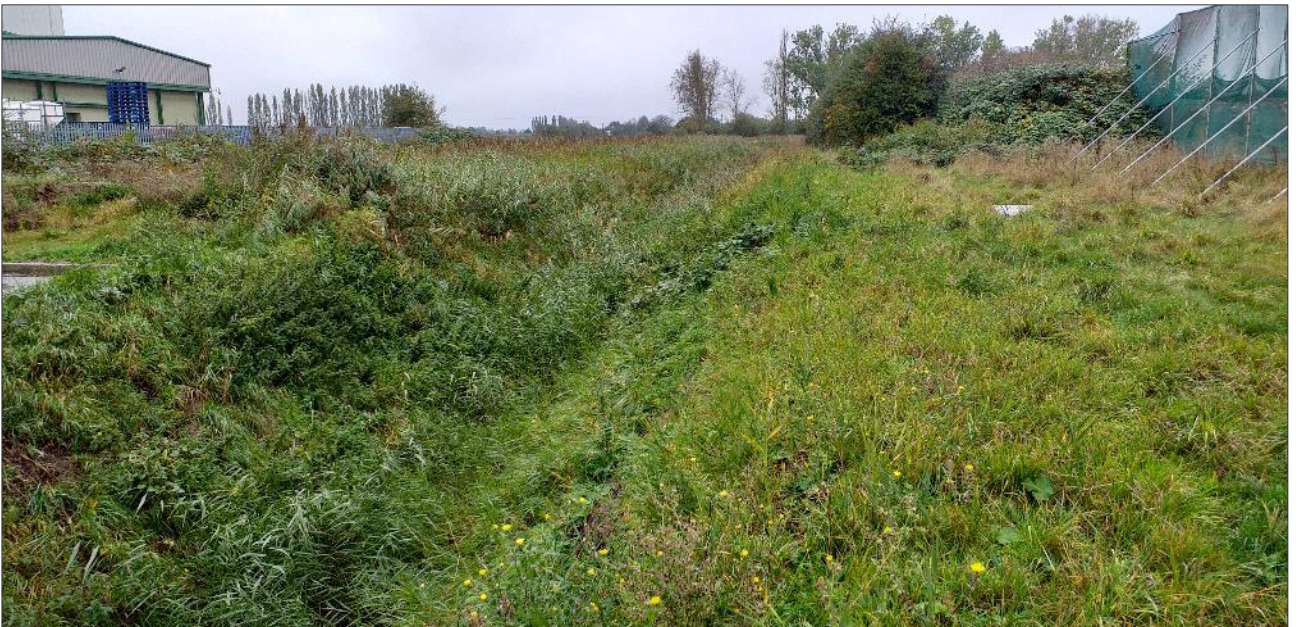
Plate 10

Looking south-west along the drainage channel adjacent to the south-east site boundary.

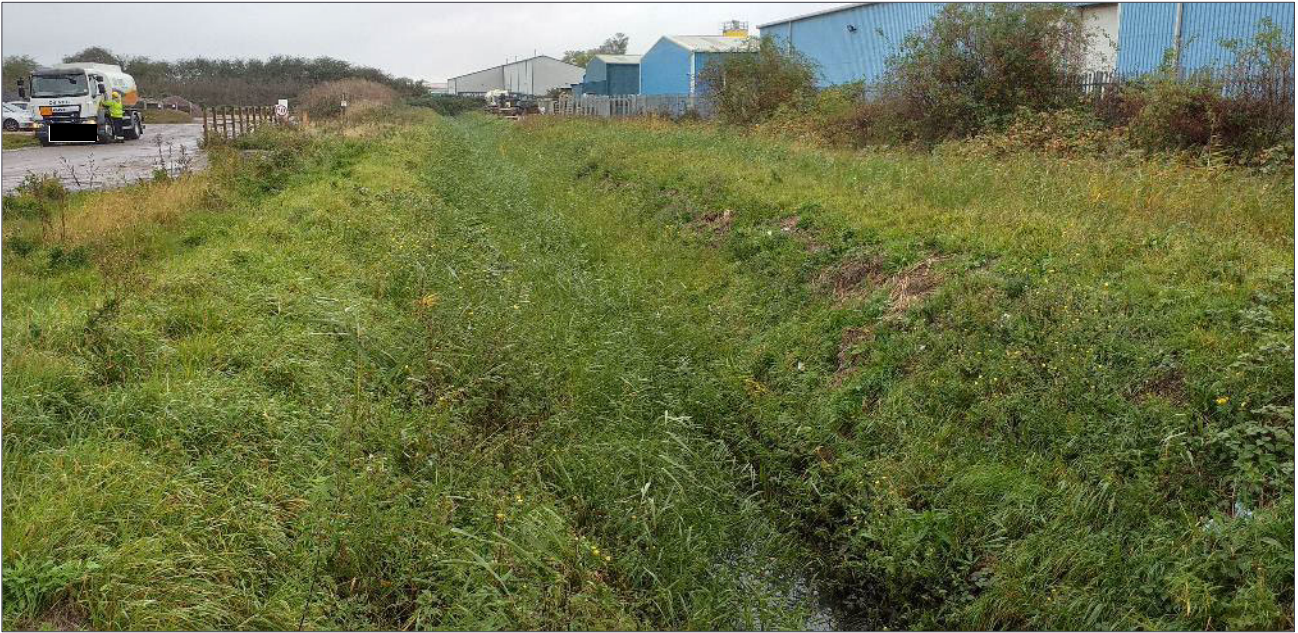
Plate 11

Looking north-west along the drainage channel adjacent to the north-east site boundary.

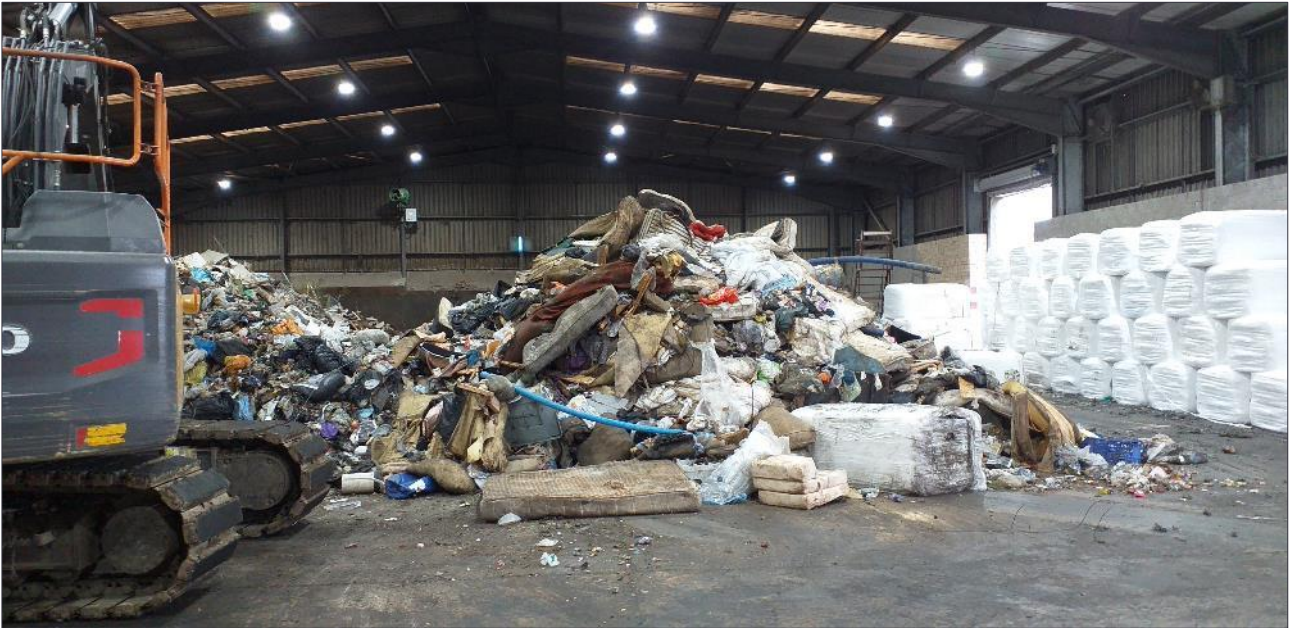
Plate 13

Looking east within the Waste Reception Area. A leachate drain is present in front of the entrance and exit in the right of the photograph.

<p>A leachate (Aco) drain spans the length of the south-west façade. The Aco drain feeds into a 20 m³ below-ground holding tank located adjacent to the south-west corner of warehouse. The tank is pumped of its contents when required. At the time of the walkover, the Aco drain looked blocked.</p> <p><i>Welfare Facilities & Weighbridge</i></p> <p>A staff car park, weighbridge and three portable welfare / storage cabins are present adjacent to the north-west of the waste reception warehouse (Plates 1 & 6).</p> <p>Wood was informed by the EfW CHP Facility site occupants that a 2500 litre below ground diesel fuel tank and filling station is located beneath a storage container located between the weighbridge and welfare cabins. The tank provides fuel for on-site vehicles. An above-ground 2000 litre unbunded double skinned tank containing AdBlue is located to the east of the storage container. An above-ground 1000 litre unbunded diesel tank is located adjacent to the north-west corner of the waste reception warehouse. An unbunded double skinned above ground diesel tank and generator are located adjacent to the north-west corner of the waste reception warehouse (Plate 17).</p> <p>The welfare facilities utilise a below-ground sewage treatment unit located adjacent to the south-west of the weighbridge (Plate 18). The sewage tank is regularly pumped, however an outflow pipe into the drainage ditched along the south-east site boundary is marked on service drawings.</p>

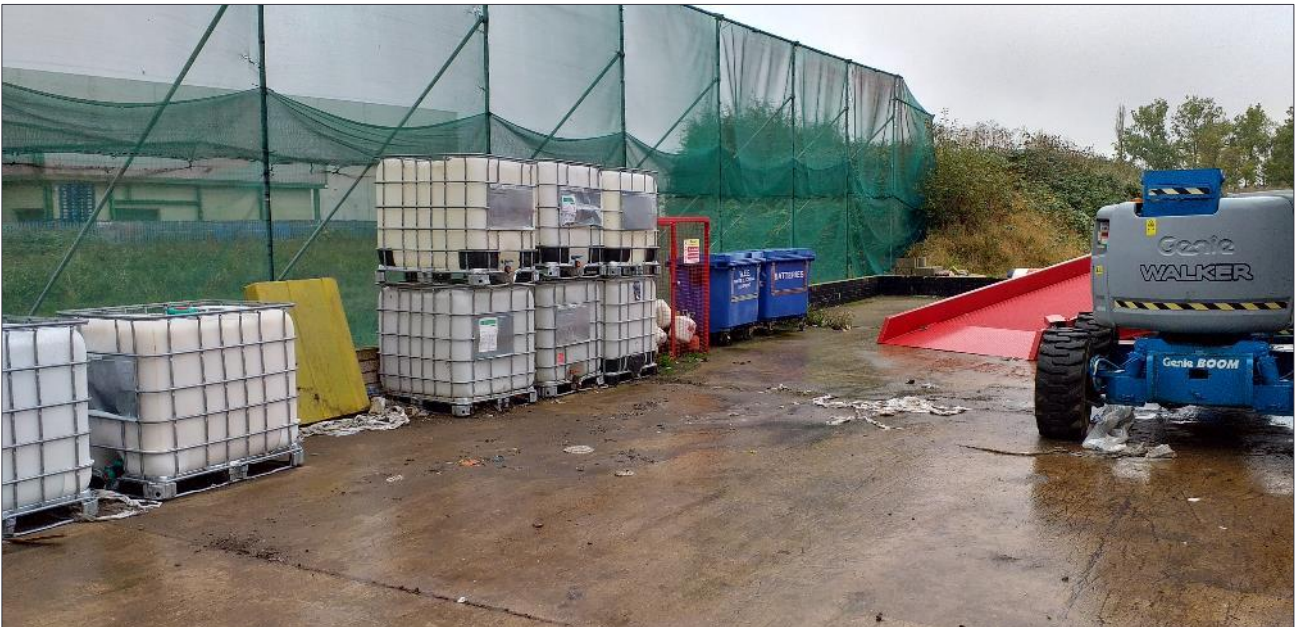
Plate 14

Looking south adjacent to the south-east corner of the WRW. Storage containers for batteries, gas cylinders and other hazardous items which are picked from the receiving household waste.

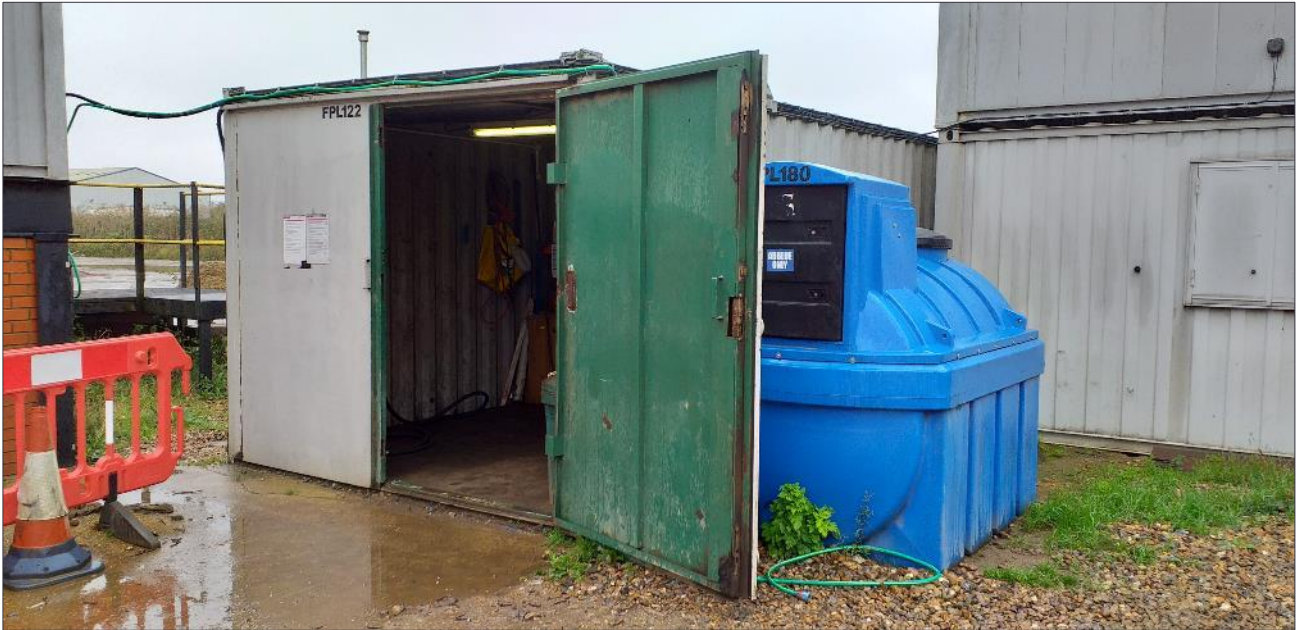
Plate 15

Looking north-west adjacent to the south-west corner of the WRW. The green storage container contains a fuel filling station and overlies a below ground fuel tank. The blue tank to the right contains 'AdBlue'.

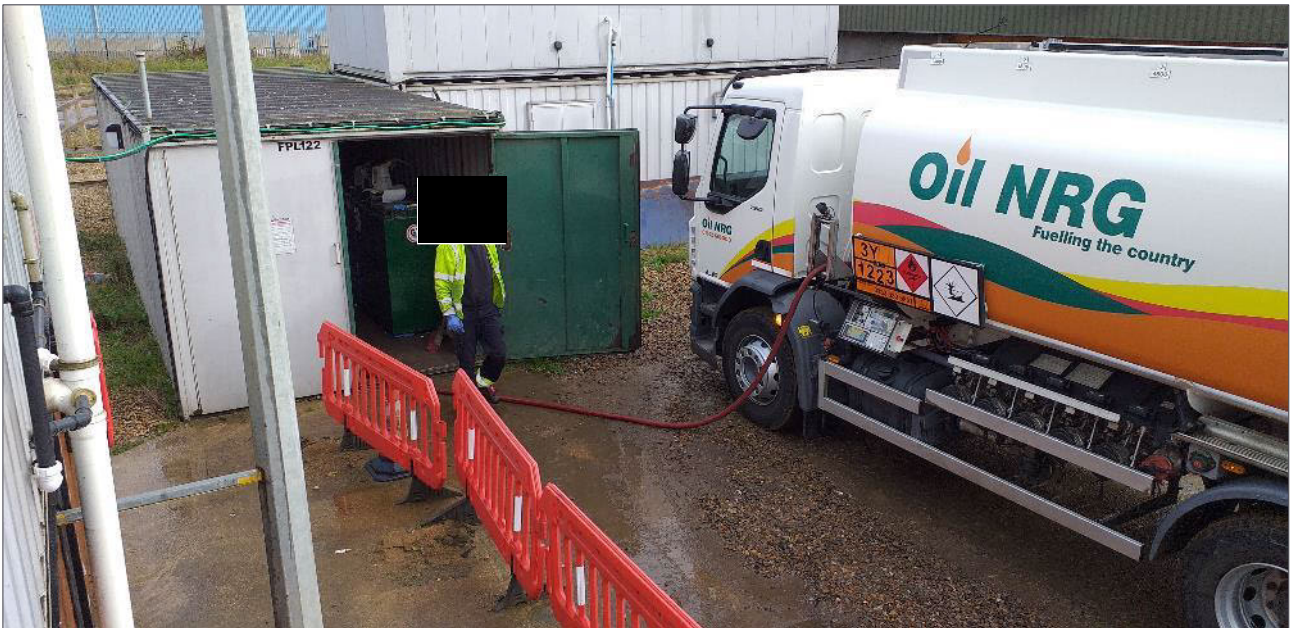
Plate 16

Fuel filling of the below ground fuel tank, located directly below the storage container. The fuel is used for on-site vehicles.

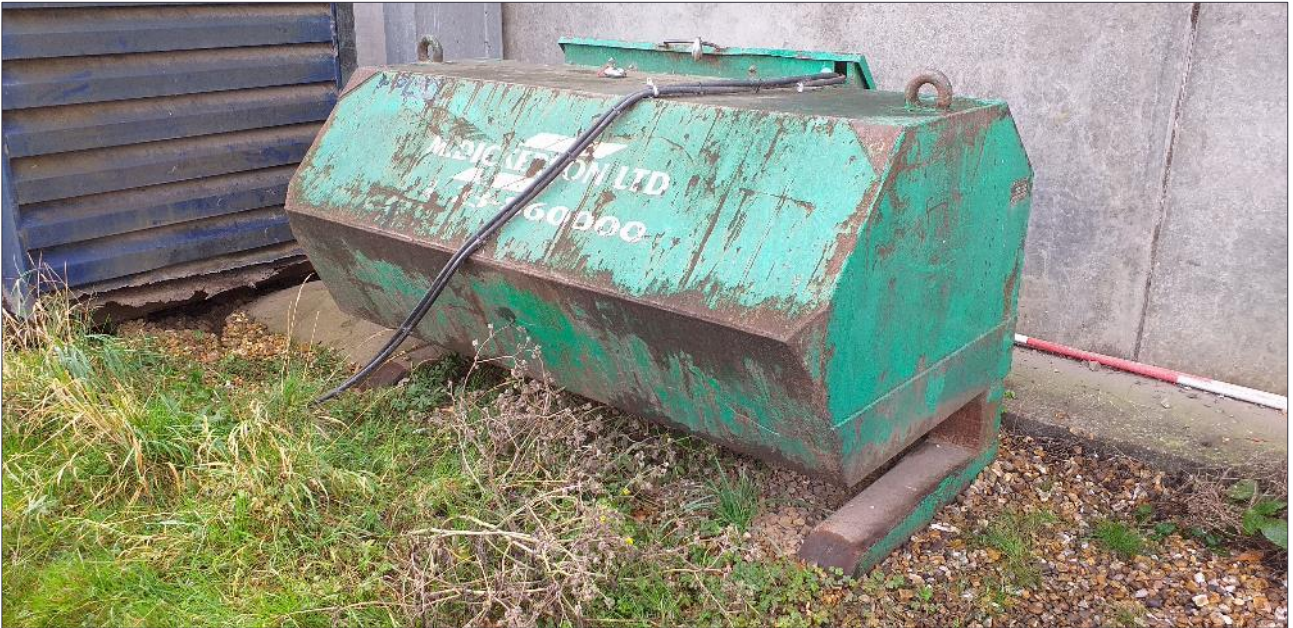
Plate 17

Diesel fuel tank adjacent to the north-west corner of the WRW used to fuel the plastic wrapping system.

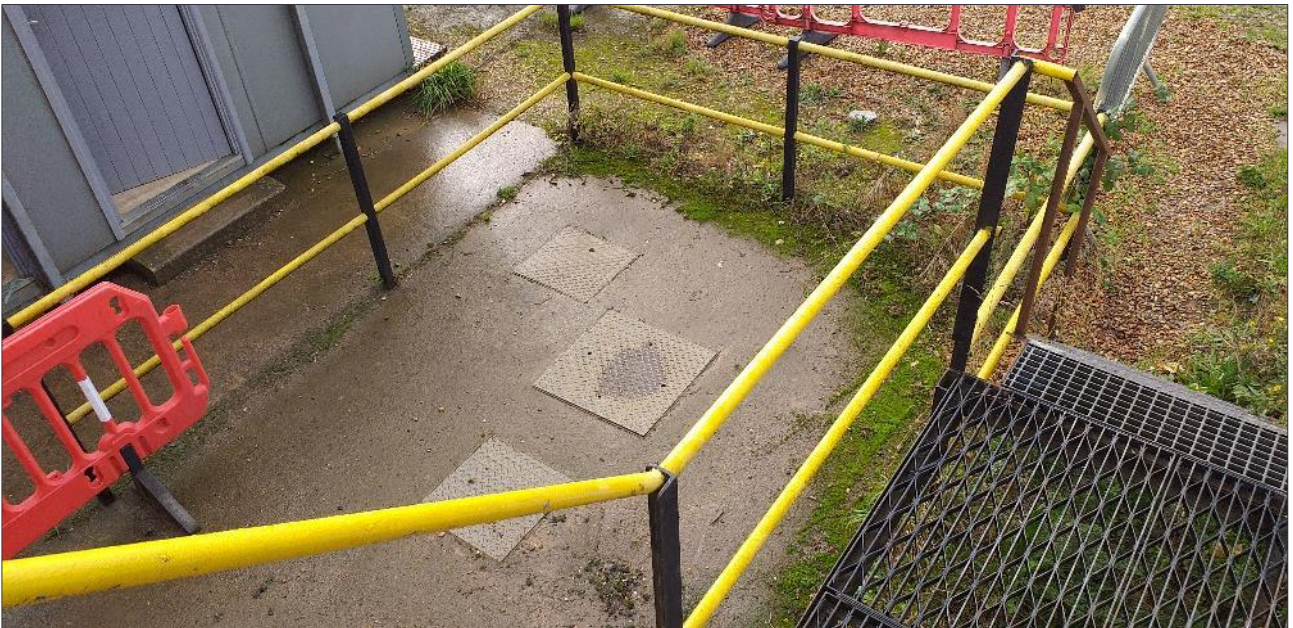
Plate 18

Location of septic tank adjacent to the south-west side of the weighbridge.

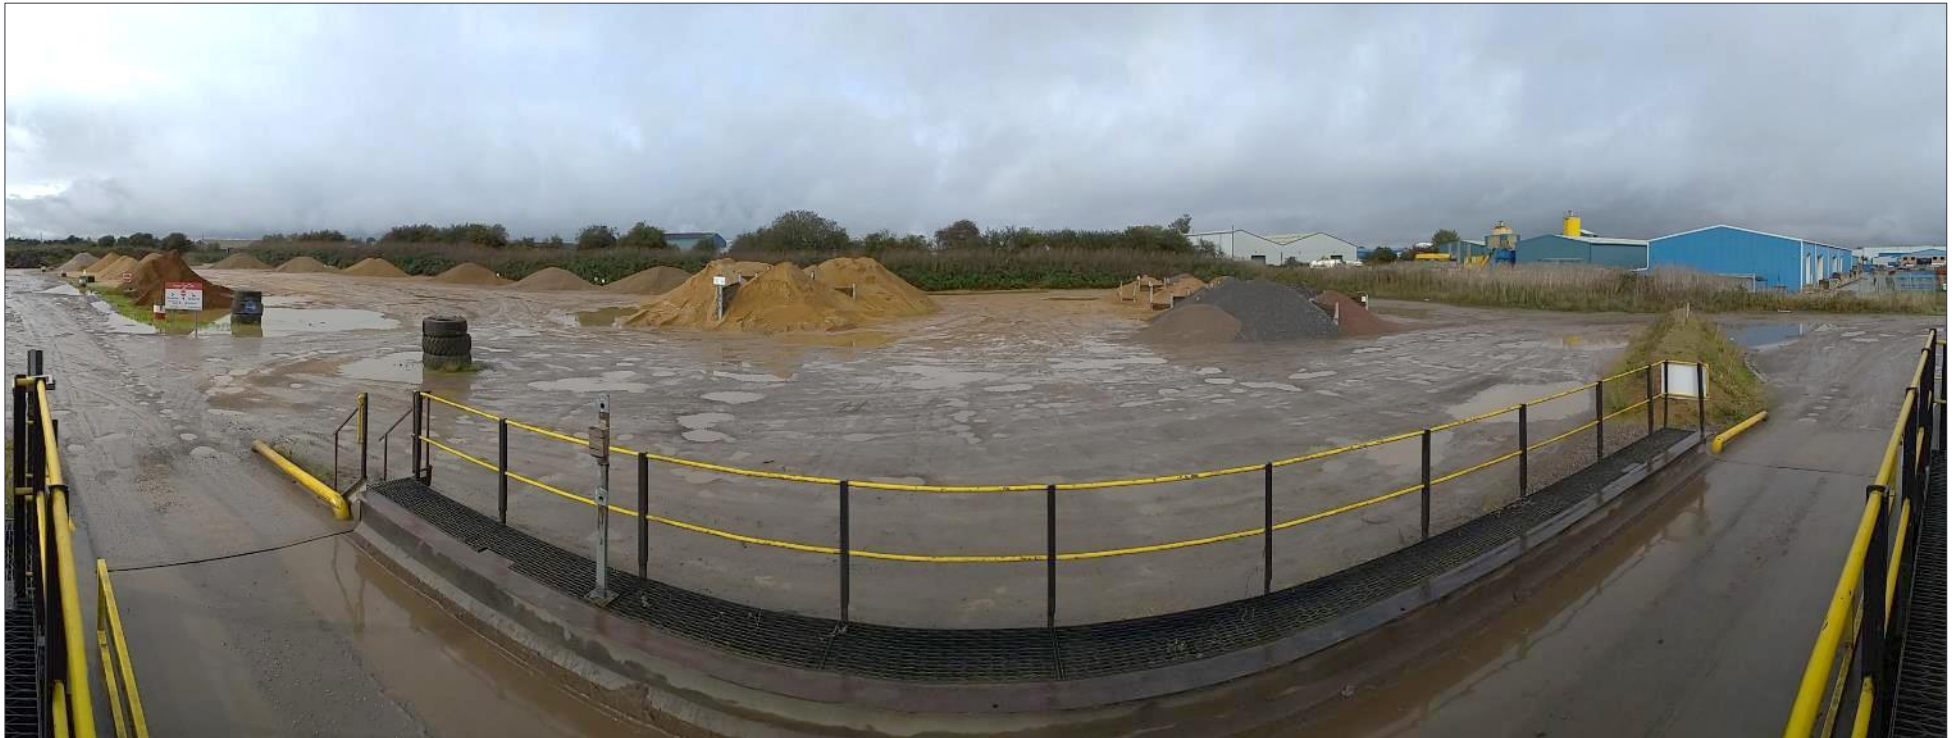
Plate 19

Panorama looking north-west from the site Weighbridge. Overlooking the aggregate storage area and the adjacent concrete products manufacturing site (blue) to the left.

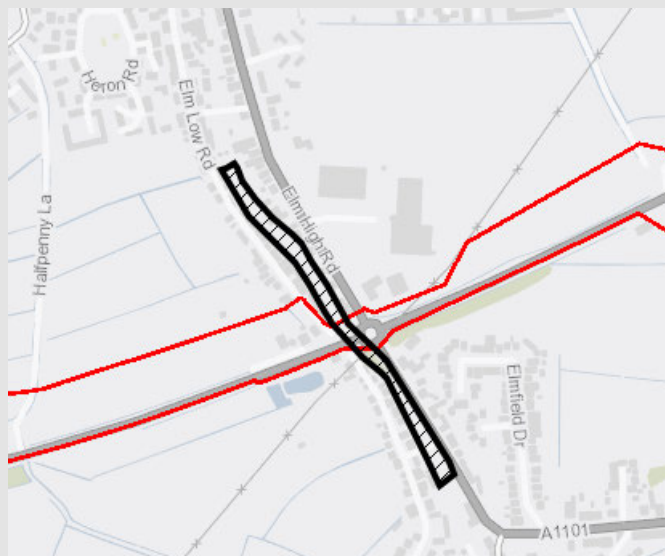
Graphic 2.4 Onsite historical al landfill (former Wisbech Canal)

Activity	On-Site	0-250m	Details
			<p>Previous investigation of the Wisbech Canal landfill, 2010 Information relating to the landfill is available on the West Norfolk Council website¹⁷. It includes a 2010 site investigation report by ESI¹⁸ that states that domestic type waste materials are present along the majority off the infilled canal but that the northern extent of the canal, north of the Blacksmiths Arms public house, which includes the section onsite, is likely to contain predominantly inert materials. Graphics showing exploratory hole locations are not provided with the report and it is therefore not known if any boreholes were completed on the site.</p> <p>Made ground was found in all boreholes located in the former canal footprint and comprised domestic waste material with an overlying cover material (0.4 to 0.8m thickness clayey gravelly sand or sandy gravelly clay with some brick and concrete fragments), the waste material typically included silty gravelly sand containing brick, ceramics, glass, clinker, fabric, plastic, metal and wood, with thickness ranging from 2.0 to 3.6m. This was underlain by natural soils comprising silty clay and slightly sandy clay. Peat lenses were found within the silts. Groundwater levels during monitoring were within the top 3m and mainly at between 1 and 2m below ground level.</p> <p>Waste samples were sent for laboratory testing at Alcontrol Laboratories for analytes including metals, ammoniacal nitrogen, sulphate, phenol, cyanide, pH, polycyclic aromatic hydrocarbons (PAH), total petroleum hydrocarbons (TPH), volatile organic compounds (VOC) and semi-volatile organic compounds (SVOC), organochloride pesticides and asbestos screen. Groundwater sampling and six rounds of gas monitoring for methane, oxygen, carbon dioxide, carbon monoxide and hydrogen sulphide were also carried out in 2010.</p> <p>No significant risks to human health were identified by ESI following screening of the soil results against the applied generic assessment criteria (GAC), or assessment of the gas results, and no significant risks to controlled waters were identified. The report concluded that the former canal site did not represent Part 2A Contaminated Land and no further investigation was recommended.</p> <p>No significant risks to controlled waters were identified however, the report notes the presence of a continuous shallow groundwater system along the length of the landfill is uncertain and that the degree of interaction between landfill leachate and local surface water features is unclear. It was assumed by ESI that shallow groundwater within the Terrington Beds will be in hydraulic continuity with the local network of surface water channels (not least since these channels are anticipated to have a drainage function), although the rate of movement through the superficial silts was anticipated to be low.</p>
