SOLAR 21 RENEWABLE ENERGY LIMITED

**EFW PLANT,
STATHER ROAD, FLIXBOROUGH, SCUNTHORPE DN15 8SE**

REPORT ON GROUND INVESTIGATION

Contract: 31554

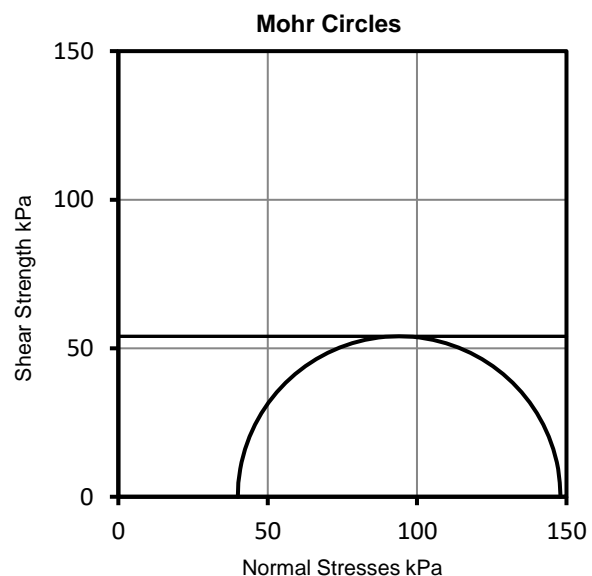
Borehole / Trial Pit	Depth (m)	Sample	Description
BH2	2.00	U10	Brown slightly gravelly sandy CLAY

Initial Sample	Test Number	1
	Original Length (mm)	450.00
	Depth from Top (mm)	27.11
	Condition	Undisturbed
	Orientation	Vertical
Length (mm)		209.24
Diameter (mm)		102.11
Moisture Content (%)		28.10
Bulk Density (Mg/m ³)		2.05
Dry Density (Mg/m ³)		1.60
Membrane Thickness (mm)		0.3
Membrane Type		Latex
Rate of Strain (%/min)		1.9
Test Results	Cell Pressure (kPa)	40
	Axial Strain (%)	15
	Membrane Corr. (kPa)	0.88
	Deviator Stress, $(\sigma_1 - \sigma_3) f$ (kPa)	108
	Undrained Shear Strength, $c_u = \frac{1}{2}(\sigma_1 - \sigma_3) f$ (kPa)	54
Mode of Failure		Compound

Deviator stress corrected for area change and membrane effects

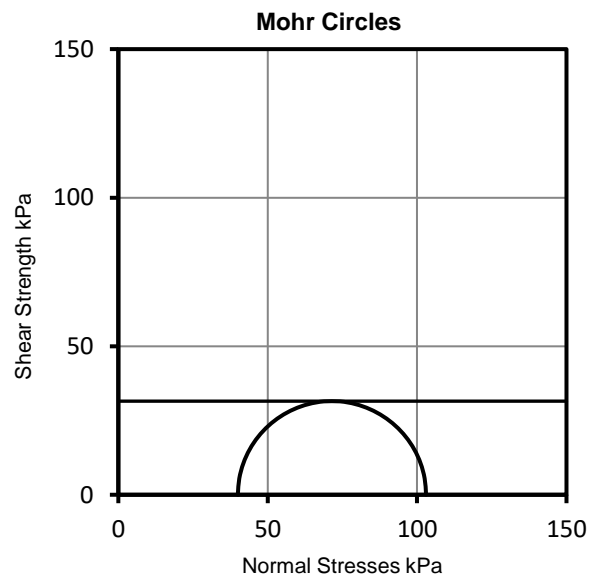
Borehole / Trial Pit	Depth (m)	Sample	Description
BH3	2.10	U7	Brown gravelly CLAY

Initial Sample	Test Number	1
	Original Length (mm)	400.00
	Depth from Top (mm)	40.00
	Condition	Undisturbed
	Orientation	Vertical
Length (mm)		204.10
Diameter (mm)		102.19
Moisture Content (%)		30.00
Bulk Density (Mg/m ³)		2.11
Dry Density (Mg/m ³)		1.62
Membrane Thickness (mm)		0.36
Membrane Type		Latex
Rate of Strain (%/min)		2.0
Test Results	Cell Pressure (kPa)	40
	Axial Strain (%)	20
	Membrane Corr. (kPa)	1.33
	Deviator Stress, ($\sigma_1 - \sigma_3$)f (kPa)	63
	Undrained Shear Strength, $c_u = \frac{1}{2}(\sigma_1 - \sigma_3)$ f (kPa)	31
	Mode of Failure	Compound

Deviator stress corrected for area change and membrane effects
