Rampion 2 Wind Farm

Evidence Plan (Part 10 of 11)

Document Reference: 7.21

Phase Four – Environmental Statement

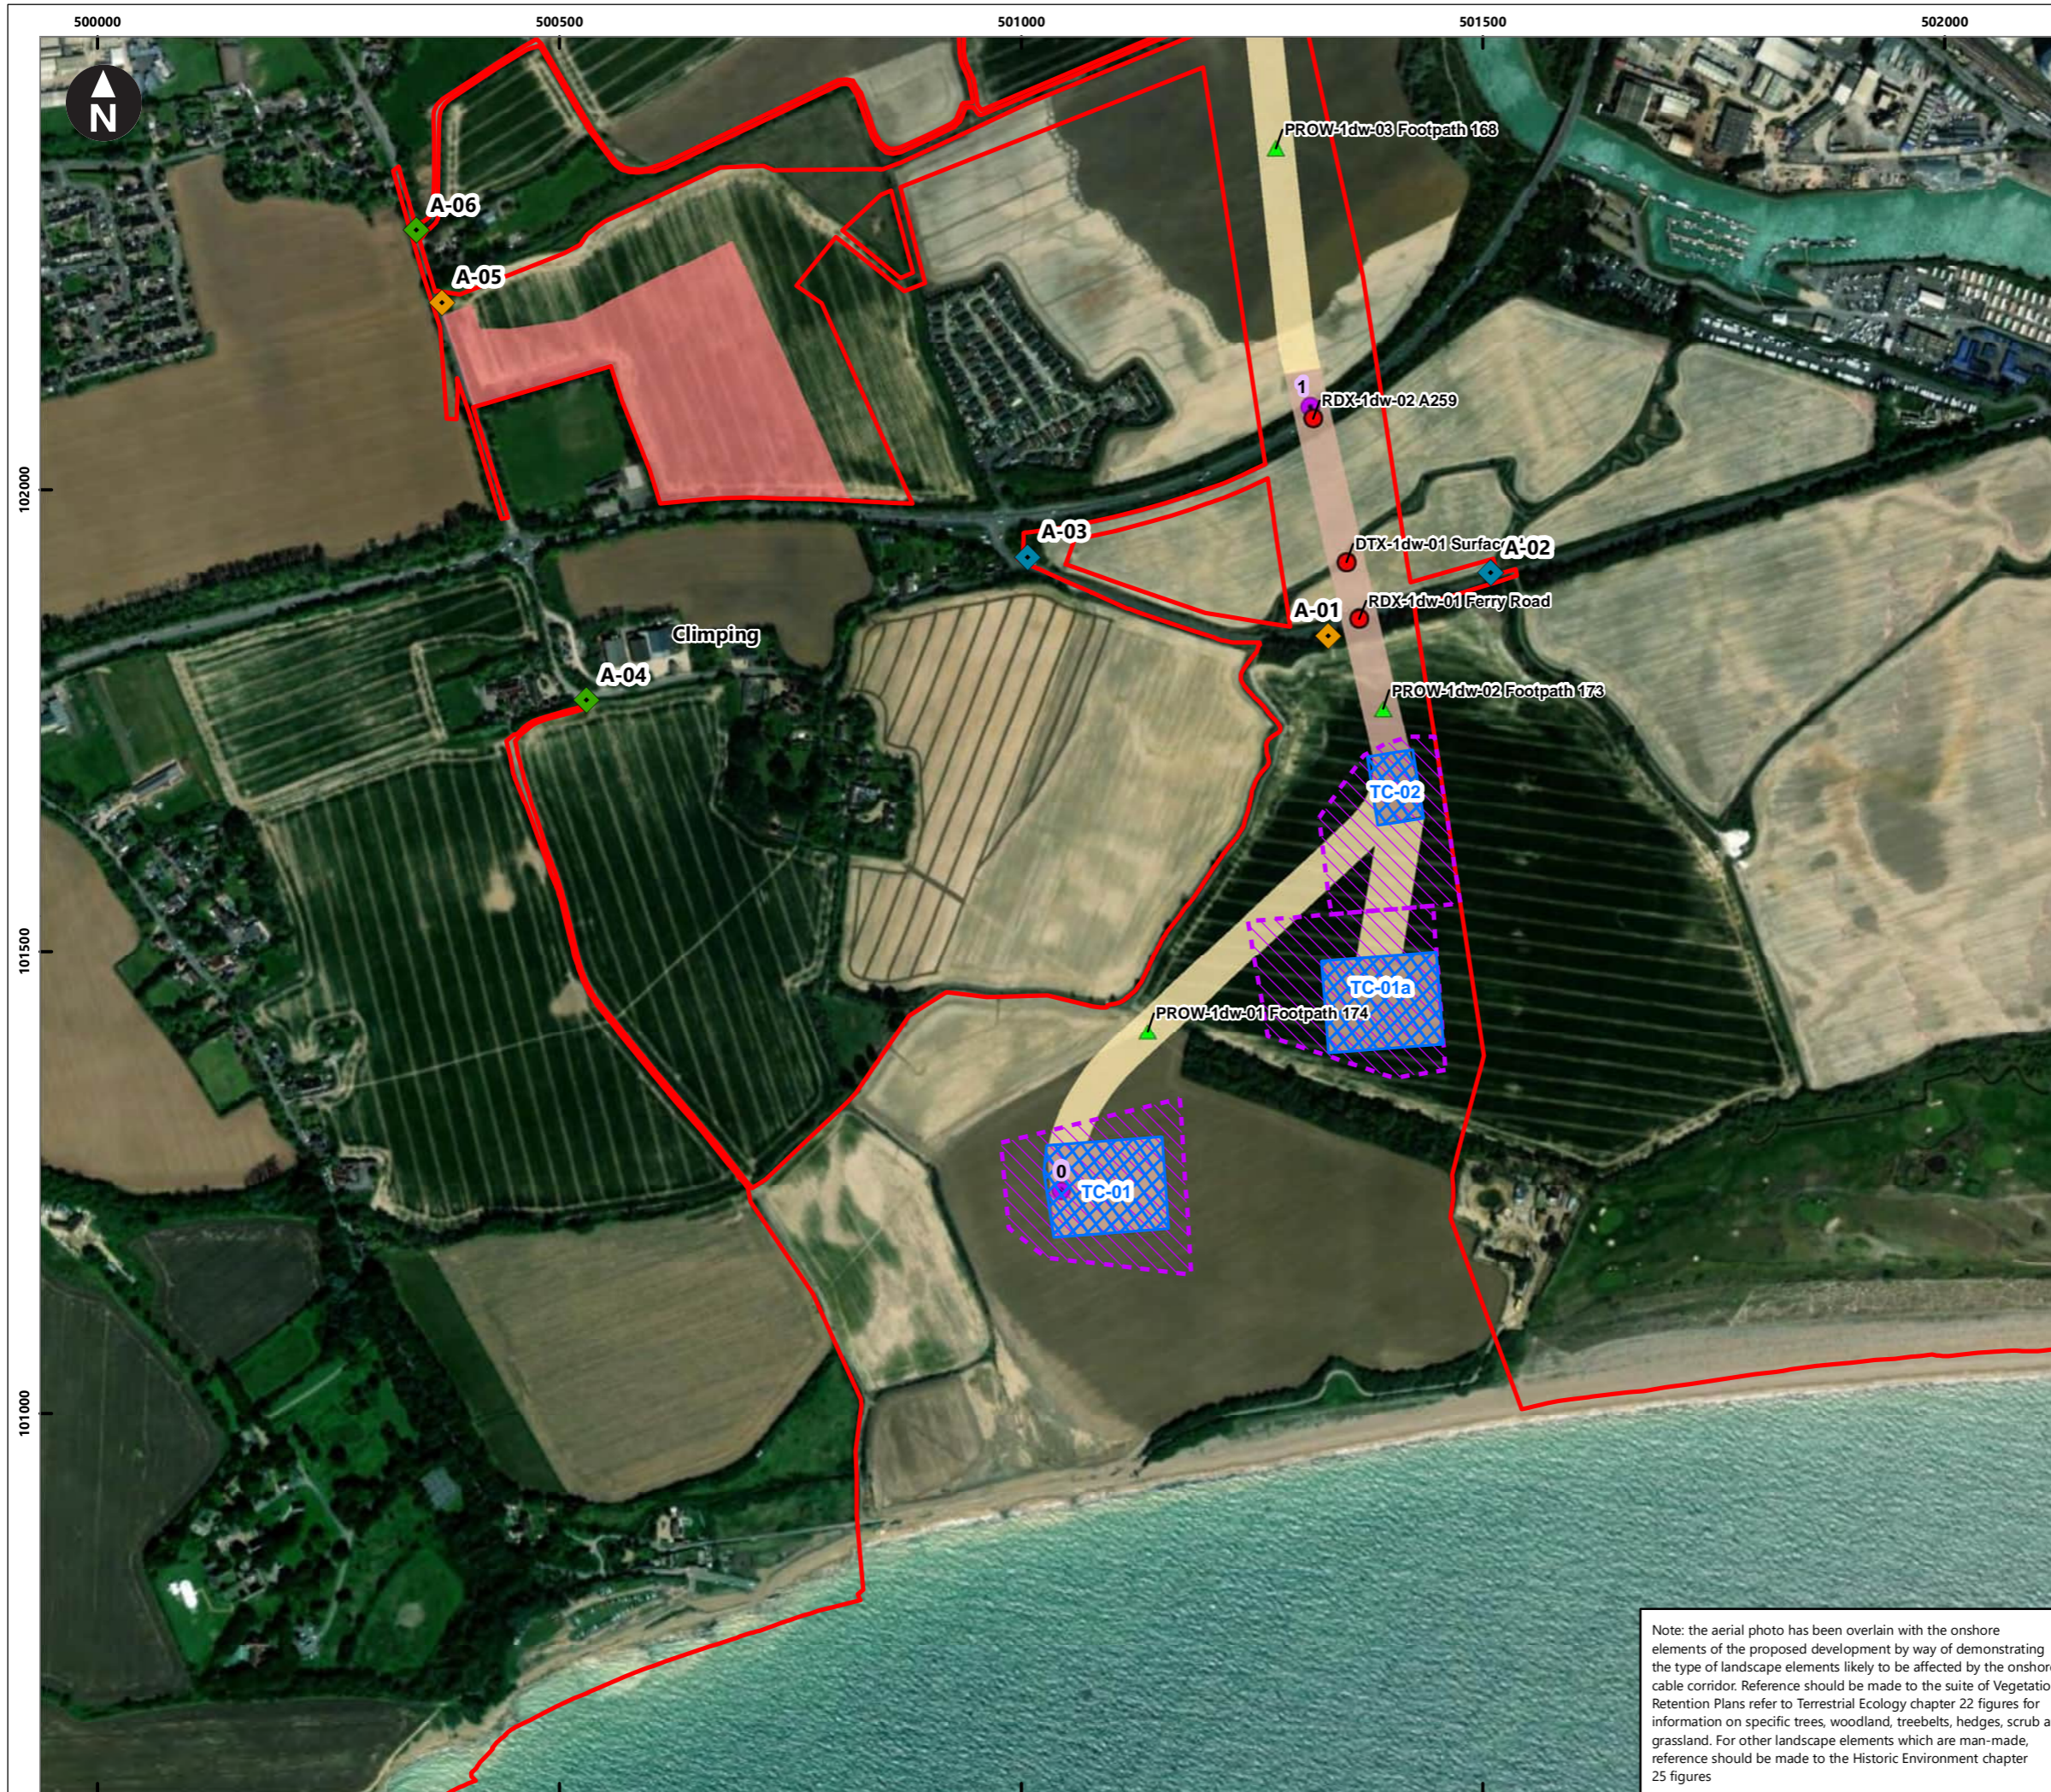
Figure 18.8 Landscape elements along cable corridor

Note: the aerial photo has been overlain with the onshore elements of the proposed development by way of demonstrating the type of landscape elements likely to be affected by the onshore cable corridor. Reference should be made to the suite of Vegetation Retention Plans refer to Terrestrial Ecology chapter 22 figures for information on specific trees, woodland, treebelts, hedges, scrub and grassland. For other landscape elements which are man-made, reference should be made to the Historic Environment chapter 25 figures

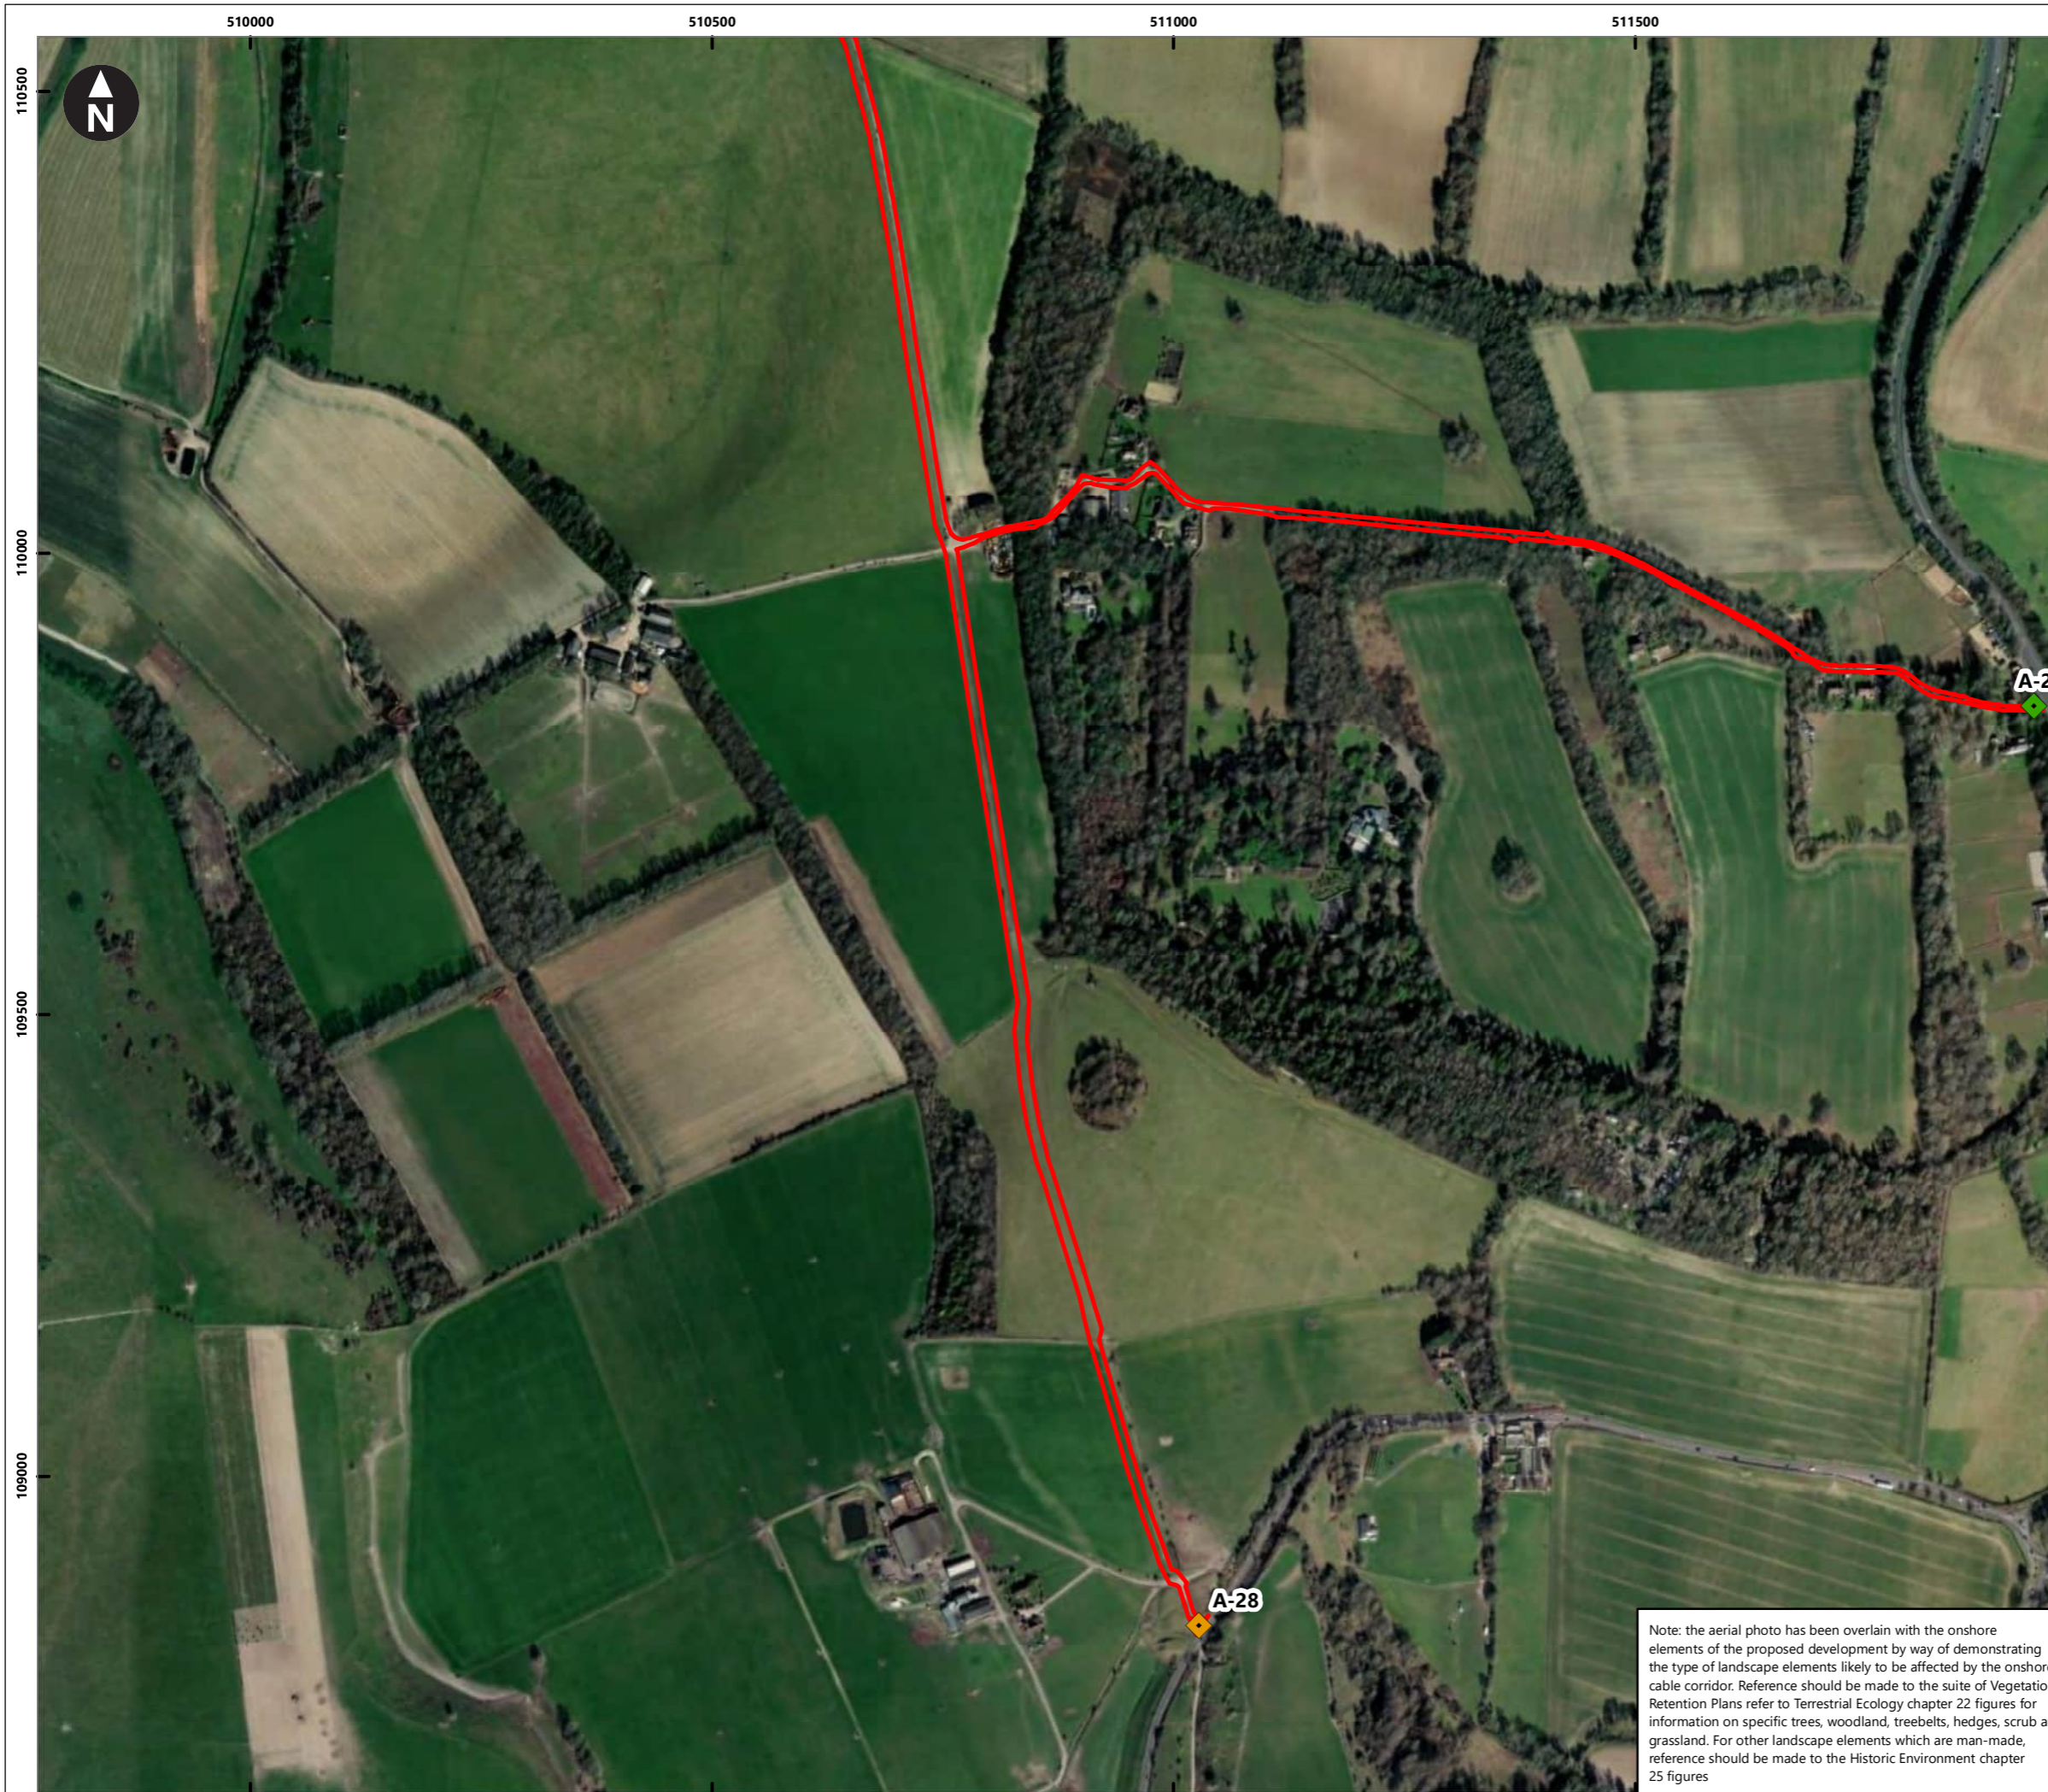
Figure 18.8 Landscape elements along cable corridor

Note: the aerial photo has been overlain with the onshore elements of the proposed development by way of demonstrating the type of landscape elements likely to be affected by the onshore cable corridor. Reference should be made to the suite of Vegetation Retention Plans refer to Terrestrial Ecology chapter 22 figures for information on specific trees, woodland, treebelts, hedges, scrub and grassland. For other landscape elements which are man-made, reference should be made to the Historic Environment chapter 25 figures

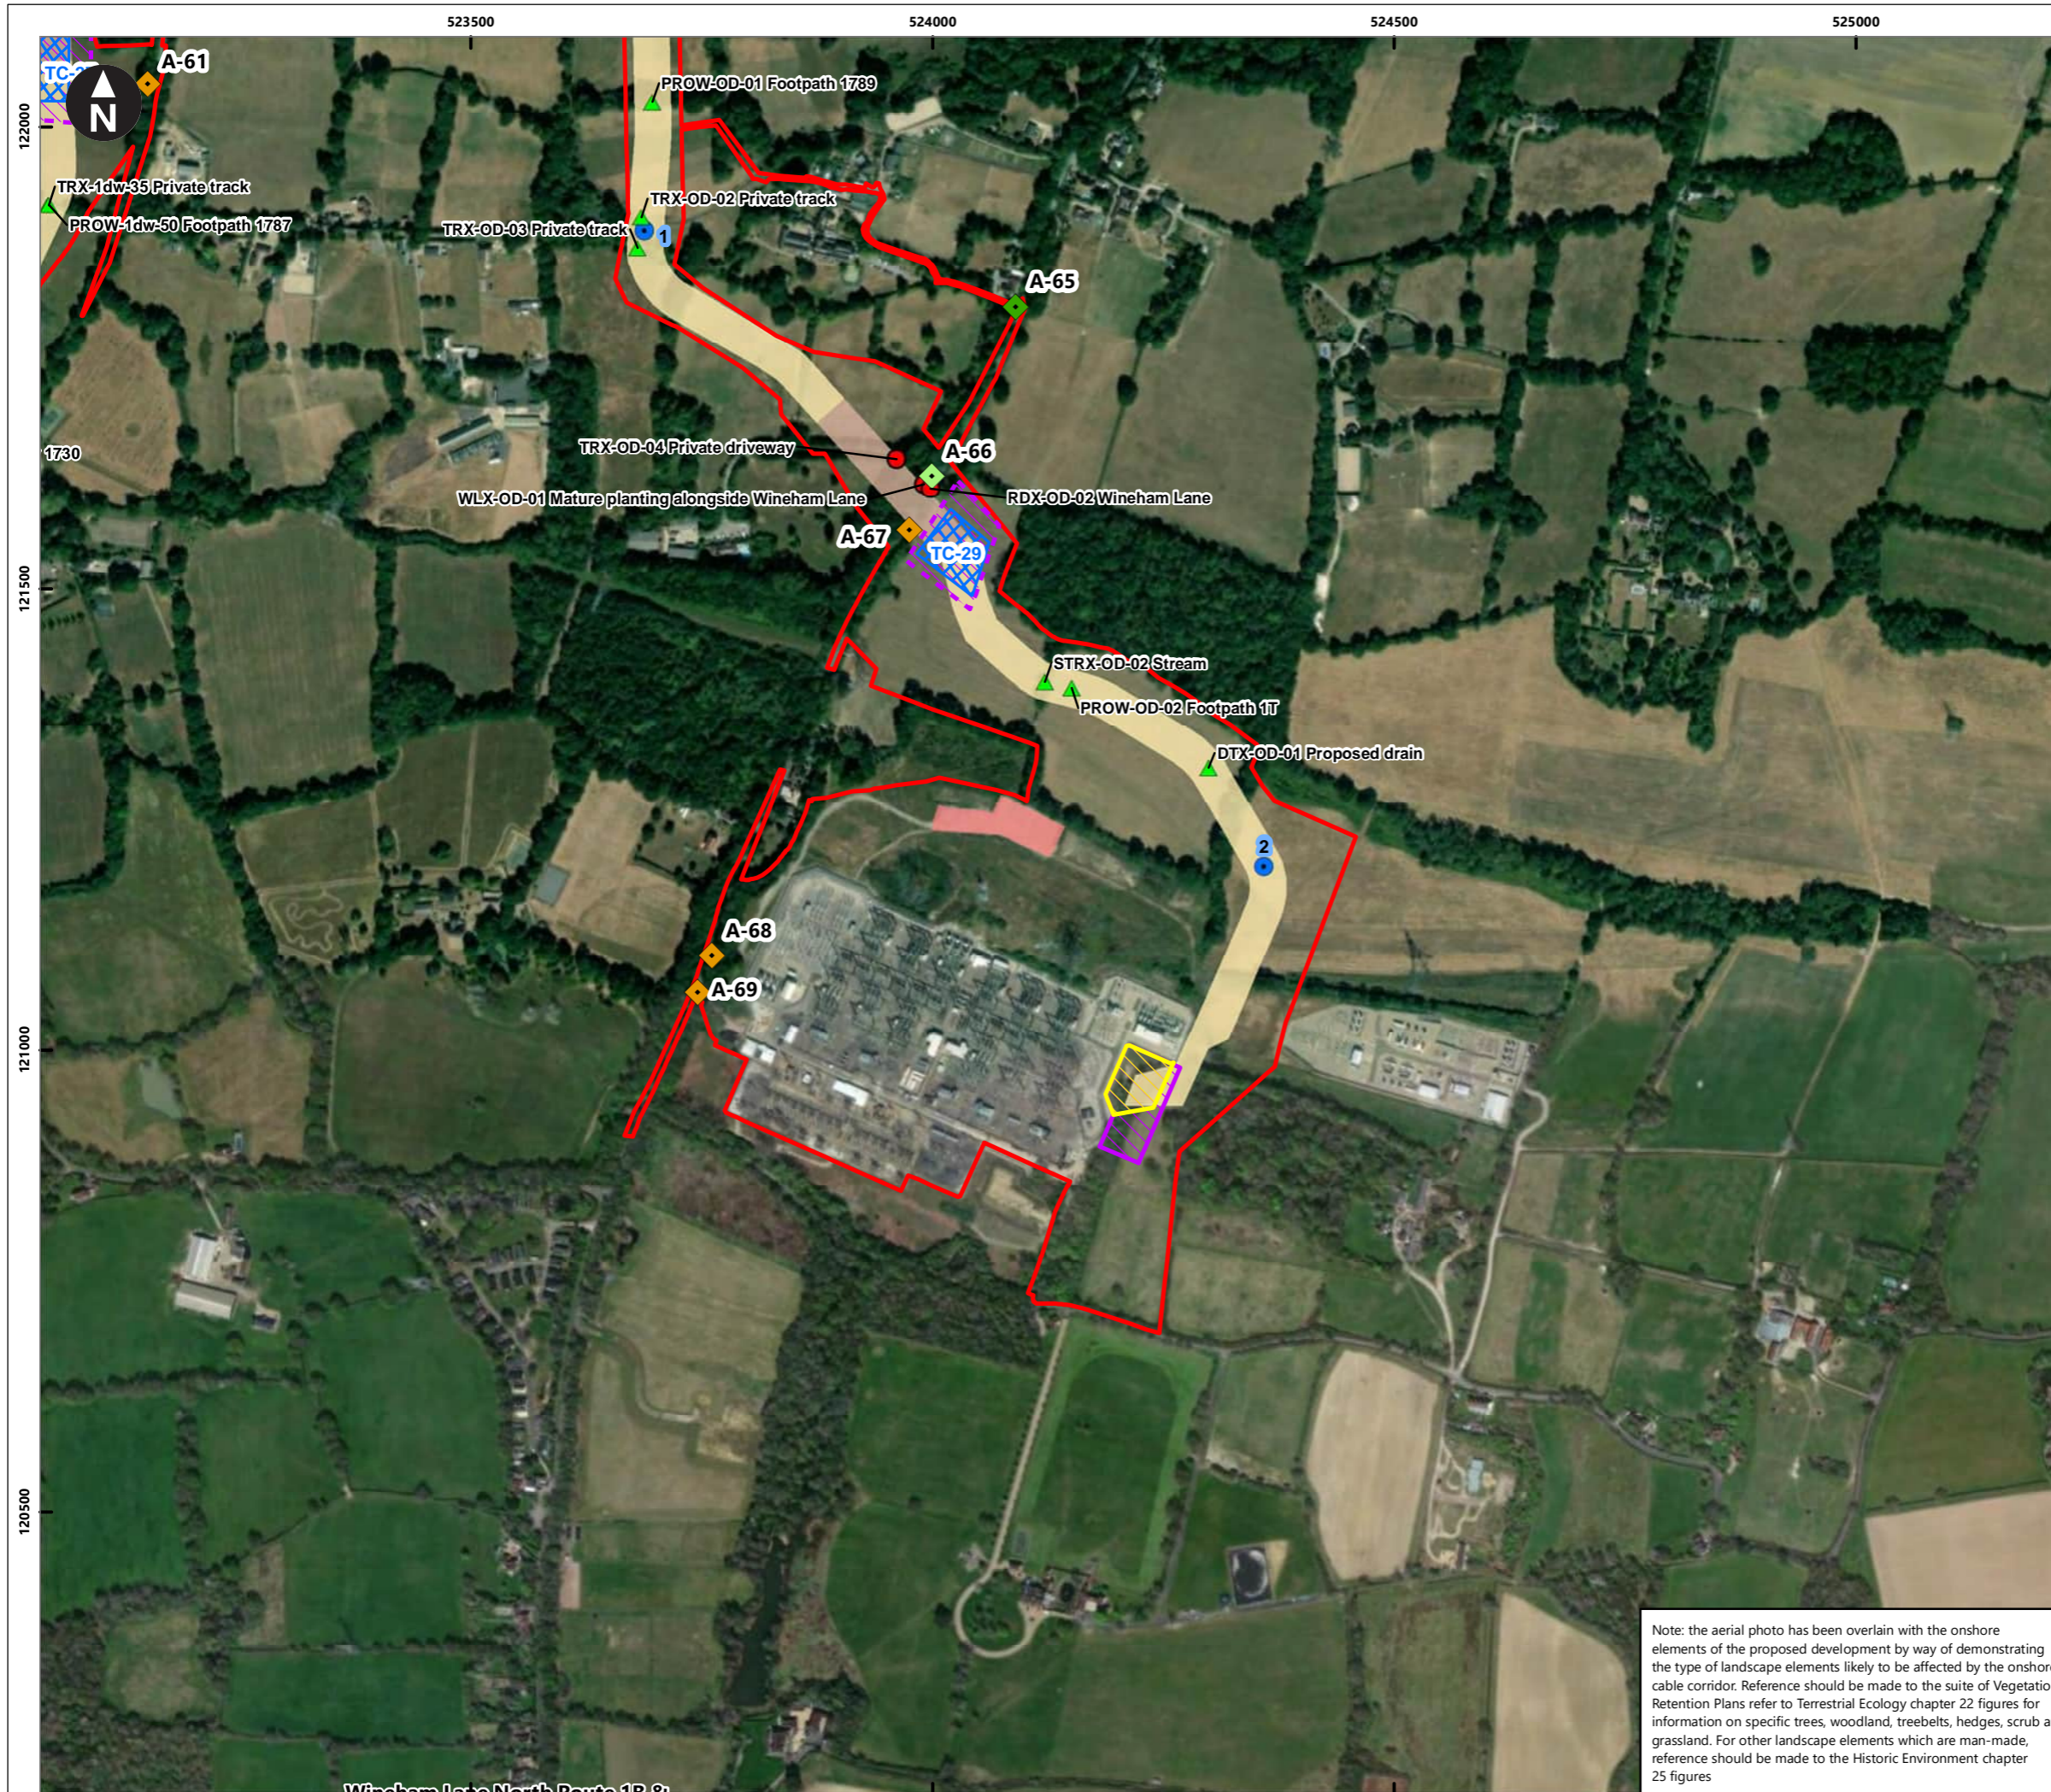
Note: the aerial photo has been overlain with the onshore elements of the proposed development by way of demonstrating the type of landscape elements likely to be affected by the onshore cable corridor. Reference should be made to the suite of Vegetation Retention Plans refer to Terrestrial Ecology chapter 22 figures for information on specific trees, woodland, treebelts, hedges, scrub and grassland. For other landscape elements which are man-made, reference should be made to the Historic Environment chapter 25 figures

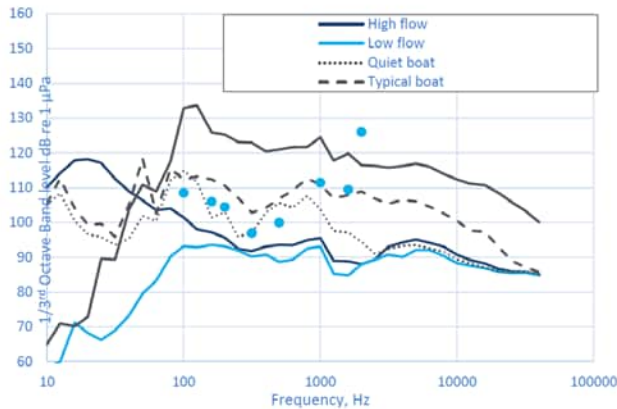
It is clear that the effect of the tides is at low frequency <100 Hz. Passing vessels increase noise across the spectrum, to 1000 Hz, and beyond if the source is loud.
