**Rampion 2 Wind Farm**  
**Category 6:**  
**Environmental Statement**  
**Volume 4, Appendix 22.6:**  
**Fisheries habitat survey report**  
**Date: August 2023**  
**Revision A**

Document Reference: 6.4.22.6  
Pursuant to: APFP Regulation 5 (2) (a)  
Ecodoc number: 004866564-01

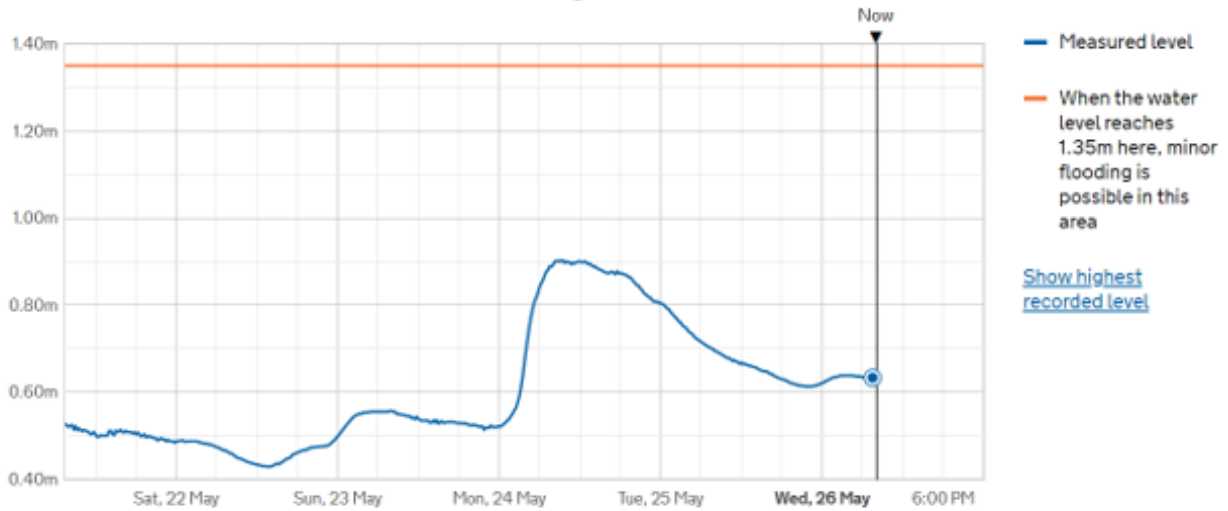
Latest recorded level 0.63m at 7:30am Wednesday 26 May 2021.

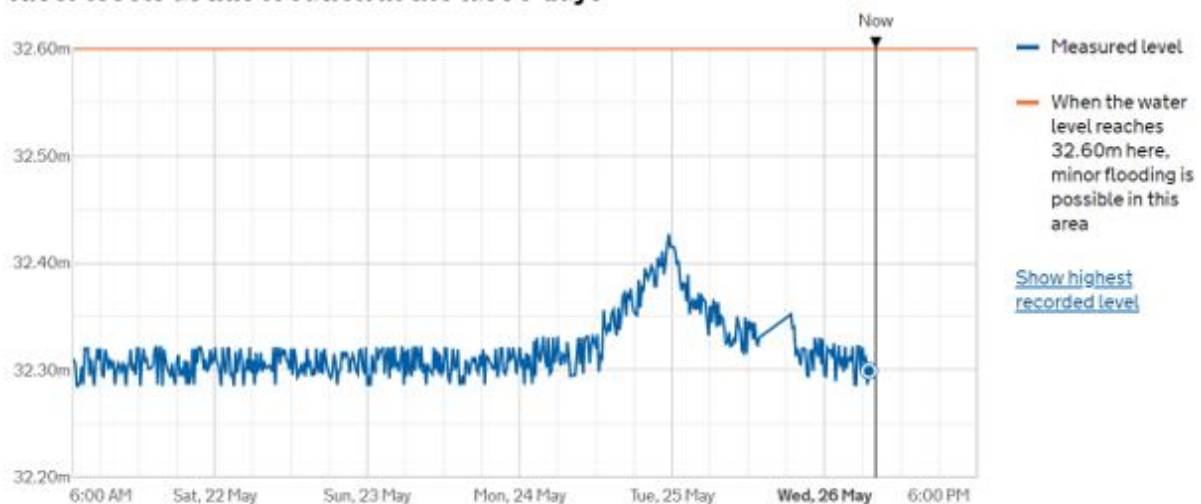
### Graphic 2-2 River Levels for the River Arun at Tanbridge, 26 May 2021

Latest recorded level 32.30m at 7:00am Wednesday 26 May 2021.

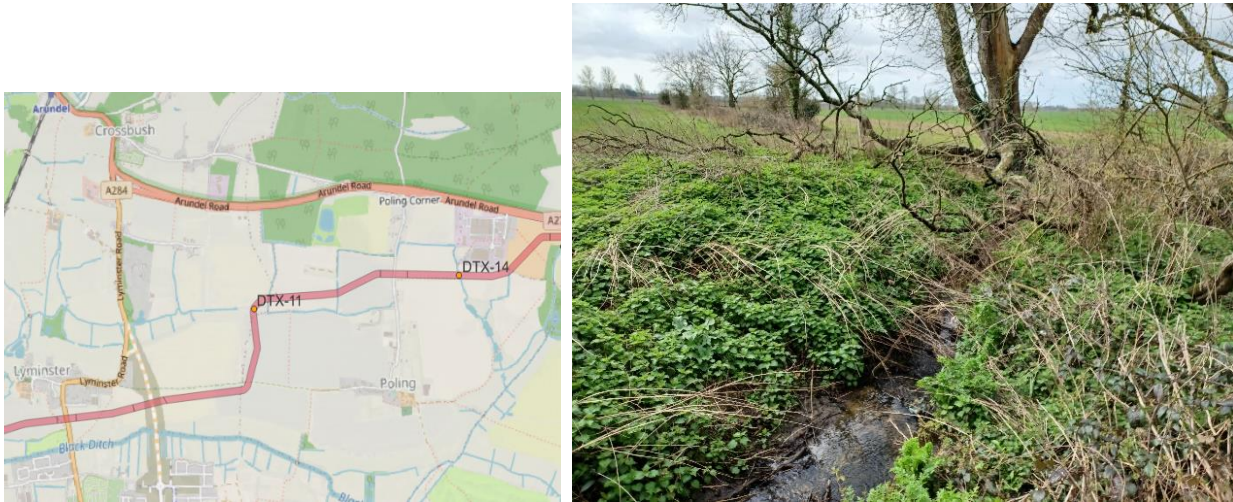
**Graphic 4-3 Onshore cable crossing at site DTX-11**

4.3.1 **Crossing method:** Open cut trenching

4.3.6 **Fisheries appraisal:** Fisheries habitat in the channel is considered suboptimal however species such as three-spined stickleback could inhabit this part of the river. The site is online and therefore potentially accessible by migratory species such as European eel. No fish were observed during the survey visit.

4.3.7 **Mitigation:** Temporary construction works during low flow period is considered to present a minimal risk to fish stocks. Due to the online nature of the water course however it is recommended that a watching brief is maintained during site preparation by the Environmental Clerks of Works equipped with hand net to relocate fish should they be present within any bunded reach. Temporary construction works should be compliant with good practice guidance for works and maintenance in or near water (Environment Agency, 2007). Mitigation recommended (see also **Table 5-2**) includes the following:

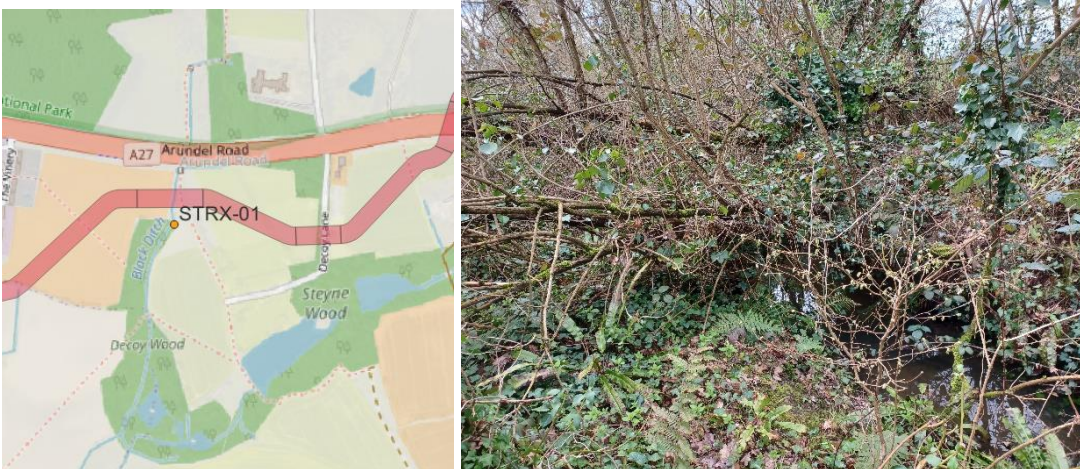
### Graphic 4-8 Onshore cable crossing site STRX-01

4.5.1 **Crossing method:** Trenchless

4.5.7 **Fisheries appraisal:** The habitat within the stream was considered suboptimal for minor fish species for example, stickleback. The site is online and therefore potentially accessible by migratory species such as European eel. No fish were observed during the survey visit.

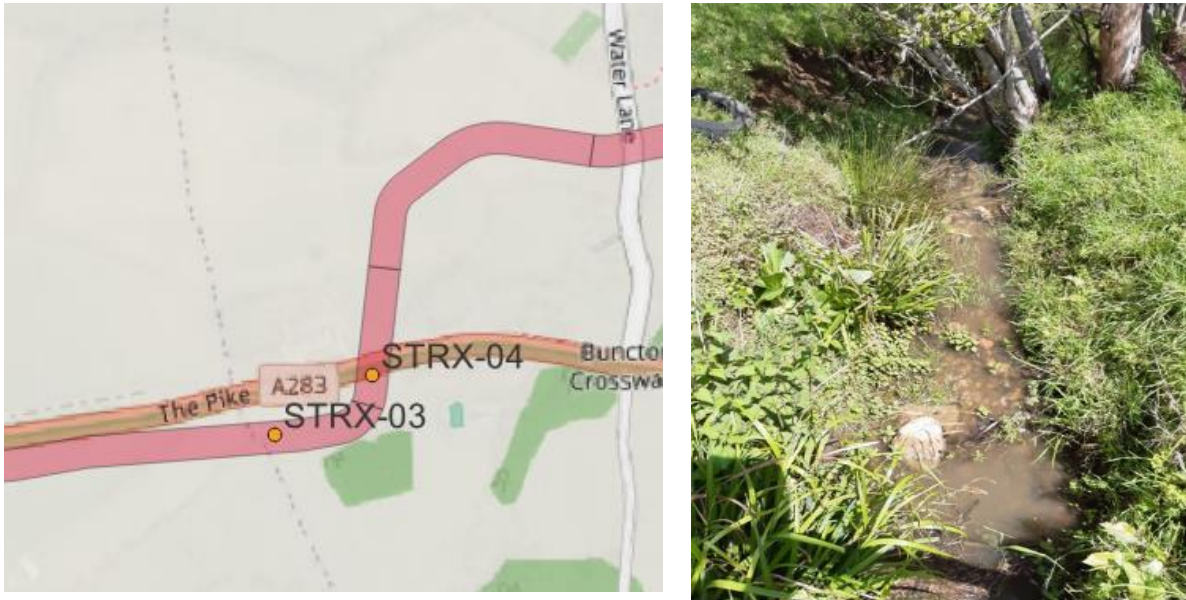
Graphic 4-14 Onshore cable crossing site STRX-03

4.7.1 **Crossing method:** Open cut trenching.

4.7.5 **Mitigation:** Whilst there is considered to be no risk to fish stocks at this proposed crossing site it is recommended that, due to the online nature of the watercourse, construction works should be compliant with good practice guidance for works and maintenance in or near water (Environment Agency 2007) (also see **Table 5-1**). Potential mitigation measures include:

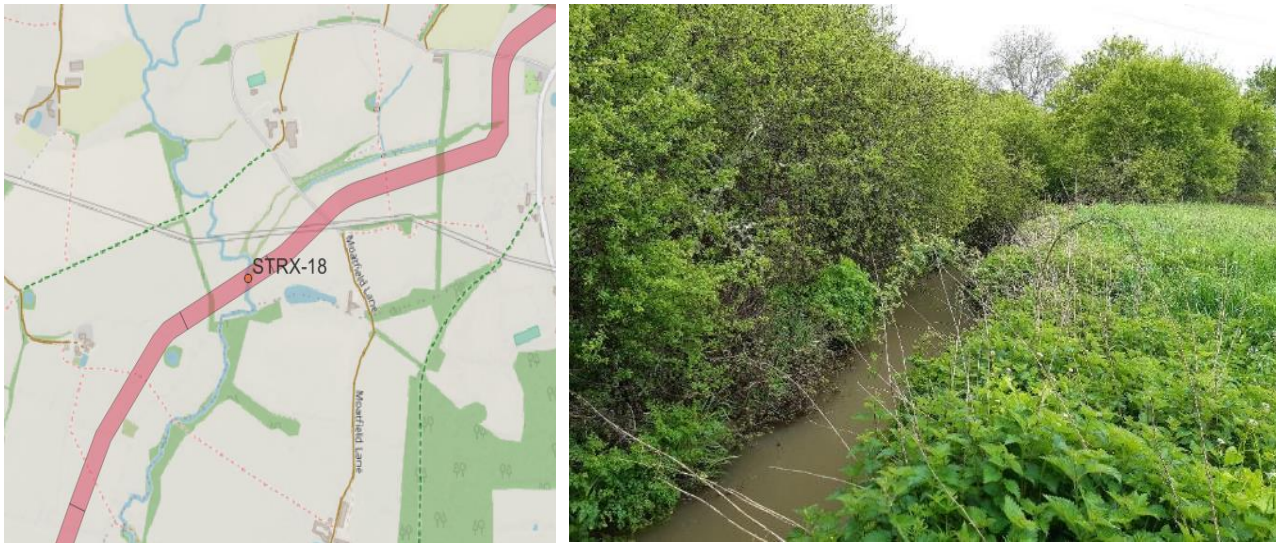
**Graphic 4-47 Onshore cable crossing site STRX-18**

- 4.17.1 **Crossing method:** Trenchless.
- 4.17.2 **Fisheries surveys:** No data.
- 4.17.3 **Fish habitat:** Crossing site STRX-18 is situated on private land. The fisheries habitat within the reach of the water course was assessed from PRow upstream and downstream of the proposed crossing site.

- 4.17.6 The banks were tree lined and shade varied from 50 – 80%. The water was turbid during the site visit which hampered clear views of the bed however no submergent or emergent macrophytes were observed. Cover was provided in the margins by over hanging riparian vegetation and trailing tree branches.

- 4.17.7 The reach was bounded by two brick culverts under farm tracks. There culverts were however clear span with no discontinuity to the bed and they did not appear to impede fish passage. Debris dams with a high degree of porosity were observed through the reach which provided fish refuge.

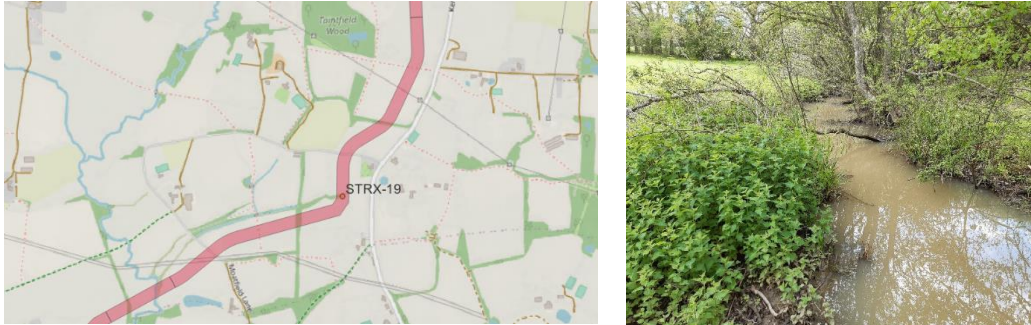
### Graphic 4-50 Onshore cable crossing at site STRX-19

- 4.18.1 **Crossing method:** Open cut trenching.
- 4.18.2 **Fisheries surveys:** No data.
- 4.18.3 **Fisheries habitat appraisal:** The proposed crossing site lies on a small, ephemeral tributary of the Cowfold Stream. Channel width varied between circa 1m to 2.5m with an average depth of <0.4m. The channel is cut into weald clay and the bed substrate comprised silts, fines & clays.

- 4.18.4 The channel was shaded by both tree canopy and riparian vegetation (circa 50%) both with trailing branches that would have provide cover for fish. There were no submergent or emergent macrophytes observed within the channel.

- 4.18.5 There were numerous tree roots intruding into the channel and debris dams along the course of the channel, that would have impeded fish passage during average and low flow conditions.

- 4.18.6 **Fisheries appraisal:** Fish are unlikely to be resident in this reach and the impact to fish is considered negligible.
- 4.18.7 **Mitigation:** The following mitigation is therefore recommended (also see **Table 5-1**):

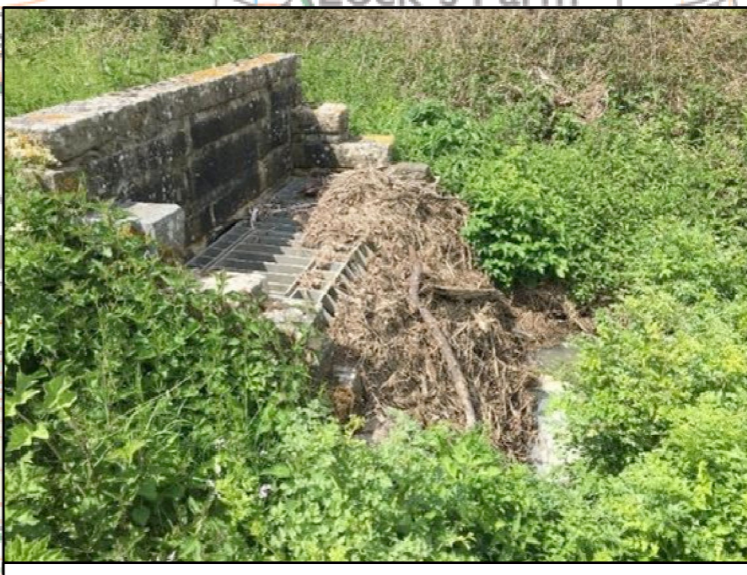
Heavily fouled coarse screening on the downstream entrance to the A283 road culvert at Washington, West Sussex immediately upstream of the proposed crossing site STRX-02

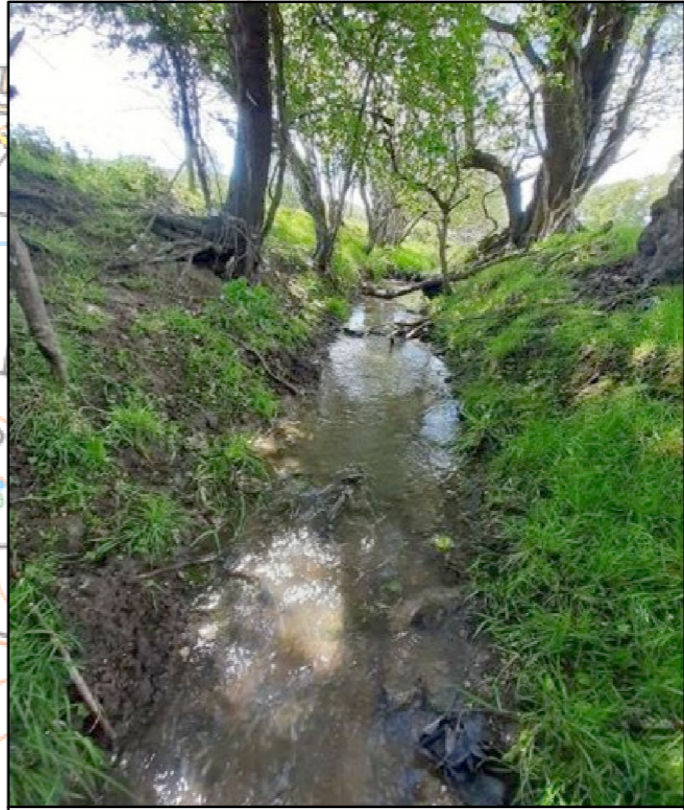
Debris dams Chancton Farm stream

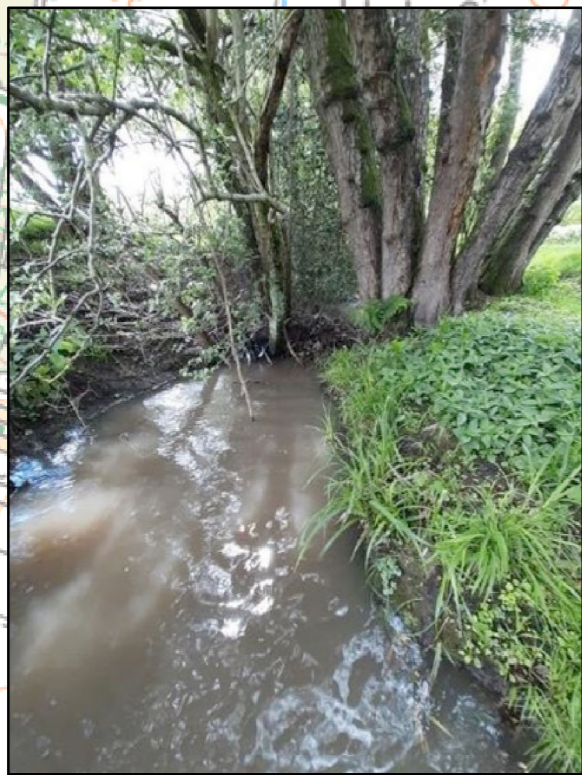
Tree root systems extended into the channel providing fish cover / habitat at site STRX-05

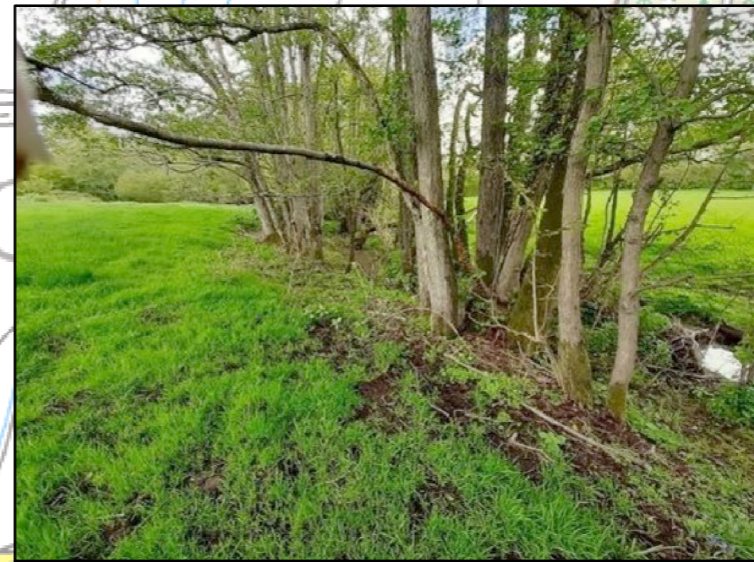
Adjacent grassland and tree-lined banks providing ~70% canopy cover at site STRX-05

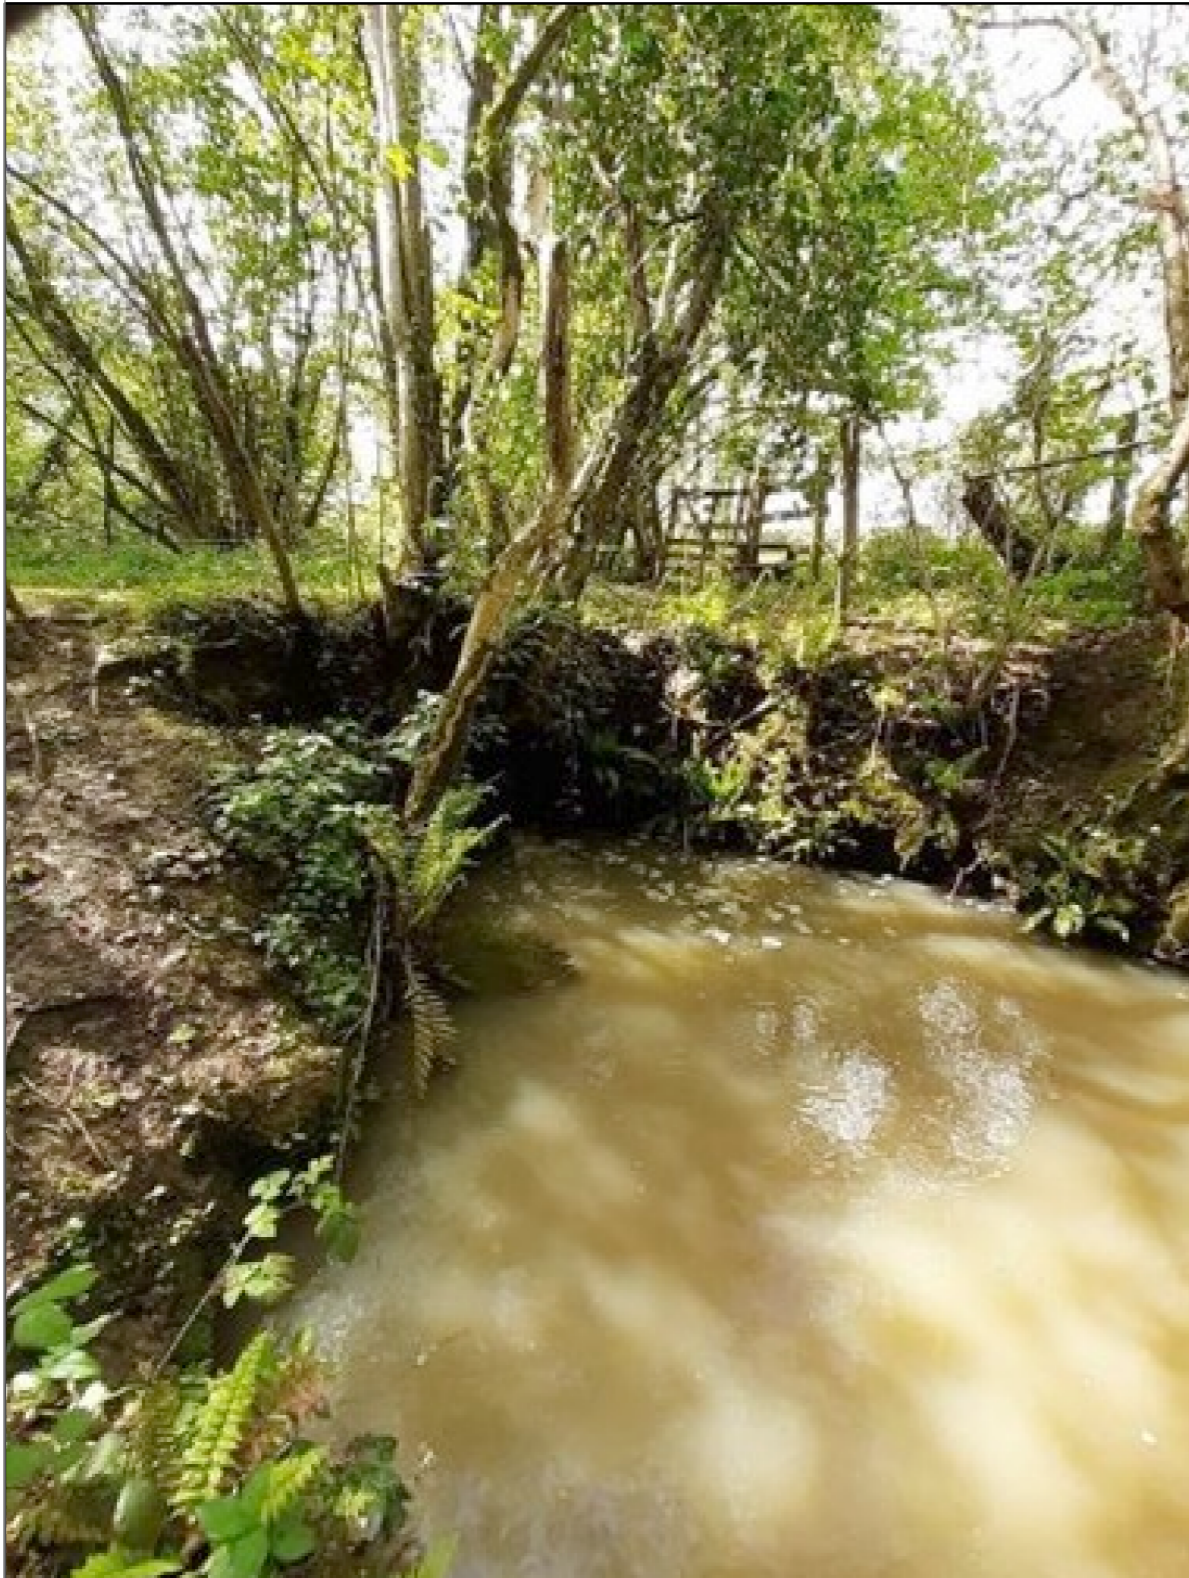
Perched culvert Guessgate Farm stream

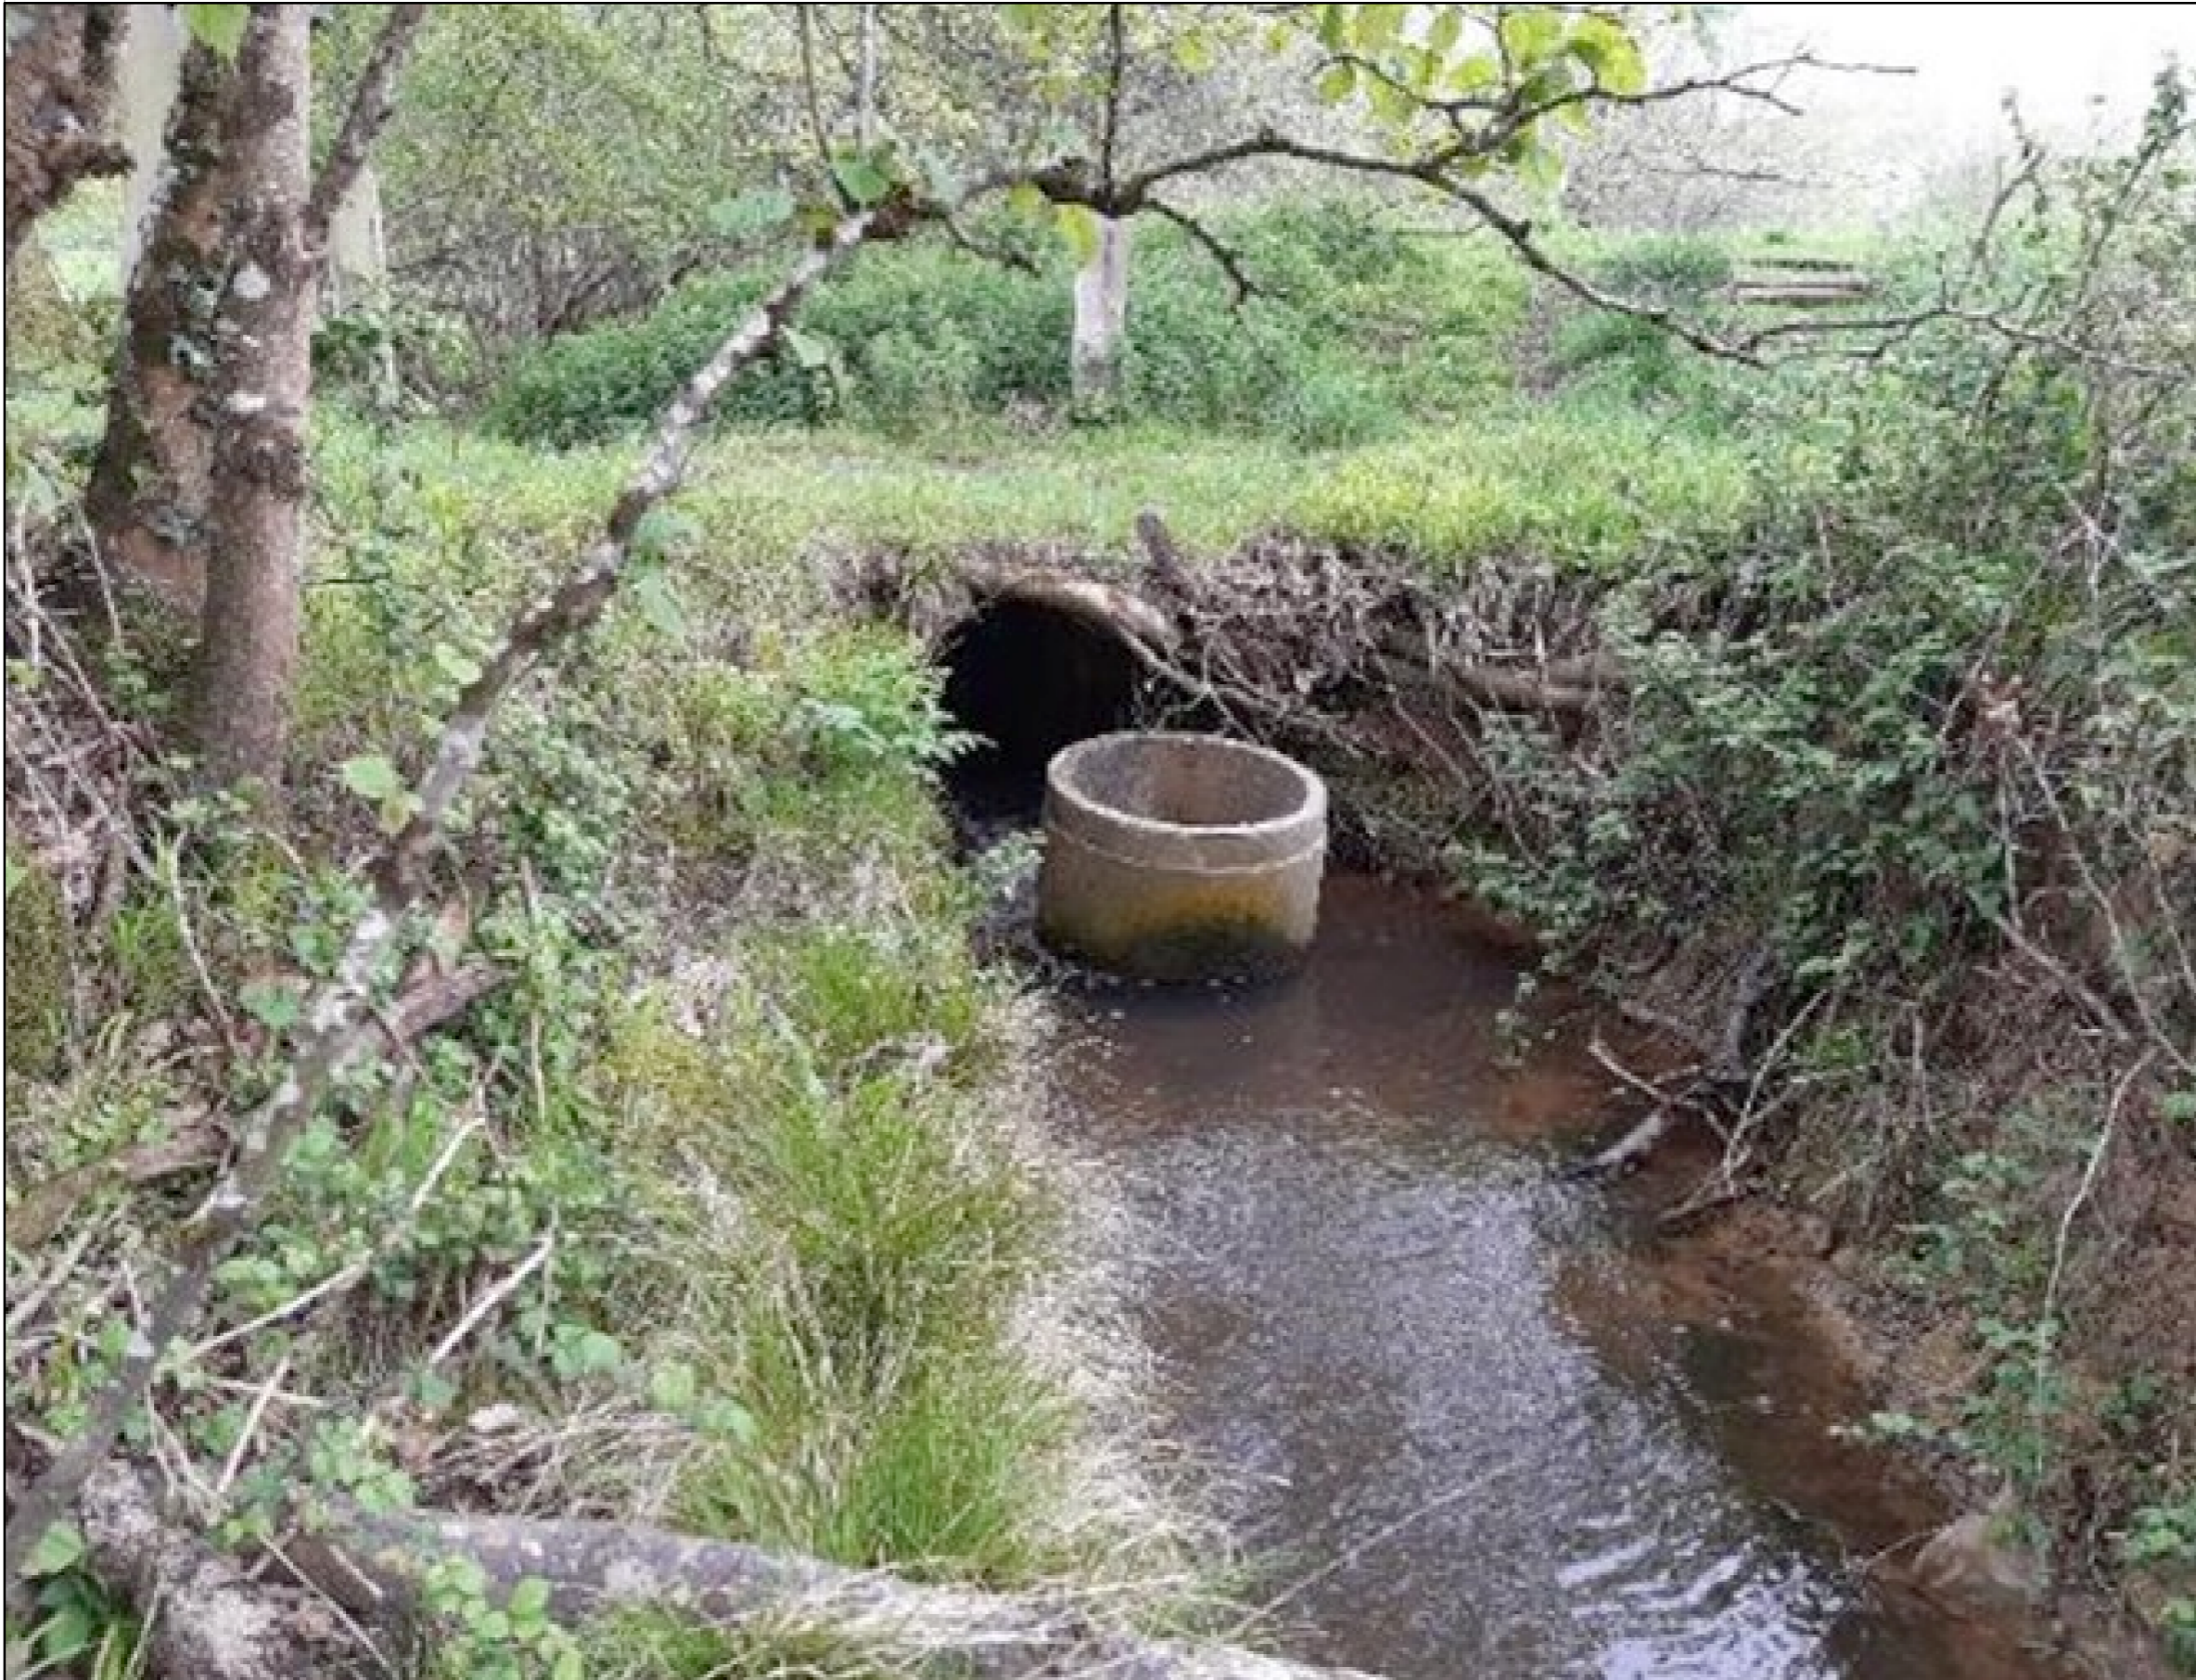
Perched culvert STRX-09

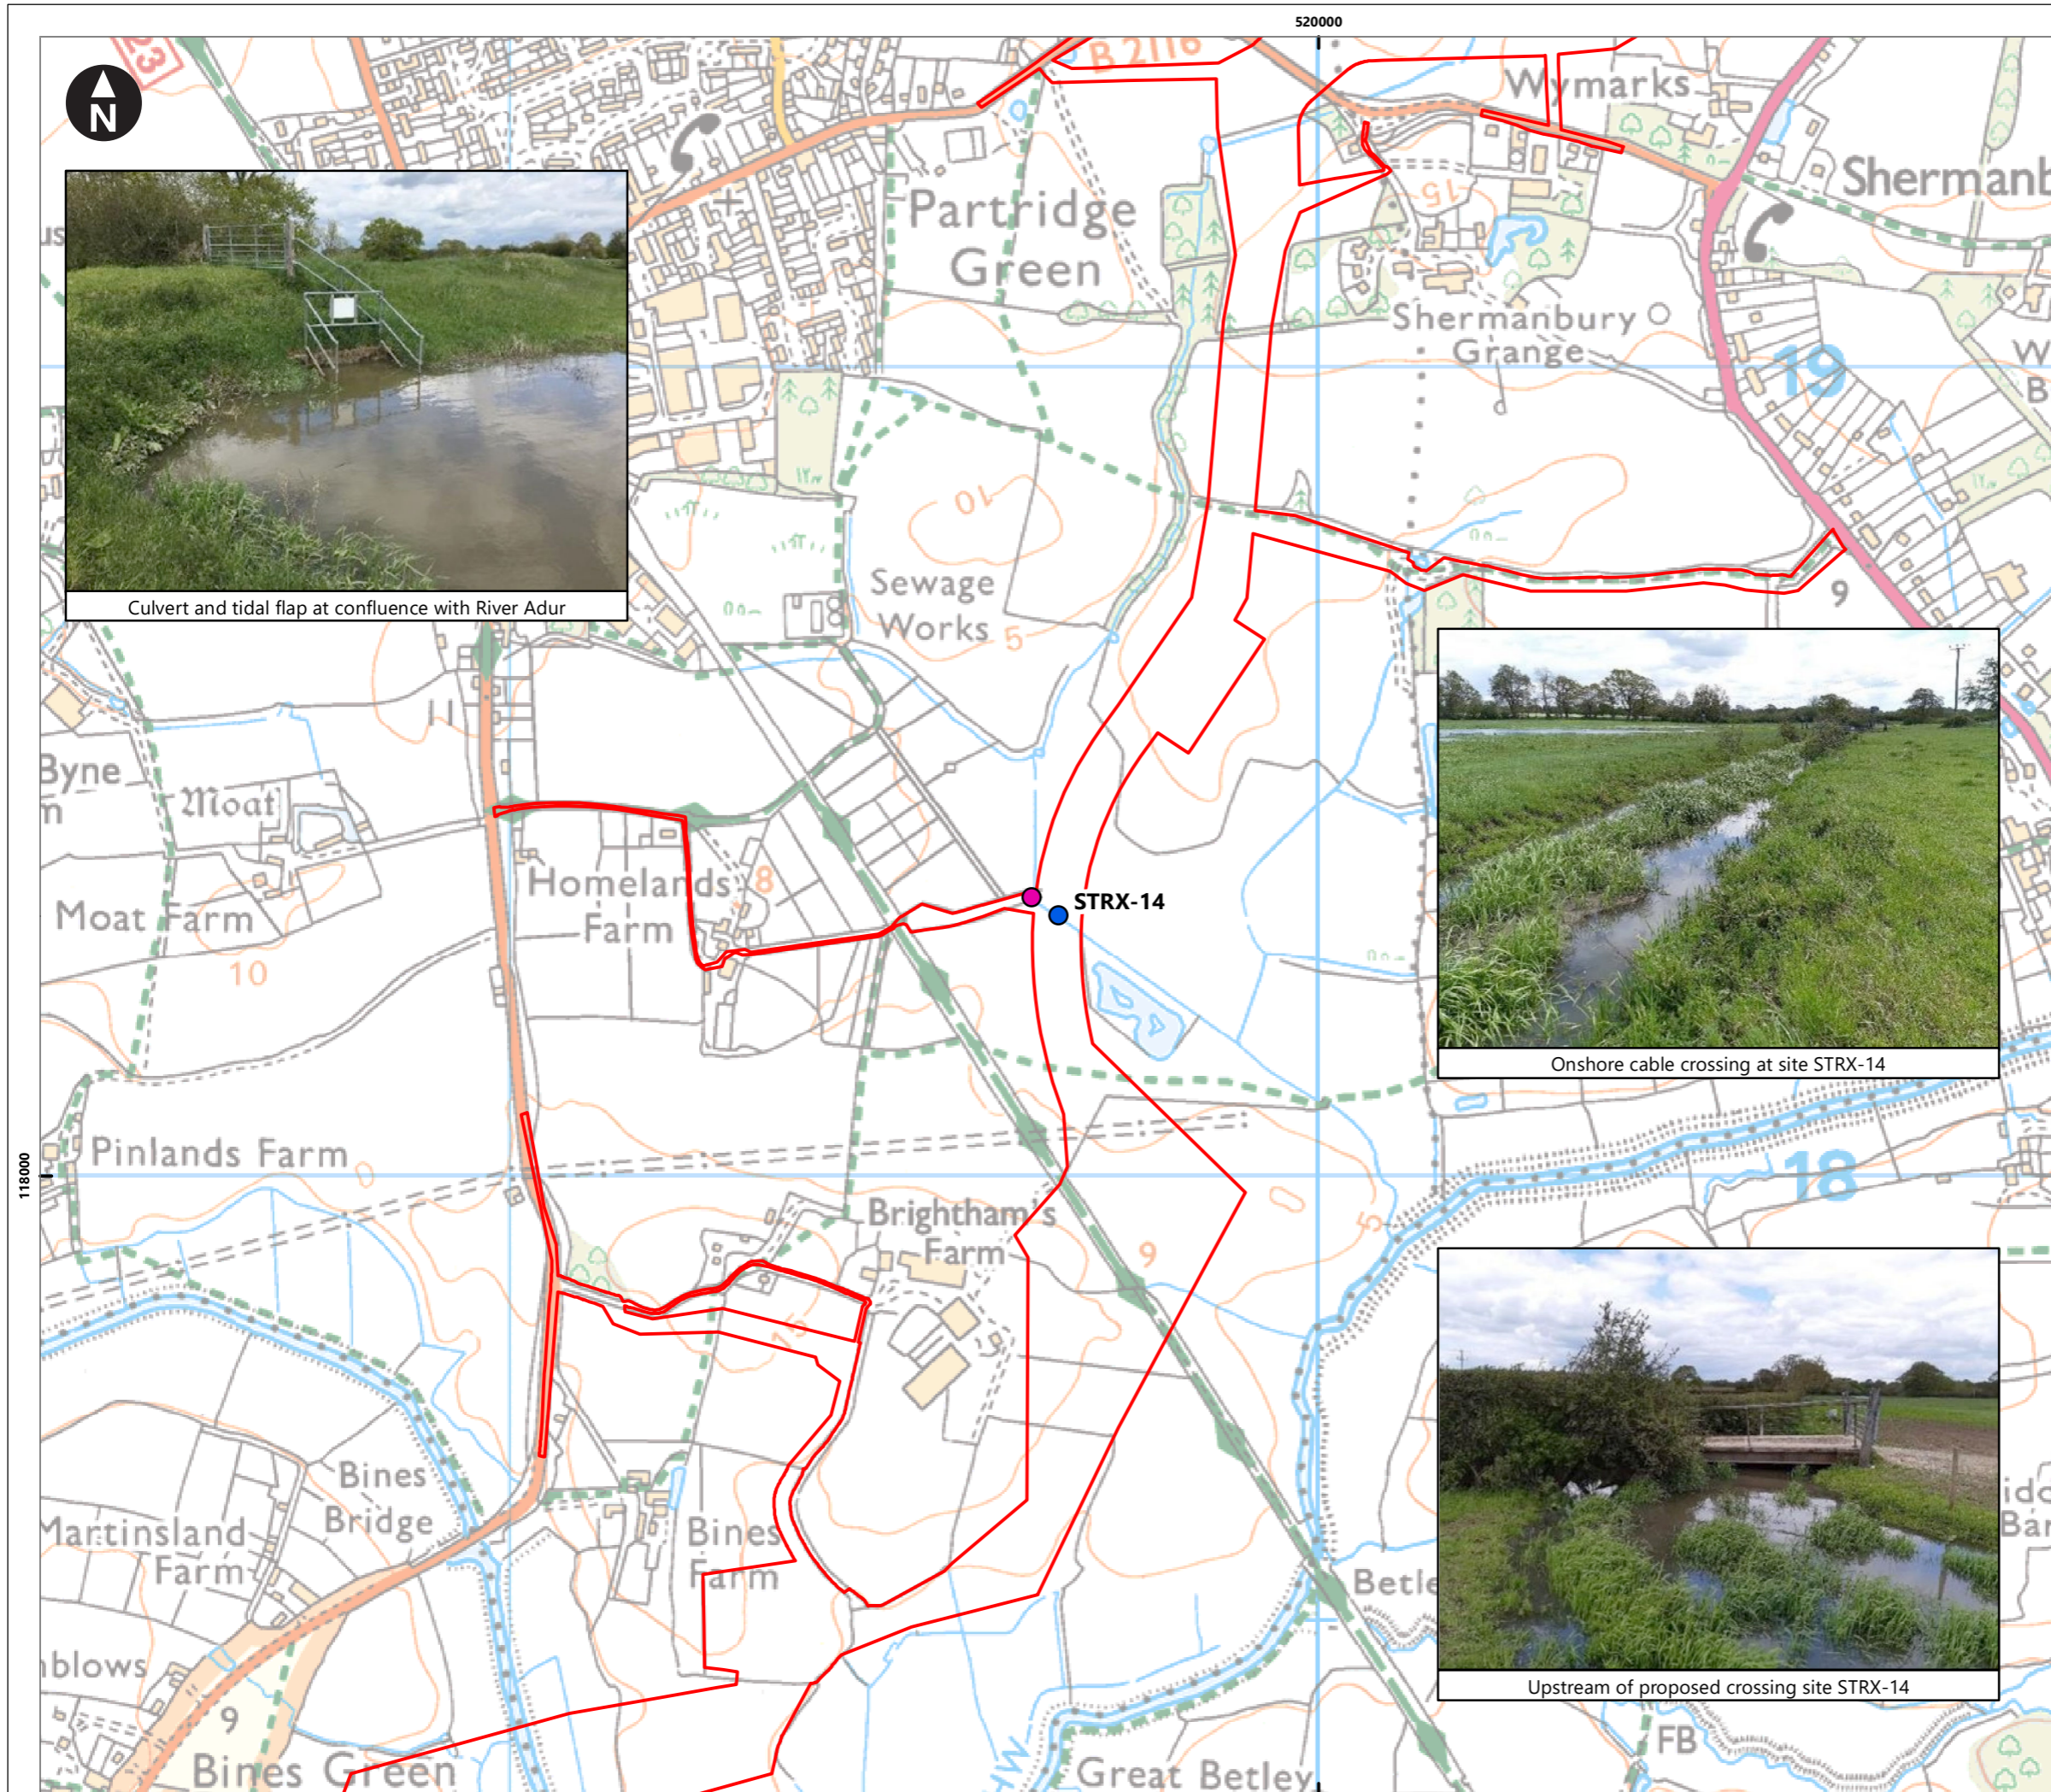
Culvert and tidal flap at confluence with River Adur

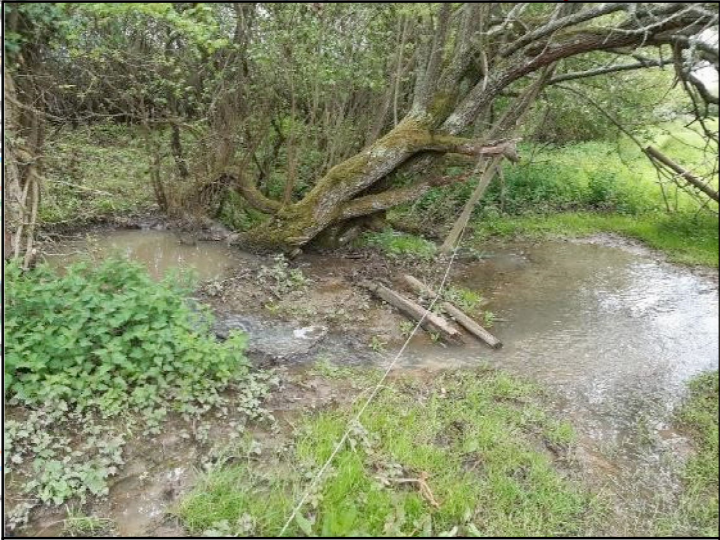
Tree roots obstructing flow upstream of crossing point STRX-19

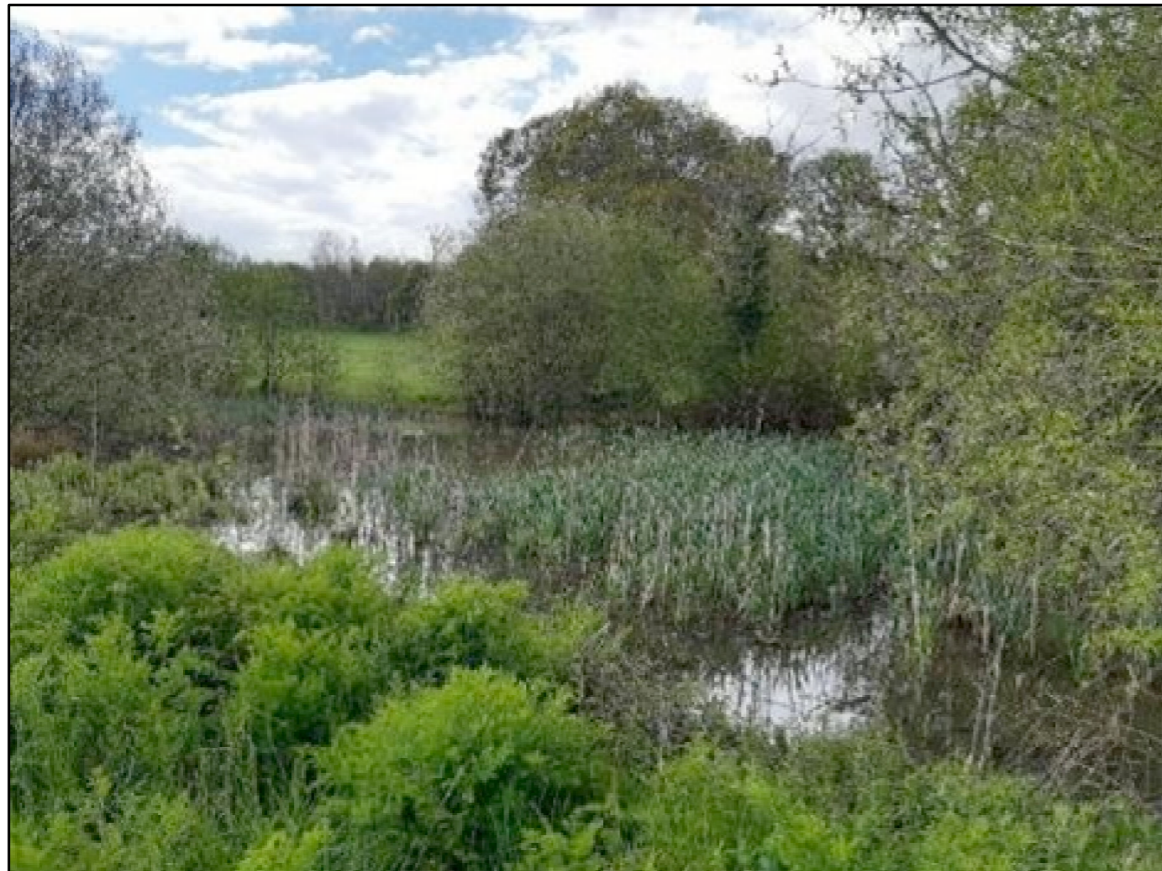
- 4.19.6 There were numerous debris dams along the course of the channel, that would have impeded fish passage during average and low flow conditions. These debris dams resulted in the channel becoming impounded and flows breaking the banks at various points along the channel.

Impounded reach upstream of lake below proposed crossing site STRX-20
