# Rampion 2 Wind Farm

## Environmental Statement

### Volume 4, Appendix 24.1: Phase 1 geo-environmental desk study

Document Reference: 6.4.24.1

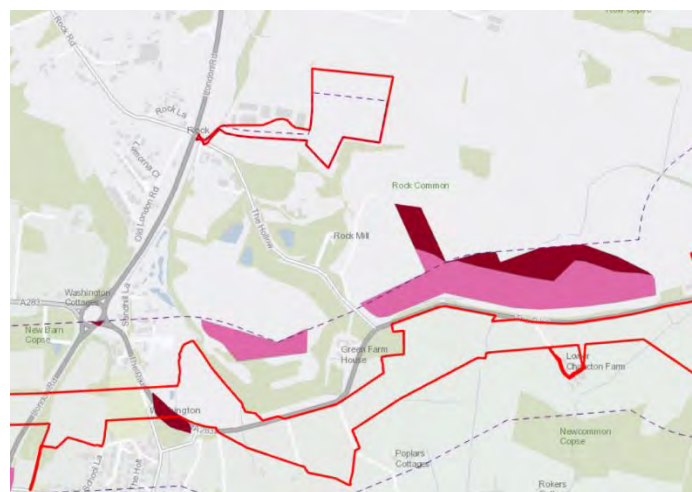
**Graphic 4-4 Worked ground onsite at Washington**

- A small area of made ground is shown onsite at Washington along the route of the A283 road (NGR TQ 122131). Offsite to the north and further east along the onshore cable corridor, there is a larger area of made ground and worked ground. This appears to correspond to various former surface workings including Windmill Sandpit and Rock Common (see **Section 4.2**).

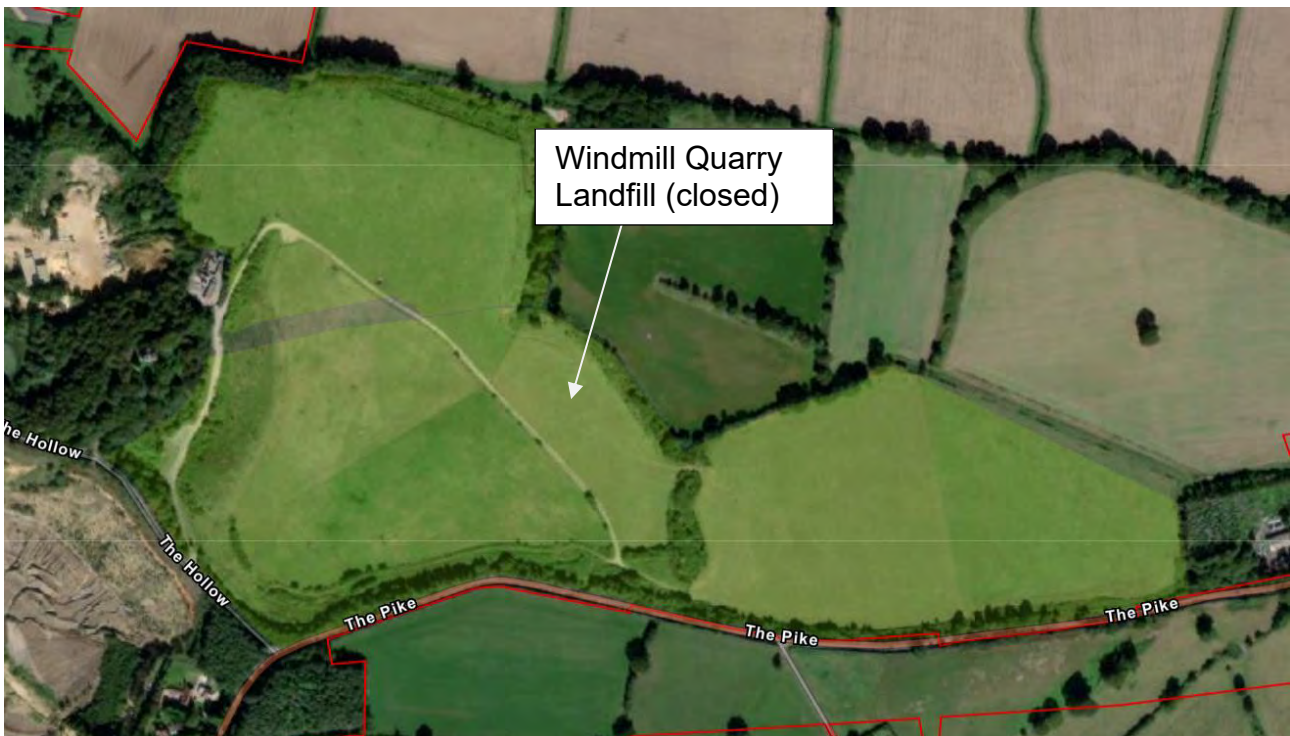
**Graphic 4-46 Aerial view of Windmill Quarry Landfill (restored as fields)**

- 4.8.2 During the October 2021 site visit, it was not possible to gain access onto the restored landfill, however, a visual inspection through the western boundary fence of the landfill area indicated that new trees had been planted across that part of the landfill. Landfill gas/leachate infrastructure was observed to be present however it was not possible to determine if this was active.

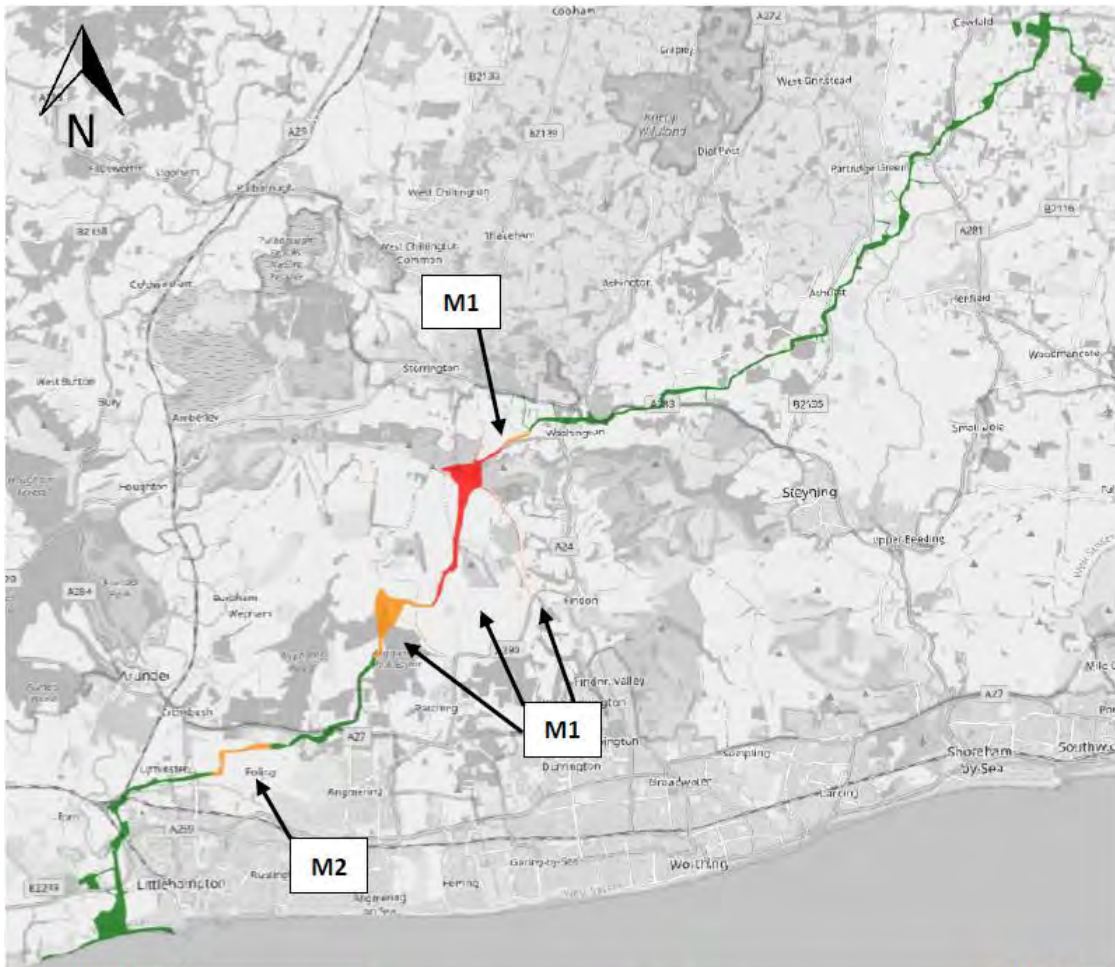
**Graphic 4-47 UXO Hazard Plan**

- 4.13.6 Based on the above information there is considered to be a low risk of encountering UXO across the majority of the Site, however, in the areas of moderate and high risk, UXO risk mitigation will be required by a specialist UXO contractor prior to excavation or trenchless crossing (HDD).

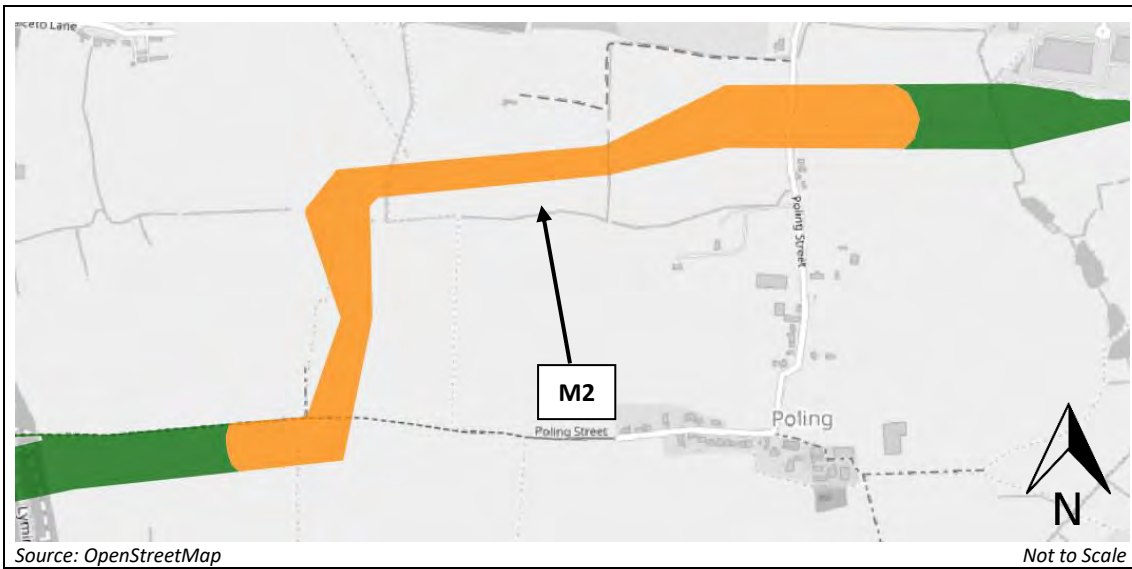
**UXO hazard zone plan of the Site (WWII Bombing)**

It should be noted that whilst ploughing activities may have encountered UXO post-WWII, there is no guarantee that any such items would have been positively identified and appropriately dealt with at the time. There is also the potential for ordnance found post-WWII to have been disposed of in ditches and hedgerows along field boundaries.

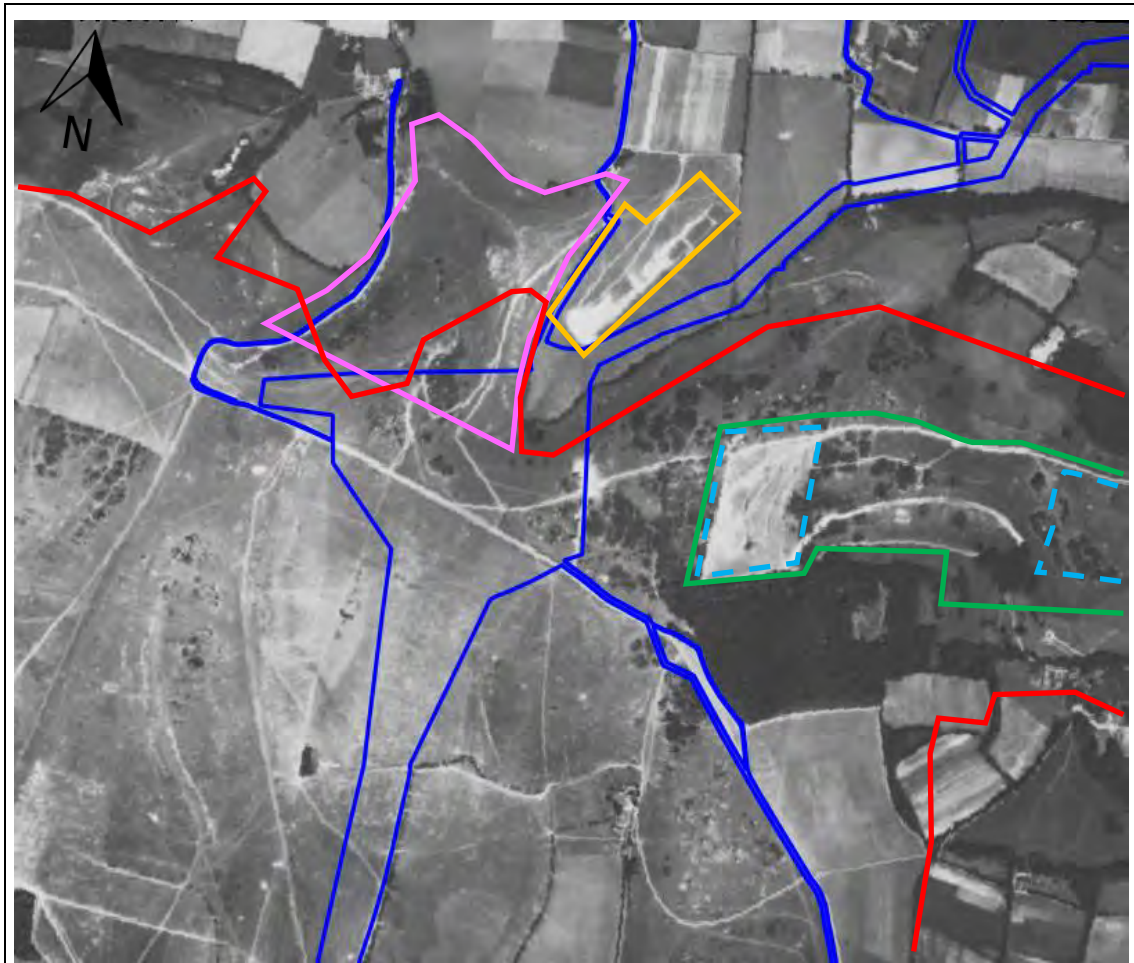
**Plate 3 Aerial photograph of ranges and training areas of Block No. 7, 16<sup>th</sup> August 1943**

Designated ranges and training areas on Block No. 7 are shown on Plate 3, an aerial photograph dated the 16<sup>th</sup> August 1943. Interpreted training features are outlined.

Widespread disturbed ground across the area is indicative of training involving infantry and armoured vehicles.

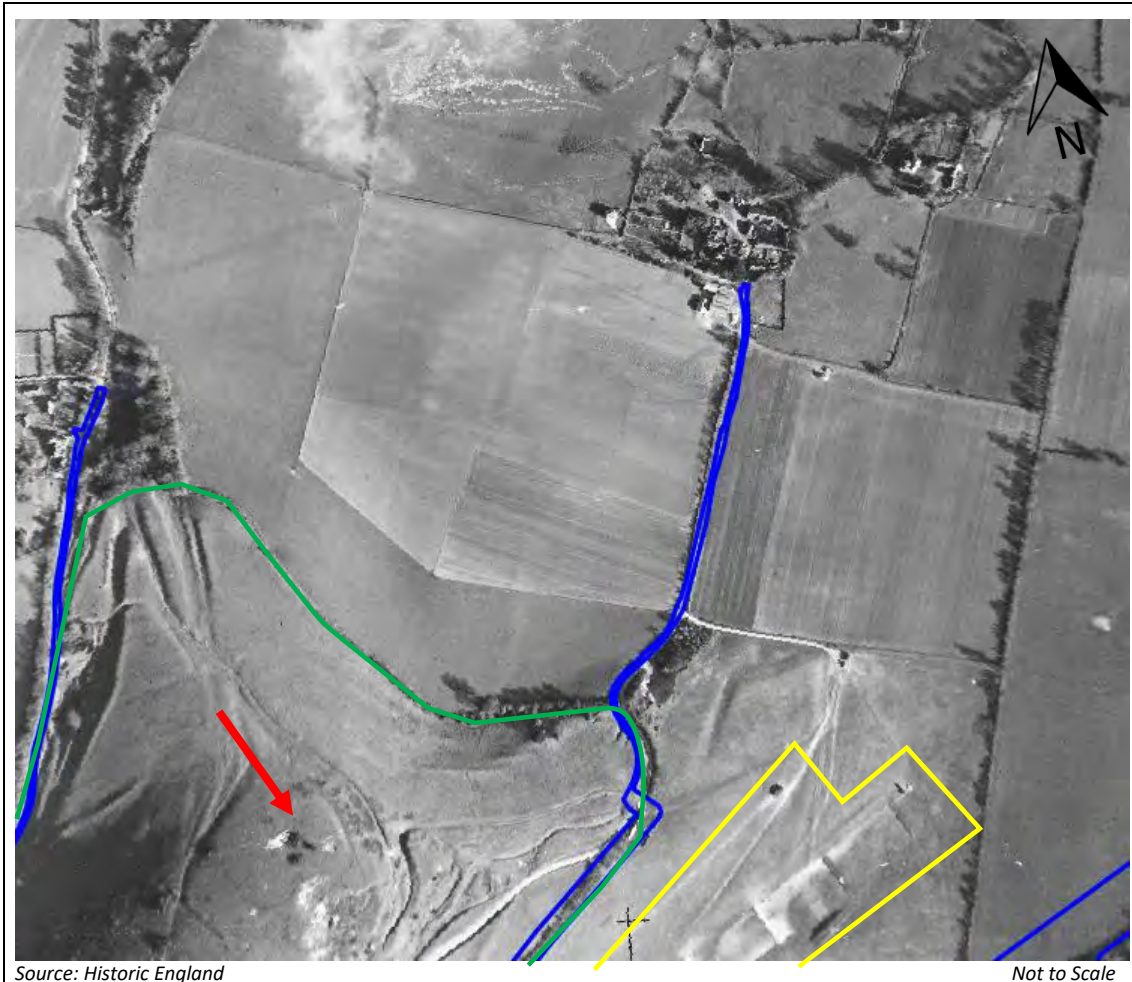
**Plate 7 Aerial photograph of Sullington Hill (north), 3<sup>rd</sup> April 1945**

Plate 7 is an aerial photograph, dated the 3<sup>rd</sup> April 1945, centred on TQ 097127. Cratering and trenches can be seen on Sullington Hill.

Sullington SA range can also be seen encroaching on the Site.

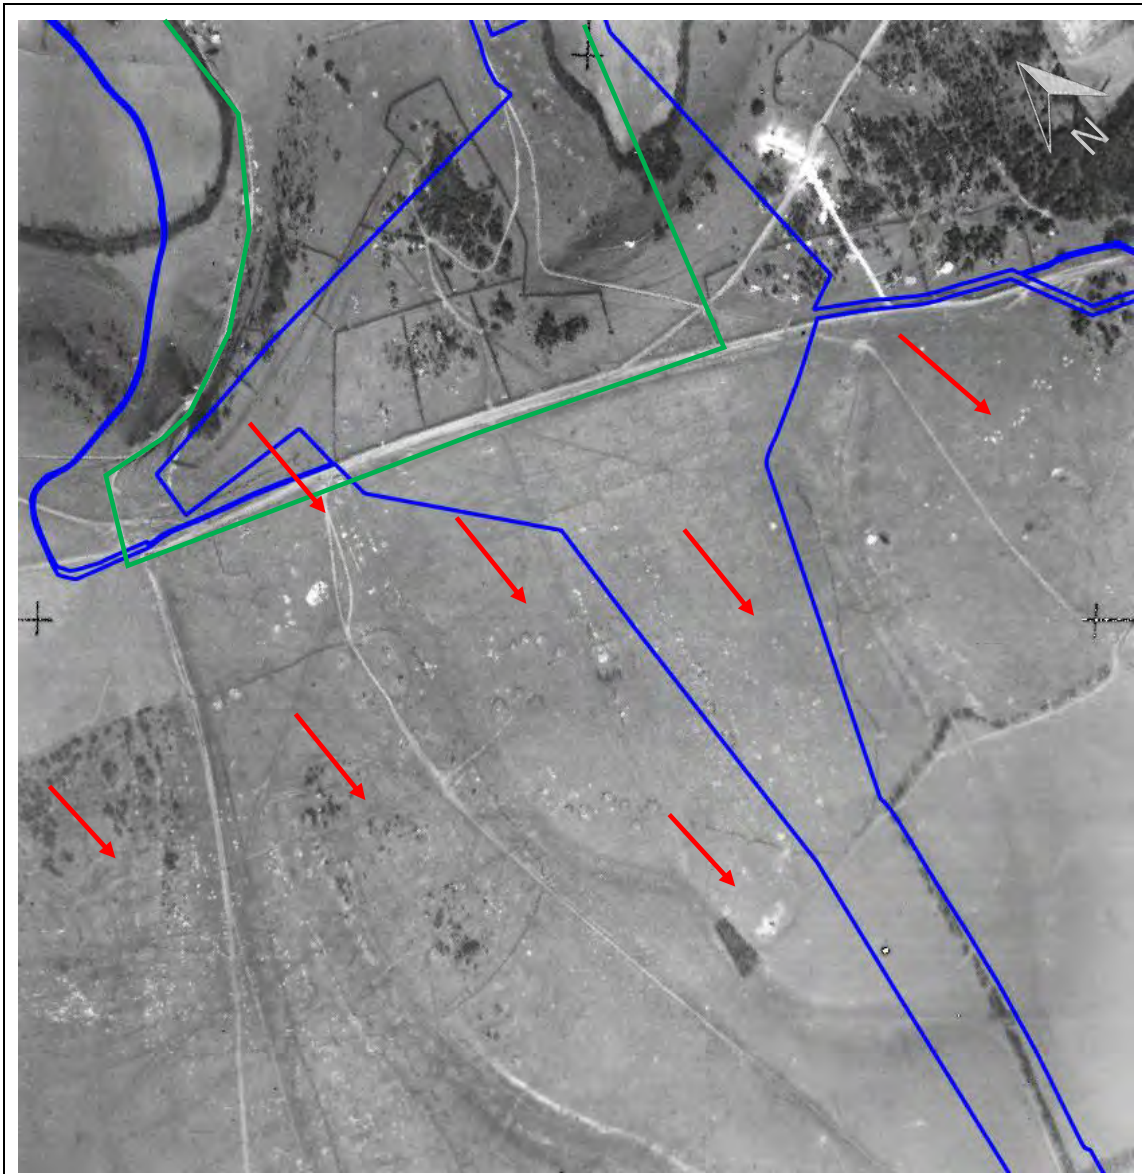
**Plate 8 Aerial photograph of Sullington Hill (south), 3<sup>rd</sup> March 1945**

Plate 8 is an aerial photograph, dated the 3<sup>rd</sup> March 1945, centred on TQ 093113.

It shows significant cratering and disturbed ground on and in the immediate vicinity of the Site indicative of extensive live-fire training.

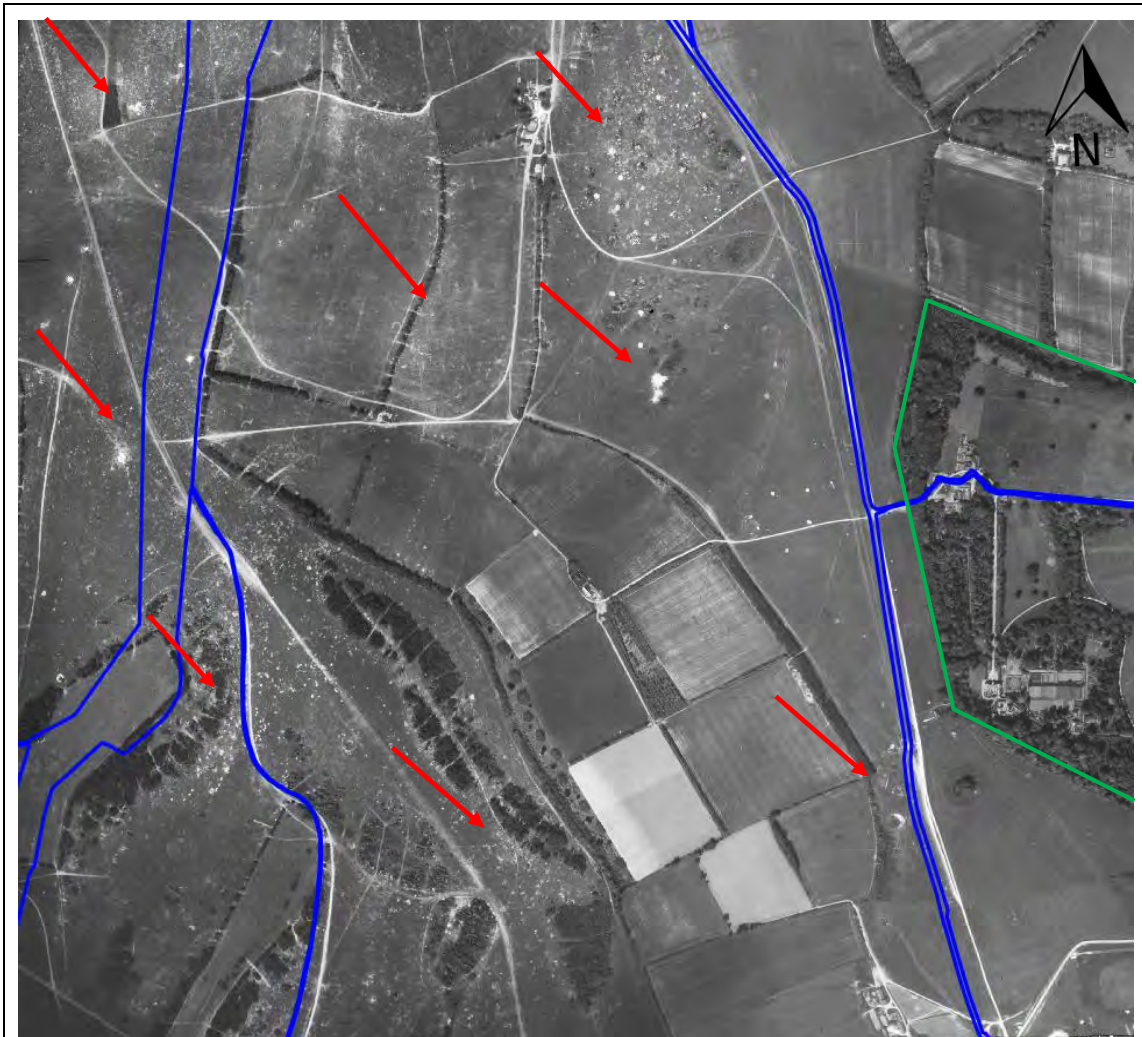
**Plate 9 Aerial photograph of Blackpatch Hill, 17<sup>th</sup> May 1945**

Plate 9 is an aerial photograph, dated the 17<sup>th</sup> May 1945, centred on TQ 102099.

The Muntham Estate camp (see Section 3.7) has also been identified.

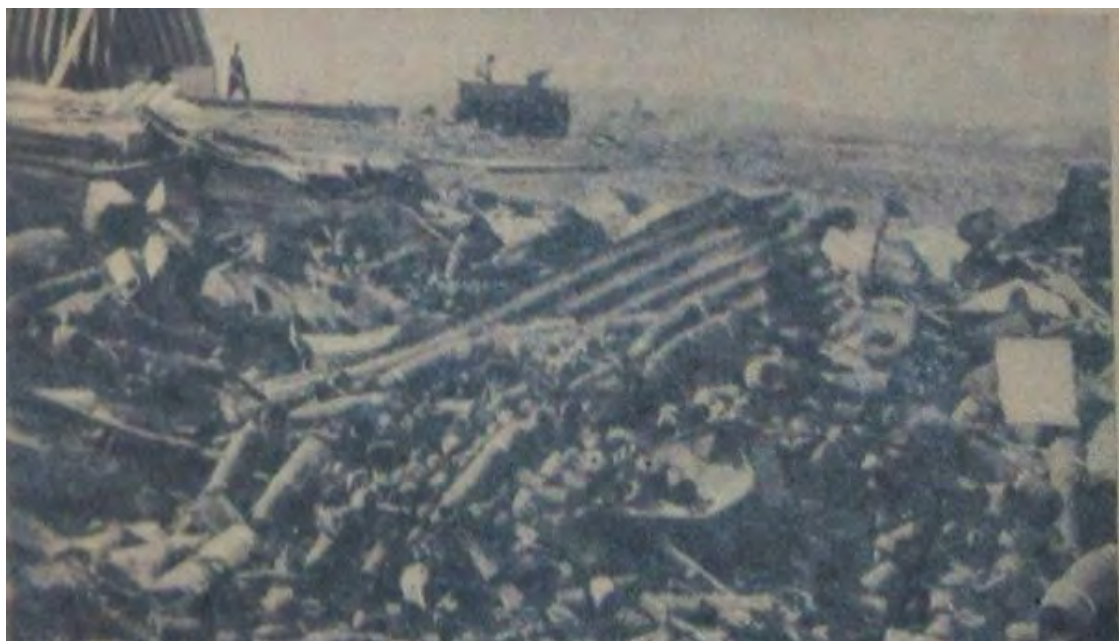
**Plate 11 Photograph of ammunition ploughed up on the South Downs, 6<sup>th</sup> September 1946**

Plate 11 is a photograph featured in an issue of *The Farmers Weekly*, dated the 6<sup>th</sup> September 1946. This shows ammunition brought to the surface during ploughing by the War Agricultural Executive Committee (WAEC).

By November 1946, Block No. 7 was considered to have been cleared of all 'visible' UXO.

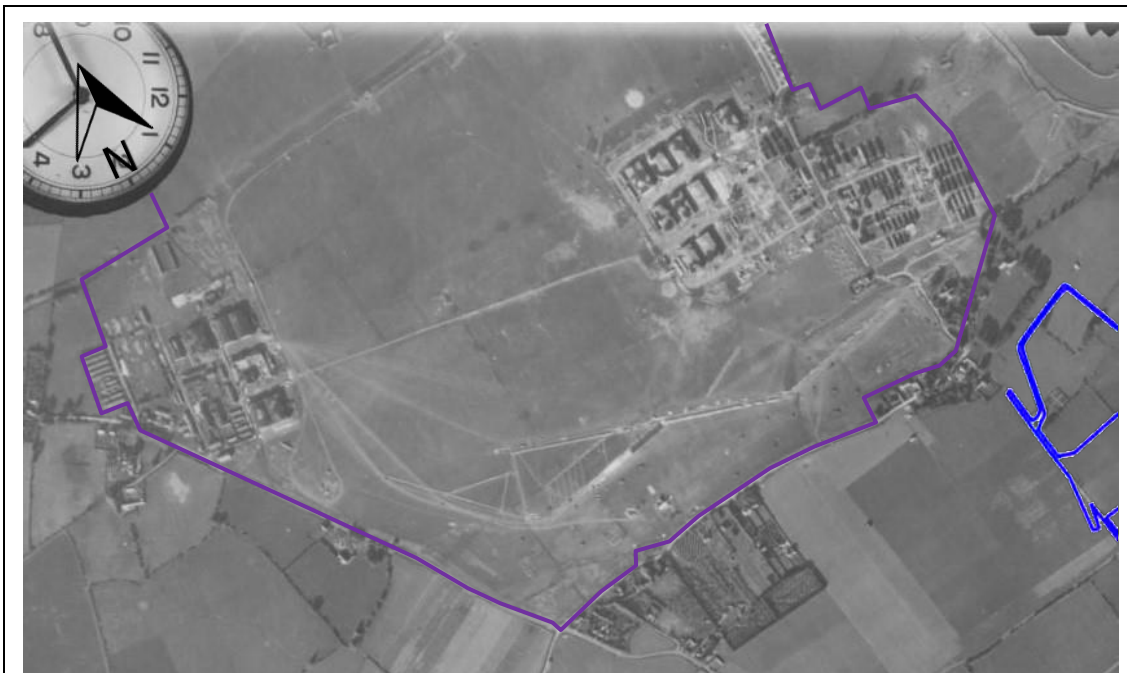
**Plate 13 Aerial photograph of HMS Peregrine (RAF Ford), 7<sup>th</sup> October 1940**

Plate 13 is an aerial photograph dated the 7<sup>th</sup> October 1940. It shows the early layout of RAF/RNAS Ford.

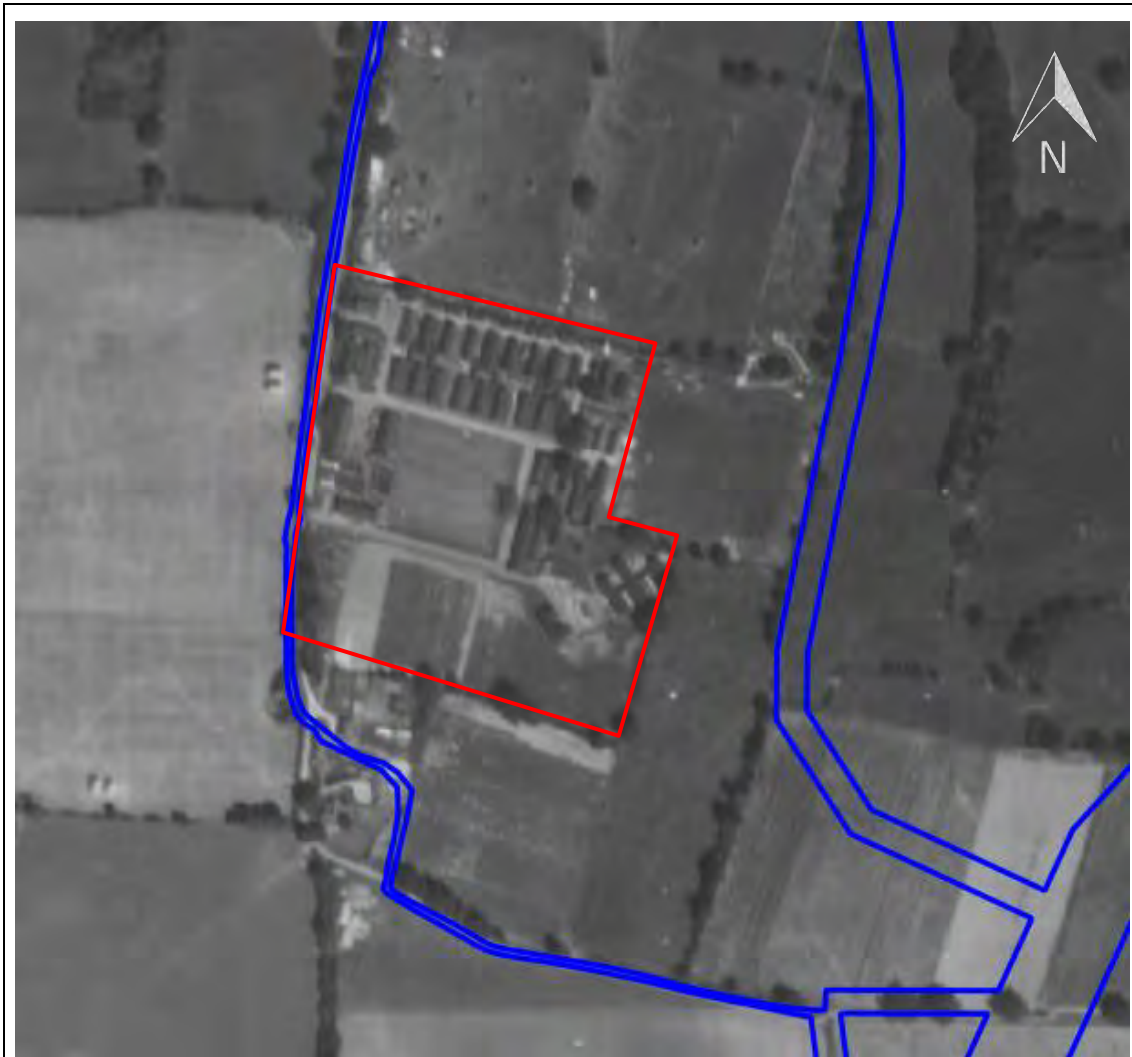
**Plate 14 Aerial photograph showing Barns Farm Camp, 16<sup>th</sup> August 1943**

Plate 14 is an aerial photograph dated the 16<sup>th</sup> August 1943 showing Barns Farm Camp encroaching on the Site.

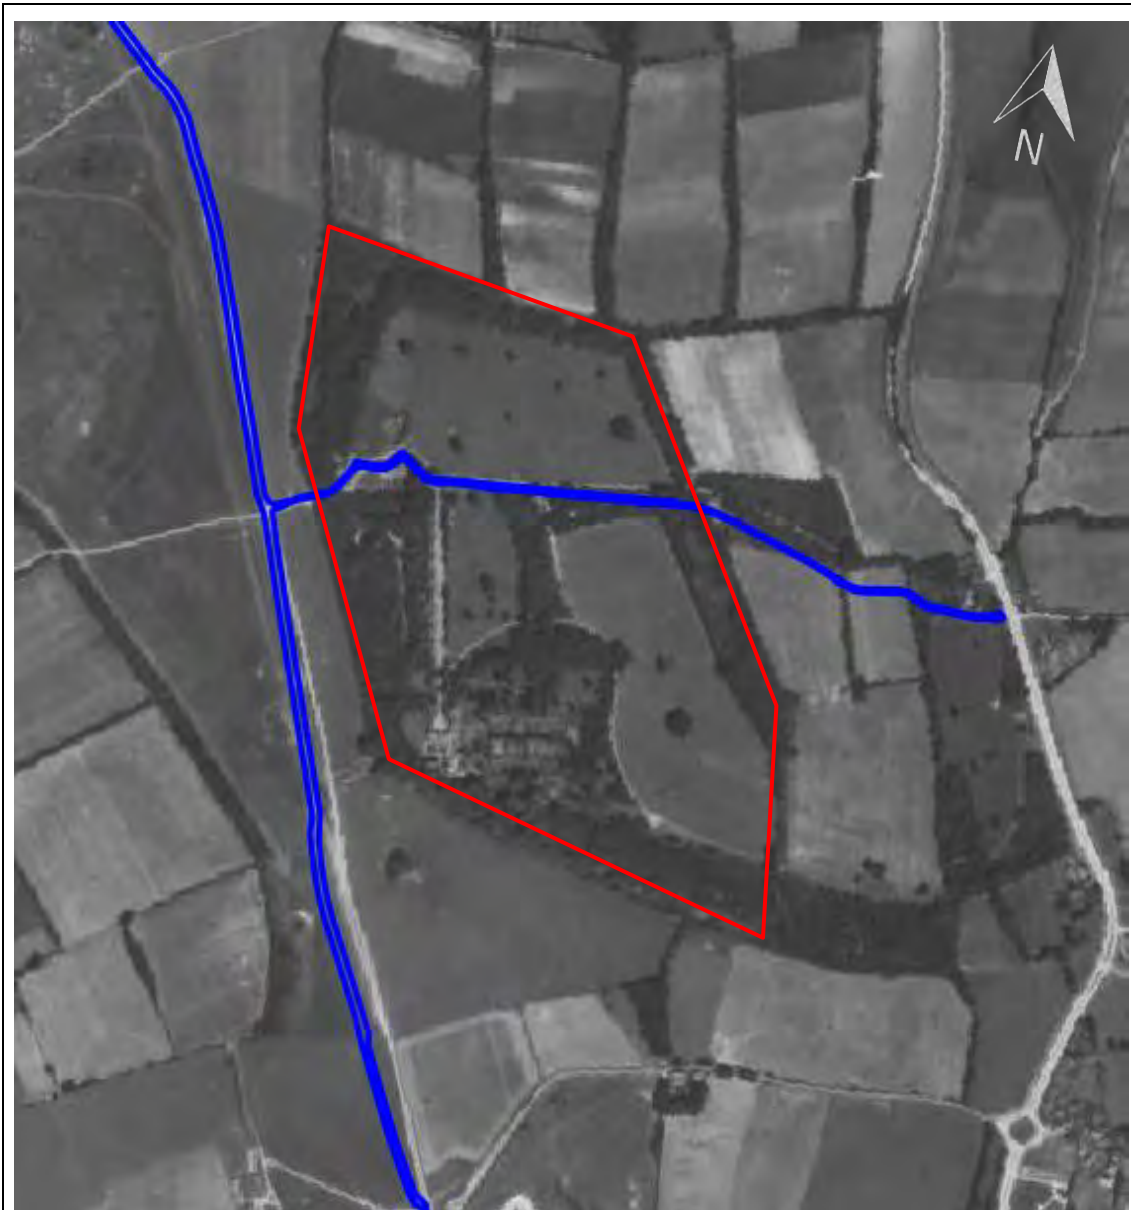
**Plate 15 Aerial photograph showing Muntham Estate Camp, 16<sup>th</sup> August 1943**

Plate 15 is an aerial photograph dated the 16<sup>th</sup> August 1943 showing Muntham Estate camp encroaching on the Site.

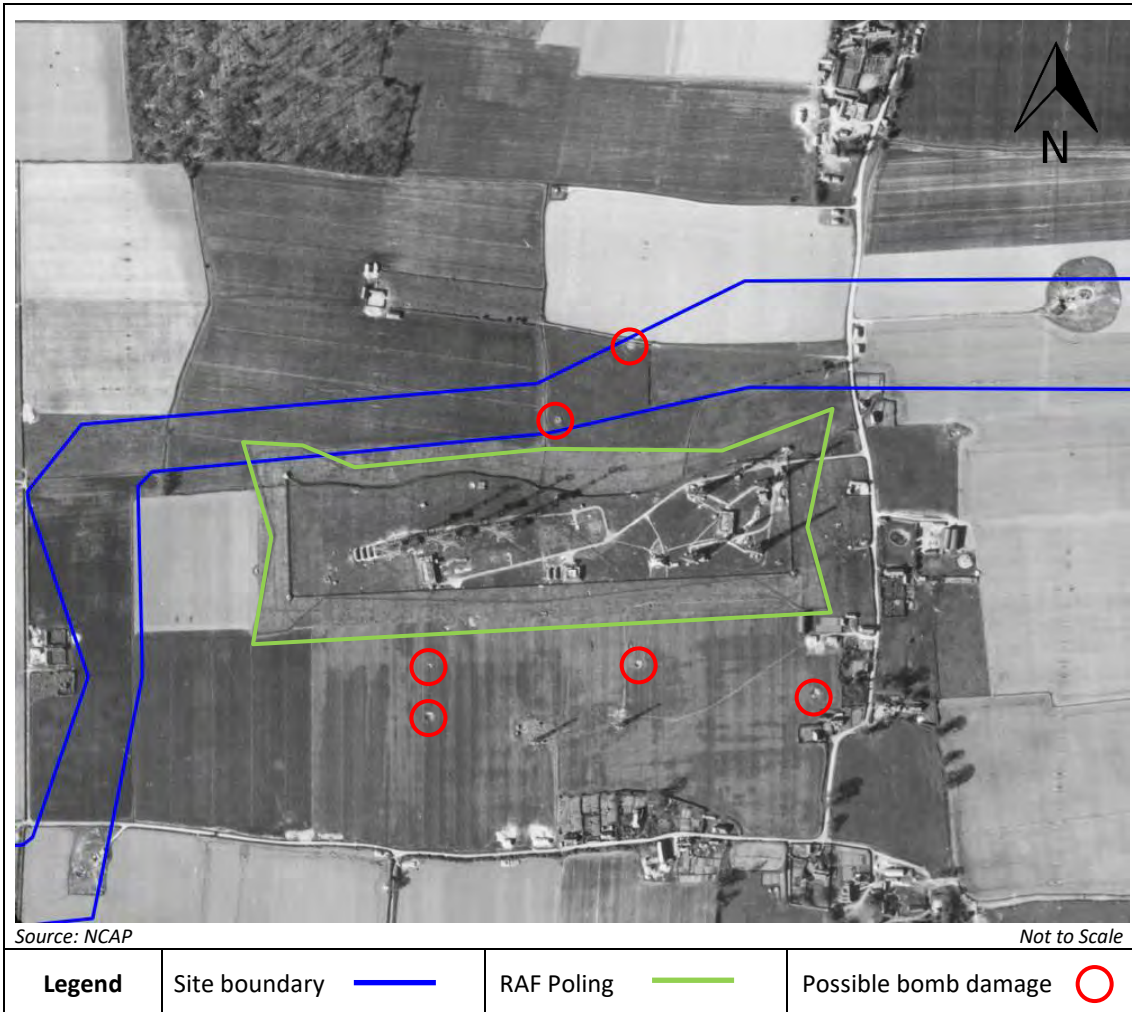
**Plate 16 Aerial photograph showing RAF Poling, 22<sup>nd</sup> April 1944**

Plate 16 is an aerial photograph dated the 22<sup>nd</sup> April 1944 showing RAF Poling encroaching on the Site.

Some potential bomb damage and cratering has been identified in the vicinity of RAF Poling (see Section 4.2).

Several craters have been identified on and in close proximity to the Site in the vicinity of RAF Poling (see Plates 16 and 18).

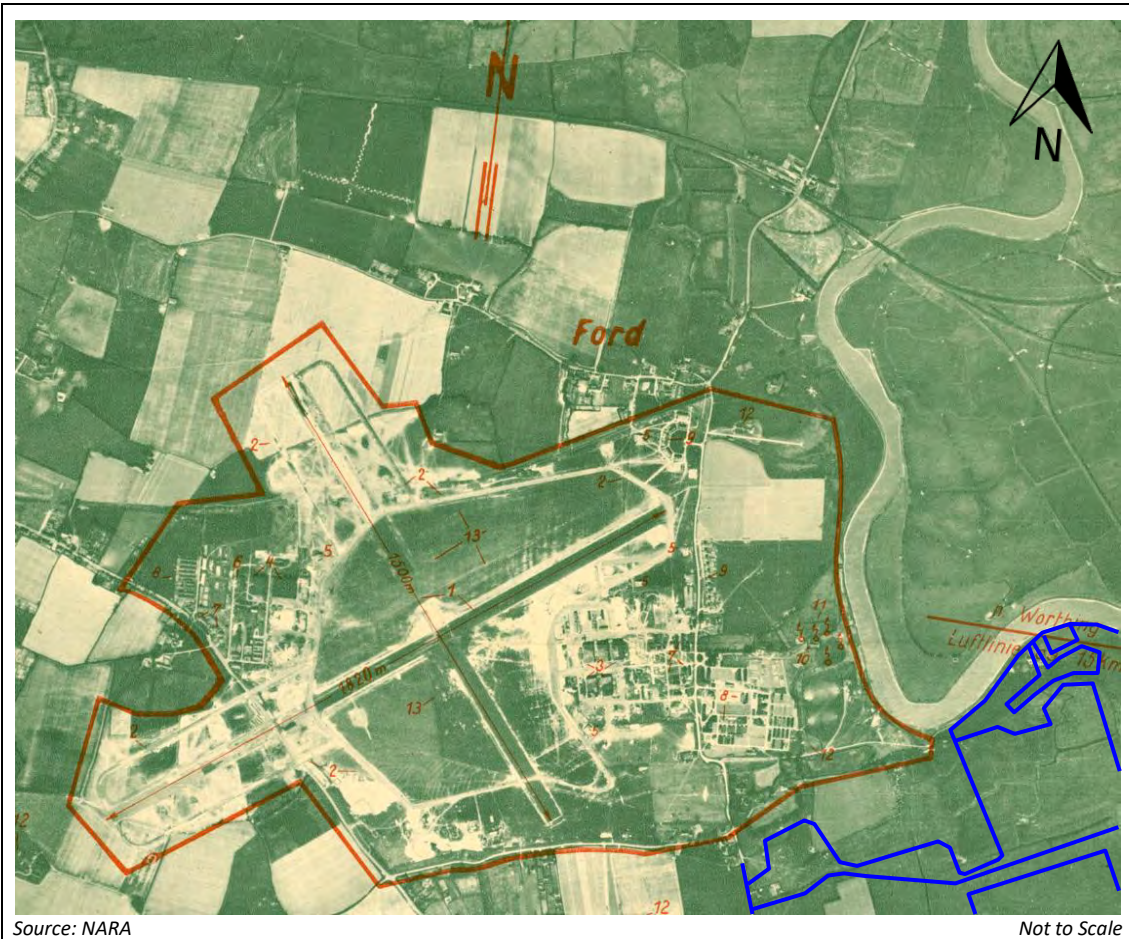
**Plate 17 Luftwaffe target photograph of RAF Ford, 14<sup>th</sup> April 1942**

Plate 17 is a Luftwaffe target photograph of RAF Ford (target GB10 83) dated the 14<sup>th</sup> April 1942. This shows the enlarged airfield with the runways highlighted (Target A).

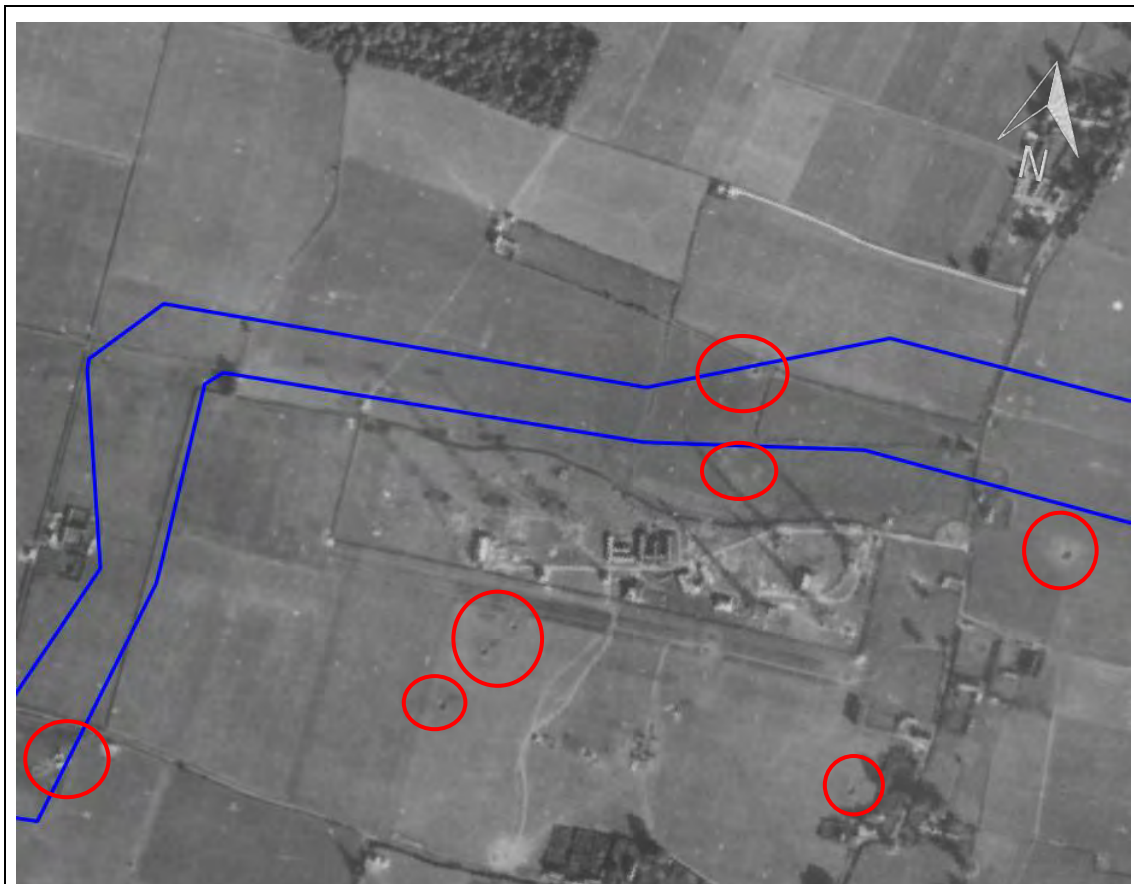
**Plate 18 Aerial photograph, 23<sup>rd</sup> September 1940**

Plate 18 is an aerial photograph dated the 23<sup>rd</sup> September 1940. Significant bomb has been identified on the Site, with several craters on and adjacent to parts of the Site near RAF Poling, likely as a result of this heavy raid.

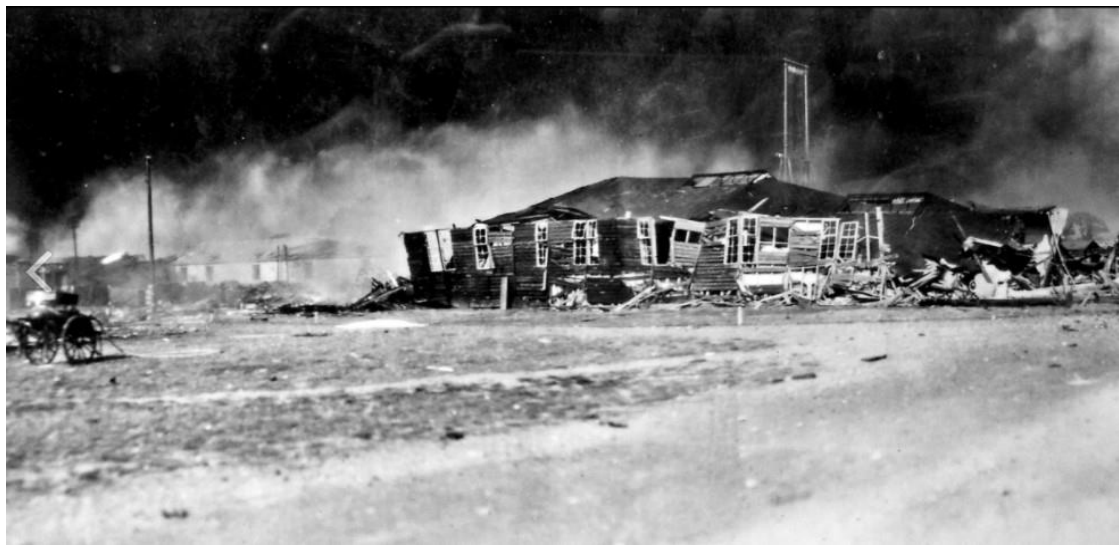
**Plate 19 Photograph of HMS Peregrine after the air raid of the 18<sup>th</sup> August 1940**

Considerable damage was caused to all the facilities and the airfield was effectively destroyed. Plate 19 illustrates some of the damage caused to the airfield property.

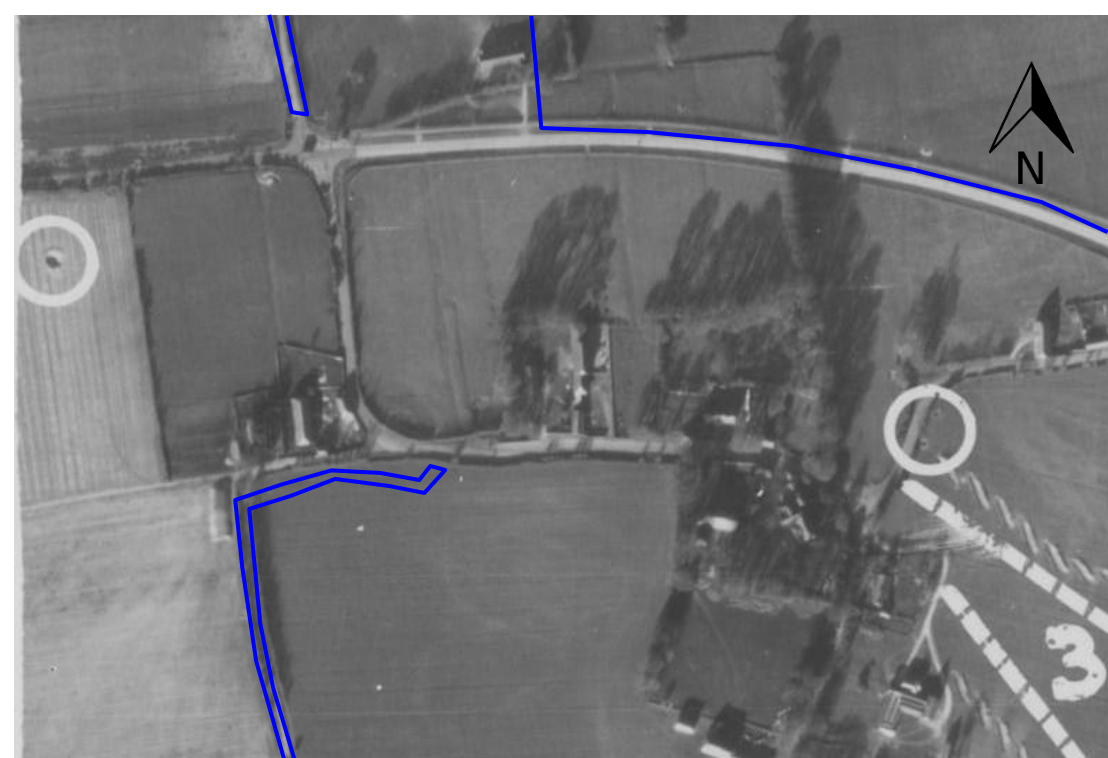
**Plate 20 Luftwaffe reconnaissance photograph of RAF Ford, 10<sup>th</sup> January 1941**

Luftwaffe reconnaissance photography dated the 10<sup>th</sup> January 1941 identifies several craters within 0.2km of the Site near RAF Ford, likely as a result of this heavy raid.

Plate 20 shows 3No. craters within approximately 0.2km south and southwest of the Site, indicated by the white circle. No cratering has been identified on the Site.

Several craters have been identified in close proximity to the Site in the vicinity of RAF Ford (see Plates 20 and 21).

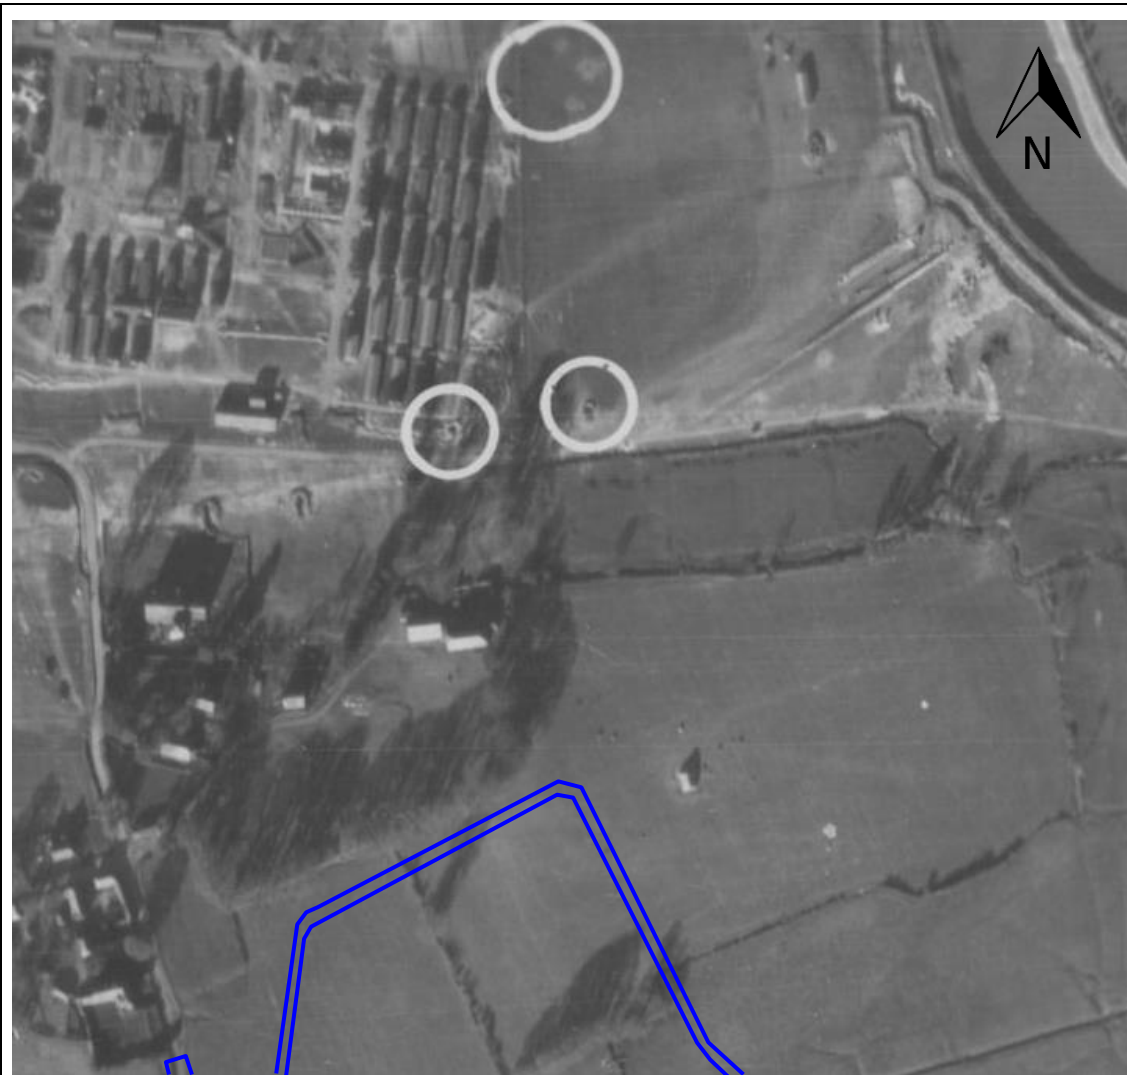
**Plate 21 Luftwaffe reconnaissance photograph of RAF Ford, 10<sup>th</sup> January 1941**

Plate 21 shows several craters approximately 0.2km and 0.4km north of the Site, identified by the white circles. No cratering has been identified on the Site.

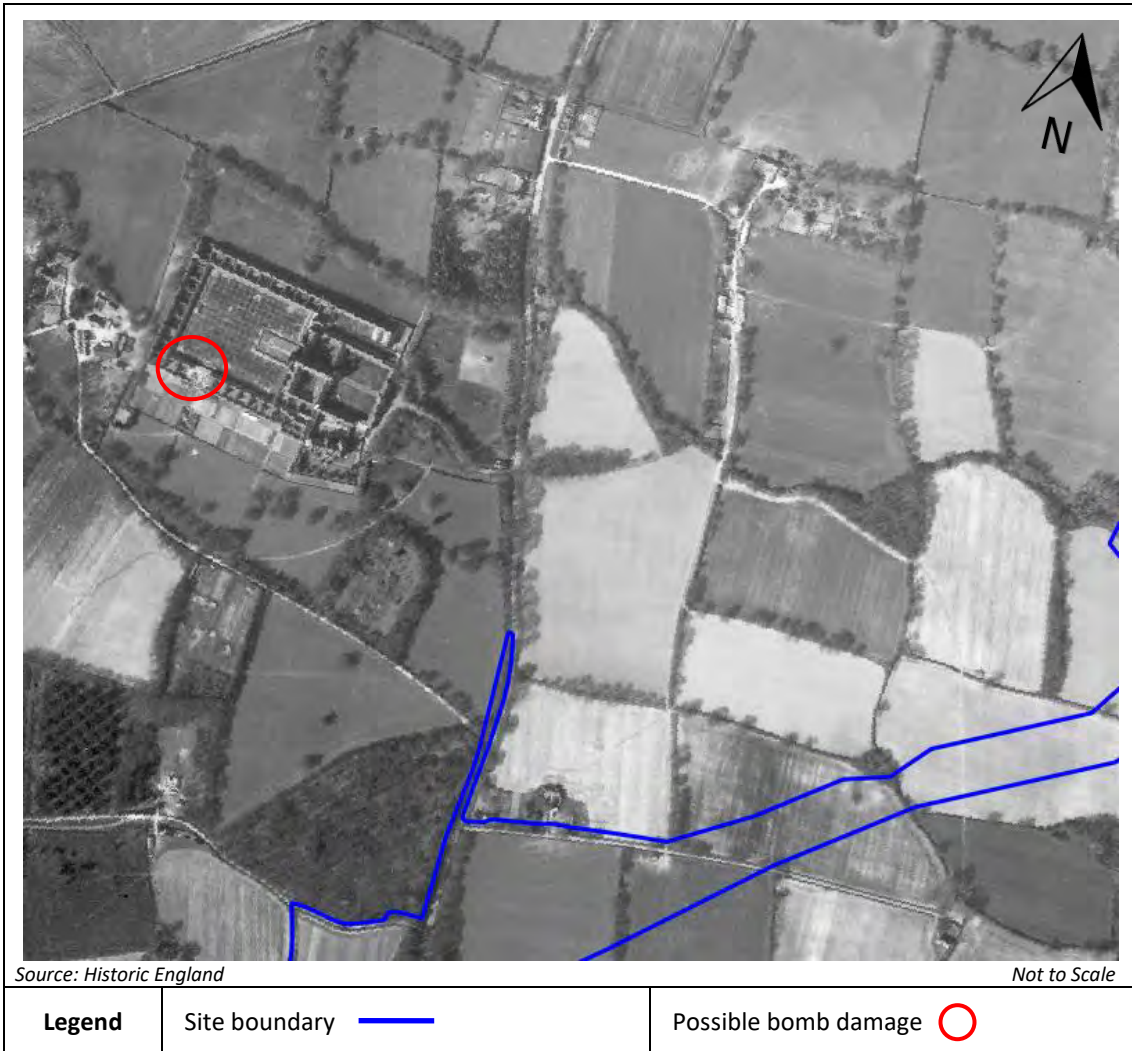
**Plate 22 Aerial photograph of Partridge Green, 16<sup>th</sup> August 1946**

Plate 22 is an aerial photograph, dated the 16<sup>th</sup> August 1946, showing the Site at Partridge Green. No damage or cratering has been identified on the Site.

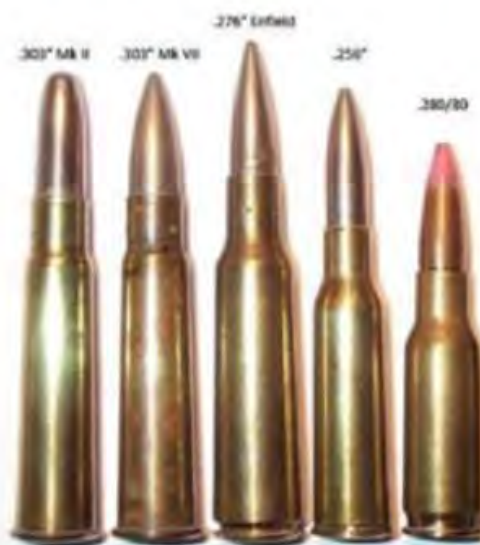
**Category** Small Arms Ammunition  
**Type** Various

**Description** Small Arms Ammunition (SAA) is one of the more recognisable categories of ordnance which is primarily designed for anti-personnel use. SAA include items such as bullets, generally up to a calibre (diameter) of 20mm.

Generally small arms ordnance has a relatively low risk as UXO, although the larger calibre categories may have the same detonation risk as larger high explosive ordnance.

SAA is often associated with discarded ammunition boxes around firing practice ranges and training areas and is often found scattered across former military airfields as a result of aircraft crashes and localised disposal

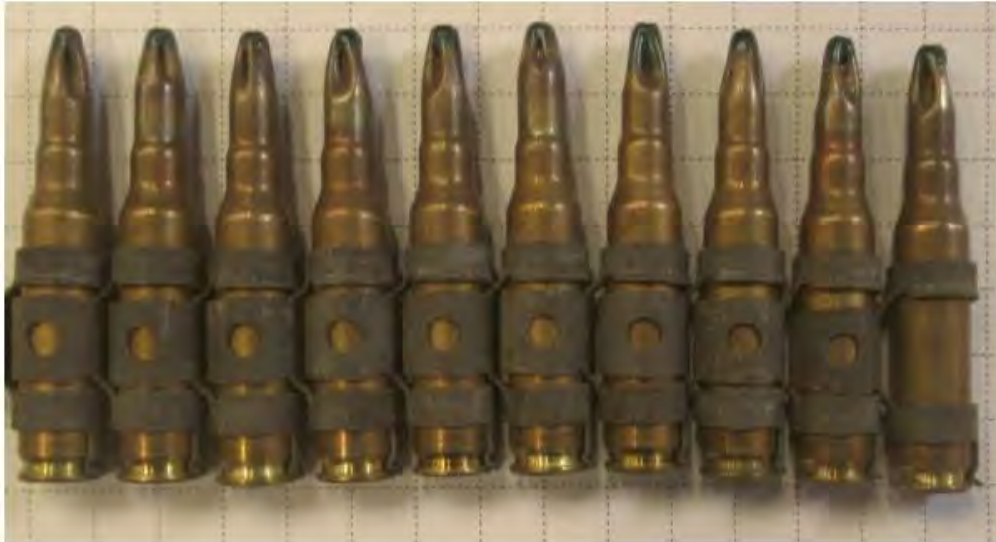
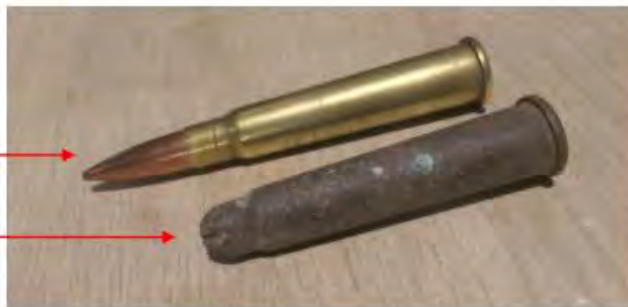
**Category** Small Arms Ammunition (Blanks)  
**Type** Various

**Description** Small Arms Ammunition (SAA) is one of the more recognisable categories of ordnance which is primarily designed for anti-personnel use. SAA include items such as bullets, generally up to a calibre (diameter) of 20mm.

Blank ammunition differs from standard SAA in that it has no projectile component. Instead, the tip of the cartridge generally comprises crimped metal or a paper disc intend to be blown out when fired.

**Live Round  
(Projectile)**

**Blank Round  
(No Projectile)**

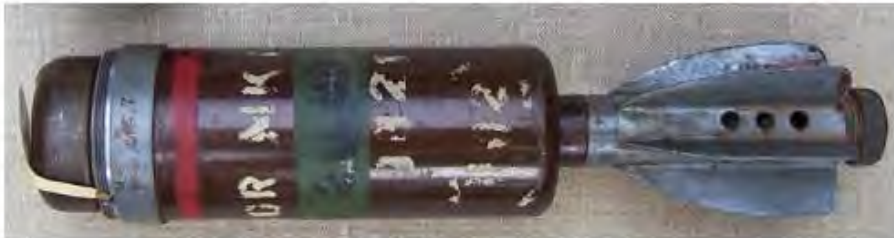
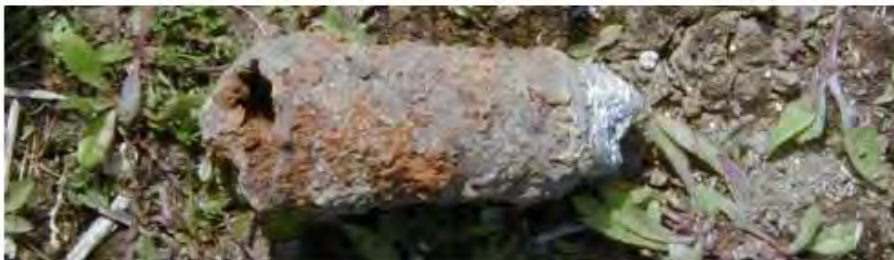
**Category** Mortar (British)  
**Type** 2-Inch Mortar Bomb

**Description** Pear-shaped steel body with 6 or 8 vanes. Originally painted buff yellow or dark grey. Filled with cast TNT, granular TNT or powdered Amatol. Also smoke, illumination and practice versions.

**Function** Small enough to be carried by one man, with a range limited to 500 yards, the 2" mortar was used in an anti-personnel role.

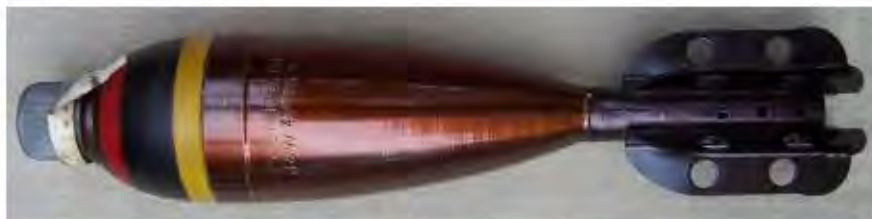
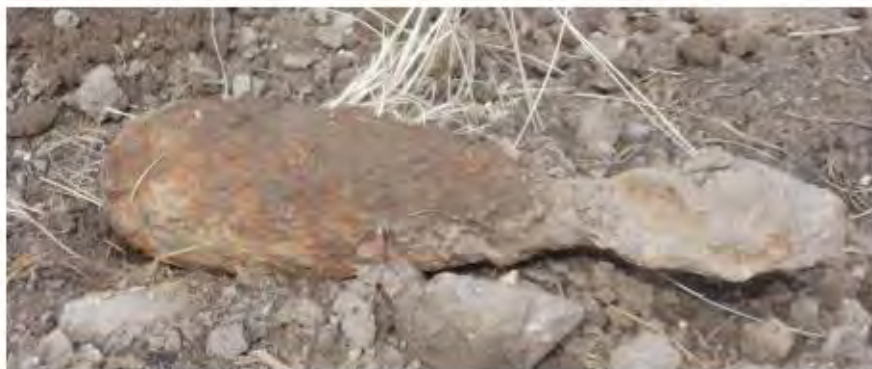
**Category** Mortar (British)  
**Type** 3-Inch Mortar Bomb

**Description** Pear-shaped steel body with vaned tail fin for stability in flight. Typically filled with high explosive or white phosphorus, the latter dispersing on detonation.

**Function** Range of up to 1,600 yards, the 3" mortar was used in an anti-personnel role.
