# Rampion 2 Wind Farm

## Environmental Statement

### Volume 4, Appendix 24.1: Phase 1 geo-environmental desk study

Document Reference: 6.4.24.1

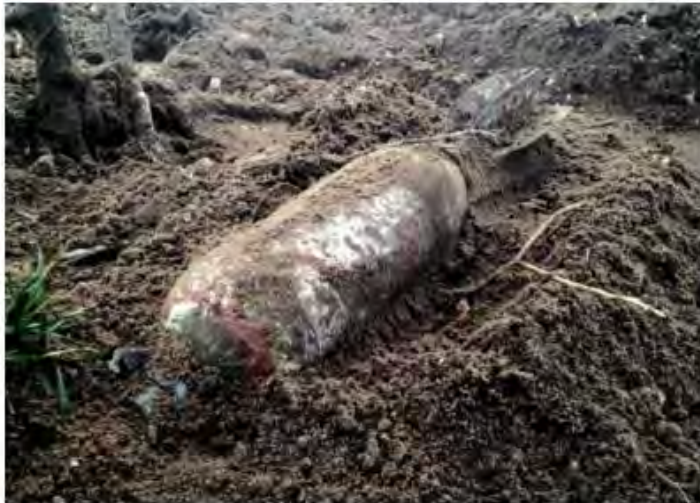
**Category** Mortar (British)  
**Type** 4.2-Inch Mortar Bomb

**Description** Pear-shaped steel body with vaned tail fin for stability in flight. Filling of high explosive, white phosphorus, smoke or chemicals.

**Function** Heavy mortar used in anti-personnel and anti-tank role.

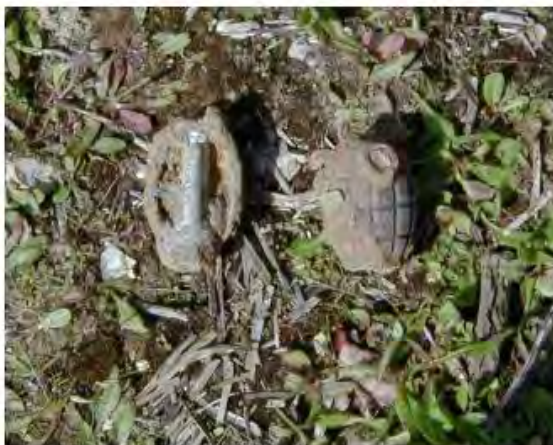
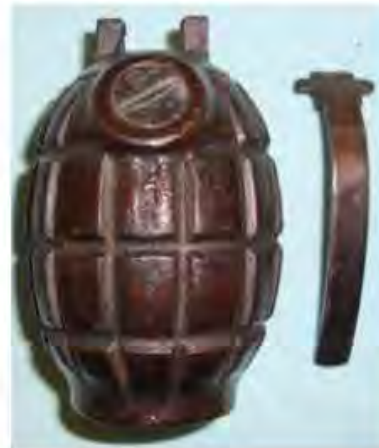
**Category** Grenades (British)  
**Type** No. 36 Hand Grenade ('Mills Bomb')

**Description** Lemon-shaped, cast-iron body filled with high explosive. Three holes in the body; one in the base for priming, one near the top for filling; one on the top holding striker.

**Function** Used as a defence against enemy personnel.

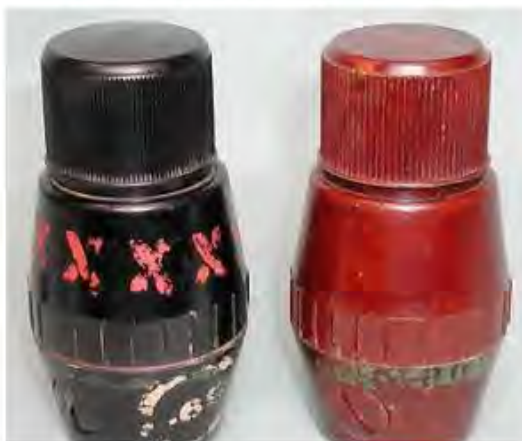
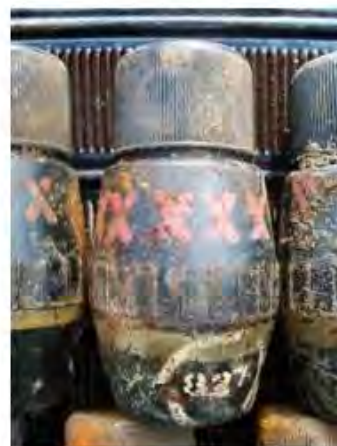
**Category** Grenades (British)  
**Type** No. 69 Hand Grenade

**Description** Two-piece body, threading together in the middle. There are a filling hole and plug and a priming hole and plug in the base section. A detonator well runs lengthwise through the filling.

**Function** Light, impact-firing grenade used for offensive action.

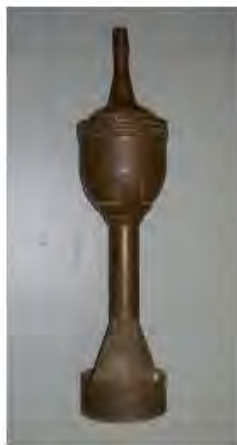
**Category** Projectiles (British)

**Description** Steel cylindrical body beneath fuze chamber with drum tail unit and guide ring at base. Fin-stabilised tail.

**Function** Used by the infantry as an anti-tank weapon and house breaker, with a maximum range of fire of 350yds. Also used extensively for training. High explosive, phosphorus and smoke fillings.

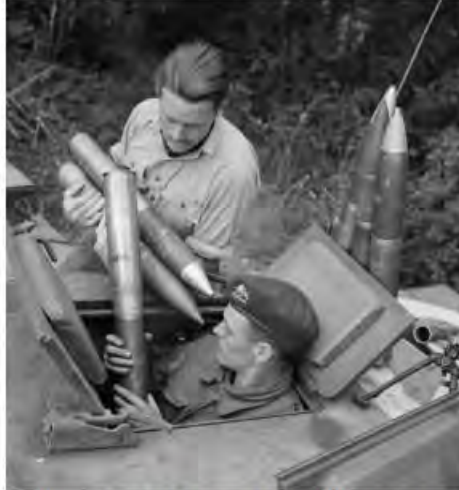
US Sherman 75mm tank shell

**Description** Wide variety of tank shells and fillings in use during WWII, but mostly 75mm projectiles in US and British tanks.

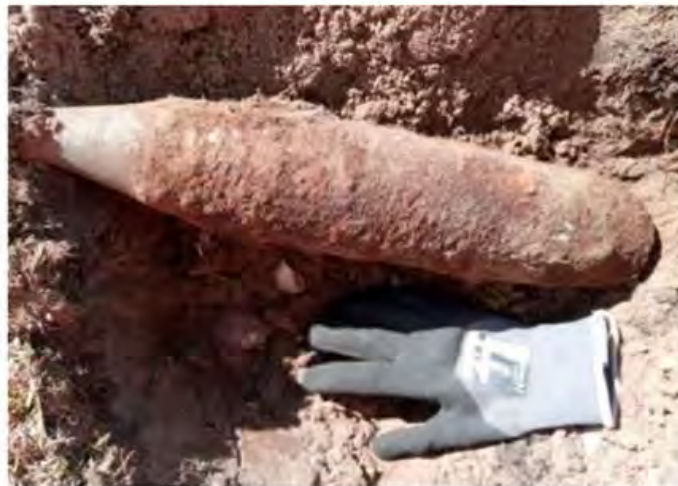
**Fuze** Percussion fuze

**Function** The Quick Fire (QF) 25-pounder became the standard British field gun and howitzer during WWII. It was highly mobile and remained in use into the 1960s

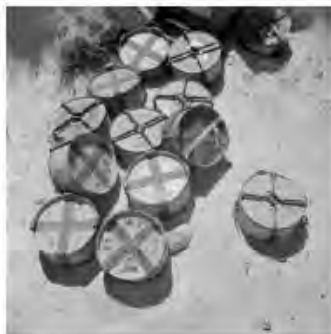
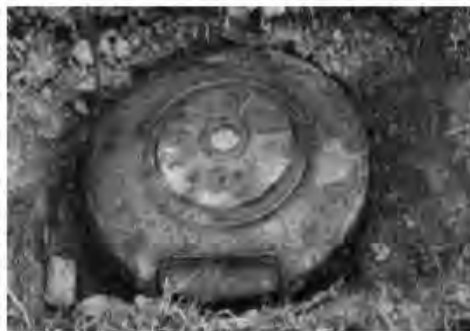
**Category** Anti-Tank Mine  
**Type** British Anti-tank mine E.P. Mk V (Mk 5)

**Description** Cylindrical, metal-cased British anti-tank blast mine

**Function** Defence against armoured cars, tanks, and other vehicles. Could also break the tracks of light or medium tanks and disable vehicles.

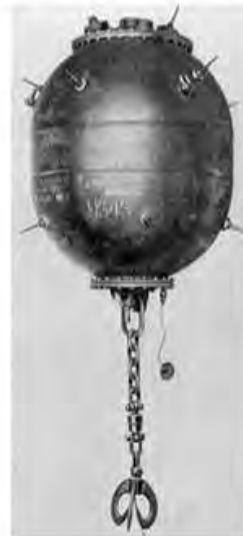
**Category** Mine (British)  
**Type** Mark XVII; Moored Contact Mine

The MK XVII was the most commonly used British naval mine, and could be moored in waters up to 915m depth.

It was a moored contact mine which was frequently used in defensive minefields within UK territorial waters.

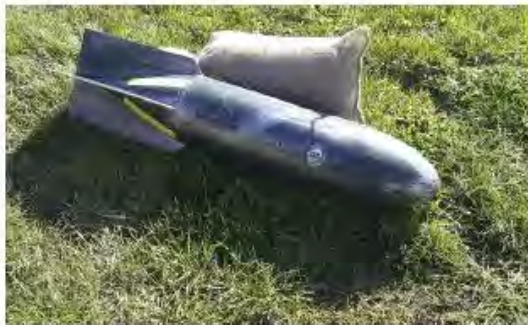
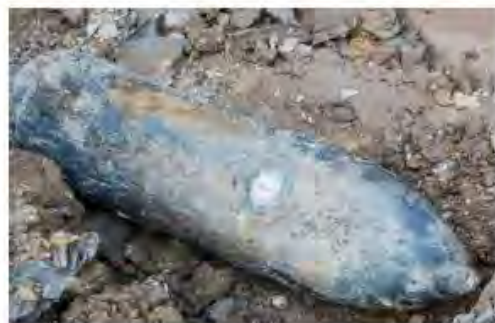
**Category** Bomb (Luftwaffe)  
**Type** Sprengbombe-Cylindrisch (SC) 50kg

**Description** Thick nose welded to a steel body. Nose may be attached to Kopfring (a triangular section steel ring) or spike. Suspension bolt in eye/body and sheet metal tail attached to body with rivets/screws. Originally painted green-grey with a yellow stripe on the tail. Cast TNT, Amatol or Trialen filling.

**Function** Designed to maximise shock waves through air, water and earth and for general demolition. Used against easily damageable targets, including roads, aircraft hangars, rolling stock and small buildings. Spike bombs/ 'Stabo' (SC 50 with spikes attached to nose) were used against rail lines and country roads, with Kopfring used against naval targets.

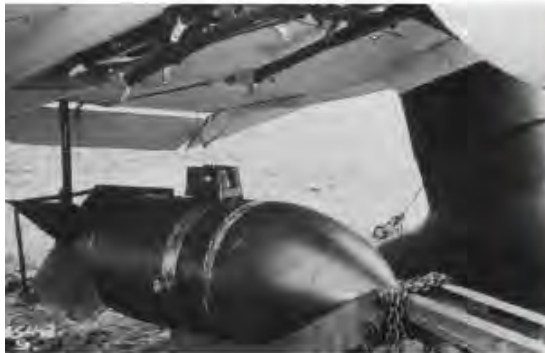
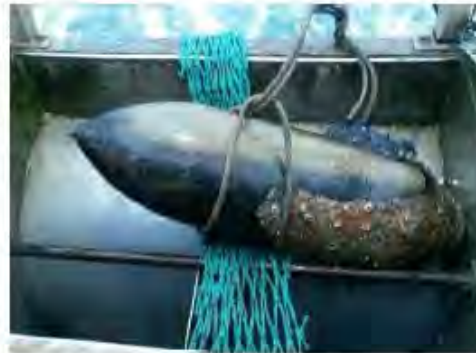
**Category** Bomb  
**Type** Sprengbombe-Cylindrisch (SC) 250kg

**Description** Thick nose welded to steel body. Nose may be attached to Kopfring (triangular section steel ring) or spike. Sheet metal tail attached to body with rivets/ screws. Suspension eye bolt in the nose/body. Originally painted green-grey with a yellow stripe on the tail. TNT; amatol; TNT and aluminium powder, naphthalene, ammonium nitrate and wax/ wood meal filling.

**Function** Designed to maximise shock waves through air, water and earth and general demolition. Used against railway installations, large buildings, ammunition depots and below-ground installations (to 8m). Spike bombs/ 'Stabo' (SC 50 with spikes attached to nose) used against rail lines and country roads.

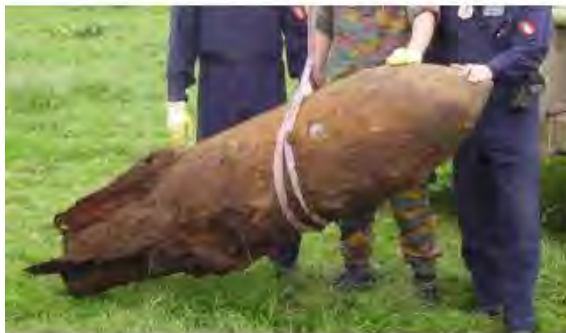
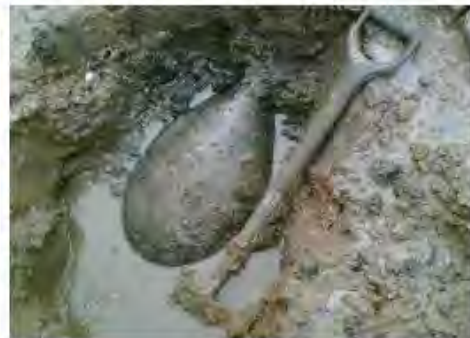
**Category** Bomb  
**Type** Sprengbombe-Cylindrisch (SC) 500kg

**Description** Thick nose welded to steel body. Nose may be attached to Kopfring (triangular section steel ring). Tail either steel sheet or drum-shaped. Suspension band. Originally painted green-grey/ buff (some later versions sky blue) with yellow stripe on tail. Filled with amatol, TNT or trialen.

**Function** Designed to maximise shock waves through air, water and earth and for general demolition. Used against railway property, large buildings, shipping and below-ground installations.

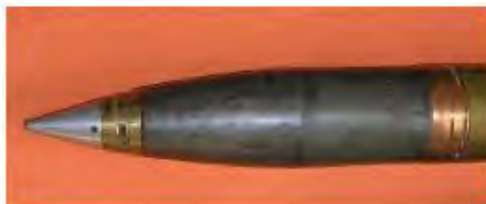
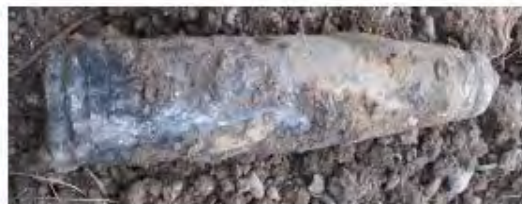
**Category** Projectile  
**Type** 3.7" Anti-Aircraft Shell

**Description** Brass cartridge case. Square-based shell with tapered nose, filled with Amatol, TNT or RDX/TNT. MK6 had forward centring bands and a wider driving band.

**Function** Used as a defence against enemy aircraft, fired from fixed batteries and mobile mountings. Could fire approximately 20 rounds per minute with a maximum ceiling of 41,000ft and horizontal range of 20,600 yards.

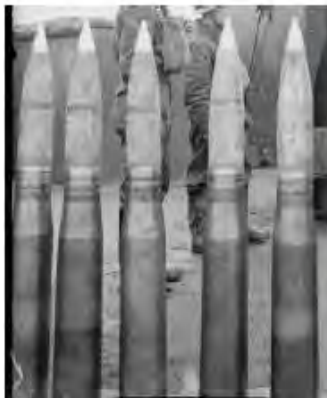
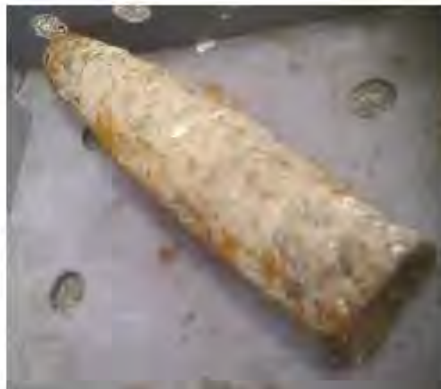
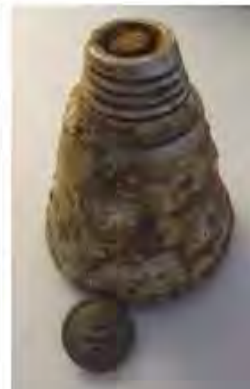
**Category** Projectile  
**Type** 4.5" Shell (Mark II – Anti-Aircraft)

- A – Missile Identification
- B – Gun and Bullet Type
- C – Weight
- D – Smoke pot
- E – Explosives Ring

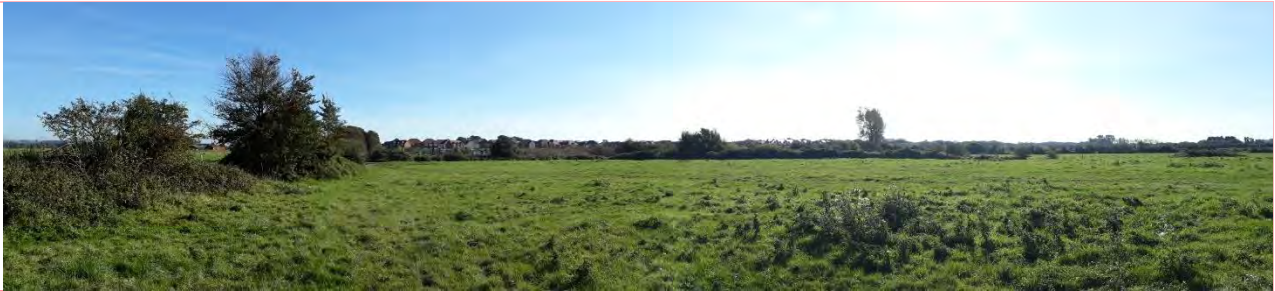
**Photo 1 – Panorama looking east across the Brookbarn Farm historical landfill towards the adjacent residential housing.**

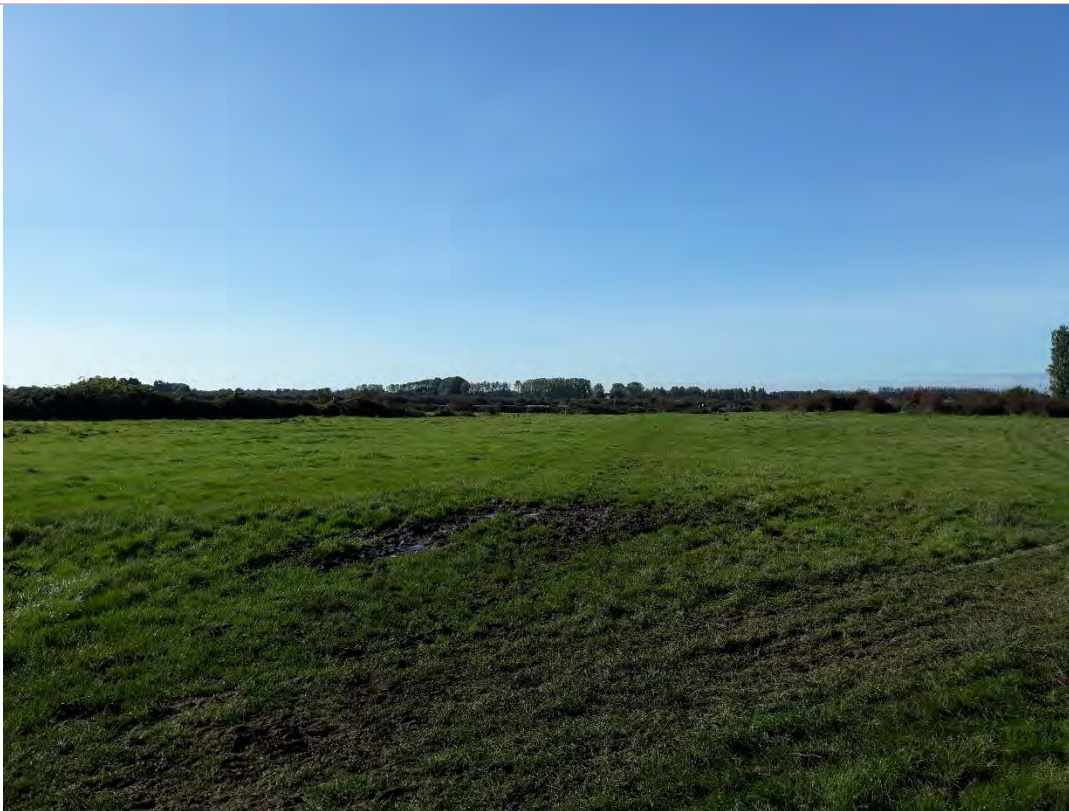
**Photo 2 – View south along the onshore cable corridor across the Brookbarn Farm historical landfill**

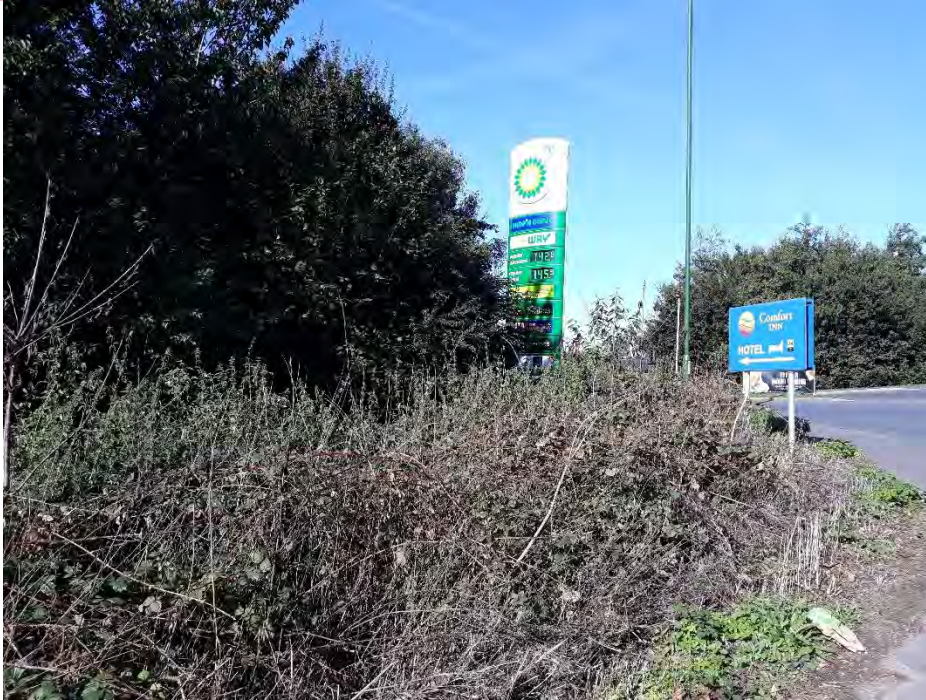
**Photo 3 – Entrance to the Crossbush Service Station taken from where the onshore cable corridor crosses the A284**

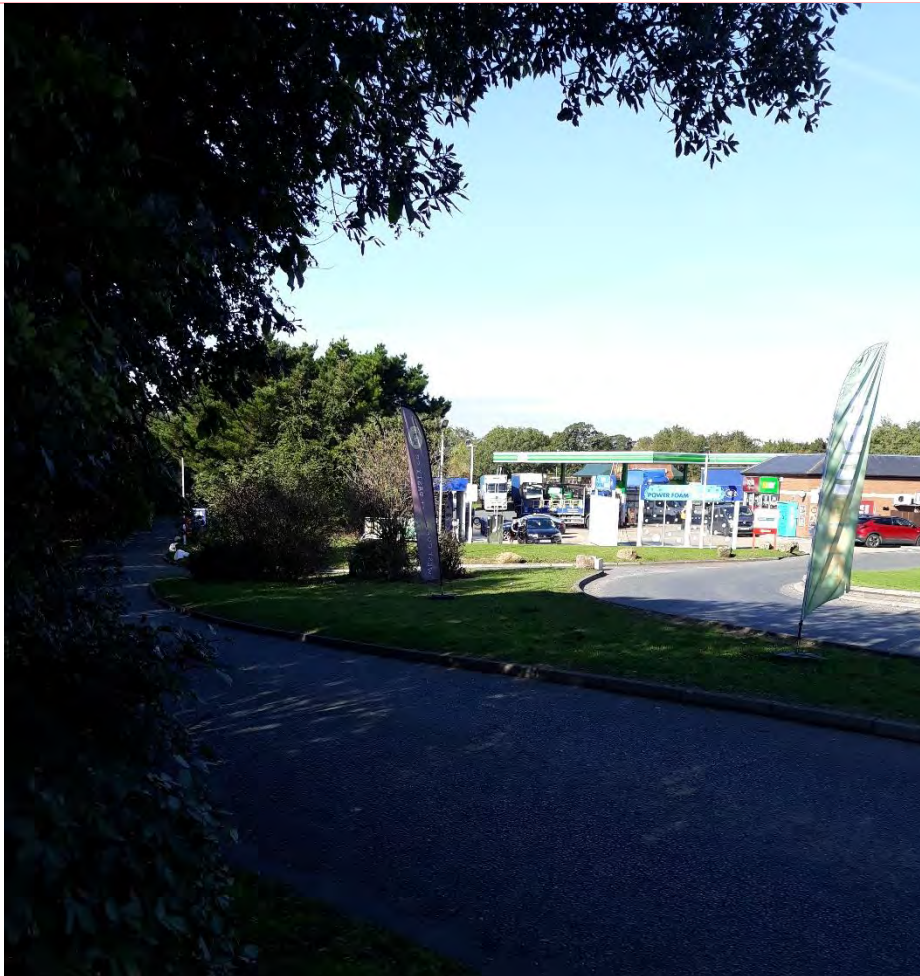
**Photo 4 – Crossbush Service Station taken from the entrance sign in Photo 3. The fuel forecourt is visible in the background under the canopy.**

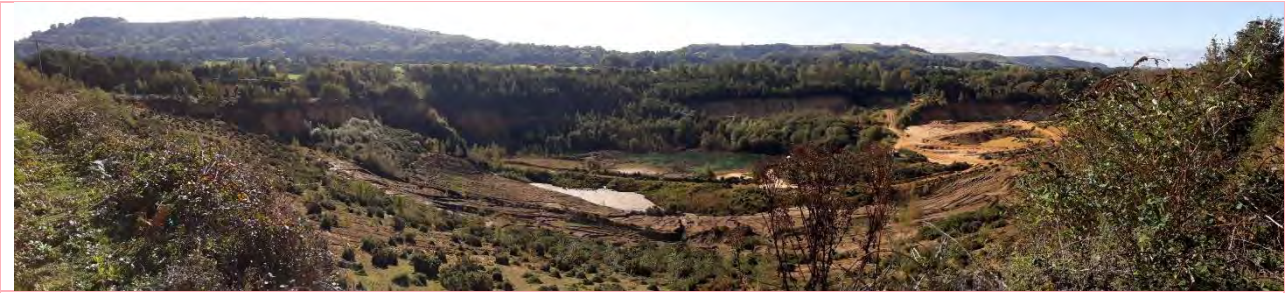
**Photo 5 – Panorama looking southwest across Rock Common Sand Quarry.**

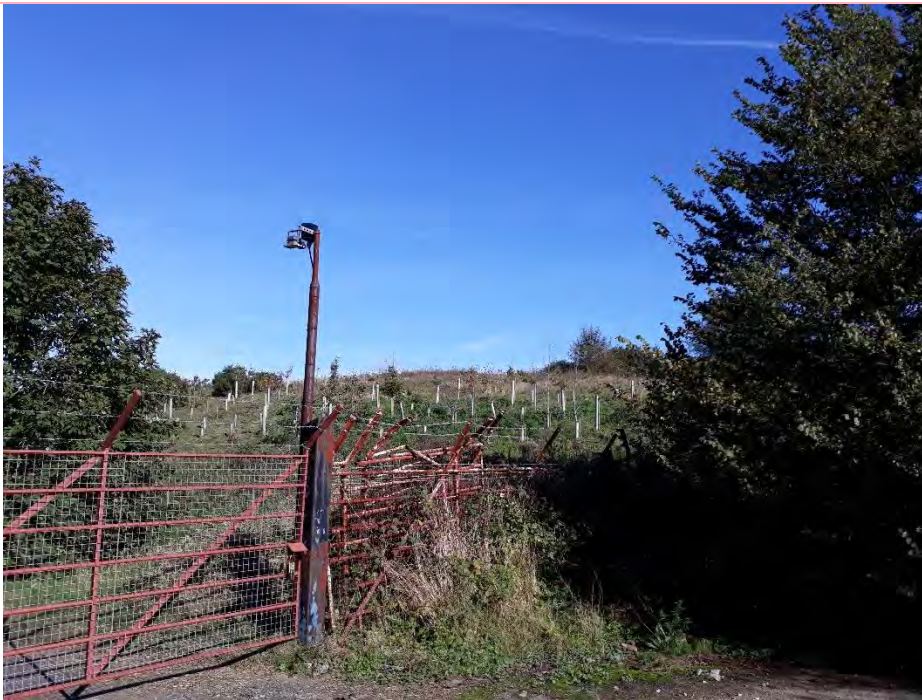
**Photo 6 – View east of the western side of Windmill Quarry authorised landfill showing newly planted trees as part of the site restoration.**

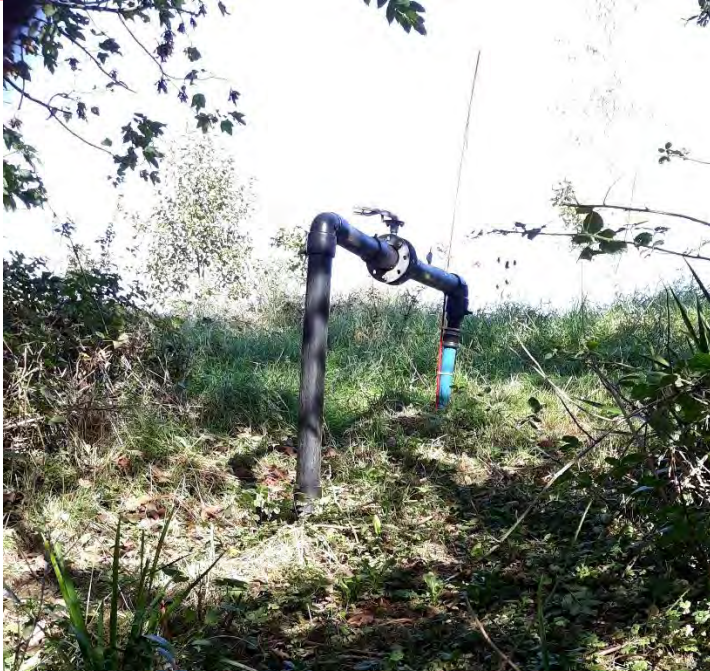
**Photo 7 – Gas/leachate infrastructure observed in the side slope of the Windmill Quarry authorised landfill. It is unclear if this infrastructure is active.**

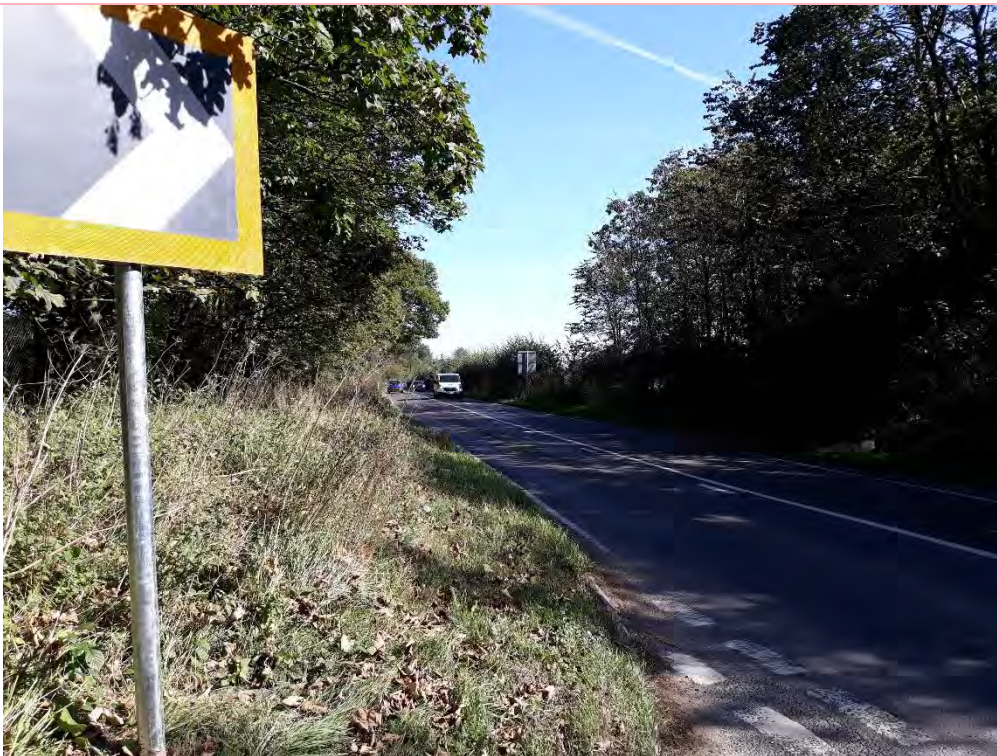
**Photo 8 – View east along the A283. Windmill Quarry authorised landfill is off to the left of the road/photo and the onshore cable corridor will be off to the right of the road/photo.**

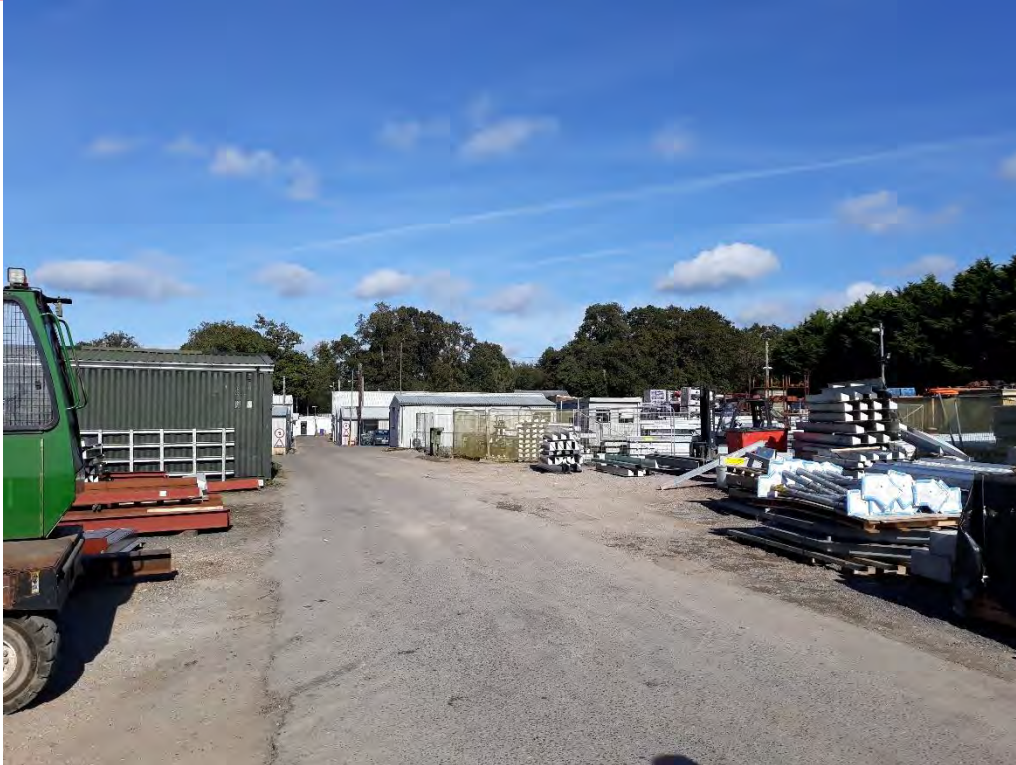
**Photo 9 – View north along the eastern side of the Oakendene Industrial Estate showing outside metal and materials storage. The buildings in the rear of the photo house light industrial uses including vehicle repair, metal fabrication and furniture makers.**

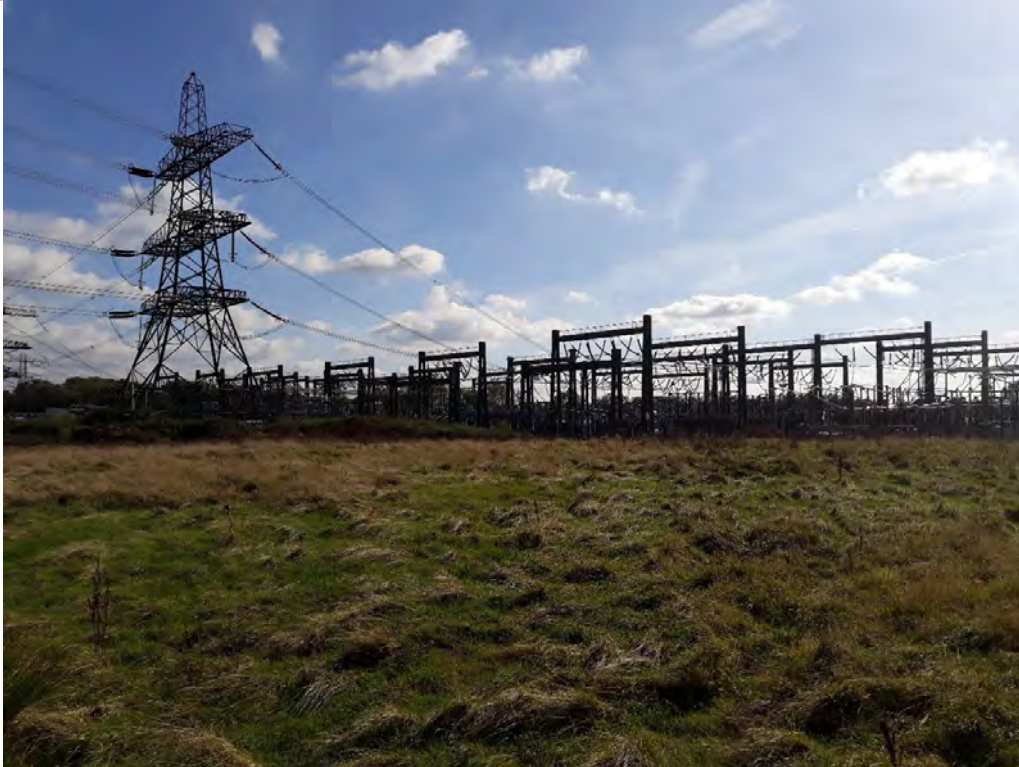
**Photo 11 – View south across the existing National Grid Bolney substation (400kV)**

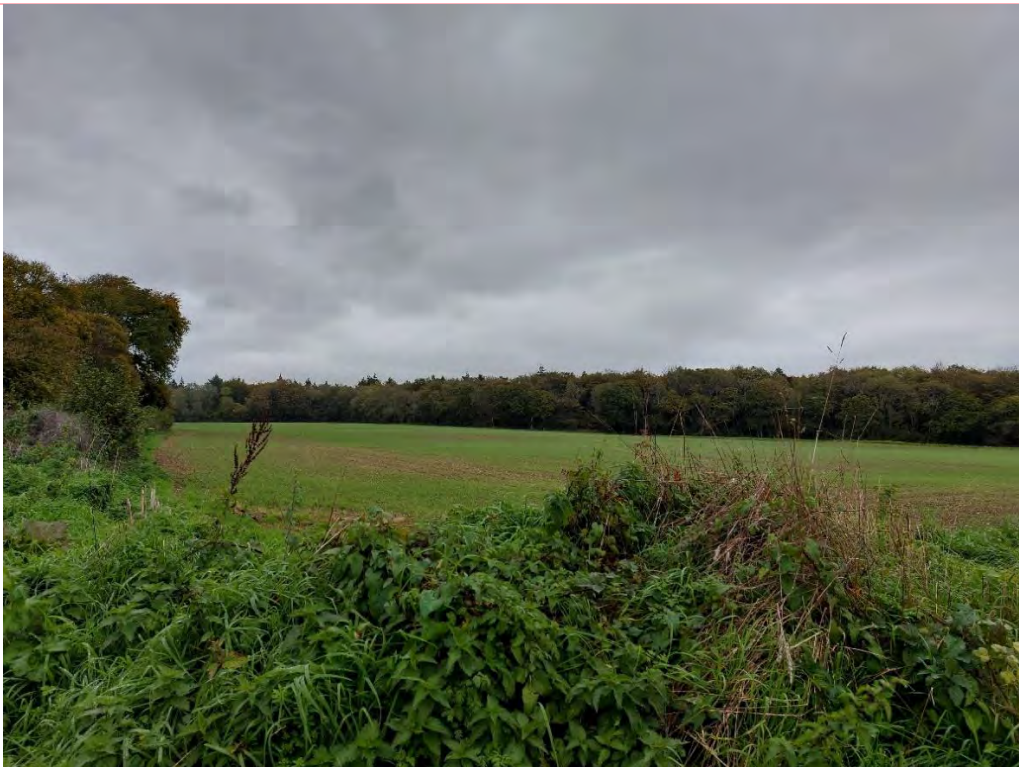
**Photo 12 – View northeast across the location of the Swillage Lane historical landfill.**

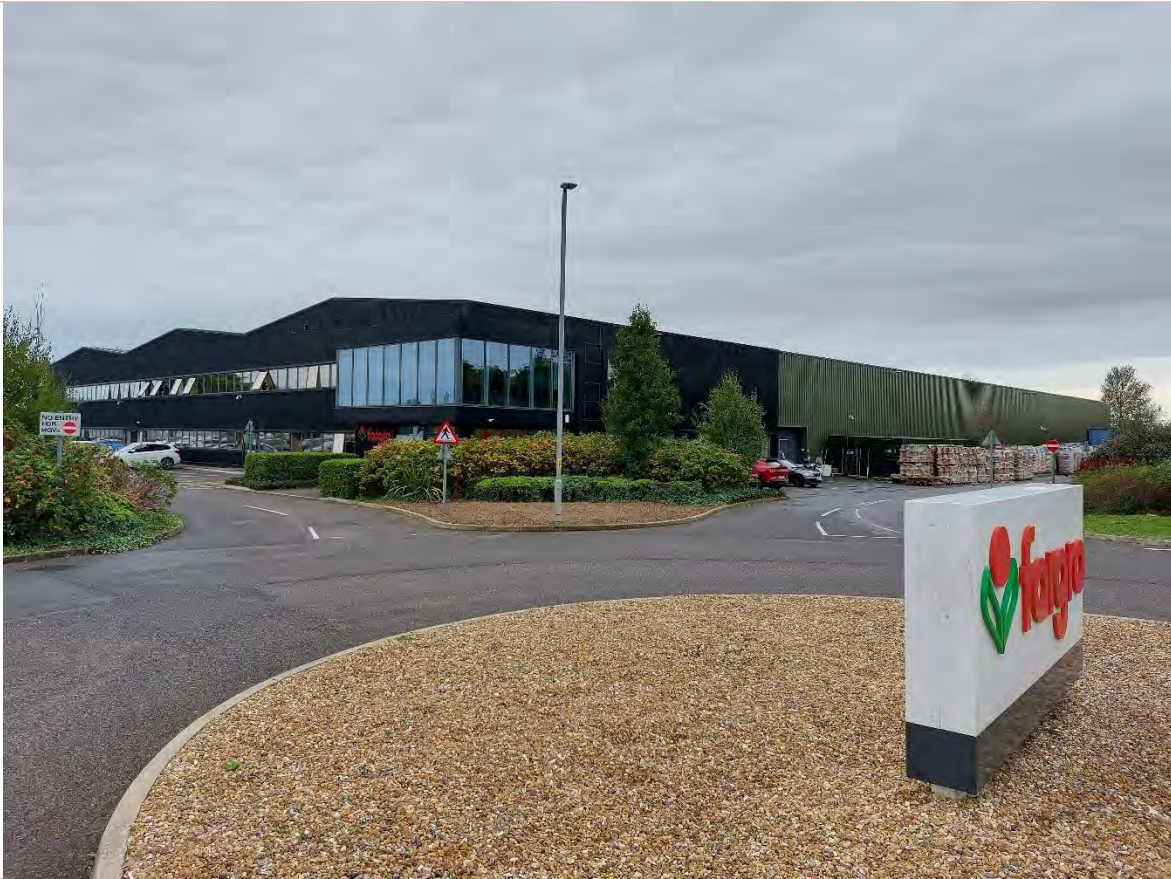
**Photo 13 – View southwest of the southernmost part of the Vinery Industrial Estate**
