Rampion 2 Wind Farm

Category 6: Environmental Statement

Volume 4, Appendix 26.4: Hydrogeological Risk Assessment

Date: August 2023

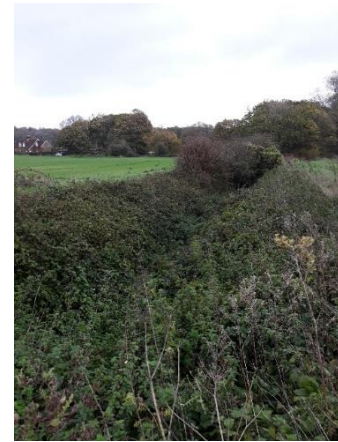
Activity	Date	Time	Field Stop Number	Notes	Photos
Spring identified on OS mapping	Monday 07 November 2022	14:26	Stop 3	<p>Location: Hammerpot off Arundel Road, travelling south to north. TQ 066057.</p> <p>Ditch between the Public Right of Way (PRoW) and private property, 0.3m wide and with water 0.2m deep which was not flowing at the time of the visit. No obvious spring was identified. Slightly north there is a cable HDD crossing east to west across the PRoW and possibly through an extended garden with horses.</p>

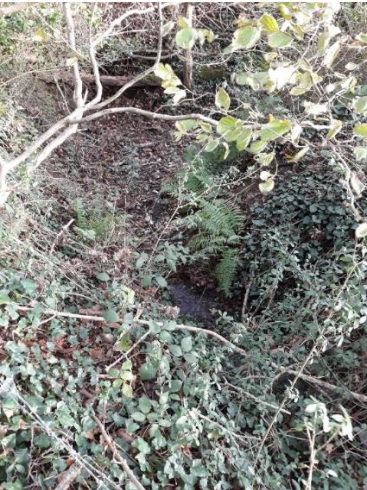
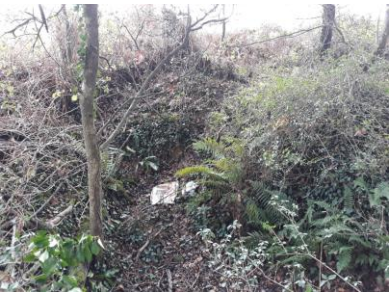
Activity	Date	Time	Field Stop Number	Notes	Photos
Karst feature – SW found swallow hole	Monday 07 November 2022	14:50	Stop 4	<p>Location: travelled north, west of “<i>The Lions</i>”. TQ 066061.</p> <p>Karst features were found in this area. A large swallow hole 5m by 5m and 1.5m deep. A ditch with water flowing west south west along woodland edge was feeding water into the swallow hole. The swallow hole was visibly takes in flowing water from the ditch at 0.2 l/s. The bottom of feature is flat, slightly modified on one side and dry.</p> <p>A smaller depression was found 10m to the east. Also 50m to the west there is a doline feature, 3m diameter, 0.5m deep, rounded, rounded, curved bottom with hazel trees growing. There is a ditch 7m to the south which was full of water at the time of the visit whilst the doline whose depth was greater than the ditch was dry. These features are on relatively flat ground, slopping from west and north. There appears to be an</p>

Activity	Date	Time	Field Stop Number	Notes	Photos
				east to west line of karst features in this area.

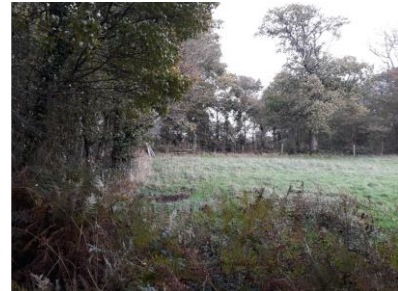
SW small Lidar depression	Monday 07 November 2022	15:15	Stop 5	<p>Location: east of Hammerpot Copse TQ 066063</p> <p>Likely a large chalk pit 30m by 60m, 7m deep. This feature is on edge of Chalk/ Lambeth geological boundary. Pine trees found growing within the center (about 30 years old). There is no exposed chalk and it has sloping sides with a shallower entrance slope to the south.</p>

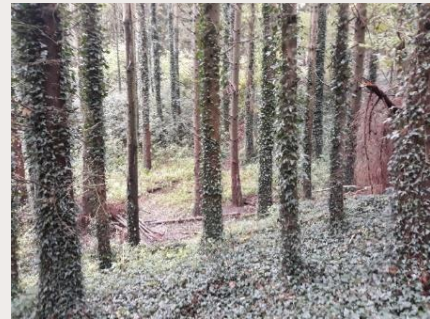
SW not accessed dissolution feature	Monday 07 November 2022	15:28	Stop 6	<p>Location: East of Hammerpot Copse. TQ 067064.</p> <p>Within woodland and on the boundary with a field. Dissolution feature labelled as not accessed. We were able to</p>

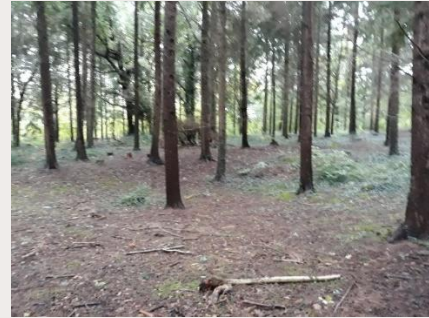
Check pit on OS mapping	Monday 07 November 2022	15:44	Stop 8	<p>Location: Northern PRow exit at Hammerpot Copse, leading up to Angmering Estate. TQ 066067.</p> <p>This is a large chalk pit, 50m by 60m, 8m deep and badger set digging has exposed chalk debris.</p>

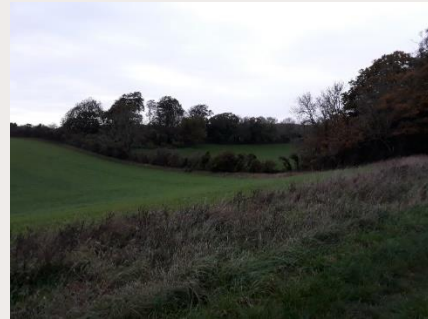
Activity	Date	Time	Field Stop Number	Notes	Photos
Topographic feature	Monday 07 November 2022	15:49	Stop 9	Location: looking west along PRow up to Angmering Estate. TQ 06690 06865. A view of a dry chalk valley

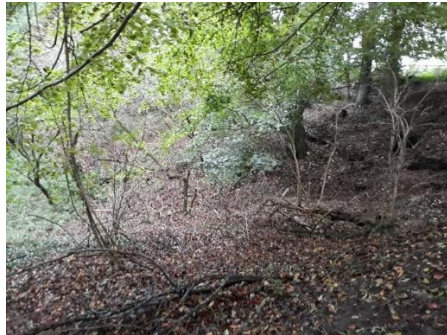
Depression identified during survey	Monday 07 November 2022	15:53	Stop 10	Location: In woodland prior to Angmering Estate. TQ 066068. A large chalk pit, 50m by 60m, 10m deep.

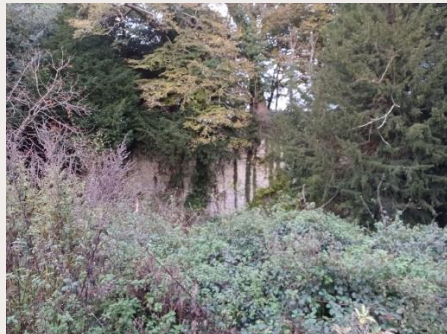
Depression identified during survey	Monday 07 November 2022	16:02	Stop 11	Location: In woodland prior to Angmering Estate. TQ 067071. Large chalk pit, 6m depth, with some flint bands visible in the exposed chalk.

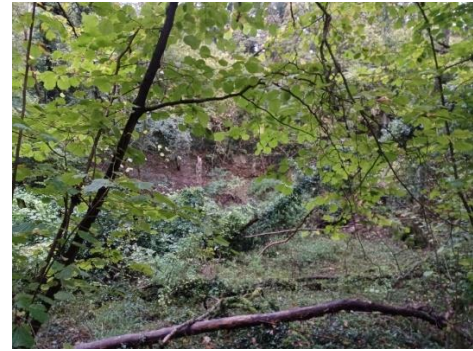
Activity	Date	Time	Field Stop Number	Notes	Photos
Depression identified during survey	Monday 07 November 2022	16:21	Stop 12	<p>Location: Northern woodland of Hammerpot Copse. TQ 065065.</p> <p>A large chalk pit, 100m by 30m by 7m, with an exposed chalk face to the east.</p>

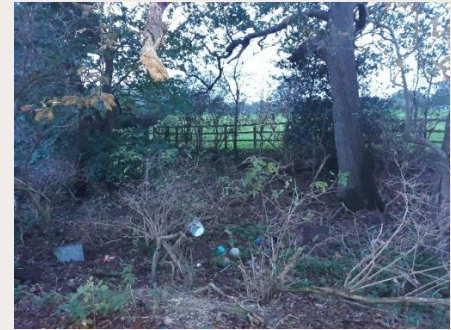
Activity	Date	Time	Field Stop Number	Notes	Photos
Surface water feature identified and private water supply well	Monday 07 November 2022	16:42	Stop 14	<p>Location: South of Priorsleas Farm near the A27. TQ 061058.</p> <p>A pond located on the Lambeth Group geology. A nearby private water supply and well, marked on OS mapping was not found.</p>

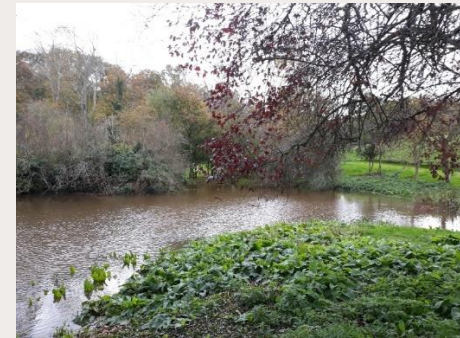
Activity	Date	Time	Field Stop Number	Notes	Photos
SW not accessed dissolution feature	Tuesday 08 November 2022	09:55	Stop 2	<p>Location: Old Waterworks Farm. TQ 038066.</p> <p>SW dissolution feature identified that was labelled as not accessed. We are able to access the location during the survey but nothing found. It is within a field and could have been filled in.</p>

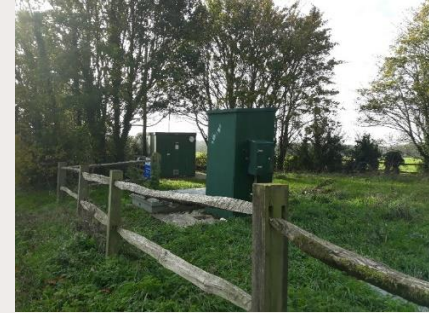
SW Warnincamp observation borehole	Tuesday 08 November 2022	10:30	Stop 6	<p>Location: Warnincamp, at corner of Blakehurst Lane. TQ 046072.</p> <p>The SWS Warnincamp abstraction borehole, this was found in a small area behind an area for car parking, very nearby the abstraction borehole (15 meters to the northeast). The label on the borehole indicates it is the property of Affinity Water, but it must SWS owned.</p>

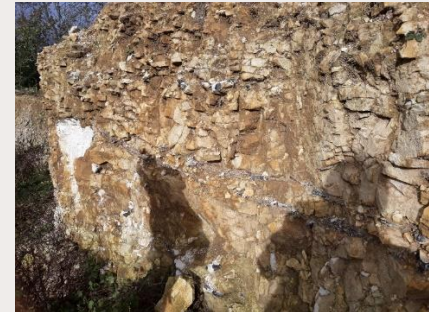
Inspection of chalk face of chalk pit	Tuesday 08 November 2022	11:05	Stop 8	<p>Location: Top of valley at Monarchs Way. TQ 045075.</p> <p>Chalk alongside of large chalk pit. Dip confirms shallow 6 degrees between south and west. Thin 1 cm tabular and modular chalk, fossils present (echinoid). Again on the boundary of Tarrant chalk and Spetisbury Chalk.</p>

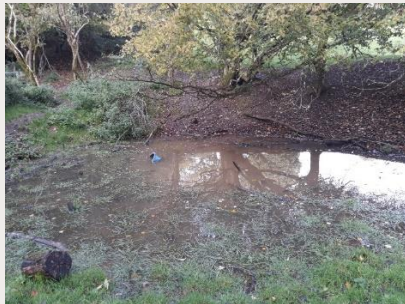
Activity	Date	Time	Field Stop Number	Notes	Photos
Surface water feature identified	Tuesday 08 November 2022	11:35	Stop 11	<p>Location: base of Warningcamp Valley, on corner of woodland. TQ 040074.</p> <p>Pond located in a depression at the base of the valley. Water is dark in colour and silty after heavy rain. It is approximately 5m by 6m, and 1m deep. Clayey soils, uncertain if water table or perched water.</p> <p>The valley bottom flat widens to 30m travelling west.</p>

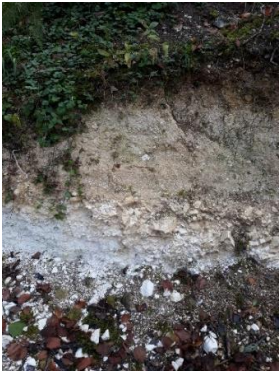
Activity	Date	Time	Field Stop Number	Notes	Photos
Ditches/ streams identified on map	Tuesday 08 November 2022	11:57	Stop 13	<p>Location: base of Warningcamp Valley on far west side. TQ 036074.</p> <p>We found a man-made ditch which is at the base of the valley and runs from one side of the valley to the other to then turn at a right angle along the valley route and down gradient. Likely water table, full of deep water, 3m wide in places, reeds seen, clear water. Geology is of superficial layer of raised marine deposits in the area It suggests water table at this elevation/ location.</p>

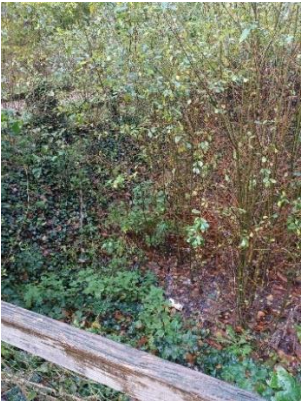
Activity	Date	Time	Field Stop Number	Notes	Photos
Depression identified	Tuesday 08 November 2022	13:50	Stop 17	<p>Location: Oldfield Copse woodland. TQ 058080.</p> <p>Pit found close to road, this was not previously identified by SW Lidar. Dimensions are 15m by 25m, 2.5m deep, oval shape, possible ramp to northeast, likely chalk pit.</p>

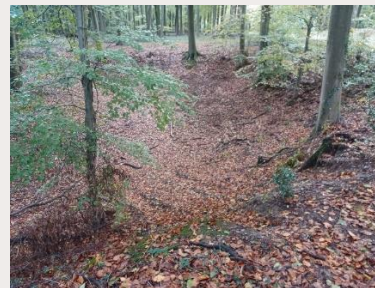
Activity	Date	Time	Field Stop Number	Notes	Photos
				on road side. No superficial geology in the area.	
Depression identified	Tuesday 08 November 2022	14:10	Stop 20	<p>Location: Upper Wepham Wood. TQ 057078.</p> <p>A small depression within woodland. It is likely a small doline, 5m by 7m, shallow 1m deep. Enclosed circular depression, on the Spetisbury Chalk member.</p>

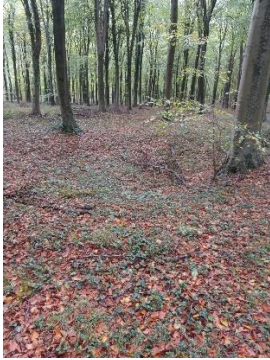
Activity	Date	Time	Field Stop Number	Notes	Photos
Depressions identified	Tuesday 08 November 2022	14:15	Stop 21	<p>Location: Upper Wepham Wood. TQ 057077</p> <p>Two depressions were found just next to each other, first is 5m diameter and 0.75m deep, circular closed and shallow. The second Larger feature is 10m to south. Oval shaped, closed but possible ramp to south, 10m by 25m, and 1.5m deep. They could also be chalk pits due to ramp. On the edge of head chalk boundary possibly indicating pit.</p>

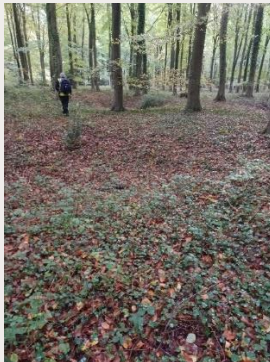
SW LiDAR feature	Tuesday 08 November 2022	14:25	Stop 22	<p>Location: Lower Oldfield Copse. TQ 058075.</p> <p>Large chalk pit identified by LiDAR data. Two separate levels. 50m by 35m, and 6m deep, irregular shape with possible two faces east and west, infilled with beech trees that are approximately 50 years old. Found on head deposits.</p>

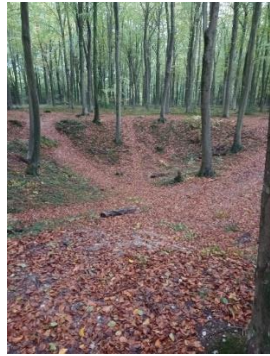
Activity	Date	Time	Field Stop Number	Notes	Photos
SW LiDAR feature	Tuesday 08 November 2022	14:34	Stop 23	<p>Location: Upper Wepham Wood. TQ 056076.</p> <p>Chalk pit found on the head boundary. 50m by 40m, and 7m deep. Oval shaped. Possible ramp to the east. Not close to any paths.</p>

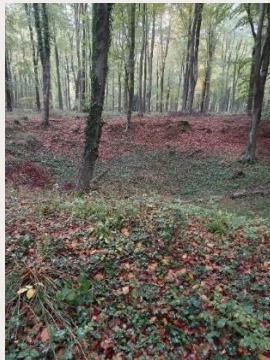
SW LiDAR feature	Tuesday 08 November 2022	14:39	Stop 24	<p>Location: Upper Wepham Wood. TQ 055077.</p> <p>Chalk pit found with dimensions 25m by 30m, and 2.5m deep. Just on the Chalk/ head boundary. Oval shaped with one steep slightly rectangular face. Next to path indicating likely chalk pit.</p>

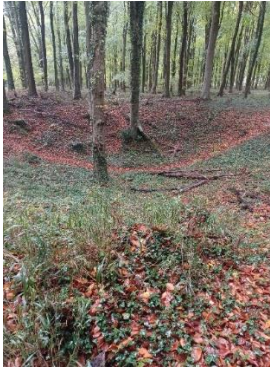
Activity	Date	Time	Field Stop Number	Notes	Photos
Chalk pit	Tuesday 08 November 2022	14:49	Stop 25	<p>Location: Upper Wepham Wood. TQ 052078.</p> <p>Chalk pit found as identified through OS mapping. It has two levels with dimensions of 40m by 30m and 6m deep. Steep on one side. Within chalk on side of valley. It has an entrance on lower valley slope to the west and irregular in shape.</p>

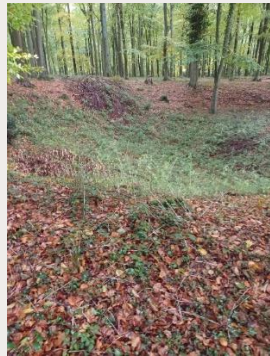
Depression identified	Tuesday 08 November 2022	15:28	Stop 28	<p>Location: Gibbet Piece. TQ 051074.</p> <p>Depression identified within woodland and it is likely to be a chalk pit. Dimensions are 10m by 25m, and 2m deep, oval shaped with shallow depression, but no obvious ramp and next to path. Located on superficial head deposit,</p>

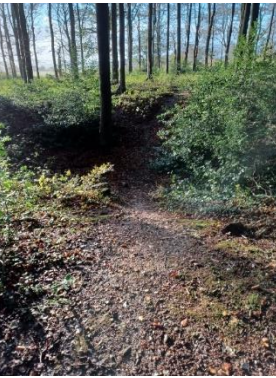
Activity	Date	Time	Field Stop Number	Notes	Photos
SW LiDAR feature	Tuesday 08 November 2022	15:36	Stop 29	<p>Location: Gibbet Piece. TQ 052072.</p> <p>A LiDAR depression was found and although it is slightly fenced off it remains visible. It is large in size at 30m by 40m and 5m deep and oval shaped, with a possible entrance to west and is likely a chalk pit on head deposits.</p>

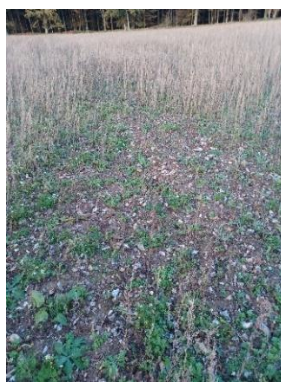
Activity	Date	Time	Field Stop Number	Notes	Photos
SW LiDAR feature	Tuesday 08 November 2022	15:48	Stop 31	<p>Location: Gibbet Piece. TQ 054071.</p> <p>Aa large chalk pit with dimensions 60m by 50m and 10m deep. Irregular in shape with numerous centres. Possible entrance to the east, near path and found on head deposit.</p>

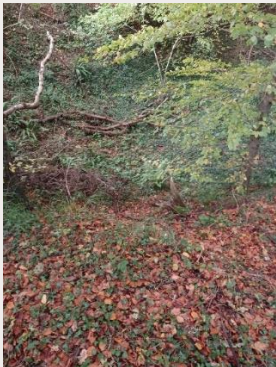
SW LiDAR feature	Tuesday 08 November 2022	16:05	Stop 32	<p>Location: Woodland next to Blakehurst Farm. TQ 049068.</p> <p>Feature picked up by SW LiDAR data, but it is in a small section of woodland that is fenced over and densely vegetated so it is not clear what might be in there. But it is likely a large chalk pit. No dissolution features were visible.</p>

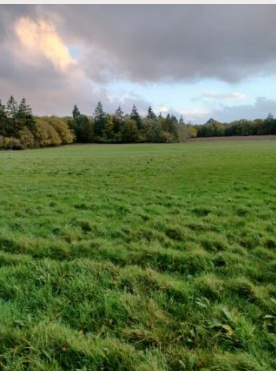
Large chalk pit – not accessed	Tuesday 08 November 2022	16:21	Stop 34	<p>Location: Bushey Field. TQ 052068.</p> <p>Large chalk pit found that had previously not been accessed. It is more than 100m in diameter, with numerous levels and steep faces on some sides. It is within a woodland area with dense vegetation within the pit.</p>

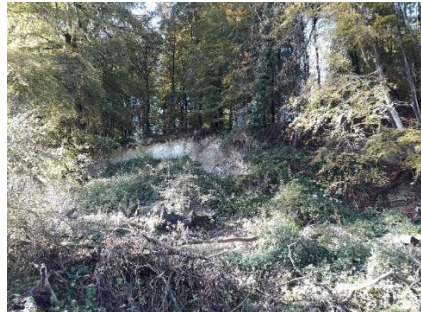
Activity	Date	Time	Field Stop Number	Notes	Photos
SW chalk pit identified	Wednesday 09 November 2022	10:04	Stop 3	chalk, but the dip of strata is not visible. Location: Top of valley at Patching Rough. TQ 082077. A large chalk pit found, 80m by 40m, and 8m deep with two centres. It has an irregular shape and there is no chalk exposed.	
SW LiDAR feature	Wednesday 09 November 2022	10:10	Stop 4	Location: Patching Rough. TQ 081078. SW LiDAR feature identified site found and it is likely to be a chalk pit. Although rounded it has possible entrance to north east. On clay with flints and chalk boundary and is 30m in diameter and 3.5m deep.

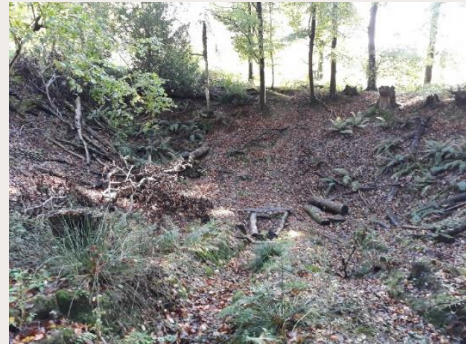
Swallow hole – not accessed	Wednesday 09 November 2022	10:34	Stop 6	<p>Location: Patching Rough. TQ 079076.</p> <p>A swallow hole identified from SW data, but when area inspected only flat ground within the woodland was observed. No drainage or sink feature appear to exist.</p>

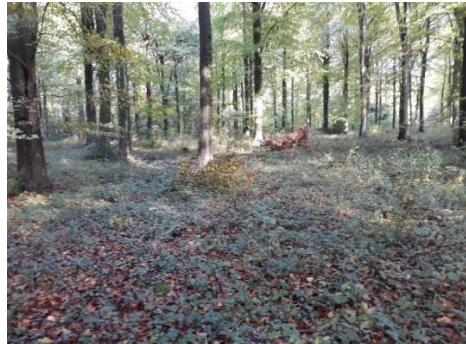
Activity	Date	Time	Field Stop Number	Notes	Photos
Depression found	Wednesday 09 November 2022	10:38	Stop 7	<p>Location: Patching Rough. TQ 079076.</p> <p>A small depression on ground, not identified from the SW LiDAR analysis. Dimensions of the feature are 5m by 5m and 0.5m deep. It is next to a track and possibly a pit on chalk with flints deposits.</p>

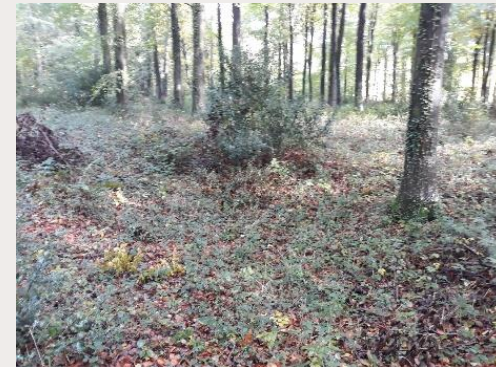
SW large LiDAR depression	Wednesday 09 November 2022	10:47	Stop 8	<p>Location: North of Barnstake Copse. TQ 077075.</p> <p>A depression found and is likely a chalk pit. It is rectangular in shape and regular, with high berms in middle running northeast to southwest with dimensions of 35m by 50m and 5m deep.</p>

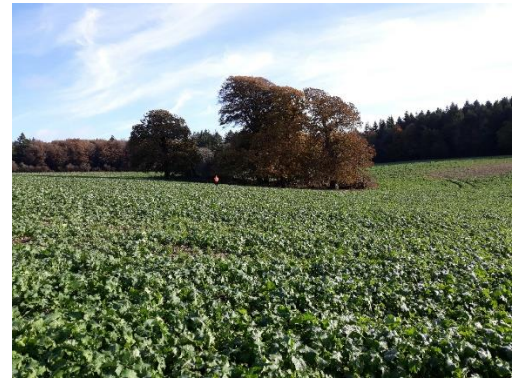
SW dissolution feature	Wednesday 09 November 2022	11:05	Stop 10	<p>Location: Angmering Park, within the field. TQ 074076.</p> <p>A dissolution feature identified within SW data, but upon inspection of the area no evidence of a dissolution feature was found, only a patch of bare ground with less crops and a possible slight scoop on north edge of valley, but no clear indications of a dissolution feature.</p>

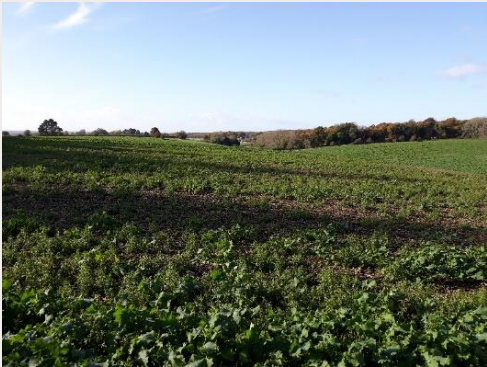
Depression found	Wednesday 09 November 2022	11:23	Stop 12	<p>Location: Boundary of Angmering Park and woodlands. TQ 076077.</p> <p>A possible chalk pit found, on the edge of a field. The dimensions are 35m by 25m, and 6.5m deep, oval shaped and just within woodland with dense vegetation inside, it is located just to the north of valley, on top of the valley. It is a closed depression, shallower on southern side where there is also a track.</p>

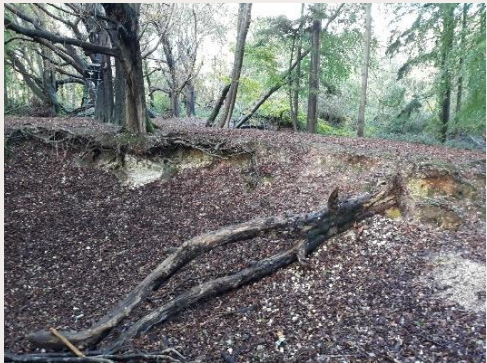
Activity	Date	Time	Field Stop Number	Notes	Photos
Three SW LiDAR features	Wednesday 09 November 2022	11:44	Stop 15	<p>Location: Oaken Copse, north of Angmering Park. TQ 070078.</p> <p>Although three LiDAR features were identified, only found two large chalk pits in a line were found. Both were oval in shape, 6m deep, large up to 30m by 40m, with some chalk exposed.</p>

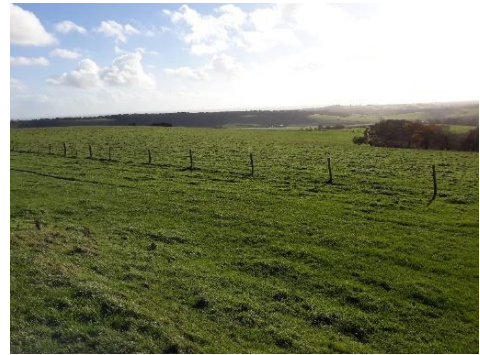
Activity	Date	Time	Field Stop Number	Notes	Photos
SW small LiDAR feature	Wednesday 09 November 2022	13:06	Stop 19	<p>Location: top of Blackpatch Hill. TQ 096095.</p> <p>At this LiDAR depression a man-made feature was found 2 with a very regular circular berm, 25m in diameter and 1 m high.</p> <p>This was at high point of hill at 175m AOD.</p>

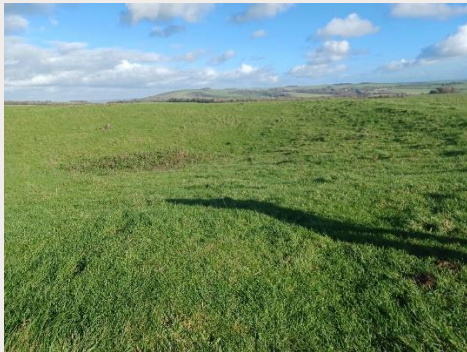
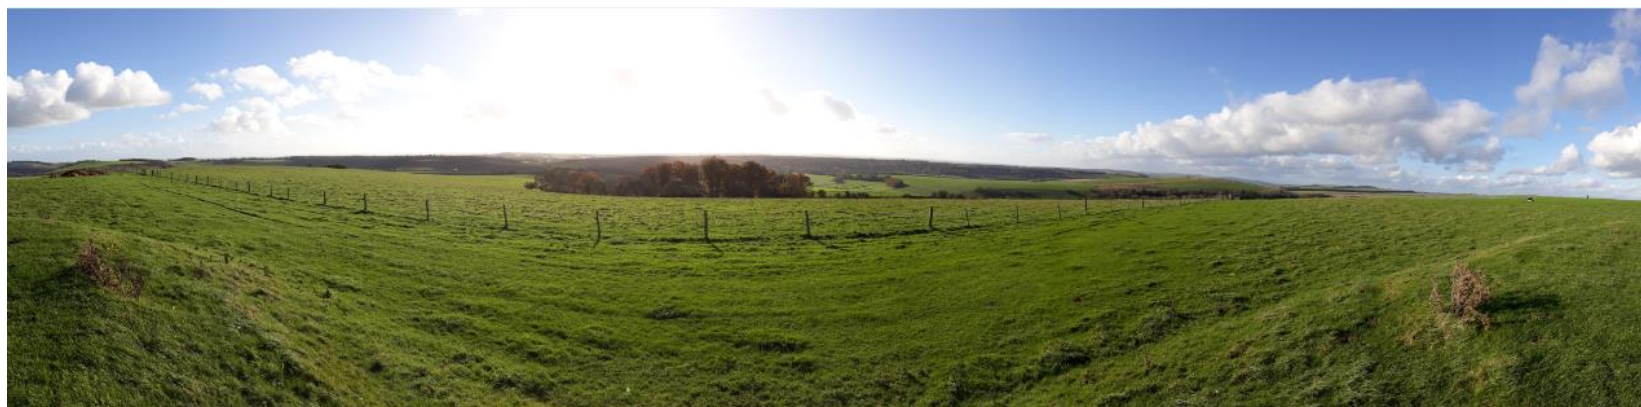
Panoramic view looking southwest, from the top of the artificial berm.

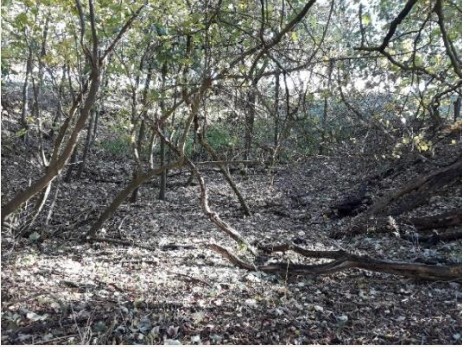
Activity	Date	Time	Field Stop Number	Notes	Photos
SW LiDAR feature	Wednesday 09 November 2022	13:21	Stop 20	<p>Location: Longfurlong Farm. TQ 094091.</p> <p>A chalk pit found as an identified LiDAR feature. It is a scoop in the hillside, rectangular shape with dimensions 20m by 25m, and 4m depth with no exposed chalk .</p>

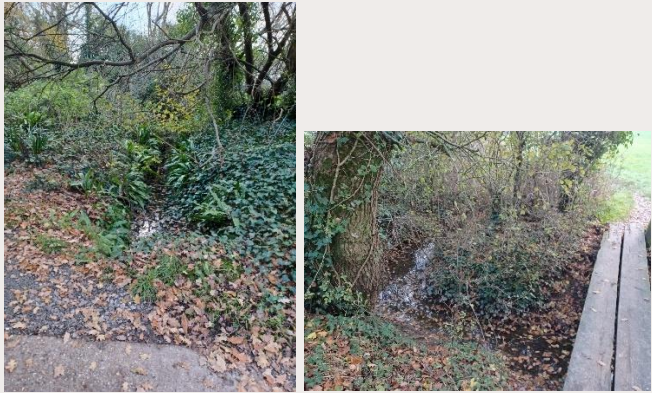
Activity	Date	Time	Field Stop Number	Notes	Photos
	Wednesday 07 December 2022	09:24	Stop 1	<p>Location: Hammerpot. TQ 067057.</p> <p>Ditch with flowing water, travels around the properties and fields. Slowly flowing water.</p>

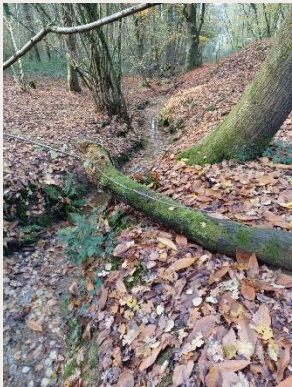
Activity	Date	Time	Field Stop Number	Notes	Photos
Flowing water	Wednesday 07 December 2022	10:50	Stop 13	<p>Location: In Fox Rough campsite. TQ 072059.</p> <p>Clear flowing water travelling west to east. On head deposit.</p>

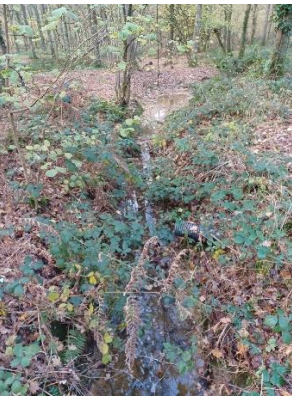
Surface and subsurface feature from mapping	Wednesday 07 December 2022	11:03	Stop 14	<p>Location: In Fox Rough campsite. TQ 073060.</p> <p>Clear flowing water travelling west to east. There is a pipe coming from the northeast pointing into the stream but currently no output. Children's play area nearby, swing in picture.</p>

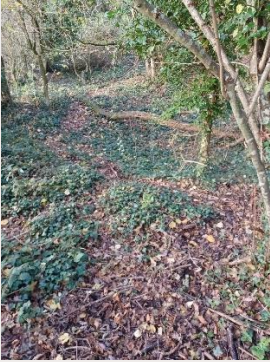
Activity	Date	Time	Field Stop Number	Notes	Photos
LiDAR feature investigated	Wednesday 07 December 2022	11:46	Stop 19	Elongated shape, with dense vegetation throughout.	
				Location: woodland between Kitpease Copse and The Lions. TQ 068063.	
				Second smaller chalk put found next to larger one at stop 19. Dimensions are 5m by 7m and 2m deep.

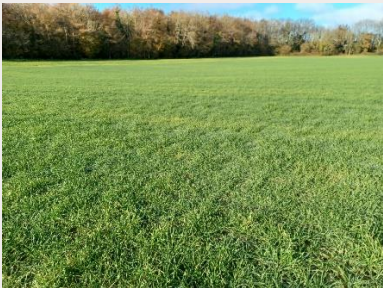
Activity	Date	Time	Field Stop Number	Notes	Photos
Dissolution feature on mapping	Wednesday 07 December 2022	11:54	Stop 21	<p>Location: Kitpease Copse. TQ 069064.</p> <p>Dissolution feature had been identified by SWS mapping work. Upon visiting the area no feature had been found. It could have possibly been filled in.</p>

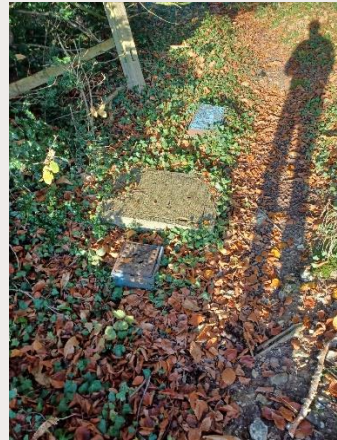
Walking near red line boundary	Wednesday 07 December 2022	14:00	Stop 25	<p>Location: boundary of field and woodland at Angmering. TQ 071068.</p> <p>Existing infrastructure found. Approximately 100m east of red line boundary.</p>

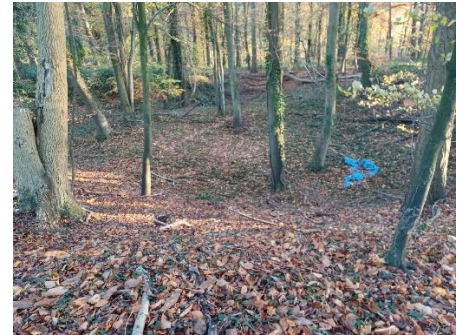
Activity	Date	Time	Field Stop Number	Notes	Photos
Chalk pit found	Wednesday 07 December 2022	15:02	Stop 32	<p>Location: In woodland near Selden Fields. TQ 072069.</p> <p>Large chalk pit found with dimensions of 25m by 20m and 5m deep. It is sloped on the southwest side displaying a natural entrance. There is a raised platform in the middle with three dips surrounding.</p>

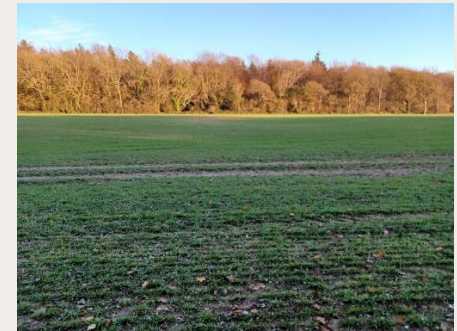
Chalk pit on mapping	Wednesday 07 December 2022	15:12	Stop 33	<p>Location Olivers Copse. TQ 072066.</p> <p>In a field with crops, a chalk put was identified through mapping. However when visited nothing could be seen, possibly there is a dip in the ground where it might have been filled in.</p>

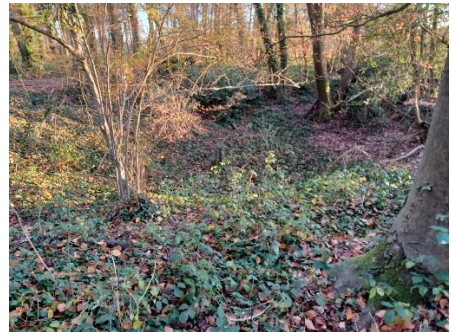
Activity	Date	Time	Field Stop Number	Notes	Photos
Chalk pit found	Wednesday 07 December 2022	15:17	Stop 34	<p>Location Parham Fields. TQ 073065.</p> <p>Chalk pit found with dimensions of 10m by 15m and 3m deep. In woodland on side of path with no chalk visible.</p>

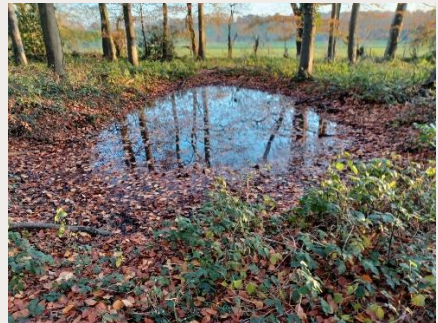
Surface water feature found	Wednesday 07 December 2022	15:21	Stop 35	<p>Location Parham Fields. TQ 075064.</p> <p>Small surface water feature found in woodland on the side near a field. It has a circular shape and has dimensions of 5m by 7m. The dissolution feature identified from the mapping could not be found nearby.</p>

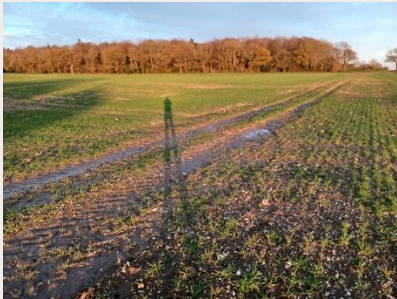
Dissolution feature on mapping	Wednesday 07 December 2022	15:40	Stop 37	<p>Location Olivers Copse. TQ 072063.</p> <p>The mapping identified a dissolution feature in the field, however upon inspection no such feature could be identified. It is in a field so could have been filled in.</p>

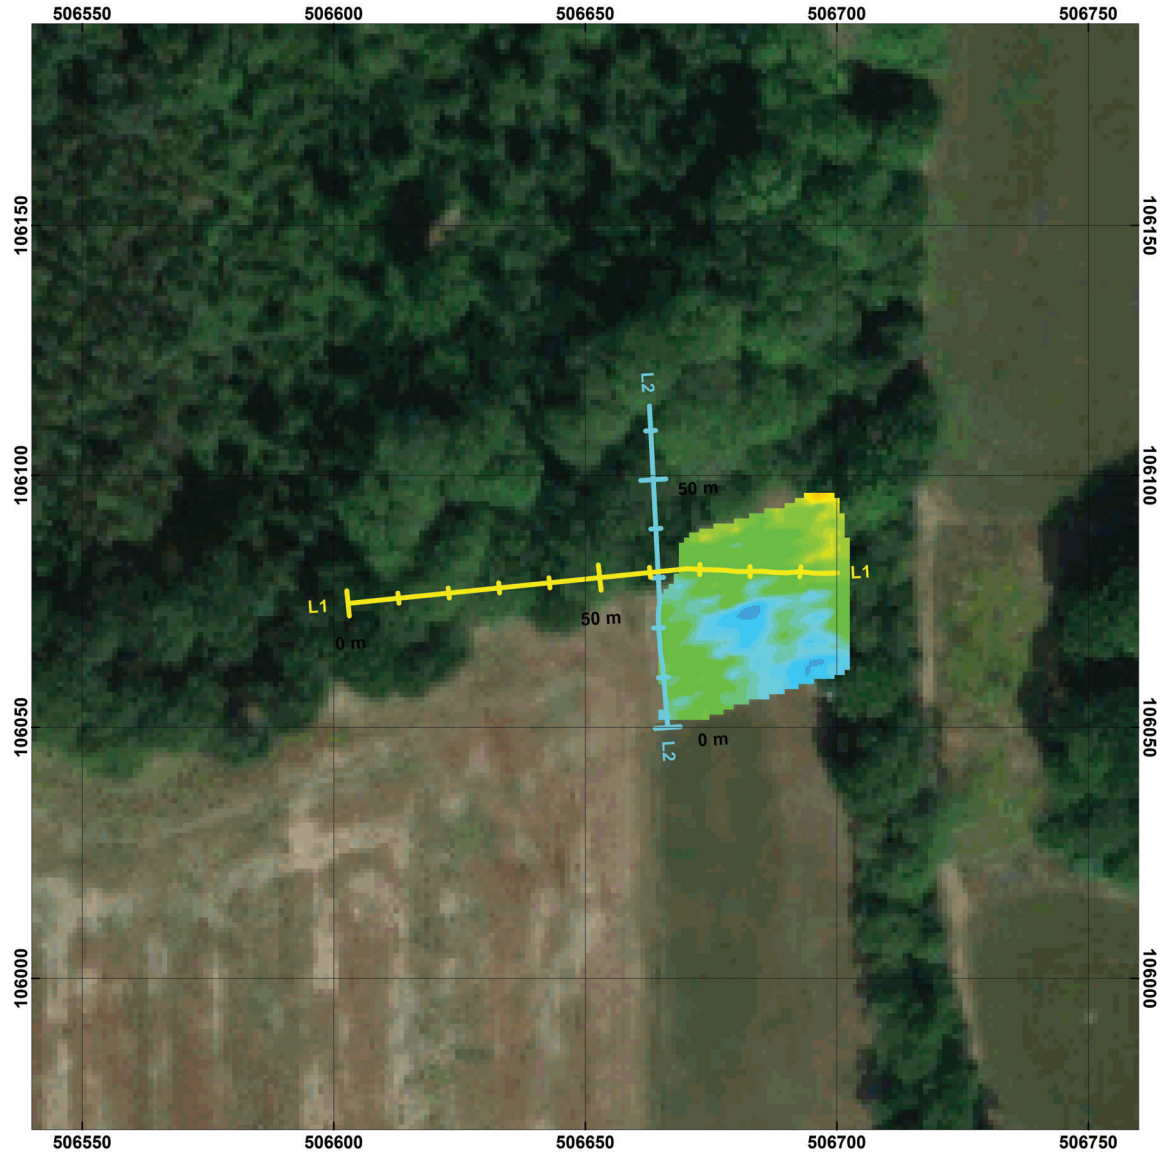
223150-D04A - LIONS TRIAL AREA EM RESULTS - APPROX. DEPTH 2.2 m

CLIENT: WSP	
PROJECT: LITTLEHAMPTON TO BOLNEY CABLE ROUTE GEOPHYSICAL SURVEY	
TITLE: LIONS TRIAL AREA EM RESULTS APPROX. DEPTH 2.2 m	
PROJECT NO.: 223150	DRAWING NO.: 223150-D04A
ISSUE REFERENCE: 01	DATE: 06/06/2023
INTERP BY: AD	DATE: 06/06/2023
CHECKED BY: BB	DATE: 06/06/2023
DRAWING SCALE: 1:1000	APPROVED BY: DK
PLOTTED DRAWING SIZE: A3 (420mm x 297mm)	
FUGRO GEOSERVICES LIMITED Fugro House, Blenheim Road Wallingford, Oxfordshire, OX10 9BB Tel: +44 (0)1793 4021400

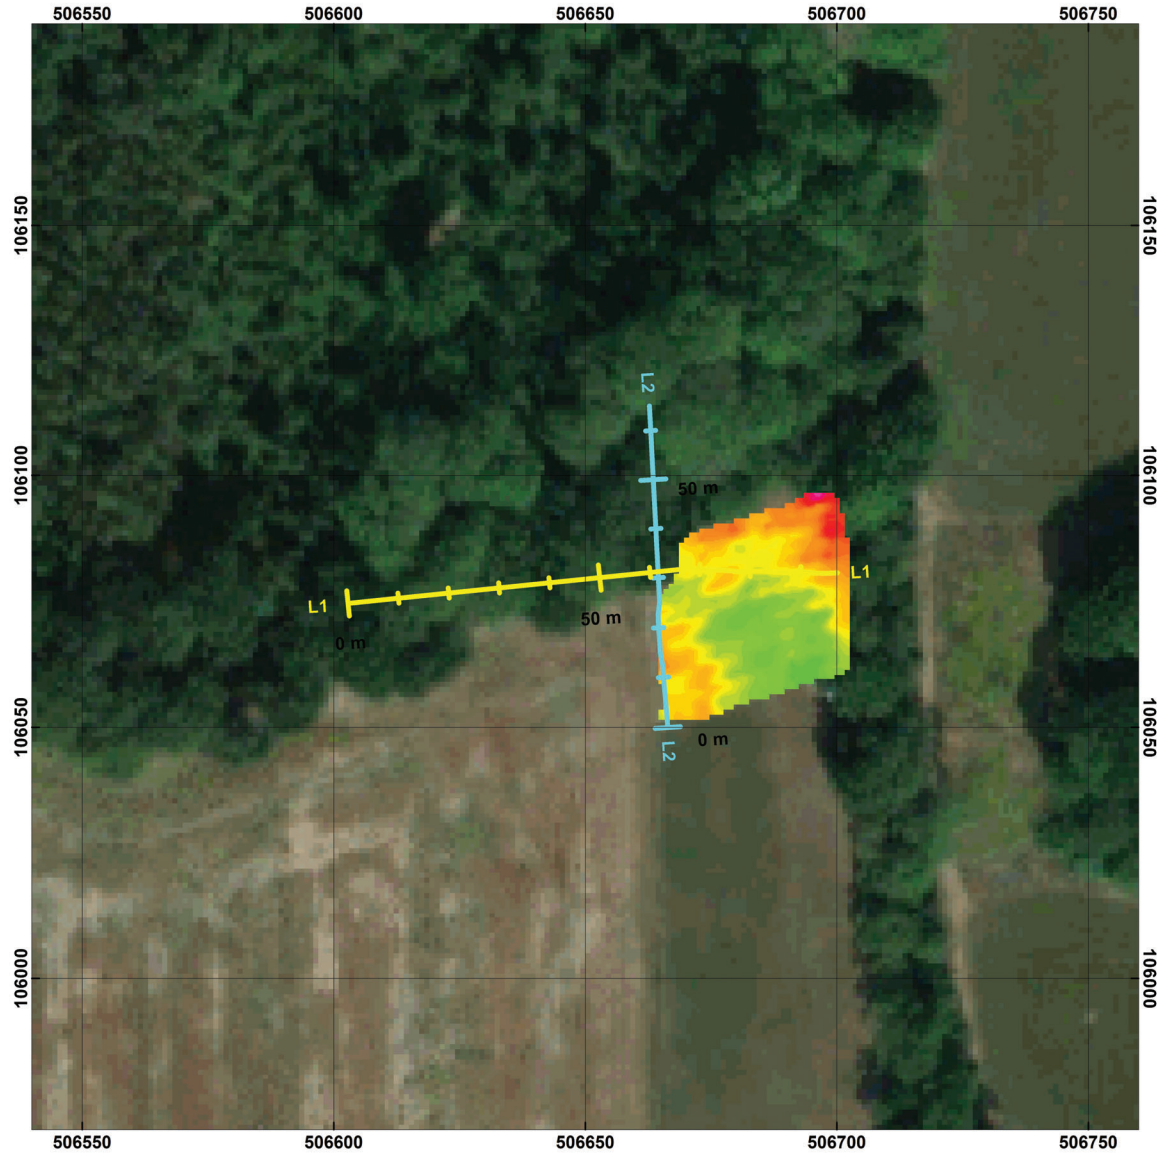
223150-D04B - LIONS TRIAL AREA EM RESULTS - APPROX. DEPTH 4.4 m

CLIENT:		WSP	
PROJECT:		LITTLEHAMPTON TO BOLNEY CABLE ROUTE GEOPHYSICAL SURVEY	
TITLE:		LIONS TRIAL AREA EM RESULTS APPROX. DEPTH 4.4 m	
PROJECT NO.:	223150	DRAWING NO.:	223150-D04B
ISSUE REFERENCE:	01	DATE:	06/06/2023
INTERP BY:	AD	DATE:	06/06/2023
CHECKED BY:	BB	DATE:	06/06/2023
DRAWING SCALE:	1:1000	APPROVED BY:	DK
PLOTTED DRAWING SIZE: A3 (420mm x 297mm)			
FUGRO GEOSERVICES LIMITED Fugro House, Blenheim Road Wallingford, Oxfordshire, OX10 9BB Tel: +44 (0)1793 4021400

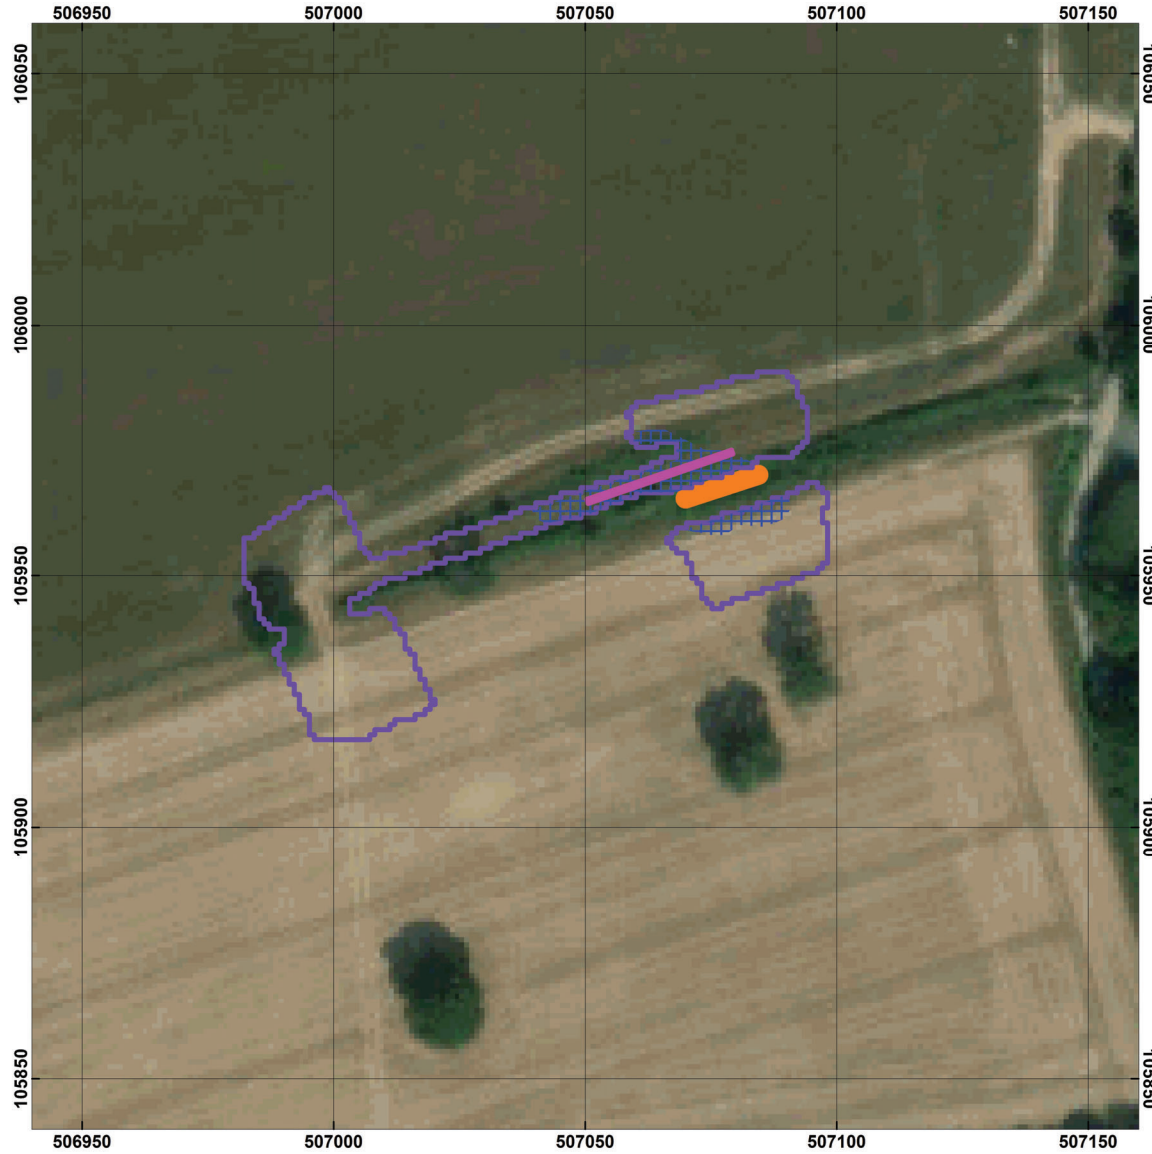
223150-D08 - SWILLAGE BARN SINK HOLE TRIAL ANOMALY LOCATION PLAN

The interpretation of the electromagnetic conductivity results for anomalies possibly related to solution features was based upon the relatively low apparent conductivity anomaly observed at the location of the Swillage barn sink hole. Localised regions of relatively low apparent conductivity were visually identified from the 3 different depth measurements across the main survey area. The larger scale trend in apparent conductivity values associated with the depth variation in the chalk bedrock provided a complication to the interpretation. To aid the visual interpretation of the EM results, a linear trend pattern was removed from the 6.6 m depth conductivity measurements. The trend which was removed from the data has been shown (drawing no. 223150-D11D). The results with the trend removed has been shown in drawing no. 223150-D11E. This trend-removed (residual) data was used in conjunction with the original data for the 2.2, 4.4 and 6.6 m depth apparent conductivity data to identify localised anomalous regions within the electromagnetic conductivity data which could possibly indicate the presence of solution features.
