**NORTH FALLS**

*Offshore Wind Farm*

### Appendix 16.1 Archaeological Assessment of Geophysical Data

Archaeological Assessment of Geophysical Data

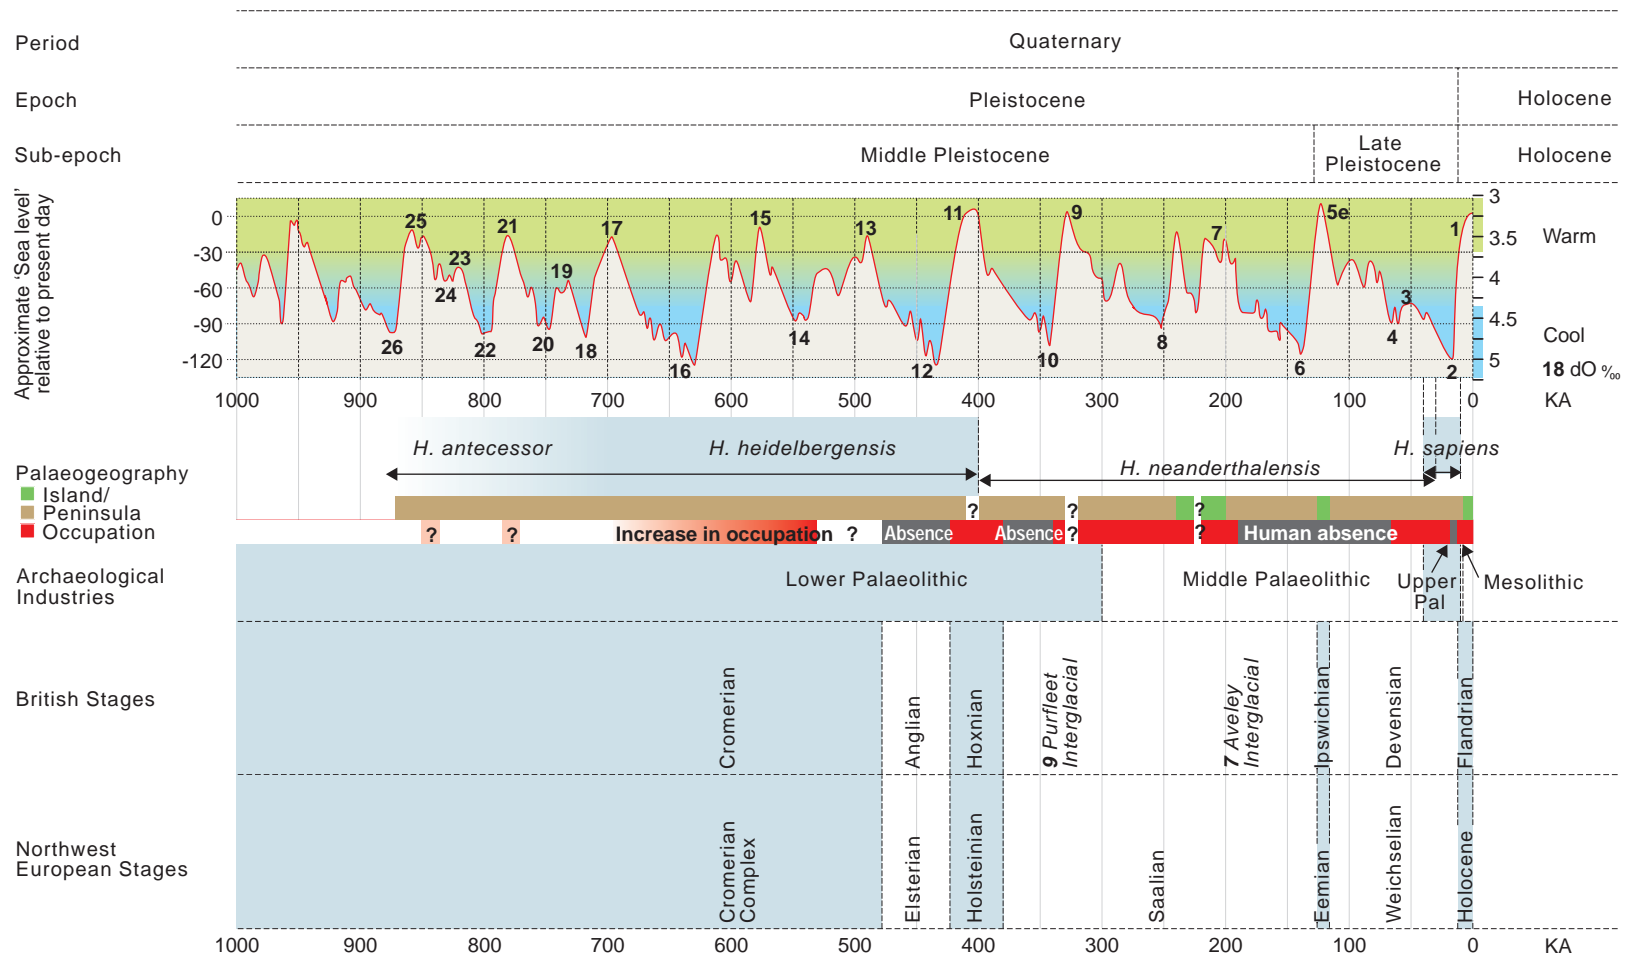
Figure 2

The figure presents information derived from several references: the global sea-level curve is from Lisiecki and Raymo (2005) and Jelgersma (1979). Details on the geology and archaeology were provided by Dix and Westley (2004); Funnel (1995); Gibbard and van Kolfshoten (2004); Kukla et al. (2002); Lee et al. (2006); Lowe and Walker (1997) and Wymer (1999).

Sea level curve and chronology of the North Sea

- 3.1.9 Whilst the archaeology at Pakefield was created during a more Mediterranean climate, around MIS 17 (Fig. 2), the remains at Happisburgh Site 3 are indicative of colder-than-present conditions at the edge of the boreal zone (Candy *et al.* 2011), indicating that earlier

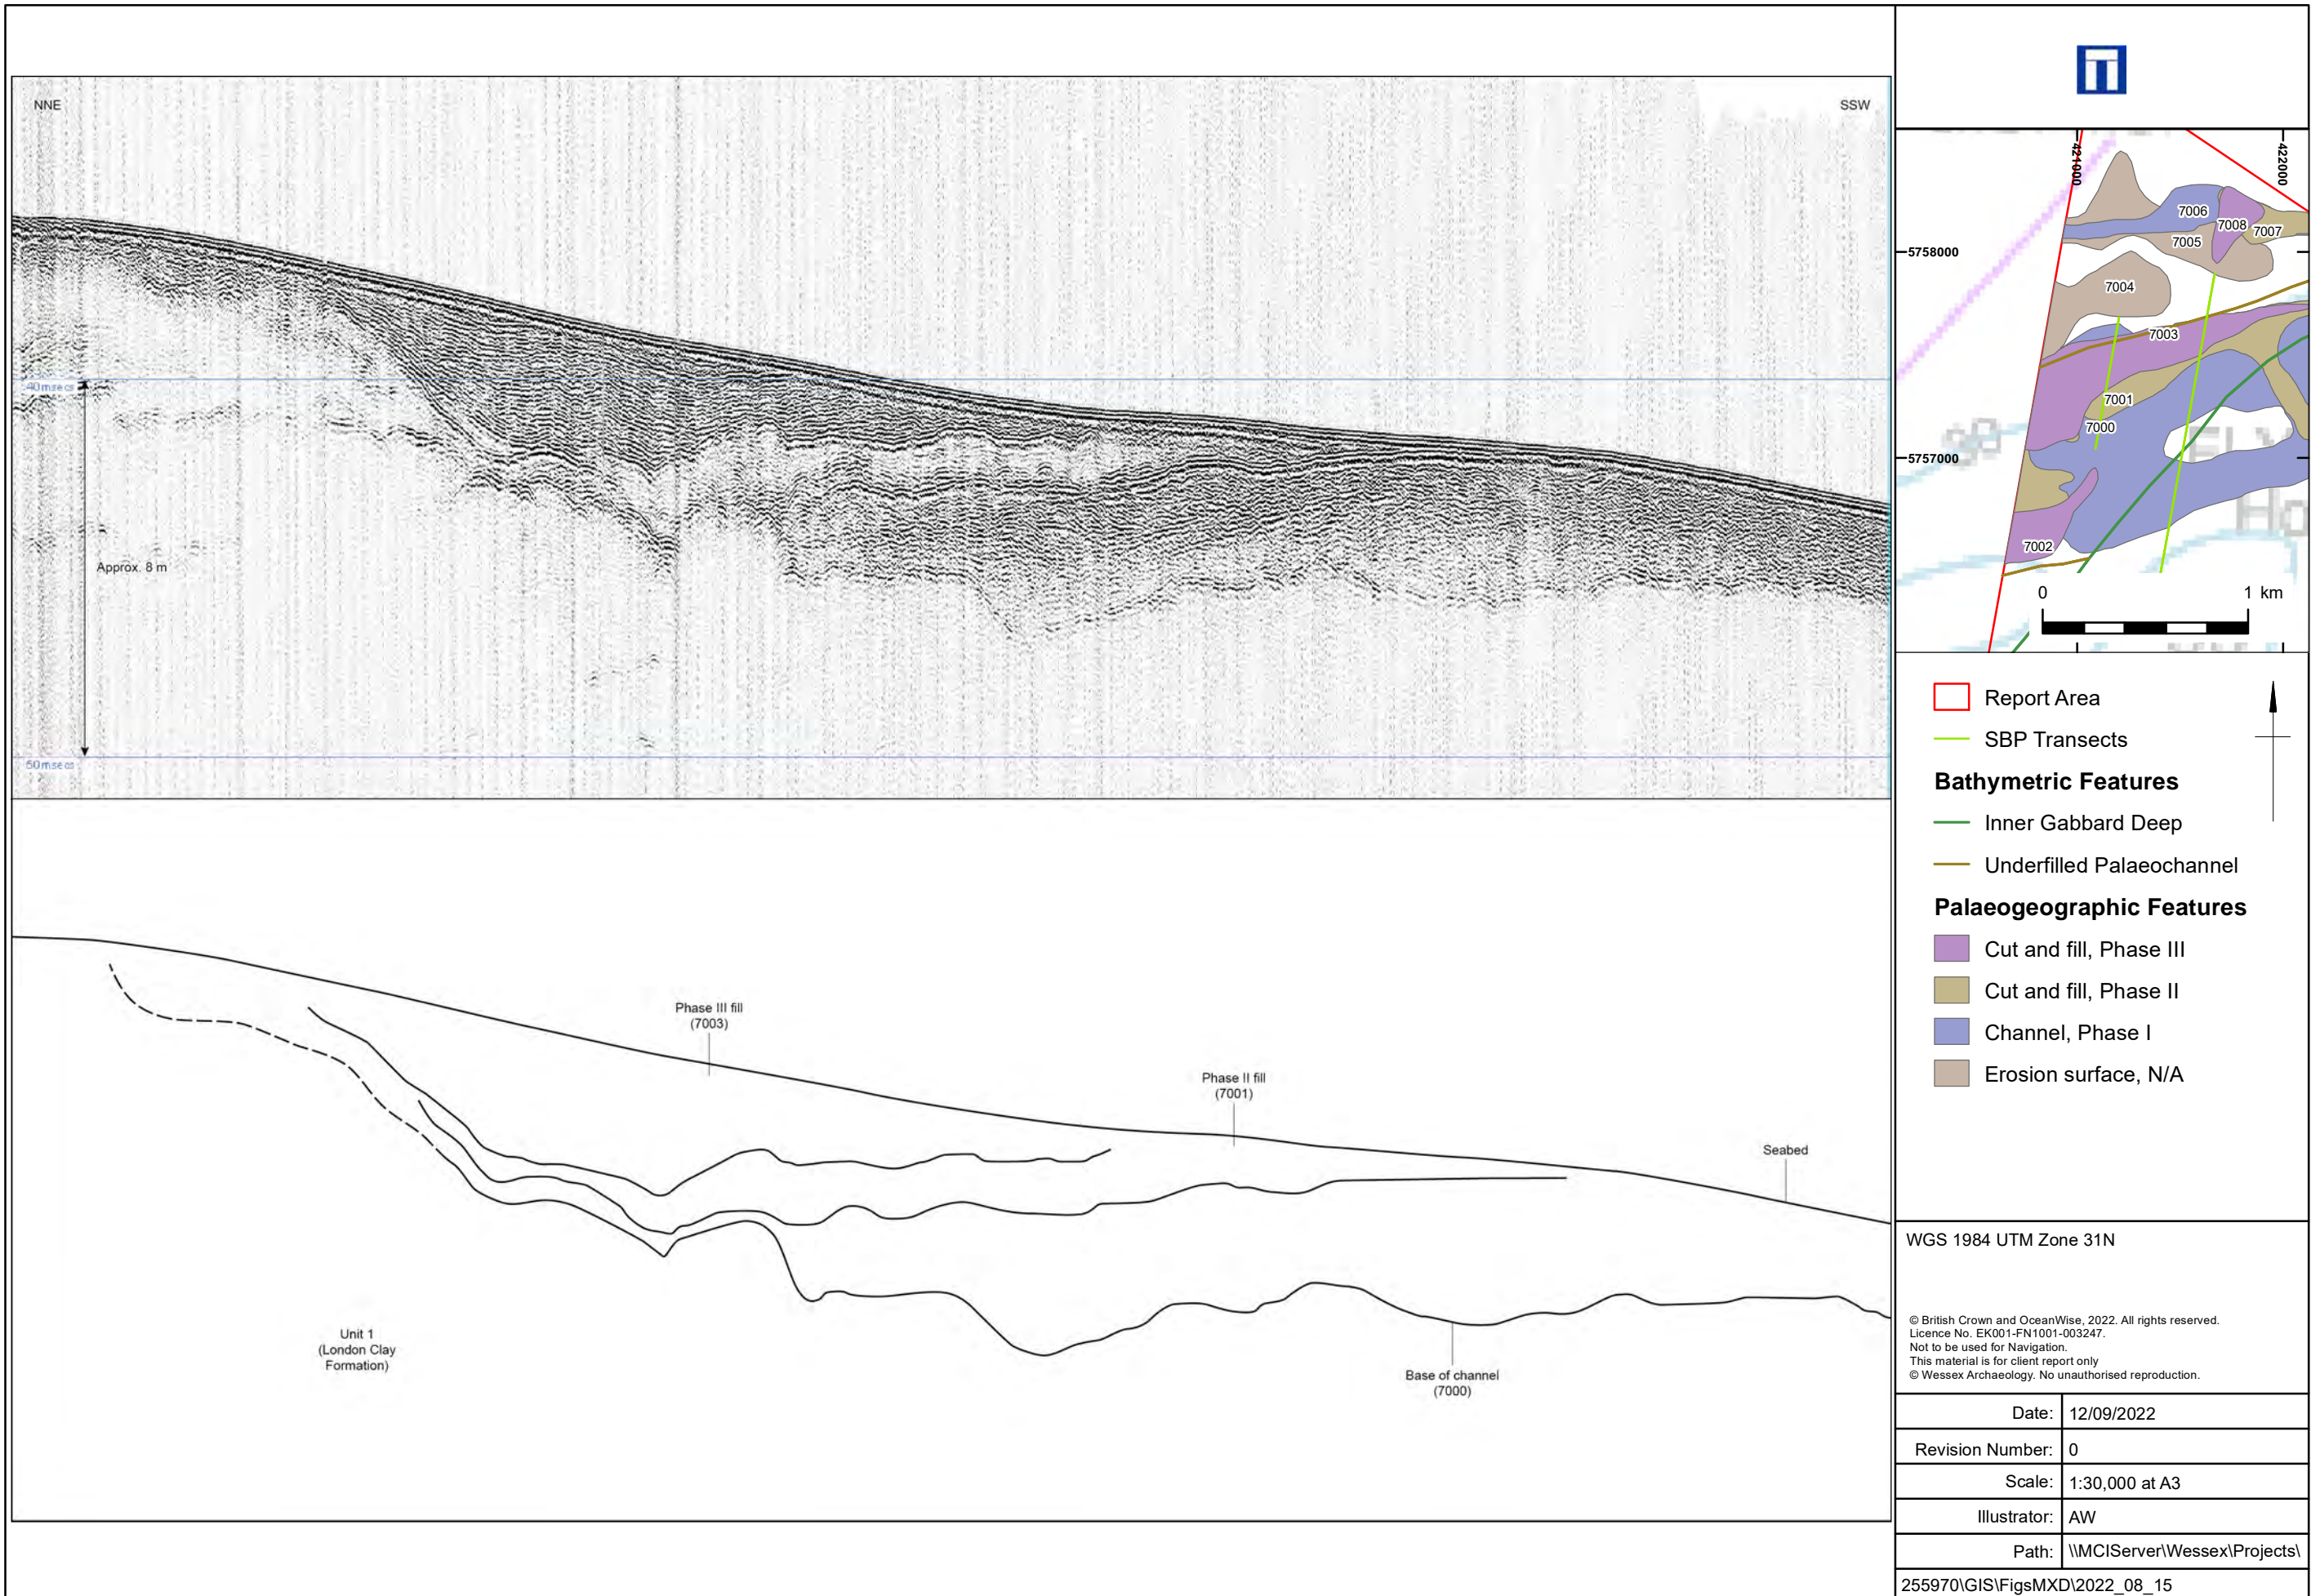
Figure 4

SBP data example – Channel 7000 and associated fills

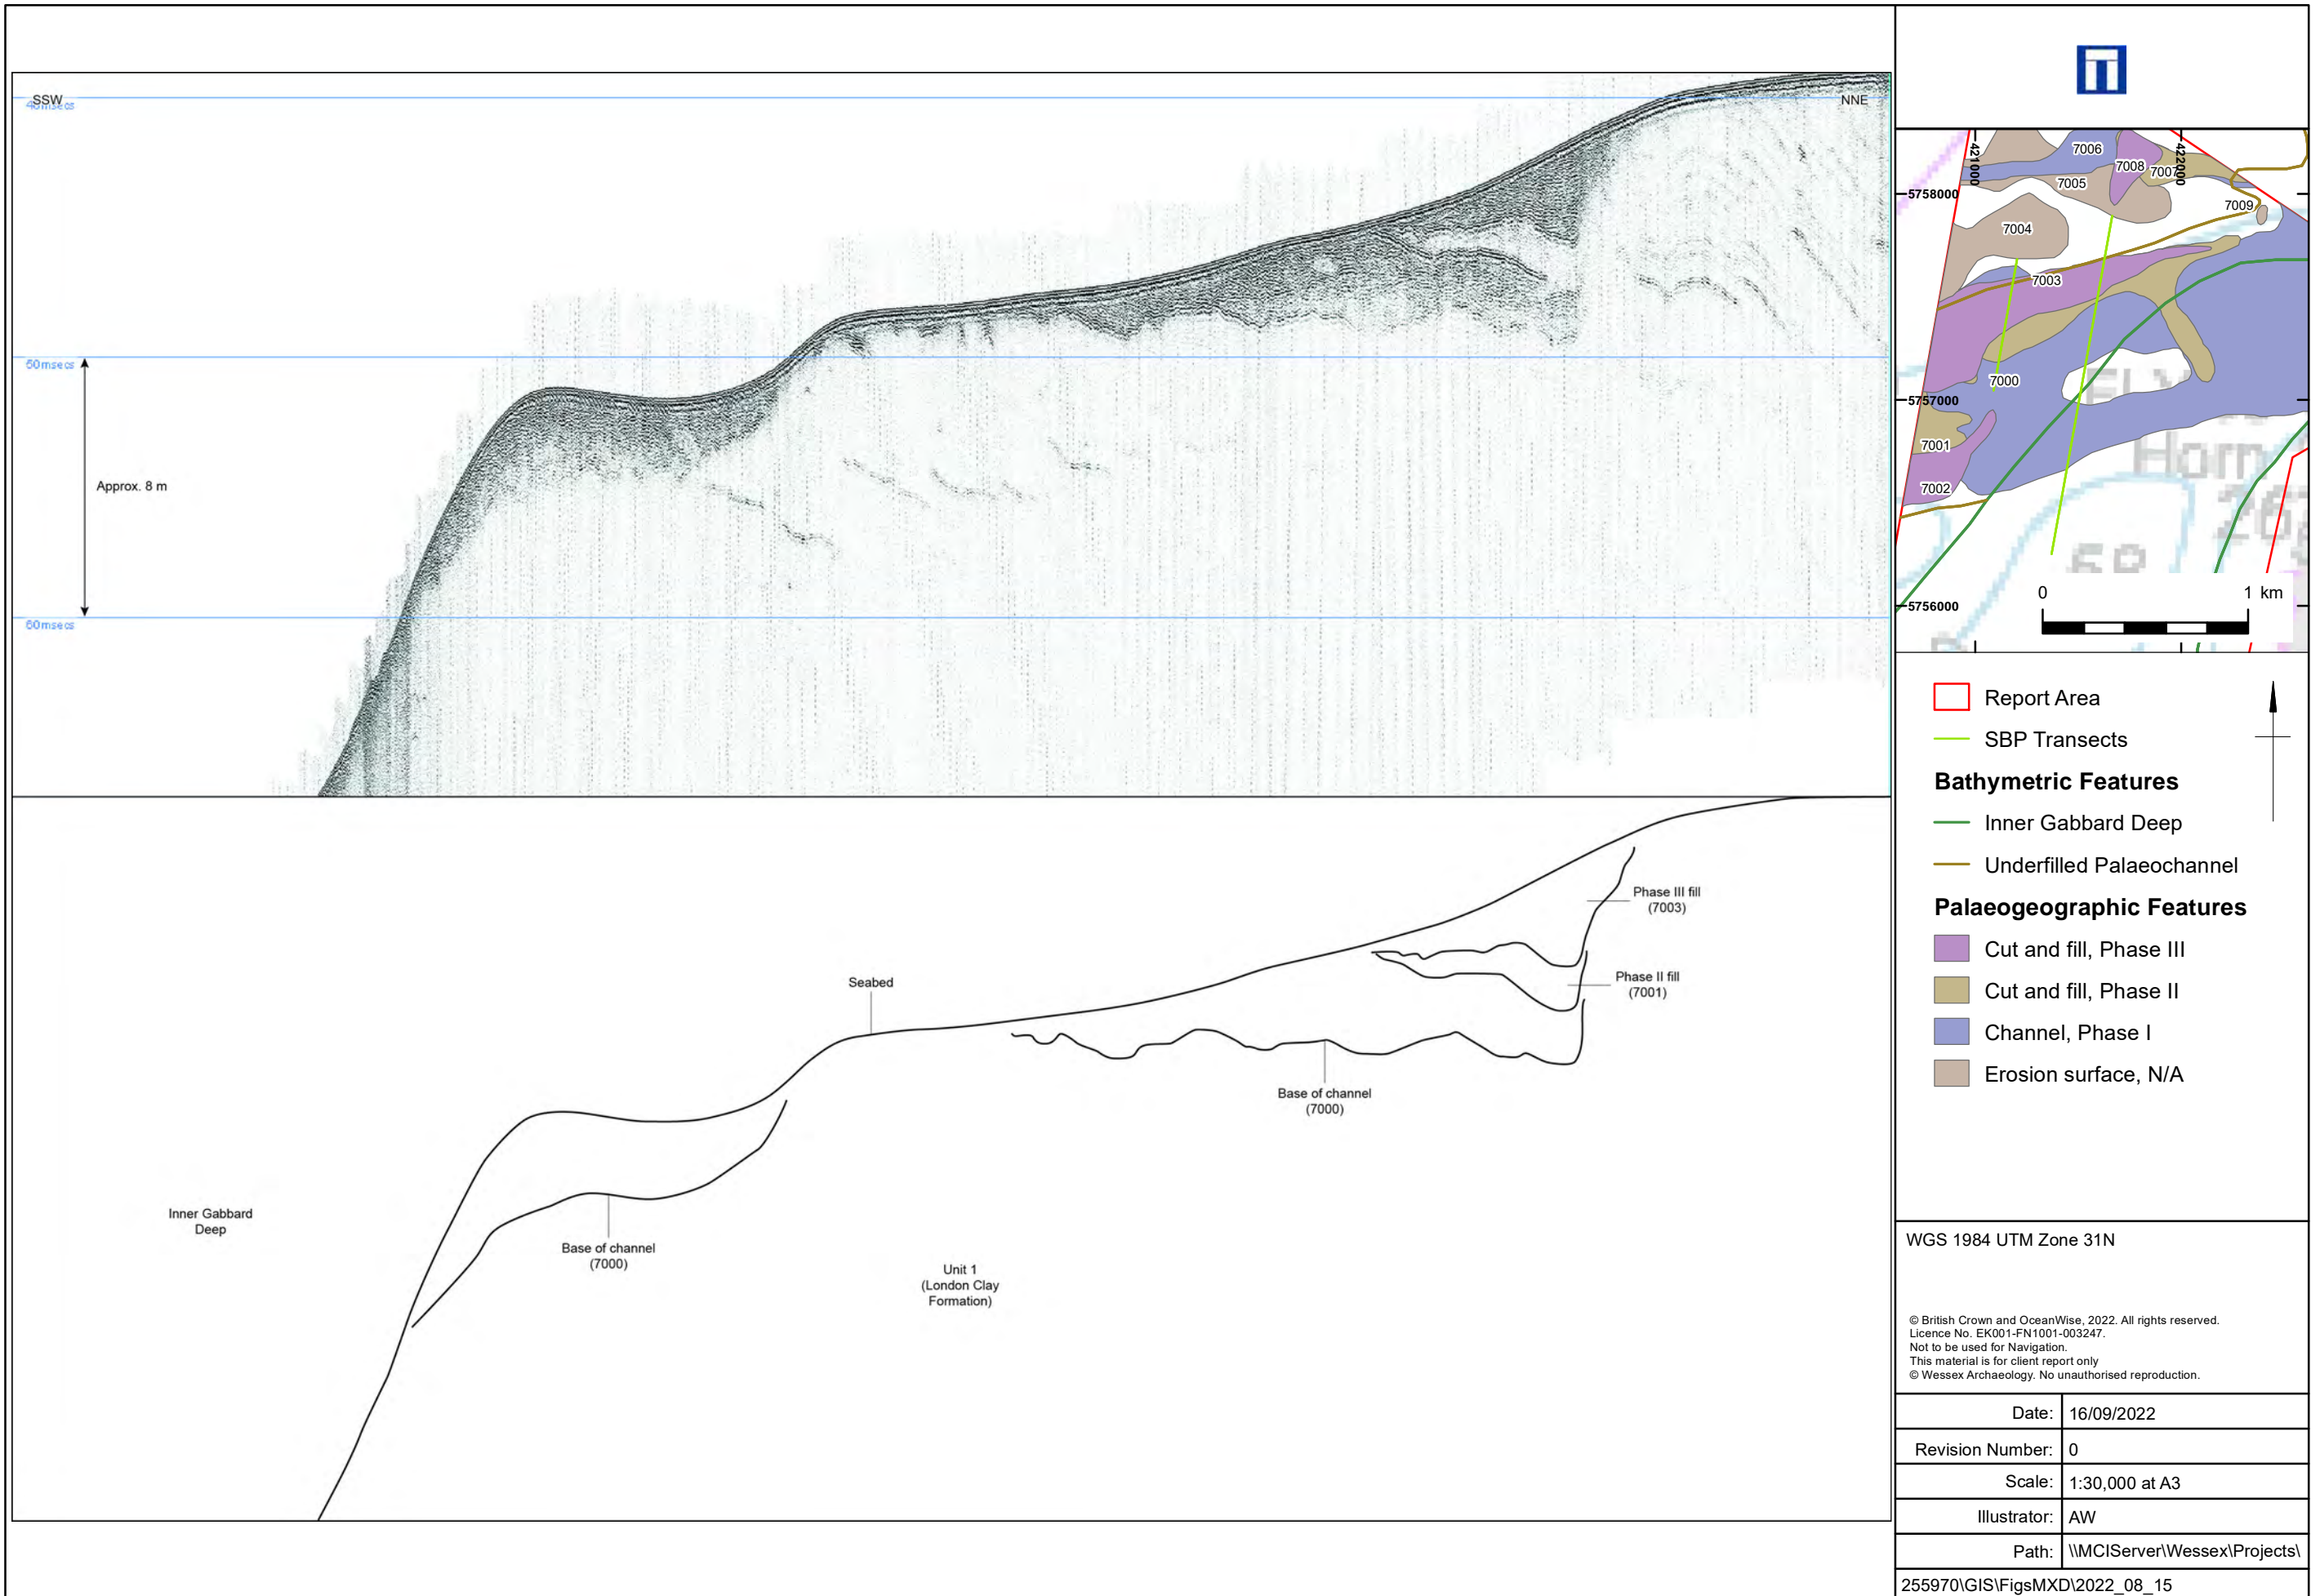
Figure 5

SBP data example – Channel 7000 and Inner Gabbard Deep

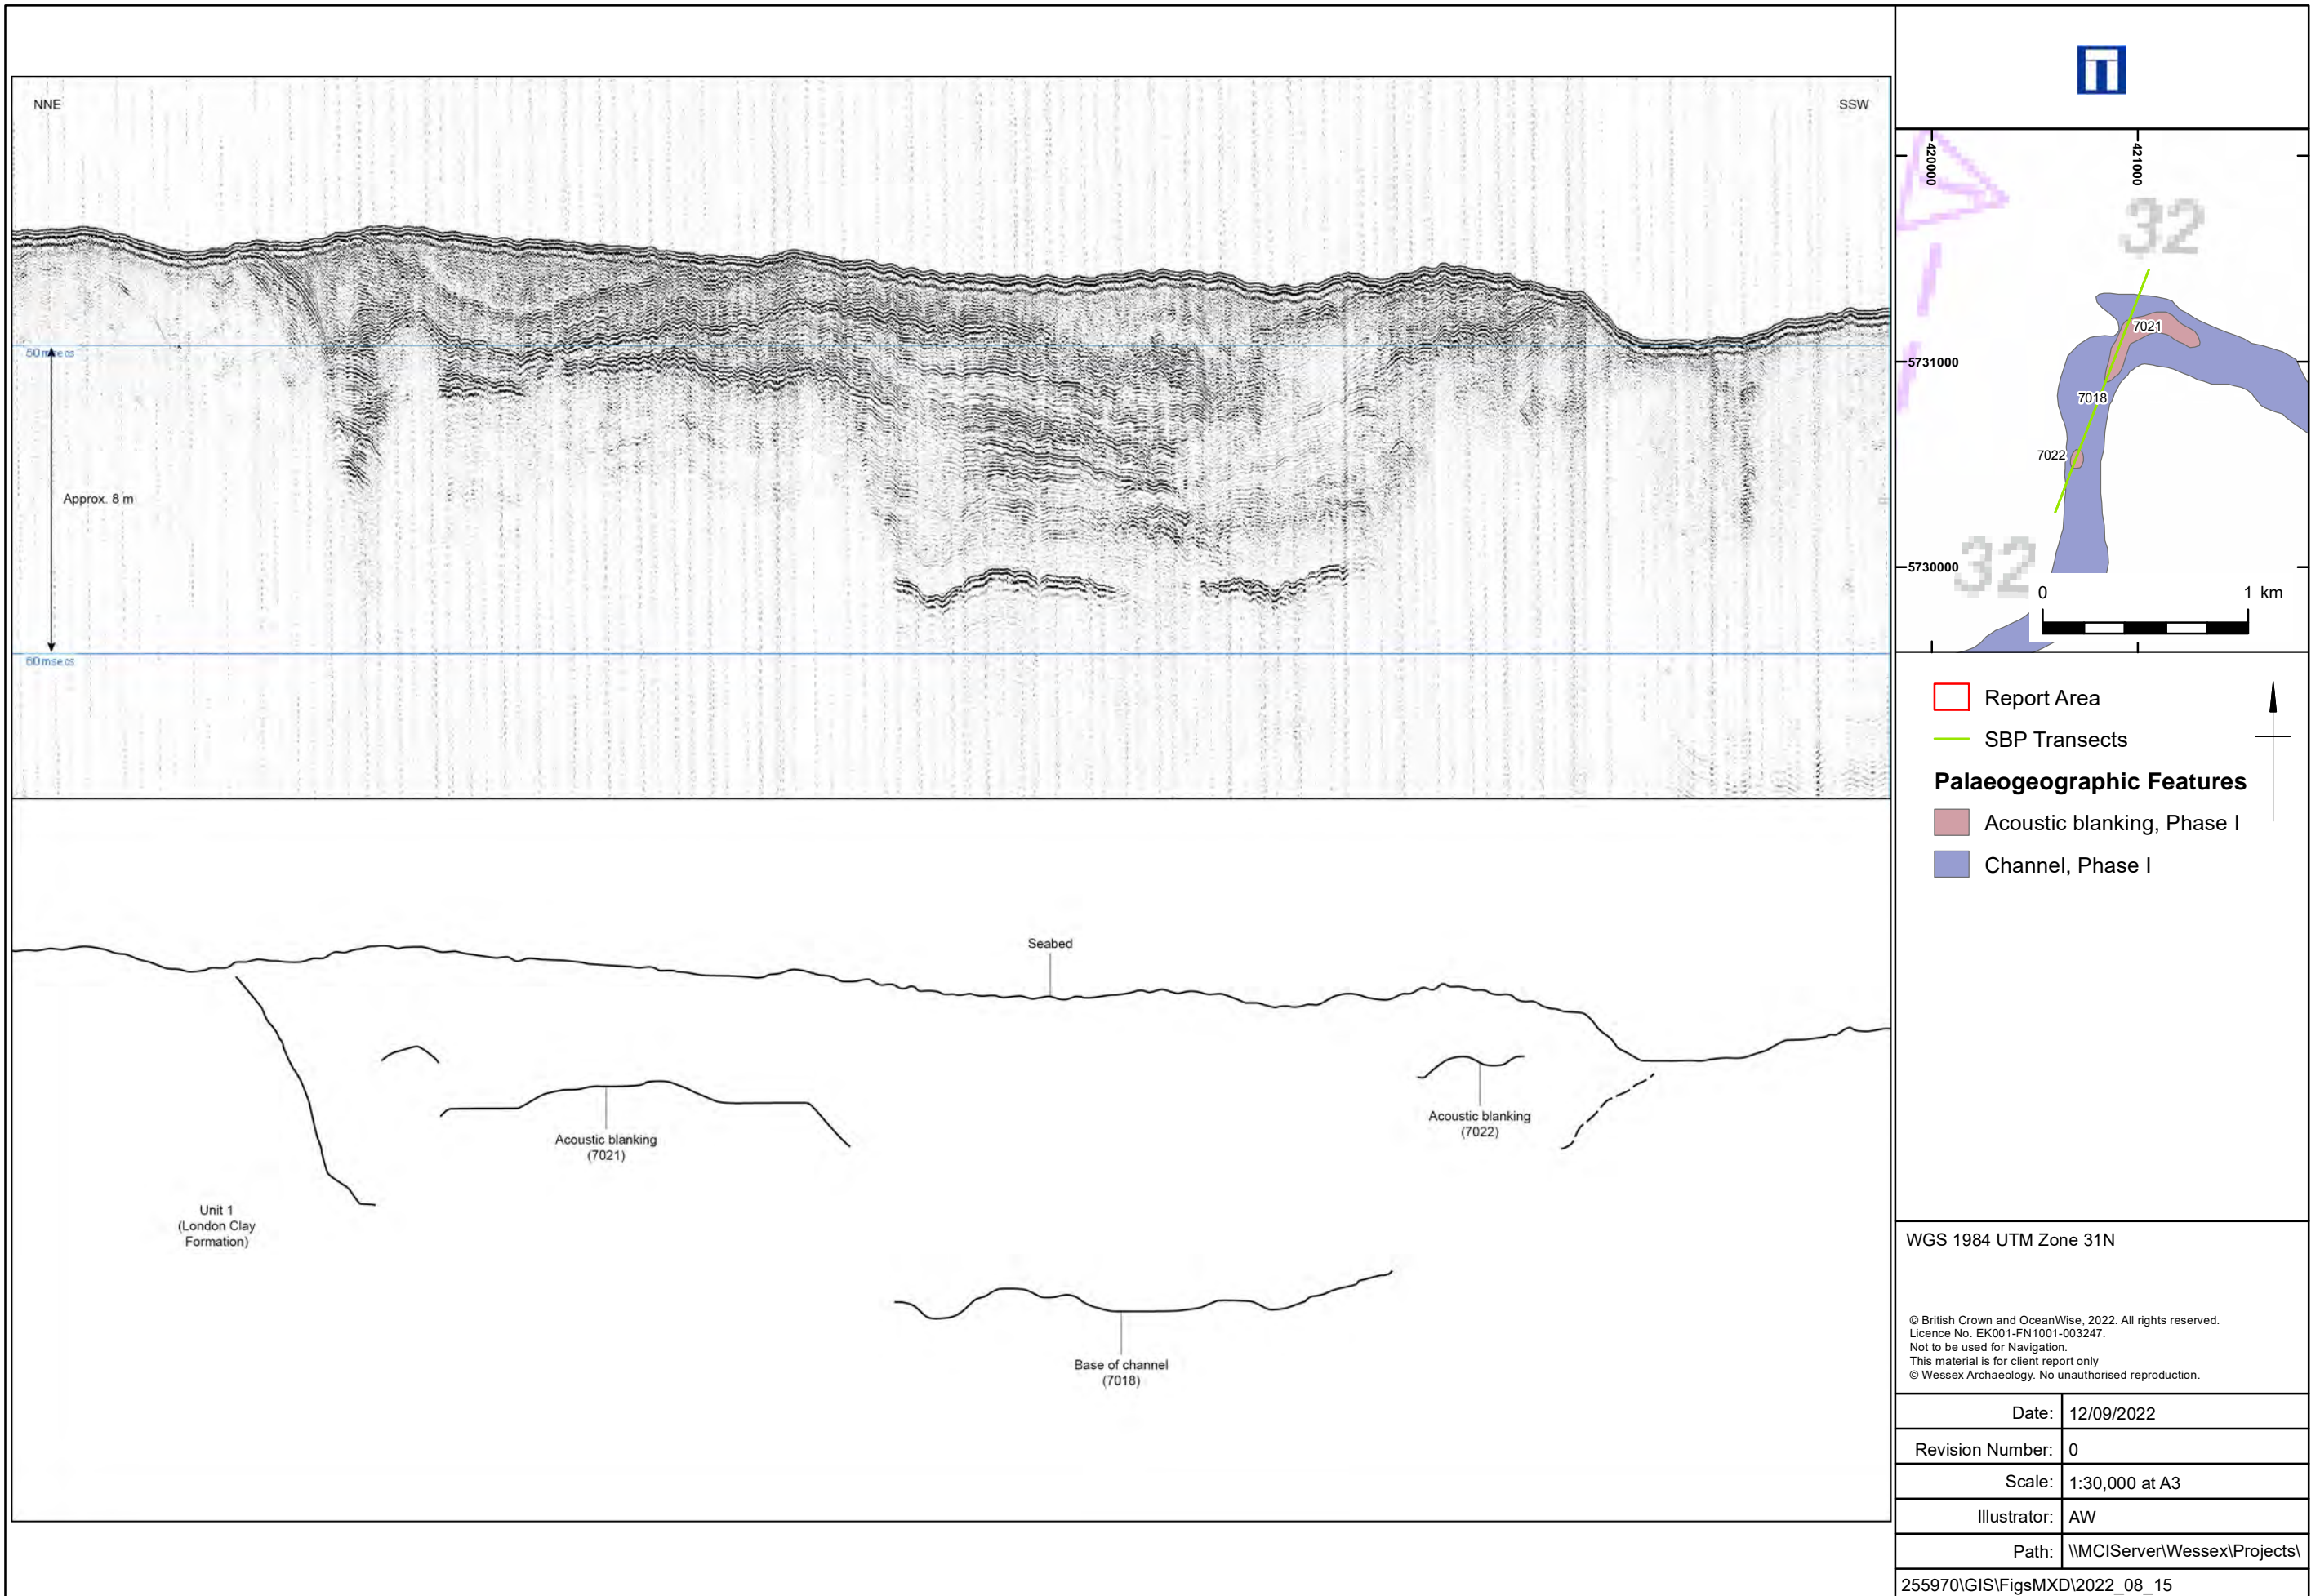
Figure 7

SBP data example – Channel 7018 and associated acoustic blanking

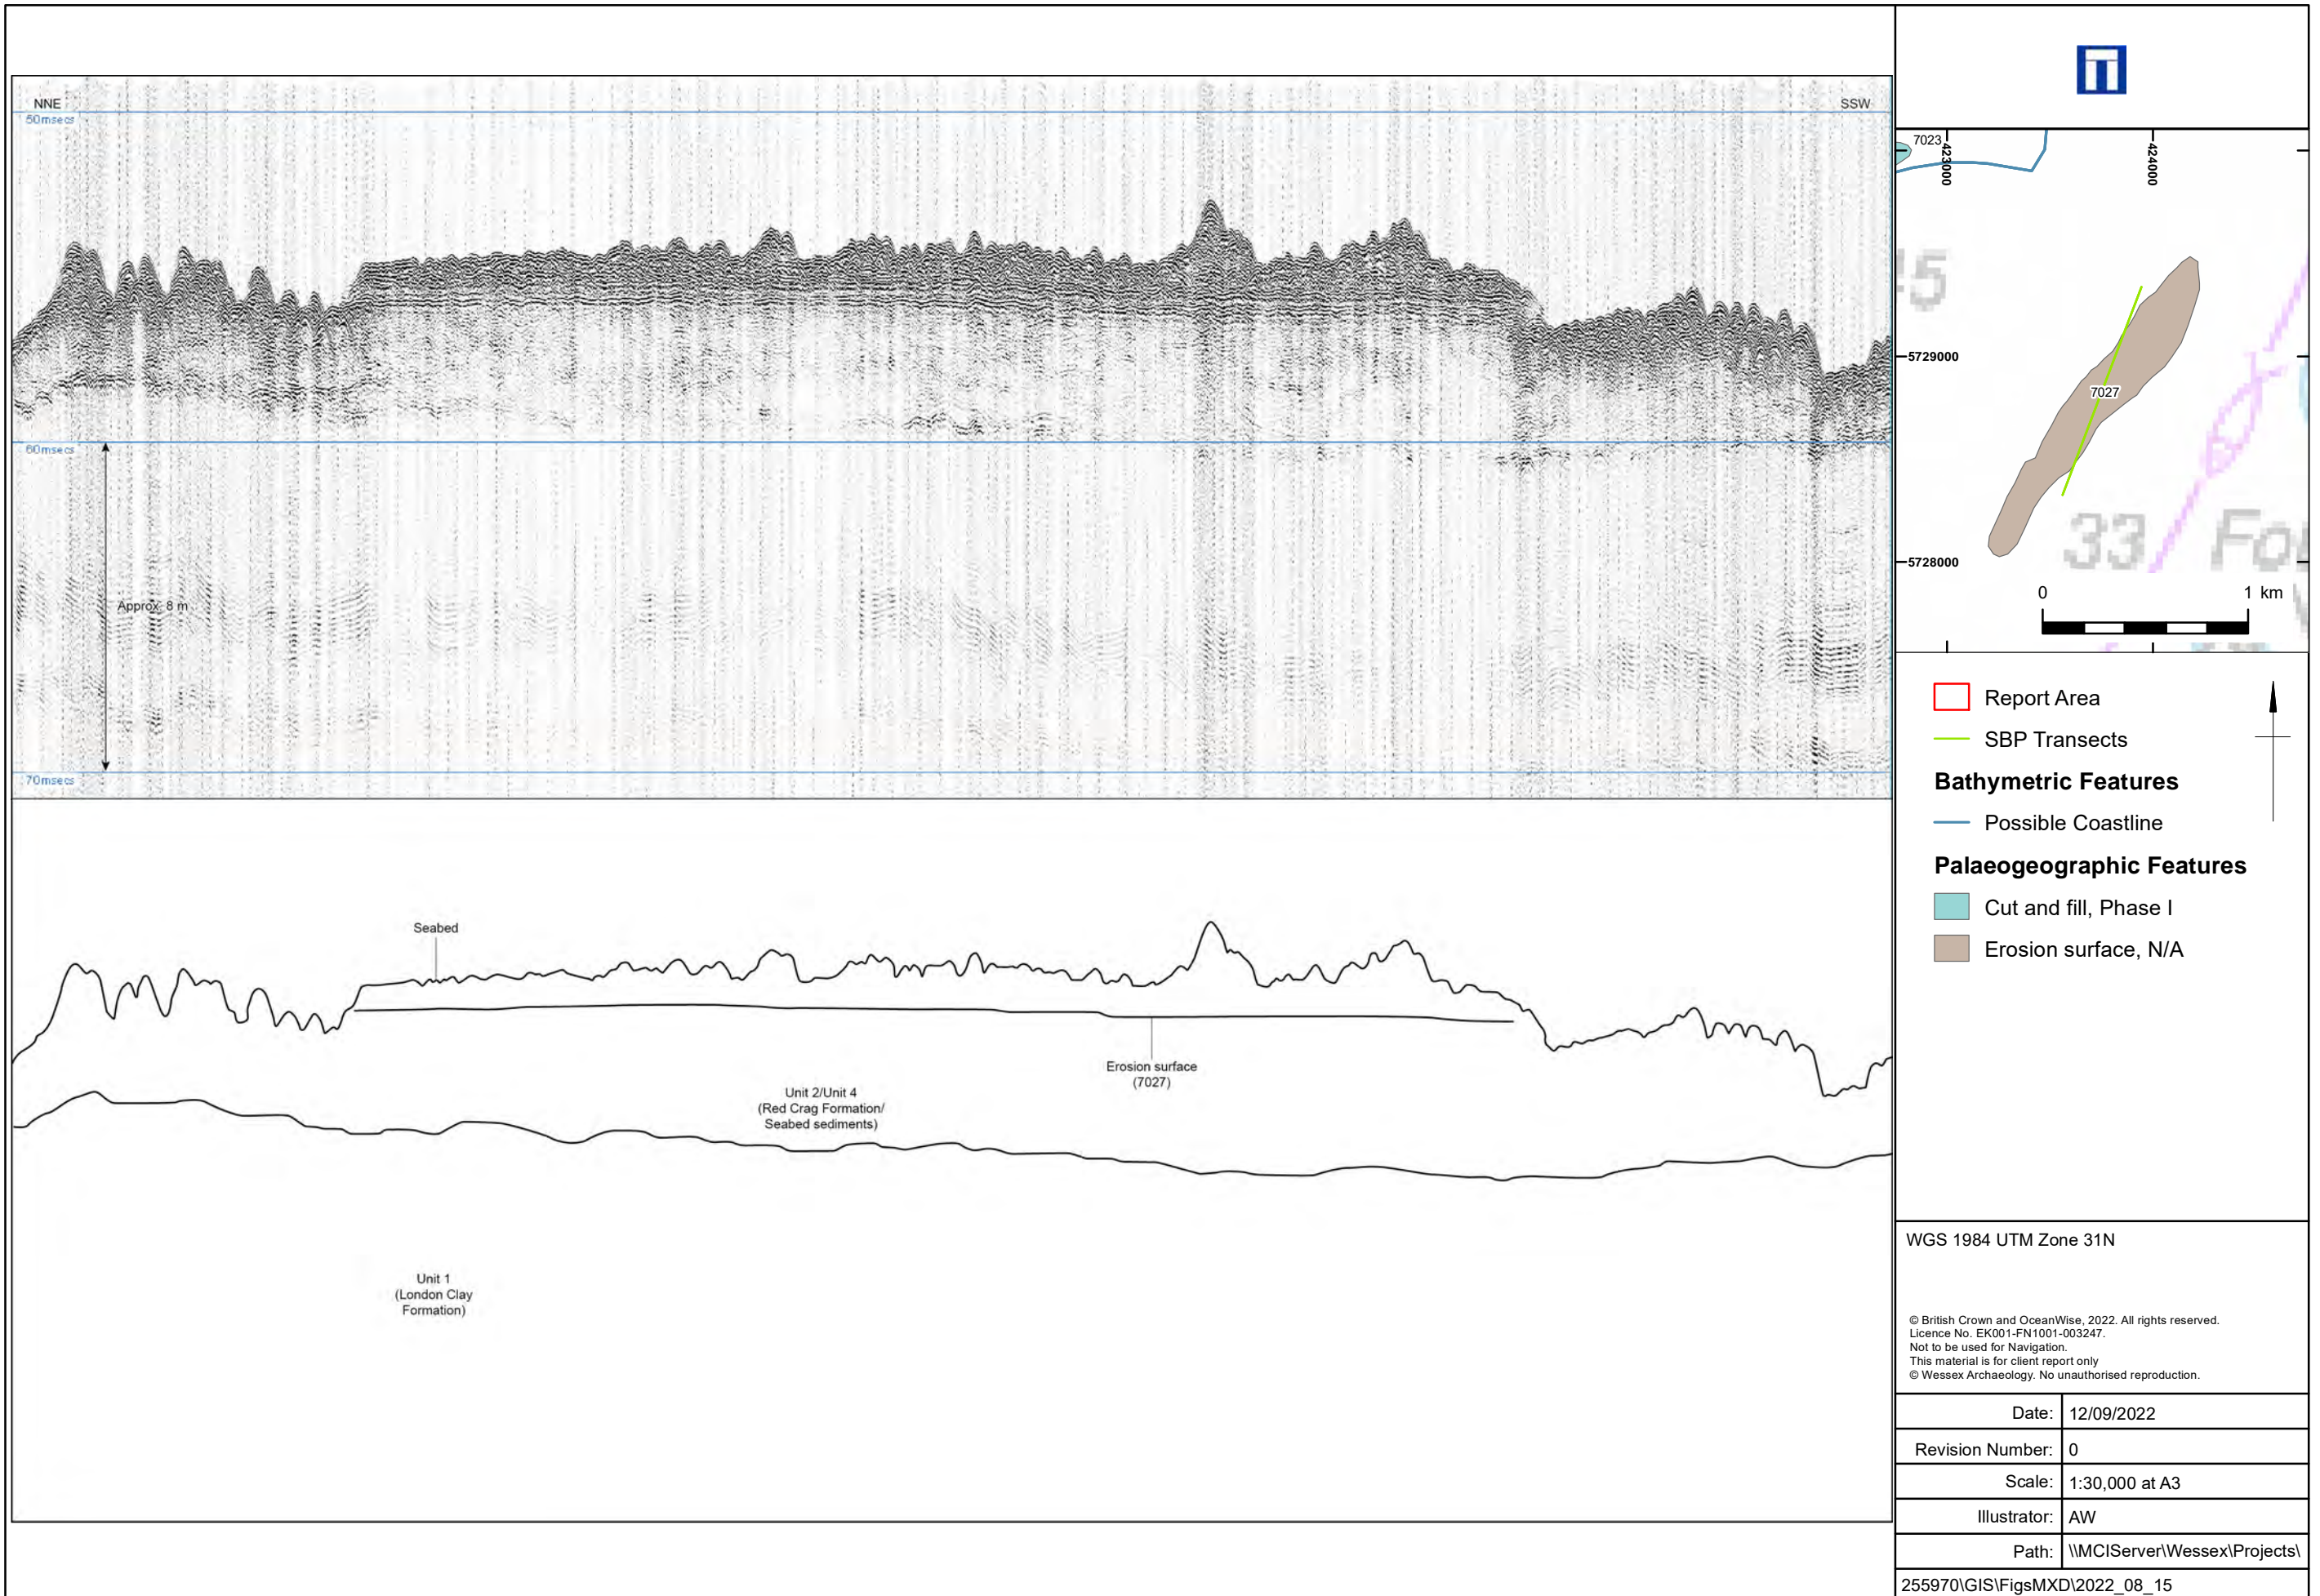
Figure 9

SBP data example – Feature 7027

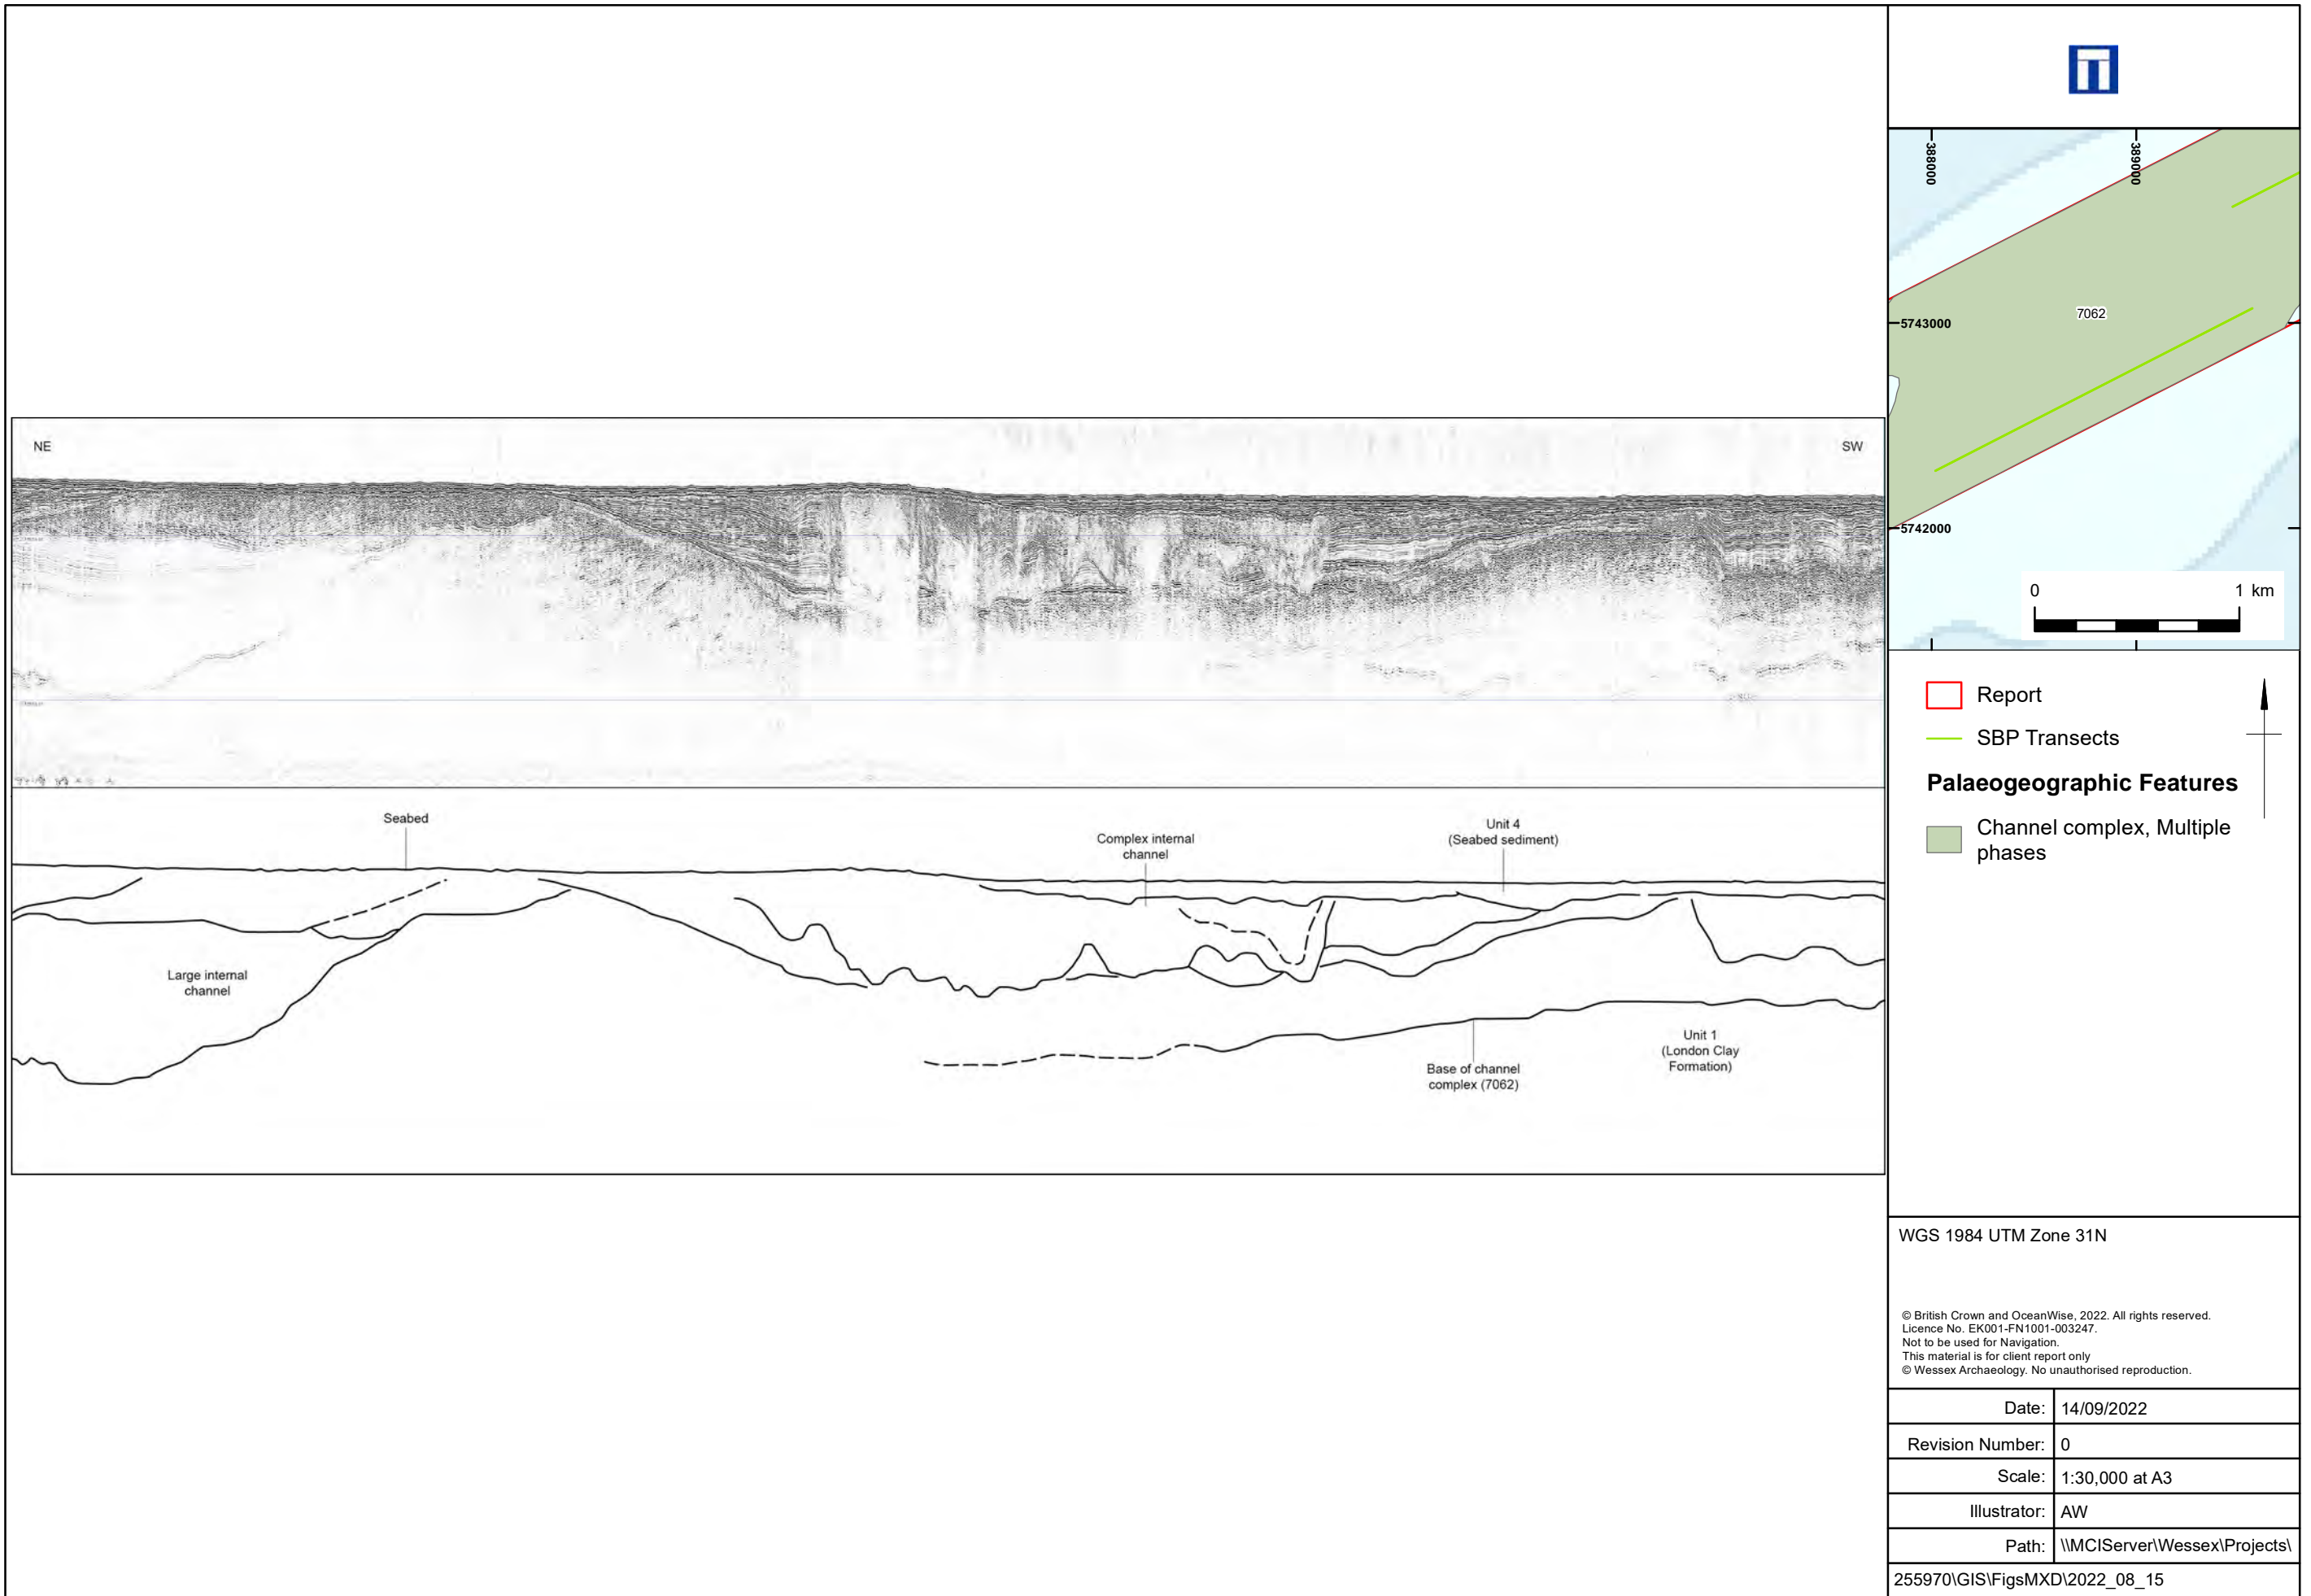
Figure 13

SBP data example – Channel complex 7062 (2)
