**NORTH FALLS**

*Offshore Wind Farm*

### Appendix 16.1 Archaeological Assessment of Geophysical Data

Archaeological Assessment of Geophysical Data

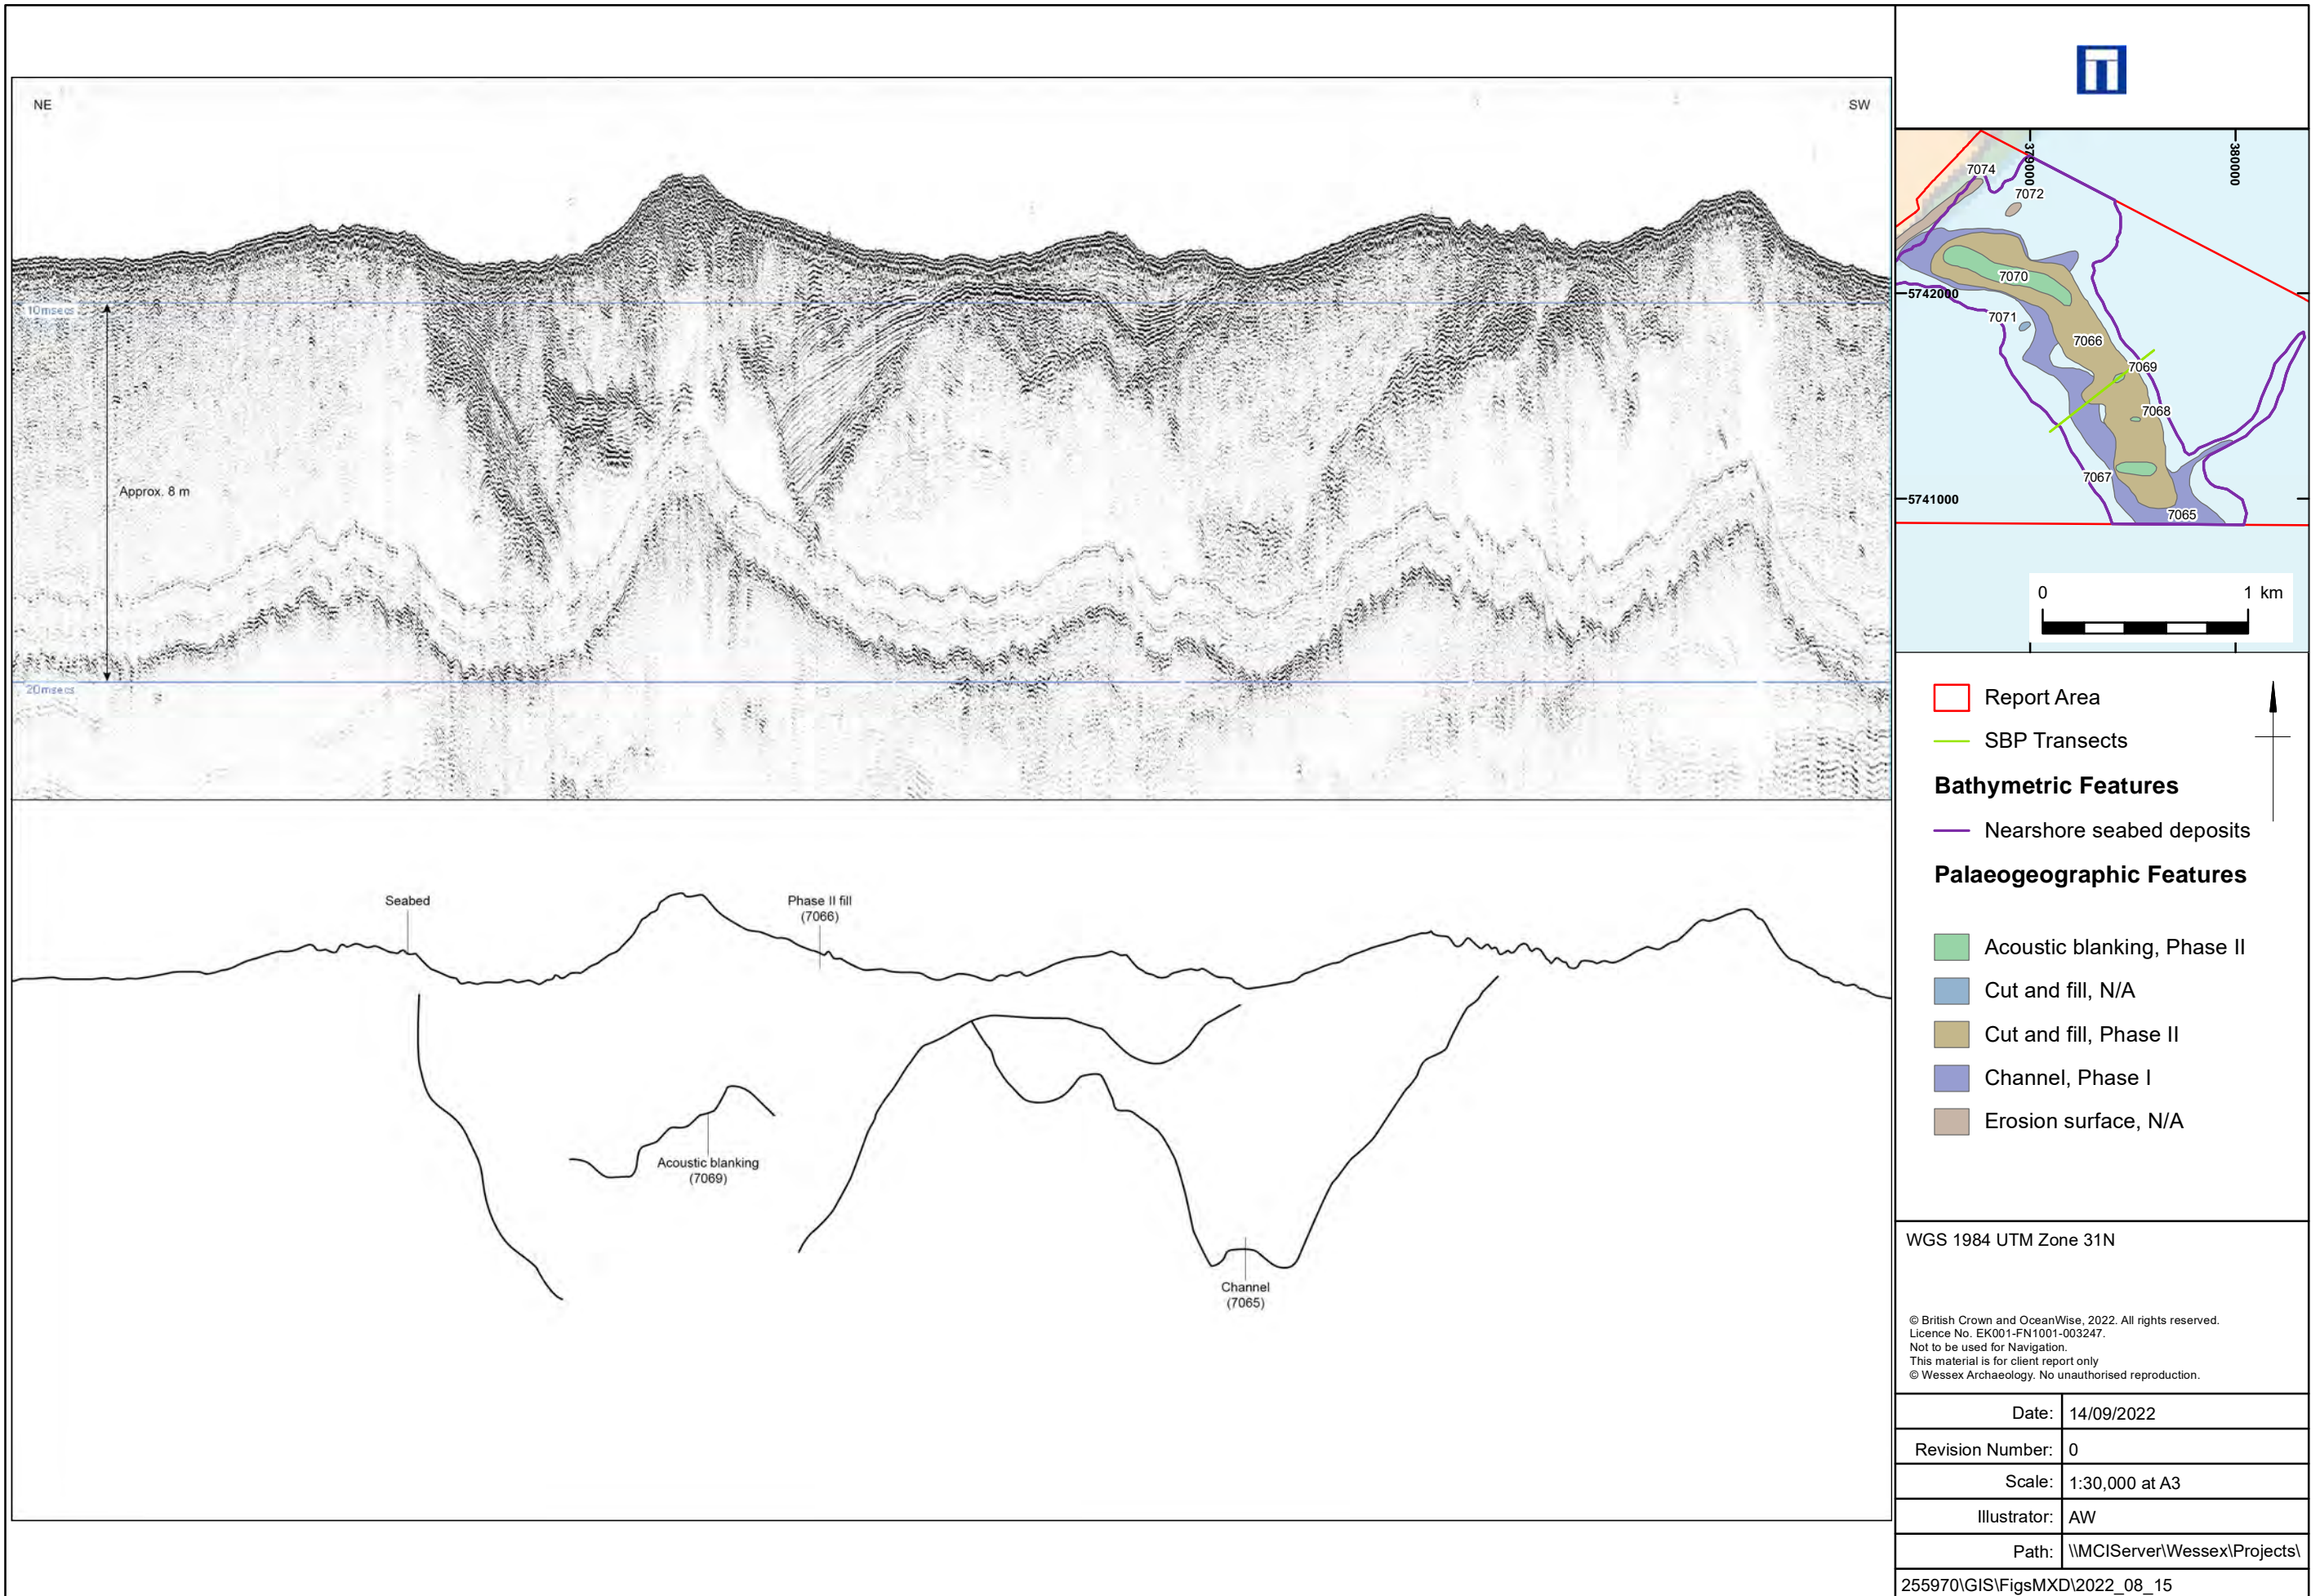
Figure 14

SBP data example – Channel 7065 and associated fills

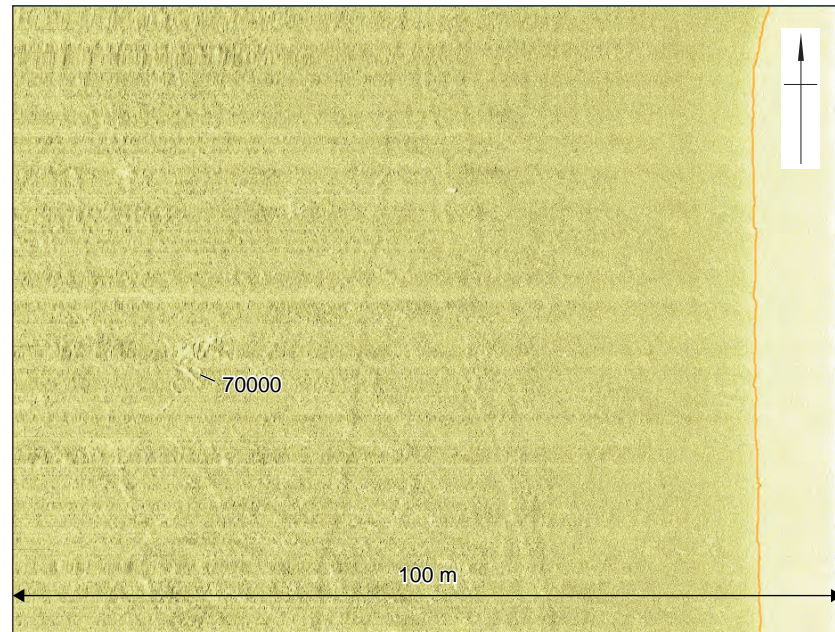
Anomaly **70000**, SSS waterfall image, 100 m range per channel

Anomaly **70000** - mag. profile image

- 4.2.5 No wrecks, either previously charted or newly identified, were observed in the northern array area.
- 4.2.6 Of the 76 anomalies in the northern array area (Figs 15a-15b), one has been classified as a debris field. Anomaly **70000** is visible in the SSS data as small cluster of straight and curved linear dark reflectors measuring 22.6 x 4.7 x 0.1m with an associated medium magnetic anomaly of 80nT (Fig. 16). This has been interpreted as possible ferrous debris.

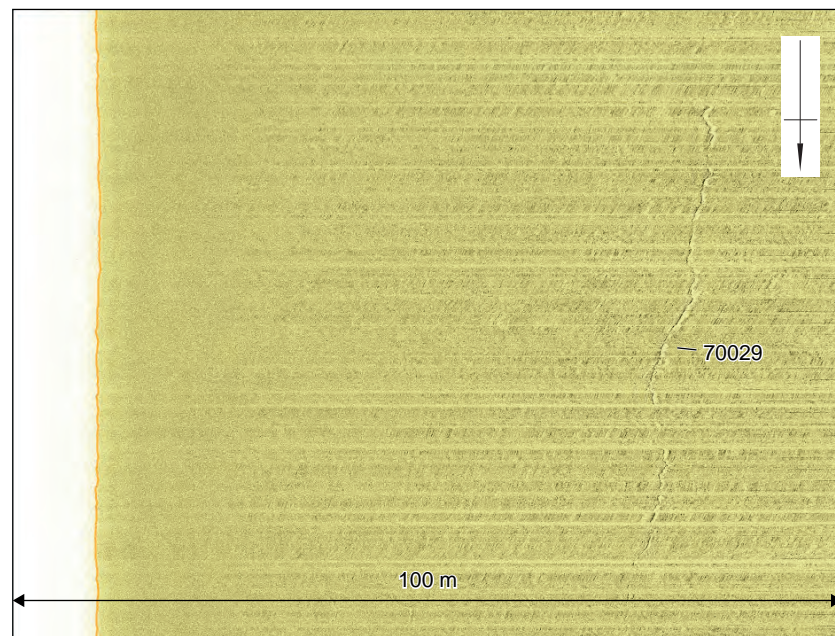
Anomaly **70029**, SSS waterfall image, 100 m range per channel

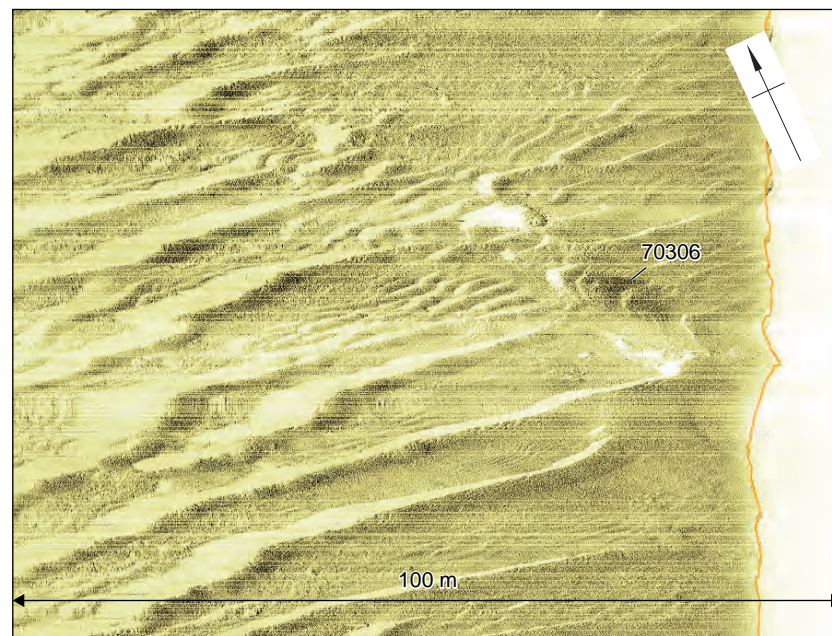
Anomaly **70306**, SSS waterfall image, 100 m range per channel

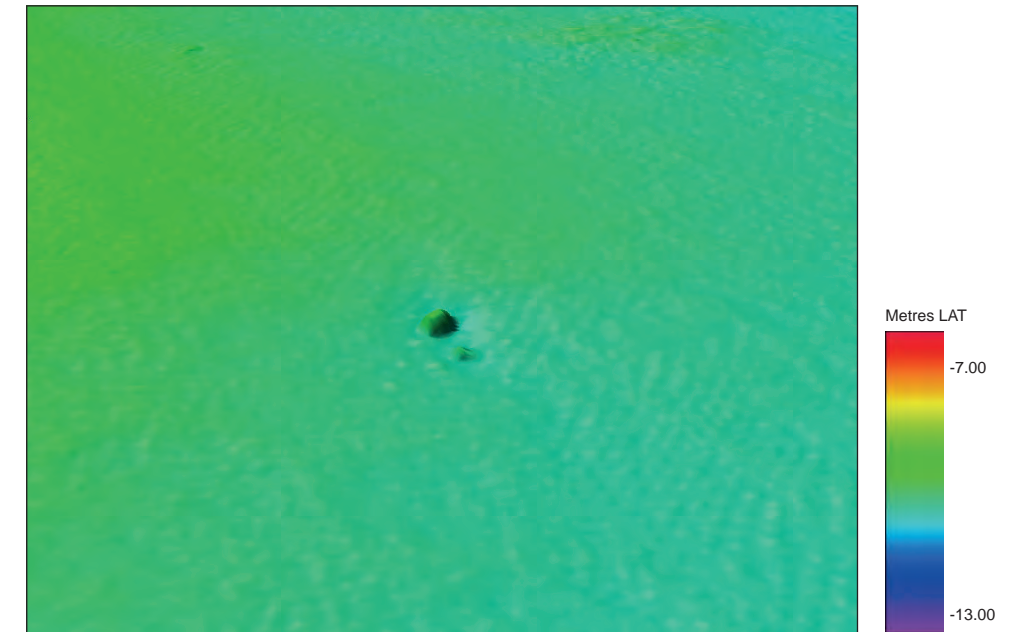
Anomaly 71476, SSS waterfall image, 50 m range per channel

Anomaly 71476, MBES grid image, x 1 vertical exaggeration, looking northeast

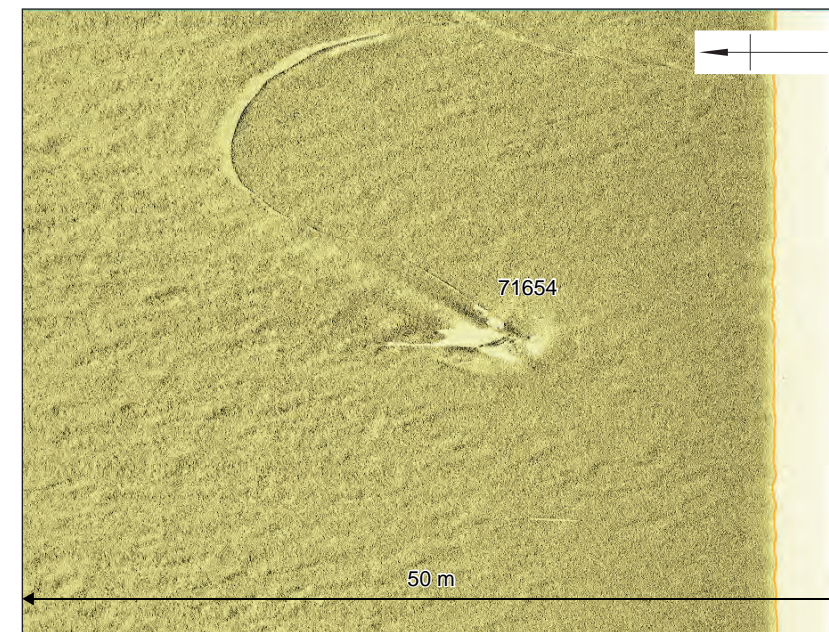
Anomaly 71654, mag. profile image

Anomaly 71654, SSS waterfall image, 50 m range per channel

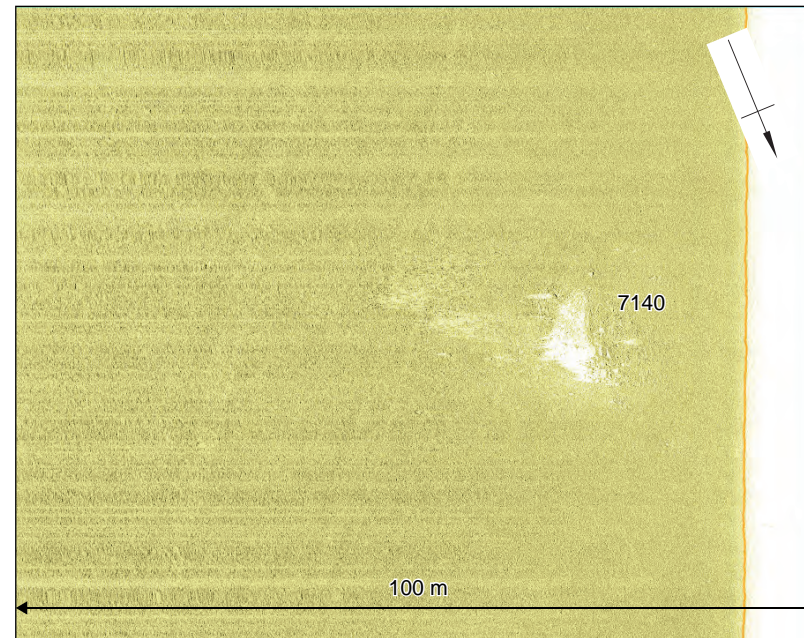
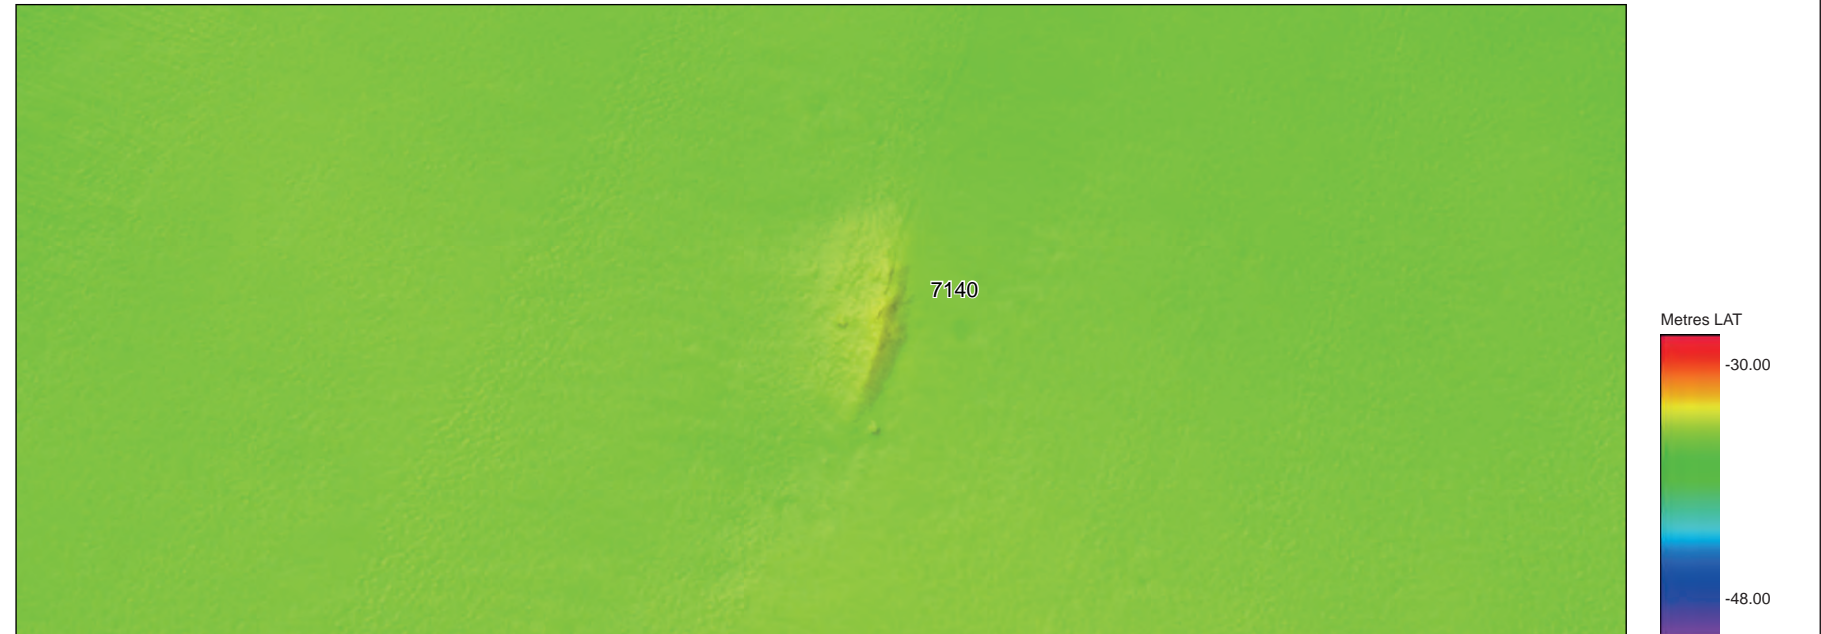
<b>Extent of Survival</b>	This was also identified by Wessex Archaeology in 2009 as a mound with little recognisable structure, measuring 46.0 x 14.0 x 1.9 m with an small associated magnetic anomaly, and interpreted as a badly damaged wreck.
	Associated with a UKHO record for an unknown wreck, first recorded by the UKHO on 6 January 1972, subsequently not found by a survey on 21 December 1995 and amended dead; most recently recorded on 20 February 2019 with a revised position.
	The wreck is described as possibly overturned and partially buried, with recorded dimensions of 39.0 x 12.5 x 1.7 m, lying at an orientation of 012 degrees.
	The apparent decrease in recorded dimensions between the 2009 and 2021 datasets indicates that degradation, damage, or collapse may have occurred to the wreck remains. These remains may also have been subject to dispersal by, or burial within, the surrounding seabed sediments.

SSS waterfall image, 100 m range per channel

MBES grid image, x 1 vertical exaggeration, looking north

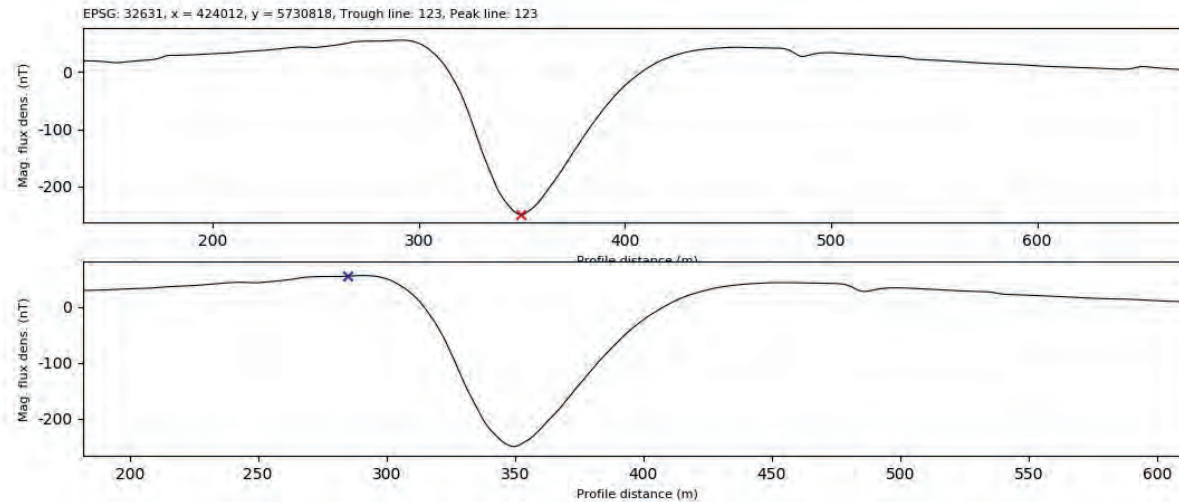
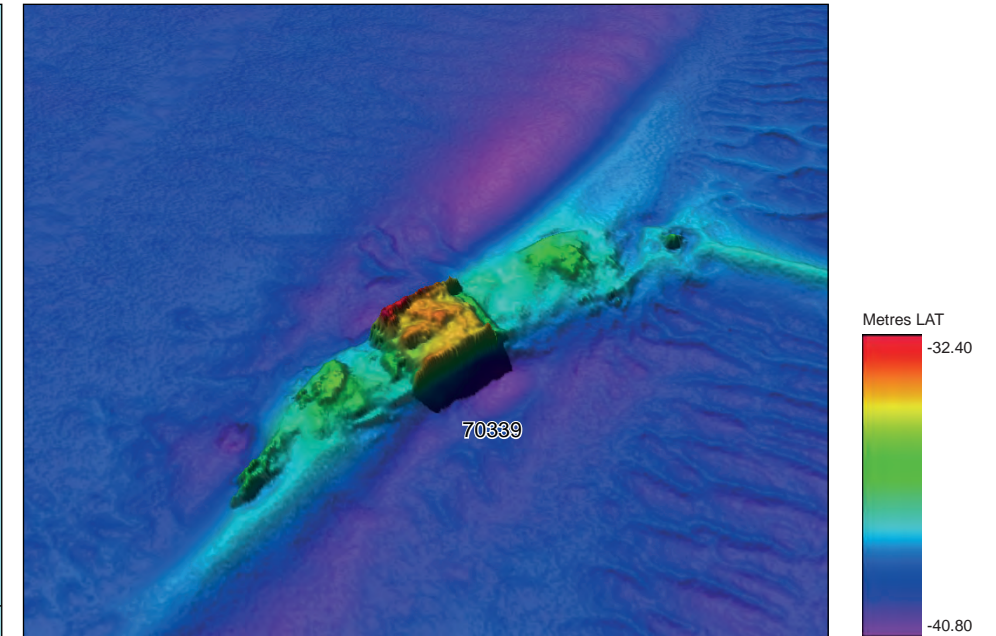
<b>Extent of Survival</b>	This wreck is associated with the UKHO record for the Dutch steam ship <i>Mecklenburg</i> .	
	The wreck has been examined multiple times, first recorded in 1916 with its mast above high water, and most recently on 11 December 2018 when its position and dimensions were revised (87.0 x 13.0 x 8.3 m, lying at an orientation of 052 degrees), described as being upright and well disintegrated.	
There seems to be distinct discrepancy in the width of the wreck between the recorded dimensions in 2018 and the visible positions in the 2021 geophysical data. This may be explained by the more detailed interpretation of the 2021 data, distinguishing debris alongside the sides as separate features.

Mag. profile image

SSS waterfall image, 100 m range per channel

MBES grid image, x 1 vertical exaggeration, looking north

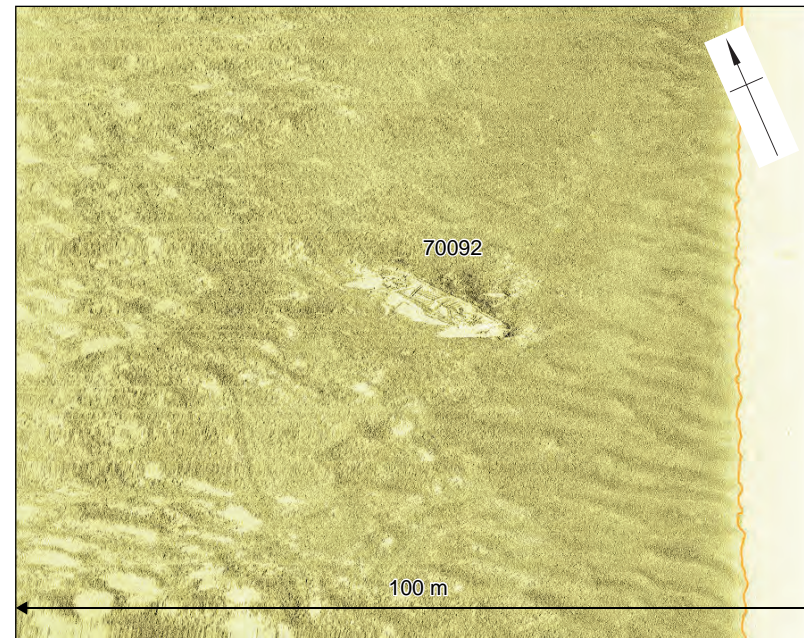
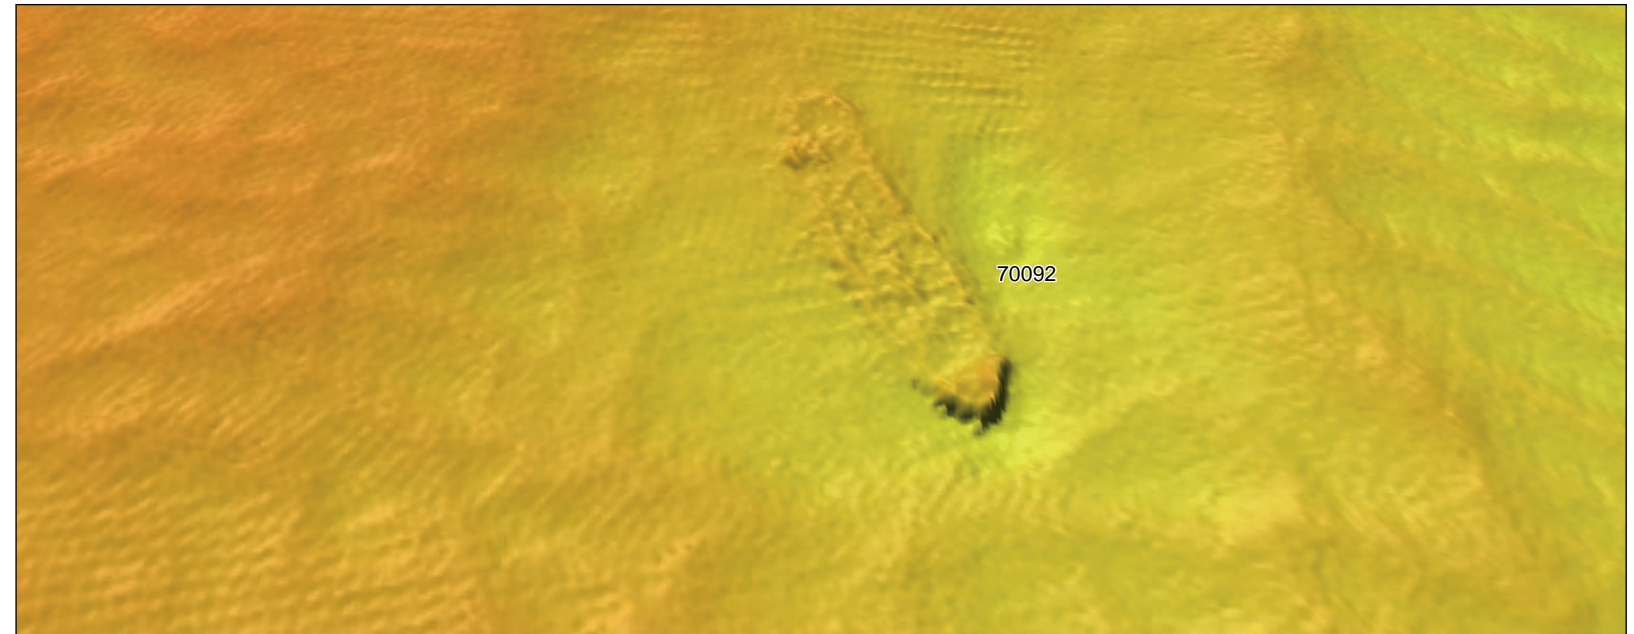
<b>Extent of Survival</b>	Associated with a UKHO record for an unknown wreck first examined 10 July 1995 with recorded dimensions of 20 x 5 m, with a small magnetic anomaly and described as the 'remains of a small broken-up wreck or debris, well scoured in'.	
	The wreck was last examined by MMT in 2016 and reported as a badly degraded wreck with remnants of hull, measuring 25.9 x 12.7 x 1.7m, lying at an orientation of 150 degrees with a strong magnetic anomaly.	
The longer length measurement and more narrow width measurement may indicate irregular seabed processes in the area and some possible sediment build-up and scouring surrounding the wreck remains.

SSS waterfall image, 100 m range per channel

MBES grid image, x 1 vertical exaggeration, looking north

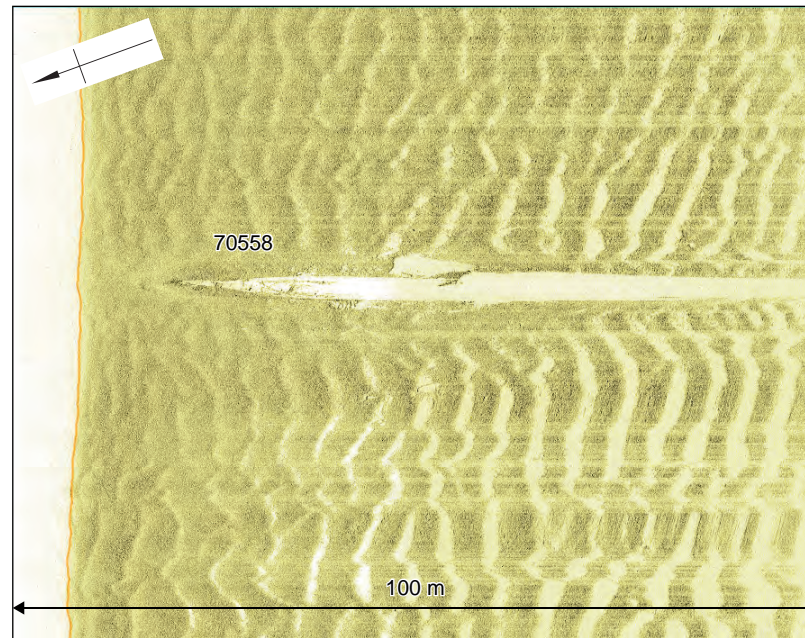
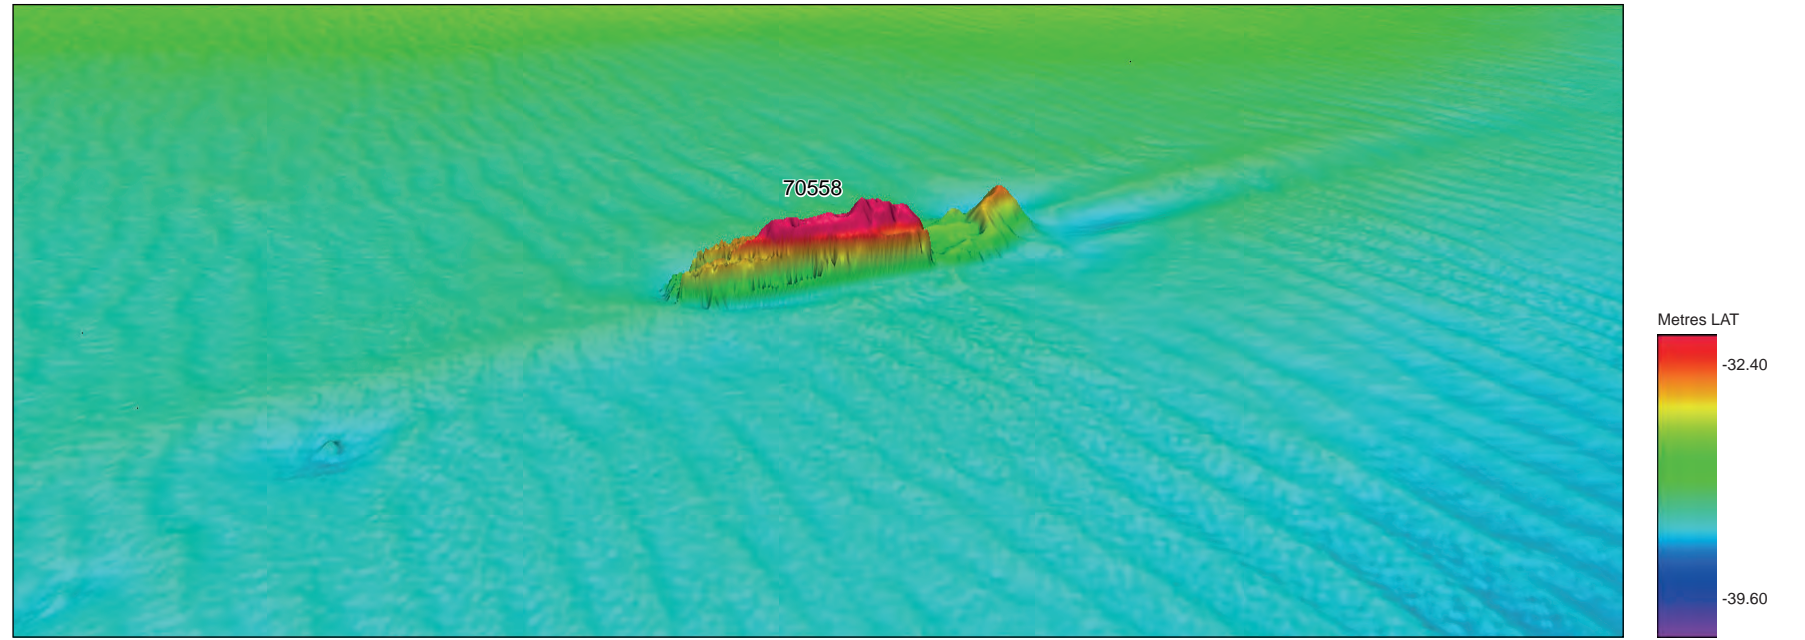
<b>Build</b>	<b>Type</b>	Trawler	
	<b>Construction</b>	Unknown	
	<b>Dimensions (m)</b>	Unknown	
	<b>Shipyard</b>	Unknown	
<b>Loss</b>	<b>Cause</b>	Unknown	
<b>Extent of Survival</b>	<p>Associated with a UKHO report (14444) for an unknown wreck first recorded by the UKHO on 6 January 1972, and most recently on 14 July 2016. The wreck has been examined many times and appears to have been investigated in 2000 and identified as the remains of a trawler, still intact from stern to midships, with the bridge at midships and degraded and collapsed in the forward section. The last surveyed dimensions were recorded as 43.0 x 15.0 x 7.3m.</p> <p>This is interpreted as a partially degraded and broken-up wreck. The slight increase in width and decrease in height may suggest further collapse and degradation, with high potential for associated debris in the vicinity, which may also be buried in the surrounding sediments.</p>

SSS waterfall image, 100 m range per channel

MBES grid image, x 1 vertical exaggeration, looking south-east

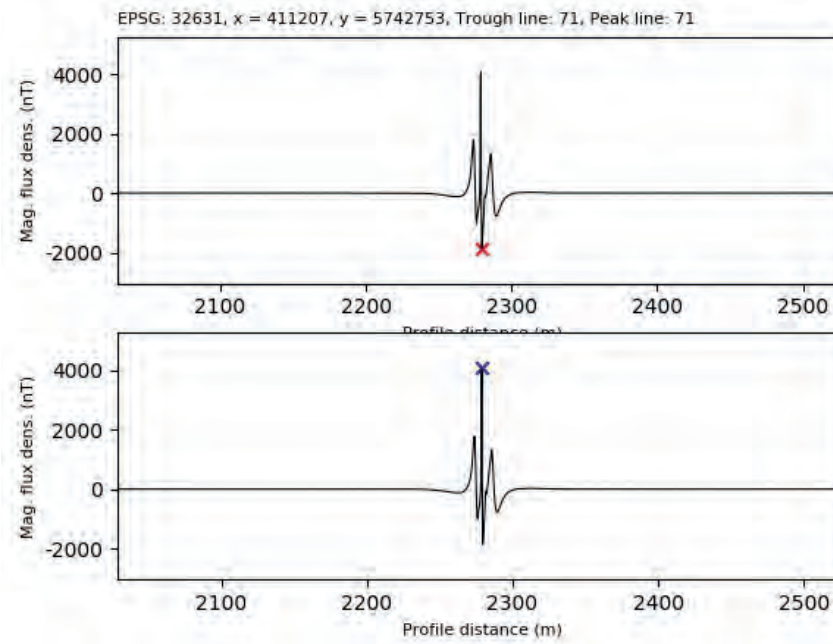
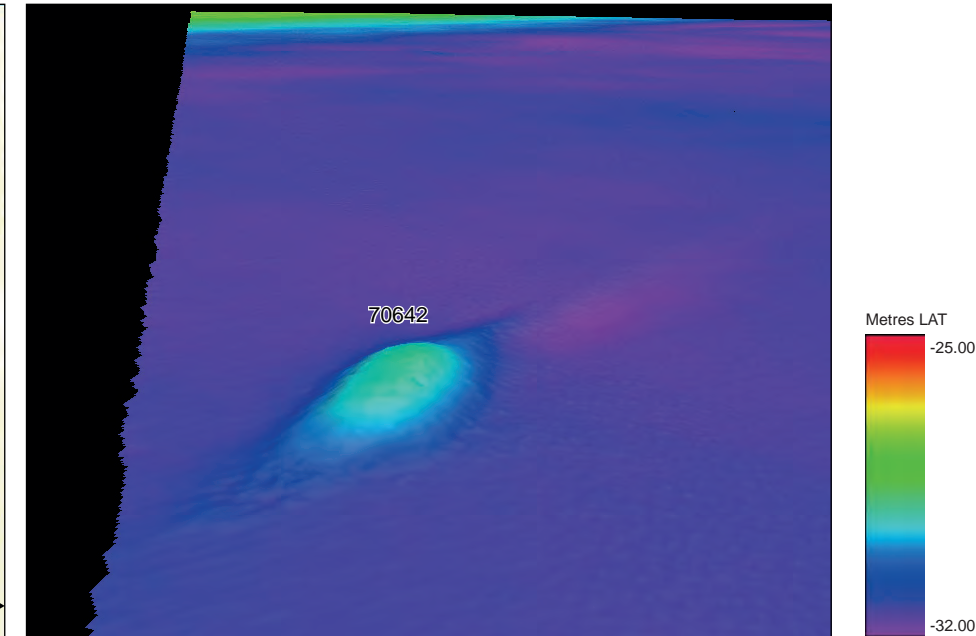
<b>Dimensions (m)</b>	Unknown	
	<b>Shipyard</b>	Unknown	
<b>Loss</b>	<b>Cause</b>	Unknown	
<b>Extent of Survival</b>	Associated with a UKHO record for an unknown wreck (14522) which was first surveyed on 6 January 1972 and most recently observed on 15 July 2016, with recorded dimensions of 22.0 x 12.0 x 3.1m, and described as a small wreck, possibly upturned on a flat seabed.		
	Any remains or surrounding debris may be buried in seabed sediments,

Mag. profile image

SSS waterfall image, 100 m range per channel

MBES grid image, x 1 vertical exaggeration, looking south

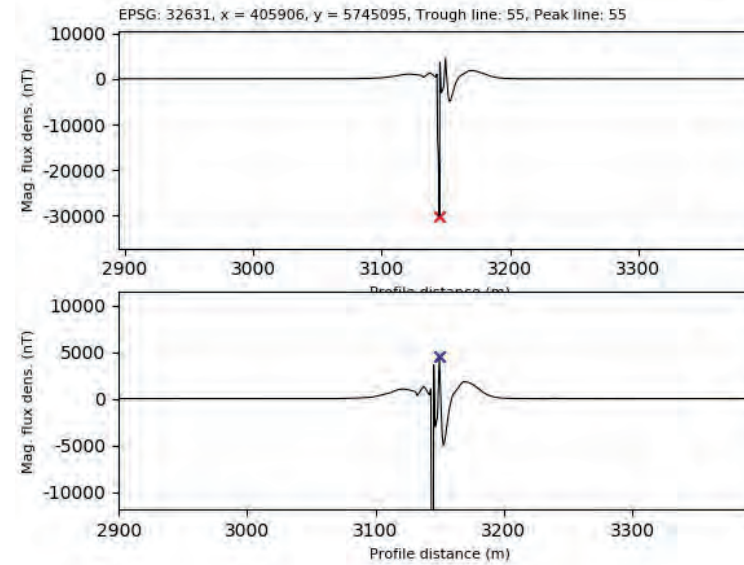
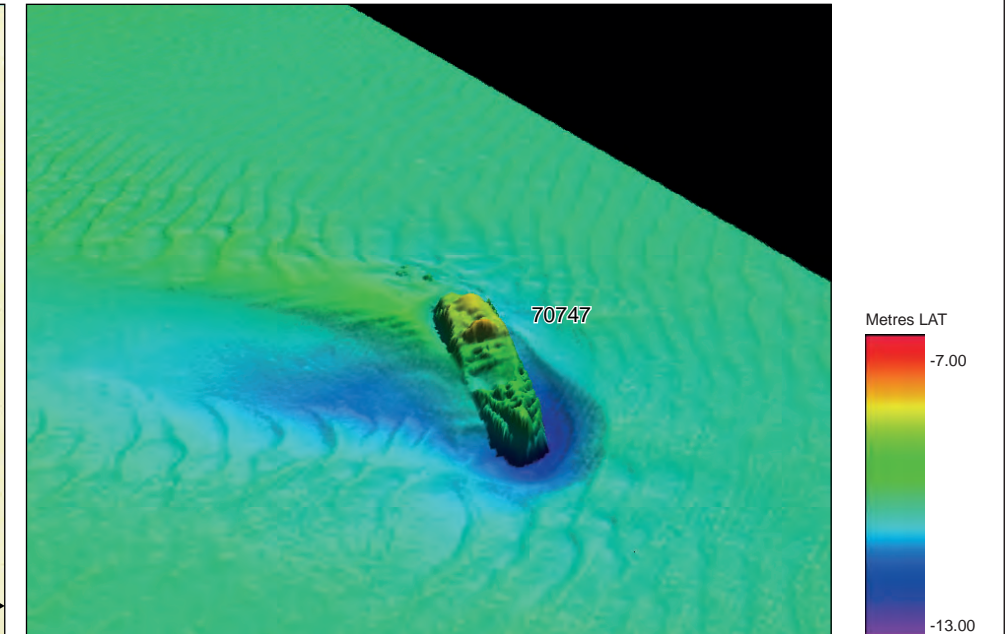
It is possible that the increase in width and height measurements recorded in the 2021 datasets suggests that further remains of the wreck structure have been uncovered by seabed sediments.

Mag. profile image

SSS waterfall image, 60 m range per channel

MBES grid image, x 1 vertical exaggeration, looking west

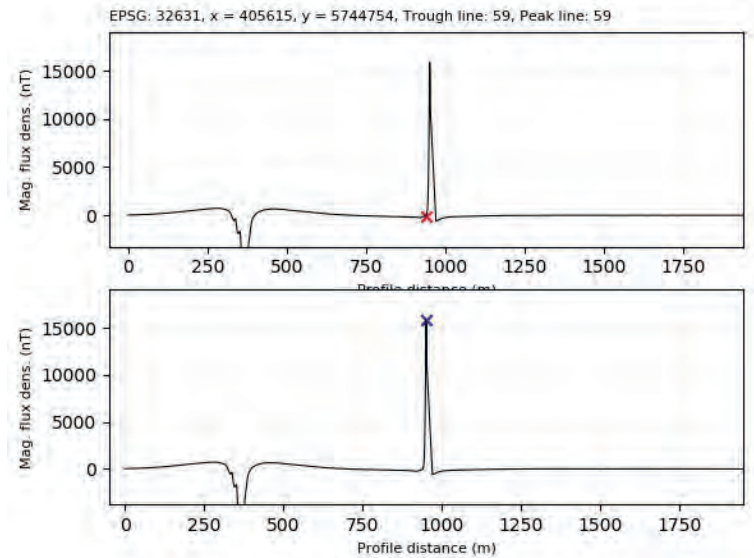
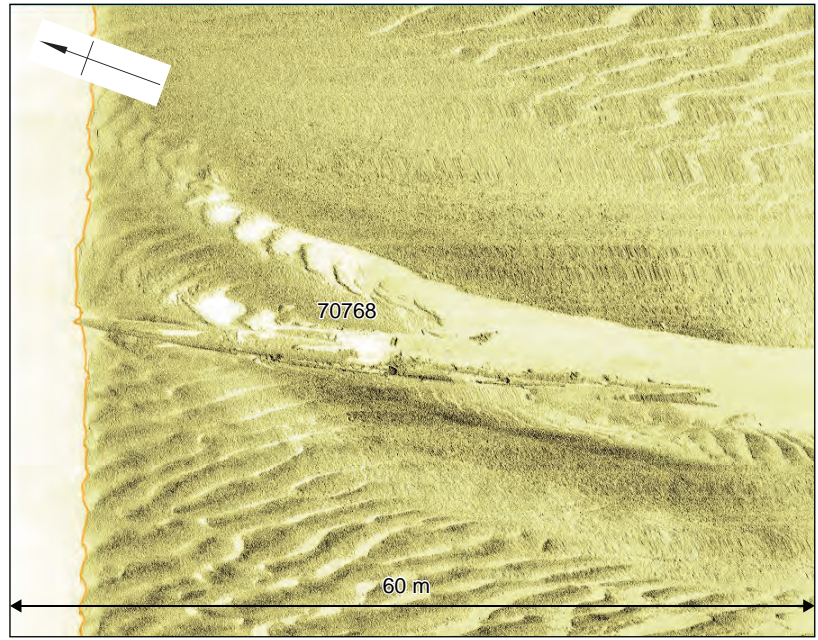
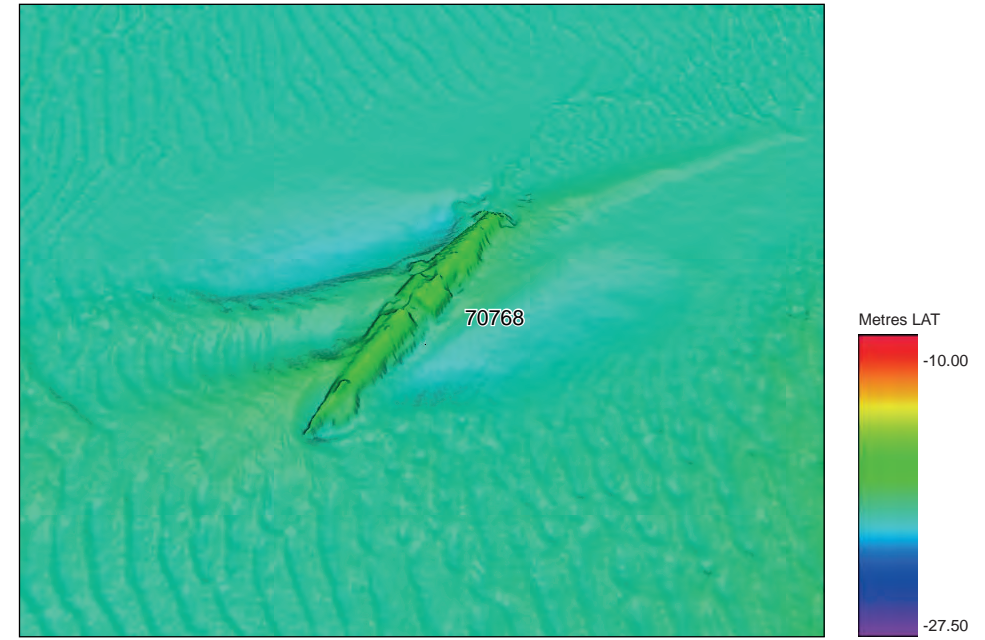
The general form of this wreck as identified in the 2021 marine geophysical datasets is consistent with the form of a possible submarine. The disparity between the width dimensions as observed in 2019 and 2021 may be accounted for uncovering of structure from sediment, or the general spread and collapse of structure and associated debris.

Mag. profile image

SSS waterfall image, 60 m range per channel

MBES grid image, x 1 vertical exaggeration, looking south-east

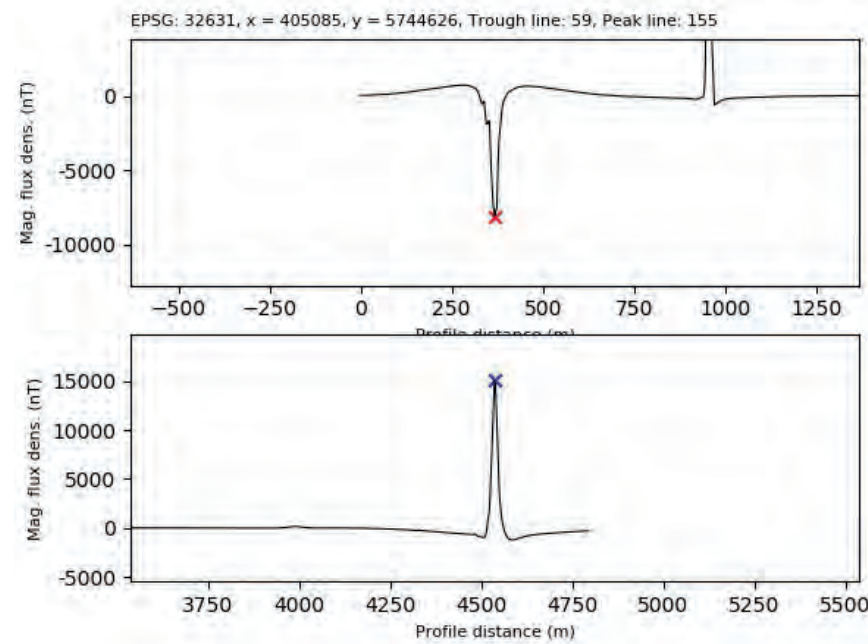
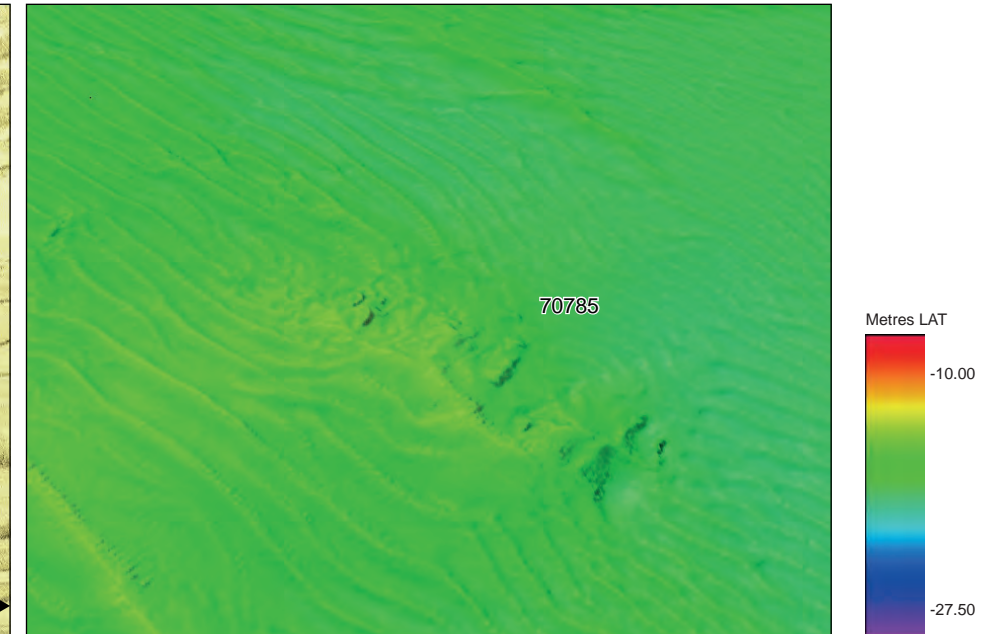
<b>Construction</b>	Unknown, likely steel	
	<b>Dimensions (m)</b>	76.5 x 11.3 x 4.9	
	<b>Shipyard</b>	Schiffswerft H Kock	
<b>Loss</b>	<b>Cause</b>	Mined	
<b>Extent of Survival</b>	Associated with a UKHO record for <i>Marie Leonhardt</i> (Probably), a steam ship built in 1902. The vessel was en route from Hartlepool to London with a cargo of coal when it struck a mine in 1917. The wreck was last surveyed in 2019 with geophysical dimensions of 45.8 x 15.7 x 1.4m and described as a large wreck with numerous features standing proud of the main body of the wreck and partially covered by a sand wave on the south-west side.		
	In the 2021 geophysical data the wreck appears to be possibly upright, but degraded with associated debris identified in the vicinity. The wreck appears to be partially buried by sand waves, though the larger dimensions recorded suggests it has become more exposed since 2019.

Mag. profile image

SSS waterfall image, 60 m range per channel

MBES grid image, x1 vertical exaggeration, looking north

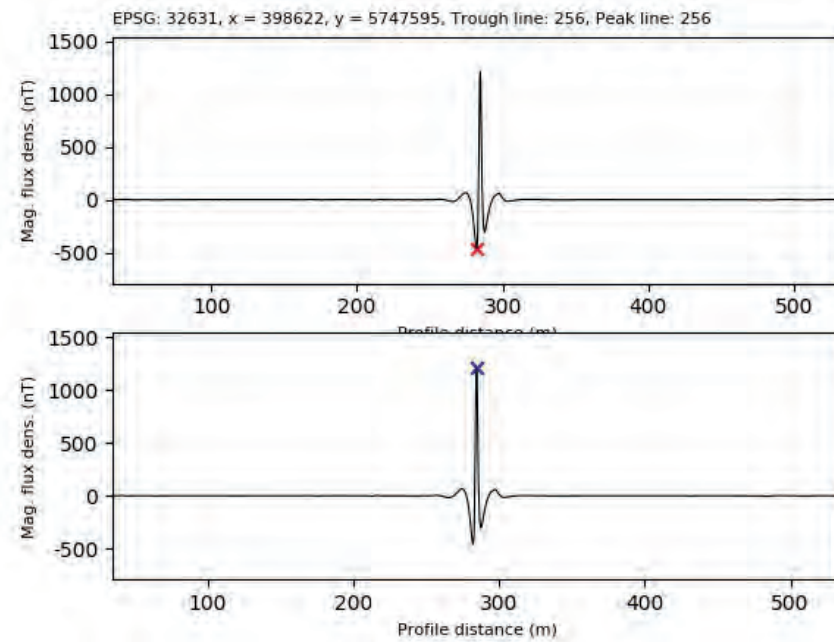
<b>Loss</b>	<b>Cause</b>	Unknown	
<b>Extent of Survival</b>	Associated with a UKHO record (15074) for an unknown possibly wooden wreck, first recorded on 30 September 1993 and most recently surveyed on 26 October 2016 with dimensions of 3.2 x 0.6 x 1.7m and described as appearing broken-up, with 0.4m deep scour extending 4.7m towards 175 degrees.		
	There is no coherent structure visible in the 2021 geophysical data which would be consistent with the description recorded by the UKHO. Interpreted as a well broken-up and possibly dispersed wreck.

Mag. profile image

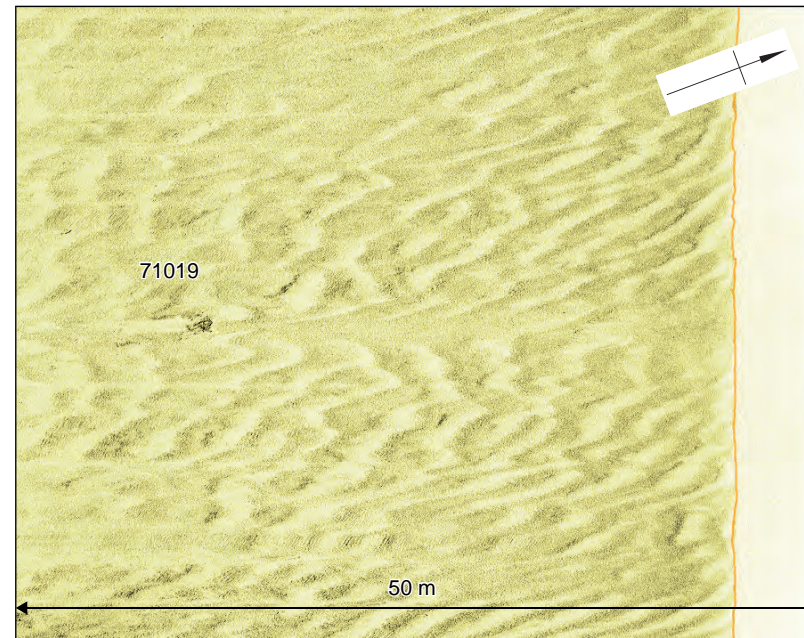
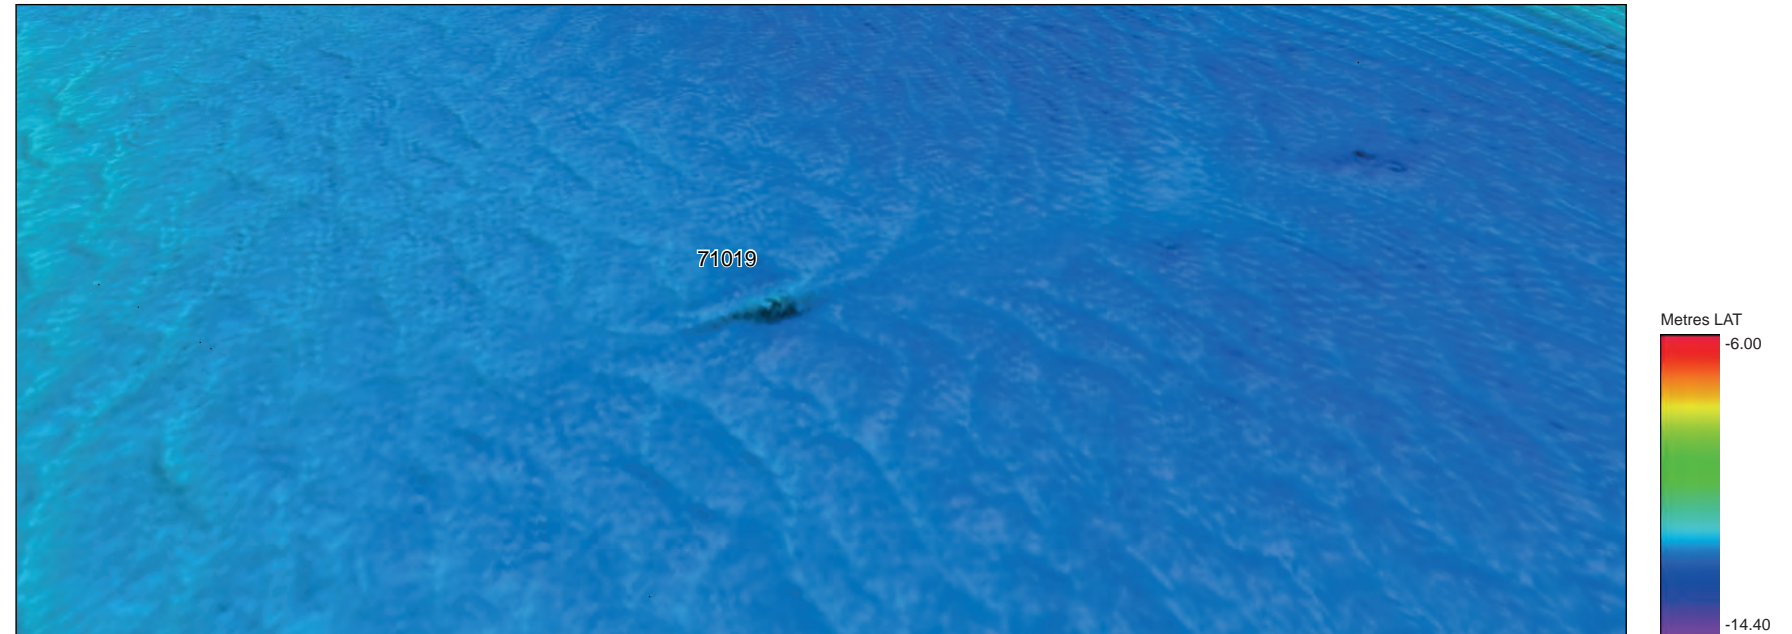
The smaller dimensions recorded in the 2021 dataset suggest that the wreck has either become more broken-up and/or collapsed, or has been buried within the surrounding seabed sediments. This feature has been interpreted as a wreck based on the information in the UKHO record, rather than how it appears in the 2021 geophysical data.

SSS waterfall image, 50 m range per channel

MBES grid image, x 1 vertical exaggeration, looking north-west
