**NORTH FALLS**

*Offshore Wind Farm*

### Appendix 16.1 Archaeological Assessment of Geophysical Data

Archaeological Assessment of Geophysical Data

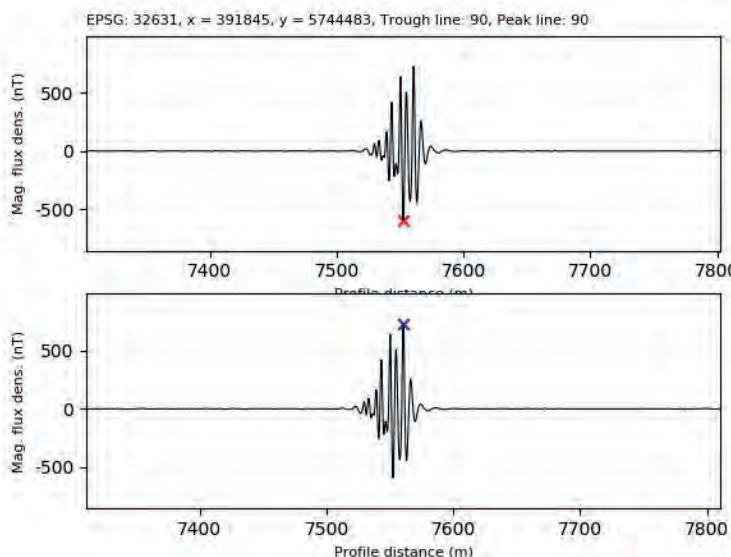
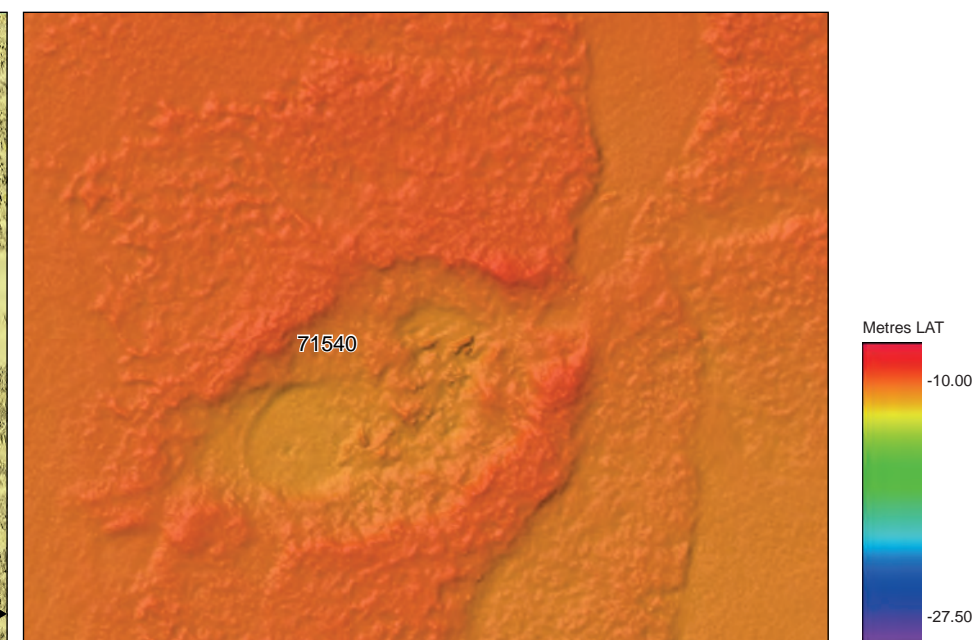
<b>Construction</b>	Unknown, likely steel		
	<b>Dimensions (m)</b>	28.0 x 6.1 x 2.4		
	<b>Shipyard</b>	J Chambers Ltd, Lowestoft		
<b>Loss</b>	<b>Cause</b>	Mined		
<b>Extent of Survival</b>		<p>Associated with a UKHO record for HMS <i>Lord St Vincent</i> (Part Of), a one-boiler triple expansion engine drifter. The vessel was hired as an armed patrol vessel from 1939 and converted to a boom defence vessel from 1940, it was mined and sunk in 1941.</p> <p>A survey over the wreck in 1988 described it as being a circular area of wreckage 30.0m in diameter with no shadow and a magnetic anomaly indicating an iron content of 55 tonnes.</p> <p>In the 2021 data the wreck has no discernible structure and is highly degraded, with associated debris identified in the vicinity.</p>

Mag. profile image

SSS waterfall image, 50 m range per channel

MBES grid image, x 1 vertical exaggeration, looking north

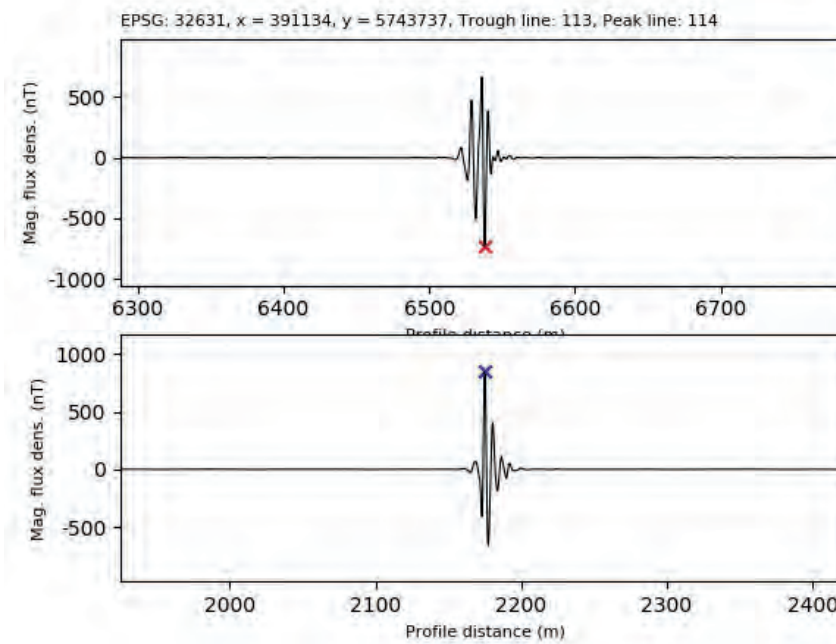
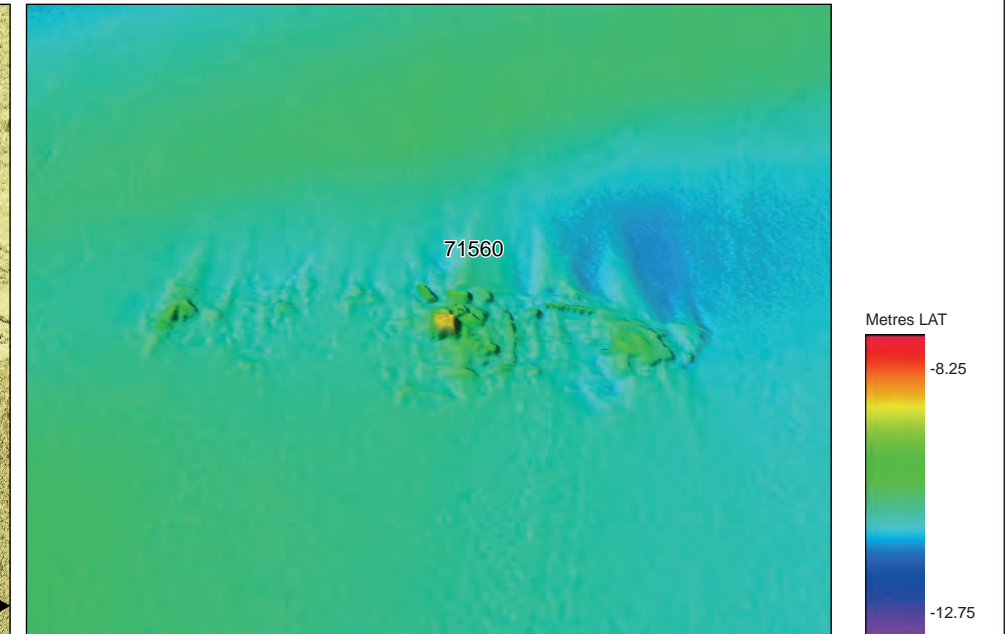
In the 2021 geophysical data the wreck appears mostly intact but highly degraded. The larger dimensions recorded indicate it has become more exposed since 1994.

Mag. profile image

SSS waterfall image, 50 m range per channel

MBES grid image, x1 vertical exaggeration, looking north-east

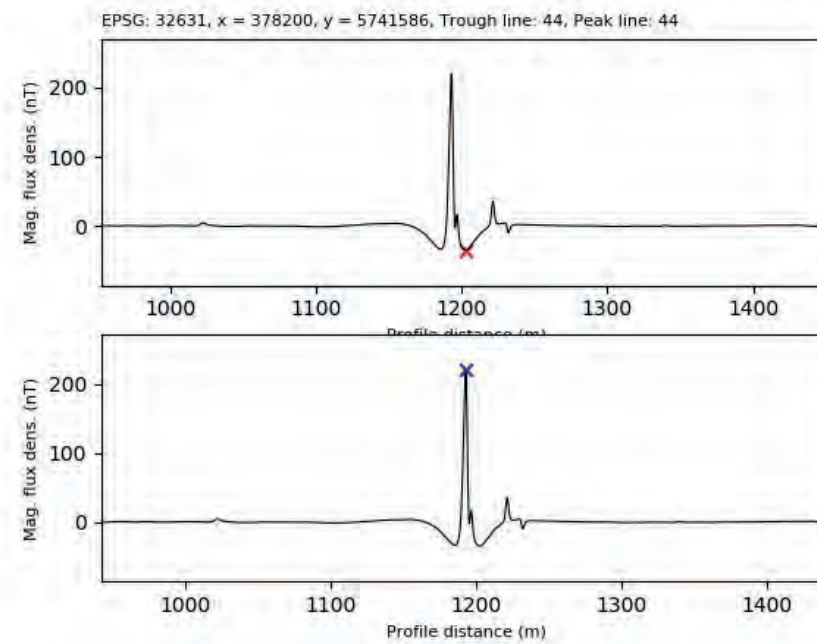
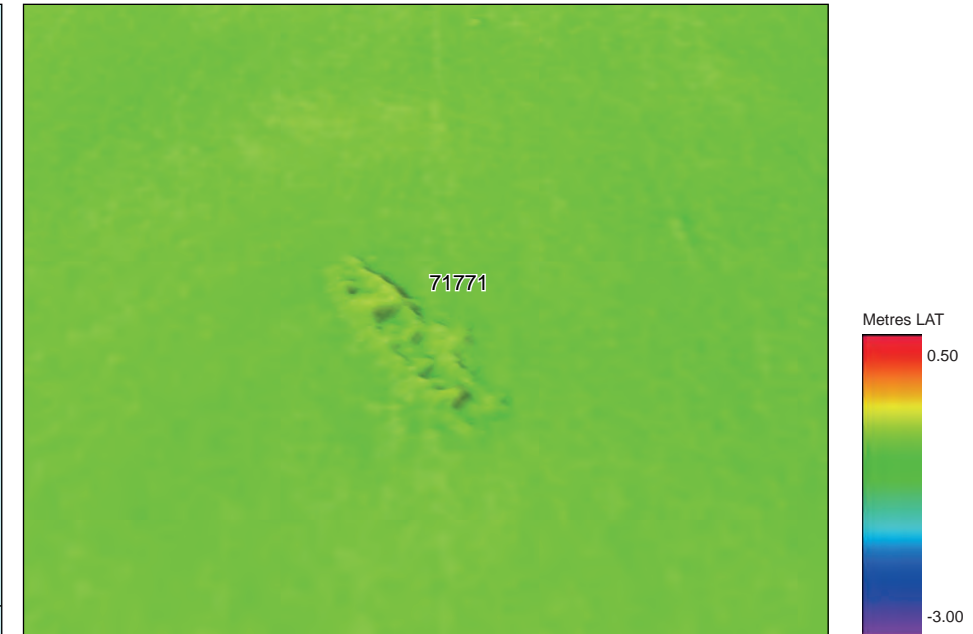
<b>Build</b>	<b>Type</b>	Unknown		
	<b>Construction</b>	Unknown, likely at least partially ferrous.		
	<b>Dimensions (m)</b>	Unknown		
	<b>Shipyard</b>	Unknown		
<b>Loss</b>	<b>Cause</b>	Unknown		
<b>Extent of Survival</b>		<p>Wreck 71771 is not a known wreck and so does not have a corresponding UKHO record.</p> <p>The wreck appears to be fairly intact, though objects identified in the vicinity of the wreck and interpreted as debris suggest it is partially broken up.</p>

Mag. profile image

SSS waterfall image, 50 m range per channel

MBES grid image, x 1 vertical exaggeration, looking north-east
