# **ENVIRONMENTAL STATEMENT – VOLUME 3 – APPENDIX 8.7**

## **Bat Building Emergence Survey Report – Repower**

### **Drax Bioenergy with Carbon Capture and Storage**

Drax Repower Project

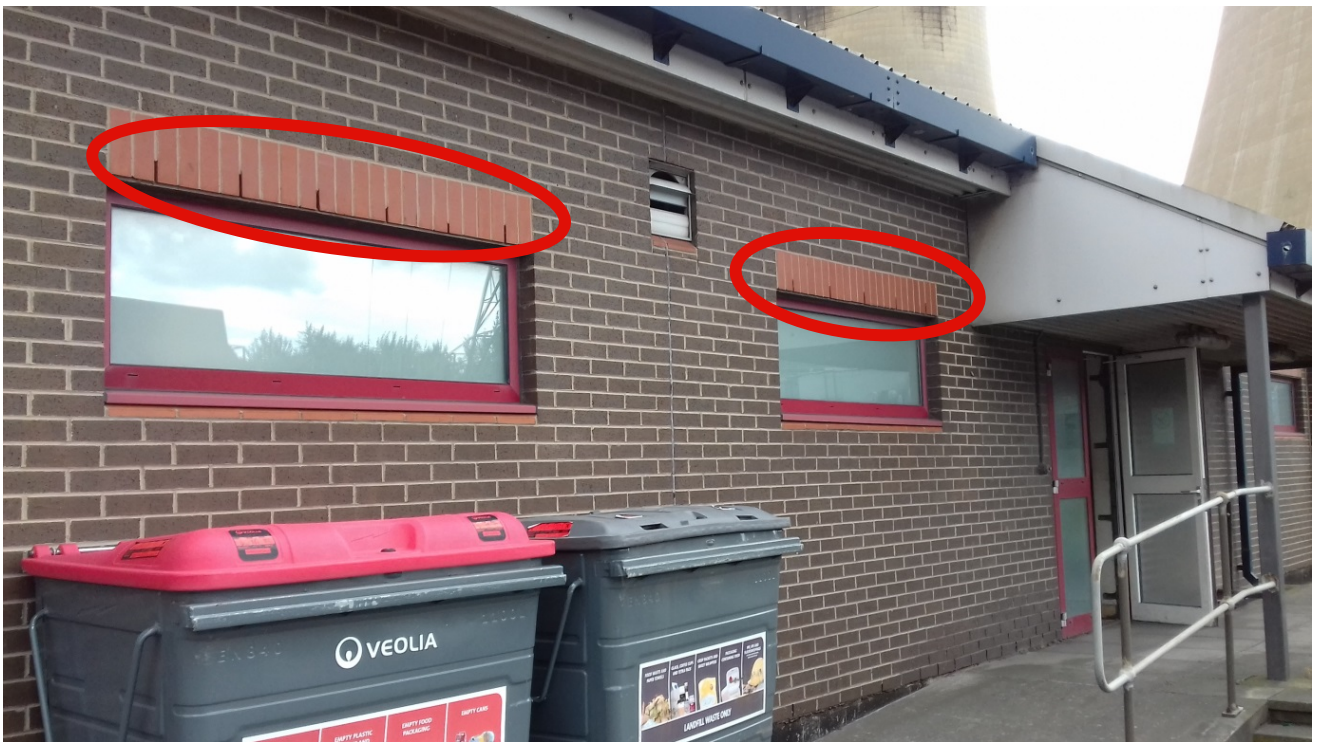
Photo 1 – Photo Building 1, Development Parcel C bat roosting opportunities

- 3.1.2. Building 1 in Development Parcel C was assessed as having low suitability for roosting bats during the Preliminary Roost Assessment. One type of feature was recorded on the building exterior, namely slits in the brick work above all windows.
- 3.1.3. The habitat surrounding Building 1 in Development Parcel C is predominantly hard standing, featuring access roads and paving. Surrounding areas include the existing power station cooling towers with some amenity grassland adjacent and scattered broad-leaved trees.
- 3.1.4. Photograph 1 (below) shows these features.

- 4.1.1. No bats, or evidence of bats, were recorded during the surveys on Development Parcel C Building 1 or Development Parcel F Buildings 1 and 2.
- 4.1.2. The slits in the brick work above the windows in Building 1 of Development Parcel C may create access points large enough for smaller bats (*Pipistrellus* and *Myotis* sp.) to crawl into. These features are considered likely to provide cool, stable conditions that could support low numbers of hibernating or transitional roosting bats. Due to the absence of other buildings with potential roosting features and the poor quality of the immediately surrounding habitat, Building 1 in Development Parcel C is considered of at most low suitability for roosting bats.

- 4.1.4. An internal inspection of the buildings will be carried out in winter 2017/18 to confirm the internal condition of the buildings. If the internal inspection identifies evidence of bats or significant additional PRF then the survey effort will be increased accordingly. In the event that a bat roost is identified and the building cannot be retained, specific avoidance and / or mitigation measures would be required. A draft European Protected Species (EPS) licence Method Statement would also need to be submitted with the DCO application in the event of a confirmed roost being lost.

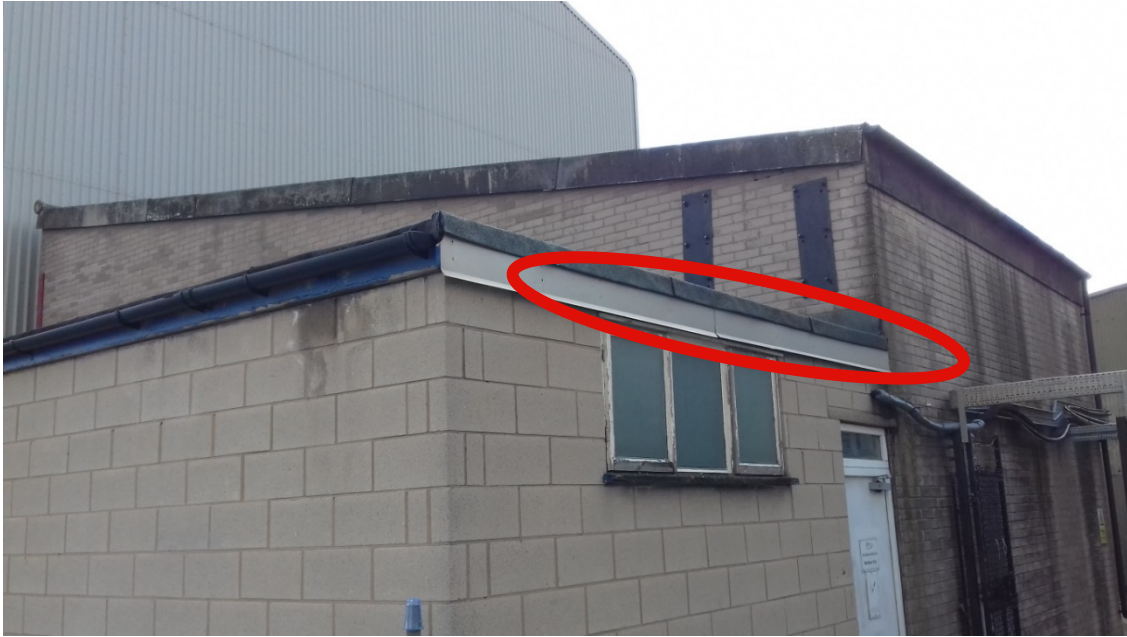
*Photo 2 - Building 1, Development Parcel F*

- 3.1.5. Building 1 and 2 in Development Parcel F were assessed as having low suitability for roosting bats during the Preliminary Roost Assessment. Gaps under the timber eaves of **Building 1** could provide suitable conditions for roosting bats. Building 2 had one hole in the north-east corner located in the eaves that could also have provided roosting opportunities for bats (See photographs 2 and 3 below).
- 3.1.6. The habitat surrounding Building 1 and 2 in Development Parcel F is predominantly hard standing, featuring access roads, paving and buildings.

- 4.1.3. The gaps under eaves (timber) in Building 1 of Development Parcel F and the hole in the eaves of Building 2 of Development Parcel F may create access points large enough for smaller bats (*Pipistrellus* and *Myotis* sp.) to crawl into. The depth of the access points and assessment of any internal space could not be made from the external preliminary roost assessment. Larger bat colonies and maternity colonies could potentially be present, although this is considered very unlikely due to the poor quality of the immediately surrounding habitat and in light of the 2017 survey results.

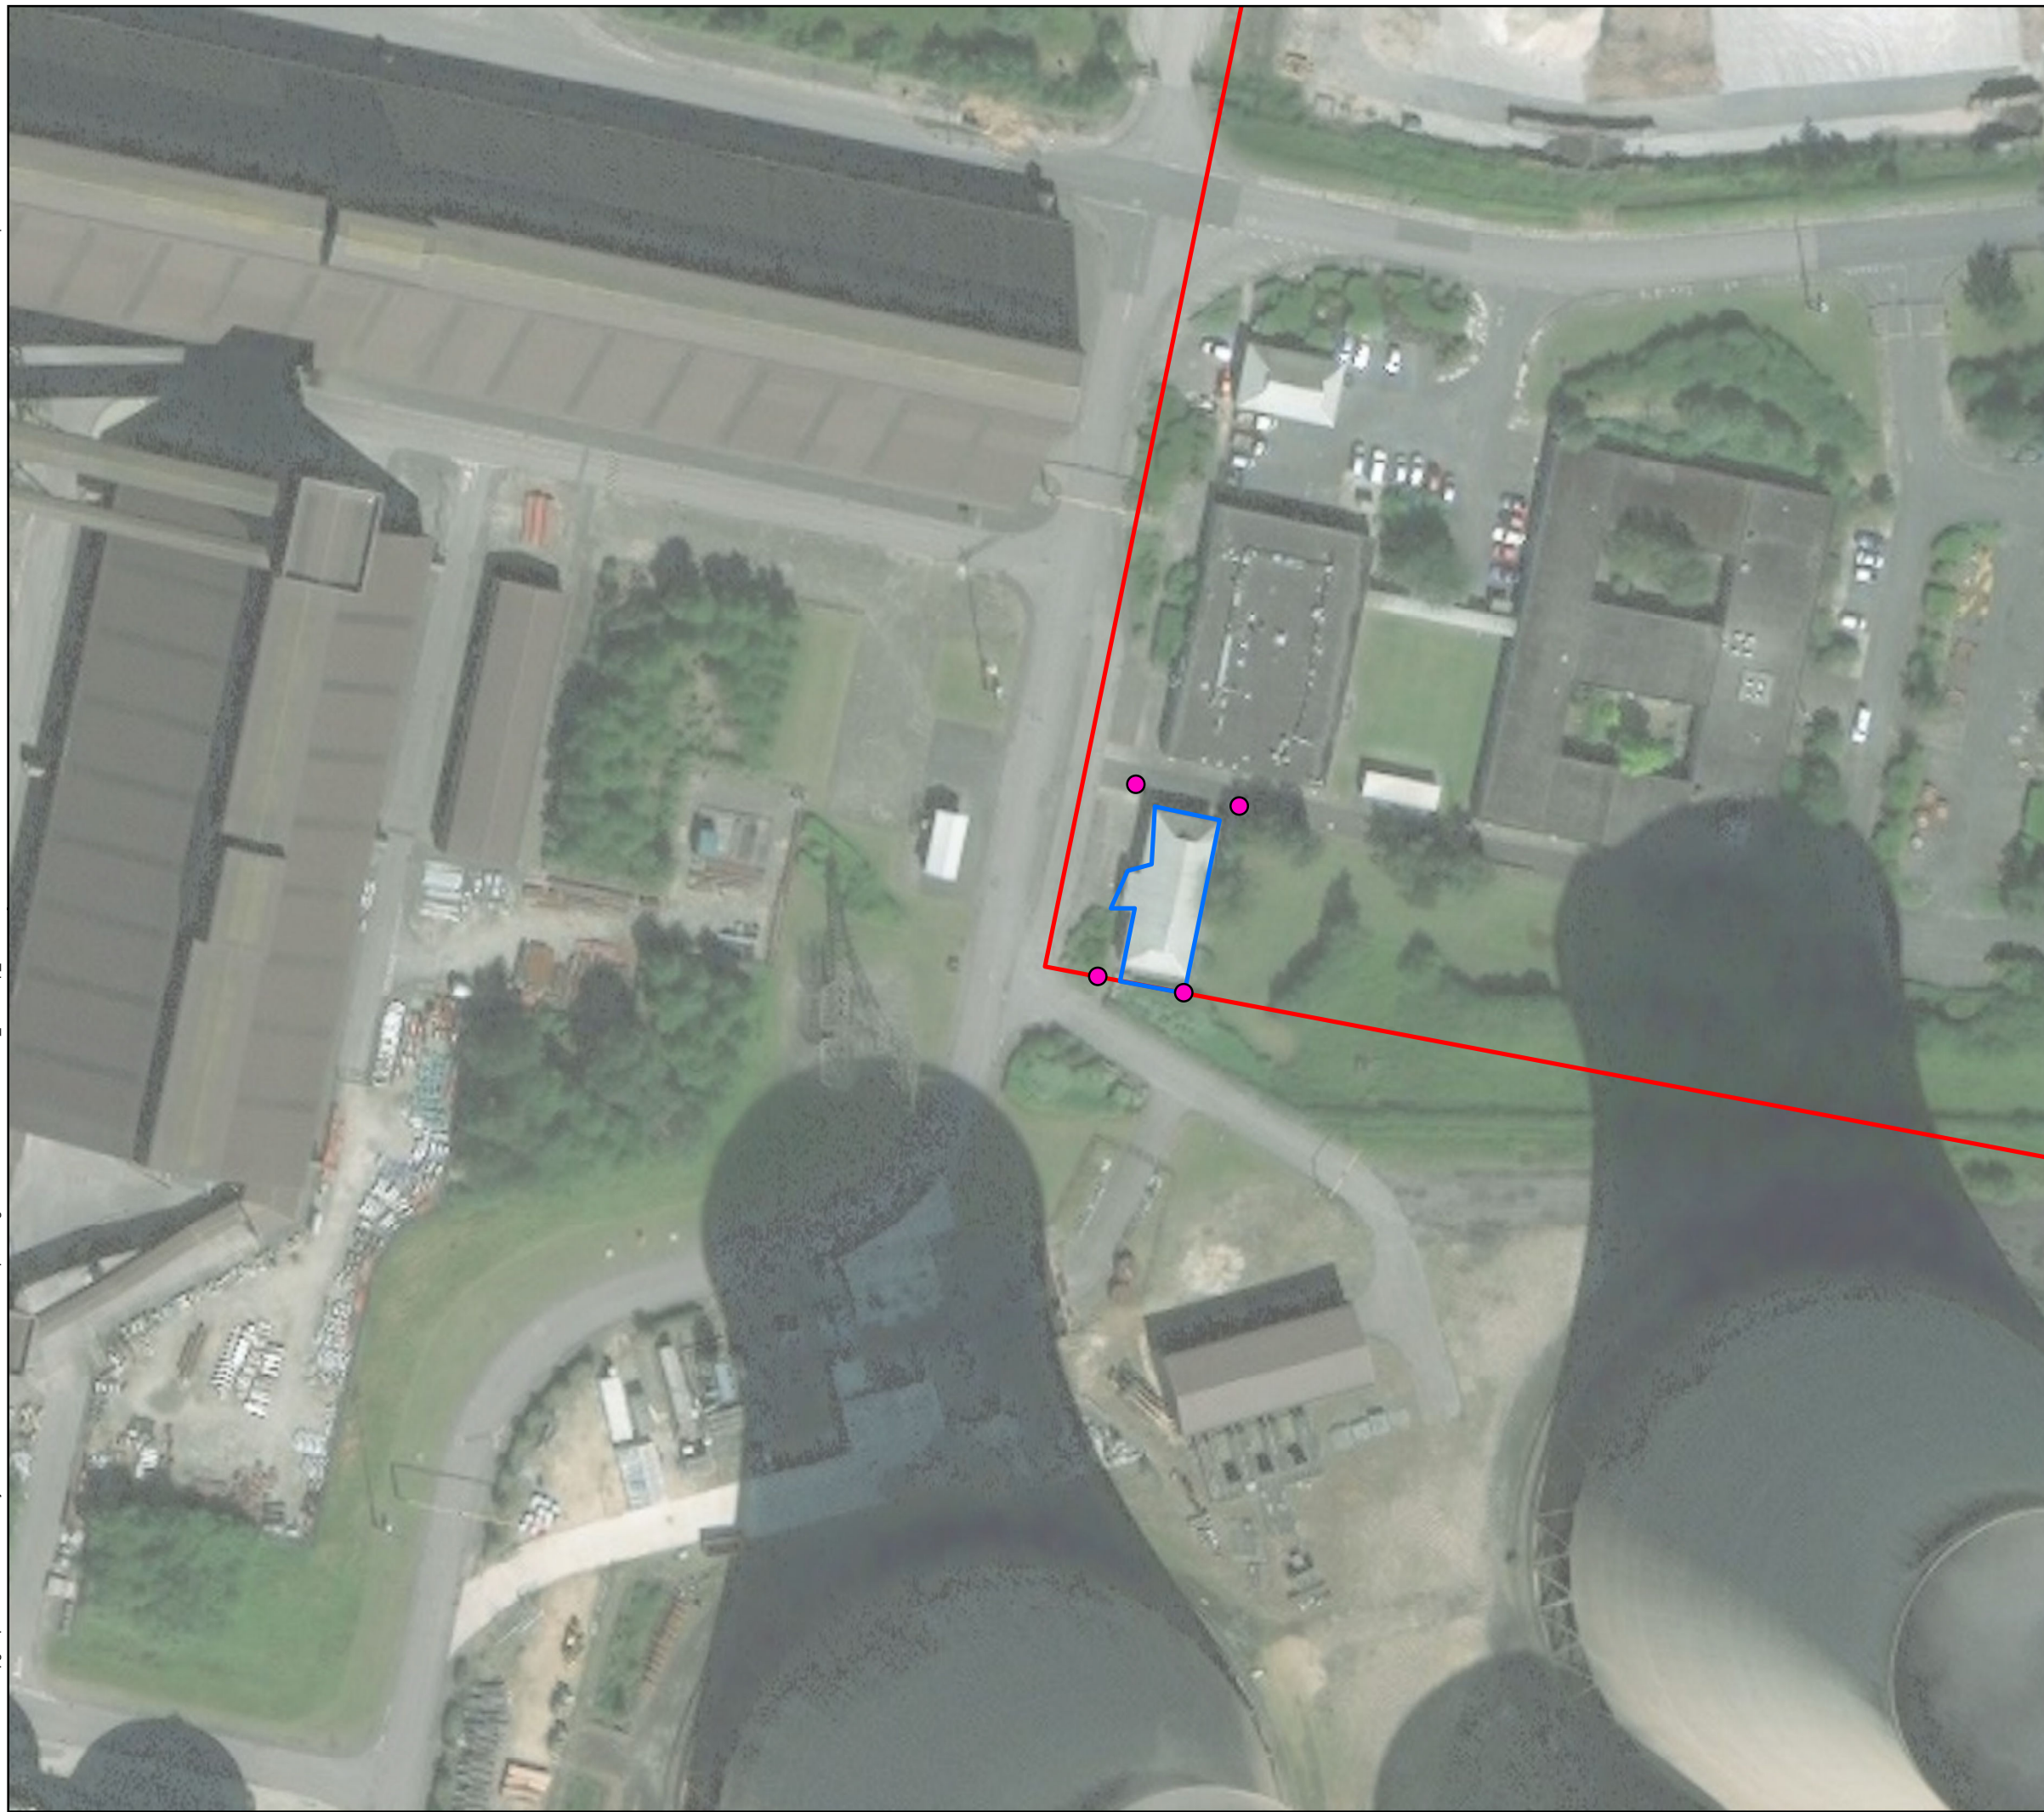
Title:  
**FIGURE 2 - DEVELOPMENT  
PARCEL C BUILDING 1**

- 3.1.8. A single dusk emergence survey was carried out on Development Parcel C Building 1. No bats were recorded emerging from or re-entering the building during the survey.

- Key
- Surveyor Positions
  - Development Parcel C Building1
  - Site Boundary

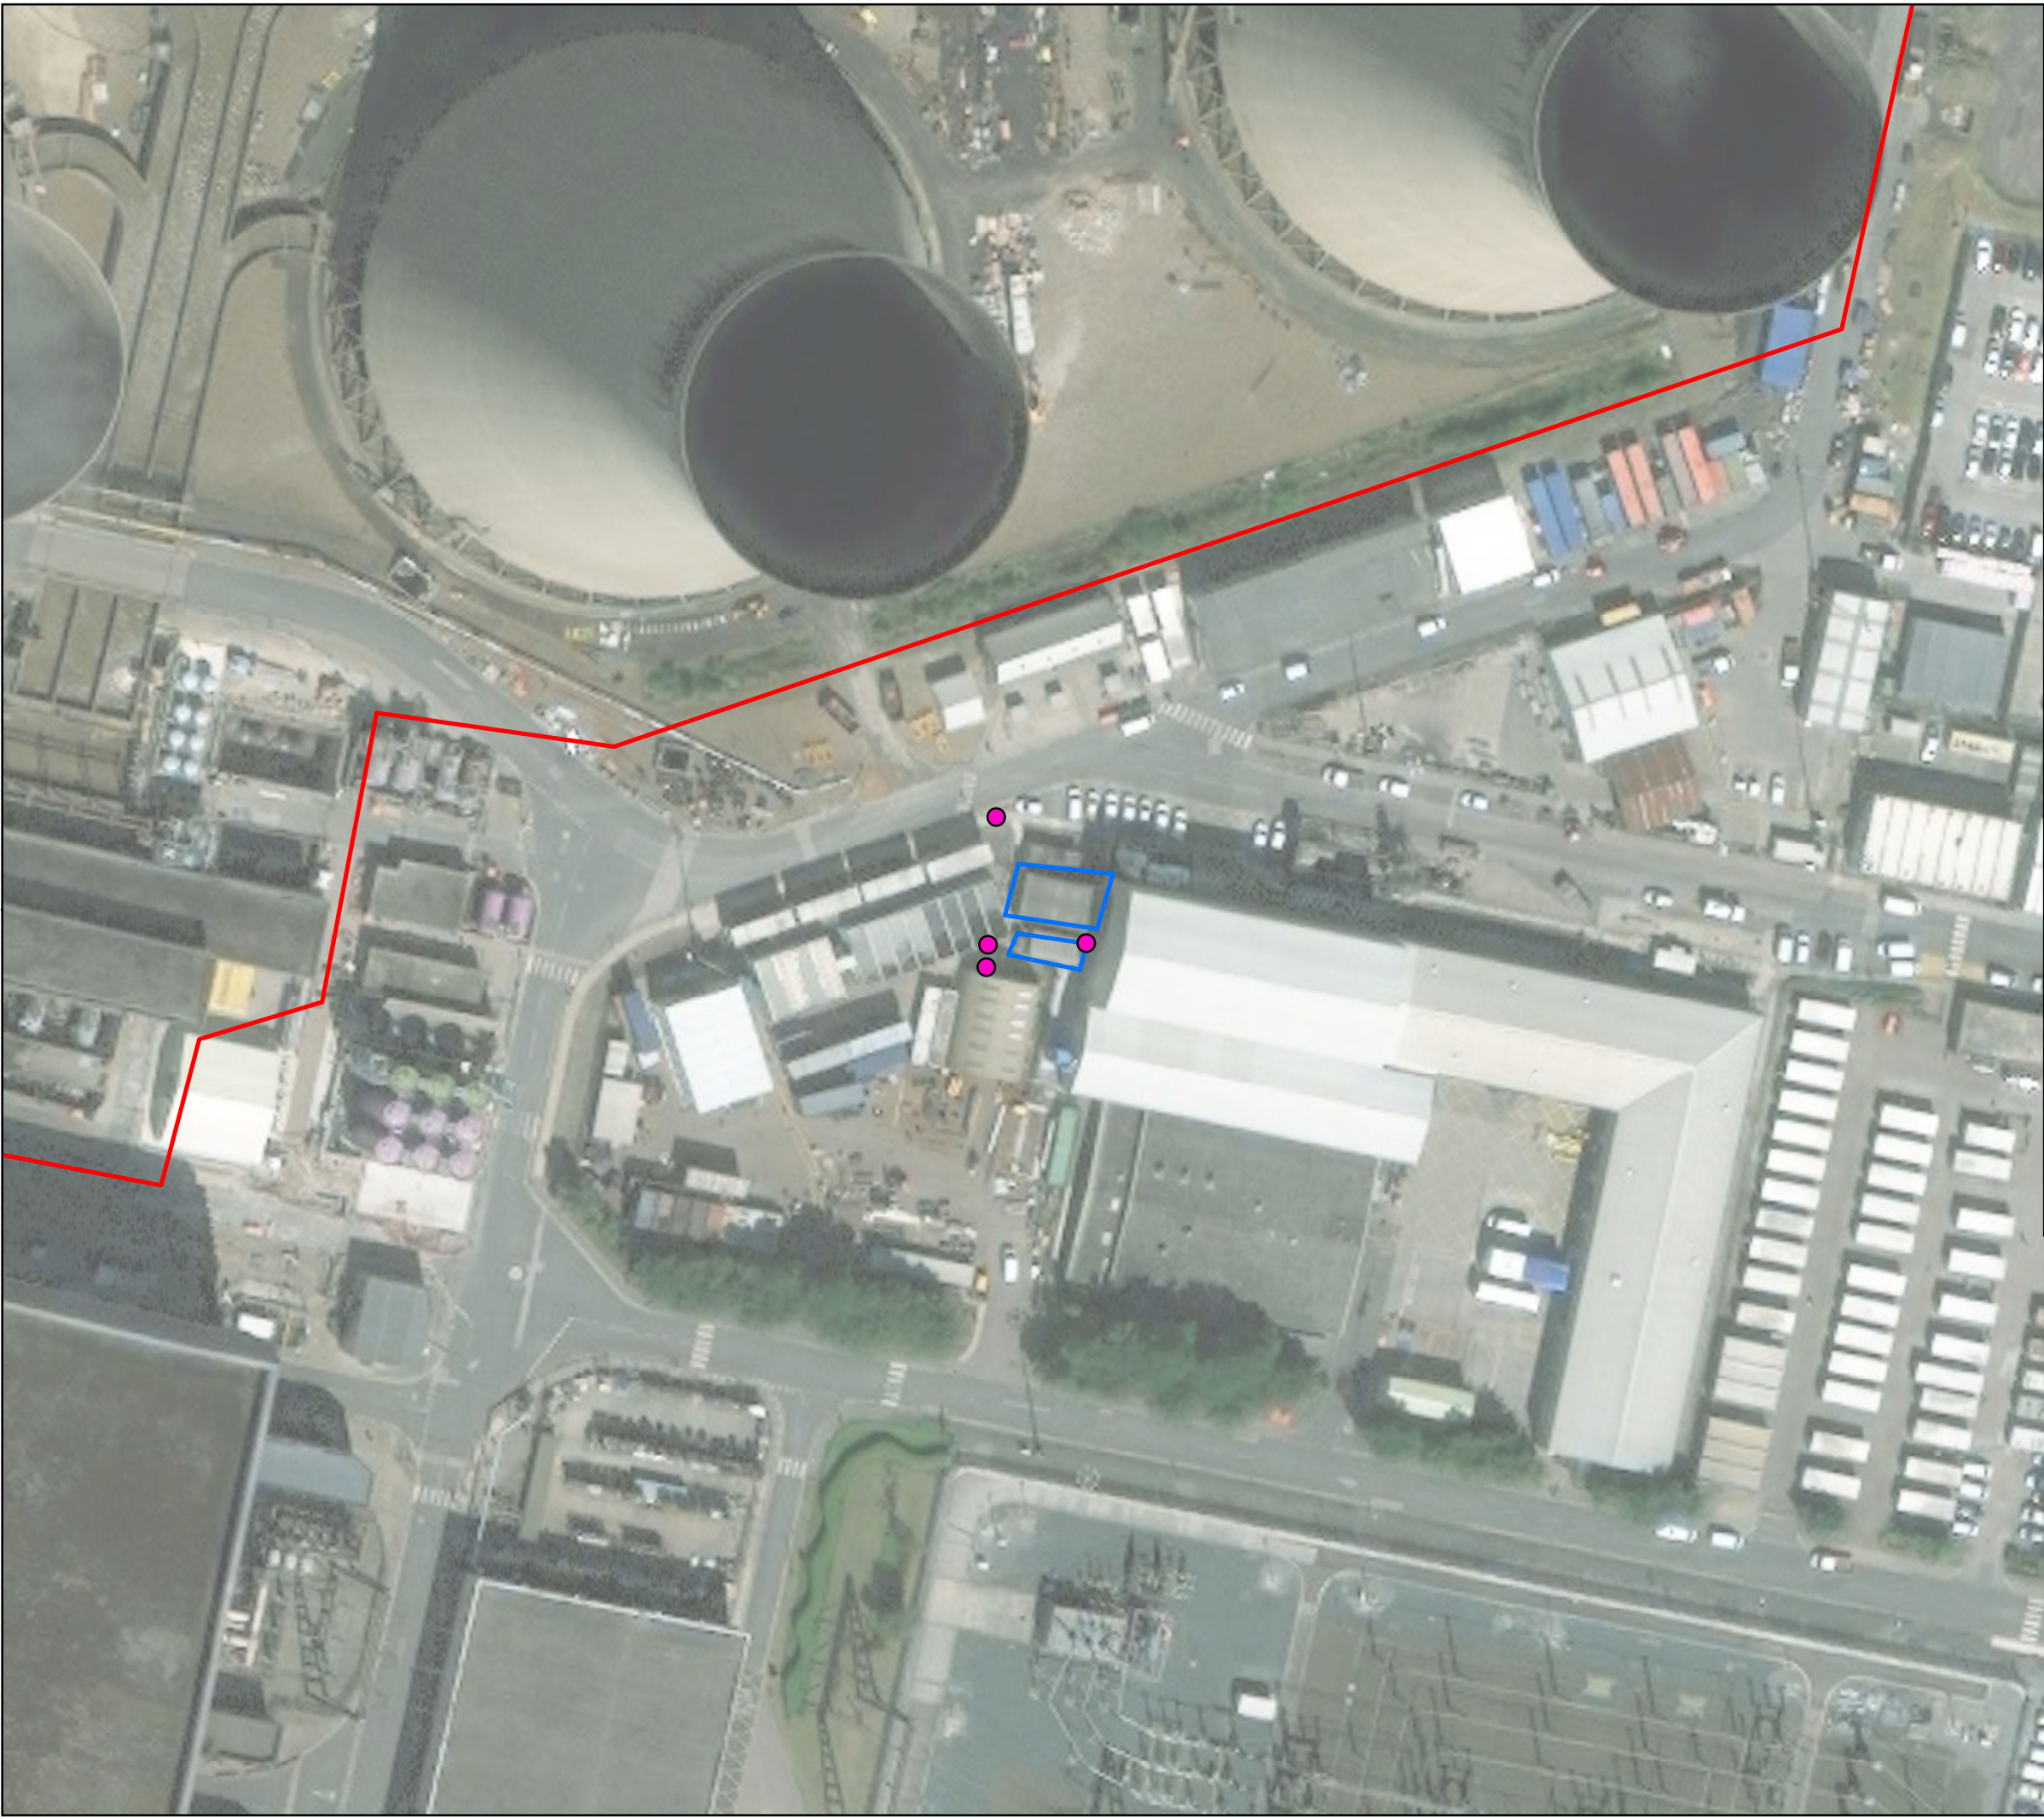
Title:  
**FIGURE 3 - DEVELOPMENT  
PARCEL F BUILDINGS 1 & 2**

- 3.1.9. A single dawn re-entry Site was carried out on Development Parcel F Buildings 1 and 2. No bats were recorded emerging from or re-entering either of the buildings during the survey.

- 3.1.10. This area of the Site was well lit throughout the survey due to the presence of artificial lighting: Buildings 1 and 2 are adjacent to access roads which are used by pedestrians and vehicles.

- Key
- Surveyors Position
  - Development Parcel F Buildings 1 & 2
  - Site Boundary
