# OAKLANDS FARM SOLAR PARK

Appendix 6.13 – River Conditions Assessment Report

Document Ref: EN010122/APP/6.1/Appx 6.13

## Oaklands Farm Solar Park Biodiversity Net Gain, Baseline River Condition Assessment

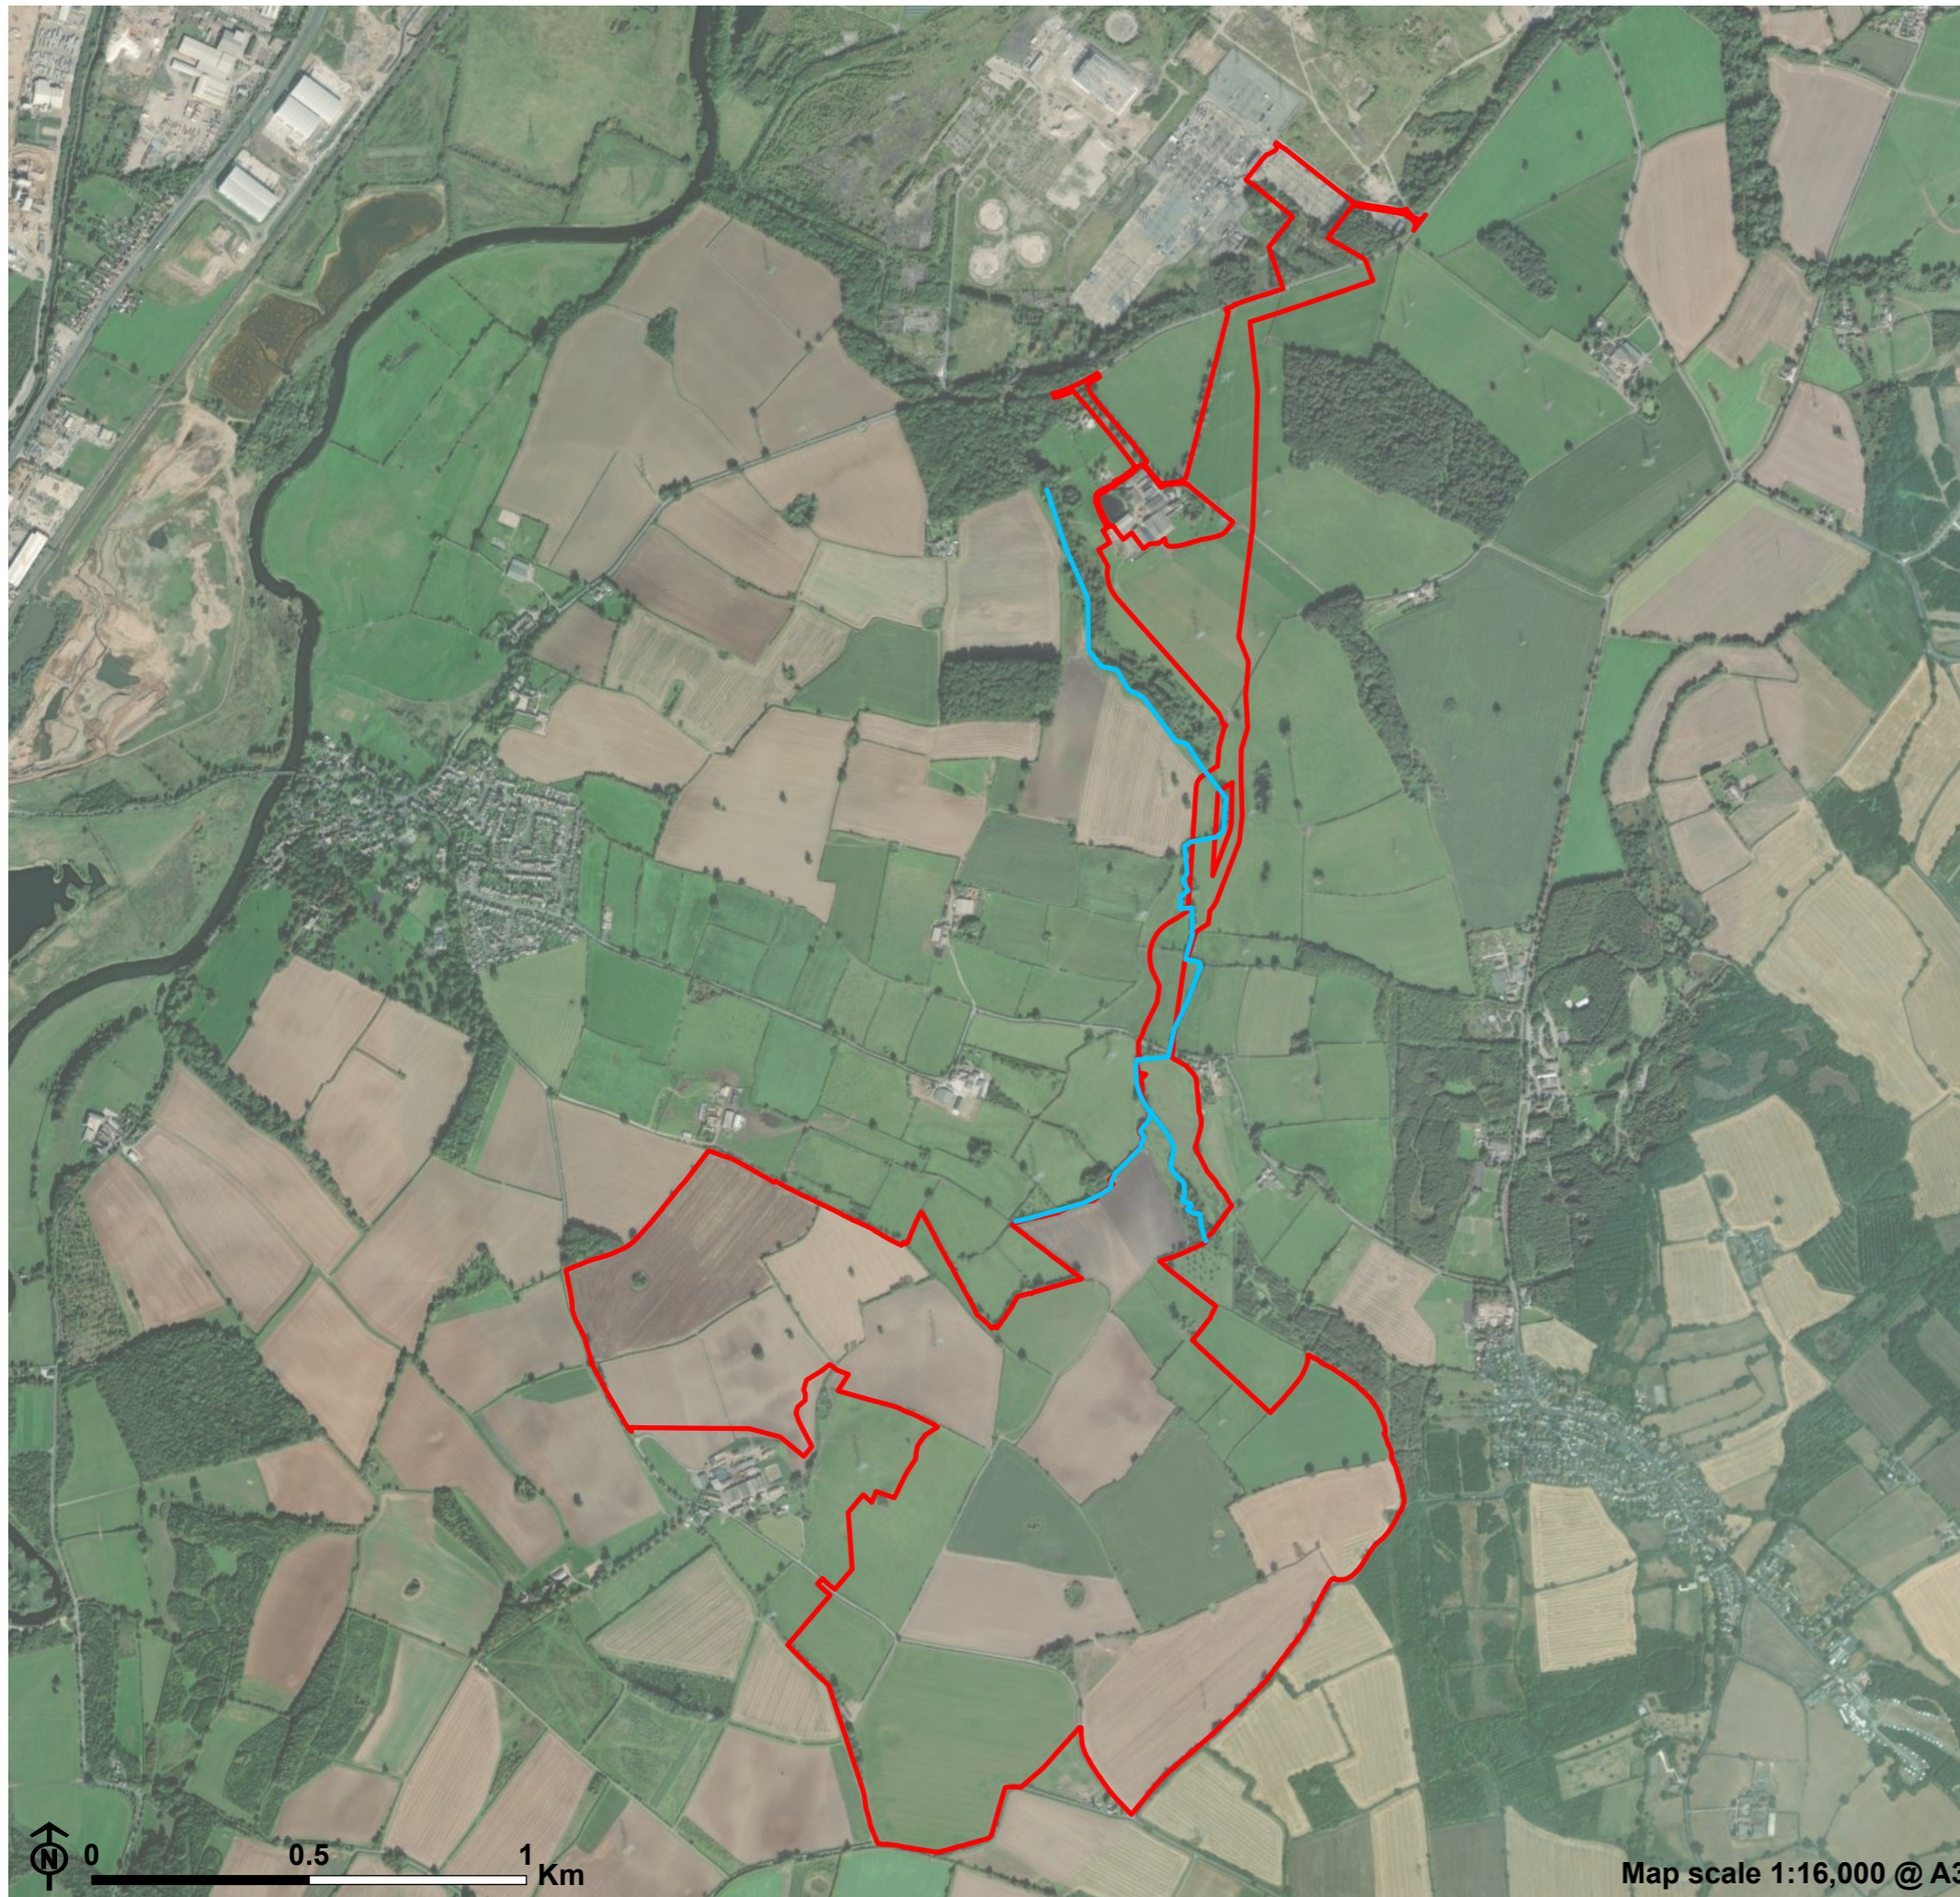
Figure 6.13.1: Watercourses within the site

**2.1** Desktop analysis confirmed the four watercourses required assessment. A map showing the extent of watercourses within the Site is provided in **Appendix A**.

**2.2** Two streams join in the central southern part of the Site to form a single stream that flows northwards through the centre and north of the Site. The streams are not named and are therefore referred to as “Tributary of River Trent” for the purposes of this report.

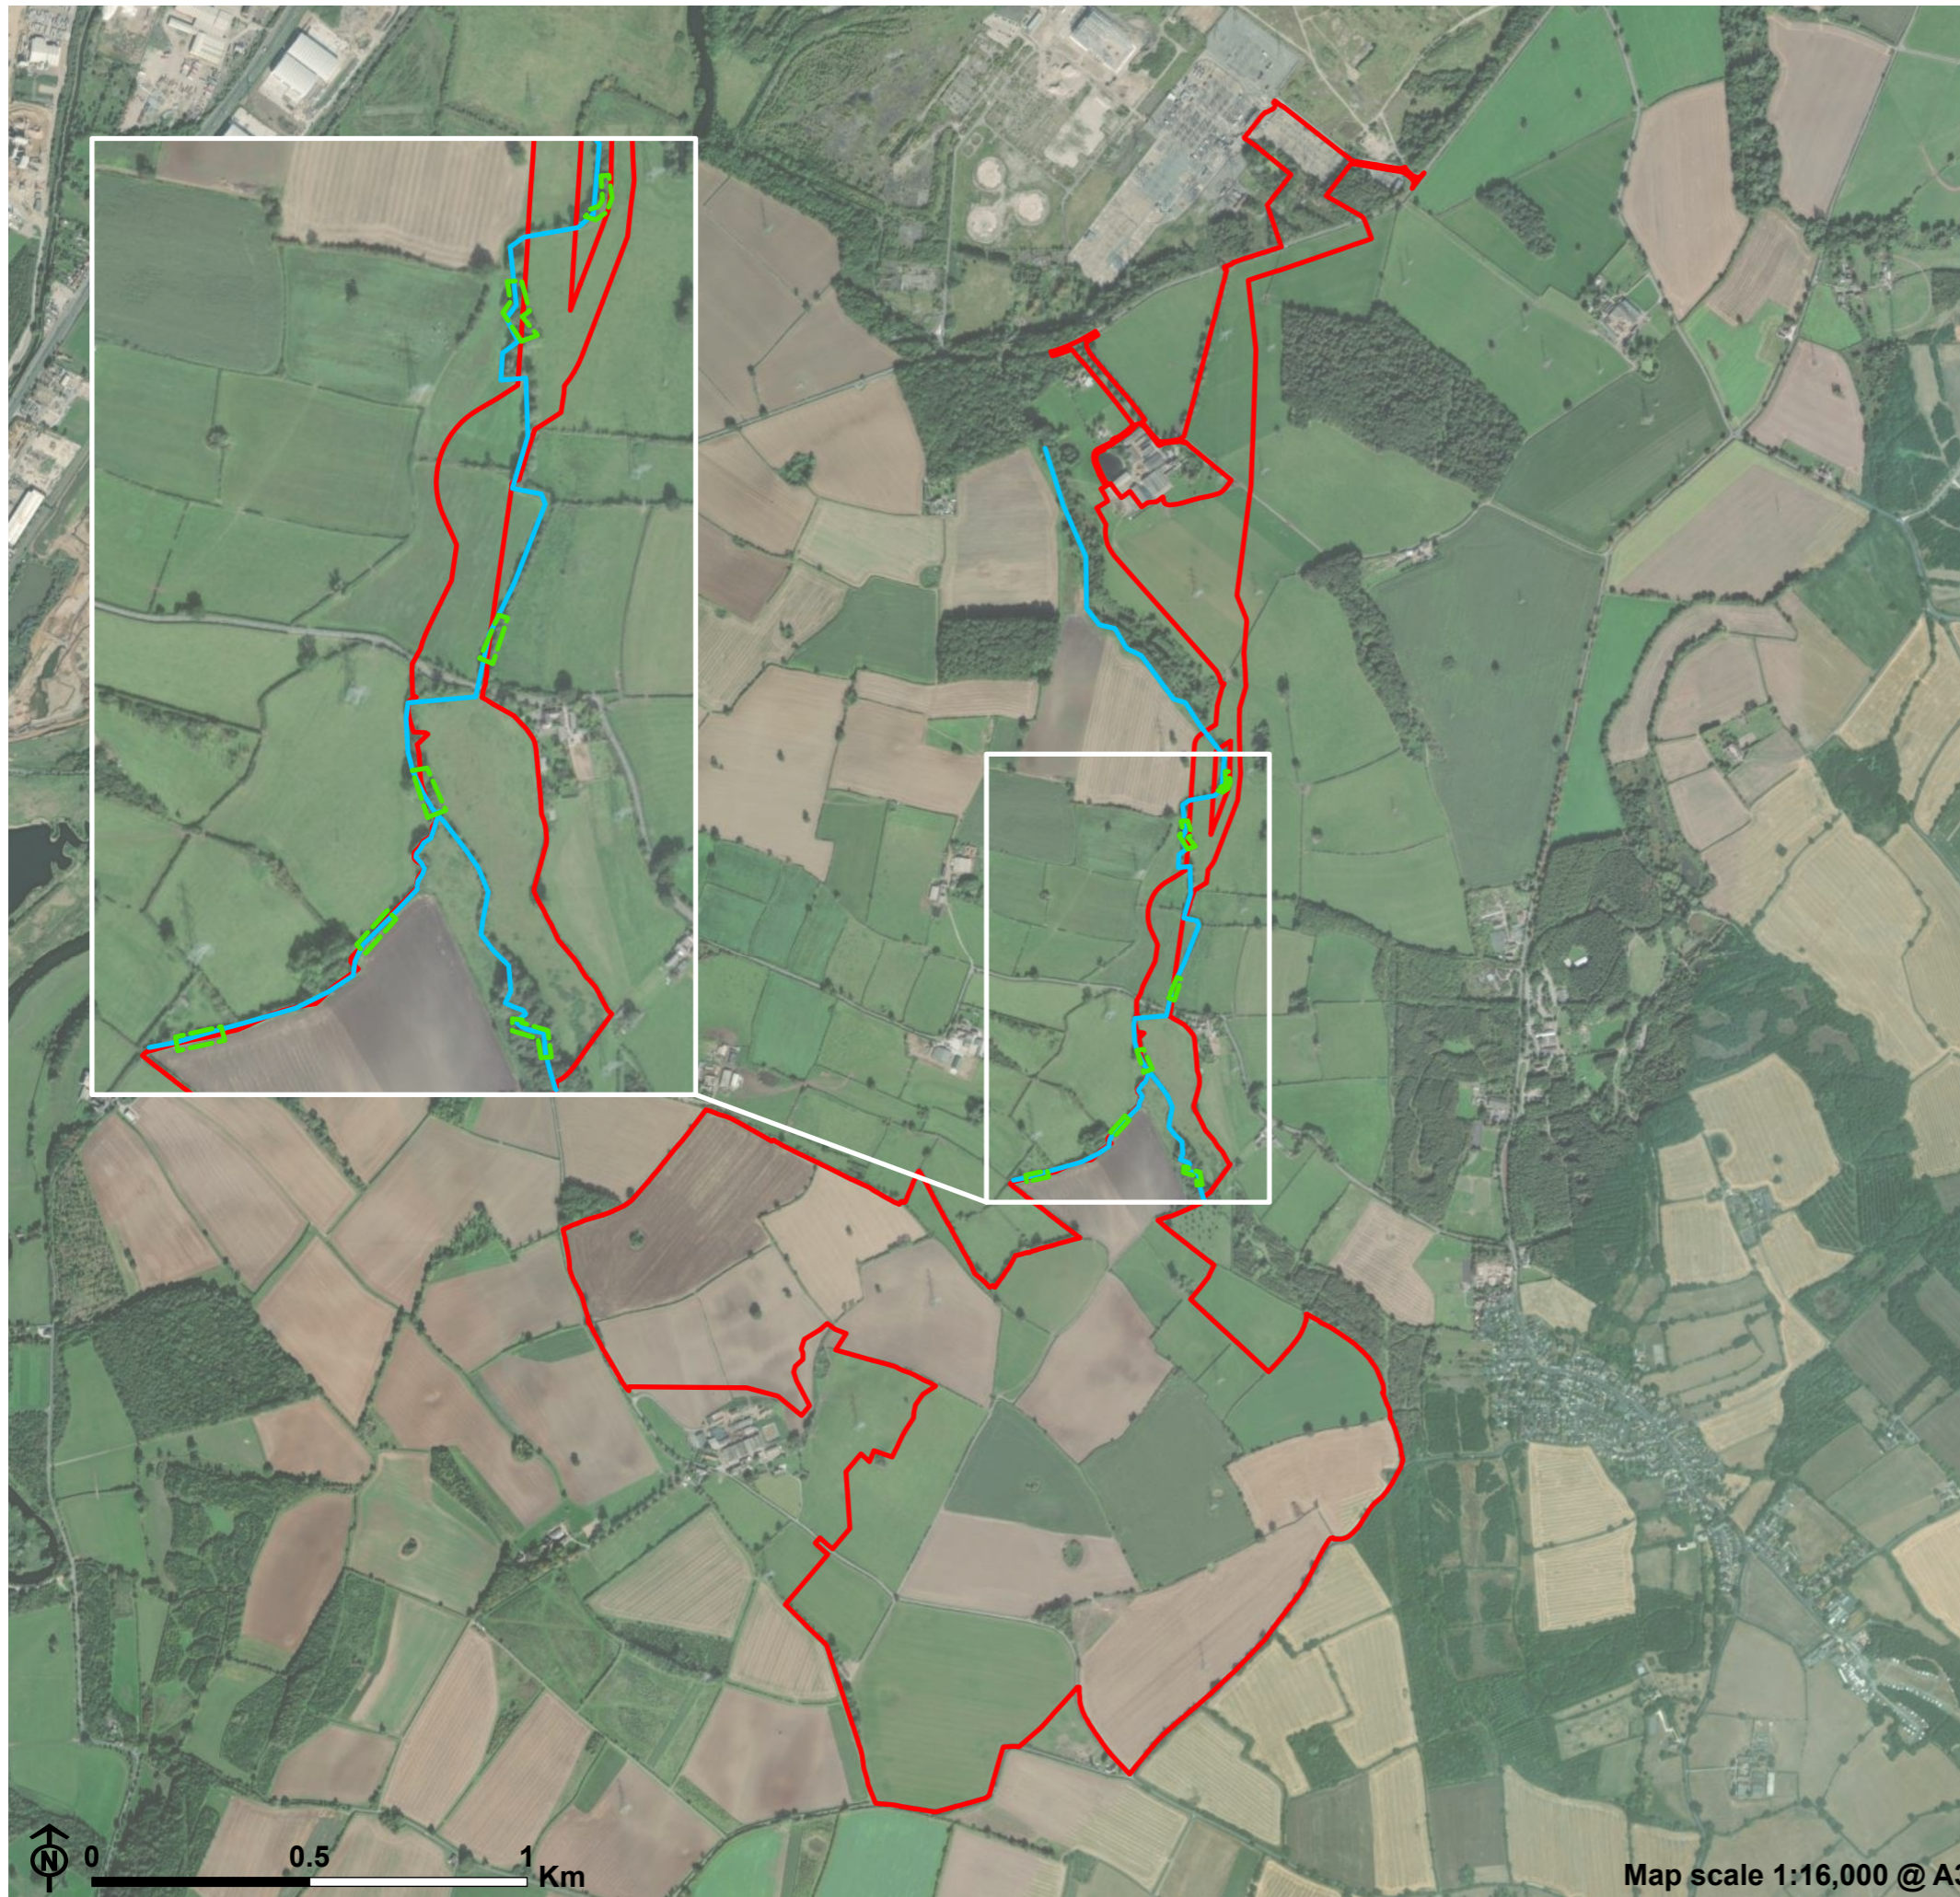
Figure 6.13.2: RCA Survey Area

**2.5** Five contiguous MoRPh module surveys (MoRPh-5) were conducted along sub-reaches <sup>3</sup> of the assessed watercourses, sufficient to survey a minimum of 20% the length of the

watercourse within the application boundary. The assessment covered the bank full width, riverbanks and the first 10m of land extending outwards from the top of the riverbank.
