# **Dogger Bank South Offshore Wind Farms**

**Environmental Statement**

**Appendix 22-5 Onshore Infrastructure Settings  
Assessment**

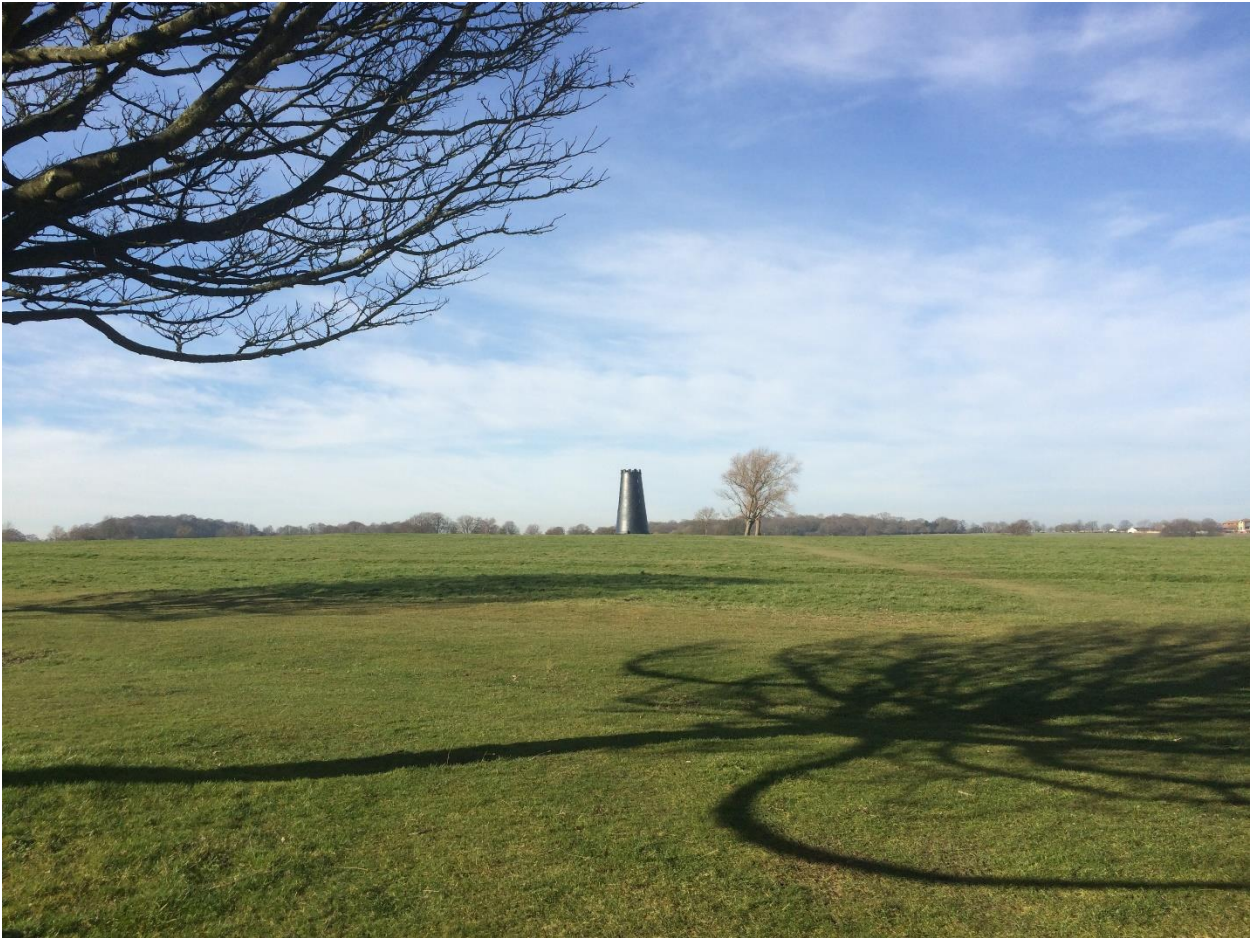
*Plate 22-5-1 General view looking northwest towards the group of prehistoric barrows with Black Mill (1310087) at centre of image*

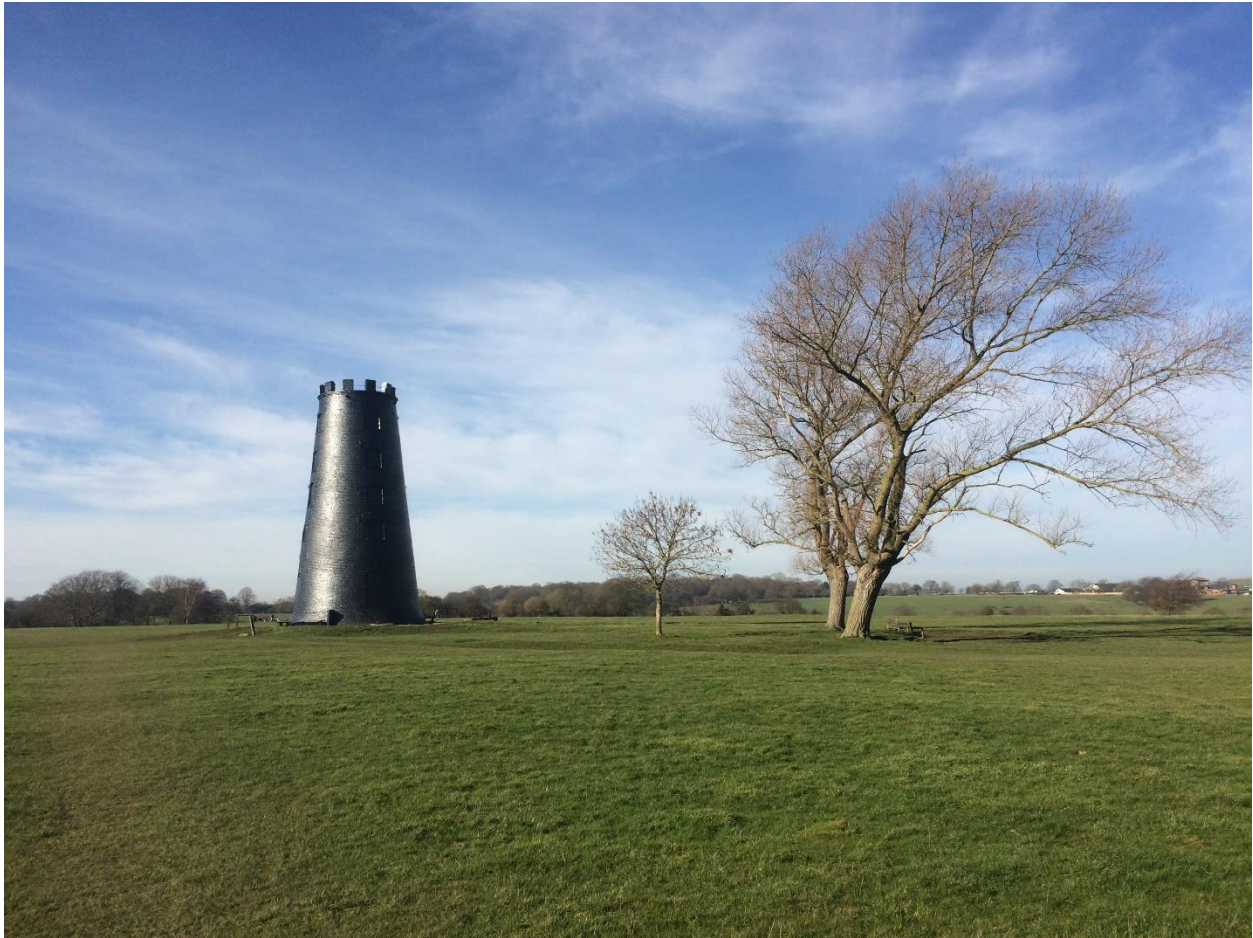
*Plate 25-5-2 Black Mill (1310087), viewed from the east*

56. Black Mill was damaged by fire in 1868 and all the timber parts and working gear were dismantled, with the mill later used as a dwelling until 1934.

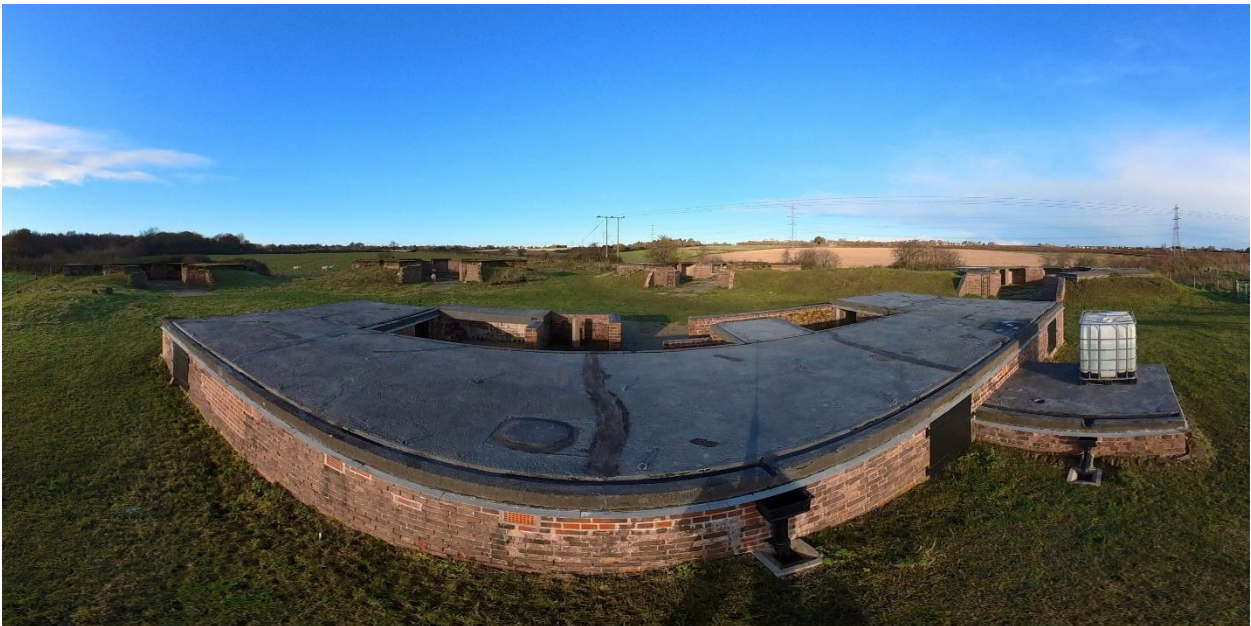
*Plate 22-5-3 Heavy Anti-aircraft gunsite (1019186) with the command post in the foreground, viewed from southeast (taken with a 360° camera).*

72. Its original location within an open, agricultural landscape adjacent to Butt Farm can still be appreciated, however following the walkover it was noted that the touring caravan campsite and road noise from the A1079 does detract from this to a degree. Additionally, much of the associated military infrastructure, such as the radar mat, which would have been presented to the south no longer survives as above ground remains.

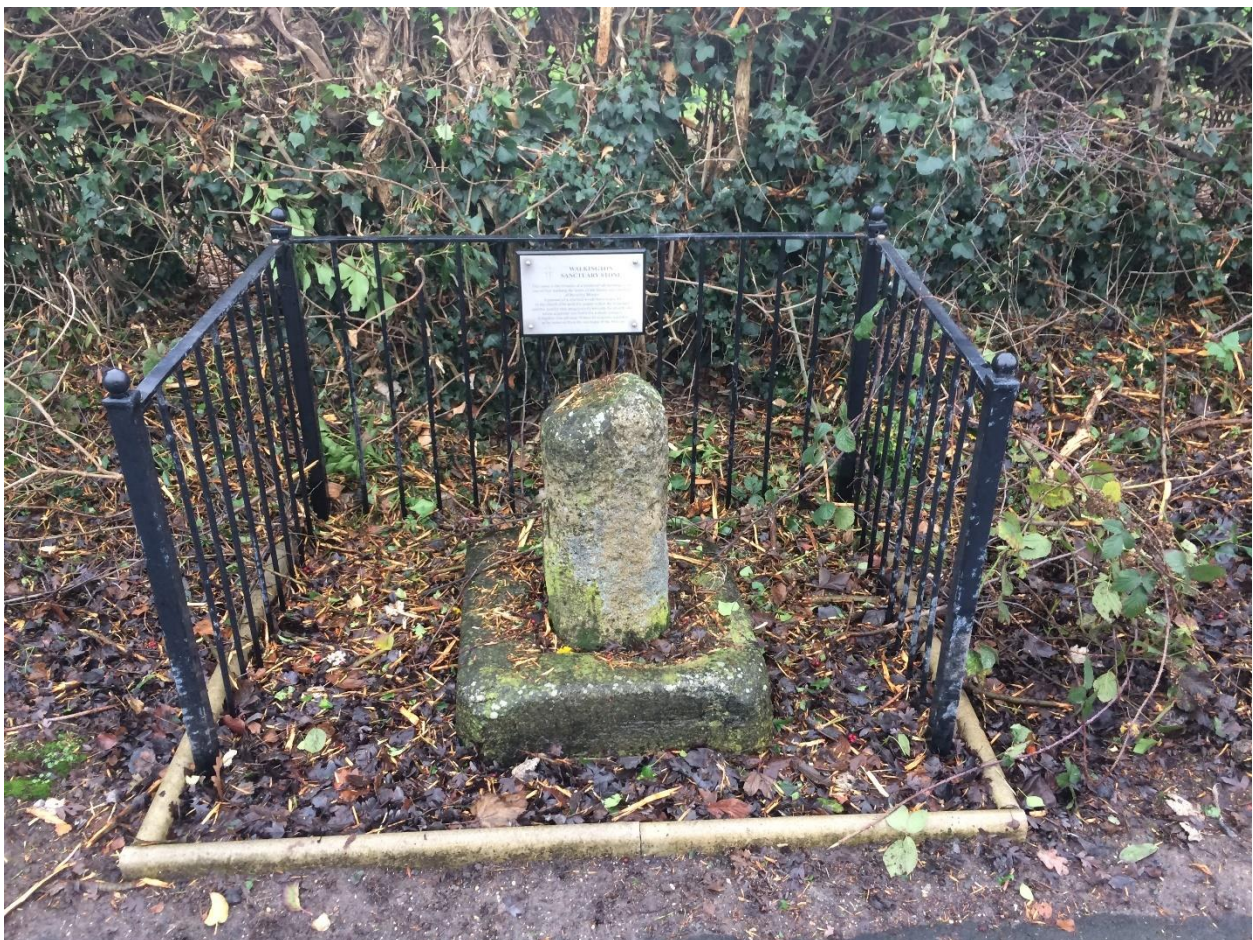
*Plate 22-5-4 Walkington Cross (1012591), viewed from the north on East End Road*

93. An appreciation of the Scheduled Monument is achieved from its roadside setting and location between Beverley and Walkington. The wider landscape is not considered to contribute to the asset's heritage significance and therefore the location of the Onshore Substation Zone is not considered to alter its setting or detract from its heritage significance. As such, there will be no change to its heritage significance.

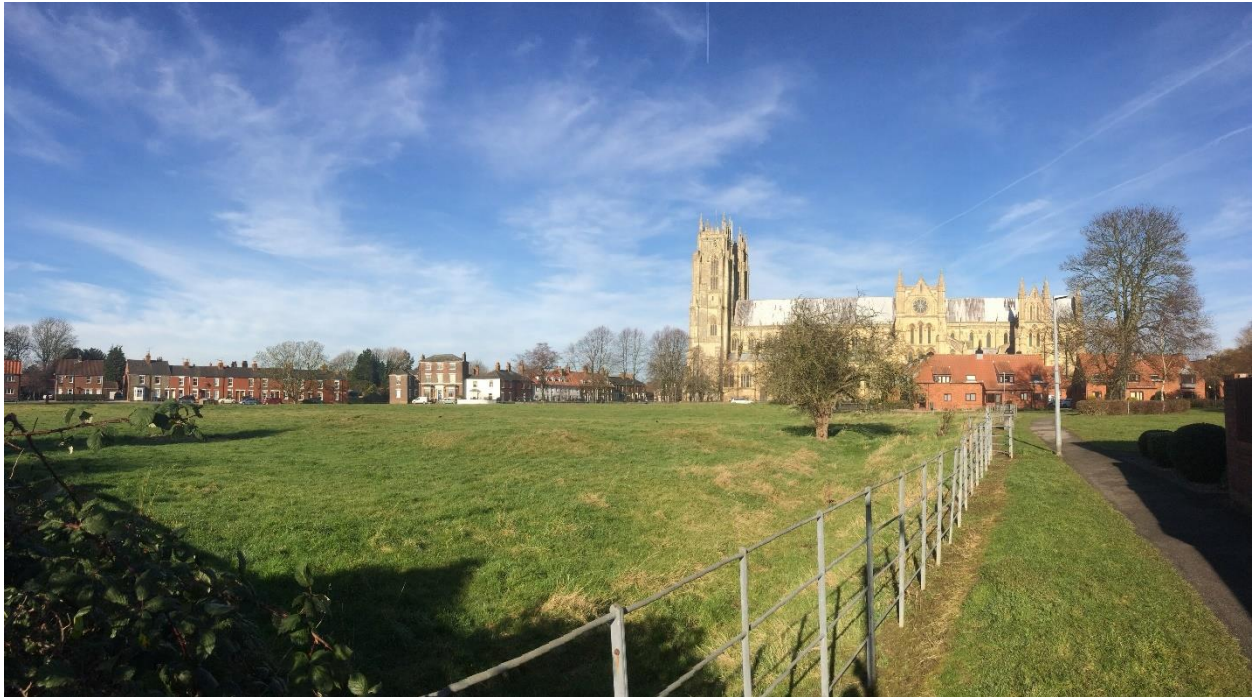
*Plate 22-5-6 Beverley Minster (1084028) with Hall Garth Scheduled moated site (1008122) in the foreground*

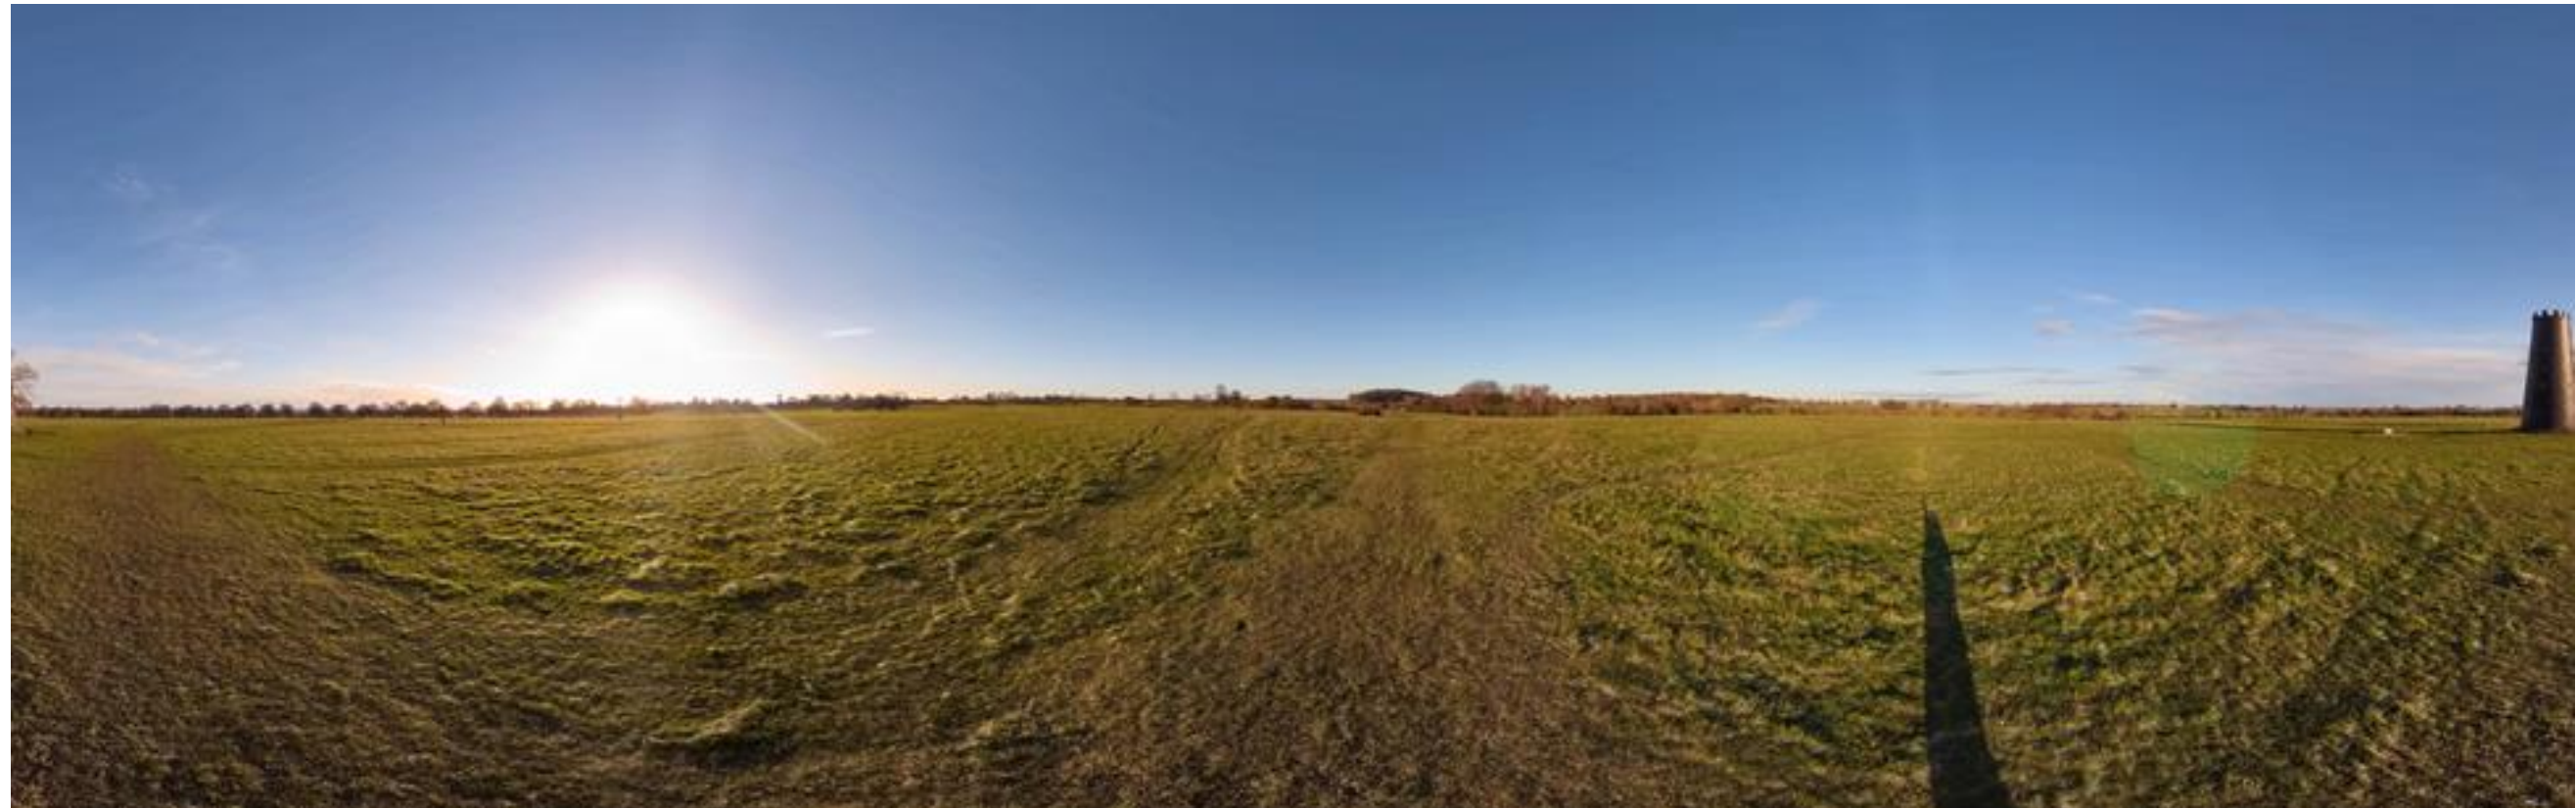
Plate 22-5-8 360° view from Westwood Common with Black Mill (1310087) to the right of the image and Beverley Minster (1084028) to the left of the image.

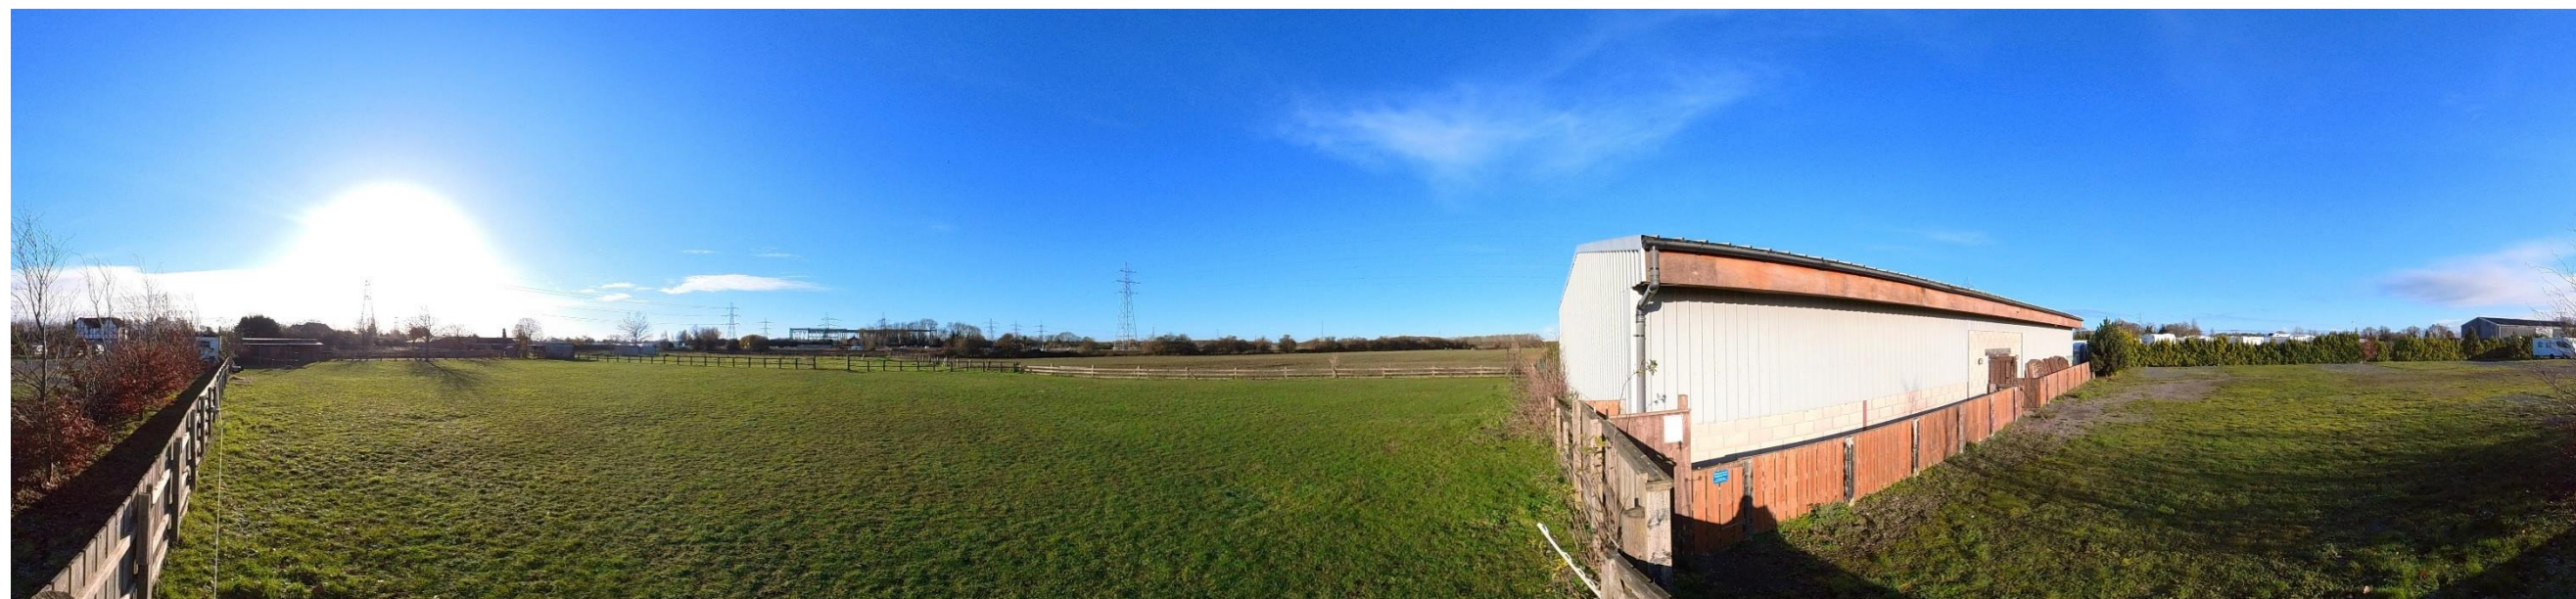
Plate 22-5-9 360° view from field located south of the Scheduled Bowl Barrow (1007731). Approximate location the Substation Zone is beyond the trees located towards the centre of the image.

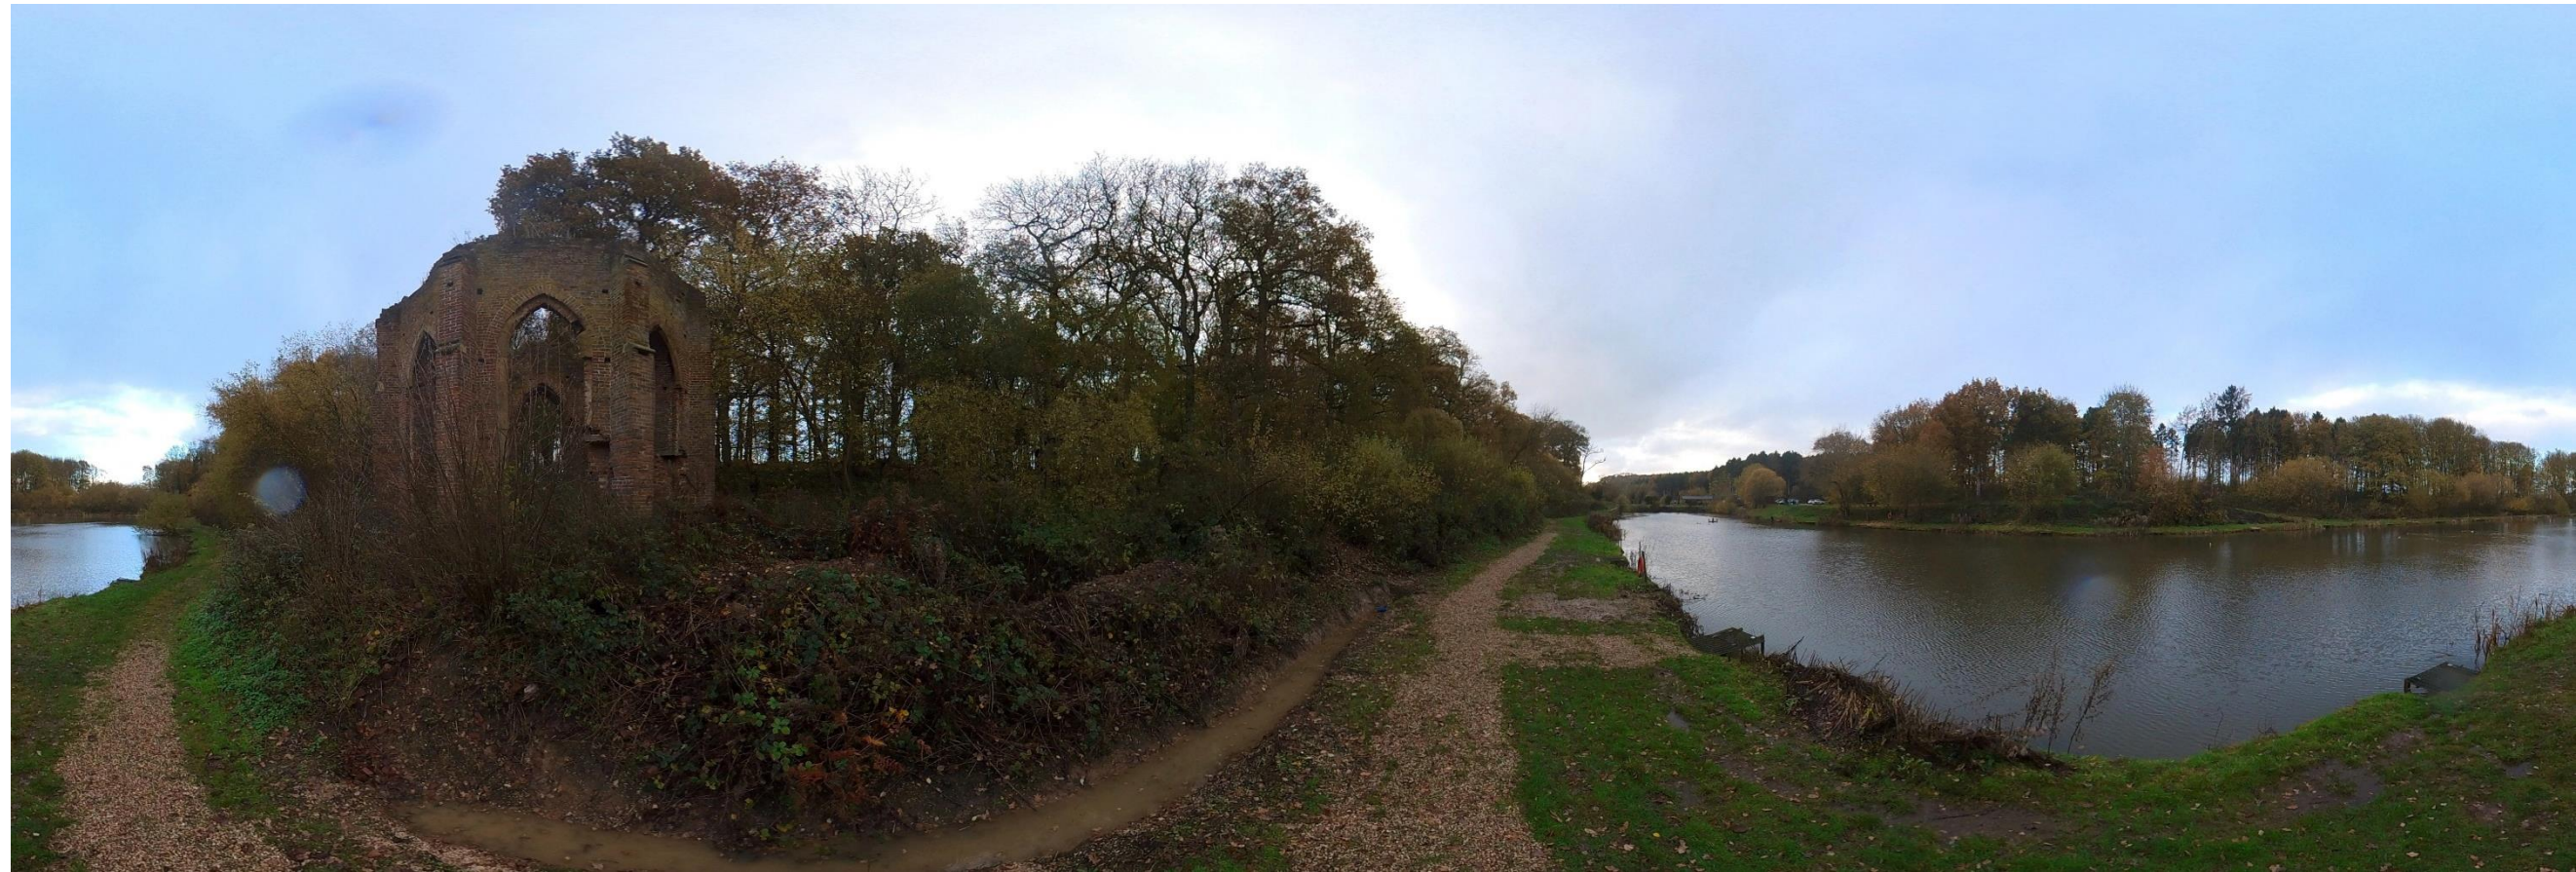
*Plate 22-5-10 360° view from within Risby Hall Registered Park and Garden (1001419) with the Grade II Listed Folly in Fishpond Wood (11611815) to the left of the image.*
