# **Dogger Bank South Offshore Wind Farms**

**Environmental Statement**

**Appendix 8-2 Met Mast Survey Analysis**

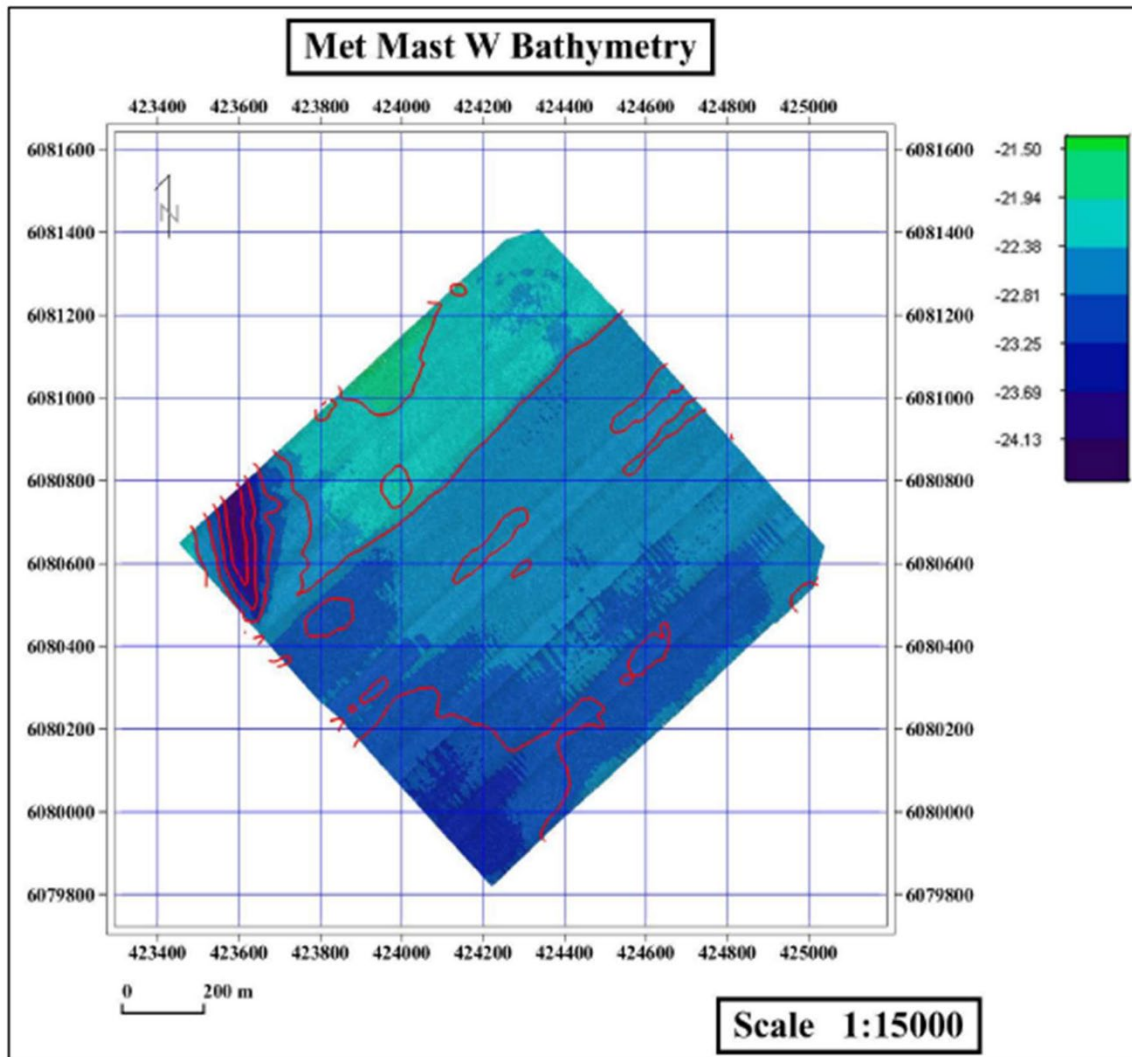
Plate 8-2-3 Met Mast West Survey Area Bathymetry (Pre-Installation)

*Water depth in the Met Mast West survey area ranges between 21.4m in the north, and 24.5m in the west. The seabed as seen in **Plate 8-2-3** is generally flat with a valley feature 2m deeper on the west corner of the survey area. The whole survey area lies within 20m – 25m below LAT. The gradient throughout the majority of the survey area does not exceed 0.5° with the exception of the western corner, where the seabed slopes at up to 2 degrees. The seabed sediments within the survey area are likely to consist mainly of gravelly SAND, usually in the range of 0.1 to 0.2m thick and generally less than 1m thick.*

*Met Mast West was located centrally within the survey area on flat level seabed at a depth of 22.6m.*

16. In the Met Mast West survey area, there appears to be a slight 'banding' in the bathymetry that was derived from the pre-installation survey (see earlier Figure 3). Given that this effect appears along the alignment of the main survey lines, it is concluded that this is an apparent bathymetric effect caused by the stitching together of data from adjacent survey lines. This has been investigated further by extracting some transects through the pre-installation data, the location of which are shown in **Plate 8-2-10** and the cross-sectional profiles of which are shown in **Plate 8-2-11**. These plots clearly show the 'jumps' in level at relatively even spacings along the transects from the pre-installation survey and can be compared against the much smoother cross-section of the post-recovery survey at an equivalent transect location (although this is partly due to the re-orientation of survey lines during the data collection).

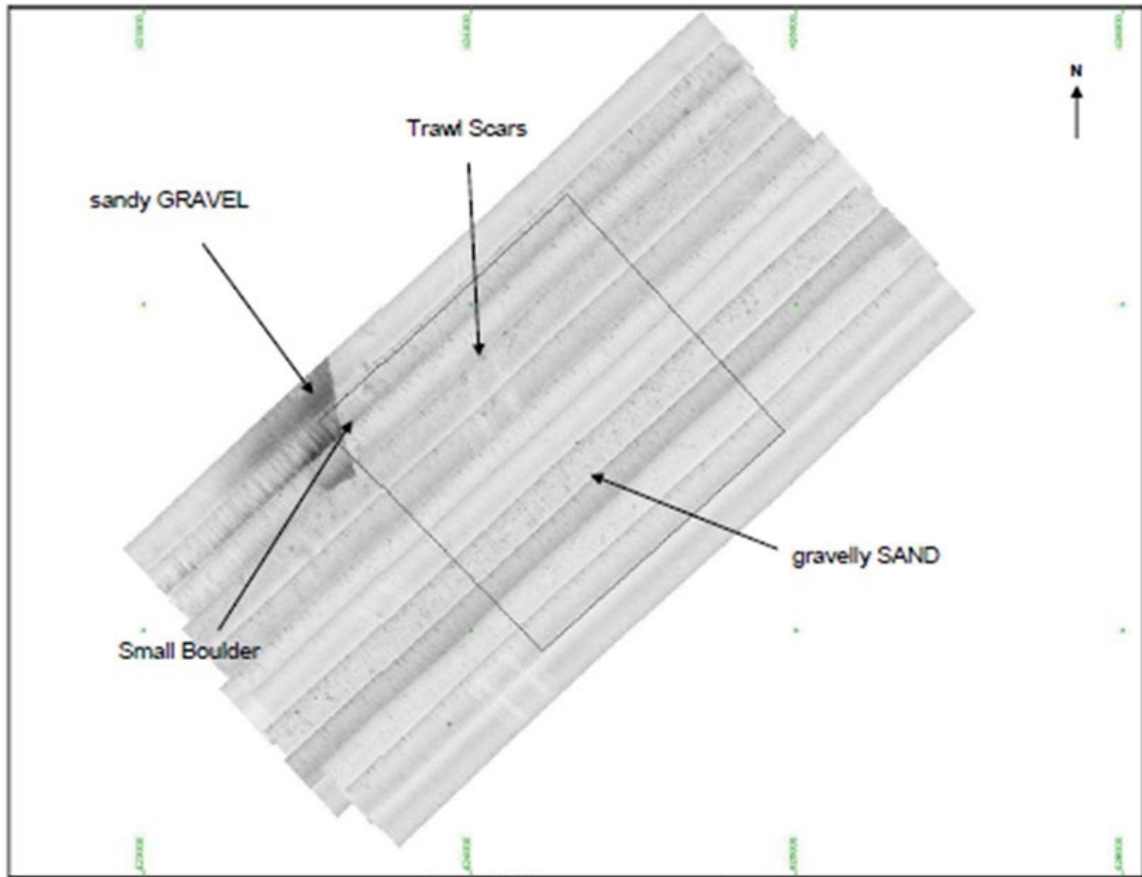
Plate 8-2-4 Trawl Scars in Met Mast West Survey Area (Pre-installation) Side-scan Sonar

6. Trawl scars were identified within the survey area (**Plate 8-2-4**), passing close to the Met Mast West location. These scars trended with a north west to south east alignment.

19. The aforementioned trawl scars are also subtly apparent in the pre-installation survey. In fact, there appear to be several other seabed scars in this survey running in twin lines approximately north-south aligned in parts of the survey area in addition to those described in the factual report. However, by the time of the post-recovery survey these are not at all visible in the data, suggesting that a veneer of sand has infilled them.

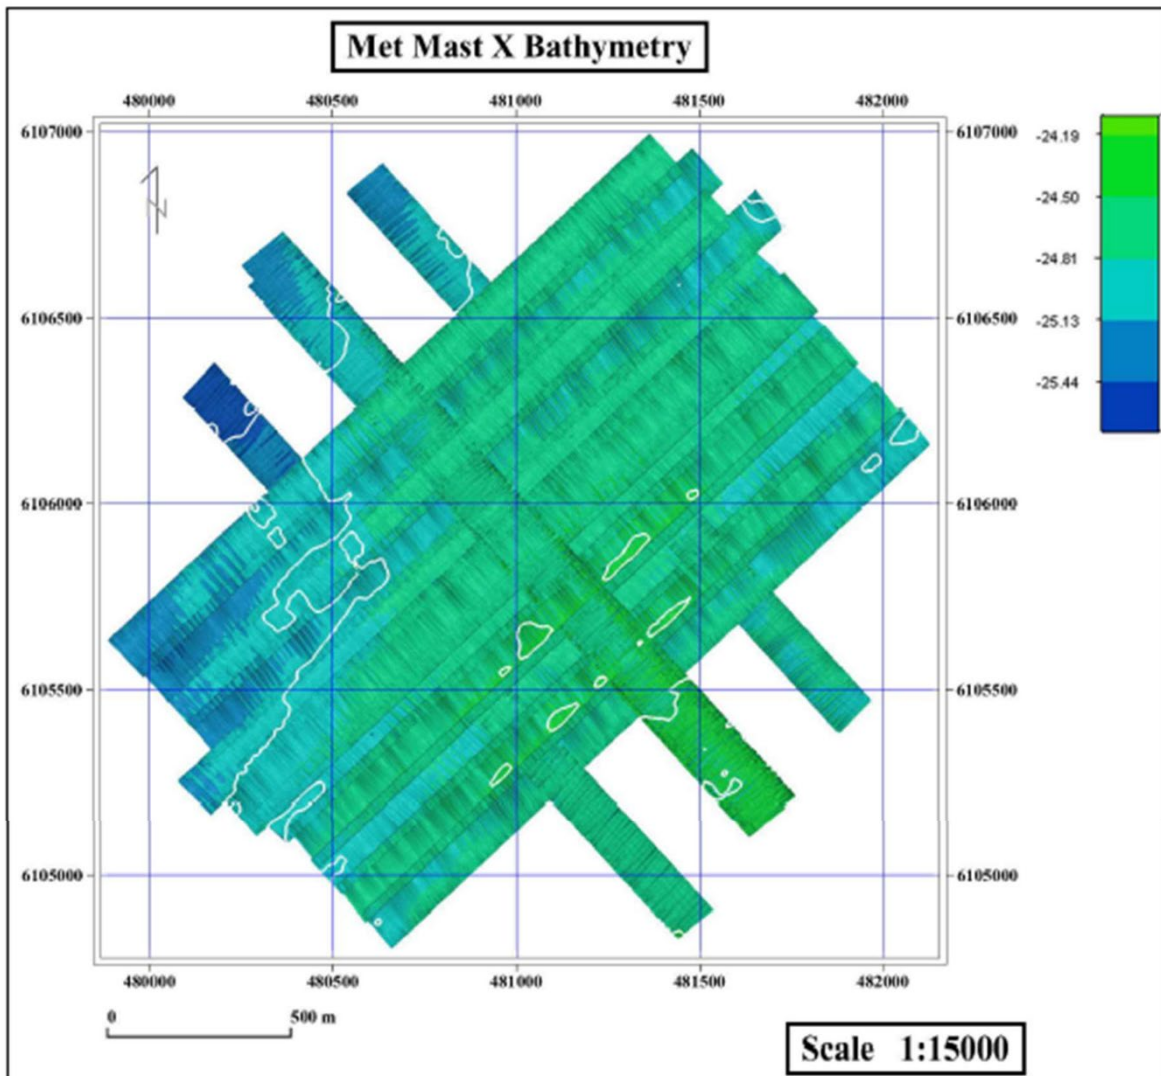
Plate 8-2-5 Met Mast East Survey Area Bathymetry (Pre-installation)

*The water depth in the Met Mast East survey area varied from 24.3m in the “south-east, to 25.6 m in the west (Plate 8-2-5). The seabed is generally flat with no distinguishable features visible and generally with a dominant surface sediment likely to be gravelly SAND.*

*Met Mast East was located centrally within the survey area on flat level seabed at a depth of 24.6m.*

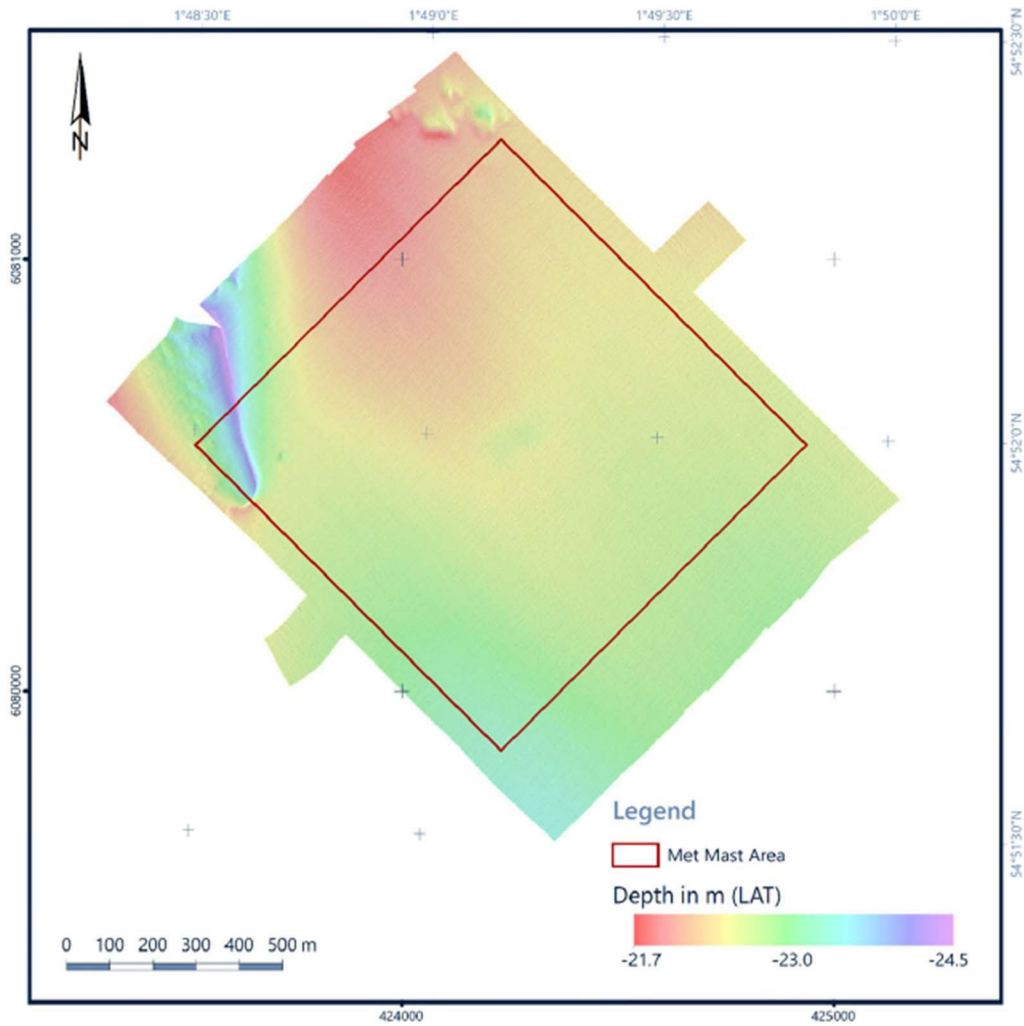
Plate 8-2-7 Met Mast West Survey Area Bathymetry (Post-recovery)

*Water depth in the Met Mast West survey area ranges between 21.7m in the north, and 24.5m in the west **Plate 8-2-7**. The seabed was observed to be relatively flat, with the exception of a trench which is around 470m in length, seen in **Plate 8-2-8** along with a cross profile of water depth across the trench. It is roughly orientated in a north-south direction cutting through the west section of the site. There are also some small depressions located to the north of the site, which are located within 200m of each other. The depths of these depressions range from 22.5m to 23m LAT.*

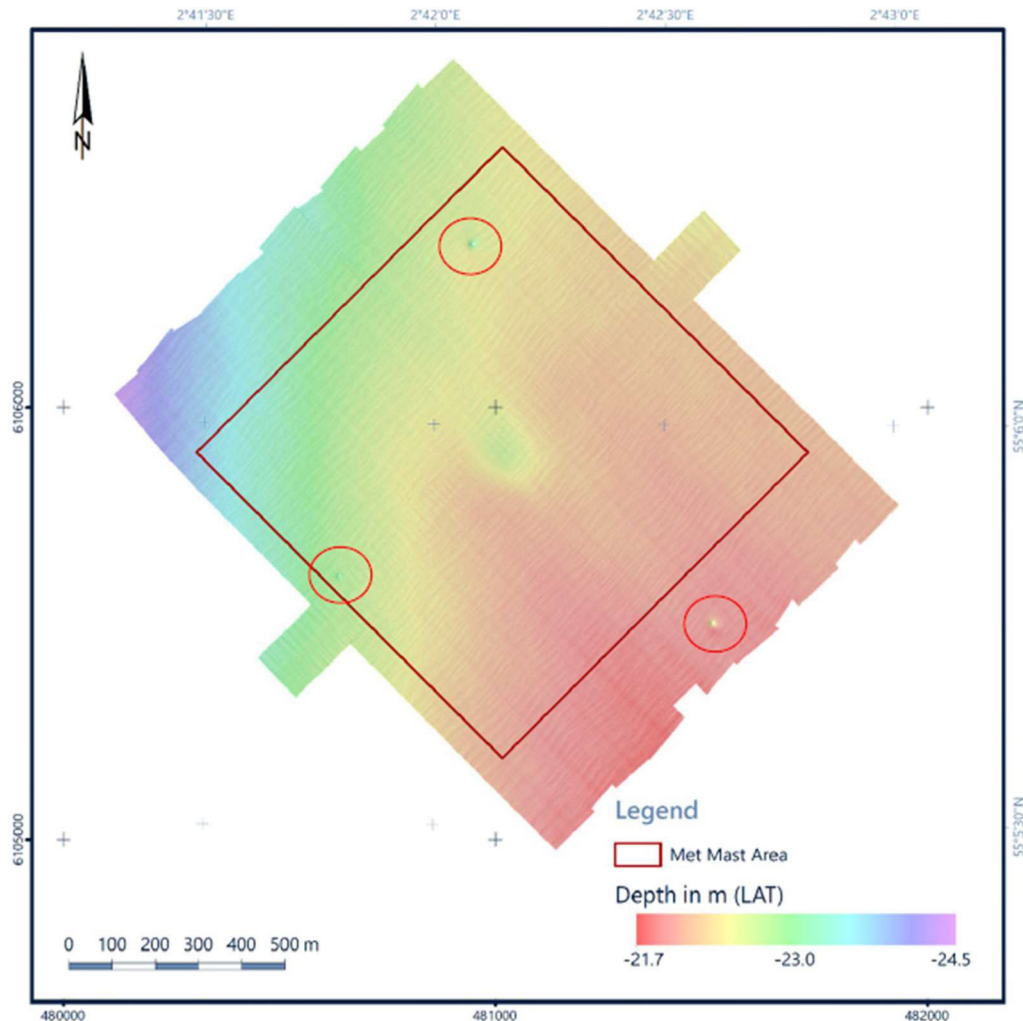
Plate 8-2-9 Met Mast East Survey Area Seabed Depressions (Post-recovery)

*The water depth in the Met Mast East survey area varied from 24.5m in the south-east, to 25.5m in the west. The natural seabed was observed to be flat and featureless, with the exception of three small depressions (indicated with red circles in **Plate 8-2-9**).*

25. The three previously-described seabed depressions are seen in the post-recovery survey, but at distances well away from the met mast location.
26. When considering the seabed in the immediate vicinity of the met mast location (Figure 18b), there are no scouring effects visible in the hill shade layer close to the met mast location. However, the -24.8mCD seabed contour has a notable curvature in plan alignment, with the seabed remaining slightly deeper around the met mast location than the seabed further east, north and south. Also, it is noticeable from Figure 16 that there is an apparent slight 'dip' in seabed level in the post-recovery survey at Section 2, centred on the met mast location (this dip is not apparent in Section 1 or Section 3 which do not cross the met mast location). This is similar to that experienced at Section 2 of the Met Mast West location.

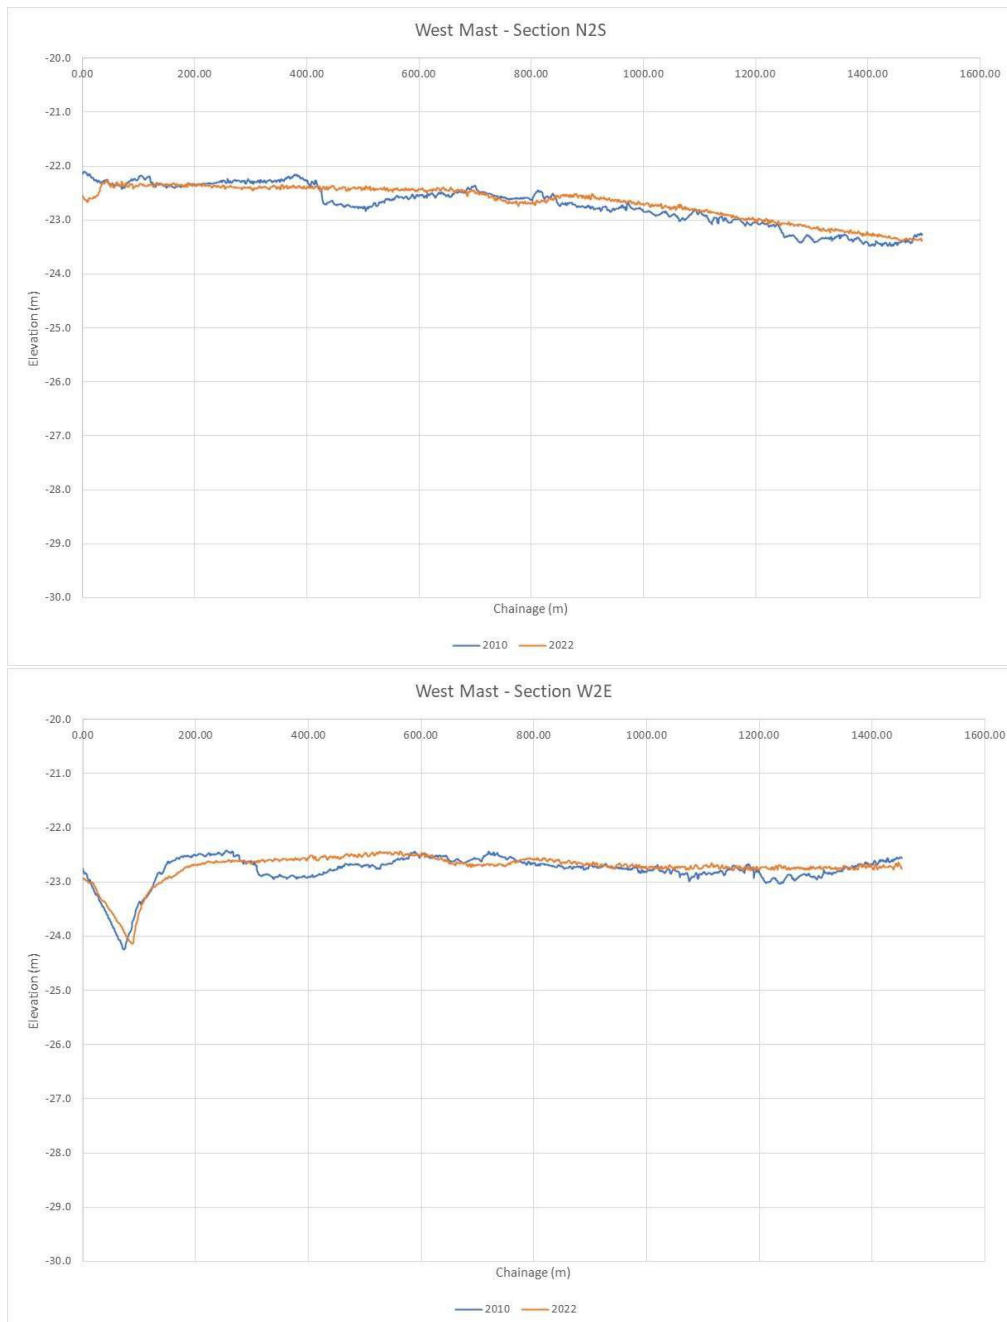
Plate 8-2-13 N-S (top) and W-E (bottom) Transect Cross-sections Centred at Met Mast West ( Note: Met mast was at N-S transect chainage 781m and W-E transect chainage 687m)

22. The resulting cross-sectional profiles are presented in **Plate 8-2-13**. It should be noted that the y-axis, depicting the vertical depth level of the seabed, is much exaggerated compared to the x-axis showing the chainage along the survey transect. Nonetheless, there is a slight depression in the seabed centred around the former met mast location (with levels around 0.1 – 0.2m lower than surrounding seabed). This is not a significant depth change and is barely distinguishable when viewed at a different (less refined) scale and some lower areas of seabed appears at this location along both transect locations in the pre-installation survey (although see earlier comments regarding that survey's accuracy).

31. However, the extraction and examination of cross-sectional transects (N-S and W-E) centred on each met mast location reveal a very subtle shallow (0.1 – 0.2m) panning of the seabed centred on each former met mast location. These are not significant features and are very difficult to discern from the data. This is likely to be an artefact of (near-complete) infilling of a former scour hole following removal of each met mast.

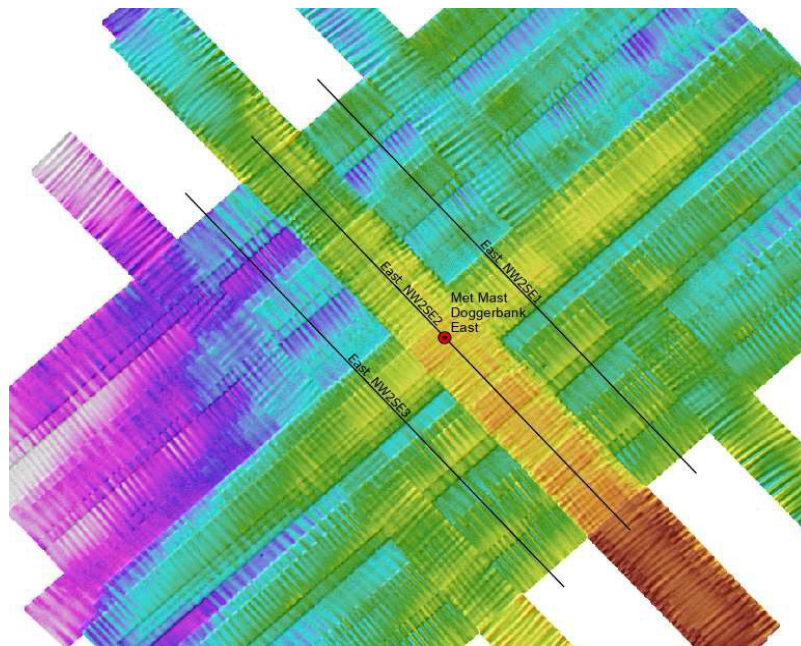
Plate 8-2-14 Transect Locations through the Met Mast East Survey Area

23. In the Met Mast East survey area, there is considerable ‘banding’ in the bathymetry that was derived from the pre-installation survey (Figure 5). As for the Met Mast West survey, this has been investigated further by extracting some transects through the pre-installation data. the transect locations are shown in **Plate 8-2-14**. The cross-sectional profiles of these transects are show in **Plate 8-2-15**. These plots show distinct ‘jumps’ in level at relatively even spacings along the transects from the pre-installation survey and can be compared against the much smoother cross-section of the post-recovery survey at an equivalent transect location (although this is partly due to the re-orientation of survey lines during the data collection). This effect translates itself into the difference plot where apparent lowering appears in bands throughout the survey area.

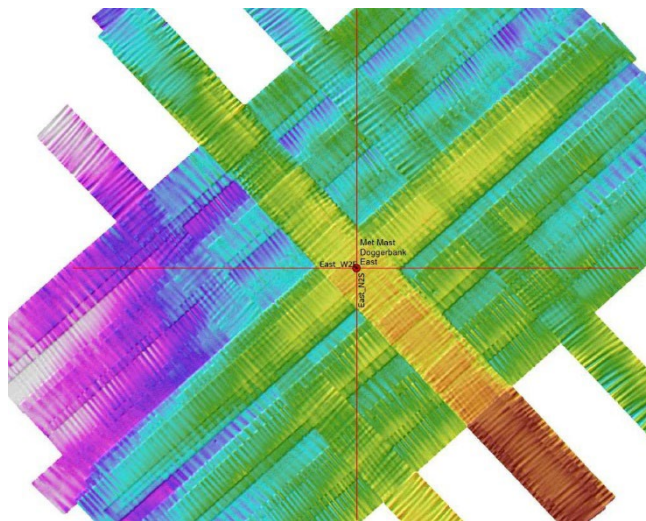
Plate 8-2-16 N-S and W-E Transects Locations through the Met Mast East Survey Area

27. So, to investigate this further at a micro-scale a N-S aligned transect and a W-E aligned transect have been taken across the Met Mast West survey area, each centred on the met mast location (**Plate 8-2-16**).

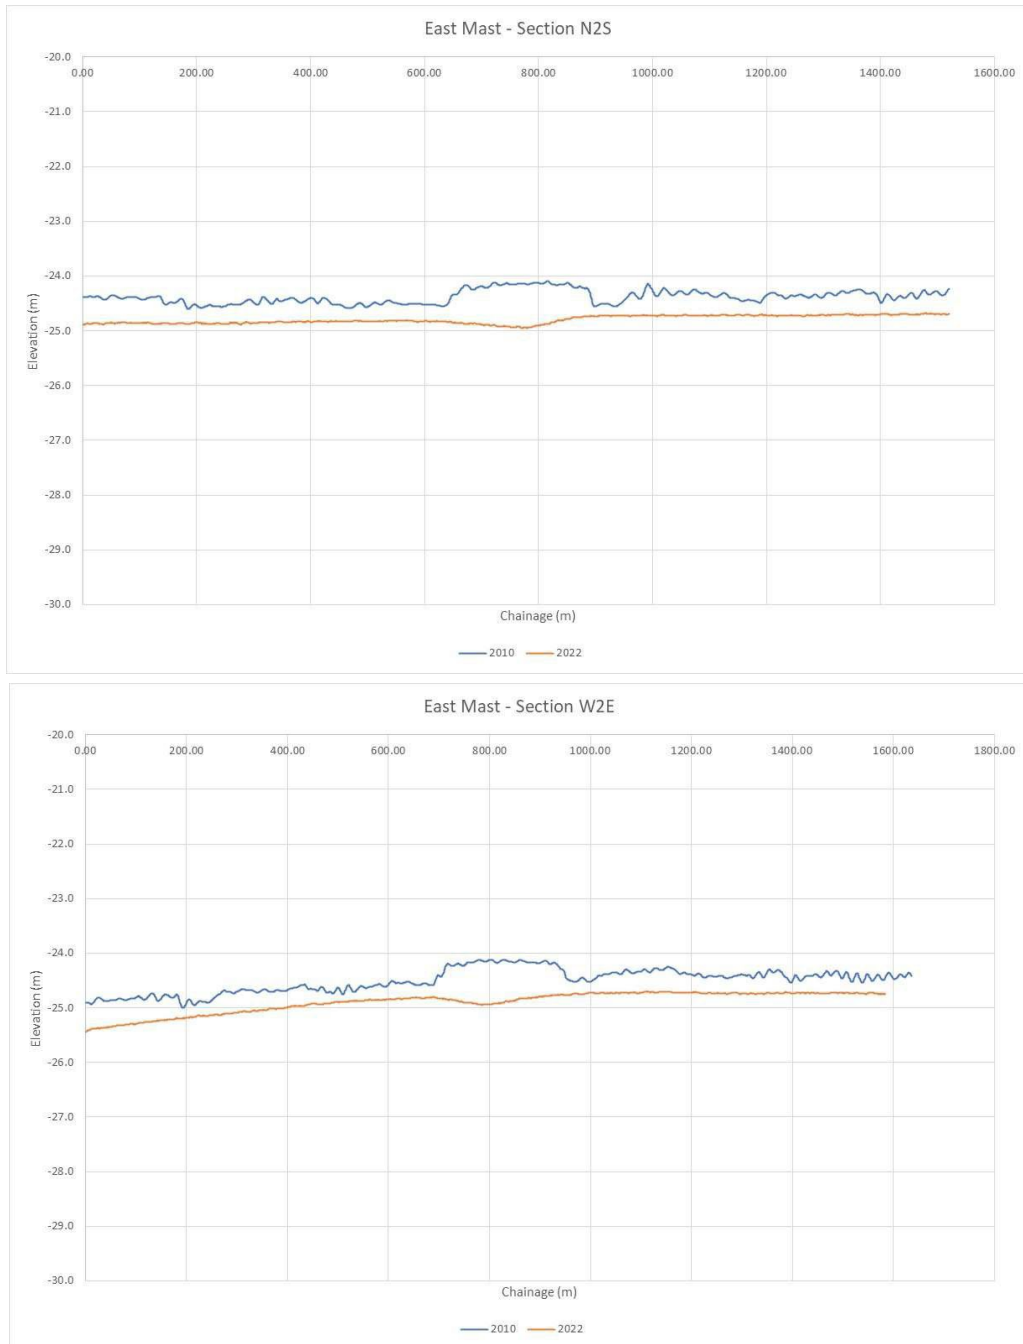
Plate 8-2-17 N-S (top) and W-E (bottom) Transect Cross-sections Centred at Met Mast East (Note: Met mast was at N-S transect chainage 770m and W-E transect chainage 822m)

28. The resulting cross-sectional profiles are presented in **Plate 8-2-17**. It should be noted that the y-axis, depicting the vertical depth level of the seabed, is much exaggerated compared to the x-axis showing the chainage along the survey transect. Nonetheless, there is a slight depression in the seabed centred around the former met mast location (with levels around 0.1 – 0.2m lower than surrounding seabed). This is not a significant depth change and is barely distinguishable when viewed at a different scale and some lower areas of seabed appears at both transect locations in the pre-installation survey (although see earlier comments regarding that survey's accuracy).
