Dogger Bank South Offshore
Wind Farms

Review of evidence on recovery of sandbank
habitat following habitat damage

Document Date: 08 November 2024

Application Reference: 10.36

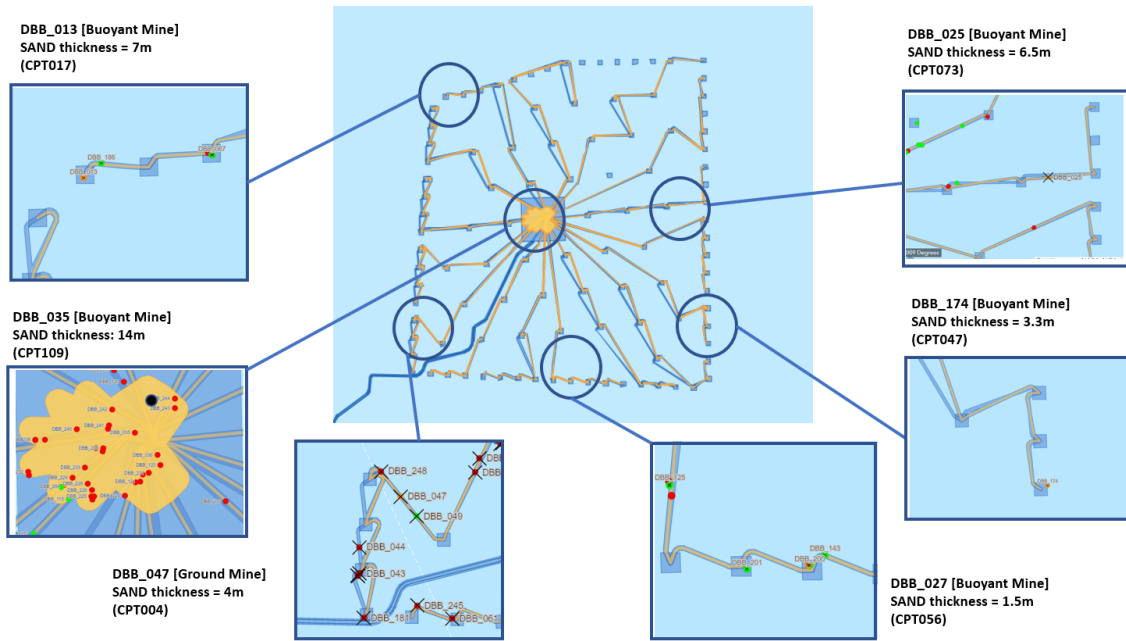
Figure 1. Location of cUXO in Dogger Bank B array area cleared in February and March 2023.

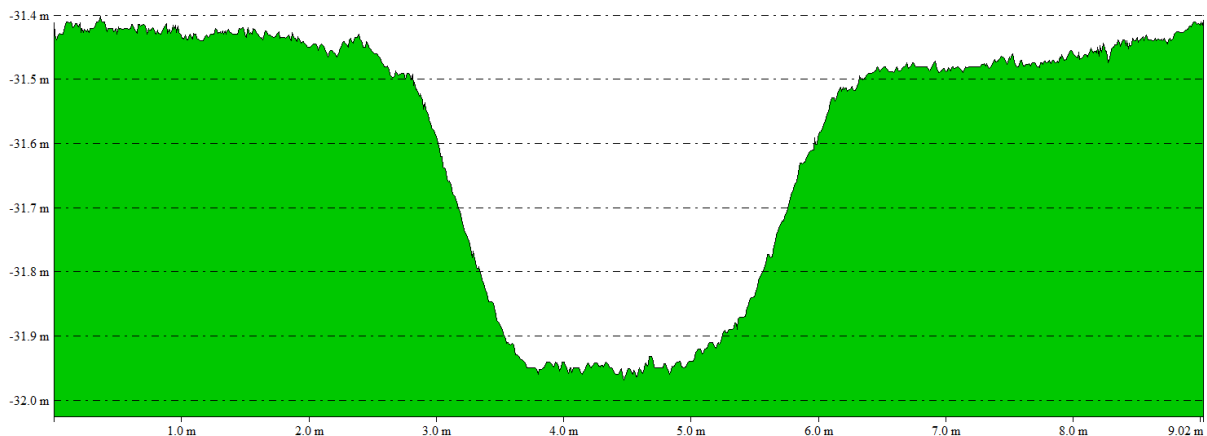
Figure 2 below shows the post-clearance survey results from the *Kamara* for target DBB_013. The site was located over an approximately 7m deep sand layer. The post-clearance ‘as left’ survey on 20 February 2023 following clearance of the buoyant mine demonstrated that a crater of approximately 0.5m remained after the high order target clearance. The *Mimer* survey on 5 June 2023 showed that the crater had largely infilled within the intervening time period, with a small depression of >0.1m remaining at this location.

Figure 2. Target DBB_013 MBES surveys 'As left' on 22 February 2023 and Mimer 5 June 2023.

On the basis of the results presented here at target locations DBB_013, DBB_025 and DBB_174 where ‘as left’ UXO clearance craters surveyed in June 2023 appear to have already infilled, no further surveys are proposed. The Project asks the MMO to confirm agreement with this strategy. Further surveys are planned for targets DBB_027 and DBB_047 where high order clearance craters had not fully infilled at the time of the *Mimer* survey in June 2023, together with the missing post-clearance survey at DBB_035.
