CGW Mallard Pass Solar Farm Written Representation

Topic 1. Mallard Pass Solar Farm Proposal - Flood Risk Implications

By Chris Granville-White. Flood Warden for Greatford village since 1Feb2013

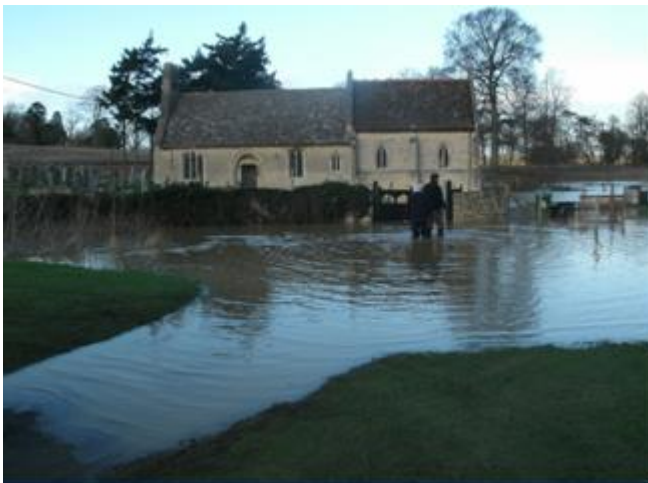
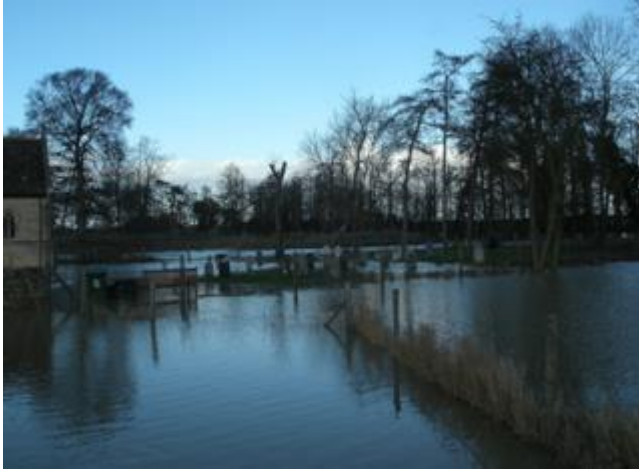
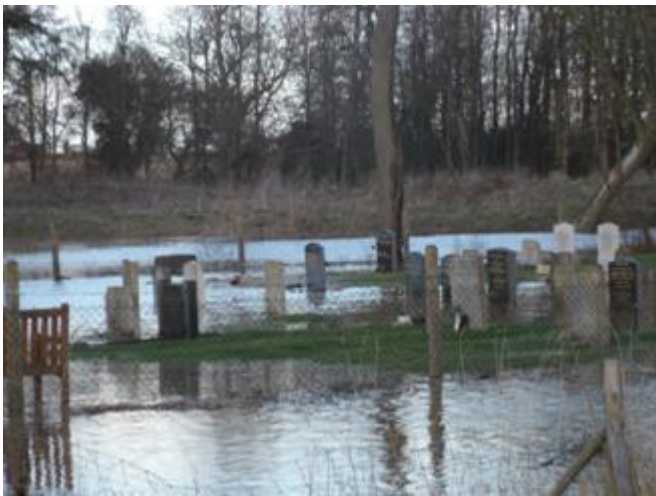
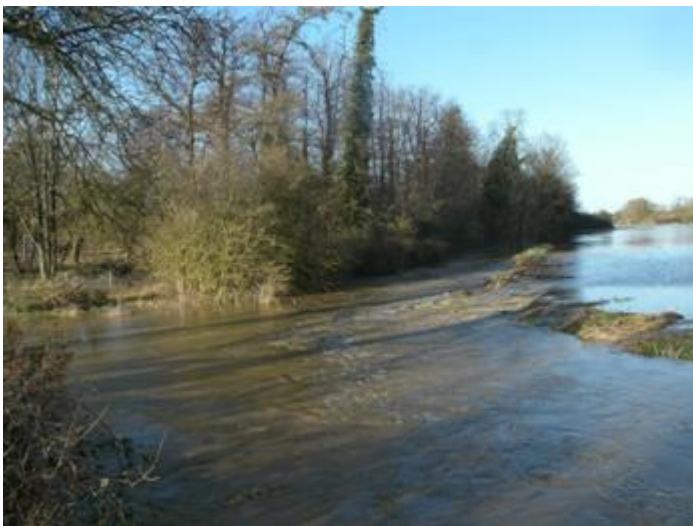
Essendine Flooding

The area where the West Glen flows near the ancient church in Essendine is prone to serious flooding, as shown below:

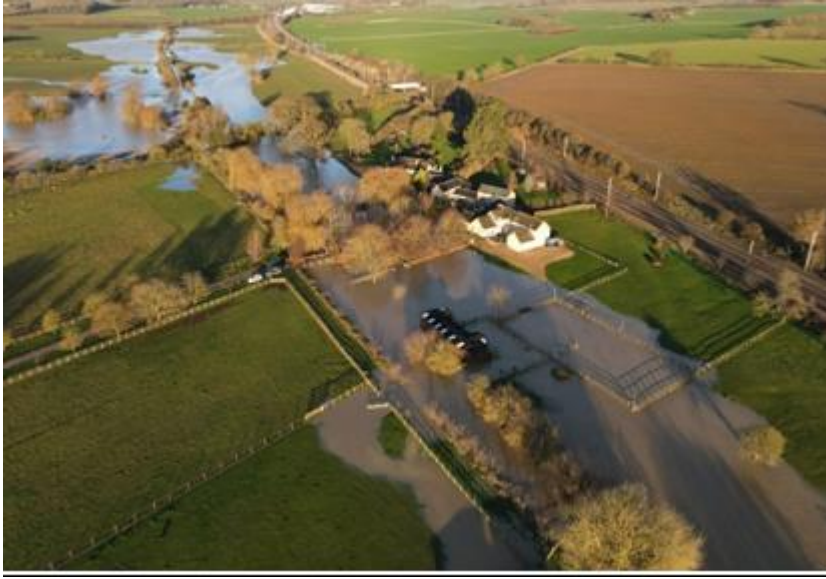
A mile downstream of Essendine, the West Glen river flows along the south-west frontage of Banthorpe Lodge properties before passing under the main north-south railway line. The aerial photo below shows the impact of river overflow alongside these properties.

Banthorpe Lodge Properties, looking north-west along the railway line towards Essendine with its large white warehouse in the distance. On this typical occasion, the flood water came close to the houses.

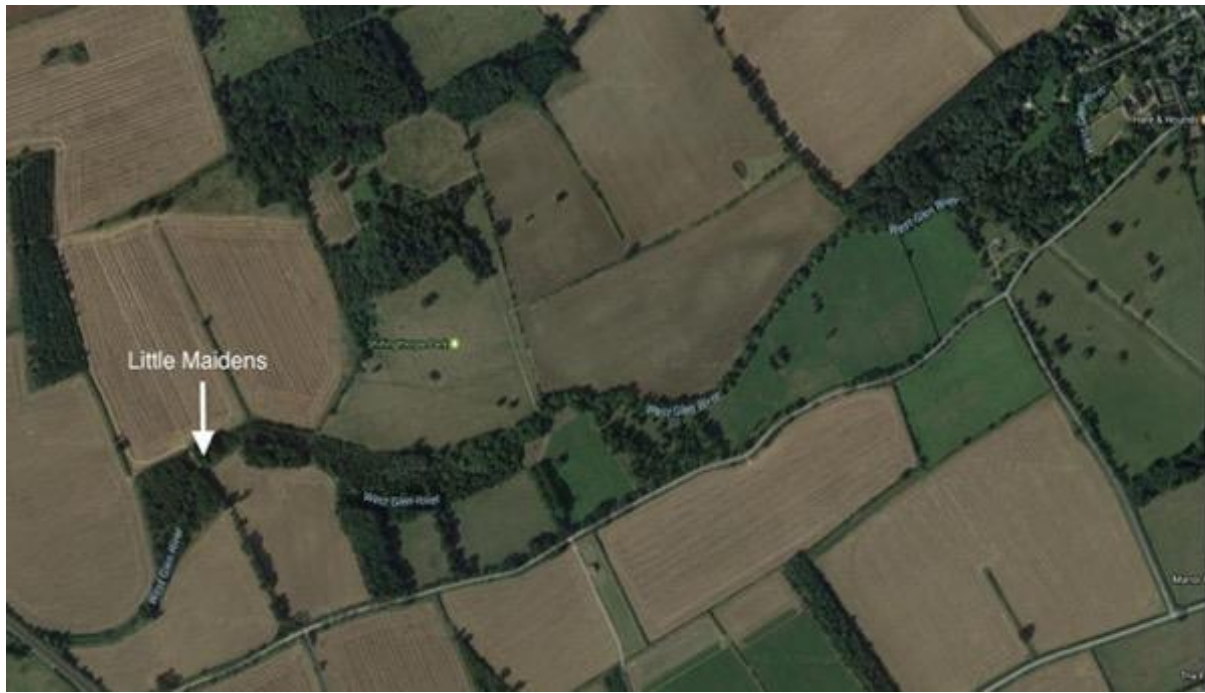
The West Glen River from the railway crossing (bottom left corner) to Little Maidens, thence lower edge of Shillingthorpe park (left of centre) to Greatford (top right)

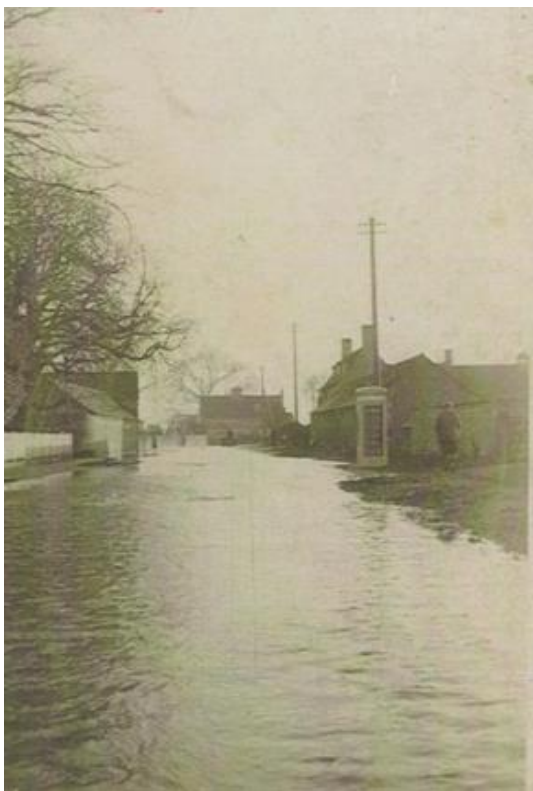
Greatford Main Street Flooding 27Aug1912

This flooding extended along the Main Street until 1956 when the Greatford Sluice was installed with an associated Cut to divert excess water to the Welland river near Market Deeping. Although the sluice and cut have been effective in reducing the overall flood risk, there continues to be periodic flooding in the area of Greatford Gardens where 14 properties were built in the early 1970s in a 5-acre field known to flood.

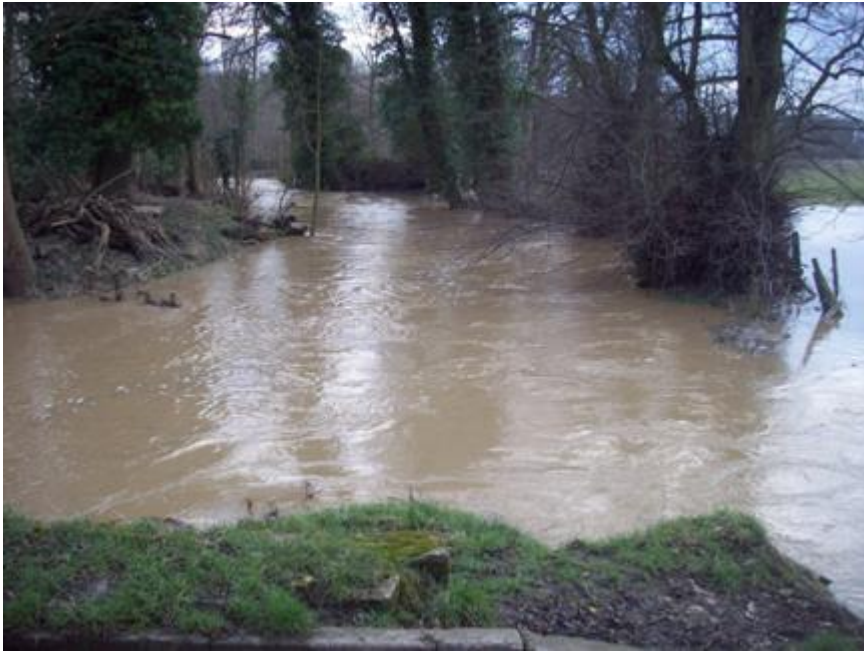
Looking upstream from Shillingthorpe Bridge, with overflow into Shillingthorpe Park at right.

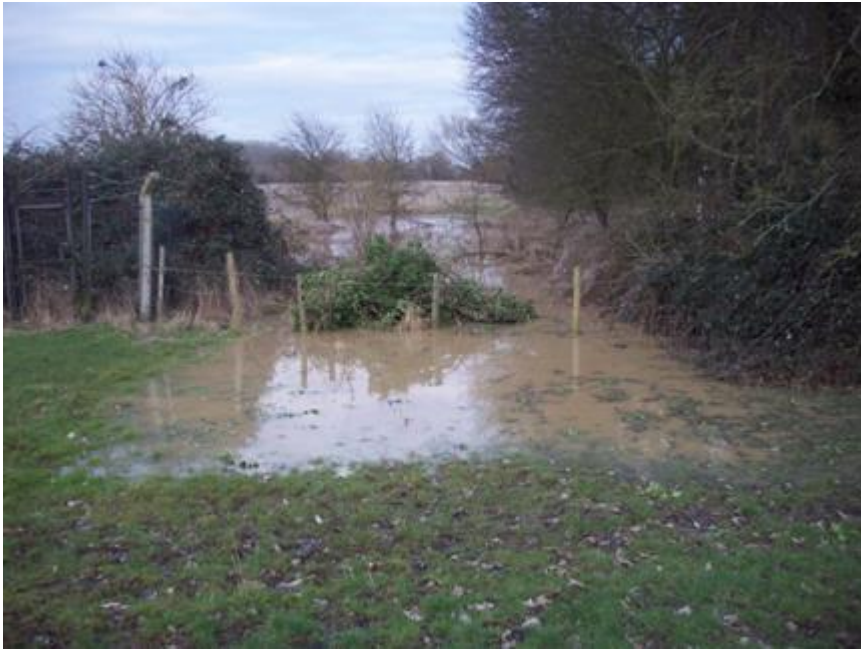
Looking downstream from Shillingthorpe Park driveway. River overflowing into west end of the large field towards Greatford.

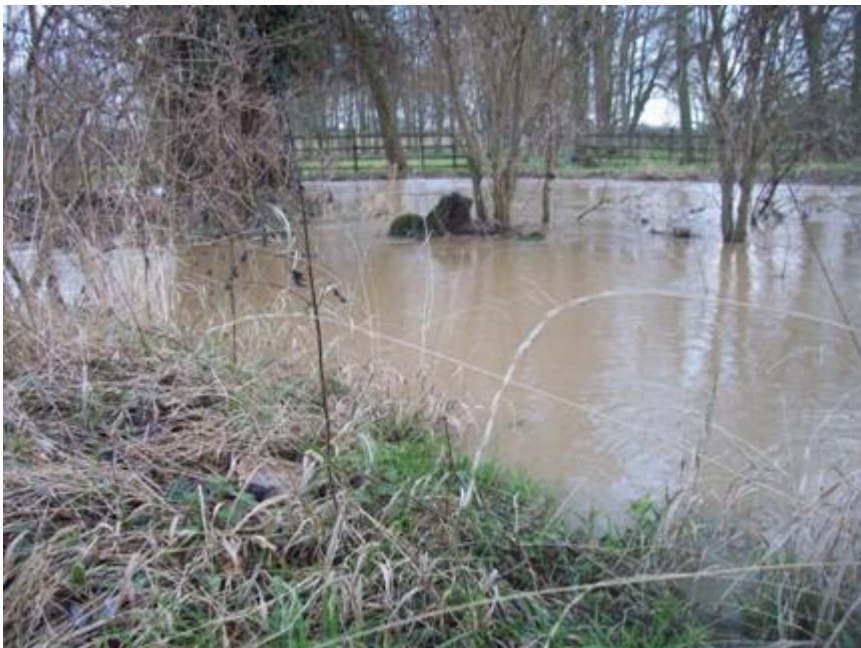
River and secondary drain combined with rising water. Looking from field edge towards Steadings bank.

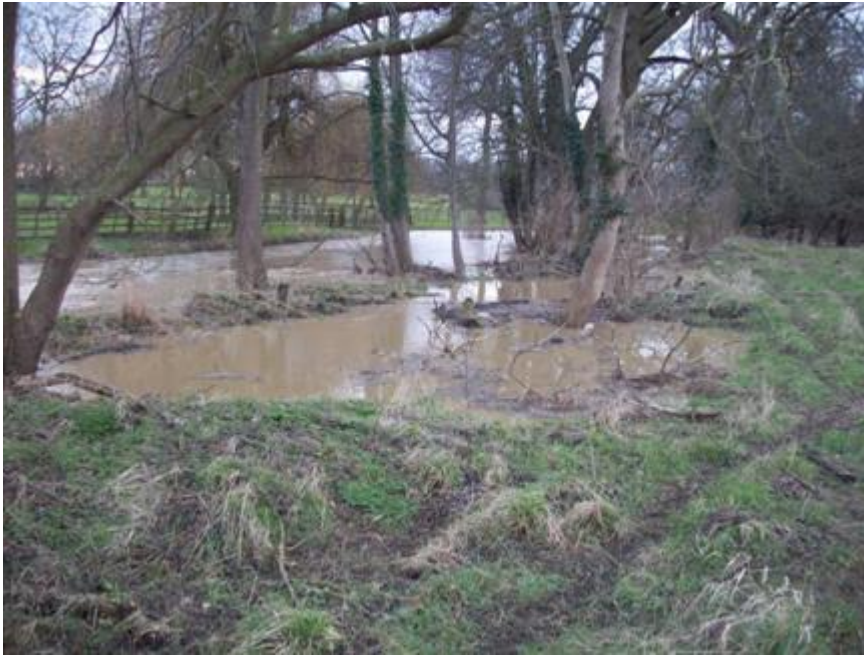
As above, with water only just contained here.

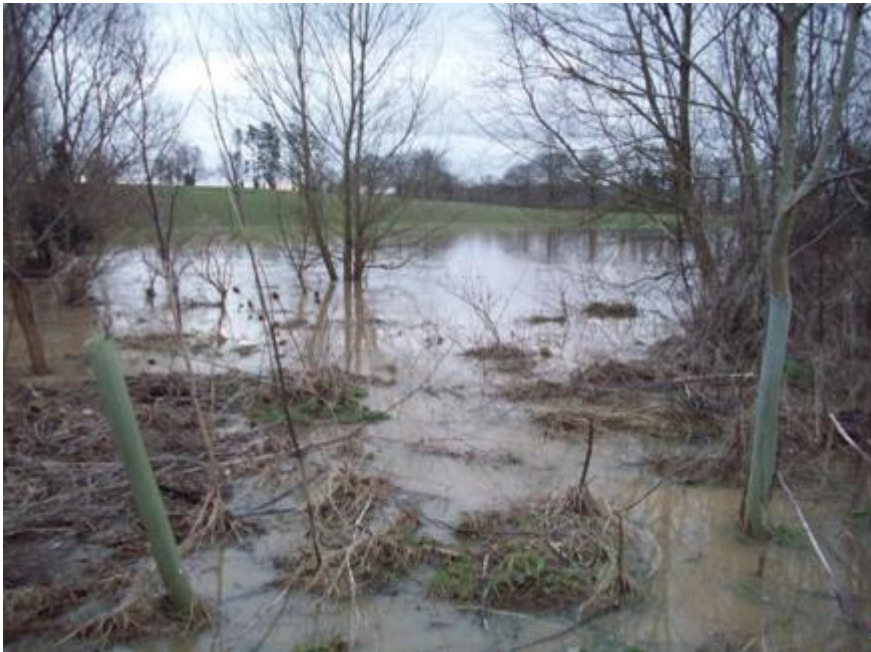
Further upstream. High treeline on far left background alongside road from Greatford to level crossing, and treeline on right background alongside gated track from road to Little Maidens

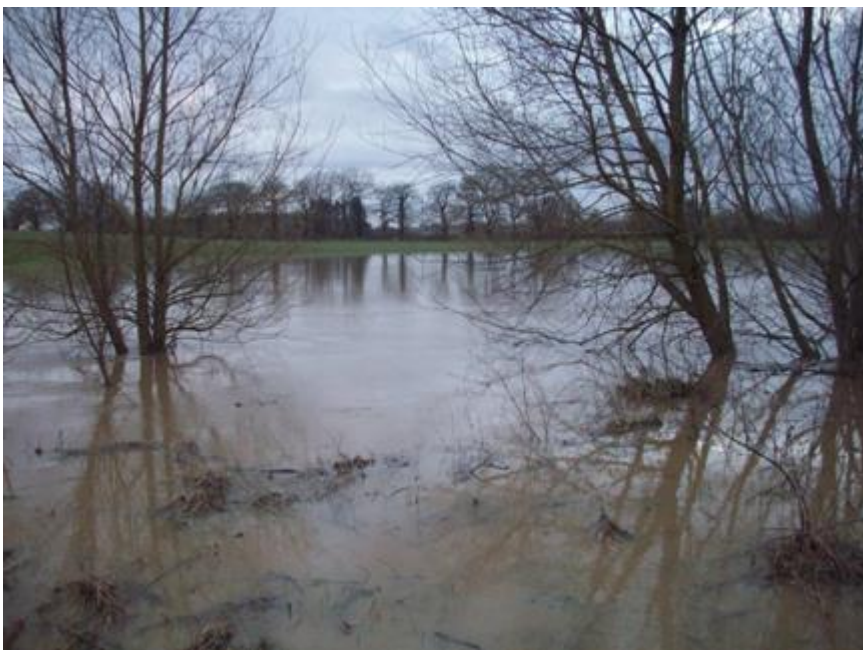
Extensive overflow in this area towards Little Maidens

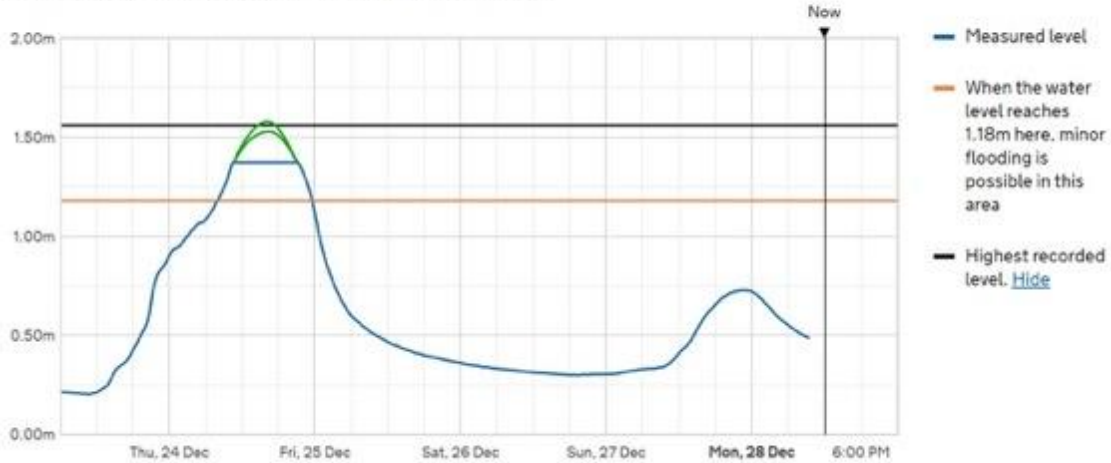
EA Graph for Christmas 2020

As the gauge at Shillingthorpe, flat-lined for a period indicating about 1.37m, projections in green by the author is based on historic river height curves at the Shillingthorpe Gauge. The actual peak height appears to be about 1.55m.

The flat-lining was caused by river water overflowing the container walls surrounding the measuring equipment at the Shillingthorpe gauge station. The sides of the gauge walls have since been built up to prevent this gauging problem in future.

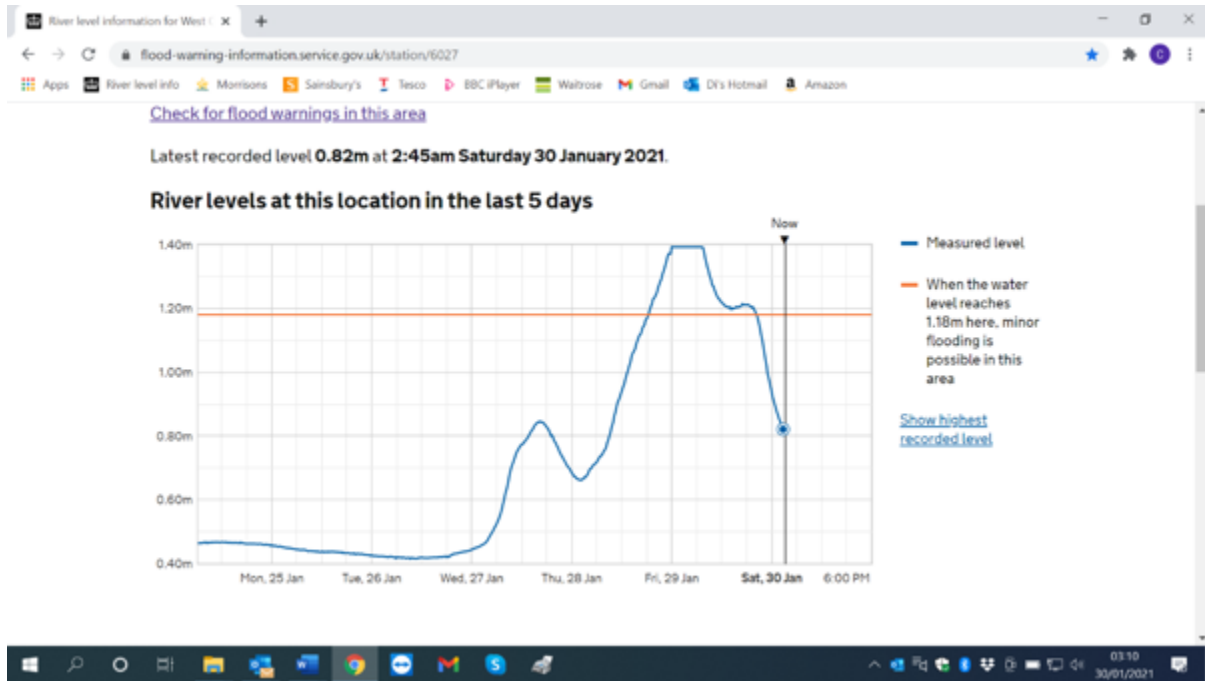
29 Jan 2021

A similar horizontal line occurred at 1.37m - 1.39 m on three other occasions in Jan 2021, as below for the flooding on 29 Jan incorrectly indicating a constant 1.39m with no peak.

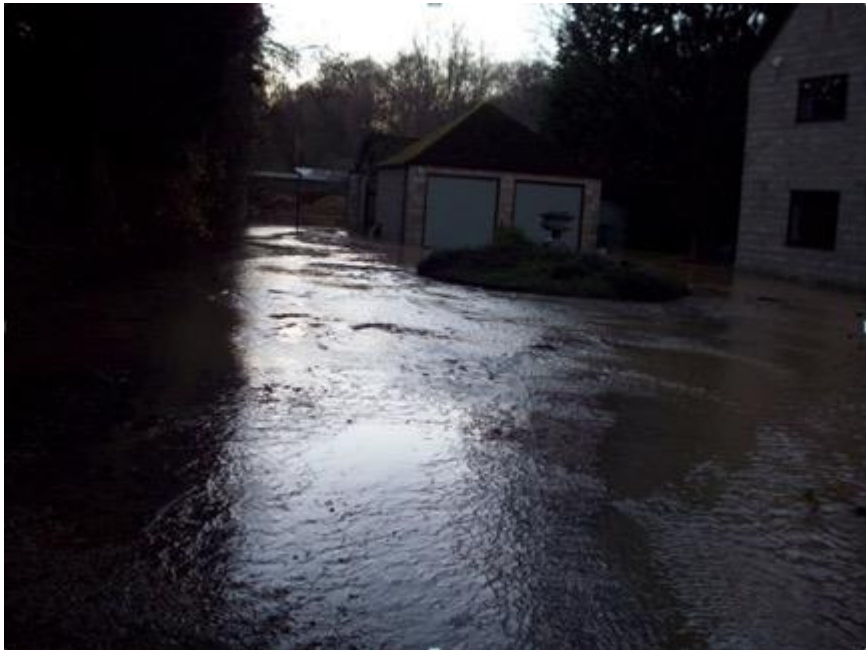
Flood water advancing towards the camera from the rear gates of Greatford Hall and up the private drive past the house on the right. As seen on previous occasions, once started the water progressed swiftly at walking speed.

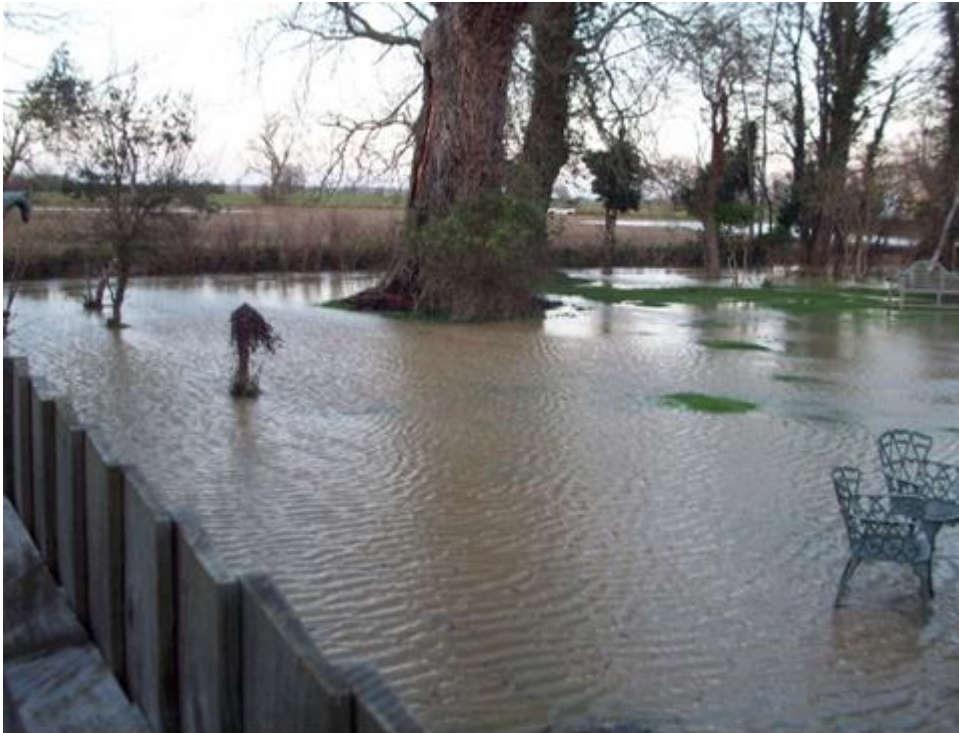
Water overflowing from the small watercourse (flowing left to right behind the large tree) into the garden of a property in Greatford. Christmas Eve pm 2020.

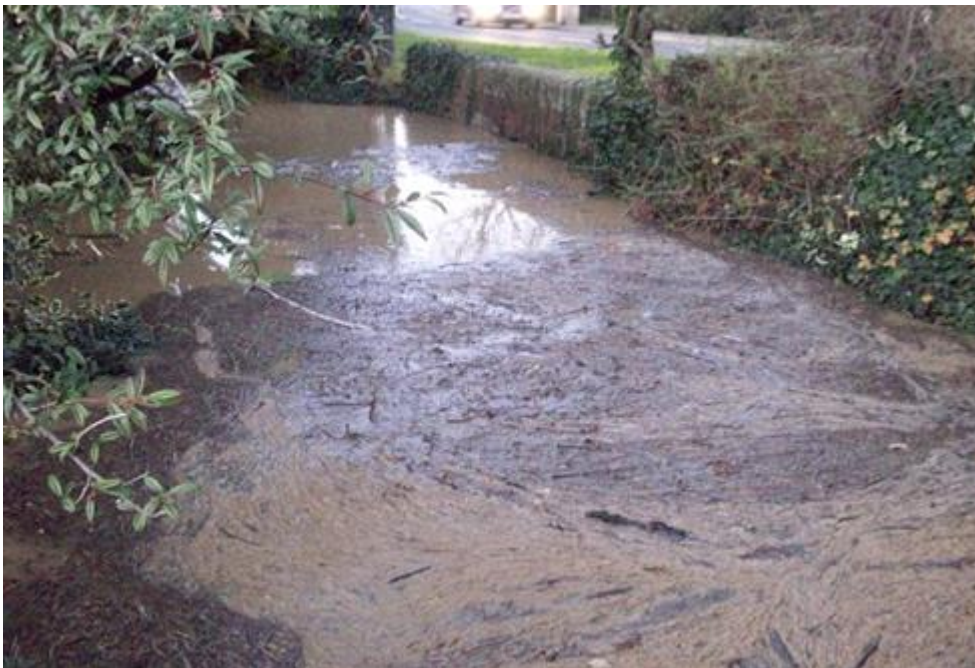
The junction of the small watercourse around Greatford Gardens with the drainage ditch alongside Carlby Road. The water is backing up against the brick front of the overloaded culvert under Carlby Rd (constructed 1837). The water height is above the flooded arch. Christmas 2020

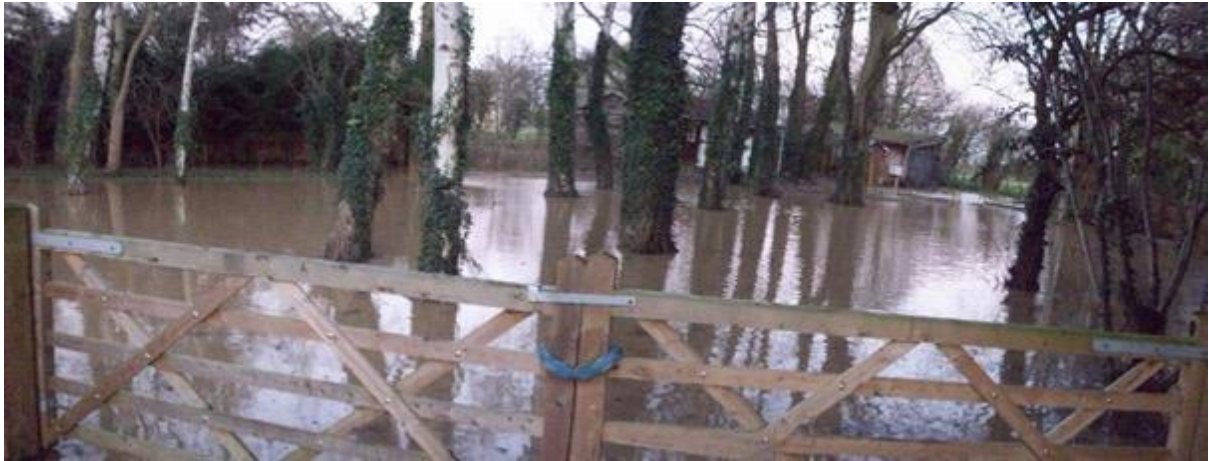
Overflow from small watercourse in the Old Rectory stables area

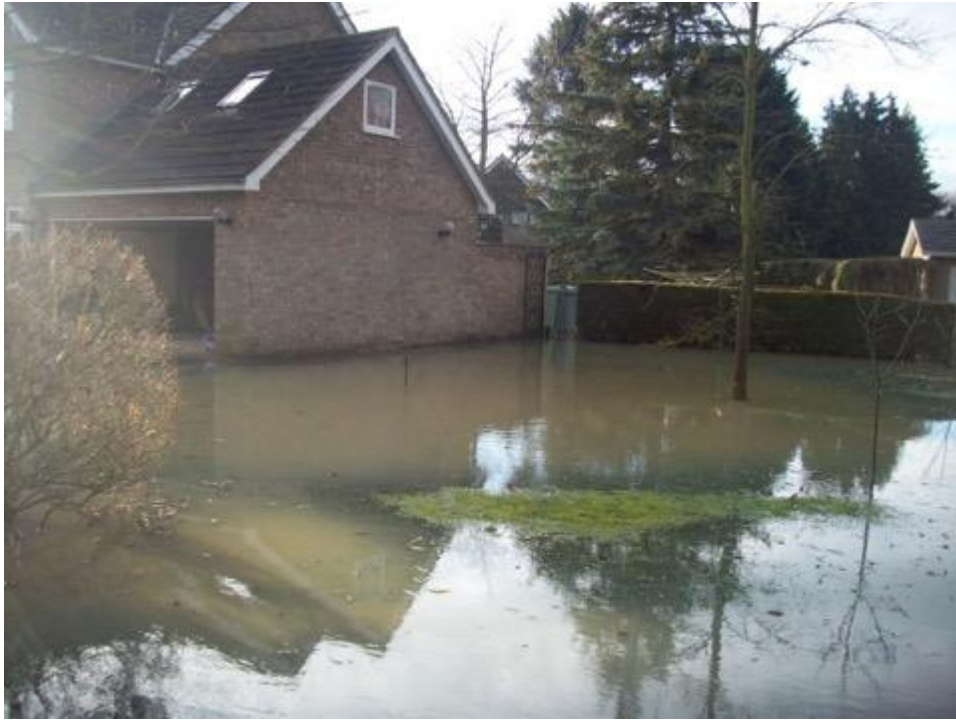
Flooding around a house & garage. 24Dec2020

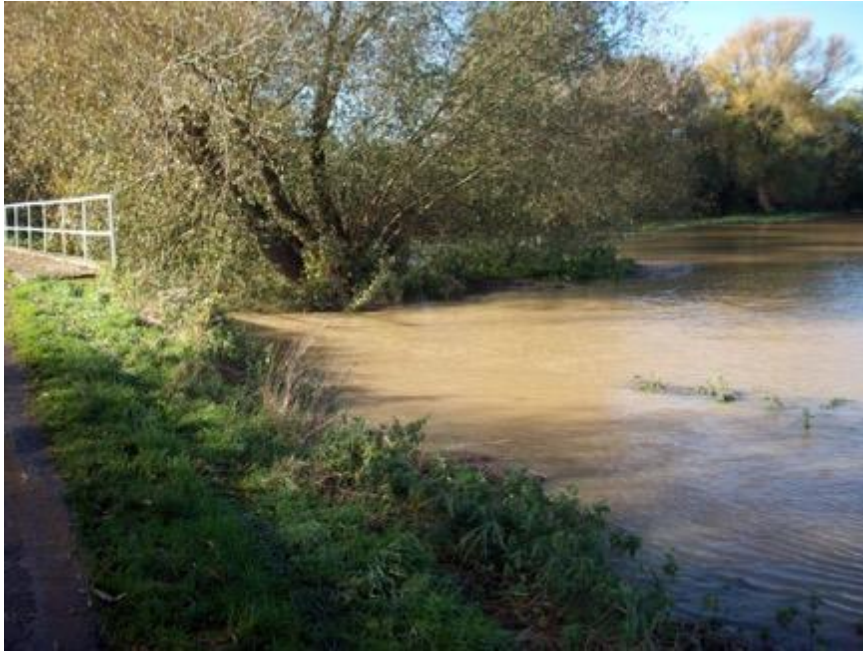
Flooding around East Glen bridge area, Braceborough

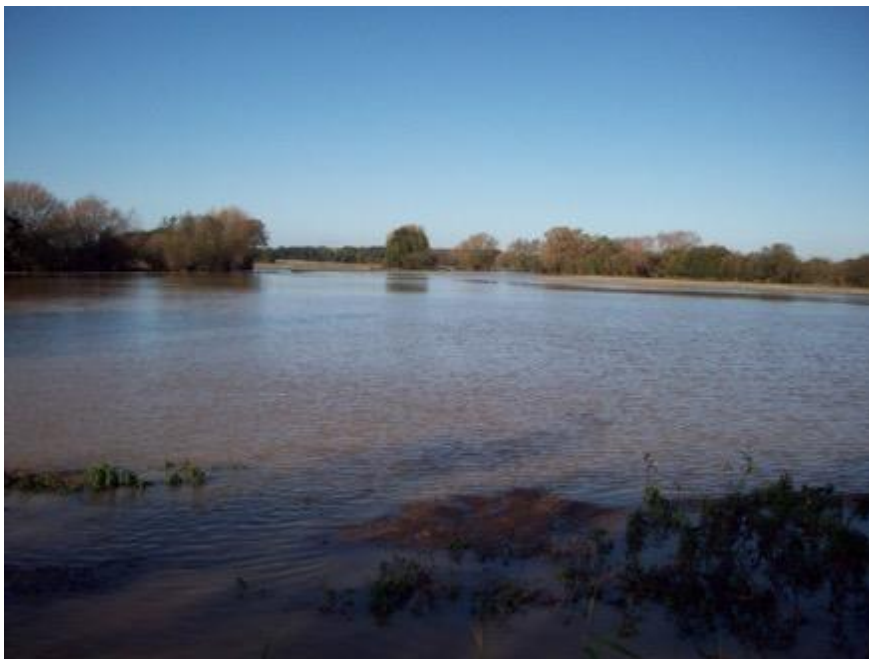
East Glen flooding to north of Braceborough-Wilsthorpe road

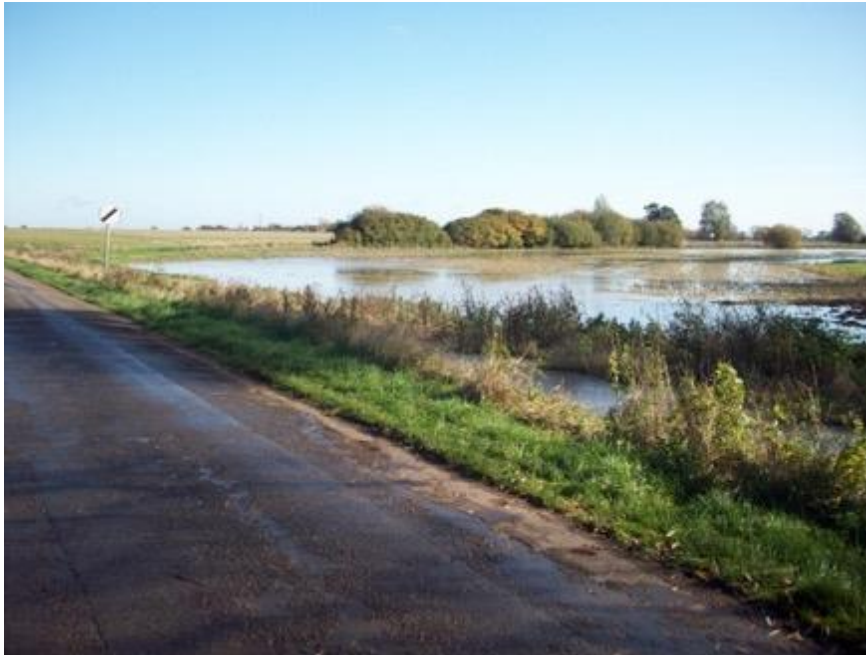
East Glen flooding to south of Braceborough-Wilsthorpe road.

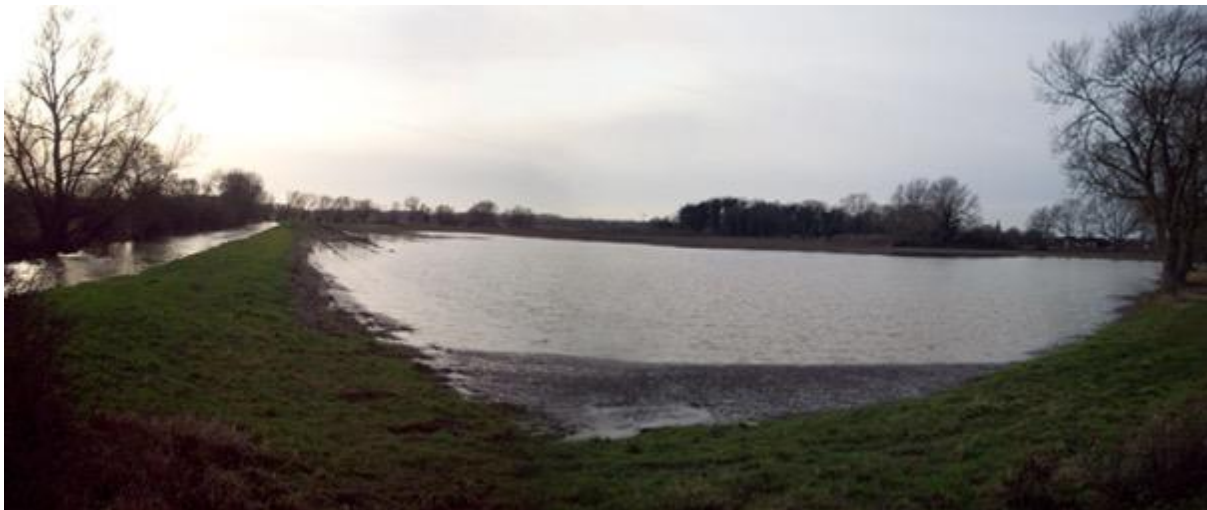
Wilsthorpe Flooding Jan 2021

Glen river on left overflowing into large farm field.
