# ENVIRONMENTAL STATEMENT: 6.3 APPENDIX: 14-1 PUBLIC RIGHTS OF WAY AND PUBLIC OPEN LAND SURVEYS REPORT

**Cory Decarbonisation Project**

**PINS Reference: EN010128**

**March 2024**

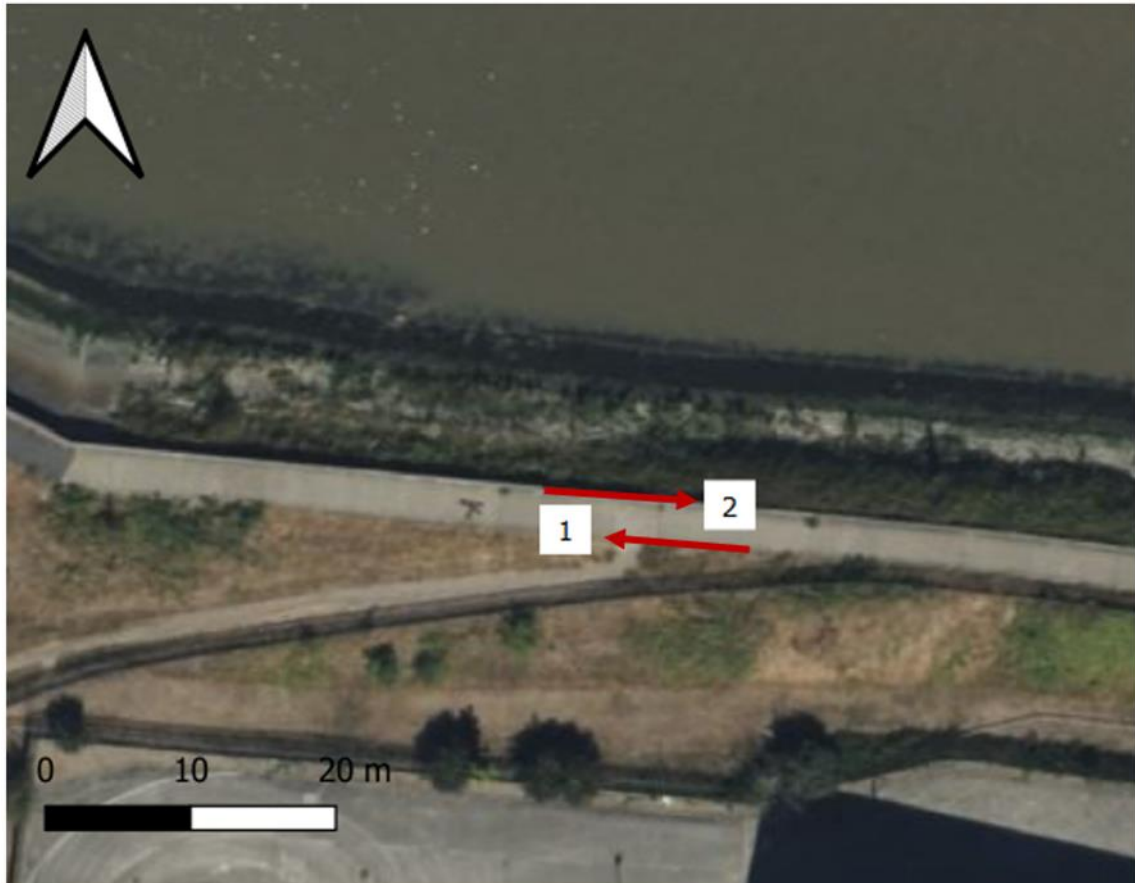
**Figure 2-1: Monitoring Point Location 1**

2.1.1. Two cameras were set up at Location 1 (as shown on **Figure 2-1** below) to capture both eastwards and westwards movements on the England Coast Path (FP3/NCN1). Arrows shown on **Figure 2-1** denote the direction of movement captured – camera 1 captured westward movements and camera 2 captured eastward movements.

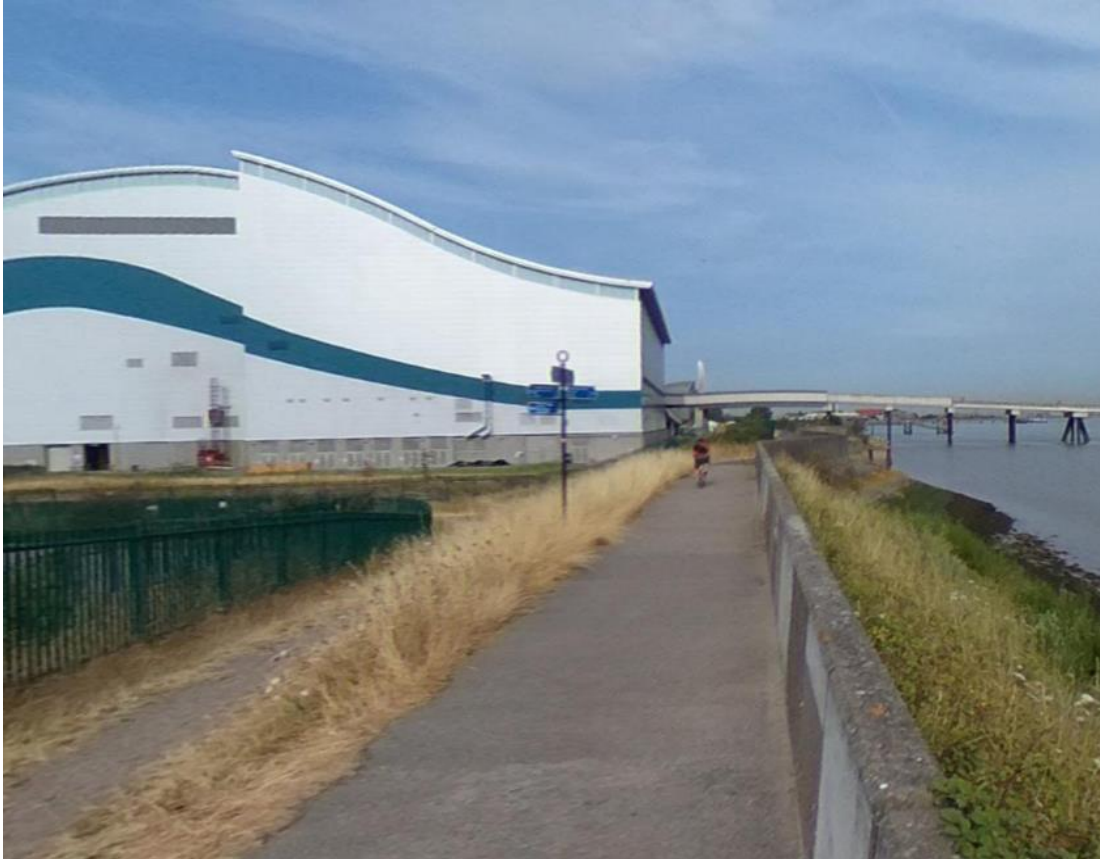
**Figure 2-2: Condition of England Coast Path (FP3/NCN1) (Looking west at the Junction with FP4)**

- 2.4.1. The England Coast Path (FP3/NCN1) was well signposted and in relatively good condition; however, there are some areas where the edges were slightly overgrown.
- 2.4.2. The survey footage shows that users remain on these paths and do not deviate from these routes.

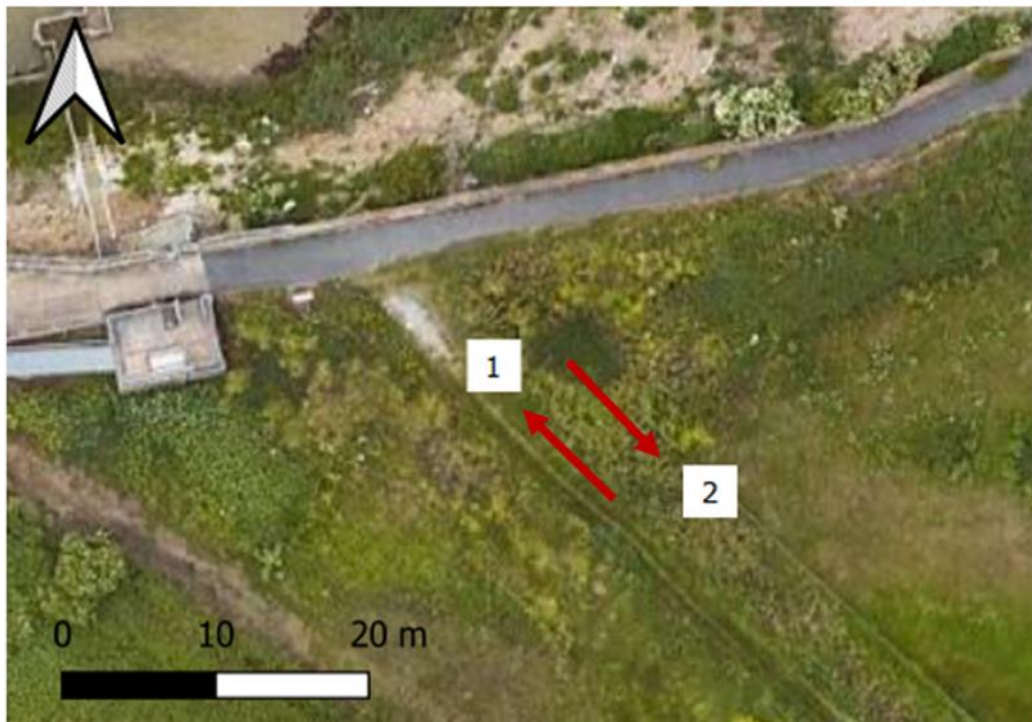
**Figure 3-1: Monitoring Point Location 2**

3.1.1. Two cameras were set up on FP2 at Location 2 (as shown on **Figure 3-1** below) to capture movement both northwest towards the England Coast Path (FP3/NCN1) and southeast towards Crossness LNR along FP2. Arrows shown on **Figure 3-1** denote the direction of movement captured by each of the cameras – Camera 1 captured northwest movements and camera 2 captured southeast movements.

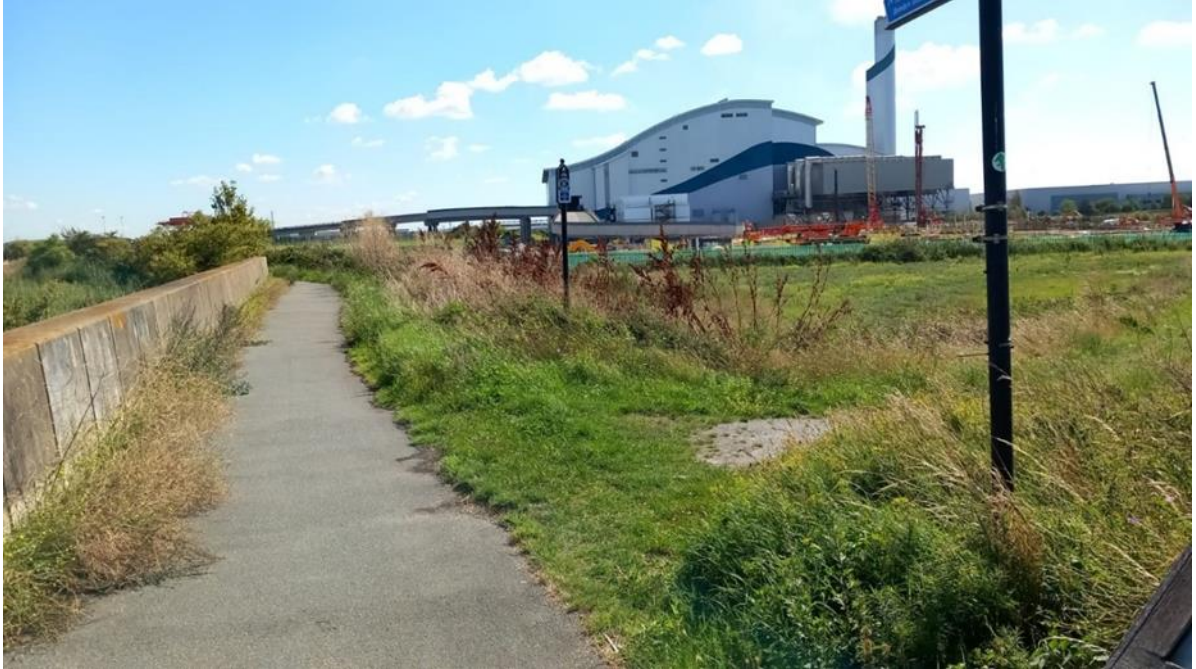
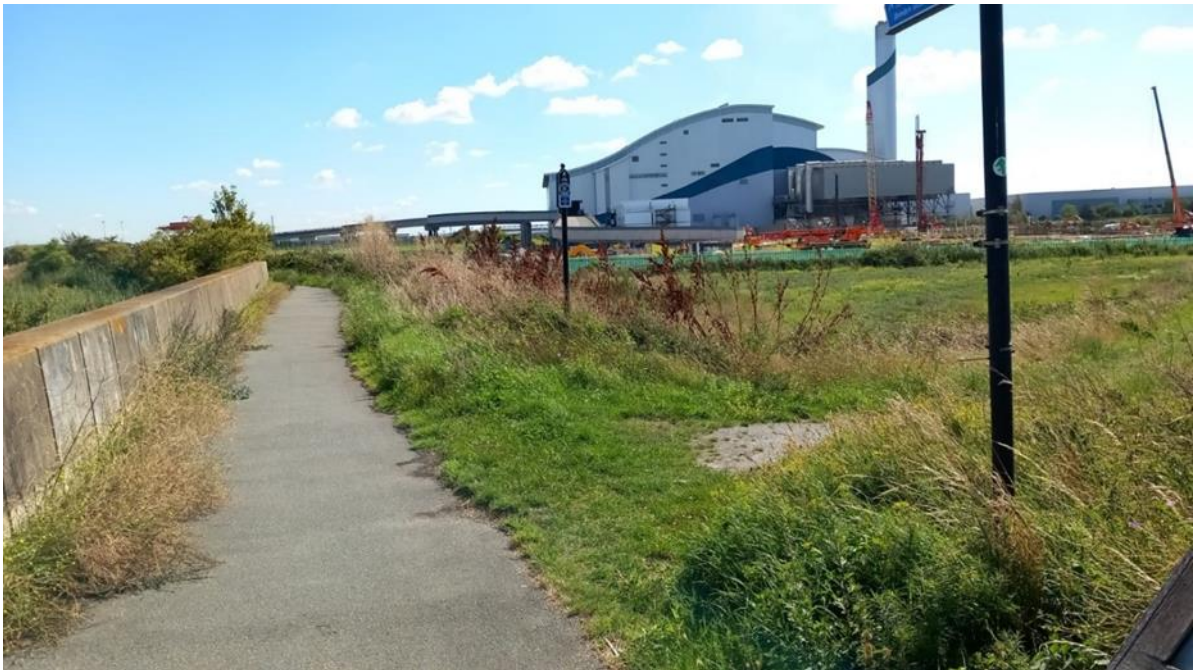
**Figure 3-2: Condition of FP2 (Looking east at the junction with the England Coast Path (FP3/NCN1))**

3.4.1. The surface of the northern part of FP2, which connects to the South England Coast Path, was uneven and was not fully paved (see

3.4.2. **Figure 3-2** below), making the exact route direction unclear in places. This has led to some deviating off this route into the surrounding open land. Those users captured deviating off the path were using the open land for dog walking and recreation (e.g. football).

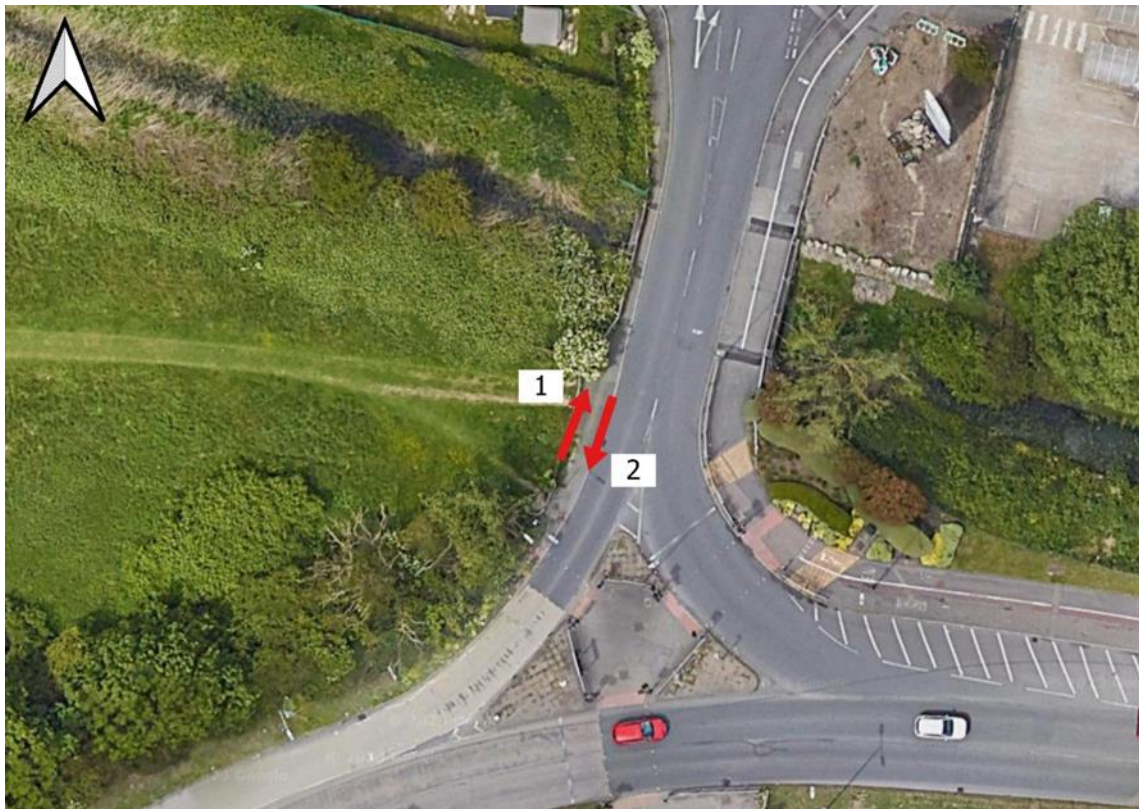
**Figure 4-1: Monitoring Point Location 3**

4.1.1. Two cameras were set up at Location 3 (as shown on **Figure 4-1** below) to capture movement both north and south along Norman Road (entering FP2) and adjacent to the Norman Road Field. Arrows shown on **Figure 4-1** denote the direction of movement captured by each of the cameras – Camera 1 captured northern movements and camera 2 captured southern movements. Both cameras were intended to capture those entering the Norman Road Field.

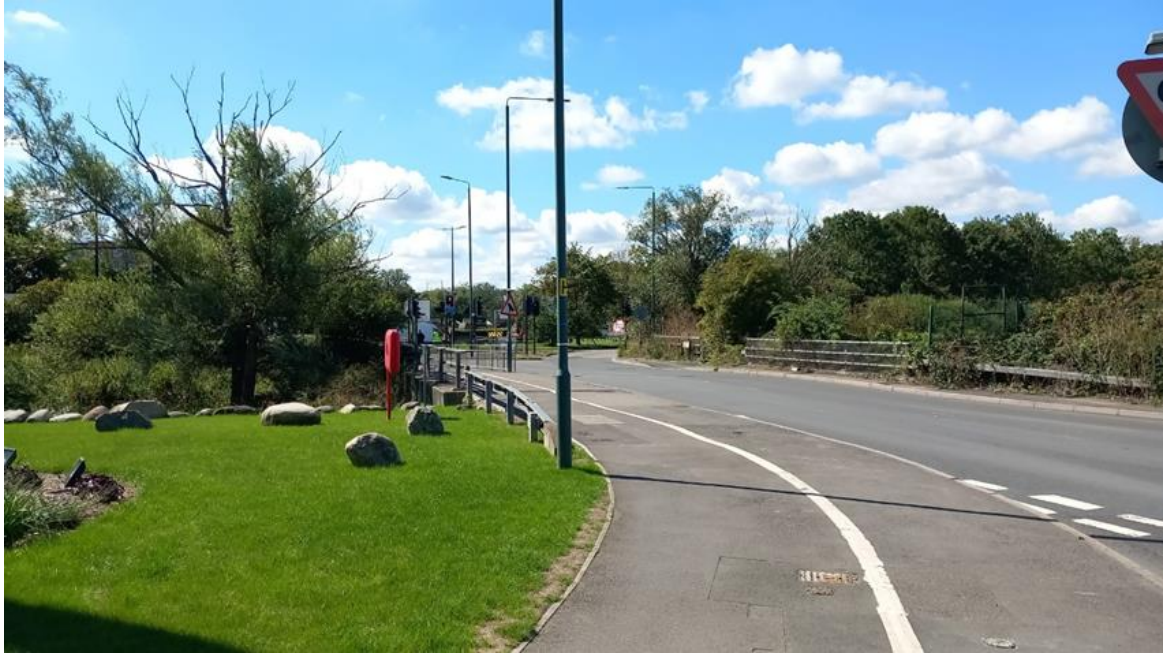
**Figure 4-2: Condition of Norman Road (Looking south at the A2016)**

- 4.4.1. The surface of Norman Road was even and fully paved, and in relatively good condition (see **Figure 4-2** below). The pavement had clear segregation between pedestrian and cyclists and clear wayfinding. Access to FP2 was clearly signposted through a gate (as shown on **Figure 4-3** below). Camera footage picked up a number of pedestrians and dog walkers crossing over into Norman Road Field.

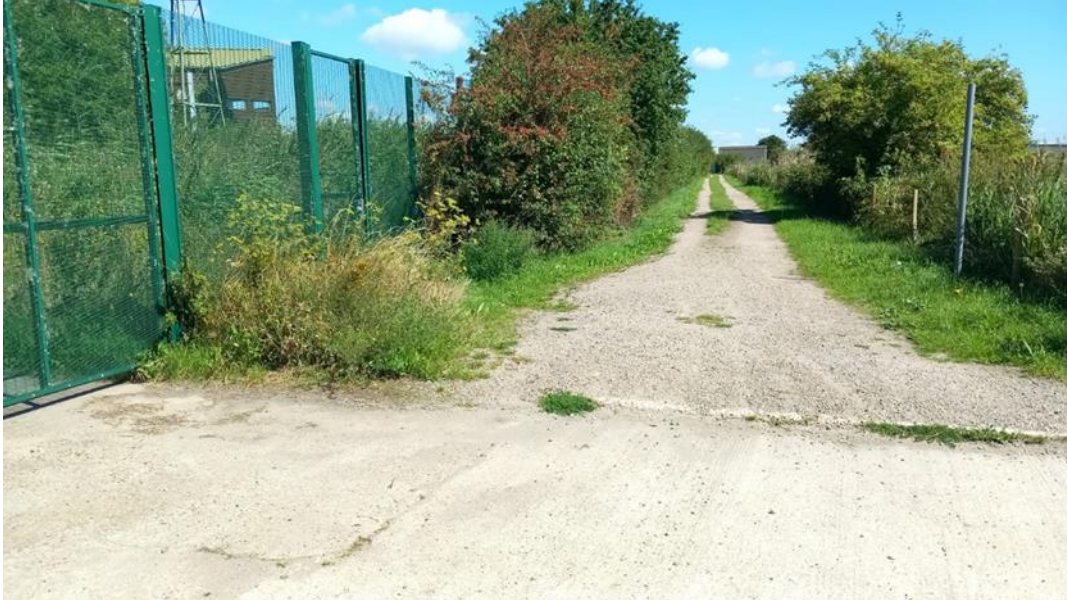
**Figure 5-2: Condition of FP2 at Location 4 (Looking North East)**

- 5.4.1. The surface of FP2 was in relatively good condition, however the surface material changed at this location from a gravel track to a paved path, as shown on **Figure 5-2** below. Along the gravel track the paths were not equal widths. The path was well signposted.

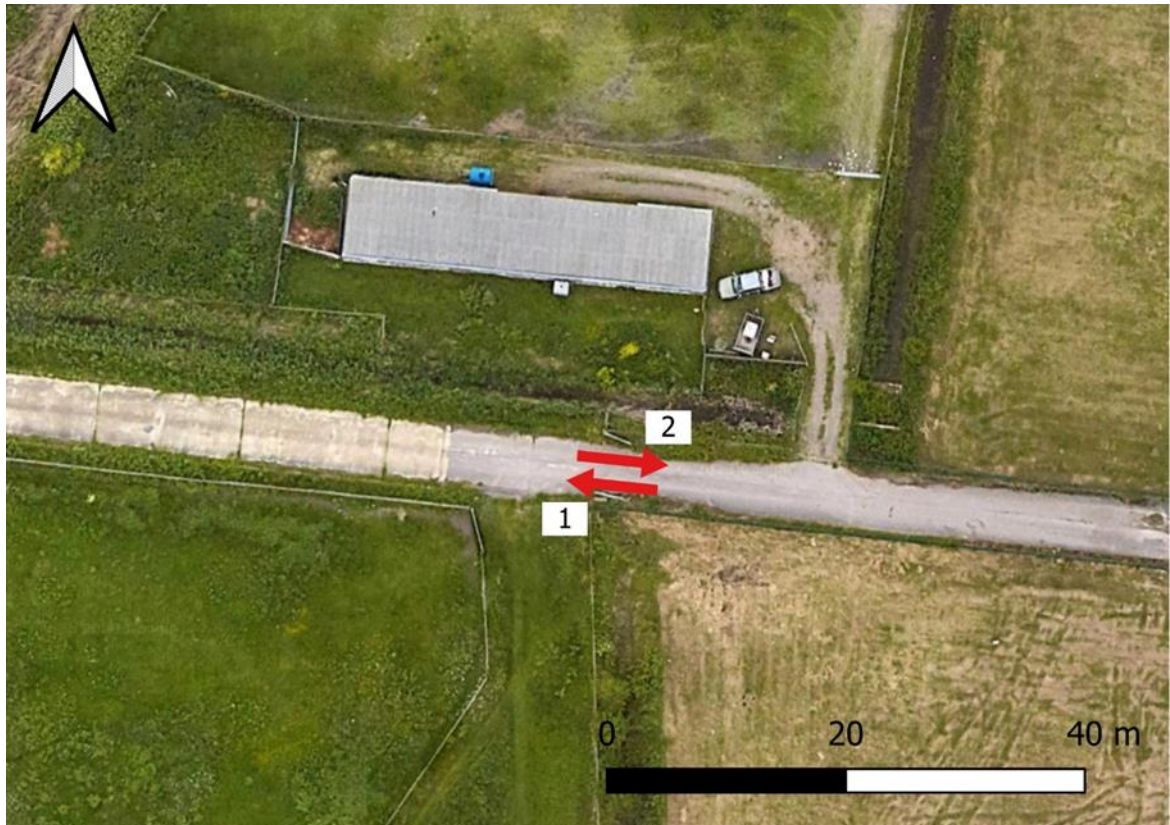
**Figure 6-1: Monitoring Point Location 5**

6.1.1. Two cameras were set up on FP2 at Location 5 (as shown on **Figure 6-1** below) to capture movement both westwards (camera 1) and eastwards (camera 2) (camera 1) along FP2 adjacent to the Stable Paddock.

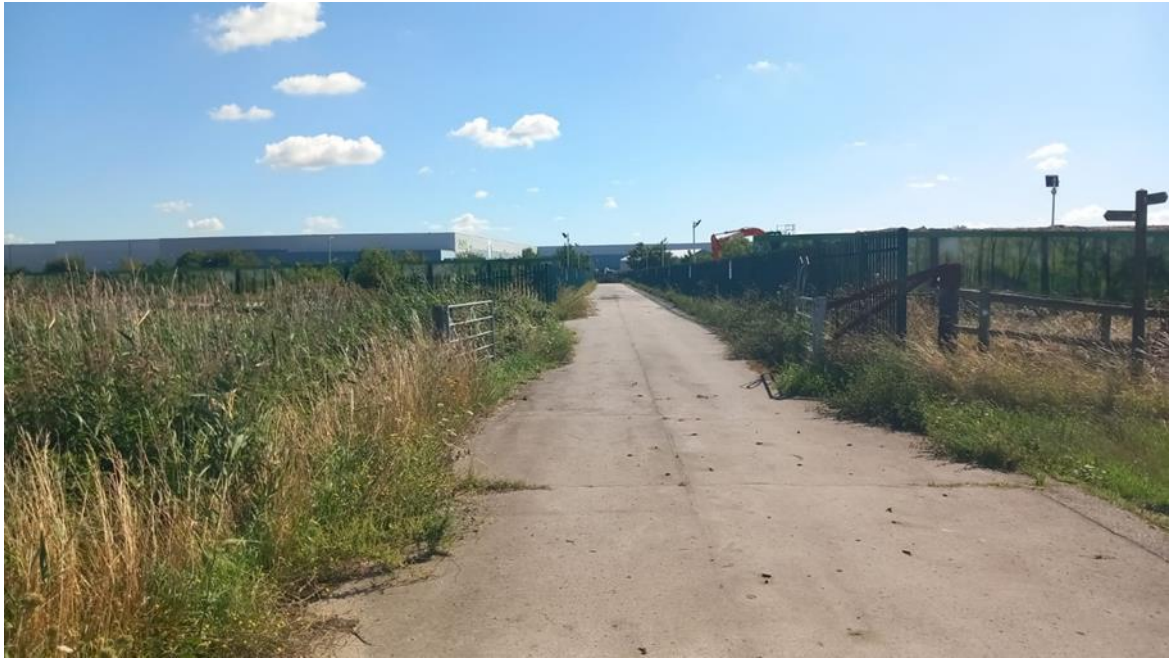
**Figure 6-2: Condition of Access Road (Looking West)**

- 6.4.1. The condition of the paved access road was relatively good, however there were some areas where the edges were slightly overgrown, as shown on **Figure 6-2** below. The footpath was well sign posted. The footage also demonstrated that the path was used by the grazer accessing the Stable Paddock.

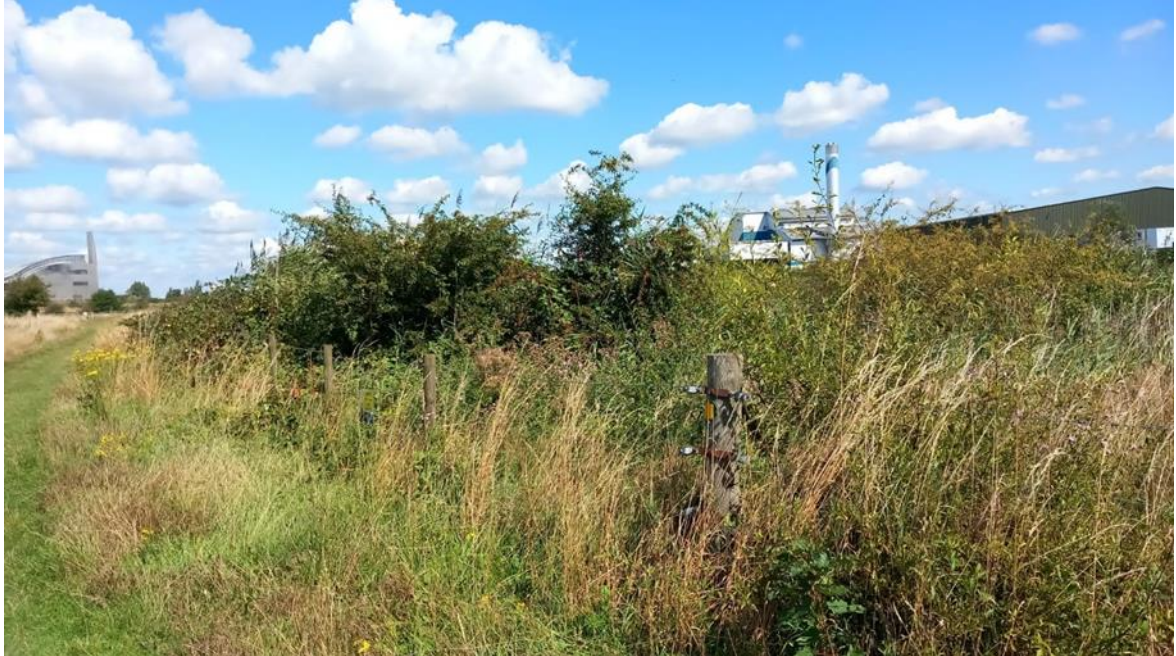
**Figure 7-2: Condition of FP2 within the Norman Road Field (Looking towards the Riverside 1)**

- 7.4.1. The surface of FP2 within the Norman Road Field was unsealed, though in relatively good condition and well maintained, as shown on **Figure 7-2** below. However, the edges of the field were overgrown.

- 7.4.2. The route was unclear in places which has led to some deviating off this route into the surrounding Accessible Open Land and designated open space. The survey footage showed that pedestrians and cyclists used the Accessible Open Land and designated open space informally and often strayed off the paths.

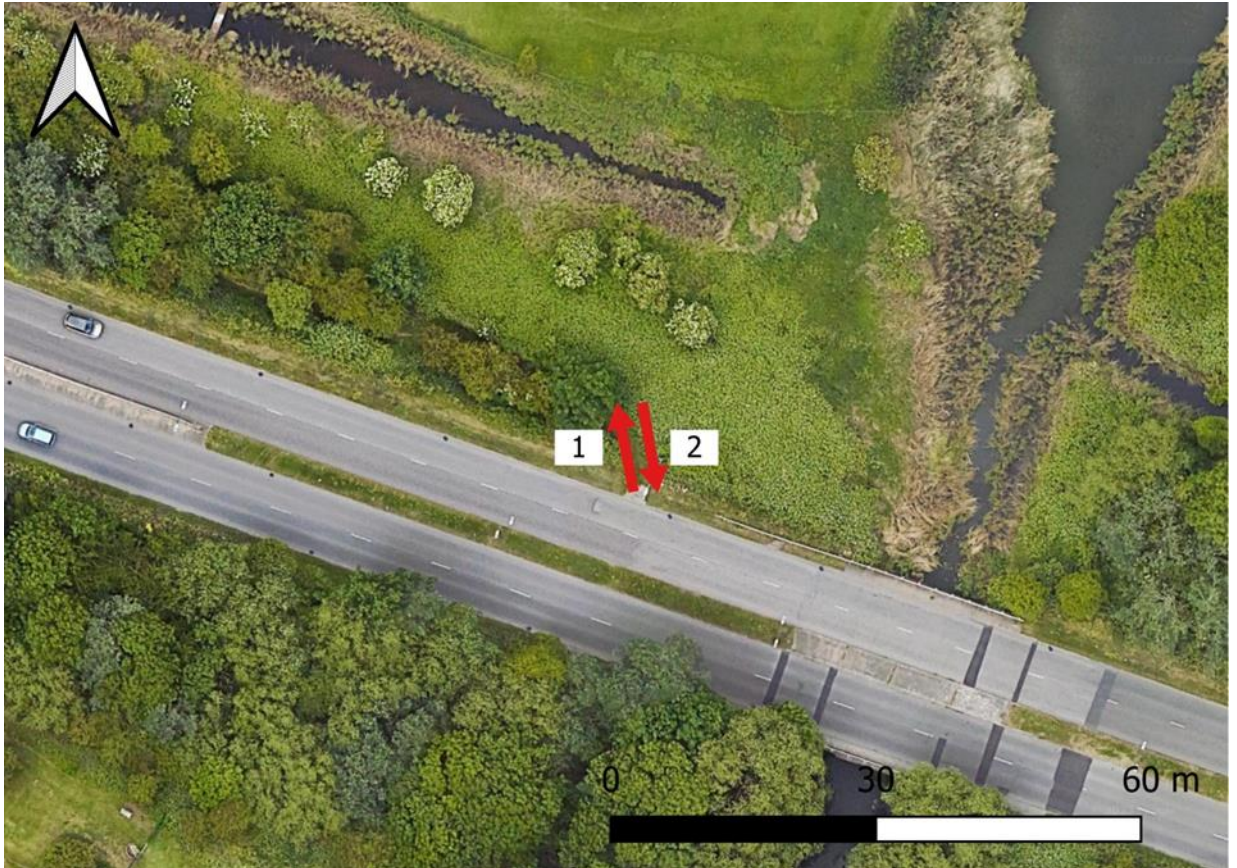
**Figure 8-1: Monitoring Point Location 7**

8.1.1. Two cameras were set up on FP1 at Location 7 (as shown on **Figure 8-1** below) to capture movement both northwest towards Crossness LNR (camera 1) and southeast (camera 2) towards Eastern Way (A2016).

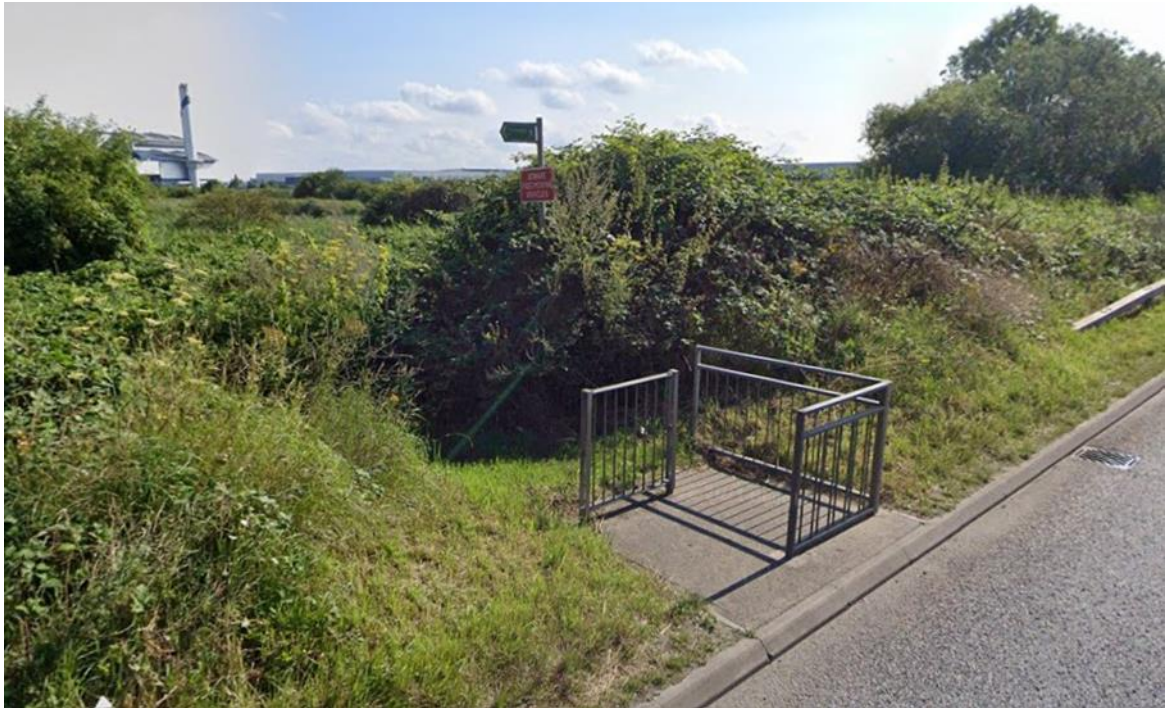
**Figure 8-2: Condition of the Footpath North of Eastern Way (Looking North)<sup>3</sup>**

- 8.4.1. Access to FP1 north of Eastern Way was provided via a curb onto a small concrete surface, as shown on **Figure 8-2** below. Towards Crossness LNR the surface was unsealed and in relatively good condition, however, those areas underneath the tree cover were very overgrown. The path was well signposted, although the overgrown nature of part of the path could make wayfinding challenging for some users.

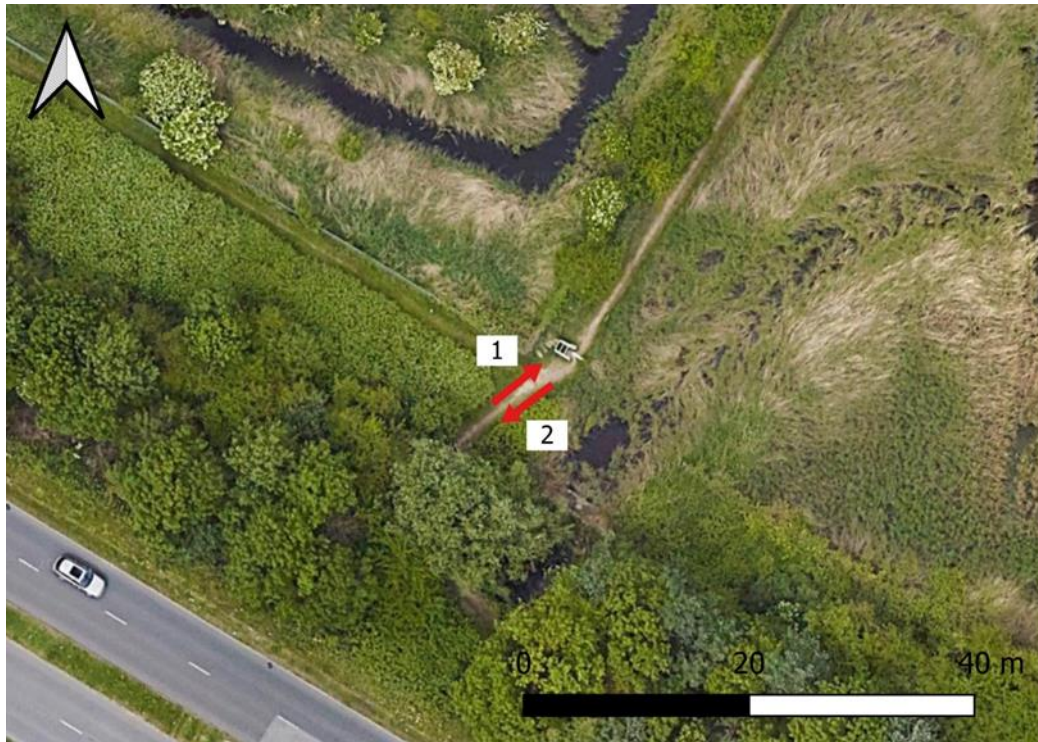
**Figure 9-1: Monitoring Point – Location 8**

9.1.1. Two cameras were set up on FP1 at Location 8 (as shown on **Figure 9-1** below) to capture movement both northeast (camera 1) and southwest (camera 2) and users of Crossness LNR, south of the kissing gates.

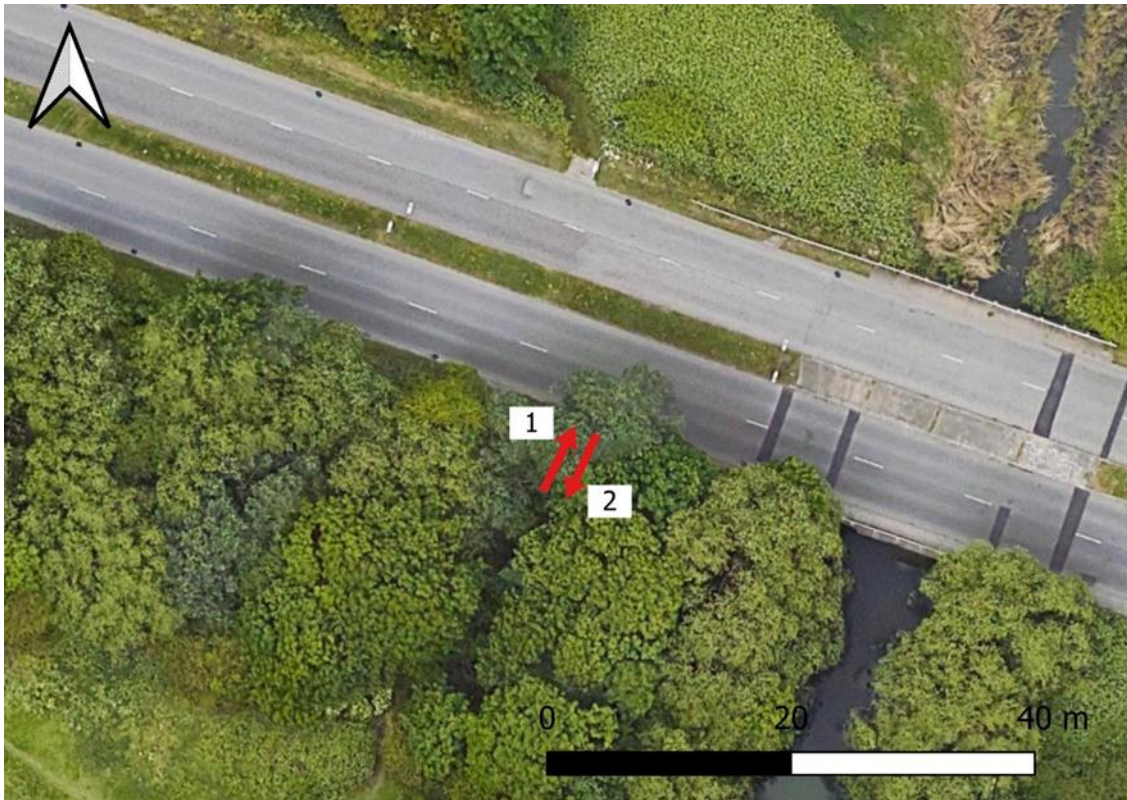
**Figure 10-1: Monitoring Point – Location 9**

- 10.1.1. Two cameras were set up on FP1 at Location 9 (as shown on **Figure 10-1** below) to capture movement both north towards Eastern Way (A2016) (camera 1) and south into Erith Marshes (South).

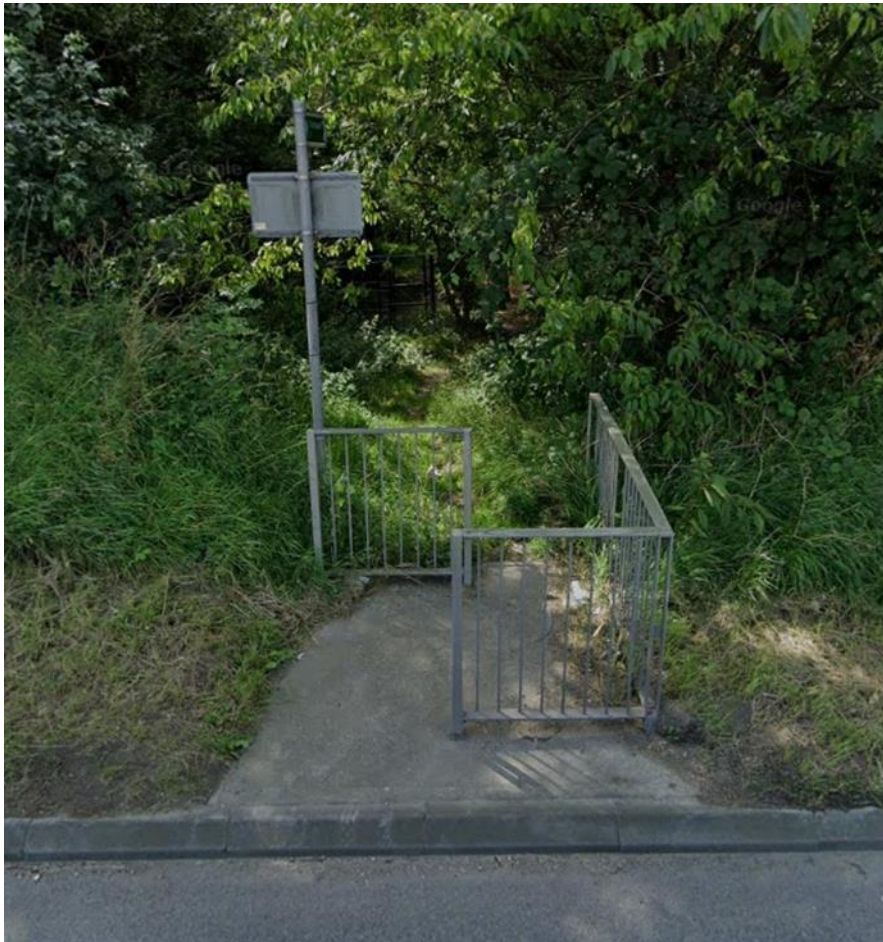
**Figure 10-2: Condition of the Footpath South of Eastern Way (Looking South)<sup>4</sup>**

- 10.4.1. Access to FP1 south of Eastern Way was provided via a curb onto a small concrete surface, as shown on **Figure 10-2** below. Towards Erith Marshes (South) the surface was unsealed and in relatively good condition, however there were some areas where the edges were overgrown. FP1 was well signposted.
