OUTLINE LANDSCAPE, BIODIVERSITY, ACCESS AND RECREATION DELIVERY STRATEGY: 7.9

Cory Decarbonisation Project

PINS Reference: EN010128

March 2024

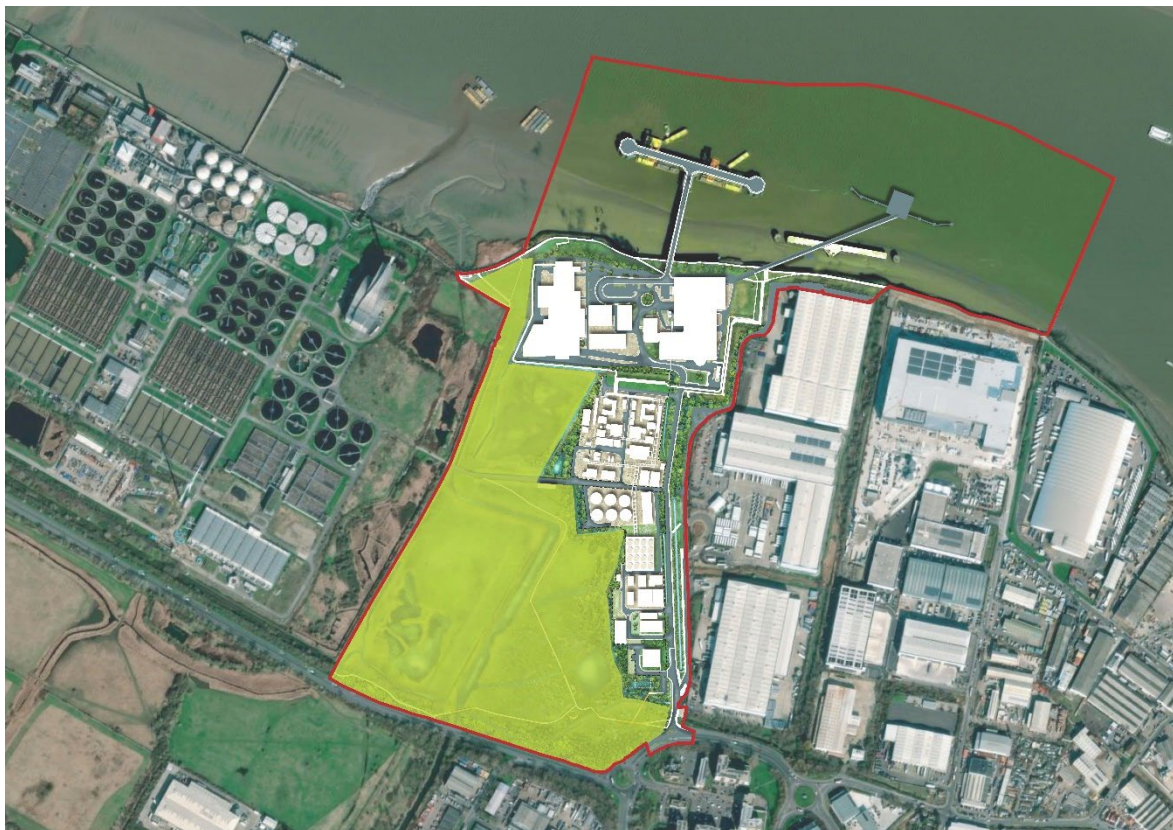
Figure 3 - Mitigation and Enhancement Area

5.2.2. The area is identified to allow for comprehensive masterplanning of a coordinated green infrastructure strategy and to support the proposed enlargement of the Crossness LNR to include Norman Road Field. This proposal is outlined in section 9.

5.2.3. Both the Norman Road Field and Crossness LNR have been subject to ecological surveys to inform an understanding of the presence of existing habitats and their current condition.

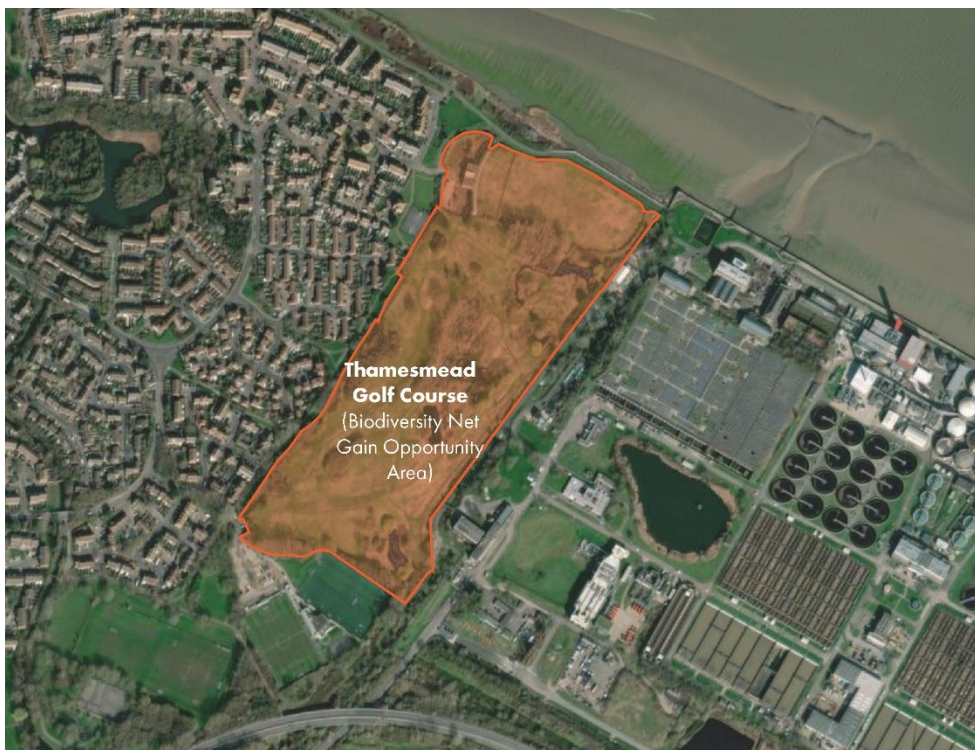
Figure 4 - Offsite BNG Opportunity Area

5.3.1. The BNG Opportunity Area is a possible area for offsite BNG provision located at the former Thamesmead Golf Course on the Thamesmead Estate, illustrated in **Figure 4**. The land is owned by the Peabody Trust and comprises a disused golf course that formed part of the Thamesmead development masterplan and has been identified in Peabody’s ‘Living in the Landscape’ framework document as an area with potential for enhancement. The golf course has been subject to an ecological survey to understand the presence of existing habitats and their current condition.

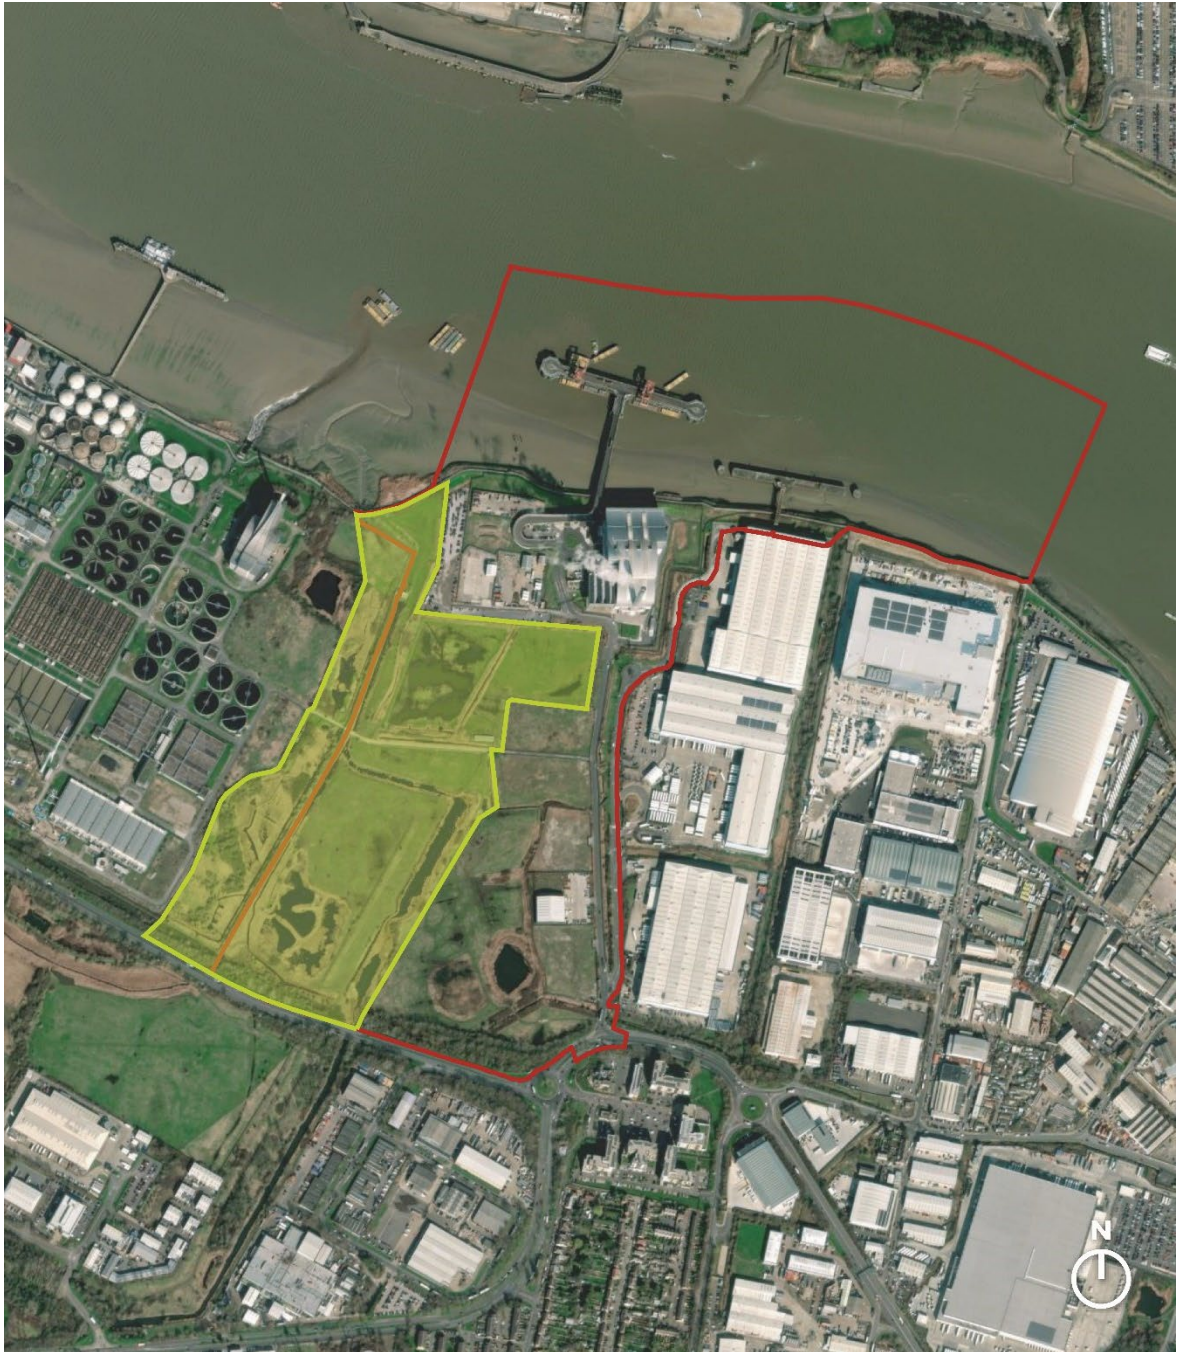
- 5.4.3. The Crossness LNR is managed in accordance with an agreed management plan. The management plan is appended at Appendix 2.
- 5.4.4. **Figure 5** illustrates the extents of the Crossness LNR.

- Site boundary
- Existing Nature Reserve

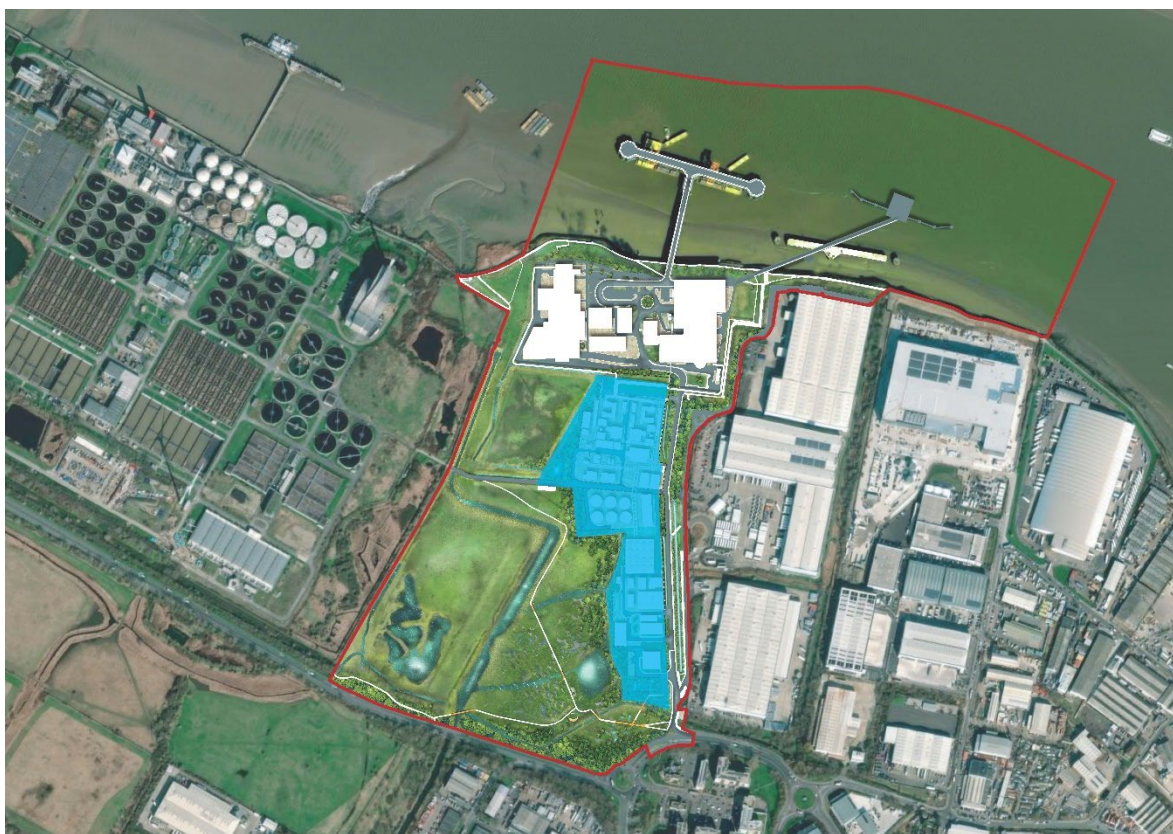
Figure 6 Carbon Capture Facility (CCF) Area

- 5.5.1. The CCF Area is illustrated in **Figure 6** and comprises a secure operational area adjoining the Mitigation and Enhancement Area to the west and Norman Road to the east. Norman Road comprises an adopted road that extends to the roadside kerb to the west (including a narrow grassed verge, portions of the existing ditch/main river feature) and a pavement to the west.

- 5.5.2. The CCF Area includes planting and habitat proposals to the east and western boundaries inside and outside the secure fence line. To the east, the existing ditch (water course) network is retained adjoining the Norman Road corridor along with new planted areas. To the west, the existing ditch profile is to be improved to support habitat development and soil rewetting along with new planting. To the southern end of the CCF Area, opportunities for habitat creation and planting are identified in combination with water management infrastructure and associated with the proposed LNR visitor car park.

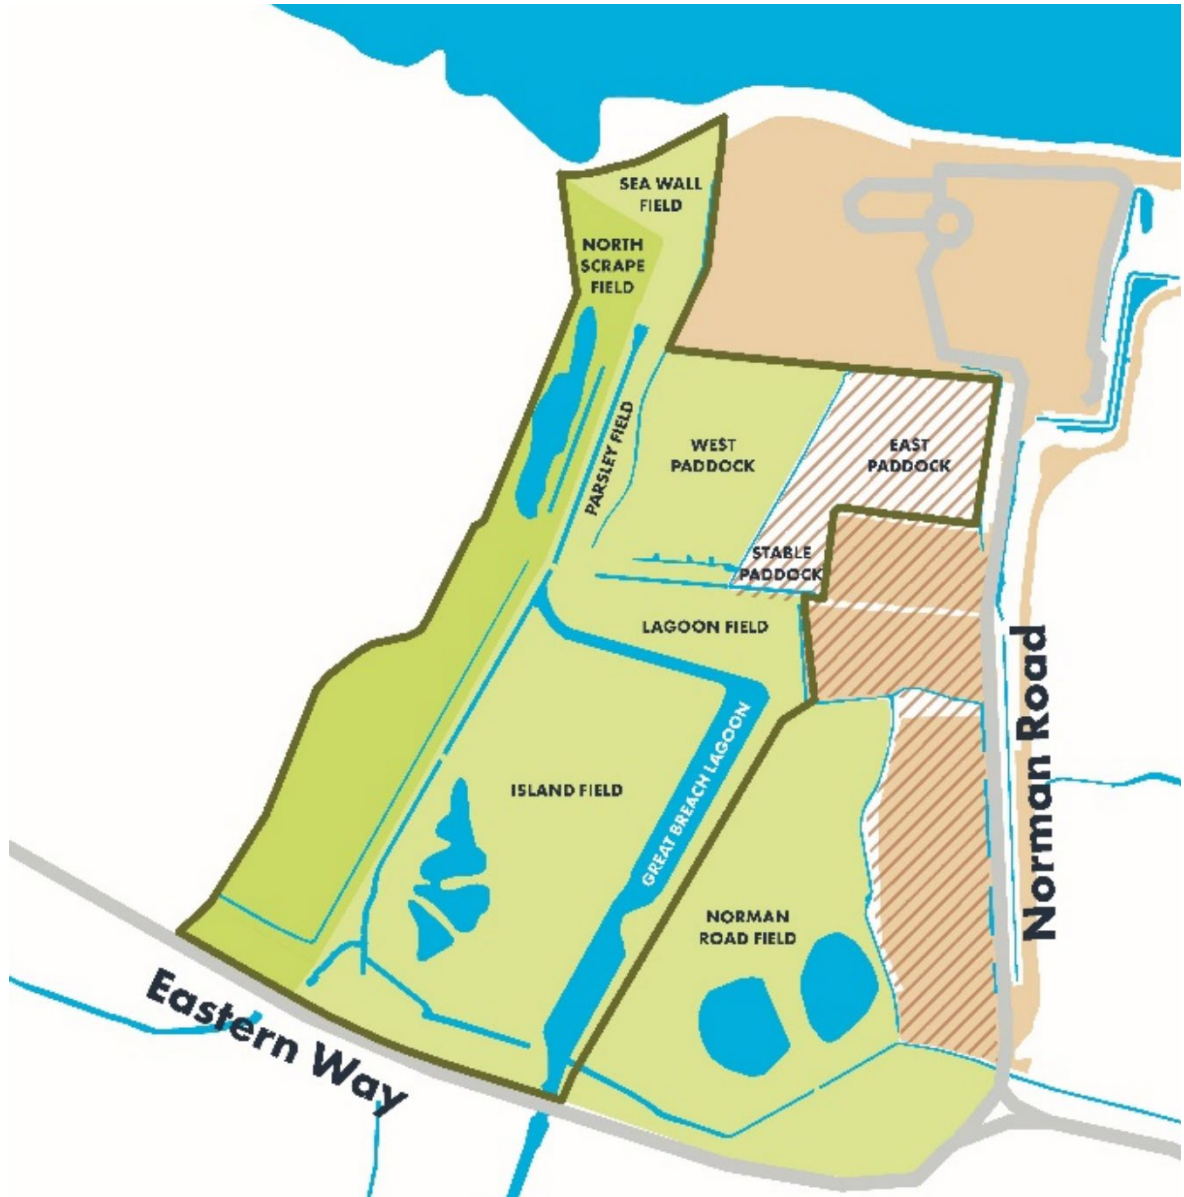
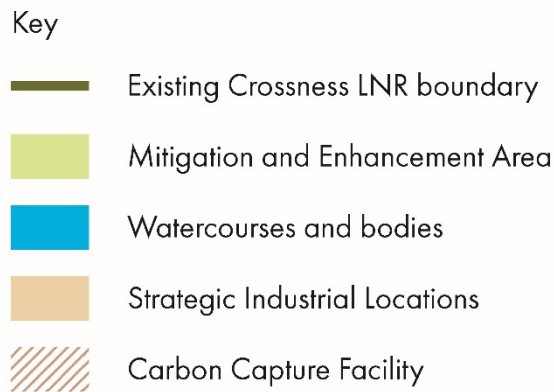
Figure 7 – Onsite works Area and Field reference plan

- Island Field - habitat enhancement
 - Lagoon Field - Proposed PRoW diversion and stable relocation (mitigation) and habitat enhancement
 - West Paddock - CCF pipework connection and associated new ditch (mitigation) and habitat enhancement

- Sea Wall Field - CCF pipework connection and associated new ditch (mitigation) and habitat enhancement
- 6.2.4. Note: the Mitigation and Enhancement Area also extends across the existing Thames Water access road.

6.2.5. The extents of the CCF Area and onsite mitigation works overlay in part, the existing Crossness Local Nature Reserve (CLNR).

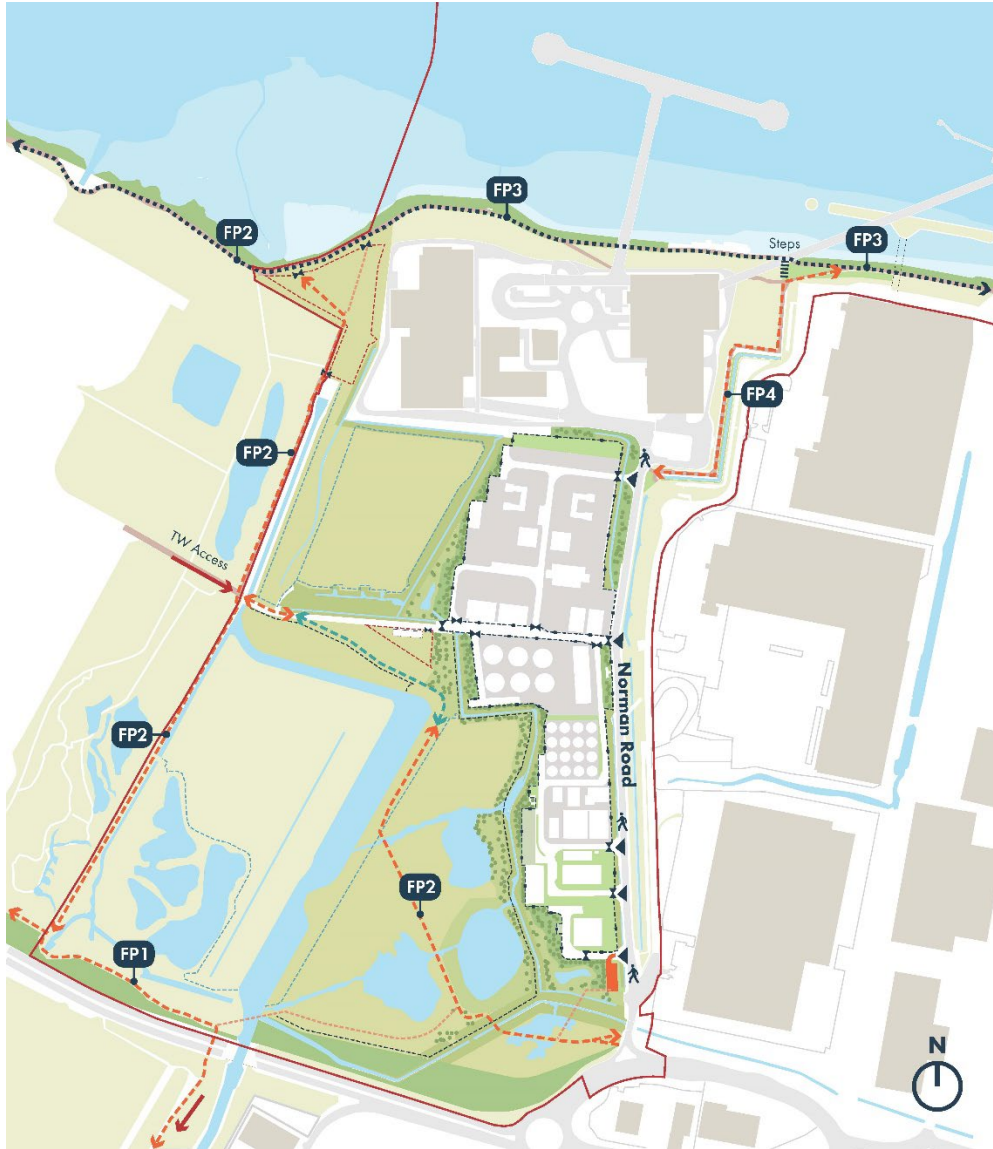
Figure 9 – Operational phase PRoW diversions and PRoW creations

- 6.4.14. Additional PRoW routes are proposed illustrated on Figure 9 and detailed in section 9. Additionally, enhancements will be developed and provided including for example, interpretation boards and localised works to the boundaries to the immediate context of the England Coast Path (FP3/NCN1). These will be detailed as part of the full LaBARDS.

Key			
	Site boundary		Amended fenceline
	Public Rights of Way (PRoW)		Proposed fenceline
	PRoW Diversion		Direction/access towards nearby locations
	New PRoW		Proposed gates
	Other public access route and cycleway		Vehicular access
	Security fenceline to carbon capture facility		Proposed pedestrian crossings
	Existing fenceline		Proposed car park

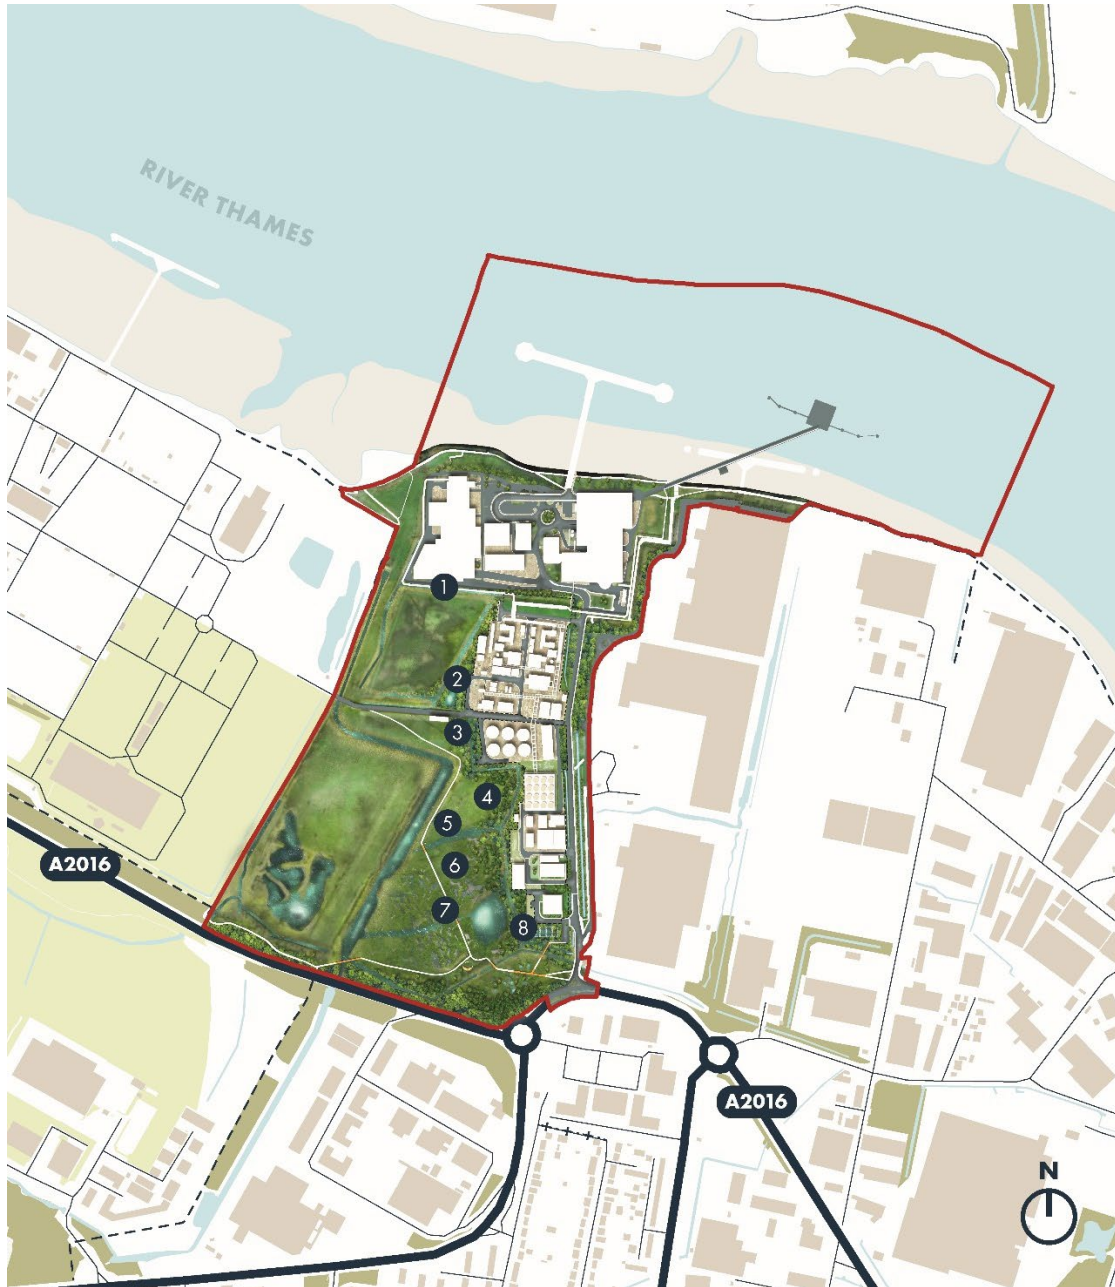
- Site boundary
 - ① Existing ditch relocation associated with flue gas ductwork
 - ② Attenuation basin
 - ③ Potential relocation of stable block
- ④ Tree planting screening
 - ⑤ Enhanced grazing marsh
 - ⑥ Wetland habitat
 - ⑦ Boardwalk over wetland habitat
 - ⑧ Attenuation basin/water storage

- 10.1.12. Improve the distinctiveness and condition of existing valued flood plain grazing marsh habitats, delivered by raising water table and managed grazing densities, delivering direct mitigation for the physical loss of grazing marsh habitat; provide additional habitat measures to mitigate impacts and improve biodiversity; and onsite BNG. These measures and proposals are described and illustrated below and are to be delivered within the CCF Area and Mitigation and Enhancement Area.

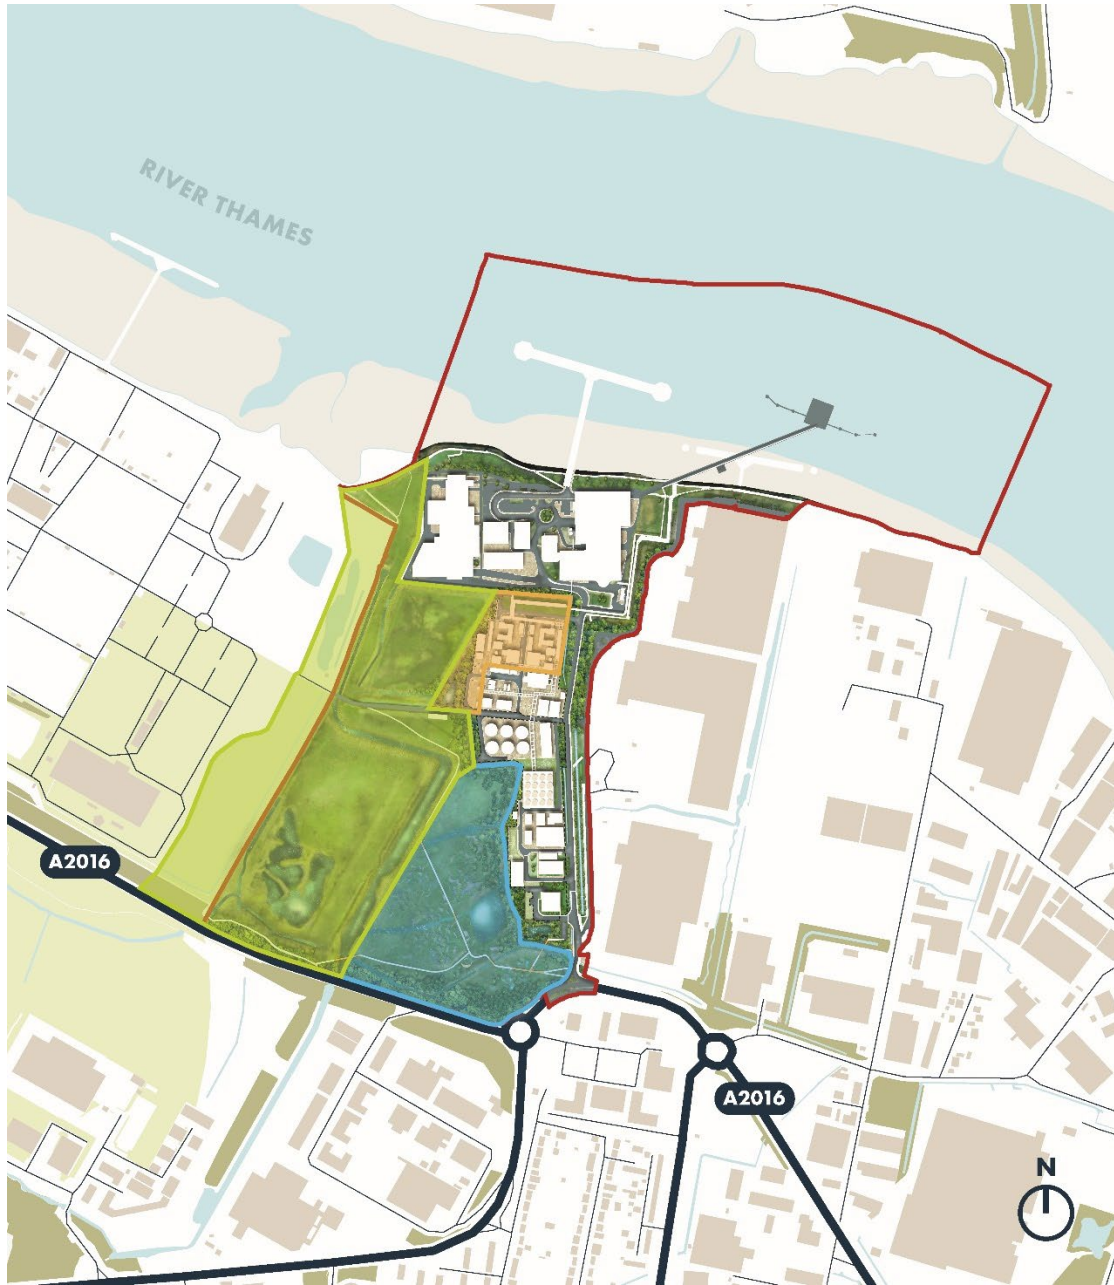
Figure 16 – Existing and Proposed expanded Crossness LNR

- 10.1.7. The total area of the existing Crossness LNR is 25ha. In total, the Proposed Scheme would lead to the following impacts:
- The area of LNR lost to the CCF footprint comprises: 2.3ha
 - The area of LNR lost to the CCF connecting pipework connecting to Riverside 1 and 2 requiring the relocation of the existing ditches to establish a new LNR boundary to the north, comprises: 1ha (worst case)
 - The land proposed to be incorporated into the management of the existing LNR: 8.4ha.
 - The net area by which the Crossness LNR would be expanded: 5-6ha.
- 10.1.8. The Environmental Proposals are illustrated in **Figure 15** and reflect how the Applicant has sought to respond to planning policy constraints identified during design development, the results of the EIA process and the desire to integrate the CCF into its setting.

- Site boundary
- Existing Nature Reserve used for CCF
- Existing Nature Reserve retained
- Extended and managed Nature Reserve

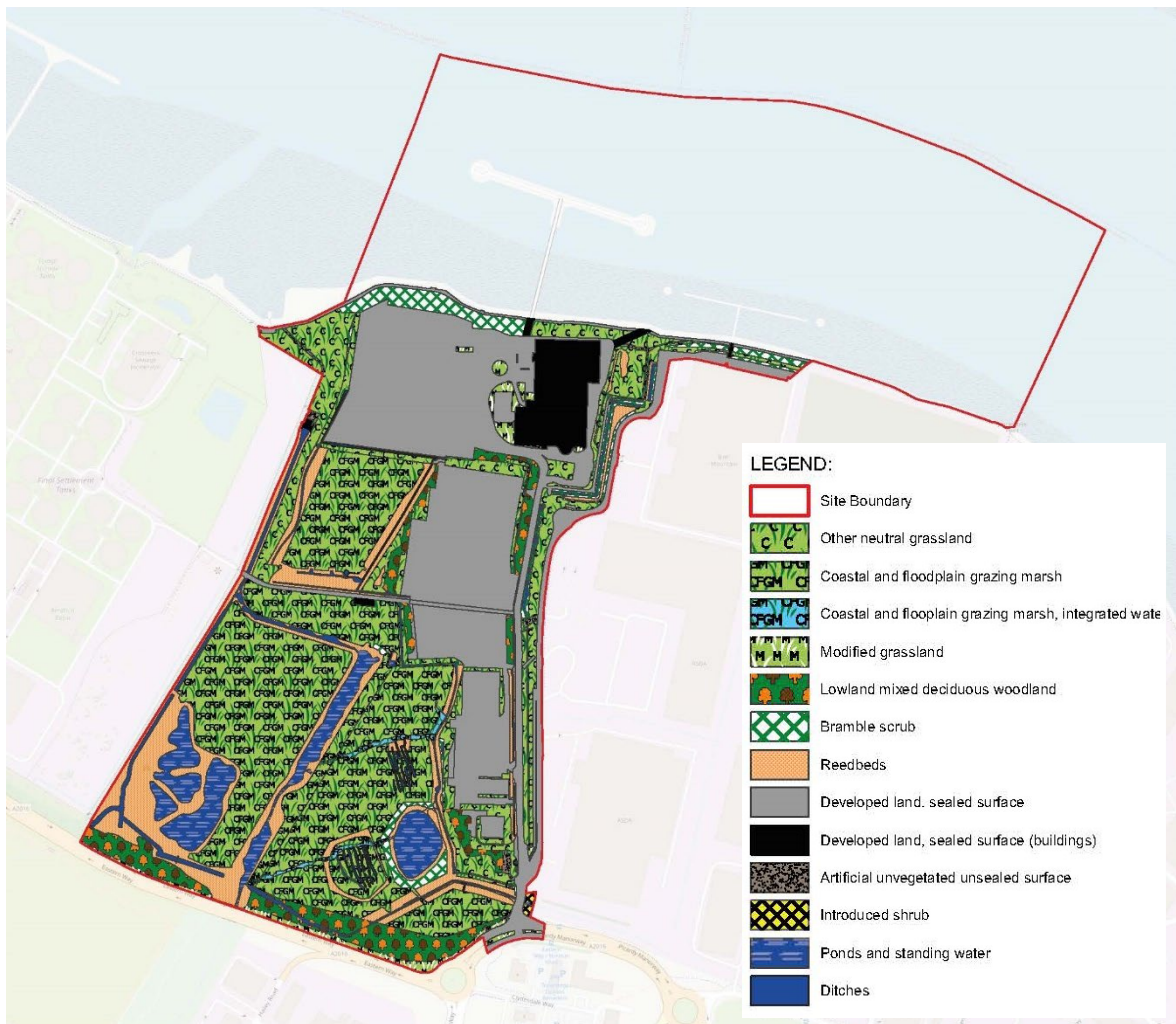
Figure 17 – Post Development Biodiversity Strategy

10.1.17. The priorities of the Environmental Proposals include:

- mitigating the loss of Local Nature Reserve area and habitats within the Site;
- mitigating visual impact of the development through landscape proposals which will establish a buffer zone comprising planting of appropriate character associated with an enhanced ditch habitat that will minimise the impact on visual openness arising from the CCF and integrate the CCF into its setting;
- securing the beneficial use of Metropolitan Open Land (MOL) supporting the promotion of public access, outdoor recreation, retaining and enhancing landscapes, visual amenity, biodiversity or to improve damaged or derelict land;
- protecting open space, avoiding loss of Accessible Open Land;

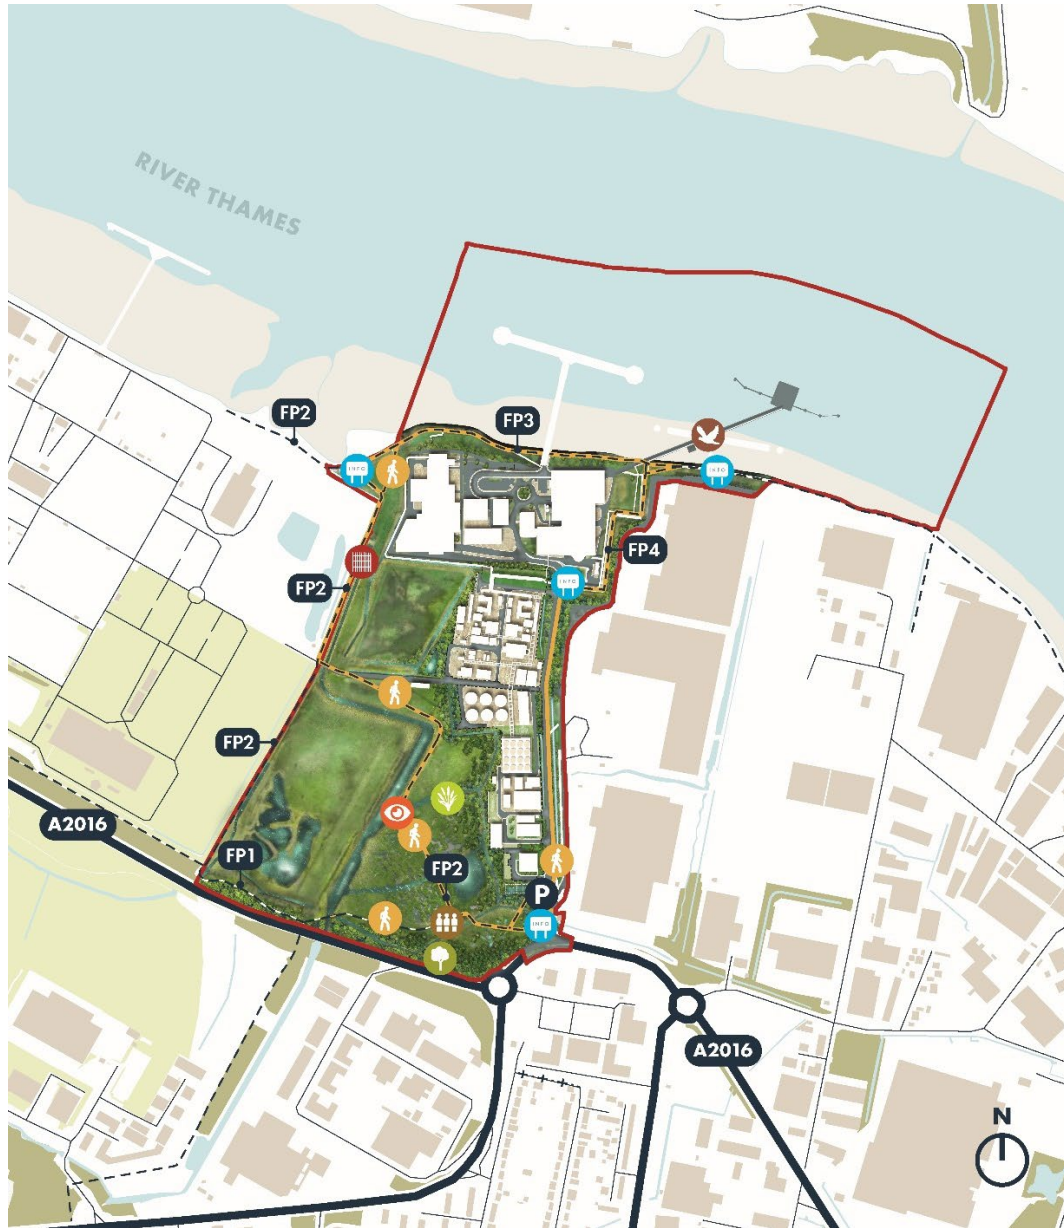
Figure 18 – Access and Recreation Proposal

- 10.2.1. The Access and Recreation Proposals are illustrated in **Figure 18** and supported by the Access and Movement Strategy illustrated in the **DAD (Document Reference 5.6)**.
- 10.2.2. The Access and Recreation Proposals provide enhanced PRow routes and connectivity within the Site and works offsite. The proposals encourage improved opportunity for active travel access, improved amenity and recreation experience and safety of routes.

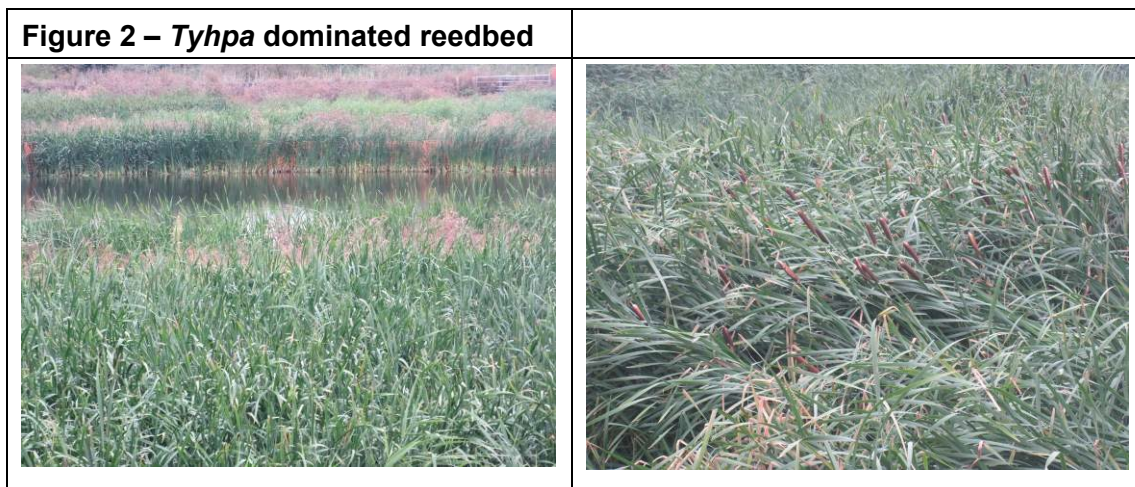
Following dominant *Typha* colonisation in Year 1 (2011) where the east section of the reedbed was found to be approx 95% cover and the west section approx 65%, remedial action is required (Fig. 2).

Hand-pulling small sections of *Typha* on both the east and west reedbed was attempted in October 2011, however without the ability to replant *Phragmites* at that time, *Typha* is growing back, at a lower density, in Year 2.

In March 2012, a local source of mature, hand-pulled *Phragmites* were translocated into two areas within the east section reedbed. Majority were planted in the central section of shallow water devoid of vegetation (Fig. 3), and a smaller number in the hand-pulled section where *Typha* was beginning to return, but was not yet mature or dense, in the hope that *Phragmites* might eventually outcompete the *Typha*.

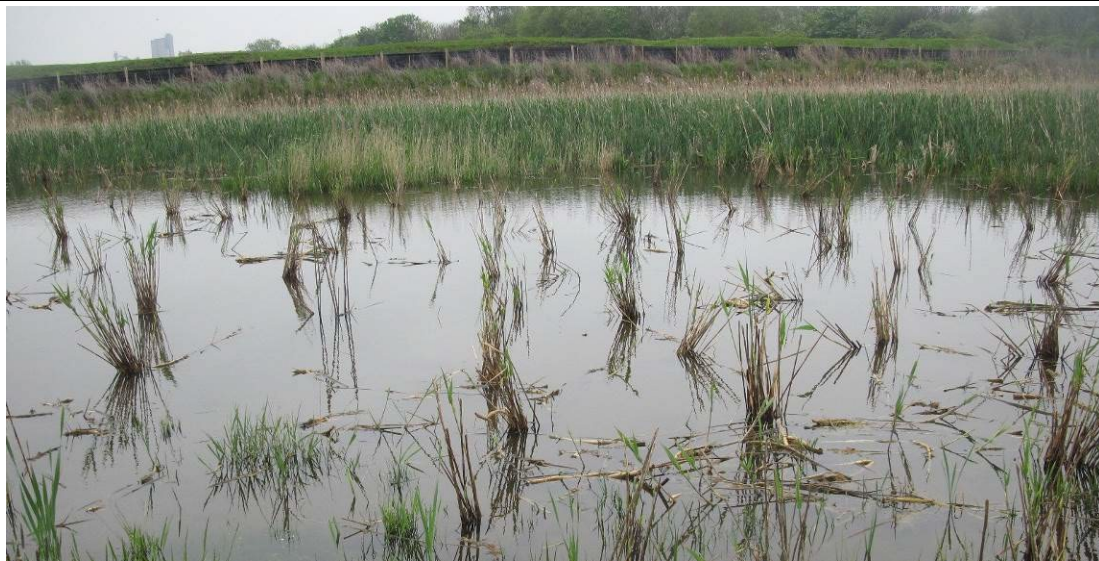
Figure 3 – Mature reeds translocated into shallow pool in March 2012 showing new growth evident by green shoots, in May 2012

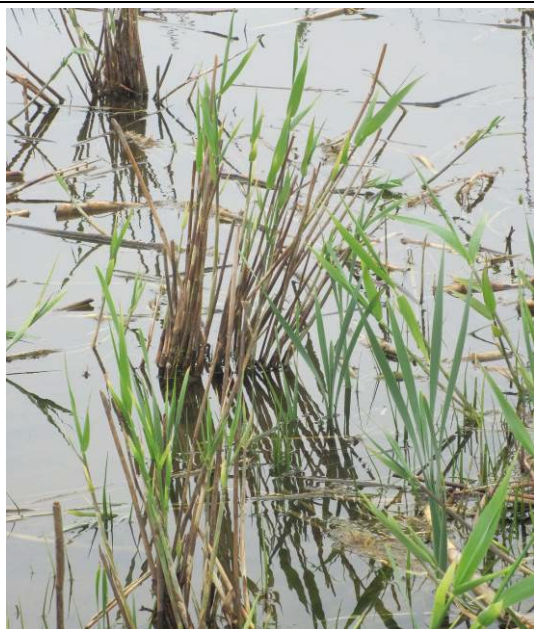
Figure 4 – New *Phragmites* growth in main pool

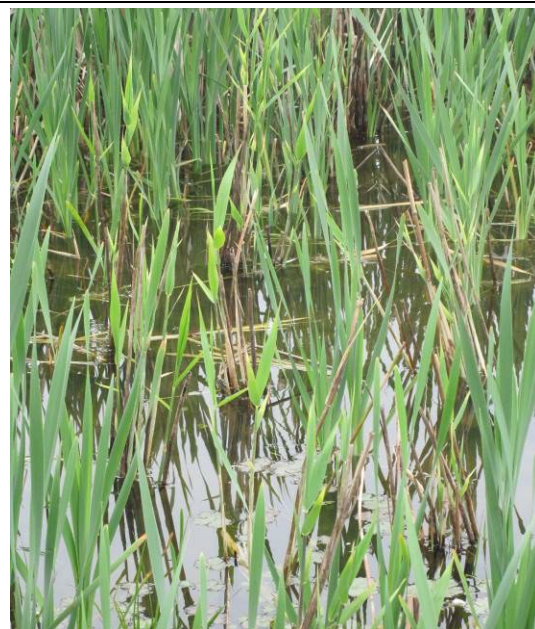
***Phragmites* among *Typha* in southern reedbed section**

Water levels will be monitored and controlled via the existing sluice connections to adjacent ditches and a temporary pump, to ensure that levels remain high and therefore less suitable for *Typha* colonisation.

New *Phragmites* plugs will be planted in the 0.8 ha excavated area in spring 2013, at a higher density of 9 plugs per square meter. This is a recommended density for successful reedbed creation; it is also closer to the density planted in the south-west reedbed: the only area where *Phragmites* is dominant. This will result in the planting of 72000 *Phragmites* plugs. Water level control, and hand-pulling of *Typha* and other invasive species, will be managed by the Crossness Nature Reserve Manager.
