**OUTLINE LANDSCAPE,
BIODIVERSITY, ACCESS
AND RECREATION
DELIVERY STRATEGY: 7.9**

Cory Decarbonisation Project

PINS Reference: EN010128

January 2025

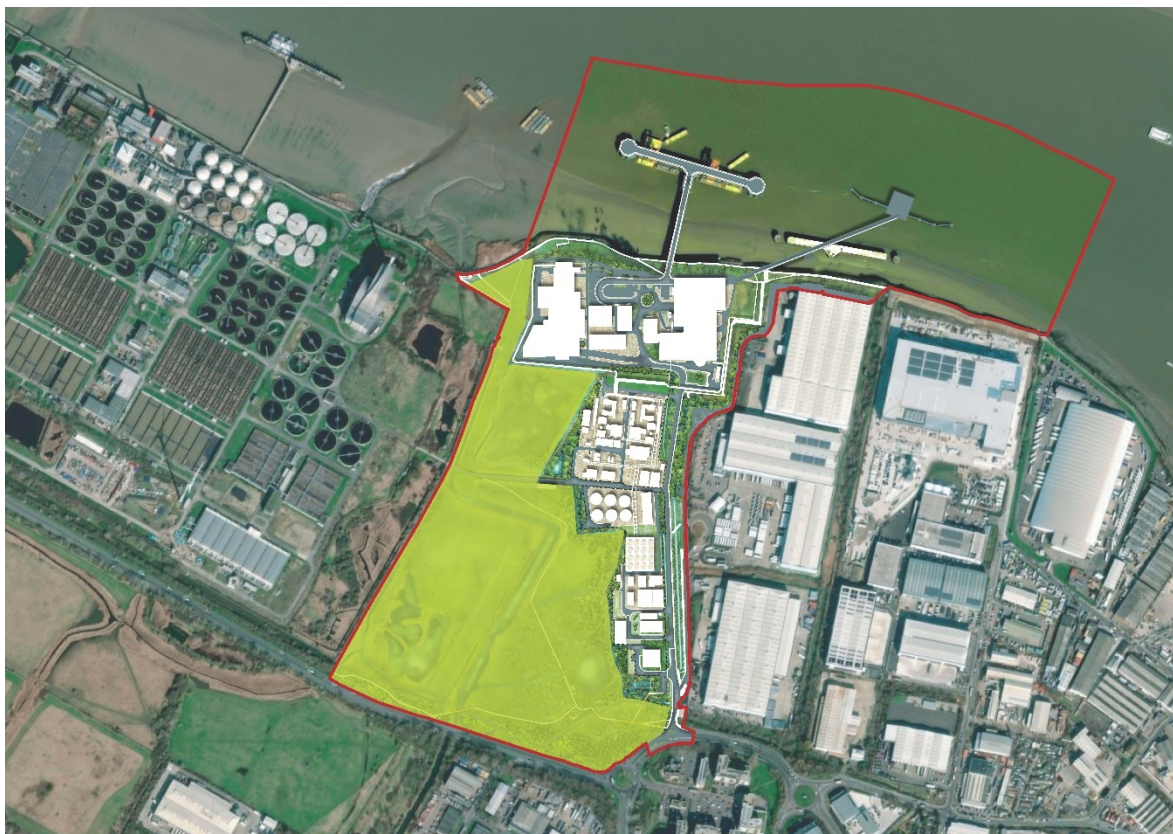
Figure 3 - Mitigation and Enhancement Area

5.2.2. The area is identified to allow for comprehensive masterplanning of a coordinated green infrastructure strategy and to support the proposed enlargement of the Crossness LNR to include Norman Road Field. This proposal is outlined in section 9.

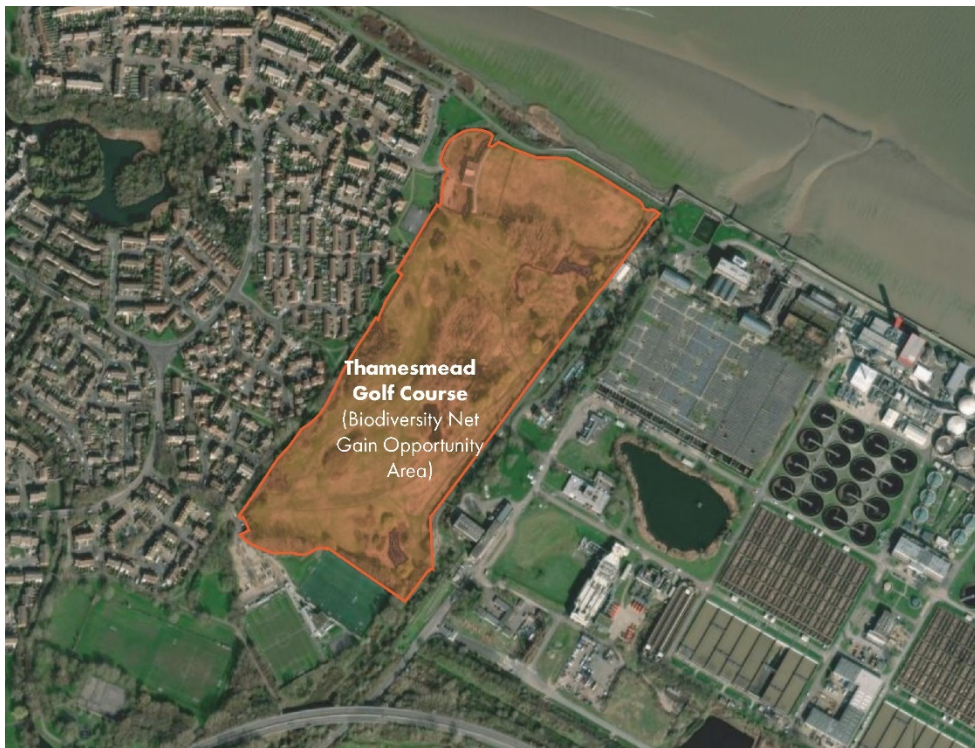
Figure 4 - Offsite BNG Opportunity Area

5.3.1. The BNG Opportunity Area is a possible area for offsite BNG provision located at the former Thamesmead Golf Course on the Thamesmead Estate, illustrated in **Figure 4**. The land is owned by the Peabody Trust and comprises a disused golf course that formed part of the Thamesmead development masterplan and has been identified in Peabody’s ‘Living in the Landscape’ framework document as an area with potential for enhancement. The golf course has been subject to an ecological survey to understand the presence of existing habitats and their current condition.

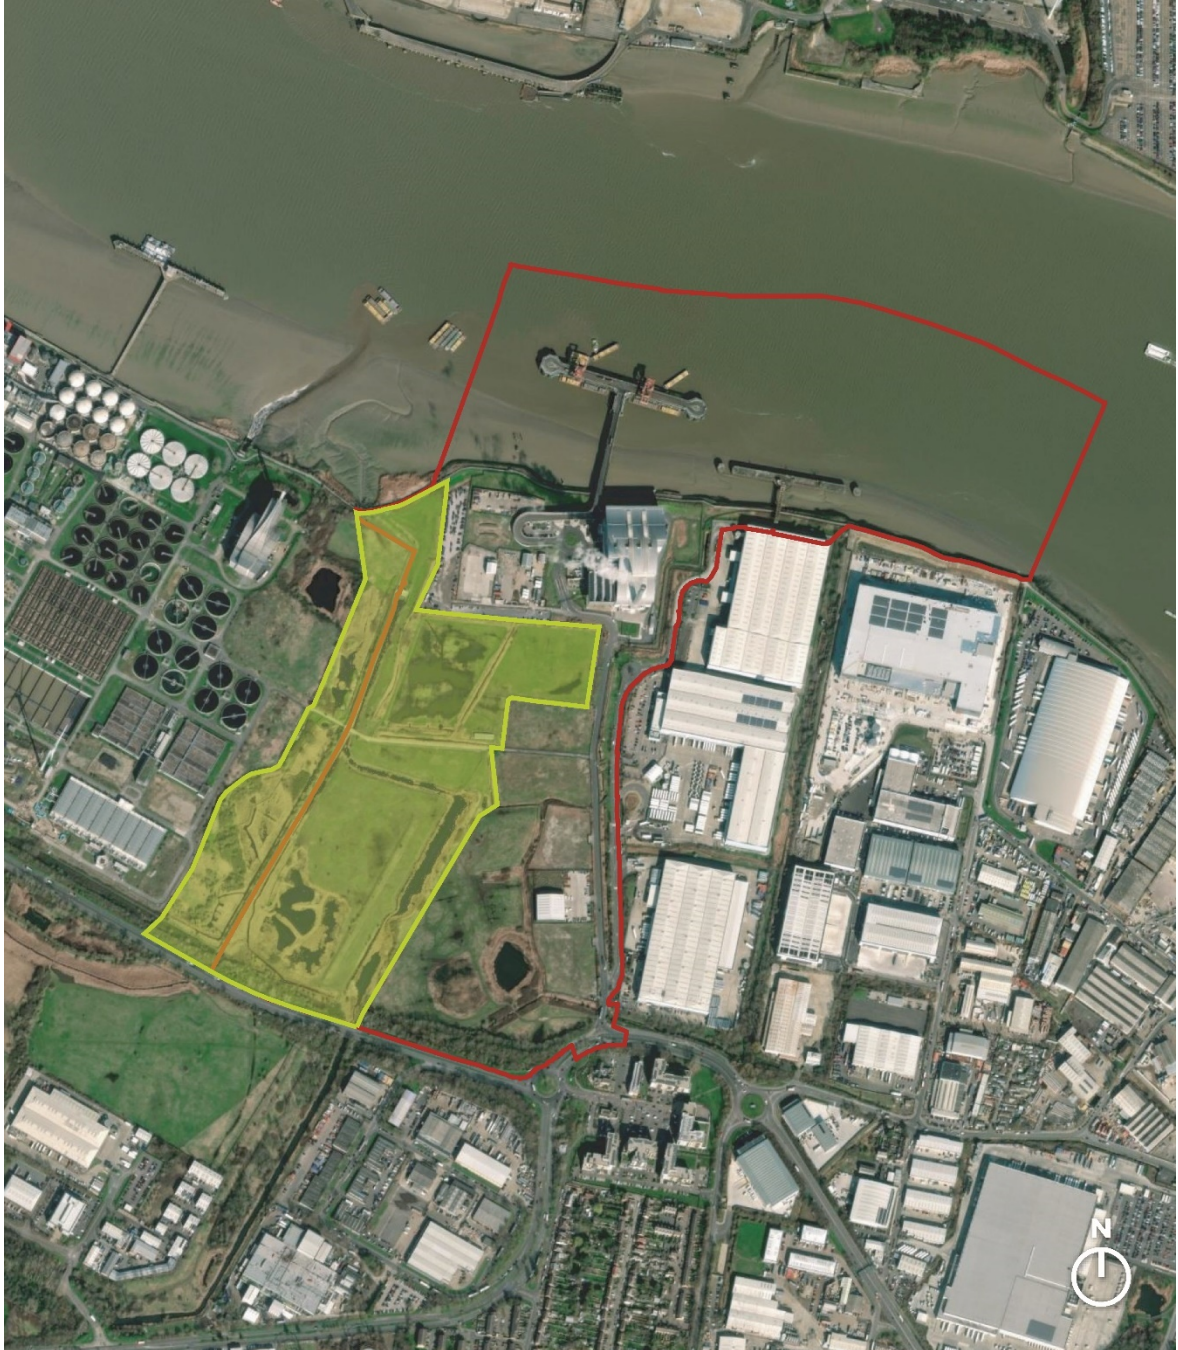
- 5.4.4. **Figure 5** illustrates the extents of the Crossness LNR.

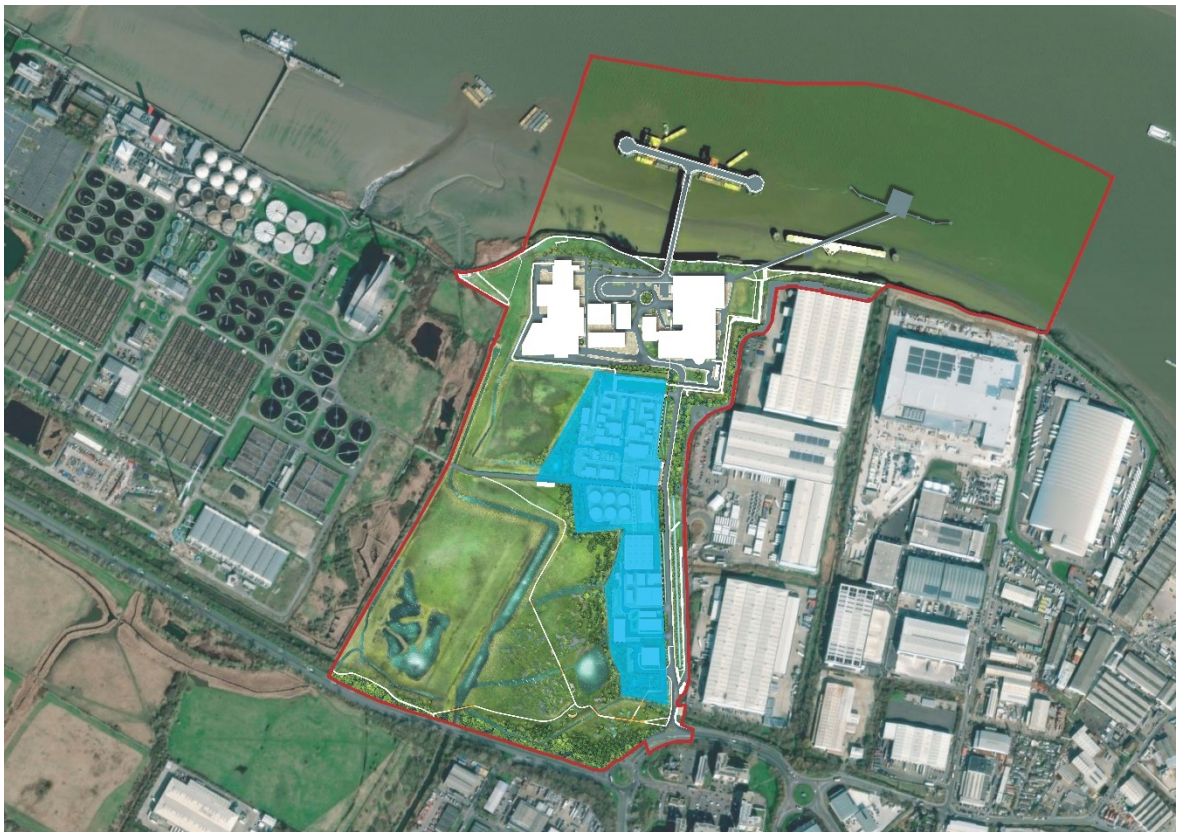
Figure 6 Carbon Capture Facility (CCF) Area

- 5.5.1. The CCF Area is illustrated in **Figure 6** and comprises a secure operational area adjoining the Mitigation and Enhancement Area to the west and Norman Road to the east. Norman Road comprises an adopted road that extends to the roadside kerb to the west (including a narrow grassed verge, portions of the existing ditch/main river feature) and a pavement to the west.

- 5.5.2. The CCF Area includes planting and habitat proposals to the east and western boundaries inside and outside the secure fence line. To the east, the existing ditch (water course) network is retained adjoining the Norman Road corridor along with new planted areas. To the west, the existing ditch profile is to be improved to support habitat development and soil rewetting along with new planting. To the southern end of the CCF Area, opportunities for habitat creation and planting are identified in combination with water management infrastructure and associated with the proposed LNR visitor car park.

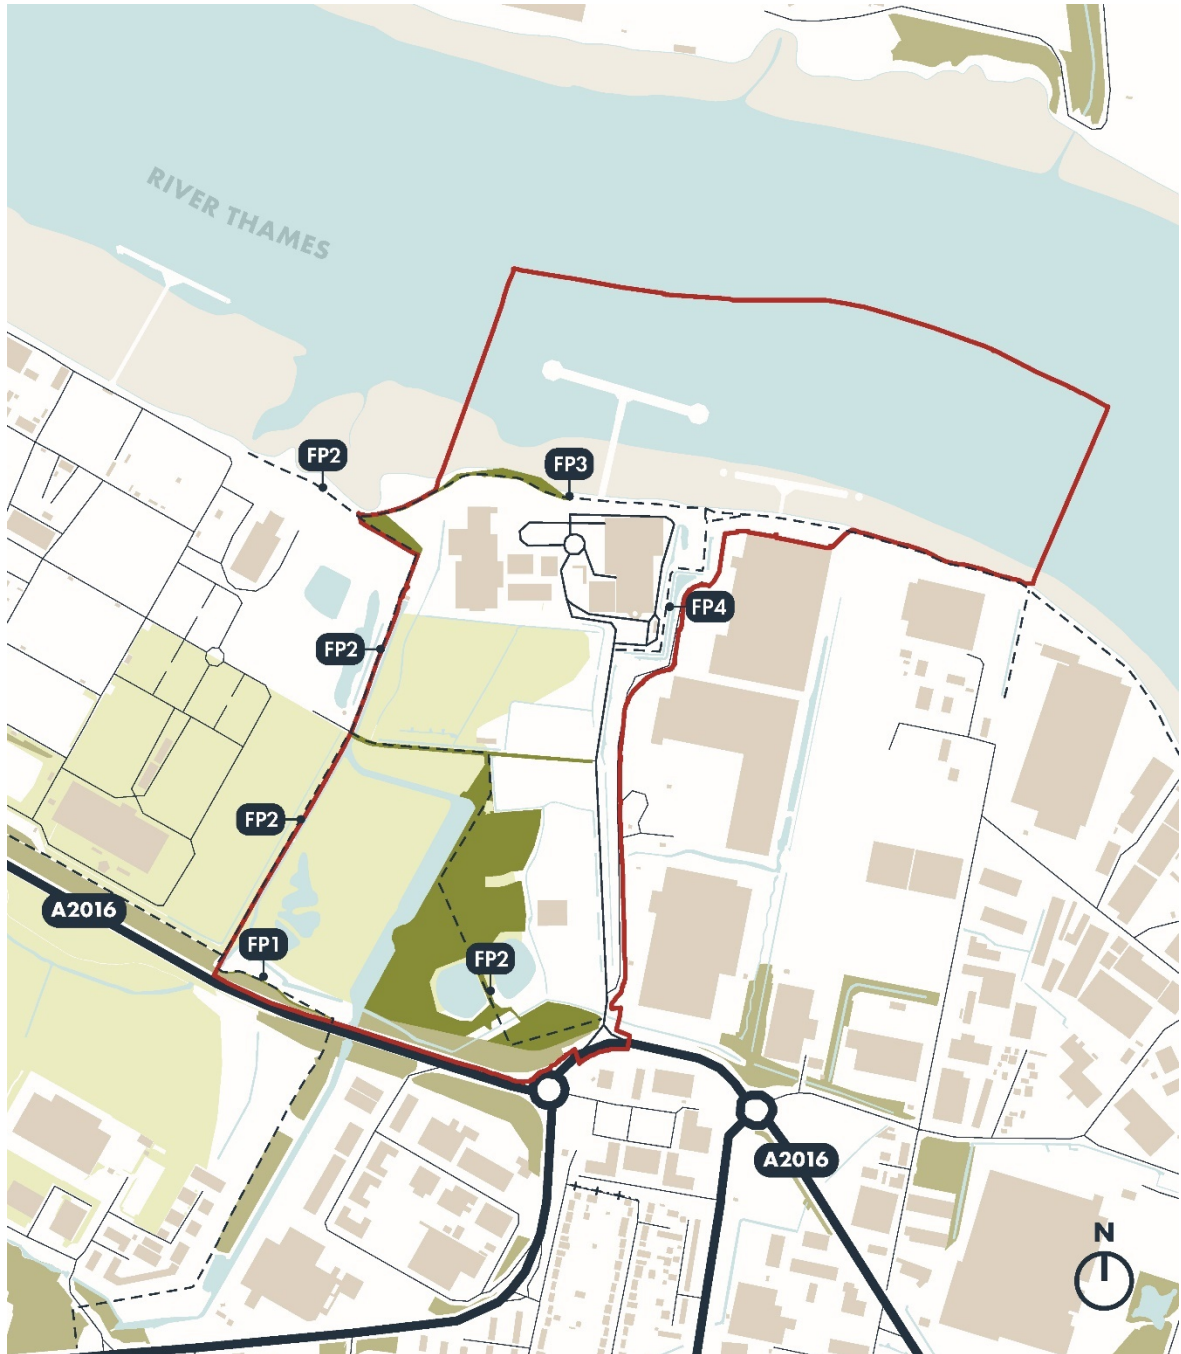
6.4.1. A description of the construction and operational phase works associated with PRoW is outlined below. The existing PRoW subject to diversion (temporary or permanent) are illustrated in **Figure 8** and additional proposed PRoW are illustrated in **Figure 9**.

- 6.4.14. Additional PRoW routes are proposed illustrated on Figure 9 and detailed in section 9. Additionally, enhancements will be developed and provided including for example, interpretation boards and localised works to the boundaries to the immediate context of the England Coast Path (FP3/NCN1). These will be detailed as part of the full LaBARDS. The DCO also provides for the Applicant to be able to authorise motorised use of FP1 – FP4 during both the construction and operational phases – this is for the Applicant’s requirements, but also to allow for improved access arrangements for graziers and the Friends of Crossness LNR, if required. Proposals for new footpath and permissive paths or links will be developed with terrestrial biodiversity in mind and through engagement with LBB and relevant user groups to ensure that potential negative impacts are understood, mitigated and managed through construction and operation phases. This could include installation of boardwalks, fences, all weather surfacing, gates and signage, with the aim of improving the user experience and conservation of habitats. The alignment of new public rights of way (footpaths) will be secured through submission and approval of the full LaBARDS

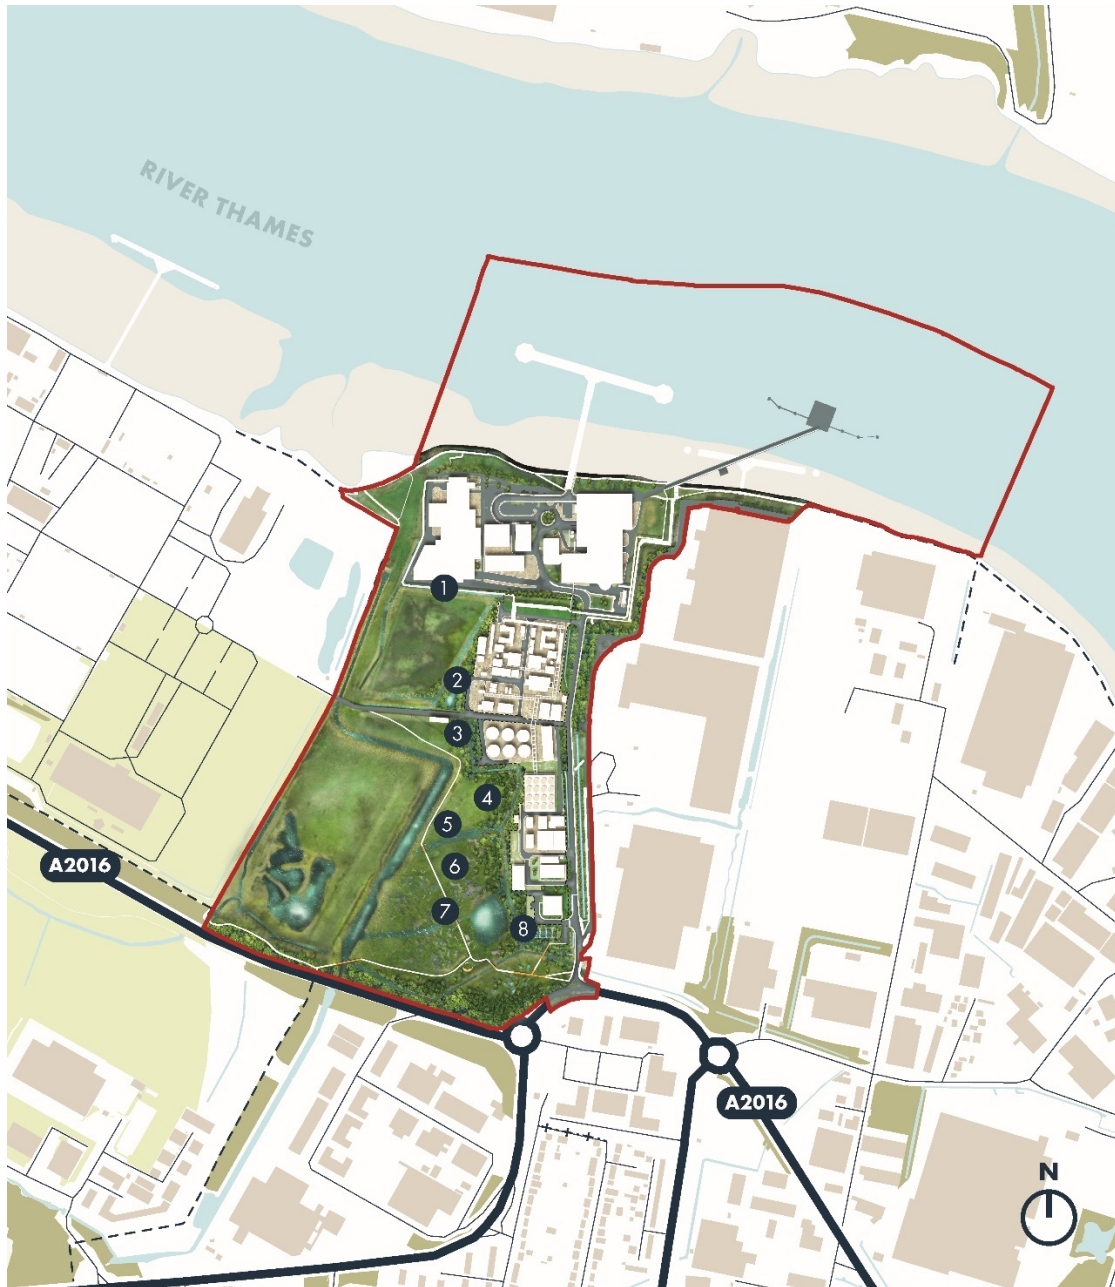
- 10.1.8. The Environmental Proposals are illustrated in **Figure 15** and reflect how the Applicant has sought to respond to planning policy constraints identified during

design development, the results of the EIA process and the desire to integrate the CCF into its setting.

- 10.1.12. Improve the distinctiveness and condition of existing valued flood plain grazing marsh habitats, delivered by raising water table and managed grazing densities, delivering direct mitigation for the physical loss of grazing marsh habitat; provide additional habitat measures to mitigate impacts and improve biodiversity; and onsite BNG. These measures and proposals are described and illustrated below and are to be delivered within the CCF Area and Mitigation and Enhancement Area.

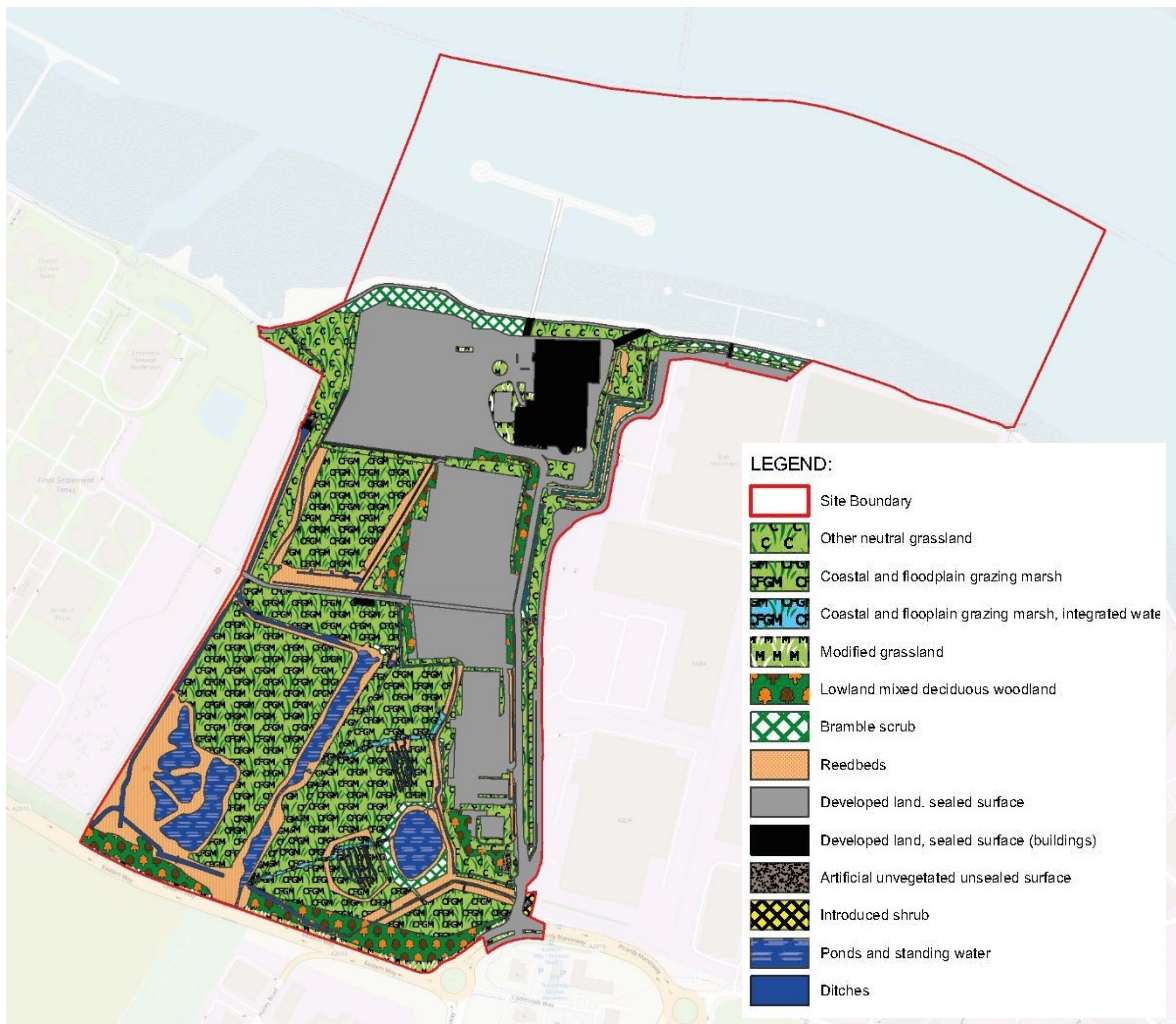
Figure 17 – Post Development Biodiversity Strategy

10.1.17. The priorities of the Environmental Proposals include:

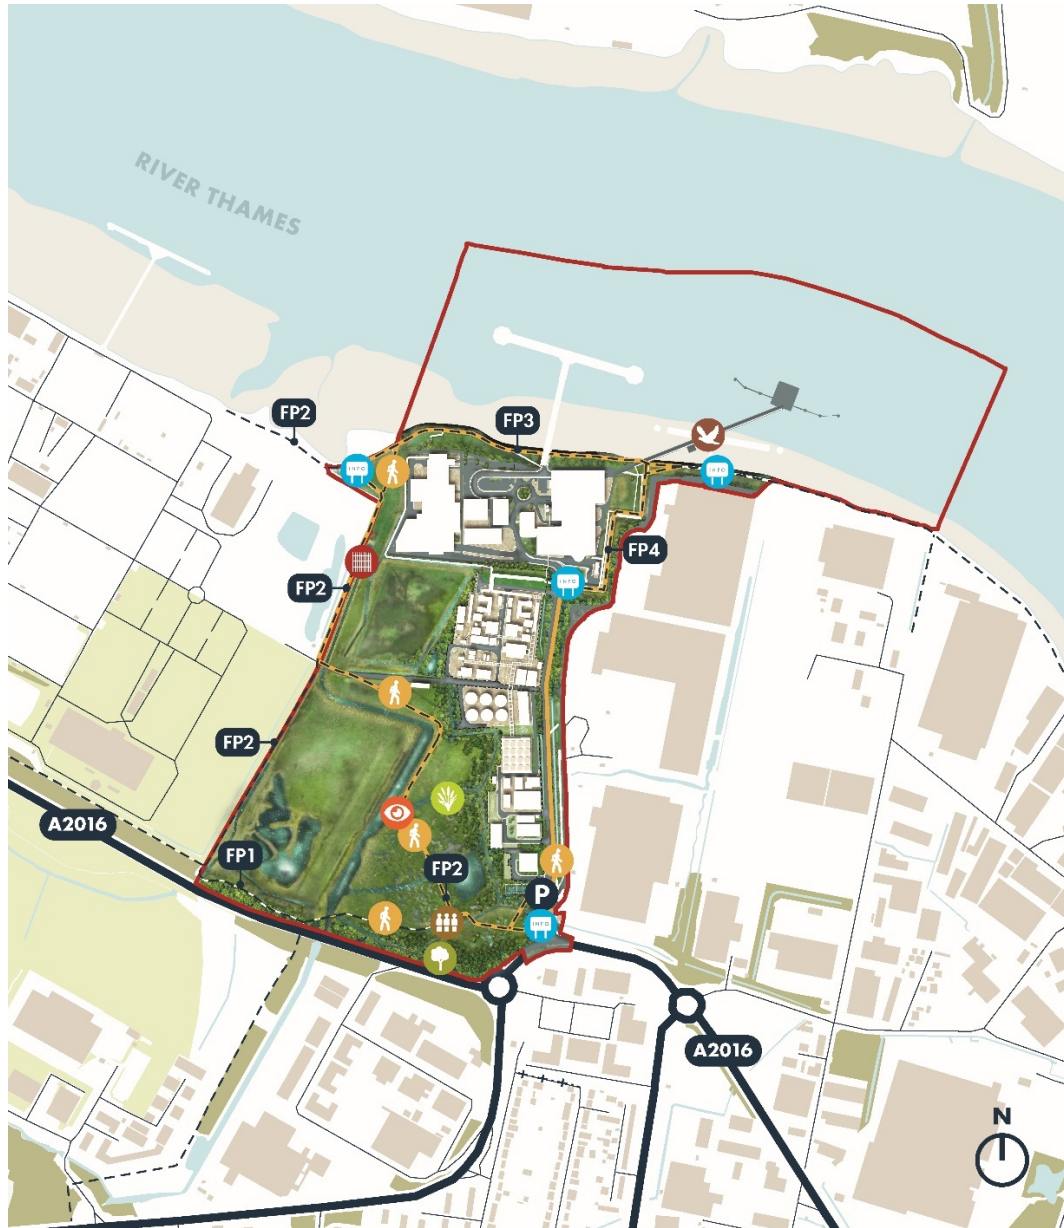
Figure 18 – Access and Recreation Proposal

- 10.2.1. The Access and Recreation Proposals are illustrated in **Figure 18** and supported by the Access and Movement Strategy illustrated in the **DAD (Document Reference 5.6)**.
- 10.2.2. The Access and Recreation Proposals provide enhanced PRow routes and connectivity within the Site and works offsite. The proposals encourage improved opportunity for active travel access, improved amenity and recreation experience and safety of routes.

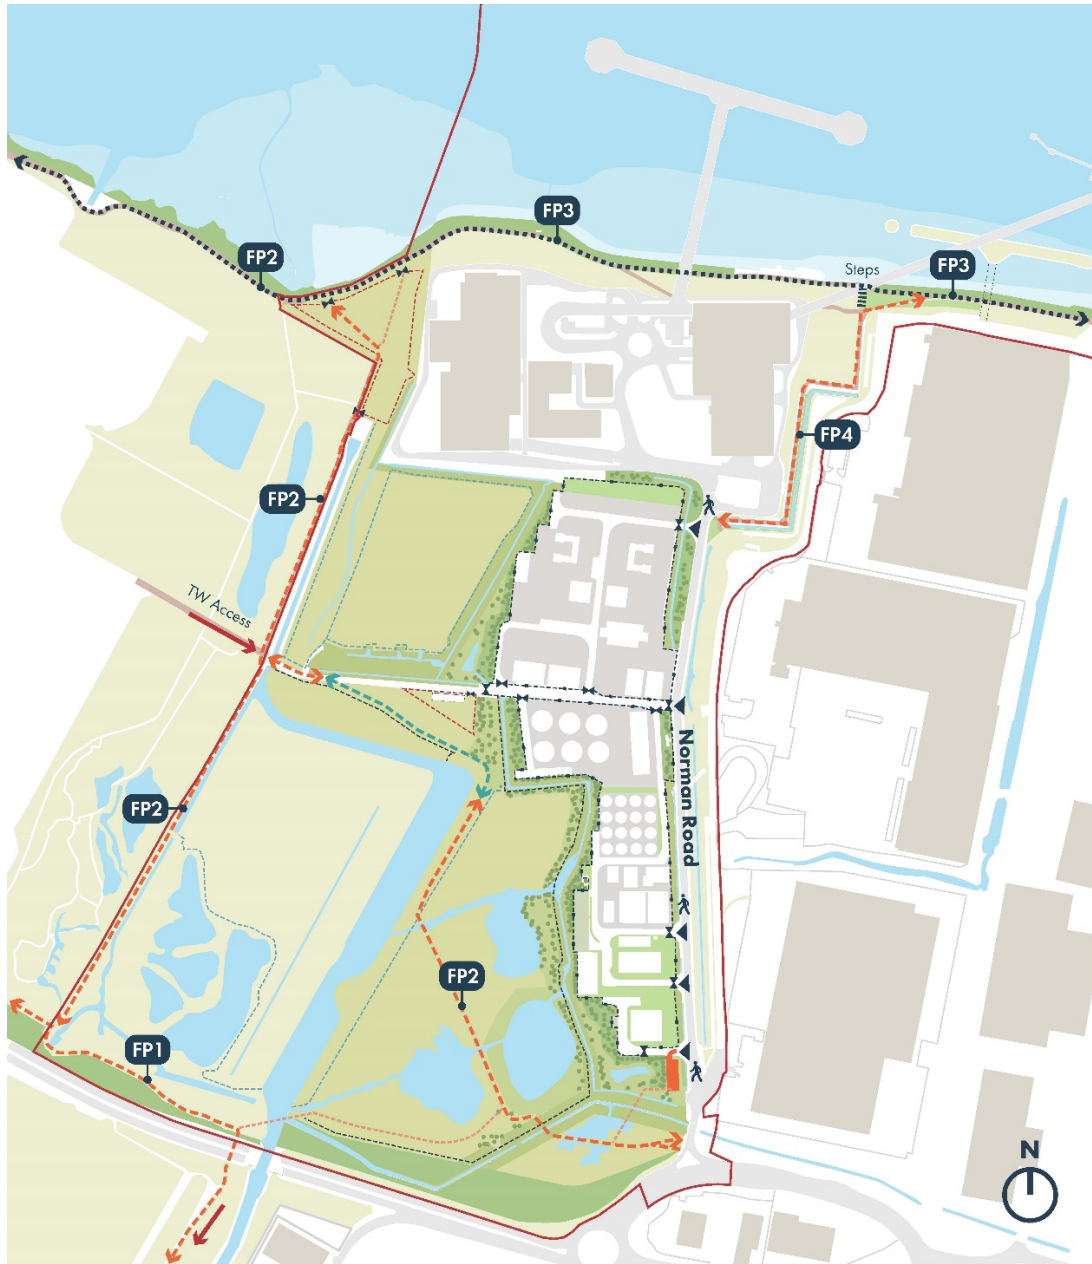
Figure 9 – Operational phase ProW diversions and ProW creations (repeat)

Key	
	Site boundary
	Public Rights of Way (PRoW)
	PRoW Diversion
	New PRoW
	Other public access route and cycleway
	Security fenceline to carbon capture facility
	Existing fenceline
	Amended fenceline
	Proposed fenceline
	Direction/access towards nearby locations
	Proposed gates
	Vehicular access
	Proposed pedestrian crossings
	Proposed car park
