SLOUGH MULTIFUEL EXTENSION PROJECT

Appendix 10C - SSE Slough Bat Survey Report

SSE Slough Bat Survey Report

SSE Slough Demolition and Decommissioning

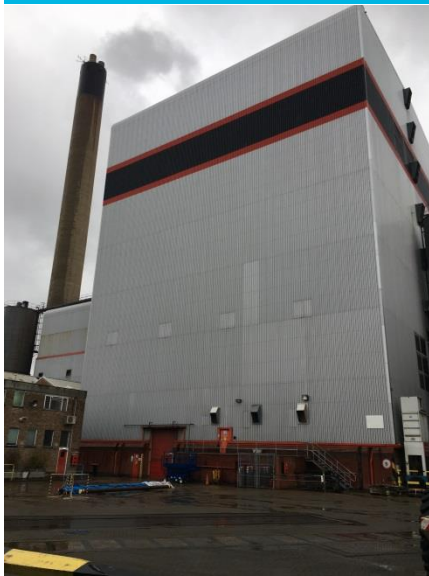
Photograph 1: View of the large buildings within the Site showing metal panel construction and lack of potential roost features for bats.

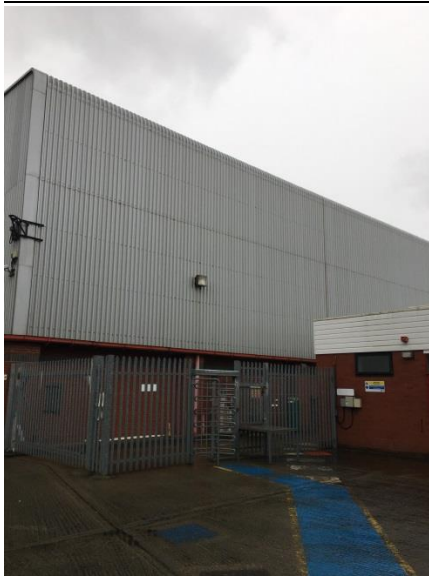
Photograph 3: Southern view of B13 showing general lack of suitability for bats.

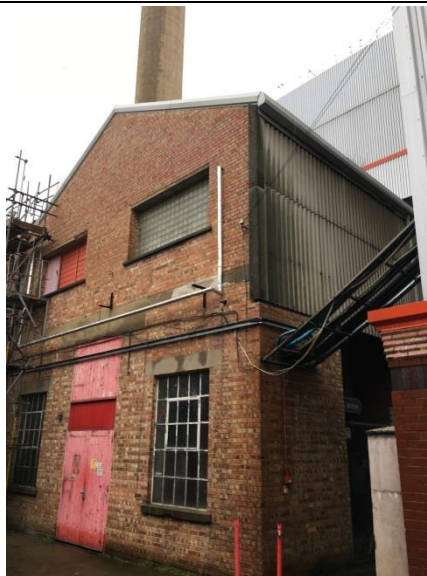
Photograph 4: B26 with corrugated asbestos sheeting providing crevices (potentially suitable roost features).

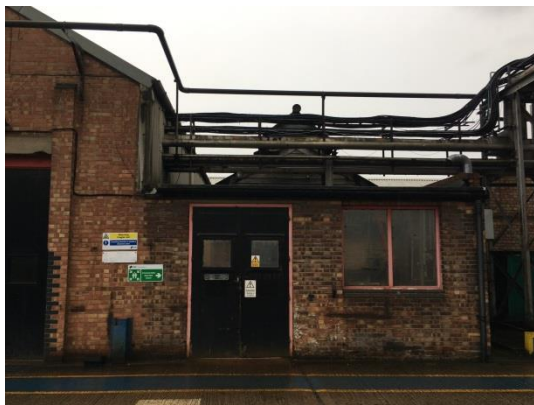
Photograph 5: Building 18 showing wooden pitched roof section (obscured by piping) as an example potential roost feature within the Site.

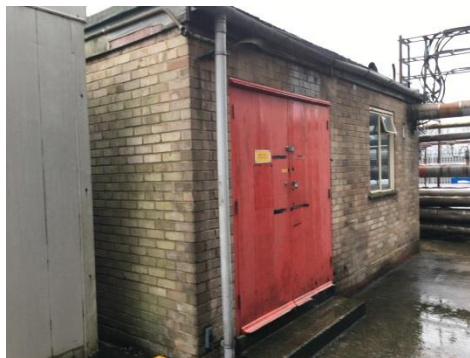
Building No./Location	2012 Assessment	Potential Roost Features	2018 Re-assessment	Potential Roost Features
B10	Low	Crevice between barge board and walls. Access into building. Missing mortar. Section of lifted felt.	Negligible	Minor crevices inspected with torch and endoscope with no evidence of bats. Given low habitat suitability (lack of habitat connectivity) and lack of any bat activity on 2012 survey it was assessed that this minor feature could be downgraded to negligible.
B12 & B13	N/A	N/A	Negligible	Large boiler and plant buildings constructed of metal panelling and with no voids, crevices or other features suitable for roosting bats
B15	Low	Raised barge boards and gaps. Missing brick/mortar. Old timber hole.	Low	Minor gap present under barge boards. Mortar and timber looked in good condition – could have been subject to previous repair works? Kept as low suitability due to extent of loose bargeboard

Photograph 6: B10 with very minor gaps under bargeboard however inspected and assessed overall (considering inspection result, minor feature and lack of habitat connectivity) as being of negligible suitability for roosting bats

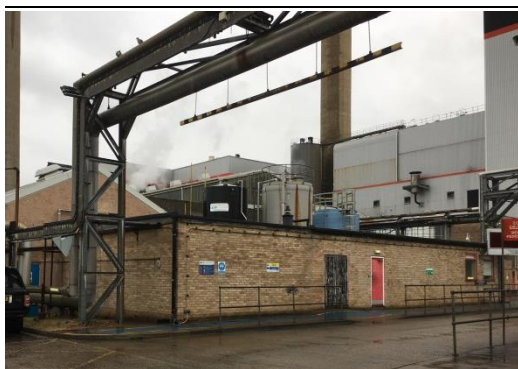
Photograph 7: Eastern elevation of B15. Bargeboard present along flat roof edge with lifted sections suitable for roosting bats –more extensive than B10.

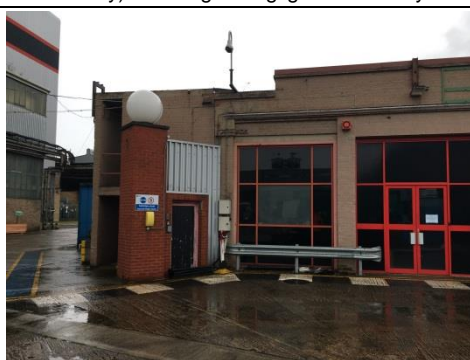
Photograph 8: Western elevation of B22 showing general lack of roost features across building (no soffits, bargeboard, missing brick work etc).

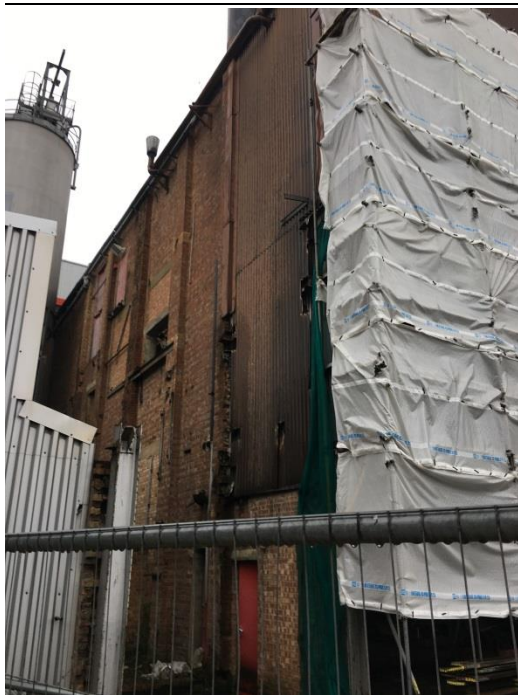
Photograph 9: Building 30 undergoing works with multiple holes and exposed walls creating a draughty and unsuitable interior.

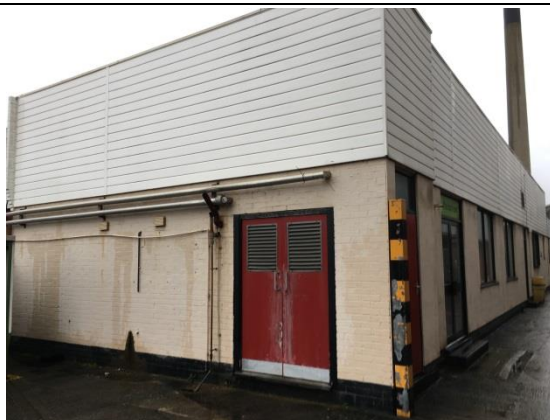
Photograph 10: B8 showing general lack of roost features – cladding tight and securely fitted.
