Outer Dowsing Offshore Wind

Environmental Statement

Appendix 21.6 Riparian Mammal

Volume 3, Appendix 21.06: Riparian Mammal Surveys

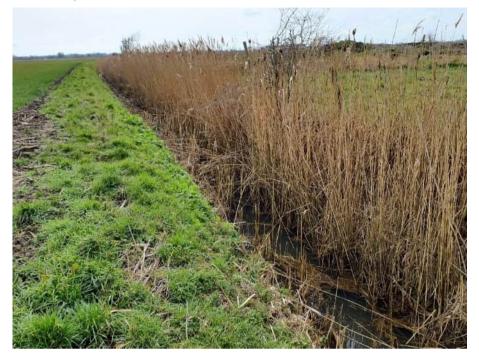
Plate 1: WCID 20091 - A Typical Wet Field Drainage Ditch with Moderate Habitat Suitability for Water Vole and Otter

37. There are a total of 636 ditches either within the Order Limits, or functionally linked within 250 m of Project. Of the 636 within the Order Limits, 9% were field ditches that remained dry over the course of the 2022/2023 ecology field surveys. Field ditches across much of the project are uniform in their profile, often with a bank profile of 45 degrees or slightly less. The majority are also subjected to regular management, with grass and reed cutting, dredging and bank profile maintenance operations evident in every Segment. Often, watercourses have little, or no shading from trees and shrubs. Away from the road network, the ditches experience only low levels of disturbance from farm vehicle movements. Plate 1 illustrates a typical wet ditch with 'moderate' habitat suitability for riparian mammals; Plate 2 is a typical dry ditch with Low habitat suitability. These two ditch categories are prevalent across the survey area.

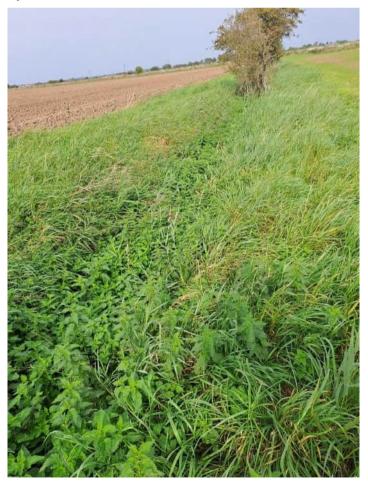
Plate 2: WCID 20148 - A Typical Dry Ditch under Eco-succession with Low Habitat Suitability for Water Vole and Otter

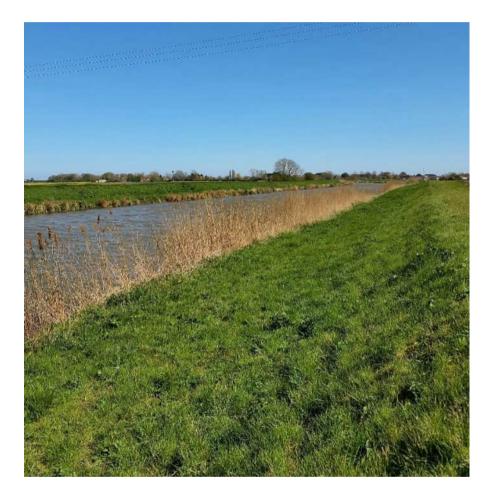
Plate 4: Wainfleet Relief Channel

43. The Wainfleet Relief Channel flows north around the village of Wainfleet All Saints. Flow rate is slow with water levels controlled by Croft Pumping Station. The channel is c.30m width and has artificial banks with a 45° bank profile, raised to provide flood defence to the village. In 2022, a programme of dredging operations was undertaken to maintain a minimum water depth of 1.5m and to reduce weed growth (East Lindsey Local Authority Website). The grassland along the vegetation is cut, although left

unmanaged at the water's edge. Species present include rosebay willowherb (*Chamaenerion angustifolium*), great willowherb (*Epilobium hirsutum*), bulrush (*Typha latifolia*), branched bur-reed (*Sparganium erectum*), water lily (*Nymphaeaceae* sp.) and common reed (*Phragmites australis*). The Wainfleet Relief Channel is considered to have 'moderate' habitat suitability for otter and 'low' suitability for water vole.

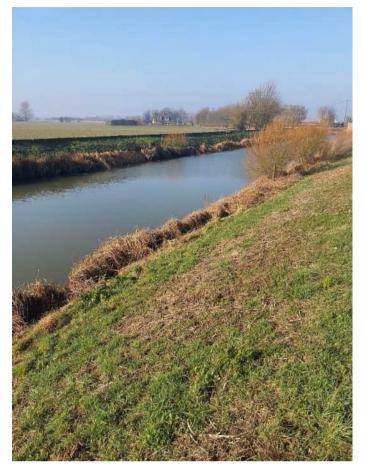
Plate 5: Steeping River

44. The **Steeping River** was recorded as having a shallow bank profile <45°, *c*.2m watercourse depth, *c*.5m width, *c*.3m channel width and the bank structure was predominantly earth. Within the channel, tree cover was rare, tall herbs were frequent, tall grass cover was occasional, short grass cover was abundant, shading was *c*.20% and reeds and sedges were dominant (Plate 5). The surrounding primary habitat here was neutral grassland. At the time of surveying, anglers were observed with cutting of adjacent grass to enable pedestrian access. Otter feeding remains were identified on the banks of the Steeping River. It has 'low' habitat suitability for water vole.

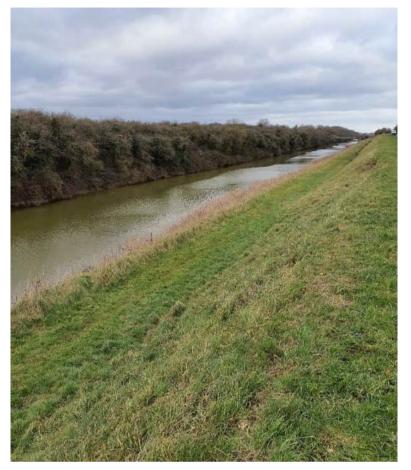
Plate 6: Hobhole Drain

- 45. **Hobhole Drain** forms part of the Witham Navigable Drains. Its water levels are artificially controlled at Hobhole Pumping Station before it discharges into the Haven. The Witham Navigable Drains have 'bad' ecological status and 'failed' chemical status according to the 2019 dataset from the Environment Agency. At the Hobhole Drain crossing point is Fishtoft Lakes, a private fishing lake and activity centre.
- 46. Hobhole Drain is very, large, straight watercourse measuring approximately 31 m across. (Plate 6). It is bordered by a public footpath within a narrow strip of broad-leaved woodland along the right bank. The left bank is managed, neutral grassland, bordered by a line of broad-leaved trees and single lane, tarmacked road.

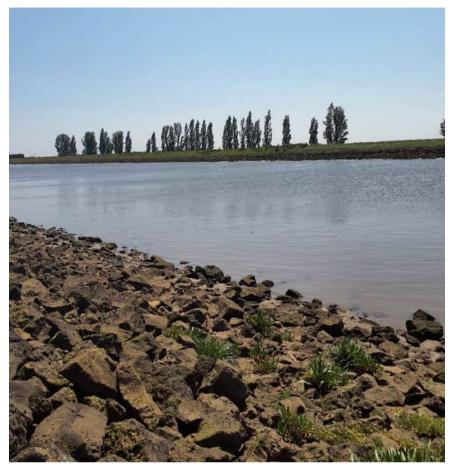
Plate 7: The Haven

- 48. The Haven is a very large river with a shallow bank profile <45°, *c*.5m watercourse depth, *c*.50m width, *c*.100m channel depth with a primary bank substrate of stone with surrounding habitat consisting of salt marshes (Plate 7). The Haven is a tidal river which links up with The Wash and boats were recorded navigating up and down the river.

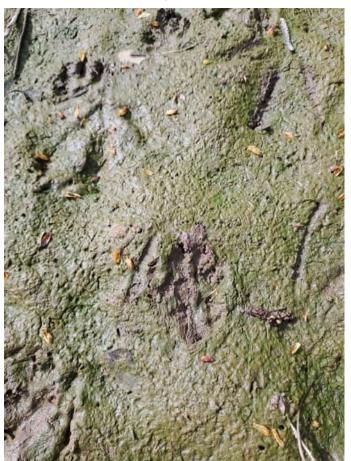
Plate 9: Evidence of Otter Presence. Footprints Recorded on WCID 1636

- 51. There were no direct observations of otter made during the targeted otter surveys or during any other ecological surveys undertaken by SLR.
- 52. Otter footprints were found within segment ECC 14: Surfleet Marsh OnSS/Marsh Drove to Weston Marsh NG Substation (WCID: 1753) and segment ECC 13: Fosdyke to Surfleet Marsh OnSS/Marsh Drove (WCID: 1636) (Plate 9).

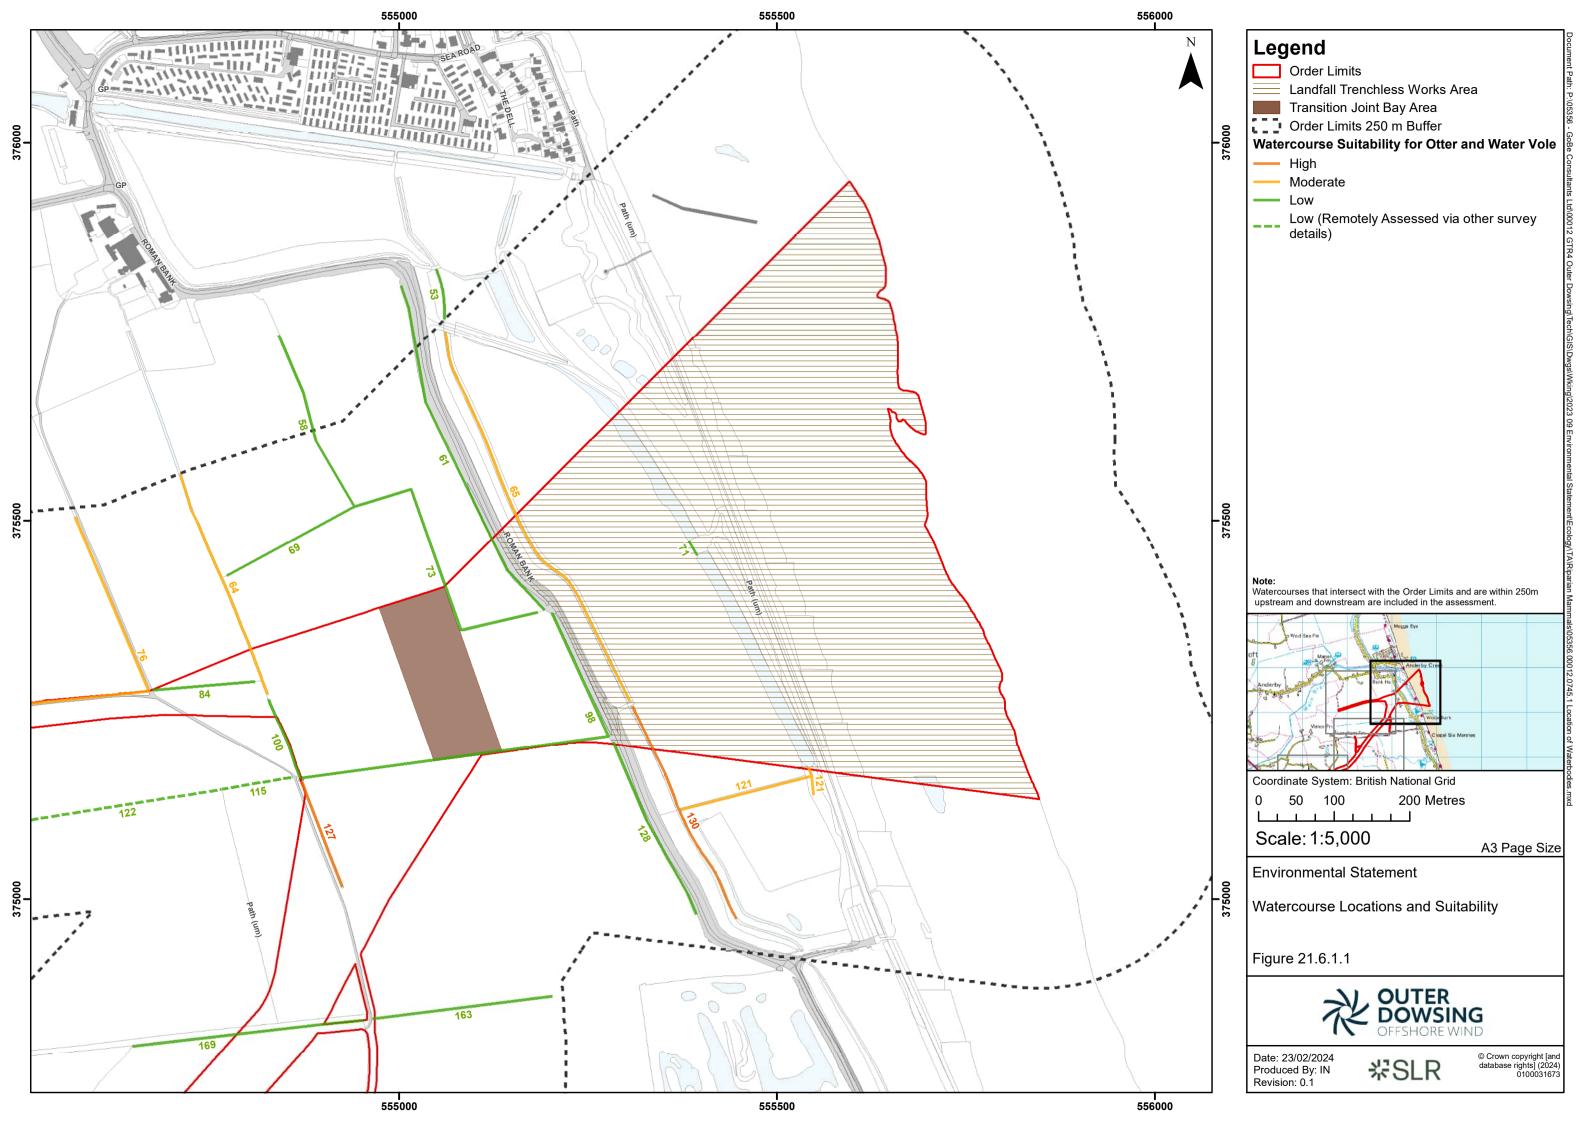
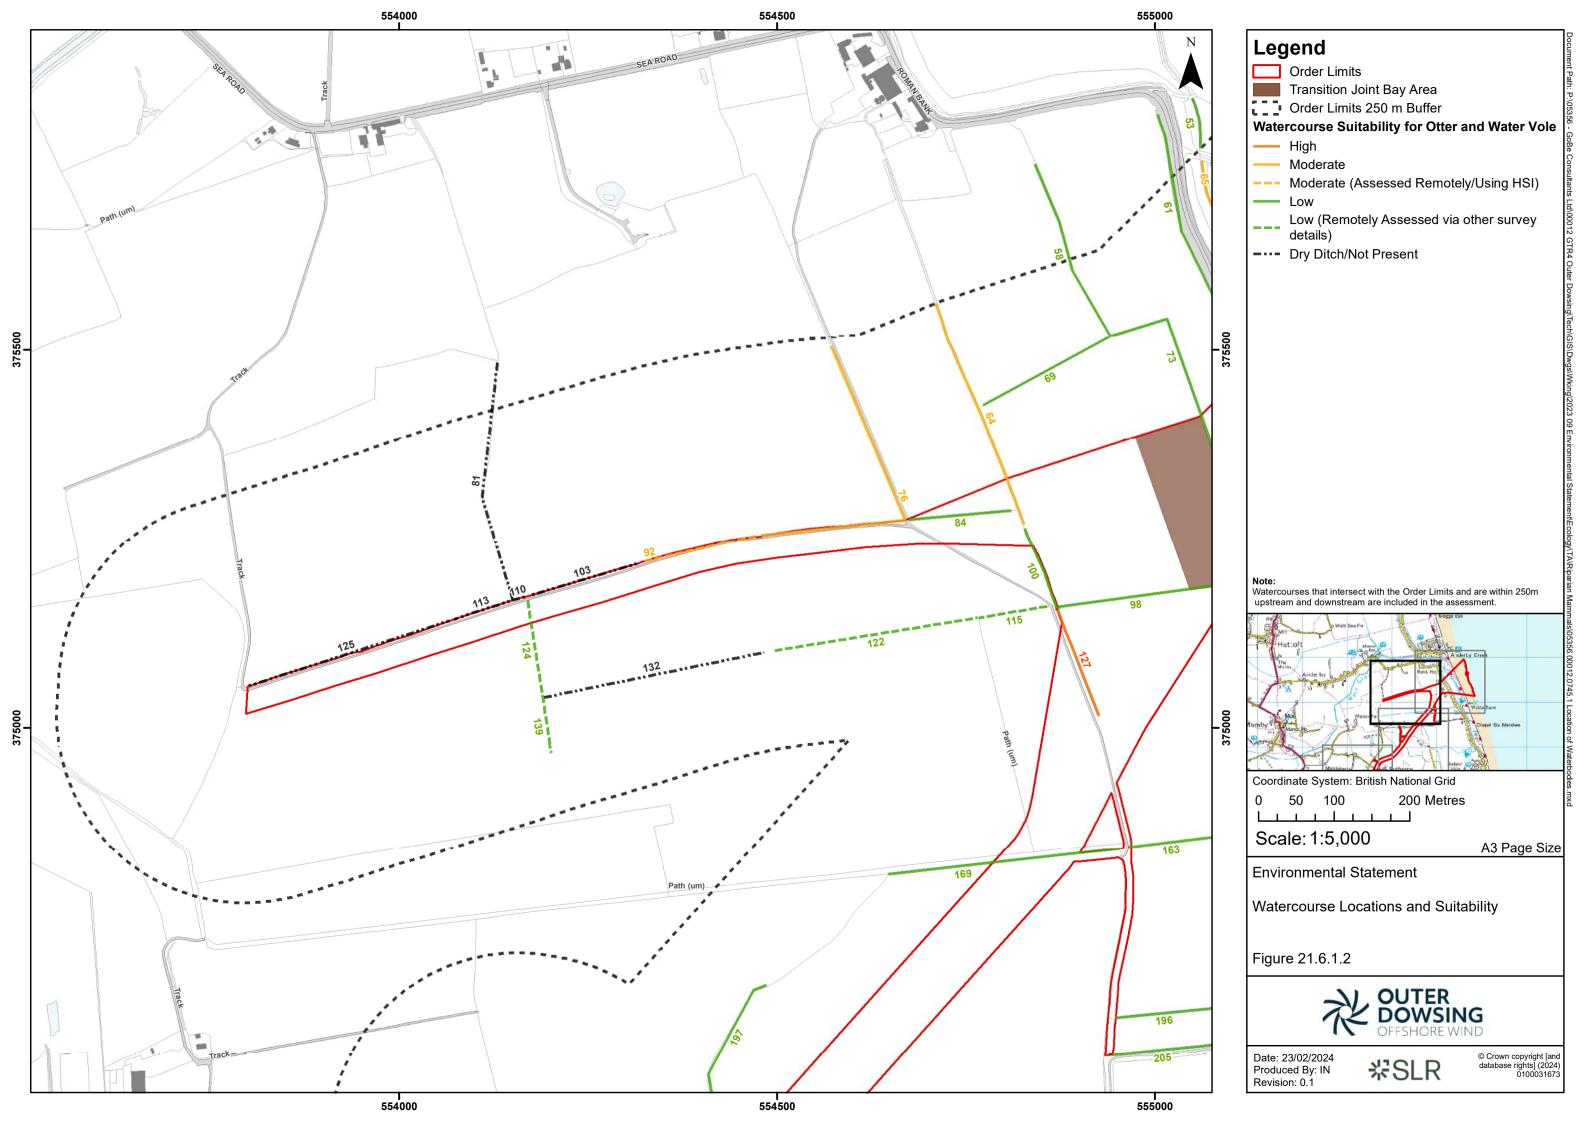
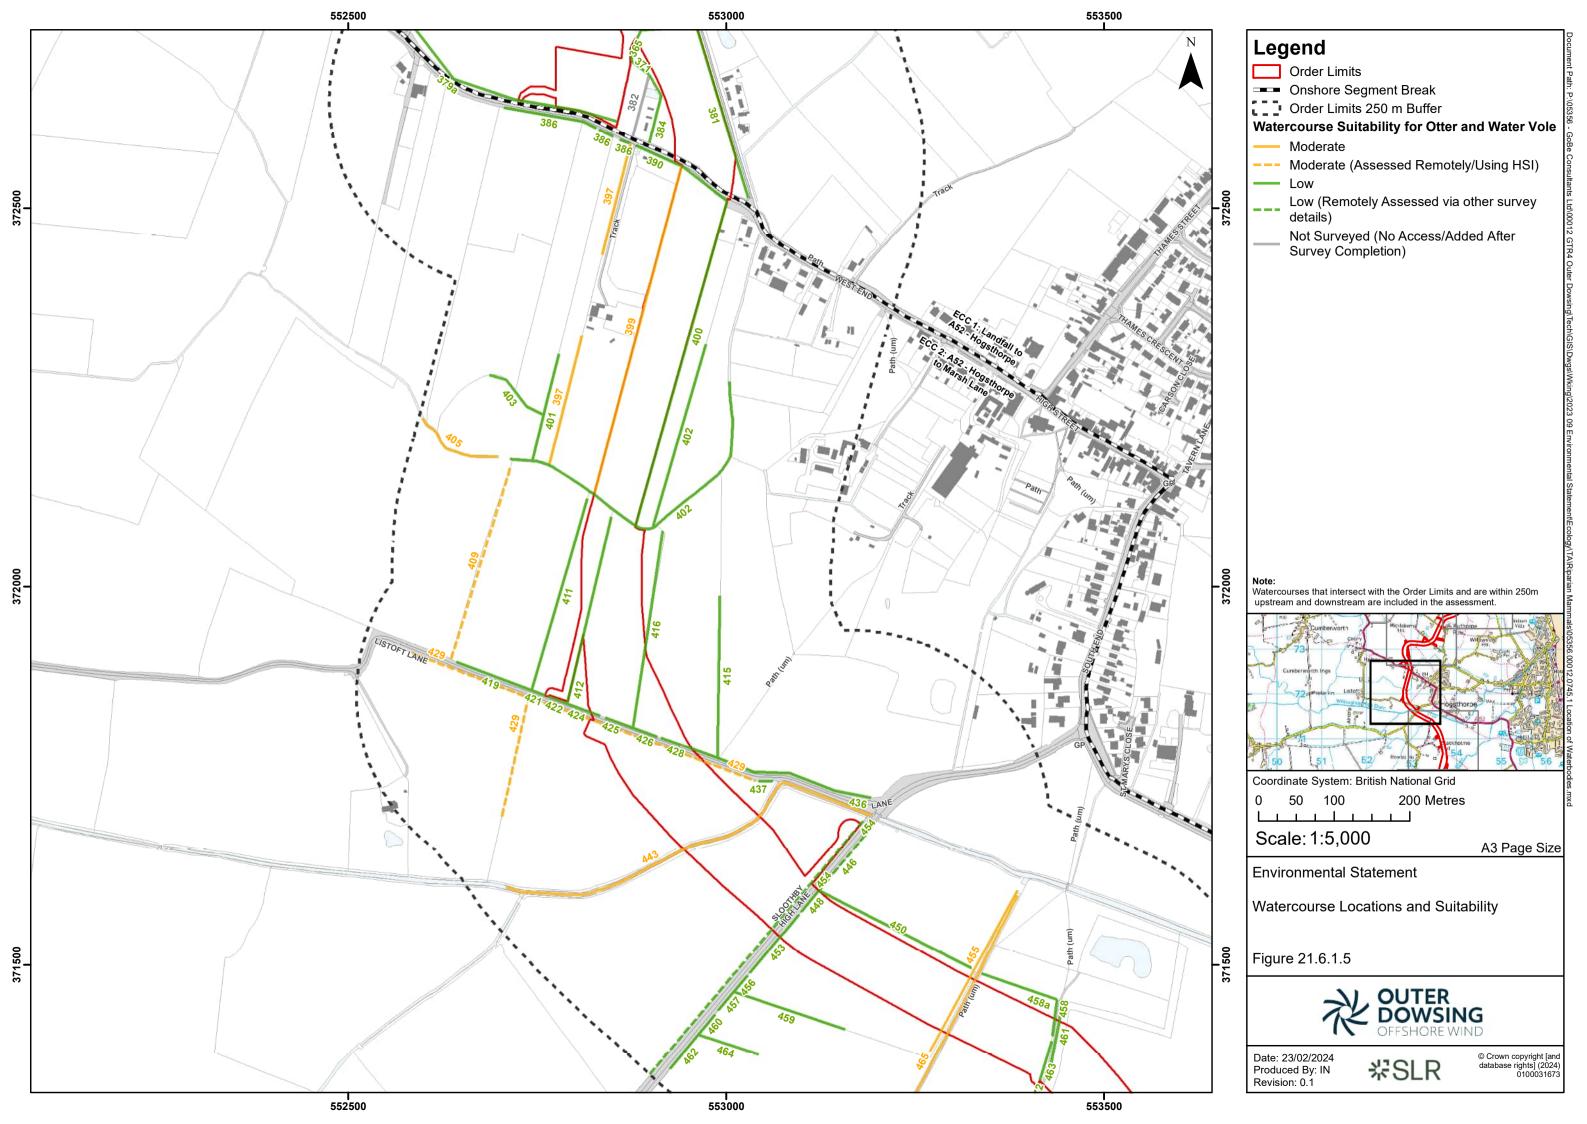
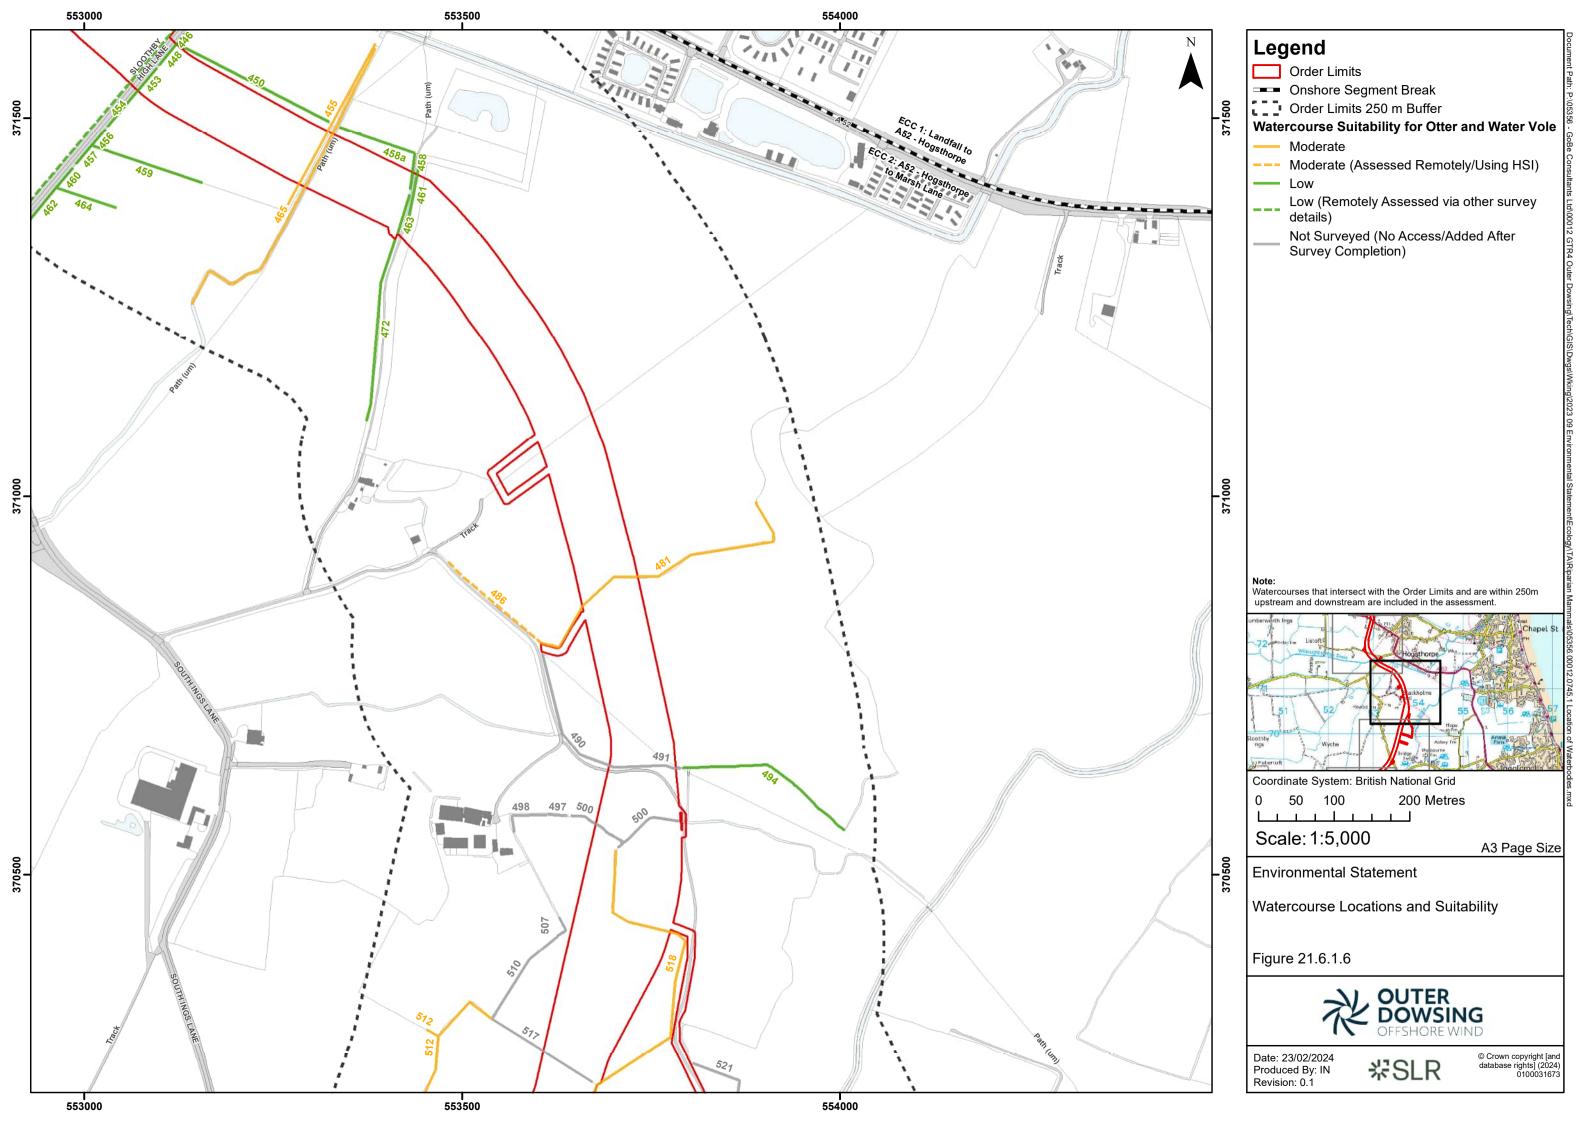
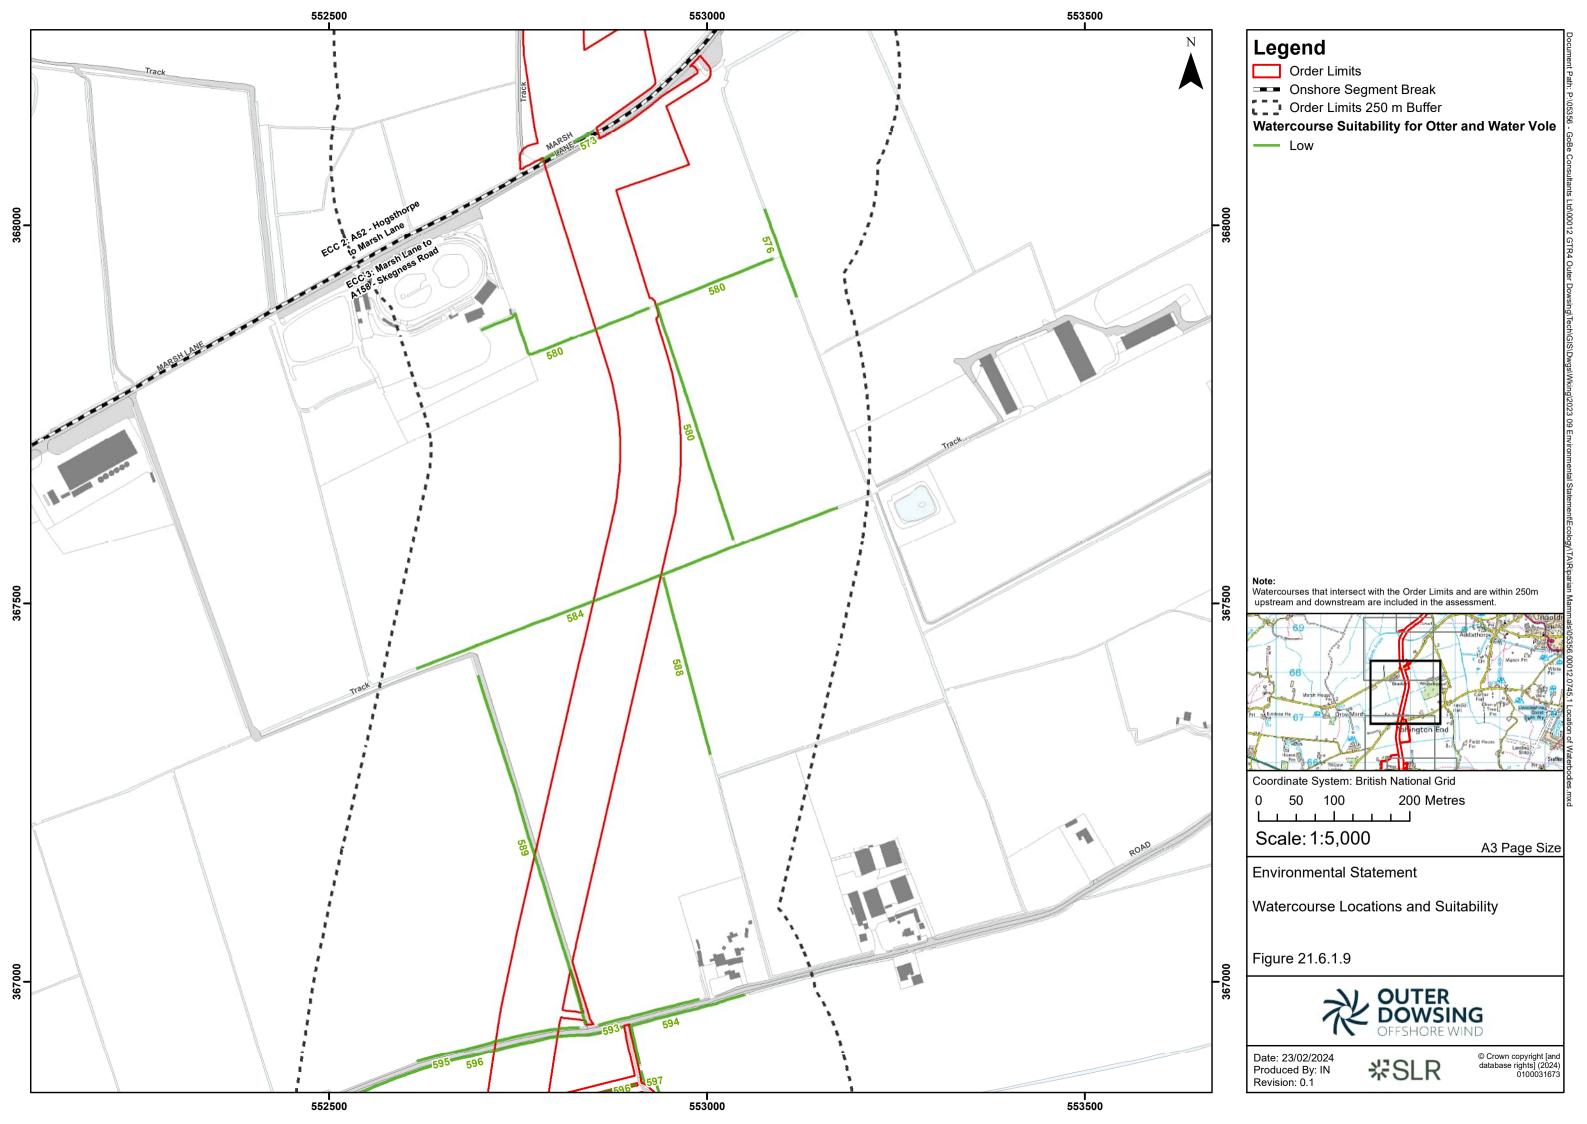
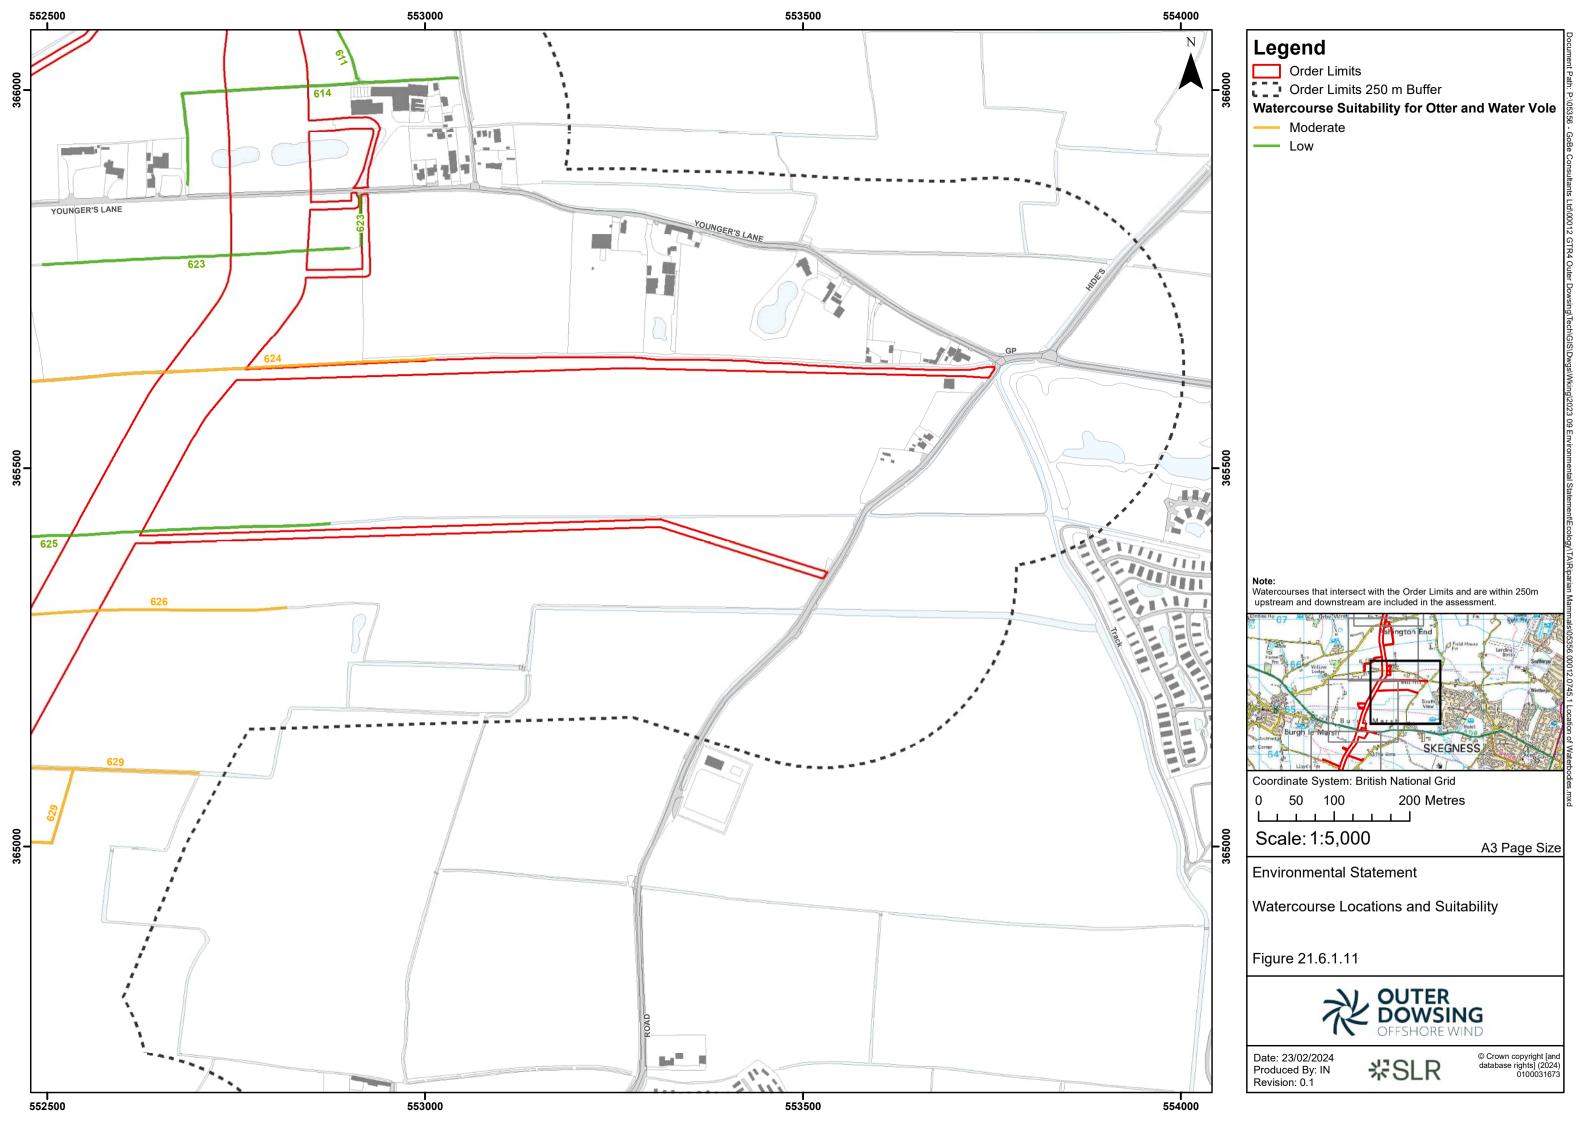
Figure 21.6.1: Watercourse Locations and Suitability

- 17. To quantify the habitats and aid data management, the riparian habitats were broken more easily into sections within the ECC and given a unique Water Course Identification (WCID) (shown in Figure 21.6.1). However, numbering is not continuous due to discovery of new waterbodies during the survey or removal of waterbodies following route changes made following numbering.
