Outer Dowsing Offshore Wind

Environmental Statement

Appendix 21.6 Riparian Mammal

Volume 3, Appendix 21.06: Riparian Mammal Surveys

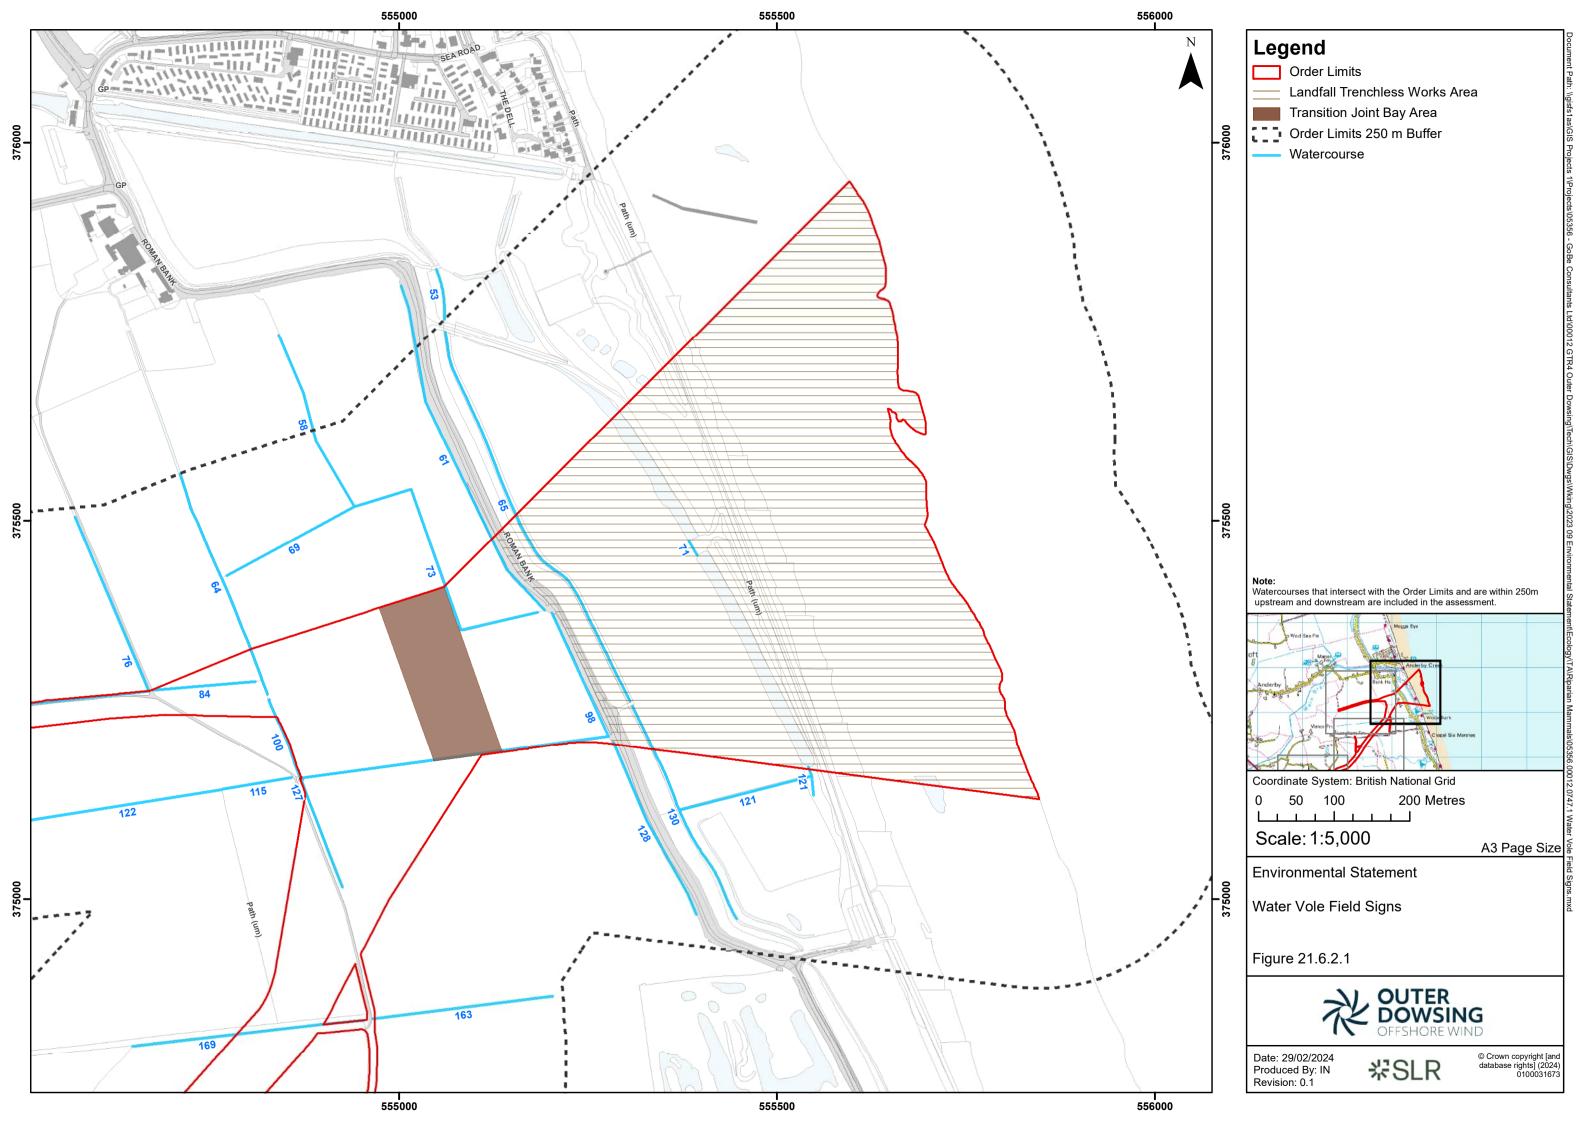
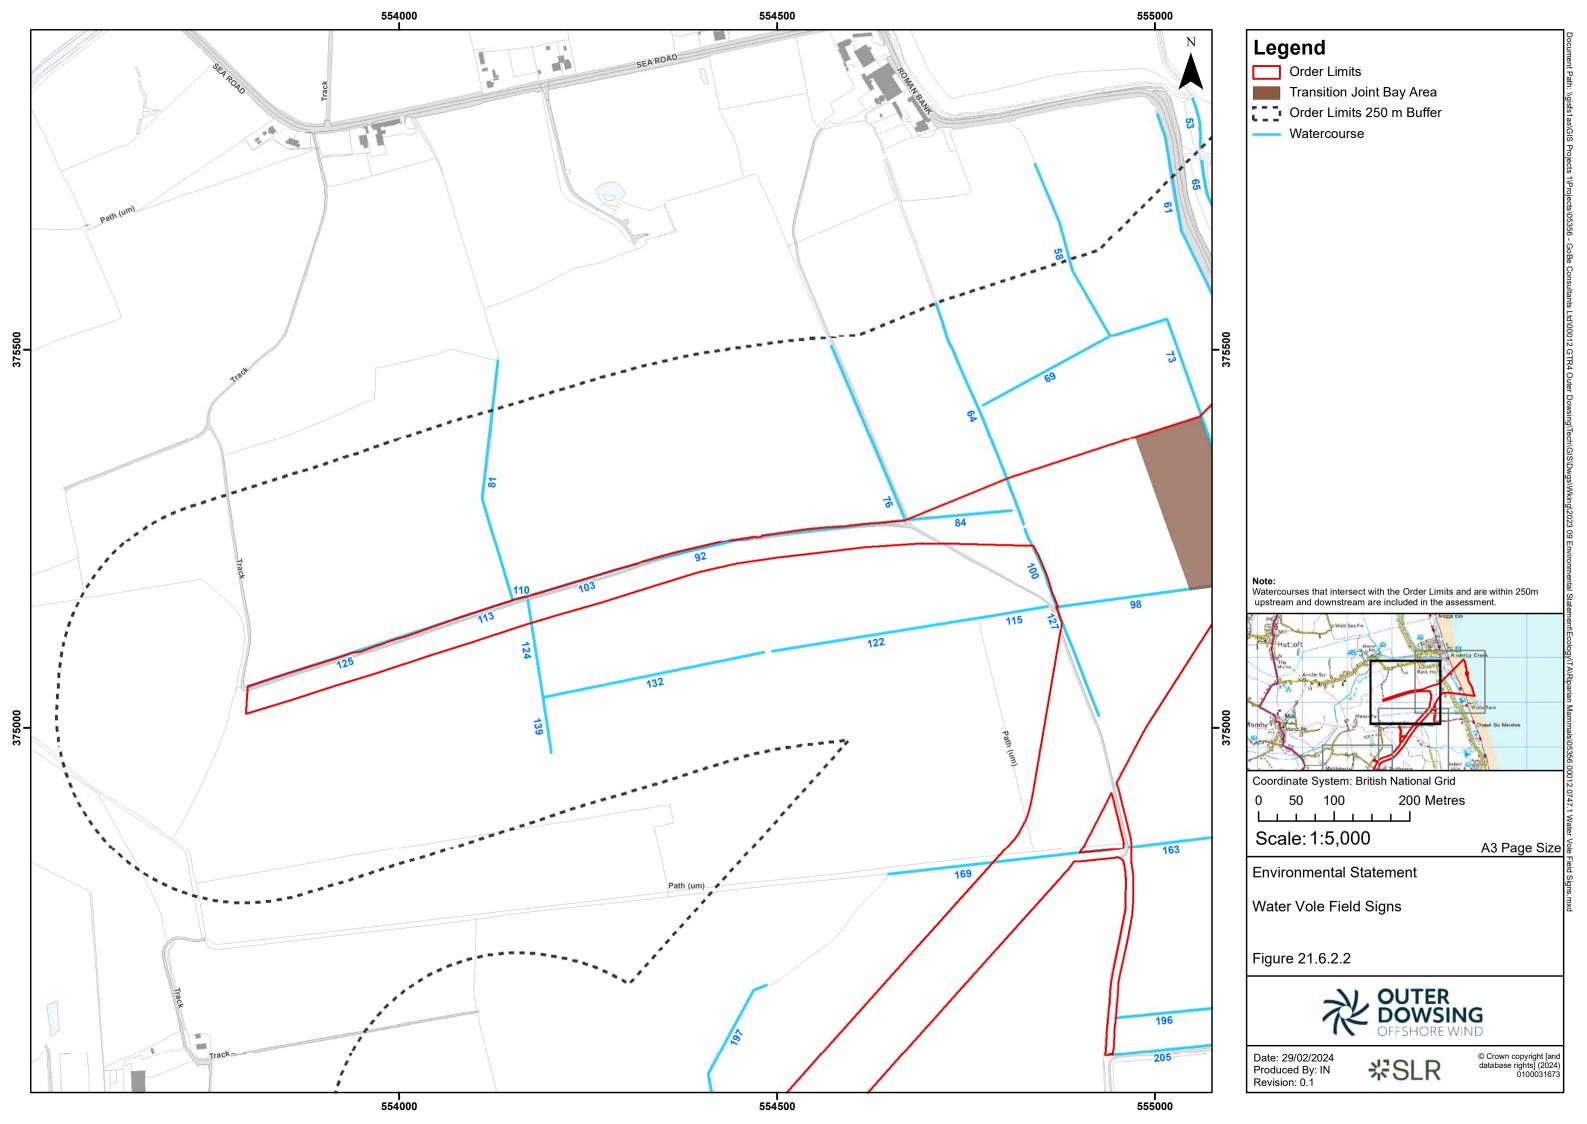
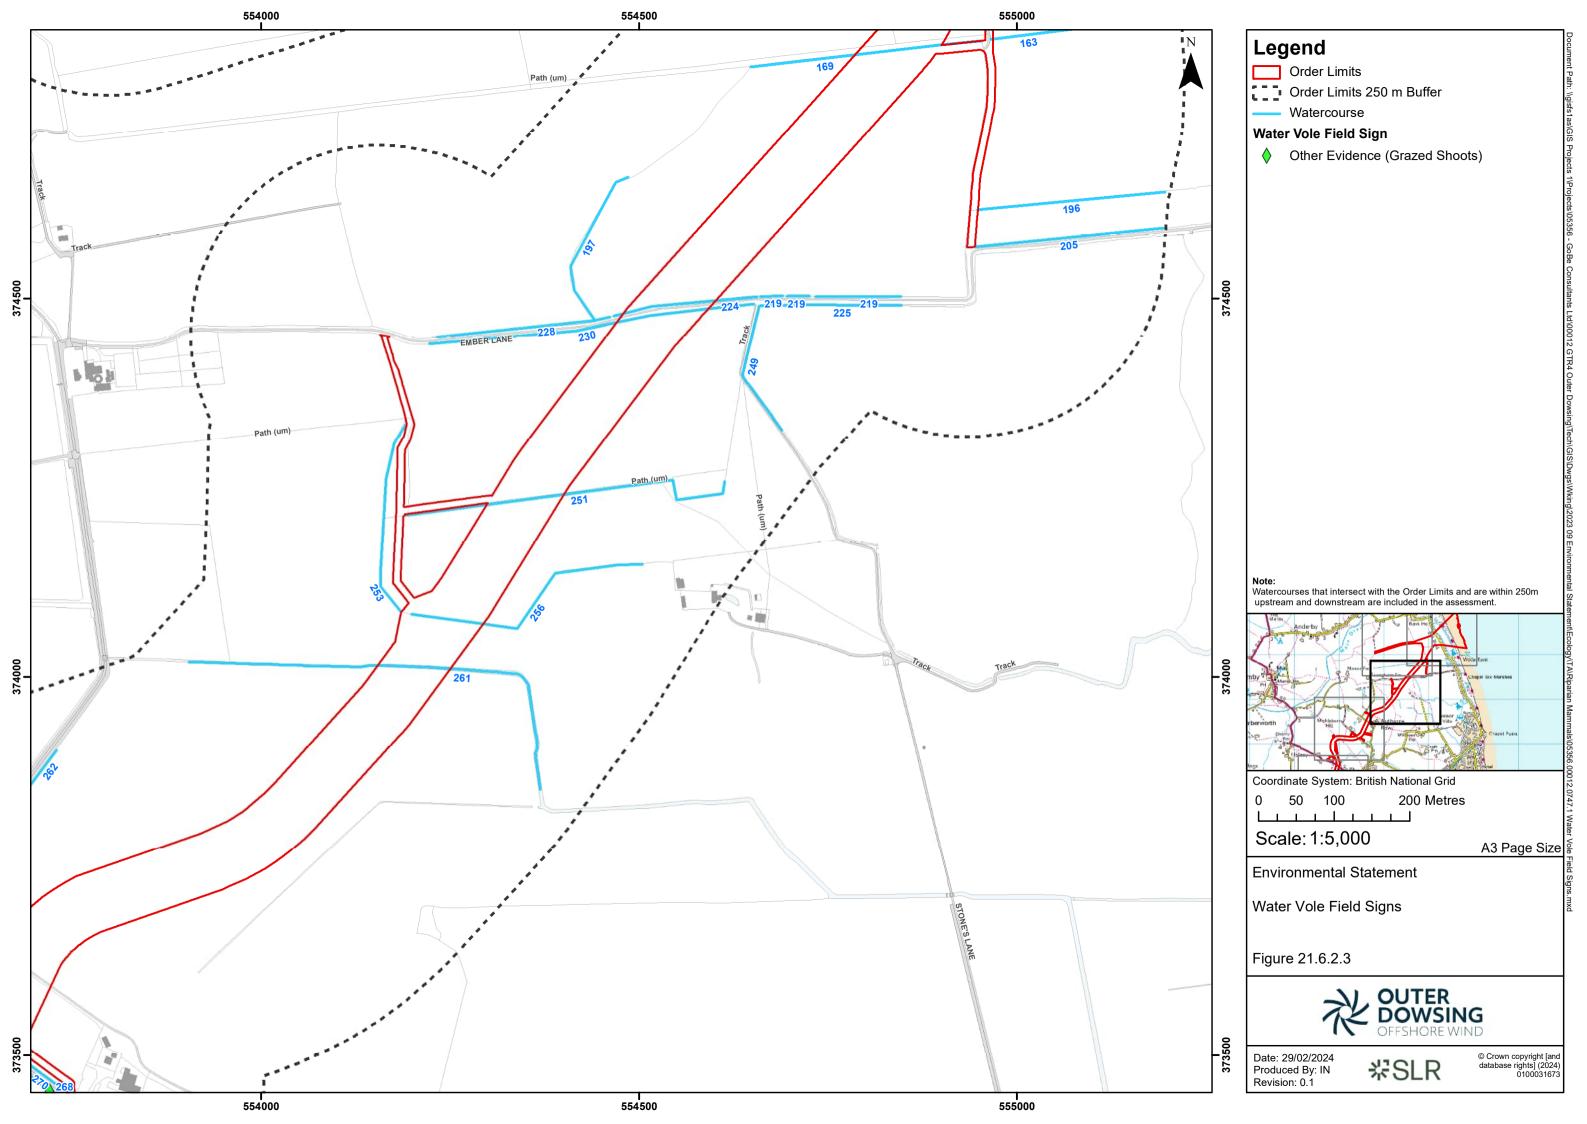
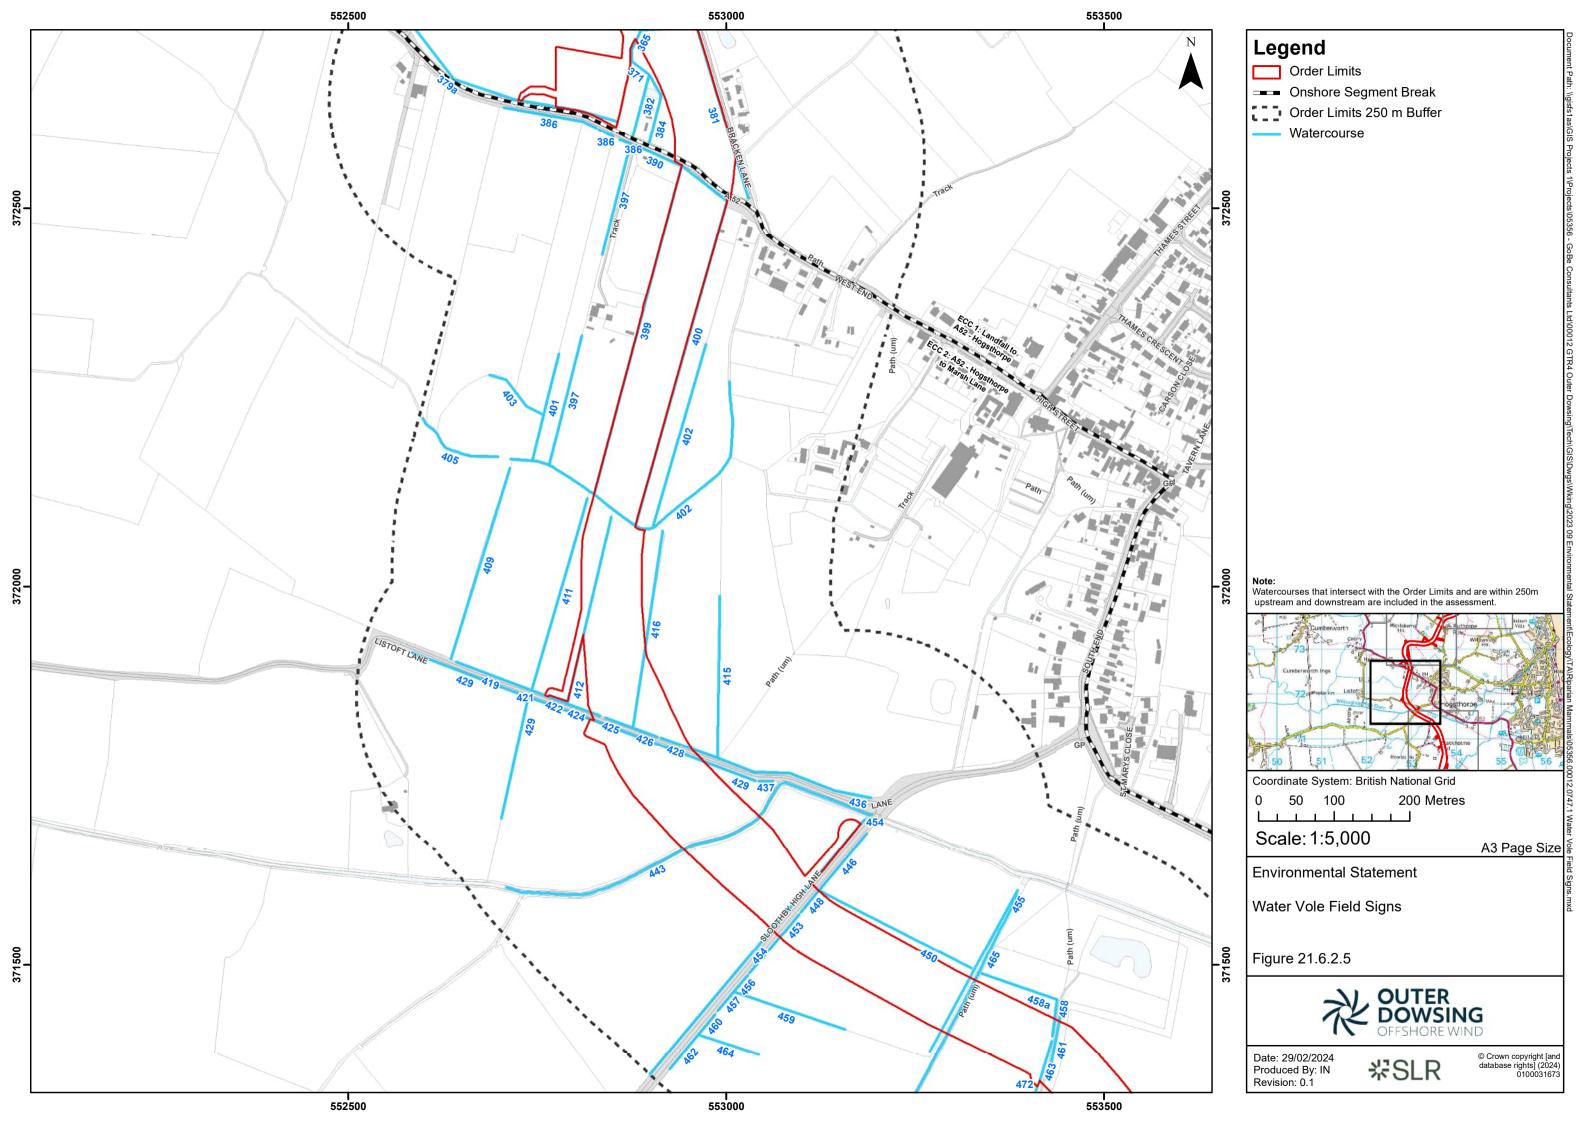
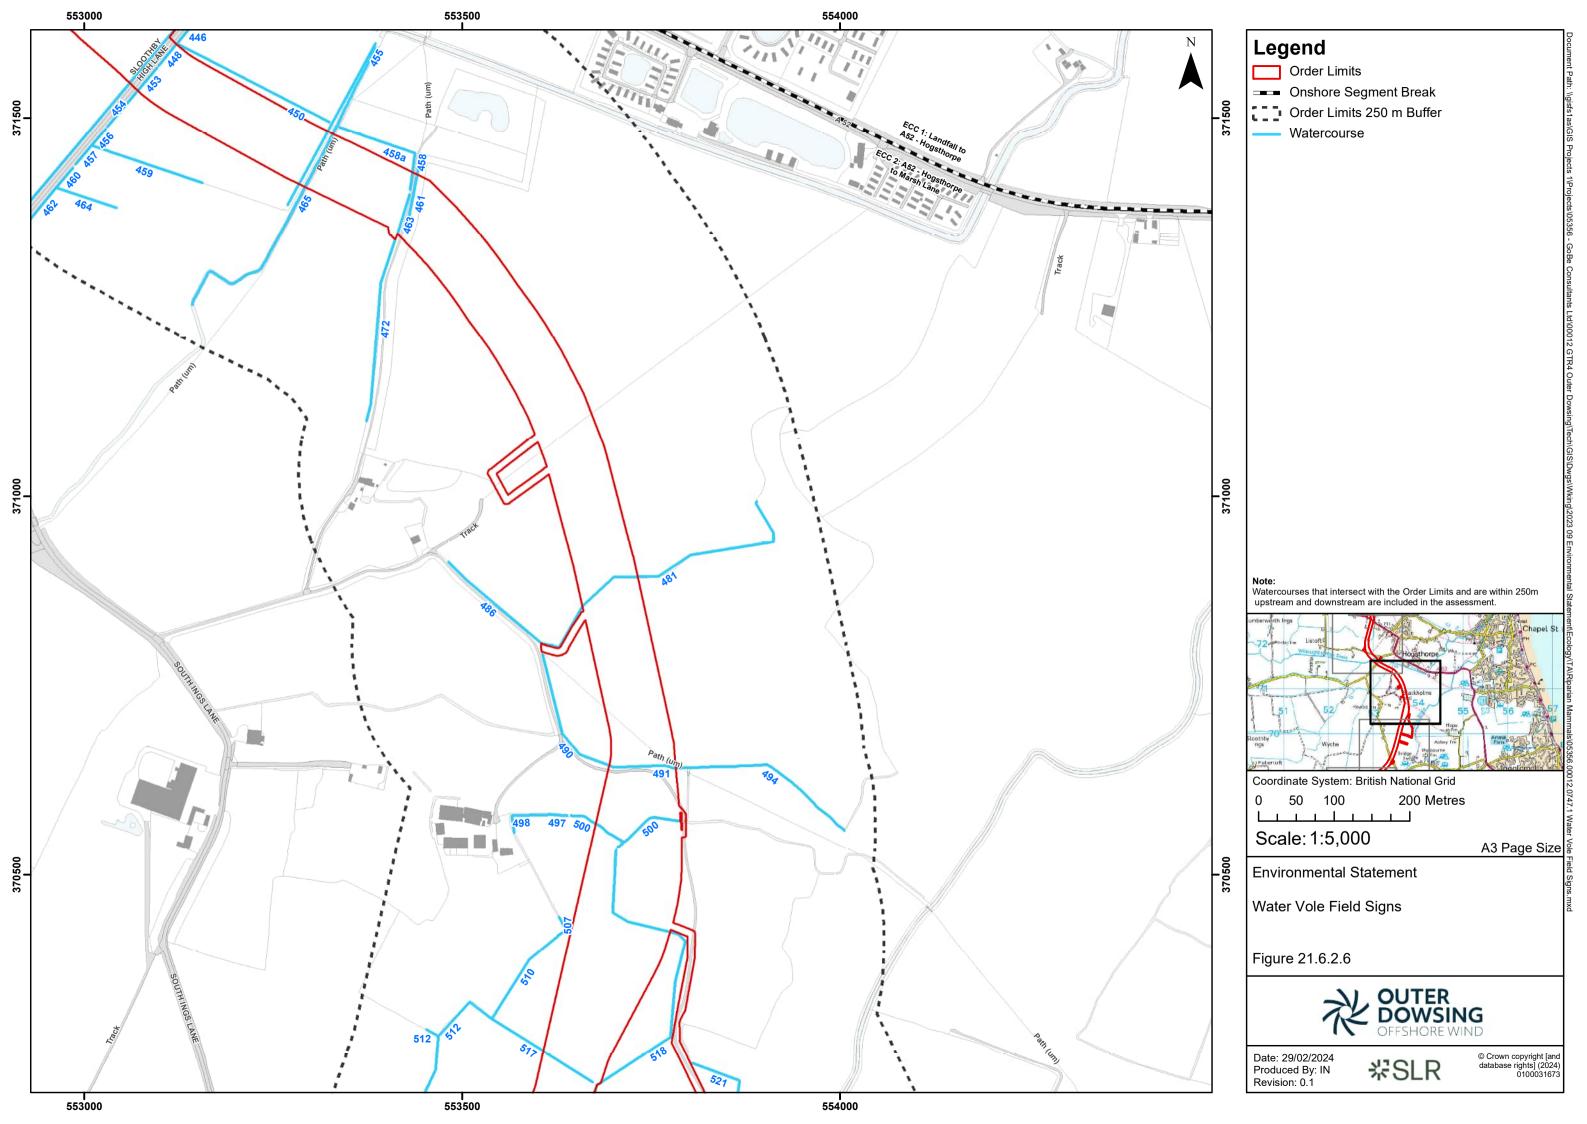
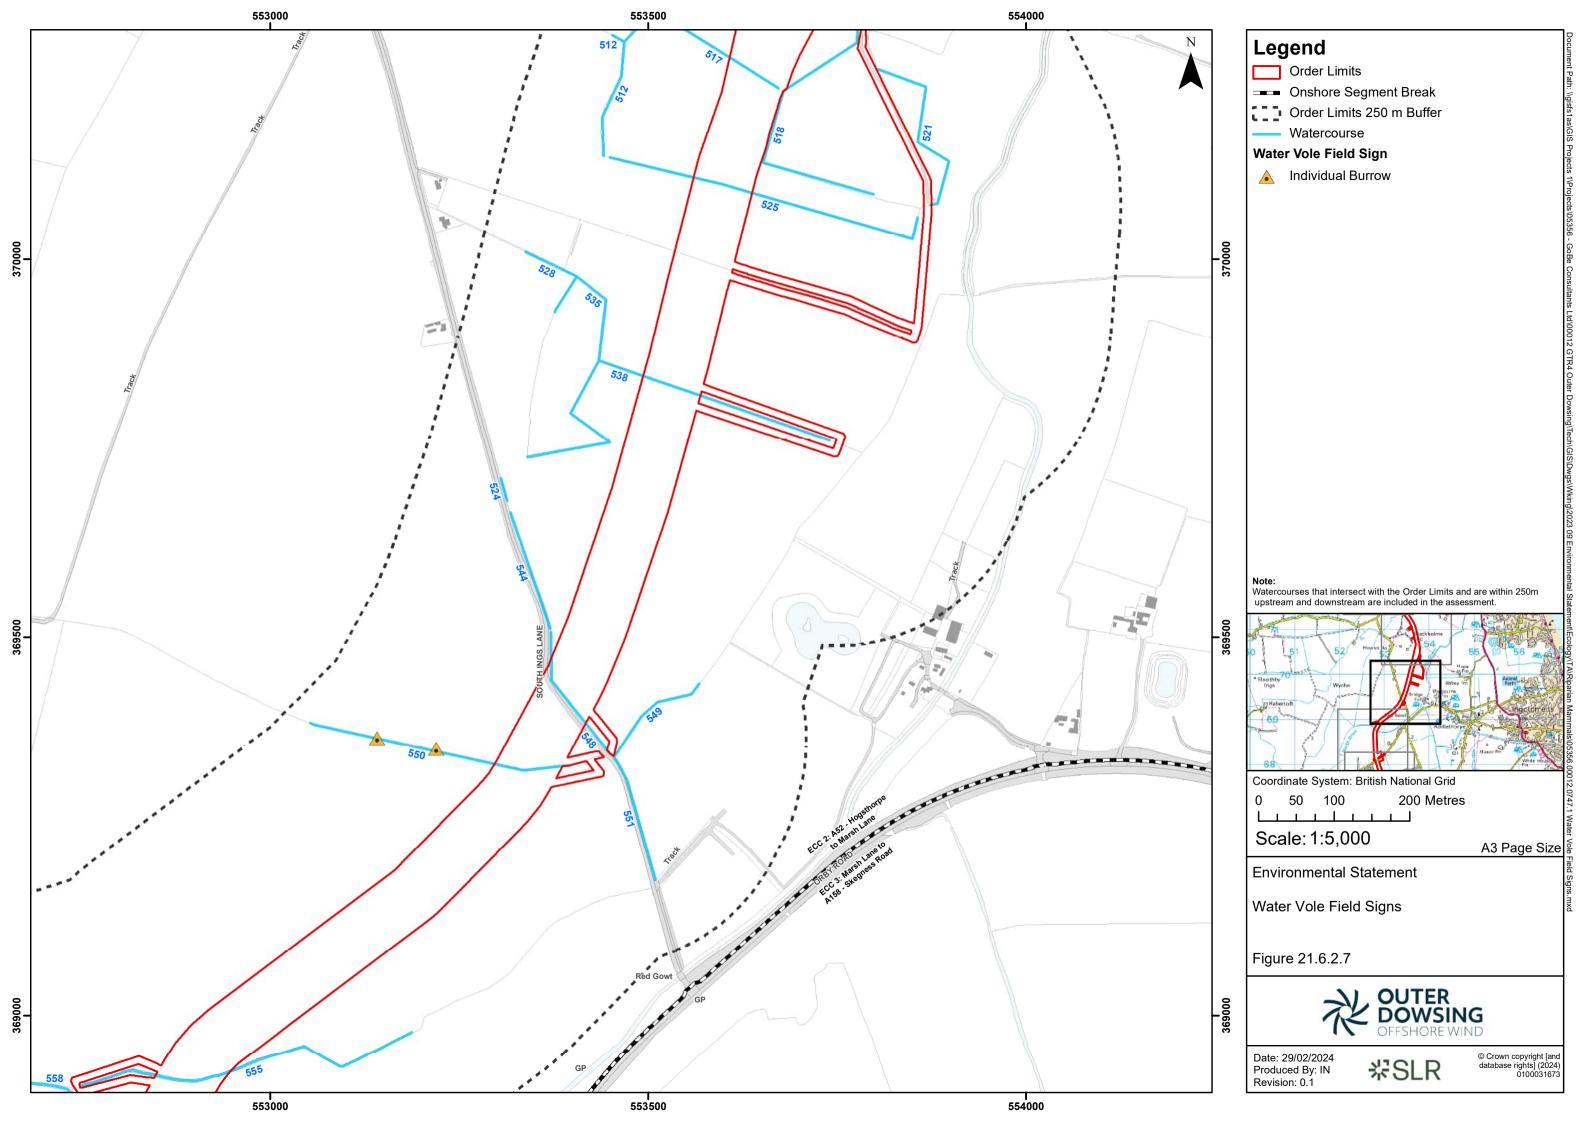
Figure 21.6.2: Water Vole Field Signs

57. Full details of water vole field signs recorded during the surveys are presented in Annex B, with their locations illustrated in Figure 21.6.2.
