Outer Dowsing Offshore Wind

Offshore Export Cable Corridor Sabellaria Spinulosa Reanalysis and Report

Document Number: 15.13

REPORT ID. 2024-130-002

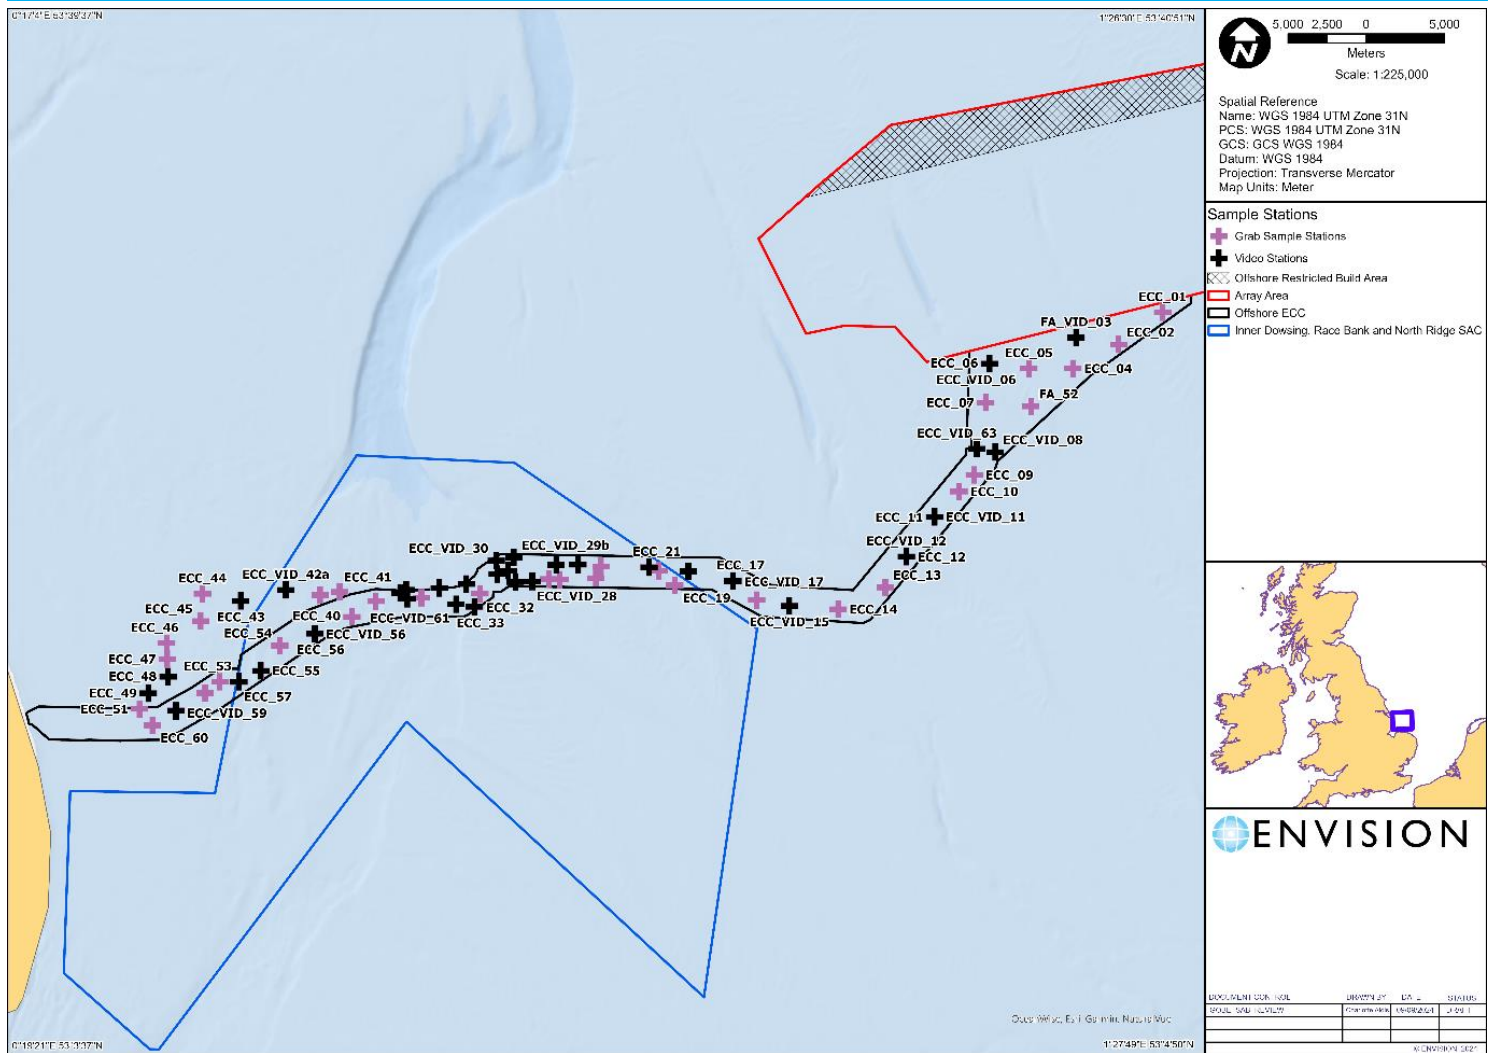
Figure 3.
Location of underwater imagery and benthic grab sample stations within the Project ECC.

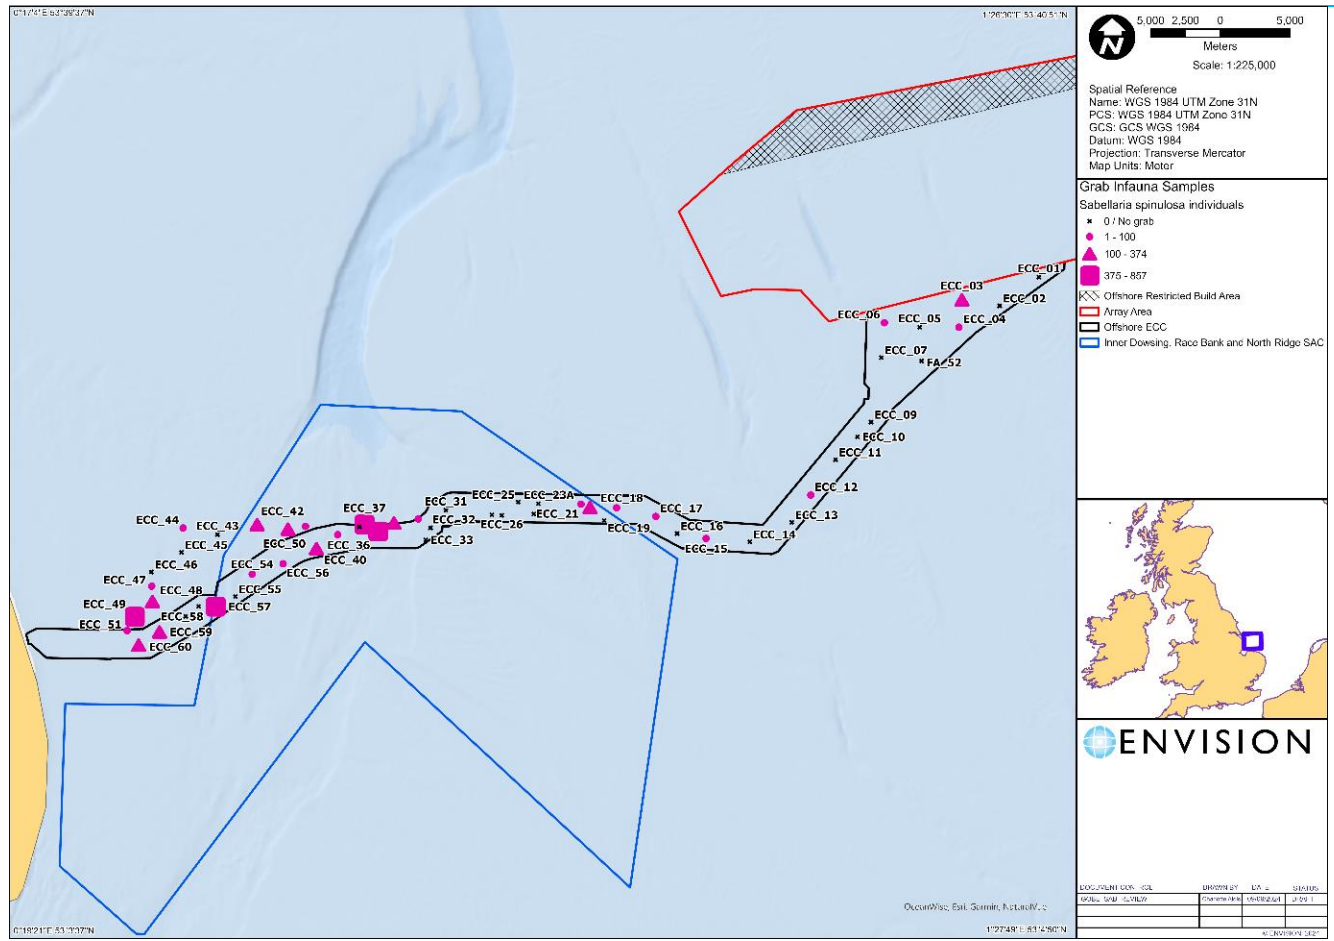
Benthic grab samples were collected from 59 stations throughout the Project ECC (Figure 4) and infaunal analysis results were reviewed. Out of the 59 grab stations, underwater imagery was collected at 28 stations.

Figure 4. Numbers of *Sabellaria spinulosa* individuals recorded from benthic grab samples across the Project ECC.

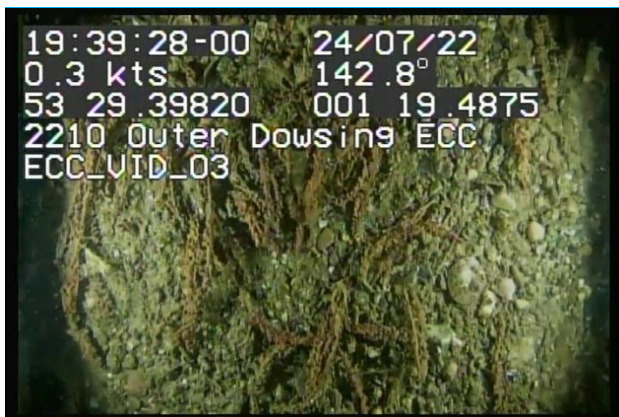
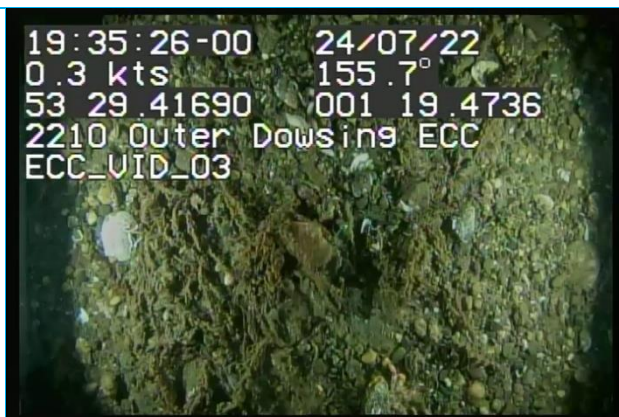
ECC_VID_03

STATION	SABELLARIA PRESENT	SABELLARIA ASSESSMENT	COMMENTS
ECC_03	YES	NO	No elevation, dead empty tubes, less than 1% of <i>Sabellaria</i> present in video, counts of <i>Sabellaria</i> from grab under 375 threshold (236).

Screen capture images and still imagery taken from video stations that recorded Sabellaria spinulosa as present in small amounts (<1m² patches) and were not assigned for further reef assessment.

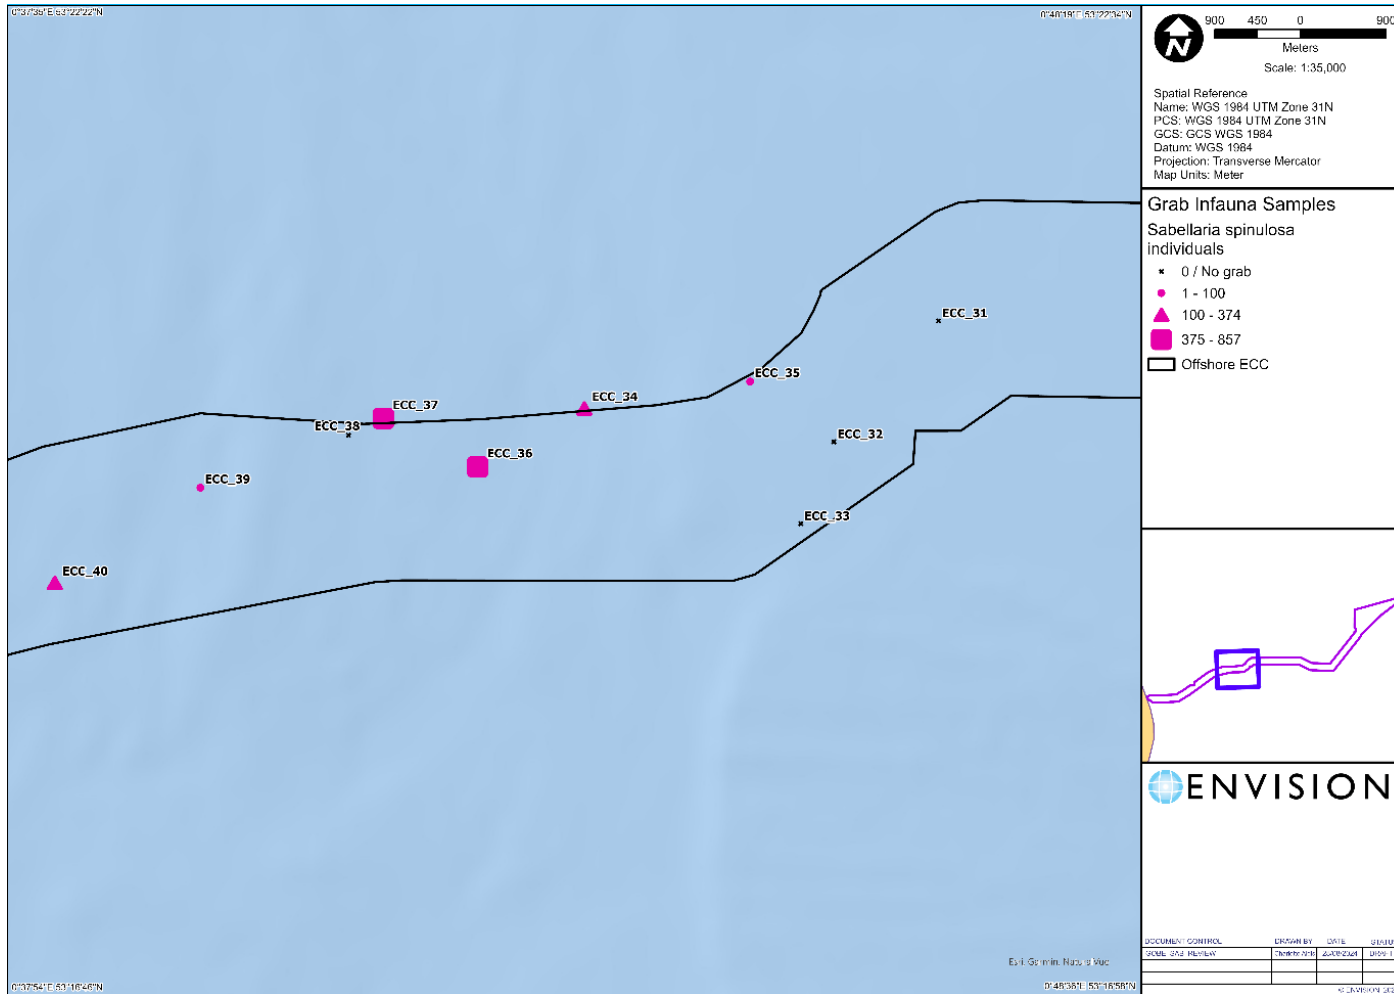
Out of the 59 benthic grab stations, 32 stations did not include underwater imagery sampling, with 12 of these stations recording *S. spinulosa* presence through infaunal analysis. Numbers of individuals of *S. spinulosa* ranged from 18 to 857 (Table 7). One station, ECC_36, had counts over the 375 individuals threshold (Limpenny *et al.*, 2010ⁱⁱⁱ) (Figure 5).

Figure 5.
 Location of station ECC_36, which recorded 857 individuals of Sabellaria spinulosa in the benthic grab sample.

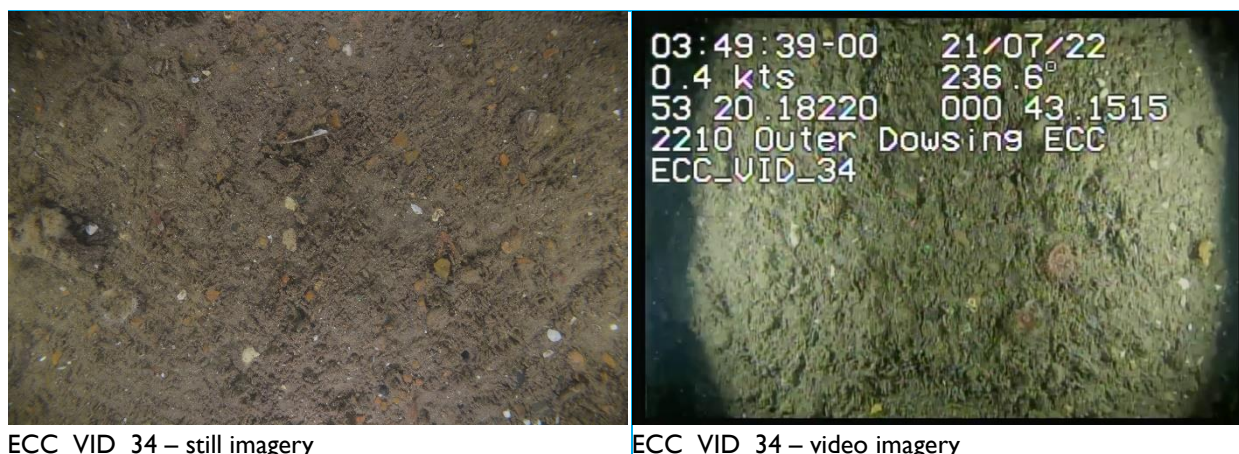
One station, ECC_VID_34, was only sampled with the SD camera system, which resulted in lower quality imagery for analysis. For this station it was not possible to confidently identify the presence and absence of *S. spinulosa* through the video imagery. Therefore, the still images captured at this station were used to review the presence or absence of *S. spinulosa* and subsequently used for full 'reefiness' assessment. Example imagery from this station is shown in Table 8.

Still imagery and screen capture image taken from video station ECC_VID_34.

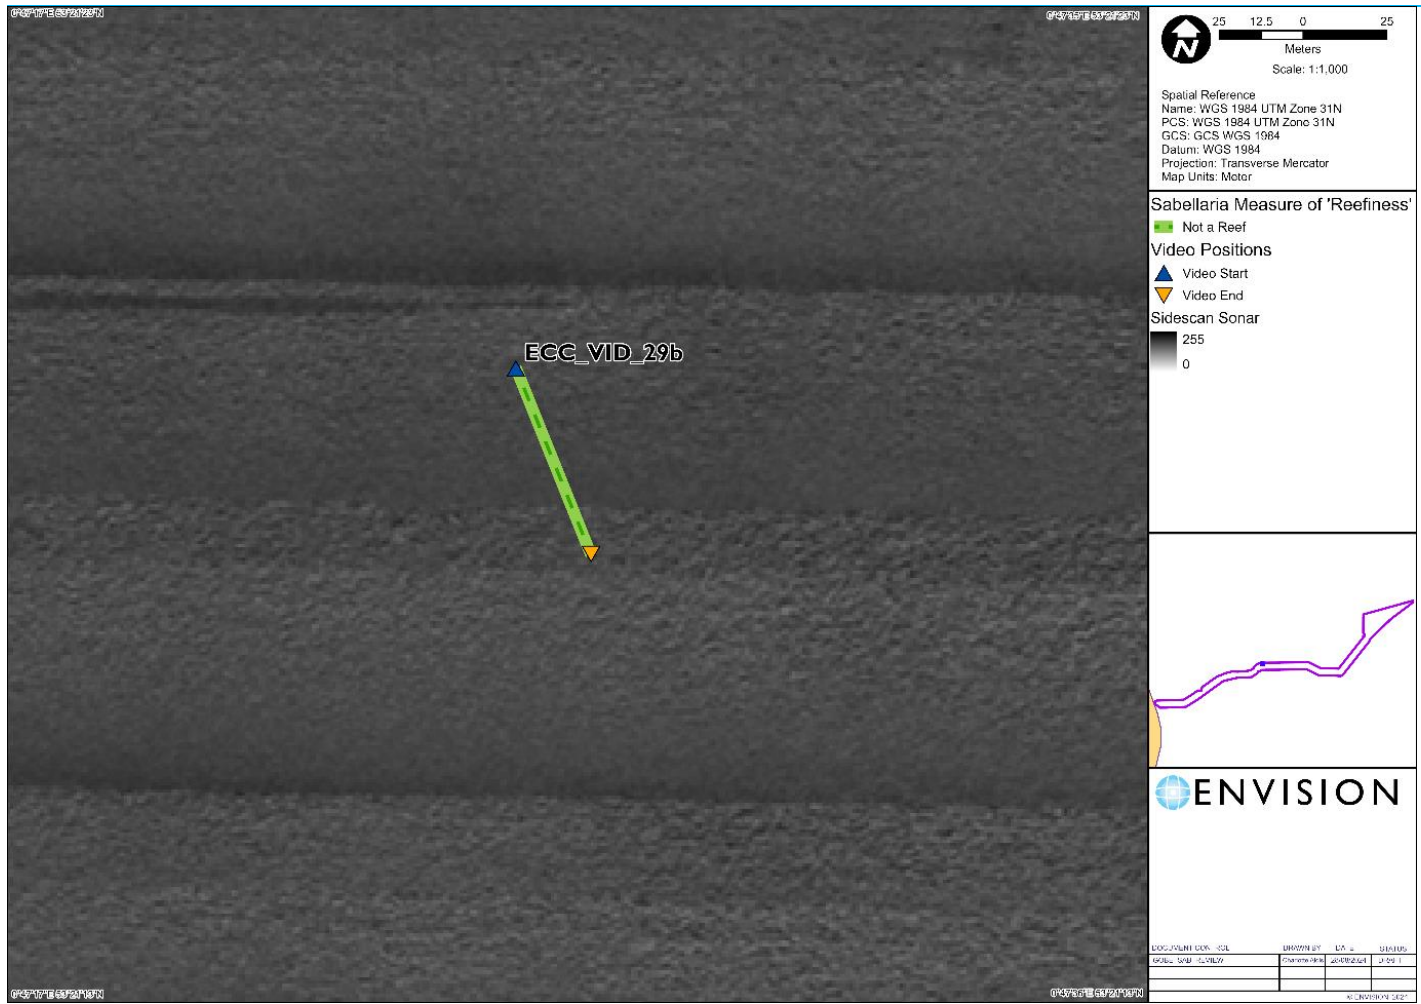
Video station ECC_VID_29b has been assessed as 'NOT a REEF' (Figure 6).

From the video footage the station was allocated 2-5 cm elevation and area between 25-10,000 m² which are both categorised as 'LOW' reef. However, the patchiness (% cover) of the *S. spinulosa* within the video was below 10%, which is categorised as 'NOT a REEF'. These are shown in Table 10.

The seabed around the video sample is relatively homogenous from the sidescan sonar data (Figure 6) with an indication of variable ground but no distinct reef features are evident.

Figure 6. 'Reefiness' allocated to ECC_VID_29b, from Sabellaria spinulosa reef assessment (Gubbay, 2007^{iv}).

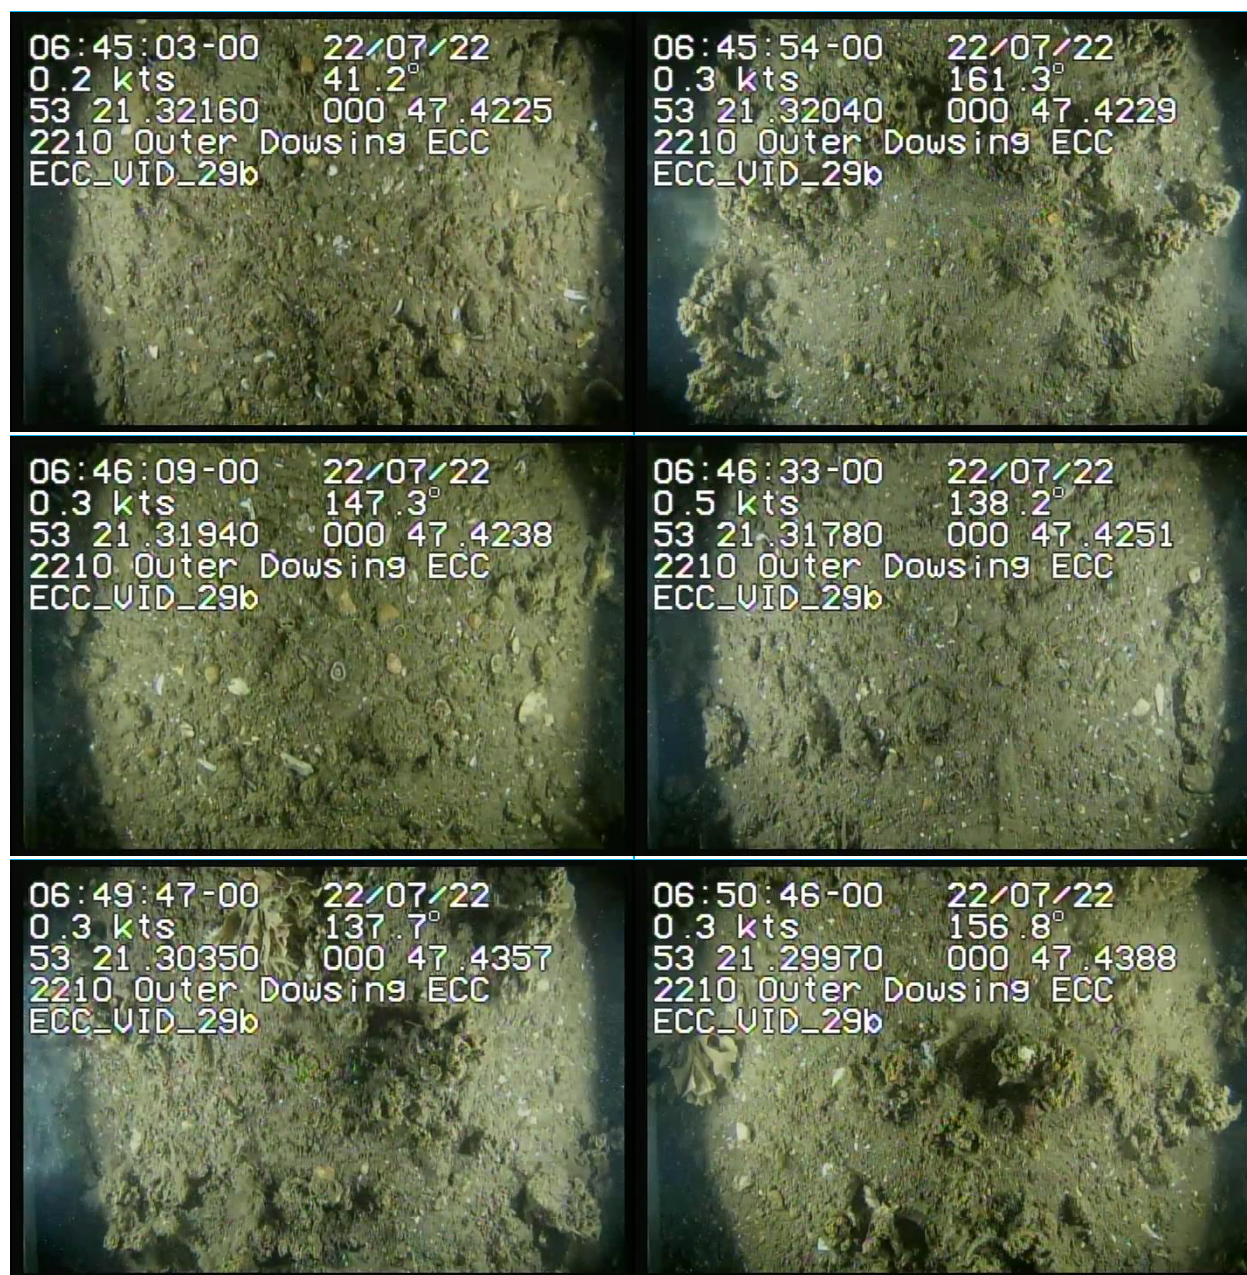
Table II.

Screen capture images taken from ECC_VID_29b, showing examples of the level of Sabellaria spinulosa present throughout video footage.

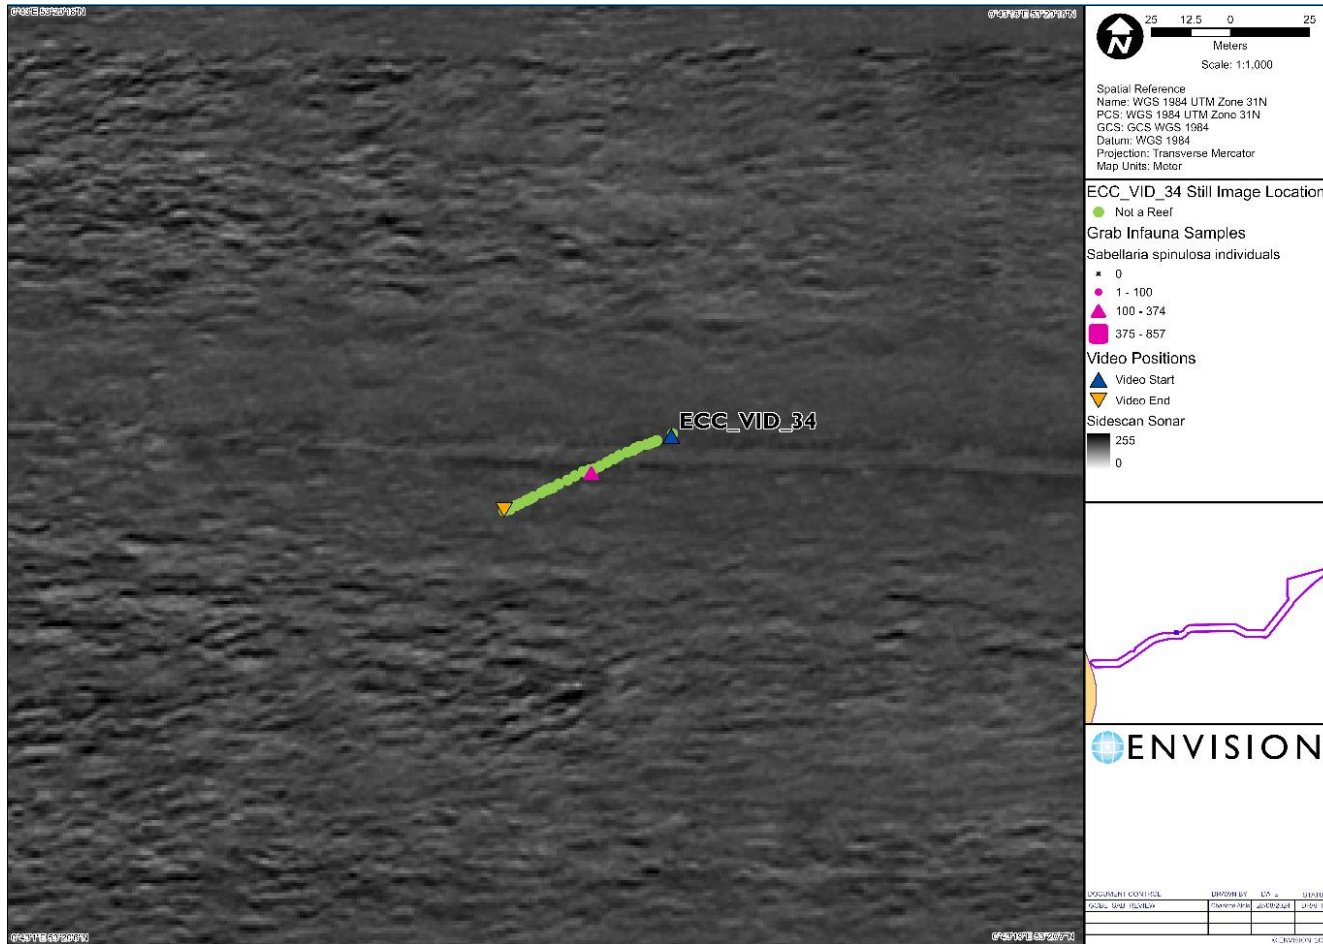
Figure 7.

Station ECC_VID_34 was assessed as 'NOT a REEF' (Figure 7).

Due to the poor quality of the video footage at this station, still images were individually assessed. A total of 42 stills were analysed, with all assessed as <25 m² for area, which is categorised as 'NOT a REEF'. Six still images were assessed as 10-20 patchiness (% cover), which is 'LOW' reef, with the remaining 36 images assessed as <10%, categorised as 'NOT a REEF'. For elevation, 13 images were assessed as 2-5 cm which is 'LOW' reef, with the remaining 29 images assessed as <2 cm, categorised as 'NOT a REEF'. All still images were assessed as 'NOT a REEF' (Table 12), with a summary shown in Table 13 and full results presented in Appendix 5.3: ECC_VID_34 Still Image *Sabellaria spinulosa* Reef Assessment Results.

Numbers of individuals of *S. spinulosa* from the benthic grab sample collected at this station were 147, which is below the 375 threshold (Limpenny *et al.*, 2010ⁱⁱⁱ).

'Reefiness' allocated to still images collected at ECC_VID_34, from Sabellaria spinulosa reef assessment (Gubbay, 2007^{iv}).

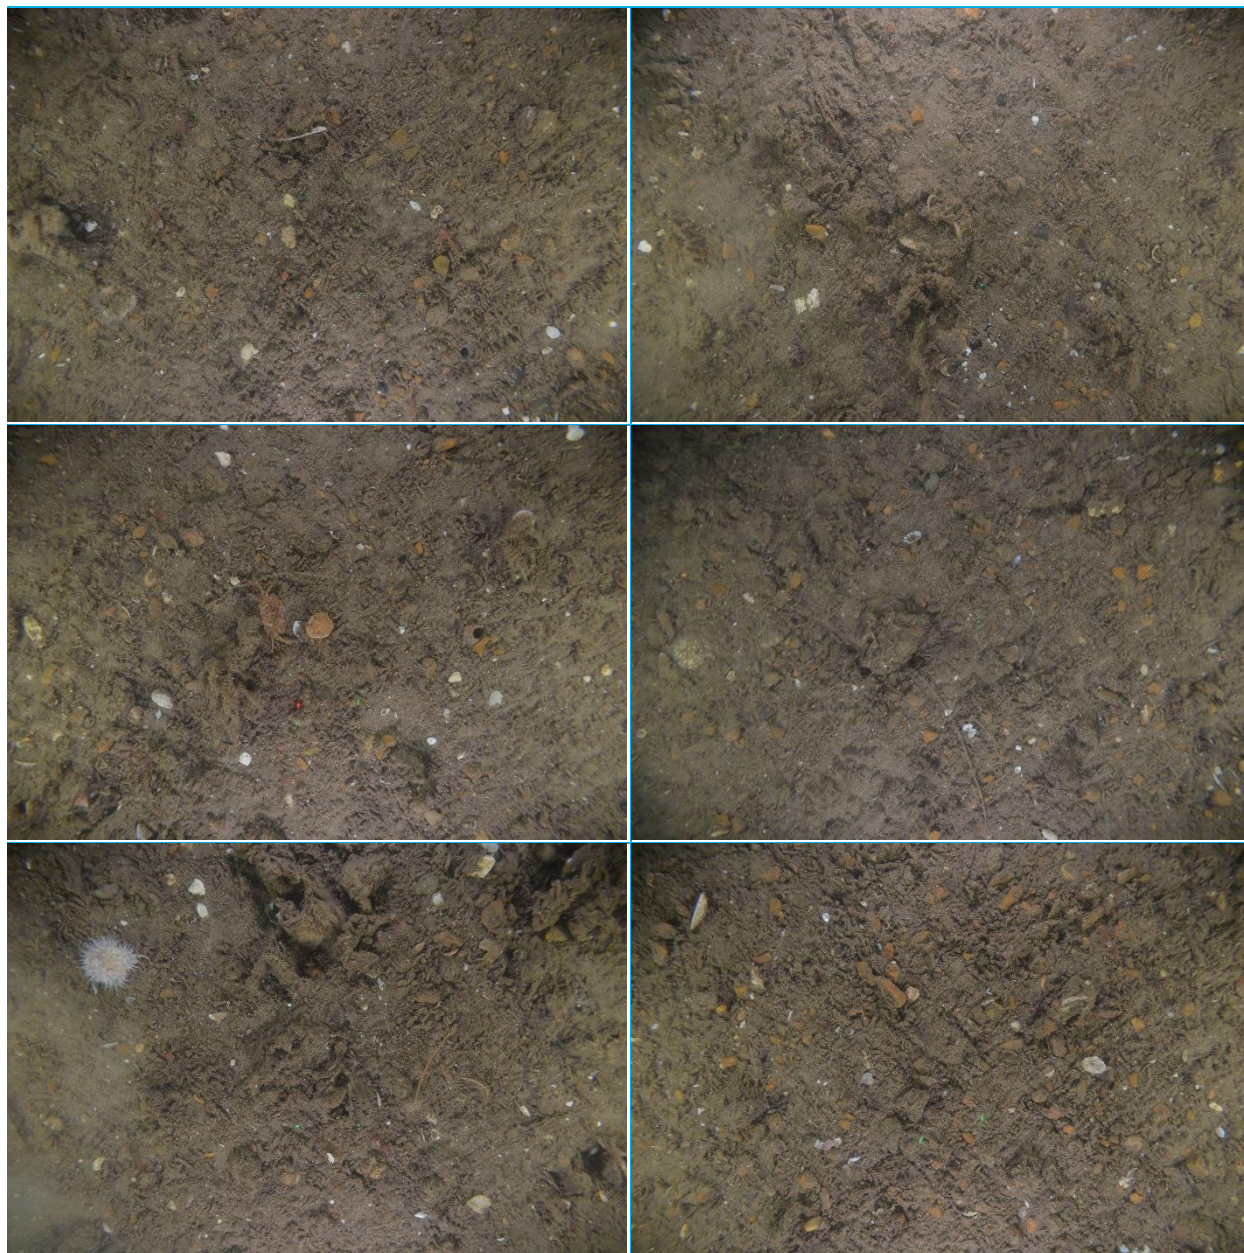
Table I4.

Still images captured at ECC_VID_34, showing examples of the level of Sabellaria spinulosa present.

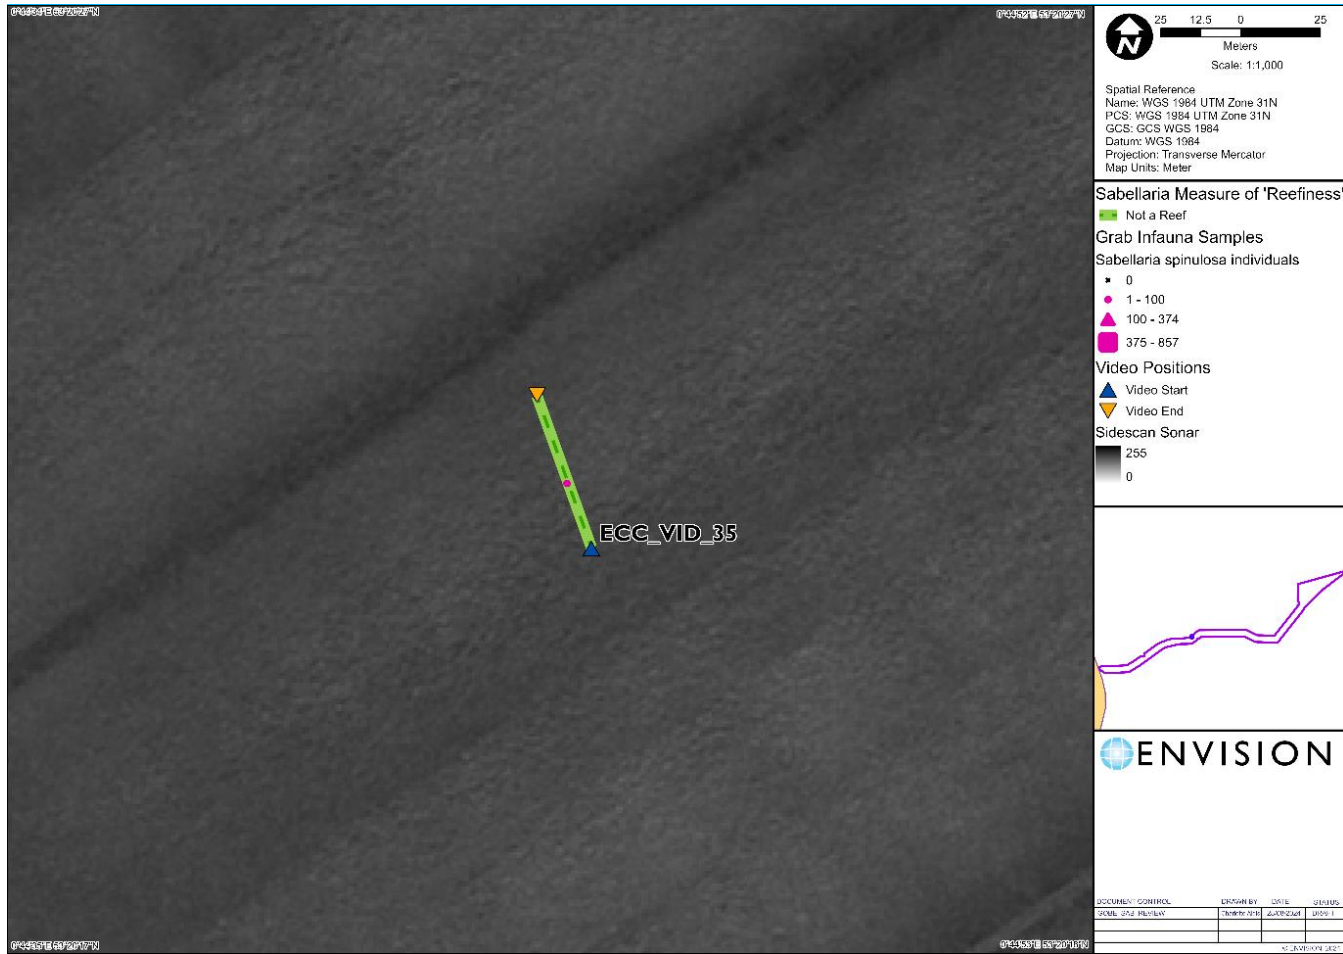
Video station ECC_VID_35 was assessed as 'NOT a REEF' (Figure 8).

Numbers of individuals of *S. spinulosa* from the benthic grab sample collected at this station was 96, which is below the 375 threshold (Limpenny *et al.*, 2010ⁱⁱⁱ).

Figure 8. 'Reefiness' allocated to ECC_VID_35, from Sabellaria spinulosa reef assessment (Gubbay, 2007^{iv}).

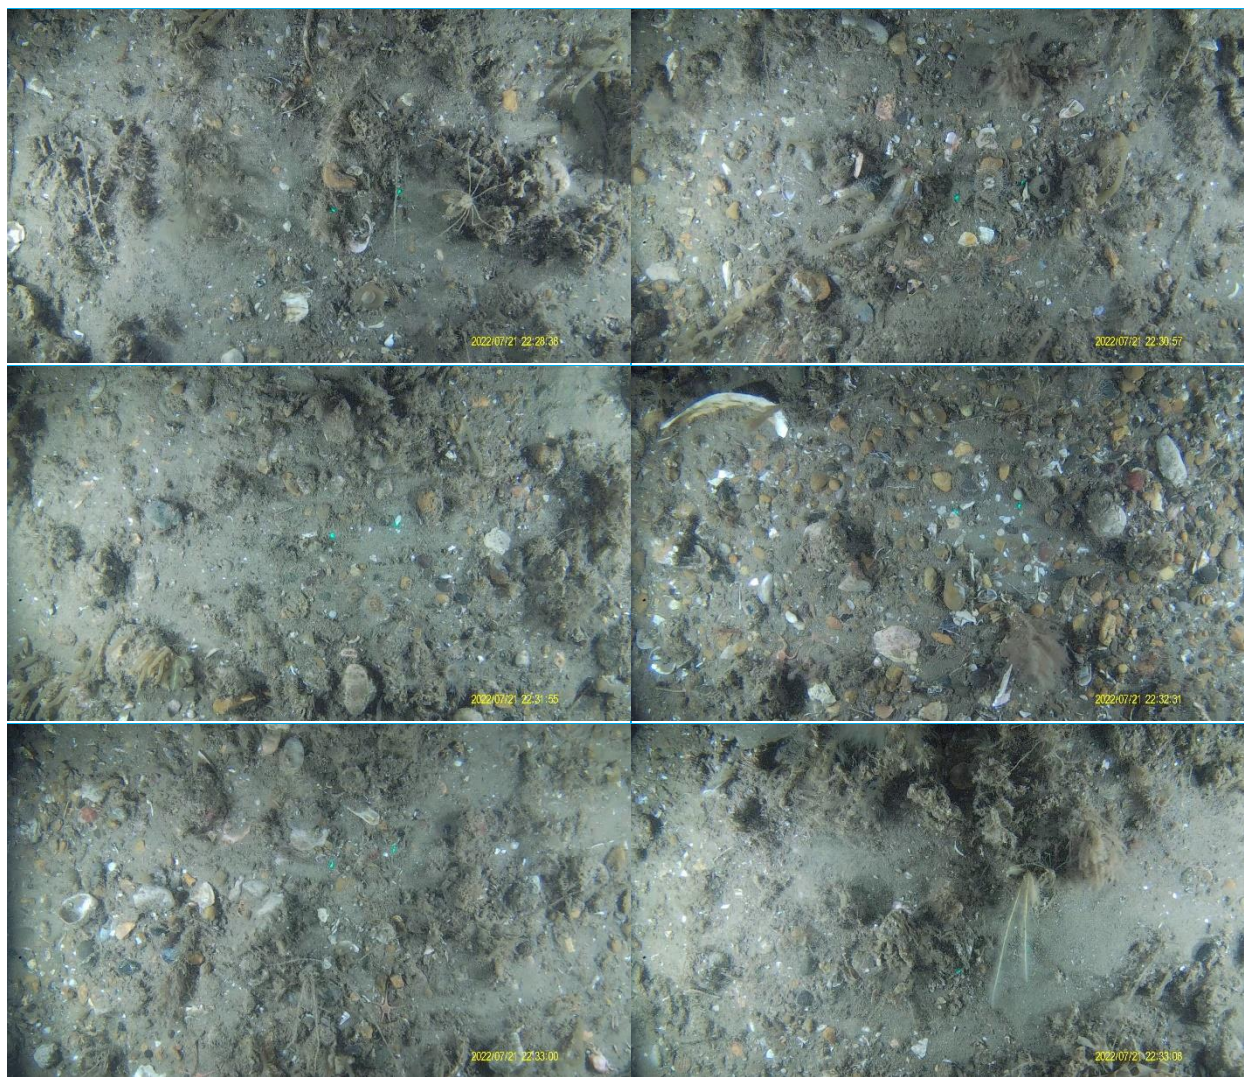
Table 16.

Screen capture images taken from ECC_VID_35, showing examples of the level of Sabellaria spinulosa present throughout video footage.

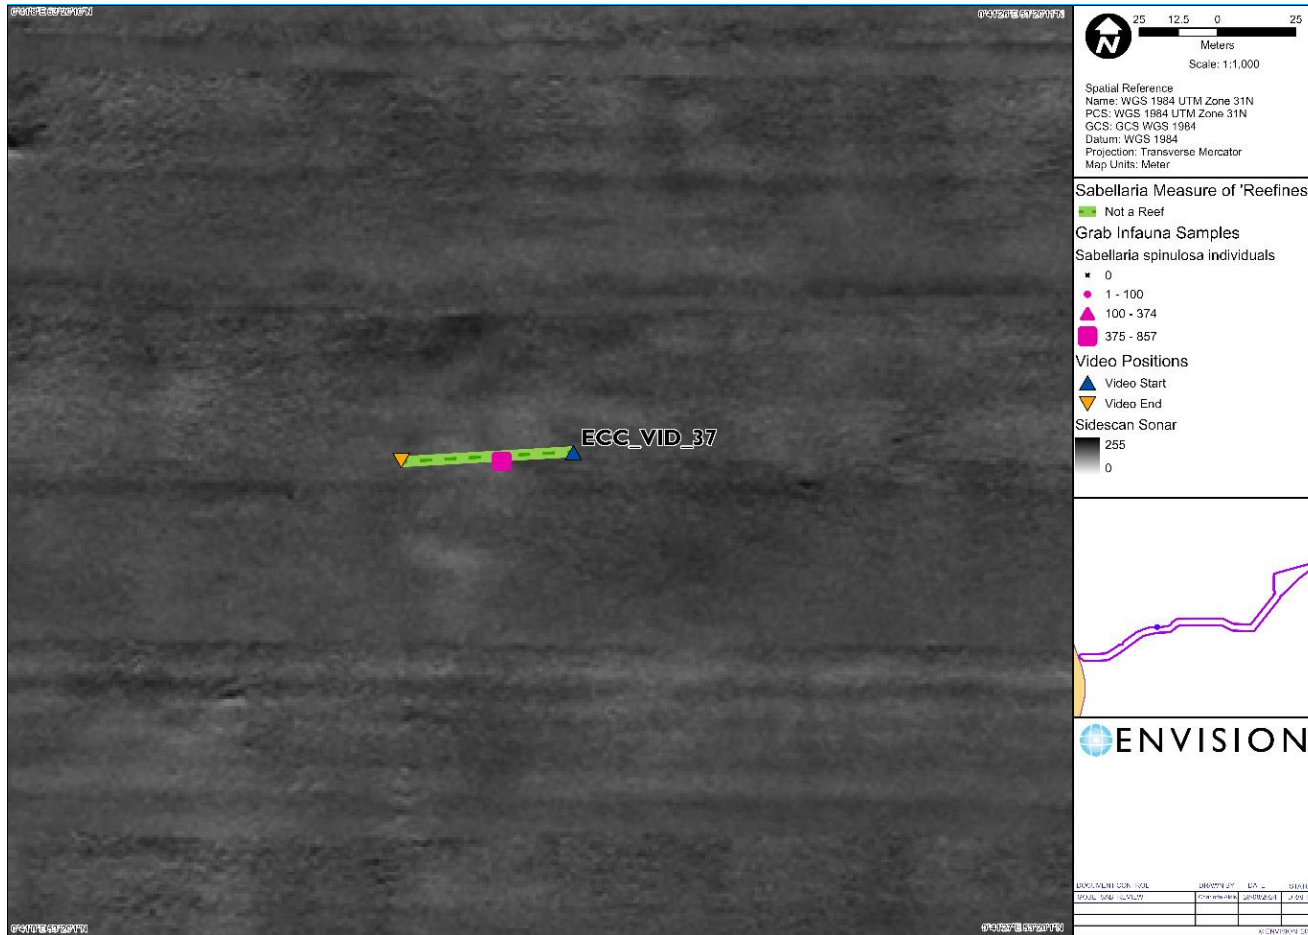
Video station ECC_VID_37 was assessed as 'NOT a REEF' (Figure 9).

Numbers of individuals of *S. spinulosa* from the benthic grab sample collected at this station was 493, which is above the density of individuals for reef as detailed by Limpenny *et al.*, (2010ⁱⁱⁱ). However, underwater imagery and data from sidescan sonar confirm this station is 'NOT a REEF'.

Figure 9.
 'Reefiness' allocated to ECC_VID_37, from Sabellaria spinulosa reef assessment (Gubbay, 2007^{iv}).

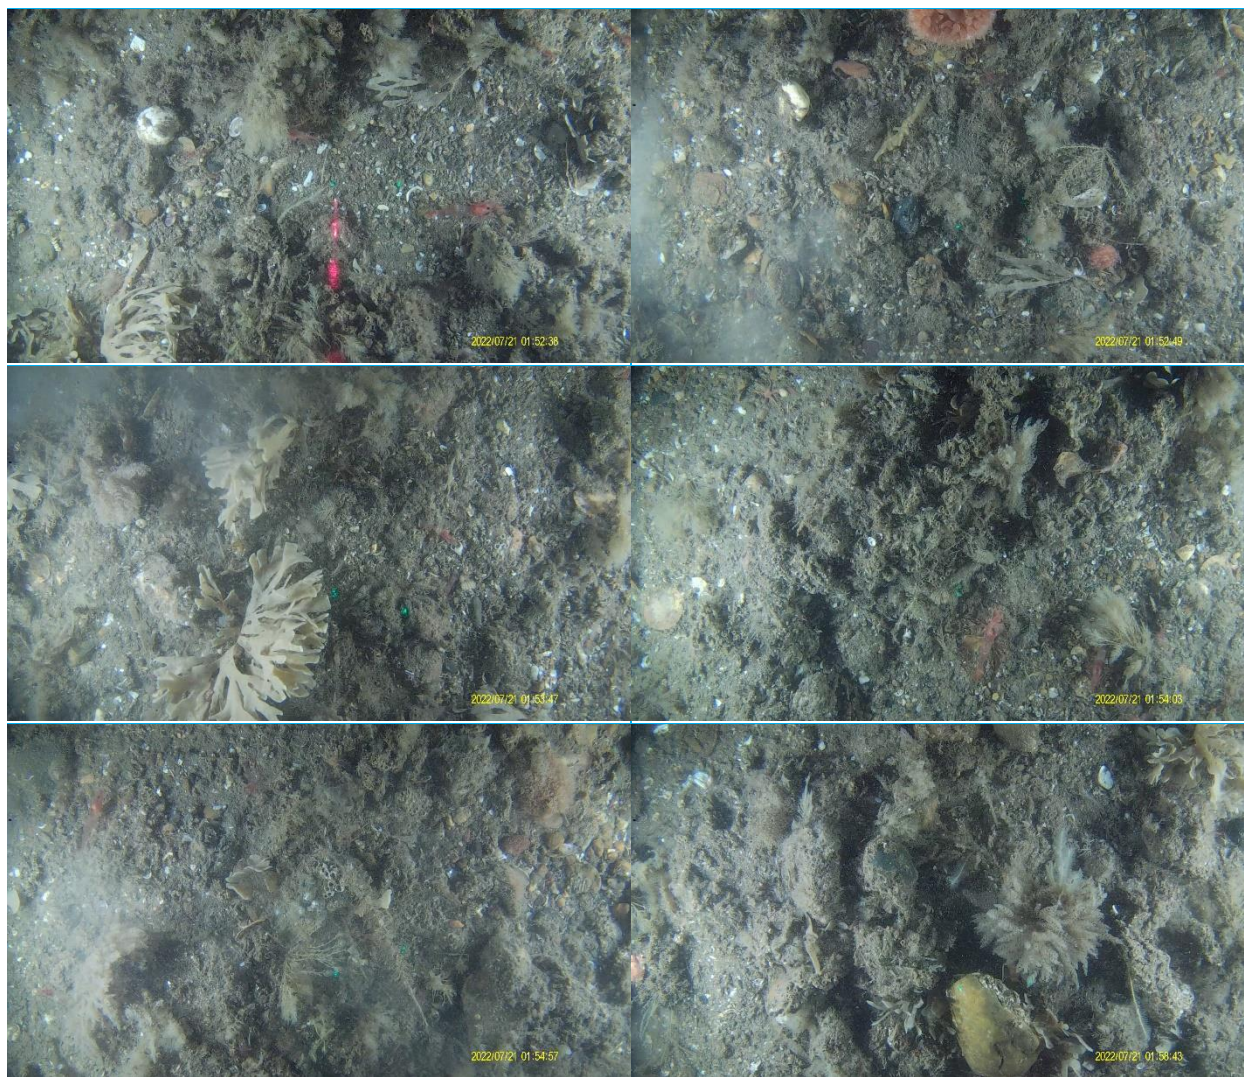
Table 18.

Screen capture images taken from ECC_VID_37, showing examples of the level of Sabellaria spinulosa present throughout video footage.

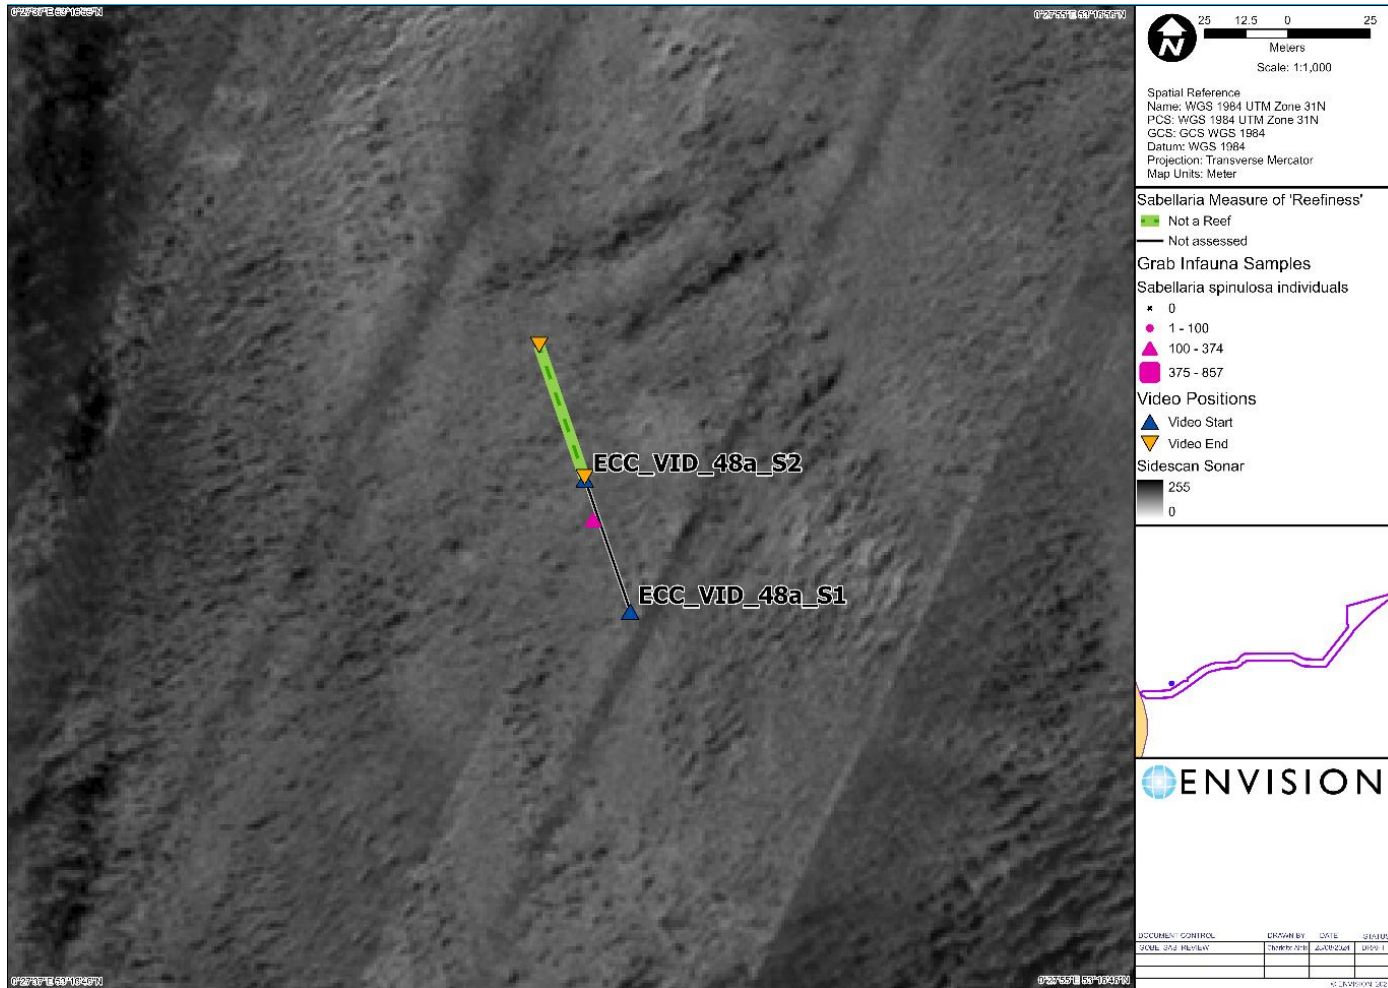
Video station ECC_VID_48a was assessed as 'NOT a REEF' (Figure 10).

Numbers of individuals of *S. spinulosa* from the benthic grab sample collected at this station was 191, which is below the 375 threshold (Limpenny *et al.*, 2010ⁱⁱⁱ).

Figure 10. 'Reefiness' allocated to ECC VID_48a, from Sabellaria spinulosa reef assessment (Gubbay, 2007").

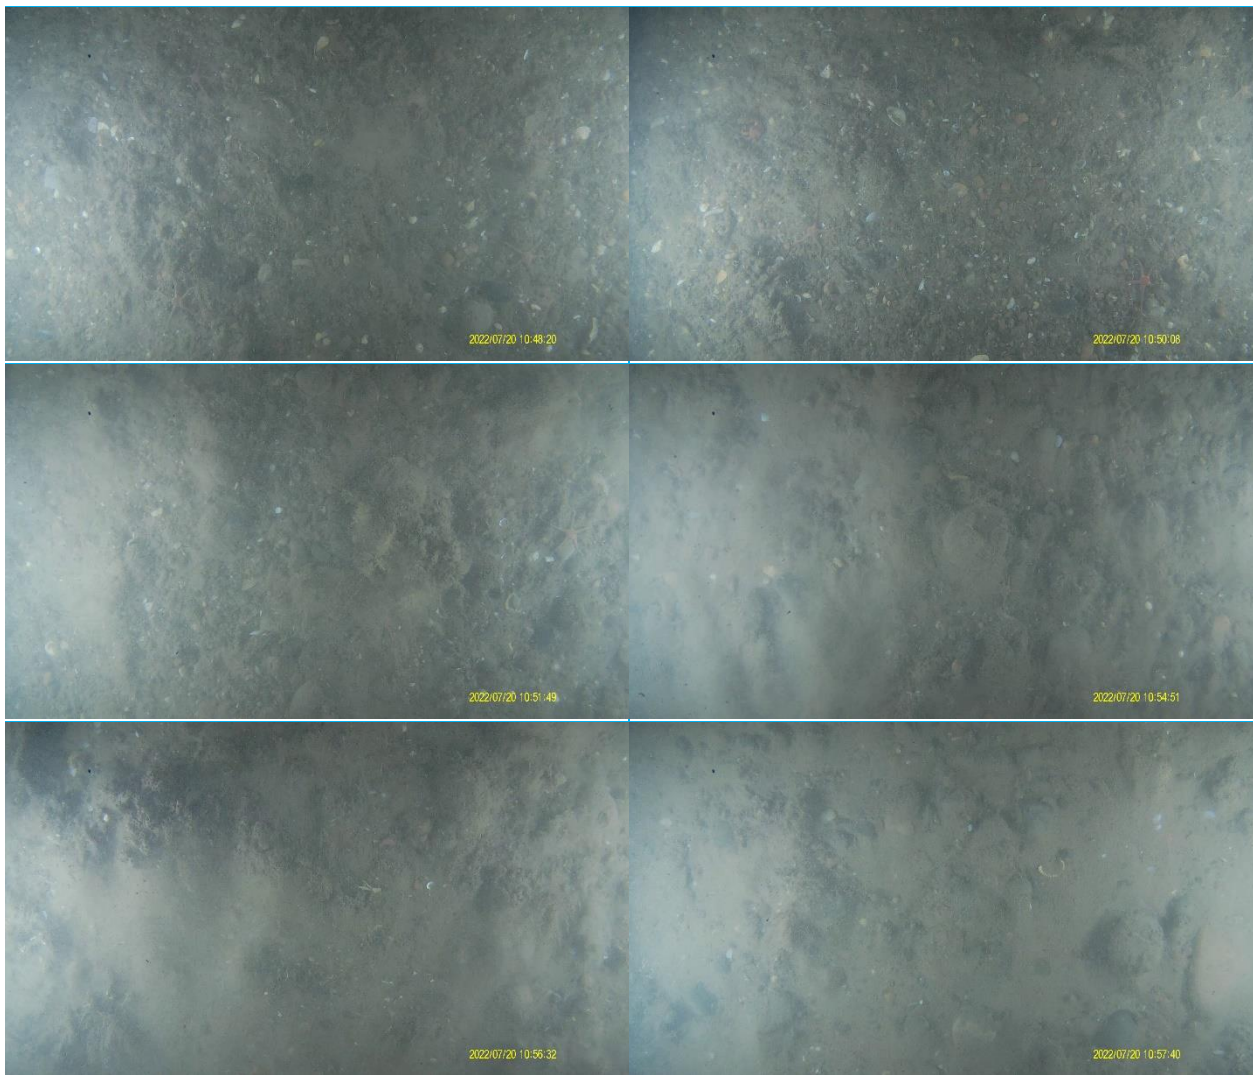
Table 20.

Screen capture images taken from ECC_VID_48a, showing examples of the level of Sabellaria spinulosa present throughout video footage.

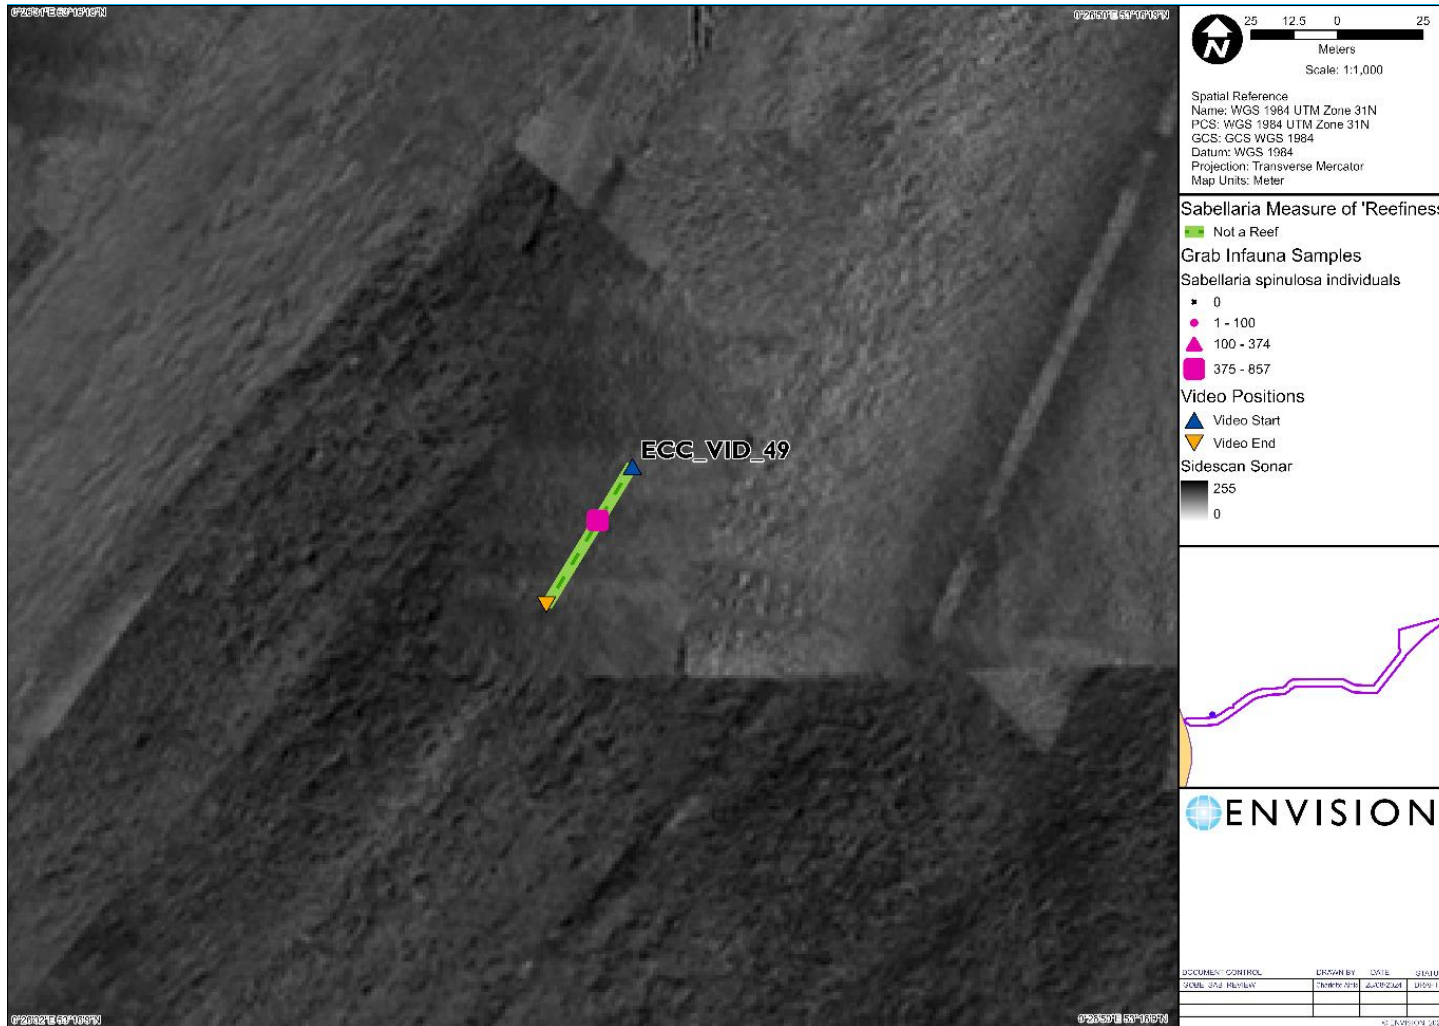
Video station ECC_VID_49 was assessed as 'NOT a REEF' (Figure 11).

Numbers of individuals of *S. spinulosa* from the benthic grab sample collected at this station was 563, which is above the density of individuals for reef as detailed by Limpenny *et al.*, (2010ⁱⁱⁱ). However, underwater imagery and data from sidescan sonar confirm this station is 'NOT a REEF'.

Figure 11. 'Reefiness' allocated to ECC_VID_49, from Sabellaria spinulosa reef assessment (Gubbay, 2007^{iv}).
