Outer Dowsing Offshore Wind

Offshore Export Cable Corridor Sabellaria Spinulosa Reanalysis and Report

Document Number: 15.13

REPORT ID. 2024-130-002

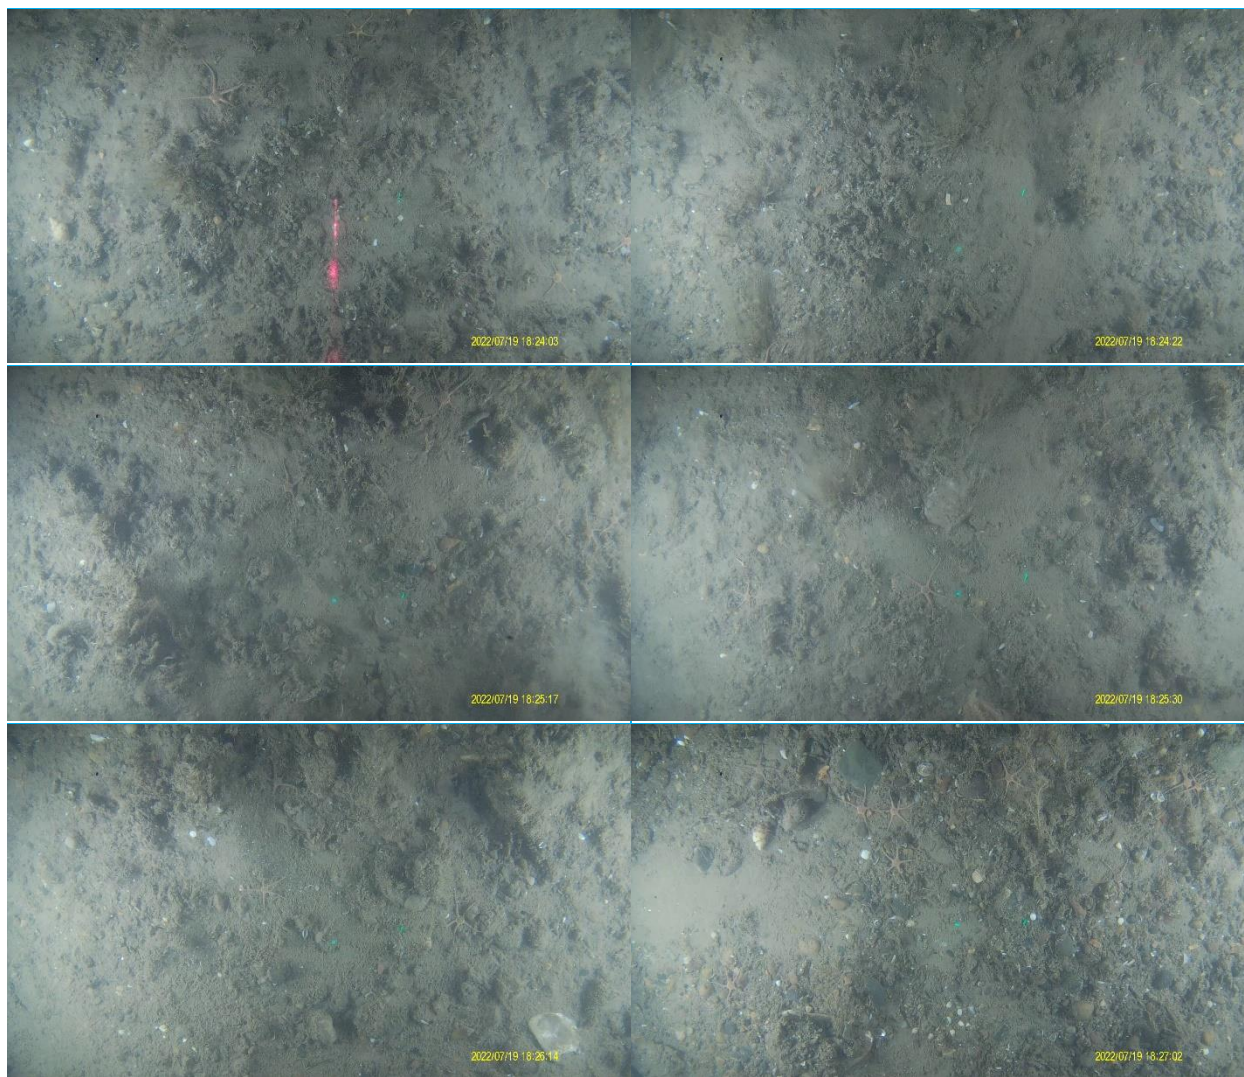
Table 22.

Screen capture images taken from ECC_VID_49, showing examples of the level of Sabellaria spinulosa present throughout video footage.

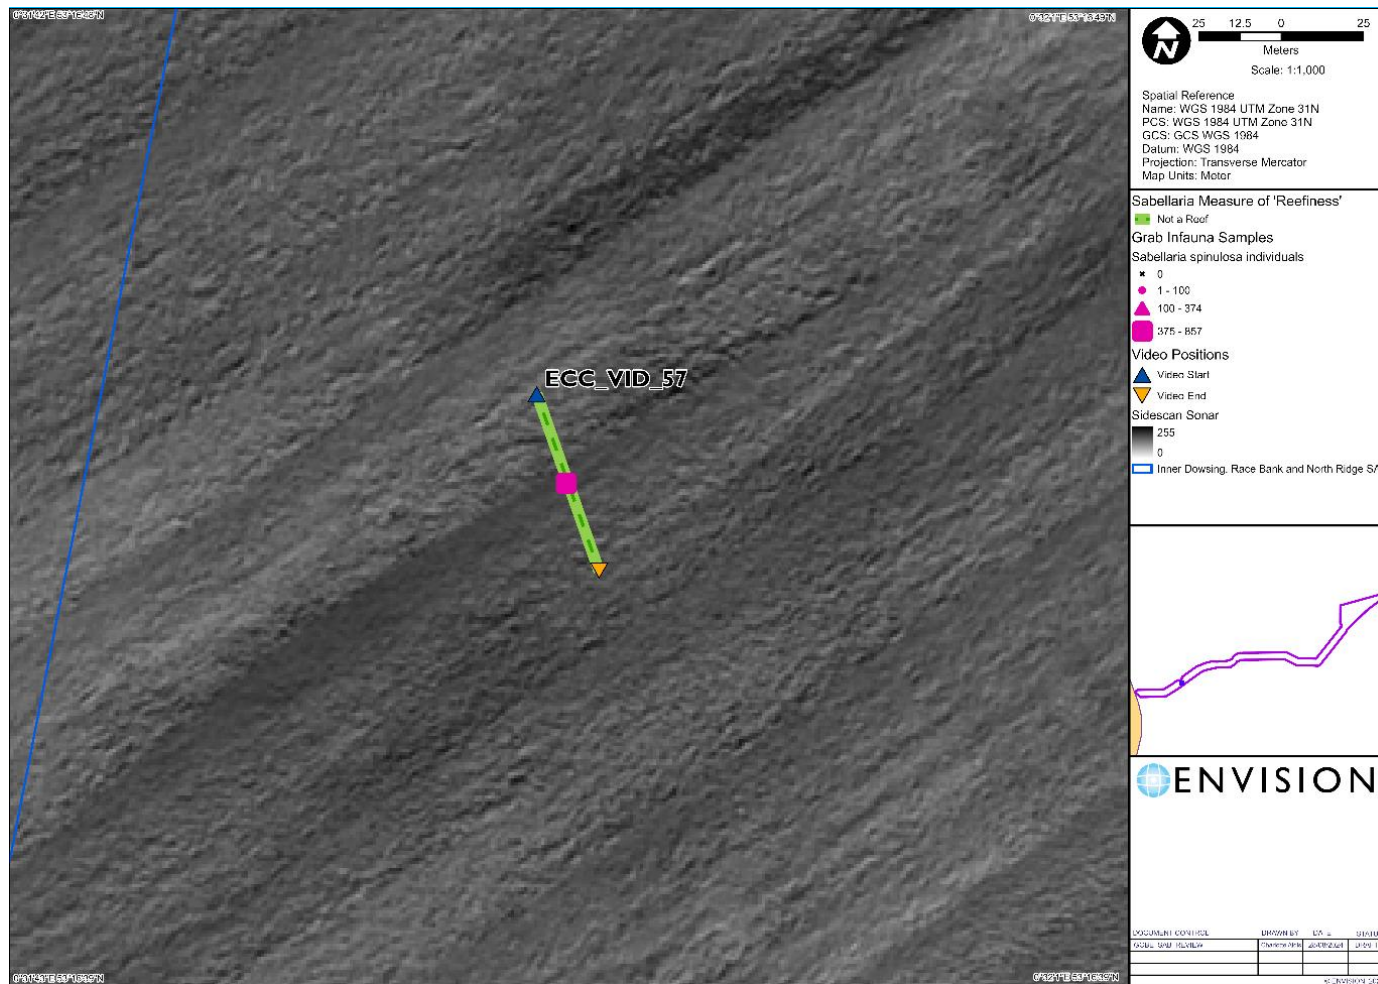
Video station ECC_VID_57 was assessed as 'NOT a REEF' (Figure 12).

Numbers of individuals of *S. spinulosa* from the benthic grab sample collected at this station was 755, which is above the density of individuals for reef as detailed by Limpenny *et al.*, (2010ⁱⁱⁱ). However, underwater imagery and data from sidescan sonar confirm this station is 'NOT a REEF'.

Figure 12. 'Reefiness' allocated to ECC_VID_57, from Sabellaria spinulosa reef assessment (Gubbay, 2007^{iv}).

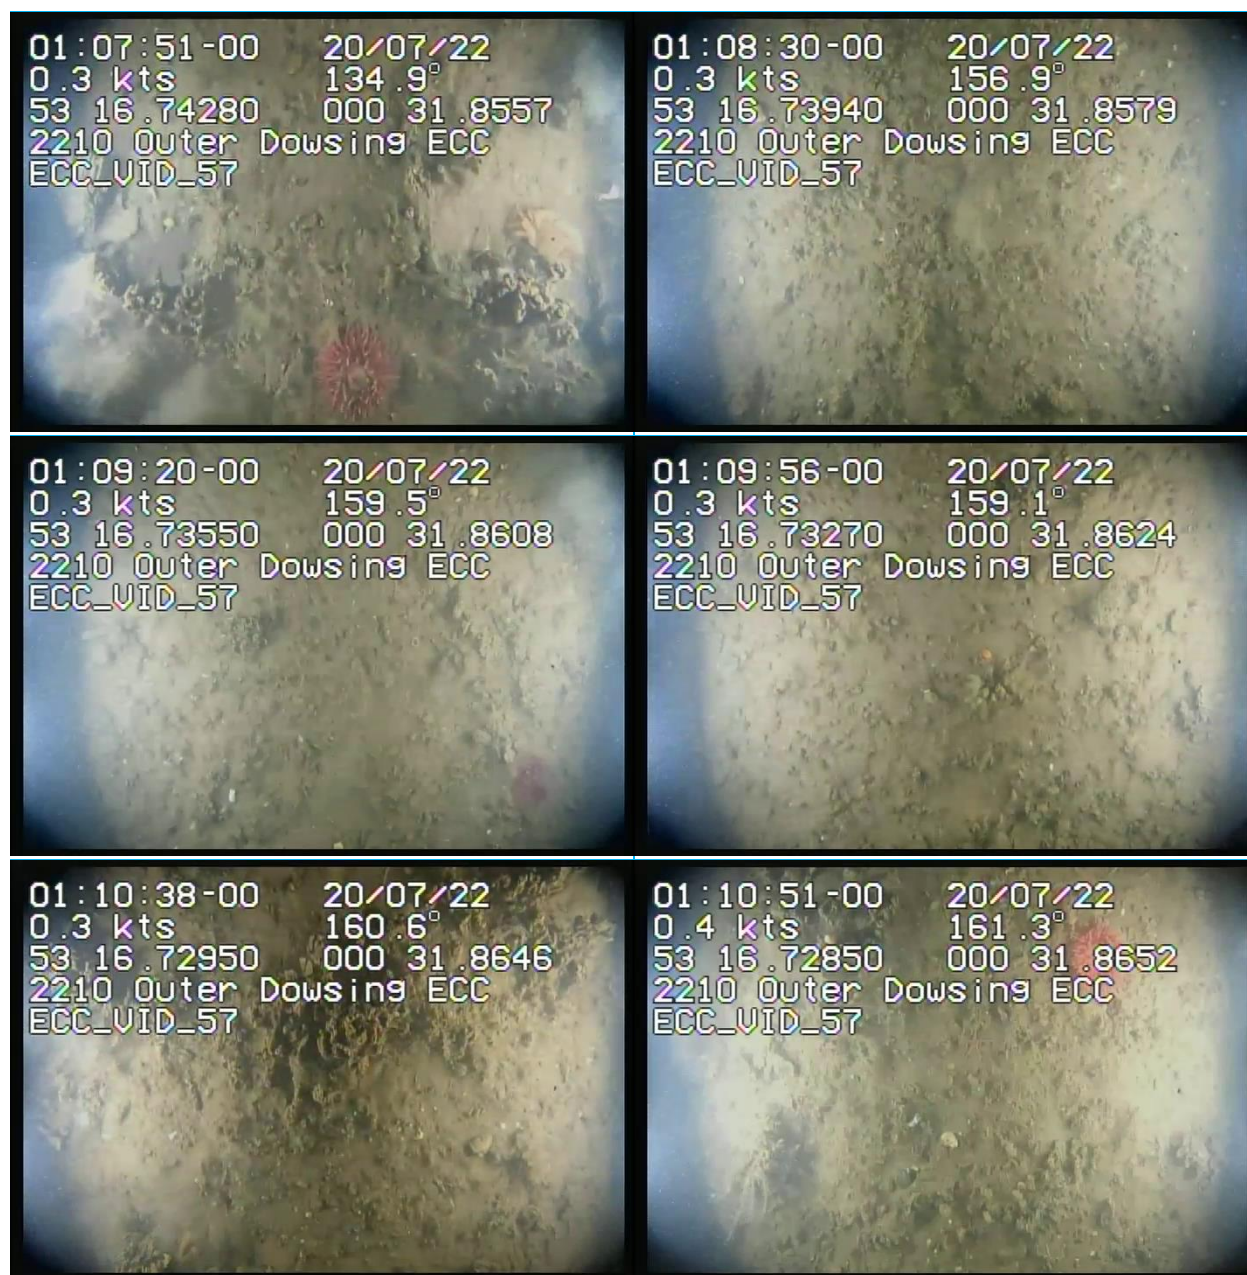
Table 24.

Screen capture images taken from ECC_VID_57, showing examples of the level of Sabellaria spinulosa present throughout video footage.

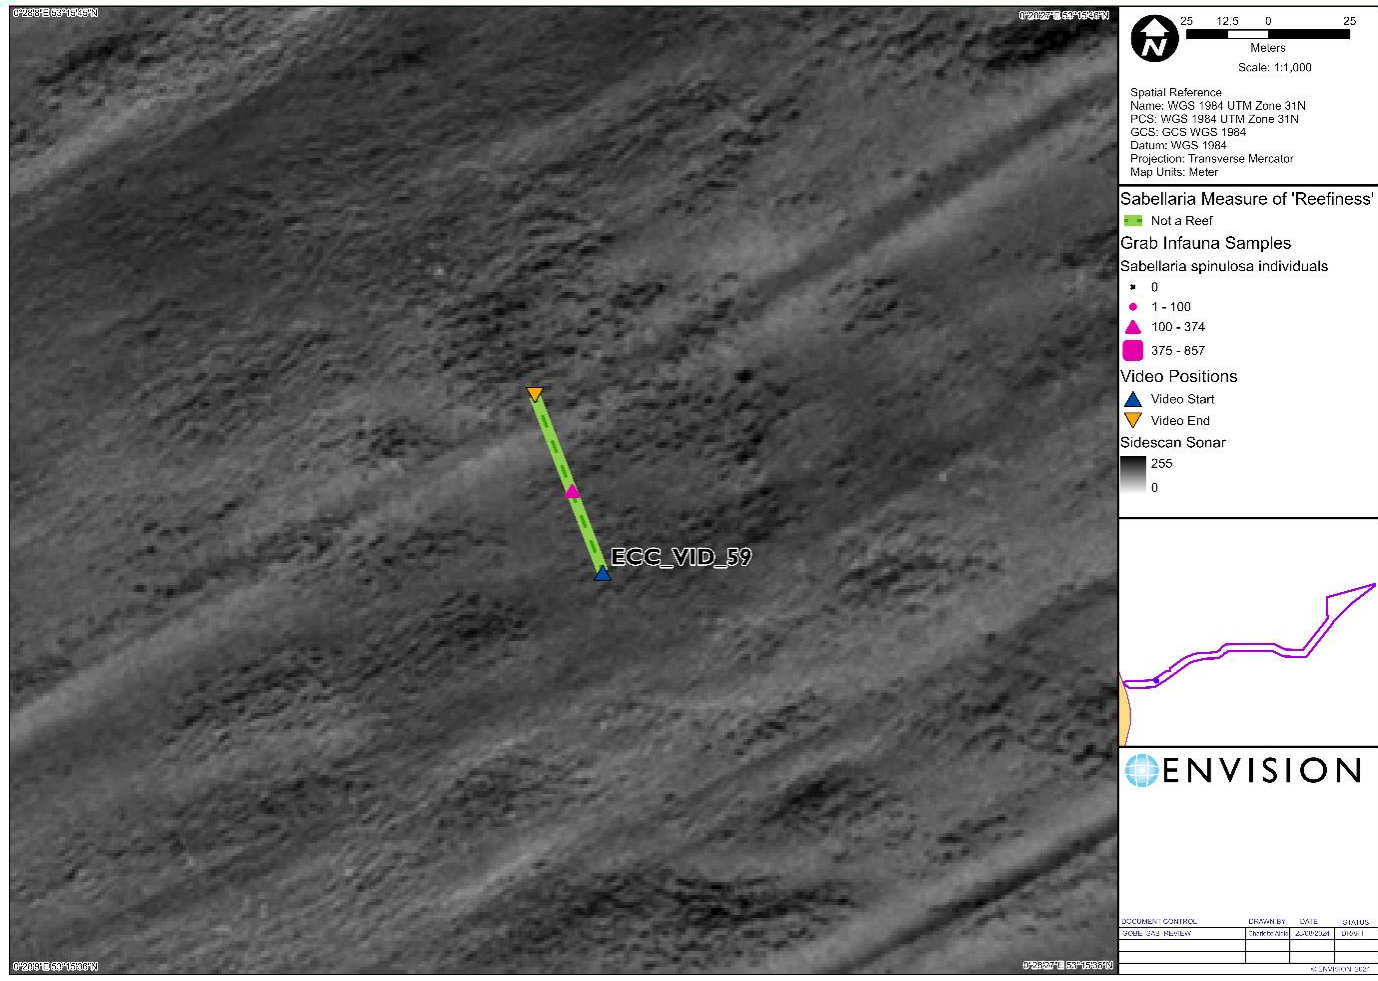
Video station ECC_VID_59 was assessed as 'NOT a REEF' (Figure 13).

Numbers of individuals of *S. spinulosa* from the benthic grab sample collected at this station was 195, which is below the 375 threshold (Limpenny *et al.*, 2010ⁱⁱⁱ).

Figure 13. 'Reefiness' allocated to ECC_VID_59, from Sabellaria spinulosa reef assessment (Gubbay, 2007^m).

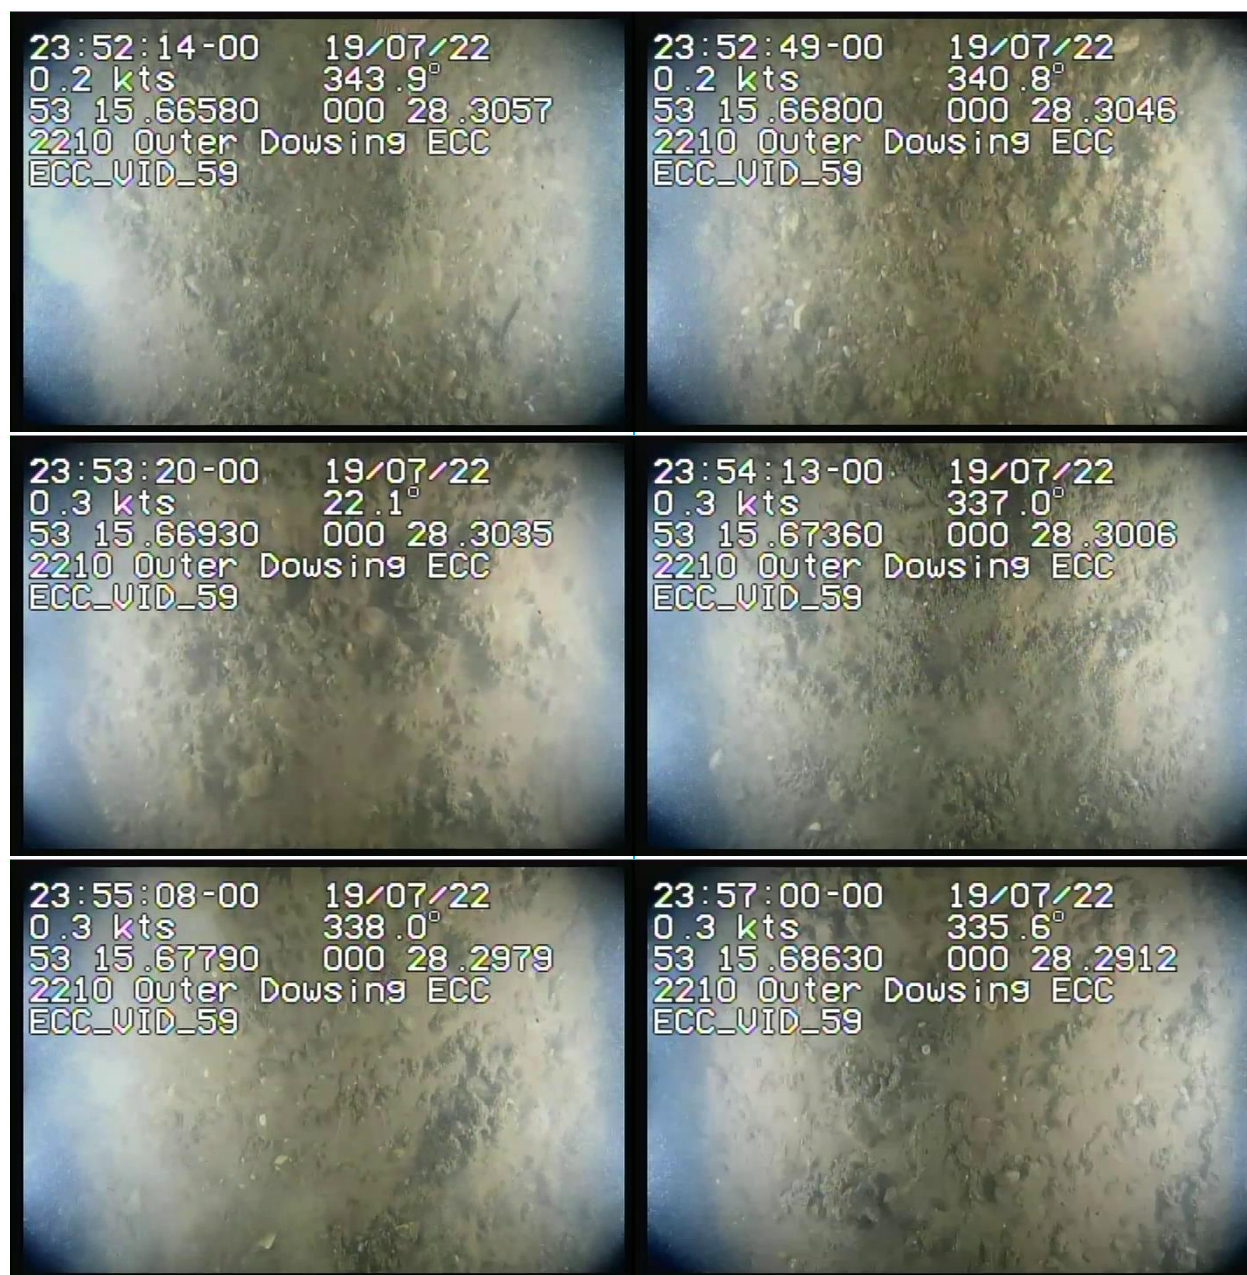
Table 26.

Screen capture images taken from ECC_VID_59, showing examples of the level of Sabellaria spinulosa present throughout video footage.

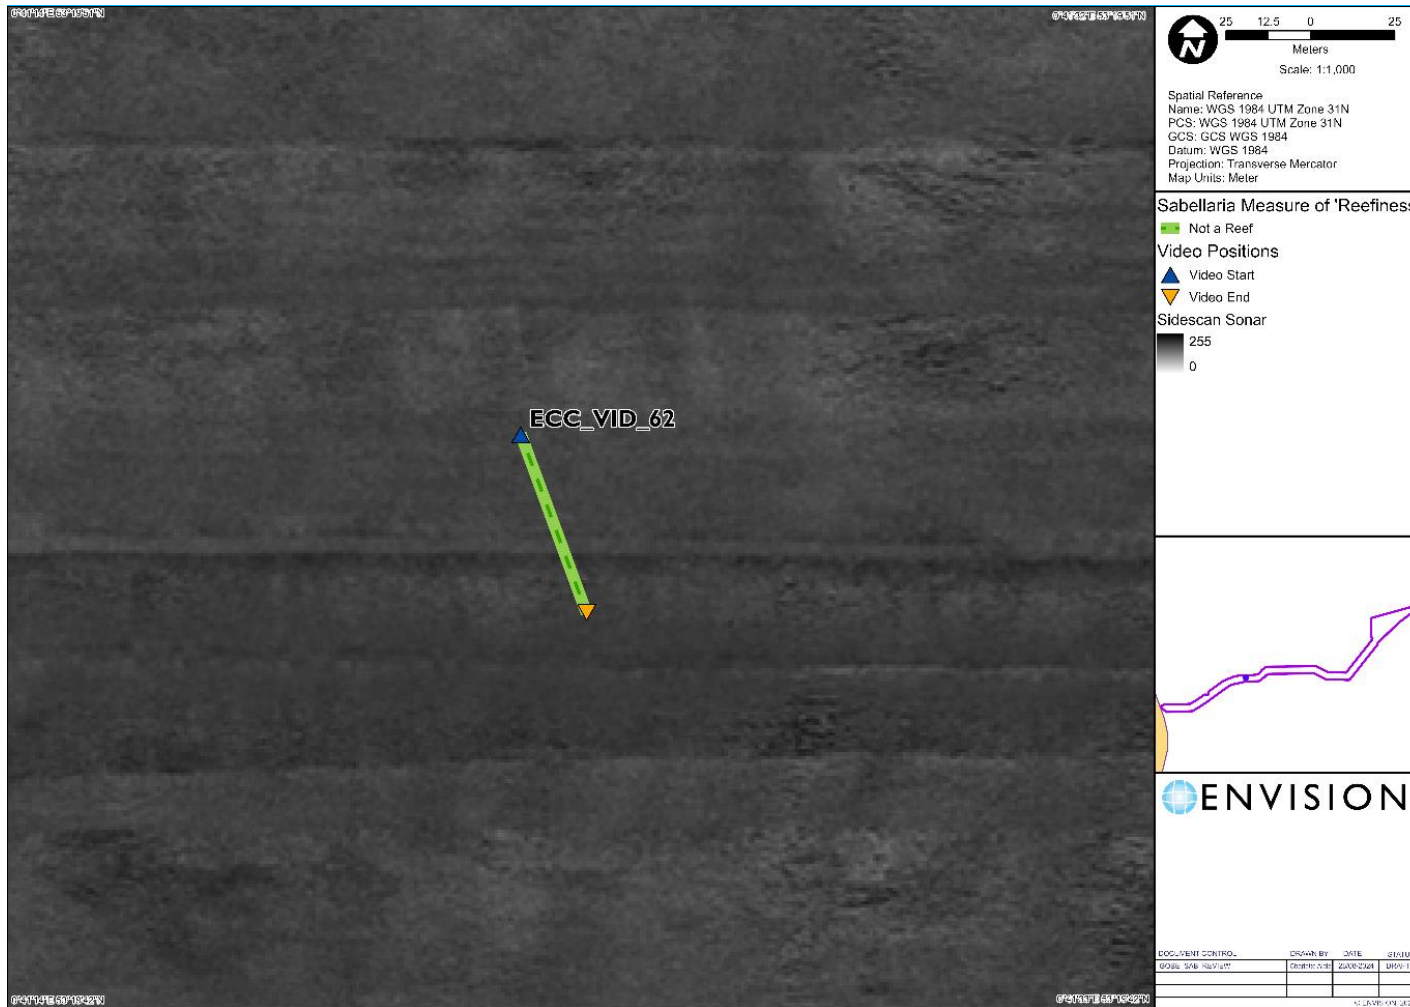
Video station ECC_VID_62 was assessed as 'NOT a REEF' (Figure 14).

Sidescan sonar data (Figure 14) does not indicate any features distinct from the surrounding seabed or any elevated features.

Figure 14.
 'Reefiness' allocated to ECC_VID_62, from Sabellaria spinulosa reef assessment (Gubbay, 2007TM).

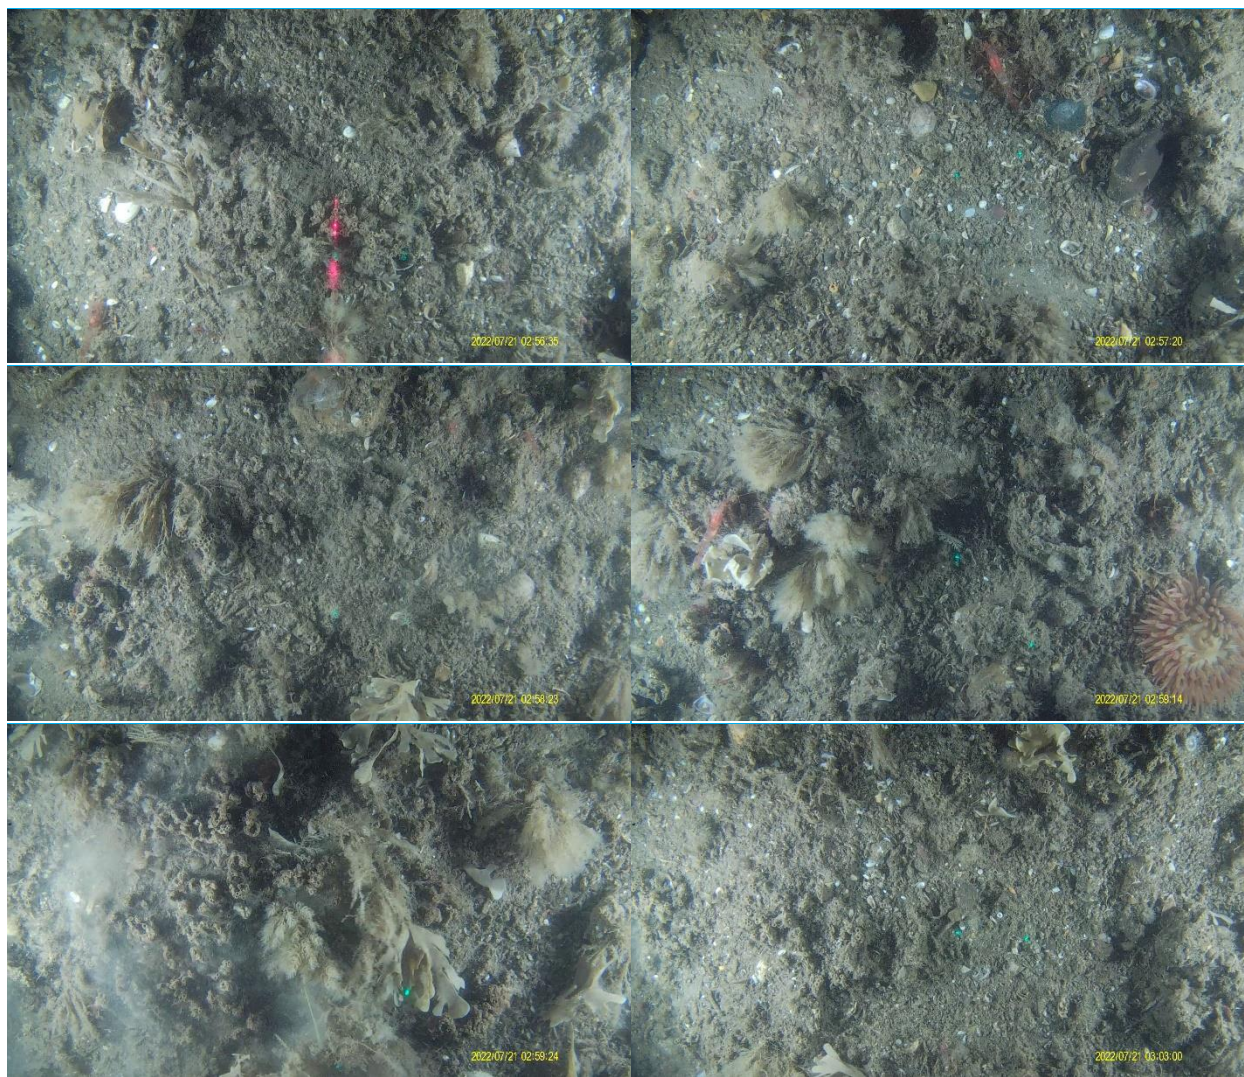
Table 28.

Screen capture images taken from ECC_VID_62, showing examples of the level of Sabellaria spinulosa present throughout video footage.

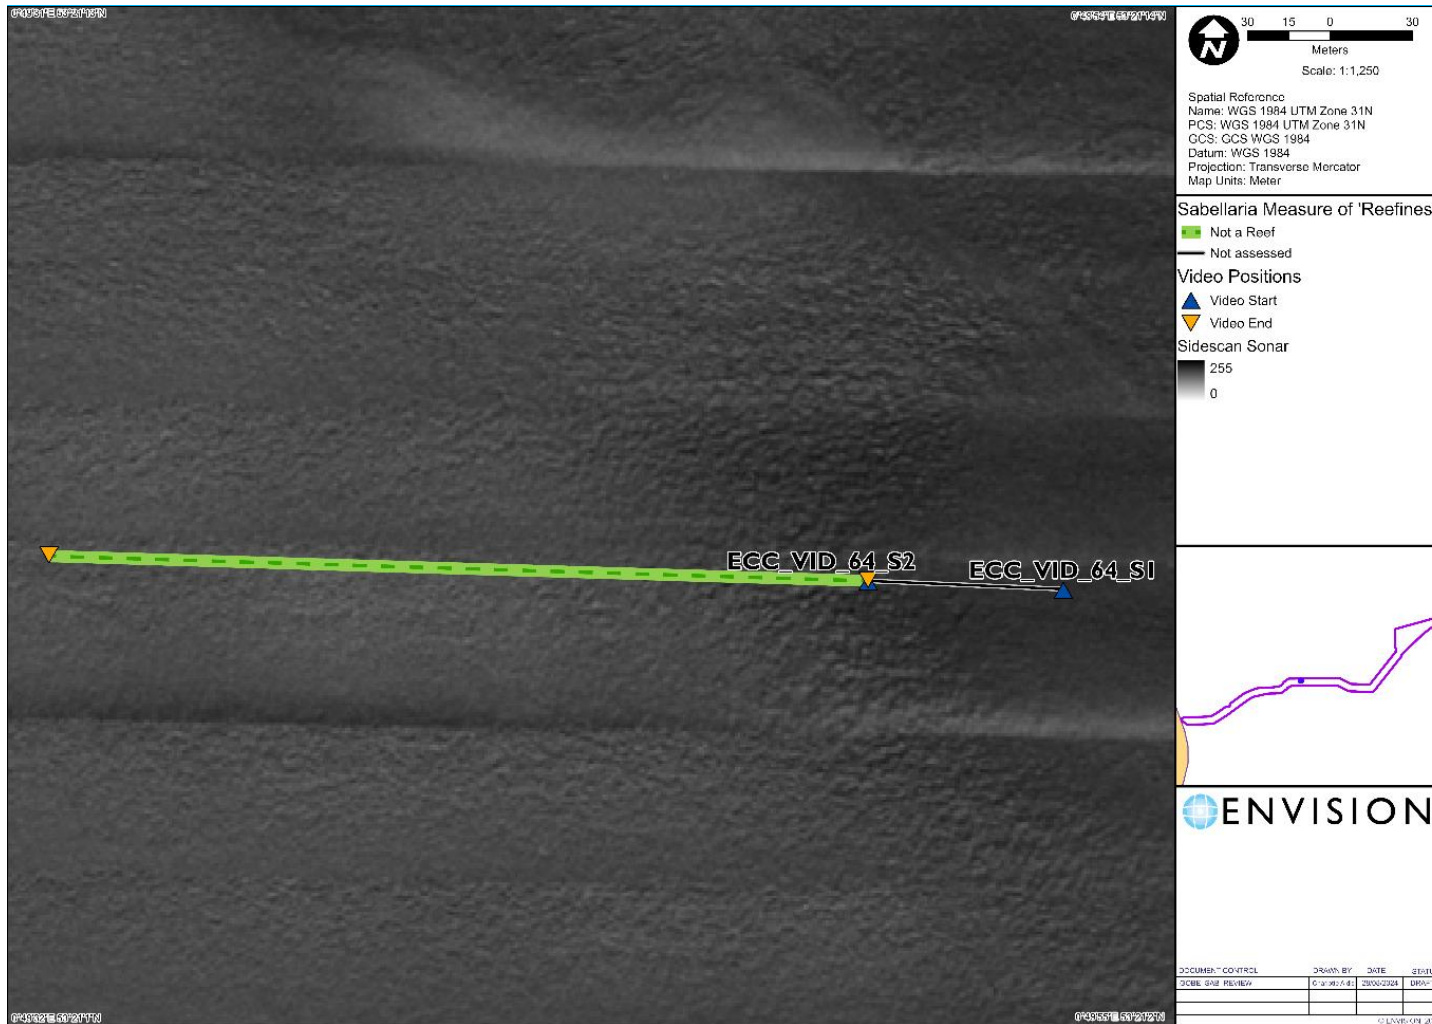
Video station ECC_VID_64 was assessed as 'NOT a REEF' (Figure 15).

The seabed along the video sample and adjacent to it, shows some indication of variable ground with this area being approximately 30,000 square metres in size. However, with assessment of video footage allocating patchiness (% cover) as below 10% and area of less than 25 m² of *S. spinulosa* cover, station ECC_VID_64 is 'NOT a REEF'.

Figure 15. 'Reefiness' allocated to ECC_VID_64, from Sabellaria spinulosa reef assessment (Gubbay, 2007^{iv}).

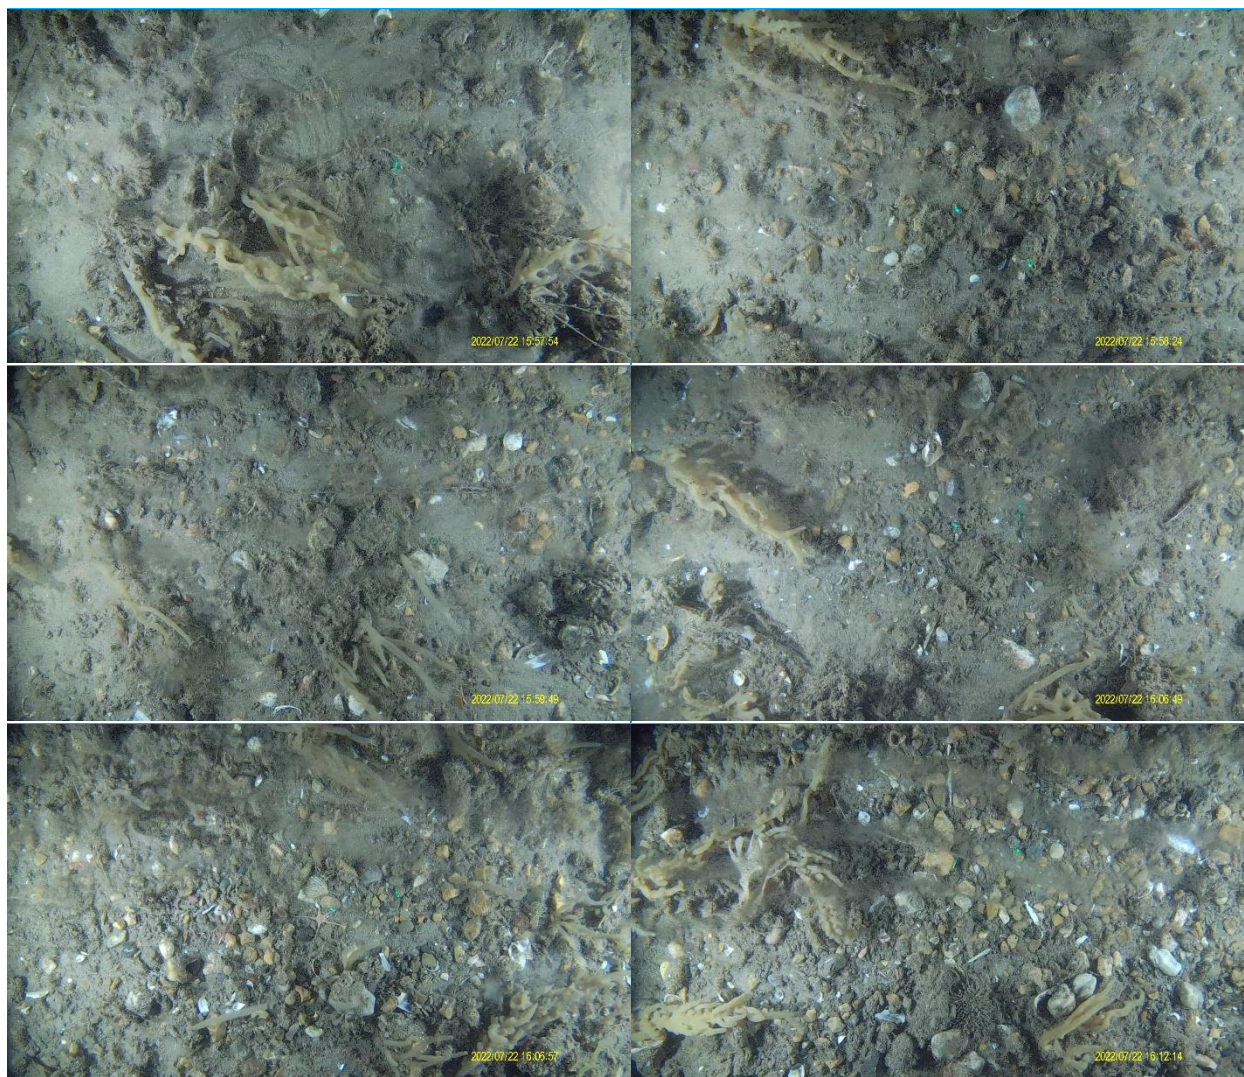
Table 30.

Screen capture images taken from ECC_VID_64, showing examples of the level of Sabellaria spinulosa present throughout video footage.

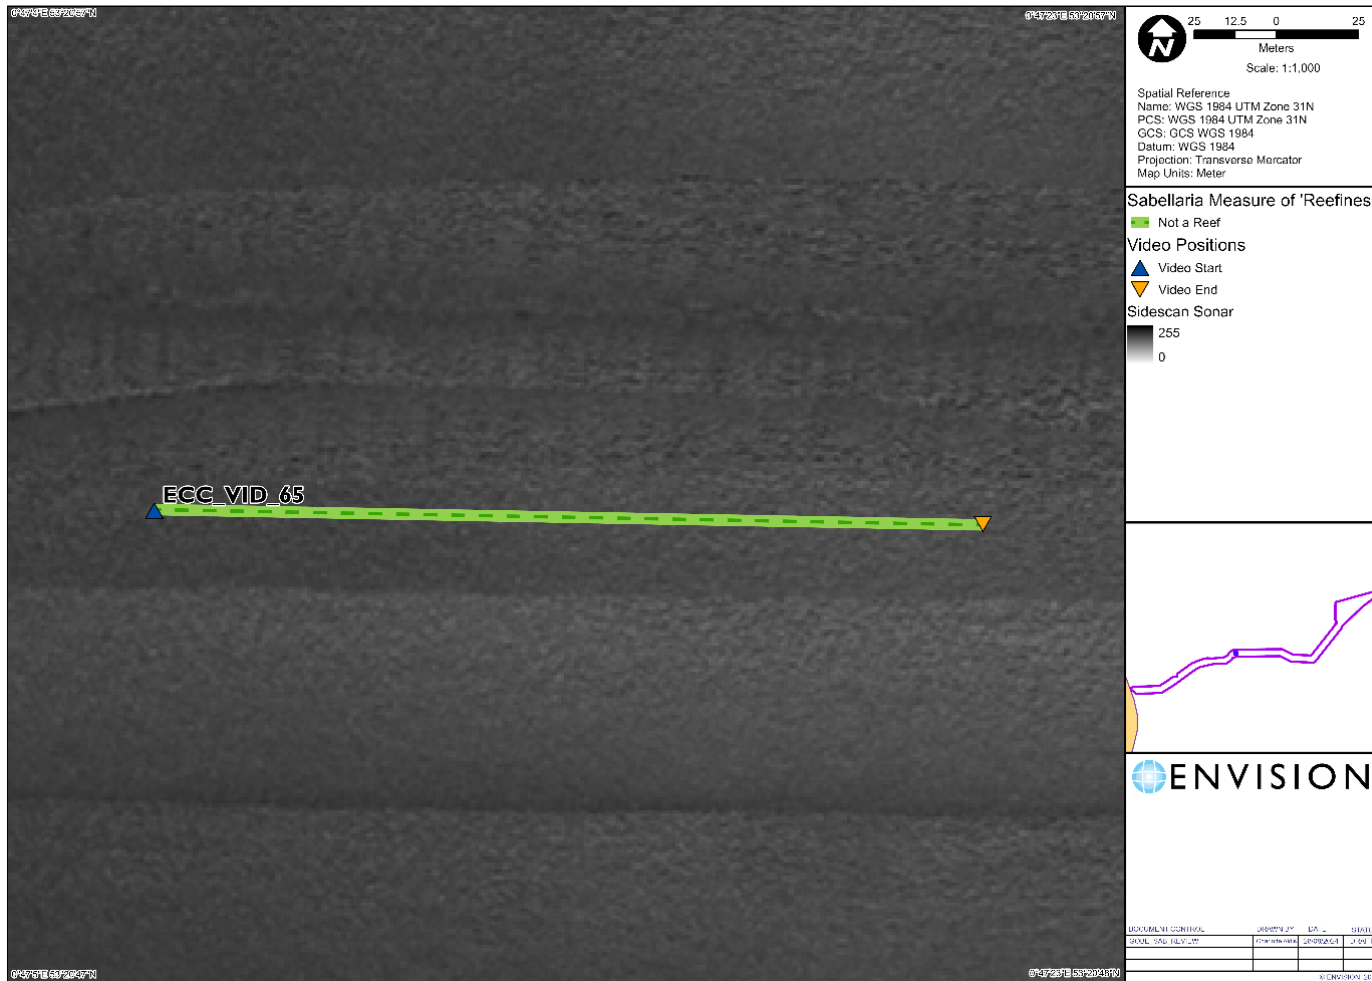
Video station ECC_VID_65 was assessed as 'NOT a REEF' (Figure 16).

Sidescan sonar data (Figure 16) does not indicate any features distinct from the surrounding seabed or any elevated features.

Figure 16. 'Reefiness' allocated to ECC_VID_65, from Sabellaria spinulosa reef assessment (Gubbay, 2007^{iv}).

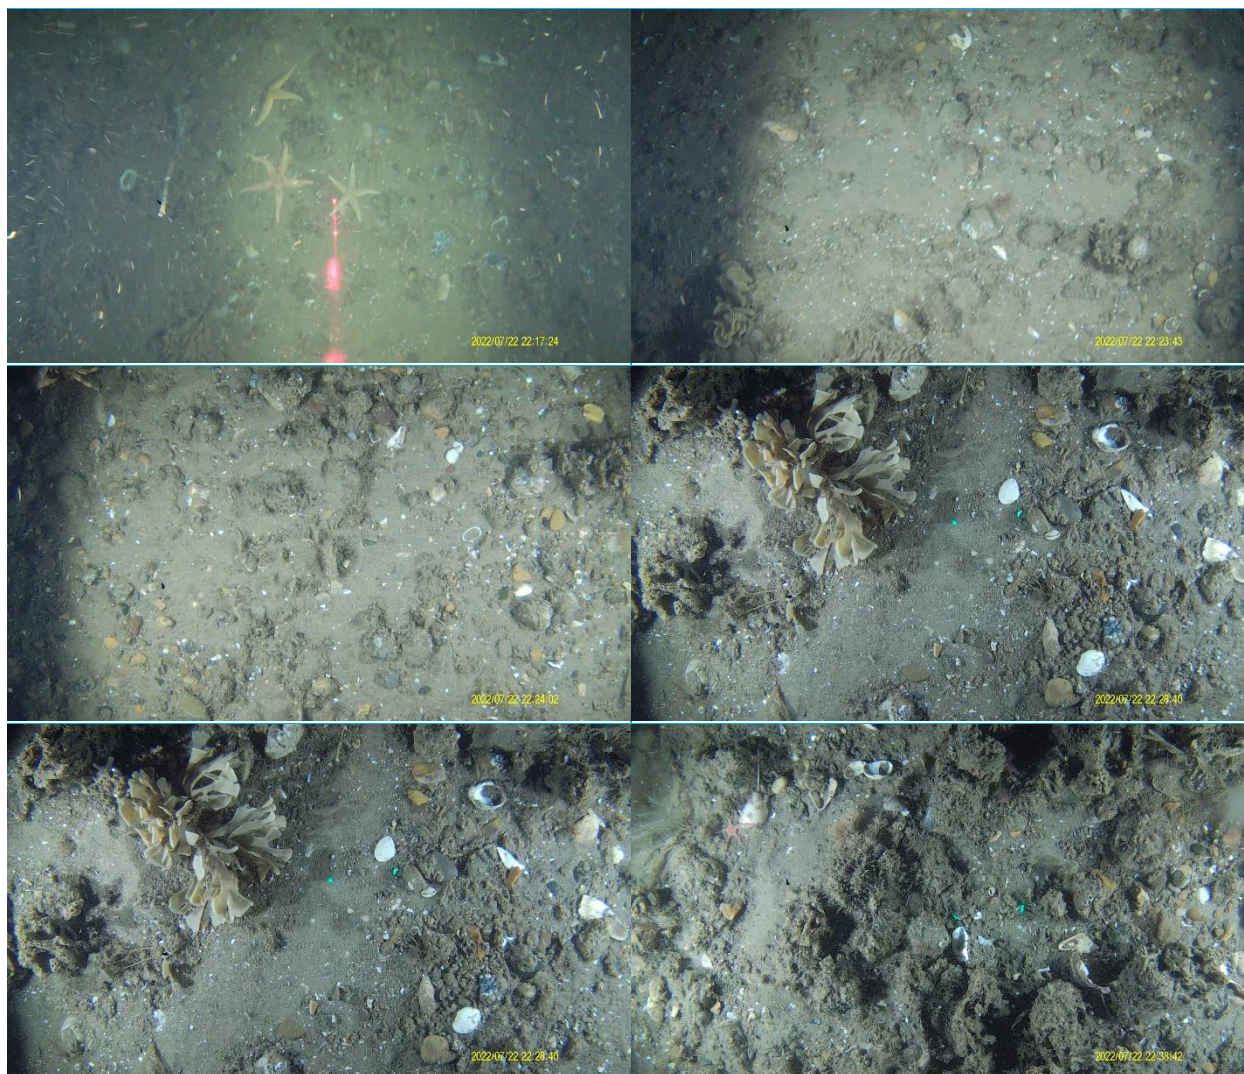
Table 32.

Screen capture images taken from ECC_VID_65, showing examples of the level of Sabellaria spinulosa present throughout video footage.

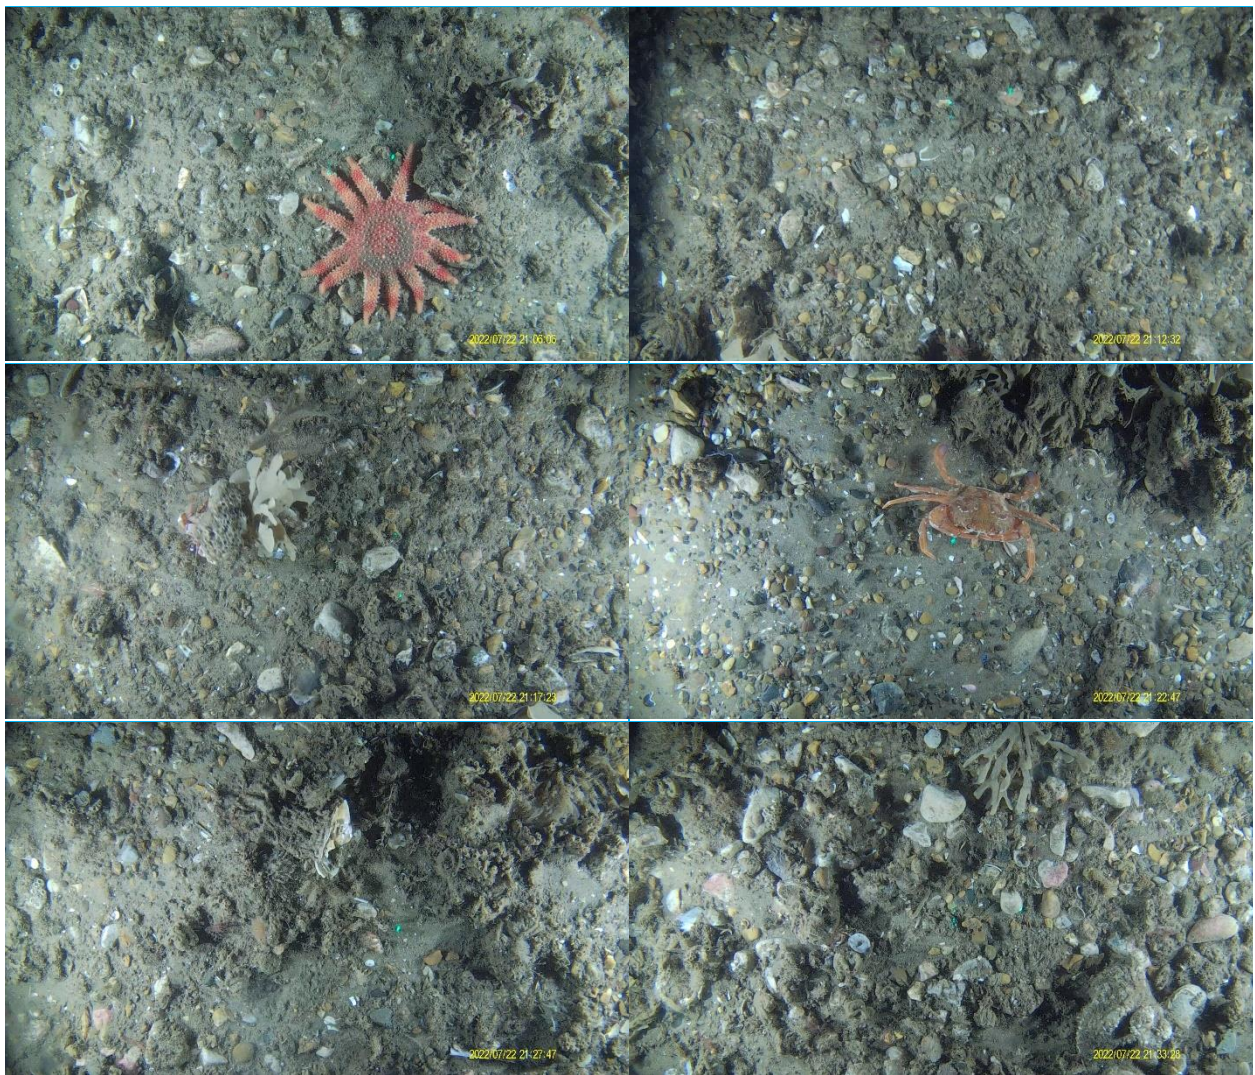
Table 34.

Screen capture images taken from ECC_VID_66, showing examples of the level of Sabellaria spinulosa present throughout video footage.
