Outer Dowsing Offshore Wind

Offshore Export Cable Corridor

Sabellaria Spinulosa Reanalysis and Report

Document Reference: 15.13 V2
Revision: 2.0

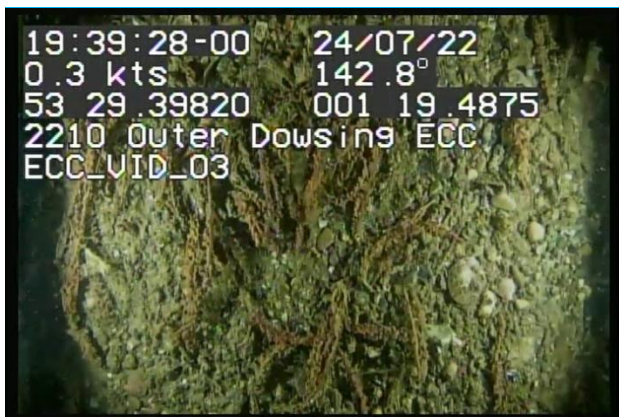
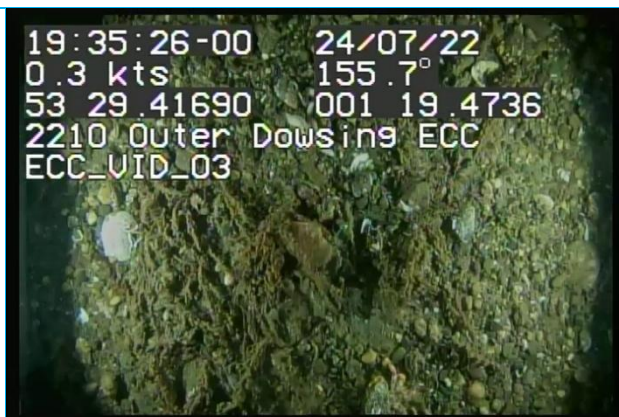
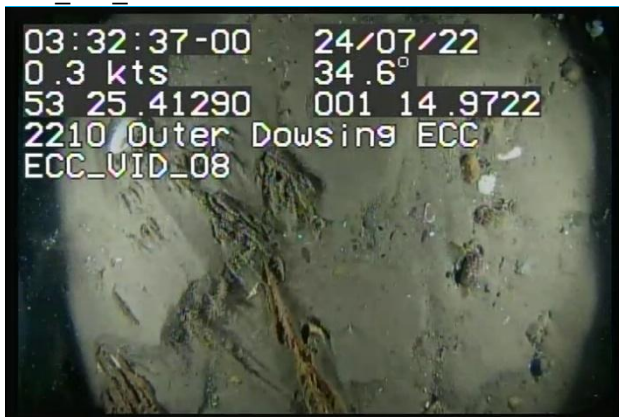
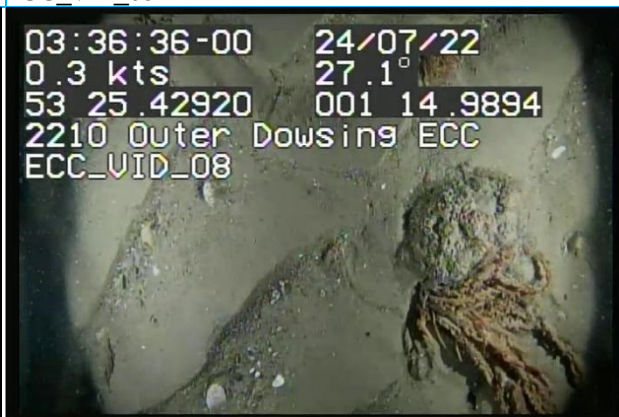
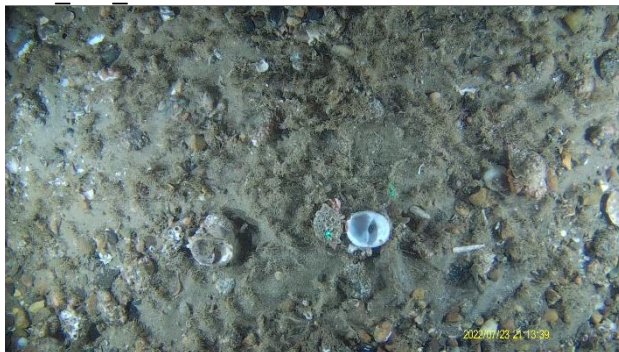
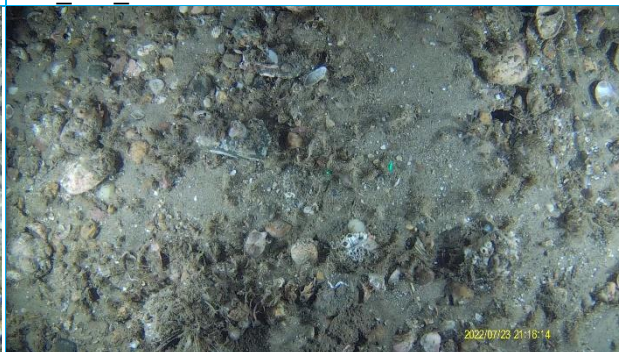
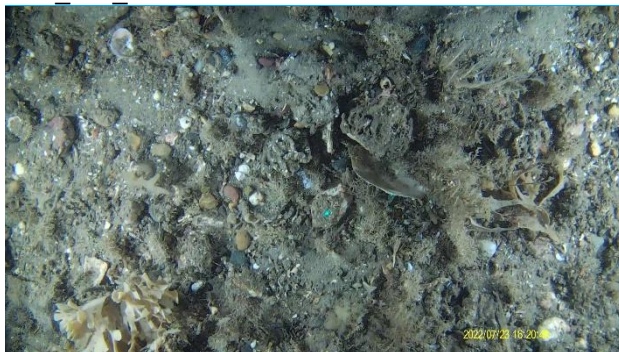
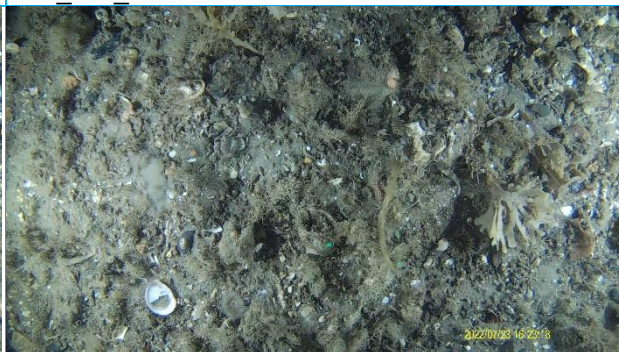
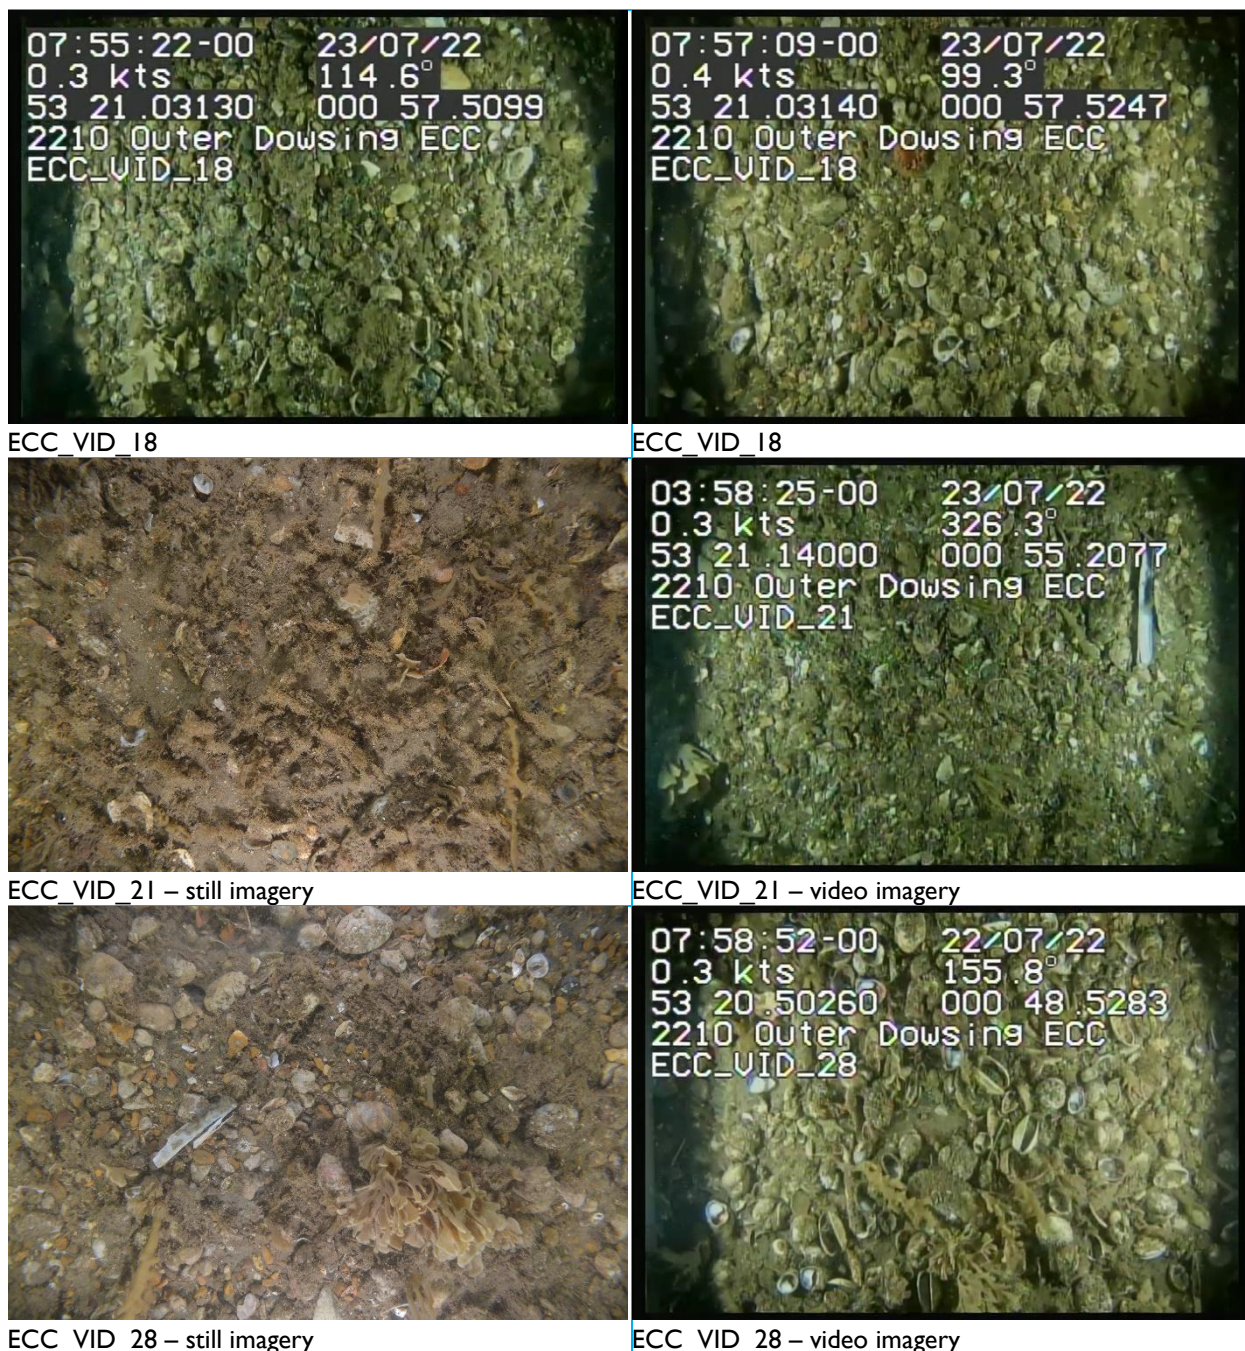
Screen capture images and still imagery taken from video stations that recorded Sabellaria spinulosa as present in small amounts (<1m² patches) and were not assigned for further reef assessment.

Seven stations were identified as having *S. spinulosa* present in small patches, which were less than 1m² and were recorded as dead, empty tubes, these stations were ECC_VID_03, ECC_VID_08, ECC_VID_12, ECC_VID_15, ECC_VID_18, ECC_VID_21 and ECC_VID_28. The instances of *S. spinulosa* observed were not assigned for reef assessment due to the distinct lack of elevation, area and percentage cover, which were all well below the thresholds described in Gubbay (2007^{iv}). The review of the video footage for stations ECC_VID_21 and ECC_VID_28 did not record *S. spinulosa* as present, however, the still images for these stations had very small patches, less than 0.5 m². Therefore, these stations were recorded as having *S. spinulosa* present but were not assigned for reef assessment. Example images taken from each of the seven stations are shown in Table 4.

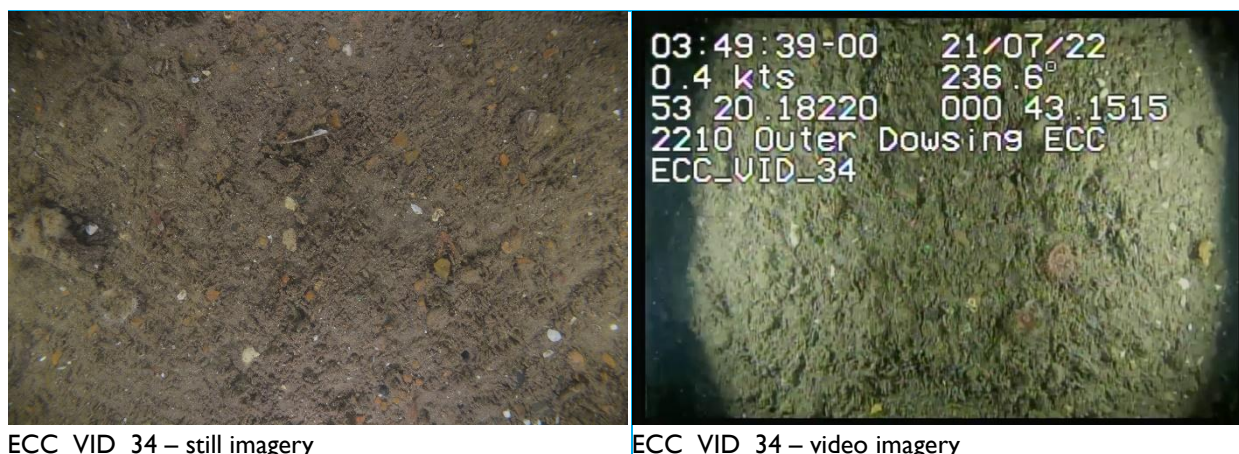
Still imagery and screen capture image taken from video station ECC_VID_34.

One station, ECC_VID_34, was only sampled with the SD camera system, which resulted in lower quality imagery for analysis. For this station it was not possible to confidently identify the presence and absence of *S. spinulosa* through the video imagery. Therefore, the still images captured at this station were used to review the presence or absence of *S. spinulosa* and subsequently used for full 'reefiness' assessment. Example imagery from this station is shown in Table 8.

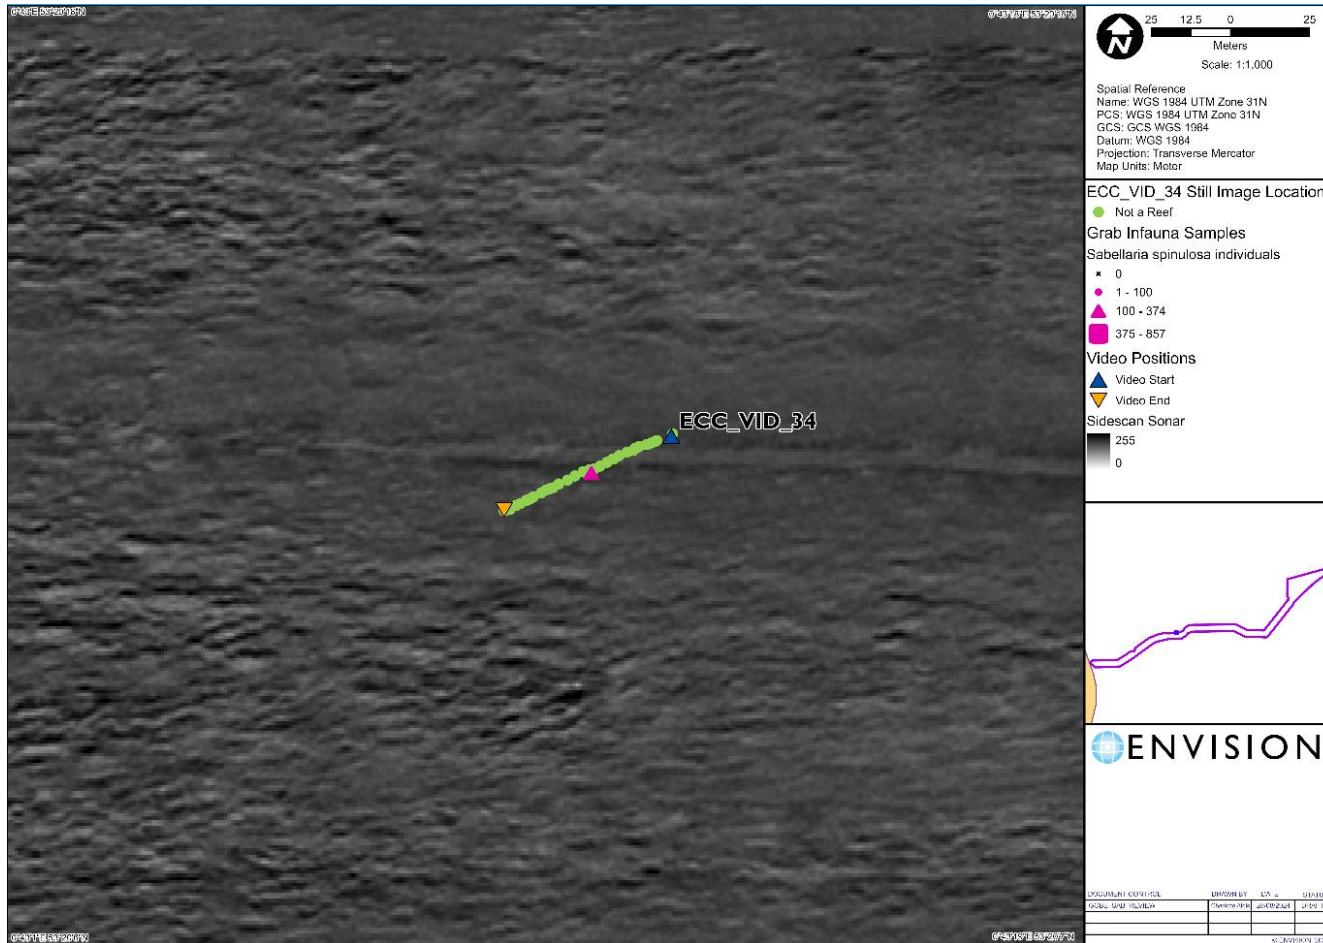
Figure 7.

'Reefiness' allocated to still images collected at ECC_VID_34, from Sabellaria spinulosa reef assessment (Gubbay, 2007^{iv}).

Station ECC VID 34 was assessed as 'NOT a REEF' (Figure 7).

Numbers of individuals of *S. spinulosa* from the benthic grab sample collected at this station were 147, which is below the 375 threshold (Limpenny *et al.*, 2010ⁱⁱⁱ).

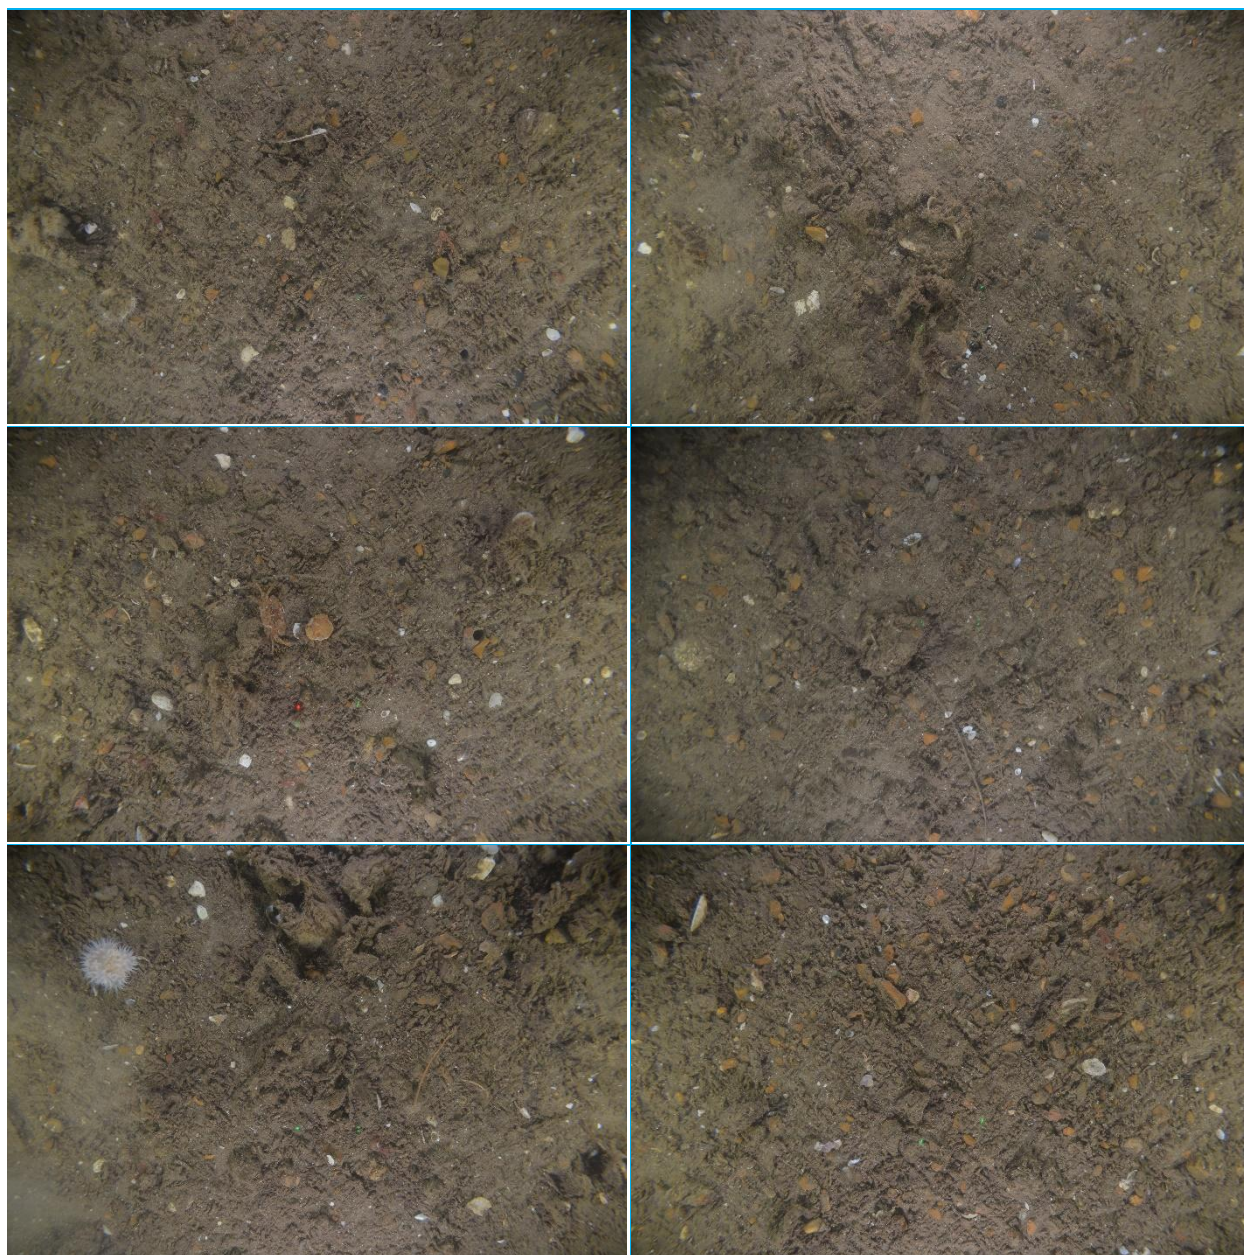
Table I4.

Still images captured at ECC_VID_34, showing examples of the level of Sabellaria spinulosa present.

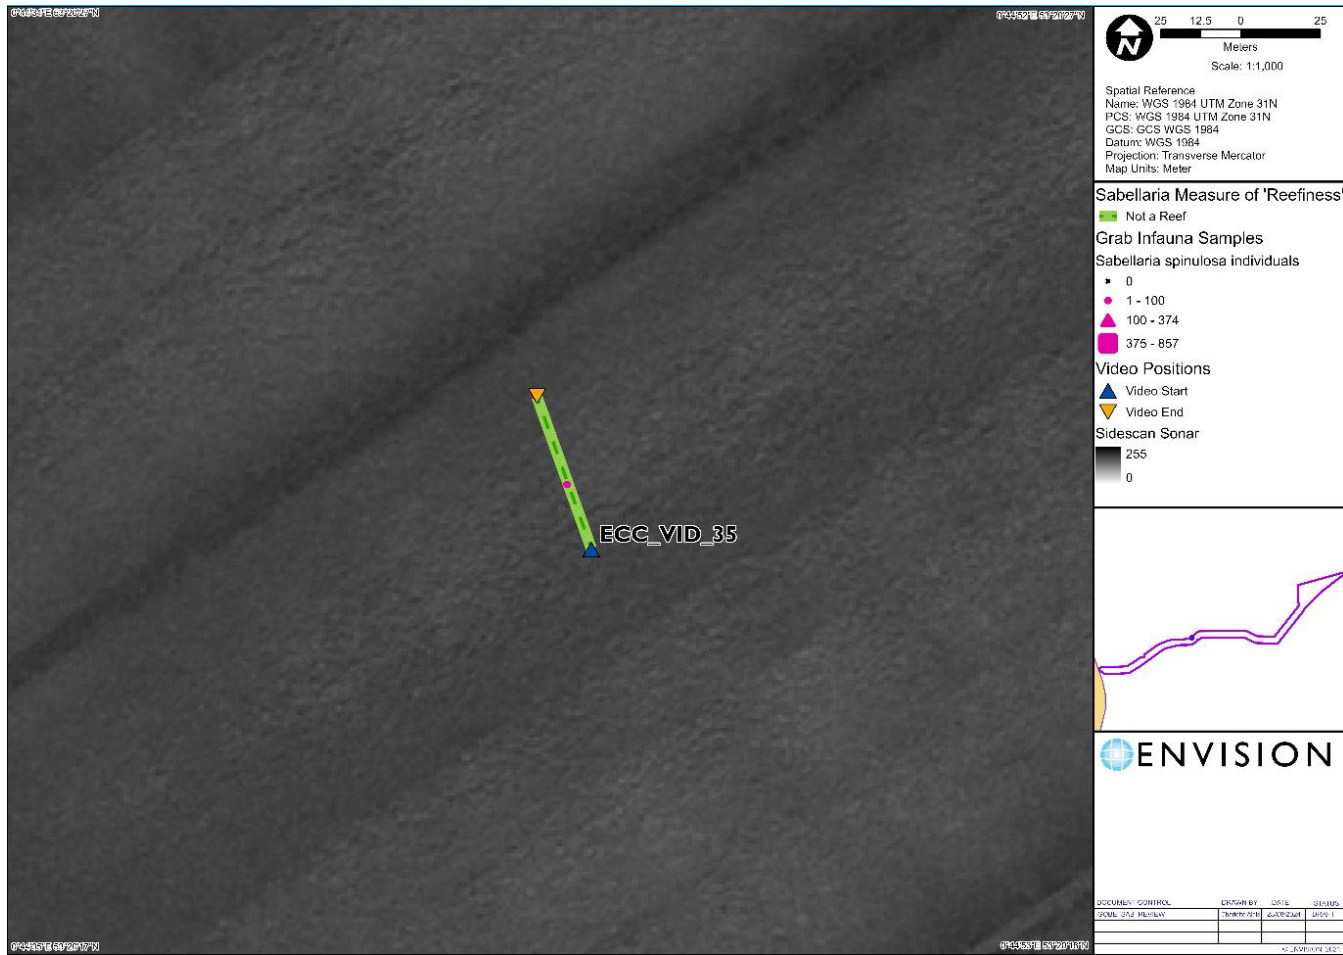
Figure 8. 'Reefiness' allocated to ECC_VID_35, from Sabellaria spinulosa reef assessment (Gubbay, 2007^{iv}).

Video station ECC_VID_35 was assessed as 'NOT a REEF' (Figure 8).

Numbers of individuals of *S. spinulosa* from the benthic grab sample collected at this station was 96, which is below the 375 threshold (Limpenny *et al.*, 2010ⁱⁱⁱ).

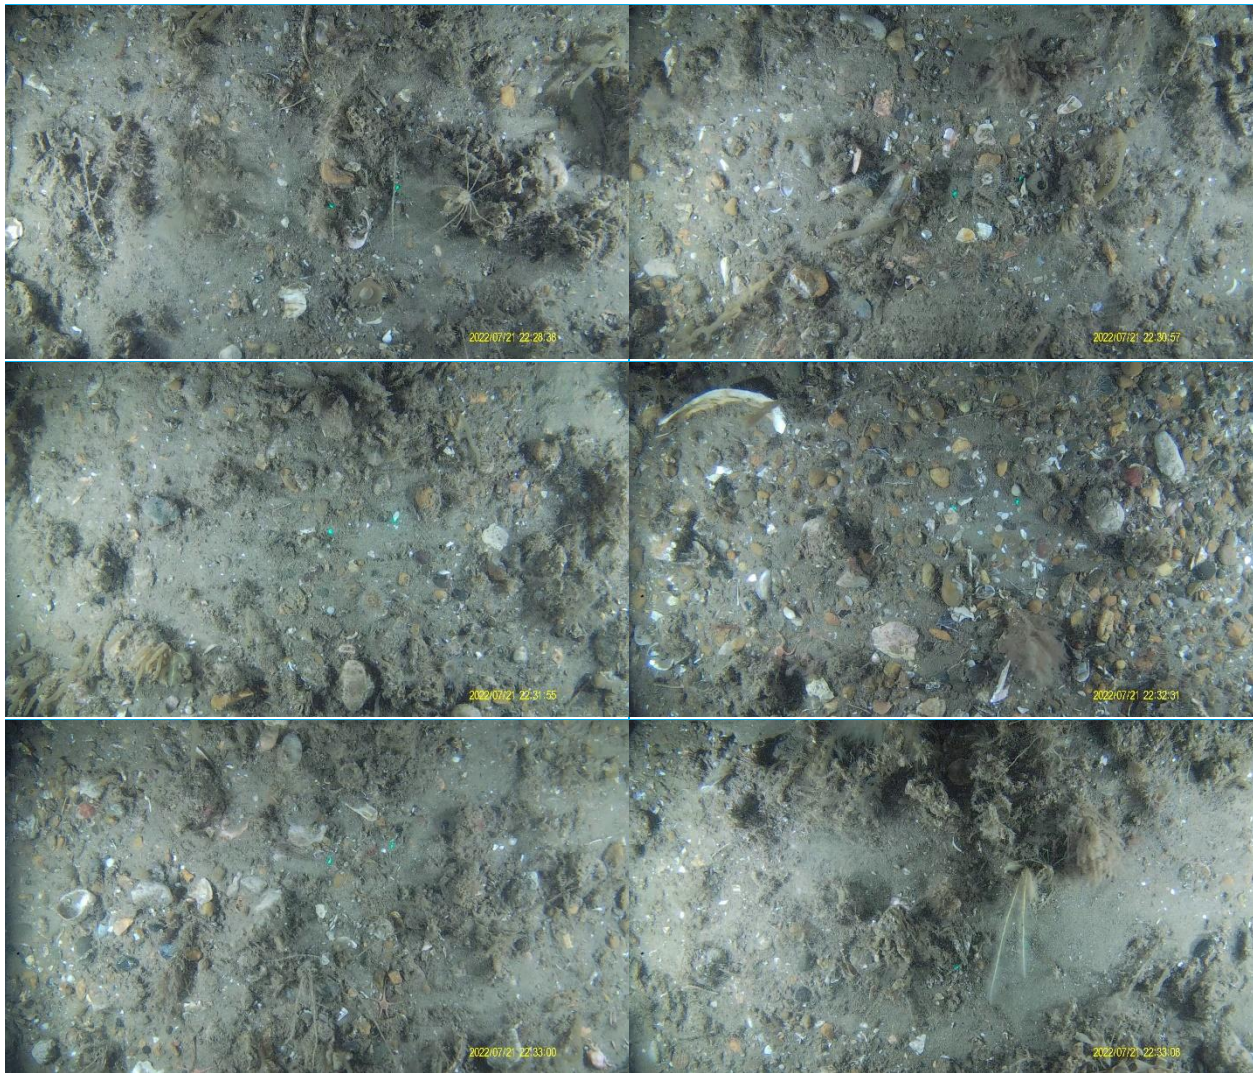
Table 16.

Screen capture images taken from ECC_VID_35, showing examples of the level of Sabellaria spinulosa present throughout video footage.

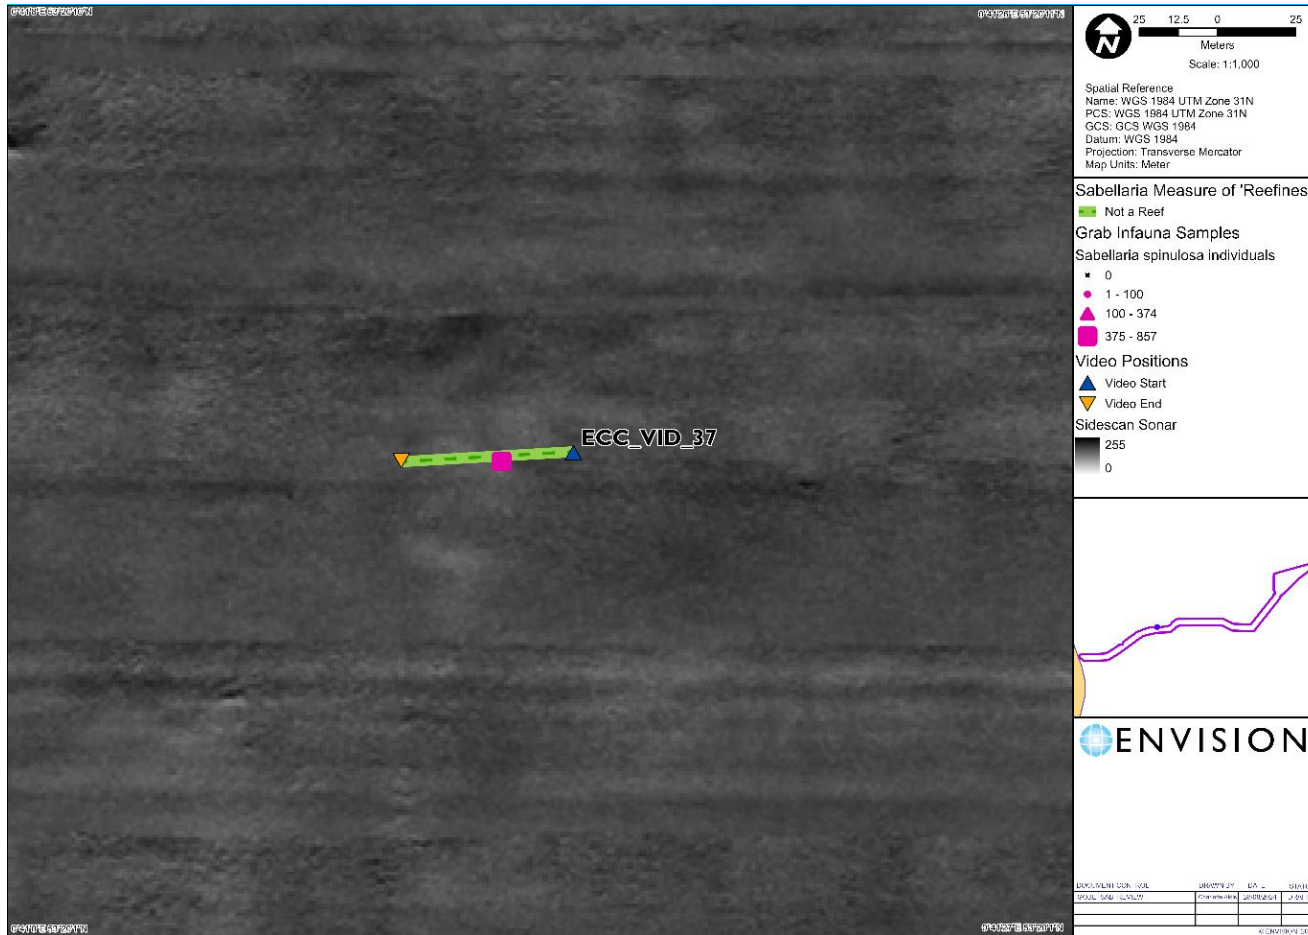
Figure 9.
'Reefiness' allocated to ECC_VID_37, from Sabellaria spinulosa reef assessment (Gubbay, 2007^{iv}).

Video station ECC_VID_37 was assessed as 'NOT a REEF' (Figure 9).

Numbers of individuals of *S. spinulosa* from the benthic grab sample collected at this station was 493, which is above the density of individuals for reef as detailed by Limpenny *et al.*, (2010ⁱⁱⁱ). However, underwater imagery and data from sidescan sonar confirm this station is 'NOT a REEF'.

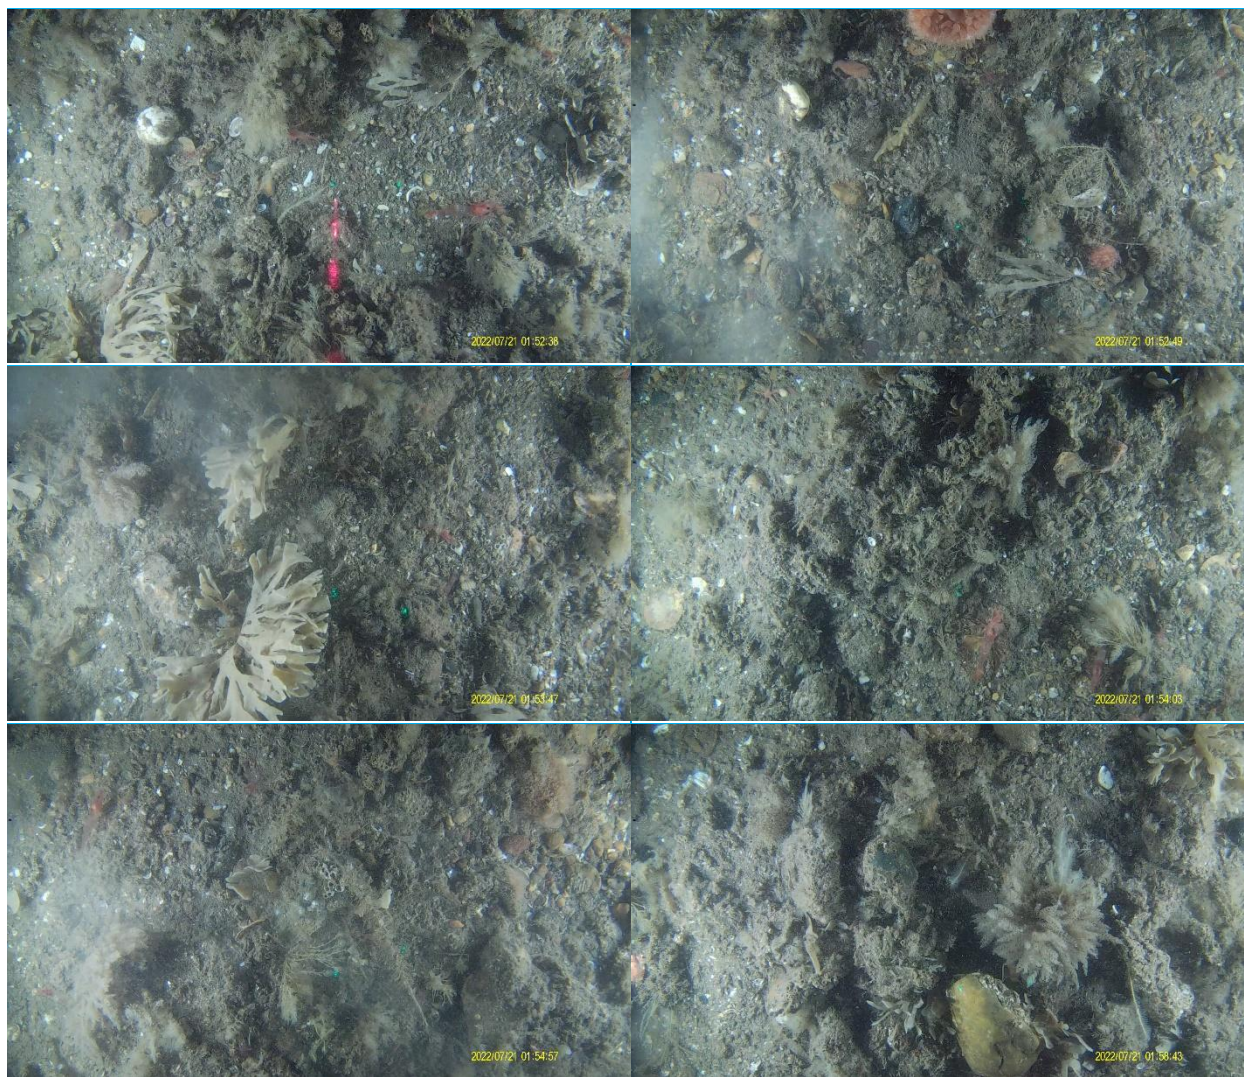
Table 18.

Screen capture images taken from ECC_VID_37, showing examples of the level of Sabellaria spinulosa present throughout video footage.

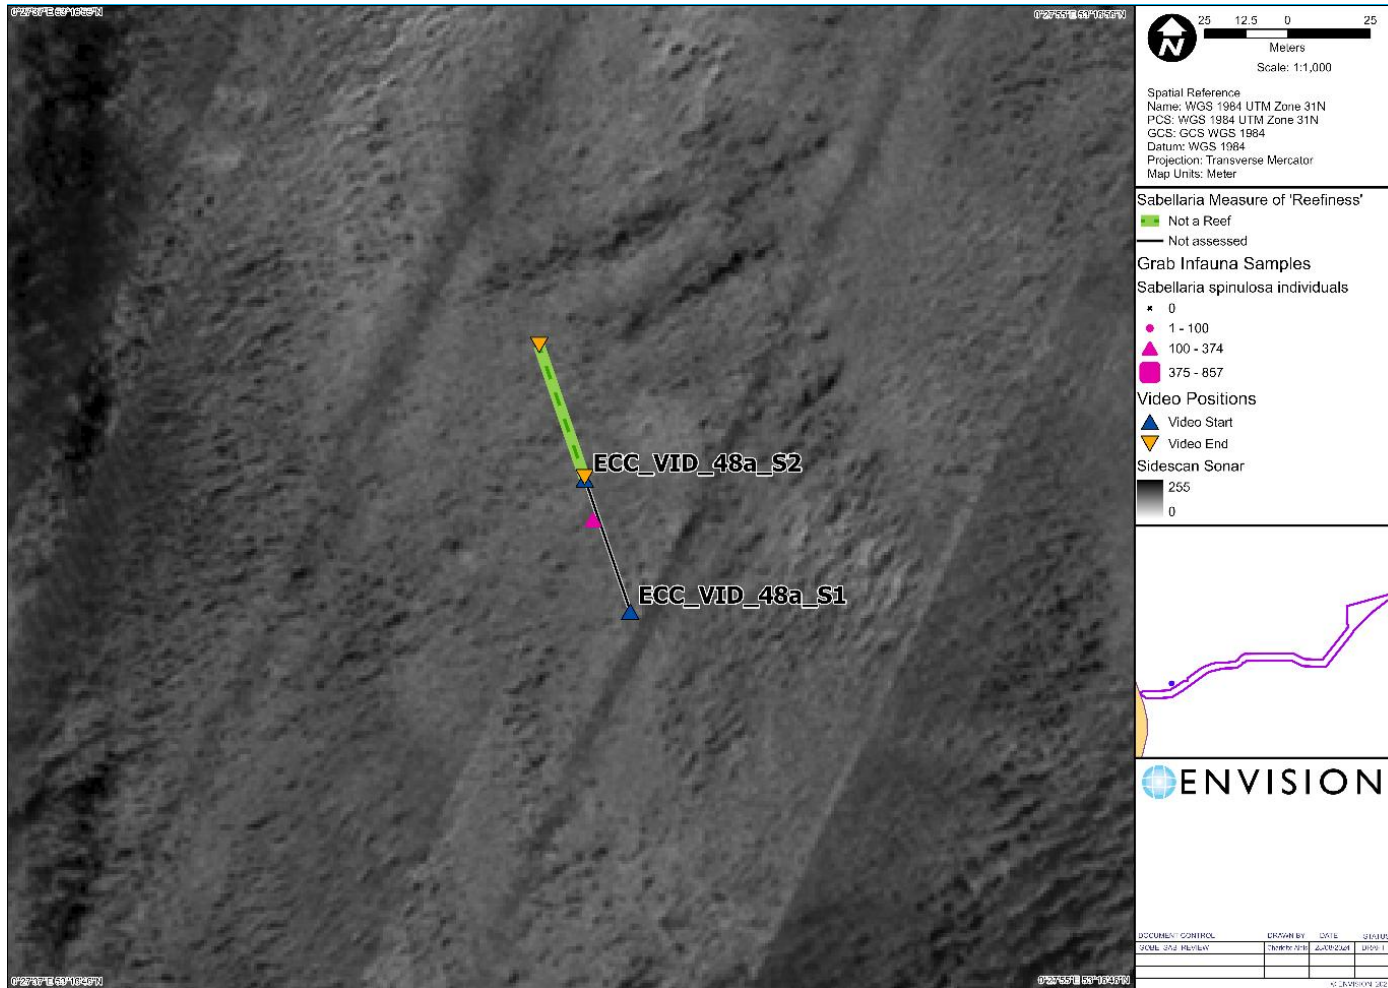
Figure 10.
'Reefiness' allocated to ECC_VID_48a, from Sabellaria spinulosa reef assessment (Gubbay, 2007").

Video station ECC_VID_48a was assessed as 'NOT a REEF' (Figure 10).

Numbers of individuals of *S. spinulosa* from the benthic grab sample collected at this station was 191, which is below the 375 threshold (Limpenny *et al.*, 2010ⁱⁱⁱ).

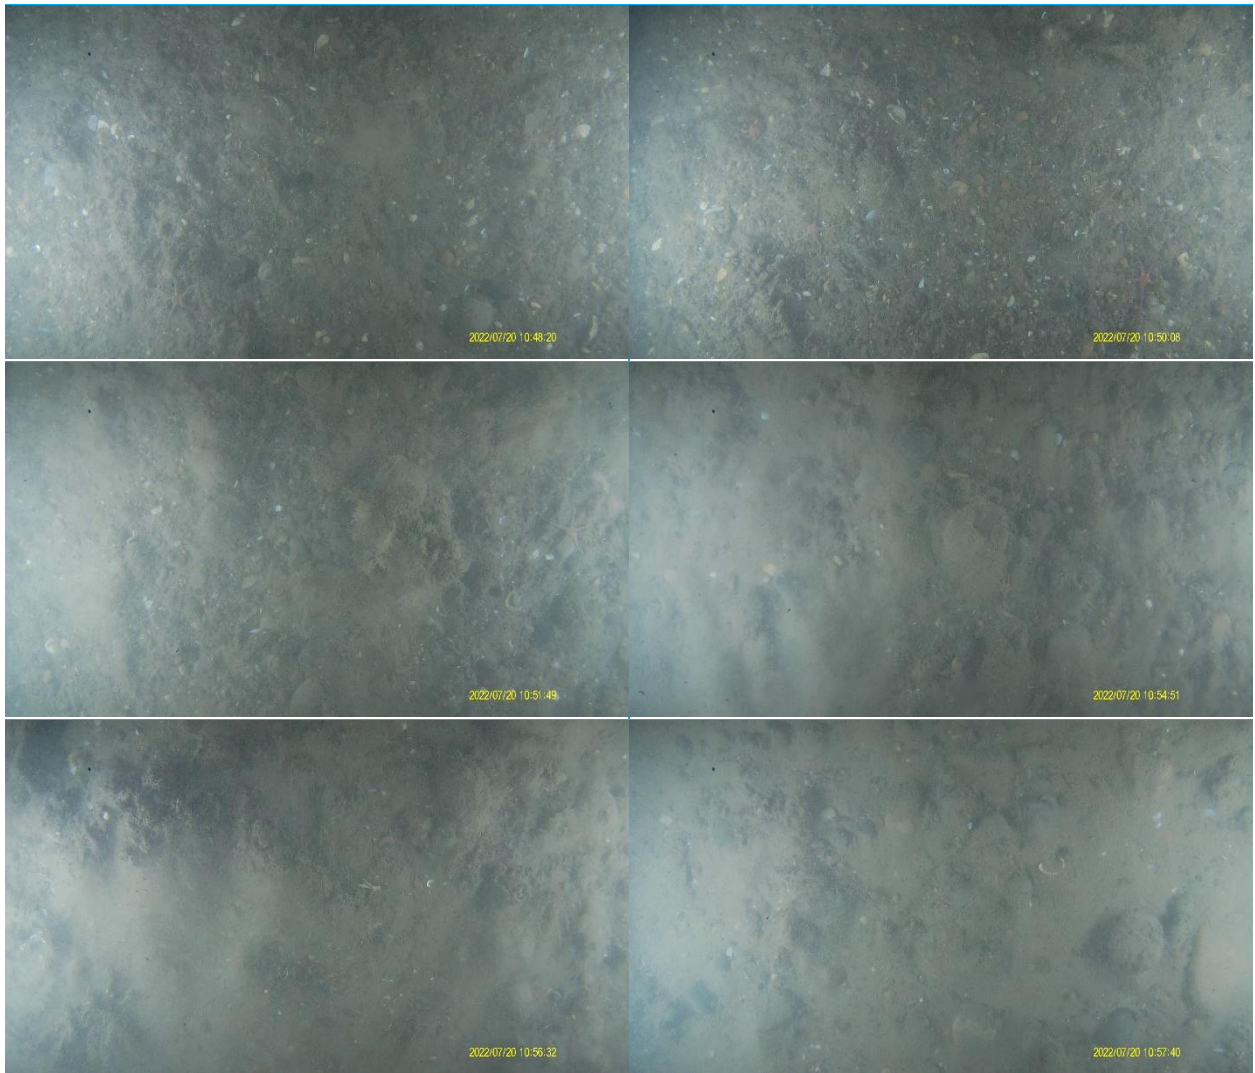
Table 20.

Screen capture images taken from ECC_VID_48a, showing examples of the level of Sabellaria spinulosa present throughout video footage.

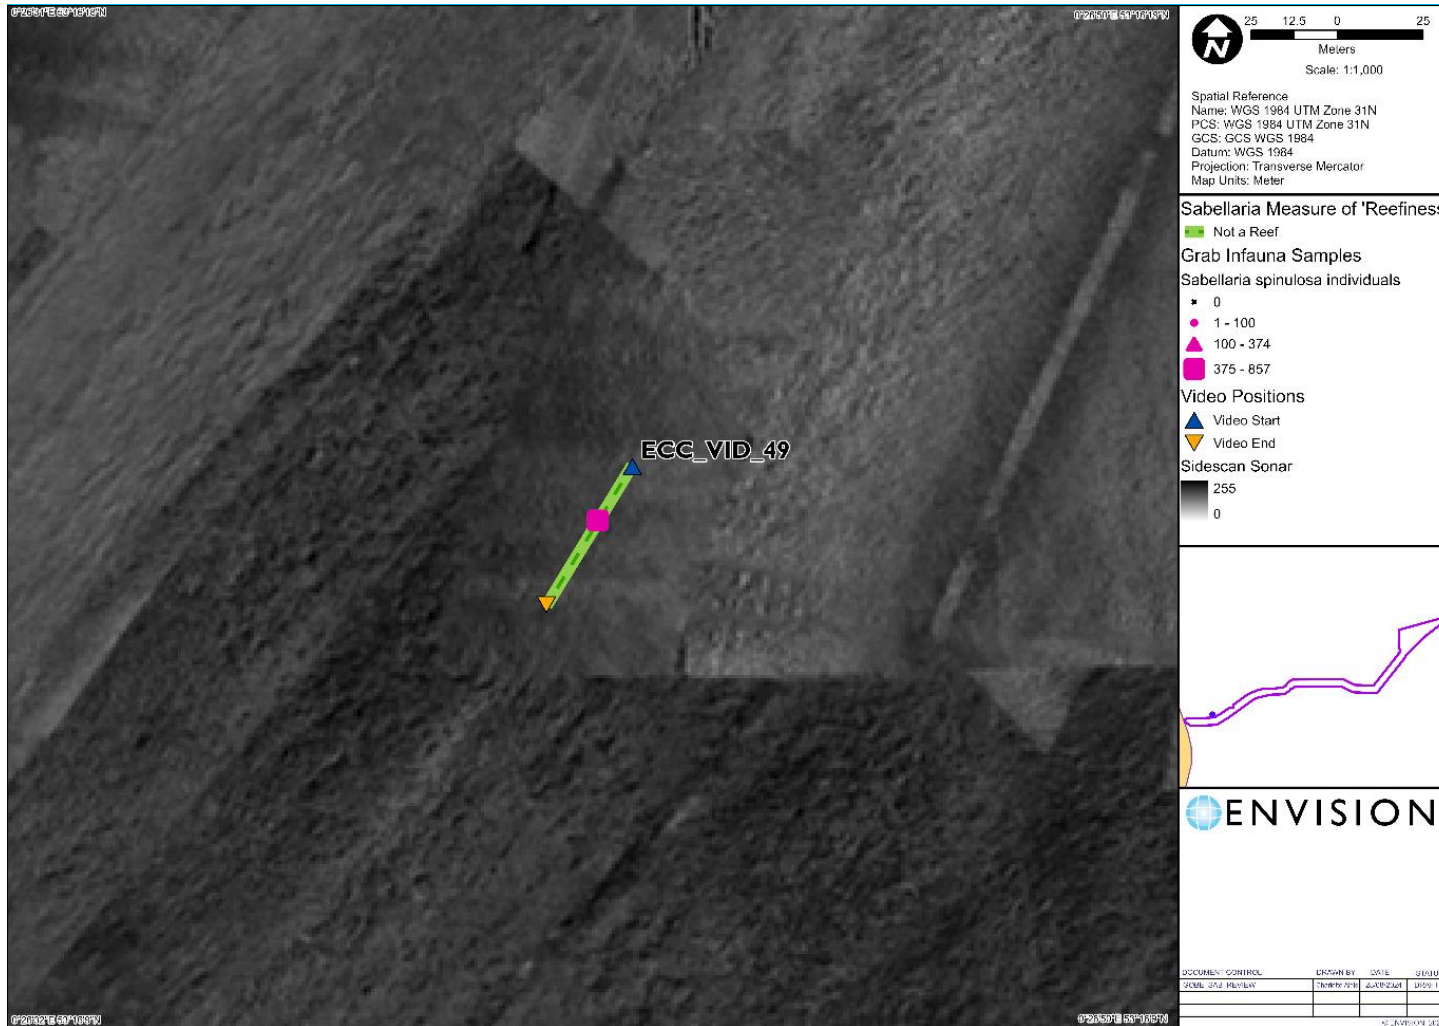
Figure 11. 'Reefiness' allocated to ECC_VID_49, from Sabellaria spinulosa reef assessment (Gubbay, 2007^{iv}).

Video station ECC_VID_49 was assessed as 'NOT a REEF' (Figure 11).

Numbers of individuals of *S. spinulosa* from the benthic grab sample collected at this station was 563, which is above the density of individuals for reef as detailed by Limpenny *et al.*, (2010ⁱⁱⁱ). However, underwater imagery and data from sidescan sonar confirm this station is 'NOT a REEF'.

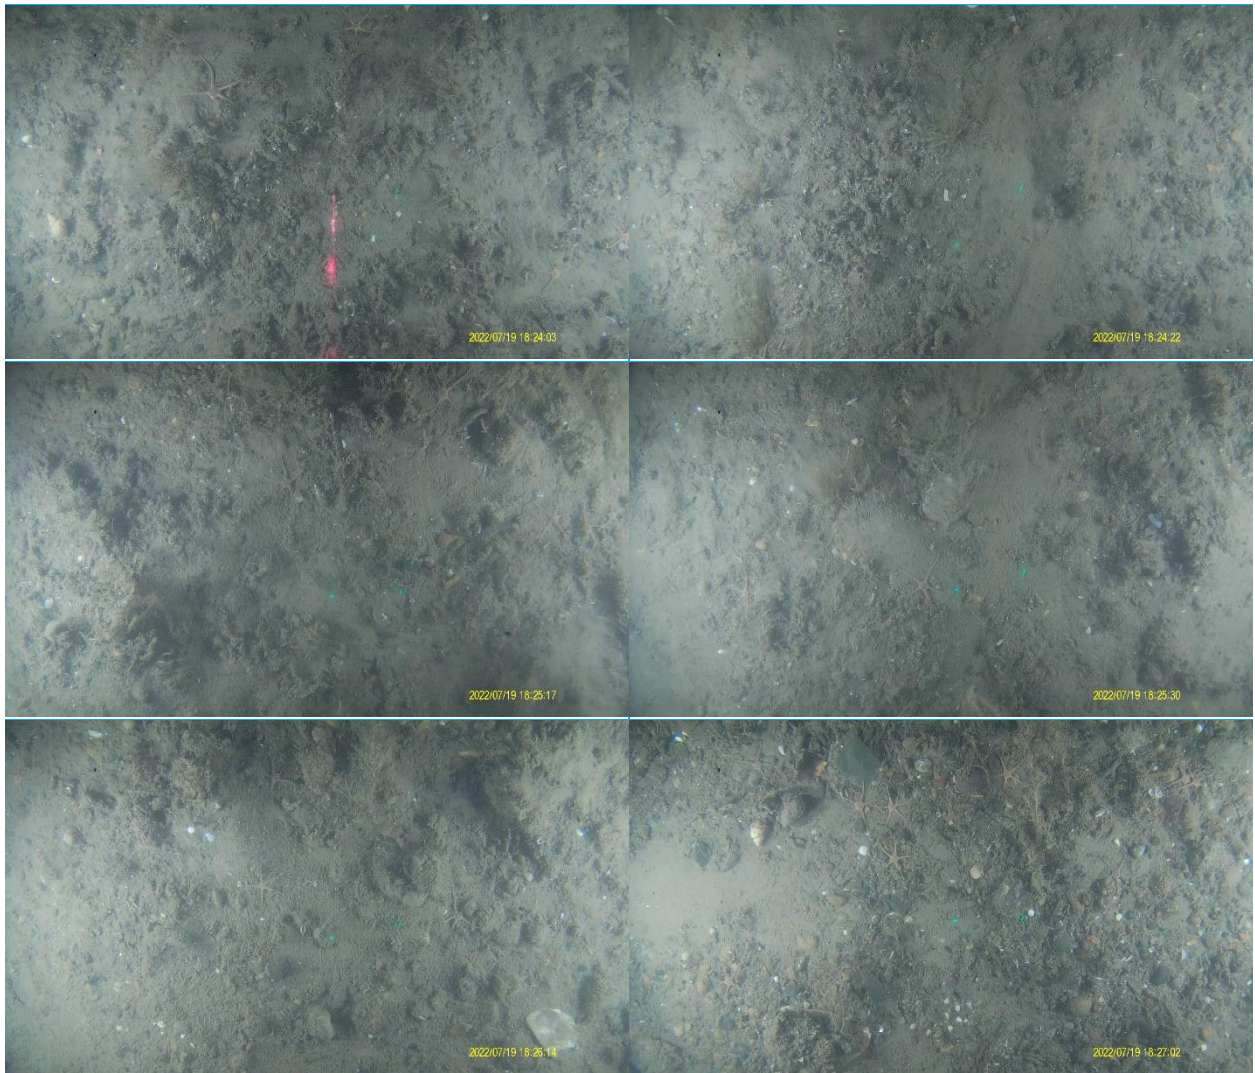
Table 22.

Screen capture images taken from ECC_VID_49, showing examples of the level of Sabellaria spinulosa present throughout video footage.

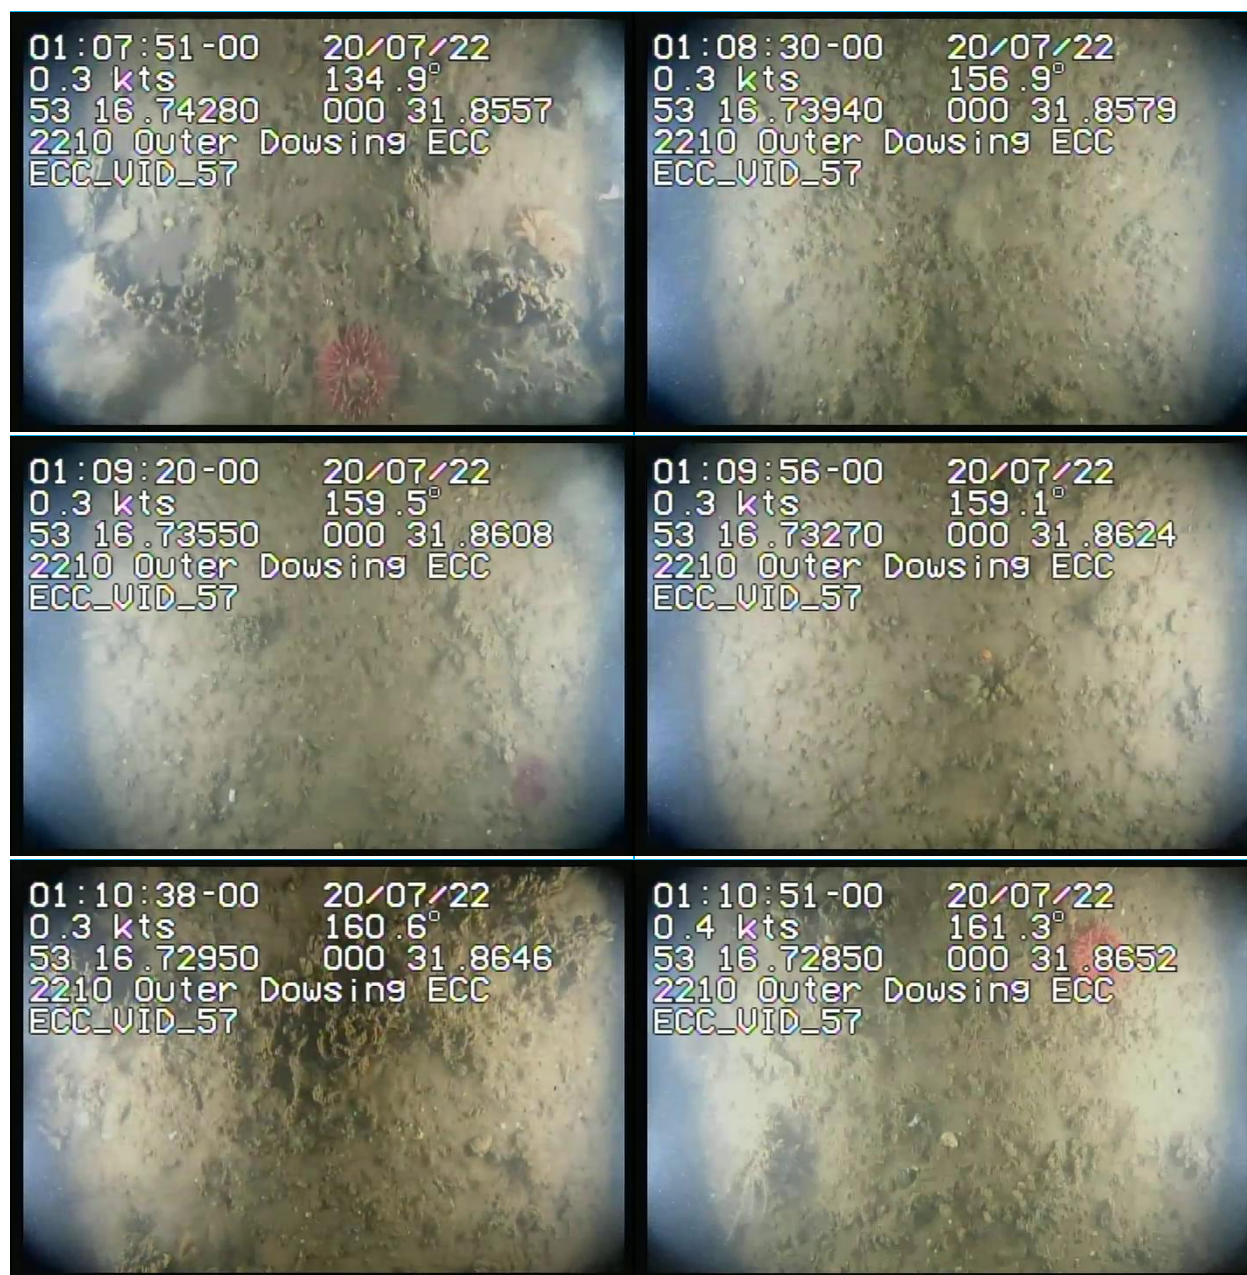
Table 24.

Screen capture images taken from ECC_VID_57, showing examples of the level of Sabellaria spinulosa present throughout video footage.

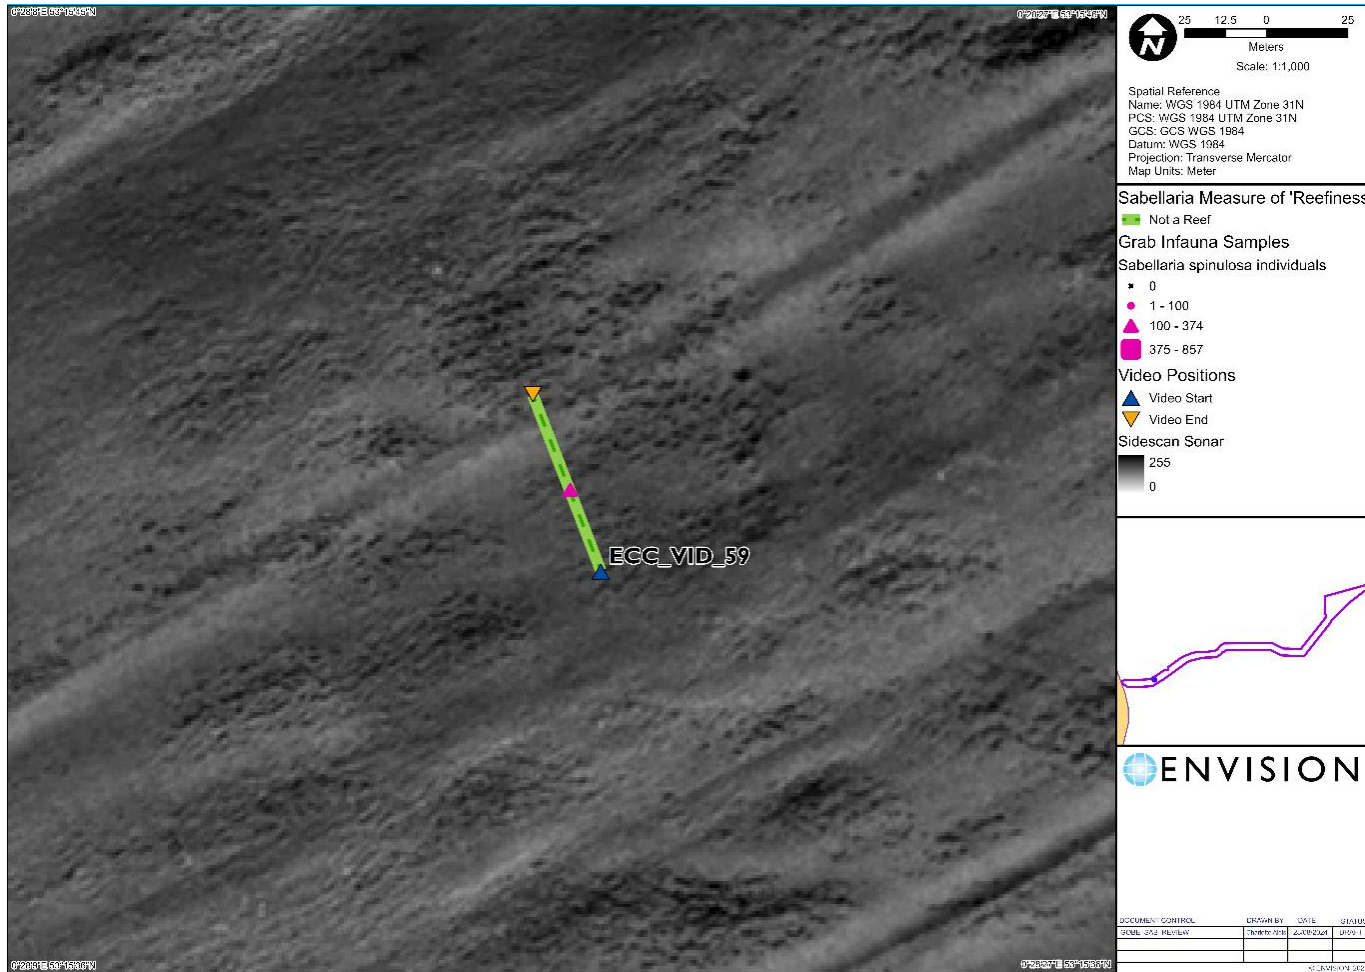
Figure 13. 'Reefiness' allocated to ECC_VID_59, from Sabellaria spinulosa reef assessment (Gubbay, 2007^m).

Video station ECC_VID_59 was assessed as 'NOT a REEF' (Figure 13).

Numbers of individuals of *S. spinulosa* from the benthic grab sample collected at this station was 195, which is below the 375 threshold (Limpenny *et al.*, 2010ⁱⁱⁱ).
