Outer Dowsing Offshore Wind

Offshore Export Cable Corridor

Sabellaria Spinulosa Reanalysis and Report

Document Reference: 15.13 V2
Revision: 2.0

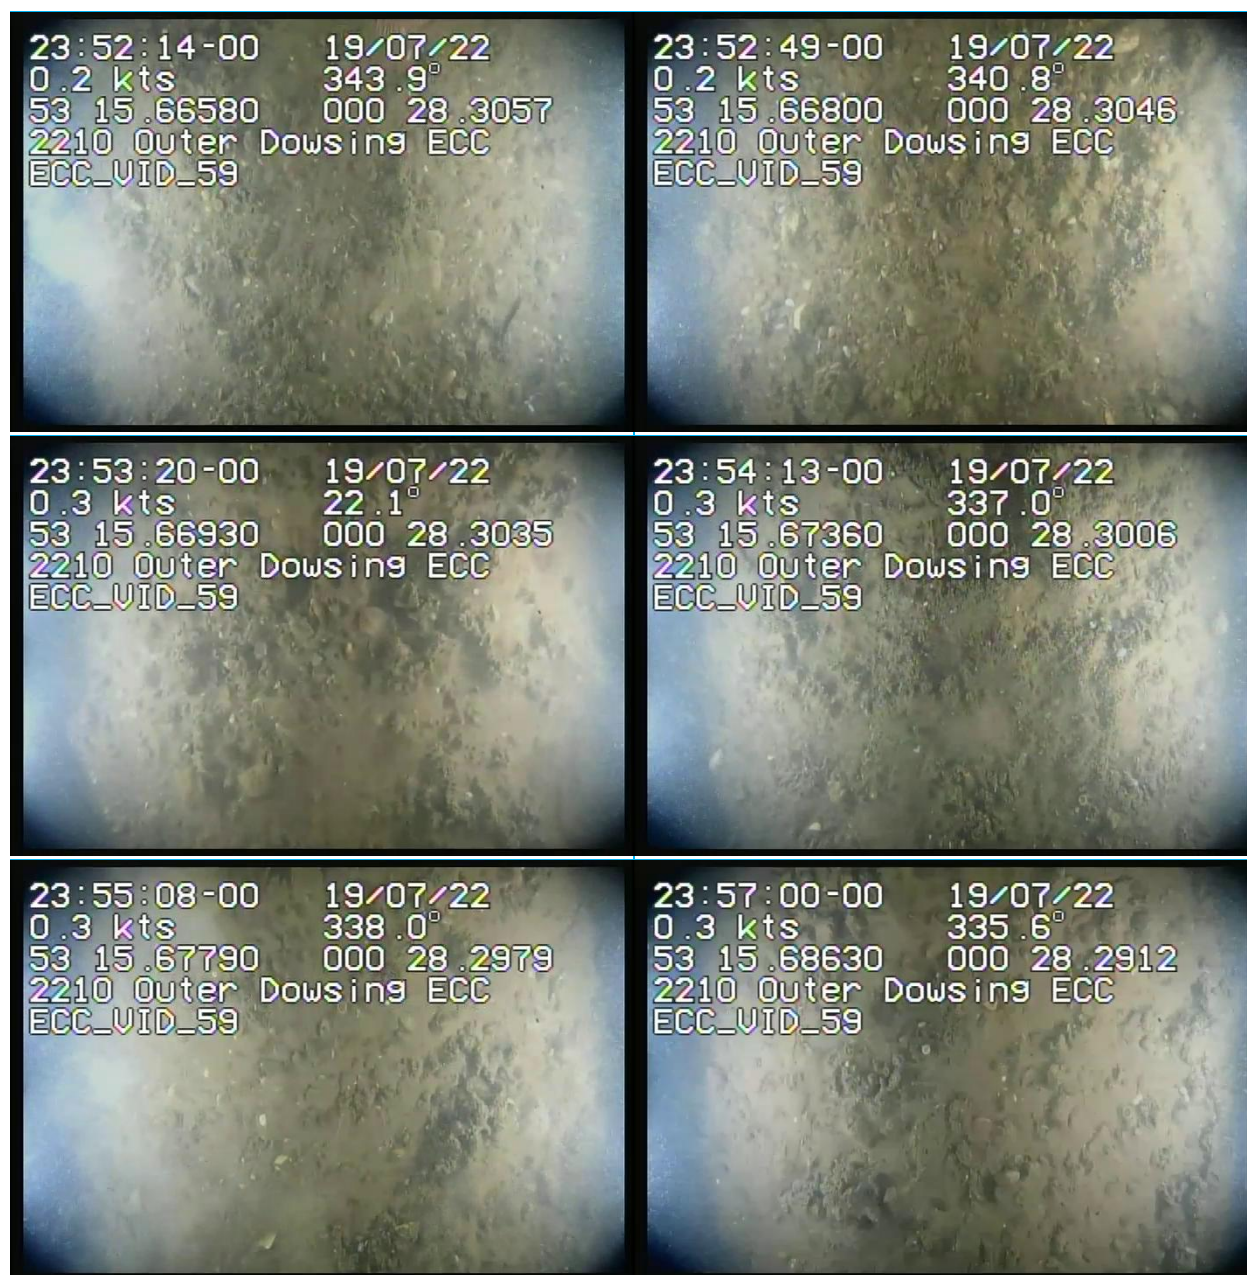
Table 26.

Screen capture images taken from ECC_VID_59, showing examples of the level of Sabellaria spinulosa present throughout video footage.

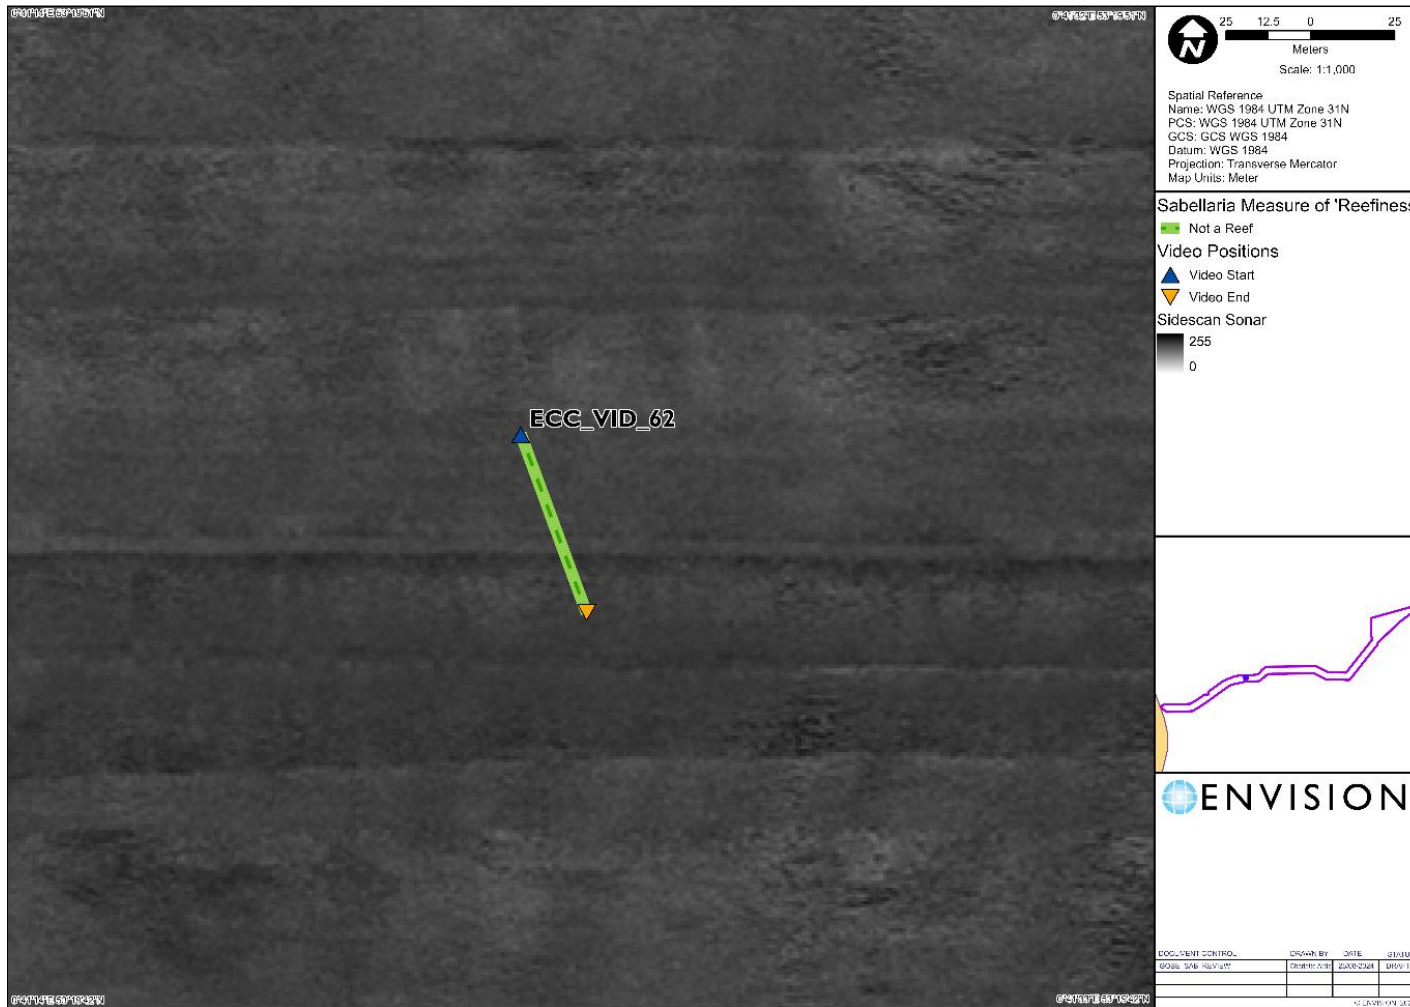
Sidescan sonar data (Figure 14) does not indicate any features distinct from the surrounding seabed or any elevated features.

Figure 14.
 'Reefiness' allocated to ECC_VID_62, from Sabellaria spinulosa reef assessment (Gubbay, 2007TM).

Video station ECC_VID_62 was assessed as 'NOT a REEF' (Figure 14).

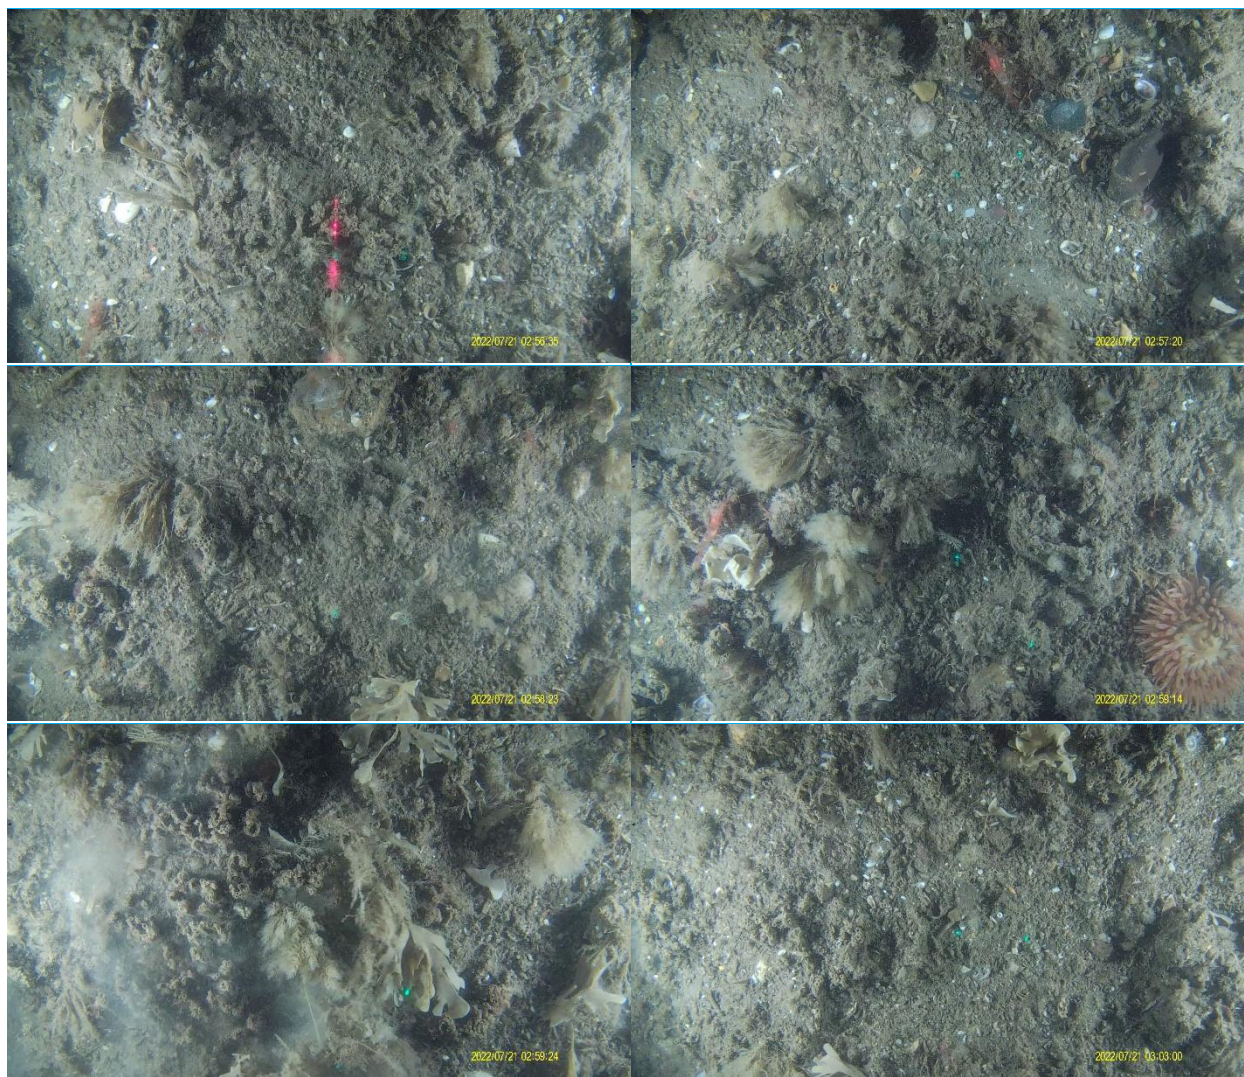
Table 28.

Screen capture images taken from ECC_VID_62, showing examples of the level of Sabellaria spinulosa present throughout video footage.

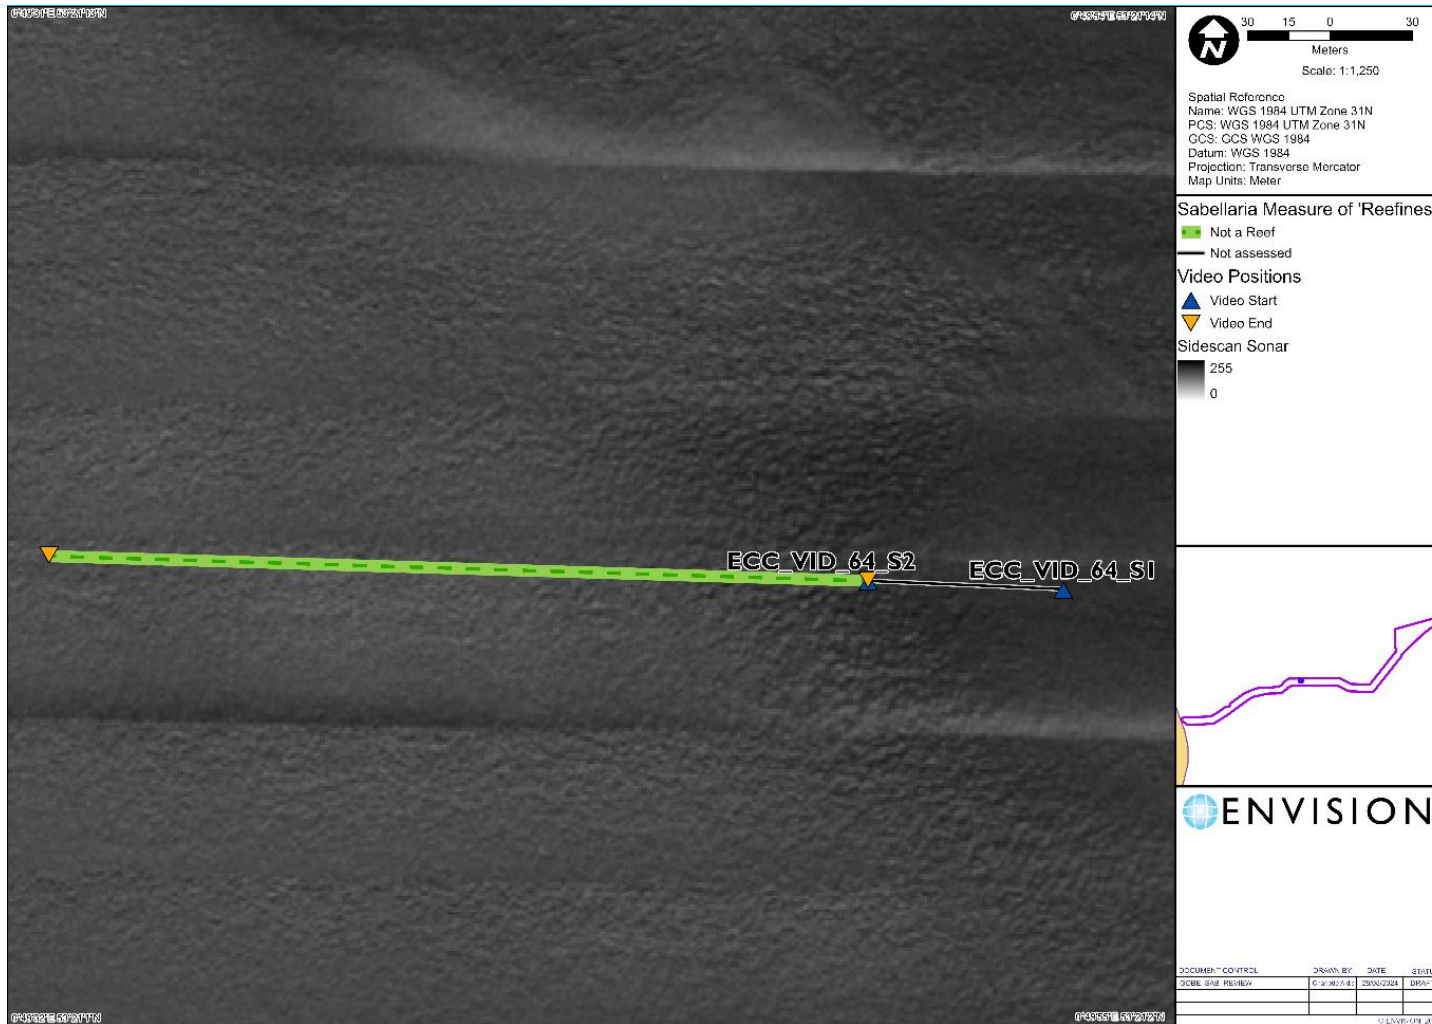
The seabed along the video sample and adjacent to it, shows some indication of variable ground with this area being approximately 30,000 square metres in size. However, with assessment of video footage allocating patchiness (% cover) as below 10% and area of less than 25 m² of *S. spinulosa* cover, station ECC_VID_64 is 'NOT a REEF'.

Figure 15.
 'Reefiness' allocated to ECC_VID_64, from Sabellaria spinulosa reef assessment (Gubbay, 2007^{iv}).

Video station ECC_VID_64 was assessed as 'NOT a REEF' (Figure 15).

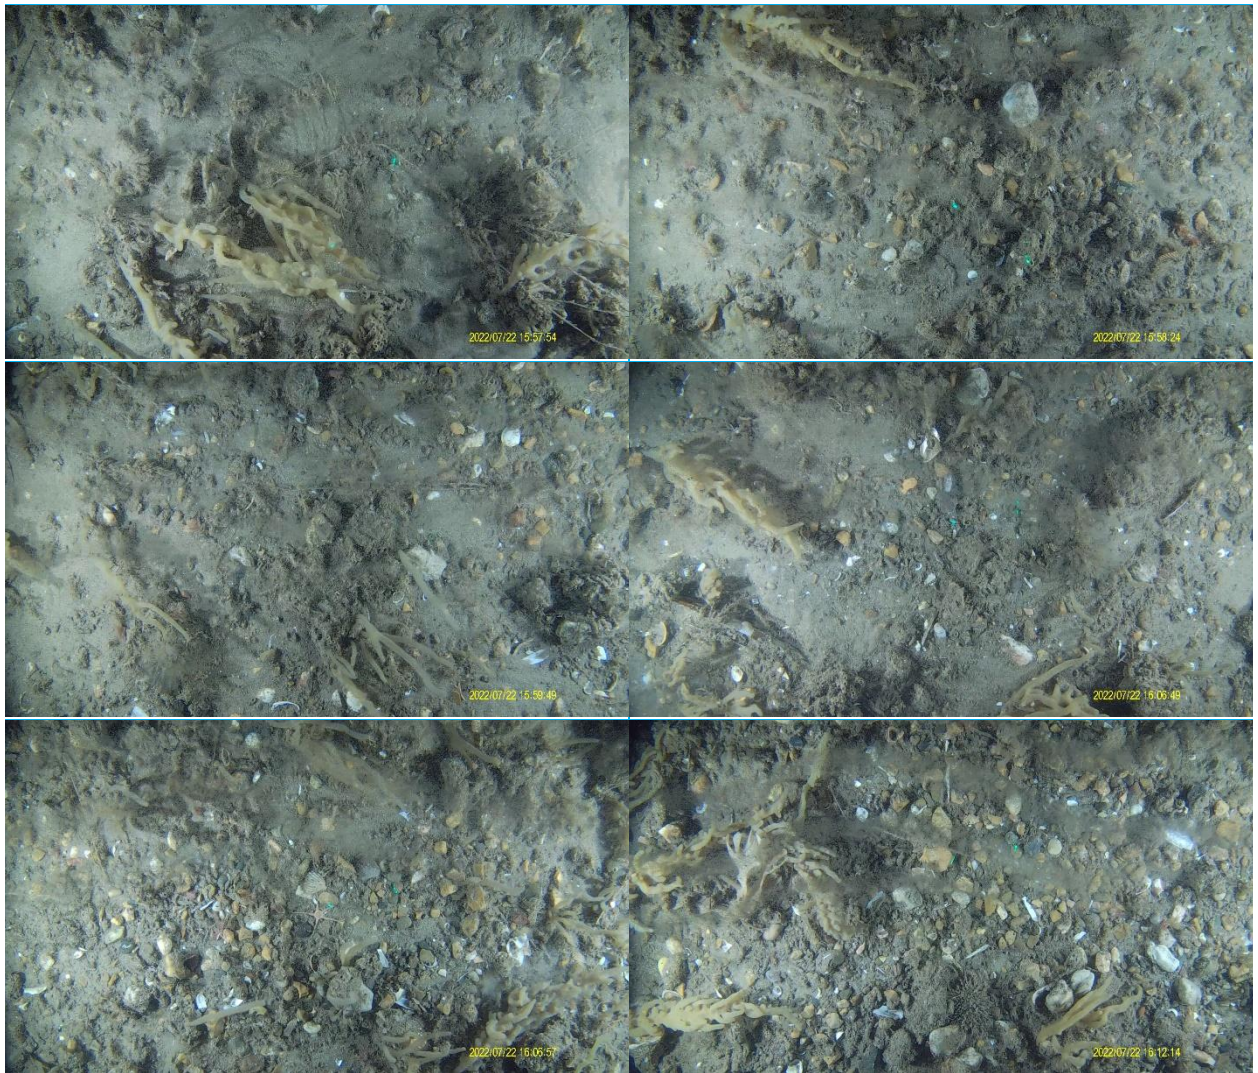
Table 30.

Screen capture images taken from ECC_VID_64, showing examples of the level of Sabellaria spinulosa present throughout video footage.

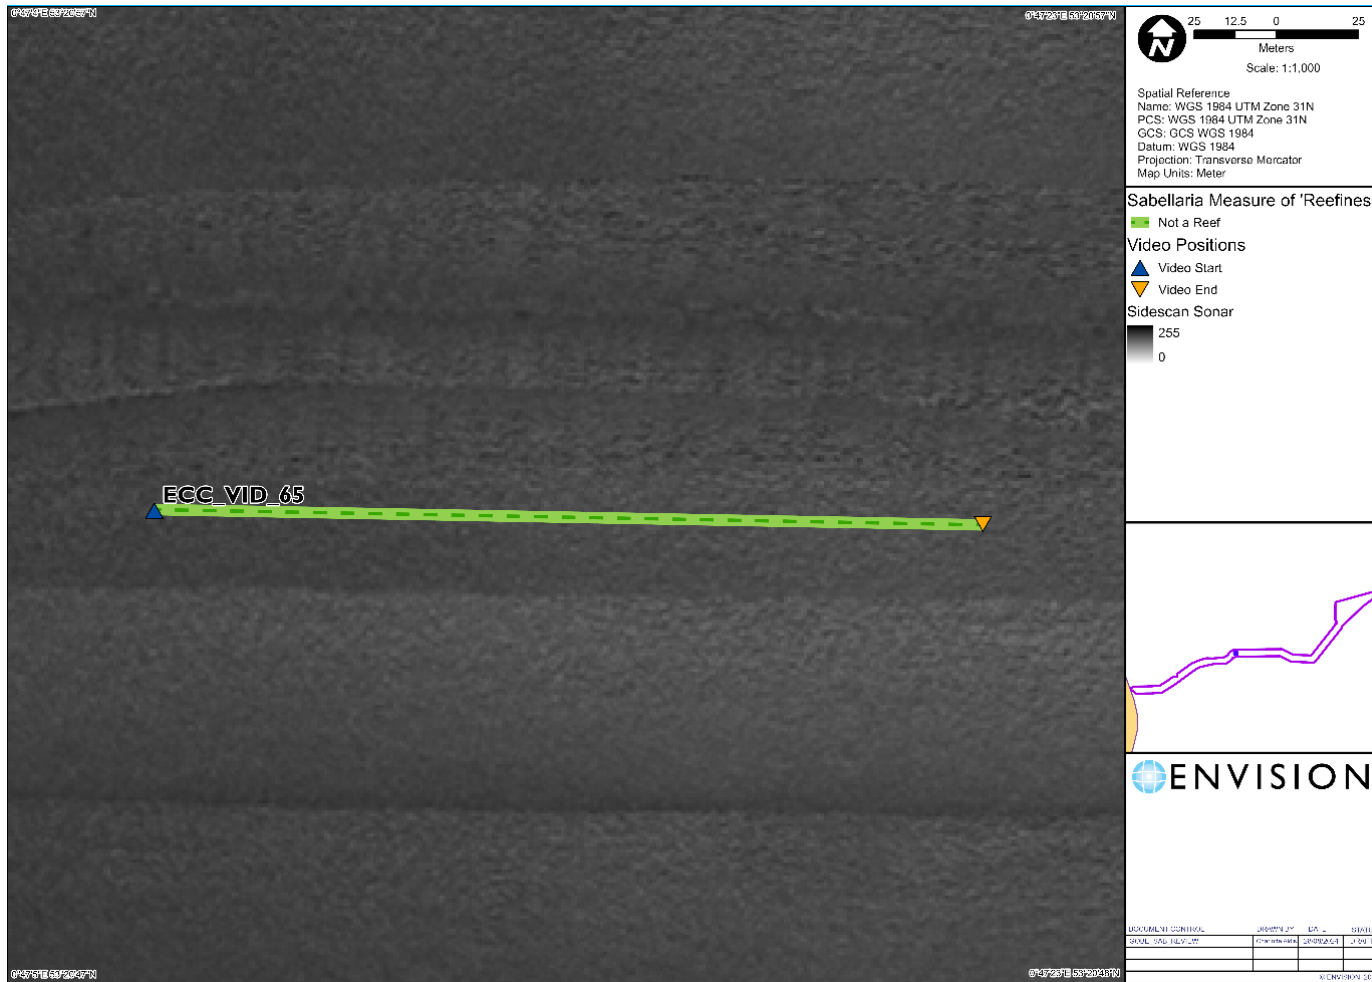
Sidescan sonar data (Figure 16) does not indicate any features distinct from the surrounding seabed or any elevated features.

Figure 16. 'Reefiness' allocated to ECC_VID_65, from Sabellaria spinulosa reef assessment (Gubbay, 2007^{iv}).

Video station ECC_VID_65 was assessed as 'NOT a REEF' (Figure 16).

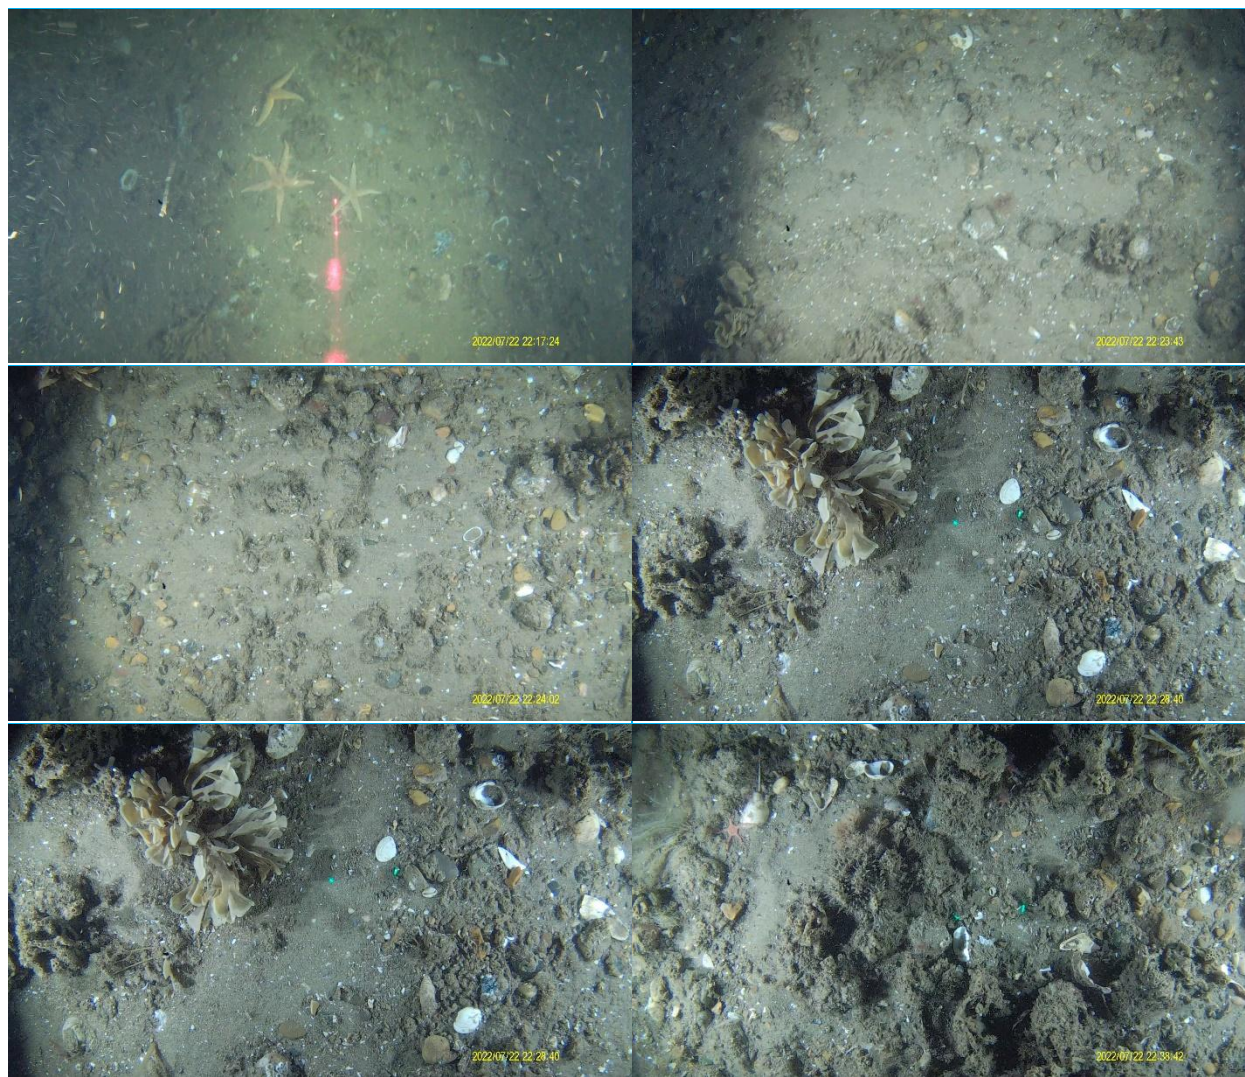
Table 32.

Screen capture images taken from ECC_VID_65, showing examples of the level of Sabellaria spinulosa present throughout video footage.

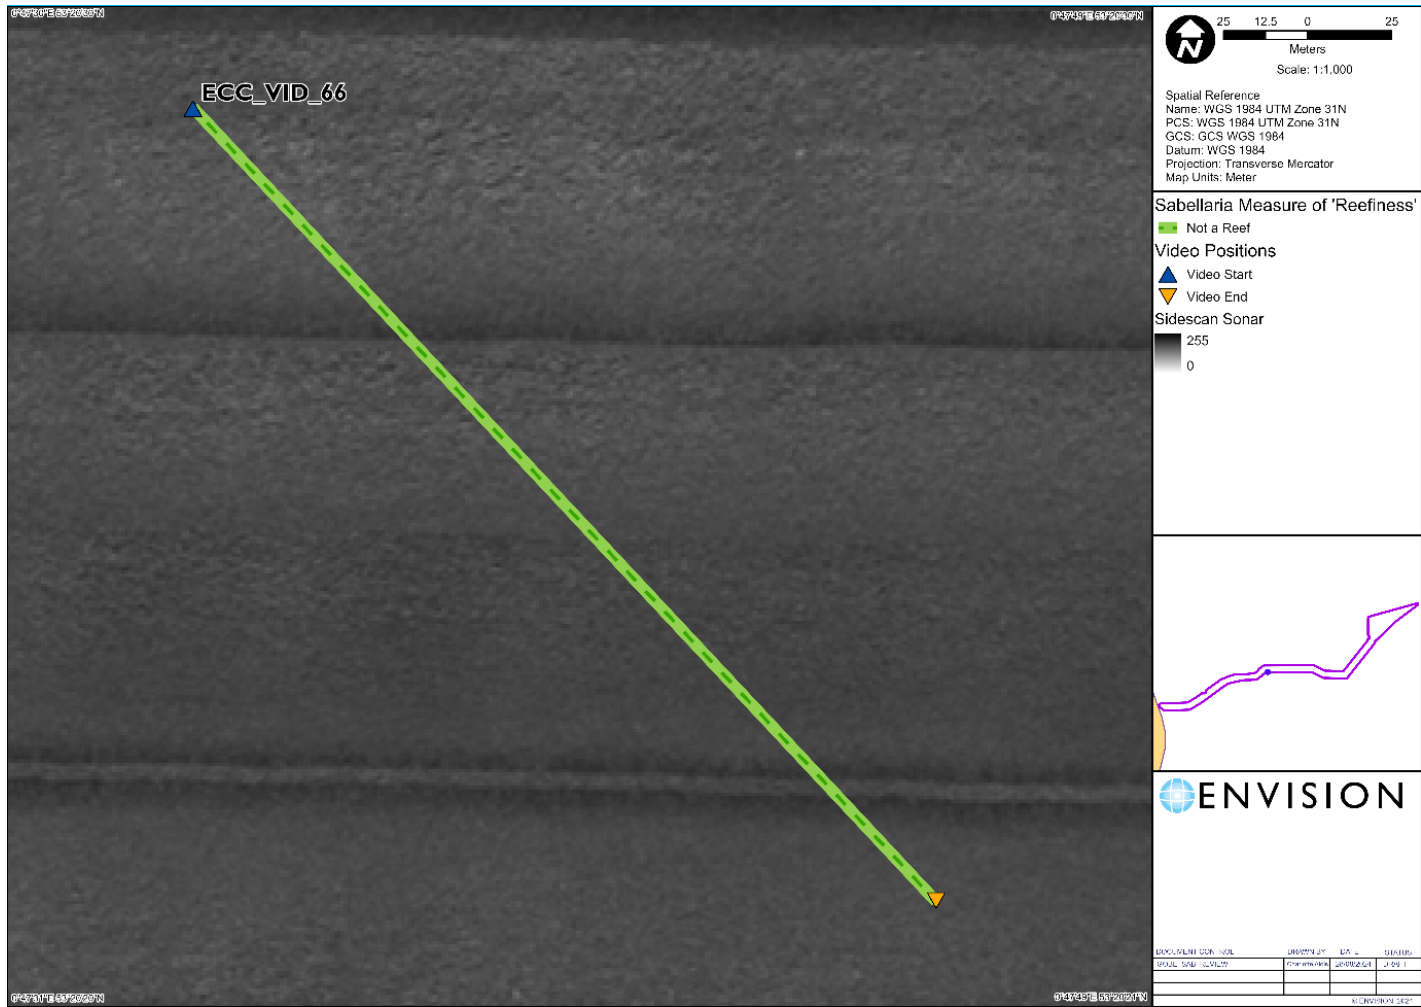
Sidescan sonar data (Figure 17) shows some variability in seabed texture but no features which are distinct from the surrounding seabed or any elevated features.

Figure 17. 'Reefiness' allocated to ECC_VID_66, from Sabellaria spinulosa reef assessment (Gubby, 2007TM).

Video station ECC_VID_66 was assessed as 'NOT a REEF' (Figure 17).

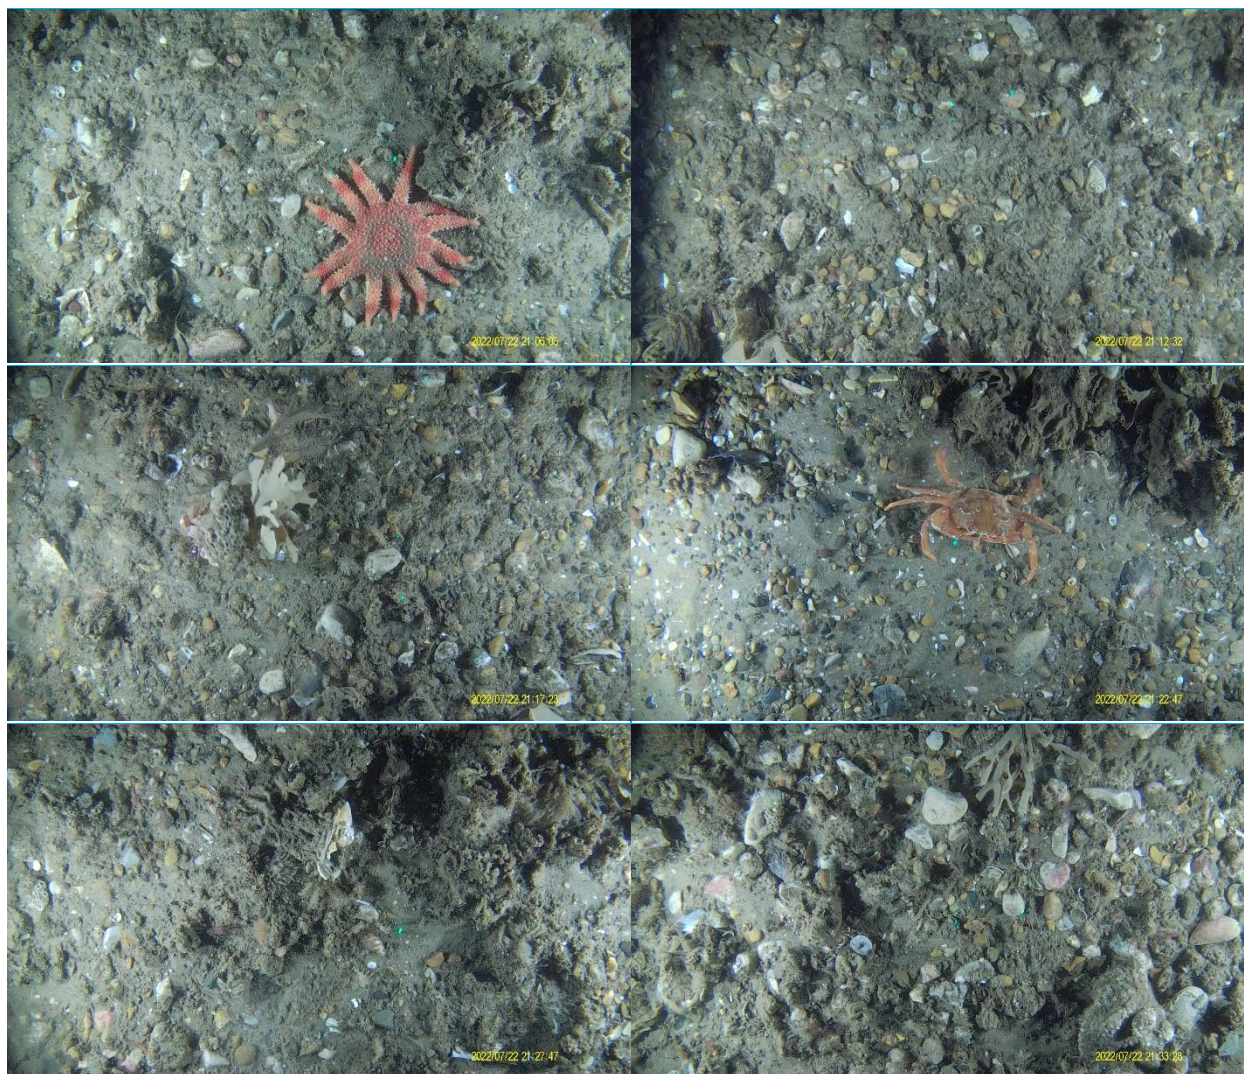
Table 34.

Screen capture images taken from ECC_VID_66, showing examples of the level of Sabellaria spinulosa present throughout video footage.
