West Burton Solar Project

Environmental Statement Appendix 2.1: EIA Scoping Report (Part 5 of 5)

EIA Scoping Report Appendices (Part 4 of 4): Chapters 11-22

West Burton Solar Project: EIA Scoping Report

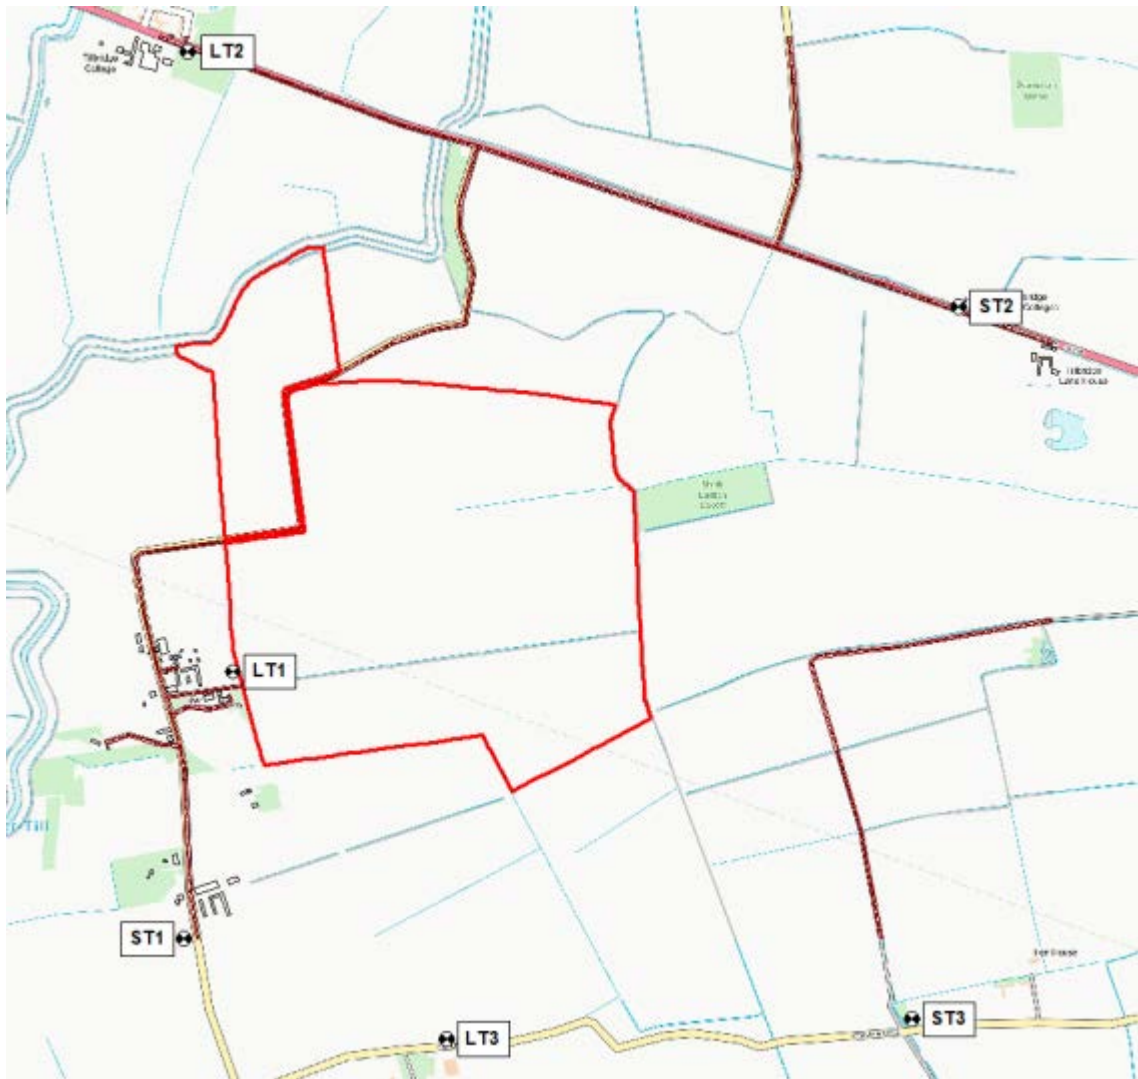
Figure 15.1 Noise Monitoring Locations

15.1.2 The dominant noise source found in the area include road traffic noise from Broxholme Lane and Carlton Lane. A summary of the baseline noise monitoring survey is shown in Table 15.1 below.

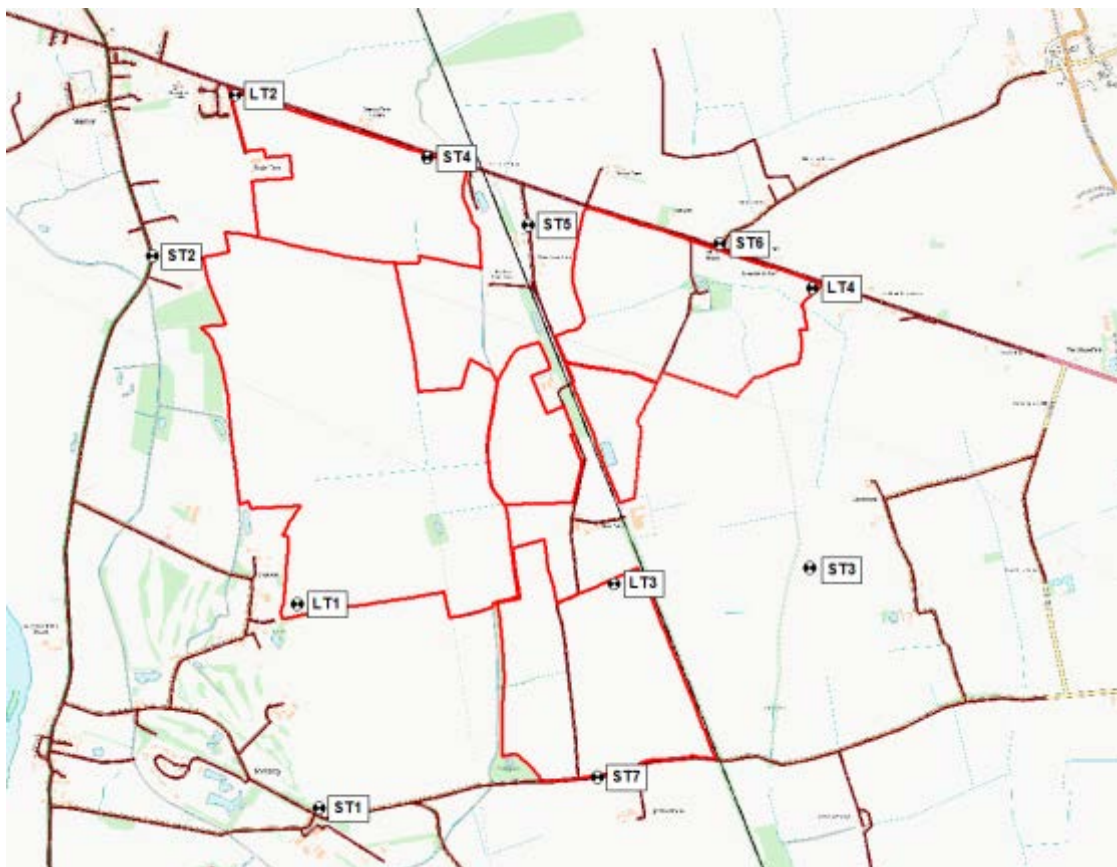
Figure 15.3 Noise Monitoring Locations

The baseline noise environment has been established following a noise survey undertaken from Thursday 16th September 2021 to Wednesday 17th November 2021. Attended 15-minute short-term measures were undertaken at four locations during the day, evening and night-time periods with two additional locations being measured unattended over a 117-hour period. Full details of the noise monitoring survey will be presented within the noise technical report, with a brief summary provided below. The locations of these measurements can be found on Figure 15.3 below.

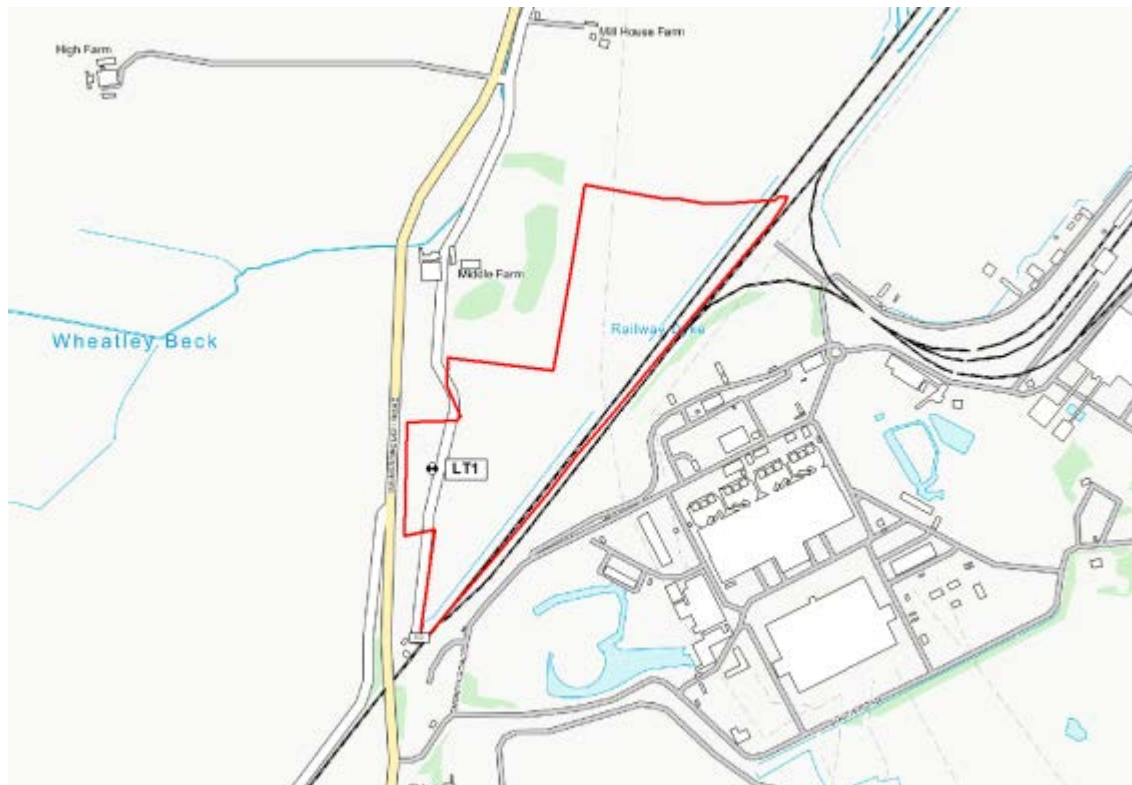
Figure 15.5 Noise Monitoring Locations

15.5.1 The baseline noise environment has been established following a noise survey undertaken from Tuesday 21st September 2021 to Monday 27th September 2021. Unattended long-term measurements were undertaken at one location over a 150-hour period. Full details of the noise monitoring survey will be presented within the noise technical report, with a brief summary provided below. The locations of these measurements can be found on Figure 15.5 below.

15.5.2 A summary of the baseline noise monitoring survey is shown in Table 15.5 below.

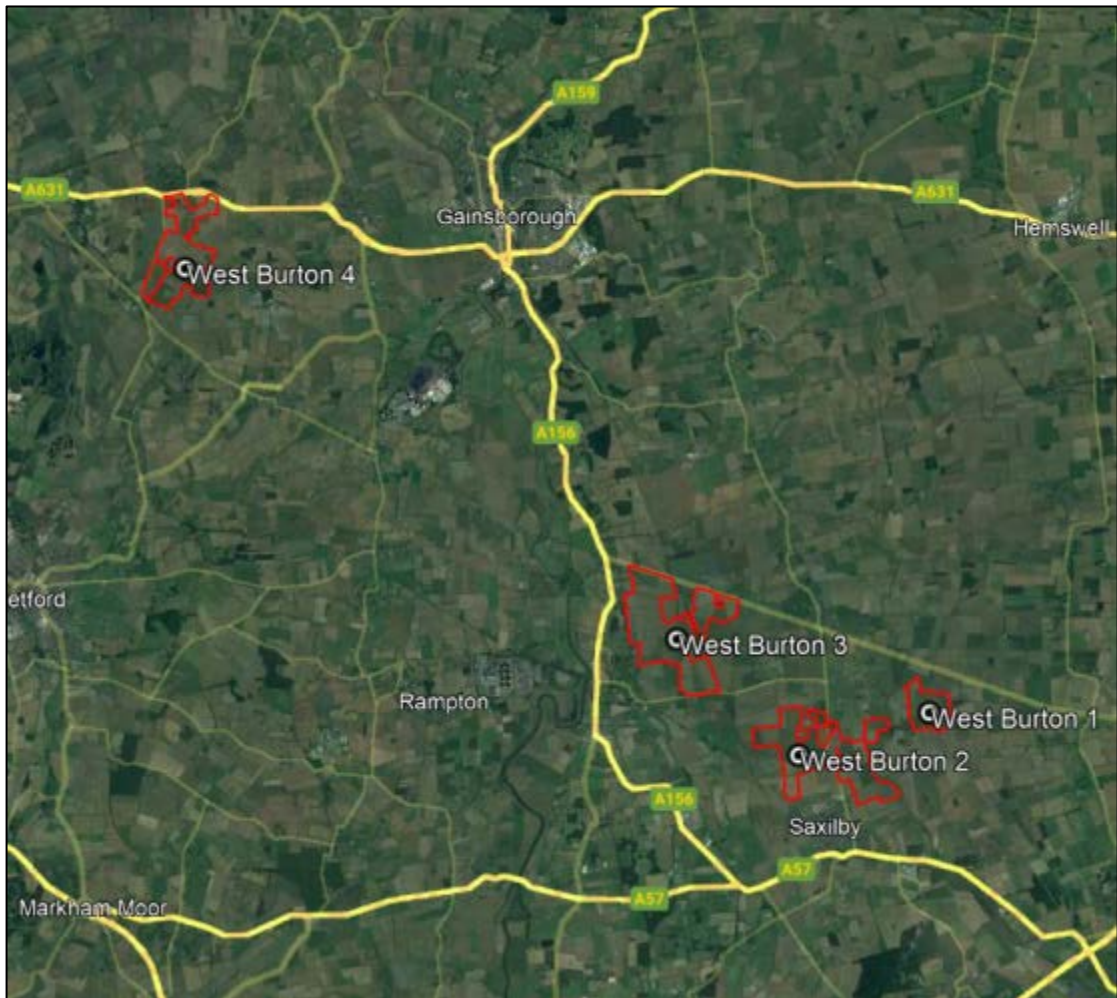
Figure 1 Proposed solar development location

The proposed development will consist of four potential locations known as West Burton 1 to 4. The location for the proposed development is shown by the red line boundaries in Figure 1² below.

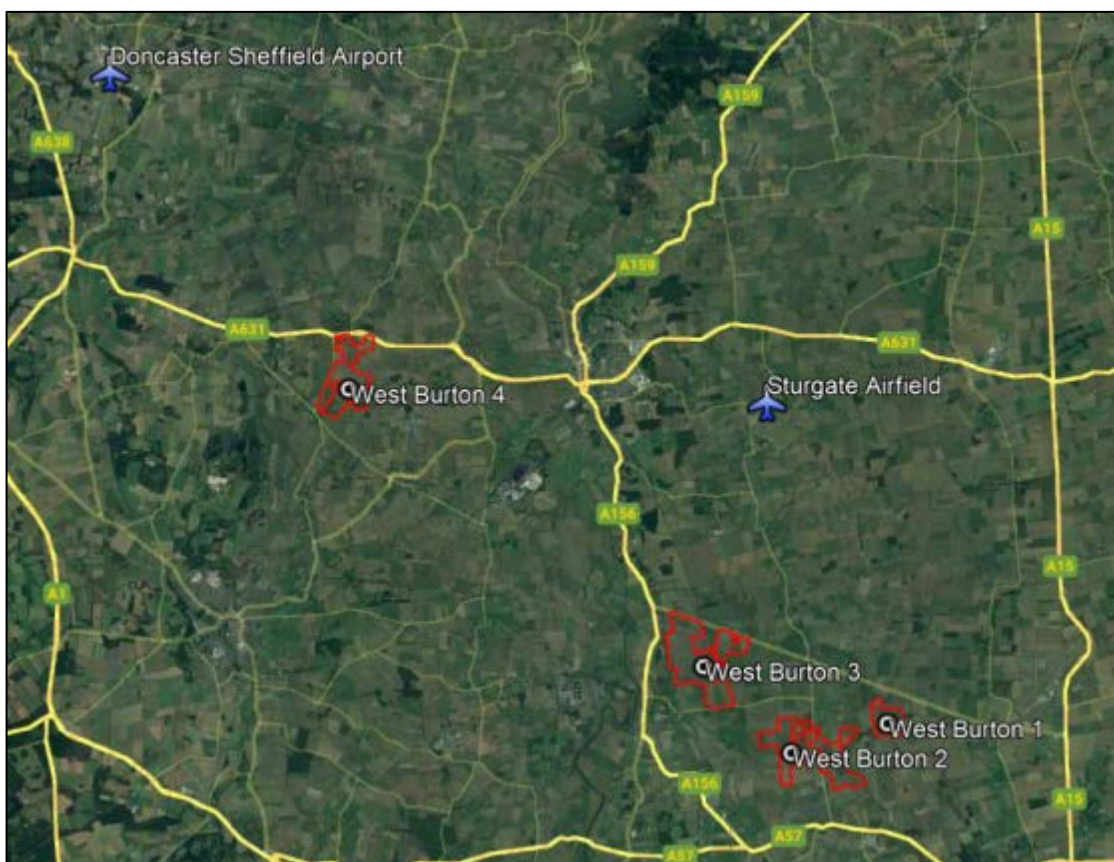
Figure 2 Doncaster Sheffield Airport and Sturgate Airfield, relative to the proposed development

Doncaster Sheffield Airport and Sturgate Airfield are located approximately 10.5km north-west and 13km south-east of West Burton 4 respectively. Doncaster Airport has one runway 02/20, and Sturgate Airfield has two 09/27 and 14/32. Their locations relative to the proposed development are shown in Figure 2² below

The orientation of the runways, for Sturgate Airfield, is such that the proposed development will be outside the pilot's primary field of view (50 degrees either side of the approach bearing) for pilots approaching thresholds 09 and 32. This means that, even if solar reflections are predicted towards pilots, the reflection will originate from outside the pilot's field of view and will therefore not be deemed significant.

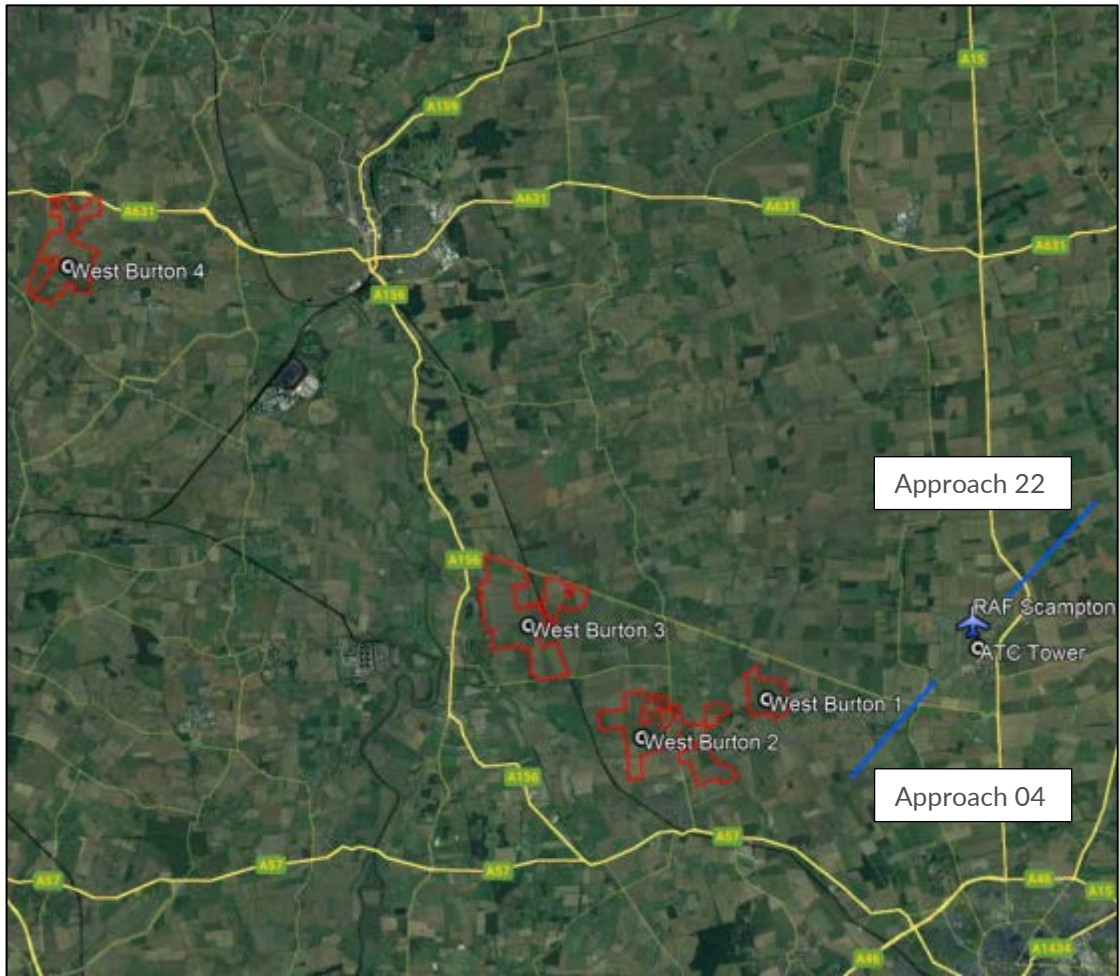
Technical modelling for RAF Scampton will only be carried out for West Burton sites 1, 2 and 3. While only a high level assessment will be needed for West Burton 4 due to the large separation distance and the orientation of the runways.

Figure 3 RAF Scampton runway approach receptors and ATC Tower

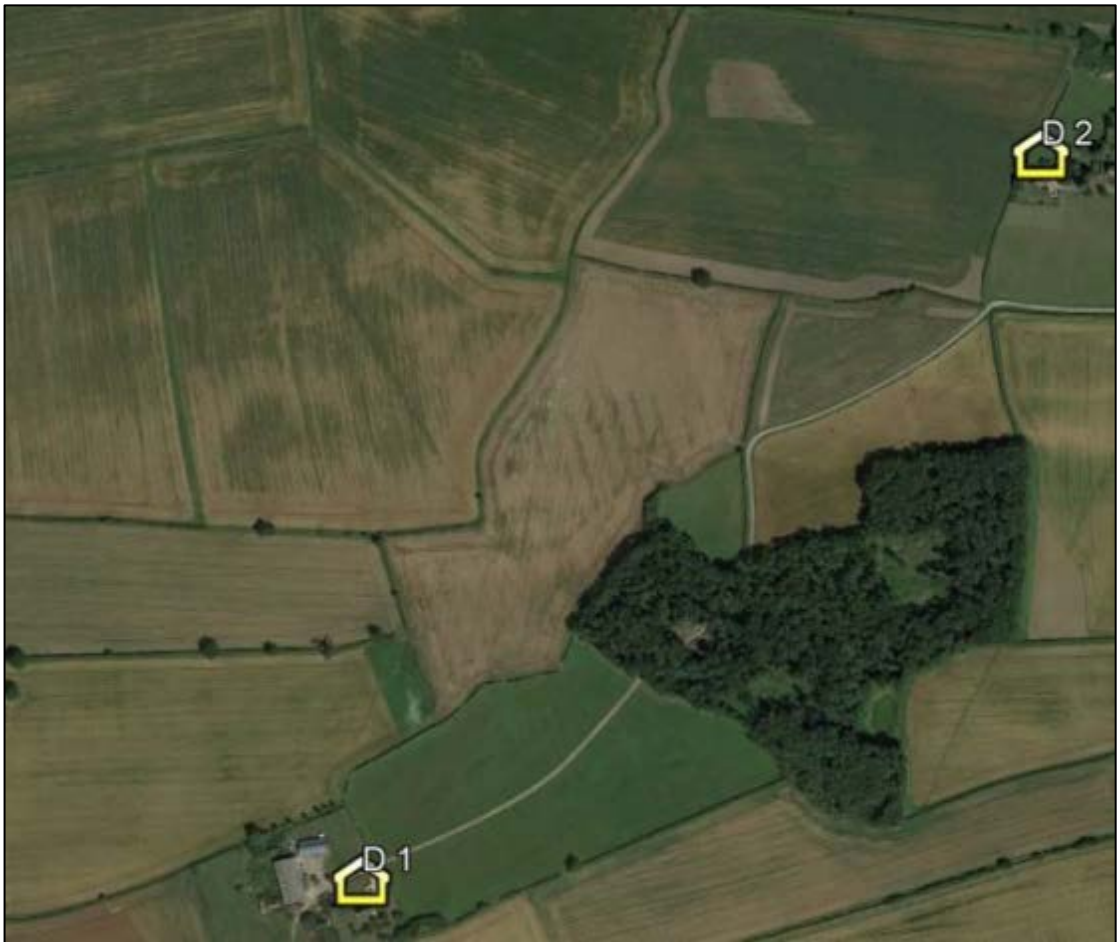
Figure 35 West Burton 4: Dwelling location overview

In total, 127 dwelling receptors points have been identified for the assessment of this area. The assessed dwellings are shown from Figure 35 to Figure 43 below and on the following pages².

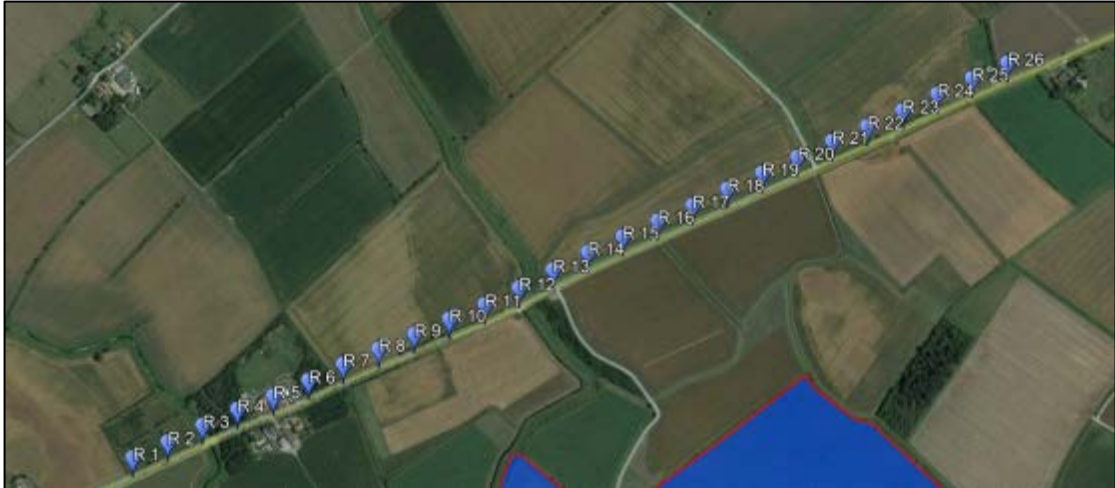
Figure 44 West Burton 1: Identified road receptors

One road has been identified for the assessment (Till Bridge Lane) which is shown in Figure 44² below. In total, 26 road receptor points have been identified for the assessment of this area.

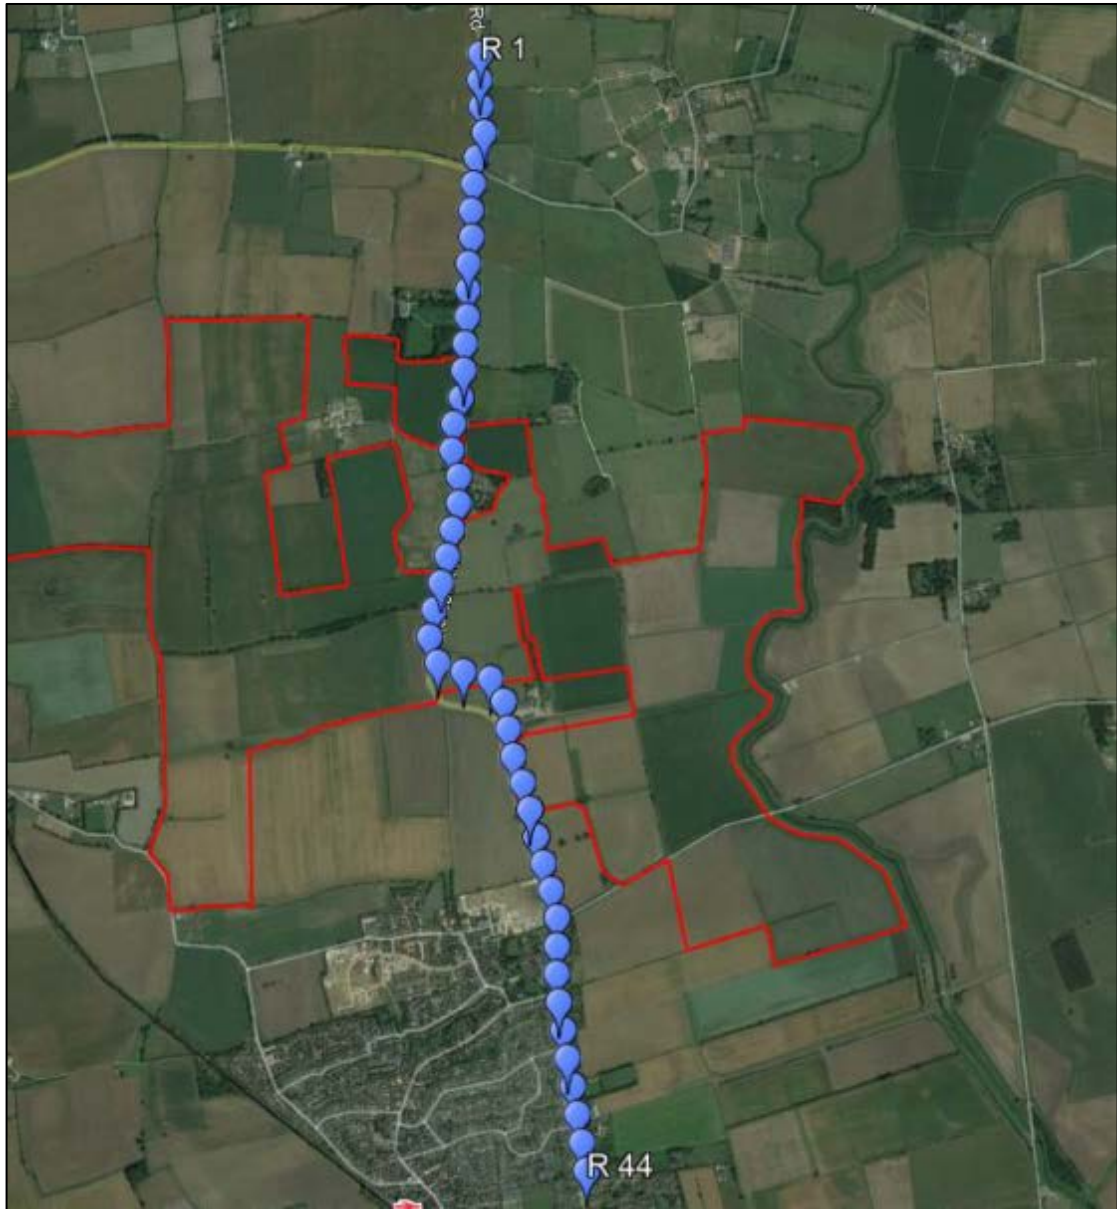
Figure 45 West Burton 2: Sturton Road, receptors 1 to 44

In total, 54 road receptor points have been identified for the assessment of this area over two roads: Sturton road and Church Road, shown in Figure 45² to Figure 46² below and on the following page.

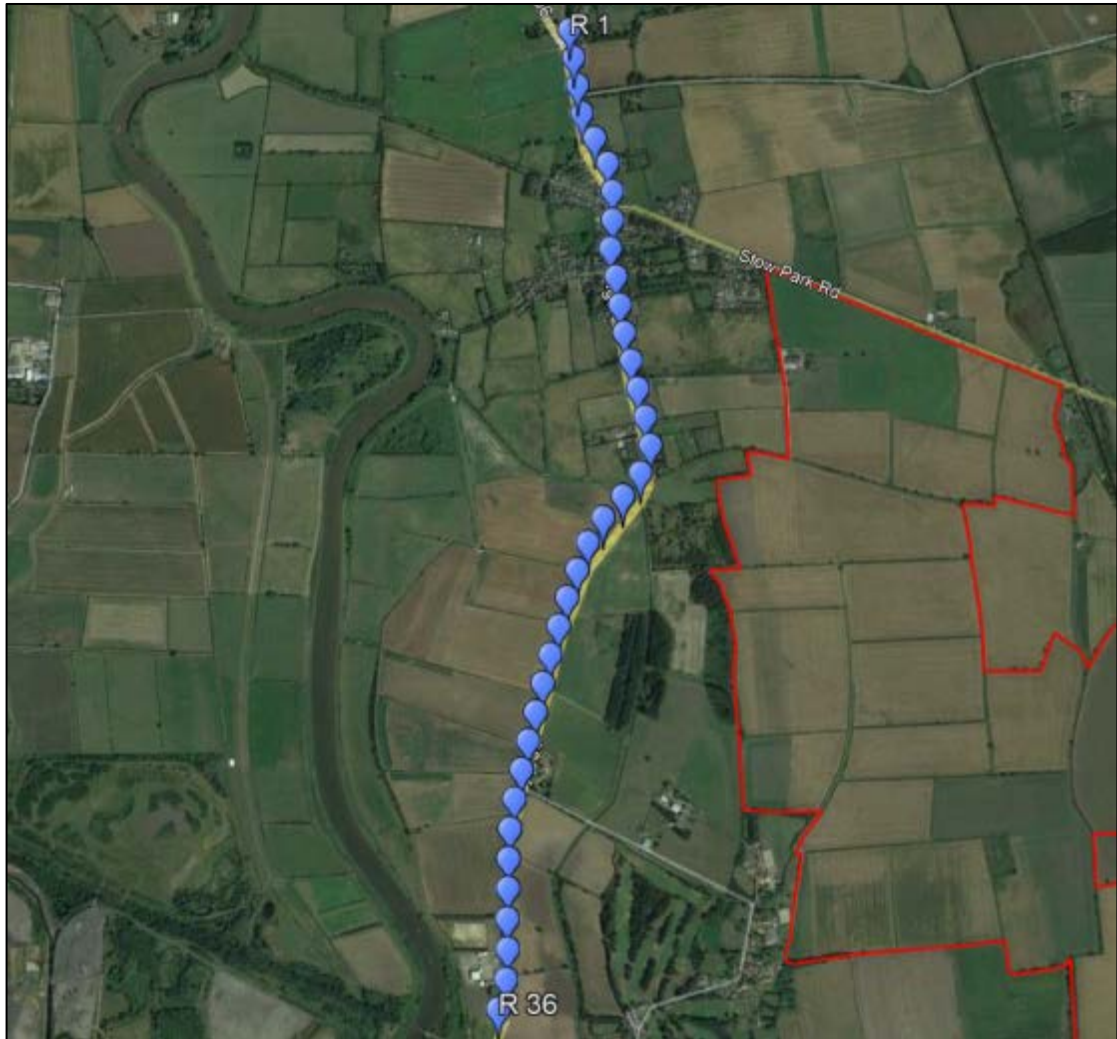
Figure 47 West Burton 3: A156, receptors 1 to 36

In total, 79 road receptor points have been identified for the assessment of this area over two roads: the A156 and Stow Park Road, shown in Figure 47 and Figure 48² below and on the following page.

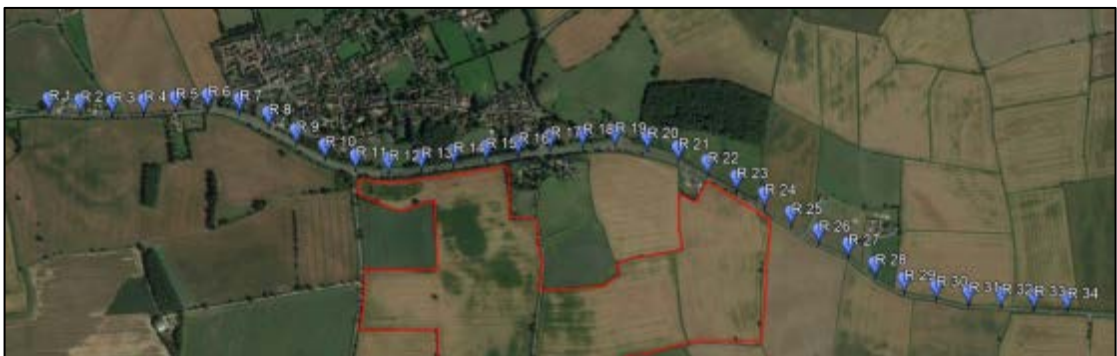
Figure 49 West Burton 4: A631, receptors 1 to 34

In total, 95 road receptor points have been identified for the assessment of this area split over four roads: A631; Clayworth Road; B1403; Wheatley Road, shown in Figure 49 to Figure 52² below and on the following pages.

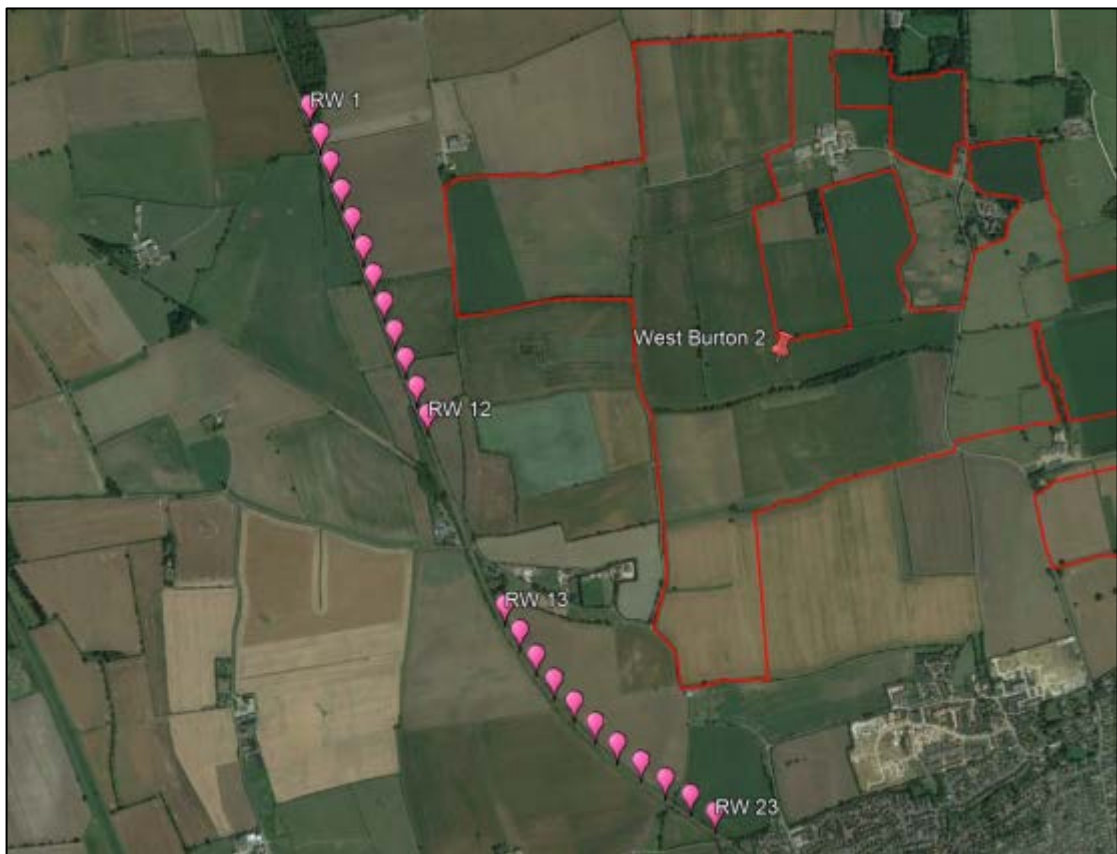
Figure 53 West Burton 2: Railway receptors 1 to 23

Figure 53² below shows the two sections of railway identified within 500m of the proposed development; 23 railway receptors were identified.

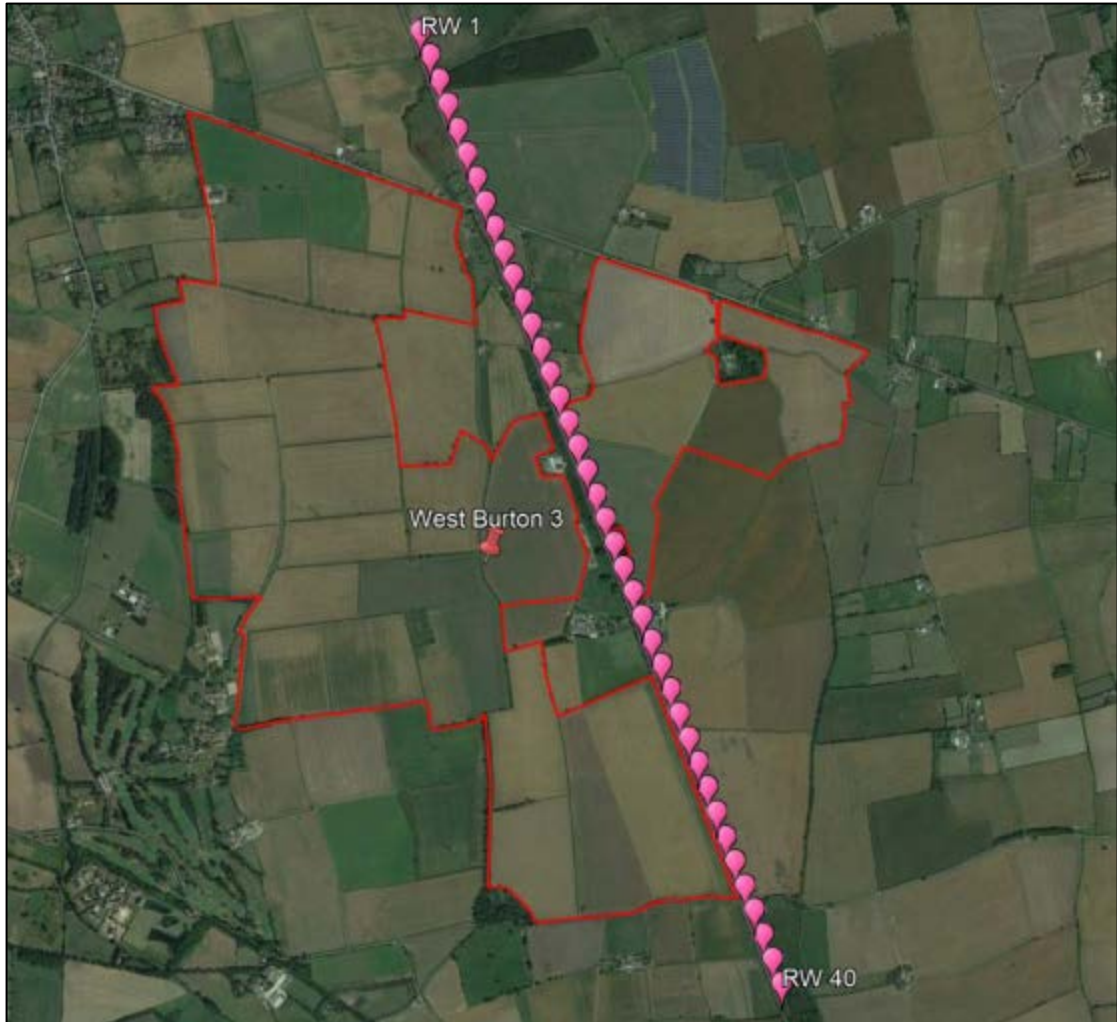
Figure 54² below shows the section of railway identified within 500m of the proposed development; 40 railway receptors were identified.

Figure 54 West Burton 3: Railway receptors 1 to 40

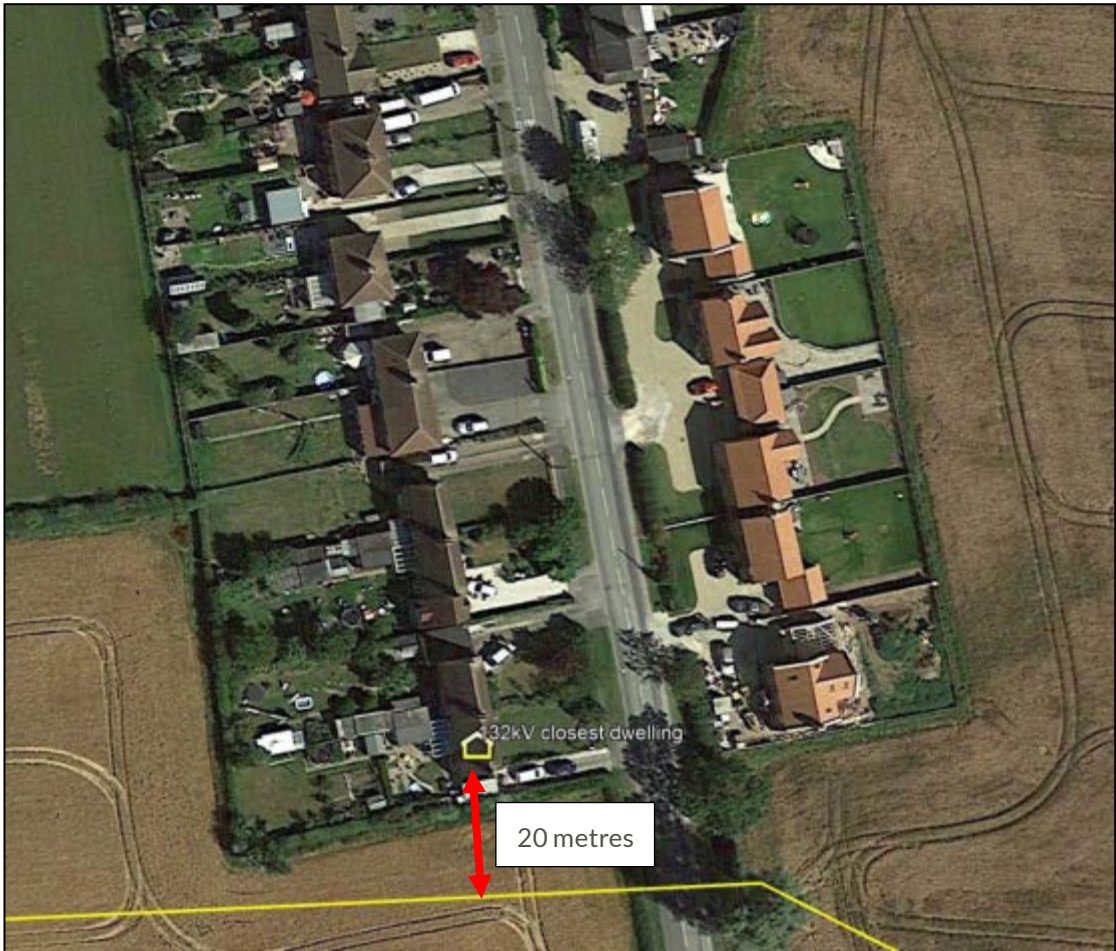
Figure 10 Minimum distance between 132 kV underground cable route and dwellings

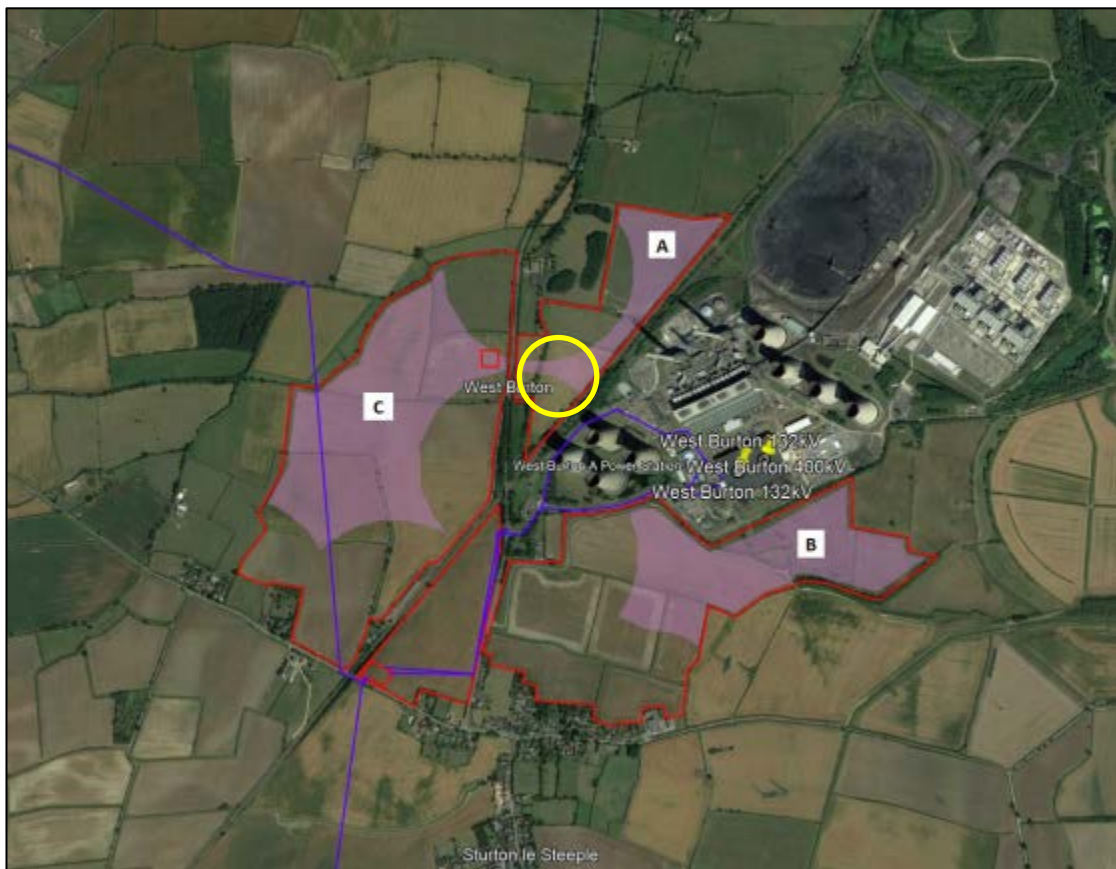
The most significant source of radiation other than the cables is the West Burton Interconnector Substation and batteries to be located at the West Burton 5 land parcel. This will be a 400/133 kV substation with 20MW batteries. The currently proposed location is the southern area of the land parcel marked Option A in Figure 12¹³ below, within the part highlighted in pink. This area has been circled in yellow. The batteries are planned to be located next to the substation.

Figure 12 Proposed location for West Burton Interconnector Substation
