# Cottam Solar Project

# EIA Scoping Report (Part 4 of 4)

Prepared by: Lanpro Services Ltd.

PINS reference: EN010133 Document reference: APP/C6.3.2.1

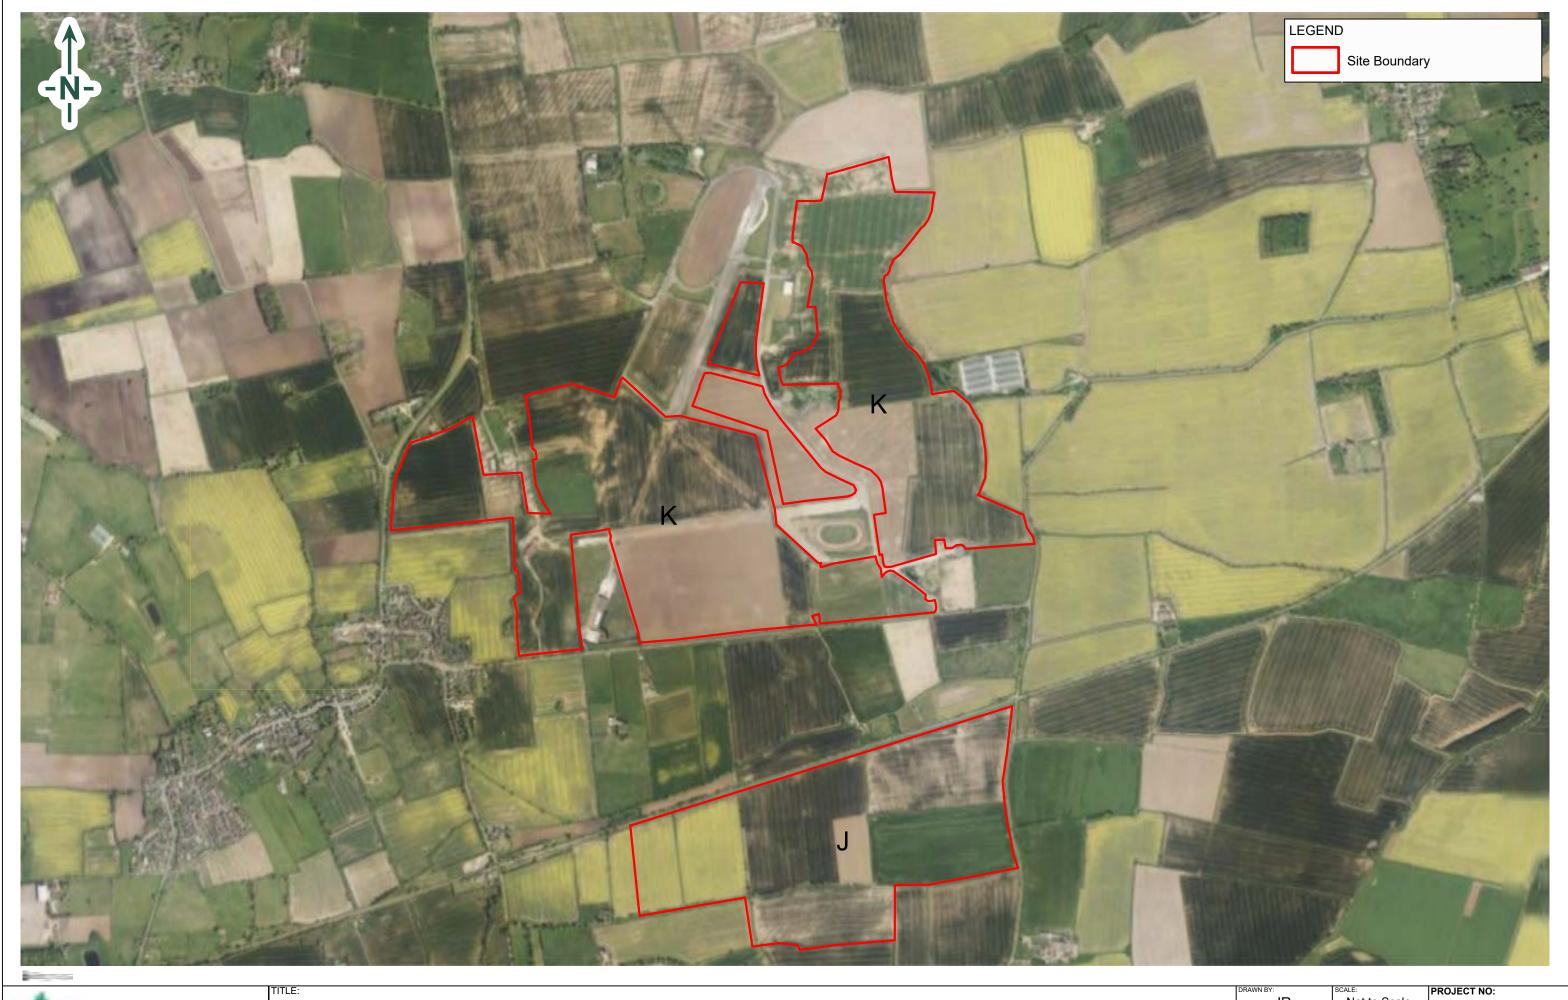
# Figure 2 – Site Layout Plan

Site Layout Plan Cottam Solar Project Cottam 3

Co-ordinates	Centred at National Grid Reference:	Elevation	Field J – 20 to 25 m AOD		
	Field J – 486720, 394200		Field K - 21 to 22 m AOD		
	Field K – 486740, 395830	Area	Field J – 70 Ha		
			Field K – 173 Ha		
Site Address and Location	The Site comprises a series of agricultural fields located off Kirton Road and Pilham Lane, Blyton, approximately 9 km north east of Gainsborough town centre. A Site Location Map is included as Figure 1.				
Site Description	The Site has been assessed through readily available online aerial and street view imagery and a Site Layout Plan is included as Figure 2. In addition, a Delta-Simons representative undertook a Site walkover of readily accessible areas of 24 <sup>th</sup> November 2021. Pertinent features observed or reported on Site are described below and shown on Figure 3, with supporting photographs.				
	The Site is separated into two areas located approximately 400 m apart, as such, the areas have been separated into two field references, Field K in the north off Kirton Road and Field J to the south of Pilham Lane, as shown on Figure 2 and included as Drawing 1.

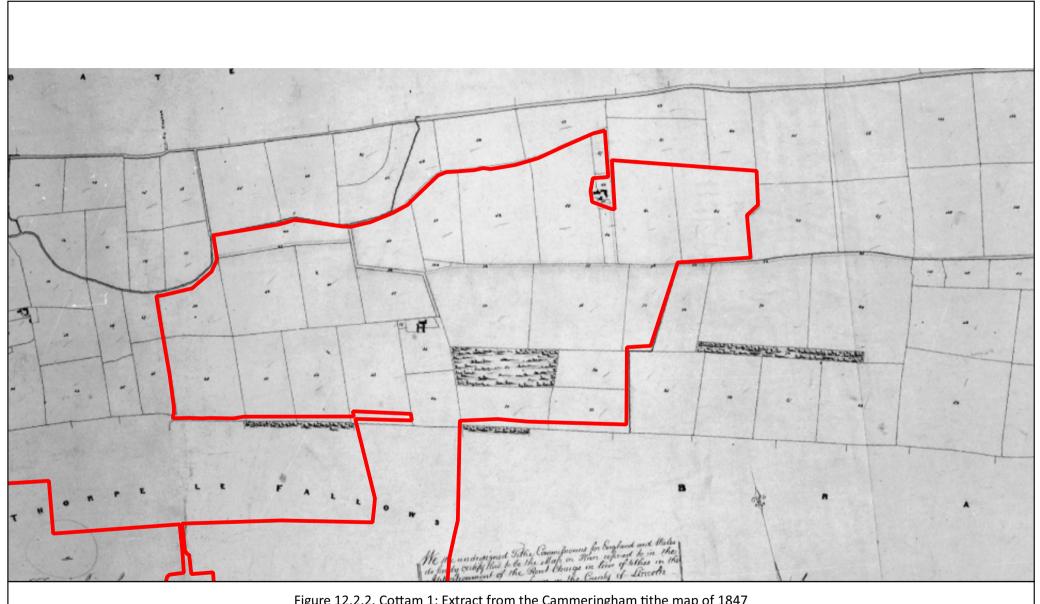
Figure 12.2.2. Cottam 1: Extract from the Cammeringham tithe map of 1847

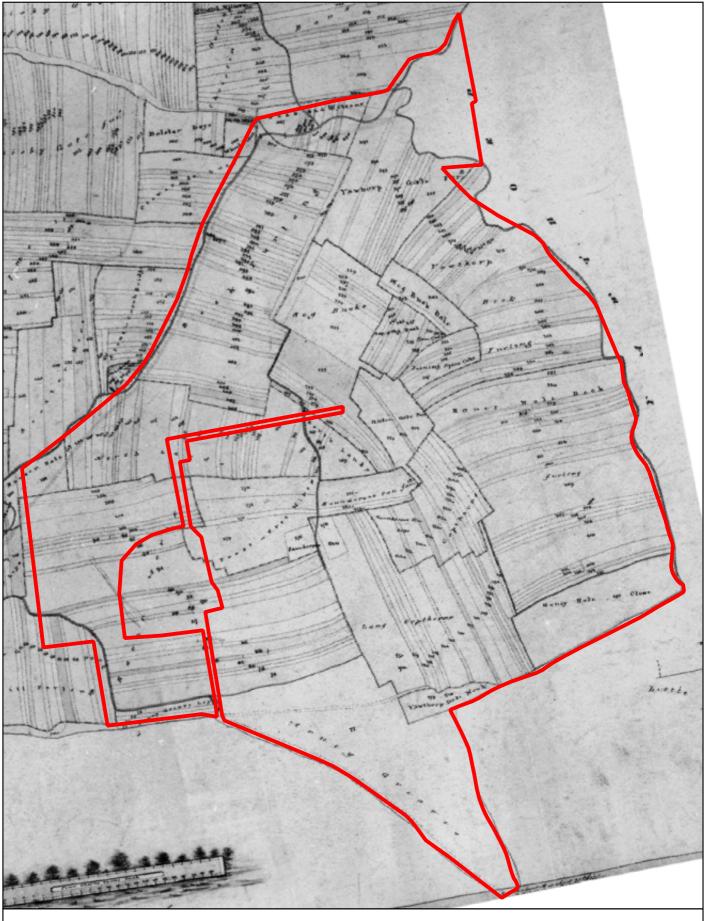
Figure 12.2.10. Cottam 2: Extract from the Corringham pre-enclosure tithe map of 1842

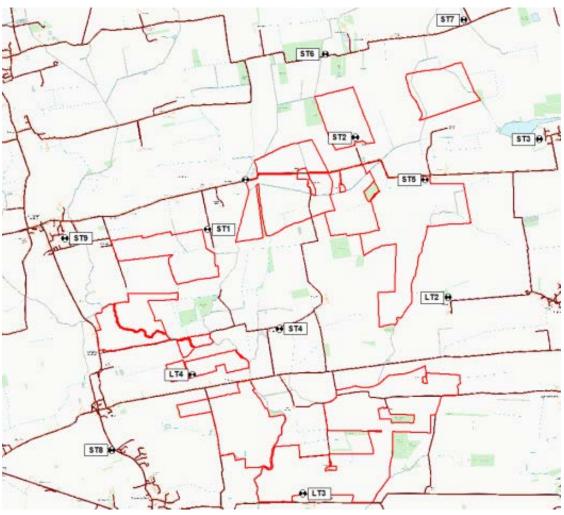
Figure 15.1 Noise Monitoring Locations

The baseline noise environment has been established following a noise survey undertaken from Thursday 9th September 2021 to Thursday 16th September 2021. Attended 15-minute short-term measures were undertaken at nine locations during the day, evening and night-time periods with four additional locations being measured unattended over a 161-hour period. Full details of the noise monitoring survey will be presented within the noise technical report, with a brief summary provided below. The locations of these measurements can be found on Figure 15.1.1 below.

The existing ambient noise climate was mainly dominated by road traffic noise and occasional farming related noise. The main sources of this noise included: Kexby Road, Willingham Road, Stow Road, the A1500 and the B1241. A summary of the baseline noise monitoring survey is shown in Table 15.1.1 below.

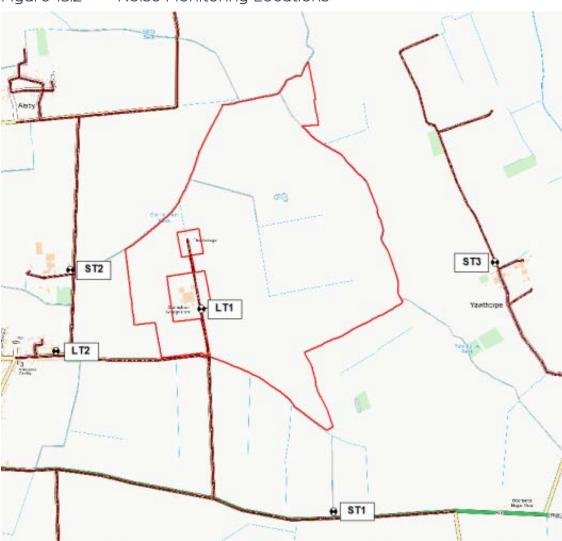
Figure 15.2 Noise Monitoring Locations

The baseline noise environment has been established following a noise survey undertaken from Thursday 9<sup>th</sup> September 2021 to Thursday 16<sup>th</sup> September 2021. Attended 15-minute short-term measures were undertaken at three locations during the day, evening and night-time periods with two additional locations being measured unattended over a 161-hour period. Full details of the noise monitoring survey will be presented within the noise technical report, with a brief summary provided below. The locations of these measurements can be found on Figure 15.1.2 below.

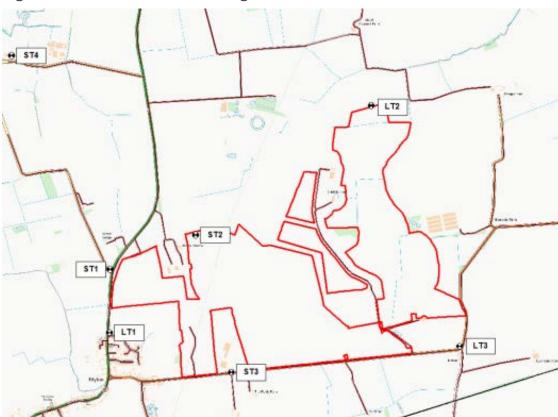
Figure 15.3 Noise Monitoring Locations

The baseline noise environment has been established following a noise survey undertaken from Thursday 9th September 2021 to Thursday 16th September 2021. Attended 15-minute short-term measures were undertaken at four locations during the day, evening and night-time periods with two additional locations being measured unattended over a 169-hour period. Full details of the noise monitoring survey will be presented within the noise technical report, with a brief summary provided below. The locations of these measurements can be found on Figure 15.1.3 at the end of this chapter.

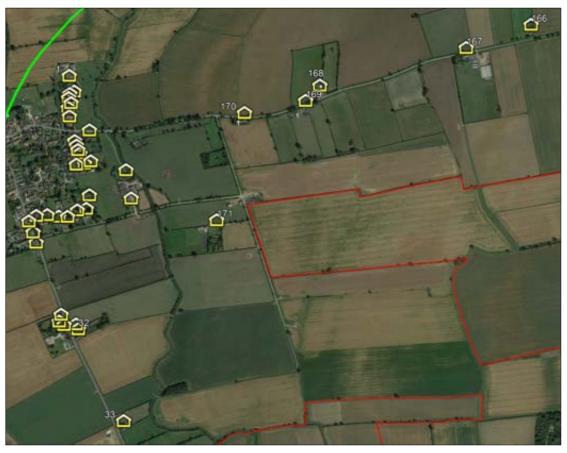
Figure 5 Cottam 1: dwelling locations 1 to 33 and 166 to 171

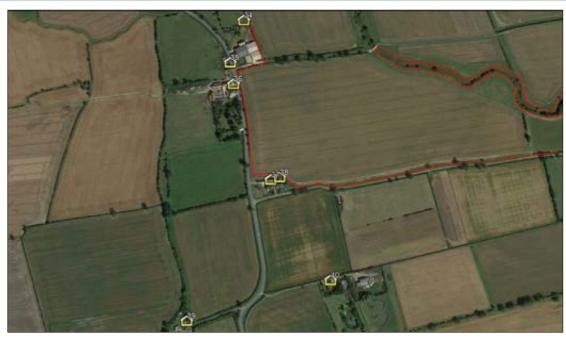
Figure 6 Cottam 1: dwelling locations 34 to 40

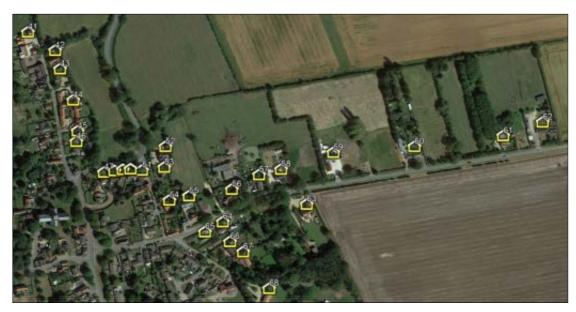
Figure 7 Cottam 1: dwelling locations 41 to 68

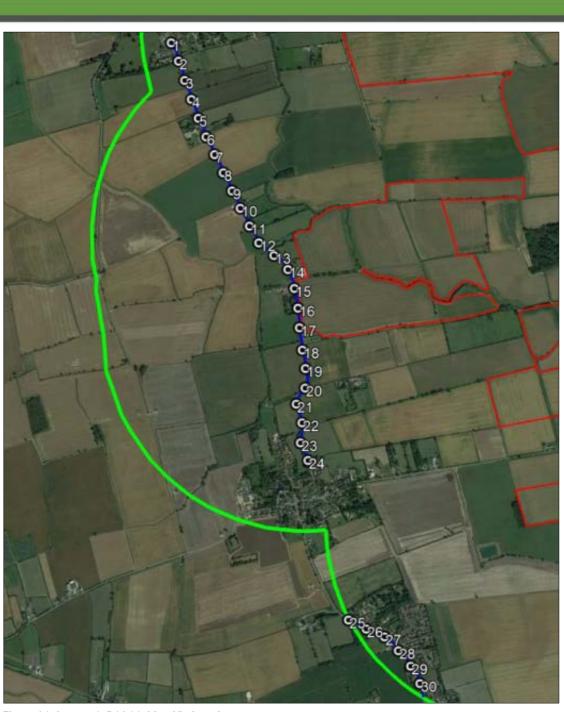
Figure 31 Cottam 1, B1241: identified road receptors

In total, 46 road receptor locations have been identified for the assessment consisting of two roads: the B1241 (blue line – receptors 1 to 30, see Figure 31<sup>2</sup> on the following page) and Till Bridge Lane (orange line – receptors 31 to 46, see Figure 32<sup>2</sup> on page 35).

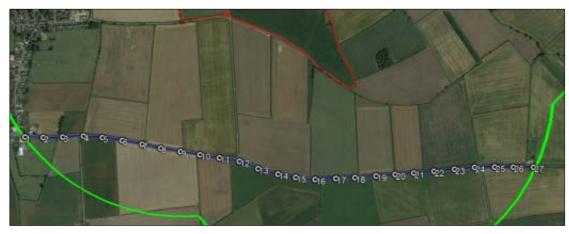
Figure 33 Cottam 2, A631: identified road receptors

In total, 27 road receptor locations have been identified for the assessment consisting of one road: the A631 (blue line – receptors 1 to 27, see Figure 33<sup>2</sup> below).

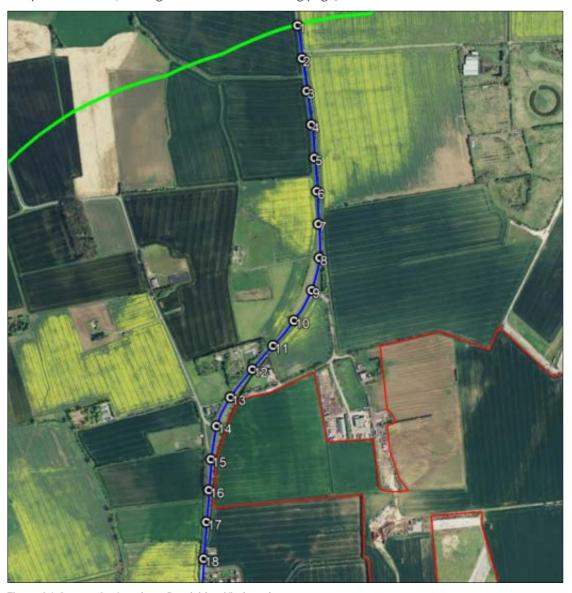
Figure 34 Cottam 3a, Laughton Road: identified road receptors

In total, 61 road receptor locations have been identified for the assessment consisting of three roads: Laughton Road (blue line – receptors 1 to 18, see Figure 34<sup>2</sup> below), Kirton Road (orange line – receptors 19 to 54, see Figure 35<sup>2</sup> on the following page) and Station Road (yellow line – receptors 55 to 61, see Figure 36<sup>2</sup> on the following page).

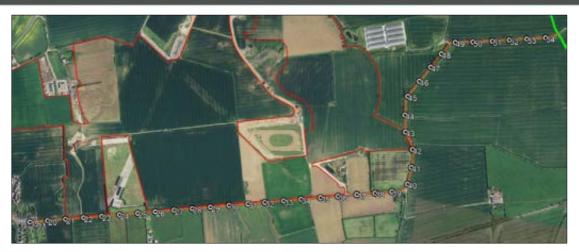
Figure 35 Cottam 3a, Kirton Road: identified road receptors

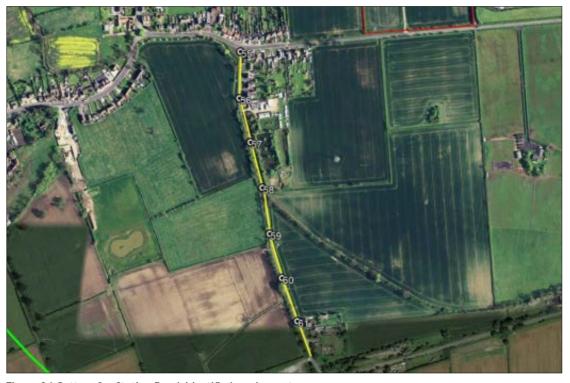
Figure 36 Cottam 3a, Station Road: identified road receptors

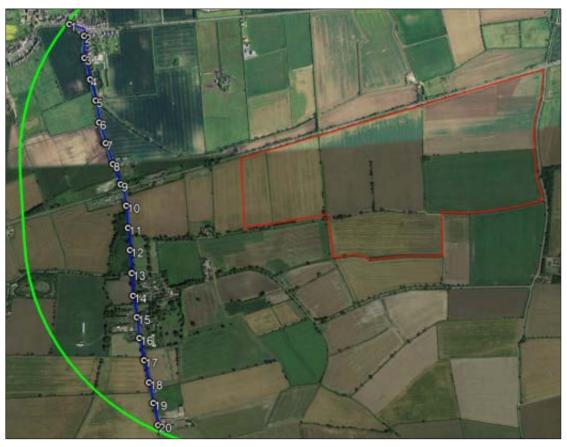
Figure 37 Cottam 3b, Station Road: identified road receptors

In total, 49 road receptor locations have been identified for the assessment consisting of three roads: Station Road (blue line – receptors 1 to 20, see Figure 37<sup>2</sup> below) and Kirton Road (yellow line – receptors 21 to 49, see Figure 38<sup>2</sup> on the following page).

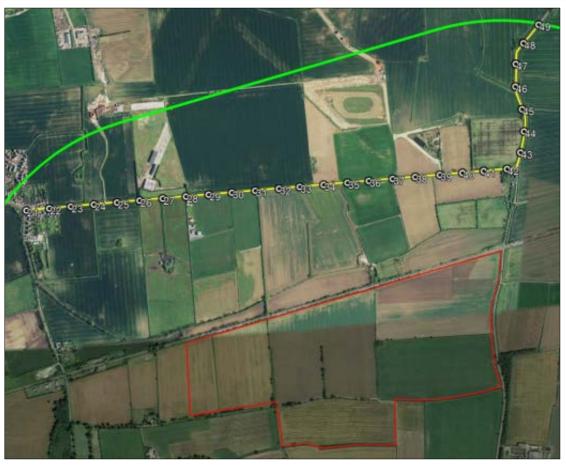
Figure 38 Cottam 3b, Kirton Road: identified road receptors

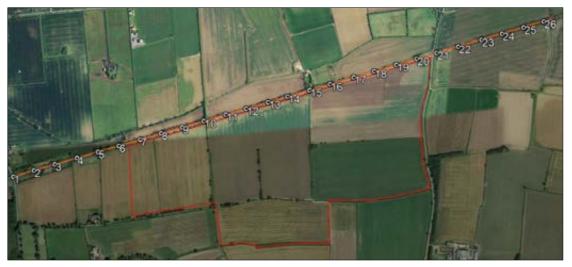
Figure 39 Cottam 3b, train driver locations

The identified train driver receptor points along the assessed section of railway line are shown in Figure 39<sup>4</sup> below. Based on previous consultation<sup>5</sup>, a train driver's eye level is typically 2.75m above rail level.

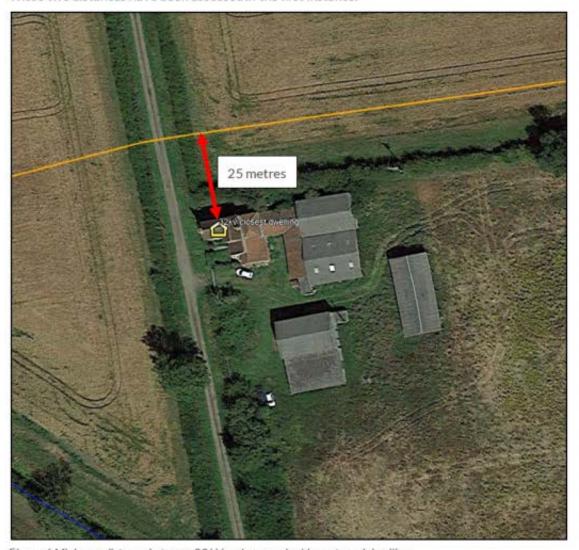
Figure 6 Minimum distance between 33 kV underground cable route and dwelling

The minimum distance between the proposed 33 kV underground cable route and any dwelling is approximately 25 metres. The minimum distance between the 400 kV underground cable route and any dwelling is approximately 40 metres. These are shown in Figure 6 below and Figure 7 on the following page<sup>9</sup>.

Dwelling	Horizontal distance from Cable (m)	Typical Magnetic Field for 33 kV underground cable (micro Teslas)	Public Exposure Limit <sup>10</sup> as per Guidance (micro Teslas)	Conclusion
Nearest	25	<0.07 (no data shown at this range)	100	Predicted levels are well below the recommended limit.

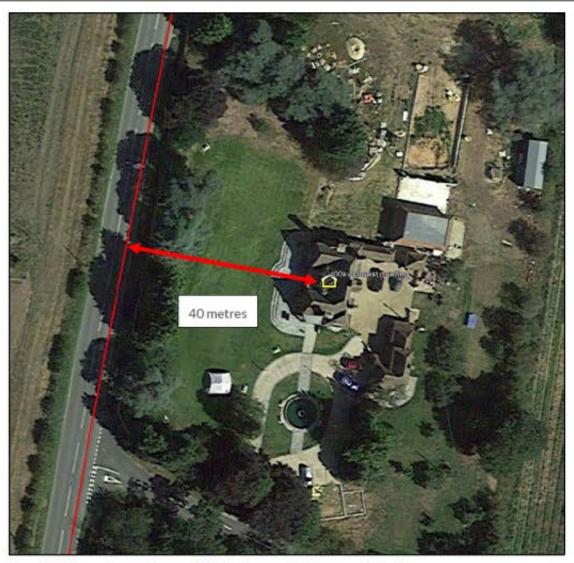
Figure 7 Minimum distance between 400 kV underground cable route and dwellings

Dwelling	Horizontal distance from Cable (m)	Maximum Magnetic Field for 400 kV underground cable (micro Teslas)	Public Exposure Limit <sup>10</sup> as per Guidance (micro Teslas)	Conclusion
Nearest	40	<0.92 (no data shown at this range)	100	All predicted levels are well below the recommended limit.

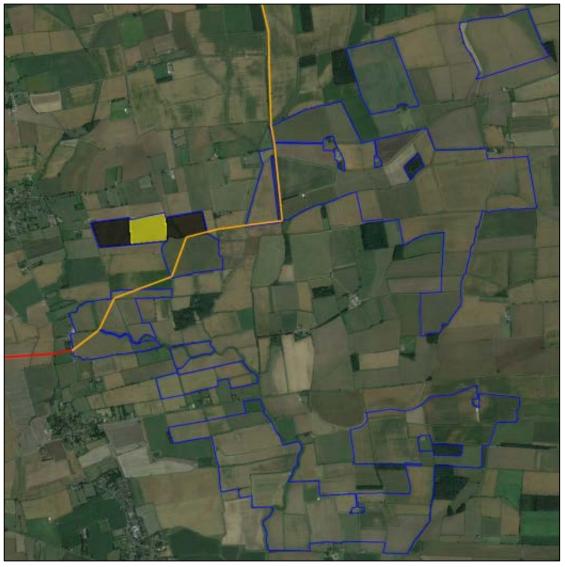
Figure 8 Proposed location for Cottam 1 substation

The most significant source of radiation other than the cables is the substation and batteries to be located at the Cottam 1 land parcel. This will be a 400/33 kV substation with 600 MW batteries. The currently proposed location is shown in Figure 8<sup>11</sup> on the following page, with the yellow polygon representing the substation location, and the black polygons representing the battery locations.

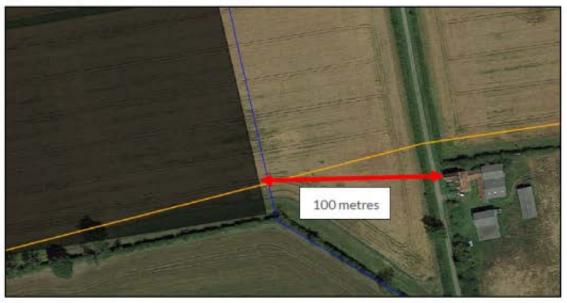
Figure 10 Minimum distance between batteries and a dwelling

The minimum horizontal distance between the proposed battery locations and any dwelling is approximately 100 metres, as shown in Figure 10<sup>11</sup> below.
