# Cottam Solar Project

### Appendix 9.6: Otter and Water Vole Survey

**OTTER AND WATER VOLE SURVEY REPORT**  
**COTTAM SOLAR PROJECT**

Project title:	Cottam Solar Project		
Document title:	Otter and Water Vole Survey Report	Project number:	7479
Client:	Cottam Solar Project Ltd.	Author:	Joel Wright
Version 1	Final Draft	Issued on:	10/10/22
Quality Assurance	Checked by:	Approved by:	
	Harry Fox	Tom Clarkson

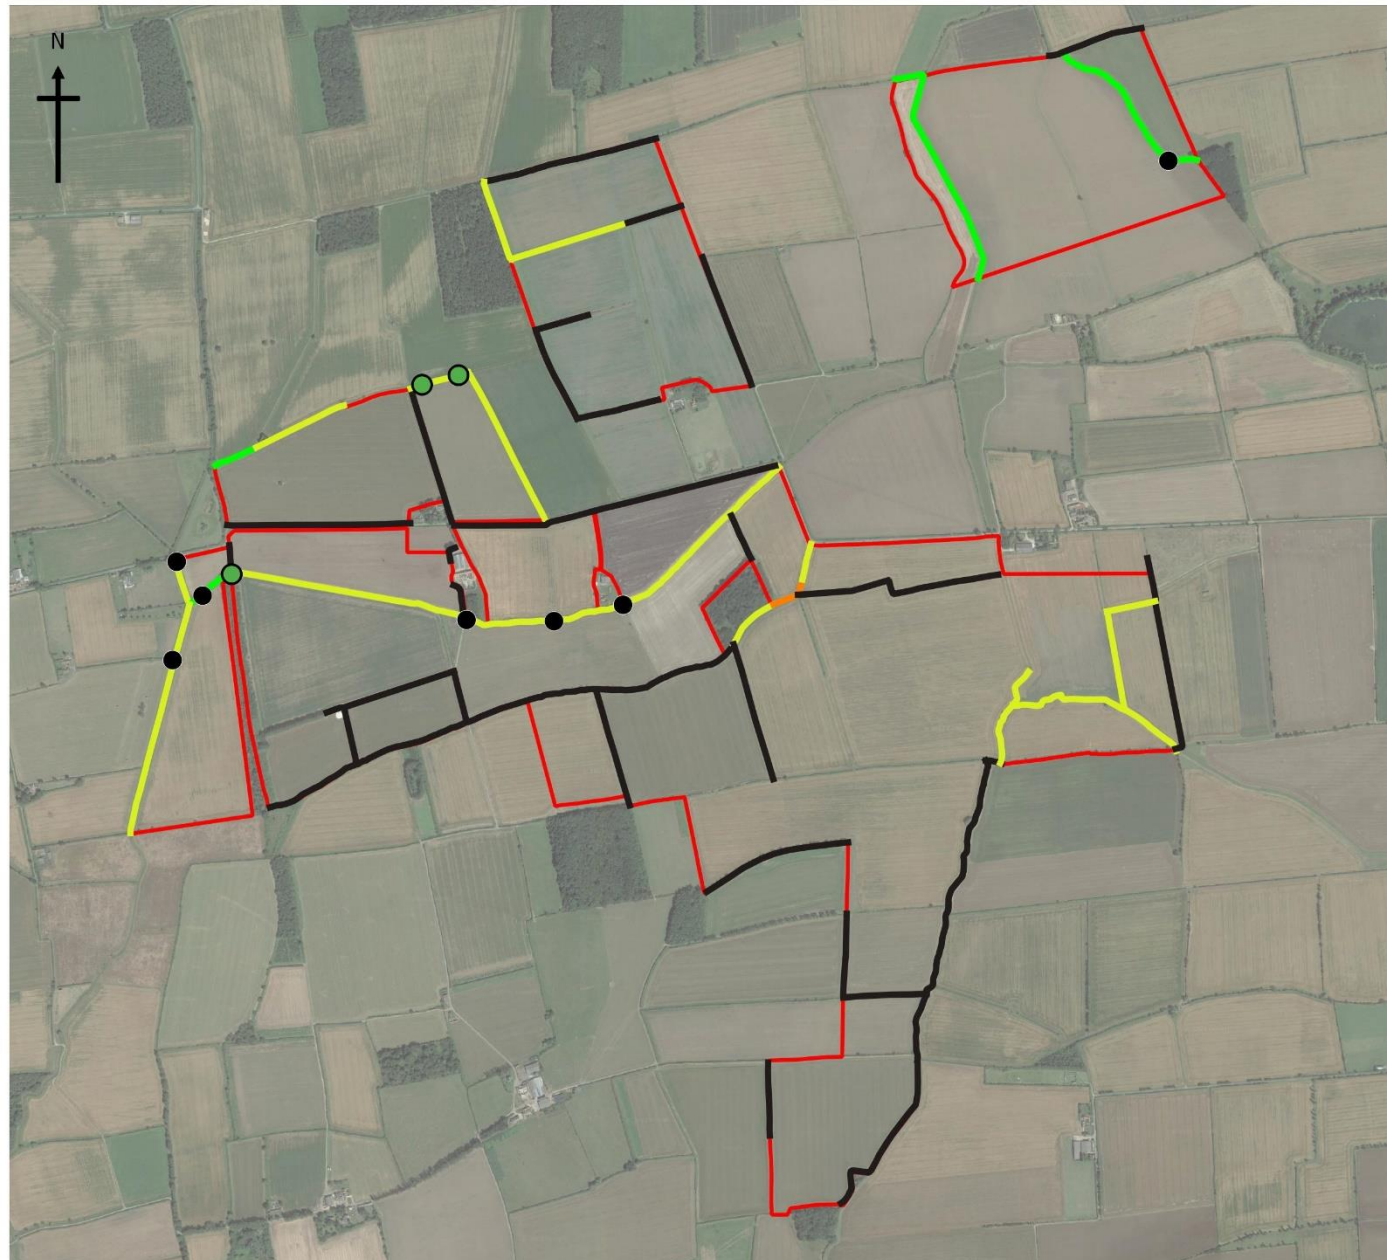
**Figure Number**  
Figure 2

- 3.2.4 The results of the otter survey for Cottam 1 North are presented in Figure 2 below. Overall, relatively few watercourses offered typically suitable habitat for otter, although roughly half of those which did were found to contain otter field signs, indicating relatively widespread movement by otter within the wetted ditch network.

- 3.2.5 The drainage network within the Site comprised agricultural ditches at field boundaries of varying suitability for otter several of which are more substantial ditches that are tributaries of the River Till. The majority were recorded as being usually dry and the ditch associated with H36 was assessed as being of negligible suitability.

- 3.2.6 A number of ditches and ditches associated with hedgerows were assessed as providing suitable but poor habitat for otters including D1, D3, D4, D7, D10, D11, D13, D16, D20, D21, D22, H2, H37 and H63. A number of otter field signs were recorded within several of these 'suitable but poor' ditches including spraints recorded within D5, D7, D10 and a ditch associated with H20. Cavities suitable for use by otter and a couch were also recorded within D3.

- 3.2.7 Ditches assessed as being of 'good' suitability for otter were recorded at D6, D17, D23, D24 and spraints were recorded along D6 and D24 and a cavity suitable as a resting place was recorded along D6.

**Title**  
Cottam 1 North Otter Survey Results

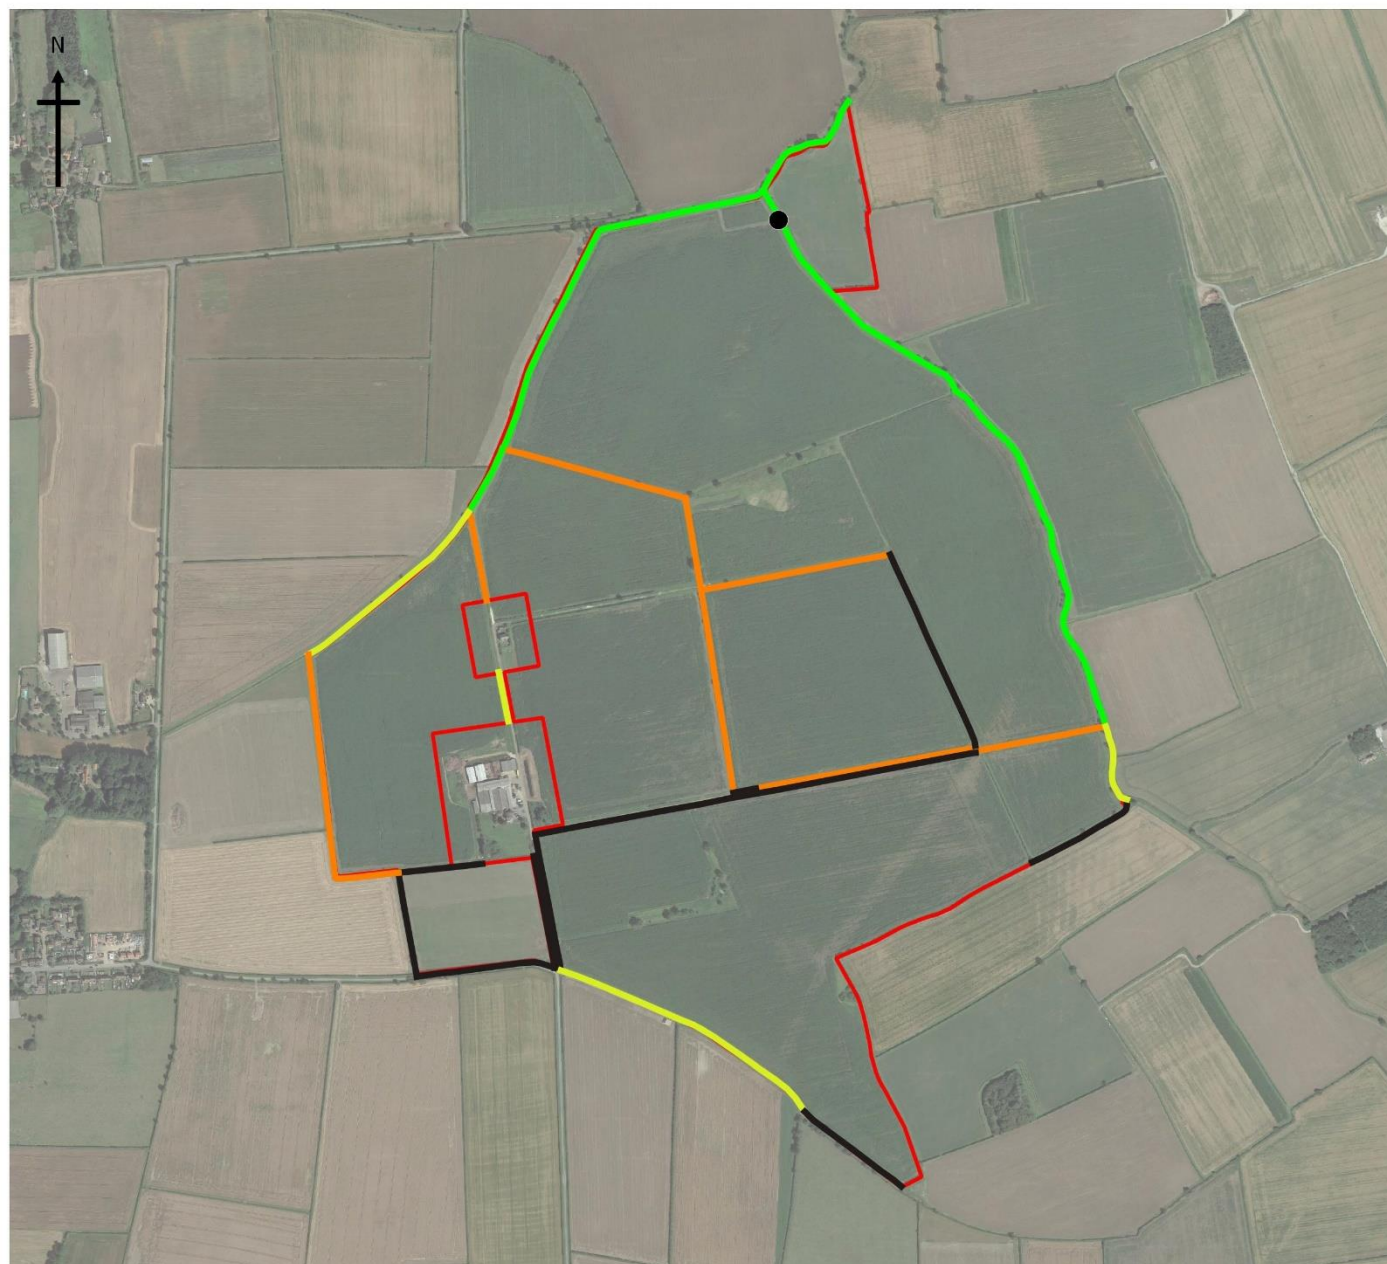
<b>Project</b>	Cottam Solar Project
<b>Title</b>	Cottam 2 Otter Survey Results
<b>Figure Number</b>	Figure 5
<b>Scale</b>	<div style="display: flex; align-items: center;"> <span style="margin-right: 20px;">0</span> <span style="margin-right: 20px;">200</span> <span>400 m</span> </div>

- 3.2.16 The results of the otter survey for Cottam 2 are presented in Figure 5 below.
- 3.2.17 This Site contained a number of agricultural drainage ditches of good interconnectedness within the interior of the Site with the more significant ditches of Corringham and Yarthorpe Becks forming much of the

boundary of the Site. These ditches join at the northern end of the Site to form the start of River Eau. The majority of the internal ditches were recorded as being usually dry and the ditches D2, D4, D5, D6, D10, H8, H23, H24, H29, were assessed as being of negligible suitability. One internal ditch (D8) and several ditches forming the boundary of the Site were assessed as providing suitable but poor habitat for otters including the upper sections of the Corringham and Yarthorpe Becks (H18, D3, D9). The remaining sections of the Corringham Beck (D7, H9, H10) and Yarthorpe Beck (D1, H5, H6) and the short section of the River Eau (H1) that form the boundary of the Site were assessed as providing good habitat for otter. An otter spraint was recorded along Yarthorpe Beck (H5).

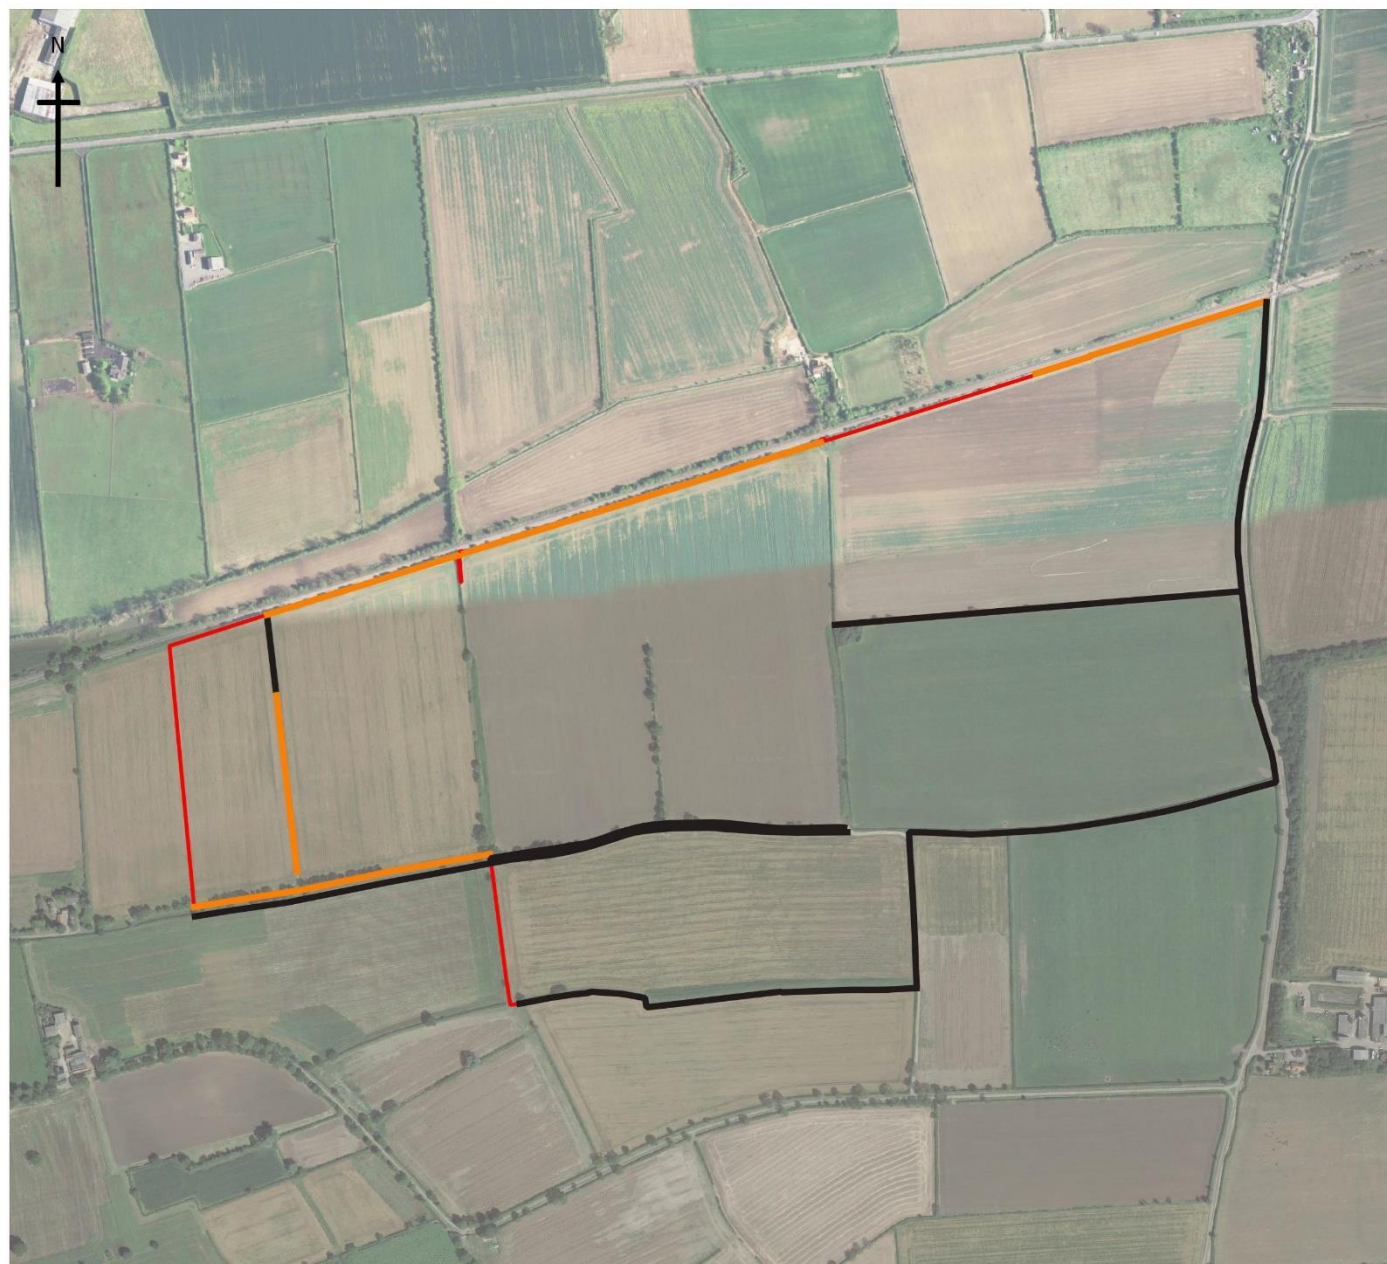
Figure 7

- 3.2.20 The results of the otter survey for Cottam 3b are presented in Figure X below.
- 3.2.21 The agricultural drainage ditches within the Site were all assessed as being usually dry or of negligible suitability for otter. No field signs of otter were recorded within the Site.

Cottam 3b Otter Survey Results

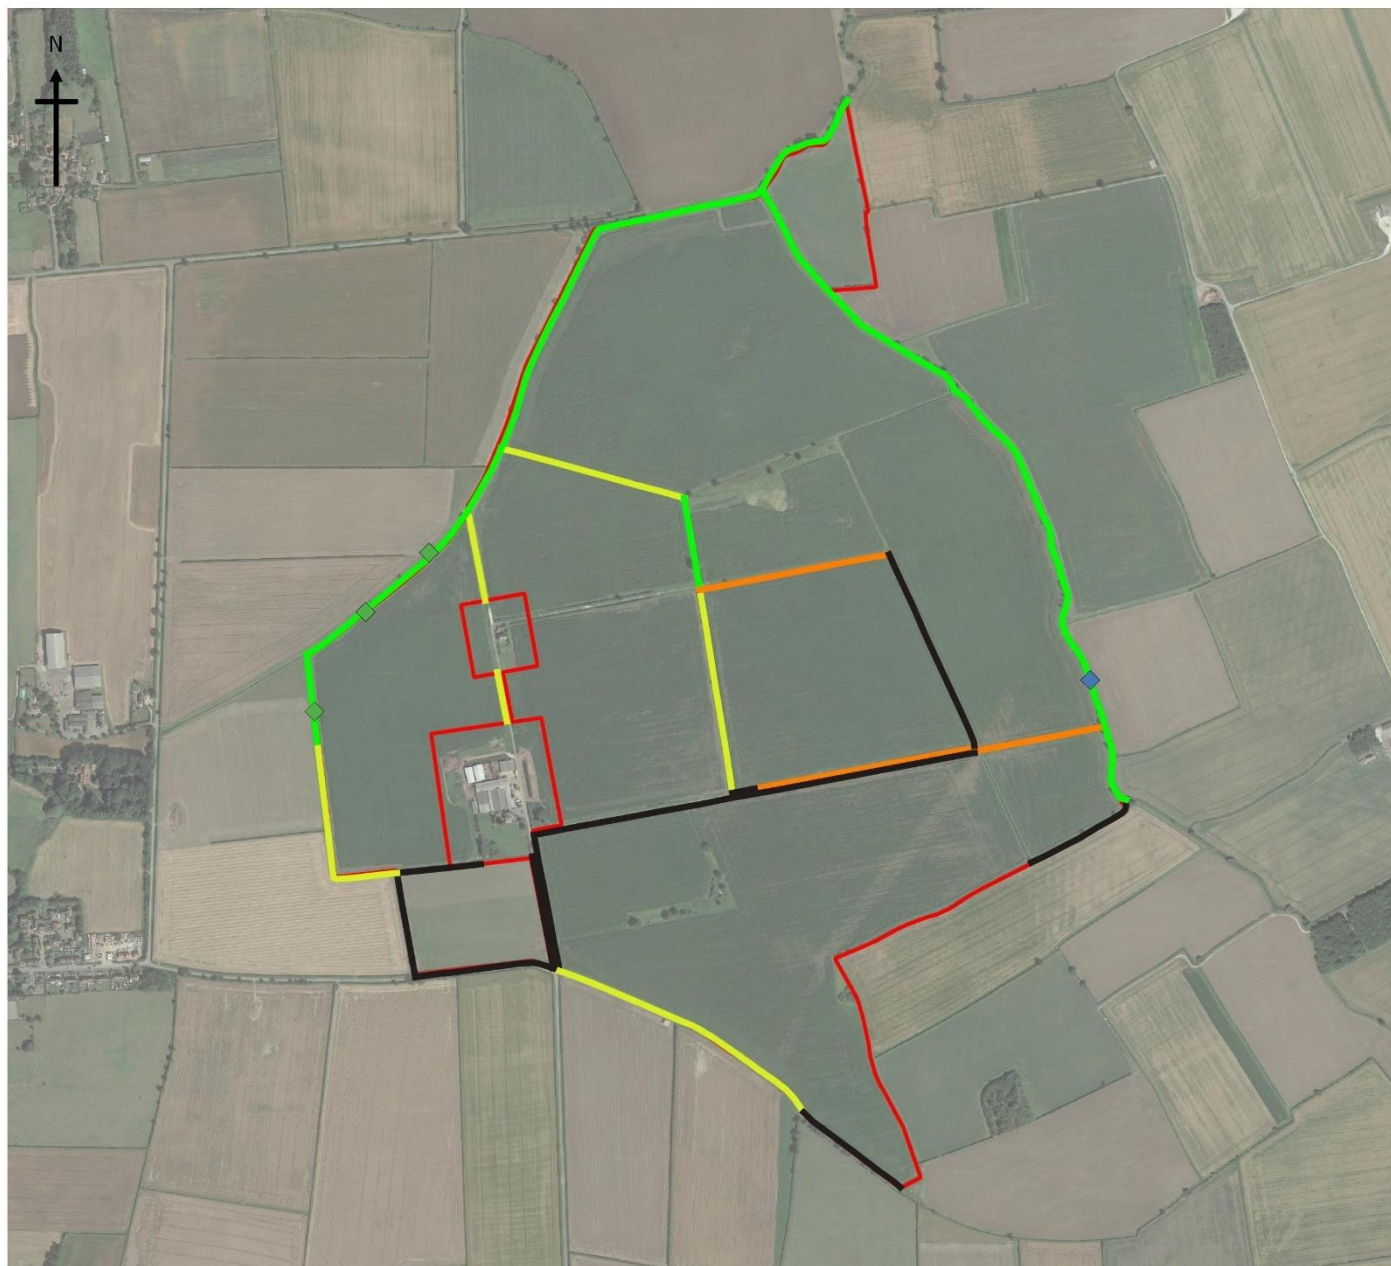
**Key:**

Survey area

Observed signs of water vole

3.2.22 Watercourses and ditch reference numbers that are referred to in the text below are provided in Appendix B. Results are depicted on Figures 8-13 overleaf. Where no ditch habitat classification is shown, no ditch was present at that location. Table 2, below, shows the breakdown of the ditch network within the Survey Area which were observed as being suitable to water voles as well as the presence of observed field signs. This information is discussed in more detail in subsequent paragraphs.
