Cottam Solar Project

Environmental Statement Appendix 14.1: Transport Assessment Revision A

Transport Assessment

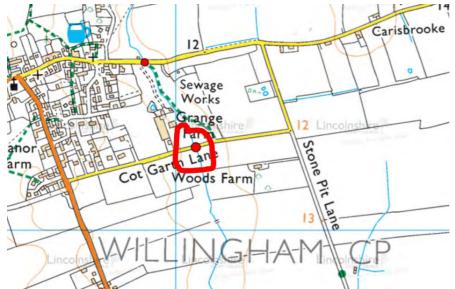
Cot Garth Bridge -88/84/02 - 30HB 11m span - on route to Cottam 1near Willingham by Stowe

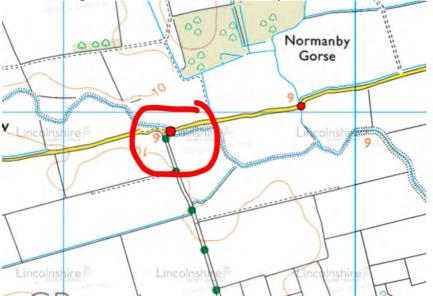
Coates Bridge - 88/92/39 - 30HB 12.5m span - on alt route to Cottam 1 south of site north east of Stowe

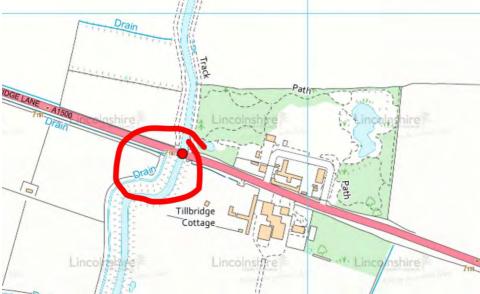
Till Bridge - 97/09/77 - 38HB 9.25m span - A1500 on approach to Sturton by Stow

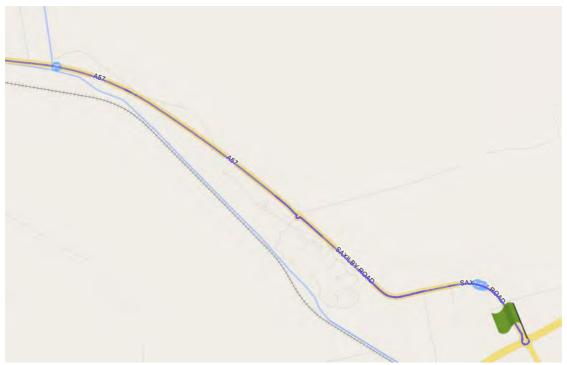
A57 structures on ESDAL?

Further to my email below I have tried to call you and Ian a few times over the last week but the numbers just ring out. I am looking at completing an interim report to my client next week. In addition to the missing structures I mentioned before I see that there are others, for example on A1500 and A57 as per ESDAL screenshots below.
