**Stonestreet Green Solar**  
**Environmental Statement**  
**Volume 4: Appendices**  
**Chapter 11: Land Contamination**  
**Appendix 11.2: Phase 1 Geoenvironmental and**  
**Geotechnical Desk Study Part 4 of 5**

PINS Ref: EN010135

Doc Ref. 5.4

#### UXO hazard zone plan of the Site

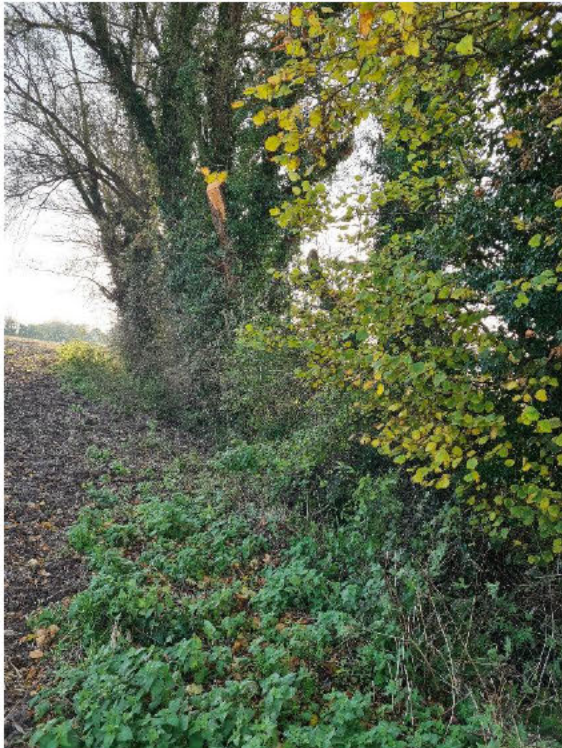
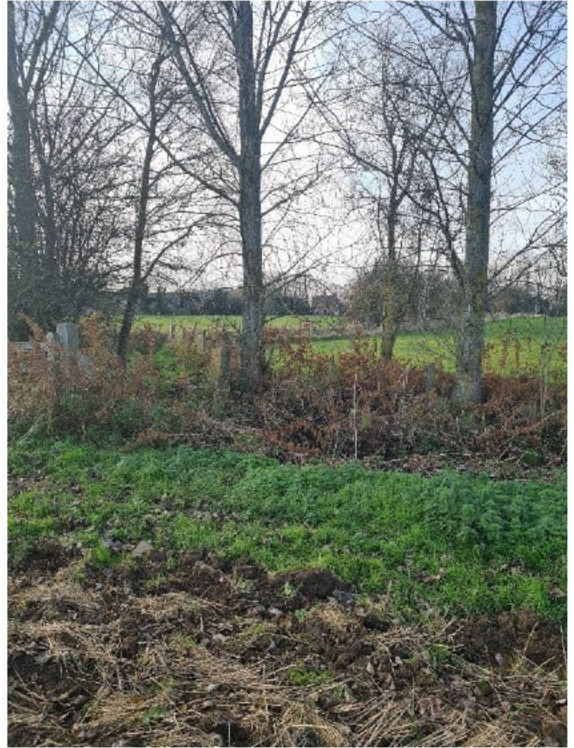
Plate  
No. 1

Title: A view of south-eastern fields.

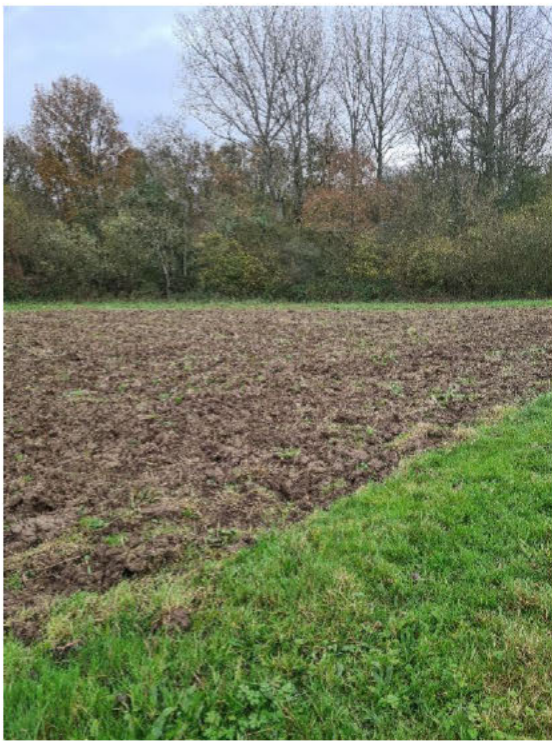
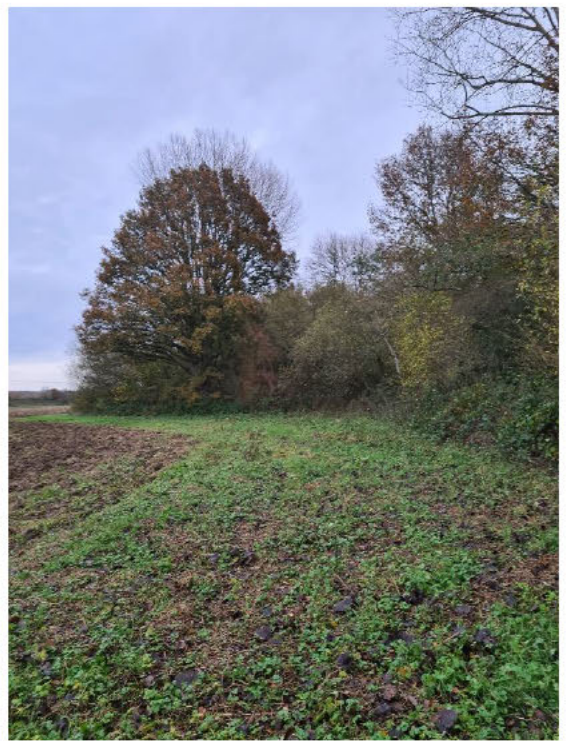
<p>Picture Taken: 29/11/2021</p>	<p>Plate No. 13</p>	<p>Title: A view of woodland within the north-east.</p>
--------------------------------------	-------------------------	---

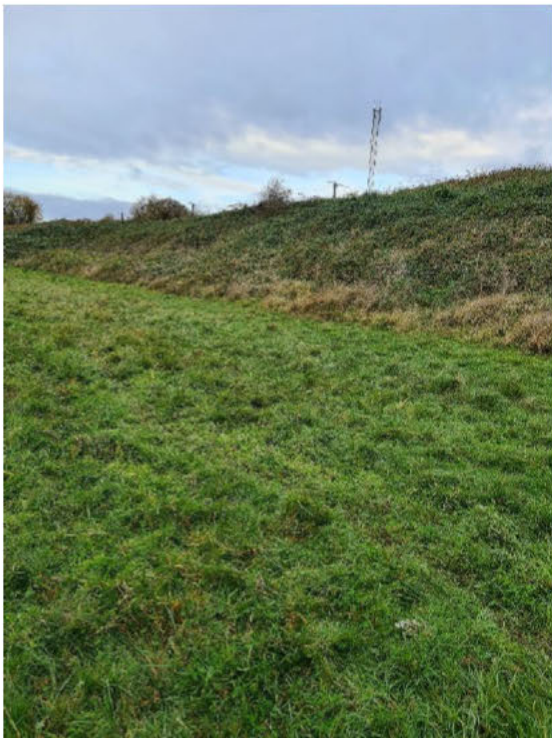
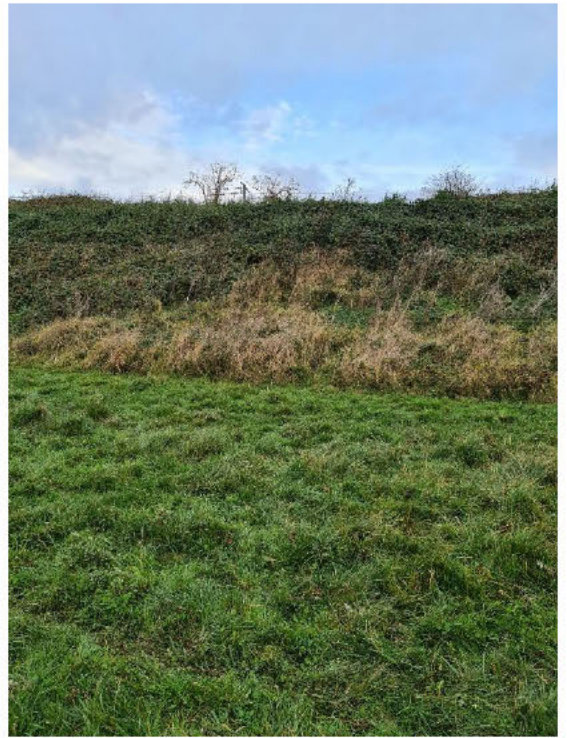
<p>Picture Taken: 29/11/2021</p>	<p>Plate No. 14</p>	<p>Title: A view of the railway embankment traversing the north east boundary of the site.</p>
--------------------------------------	-------------------------	--

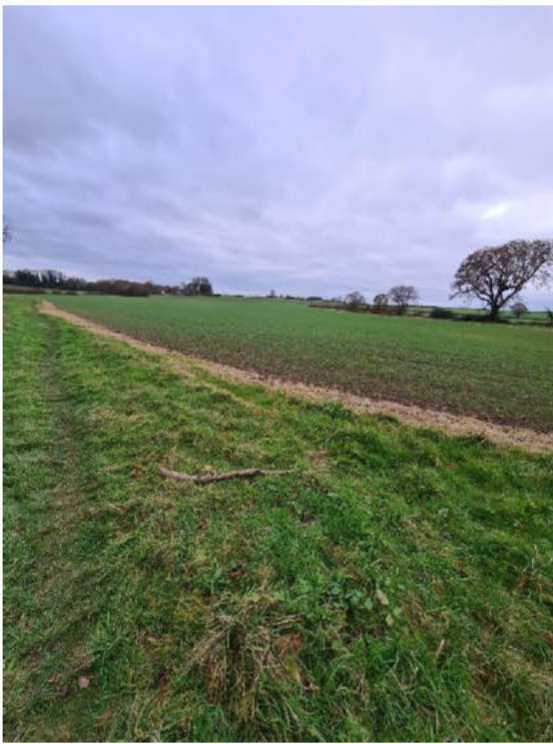
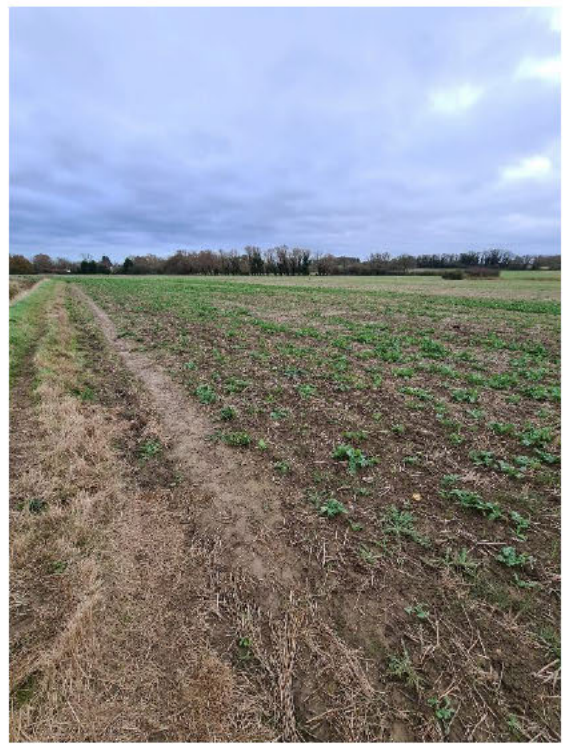
Picture Taken: 30/11/2021	Plate No. 17	Title: A view of the northern fields.
------------------------------	-----------------	---------------------------------------

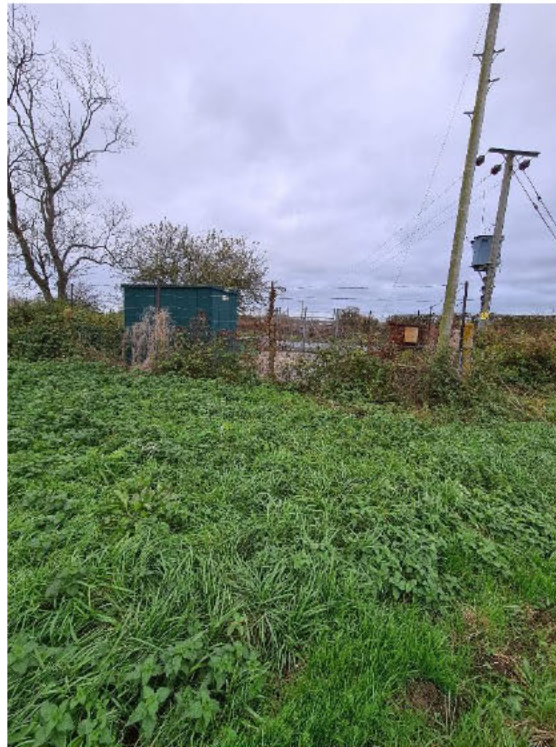
In the north of the site a fertiliser storage tank is located in the field leading of from Goldwell Lane. There is also a tarmacked area ideal for parking. During the site visit several large piles of animal waste were noted in the north of the field (see photographs). In the field north west from this location also accessed by Goldwell Lane an electricity sub-station was present.

Picture Taken: 30/11/2021	Plate No. 18	Title: Substation located adjacent to the northern fields.
------------------------------	-----------------	--

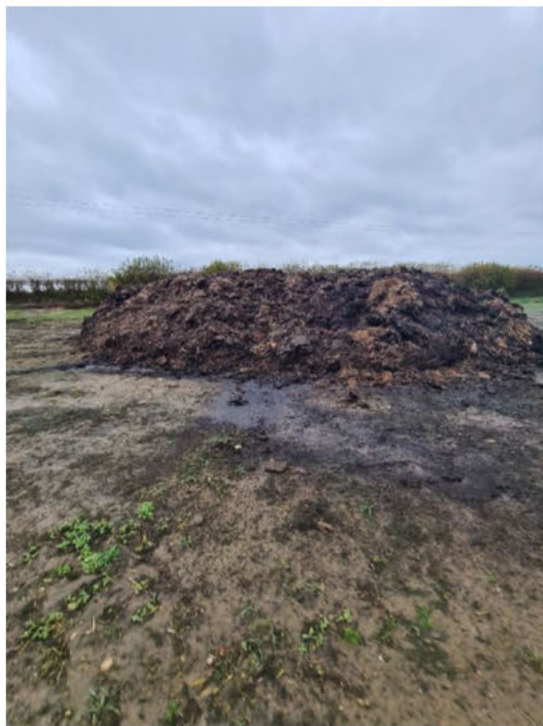
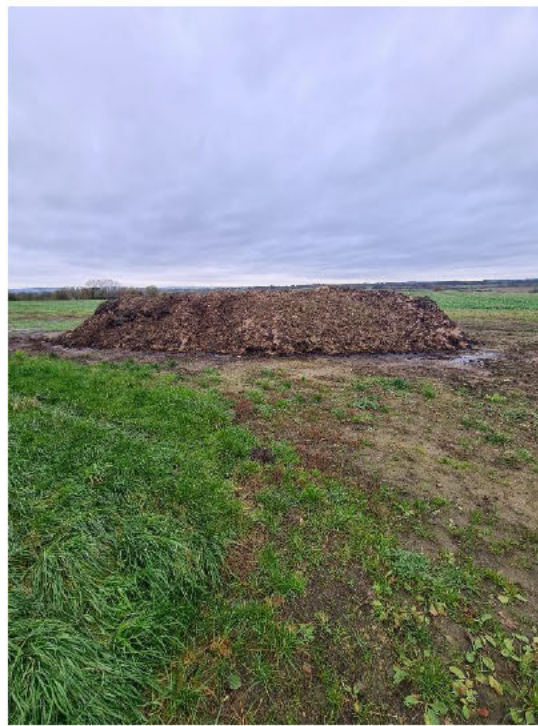
Plate  
No. 19

No waste management issues were noted apart from the previously mentioned animal waste stockpiles (see activities/process on site).

Title: Stockpiles of manure within the west.

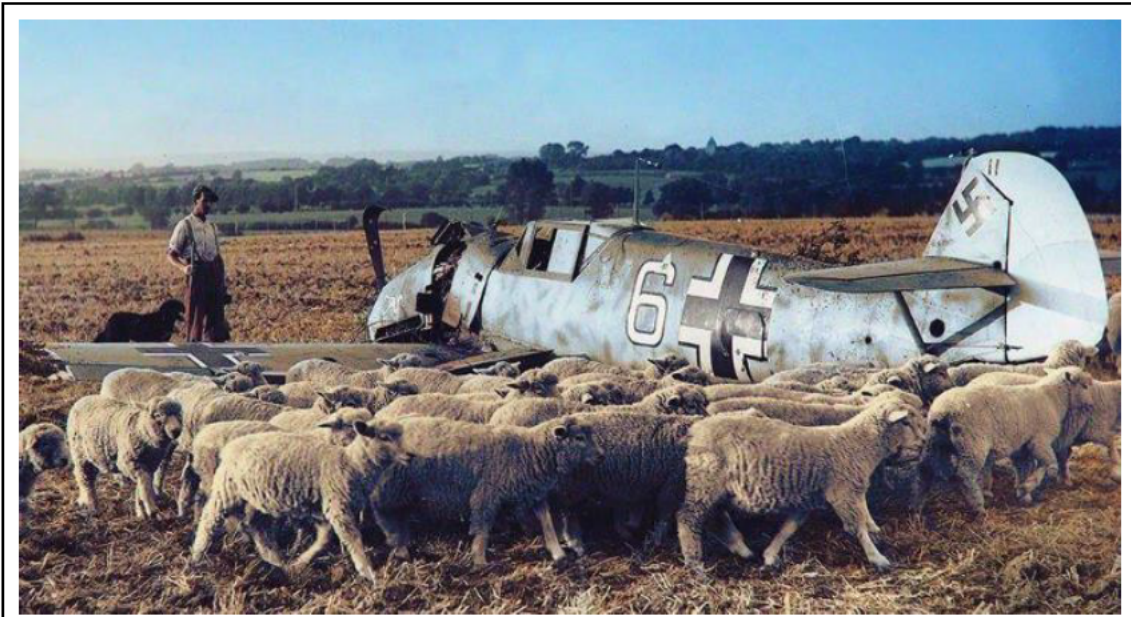
**Plate 2 Colourised photograph of the crashed Messerschmitt Bf109E-4, 5<sup>th</sup> September 1940**

Plate 2 is a colourised photograph of the Messerschmitt Bf109E-4 on the 5<sup>th</sup> September 1940 after its forced landing. This shows that the aircraft did not explode on impact and stayed relatively intact with only minimal spread of debris.

The aircraft was removed from the field and broken up away from the Site.

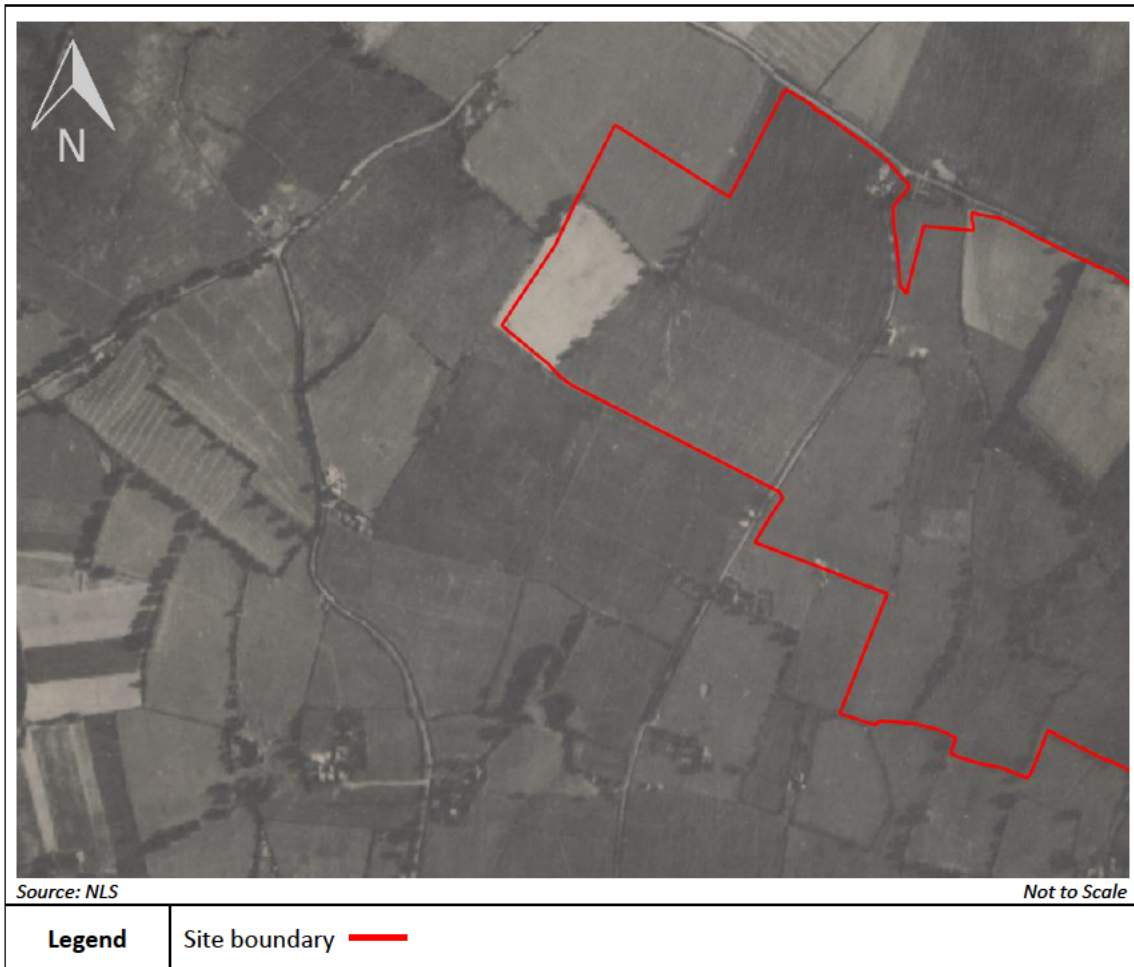
**Plate 3 Aerial photograph of the western part of the Site, c. 1946**

Plate 3 is an aerial photograph dating from 1946 of the western part of the Site. No bomb damage or cratering has been identified on the Site.

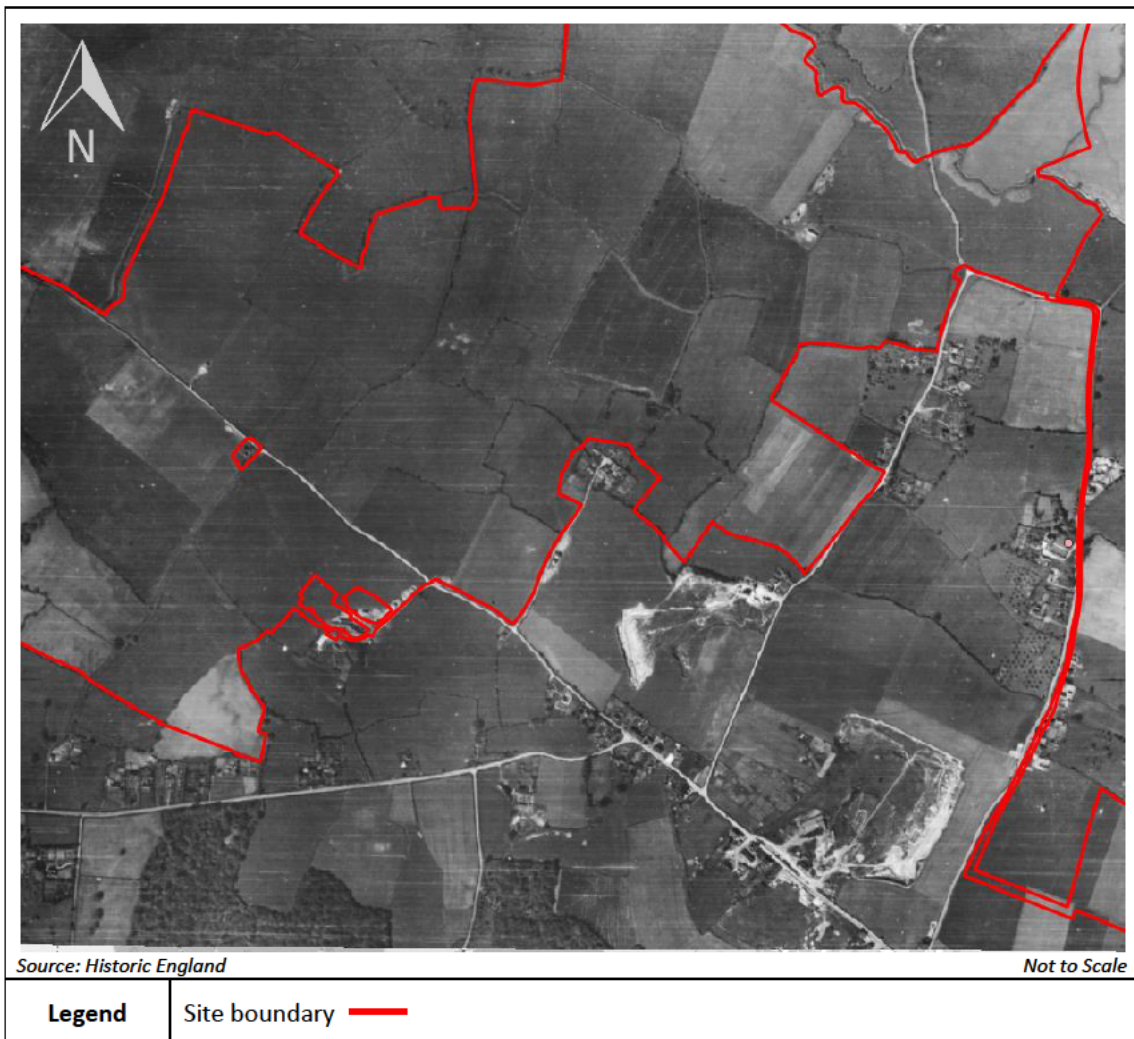
**Plate 4 Aerial photograph of the central part of the Site, 30<sup>th</sup> April 1946**

Plate 4 is an aerial photograph dated the 30<sup>th</sup> April 1946 of the central part of the Site. No bomb damage or cratering has been identified on the Site.

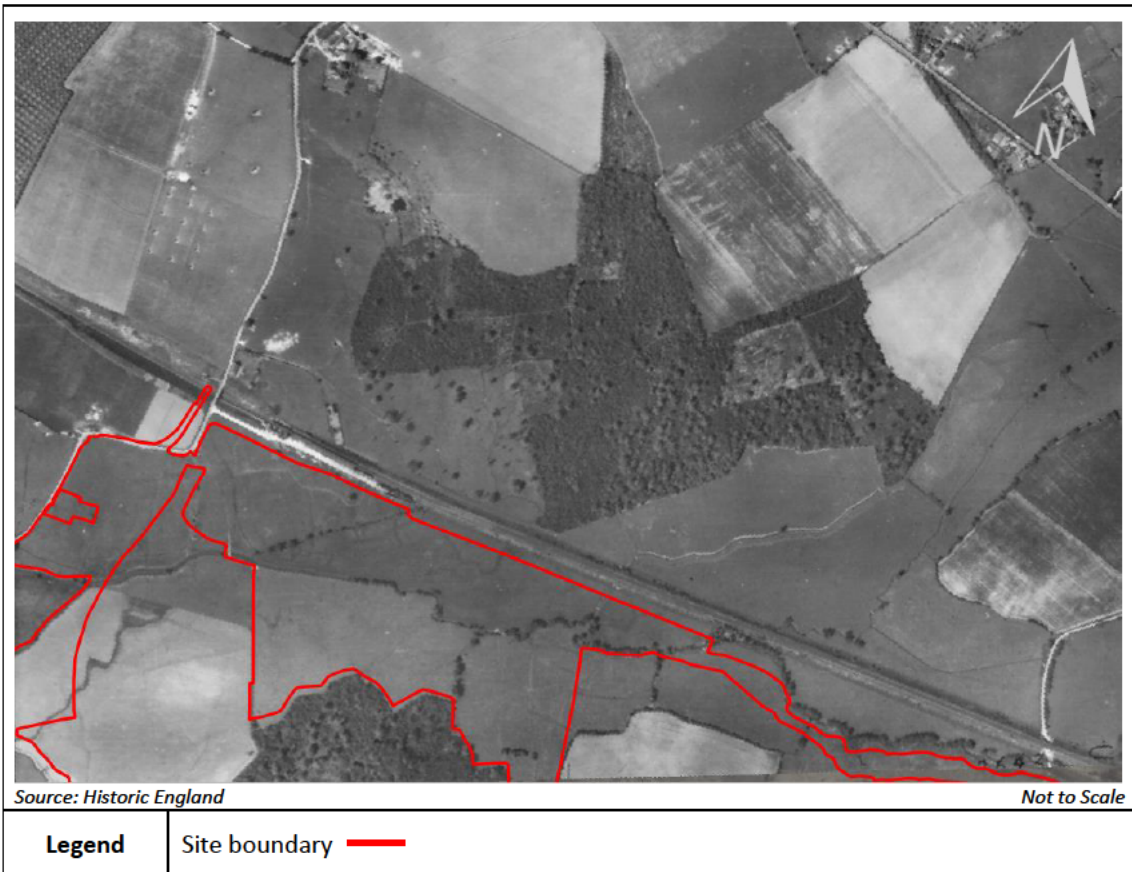
**Plate 5 Aerial photograph of the north-eastern part of the Site, 1<sup>st</sup> May 1946**

Plate 5 is an aerial photograph dated the 1<sup>st</sup> May 1946 of the north-eastern part of the Site. No bomb damage or cratering has been identified on the Site.

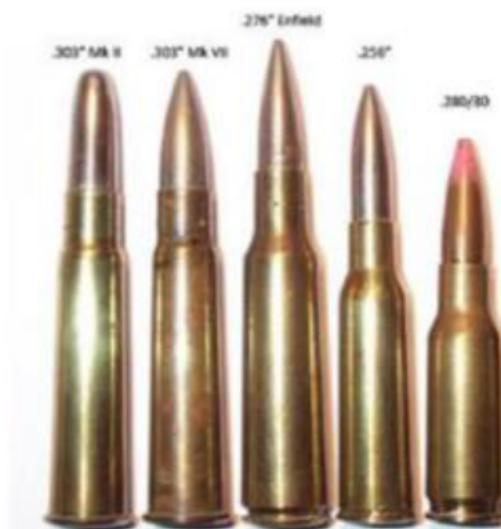
**Category** Small Arms Ammunition  
**Type** Various

**Description** Small Arms Ammunition (SAA) is one of the more recognisable categories of ordnance which is primarily designed for anti-personnel use. SAA include items such as bullets, generally up to a calibre (diameter) of 20mm.

Generally small arms ordnance has a relatively low risk as UXO, although the larger calibre categories may have the same detonation risk as larger high explosive ordnance.

SAA is often associated with discarded ammunition boxes around firing practice ranges and training areas and is often found scattered across former military airfields as a result of aircraft crashes and localised disposal

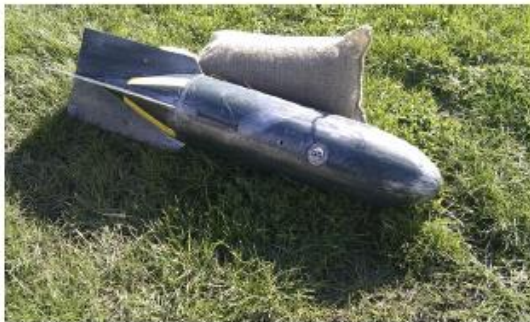
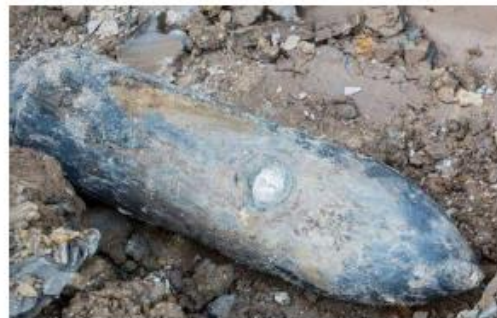
**Function** Designed to maximise shock waves through air, water and earth and for general demolition. Used against easily damageable targets, including roads, aircraft hangars, rolling stock and small buildings. Spike bombs/ 'Stabo' (SC 50 with spikes attached to nose) were used against rail lines and country roads, with Kopfring used against naval targets.

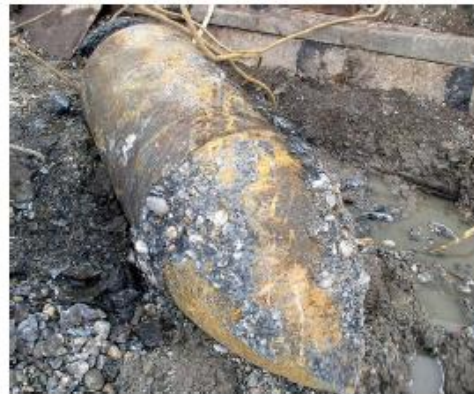
**Category** Projectile  
**Type** 3.7" Anti-Aircraft Shell

**Description** Brass cartridge case. Square-based shell with tapered nose, filled with Amatol, TNT or RDX/TNT. MK6 had forward centring bands and a wider driving band.

**Function** Used as a defence against enemy aircraft, fired from fixed batteries and mobile mountings. Could fire approximately 20 rounds per minute with a maximum ceiling of 41,000ft and horizontal range of 20,600 yards.

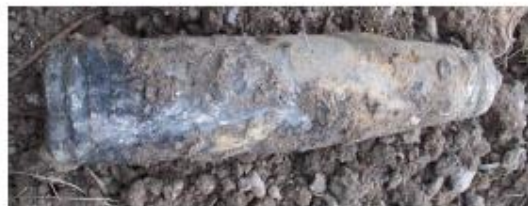
**Category** Projectile  
**Type** 4.5" Shell (Mark II – Anti-Aircraft)

**Description** Square-based, tapered-nosed shell filled with TNT or Amatol. Steel casing, rotating band of either copper or gilding metal located 3.5" in front of the base end with single groove.

**Function** Used as field artillery and adapted for use in anti-aircraft defence from fixed batteries. Rate of fire of 8 rounds per minute, maximum ceiling of 44,000ft and horizontal range of 22,800 yards.

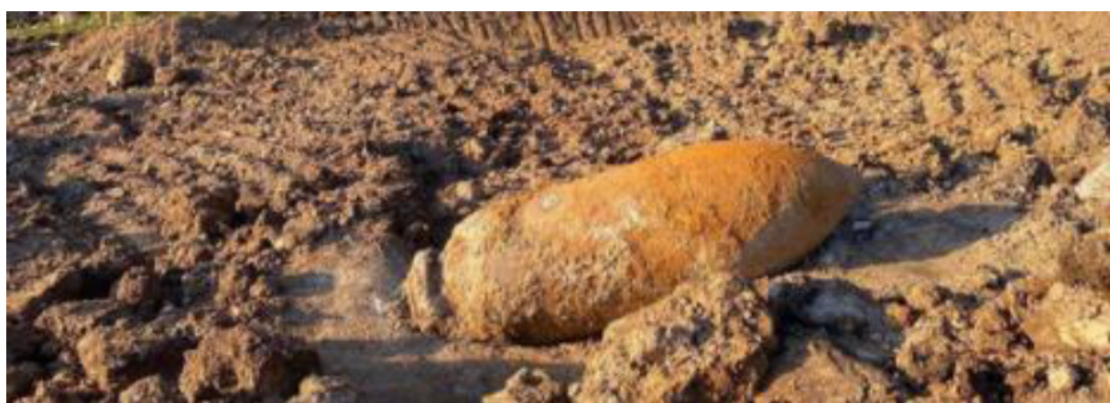
On the 26<sup>th</sup> February 2021, a 1,000kg German "Hermann" UXB was discovered by builders at Exeter University campus (see plate below). It was investigated and detonated in-situ following the evacuation of nearby properties and University halls of residence.
