Stonestreet Green Solar
Environmental Statement
Volume 4: Appendices
Chapter 11: Land Contamination
Appendix 11.2: Phase 1 Geoenvironmental and
Geotechnical Desk Study Part 5 of 5

PHASE I ENVIRONMENTAL ASSESSMENT (DESK STUDY REPORT)

Site: The Rear of 2 to 16 Longsfield, Aldington, near Ashford, Kent TN25 7DP

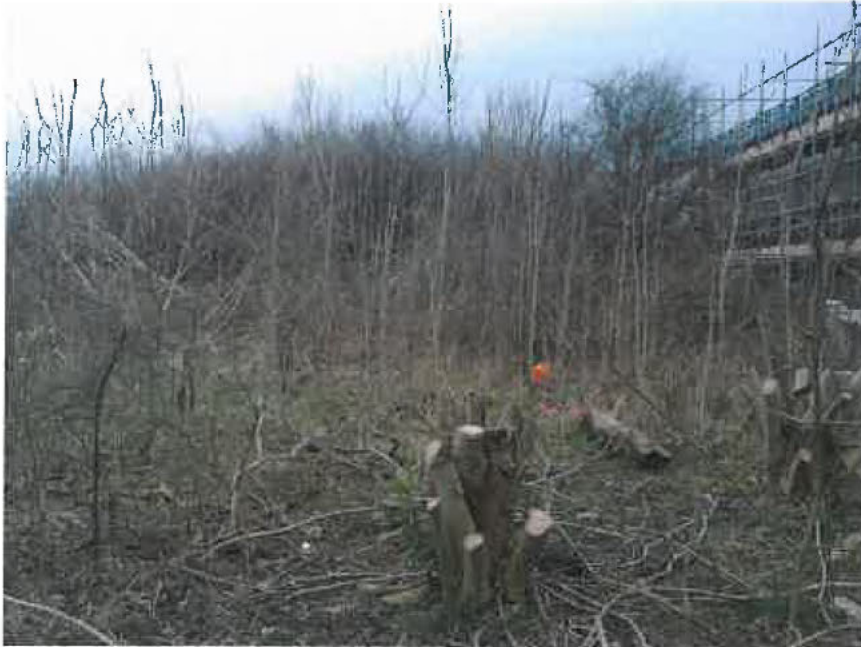
PHOTOGRAPH 1

Looking west across the north area of the site. This area will mainly be the new vehicle access. The adjacent new development is on the far right.

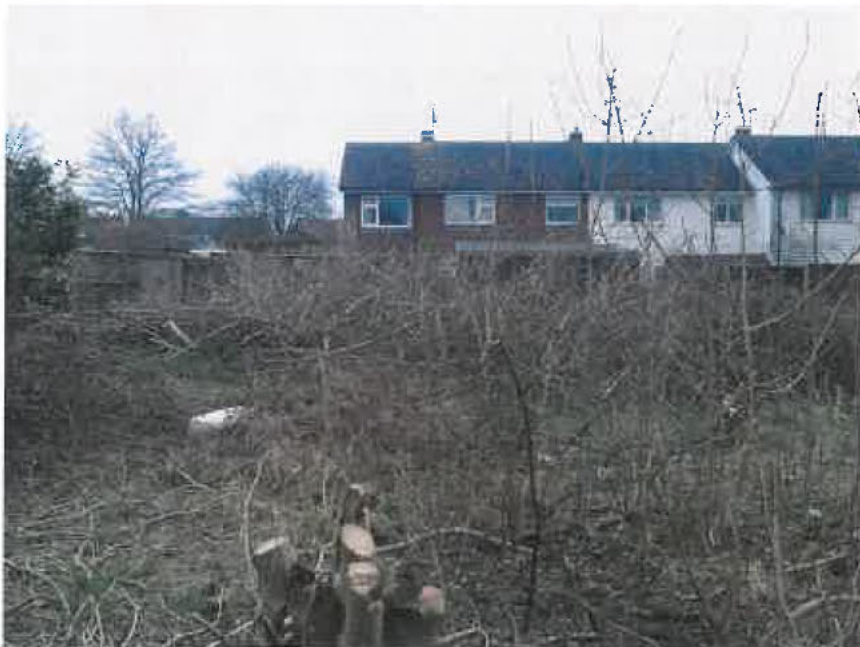
PHOTOGRAPH 2

Looking south across the east area showing the adjacent houses in Longsfield. This area will be mainly occupied by two of the new dwellings with vehicle access in the foreground.

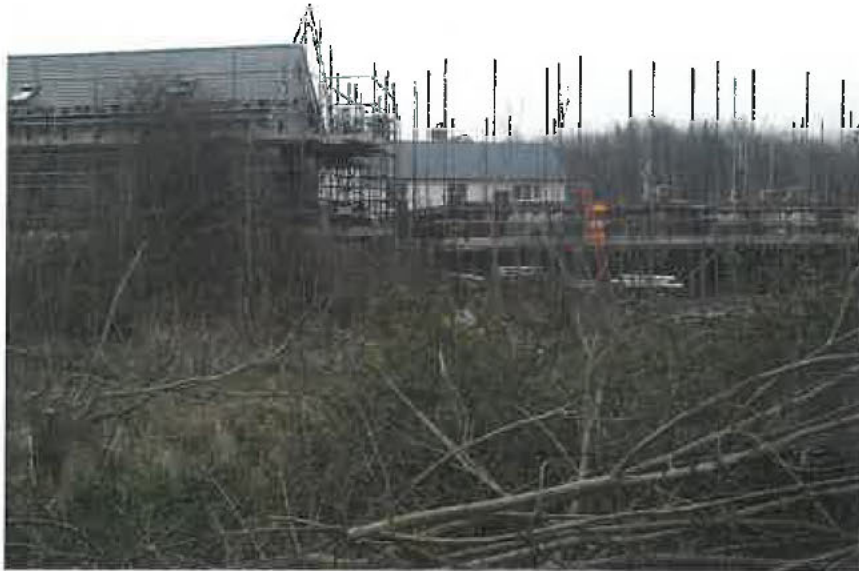
PHOTOGRAPH 3

Looking north/northeast across part of the central area of the site. This area will mainly be private gardens. The adjacent new development is in the background.

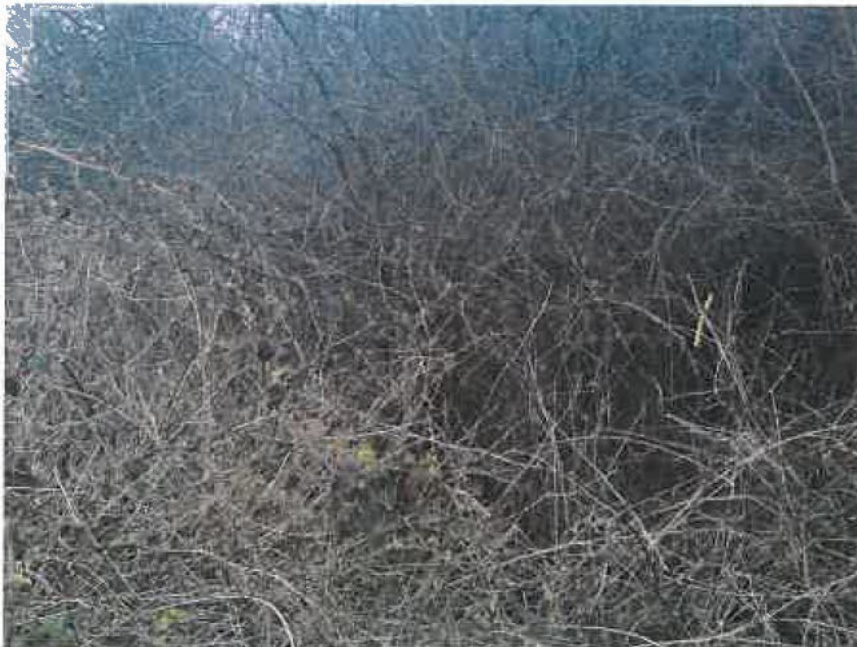
PHOTOGRAPH 4

Looking north/northeast across the west area of the site that is heavily overgrown. This area will be private gardens.

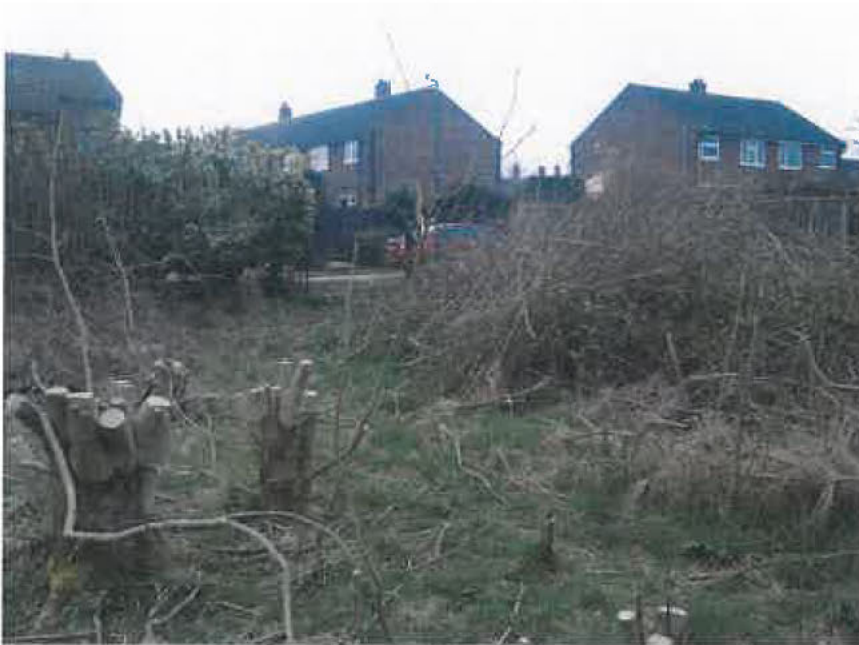
PHOTOGRAPH 5

Looking south across part of the central area of the site. This area will be vehicle access in the foreground with private gardens and two houses in the background. The adjacent houses in Ragstone Hollow that are beyond Quarry Wood are in the far background.

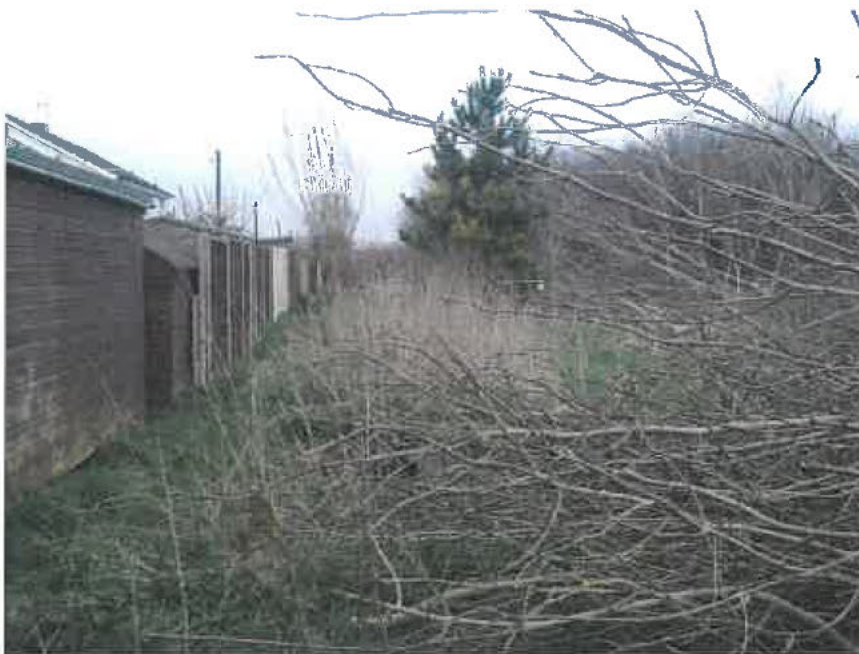
PHOTOGRAPH 6

Looking west/northwest along the south boundary of the site with the rear of the houses in Longsfield on the left. This area will be the side access to one of the houses.
