# NRW National Culverts Study

Report No: 642

Author Affiliation: Ove Arup and Partners Limited (Arup)

Title: **National Culverts Study**

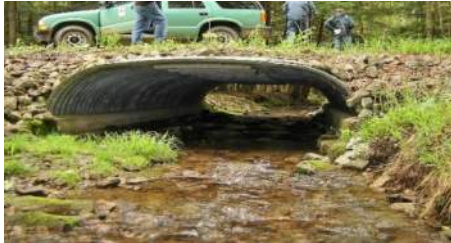
<p>Photo credit: Arup (March 2022)</p>
<p>Box or Bottomless Culvert</p>	<p><u>Bottomless arch culvert</u></p>

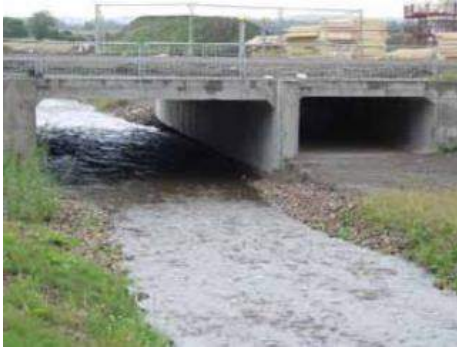
<p><u>Box culvert</u></p>

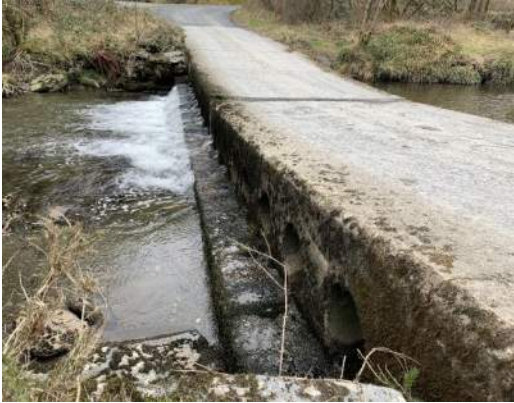
<p>Vented causeway (Piped bridge)</p>

Vented causeways (also known as piped bridges) typically comprise a series of parallel pipes or culverts cased in a concrete surround to form the carriageway (Forestry Commission, 2016). Such crossings are designed to pass the normal dry weather flow of the river through pipes below the road, with surcharge and overflow during high flows (Larcher *et al.*, 2010). Most often vented causeways are used in level terrain, without steep crossings or longitudinal falls.

Vented causeways are not recommended for forestry use (Forestry Commission, 2011). Their relatively small openings are prone to blockage and disrupt natural flows (Forestry Commission, 2019). They also typically represent a significant barrier to fish migration and alter natural processes, resulting in habitat degradation.

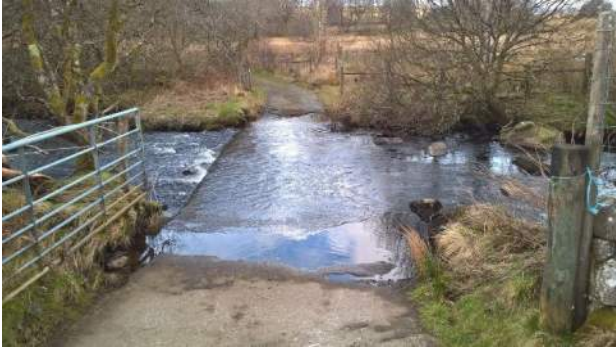
Ford

Fords also result in the same problems as vented causeways, including pollution risk, alteration of sediment transport and barriers to fish migration. These disrupt natural processes and thereby degrade habitats and species.

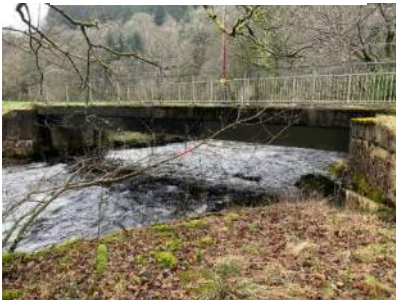
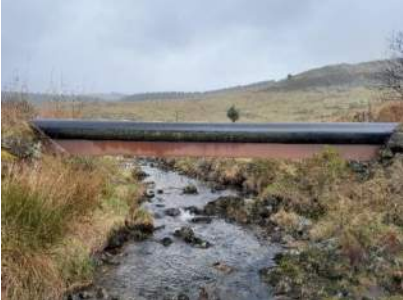
<p data-bbox="1193 533 1374 555">Photo credit: NRW</p>
Bridge (with and without in-channel supports)	<p data-bbox="501 651 724 674"><u>Single span bridge</u></p> <div style="display: flex; justify-content: space-around;">

Single span structures can come in a variety of forms including pre-cast concrete structures (arch or portal [rectangular]), panel bridges that come in prefabricated sections and bridges designed for site specific requirements. Some prefabricated structures require foundations to be constructed at the site whilst others can have prefabricated foundations provided (SEPA, 2010).

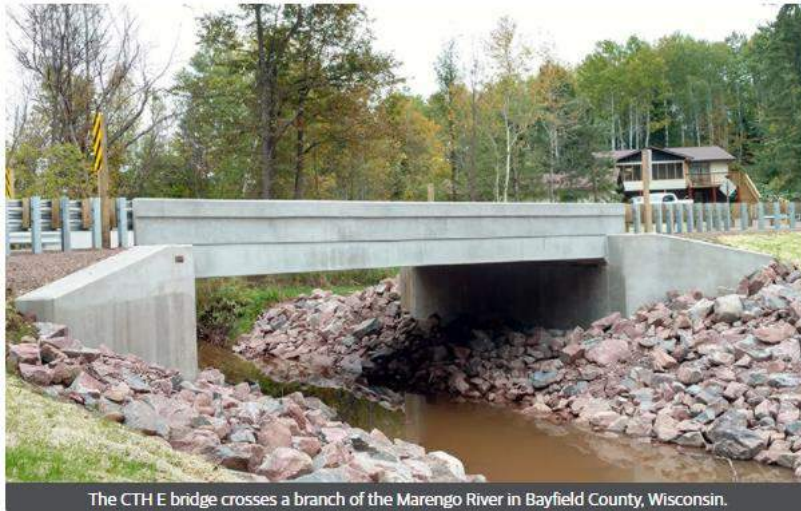
**SINGLE SPAN CROSSING – TIMBER, STEEL OR CONCRETE BRIDGE**

The CTH E bridge crosses a branch of the Marengo River in Bayfield County, Wisconsin.

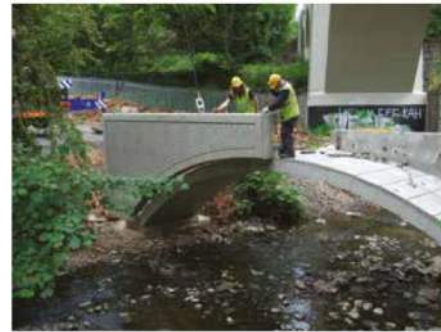
## SINGLE SPAN CROSSING - BOTTOMLESS ARCH CULVERT

Figure 3.4 Use of pre-cast concrete segments for a bridge as a low-cost alternative to a culvert (courtesy WDR & RT Taggart)

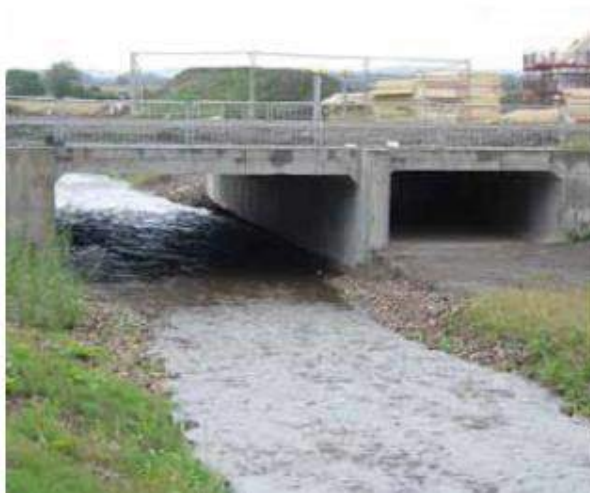
## CULVERT – OVERSIZED CONCRETE BOX

Should be designed for open flows conditions.

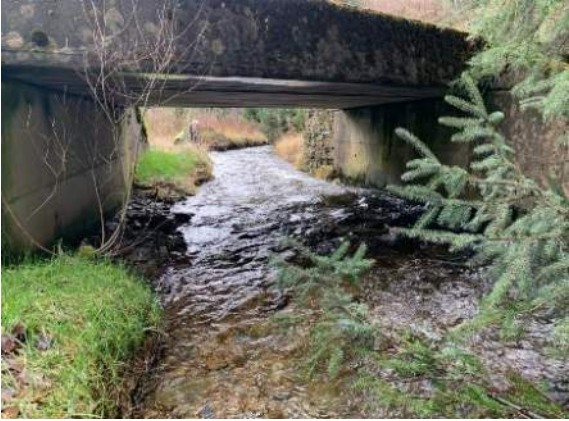
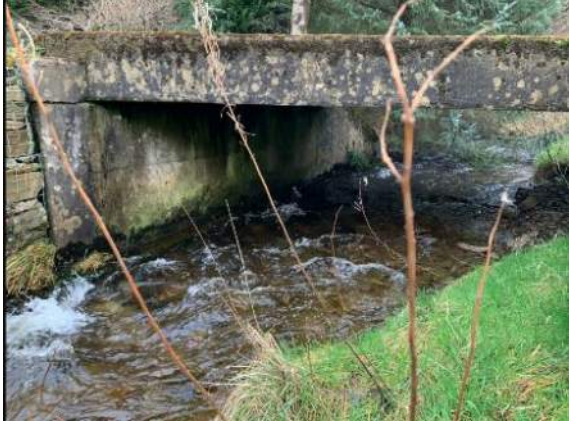
Region: North Wales - 1 Site name: Nant Ystrad-y-groes			
<b>Grid ref. (Lat Long)</b>	52.8640587 -3.5510837	<b>Crossing type</b>	Bridge
<b>Watercourse bed material</b>	Gravel	<b>Crossing material</b>	Concrete abutments
<b>Upstream of crossing</b>	Flow depth approx. 300mm No deposition upstream	<b>Crossing condition</b>	Good condition
<b>Downstream of crossing</b>	Flow depth ~ 300mm No erosion downstream	<b>Crossing dimensions</b>	4m long 6m breadth
<b>Current crossing/watercourse</b>	Low gradient	<b>Crossing notes</b>	Slight deposition under the bridge. Downstream gabions are at risk of eroding under.
<b>Photographs</b>			
Upstream		Downstream

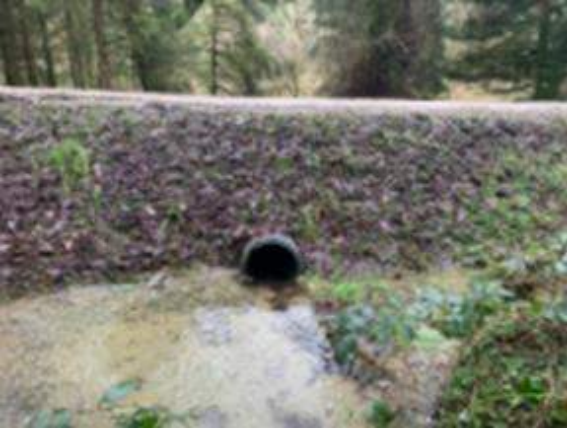
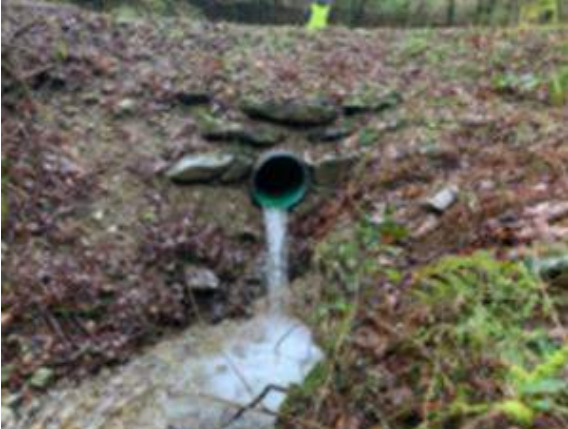
Region: North Wales - 6 Site name: Unnamed Tributary of Hirnant			
<b>Grid ref. (Lat Long)</b>	52.8833341 -3.5525929	<b>Crossing type</b>	Pipe
<b>Watercourse bed material</b>	Coarse Gravel with some Silt	<b>Crossing material</b>	HDPE with rock headwalls
<b>Upstream of crossing</b>	Flow depth ~ 100mm Significant deposition upstream – pooling ~800mm wide, 70mm deep	<b>Crossing condition</b>	Recently (past 5 years) installed - Good
<b>Downstream of crossing</b>	Flow depth ~ 100mm Slight erosion downstream	<b>Crossing dimensions</b>	9m length 450mm diameter 1500mm depth to soffit
<b>Current crossing/watercourse</b>	Moderate gradient, flowing onto valley floor.	<b>Crossing notes</b>	Deposition build up at inlet (1m from crest, 1.3m from crest to road). Blockstone headwall. Impassable to fish
<b>Photographs</b>			
Upstream		Downstream

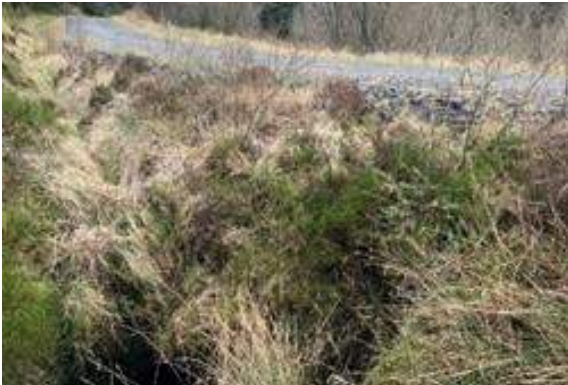
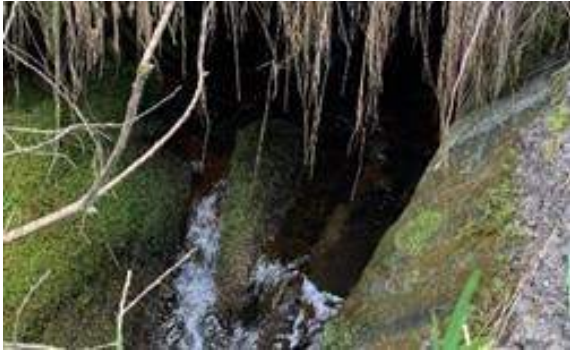
Region: Mid Wales - 1 Site name: Unnamed Watercourse			
<b>Grid ref. (Lat Long)</b>	52.41893 -3.731391	<b>Crossing type</b>	Pipe
<b>Watercourse bed material</b>	Bedrock, limited cobbles	<b>Crossing material</b>	Steel
<b>Upstream of crossing</b>	Flow depth ~ 50mm No deposition upstream Watercourse 1m wide	<b>Crossing condition</b>	Poor
<b>Downstream of crossing</b>	Flow depth ~ 100mm Slight erosion downstream	<b>Crossing dimensions</b>	9m length 1500mm diameter 2200mm depth to soffit
<b>Current crossing/watercourse</b>	Moderate gradient	<b>Crossing notes</b>	None
<b>Photographs</b>			
Upstream		Downstream

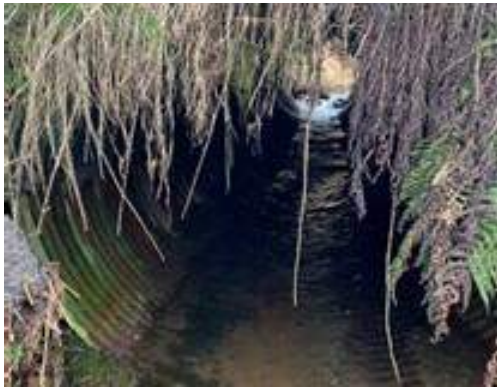
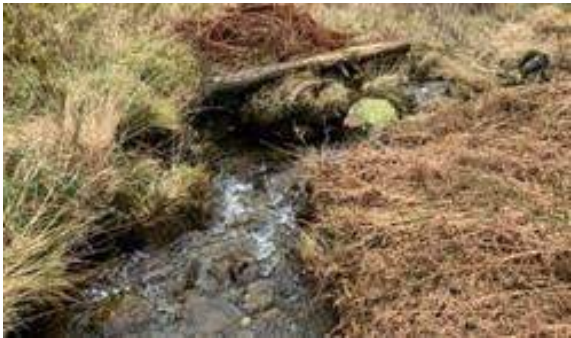
Region: Mid Wales - 2 Site name: Unnamed Watercourse			
<b>Grid ref. (Lat Long)</b>	52.419348 -3.730361	<b>Crossing type</b>	Pipe
<b>Watercourse bed material</b>	Cobble to Gravel	<b>Crossing material</b>	Steel
<b>Upstream of crossing</b>	Flow depth ~ 50mm Slight deposition upstream Watercourse 1.2m wide	<b>Crossing condition</b>	Poor
<b>Downstream of crossing</b>	Flow depth ~ 50mm No erosion downstream Watercourse 2m wide Evidence of deposition	<b>Crossing dimensions</b>	12m length 1500mm diameter 2000mm depth to soffit
<b>Current crossing/watercourse</b>	Moderate gradient	<b>Crossing notes</b>	None
<b>Photographs</b>			
Upstream		Downstream

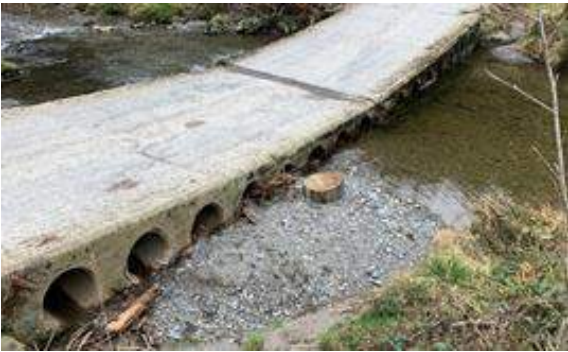
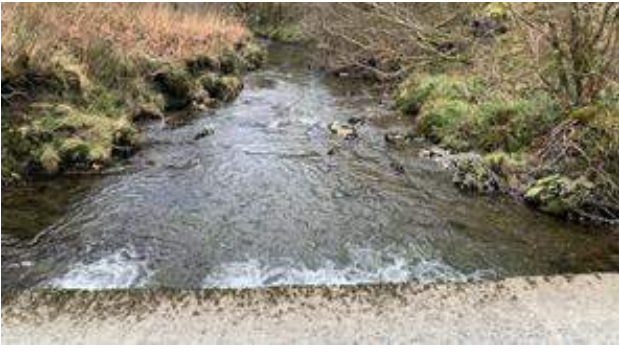
Region: Mid Wales - 7 Site name: River Severn			
<b>Grid ref. (Lat Long)</b>	52.466334 -3.677763	<b>Crossing type</b>	Vented Causeway
<b>Watercourse bed material</b>	Cobble to fine gravel	<b>Crossing material</b>	Concrete
<b>Upstream of crossing</b>	Flow depth ~ 400mm Watercourse 8m wide Slight deposition upstream	<b>Crossing condition</b>	Not assessed
<b>Downstream of crossing</b>	Flow depth ~ 400mm Watercourse 8m wide Slight erosion downstream	<b>Crossing dimensions</b>	4m length – each pipe 450mm dia. 200mm depth to soffit
<b>Current crossing/watercourse</b>	Low gradient	<b>Crossing notes</b>	Immediately downstream of bridge. 16no pipes.
<b>Photographs</b>			
Upstream		Downstream

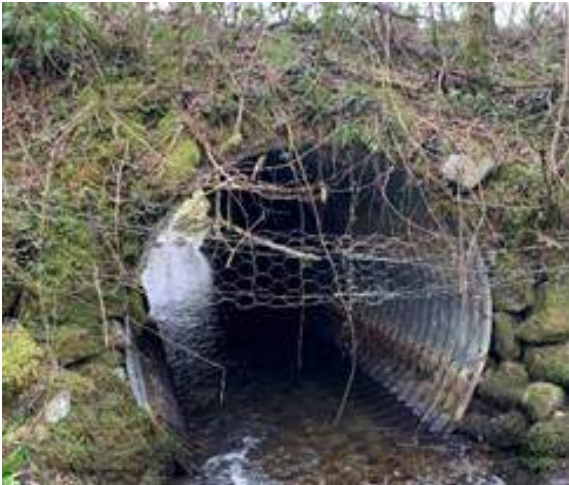
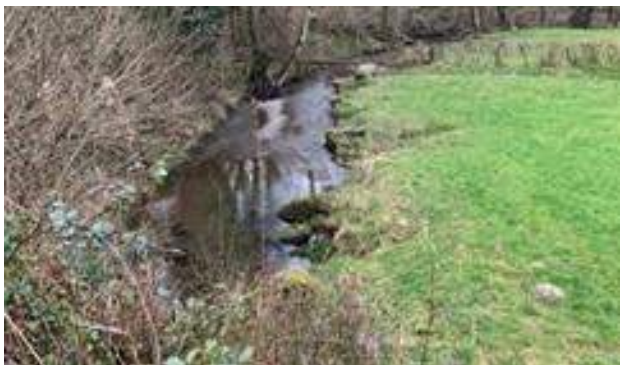
Region: South Wales - 4 Site name: Unnamed watercourse - Halfway			
<b>Grid ref. (Lat Long)</b>	52.009472 -3.682725	<b>Crossing type</b>	Pipe
<b>Watercourse bed material</b>	Cobble boulder	<b>Crossing material</b>	Steel
<b>Upstream of crossing</b>	Flow depth ~ 50mm Watercourse ~3.2m wide Slight deposition upstream	<b>Crossing condition</b>	Poor – due to be replaced.
<b>Downstream of crossing</b>	Flow depth ~ 100mm No erosion downstream	<b>Crossing dimensions</b>	12m length 2300mm diameter
<b>Current crossing/watercourse</b>	Moderate gradient	<b>Crossing notes</b>	Blockstone fish easement at downstream end causing ponding through culvert – created a natural gravel base.
<b>Photographs</b>			
Upstream		Downstream

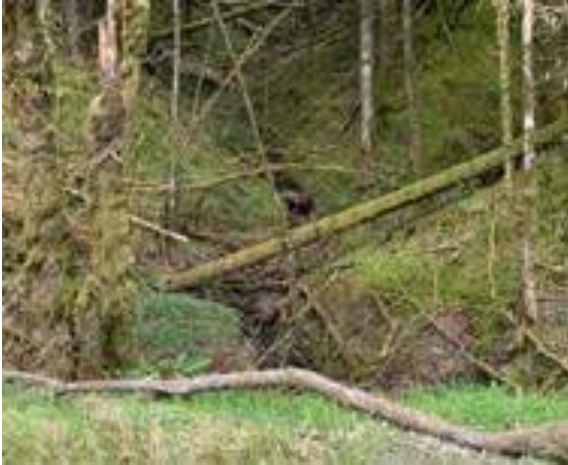
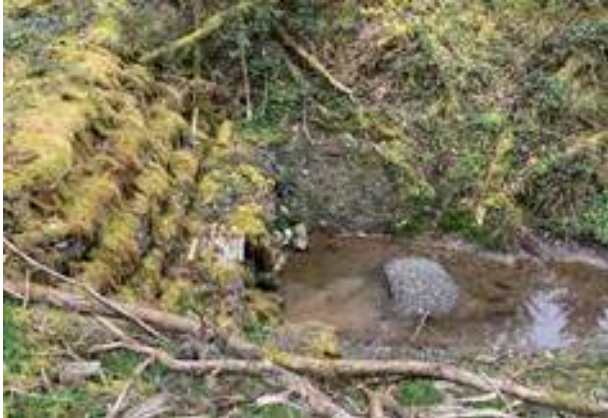
Region: South Wales - 5 Site name: Unnamed watercourse - Halfway			
<b>Grid ref. (Lat Long)</b>	52.040949 -3.691823	<b>Crossing type</b>	Pipe
<b>Watercourse bed material</b>	Cobble boulder	<b>Crossing material</b>	Steel with gabion basket outlet headwall. Inlet obscured by sedimentation.
<b>Upstream of crossing</b>	Flow depth ~ 30mm Significant deposition – culvert inlet buried and not visible.	<b>Crossing condition</b>	Poor – inlet buried.
<b>Downstream of crossing</b>	Unable to access	<b>Crossing dimensions</b>	12m length Approximately 1500mm diameter
<b>Current crossing/watercourse</b>	Steep gradient	<b>Crossing notes</b>	Located on hairpin bend in steep sided valley. Significant embankment (~8m) above culvert.
<b>Photographs</b>			
Upstream		Downstream

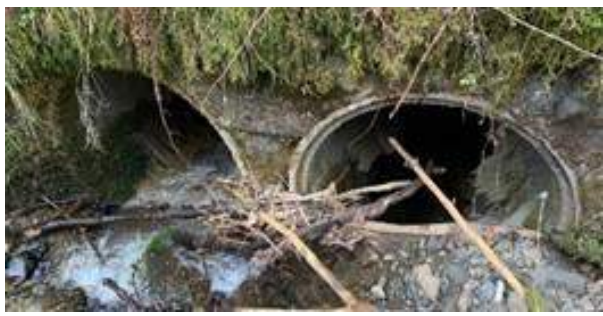
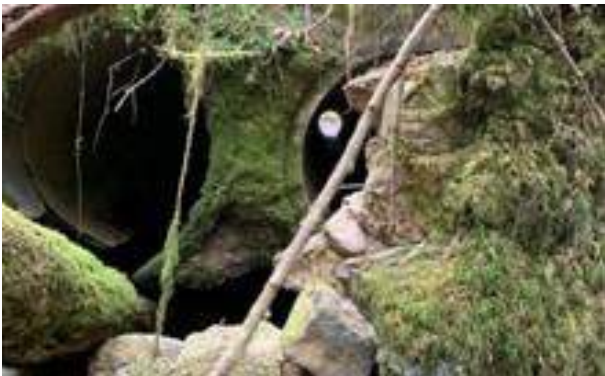
Region: South Wales - 6 Site name: Unnamed watercourse - Halfway			
<b>Grid ref. (Lat Long)</b>	52.043272 -3.683069	<b>Crossing type</b>	Twin Pipe
<b>Watercourse bed material</b>	Cobble to gravel	<b>Crossing material</b>	Concrete.
<b>Upstream of crossing</b>	Flow depth ~ 50mm Significant deposition – culvert inlet partially blocked. Watercourse 2.5m wide	<b>Crossing condition</b>	Poor, due for replacement.
<b>Downstream of crossing</b>	Outlet headwall failed.	<b>Crossing dimensions</b>	12m length 900mm diameter twin pipes. RHS failed.
<b>Current crossing/watercourse</b>	Moderate gradient	<b>Crossing notes</b>	Bank slipping above outlet headwall, which appear to have failed due to tree root pressures.
<b>Photographs</b> <div style="display: flex; justify-content: space-around;"> <div style="text-align: center;"> <p>Upstream</p>
