# MONA OFFSHORE WIND PROJECT

## Geomorphology Clarification Note

Document Reference: S\_D4\_7

Document Number: MOCNS-J3303-RPS-10313

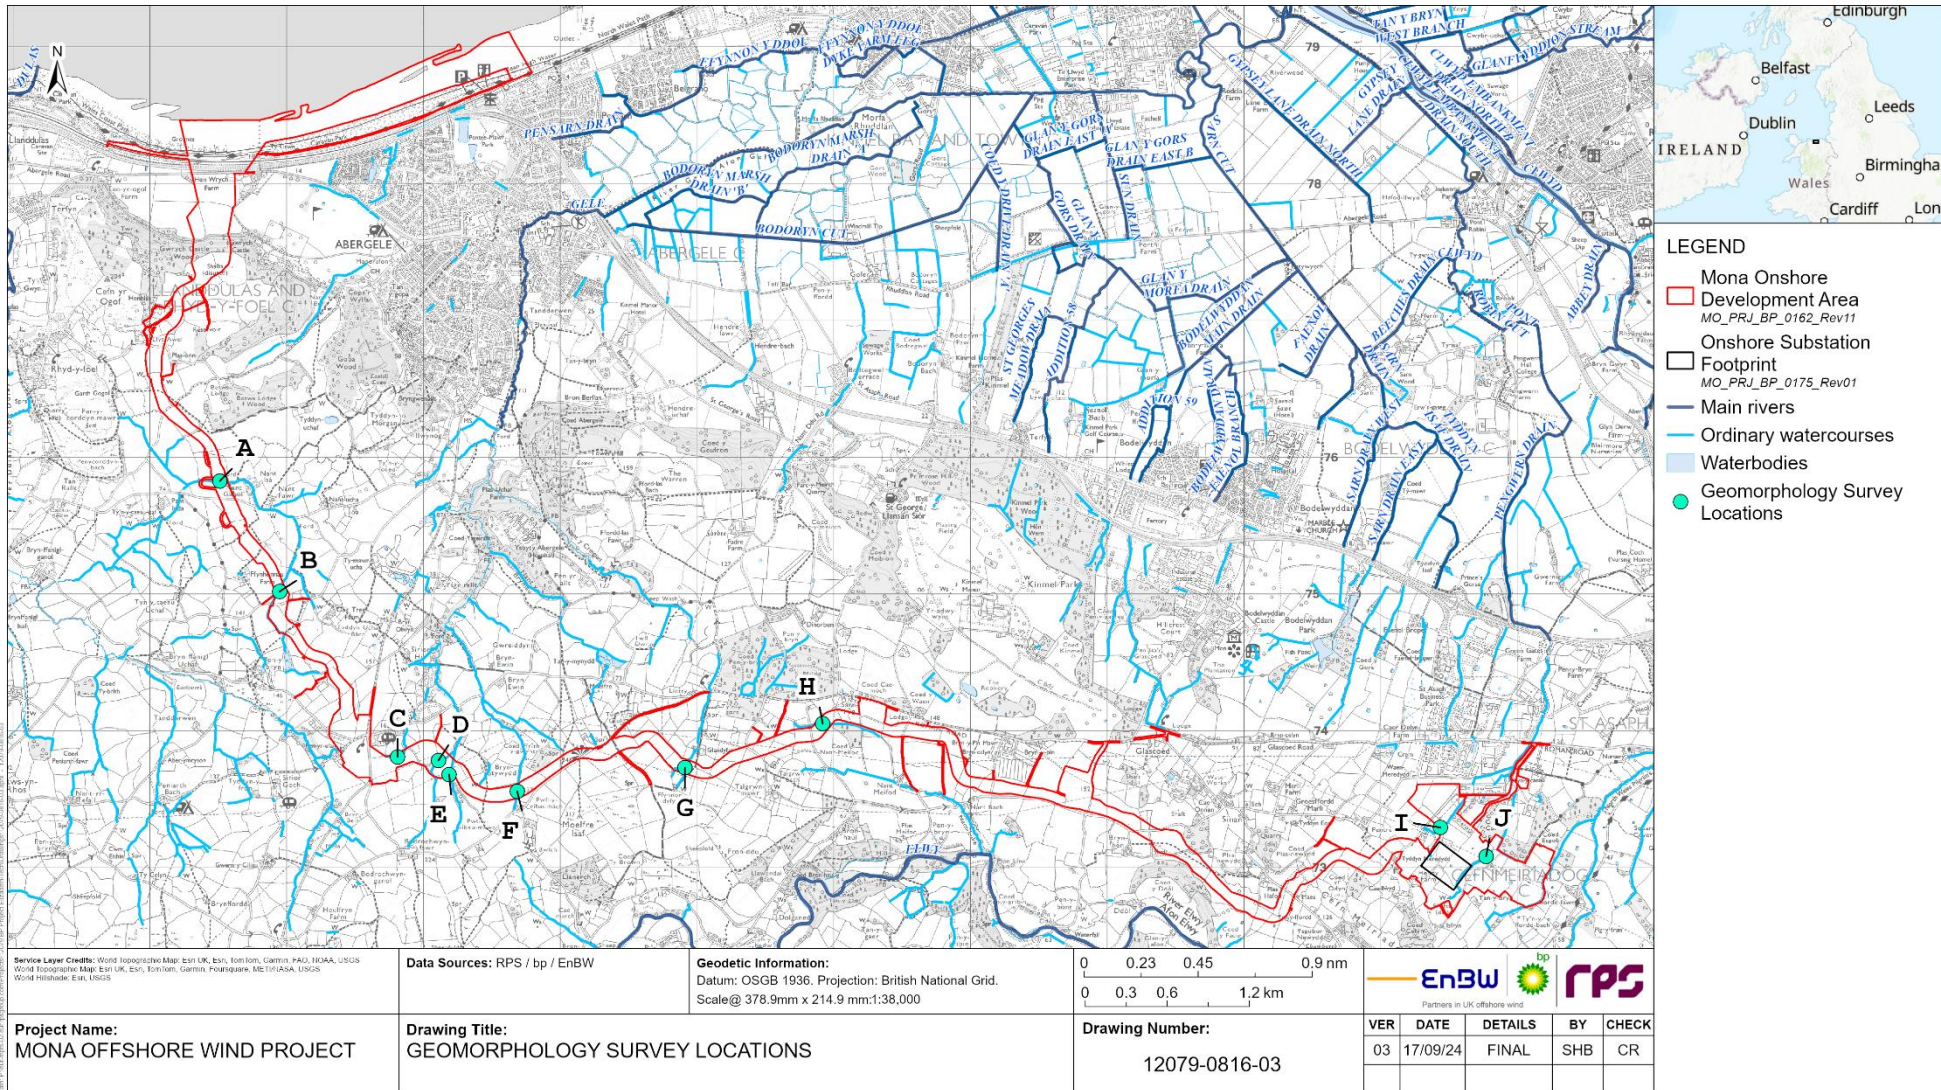
Figure 1.1: Geomorphology survey locations

1.2.1.1 The construction of the Mona Onshore Cable Corridor will cross ten Ordinary Watercourses (as shown on Figure 1.1). Information on these watercourses was gathered during onshore ecology surveys undertaken as part of the environmental impact assessment process.

1.2.3.1 The locations of the watercourses that will be crossed by the Onshore Cable Corridor and described in the geomorphology clarification note are shown on Figure 1.1 and listed in the table below:

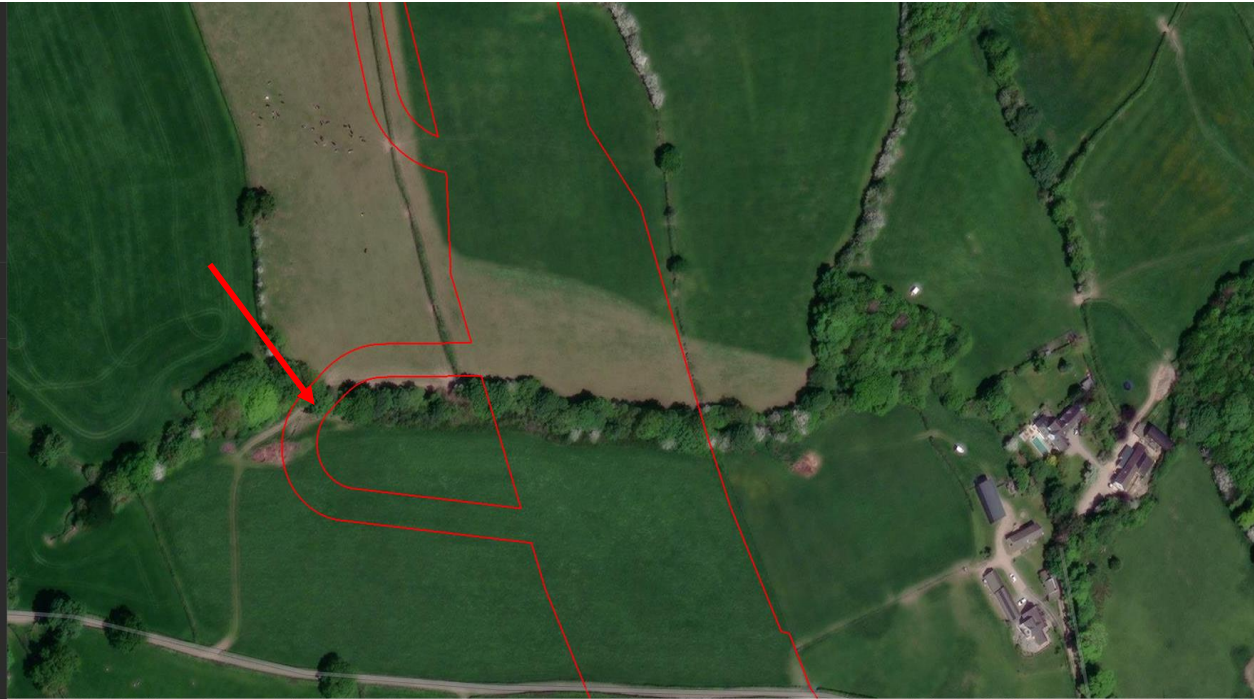
- 1.2.5.5 At this location the watercourse will be crossed using trenchless techniques and the haul road will use an existing crossing location as shown in Plate 1 below.

**Plate 1: Approximate location of existing access track at Location A**

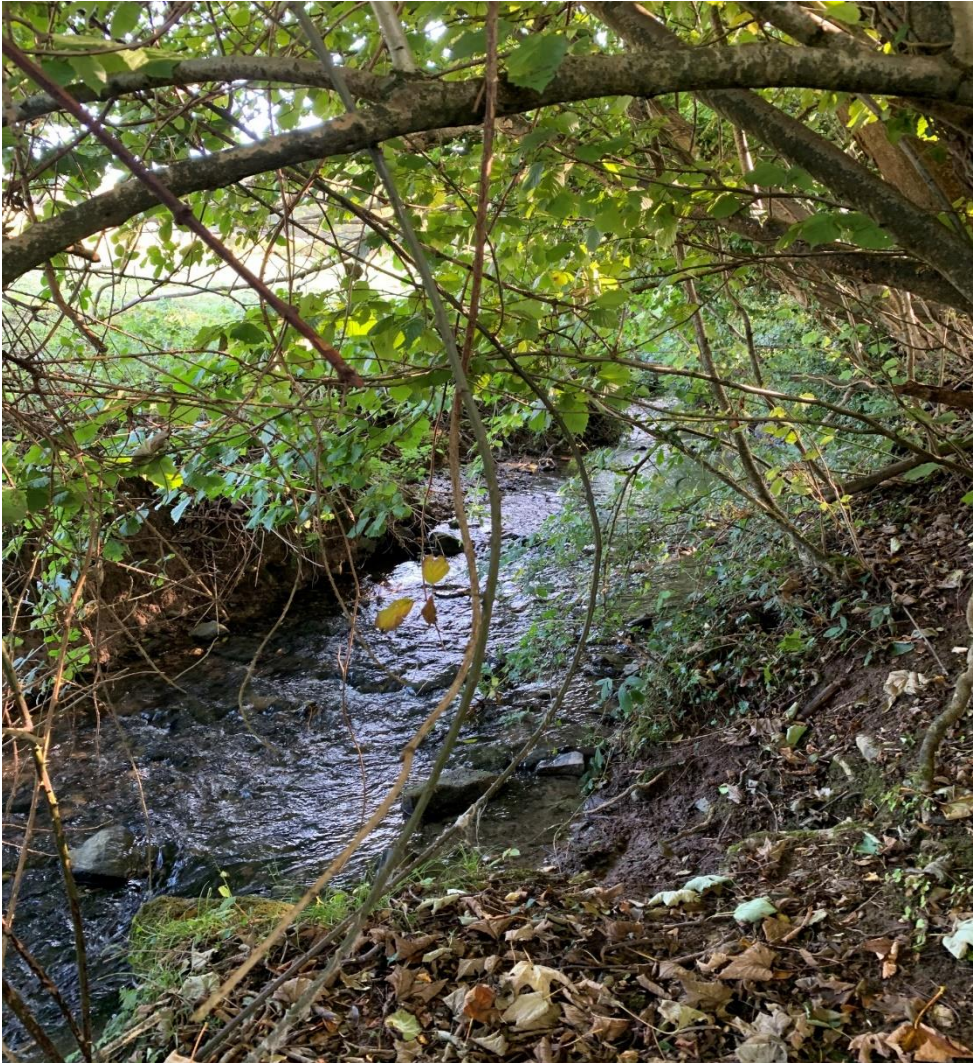
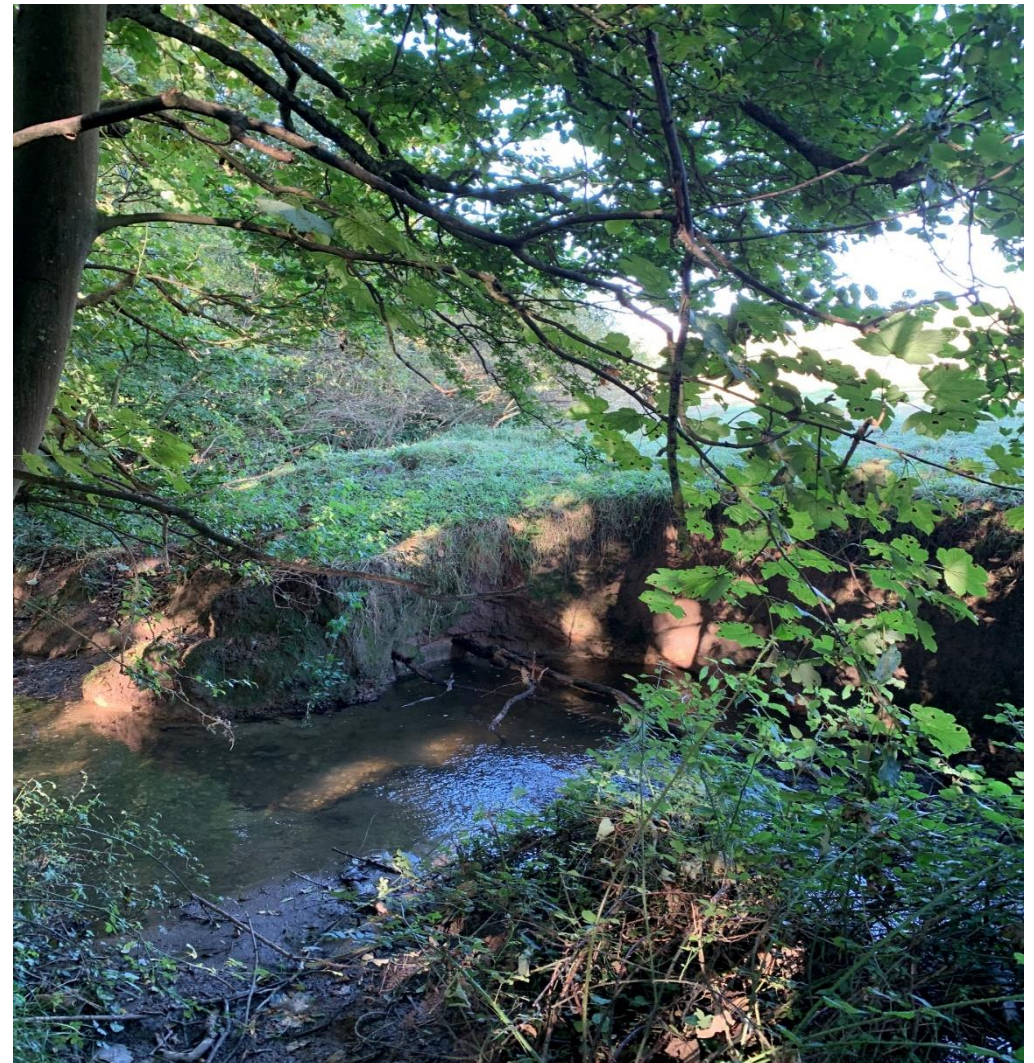
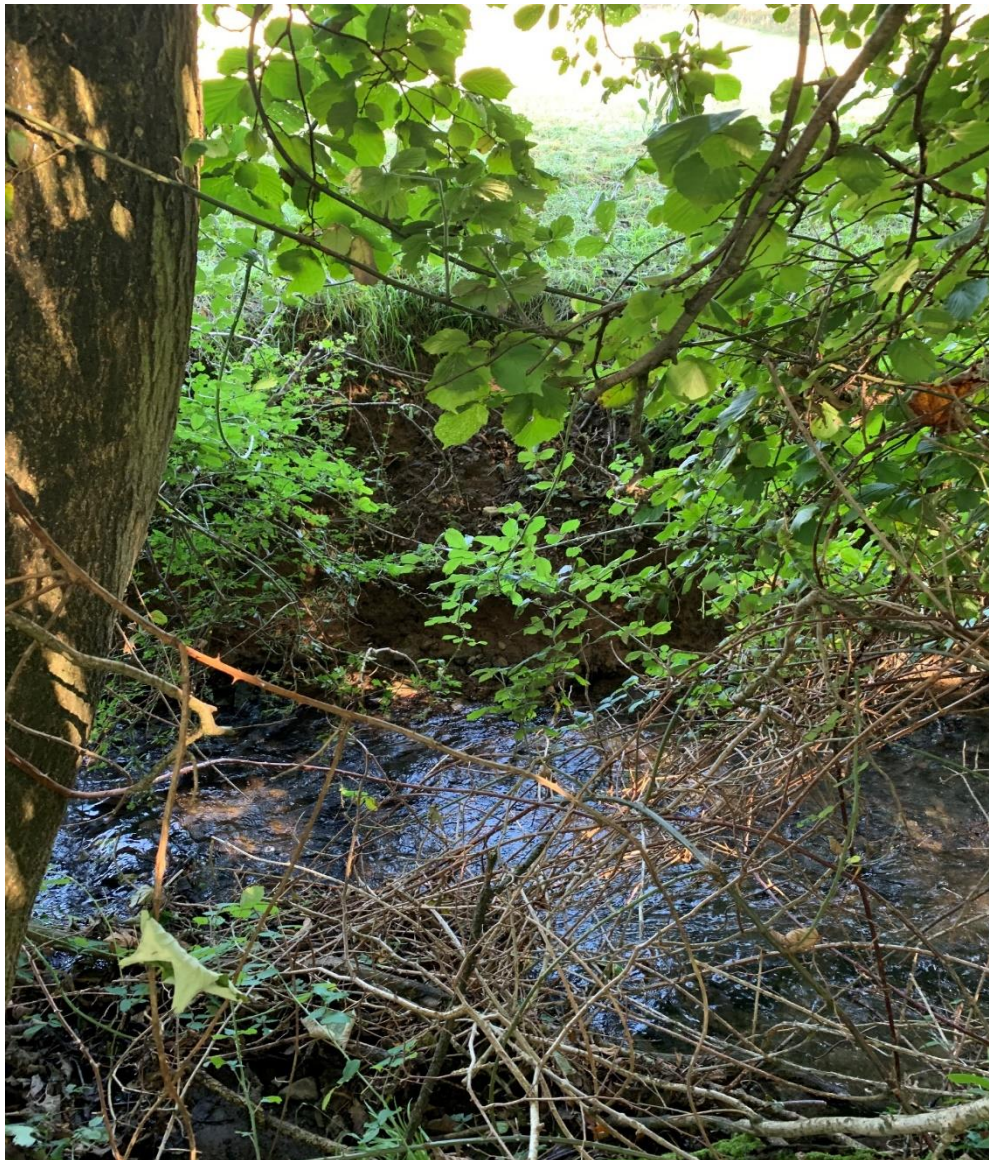
### A.4.1 Location A

- 1.2.5.2 Location A was surveyed from the left bank, the right bank top was not accessible. It is a well-established and morphologically active stretch of the Nant y Fedw watercourse with a catchment area of 1.7km<sup>2</sup>. The classification of this watercourse is River Type H – straight/sinuuous, coarsest GP (gravel-pebble), average SA (sand).

- 1.2.5.3 Cover on both bank tops was classified as permanently vegetated agriculture. Saplings and trees were present extensively on the left bank top which offered extensive channel shading. There was large wood noted on the left bank face and channel bed, and leaning trees on the left bank face. The watercourse at this location exhibited limited artificial stresses: the right bank appeared to constitute a cliff feature made up of Earth. The condition of the right bank could be improved with the establishment of a riparian buffer.

- 1.2.5.4 The stretch of watercourse has a moderate richness of morphological features with a variety of bed sediment and flow types. Unvegetated side bars and a bench were identified in the channel margins and no artificial reinforcements were identified to be present. No NNIPS (Non-Native Invasive Plants) were observed at the time of walkover.

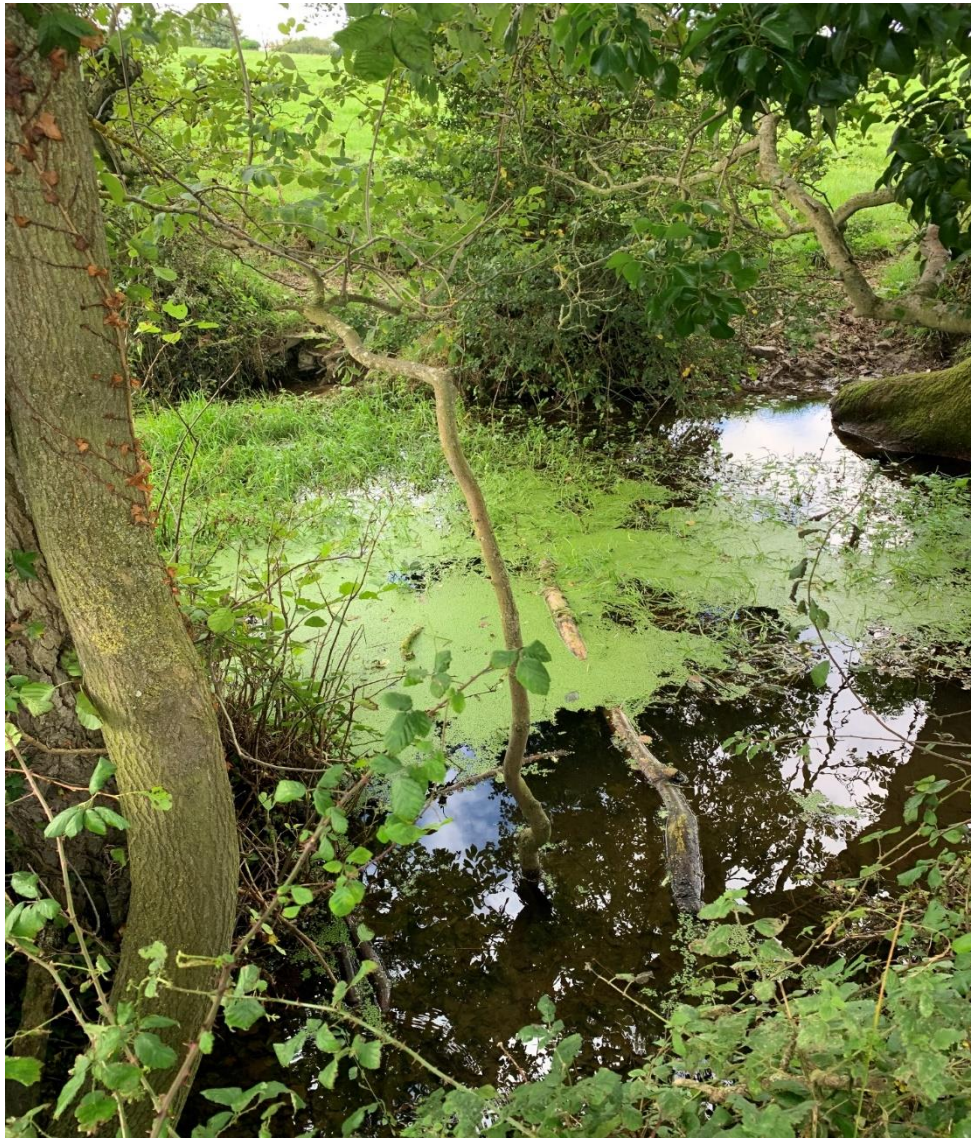
A.4.2 Location B

- 1.2.5.6 Location B was located approximately 1.3km upstream of location A and has a catchment area of 0.2km<sup>2</sup>. Cattle were present in the land parcel associated with the left bank therefore, the survey was undertaken from the right bank. The classification of this watercourse is River Type K – straight/sinuuous, coarsest SA, average SI (silt).

- 1.2.5.7 The observations noted that sections of the Nant y Fedw had running water, however at the location of the proposed crossing, the water appeared stagnant and eutrophic with no perceptible flow and choked with aquatic plants. Vegetation at the channel margin included mosses, emergent broad leaves and linear leaves in addition to free floating plants. The presence of Duckweed (*Lemnoideae*) was extensive in the channel. Large wood was also noted in the channel, right bank top and right bank face.

- 1.2.5.8 The ground cover on the top of both of the bank was classified as permanently vegetated agriculture with areas of exposed soils and short grasses. The left bank appeared heavily poached by the cattle. The watercourse was boarded with scrub/shrubs on the right bank. The channel lacks almost any morphological richness and is generally in poor condition. A marginal backwater, which is an embayment feature with lowered flow velocities was identified along the left bank channel margin. No artificial reinforcements were evident. No NNIPS (Non-Native Invasive Plants) were observed at the time of walkover.

- 1.2.5.9 At this location the watercourse will be crossed using trenchless techniques and the haul road will require a new temporary crossing to be constructed.

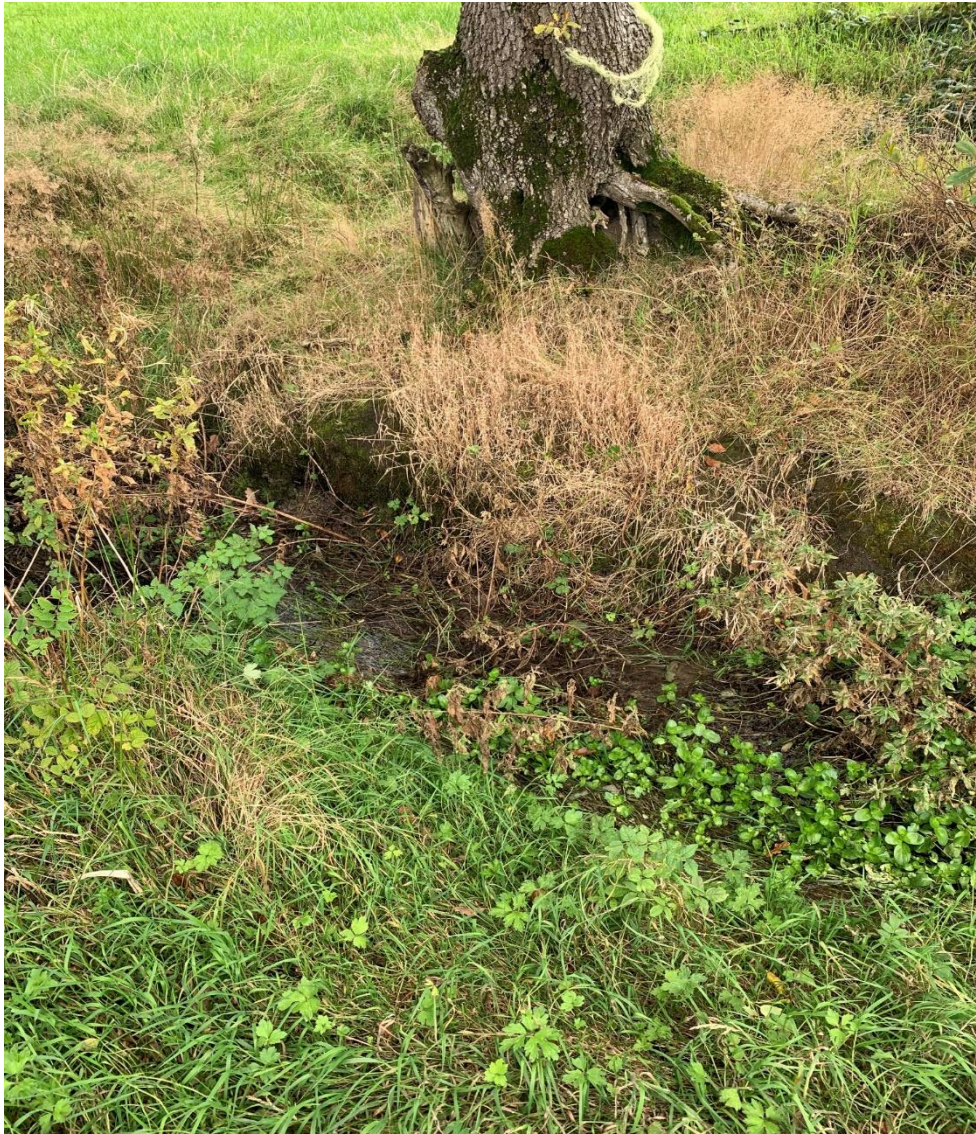
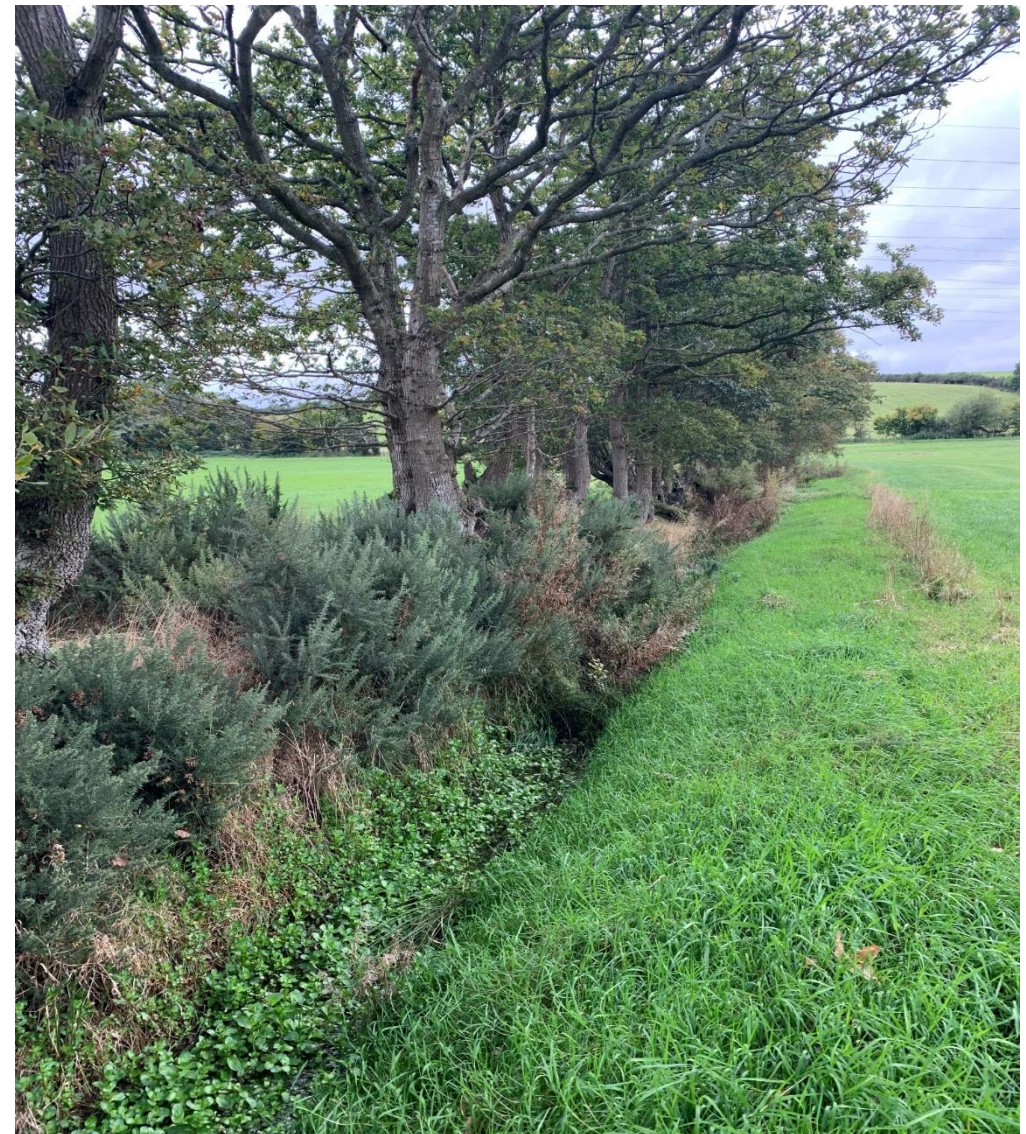
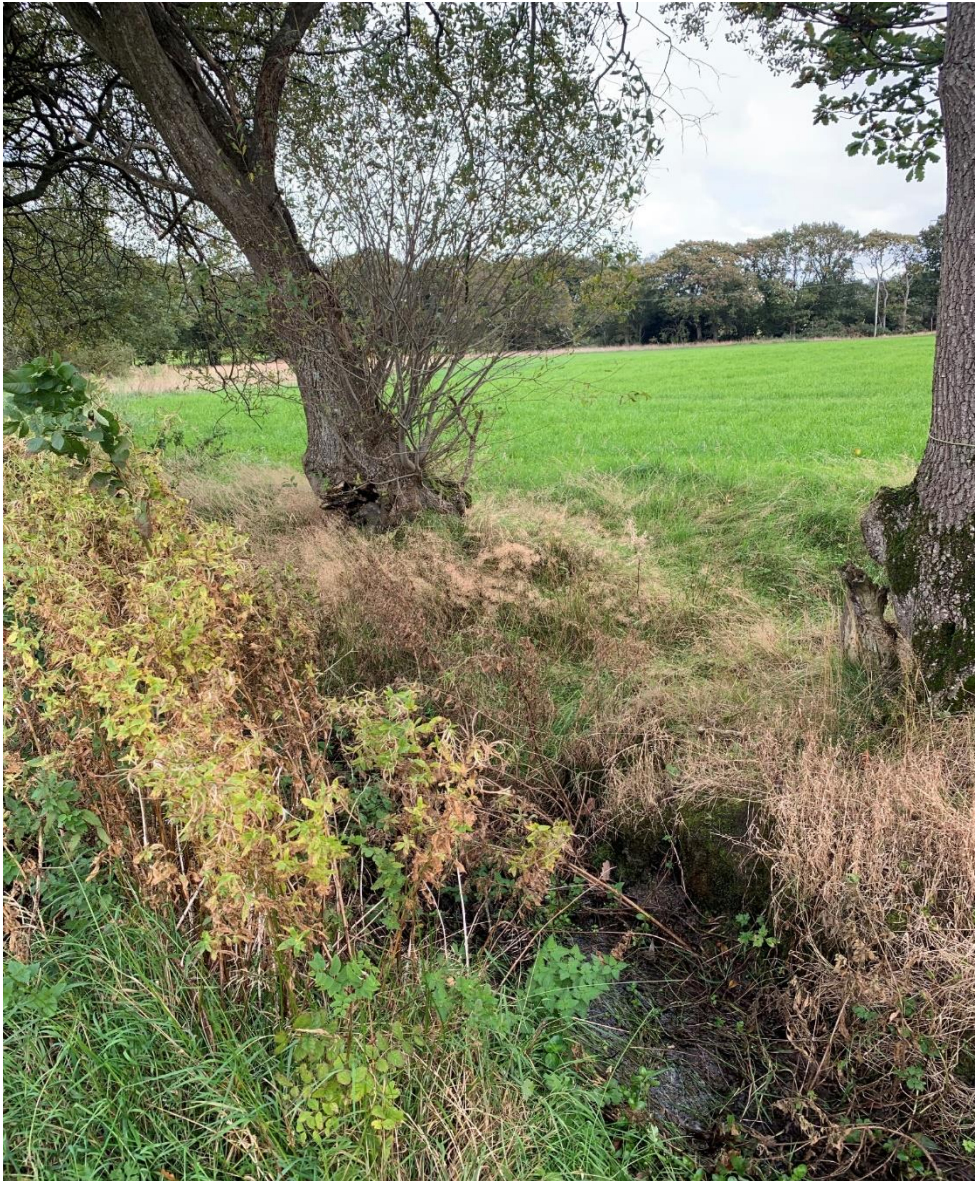
A.4.3 Location C

- 1.2.5.10 Location C is an unnamed agricultural drainage ditch with a catchment area of 0.1km<sup>2</sup>. was undertaken using the DCA methodology.
- 1.2.5.11 The completed DCA proforma for Location C is included below.

- 1.2.5.12 Overall, based on the criterion above, the watercourse at Location C achieved a 'Moderate' (2) score on the DCA.
- 1.2.5.13 The condition of the ditch could be improved by maintaining sufficient water levels in the ditch of at least 50cm.
- 1.2.5.14 At this location the watercourse will be crossed using trenched or trenchless techniques and the haul road will require a new temporary crossing to be constructed.

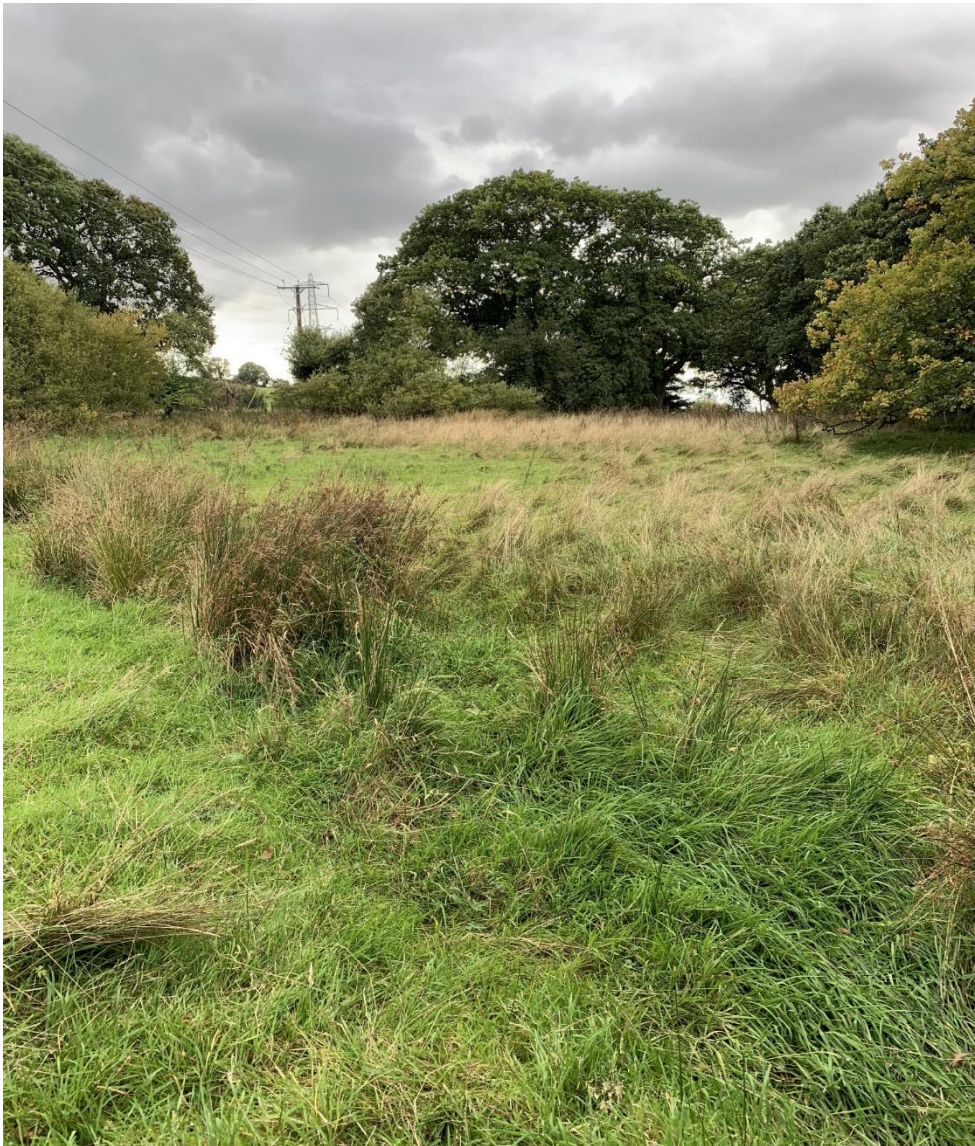
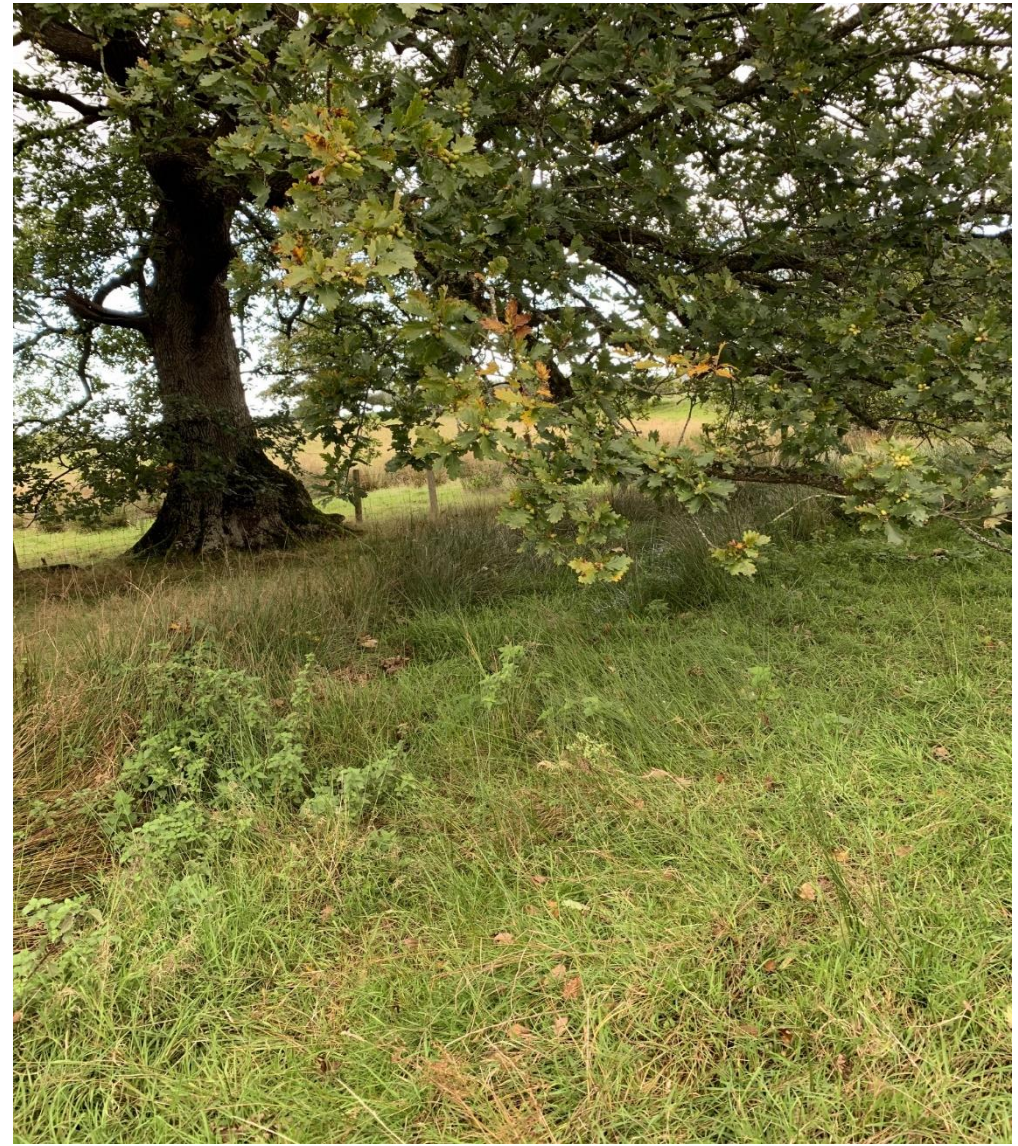
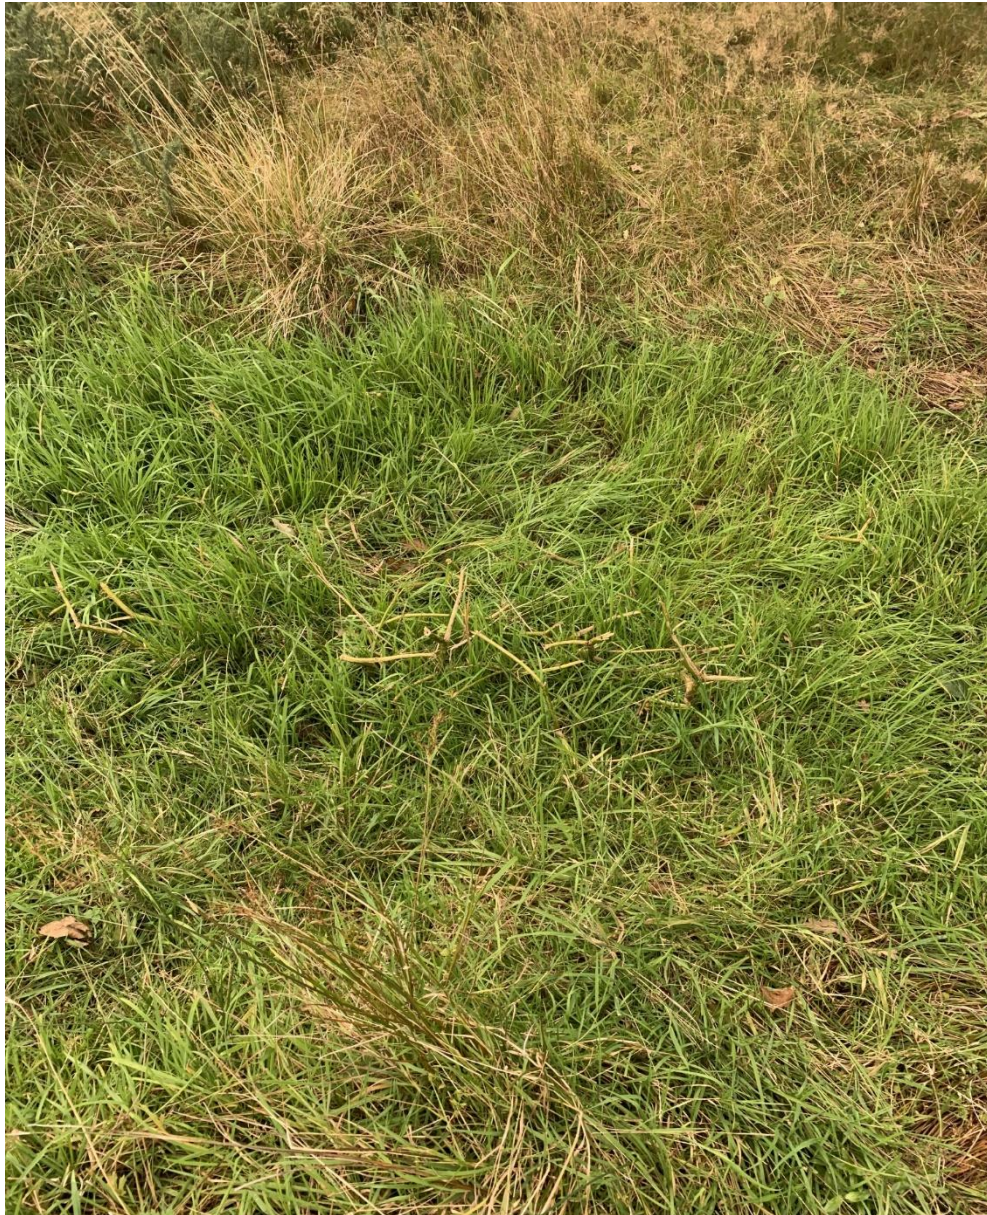
A.4.4 Location D

- 1.2.5.15 Location D comprises a seepage draining to Afon Gele with a catchment area of 0.2km<sup>2</sup>. The watercourse is not suitable for a MoRPh survey as there is insufficient flow to support morphological activity; it is also not suitable for a ditch condition assessment.
- 1.2.5.16 The seepage appeared to be generally in good condition with no noticeable turbidity or signs of pollution. There were also no signs of stress from agricultural activity such as grazing. No NNIPS were observed at the time of walkover.
- 1.2.5.17 At this location the watercourse will be crossed using trenchless techniques and the haul road will require a new temporary crossing to be constructed.

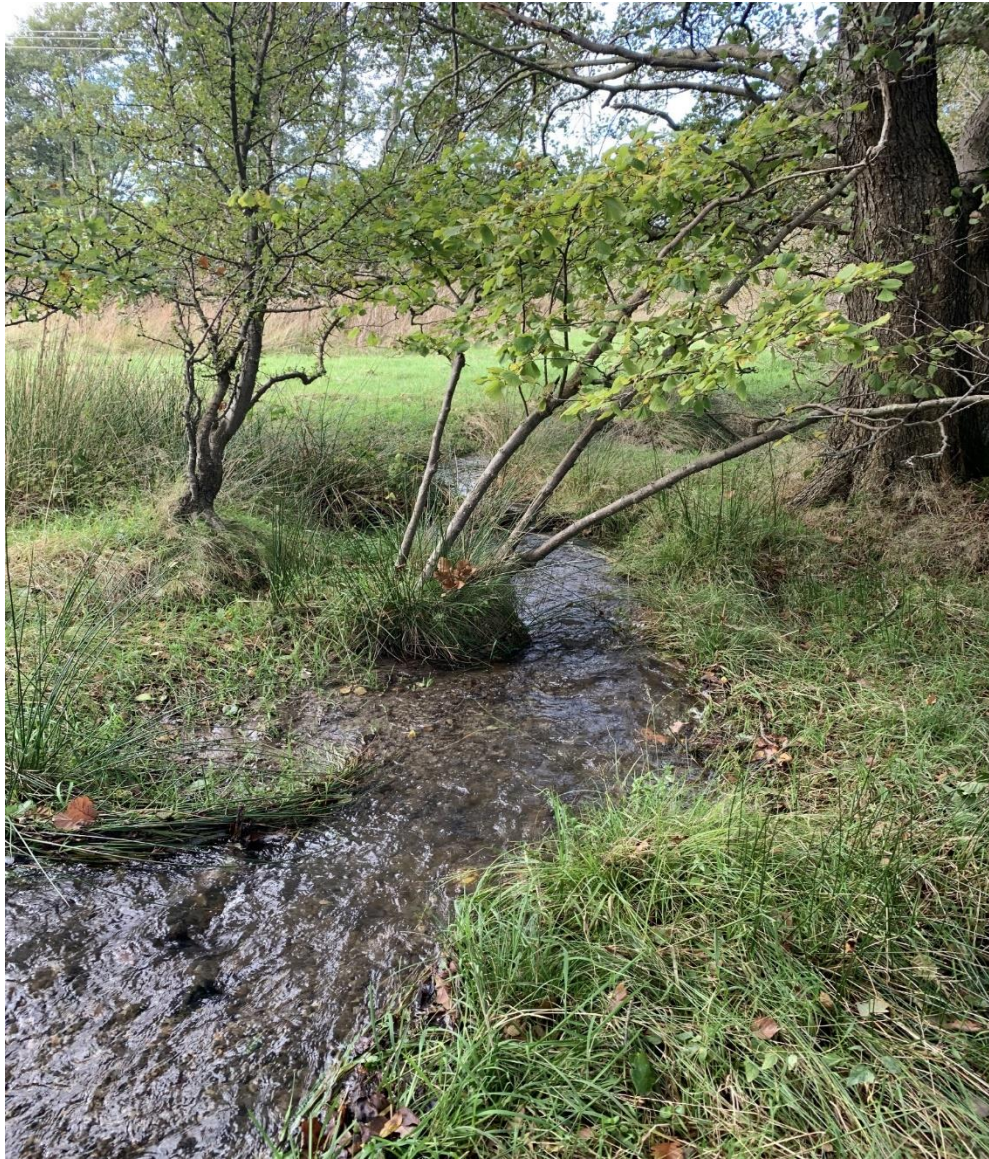
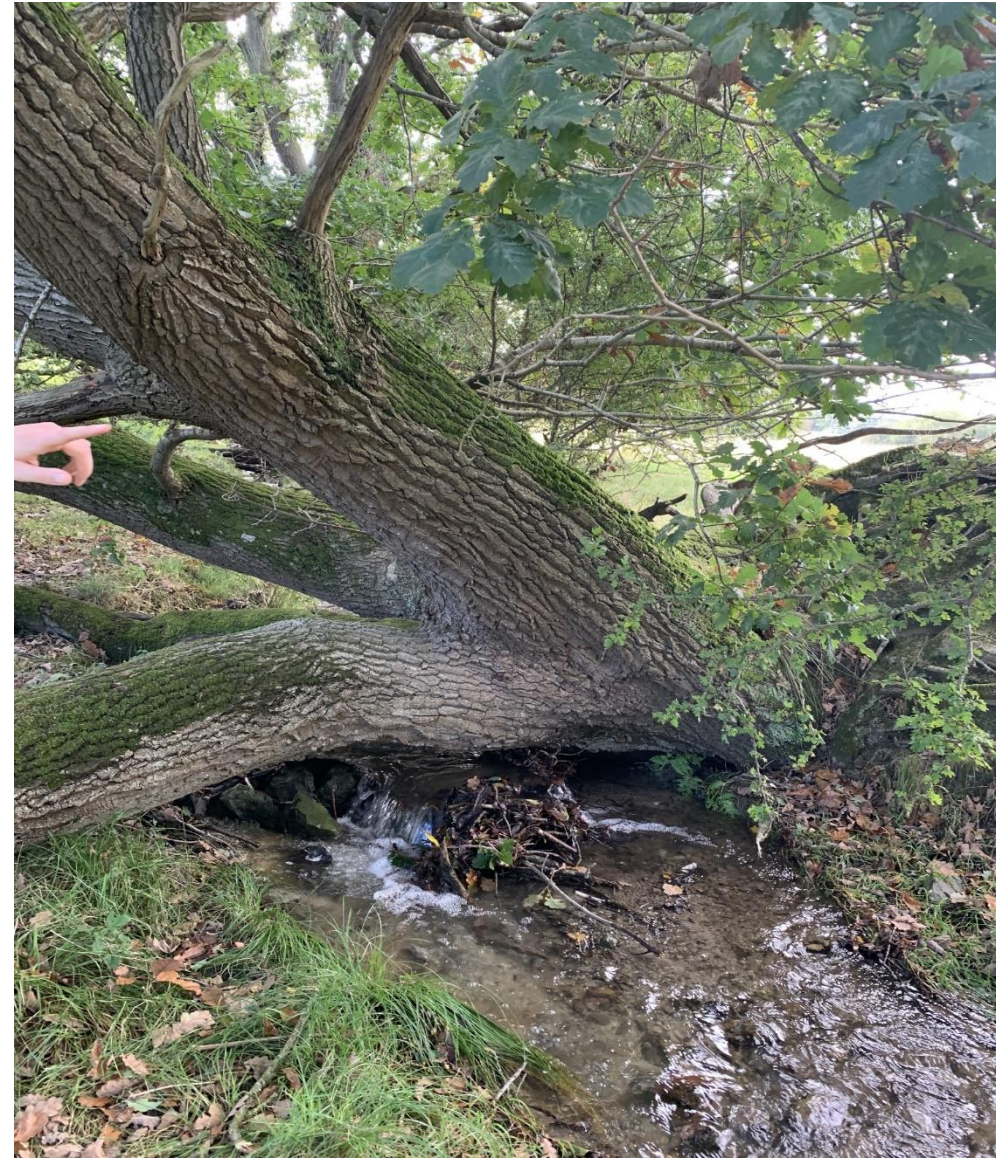
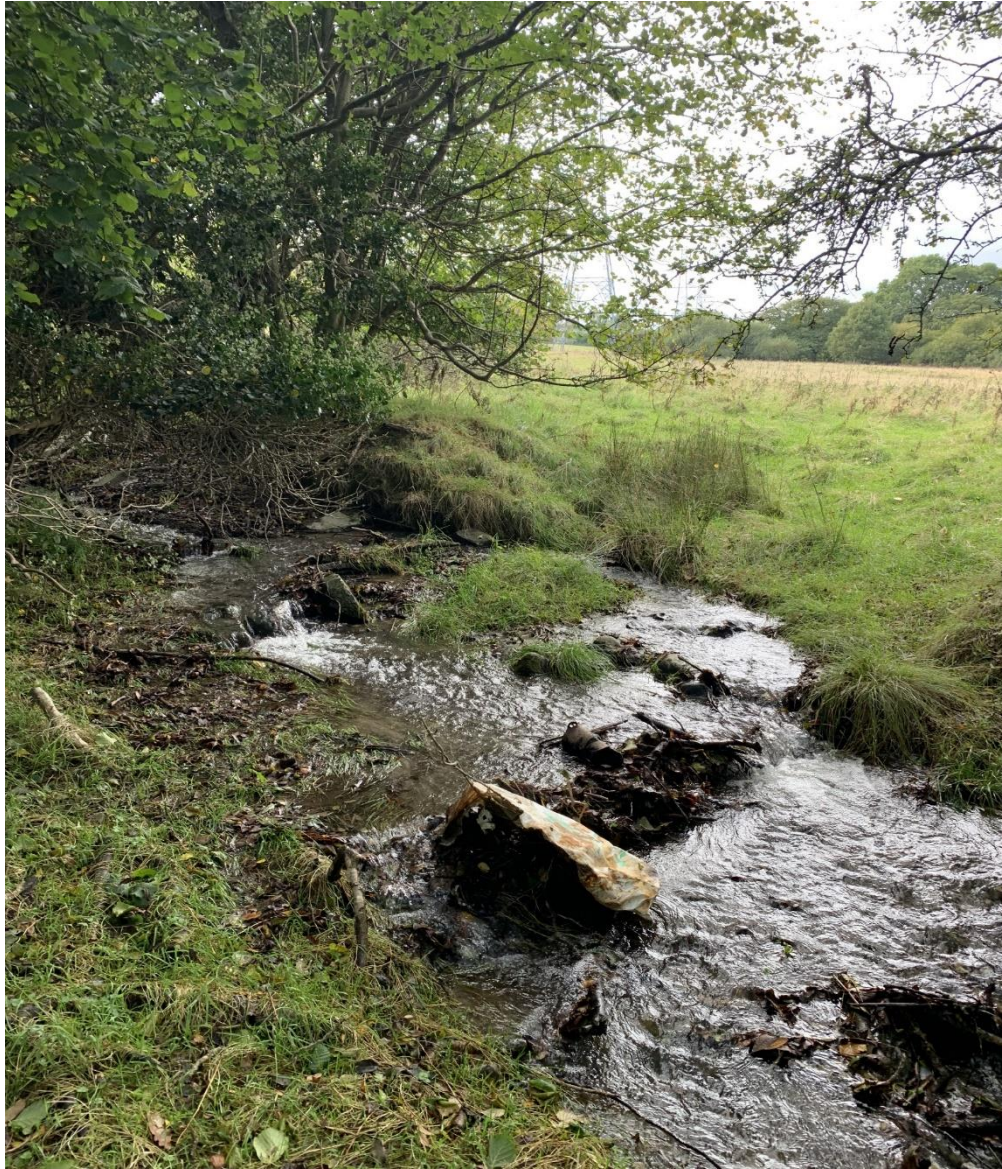
A.4.5 Location E

- 1.2.5.18 The survey at Location E was undertaken from both banks. This stretch of the Afon Gele has a catchment area of 0.4km<sup>2</sup>. The classification of this watercourse is River Type H – straight/sinuuous, coarsest GP, average SA.

- 1.2.5.19 The ground cover on the top of both banks was classified as permanently vegetated agriculture constituting extensive short grasses and tall grasses with minor areas of shrubbery on the right bank. In addition to this, the right bank face had trees that were leaning and J-shaped with some exposed tree roots. At the channel margin, mosses were identified, alongside emergent linear leaved vegetation. While the surrounding land is used for pasture, there was no evidence of poaching and the tree/shrub cover forms a partial riparian buffer.

- 1.2.5.20 The surveyed stretch is in good general condition, with a good richness of channel morphologies, flow types and bed materials. The channel bed included a chute feature, with water moving downstream primarily in unbroken and broken standing waves with areas of ripples and one riffle. The majority of the channel bed was unvegetated, with a vegetated mid channel bar and trace emergent broad leaves, emergent linear leaves and free-floating vegetation present. There was one fallen tree in the channel at time of survey.

- 1.2.5.21 No artificial reinforcements were evident. No NNIPS were observed at the time of the walkover.
- 1.2.5.22 At this location the watercourse will be crossed using trenchless techniques and the haul road will require a new temporary crossing to be constructed.
